NEXTera ENERGY
DUANE ARNOLD

Revision to Relief Request for Alternative to ASME Section XI Requirements to Use Structural Weld Overlay Repairs as an Alternative Repair Technique at the Duane Arnold Energy Center

NextEra Energy Duane Arnold
FOURTH INSPECTION INTERVAL
RELIEF REQUEST NUMBER NDE-R014

Relief Request NDE-R014

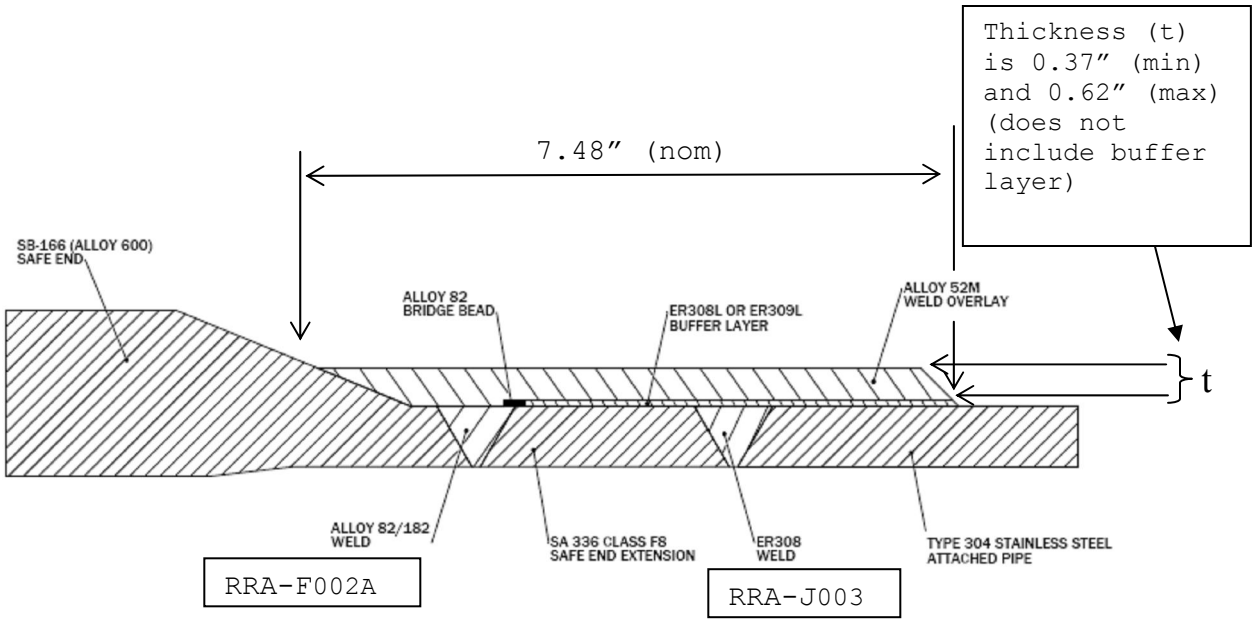
During the current DAEC refueling outage (RFO22), weld inspections were being performed in accordance with the DAEC fourth ten-year interval ISI program. The original scope of examinations included three recirculation riser safe-end-to-safe-end extension welds (RRA-F002A, RRC-F002A, and RRE-F002A). These inspections identified a new indication in the RRA-F002A Recirculation Inlet Safe End to Safe End Extension Weld.

While the determination of the formal root cause is being tracked in the Corrective Action Program (CR00591178), the preliminary assessment is that the indication is due to Stress Corrosion Cracking (SCC). As part of extent of condition, in accordance with BWRVIP-75, three additional recirculation riser safe-end-to-safe-end extension (F002A) welds have been ultrasonically examined (RRF-F002A, RRG-F002A, and RRH-F002A). The assessment of these additional exams is that there are no indications requiring weld overlay repair.

Weld Overlay Repair for Safe End-to-Safe End Extension DMW (RRA-F002A) and Adjacent Stainless Steel Weld (RRA-J003).

A full structural weld overlay repair is proposed for the safe-end-to-safe-end-extension weldment. The safe-end is Alloy 600 SB-166 austenitic nickel base Inconel forging (ASME Section II SB-166). The safe-end-extension is SA-336 Class F8 austenitic stainless steel forging (304 stainless steel). The full structural weld overlay will be extended beyond the safe end extension to stainless steel pipe weld to allow for ultrasonic examination of both of the welds, see Figure 1.

The weld overlay will be designed as one full structural overlay covering both welds, as illustrated in Figure 1. Postulated 100% through-wall flaws shall be assumed as specified in 2(b)(4) and (5), Attachment 1, for overlay length and thickness sizing per 2(b)(6) Attachment 1. Planar flaws detected during the acceptance examination will be characterized and flaw growth calculations performed using the flaw(s) detected plus the postulated 100% through-wall flaws.

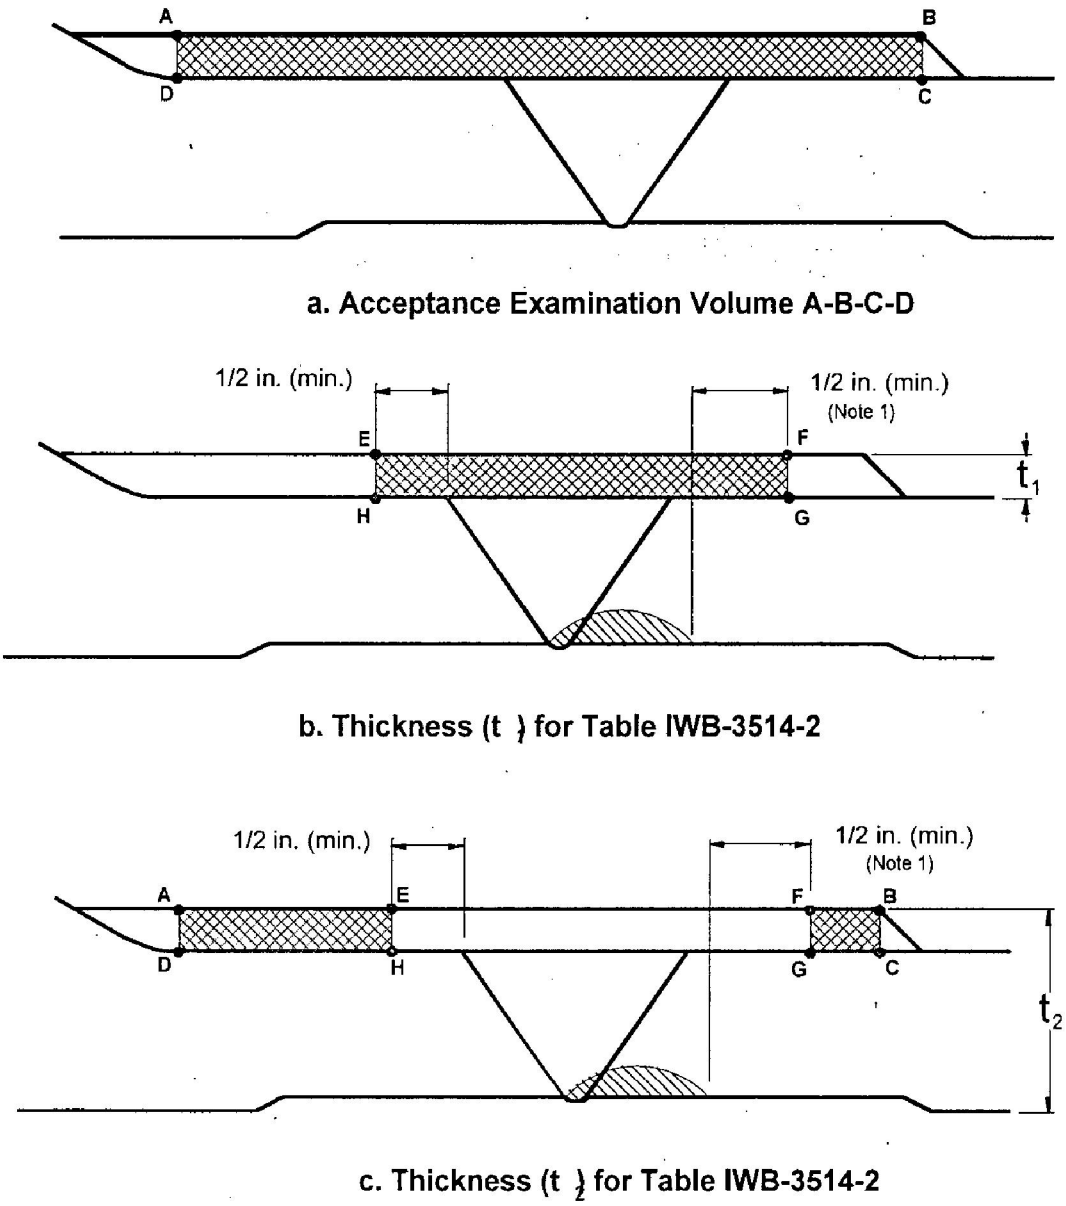
Fig. 1 Acceptance Examination Volume and Thickness Definitions

(3) The acceptance examination volume A-B-C-D in Fig. 1(a) plus the heat-affected zone beneath the fusion zone C-D shall be ultrasonically examined to assure adequate fusion (i.e., adequate bond) with the base metal and to detect welding flaws, such as interbead lack of fusion, inclusions, or cracks.

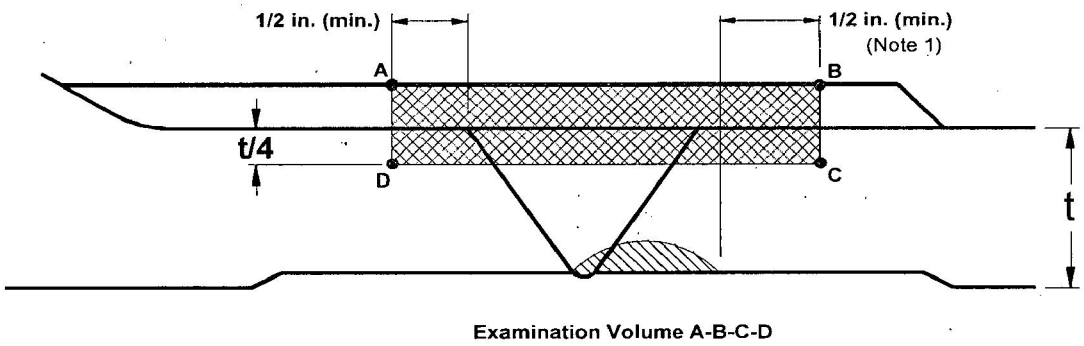
Fig. 2

Preservice and Inservice Examination Volume

(1) For axial or circumferential flaws, the axial extent of the examination volume shall extend at least ½ in. (13 mm) beyond the as-found flaw and at least ½ in. (13 mm) beyond the toes of the original weld.
