Nuclear Reactor Program

Re: Reportable Event 46484; Radiography Incident
License No. R-120
Docket No. 50-297

Neutron Imaging Facility Personnel Exposure Incident Report

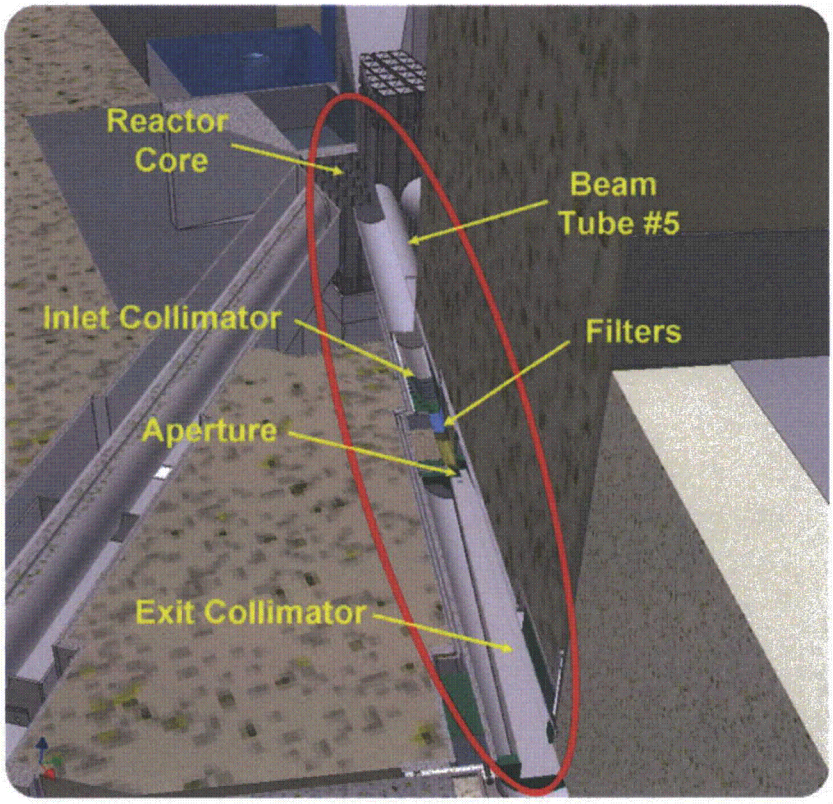
Beam tube #5 – cutaway view of NIF collimator assembly

The Neutron Imaging Facility is installed at beamport #5 of the PULSTAR reactor. The beam is collimated and filtered.

Fluence rate at the imaging plane in its current configuration is reported to be 1.8 E6 n/cm^2/sec.

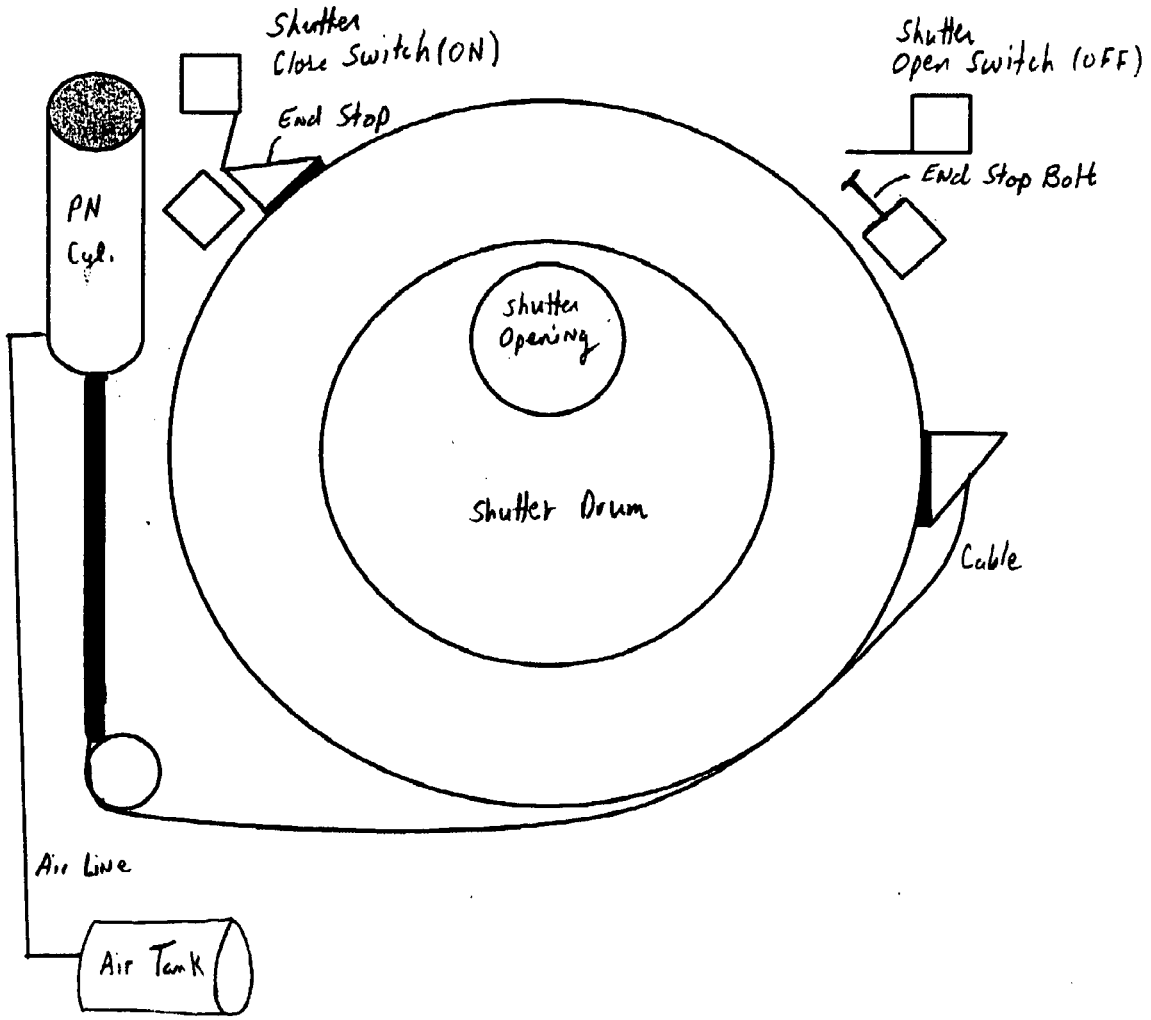
ATTACHMENT 2 **NIF SHUTTER in CLOSED POSITION**

In this incident when the timer reached zero minutes, the 24 volt circuit de-energized and air was vented from the pneumatic cylinder. Normally this would cause the shutter to close by gravity. In this incident the shutter failed to close because it hung-up on the end-stop bolt. [Refer to Attachment 2]

Due to a design flaw, the shutter got hung-up because the shutter drum had moved outward in the axial direction by approximately 0.5 inches over time from repeated opening and closing. This altered where the shutter end-stop was making contact with the end-stop bolt, and the end-stop became jammed on the end-stop bolt.

2. The end stop bolt that prevented the NIF shutter from closing has been replaced with a cylindrical block that is unlikely to get caught on the shutter end stop.

3. A retaining bar has been installed at the base of the shutter to prevent the shutter rotating drum from moving outward.
4. The shutter closed position switch AND a radiation monitor have been connected to the NIF door interlock. The shutter must now be fully closed AND the radiation monitor reading must be below a radiation set point for the NIF door to open from the outside. For egress reasons, the Exit Permit Pushbutton on the inside of the NIF remains as designed causing the shutter to close and the NIF door to open. Similar arrangements with a radiation monitor interlock are being planned for installation at the Primary Piping Vault door and Positron Facility door.

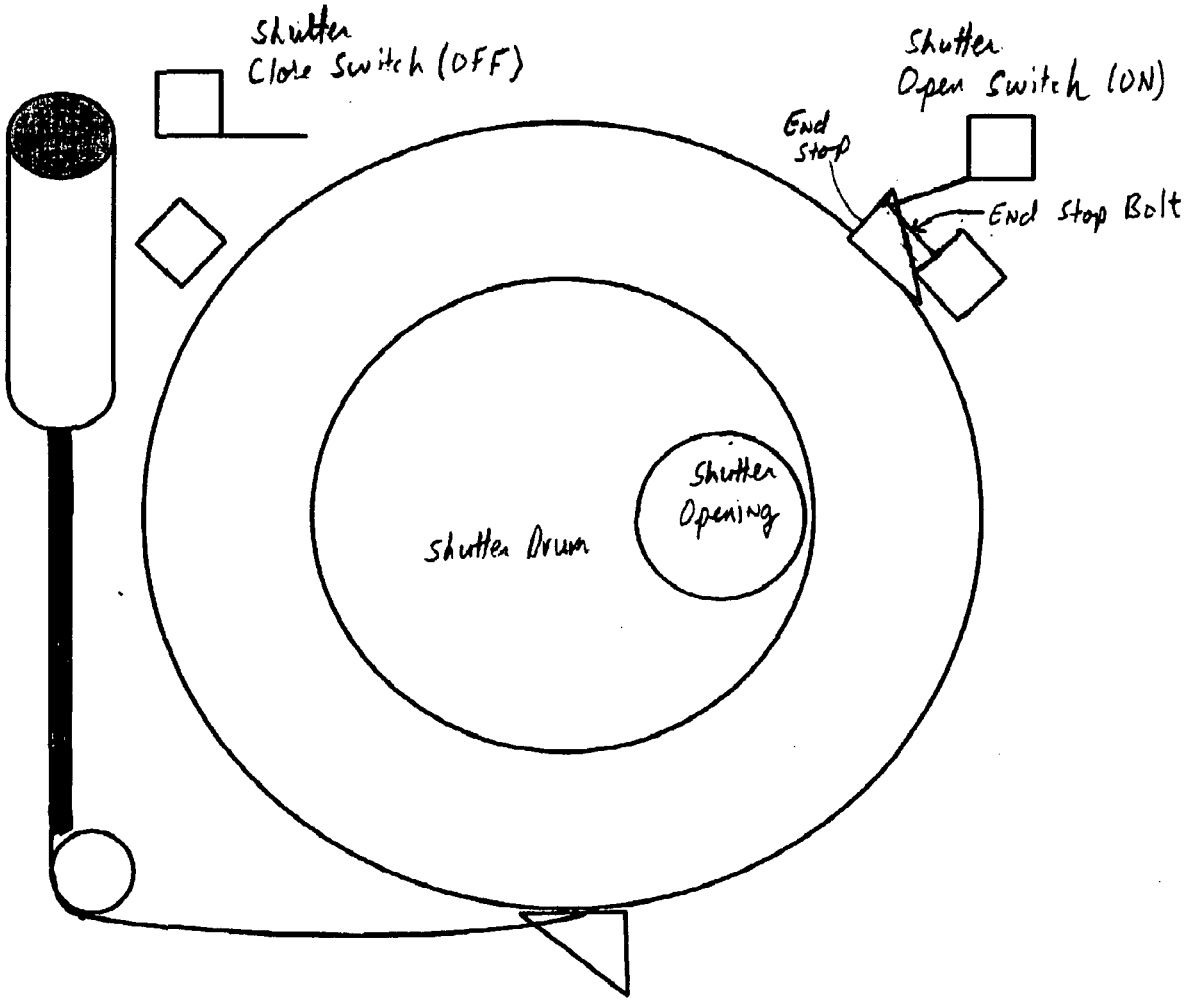
<u>ATTACHMENT 2</u> **NIF SHUTTER in OPEN POSITION**

2:55 PM	The shutter was opened to start a 7 minute radiography exposure
2:57 PM	The radiographer left the reactor room
3:02 PM	The time for the radiograph expired on the Shutter Control Computer and air was vented from the pneumatic cylinder. The shutter failed to close due the shutter end stop being hung up on the end-stop bolt.

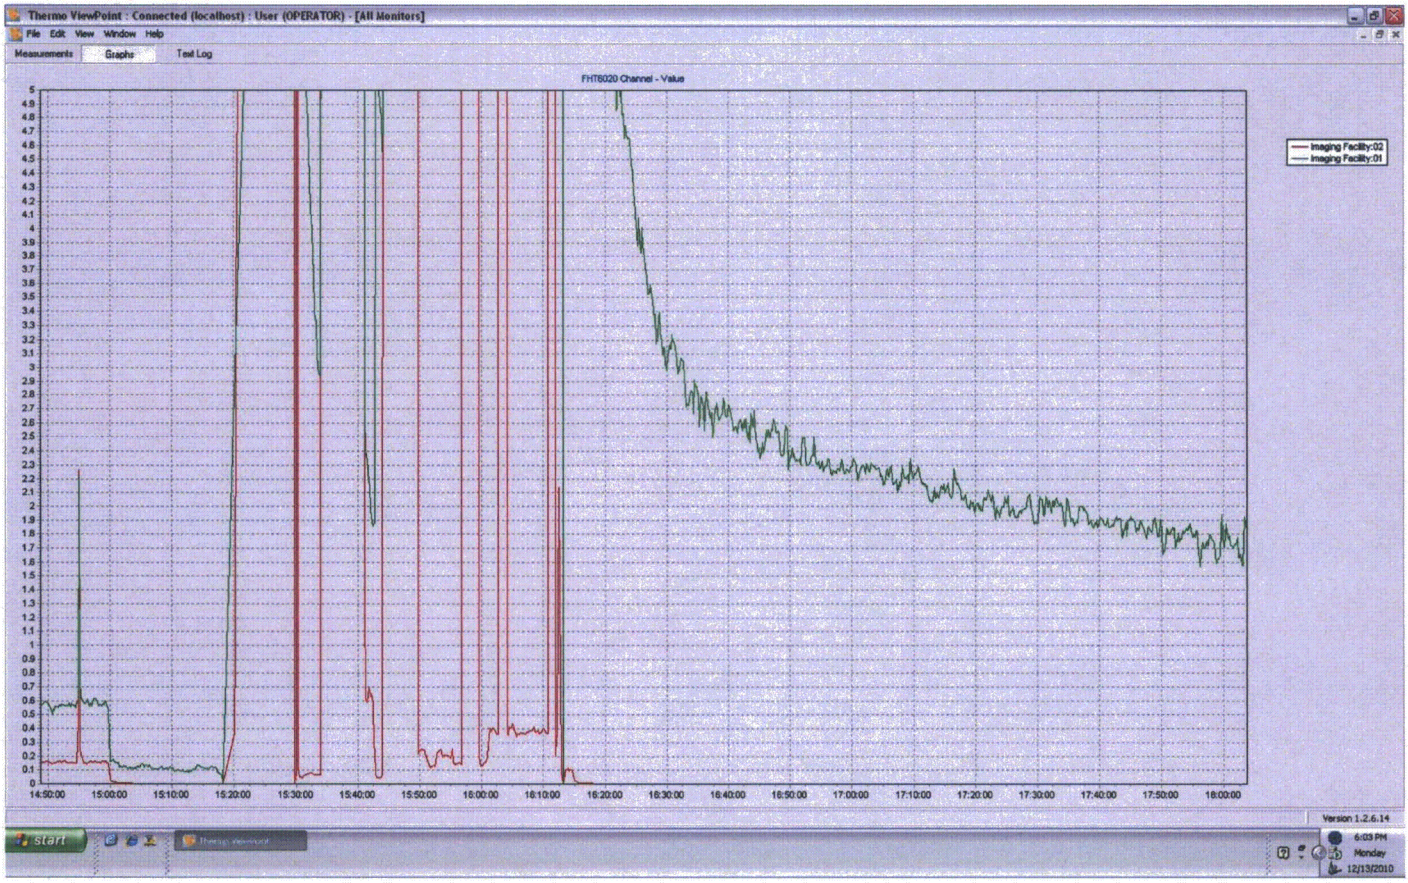
ATTACHMENT 3 NIF Radiation Monitor Display (screenshot) for 13 Dec 2010

The incident alarms (spikes) are shown on the left side of the display. The remaining display is from the dose evaluation with the radiation detectors located inside the NIF.

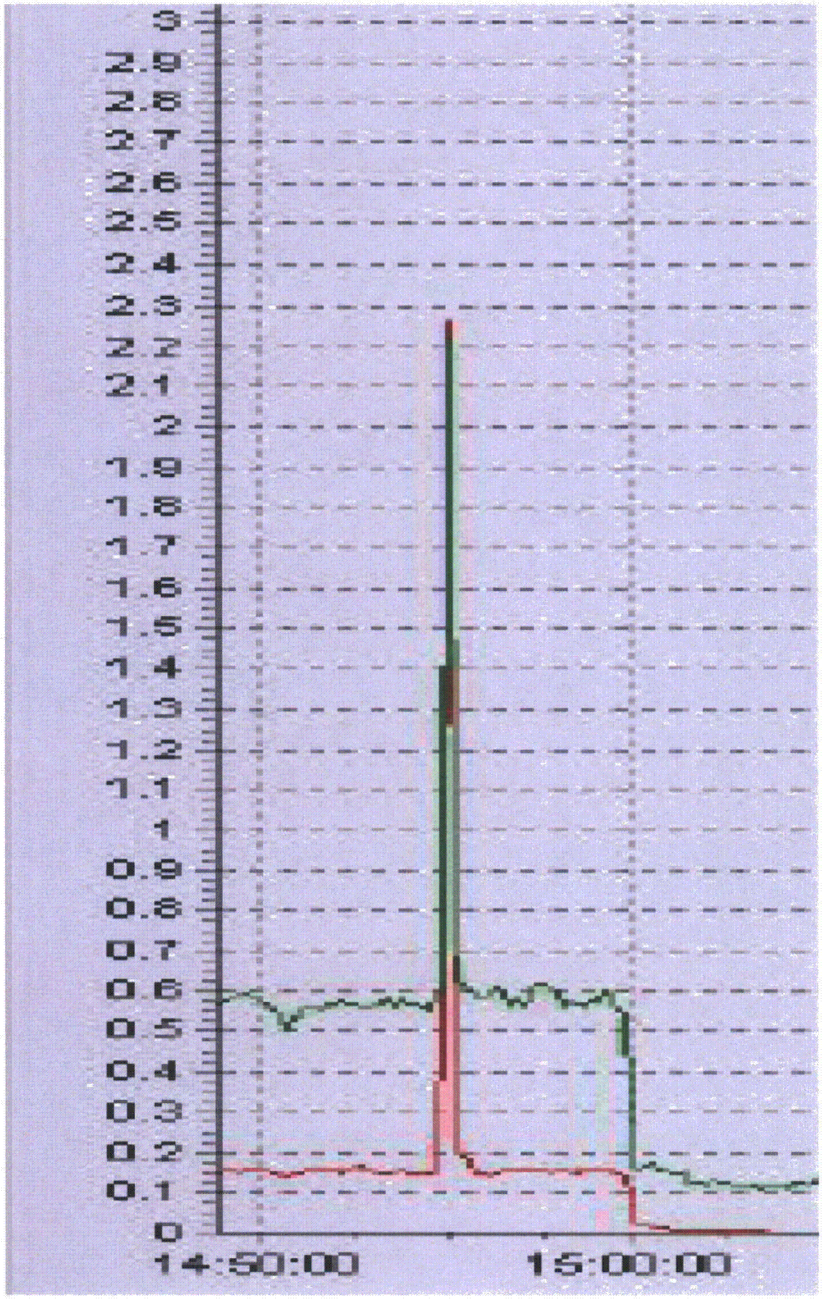
ATTACHMENT 3 **NIF Radiation Monitor Display (expanded screenshot)**

Alarm setpoints are 2 mrem/h for the gamma (green line) and neutron (red line) detectors. Both detectors went into alarm. The time stamp on the radiation monitor computer is 10 minutes slower than the security video computer. Therefore, the alarm (spike) occurred at approximately 3:05 pm, which matches the NIF entry time by the radiographer.

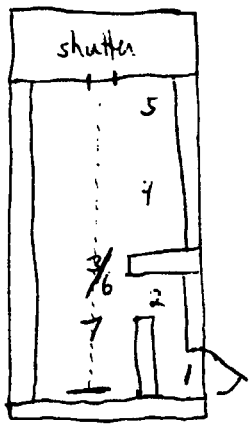
ATTACHMENT 4 **Radiation Survey**

Location	mR/h (γ)	Neutron mrem/h	Reactor Power (KW)
1	1 (a)	N/A	shut down
2	3	↓	↓
3	70	↓	↓
4	10	↓	↓
5	10 ↓	↓	↓
6	2200 (c)	2750 (c)	100
6	5200 (c)	off scale (c)	1000
7	750 (c)	2000 (b)	100
7	4250 (c)	8000 (b)	400
7	6200 (c)	offscale	1000 – cassette removed
cassette + parts	5 @ 1'	–

COMMENTS: Locations 1-5 were made by entering the NIF
Locations 6+7 were made remotely and by use of cameras
