From: Ottenberg, Geoffrey - R2
Sent: Friday, August 21, 2009 8:43 AM
To: Michel, Eric
Subject: FW: Scanned Document
Attachments: Document.pdf

In case you didn't see these- it may give some perspective to what they are planning. They are construction photos of the SSF, so you can see the piping before it was covered with soil. The first picture shows the discharge lines from the outside of the SSF (the now buried portion). The licensee believes the flaw is somewhere near the 90deg elbow (~ 23 ft below grade).

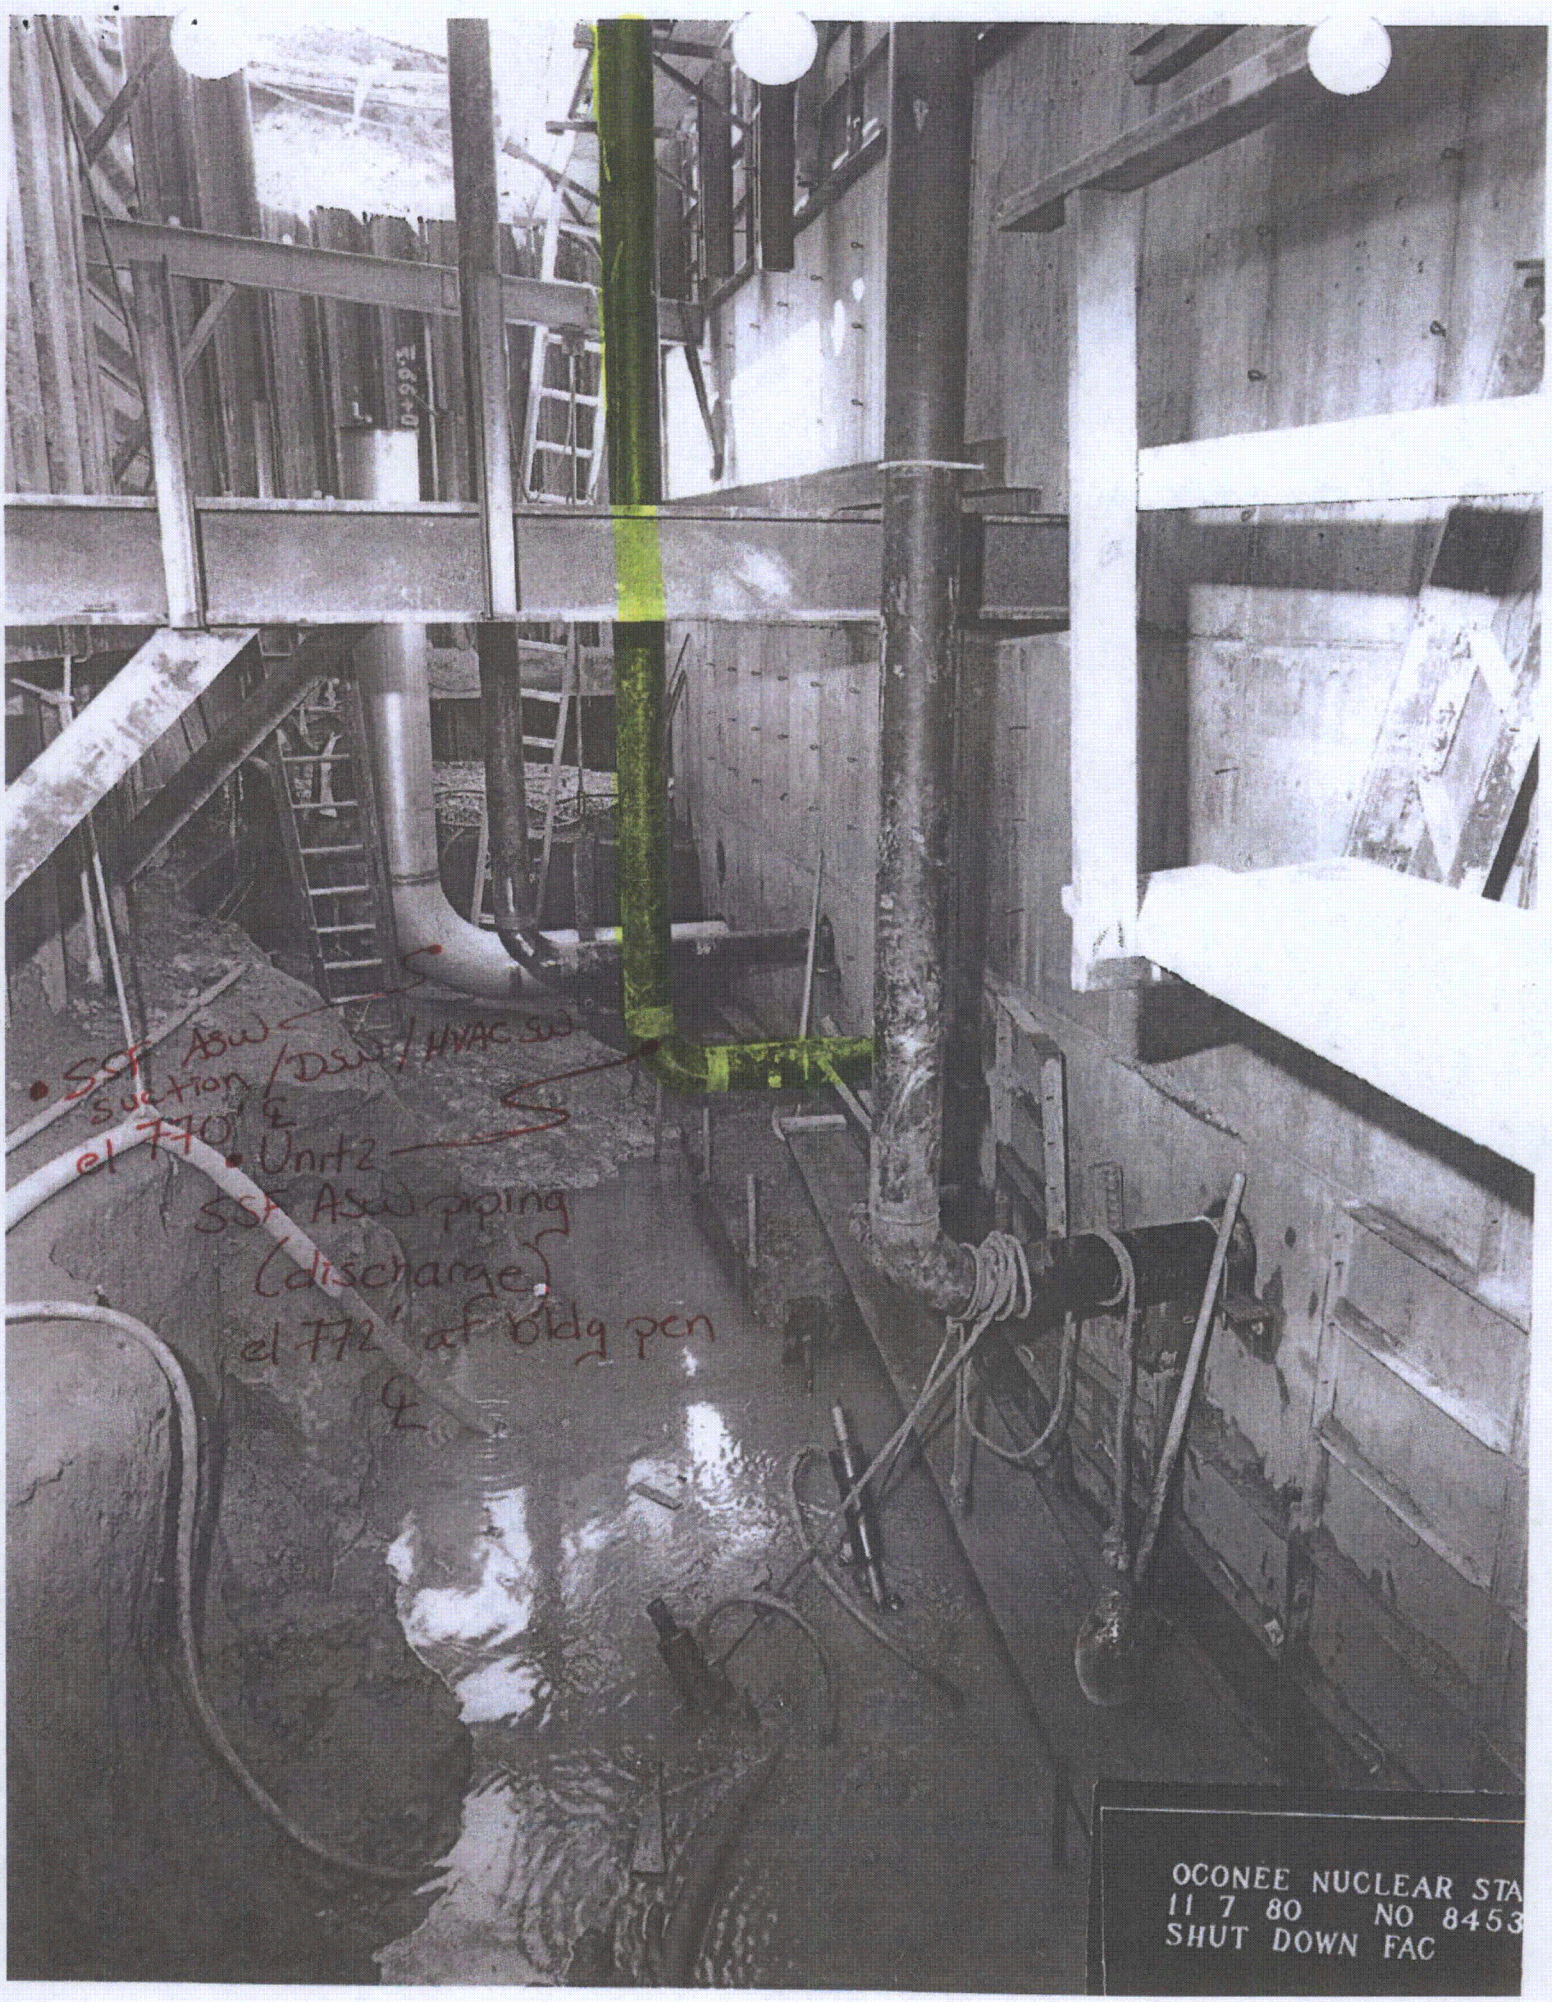
SSF ASW suction / DSW / HVAC SW
el 770' ℄
Unit 2
SSF ASW piping (discharge)
el 772' at bldg pen ℄
OCONEE NUCLEAR STA
11 7 80 NO 8453
SHUT DOWN FAC

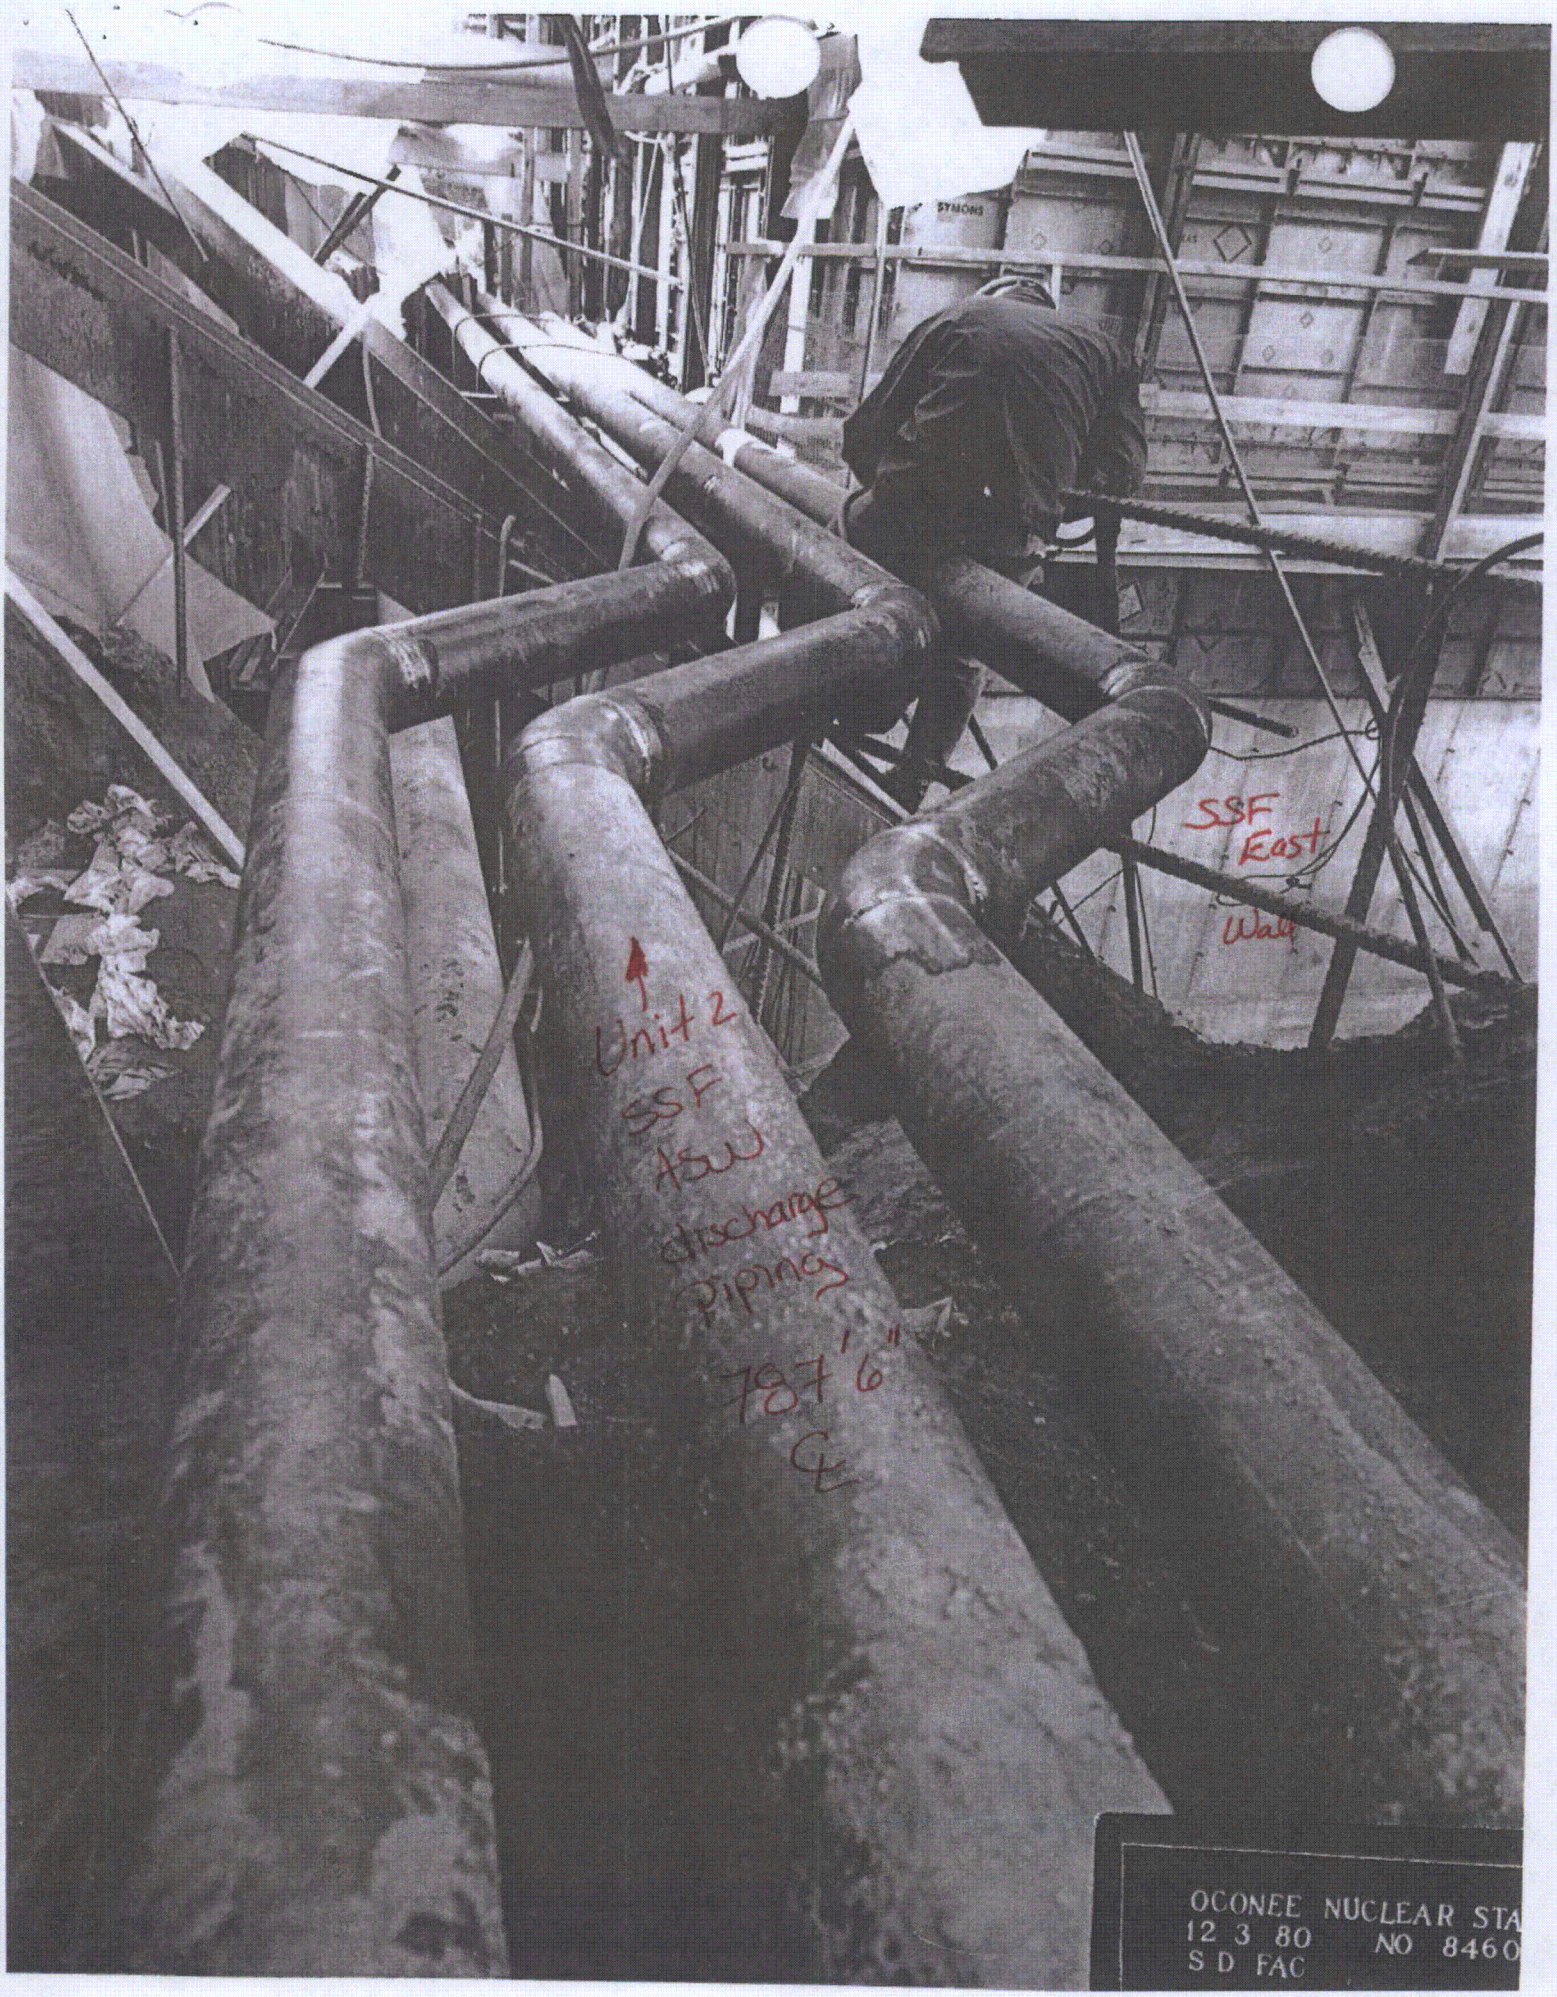
SYMONS
SSF
East
Wall
Unit 2
SSF
ASW
discharge
piping
787'6"
℄
OCONEE NUCLEAR STA
12 3 80 NO 8460
S D FAC

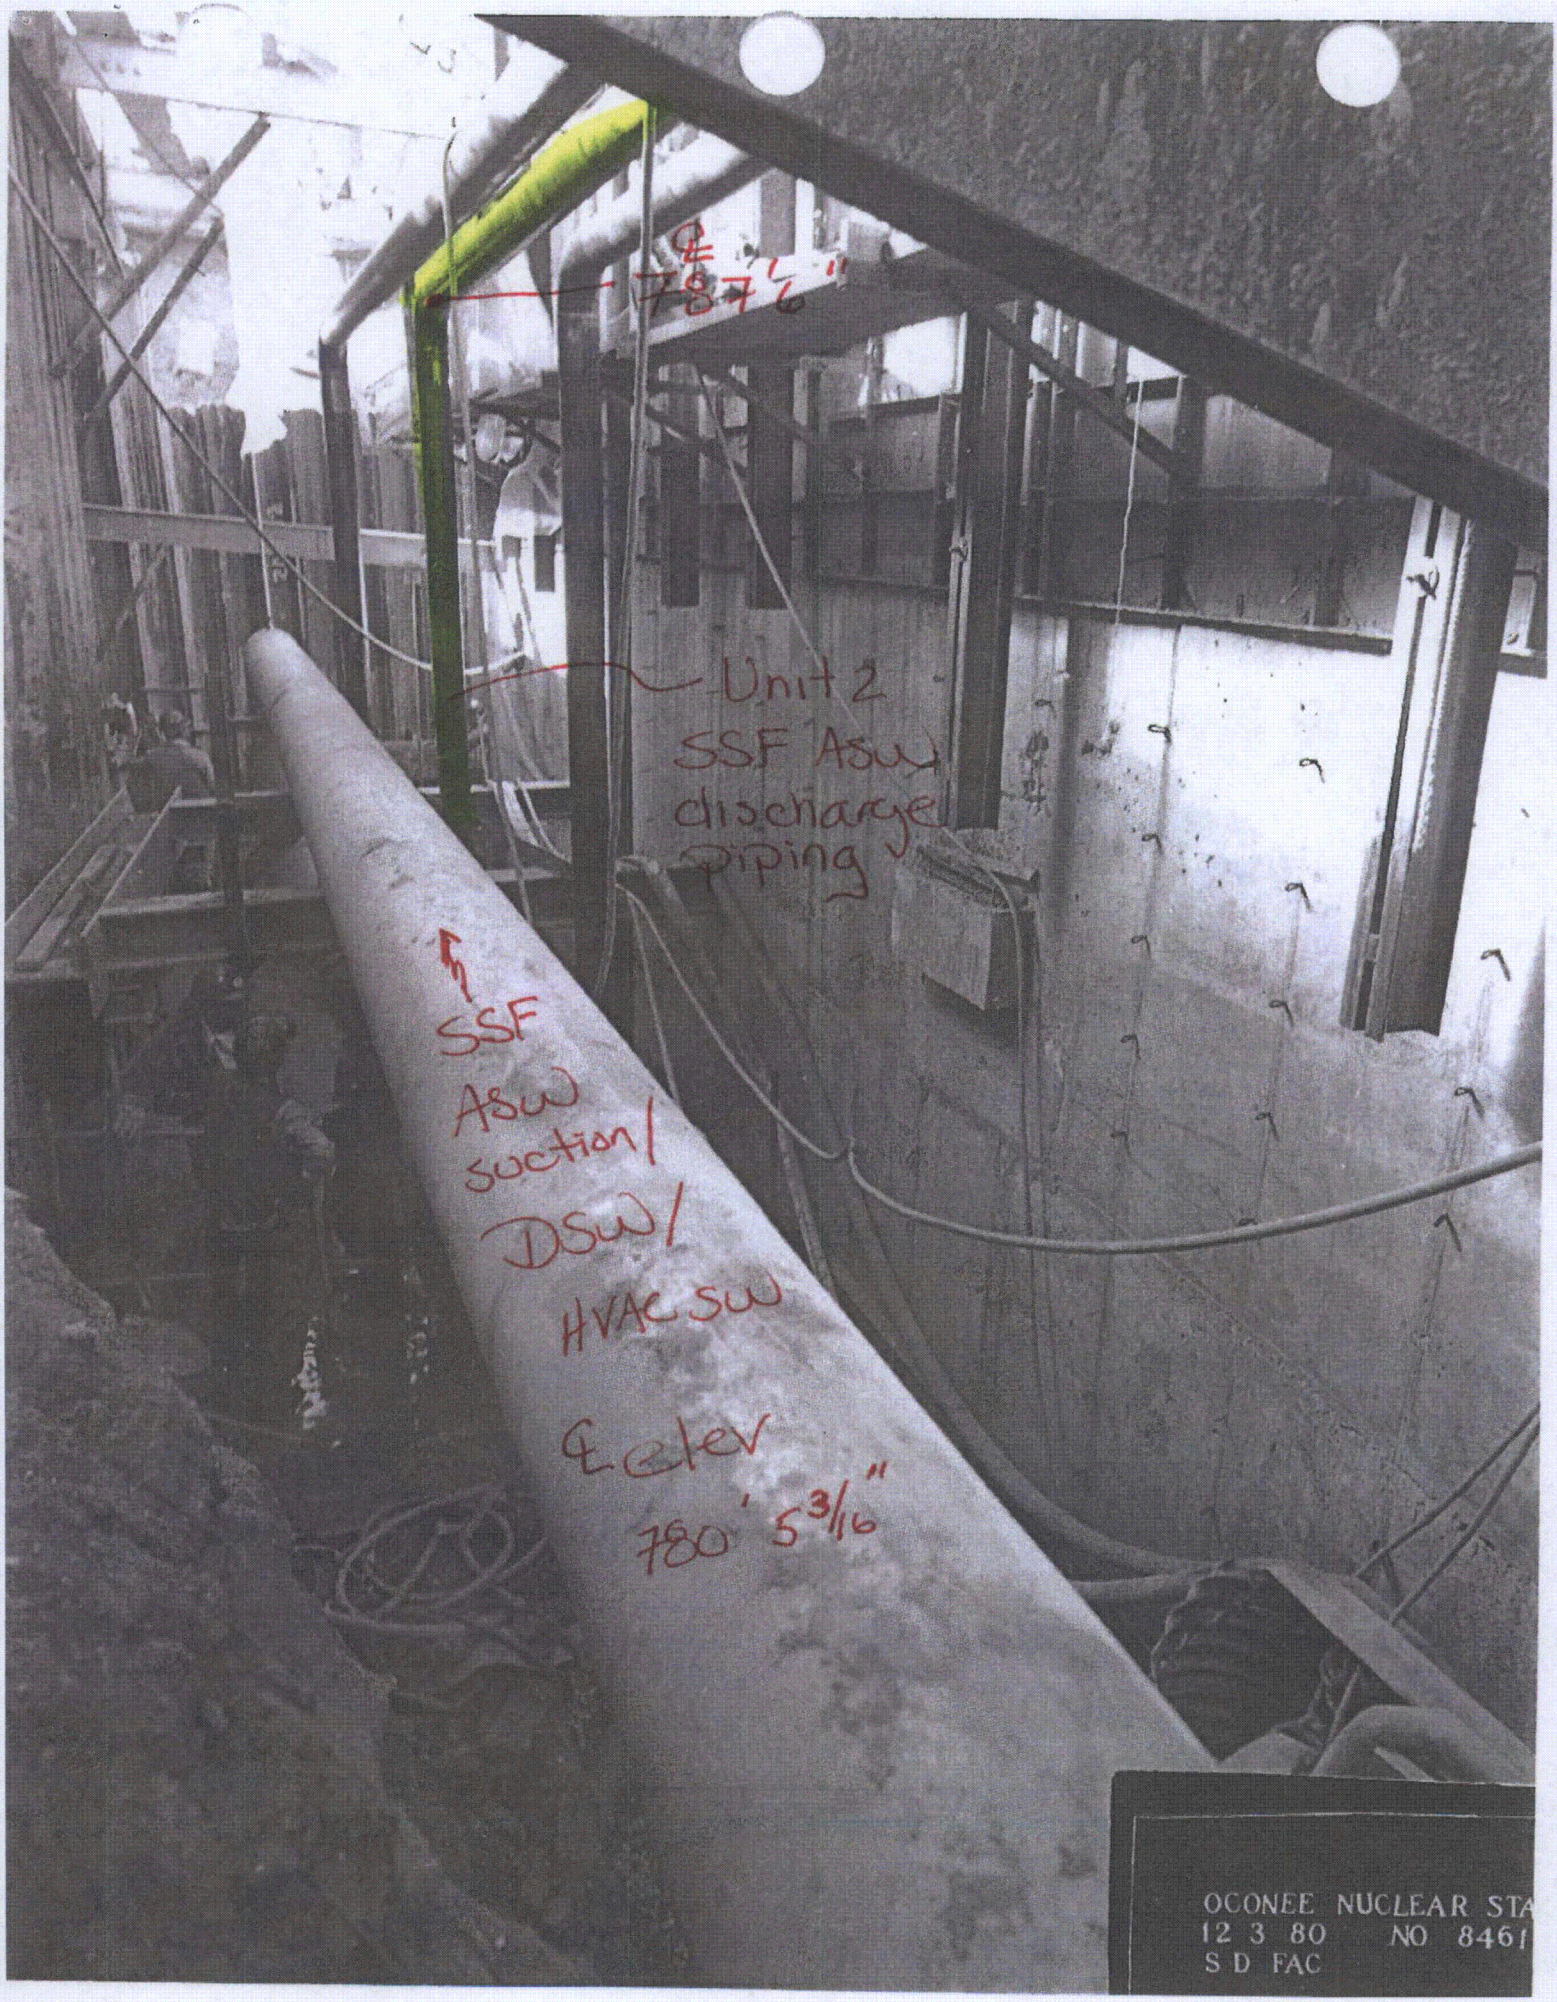
℄ 787'6"
Unit 2
SSF ASW
discharge
piping
SSF
ASW
suction/
DSW/
HVAC SW
℄ elev
780' 5 3/16"
OCONEE NUCLEAR STA
12 3 80 NO 8461
S D FAC

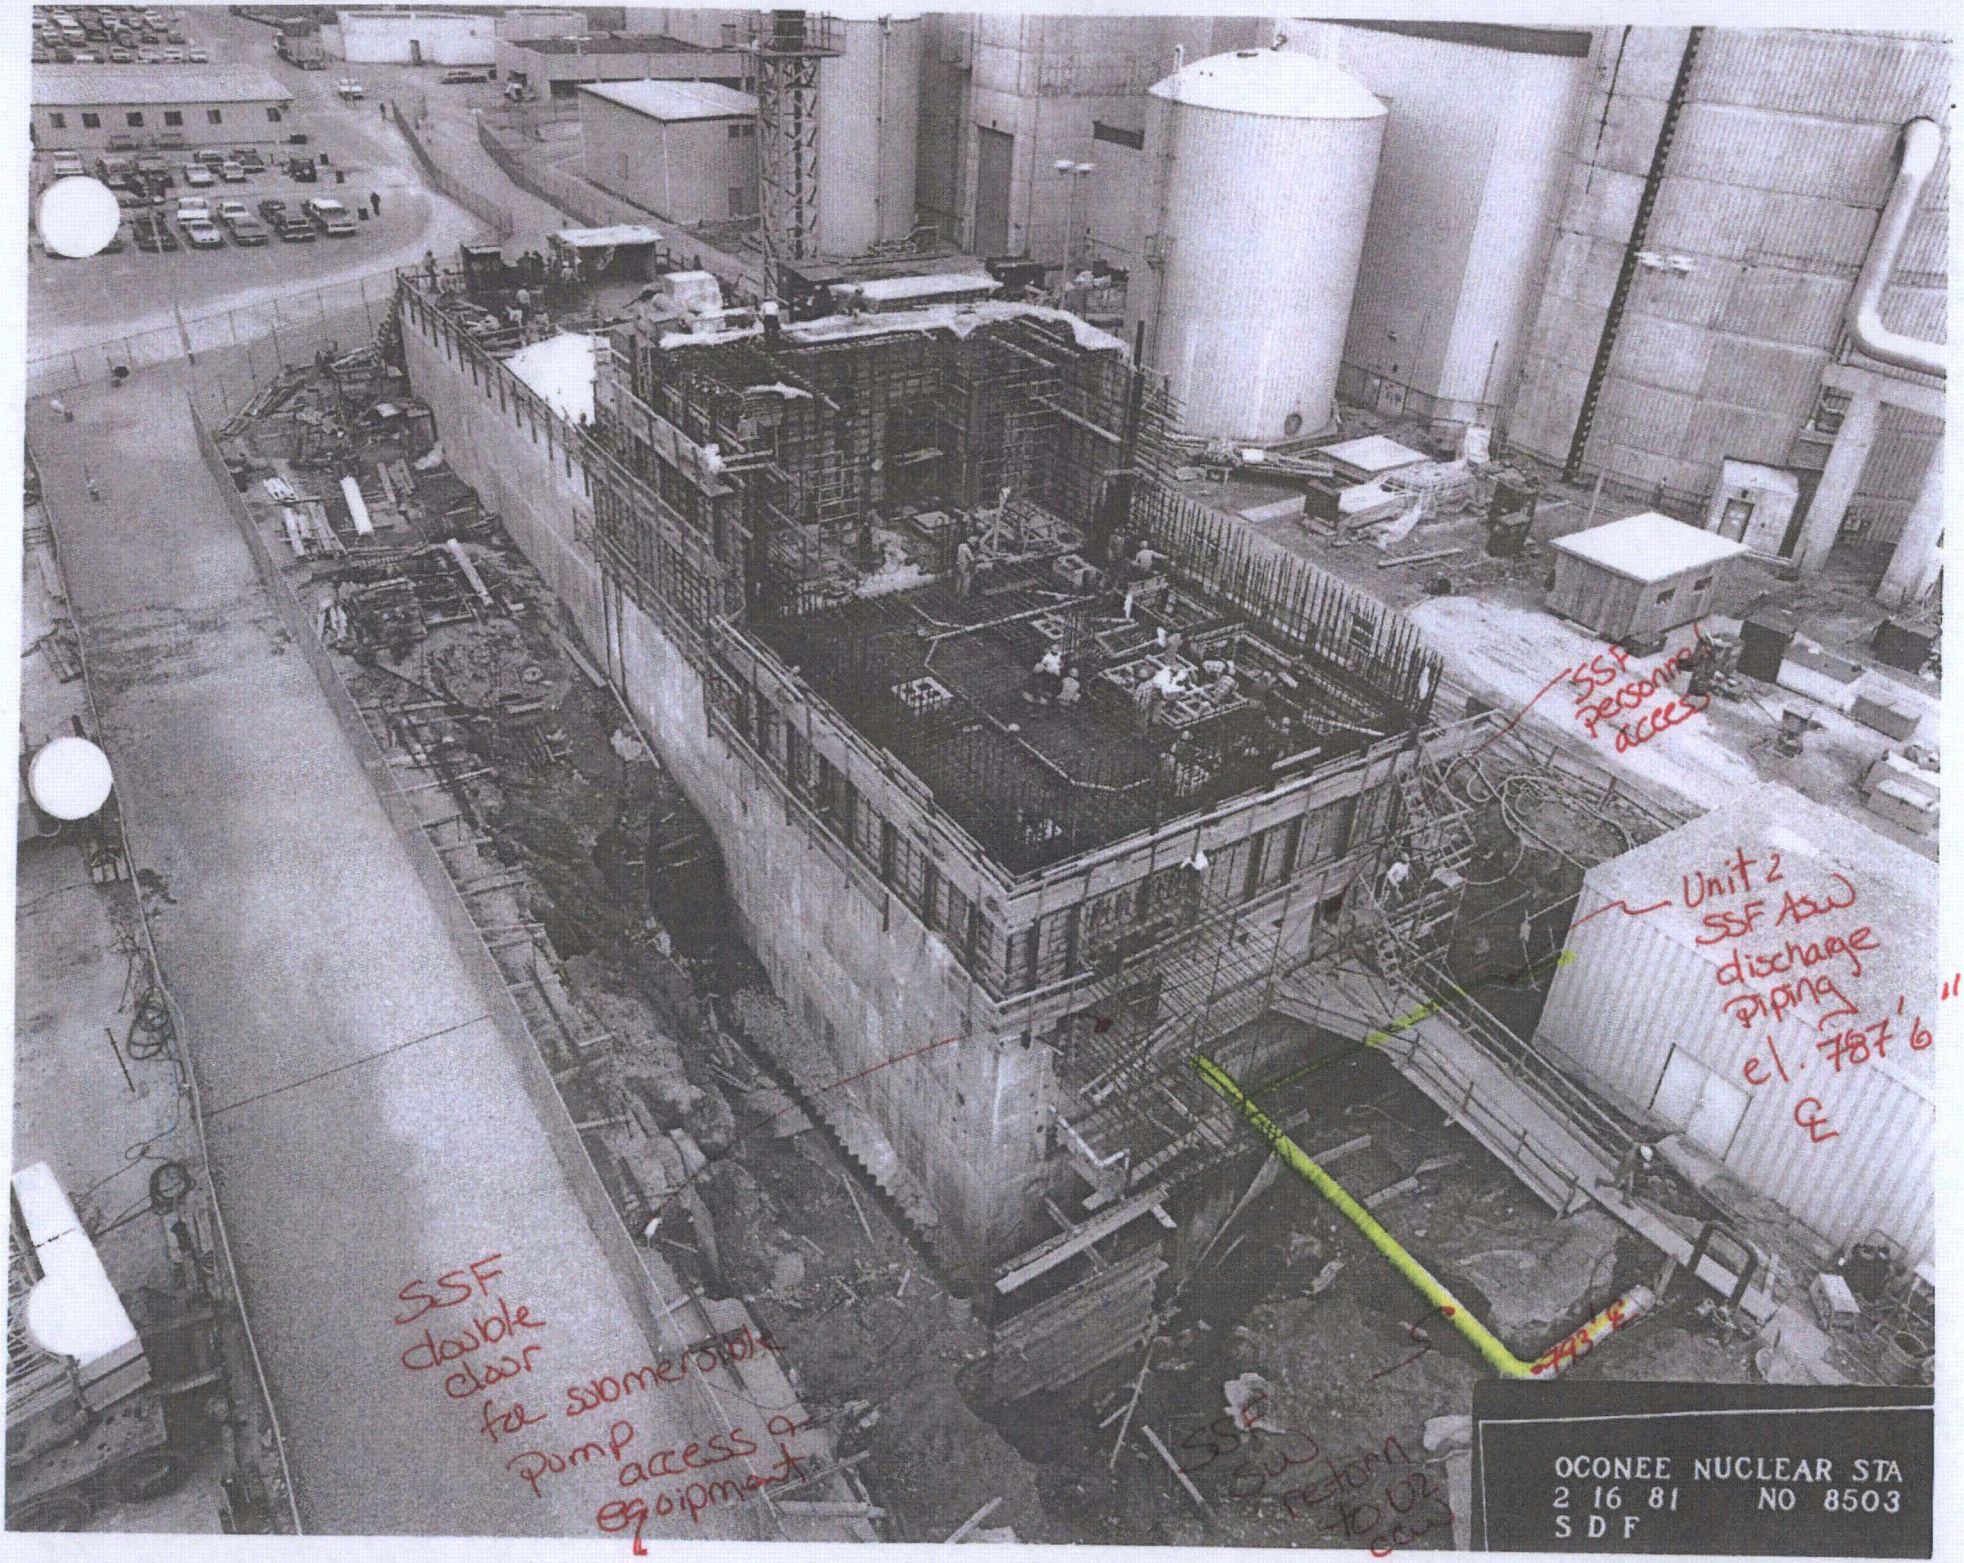
SSF personnel access
Unit 2 SSF ASW discharge piping el. 787'6" ℄
SSF double door for submersible pump access & equipment
SSF SW return to U2 SW
OCONEE NUCLEAR STA
2 16 81 NO 8503
S D F
