Homestake Mining Company
Grants Project
Large Tailings Facility
Radon Barrier Repair Project

COMPLETION REPORT

14 December 2010

Homestake Mining Company Grants Project
Radon Barrier Repairs Project
Completion Report

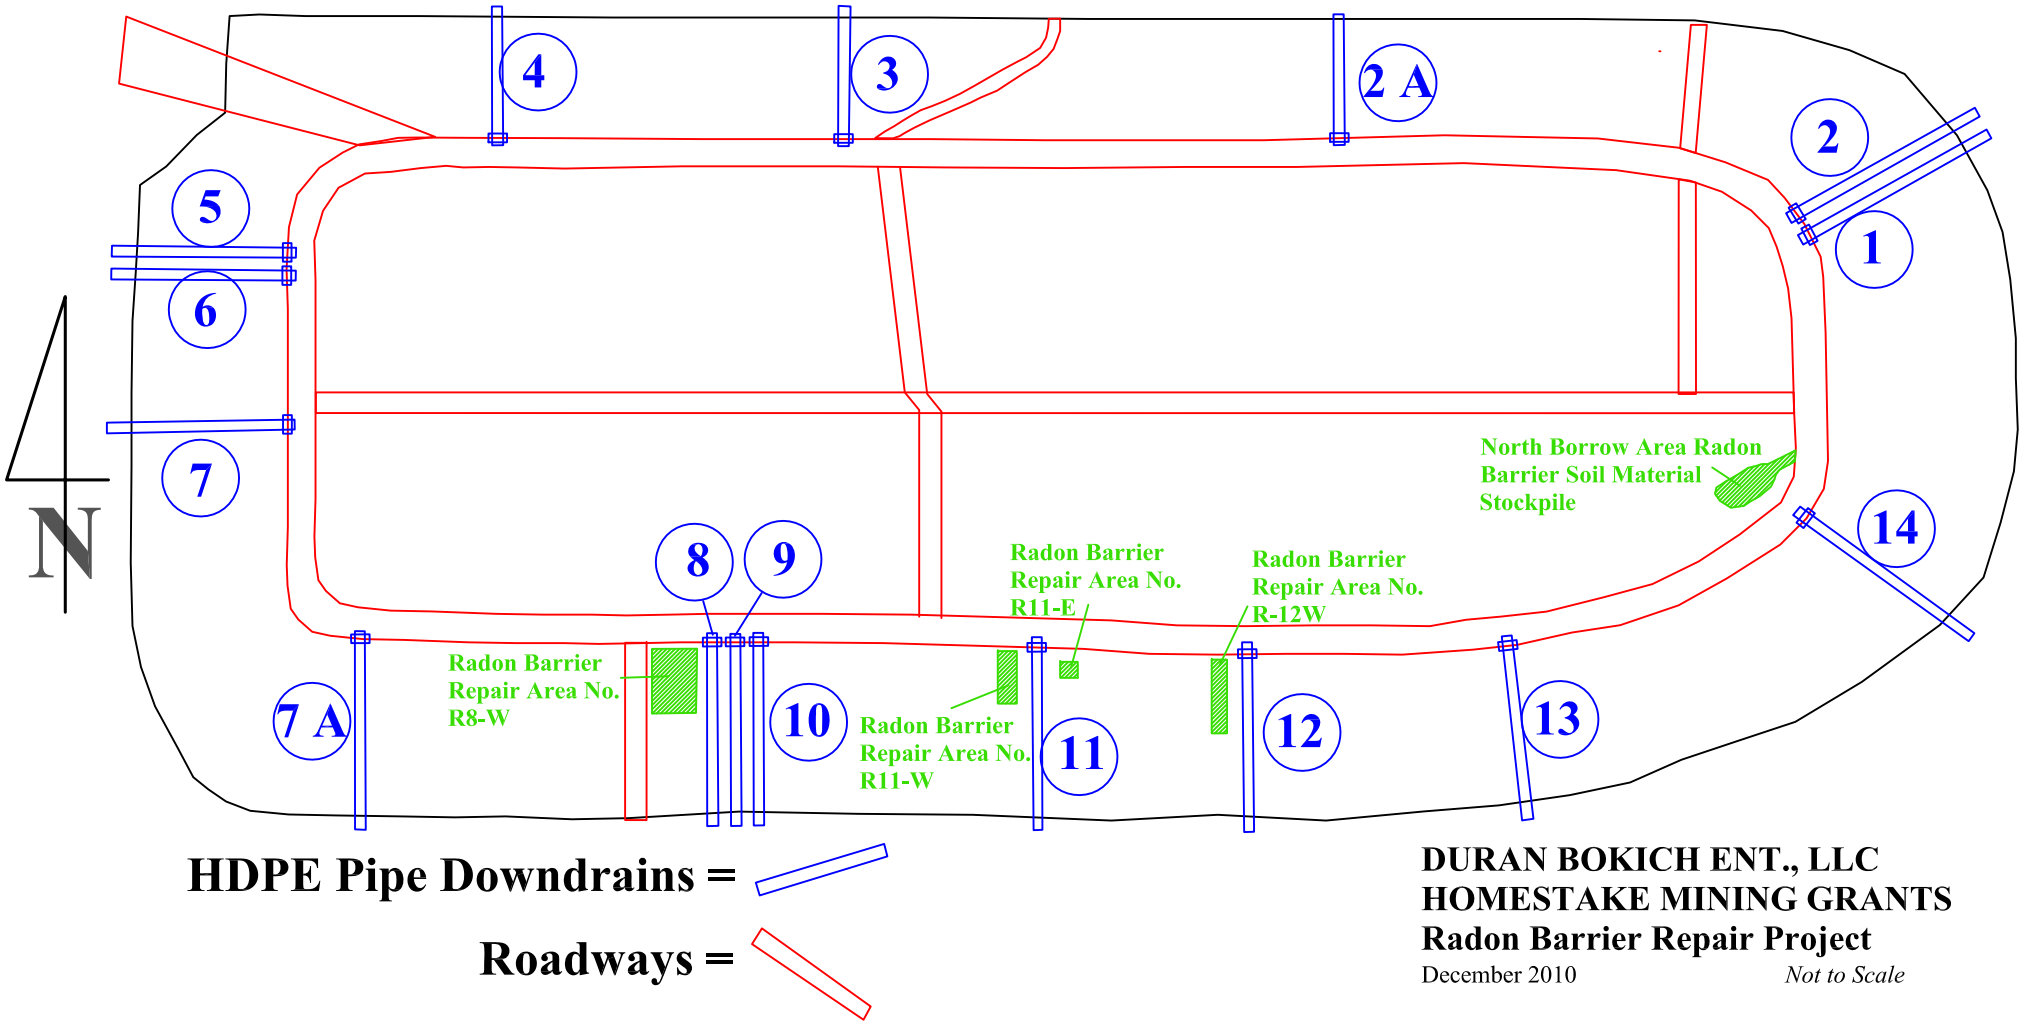
Figure 1. Radon Barrier Repair Area Locations

The locations of the repair areas are shown on Figure 1, a schematic of the Large Tailings Facility, and are referenced by their relative location to newly established Stormwater Downdrains.

1) Repair Area No. R8-W was the largest area of repair at 32 feet wide and 170 feet long, and nearly four (4) feet deep at the deepest point of repair. The general locations of the Radon Barrier Repair Areas is shown on Figure 1, a schematic of the Large Tailing Pile showing roadways, down drain locations and radon barrier repair area locations.
2) Repair Area No. R11-W is located about 35 feet West of Drain No. 11, and was about 22 feet wide by 160 long in size and also three (3) feet deep at the lowest point of repair.

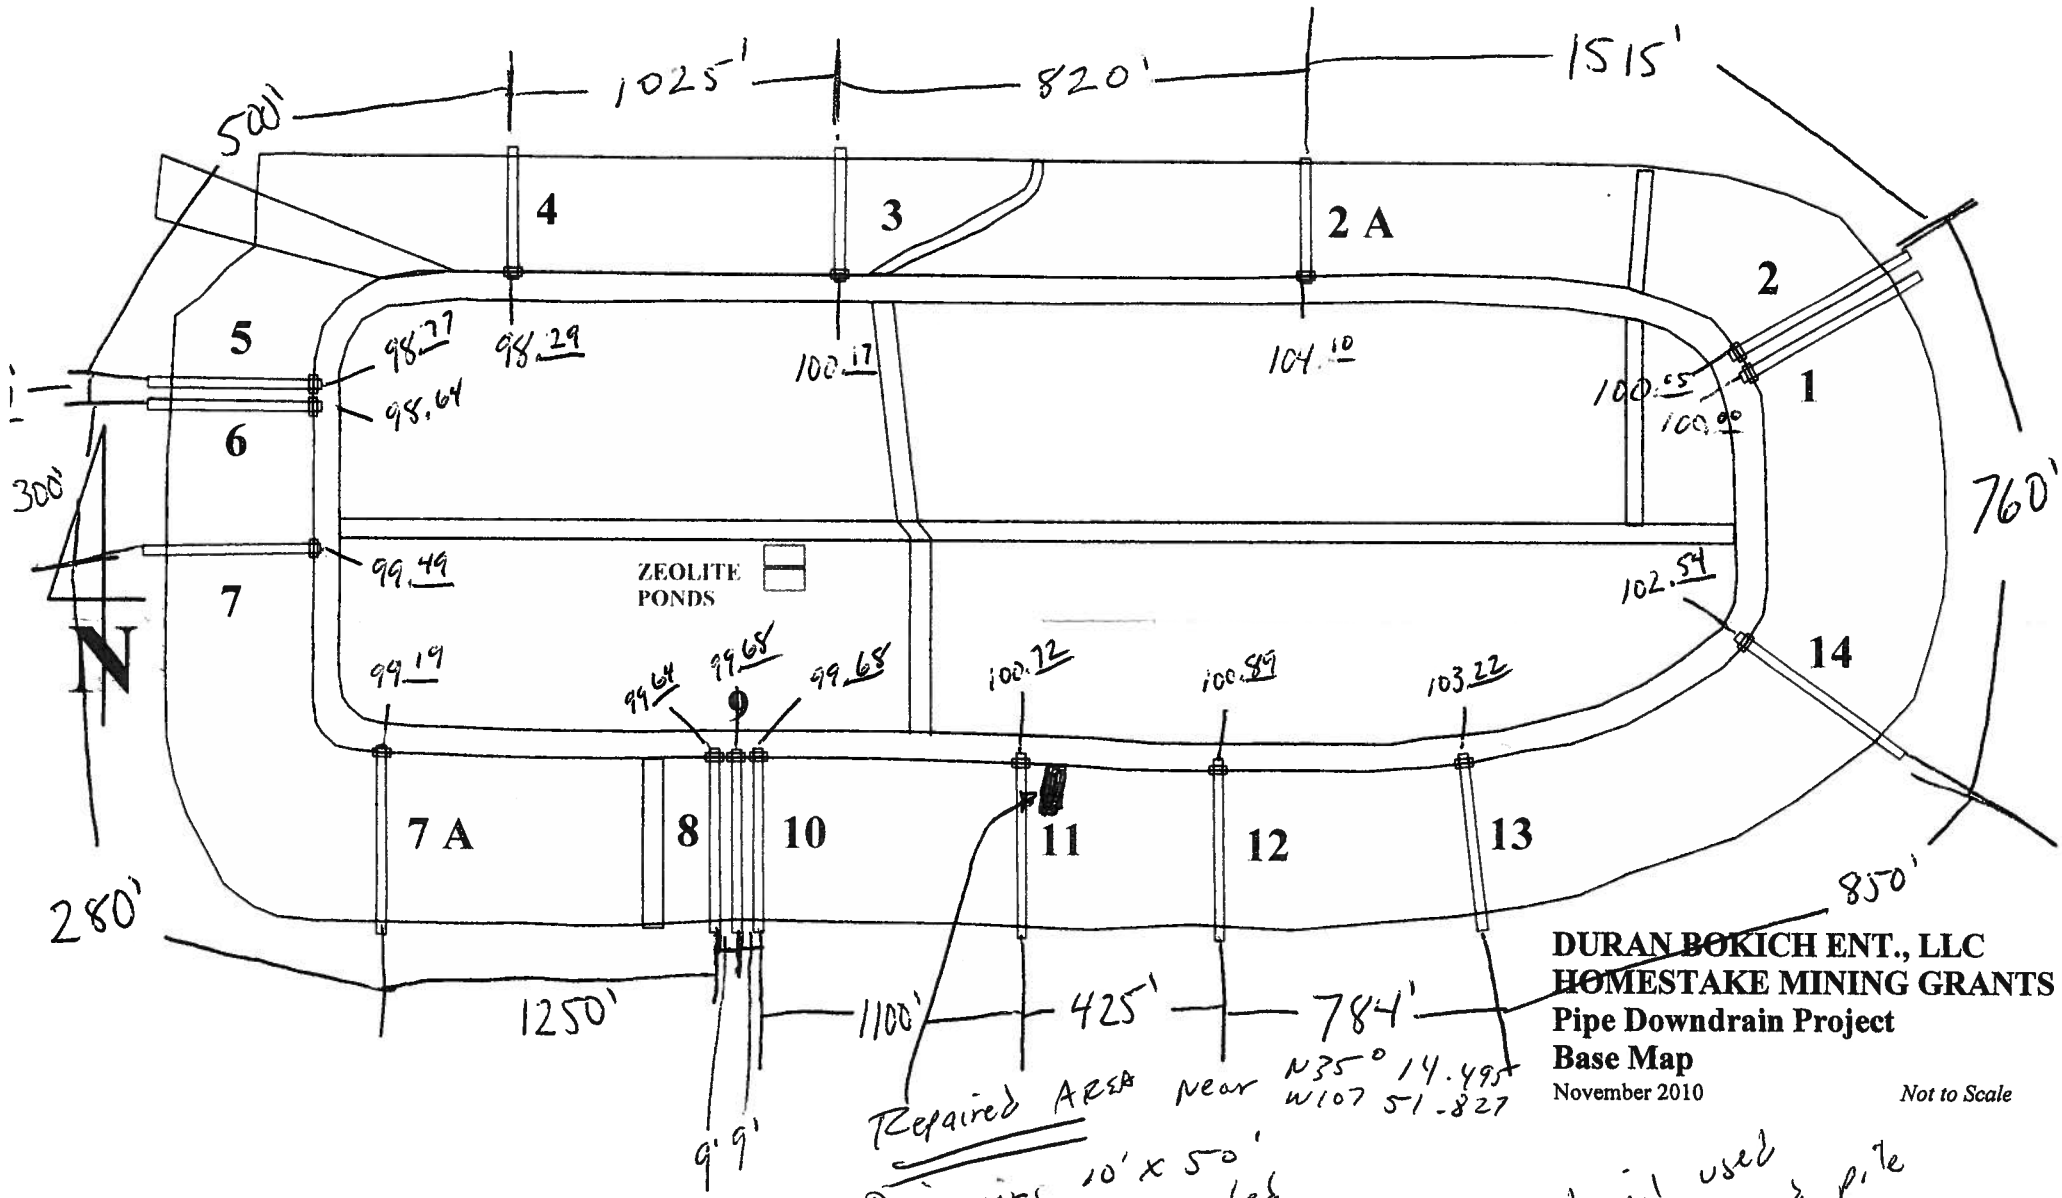
16977 07-4 Homestake Tailings
Location: 45' E. from Pipe Downdrain #11

Repaired AREA near N35° 14.495 W107 51.827
Dimensions 10' x 50'
40" of Fill Needed
started on 11-30-10
completed on 12-1-10

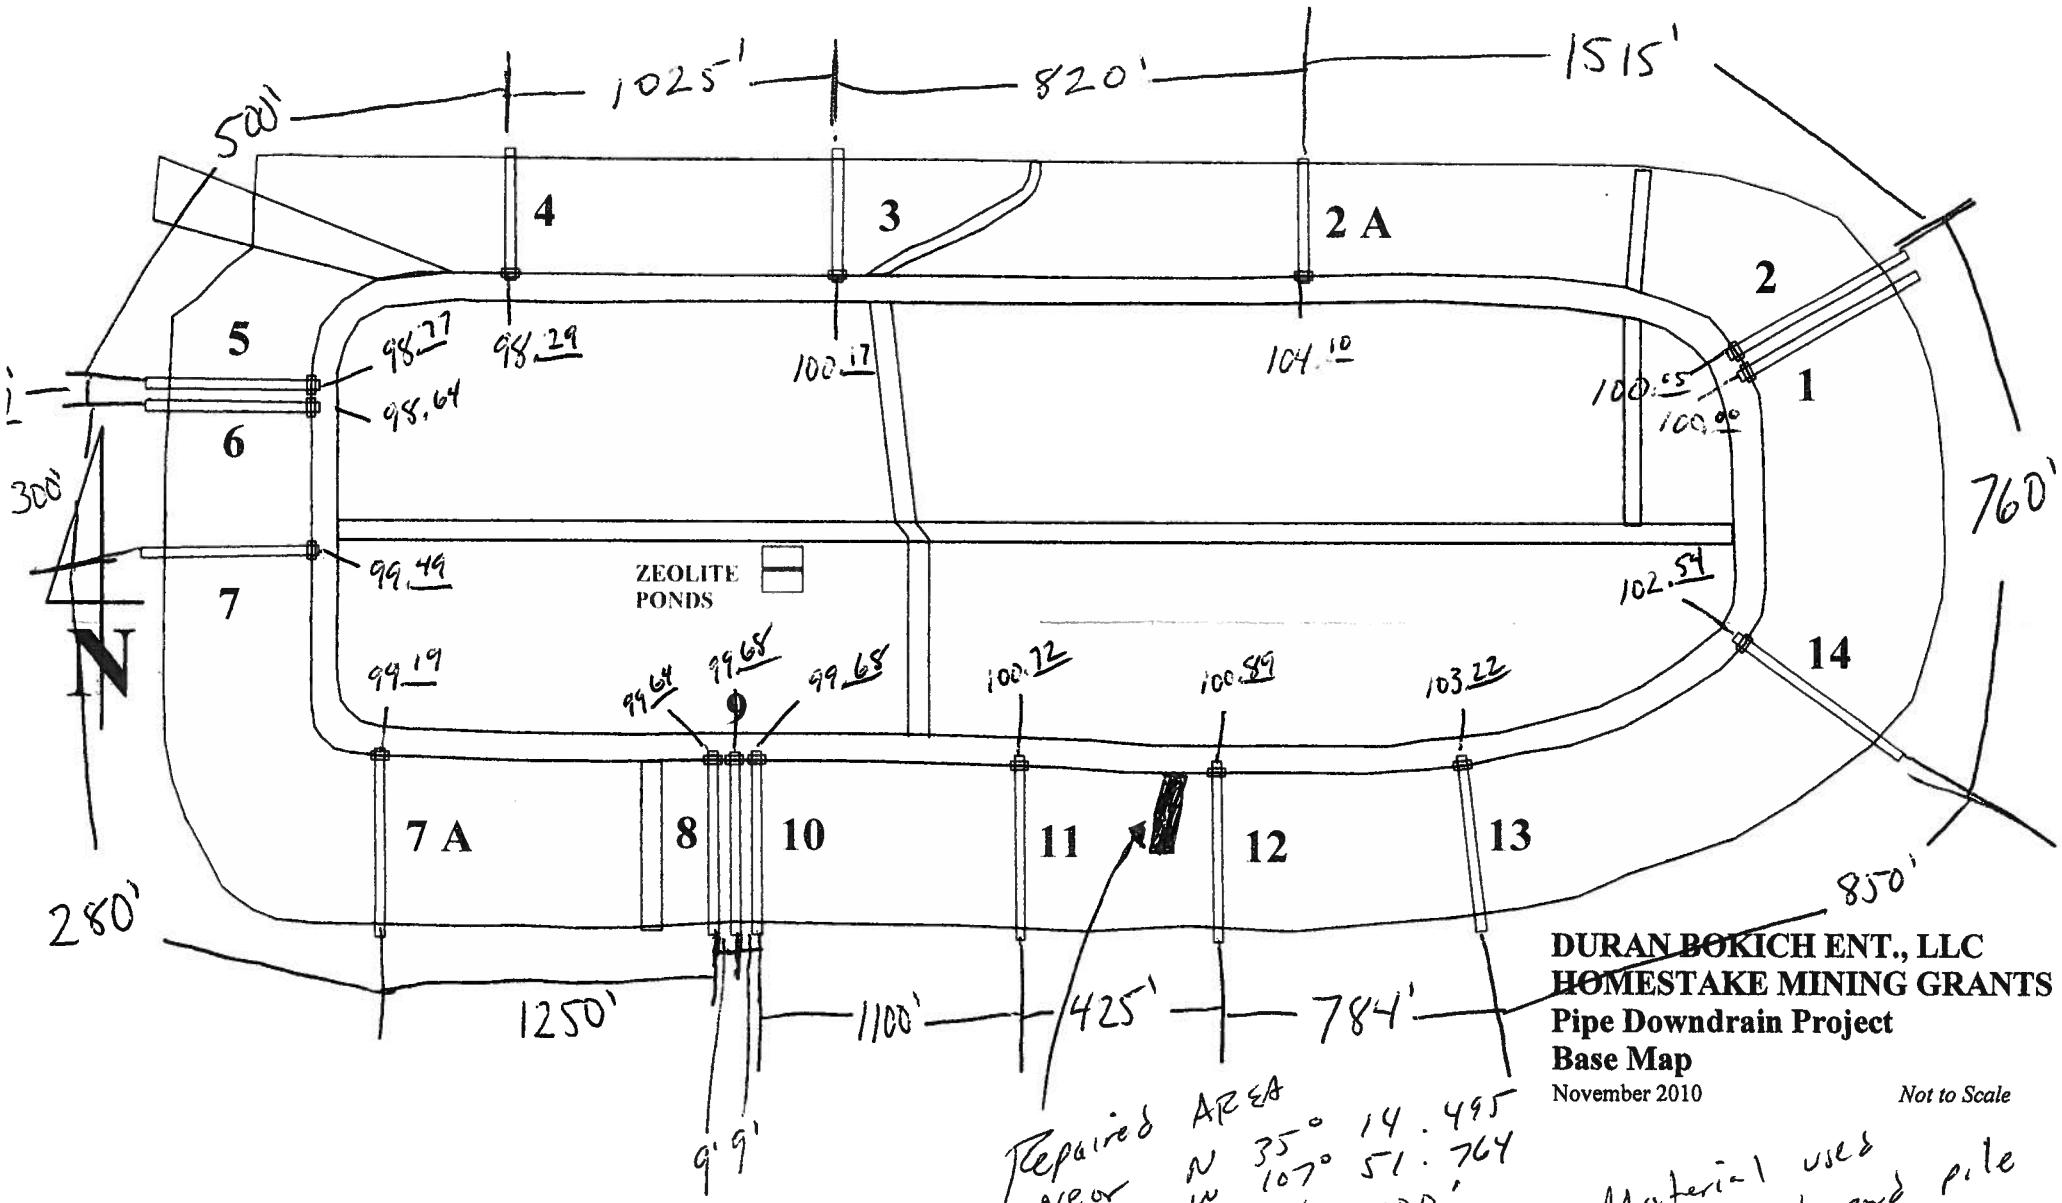
Location: 20' W from Pipe Downdrains #12

Repaired AREA
Near N 35° 14.495
W 107° 51.764
Dimensions 15' X 100'
40" of Fill Needed
Started on 12-2-10
Completed on 12-3-10
