A COMPLETE HISTORY OF THE HIGH-LEVEL WASTE PLANT
AT THE WEST VALLEY DEMONSTRATION PROJECT

Lawrence L. Petkus, James Paul, Paul J. Valenti, Helene Houston,
West Valley Nuclear Services, WVNSCO
and
Joseph May
U.S. Department of Energy

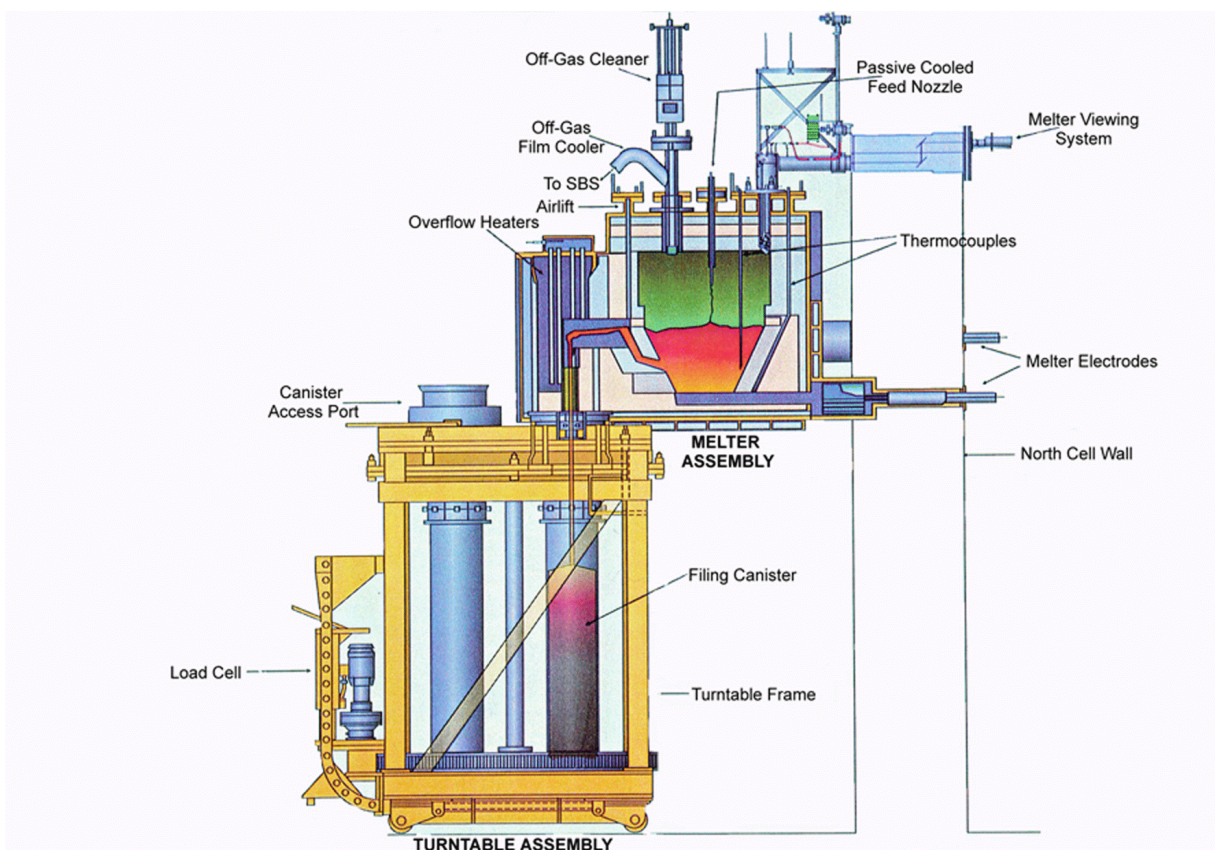
Fig.3 HLW Melter and Turntable

Melter Discharge: The melter is designed to discharge molten glass by pulling homogenized bulk glass from the main melter cavity through an under flow drain (as illustrated in the cut-away view of the melter and turntable shown in Fig. 3). Glass is directed from the under flow drain up a sloped channel that rises to a trough. The high point of the channel is the melter overflow. Normally the melter is operated at a glass level of one to two inches below overflow, using the airlift to raise glass up to the trough where it then flows by gravity to the canister. The cavity holding the trough is independently heated to maintain glass temperature during pouring. Glass discharge from the melter is a recognized point of potential failure.

Trough wear, erosion, and corrosion caused by glass flow has often been observed in both commercial and waste melters. Beyond these factors, glass pouring itself can produce dripping and thin pour streams that solidify into glass structures. Formation of such structures can functionally disable the discharge chamber. For these reasons, the final design of the HLW melter included two separated glass discharge chambers, each one equipped with removable silicon carbide heaters. These heaters were used to keep the trough and pour spout hot enough to maintain glass viscosity. The heaters that were installed are remotely replaceable units that can be used in either discharge chamber. During melter operation, only one pour spout was heated while the second chamber was maintained unheated, preventing unwanted glass pours from the "cold" discharge chamber.

A failure associated with operation of the discharge chamber occurred when the glass exit port plugged with glass. As previously described, problems with pouring such as the formation of drips can cause fibers to build up as glass is being poured. The drips form when melter pressure fluctuates. Damage to the pour tip also can cause pour problems by dividing the glass streams, each one acting like a drip. Although a direct cause of the exit port plug has not been identified, it may have been caused by the formation of drips. An examination of the discharge chamber is needed to determine the exact cause of the plug. As a result, the secondary discharge chamber had to be brought on-line with a fresh heater assembly near the end of radioactive operations. As part of the process of bringing the discharge chamber into service, an airlift tube was installed in the riser after heating the discharge chamber. Platinum was selected for the air lift tube (pipe) because it is impervious to the glass. The expectation was that it would last for the remaining life of the melter, as well as being thin-walled and flexible enough to bend as it slid down the sloped riser channel. However, flexibility proved to be detrimental in getting the tube down the riser as it bent and folded on itself (accordion style), instead of extending down the riser. Although the airlift was made operational, the design insertion depth was never obtained.

Heat up of the east discharge chamber was performed within a prescribed schedule. A slow ramp to temperature was used to limit stresses from different rates of thermal expansion within the refractory and the metal dam. Even with the slow ramp (heat up), cracking in the refractory caused air to leak between the discharge chamber and the main melter cavity. Air flow in the west discharge chamber was controlled by an orifice in the connecting jumper on top of the melter. This orifice was effectively bypassed in the east discharge chamber. Air apparently traveled past the airlift and through the seal between the lid and main cavity. This event indicates that additional work on discharge chamber seal design to reduce air flow is warranted.

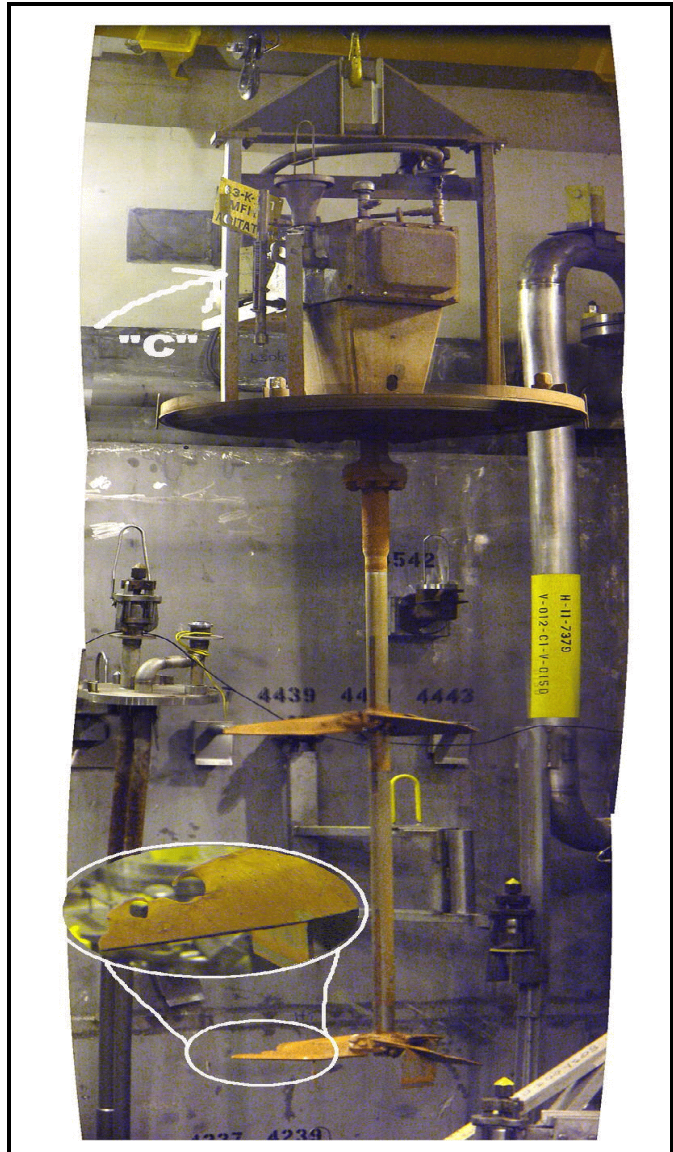
Fig.4 MFHT Agitator

Agitators: The homogeneous slurry mixture needed to make HLW glass was prepared and fed to melter using two slurry tanks, the Concentrator Feed Make-up Tank (CFMT) and the Melter Feed Hold Tank (MFHT). Homogeneity of slurry mixtures held in each tank was maintained by using commercial agitators that had been modified for remote service. Although the Vit Cell was not equipped to perform preventive maintenance on these agitators, it was possible to add oil to the agitator gear box using in-cell equipment. Radiation resistant lubricants were specified for periodic additions of oil. Generally one frame size larger than standard motors, the agitator motors were specified with a 1.15 service factor but were not radiation resistant. Both agjtators failed after five years of radioactive service. Failure mode was identical

for both agitators. Failure occurred within the flexible coupling, located between the motor and the gearbox, the metal grid holding the two mating hubs together (see Fig.4,"C"). The agitator manufacturer did indicate that grid failure occurs if the coupling is not greased periodically. When the motor housing was remotely removed from the coupling, a broken grid and hardened grease was found. As no method was available to replace the grid or the coupling, the entire agitator assembly had to be replaced. Blade wear was noticed on all blades after the agitators were removed from each tank. MFHT agitator failure occurred first because it was used on a full 24 hour cycle to keep feed slurry suspended during melter feed operations. Its blades showed the greatest amount of wear (see Fig.4 inset). Although the CFMT was used steadily, it was shut off when new batches of glass forming chemicals were being prepared.

A number of preparations had to be made so that the replacement agitators could be moved into the Vit Cell, including construction of a tipping frame used to fit the agitator assemblies through the shield door during transfer cart operation. Replacement was accomplished by bolting the agitator onto the tipping frame, placing the tipping frame onto transfer cart, and moving the transfer cart into the Vit Cell. Once inside the Vit Cell, the frame was tipped upright, allowing lubricating oil to be pumped into the agitator gear box before installation.

Electrical connections for each agitator were run through a rigid jumper with PUREX connectors. During agitator replacement, flexible jumpers were substituted for the original rigid jumpers because they are difficult to fit. Flexible jumpers also proved to be problematic because it was difficult to orient the jumper connection with the agitator. Flexible jumpers had to be made more rigid before completing assembly.
