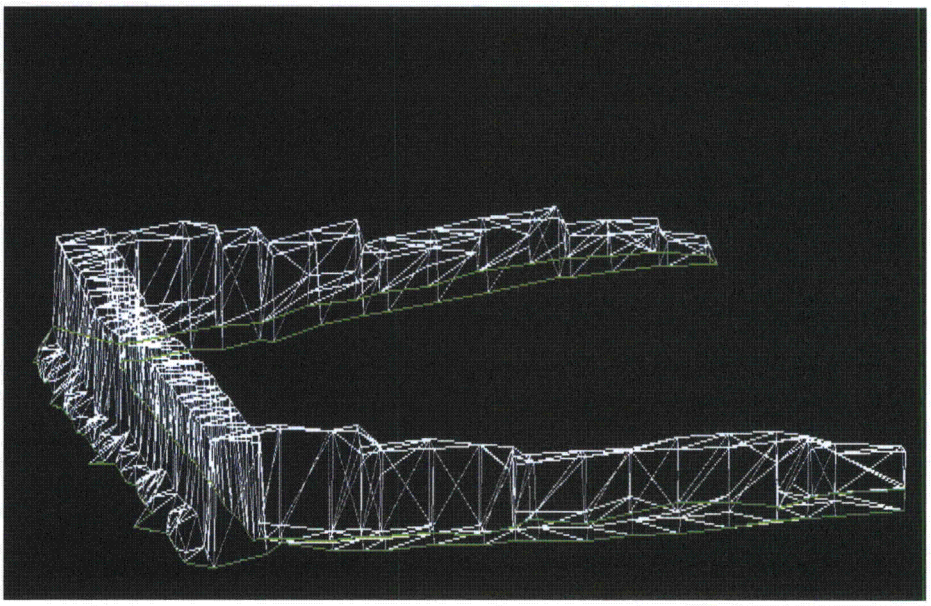
Figure 3-18. RDFW structure side view. Internal volume was 84.9 cu yd

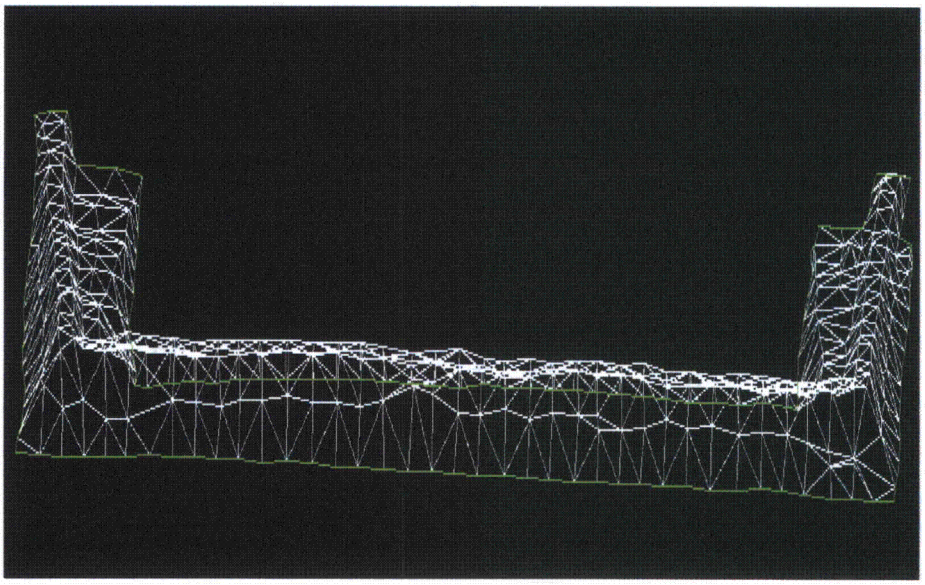
Figure 3-20. Sandbag structure viewed from riverside. Internal volume was 131.5 cu yd

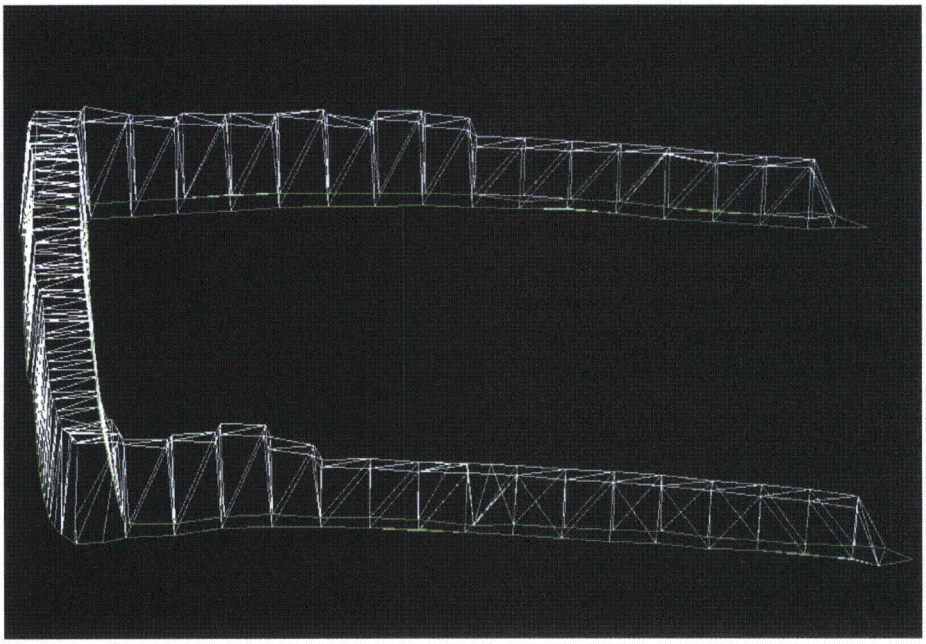
Figure 3-23. Hesco structure side view. Internal volume was 91 cu yd

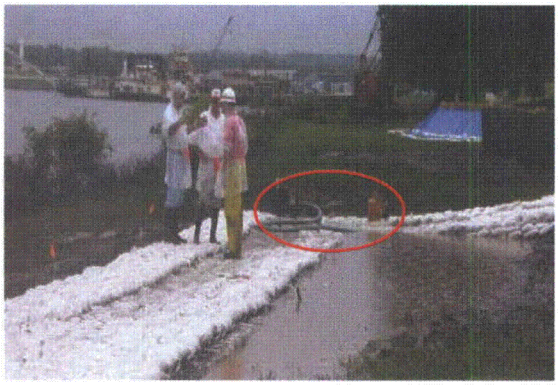
Ponding of rainwater on the inside of the structure delayed the beginning of construction on day 2 (Figure 3-38). The water was removed by pumping into the river (Figure 3-39). Once most of the water was removed, the area was bulldozed to make the site workable (Figure 3-40). The construction crew ranged from 14 to 23 laborers from both the District volunteers and the Mat Sinking Unit, and one equipment operator. Equipment used in constructing the 3-ft-high structure included a flatbed truck, trailer, and bulldozer. The construction crew took 27.5 hr (419.8 man-hours) to construct the 3-ft-high structure.

Figure 3-38. Rain water collected inside structure

Figure 3-39. Water being pumped from structure

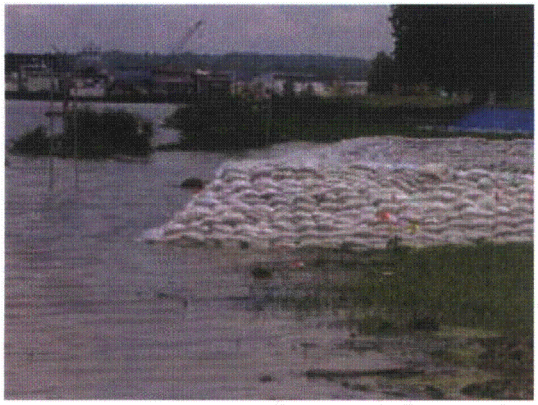
Figure 3-45. 4 June 2004, 1.0 ft of water against structure

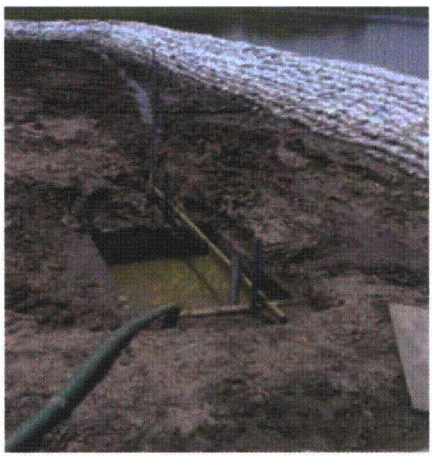
During the field test, seepage was collected in a buried concrete tank (Figure 3-51a, b). Seepage rates were determined by computing the change in volume in the tank over a specific time. As the water level against the structure rose, the seepage rates increased. The first photo was taken on 5 June 2004 while the seepage rate was low. The second photo was taken on 6 June 2004 when the seepage rate had increased. Figure 3-52 is a photo of the seepage observed through the overlapping sandbags. Figure 3-53 shows the seepage water on the protected side of the structure. To compare seepage rates for all four structures, the wetted area for each structure for given water surface elevations was computed (Figure 3-54). The seepage rate for the sandbag structure exceeded 4,500 gal/hr when the structure had almost 700 sq ft of wetted area. The rate of seepage increased markedly when the wetted area reached 500 sq ft. As the seepage rate increased, an attempt was made to reduce the seepage by draping the east tieback with plastic sheeting and weighting the sheeting with sandbags (Figure 3-55a, b). The draping of the sheeting did not decrease the flow of water through the structure. The plastic sheeting was also draped over a low section of the riverward face to protect against concentrated flow (Figure 3-56). These were the only modifications made to the sandbag structure.

Figure 3-51. Sandbag seepage collection tank

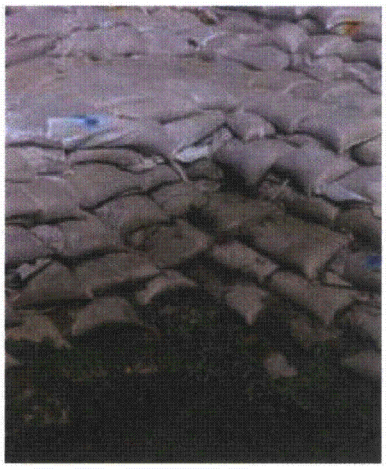
Figure 3-52. Seepage through structure

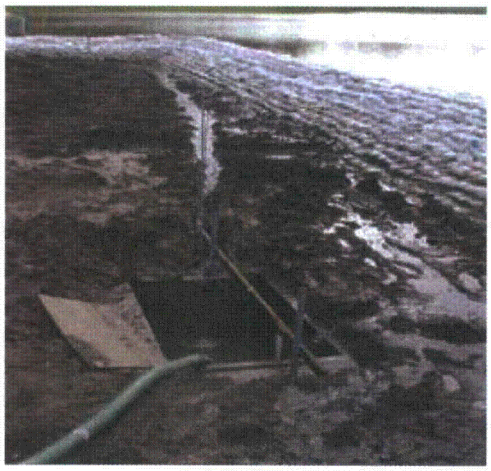
Figure 3-53. Seepage on protected side

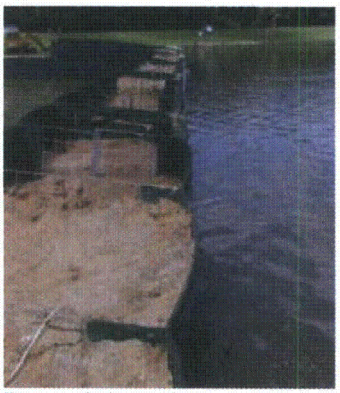
Figure 3-87. 11 June 2004, 4.0 ft of water against structure

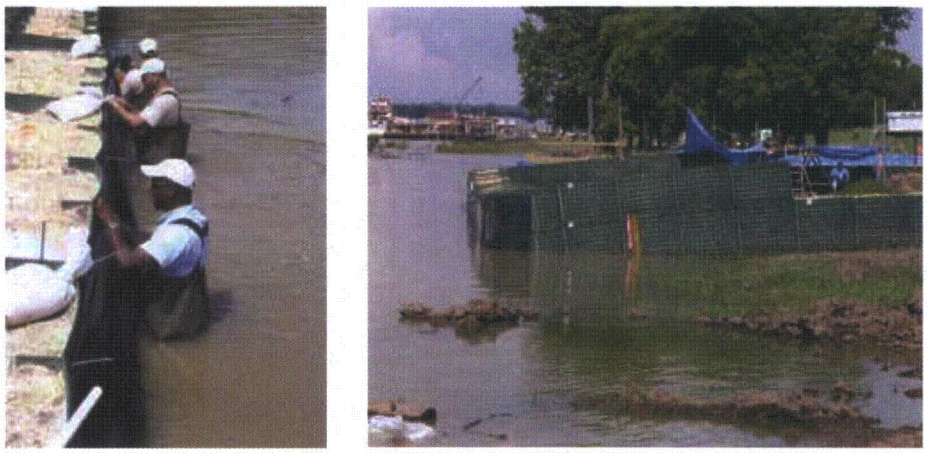
Figure 3-91. Attaching plastic sheeting to riverward face of Hesco Bastion structure

The first repair was made on 8 June and included the addition of plastic sheeting to the riverward face of the structure (Figure 3-91). This repair was made with 2.5 to 3.0 ft of water against the structure. The plastic sheeting was rolled out and attached to the top of the top layer units with zip-ties. The sheeting was weighted and held against the bottom of the base row units with sandbags. At the time that the repair was made, the seepage rate was approximately 4,000 gal/hr. The repair temporarily reduced seepage, with the rate falling to approximately 3,000 gal/hr. The repair was made on the afternoon of 8 June. By the morning of 9 June, the seepage rate had risen to approximately 4,300 gal/hr with only a few tenths of a foot rise in the river level.

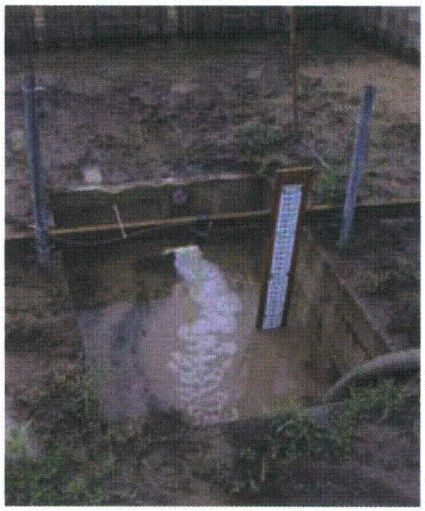
Figure 3-121. Seepage collection in sump tank

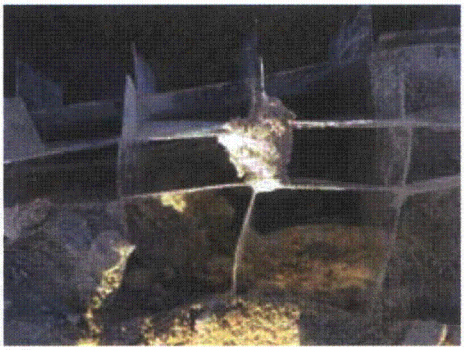
Figure 3-122. Fill material washed out of units (view down from top)

During testing, no major repairs were required to the RDFW structure. One minor repair performed by the RDFW representative was to refill units where the sand was washed out where the units had not been properly placed during construction (Figures 3-122 and 3-123). This repair was accomplished by adding sand to the washed-out compartments of the units (Figures 3-124 and 3-125). The repairs were completed by one RDFW representative, four government laborers, and one government equipment operator using shovels and a backhoe. Also during testing, a small sand boil (or pin boil) developed in the northeast corner of the structure near the sump tank. The boil was contained by placing a RDFW half unit over the boil (Figures 3-126 and 3-127).

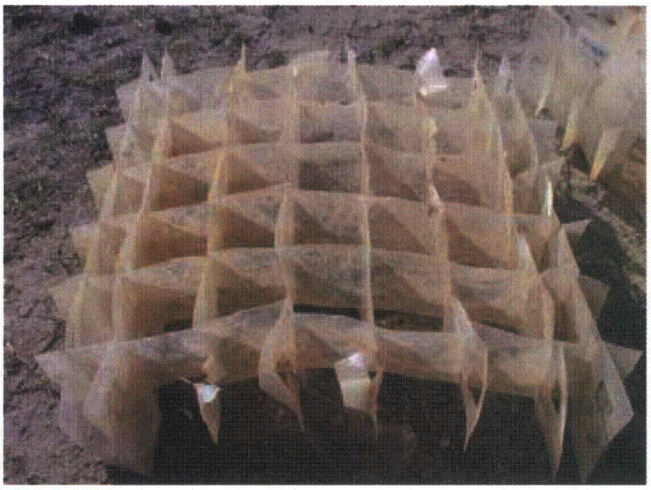
Once removed, the RDFW units were inspected for damage. Some damage to the units was identified (Figure 3-144). The most damage was to the top row, bottom row, and the end units. Some individual panels of these units could be saved with the damaged pieces being replaced. Once the damaged pieces are replaced, the unit is reusable. Each RDFW unit consists of 14 pieces. Geocell Systems conducts a replacement procedure that they term "cannibalize" the units. This procedure includes the removal and replacement of damaged pieces within a unit with undamaged pieces to make the unit reusable. While minor damage was sustained during testing from the units shifting against the weight of the water, most of the damage to the RDFW units occurred during removal. Damage to the bottom units was attributed to the use of heavy machinery. By approximate field estimates, approximately 90 percent of the units were reusable.

Figure 3-144. Damaged RDFW unit

The units can be cleaned by washing the sand, mud, and debris off with a garden hose. However, they were not cleaned during this project. The used units that were not damaged or could be repaired (cannibalized) were folded flat and returned to the wooden crates. The units damaged beyond repair were disposed of.

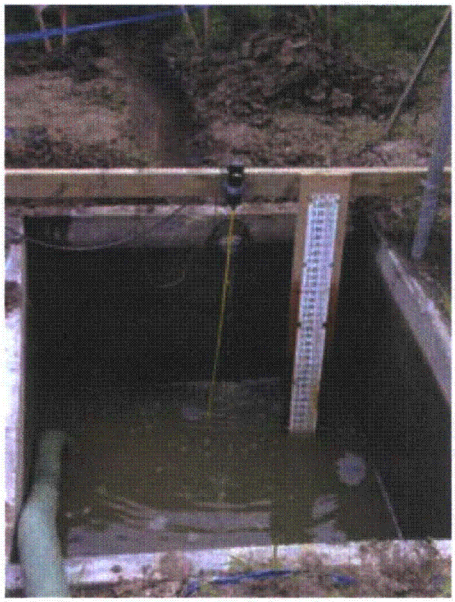
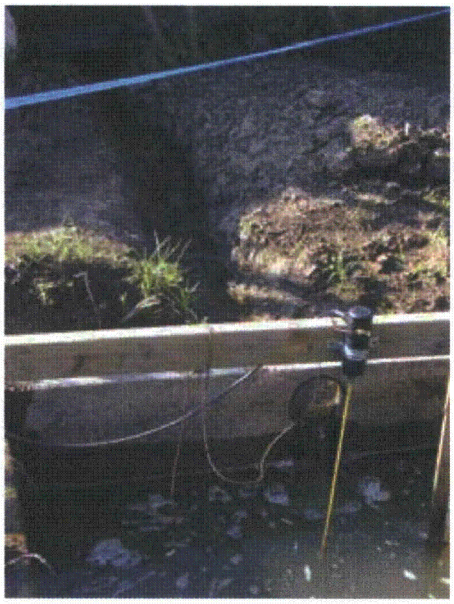
During the field test, seepage was collected in a buried concrete tank. Seepage rates were determined by computing the change in volume in the tank over a specific time. Seepage began as soon as the river rose high enough to put water against the structure. As the water levels continued to rise, the structure experienced only limited increases in seepage. Figure 3-166 shows the Portadam structure seepage tank. The first photo was taken on 6 June 2004 with less than 1.5 ft of water against the structure. The second photo was taken on 10 June 2004with over 3.5 ft of water against the structure. These photographs indicate that the seepage was not significantly greater on 10 June than it was on 6 June. Table 3-10 shows the seepage rate for the Portadam structure, which only gradually increased as the water levels against the structure increased. At the time that the Portadam structure overtopped, its seepage rate was the lowest of the four structures.

Figure 3-166. Portadam seepage collection tank

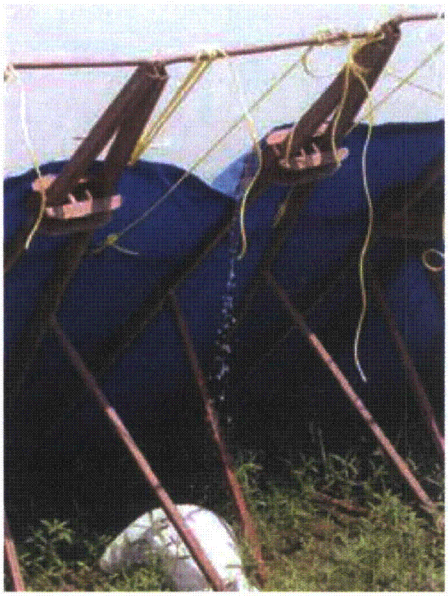
Figure 3-167. Sagging liner

During testing, no major repairs were required to the Portadam structure. However, two minor repairs and one standard preparation for overtopping were made. The minor repairs consisted of removing slack in the top of the liner membrane where the membrane was sagging. At these two locations, water began to flow over the top of the liner membrane on 10 June 2004 (Figure 3-167). The first repair included folding the top of the liner over on top of itself and holding it in place with a pair of vice grip pliers (Figure 3-168). The second repair included clamping off in the northeast 90-degree turn a section of liner with two pieces of a wooden survey stake and two c clamps (Figure 3-169). These repairs allowed for a more uniform overtopping of the structure. At the request of the Portadam representative, government laborers made the typical overtopping preparation, which consisted of placing plastic sheeting on the ground along the overtopping impact zone. This sheeting reduces the potential for erosion around the supporting frame. Figure 3-170 is a photograph of the installed plastic sheeting.

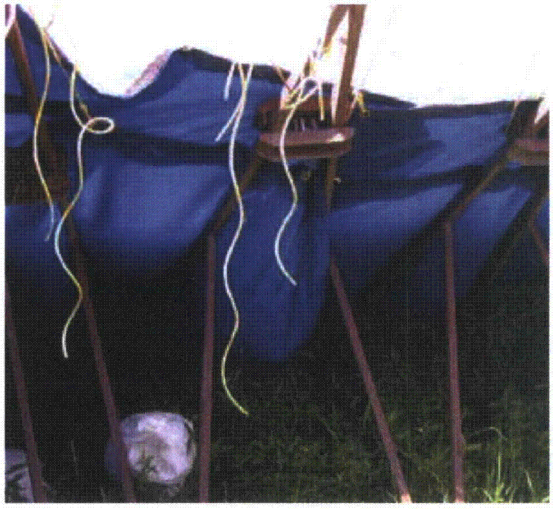
Figure 3-172. Sagging of liner between supporting frame members

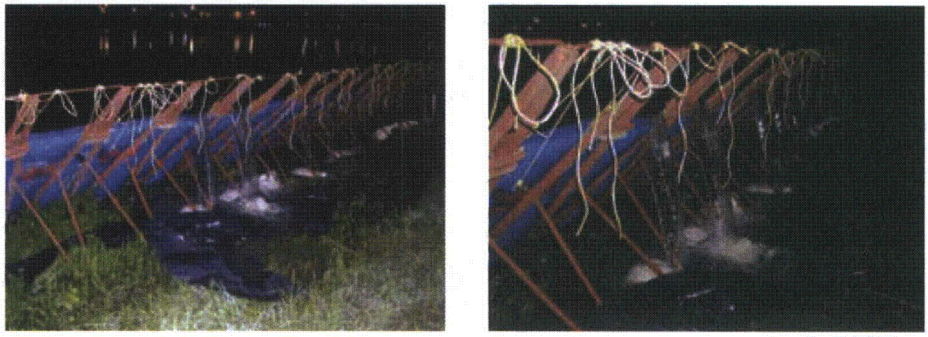
Early in the morning hours of 11 June 2004, the Portadam structure overtopped. By 5 a.m., the structure was overtopped at nine separate locations along the riverward face (Figure 3-174). Shortly thereafter, the pump capacity on the protected side of the structure was exceeded. At that point, the pump was removed and testing ended (Figure 3-175). Figure 3-176 is a photograph of the Portadam structure after the field testing had ended and the protected side had filled with water.

Figure 3-174. Overtopping of Portadam structure

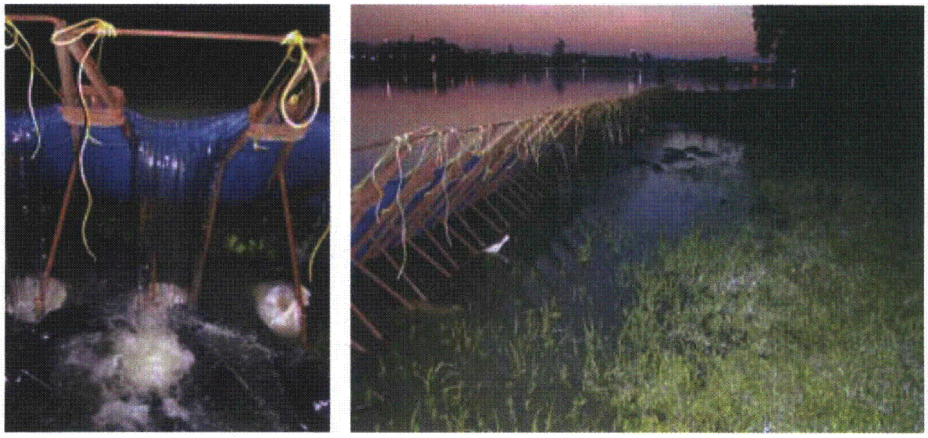
Figure 3-175. Testing complete
