TECHNICAL DATA REPORT

TDR NO. 198	REVISION NO. 0
PROJECT NO. 3739	PAGE 1 OF 22
PROJECT: TMI-2 Containment Assessment	DEPARTMENT/SECTION Engineering Management
	RELEASE DATE 10/24/80 REVISION DATE

DOCUMENT TITLE: Three Mile Island Unit 2 Reactor Building Entry Program Summary

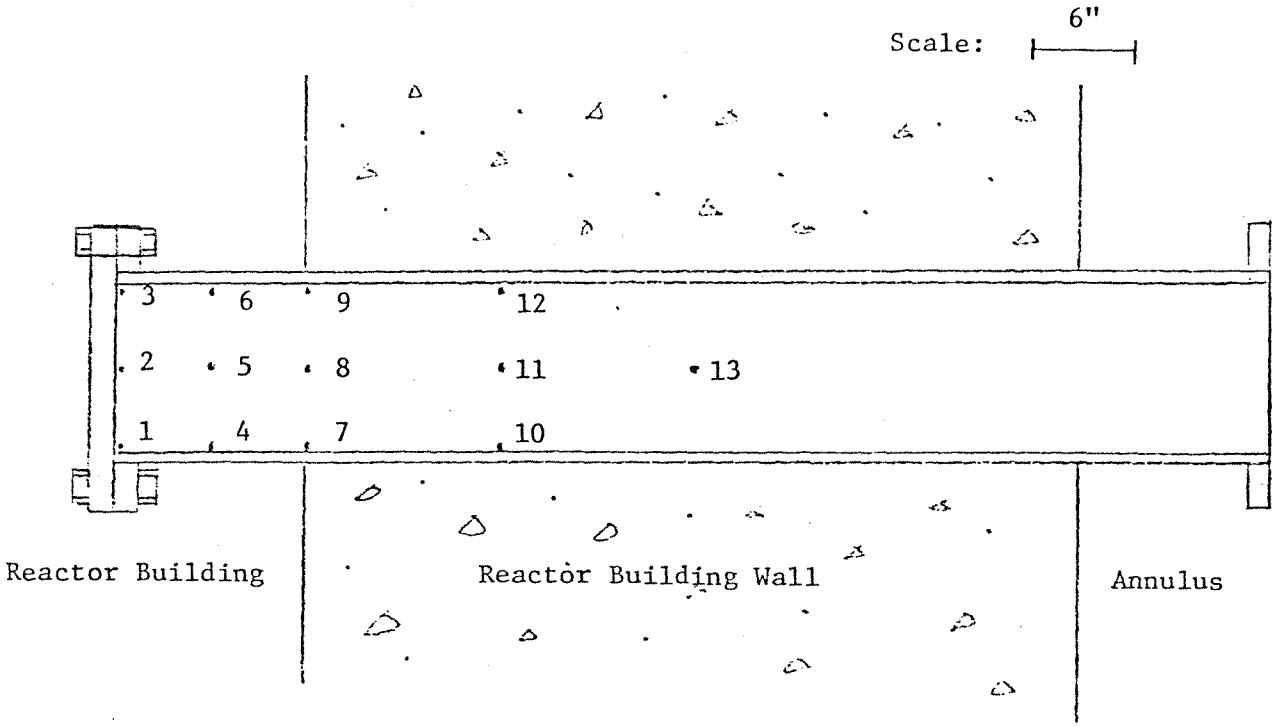
Table 9

PENETRATION R626 GAMMA DOSE RATE SURVEY RESULTS

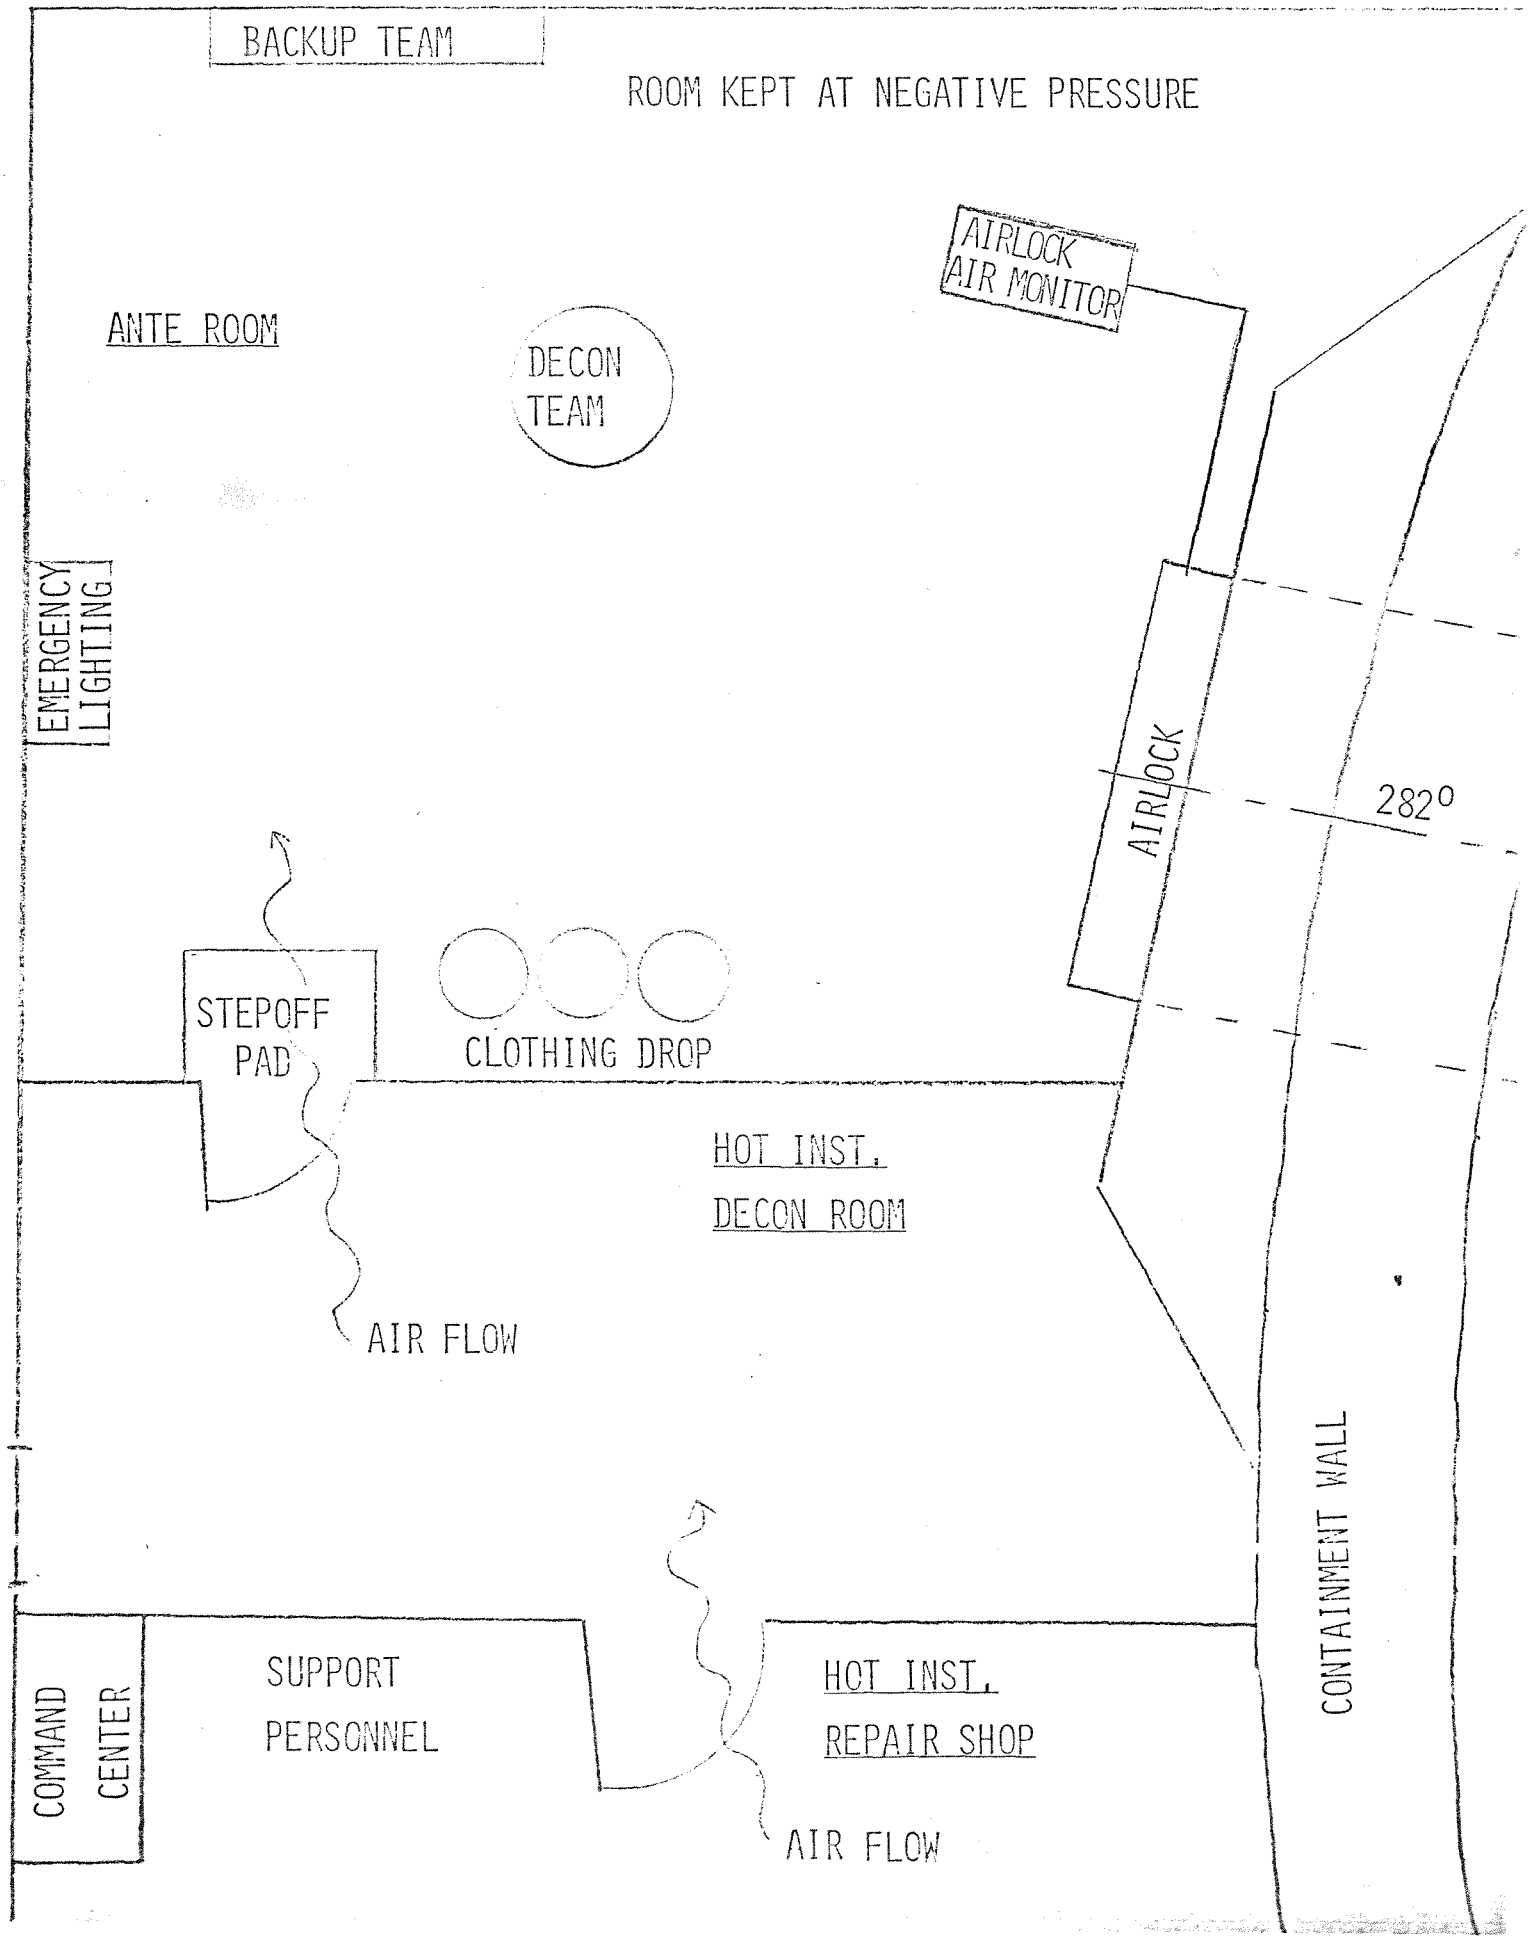
Figure 8

Temporary barrier walls and ceiling were added to divide the area near the No. 2 personnel air lock into contamination control areas. The barriers were constructed of gypsum panels on steel channel framing to provide rigid, nonflammable partitions. The new barrier partitions were coated with an epoxy painting system to permit ease of decontamination if the need arises, as are the permanent walls, floor, and ceiling in the area. All seams, joints and penetrations in the facility structure are sealed to prevent the uncontrolled flow of contaminated air. The arrangement of the area is shown on figure 8 Appendix B.

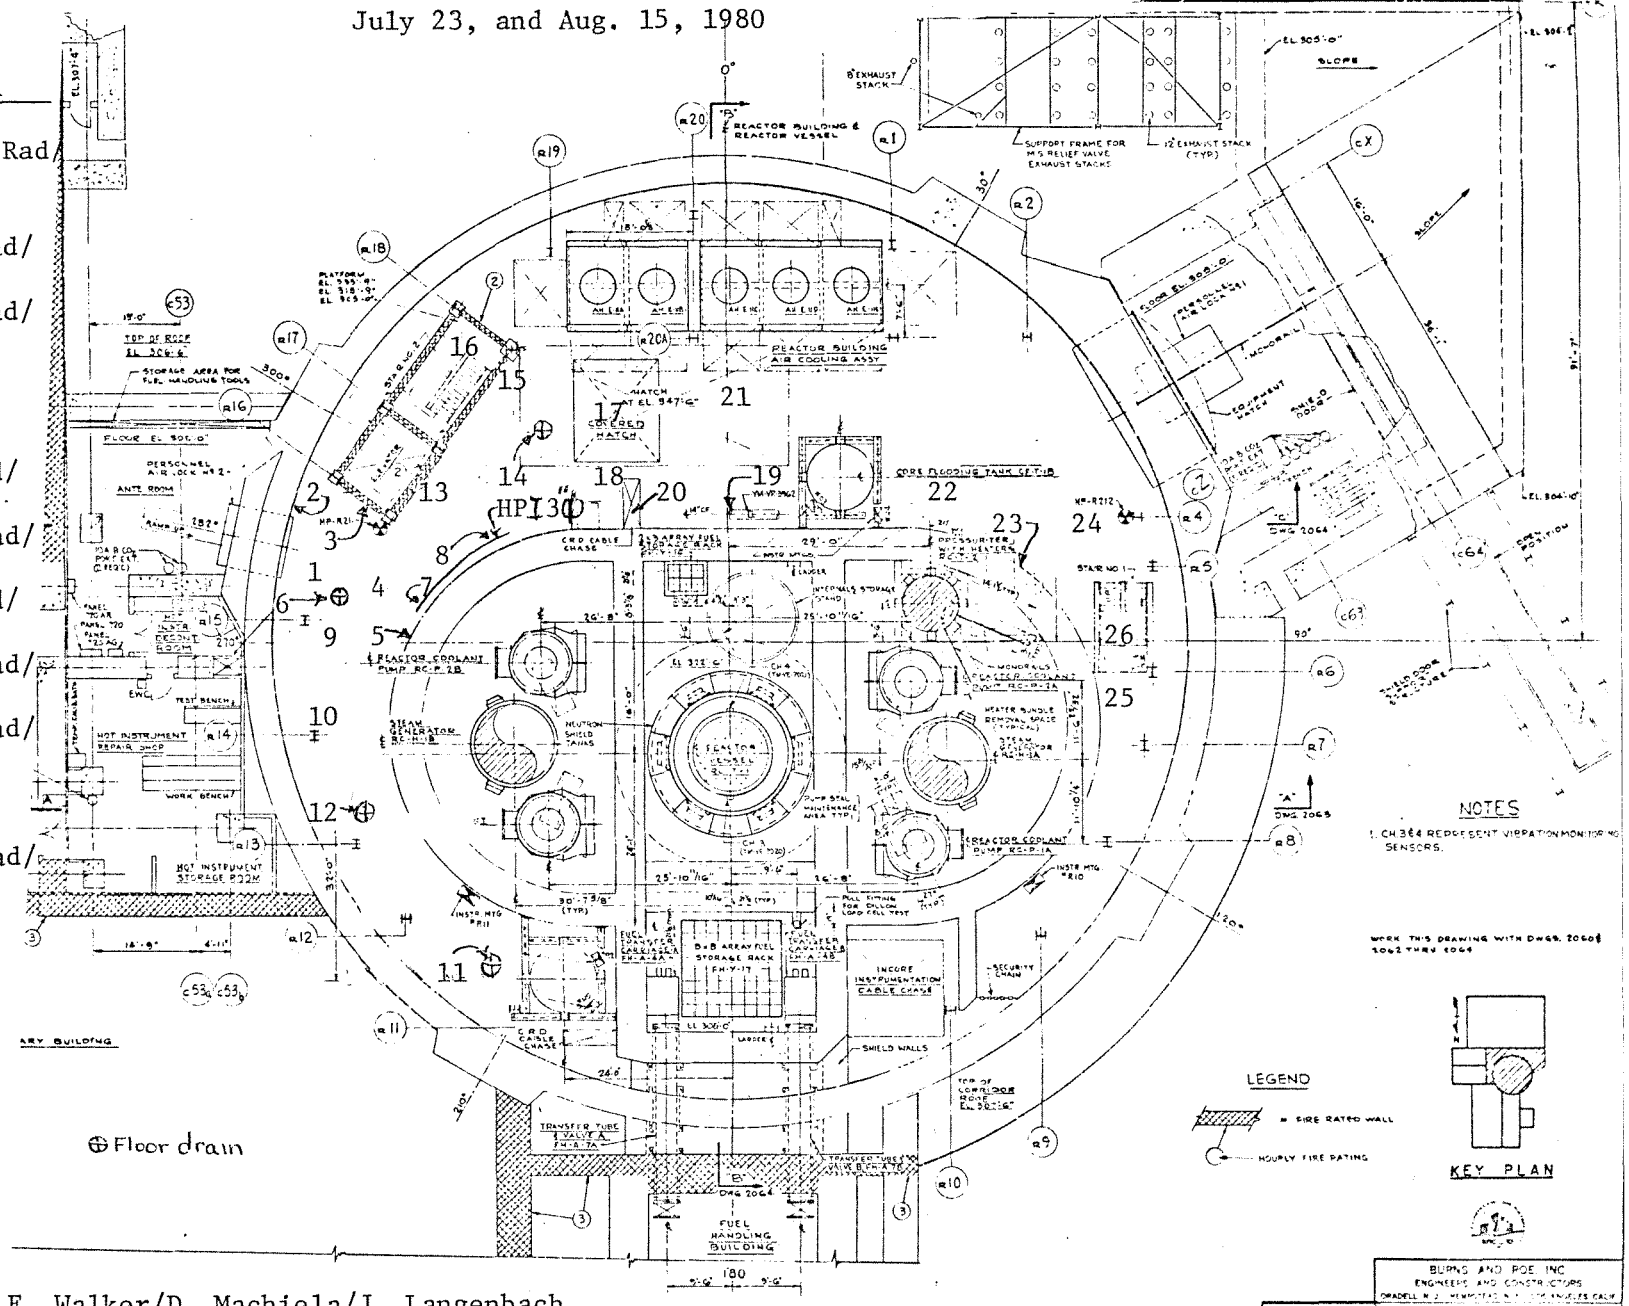
Reactor Building
Radiation Survey Summary
305' El.
July 23, and Aug. 15, 1980

LOCATION	DOSE RATE GAMMA	DOSE RATE BETA
1	0.4R/hr	-
2	0.2R/hr	1.6 Rad/hr
3	2.0R/hr	-
4	*0.5R/hr	2 Rad/hr
5	*0.5R/hr	2 Rad/hr
6	5R/hr	-
7	3R/hr	-
8	0.3R/hr	-
9	*0.5R/hr	7Rad/hr
10	0.5R/hr	1 Rad/hr
11	3R/hr	10Rad/hr
12	3R/hr	10 Rad/hr
13	3R/hr	10 Rad/hr
14	2R/hr	-
15	0.4R/hr	-
16	3R/hr	2 Rad/hr
17	10R/hr	-
18	4R/hr	-
19	3R/hr	-
20	3.5R/hr	-
21	1.4R/hr	-
22	0.7R/hr	-
23	0.4R/hr	-
24	8R/hr	-
25	2R/hr	-
26	45R/hr	-

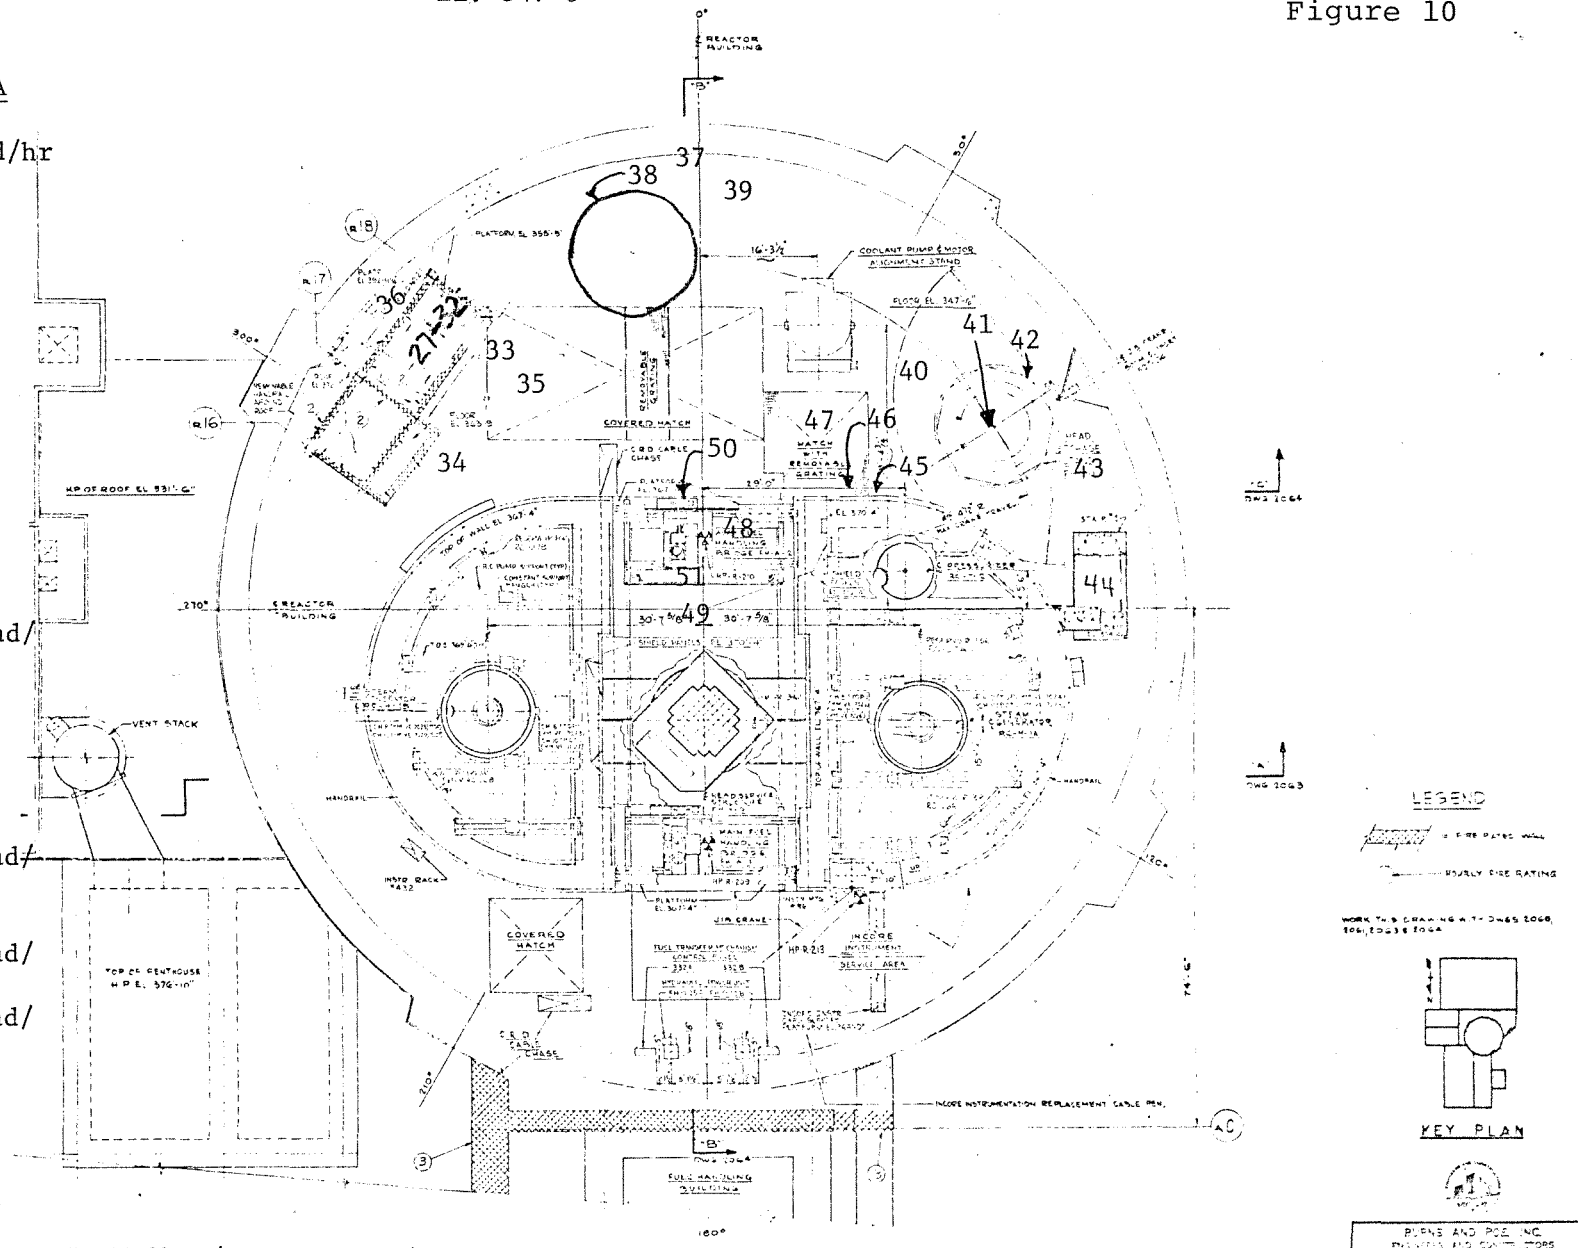
LOCATION	DOSE RATE GAMMA	BETA
#27 312' el.	2R/hr	4 Rad/hr
#28 319' el.	1R/hr	-
#29 326' el.	0.8R/hr	-
#30 333' el.	0.5R/hr	-
#31 340' el.	0.3R/hr	-
#32	0.18R/hr	-
#33	0.25R/hr	-
#34	0.1 R/hr	-
#35	0.6 R/hr	-
#36	0.05R/hr	-
#37	0.15R/hr	-
#38	0.03R/hr	-
#39	0.1R/hr	-
#40	0.4R/hr	-
#41	0.3R/hr	-
#42	0.45R/hr	6.2Rad/hr
#43	0.15R/hr	-
#44	0.55R/hr	-
#45	0.1R/hr	-
#46	2.5R/hr	-
#47	0.25R/hr	-
#48	0.17R/hr	0.9Rad/hr
#49	0.15R/hr	-
#50	*0.2R/hr	5.2Rad/hr
#51	0.12R/hr	-
#52	0.3R/hr	10.8Rad/hr

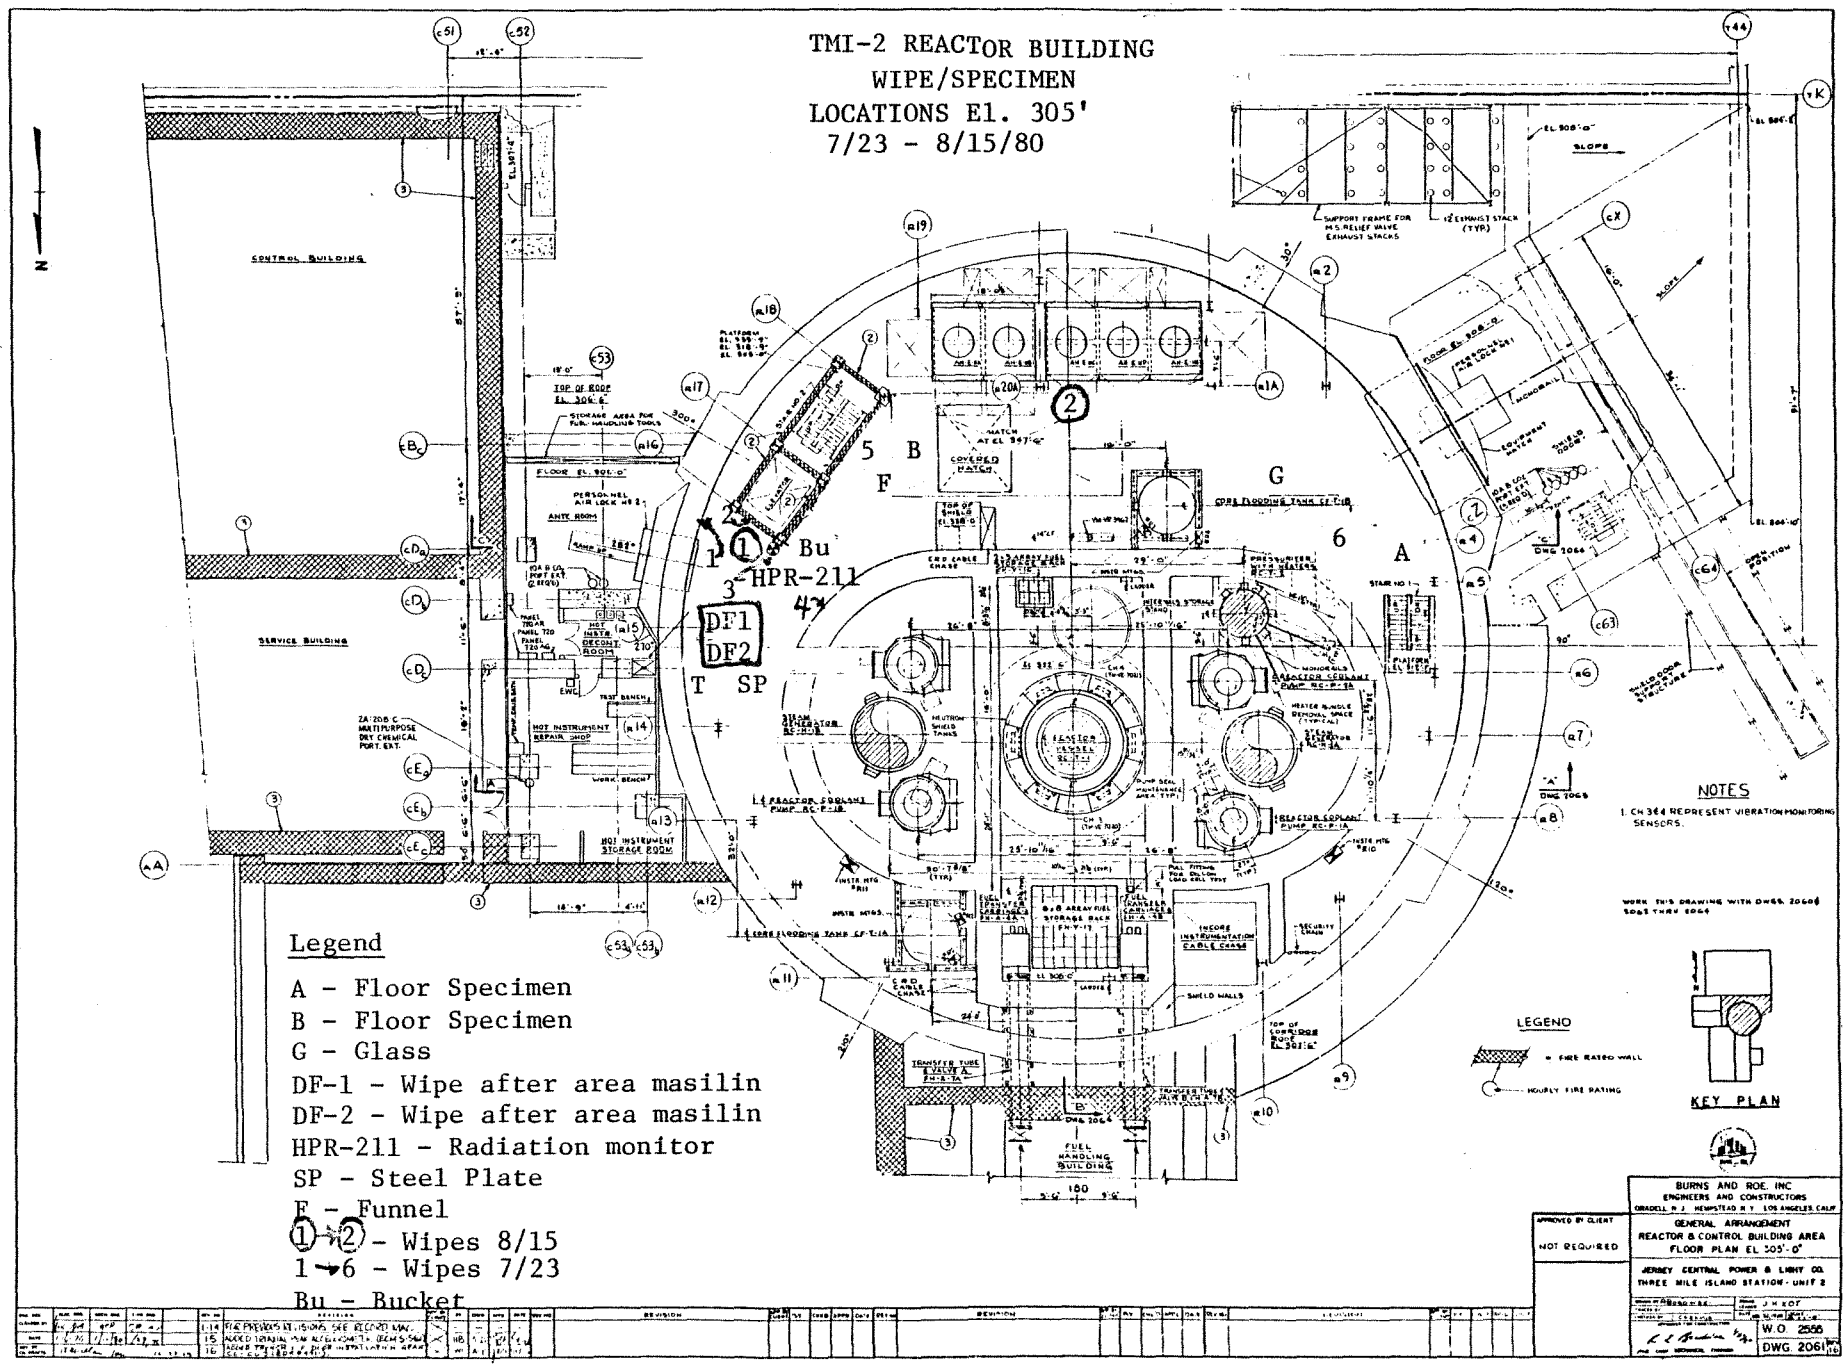
Figure 11

In addition to this figures 11 and 12 of Appendix B and Tables 19 and 21 of Appendix A show the locations of the smears and samples removed from the Reactor Building.

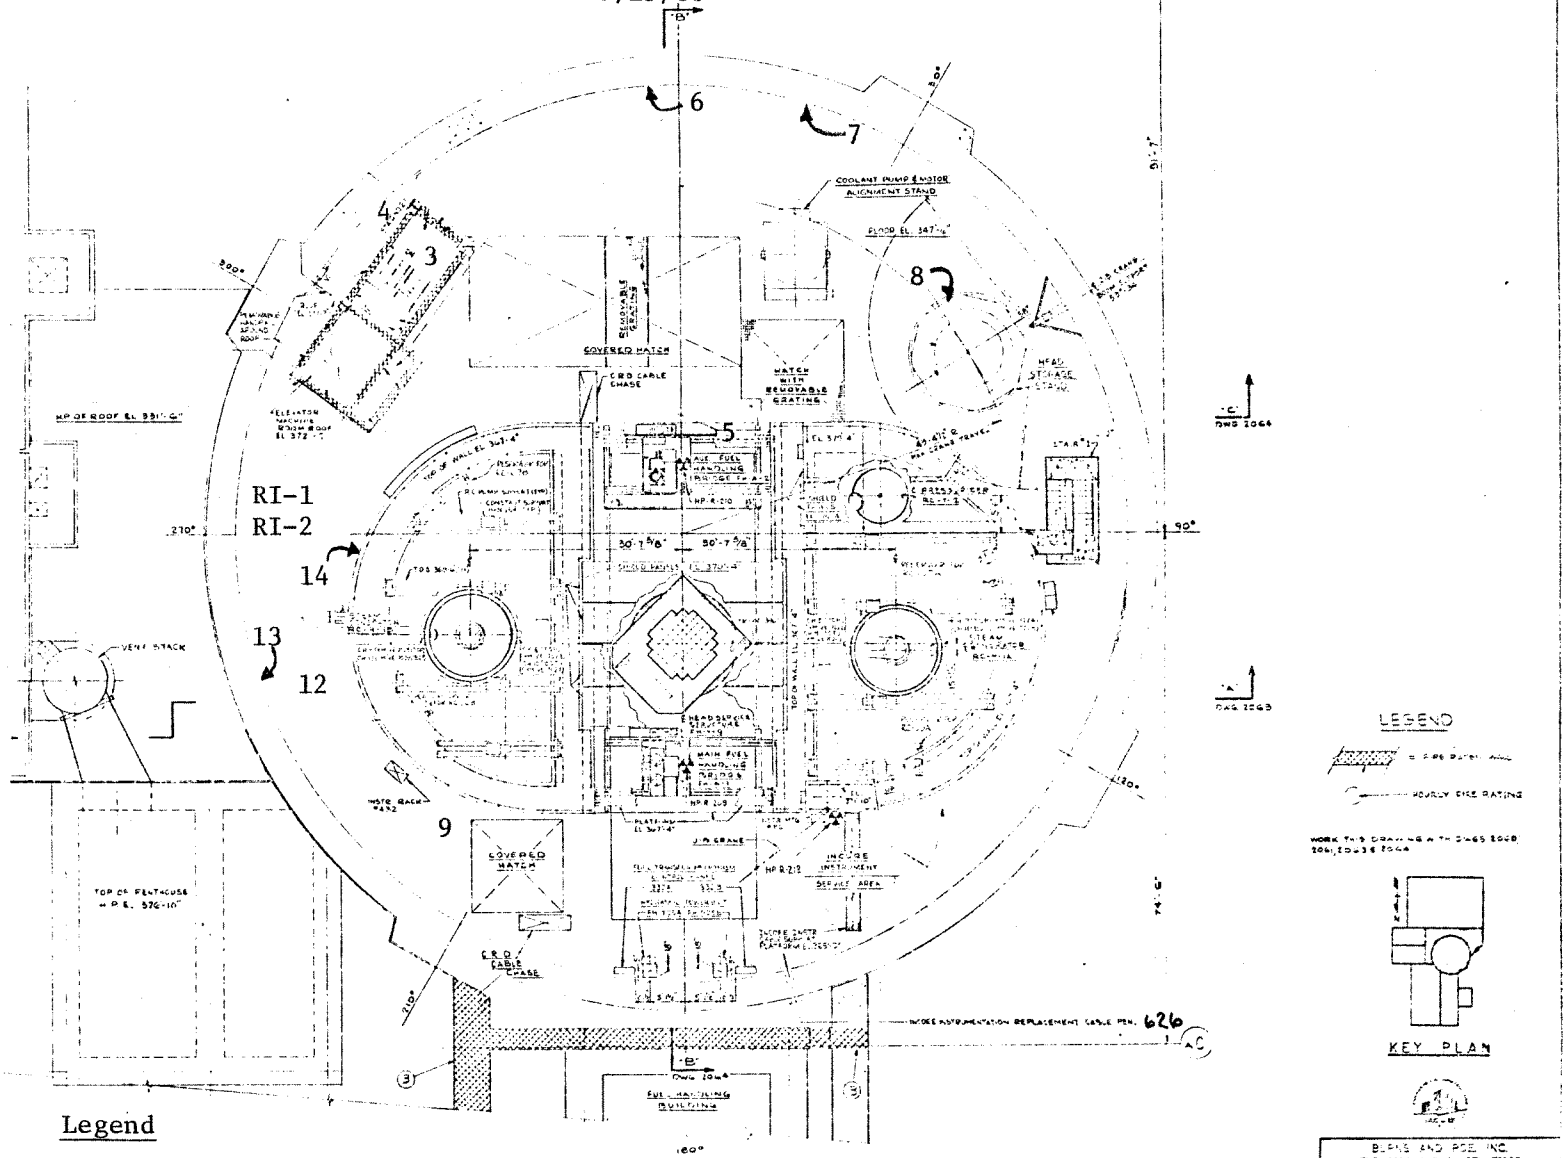
Figure 12

TMI-2
Reactor Building
Wipe/Specimen
Locations
El. 347'6"
8/15/80

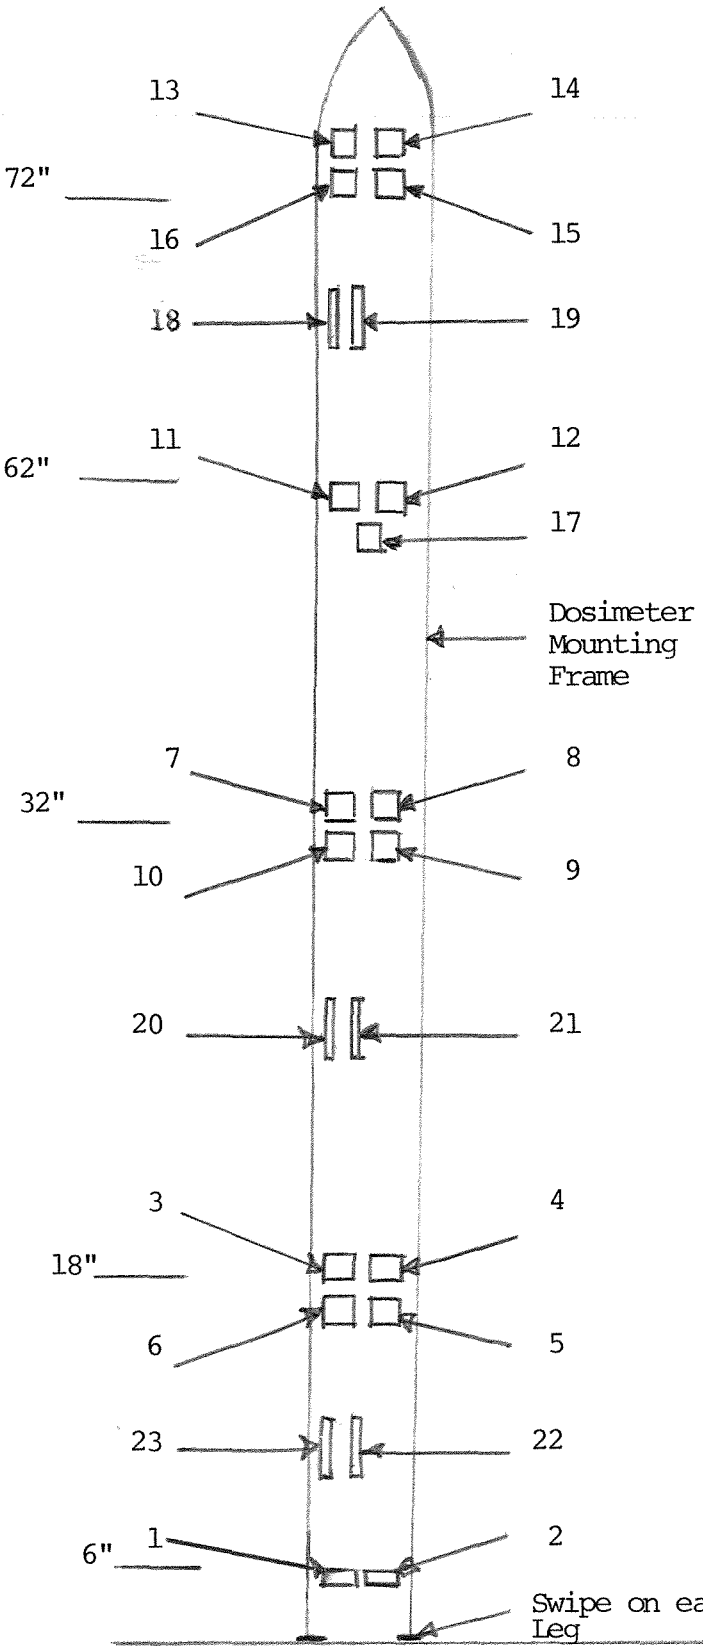
CONFIGURATION AND RESULTS OF EXPERIMENT TO DETERMINE BETA/GAMMA DOSE RATE AND PROTECTION FACTOR FOR PROTECTIVE CLOTHING USING PENETRATION R626

DOSIMETRY	BETA RAD/HR	GAMMA RAD/HR	SHIELD/ SEALANT
1 TLD	20.35	.922	NONE/POLLY
2 FILM	21.15	.510	NONE/POLLY
3 FILM	.339	.351	B G/POLLY
4 TLD	24.89	.727	NONE/POLLY
5 FILM	33.49	.945	NONE/POLLY
6 TLD	34.16	.725	NONE/POLLY
7 TLD	0.00	.849	B G/NONE
8 TLD	43.45	.891	NONE/NONE
9 TLD	27.35	.765	NONE/POLLY
10 TLD	37.07	.870	NONE/RTV
11 FILM	30.78	.555	NONE/POLLY
12 TLD	30.81	.737	NONE/POLLY
13 TLD	0.0	.869	B G/RTV
14 TLD	43.69	.848	NONE/RTV
15 TLD	0.0	.906	B G/RTV
16 TLD	33.19	.905	NONE/RTV
17 TLD	0.0	.612	VIKING/NONE
18 PD	--	.399	NONE/POLLY
19 PD	--	.441	NONE/POLLY
20 PD	--	.525	NONE/POLLY
21 PD	--	.420	NONE/POLLY
22 PD	--	.420	NONE/POLLY
23 PD	--	.378	NONE/POLLY
