TS-PIC-83003
October 1983

Installation Assessment Walter Reed Army Medical Center Washington, D.C.

Walter Reed Army Medical Center

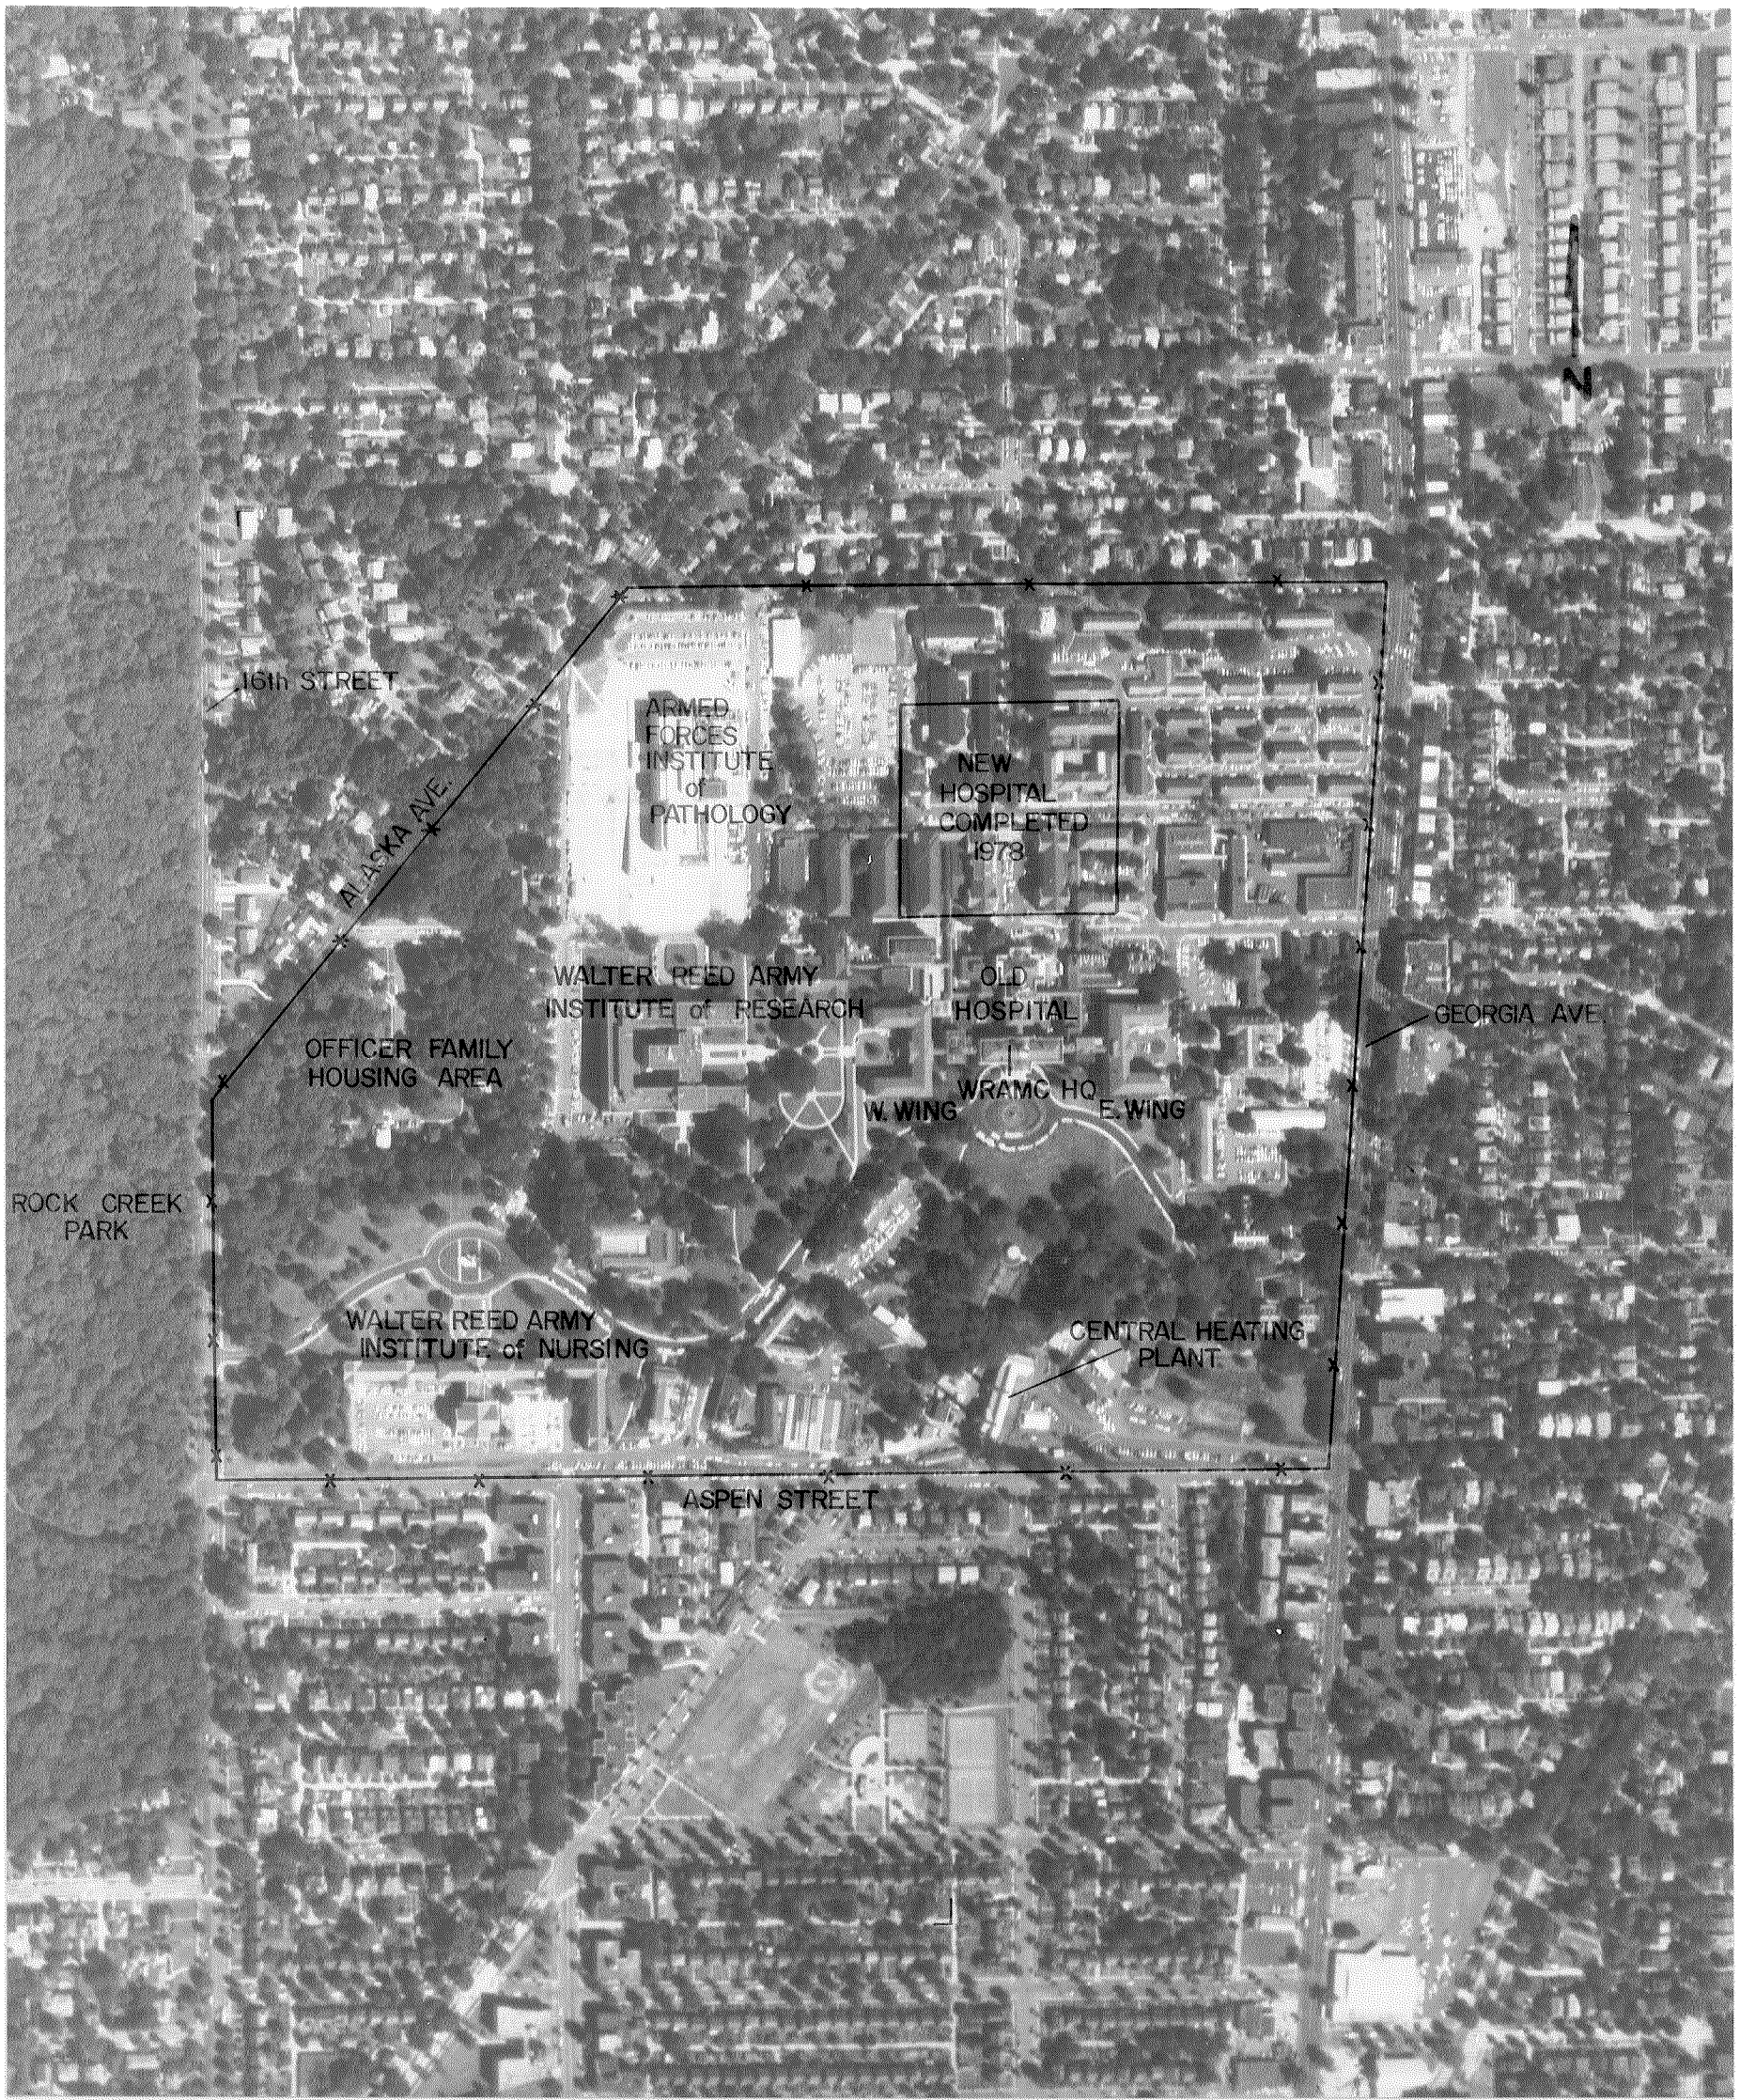
WALTER REED ARMY MEDICAL CENTER SEPTEMBER 1, 1970 APPROX. SCALE 1:5,100

Very little can be said relative to potential environmental hazards at WRAMC. The site consists of the main medical treatment facility; institutes of pathology, nursing and research; administrative buildings; barracks and service buildings. There are no impoundments or water courses within the installation. Routine household refuse is transported to other locations for disposal. Due to the nature of this site, no other photos or discussion are presented.

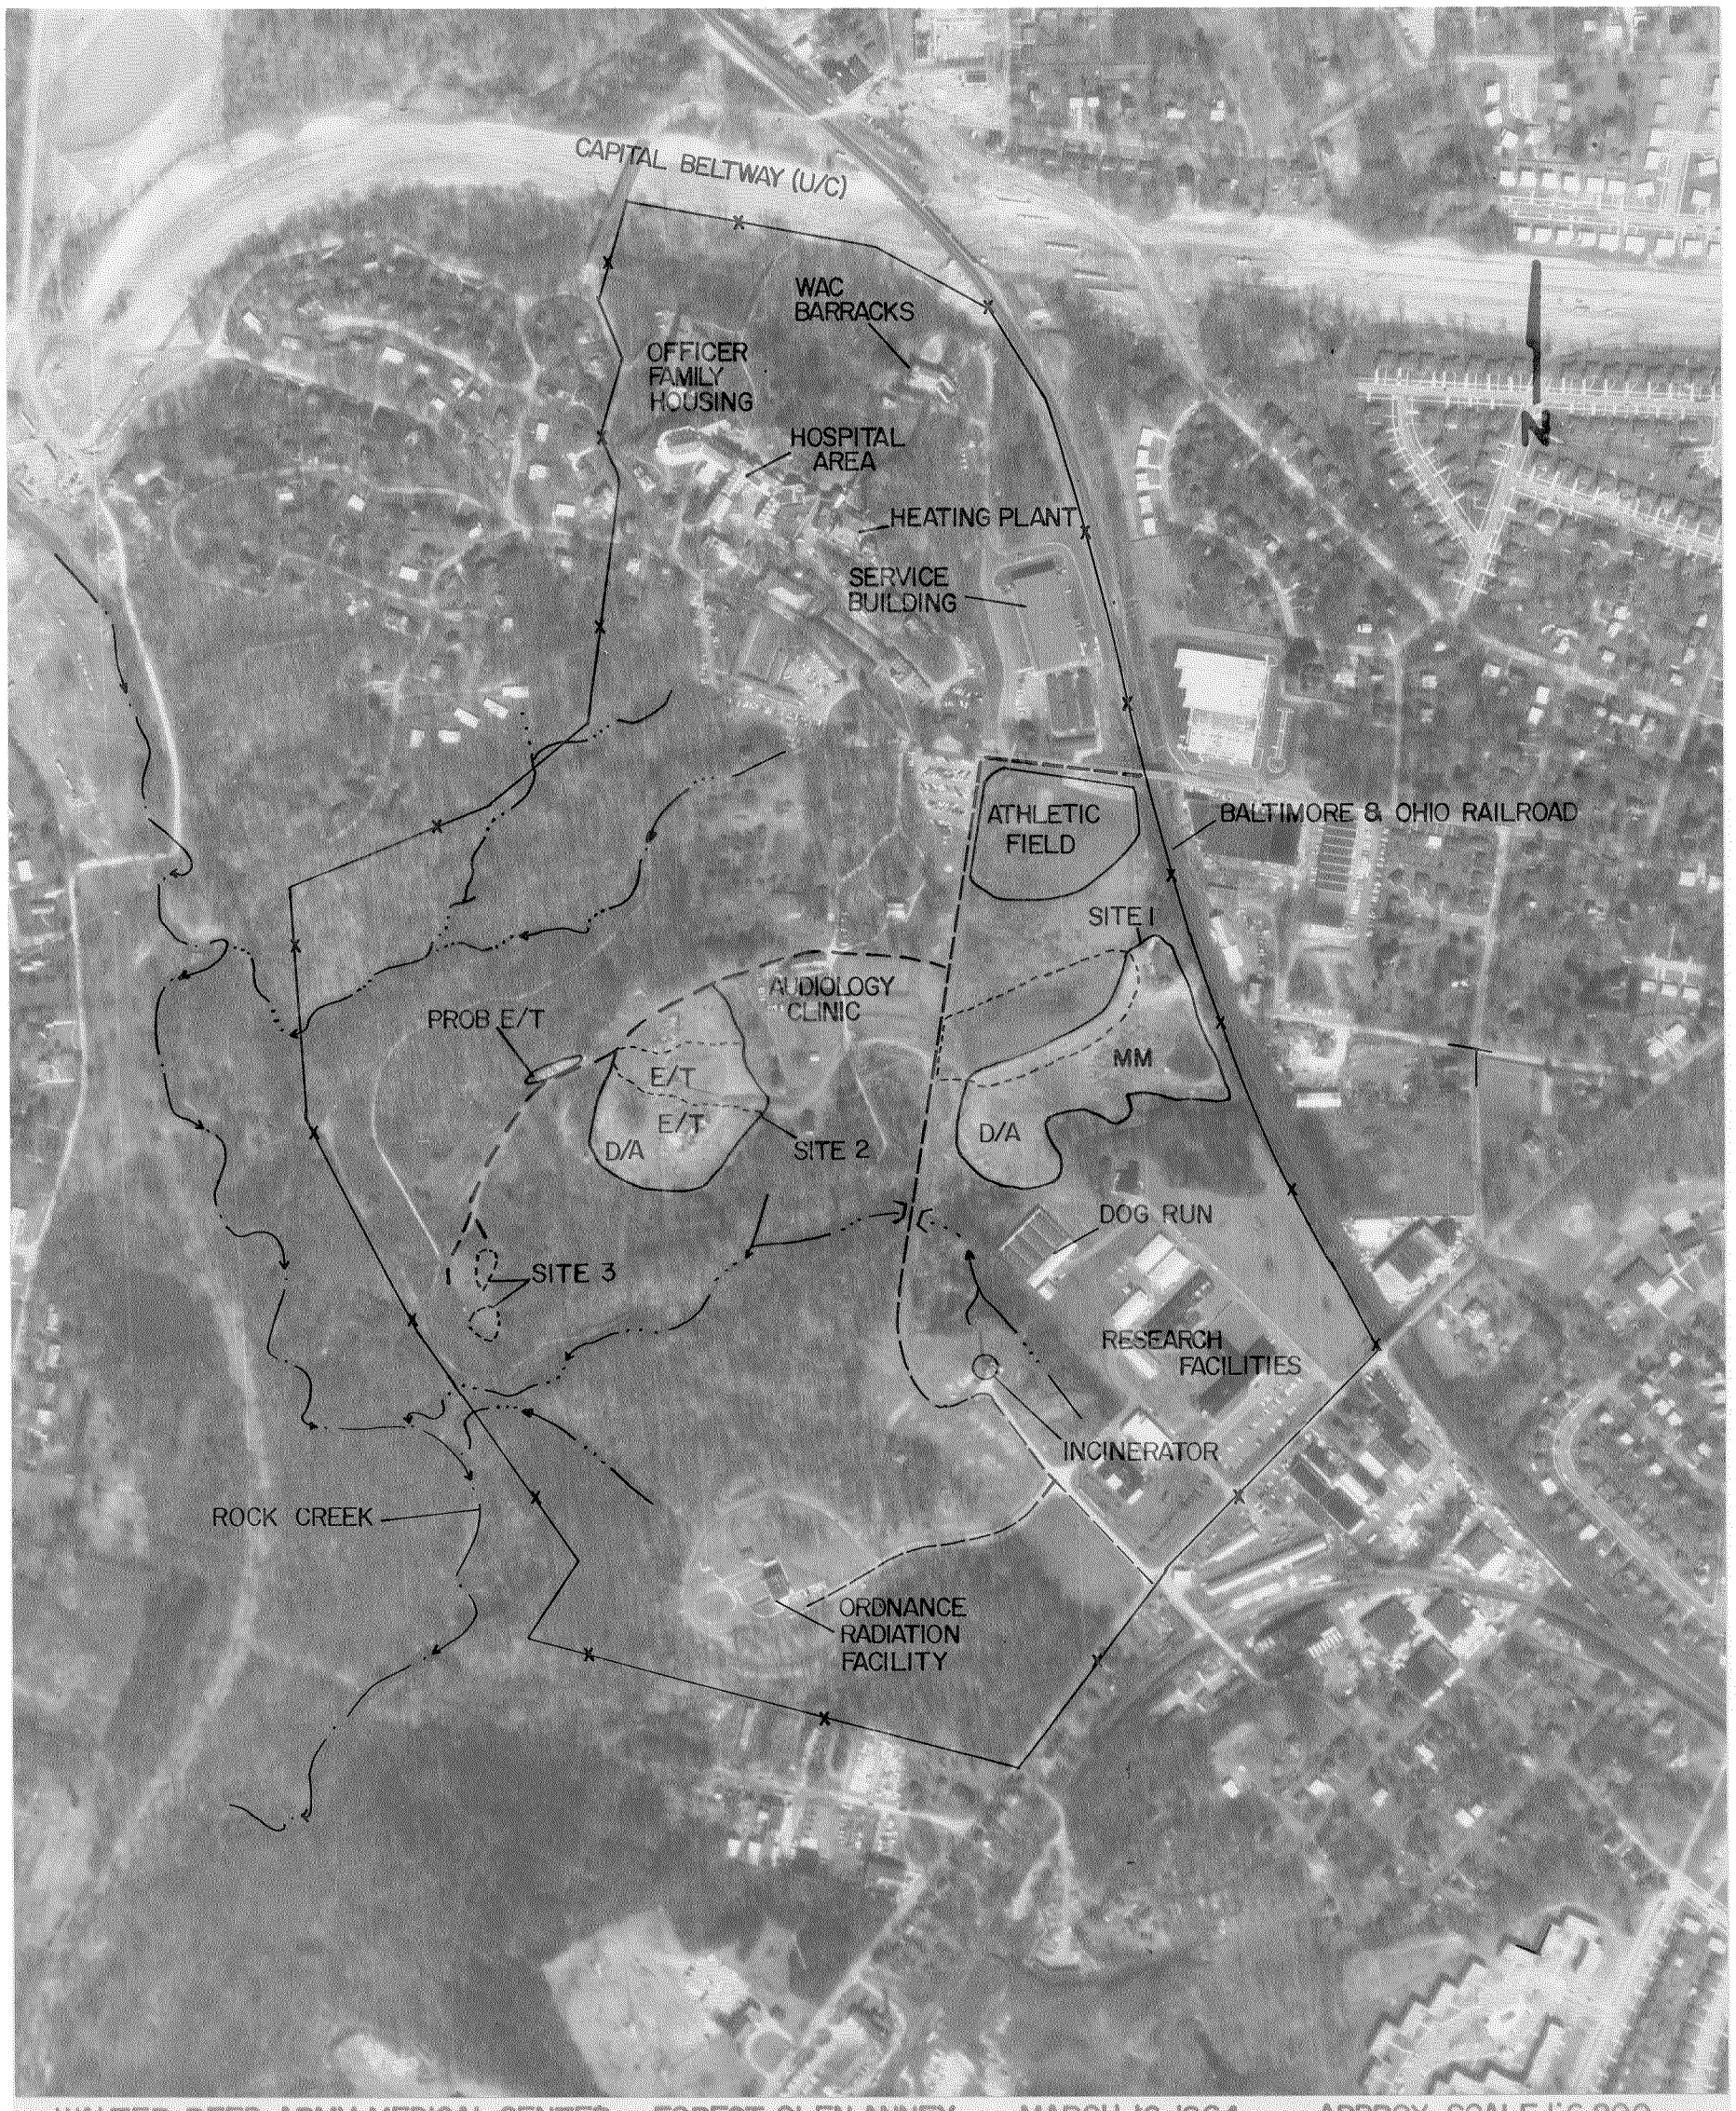
WALTER REED ARMY MEDICAL CENTER — FOREST GLEN ANNEX MARCH 16, 1964 APPROX. SCALE 1:6,800

Site 1 - Activity is still evident; the disturbance is again moving southward. Mounded material is clearly observed. Filling has apparently been occurring here for a number of years.

Site 2 - The site has expanded in size while becoming more centralized since the 1957 photo. Material being deposited here has the appearance of trash or rubble indicative of a landfill. A pile of probable exposed trash can be seen along the roadside just west of the site. The structure observed earlier is no longer evident.

Site 3 - No significant activity can be detected. However, the access road to this area appears to be used. The site has now revegetated.

Site 4 - No change has taken place since the 1957 photo. The incinerator smokestack remains.

Site 5 - Some new construction has taken place; otherwise there has been no change.

Drainage has not been altered significantly.

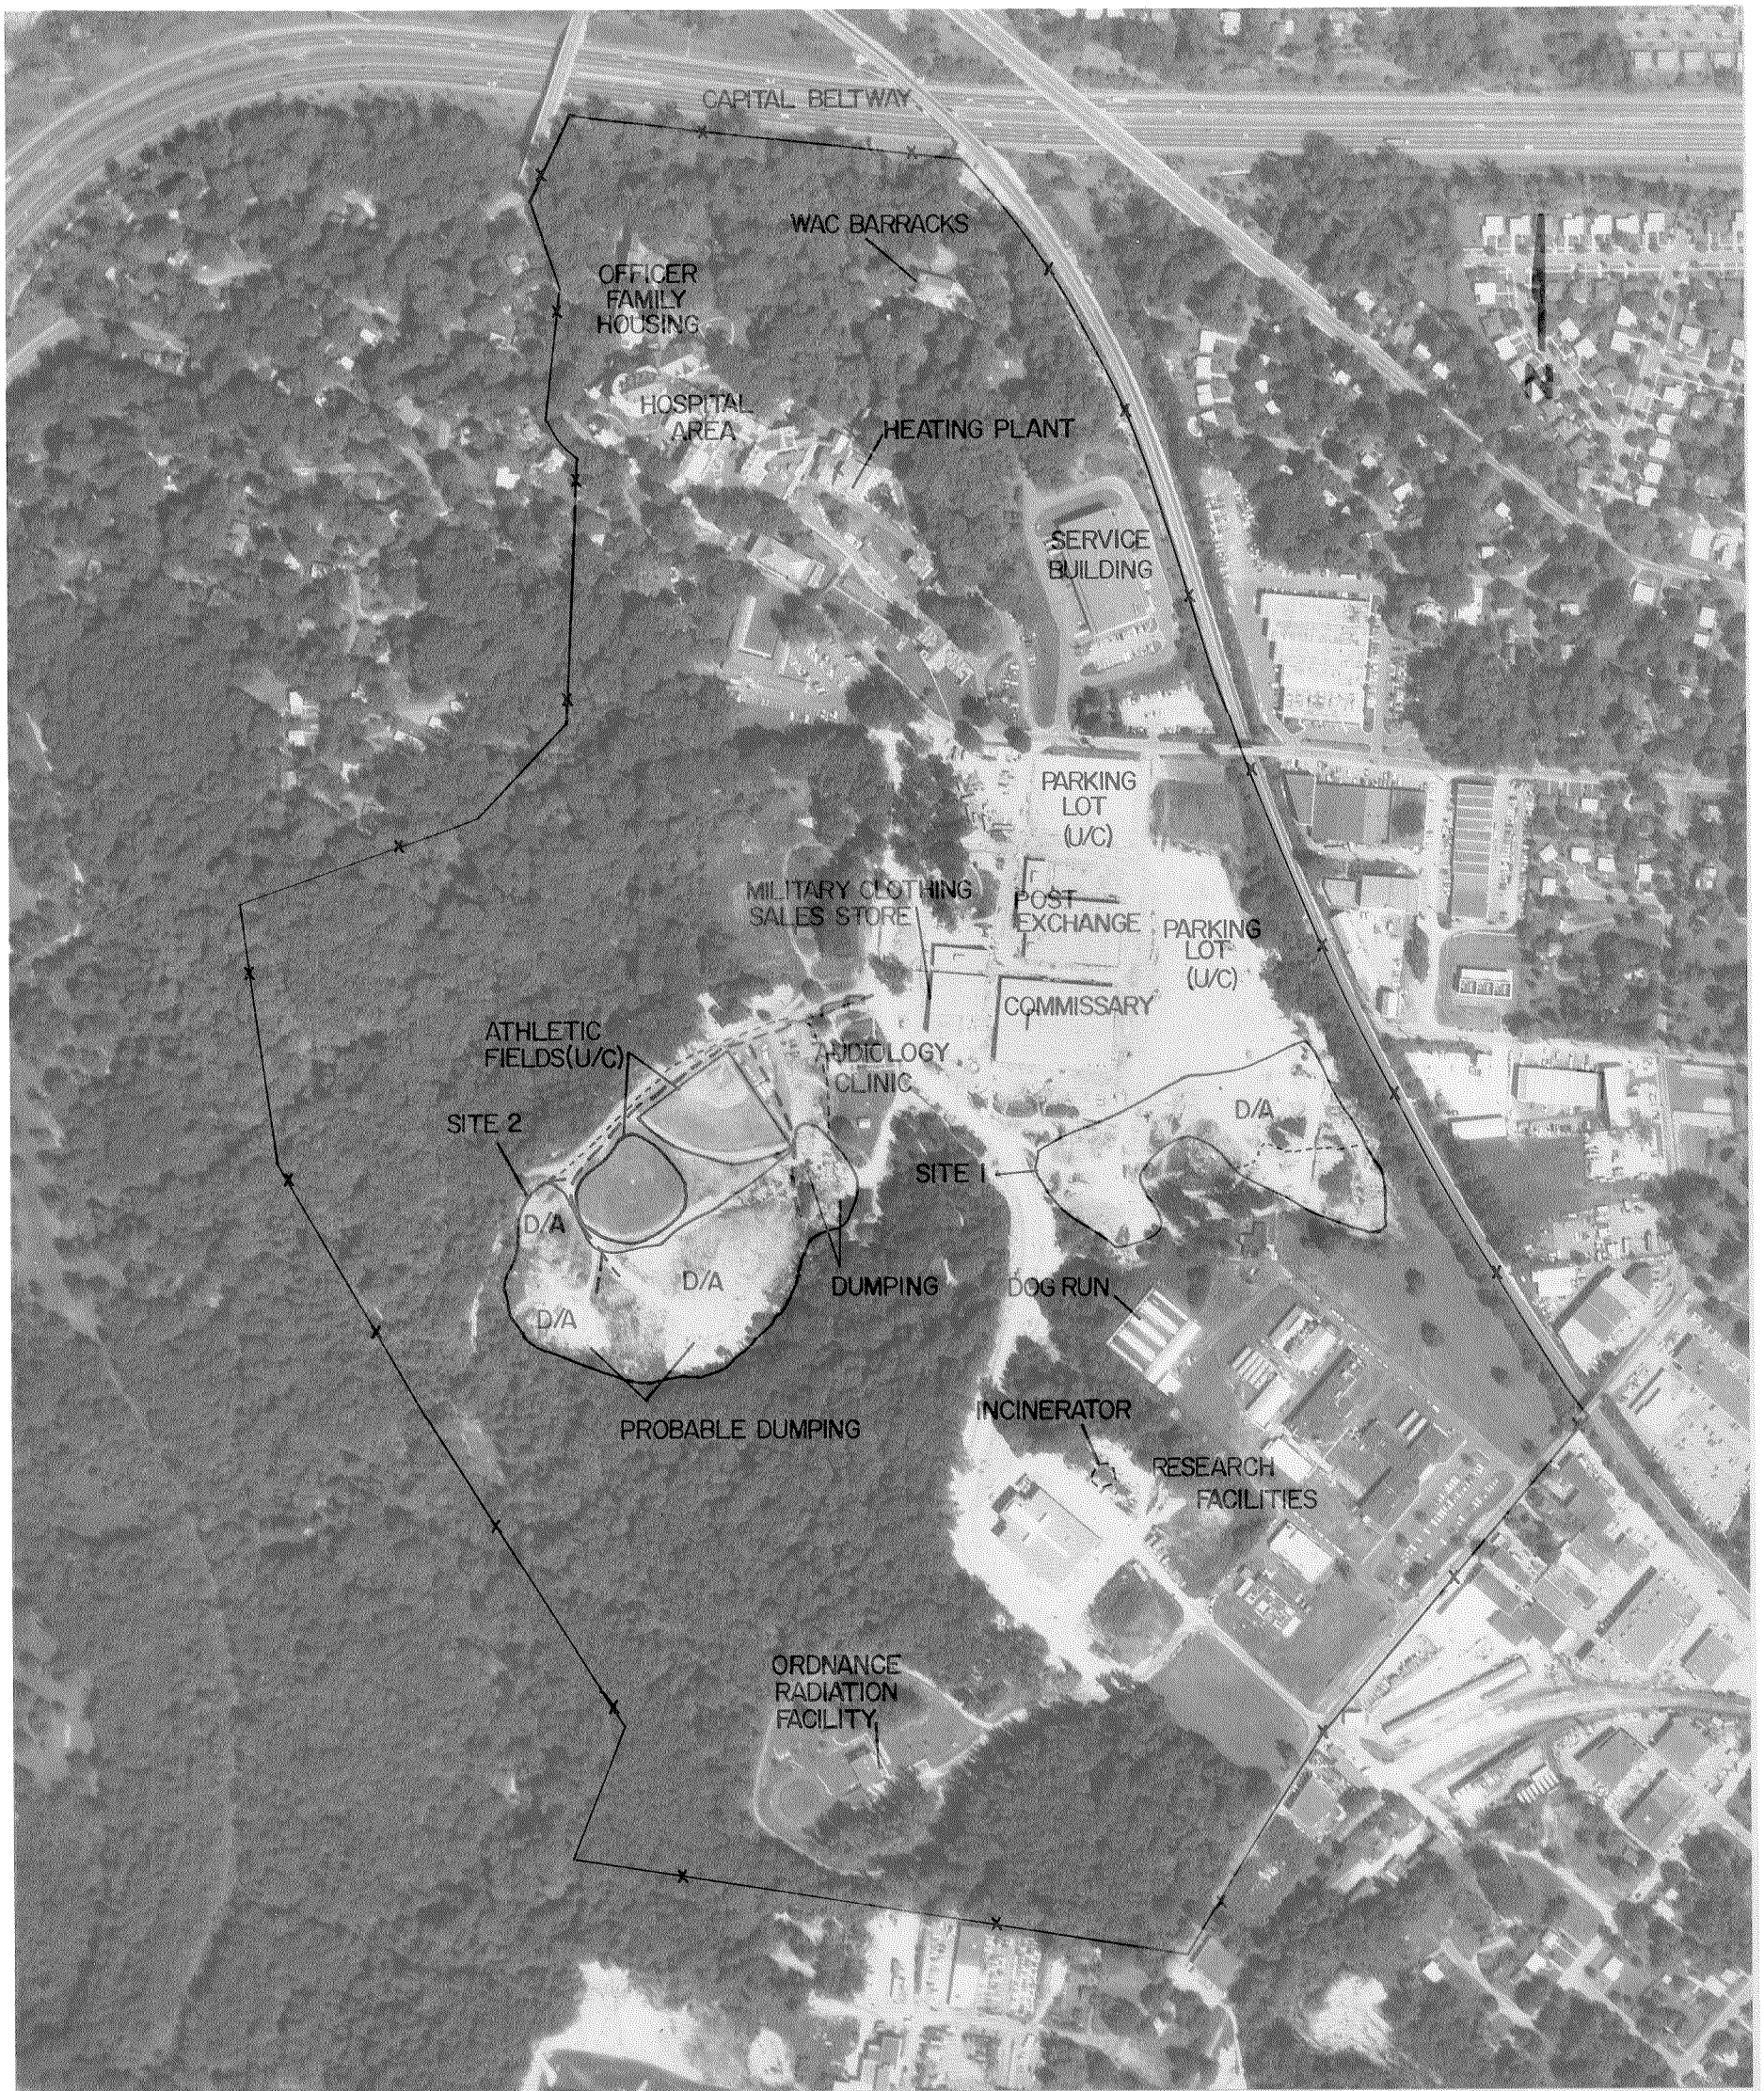
WALTER REED ARMY MEDICAL CENTER—FOREST GLEN ANNEX SEPTEMBER 1, 1970 APPROX. SCALE 1:5,000

Site 1 - Filling continues. The main military post exchange, commissary and parking lots are under construction north of the active area.

Site 2 - The landfill has expanded. Current filling areas are indicated by the presence of dumping and probable dumping. Athletic fields are being constructed on former areas of the landfill.

Site 3 - No significant change. The site has revegetated.

Site 4 - The incinerator and smokestack have been removed. A newly constructed building is now located where Site 4 had previously been.

Site 5 - Construction of research buildings has continued on the area formerly occupied by Site 5.

Due to heavy vegetation cover, drainage cannot be annotated. However, little change has occurred due to activities at the annex area.
