4 SURFACE CRACK CHARACTERIZATION

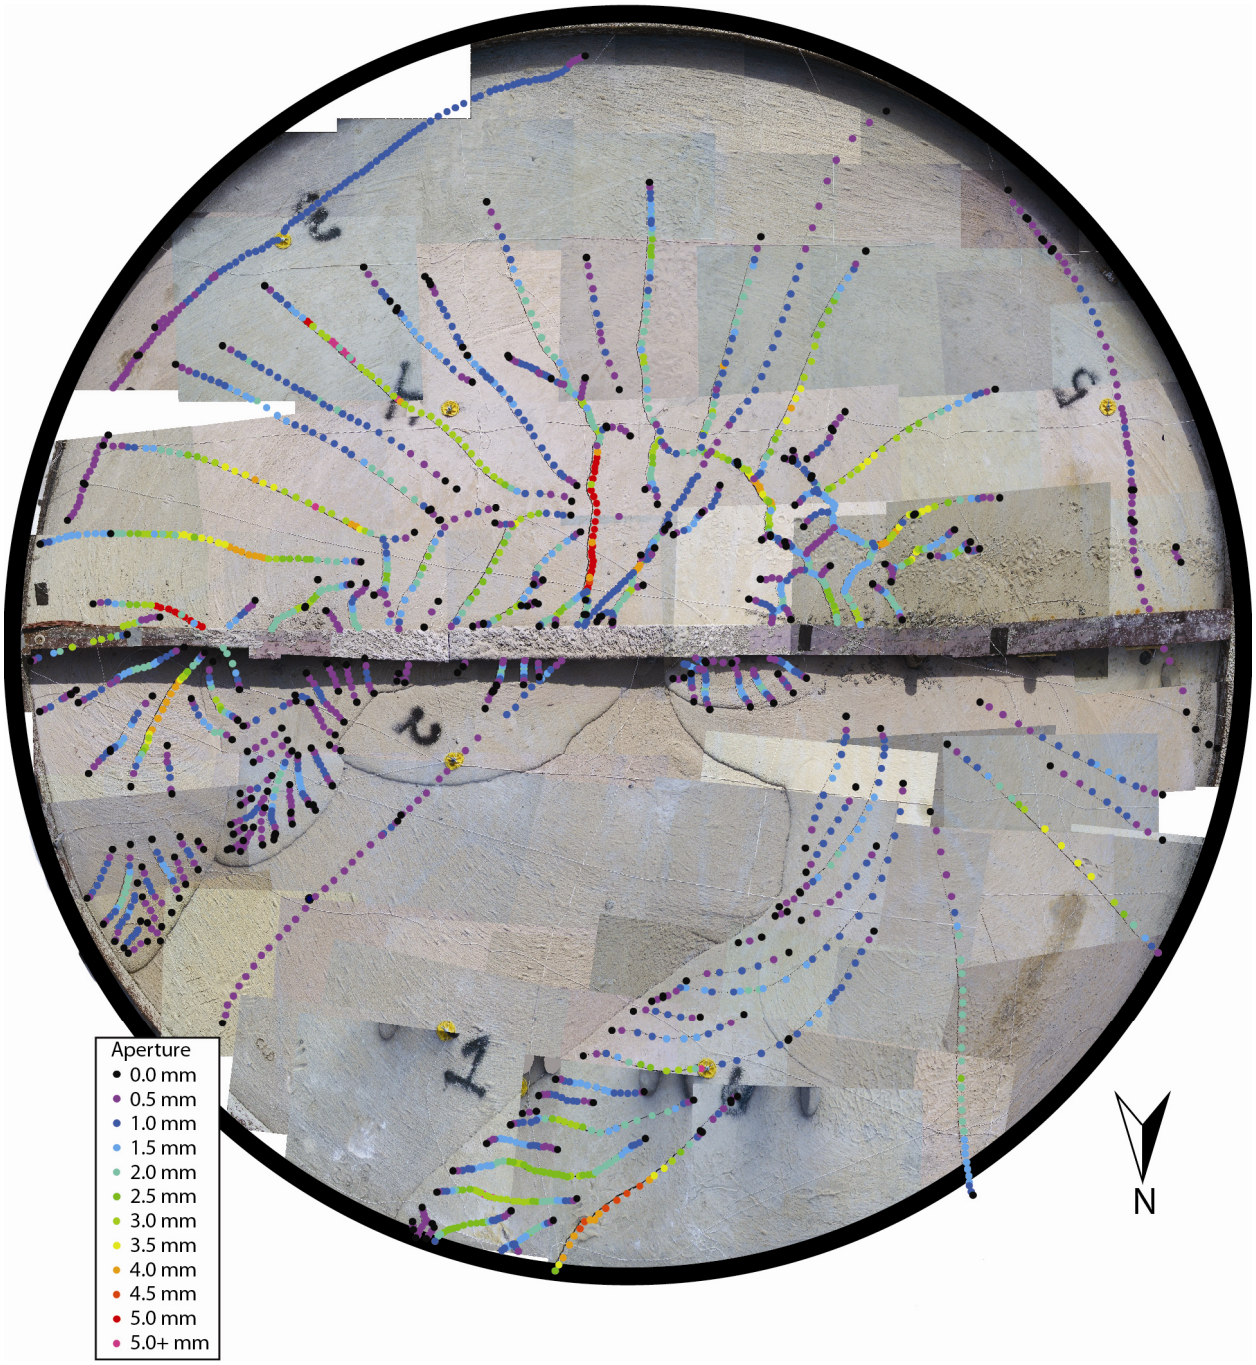
SwRI staff further characterized the 218 surface cracks on the monolith by mapping their locations (Figure 4-2) and apertures (Figure 4-3). Cracks are distributed in fairly distinct sets, including (i) radial to the monolith, (ii) roughly perpendicular to lobe flow fronts, (iii) two *en echelon* bisecting cracks, and (iv) a few cracks/crack families concentric to the monolith edge (Figure 4-2). Cracks that are roughly perpendicular to lobe flow fronts (and thus are roughly orthogonal to surface ripples within the grout flow lobe) commonly terminate between 0 and 10 cm [0 and 25 in] behind the front of the lobe, but occasionally penetrate though the front of a lobe into the underlying grout layer. As such cracks approach the tank liner wall, they are observed to be oriented roughly perpendicular to the wall, similar to the set of radial cracks (Figure 4-2). Aperture varied from <0.5 to 8 mm [<0.02 to 0.31 in], with variation in aperture along crack length (Figure 4-3). Aperture values of at least 4 mm [0.16 in] were found in each quadrant of the monolith.

Figure 4-2. Photomosaic of the 6.1-m [20-ft]-Diameter Intermediate-Scale Grout Monolith With Crack Distribution Patterns Traced and Coreholes 1–6 Shown. Yellow Cracks Belong to the Set That I Radial to the Monolith, Orange Cracks Belong to the Set That Is Perpendicular to Lobe Flow, Red Cracks Are Two Major *En Echelon* and Several Related Minor Cracks, and Purple Cracks/Crack Families Developed Late Through Coreholes 3 and 5 Concentric to the Monolith Edge.

Two vertical-to-subvertical crack families developed late and tangential to the coreholes from which Core 3 and Core 5 were extracted (Figure 4-2). The throughgoing vertical crack that developed tangential to Corehole 3 was purposefully intersected by Overcore 8 [Figures 3-5(b) and 3-6(b),(d)]. Other cracks bifurcated off the Corehole 3 crack in response to wet coring of Corehole 8. The subvertical crack family that developed tangential to Corehole 5 consists of a long series of *en echelon* cracks (Figure 4-2), one of which is exposed in cross section in the sidewall of the Section One destructive evaluation grid (Figure 3-8). These late-developed cracks/crack families, which were not present during permeability testing of Coreholes 3 and 5, are attributed to dry-coring-induced mechanical stresses, perhaps combined with diurnal tank expansion, contraction, and related differential settlement-induced stresses. The semi-parallel-to-tank-wall orientation of the crack that developed tangential to Corehole 3, combined with its location relative to the angle-iron crossbar, suggests that the formation of this crack is also potentially linked to diurnal expansion and contraction effects. Propagation of and bifurcated splitting off the Corehole 5 crack family was also observed when the Section One wall was removed for grout bonding evaluation (Figures 3-8 and 3-9). The Corehole 5 crack is clearly visible within Corehole 5 and should be further examined borescopically.
