Plum Brook Reactor Facility

Final Status Survey Report

Attachment 8

Hot Laboratory
(Building 1112)

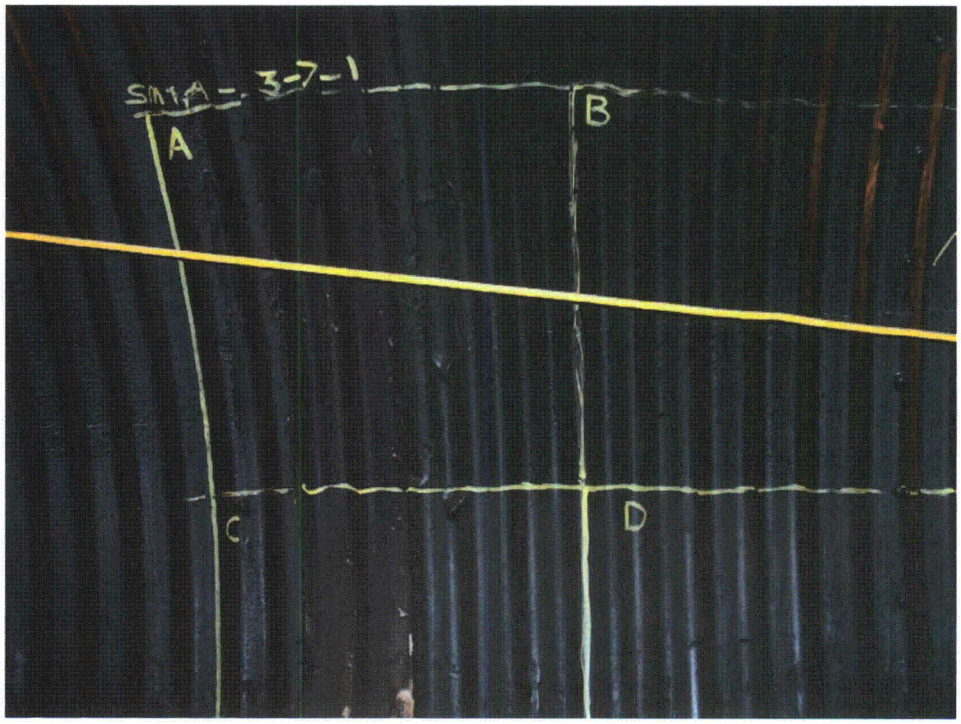
Area in Corrugated HL/ROLB Pipe Tunnel with Extruding Sealant (HL-3-7)

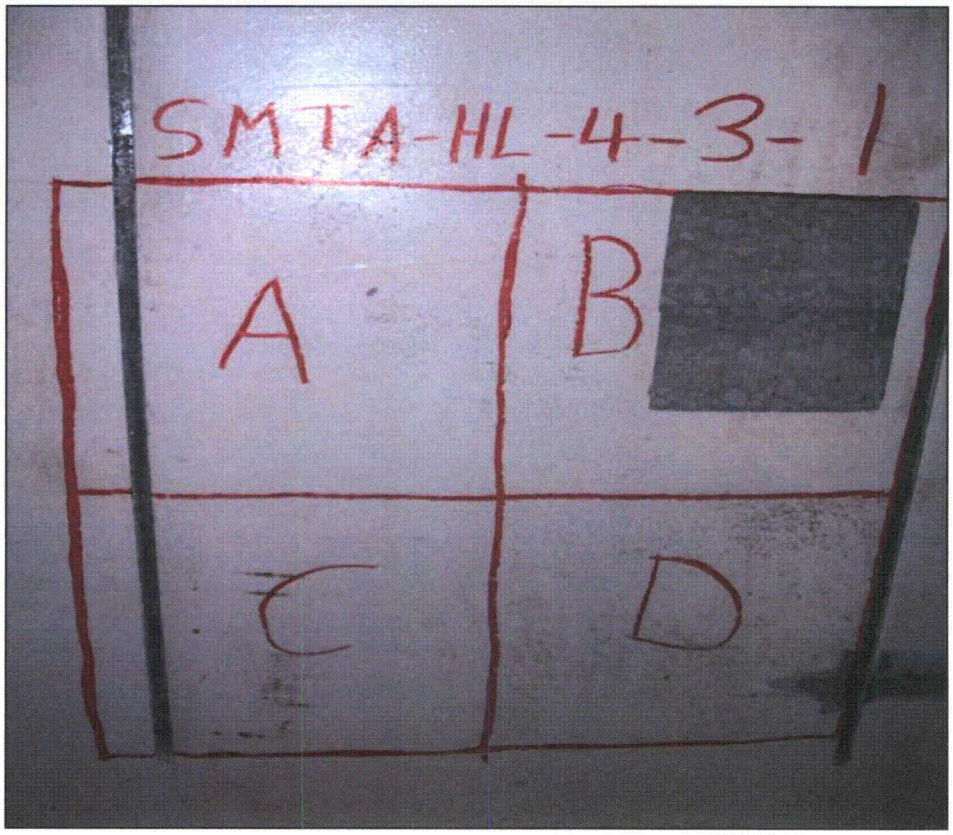
South Wall of Off Gas System Area (Rm 19A) – Unistruts and Scabbled Surfaces (HL-4-3)

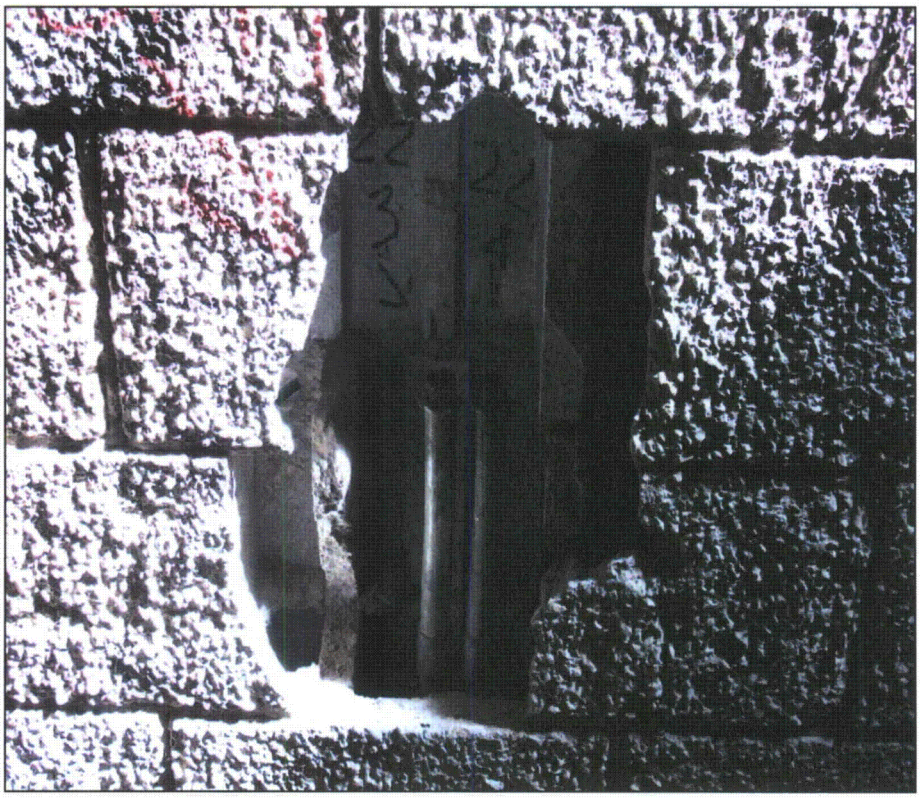
Concrete Block Wall Opening with Embedded Conduit (HL-1-74)

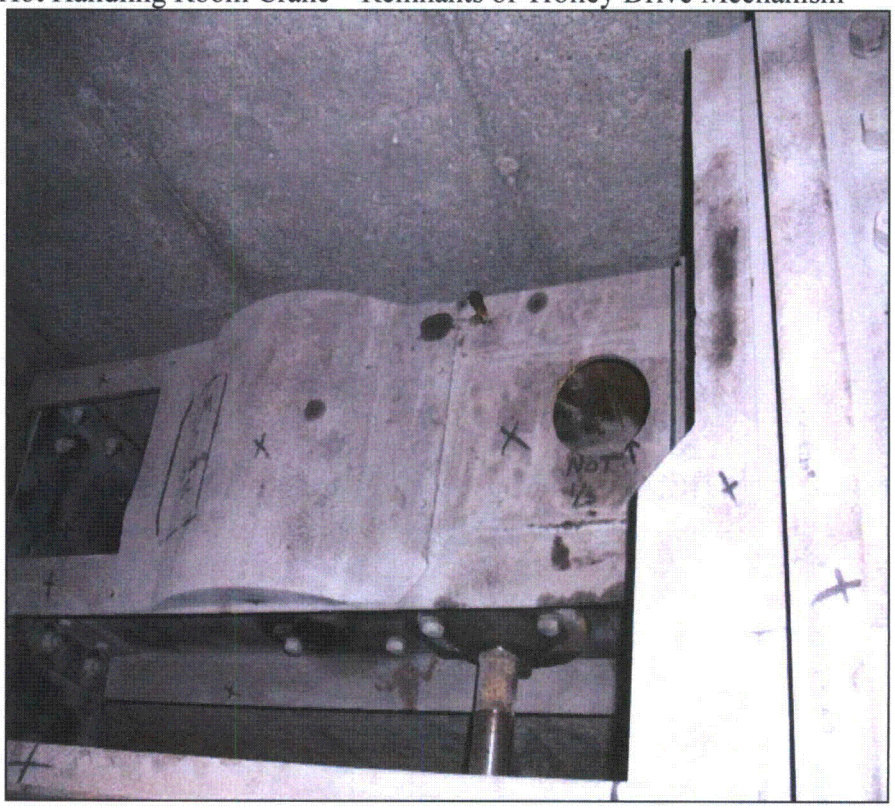
Hot Handling Room Crane – Remnants of Trolley Drive Mechanism
