NUREG/CR-6471, Vol. 1
PNNL-11143

Characterization of Flaws in U.S. Reactor Pressure Vessels

Density and Distribution of Flaw Indications in PVRUF

Pacific Northwest National Laboratory

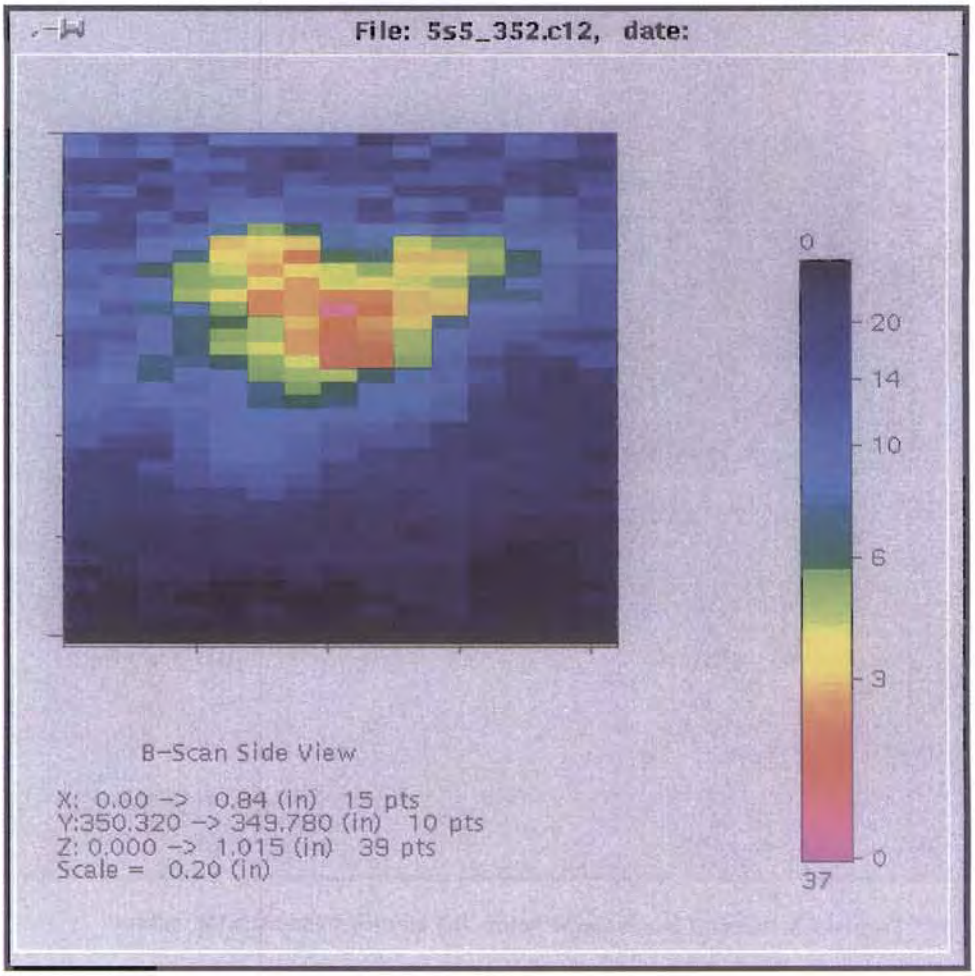
Figure 4.7 shows an example of a coin (semi-circular or elliptical) shape near the inner surface of the vessel. Underclad cracks will have a large aspect ratio, distinguishing them from near-surface inclusions, and often producing a coin shape in the transducer end view of angle beam inspections.

Figure 4.7 Coin shape near the clad-to-base-metal interface

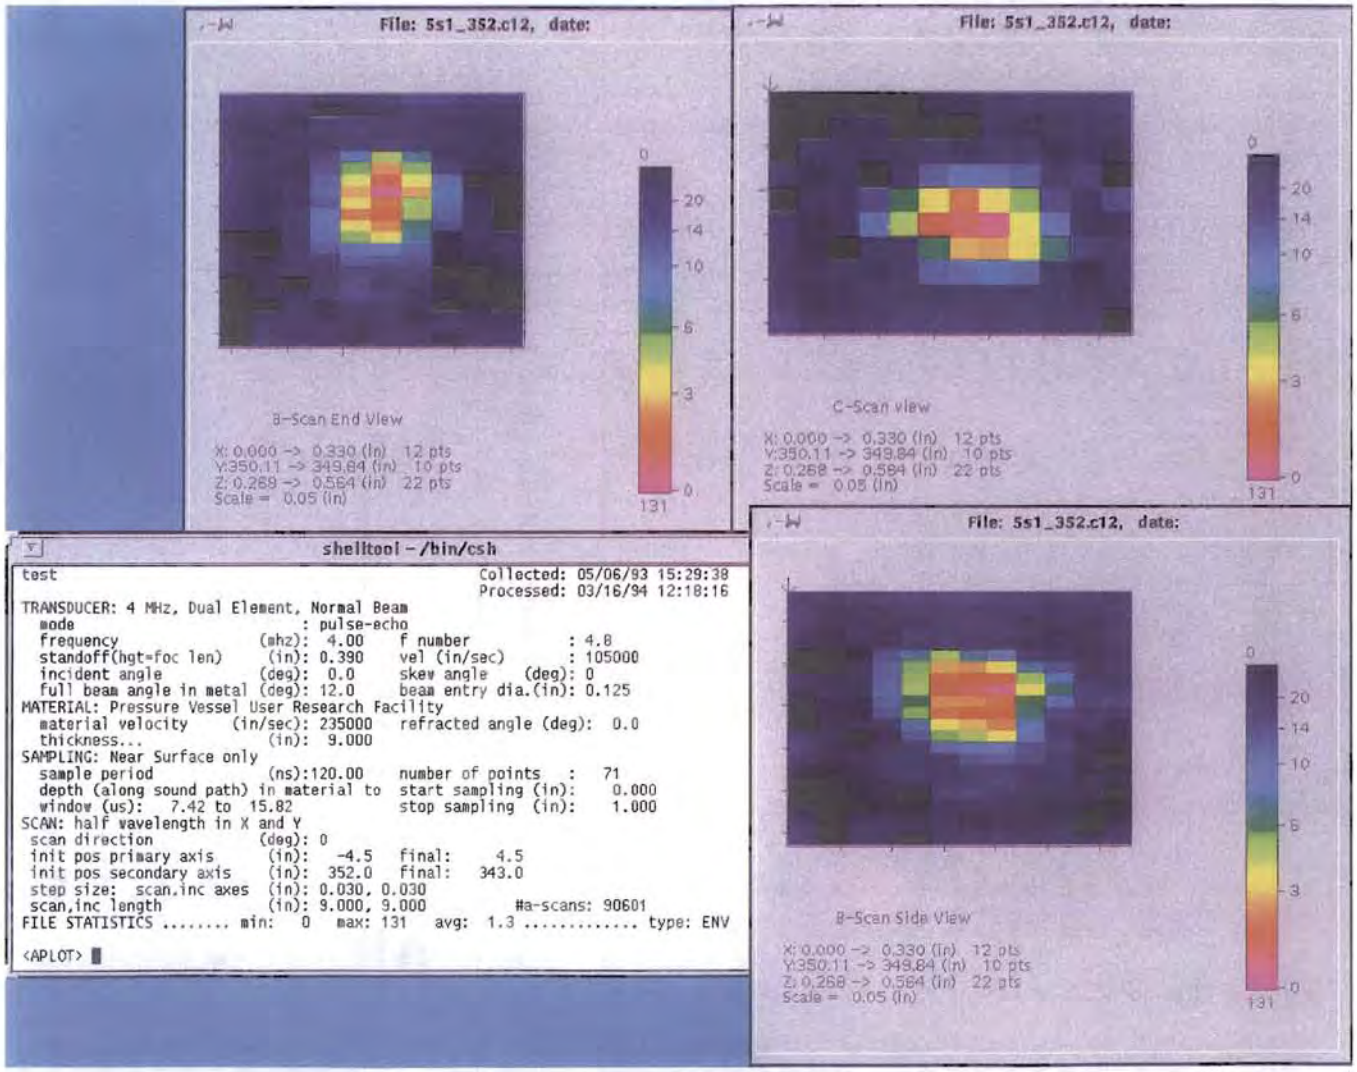
The indication shown in Figure 5.1 is detectable, based on its signal strength of 131/255. The signal amplitude of 131 can be found at the bottom of the gray scale. The location of the indication is X = 0.20" (from the B-Scan side view), Y = 348.95" (from the B-Scan end view), and Z = 0.40" (from the B-Scan side view).

Figure 5.1 Mode 1 detection of planar indication #1 in the near surface zone

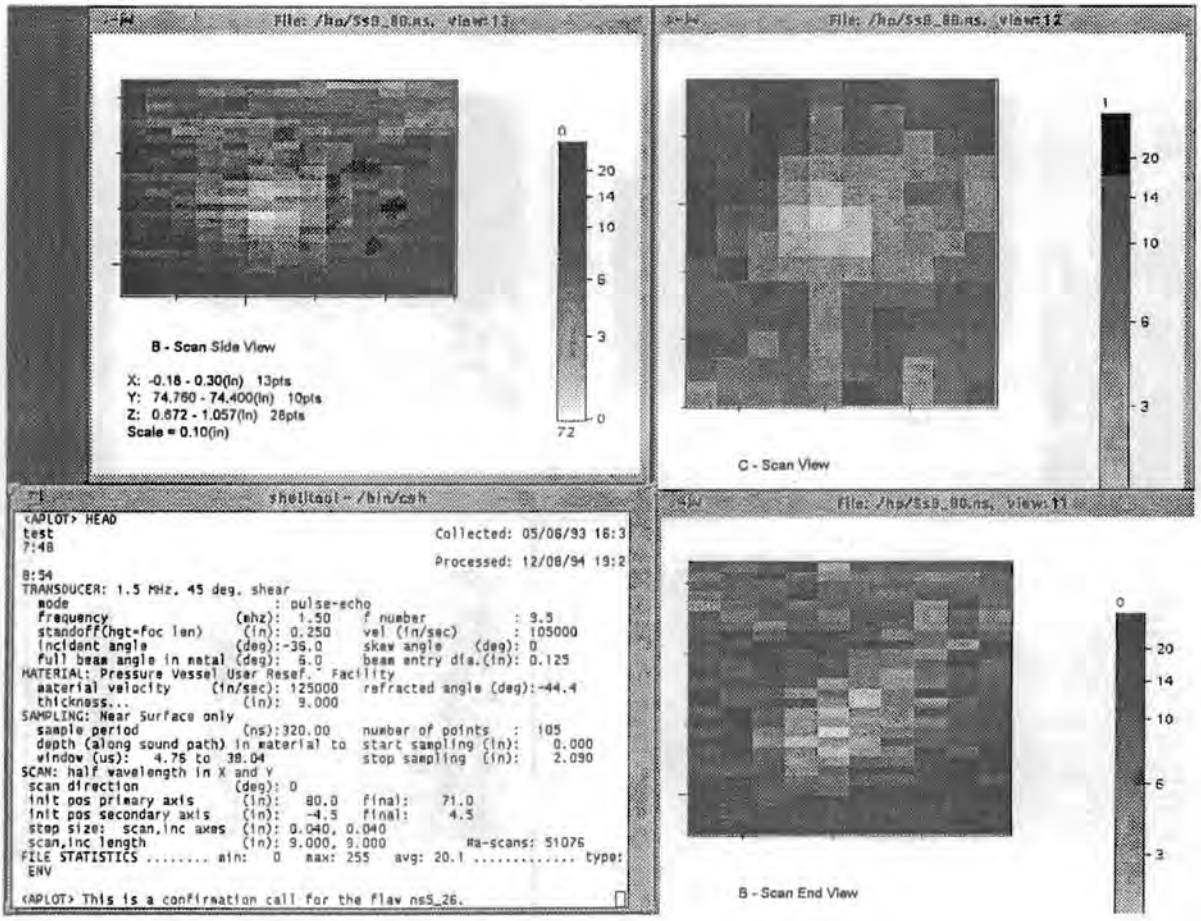
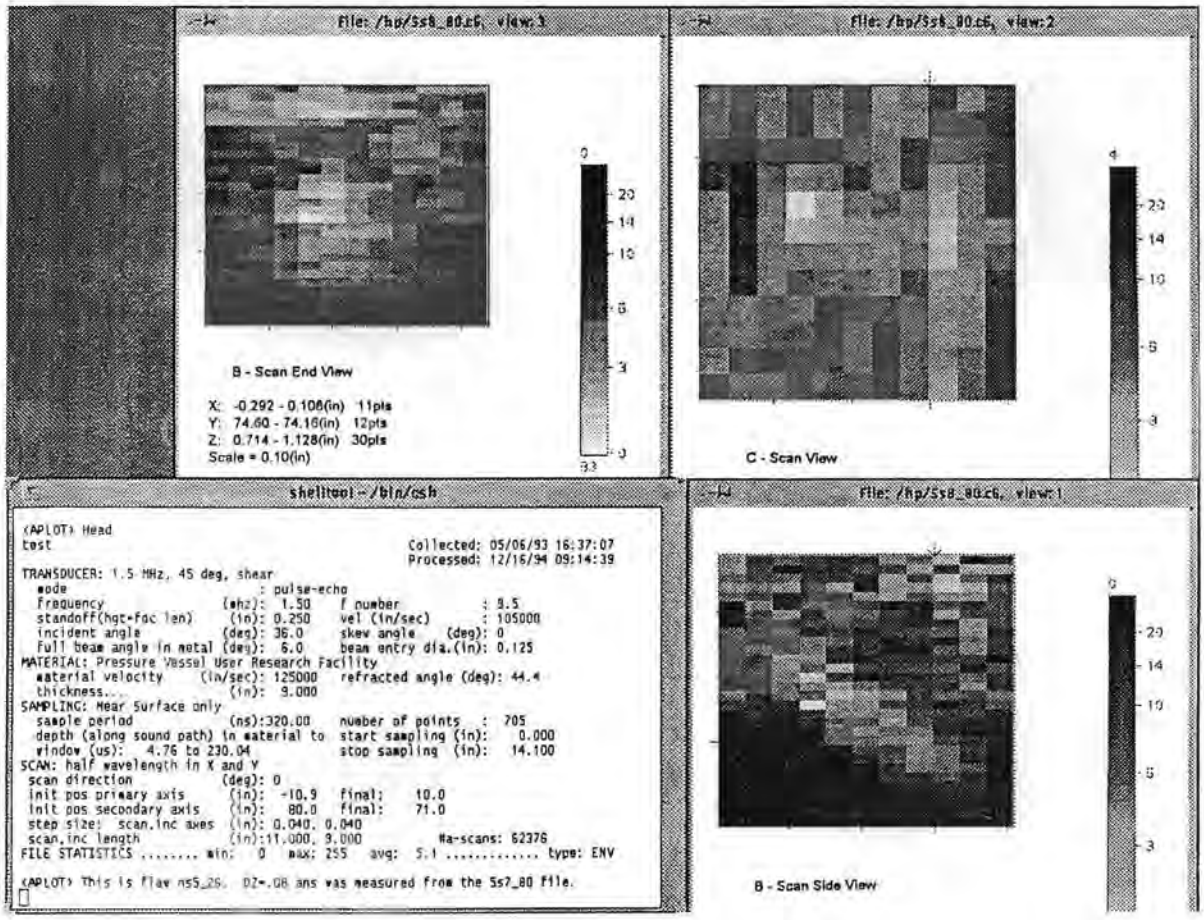
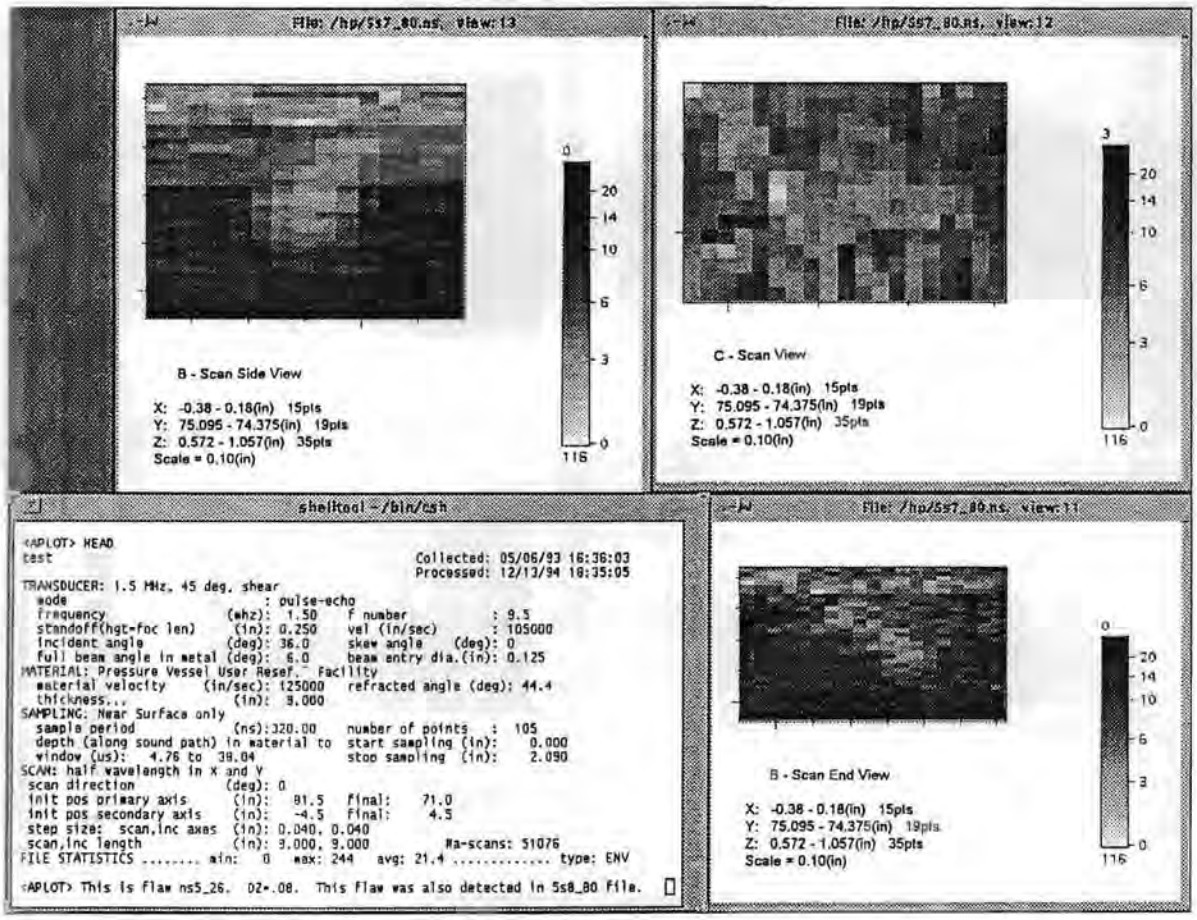
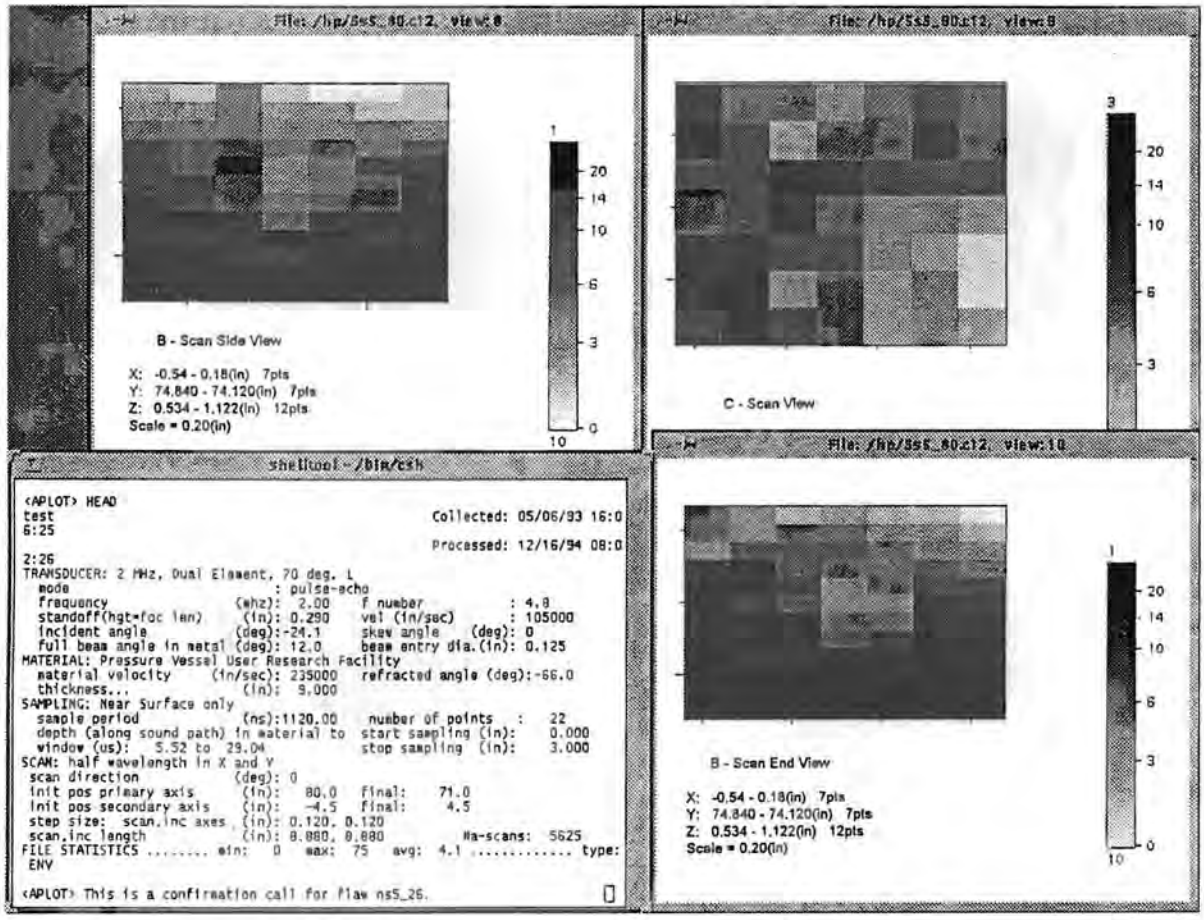
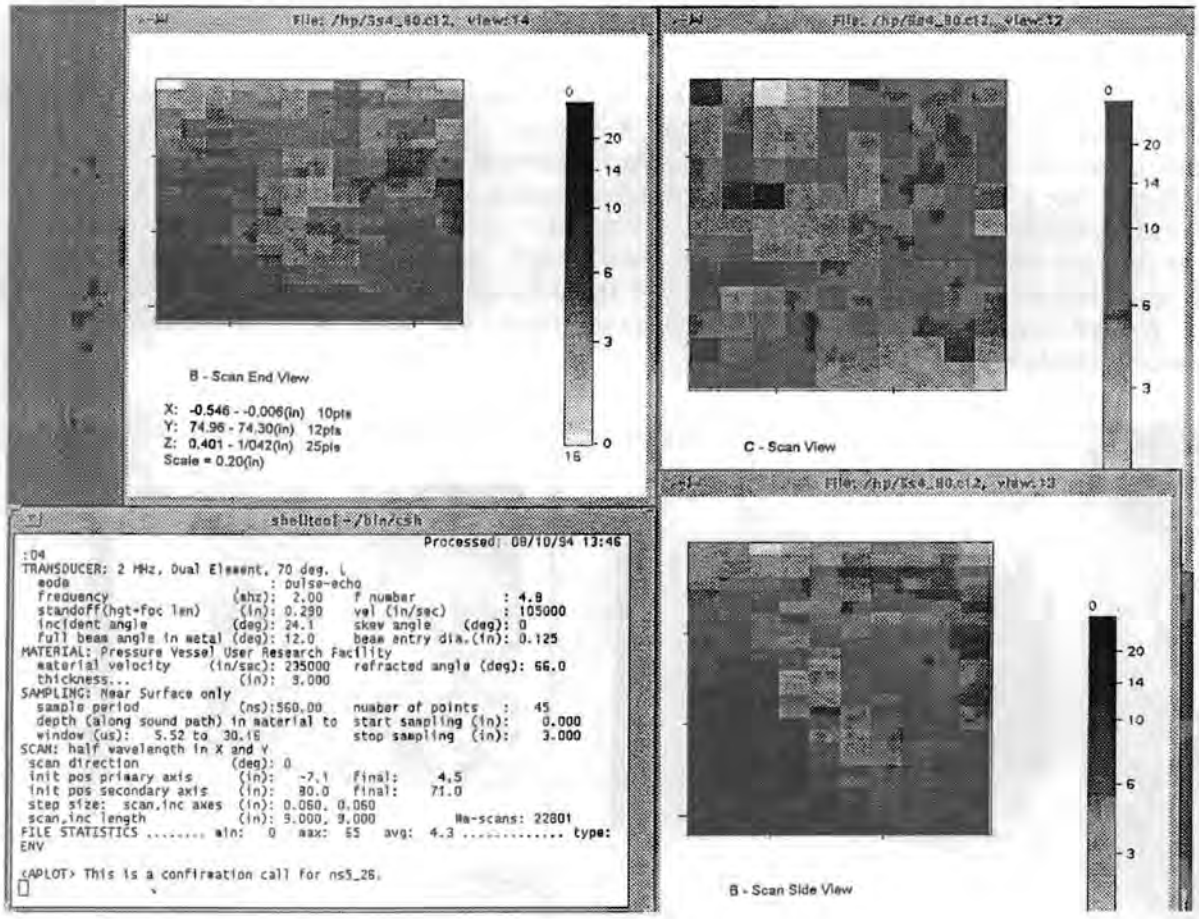
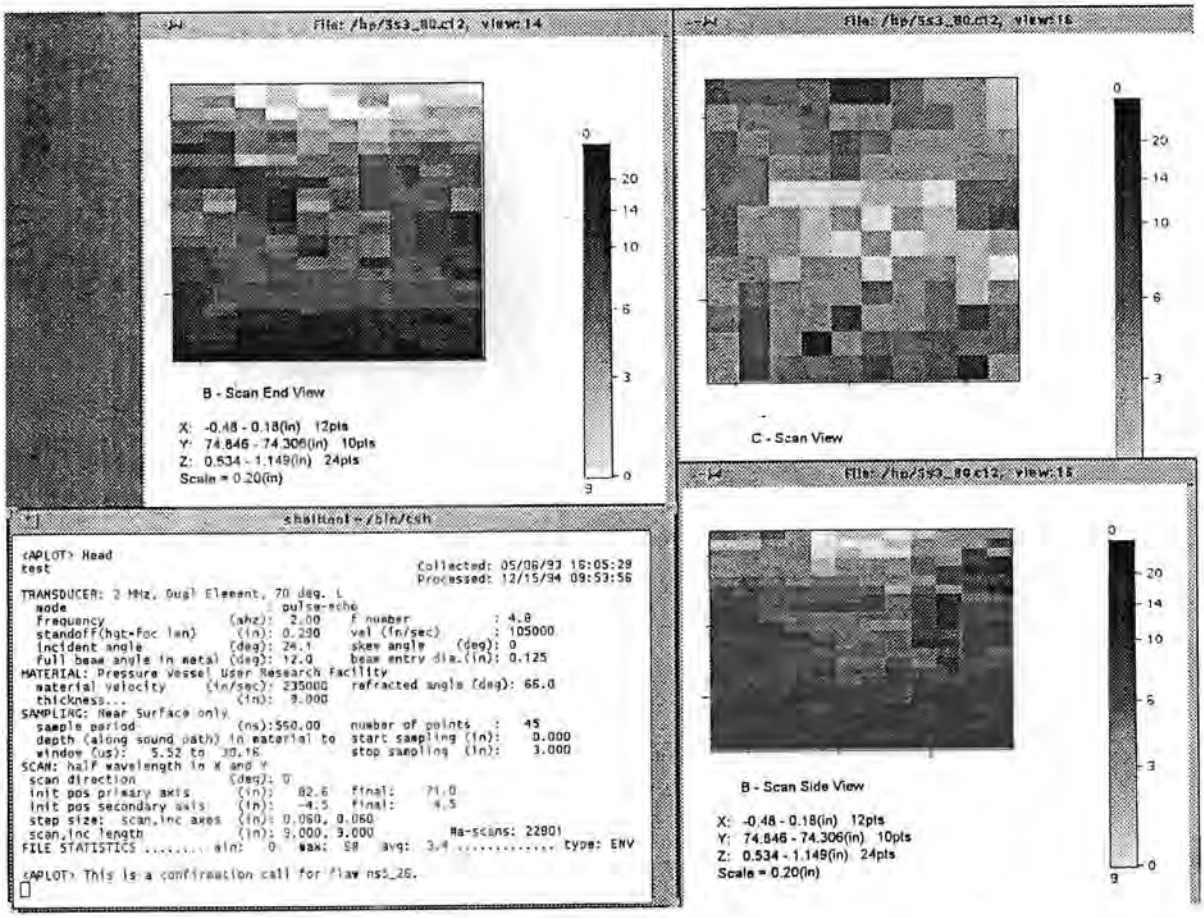
Figure A.10f Volumetric indication #1 in the near surface weldment: mode 9

Figure A.10e Volumetric indication #1 in the near surface weldment: mode 8

Figure A.10d Volumetric indication #1 in the near surface weldment: mode 7

Figure A.10c Volumetric indication #1 in the near surface weldment: mode 5

Figure A.10b Volumetric indication #1 in the near surface weldment: mode 4

Figures A.10a-f shows volumetric indication #1 in the near surface weldment. This volumetric indication has a through-wall extent of 6 mm based on different depth estimates of 18 to 24 mm. The detections were made in modes 7 and 8 where they had isolated TOF shape at depths of 20 to 24 mm. There were confirmations in modes 3, 4, 5, and 9 at depths of 18 to 23 mm. The wave packet width in modes 7 and 8 gives an alternate depth size of 2 mm. The indication is characterized as volumetric based on detection in orgothonal modes. There is no evidence of coin shape in the end views. The length is 10 mm and was made to LOS in mode 4. The width is 10 mm and was made to LOS in mode 5. The range of aspect ratios (length/depth) of this indication is 1.7 to 5. The maximum amplitude-to-noise ratio is of medium range at 97 to 30. With an X coordinate of -6 mm, the indication is clearly in the weld metal. With Z coordinates of 18 to 24 mm, the indication is clearly below the cladding.

Figure A.10a Volumetric indication #1 in the near surface weldment: mode 3

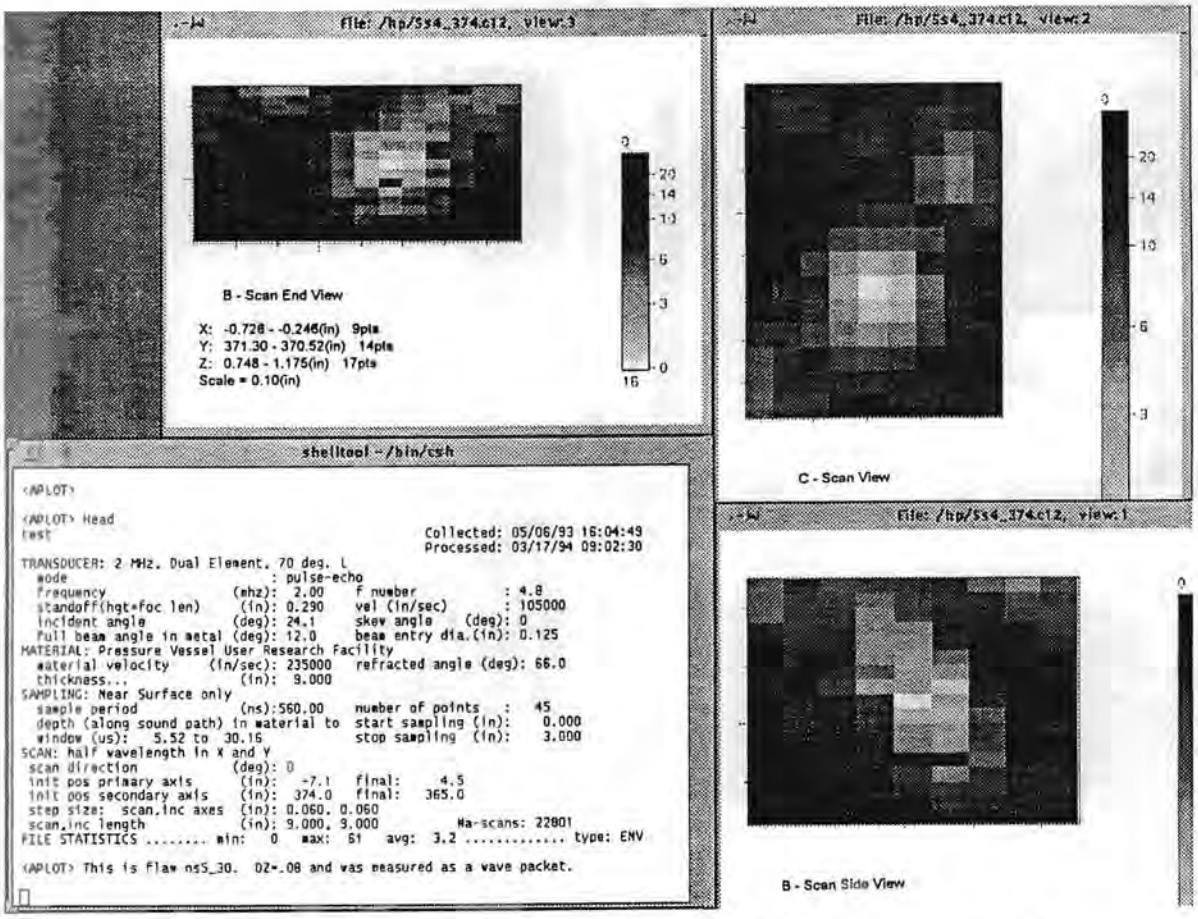
Figure A.9 shows planar indication #9 in the near surface weldment. This planar indication has a through-wall extent of 2 mm based on wave packet width. The detection was made in mode 4 where it had isolated TOF shape at a depth of 24 mm. There were no confirmations in other modes. The indication is characterized as planar based on lack of normal beam detection. There is no evidence of coin shape in the end view of mode 4. The length is 11 mm and was made to LOS. The aspect ratio (length/depth) of this indication is 6 giving an orientation along the weld. The maximum amplitude-to-noise ratio is high at 16 to 3. With an X coordinate of 12 mm, the indication is in the weld metal, possibly in the HAZ. With a Z coordinate of 24 mm, the indication is clearly below the cladding.

Figure A.9 Planar indication #9 in the near surface weldment: mode 4

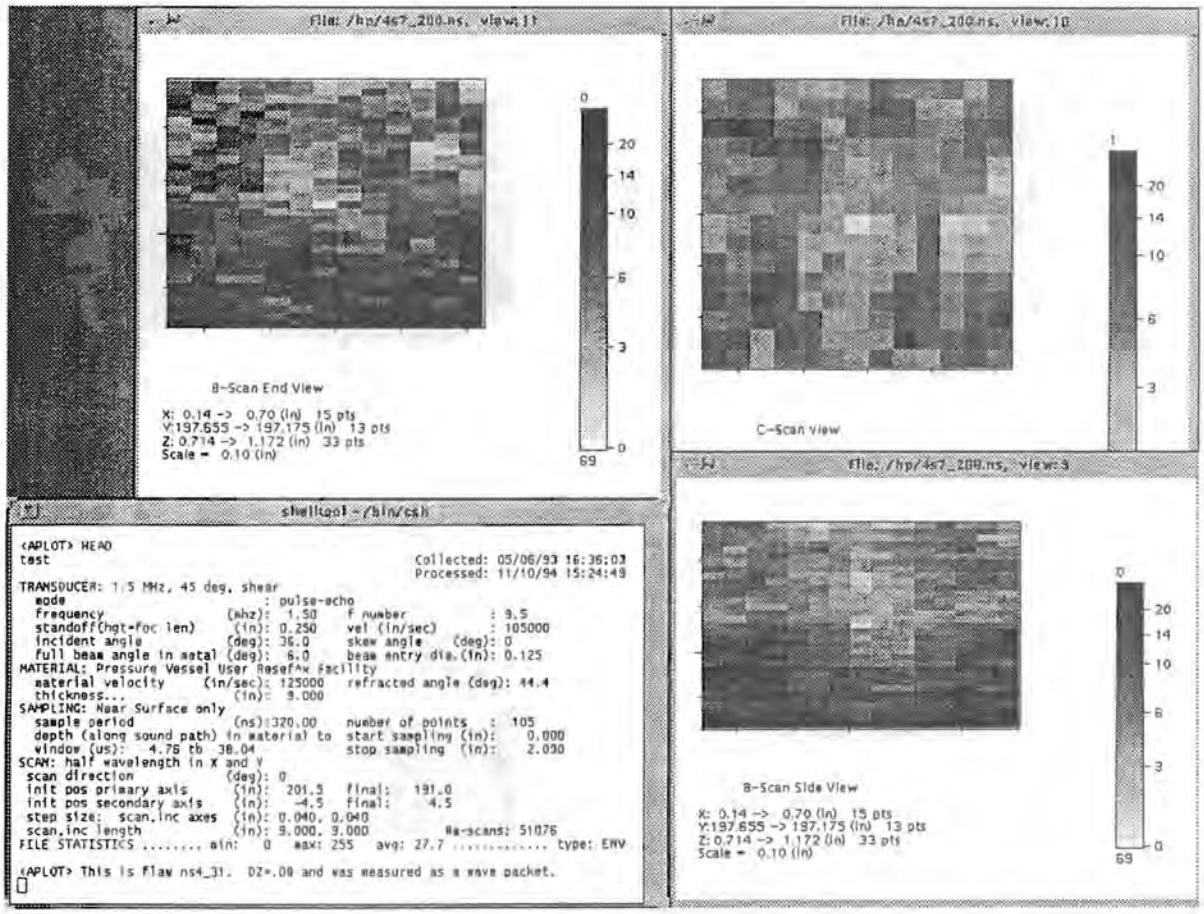
Figure A.8 shows planar indication #8 in the near surface weldment. This planar indication has a through-wall extent of 2 mm based on wave packet width. The detection was made in mode 7 where it had isolated TOF shape at a depth of 23 mm. There were no confirmations in other modes. The indication is characterized as planar based on lack of normal beam detection. There is no evidence of coin shape in the side view of mode 7. The width is 10 mm and was made to LOS in mode 7. The aspect ratio (width/depth) of this indication is 5 giving an orientation across the weld. The maximum amplitude-to-noise ratio is of medium range at 69 to 28. With an X coordinate of 11 mm, the indication is in the weld, possibly in the HAZ. With a Z coordinate of 23 mm, the indication is clearly below the cladding.

Figure A.8 Planar indication #8 in the near surface weldment: mode 7

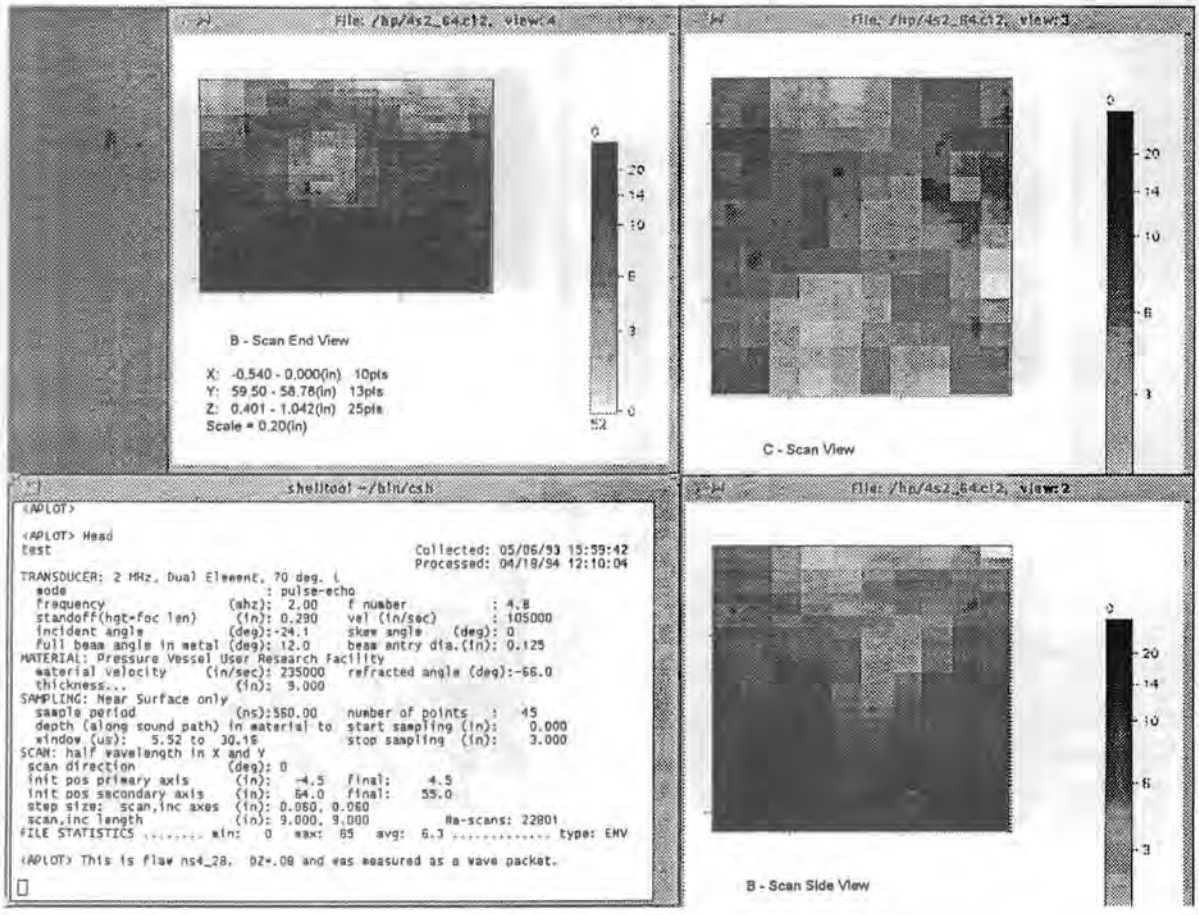
Figure A.7 shows planar indication #7 in the near surface weldment. This planar indication has a through-wall extent of 2 mm based on wave packet width. The detection was made in mode 2 where it had isolated TOF shape at a depth of 15 mm. There were no confirmations in other modes. The indication is characterized as planar based on lack of normal beam detection. There is no evidence of coin shape in the end view of mode 2. The length is 11 mm and was made to LOS in mode 2. The aspect ratio (length/depth) of this indication is 5 giving an orientation along the weld. The maximum amplitude-to-noise ratio is high at 52 to 12. With an X coordinate of -6 mm, the indication is clearly in the weld metal. With a Z coordinate of 15 mm, the indication is clearly below the cladding.

Figure A.7 Planar indication #7 in the near surface weldment: mode 2

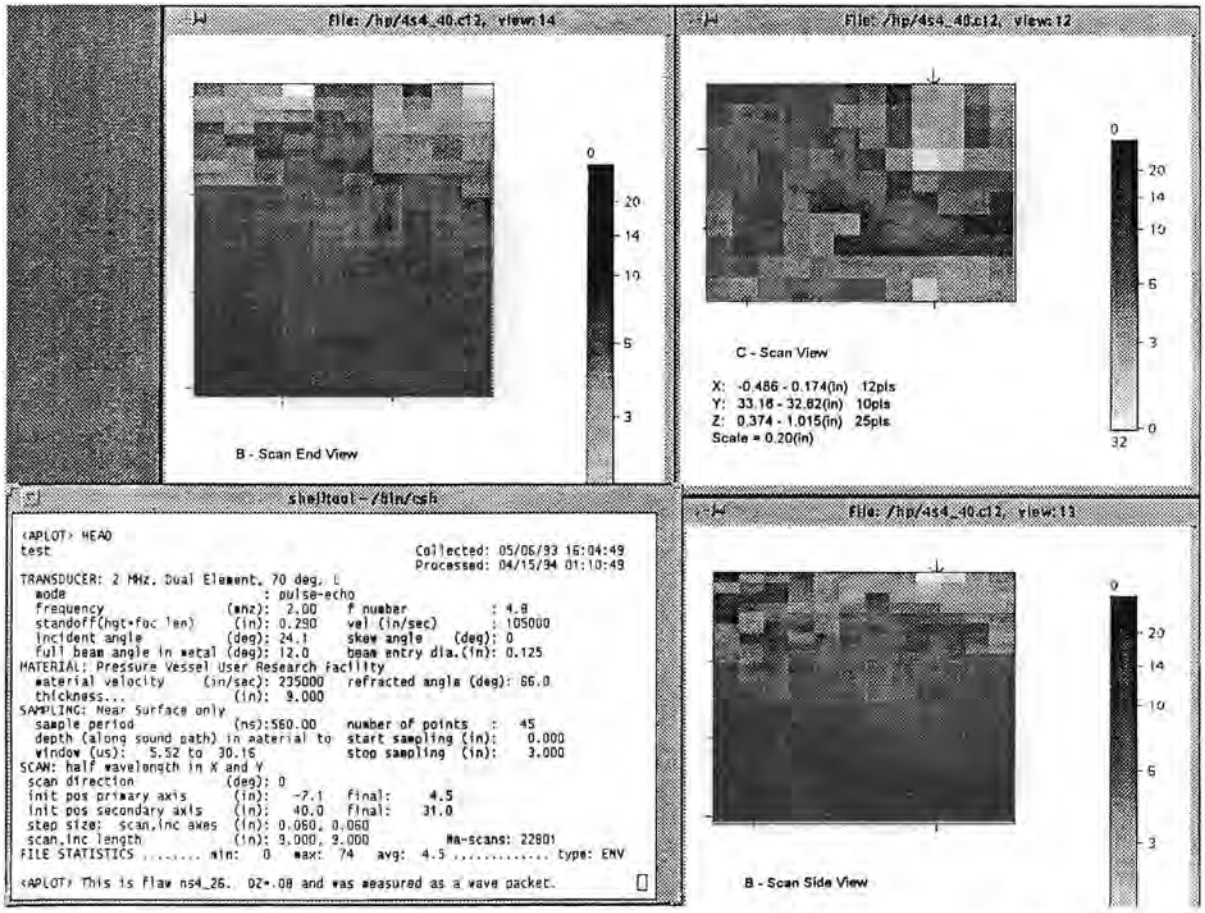
Figure A.6 shows planar indication #6 in the near surface weldment. This planar indication has a through-wall extent of 2 mm based on wave packet width. The detection was made in mode 4 where it had isolated TOF shape at a depth of 16 mm. There were no confirmations in other modes. The indication is characterized as planar based on lack of normal beam detection. There is no evidence of coin shape in the end view of mode 4. The length is 9 mm and was made to LOS in mode 4. The aspect ratio (length/depth) of this indication is 4 giving an orientation along the weld. The maximum amplitude-to-noise ratio is of medium range at 18 to 6. With an X coordinate of -3 mm, the indication is clearly in the weld metal. With a Z coordinate of 16 mm, the indication is clearly below the cladding.

Figure A.6 Planar indication #6 in the near surface weldment: mode 4

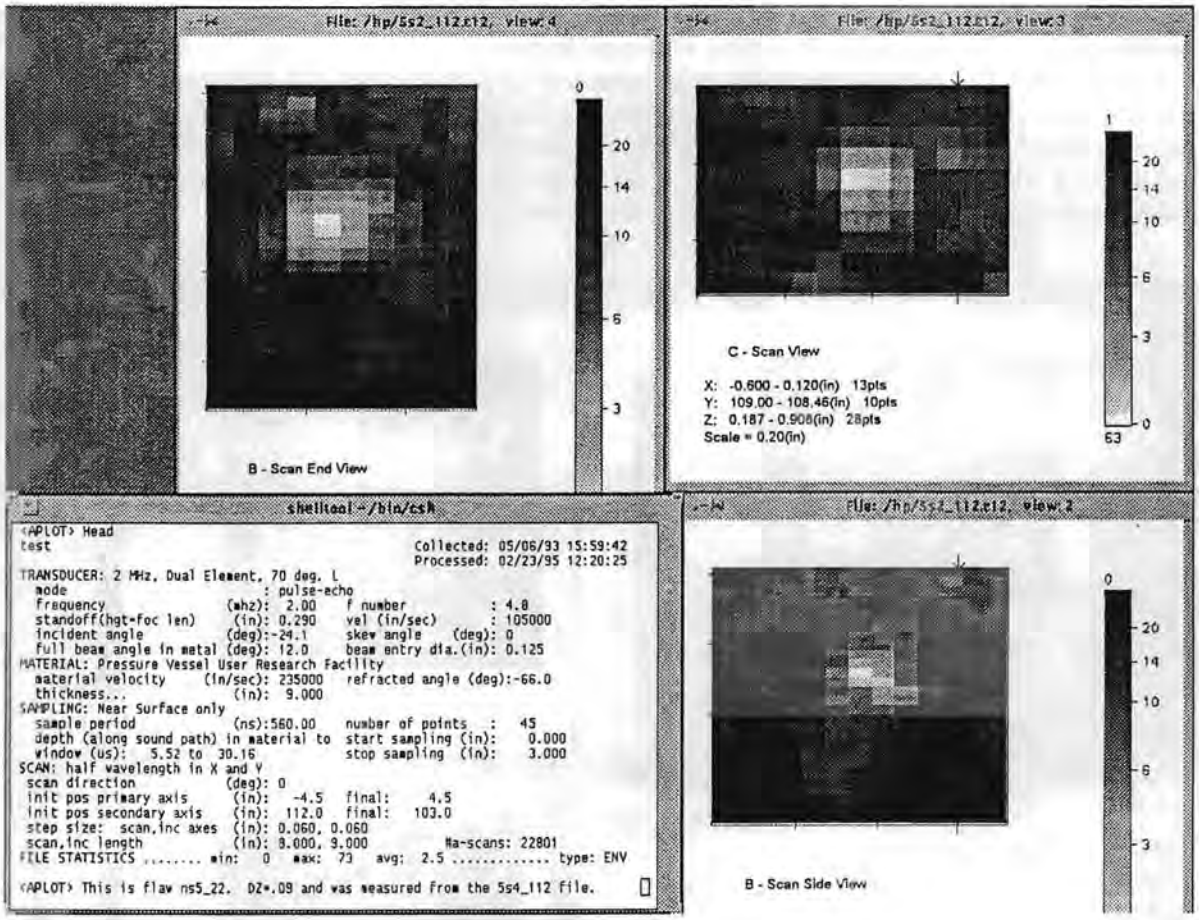
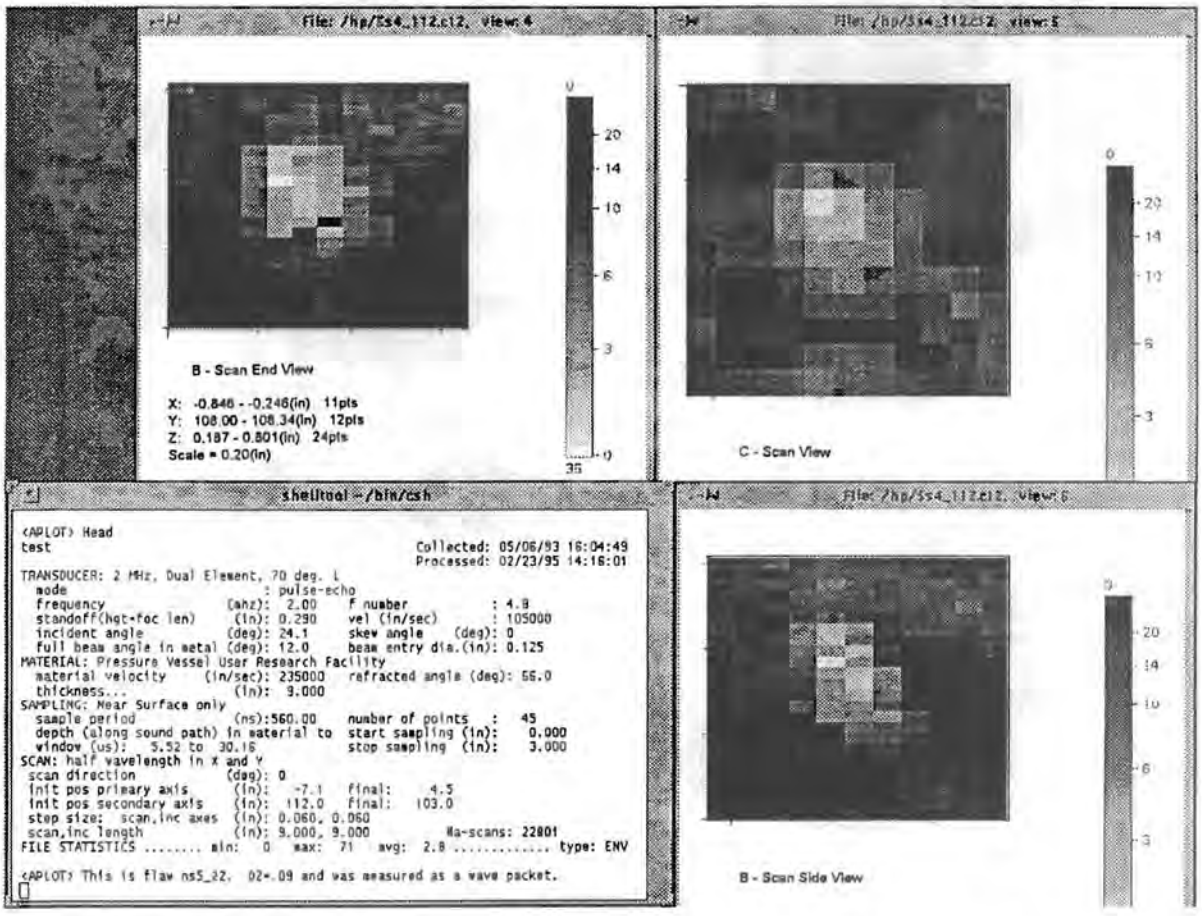
Figure A.5b Planar indication #5 in the near surface weldment: mode 2

Figures A.5a-b show planar indication #5 in the near surface weldment. This planar indication has a through-wall extent of 2.3 mm based on wave packet width. Detections were made in modes 2 and 4 where the indication had isolated TOF shapes at depths of 11 and 12 mm. The indication is characterized as planar based on lack of normal beam detection. There is some evidence of coin shape in the end view of mode 2. The length is 10 mm and was made to LOS in mode 2. The aspect ratio (length/depth) of this indication is 4 giving an orientation along the weld. The maximum amplitude-to-noise ratio is high at 63 to 12. With X coordinates of -6 and -14 mm, the indication is in the weld, possibly in the HAZ. With Z coordinates of 11 and 12 mm, the indication is clearly below the cladding.

Figure A.5a Planar indication #5 in the near surface weldment: mode 4

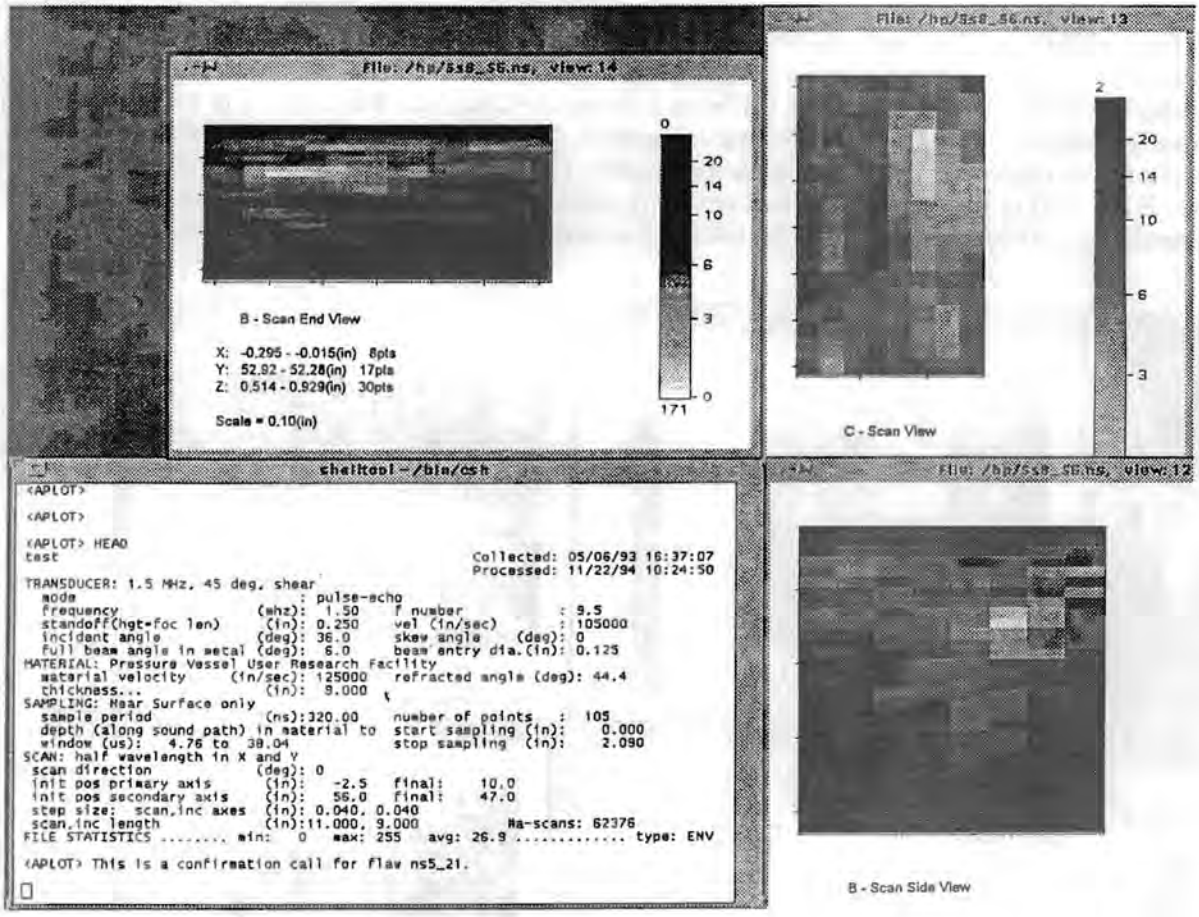
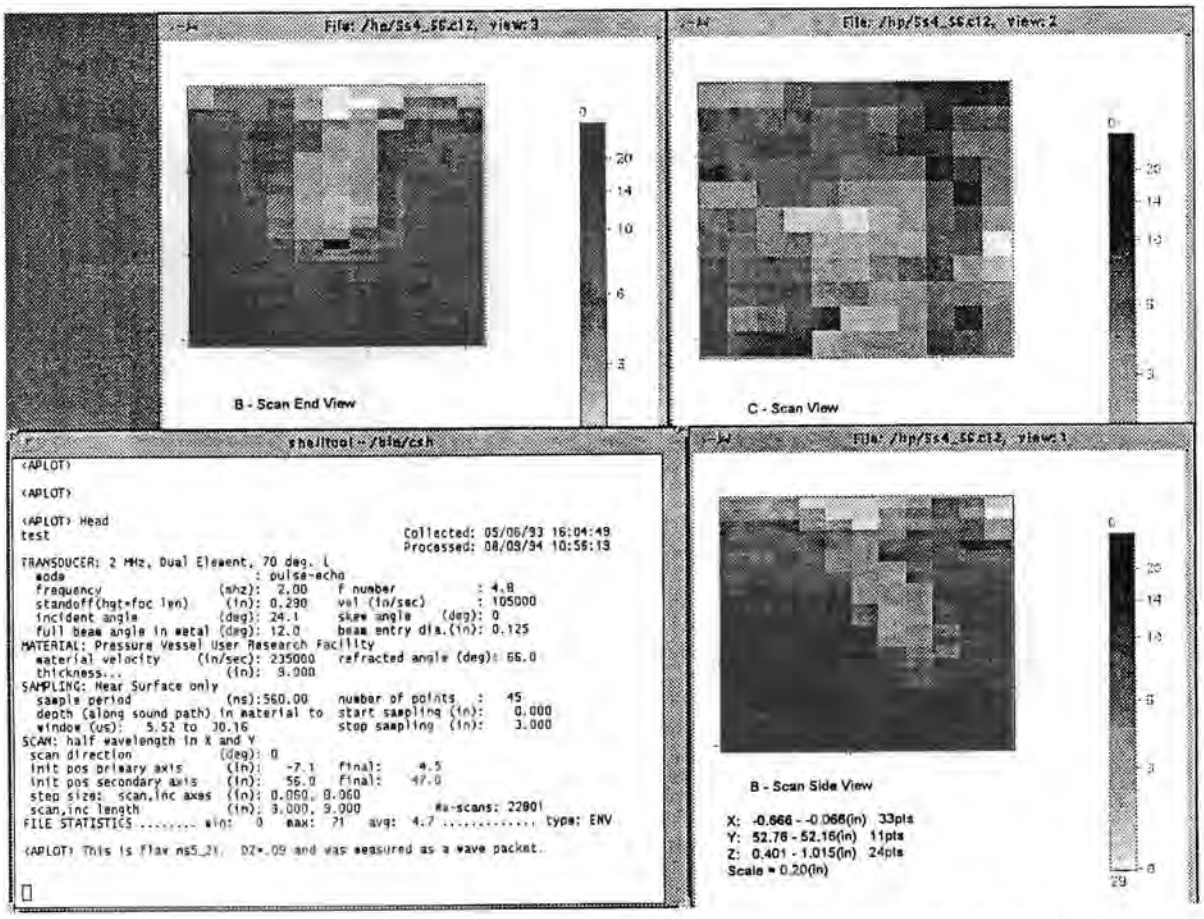
Figure A.4b Planar indication #4 in the near surface weldment: mode 8

Figures A.4a-b show planar indication #4 in the near surface weldment. This planar indication has a through-wall extent of 3 mm based on different depth estimates of 16 to 19 mm. The detection was made in mode 4 where it had isolated TOF shape at a depth of 16 mm. There was a confirmation in mode 8 at a depth of 19 mm. The wave packet width in mode 4 gives an alternate depth size of 2.3 mm. The indication is characterized as planar based on lack of normal beam detection. There is some evidence of coin shape in the end view of mode 4. The length is 14 mm and was made to LOS in mode 8. The aspect ratio (length/depth) of this indication is 5 giving an orientation along the weld. The maximum amplitude-to-noise ratio is low at 25 to 12. The X coordinates of -4 to -8 mm show that the indication is 2 to 4 mm from the HAZ. The Z coordinates of 16 to 19 mm show that the indication is clearly below the cladding.

Figure A.4a Planar indication #4 in the near surface weldment: mode 4

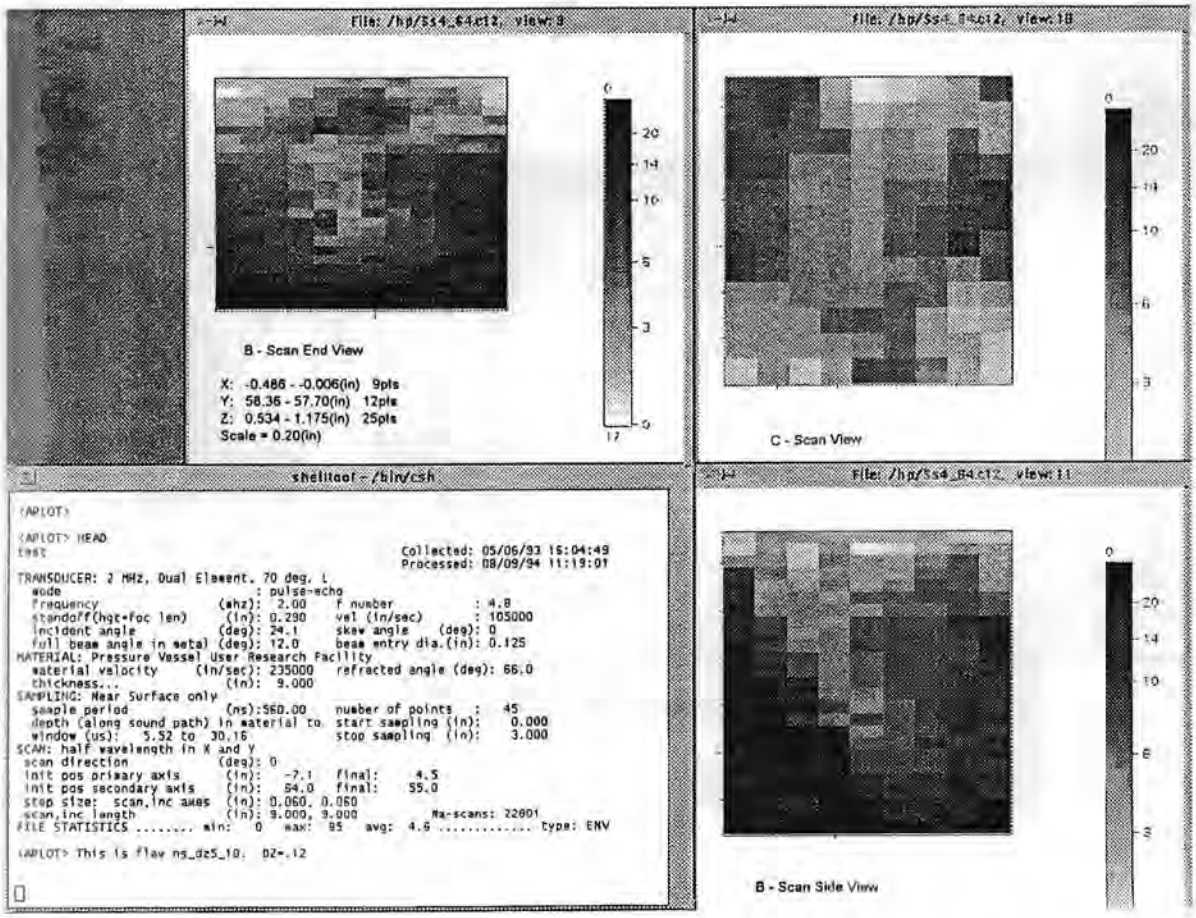
Figure A.3 shows planar indication #3 in the near surface weldment. This planar indication has a through-wall extent of 3 mm based on wave packet width. The detection was made in mode 4 where it had isolated TOF shape at a depth of 21 mm. There was no confirmation in other modes and the indication is characterized as planar based on lack of normal beam detection. There is no evidence of coin shape in the end view. The length is 10 mm and was made to LOS in mode 4. The aspect ratio (length/depth) of this indication is 3 implying that it is probably oriented along the weld. The maximum amplitude-to-noise ratio is low at 13 to 6. With an X coordinate of -8 mm, the indication is 2 mm from the HAZ. With a Z coordinate of 21 mm, the indication is clearly below the cladding.

Figure A.3 Planar Indication #3 in the near surface weldment: mode 4
