NUREG/CR-6471, Vol. 1
PNNL-11143

Characterization of Flaws in U.S. Reactor Pressure Vessels

Density and Distribution of Flaw Indications in PVRUF

Pacific Northwest National Laboratory

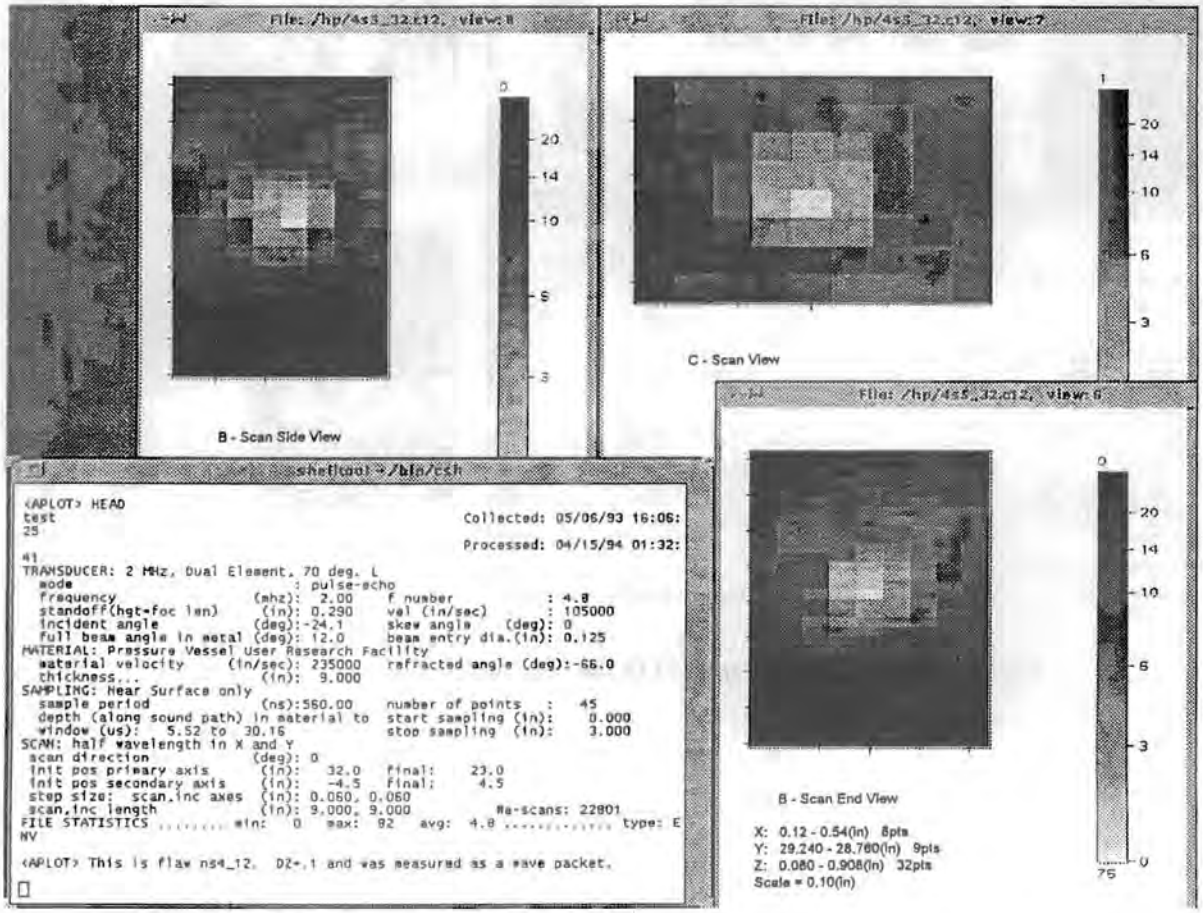
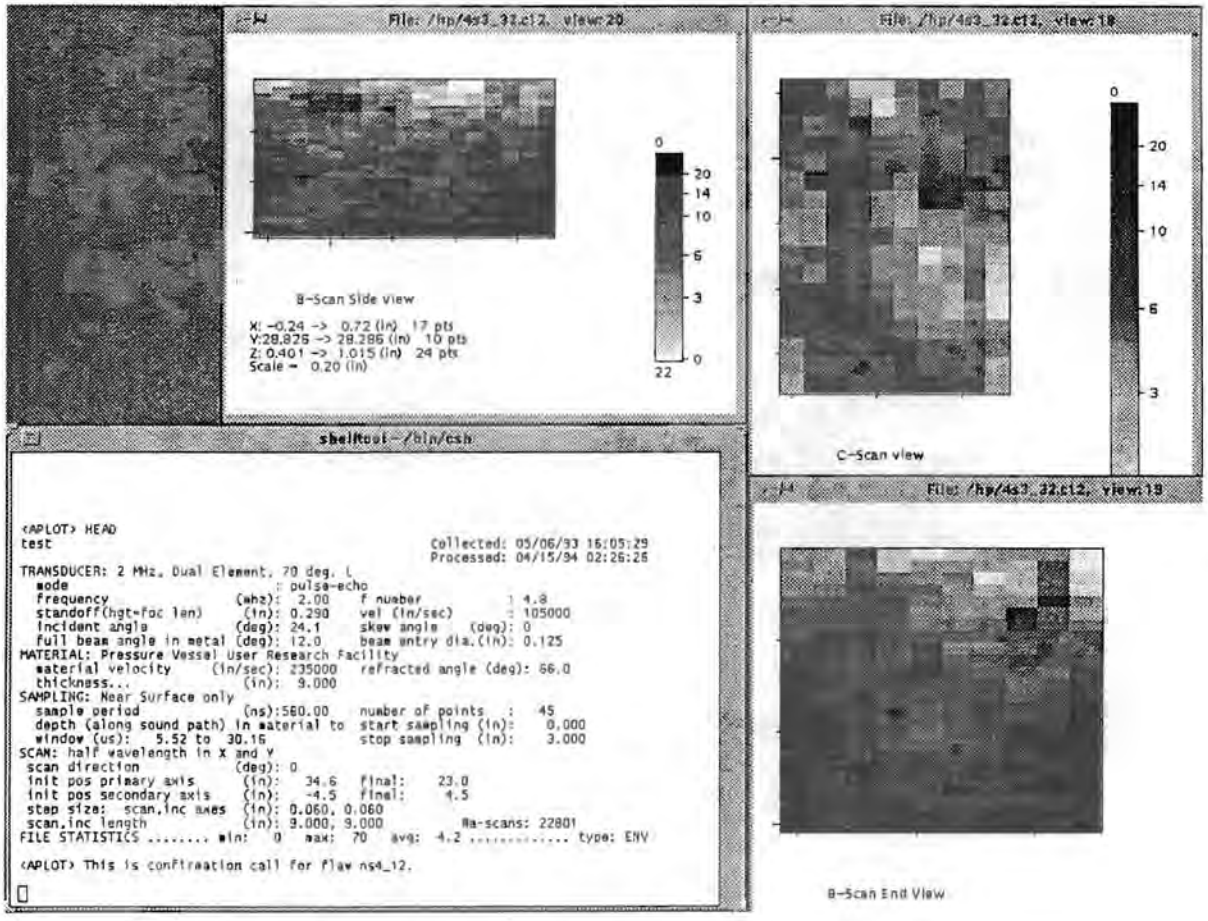
Figure A.2b Planar indication #2 in the near surface weldment: mode 3

Figures A.2a-b show planar indication #2 in the near surface weldment. This planar indication has a through-wall extent of 6 mm based on different depth estimates of 12 to 18 mm. The detection was made in mode 5 where it had isolated TOF shape at a depth of 18 mm. There was a confirmation in mode 3 at a depth of 12 mm. The wave packet width in mode 5 gives an alternate size of 2.5 mm. The indication is characterized as planar based on lack of normal beam detection. There is no evidence of coin shape in the side view of modes 3 or 5. The width is 7 mm and was made to LOS in mode 5. The range of aspect ratios (width/depth) of this indication is 1 to 3. The maximum amplitude-to-noise ratio is high at 75 to 15. With an X coordinate of 8 mm, the indication is 2 mm from the HAZ. With Z coordinates of 12-18 mm, the indication is clearly below the claddding.

Figure A.2a Planar indication #2 in the near surface weldment: mode 5

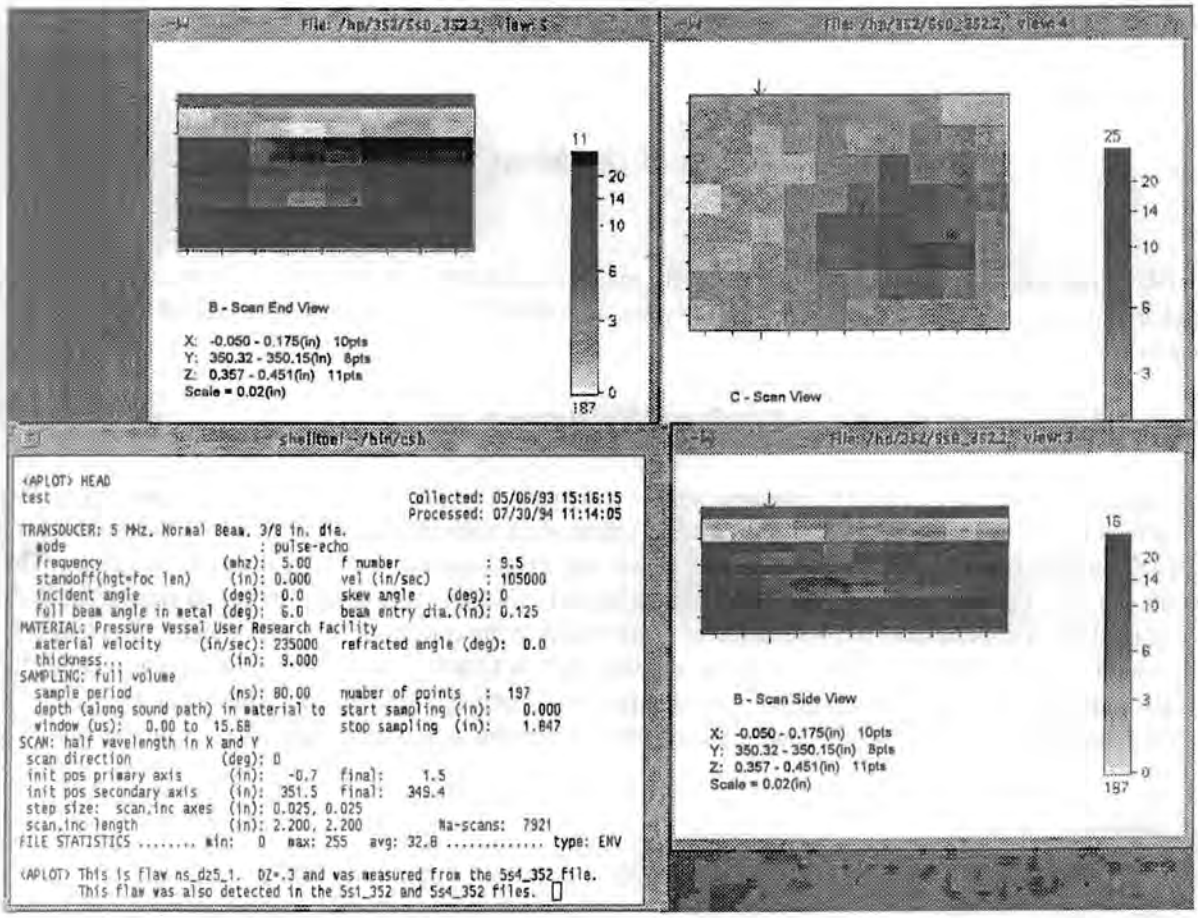
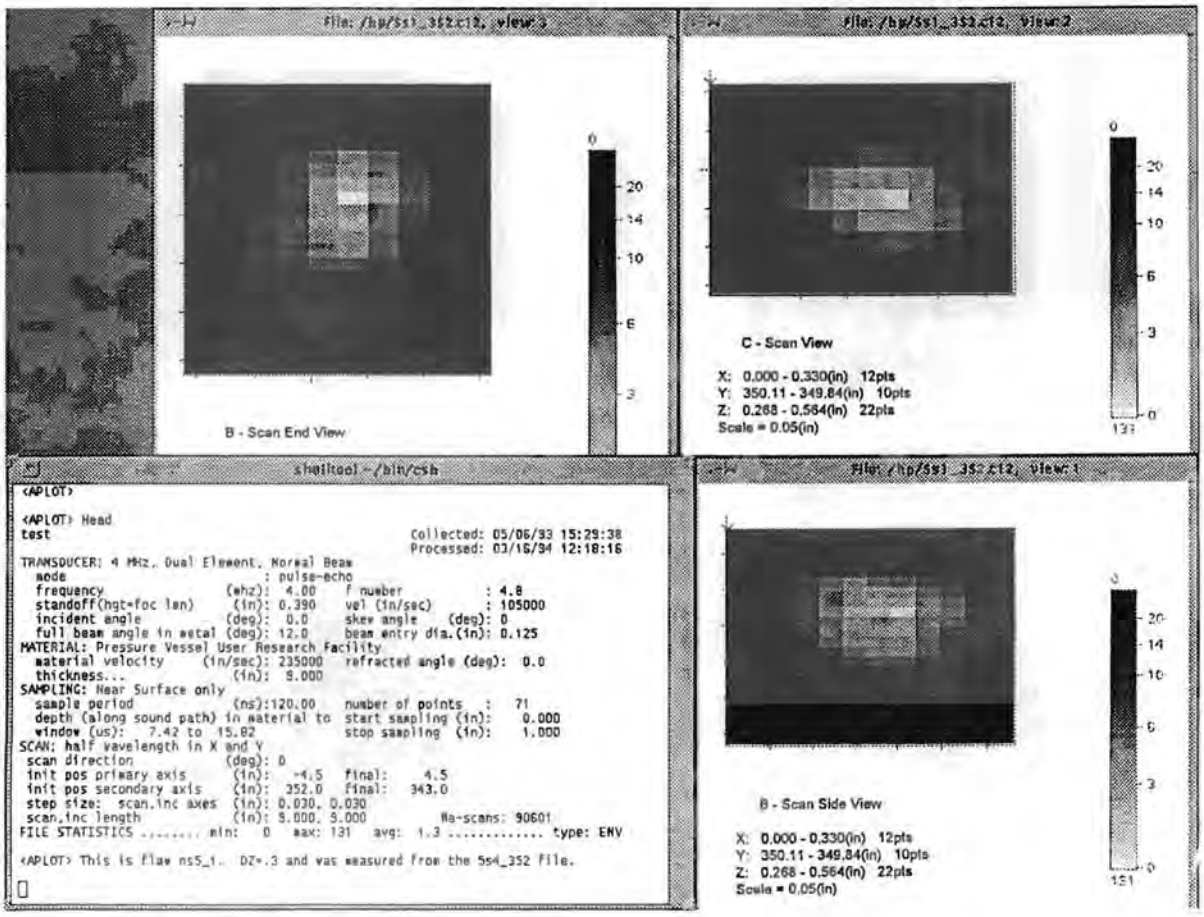
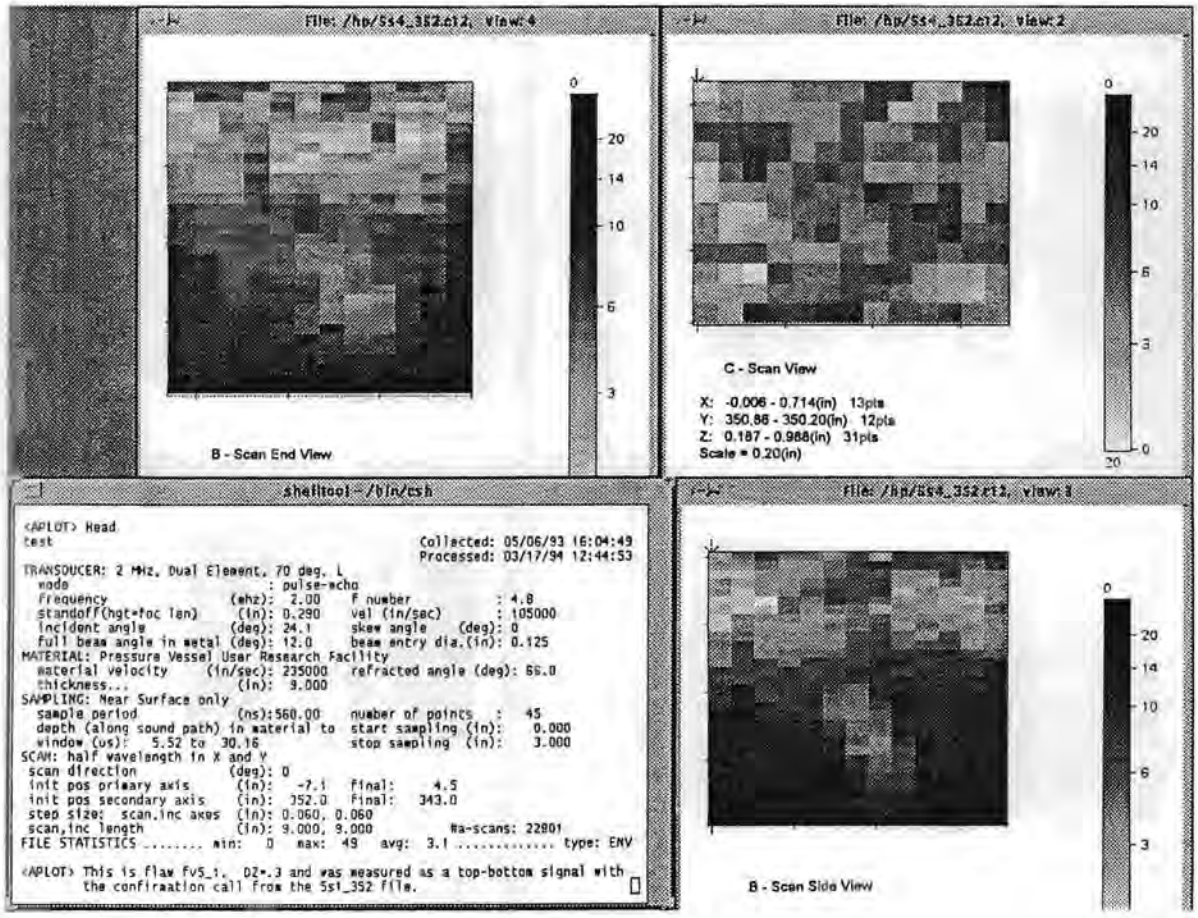
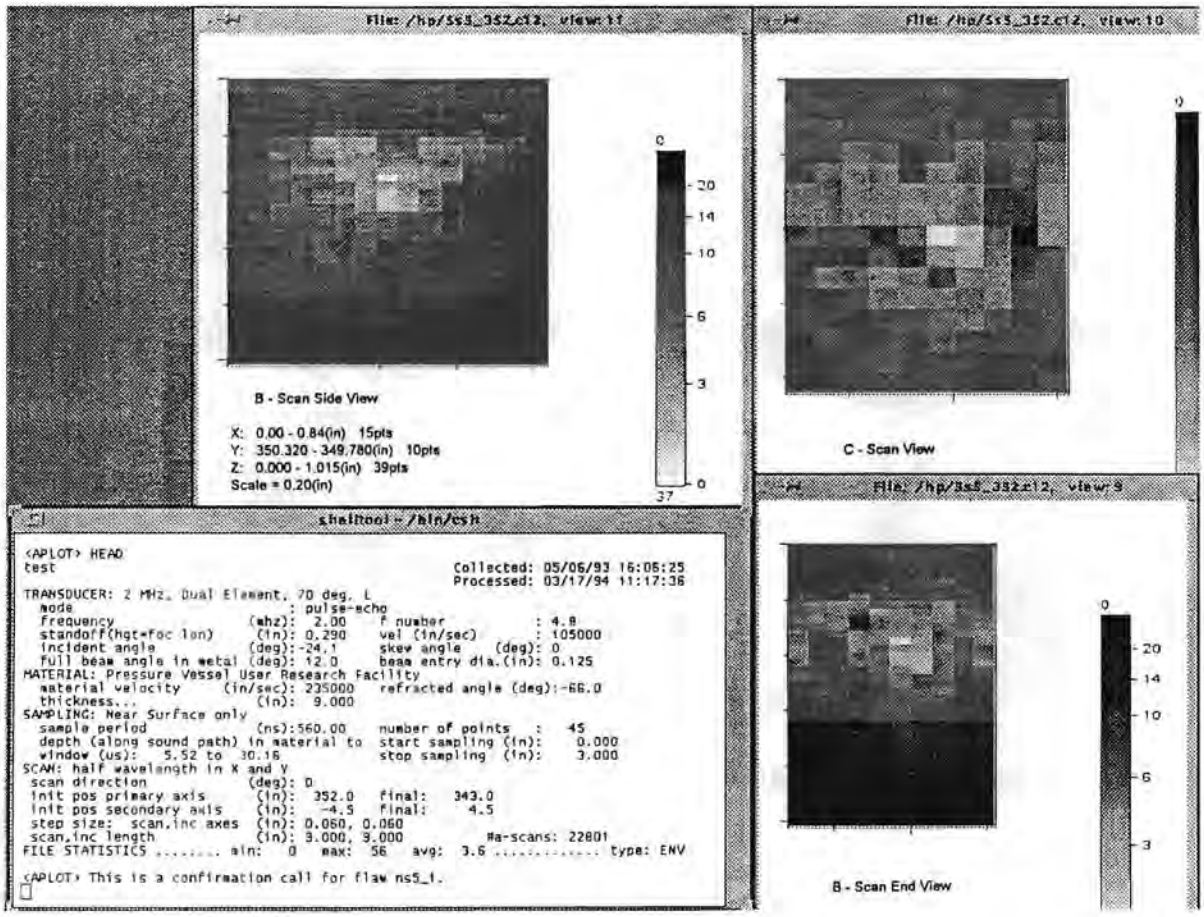
Figure A.1d Planar Indication #1 in the near surface weldment: mode 5

Figure A.1c Planar indication #1 in the near surface weldment: mode 4

Figure A.1b Planar indication #1 in the near surface weldment: mode 1

Figure A.1a Planar indication #1 in the near surface weldment: mode 10

Figures A.1a-d show planer indication #1 in the near surface weldment. This plan indication has a through-wall extent of 8 mm based on different depth estimates of 10 to 18 mm. The detections were made in modes 0, 1, and 4. In the mode 4 inspection, the indication had isolated TOF shape at a depth of 18 mm. There was a confirmation in mode 5 at a depth of 15 mm. The wave packet width in mode 4 gives a smaller size of 3 mm. There is good evidence of coin shape in the end view of mode 4 and in the side view of mode 5. The indication is characterized as planar based on the coin shape in modes 4 and 5. The length is 13 mm and was made to LOS in mode 4. The width is 13 mm and was made to LOS in mode 5. The range of aspect radios (length/ depth) of this indication is 1.6 to 3. The maximum amplitude-to-noise ratio is 8 (131 to 16). With an X coordinate of 8 mm, the indication is 2 mm from the HAZ. With Z coordinates of 10 to 18 mm, the indication is clearly below the cladding.

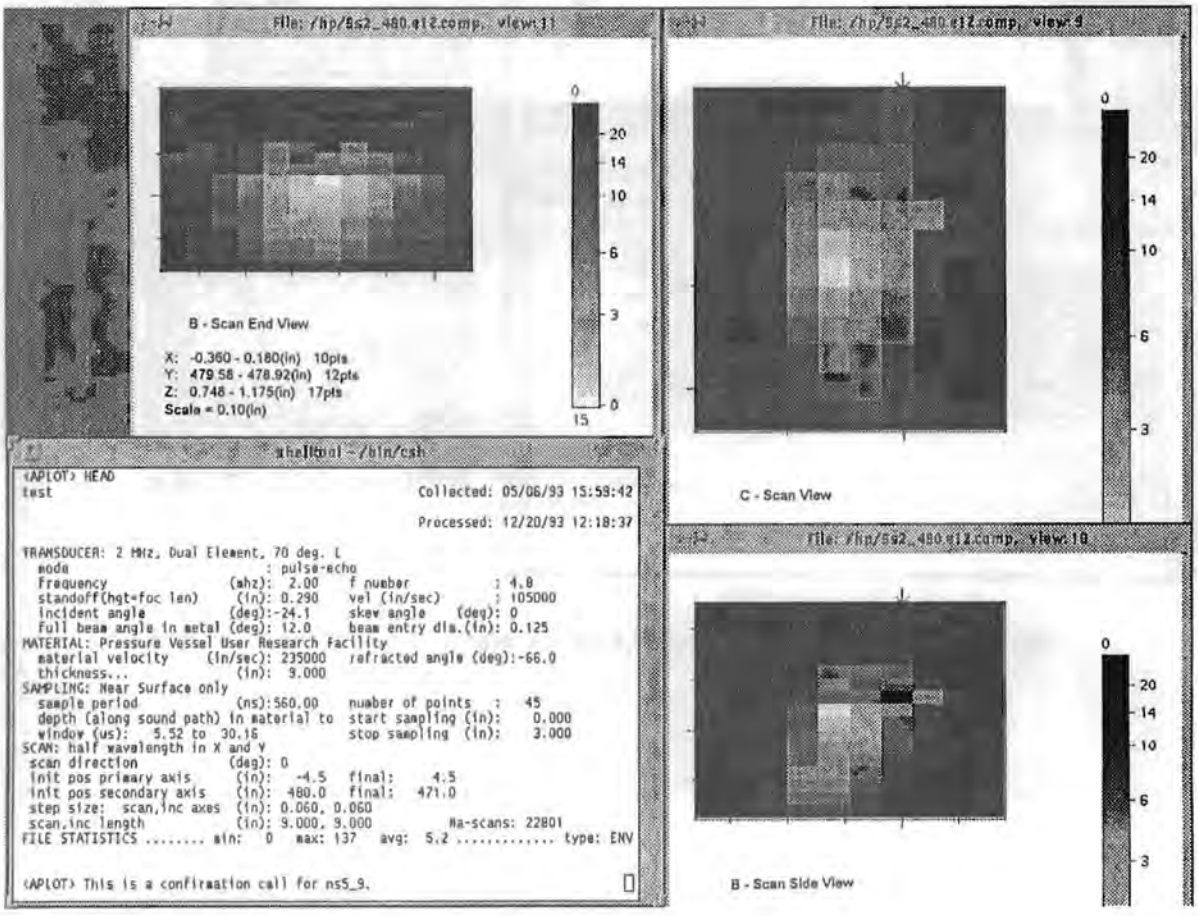
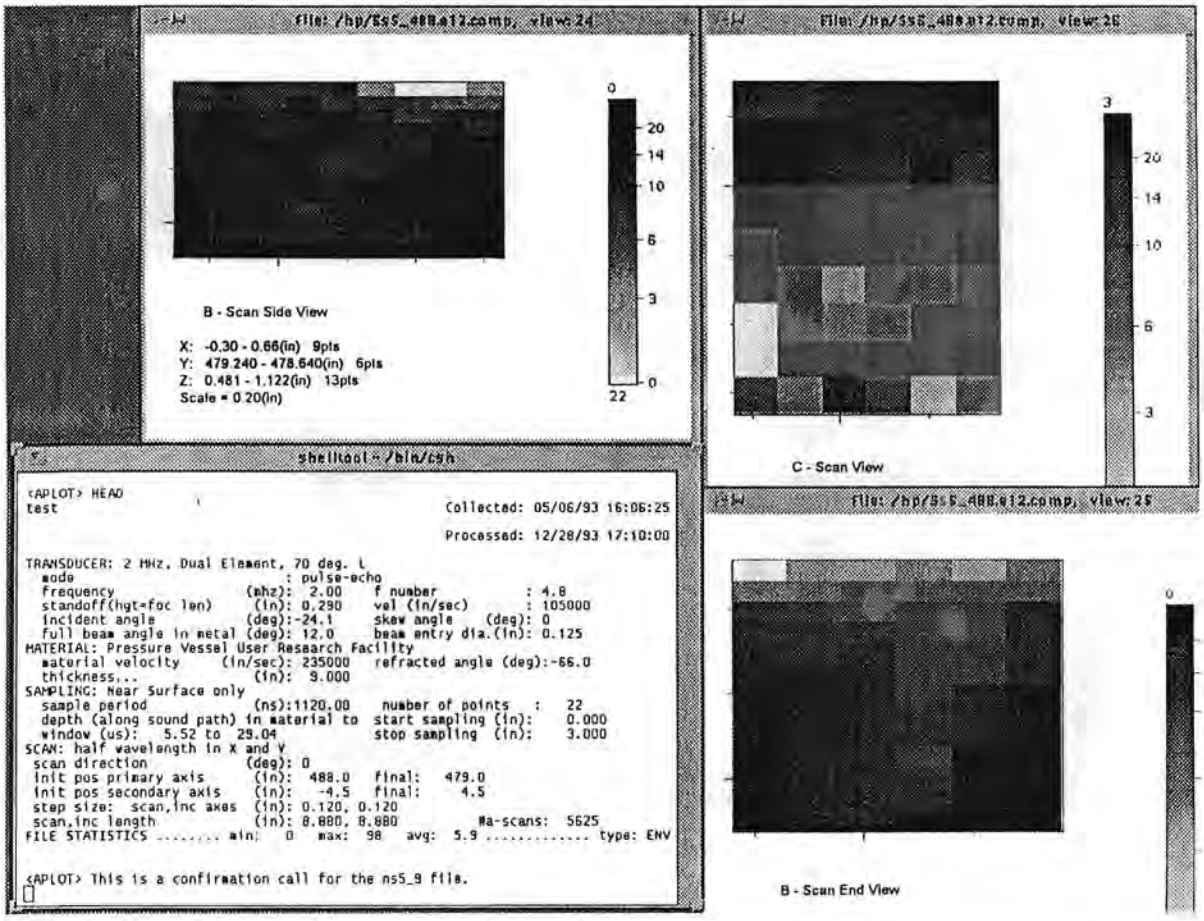
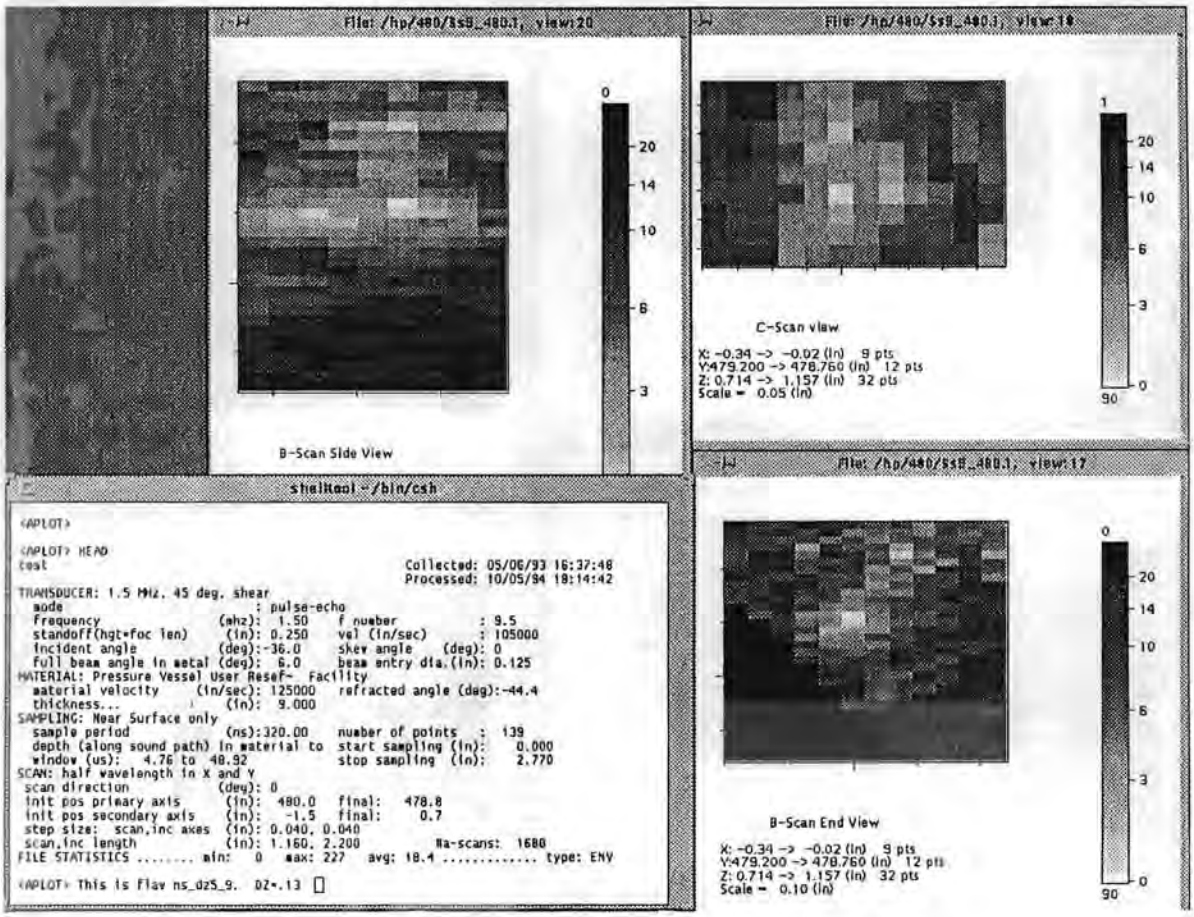
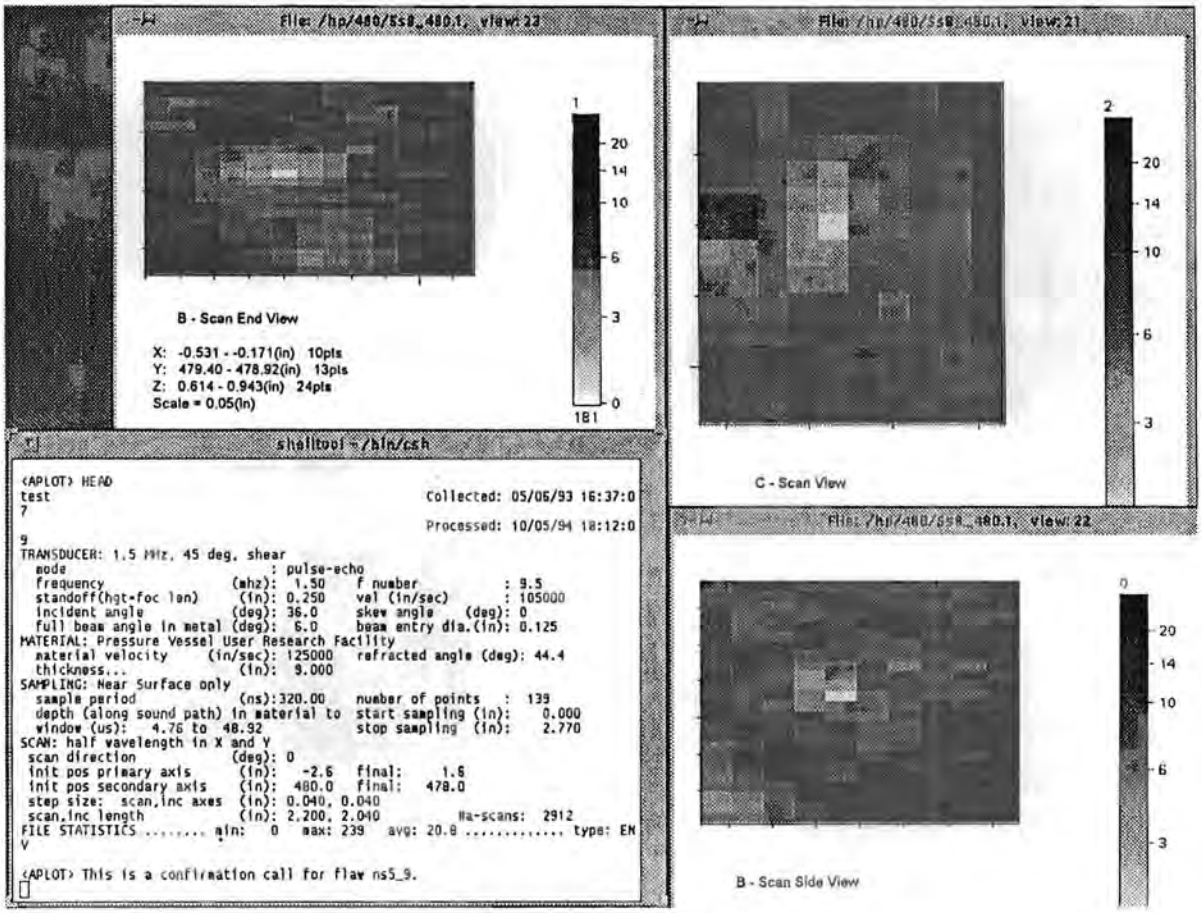
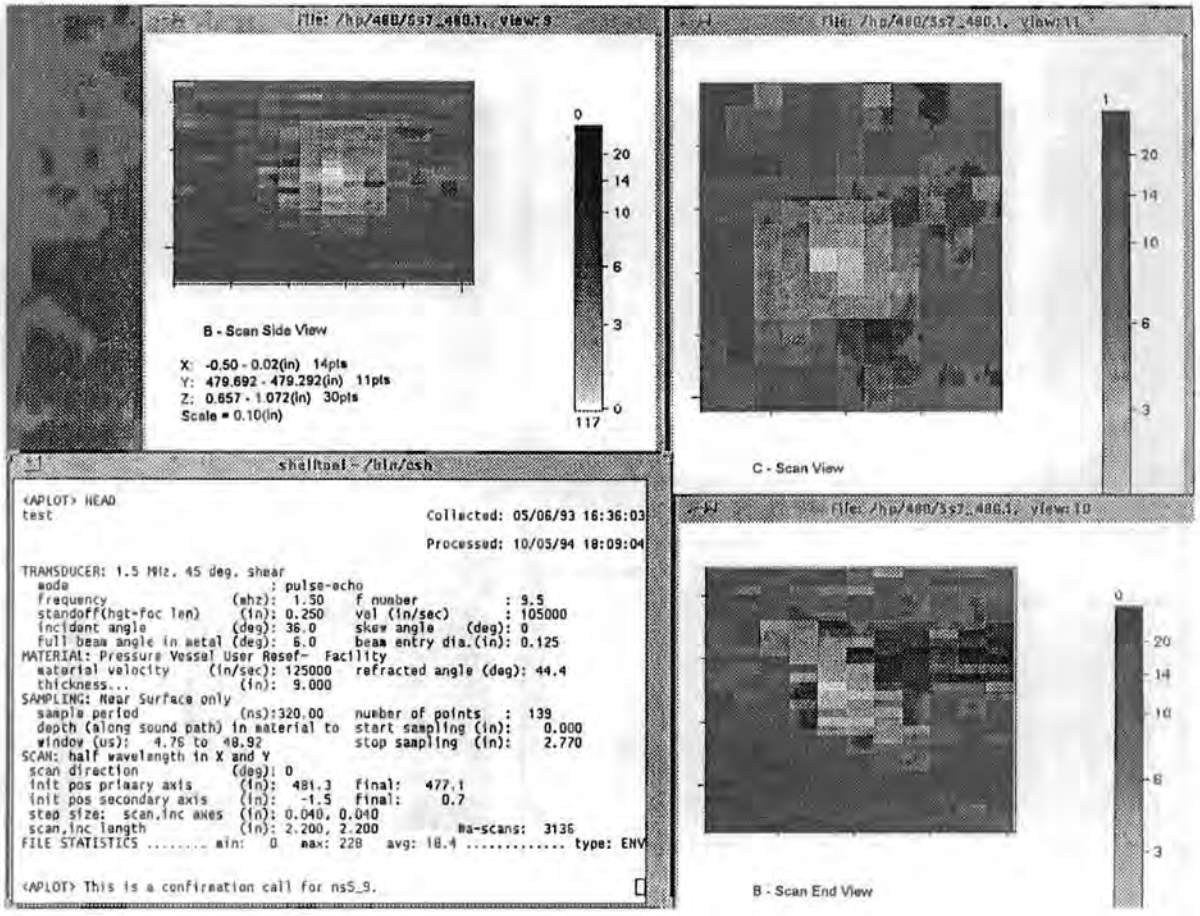
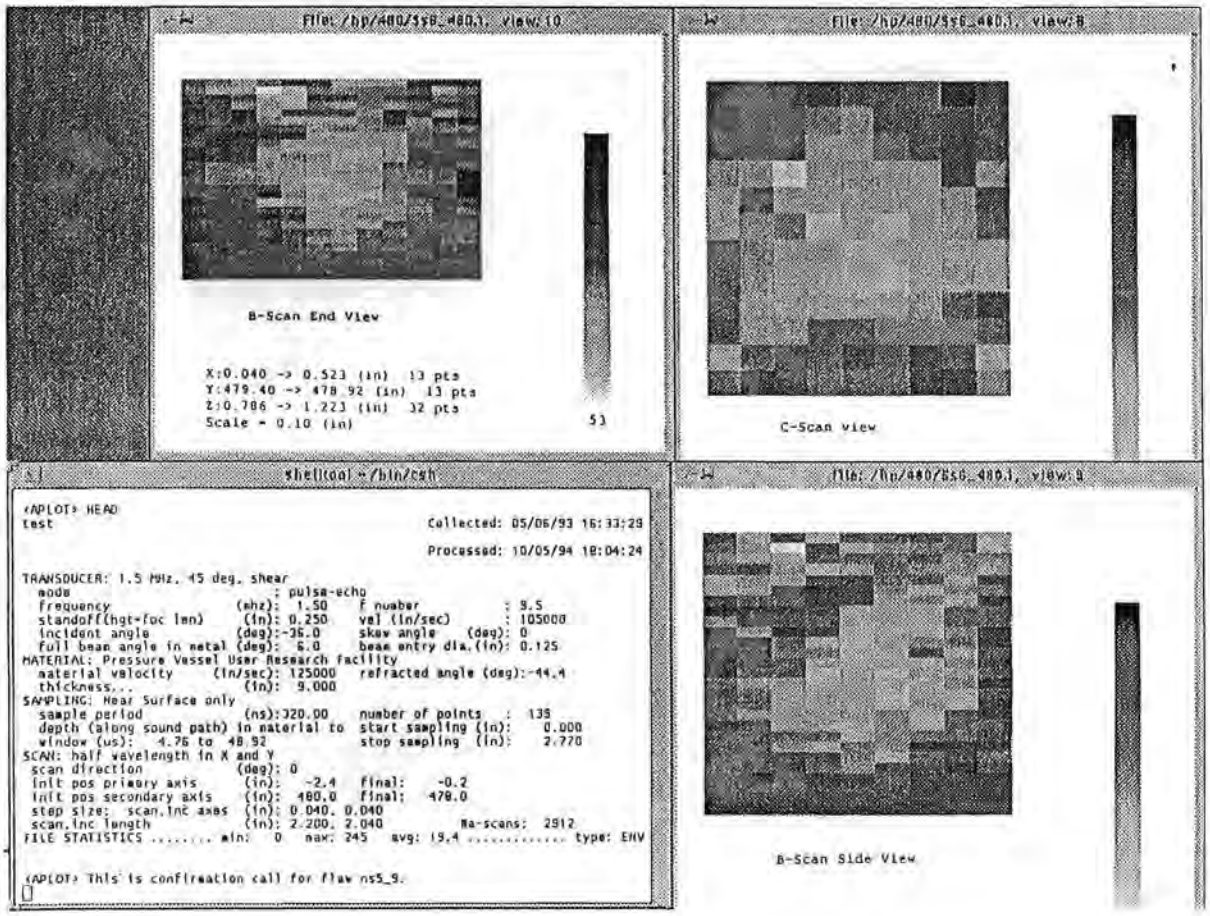
Figures A.11a-f show volumetric indication #2 in the near surface weldment. This volumetric indication has a through-wall extent of 6 mm based on different depth estimates of 20 to 26 mm. The detection was made in mode 9 where it had isolated TOF shape at a depth of 23 mm. There were confirmations in modes 2, 5, 6, 7, and 8 at depths of 20 to 26 mm. The wave packet width in mode 9 gave an alternate depth size of 3 mm. The indication is characterized as volumetric based on detection in orgothonal modes. There is good evidence of coin shape in the end view of mode 2 but the depth of the indication implies that it is not connected to the cladding. The length is 13 mm and was made to LOS in mode 2. The width is 14 mm and was made to LOS in mode 5. The range of aspect ratios (length/depth) of this indication is of medium range at 117 to 35. With an X coordinate of 9 mm, the indication is in the weld metal and 2 mm from the HAZ. With a Z coordinate of 25 mm the indication is clearly below the cladding.

Figure A.11a Volumetric indication #2 in the near surface weldment: mode 2

Figure A.11b - Volumetric indication #2 in the near surface weldment: mode 5

Figure A.11c - Volumetric indication #2 in the near surface weldment: mode 9

Figure A.11d - Volumetric indication #2 in the near surface weldment: mode 8

Figure A.11e - Volumetric indication #2 in the near surface weldment: mode 7

Figure A.11f - Volumetric indication #2 in the near surface weldment: mode 6

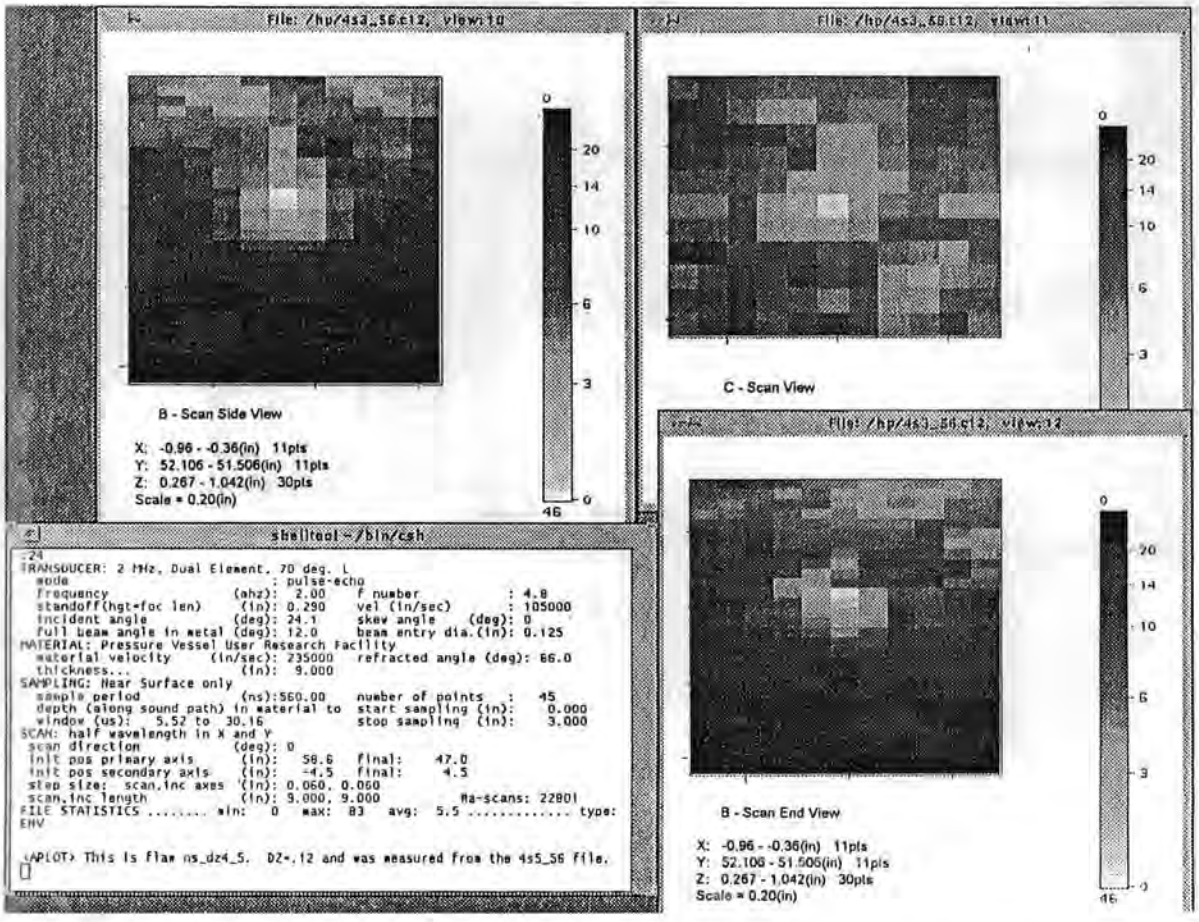
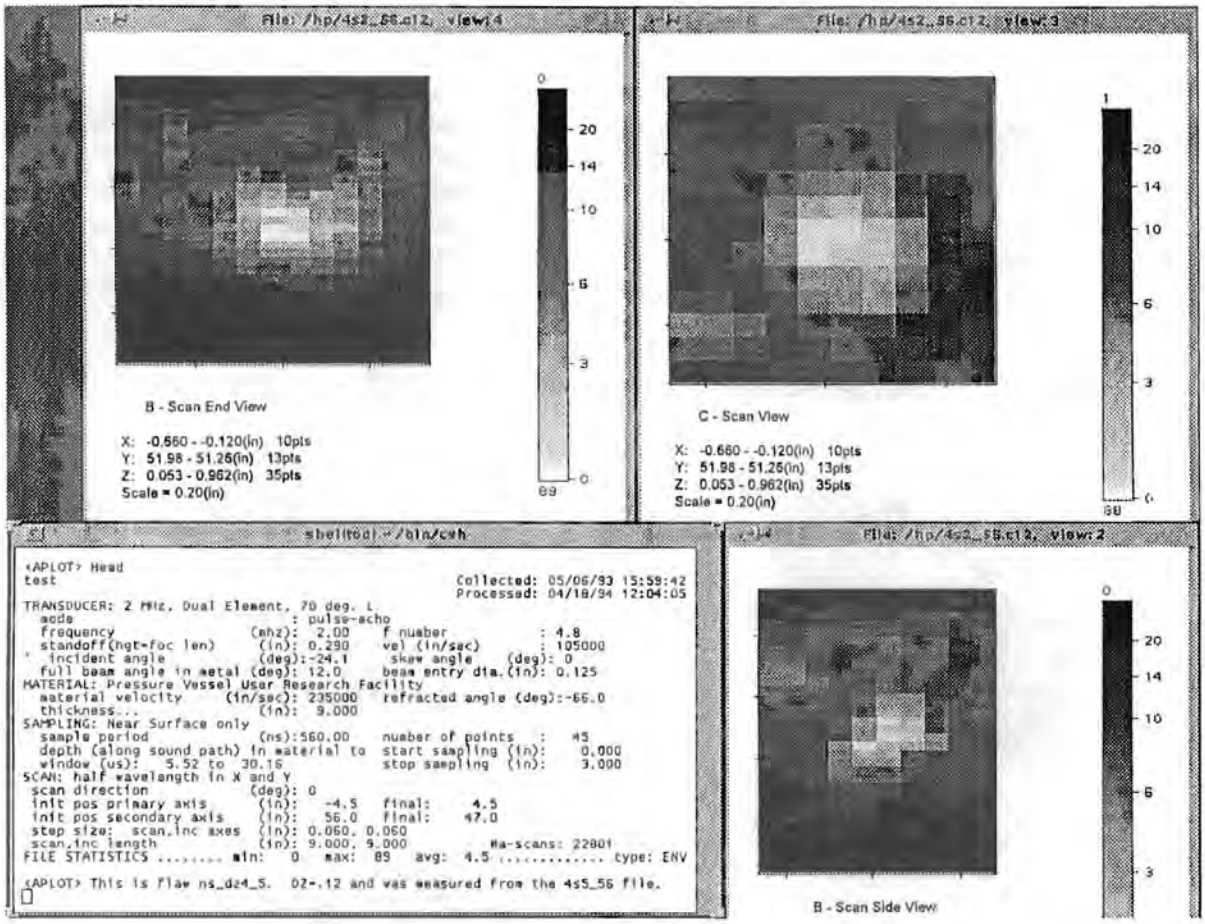
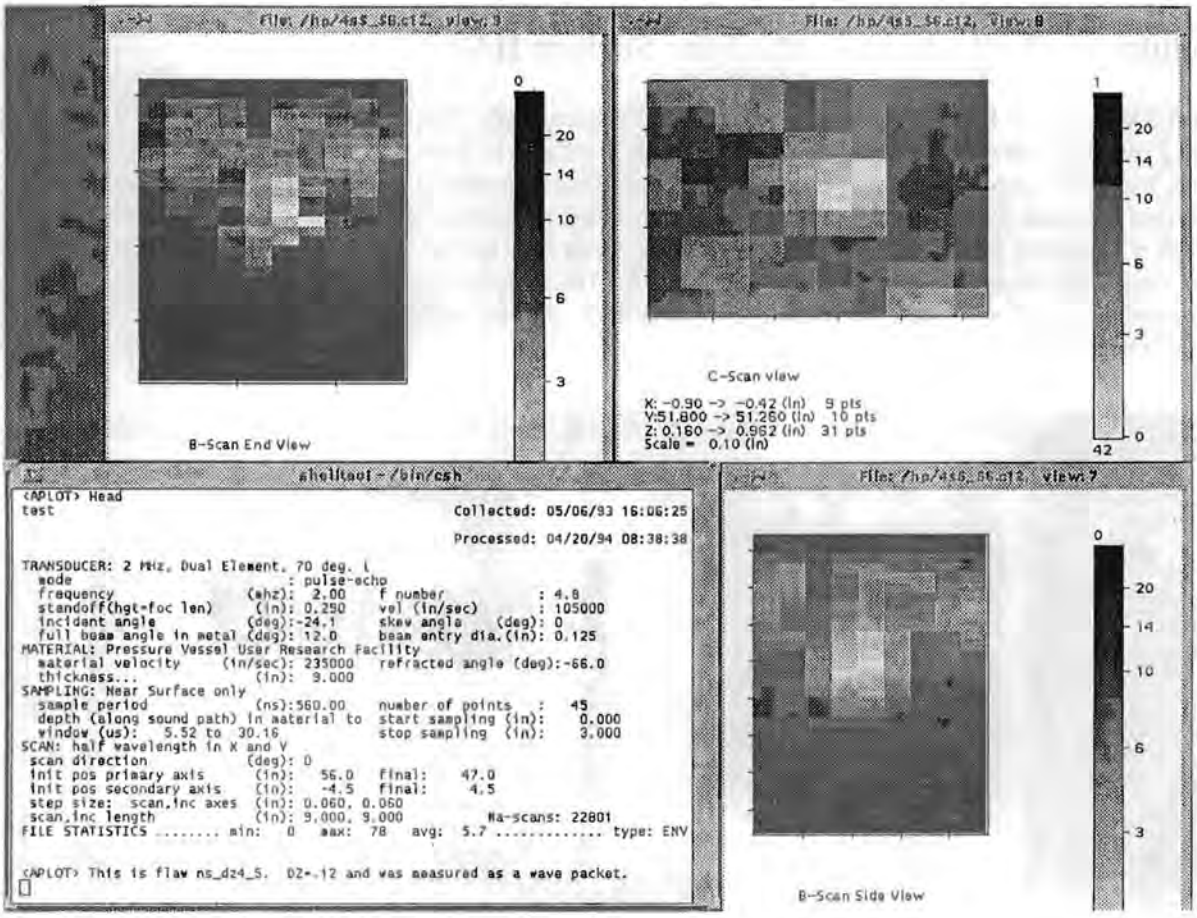
Figures A.12a-c show planar indication #1 in the near surface HAZ. This planar indication has a through-wall extent of 3 mm based on wave packet width. Detections were made in modes 2, 3, and 5 where it had isolated TOF shape at depths of 13 to 14 mm. There is good evidence of coin shape in the end view of mode 2. The indication is characterized as planar based on the coin shape in mode 2. The length is 2 mm and was made to LOS in mode 2. The width is 10 mm and was made to LOS in mode 3. The aspect ratio (length/depth) of this indication is 5 giving an orientation along the weld. The maximum amplitude-to-noise ratio is of medium range at 88 to 25. With X coordinates of 11 to 18 mm, the indication is probably in the HAZ. The Z coordinate of 13 to 14 mm shows that the indication is below the cladding by at least 4 to 5 mm.

Figure A.12a - Planar indication #1 in the near surface HAZ: mode 3

Figure A.12b - Planar indication #1 in the near surface HAZ: mode 2

Figure A.12c - Planar indication #1 in the near surface HAZ: mode 5

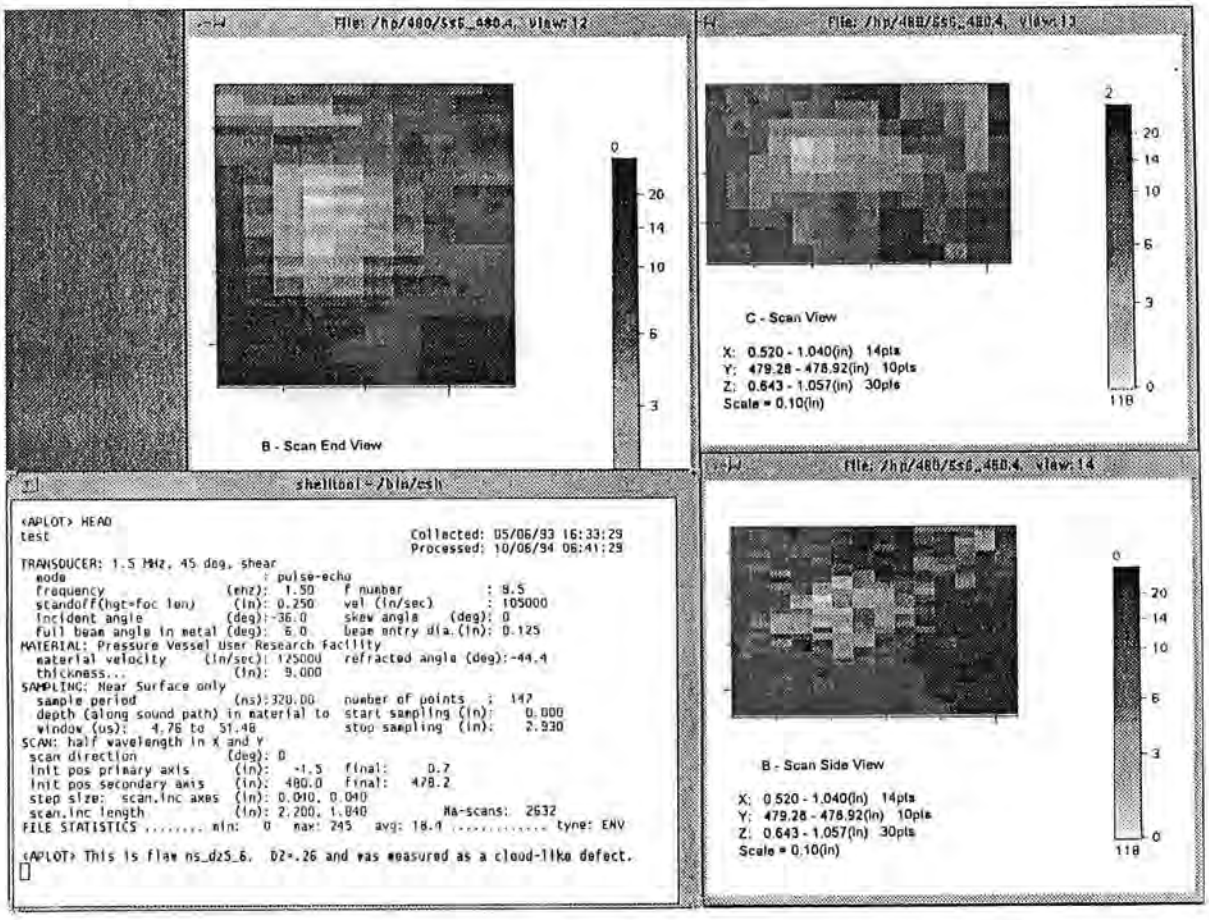
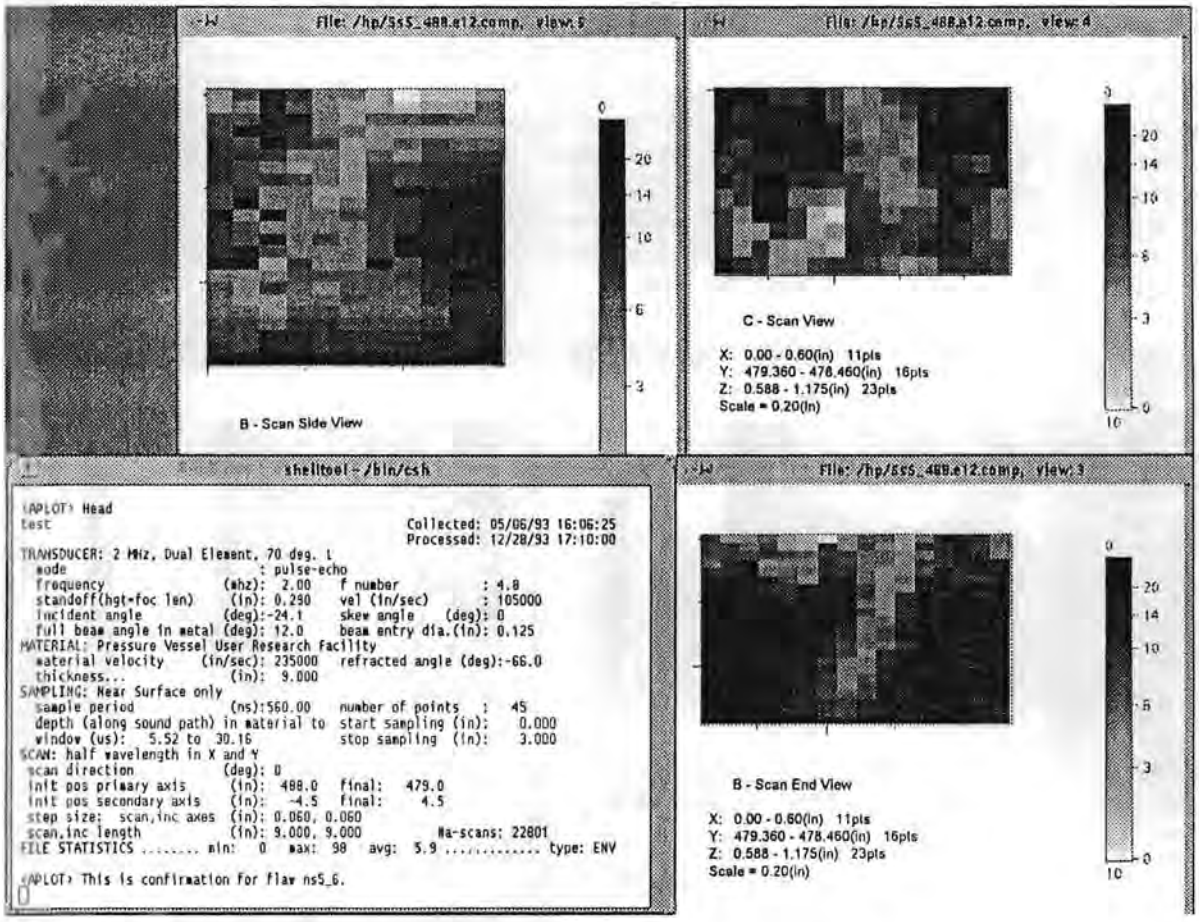
Figures A.13a-b show volumetric indication #1 in the near surface HAZ. This volumetric indication has a through-wall extent of 7 mm based on wave packet width. The detection was made in mode 6 where it had isolated TOF and possibly cloud-like shapes at a depth of 20 mm. There was a confirmation in mode 5 at a depth of 20 mm. The indication is characterized as volumetric based on detection in orgothonal modes. There is no evidence of coin shape in the end views. The length is 7 mm and was made to LOS in mode 6. The width is 13 mm and was made to LOS in mode 5. The range of aspect ratios (width/depth) of this indication is 1.8 to 2.6. The maximum amplitude-to-noise ratio is high at 118 to 25. With X coordinates of 6 to 17 mm, the indication is in the HAZ, possibly in the weld. With a Z coordinate of 20 mm, the indication is clearly below the cladding.

Figure A.13a - Volumetric indication #1 in the near surface HAZ: mode 6

Figure A.13b - Volumetric indication #1 in the near surface HAZ: mode 5

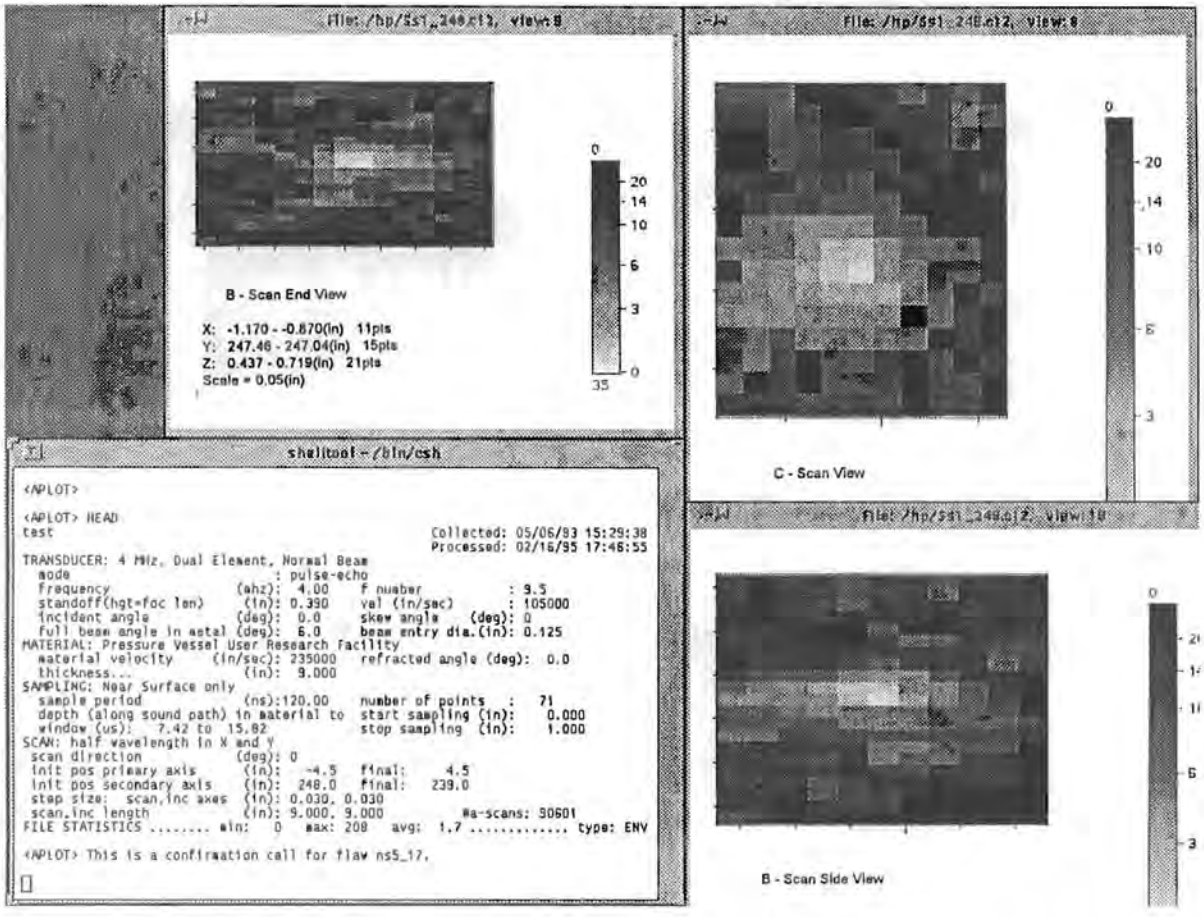
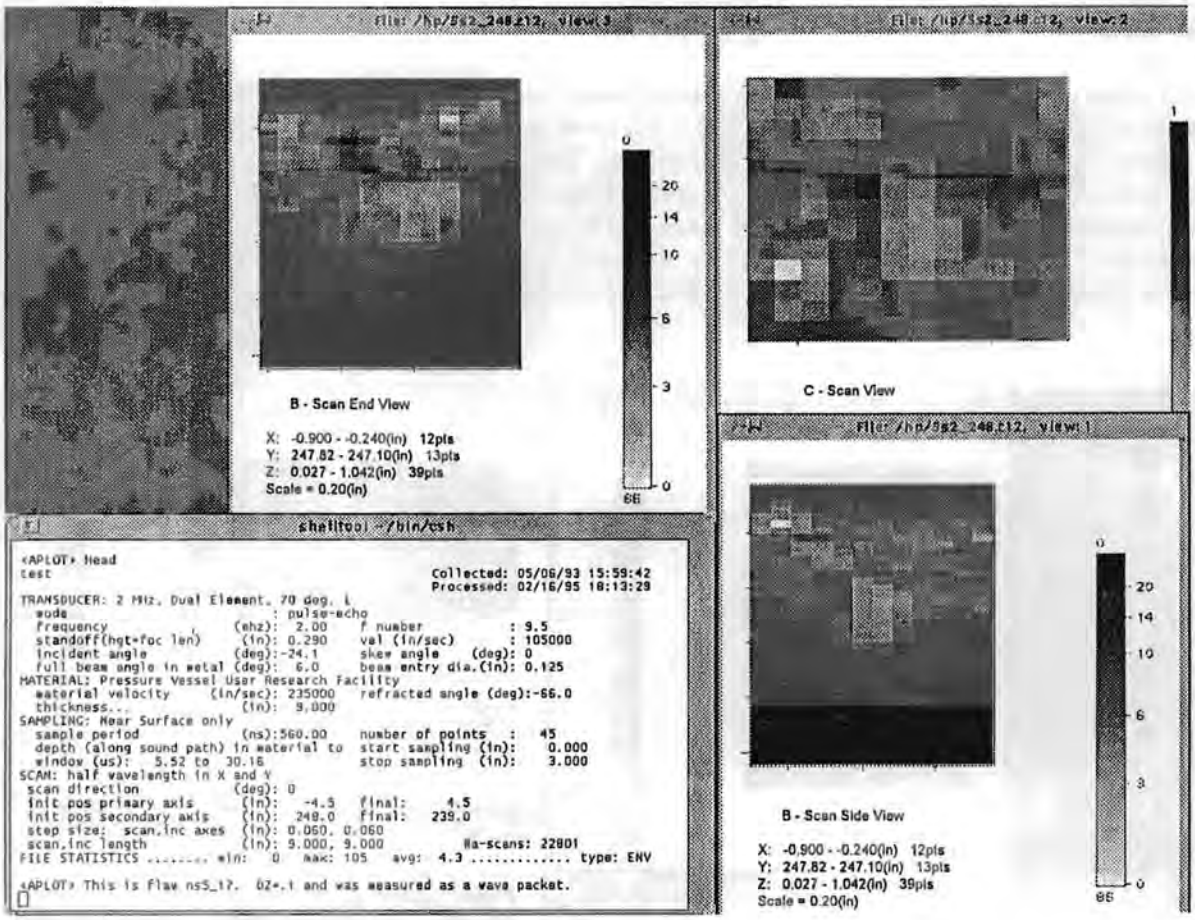
Figures A.14a-b show volumetric indication #2 in the near surface HAZ. This volumetric indication has a through-wall extent of 3 mm based on different depth estimates of 11 to 14 mm. The detection was made in mode 2 where it had isolated TOF shape at a depth of 11 mm. There was a confirmation in mode 1 at a depth of 14 mm. The wave packet width in mode 2 gave an alternate depth size of 2.5 mm. The indication is characterized as volumetric based on normal beam detection. There is no evidence of coin shape in the end views. The length is 13 mm and was made to LOS in mode 2. The width is 8 mm and was made to LOS in mode 1. The range of aspect ratios (length/depth) of this indication is 4 to 6 giving an orientation along the weld. The maximum amplitude-to-noise ratio is of medium range at 71 to 20. With X coordinates of -14 to -25 mm, the indication is in the HAZ, possibly in the base metal. With Z coordinates of 11 to 14 mm, the indication is below the cladding by at least 2 mm.

Figure A.14a - Volumetric indication #2 in the near surface HAZ: mode 1

Figure A.14b - Volumetric indication #2 in the near surface HAZ: mode 2
