NUREG/CR-6471, Vol. 1
PNNL-11143

Characterization of Flaws in U.S. Reactor Pressure Vessels

Density and Distribution of Flaw Indications in PVRUF

Pacific Northwest National Laboratory

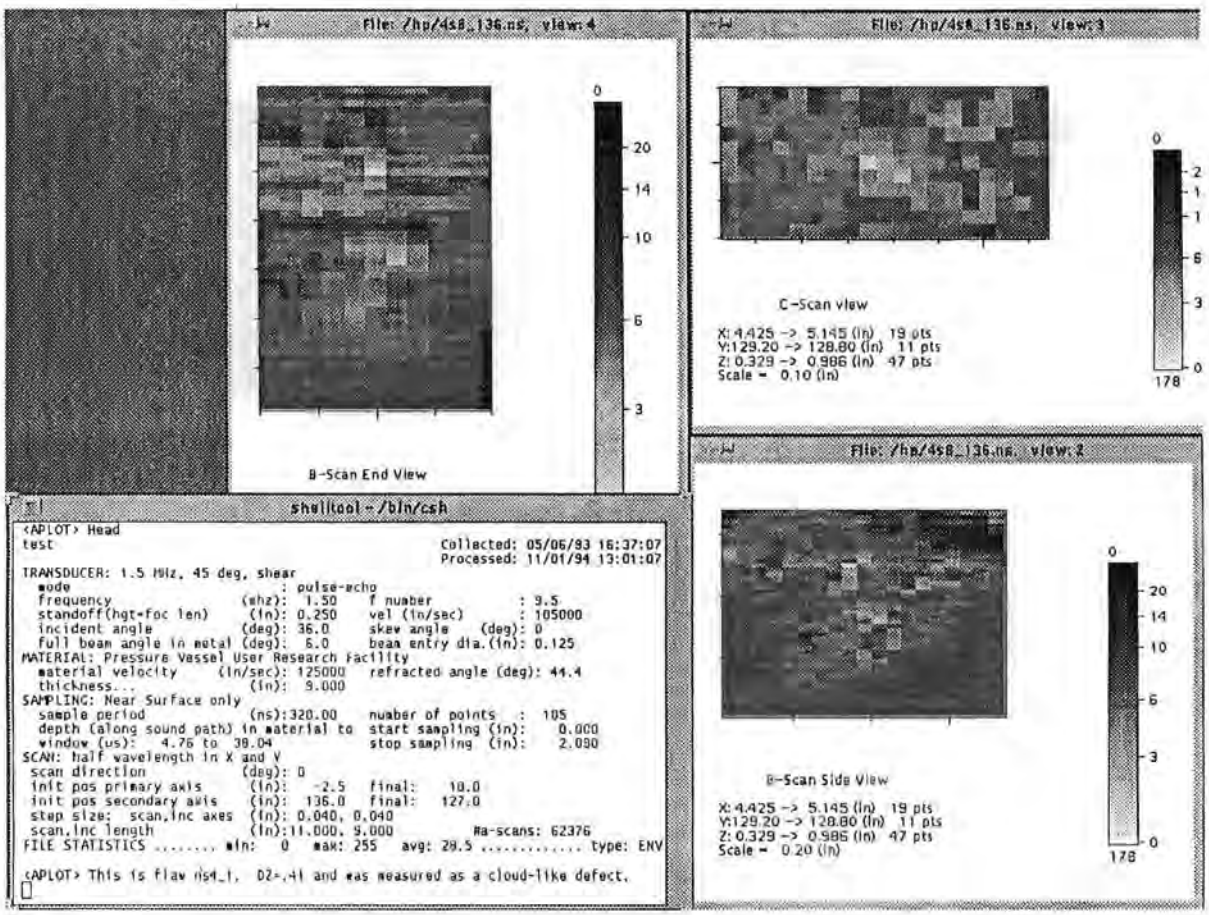
Figure A.15 shows planar indication #1 in the near surface base metal. This planar indication has a through-wall extent of 8 mm based on LOS in a cloud like shape, possibly 2.5 mm based on wave packet width. The detection was made in mode 8 where it had isolated TOF shape at a depth of 18 mm. There were no confirmations in other modes. The indication is characterized as planar based on lack of normal beam detection. There is no evidence of coin shape in the end view of mode 8. The length is 7 mm and was made to LOS in mode 8. The range of aspect ratios (length/depth) of this indication is 0.7 to 2.8. The maximum amplitude-to-noise ratio is low at 165 to 70. With an X coordinate of 122 mm, the indication is clearly in the base metal. With a Z coordinate of 18 mm, the indication is clearly below the cladding.

Figure A.15 - Planar indication #1 in the near surface base metal: mode 8

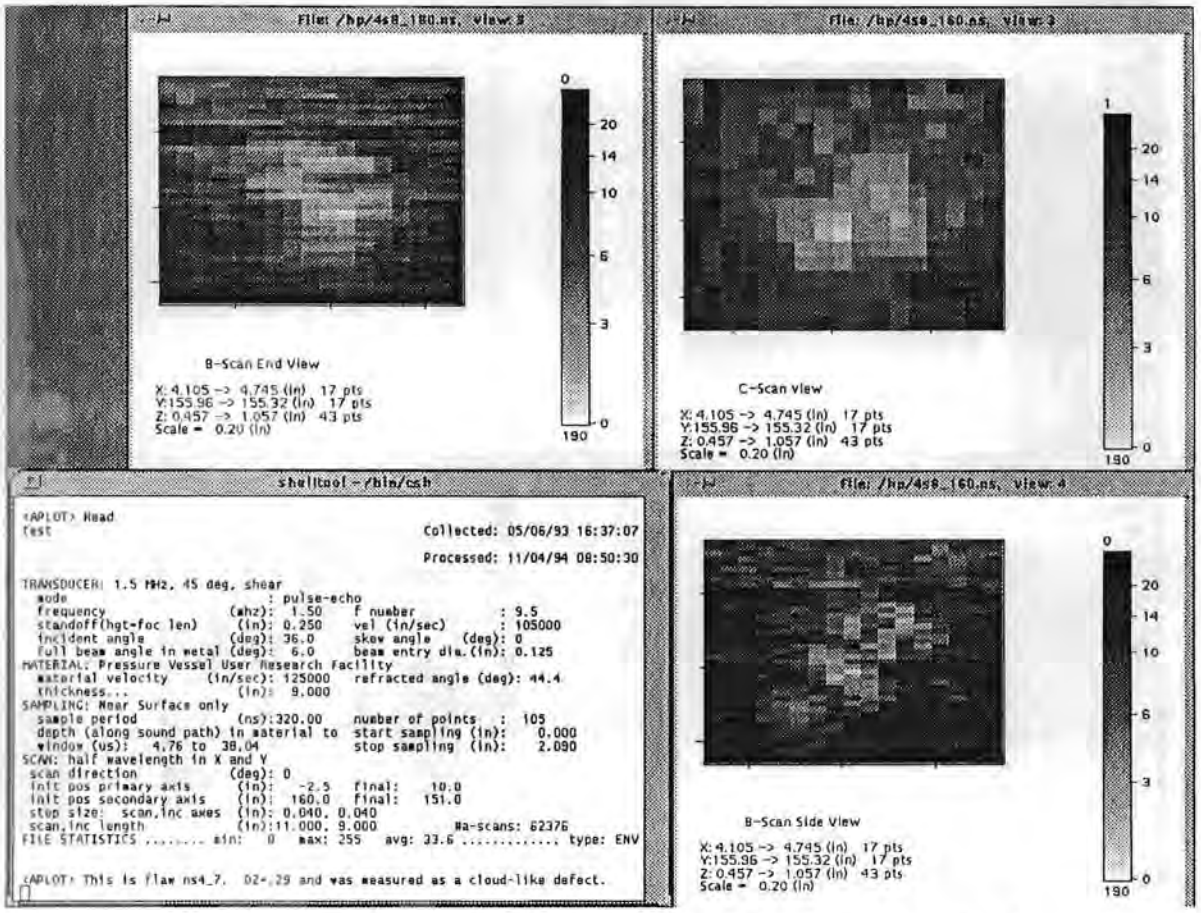
Figure A.16 shows planar indication #2 in the near surface base metal. This planar indication has a through-wall extent of 7.4 mm based on LOS in a cloud like shape, possibly 3.5 mm based on wave packet width. The detection was made in mode 8 where it had isolated TOF shape at a depth of 20 mm. There were no confirmations in other modes. The indication is characterized as planar based on lack of normal beam detection. There is no evidence of coin shape in the end view of mode 8. The length is 13 mm and was made to LOS in mode 8. The range of aspect ratios (length/depth) of this indication is 1.8 to 4. The maximum amplitude-to-noise ratio is high at 190 to 35. With an X coordinate of 112 mm, the indication is clearly in the base metal. With a Z coordinate of 20 mm, the indication is clearly below the cladding.

Figure A.16 - Planar indication #2 in the near surface base metal: mode 8

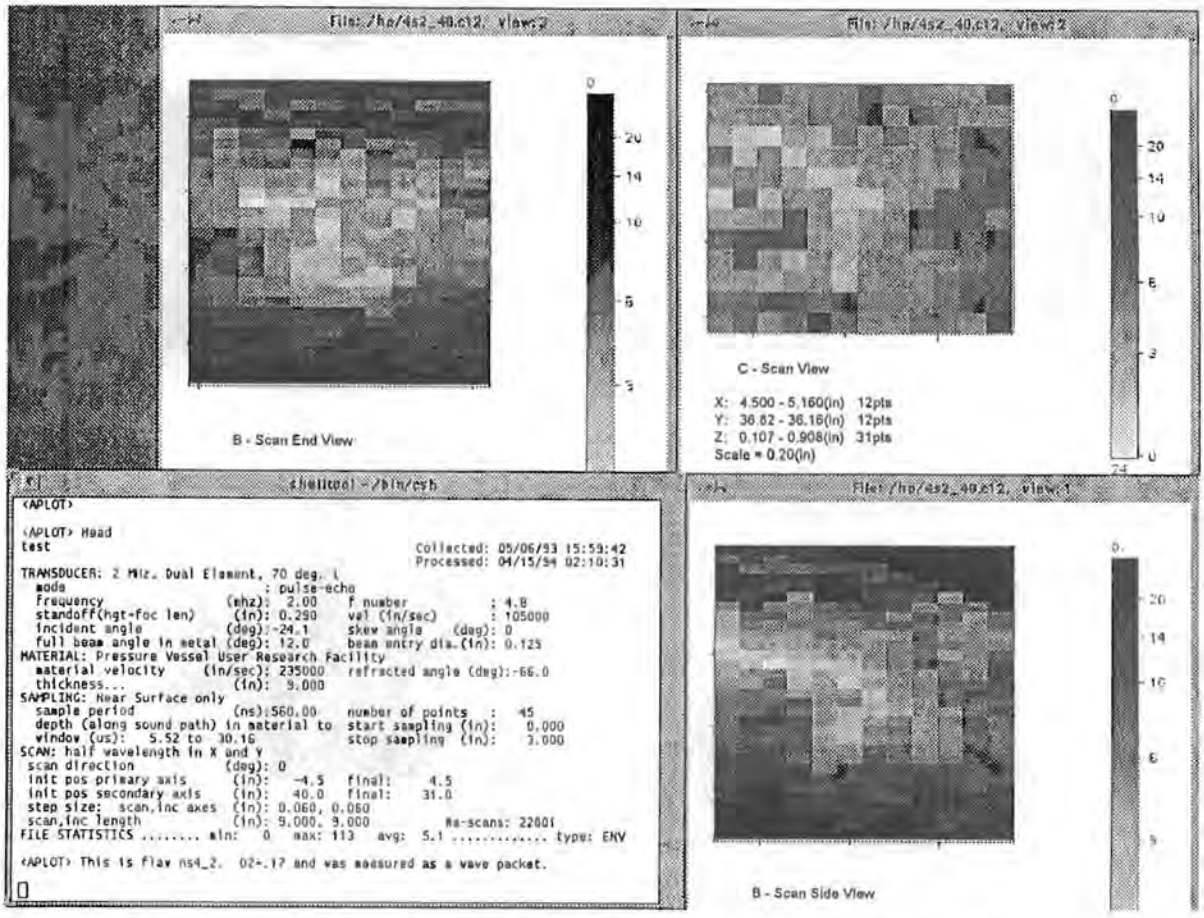
Figure A.17 shows planar indication #3 in the near surface base metal. This planar indication has a through-wall extent of 4 mm based on wave packet width. The detection was made in mode 2 where it had isolated TOF shape at a depth of 15 mm. There were no confirmations in other modes. The indication is characterized as planar based on lack of normal beam detection. There is no evidence of coin shape in the end view of mode 2. The length is 12 mm and was made to LOS in mode 2. The aspect ratio (length/depth) of this indication is 3 giving an orientation along the weld. The maximum amplitude-to-noise ratio is of medium range at 22 to 9. With an X coordinate of 122 mm, the indication is clearly in the base metal. With a Z coordinate of 15 mm, the indication is clearly below the cladding.

Figure A.17 - Planar indication #3 in the near surface base metal: mode 2

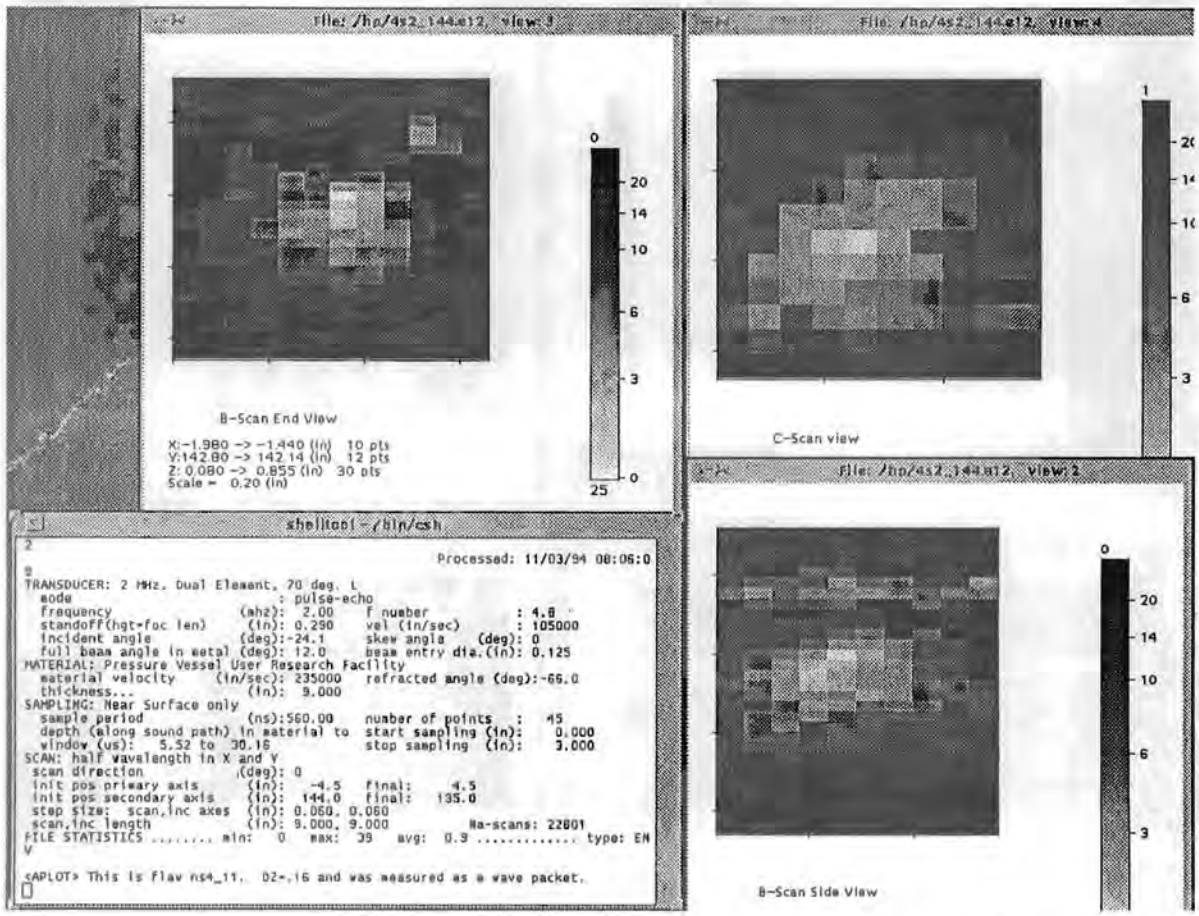
Figure A.18 shows planar indication #4 in the near surface base metal. This planar indication has a through-wall extent of 4 mm based on wave packet width. The detection was made in mode 2 where it had isolated TOF shape at a depth of 11 mm. There were no confirmations in other modes. The indication is characterized as planar based on lack of normal beam detection. There is no evidence of coin shape in the end view of mode 2. The length is 9 mm and was made to LOS in mode 2. The aspect ratio (length/depth) of this indication is 2 which is unusually low compared to the other indications detected in this data set. The maximum amplitude-to-noise ratio is high at 25 to 5. With an X coordinate of -46 mm, the indication is clearly in the base metal. With a Z coordinate of 11 mm, the indication is below the cladding by 2 mm.

Figure A.18 - Planar indication #4 in the near surface base metal: mode 2

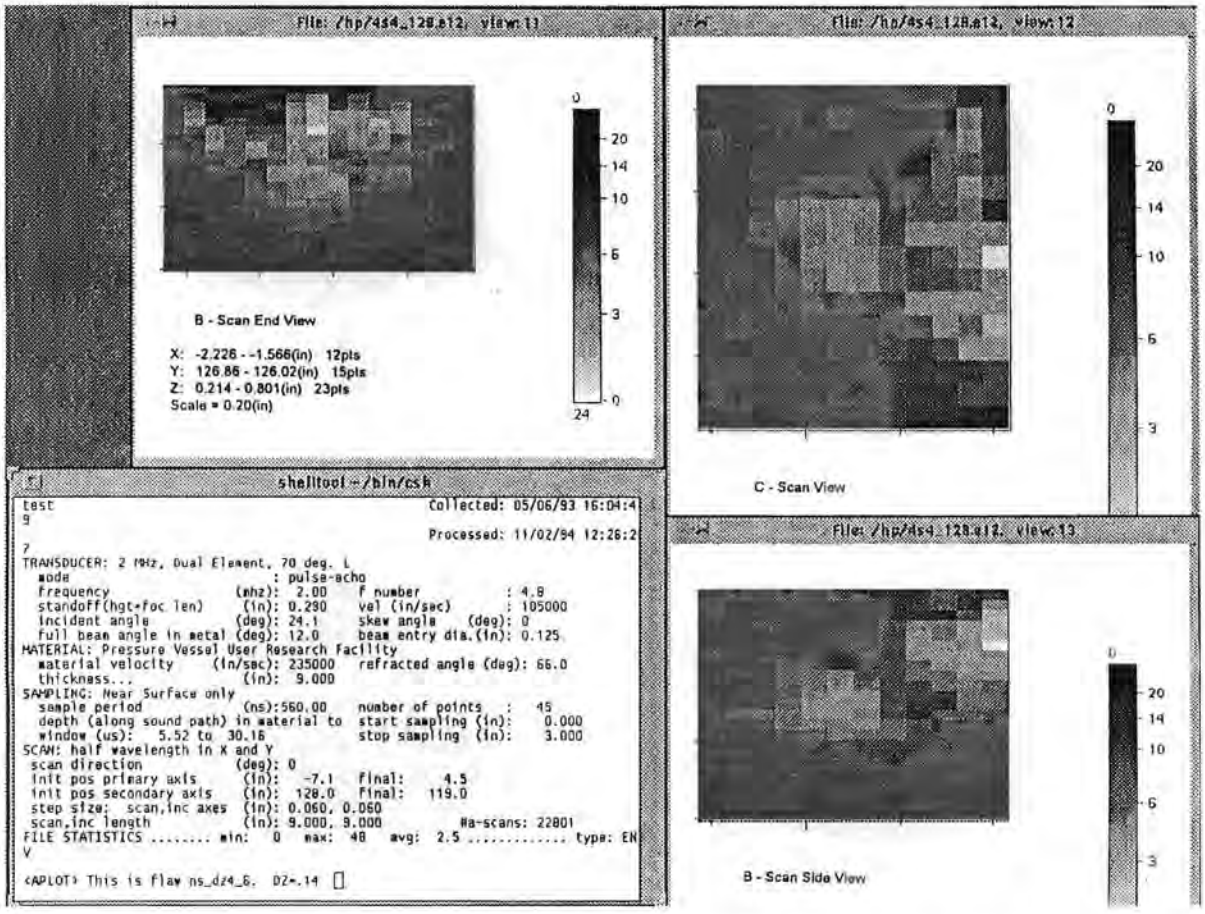
Figure A.19 shows planar indication #5 in the near surface base metal. This planar indication has a through-wall extent of 3.6 mm based on wave packet width. The detection was made in mode 4 where it had isolated TOF shape at a depth of 12 mm. There were no confirmations in other modes. The indication is characterized as planar based on lack of normal beam detection. There is good evidence of coin shape in the end view of modes 4. The length is 15 mm and was made to LOS in mode 4. The aspect ratio (length/depth) of this indication is 4 giving an orientation along the weld. The maximum amplitude-to-noise ratio is low at 19 to 9. With an X coordinate of -49 mm, the indication is clearly in the base metal. With a Z coordinate of 12 mm, the indication is below the cladding by 3 mm.

Figure A.19 - Planar indication #5 in the near surface base metal: mode 4

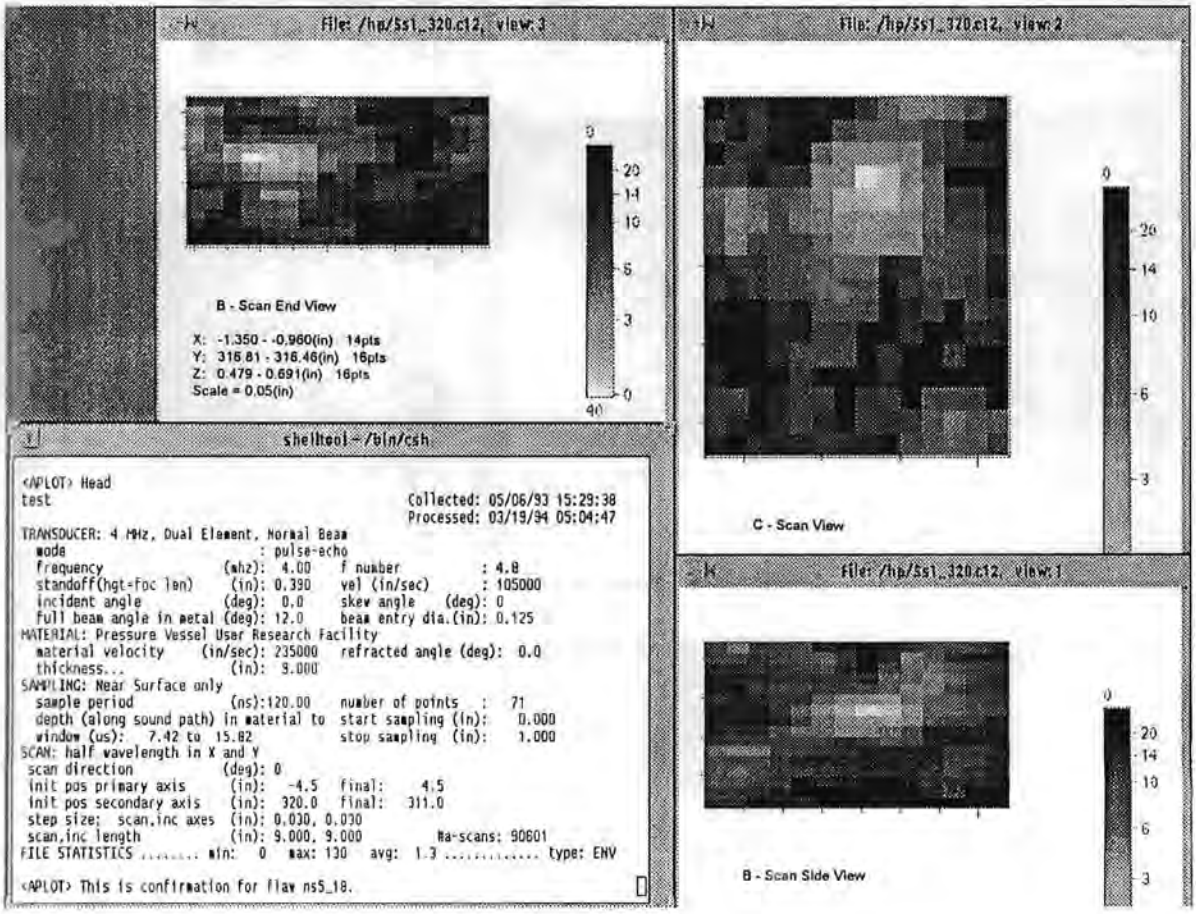
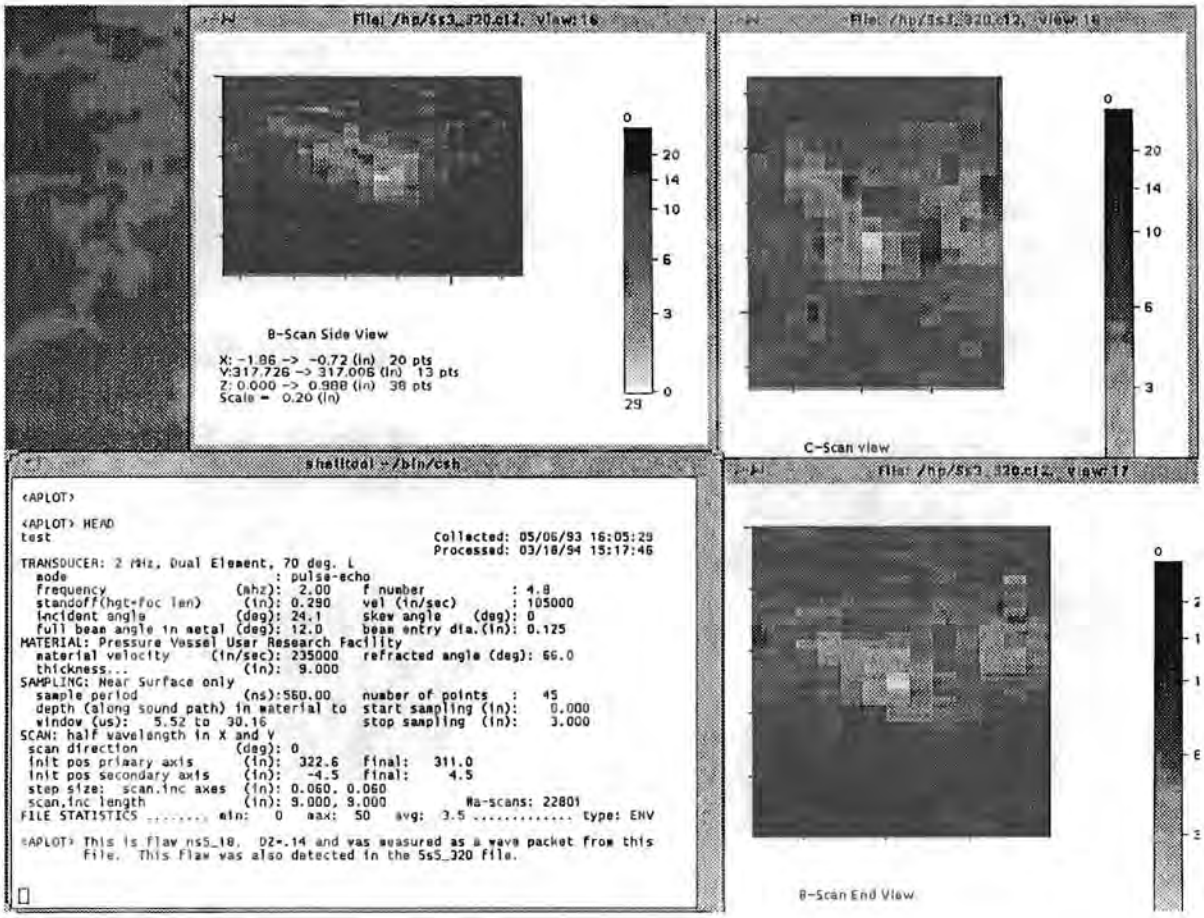
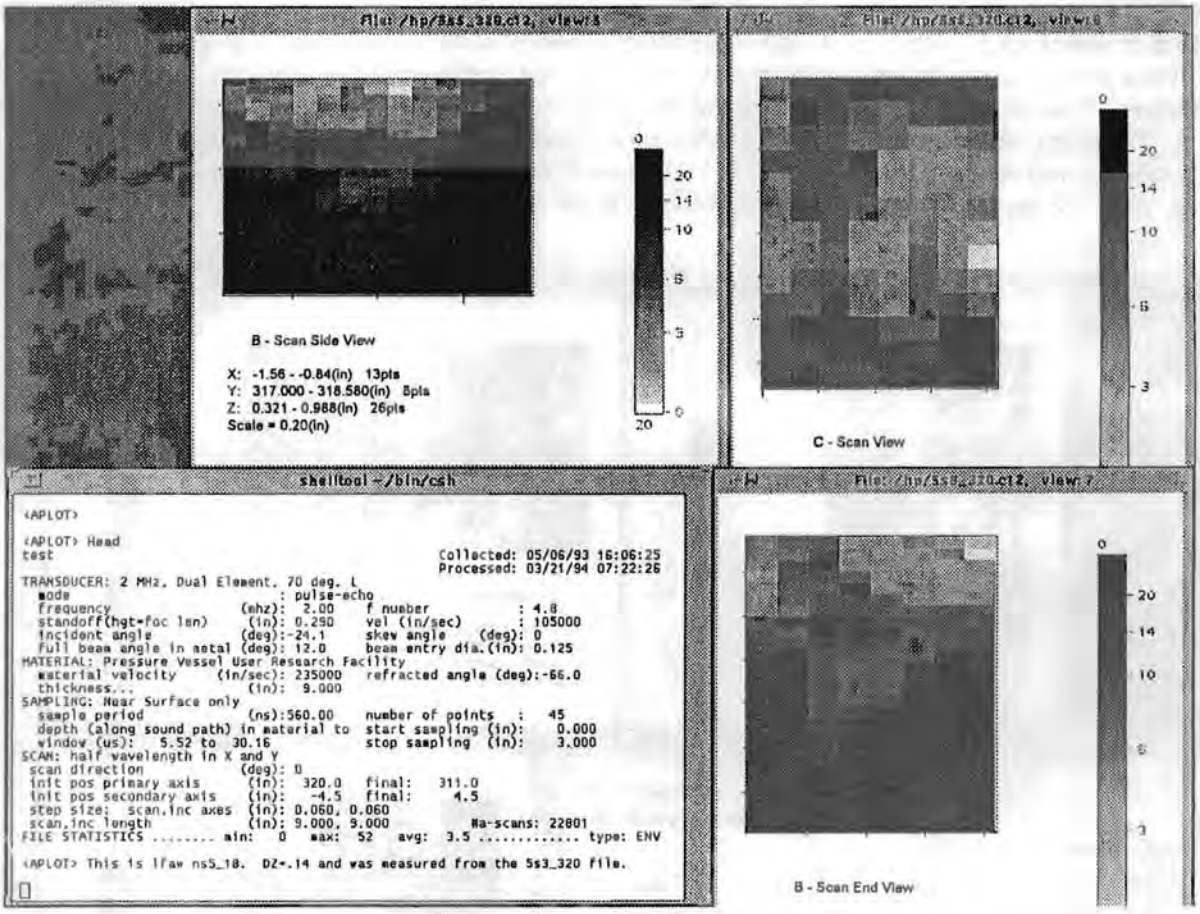
Figures A.20a-c show planar indication #6 in the near surface base metal. This planar indication has a through-wall extent of 3.5 mm based on wave packet width. The detections were made in modes 3 and 5 where it had isolated TOF shape at depths of 13 and 16 mm. The shape quality is good for this indication. There was a confirmation in mode 1 at a depth of 14 mm. The different Z values 13 to 16 mm give an alternate depth size of 3 mm. There is good evidence of coin shape in the end view of mode 3. The indication is characterized as planar based on the coin shape in mode 3. The length is 12 mm and was made to LOS in mode 1. The width is 20 mm and was made to LOS in mode 3. The aspect ratio (width/depth) of this indication is 6 which tends to confirm planar orientation. The maximum amplitude-to-noise ratio is of medium range at 29 to 10. With an X coordinate of -29 mm, the indication is clearly in the base metal. With a Z coordinate of 13 mm, the indication is below the cladding by 4 mm.

Figure A.20a - Planar indication #6 in the near surface base metal: mode 1

Figure A.20b - Planar indication #6 in the near surface base metal: mode 3

Figure A.20c - Planar indication #6 in the near surface base metal: mode 5

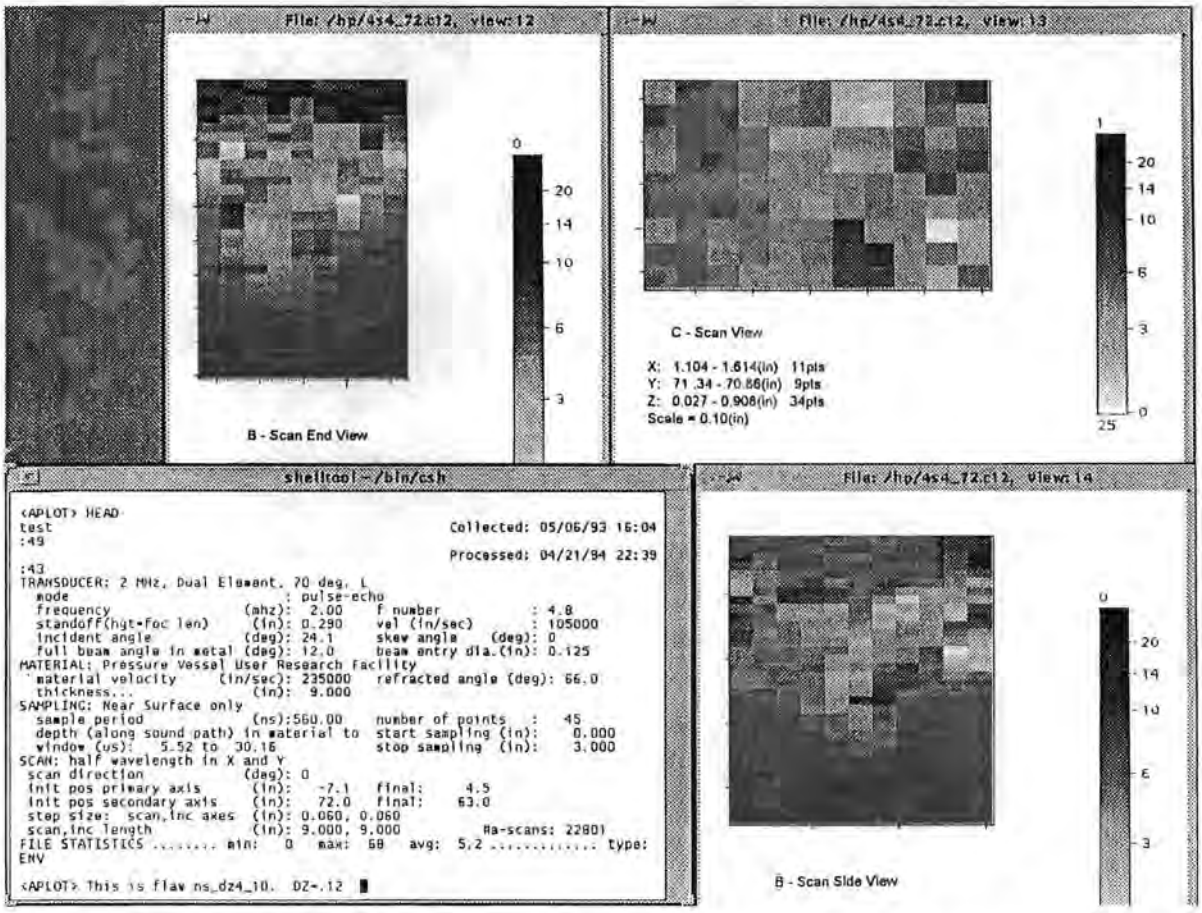
Figure A.21 shows planar indication #7 in the near surface base metal. This planar indication has a through-wall extent of 3 mm based on wave packet width. The detection was made in mode 4 where it had isolated TOF shape at a depth of 13 mm. There were no confirmations in other modes. The indication is characterized as planar based on lack of normal beam detection. There is no evidence of coin shape in the end view of mode 4. The length is 9 mm and was made to LOS in mode 4. The aspect ratio (length/depth) of this indication is 3 giving an orientation along the weld. The maximum amplitude-to-noise ratio is of medium range at 22 to 7. With an X coordinate of 32 mm, the indication is clearly in the base metal. With a Z coordinate of 13 mm, the indication is below the cladding by 4 mm.

Figure A.21 - Planar indication #7 in the near surface base metal: mode 4

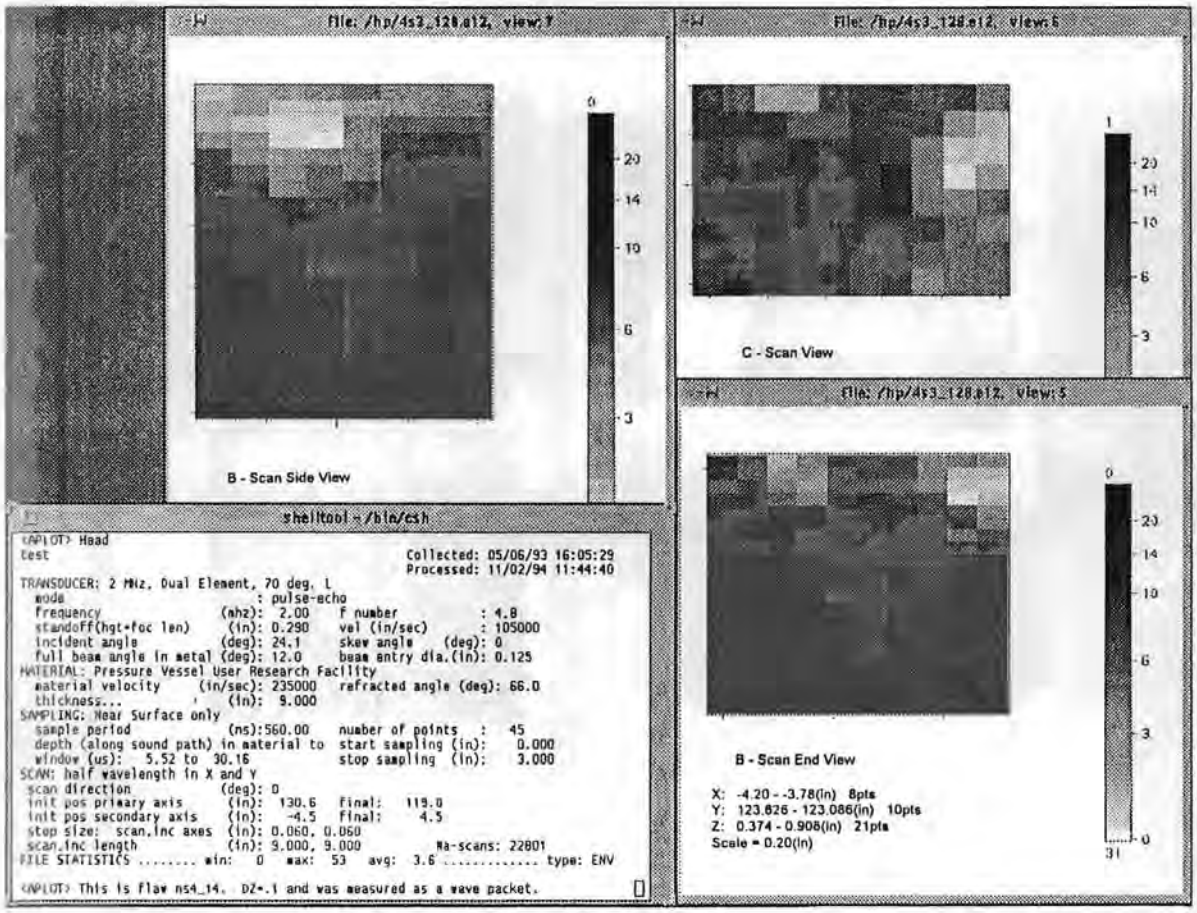
Figure A.22 shows planar indication #8 in the near surface base metal. This planar indication has a through-wall extent of 2.5 mm based on wave packet width. The detection was made in mode 3 where it had isolated TOF shape at a depth of 15 mm. There were no confirmations in other modes. The indication is characterized as planar based on lack of normal beam detection. There is no evidence of coin shape in the side view of mode 3. The width is 11 mm and was made to LOS in mode 3. The aspect ratio (width/depth) of this indication is 4 giving an orientation across the weld. The maximum amplitude-to-noise ratio is low at 14 to 7. With an X coordinate of -100 mm, the indication is clearly in the base metal. With a Z coordinate of 15 mm, the indication is clearly below the cladding.

Figure A.22 - Planar indication #8 in the near surface base metal: mode 3

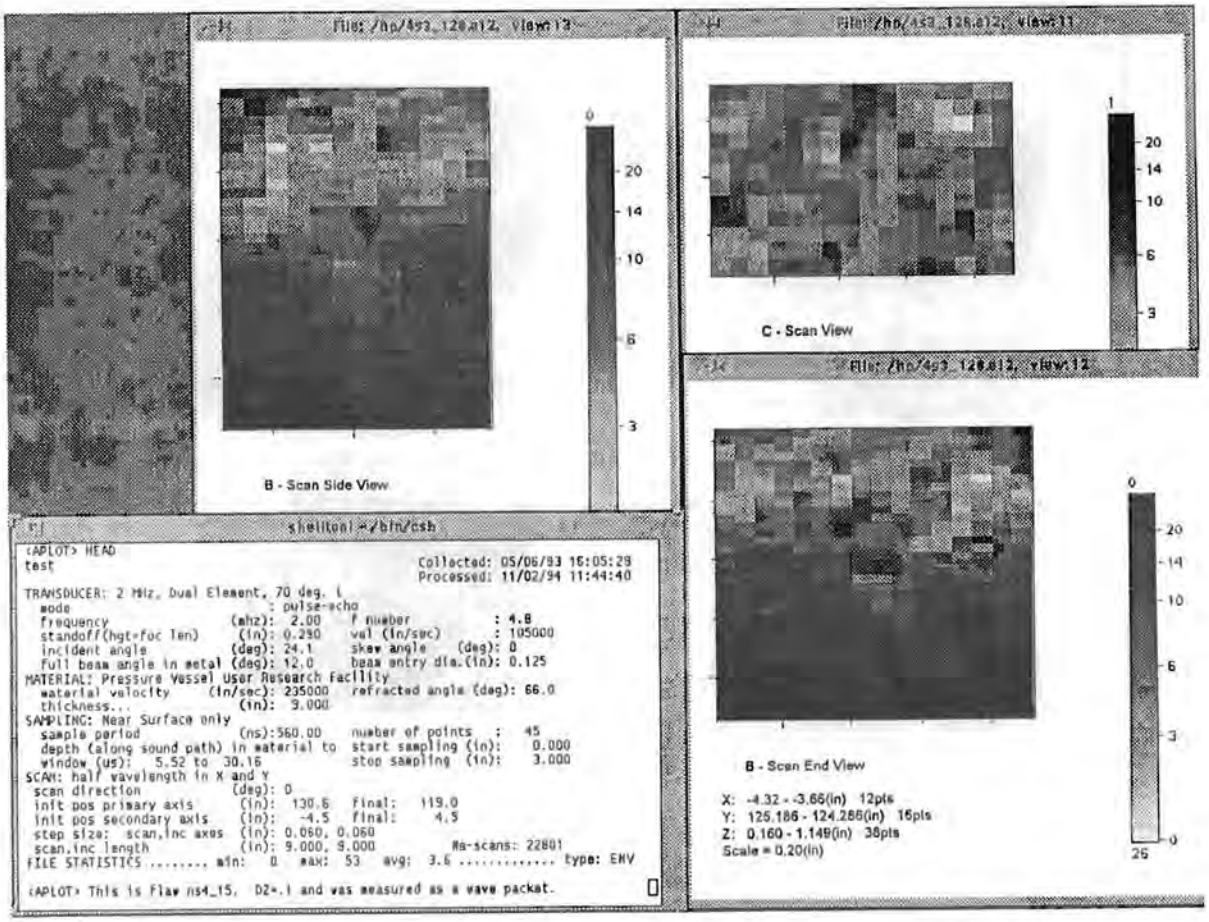
Figure A.23 shows planar indication #9 in the near surface base metal. This planar indication has a through-wall extent of 2.5 mm based on wave packet width. The detection was made in mode 3 where it had isolated TOF shape at a depth of 17 mm. There were no confirmations in other modes. The indication is characterized as planar based on lack of normal beam detection. There is no evidence of coin shape in the side view of mode 3. The width is 7 mm and was made to LOS in mode 3. The aspect ratio (width/depth) of this indication is 2.8 giving an orientation across the weld. The maximum amplitude-to-noise ratio is of medium range at 27 to 7. With an X coordinate of -102 mm, the indication is clearly in the base metal. With a Z coordinate of 17 mm, the indication is clearly below the cladding.

Figure A.23 - Planar indication #9 in the near surface base metal: mode 3

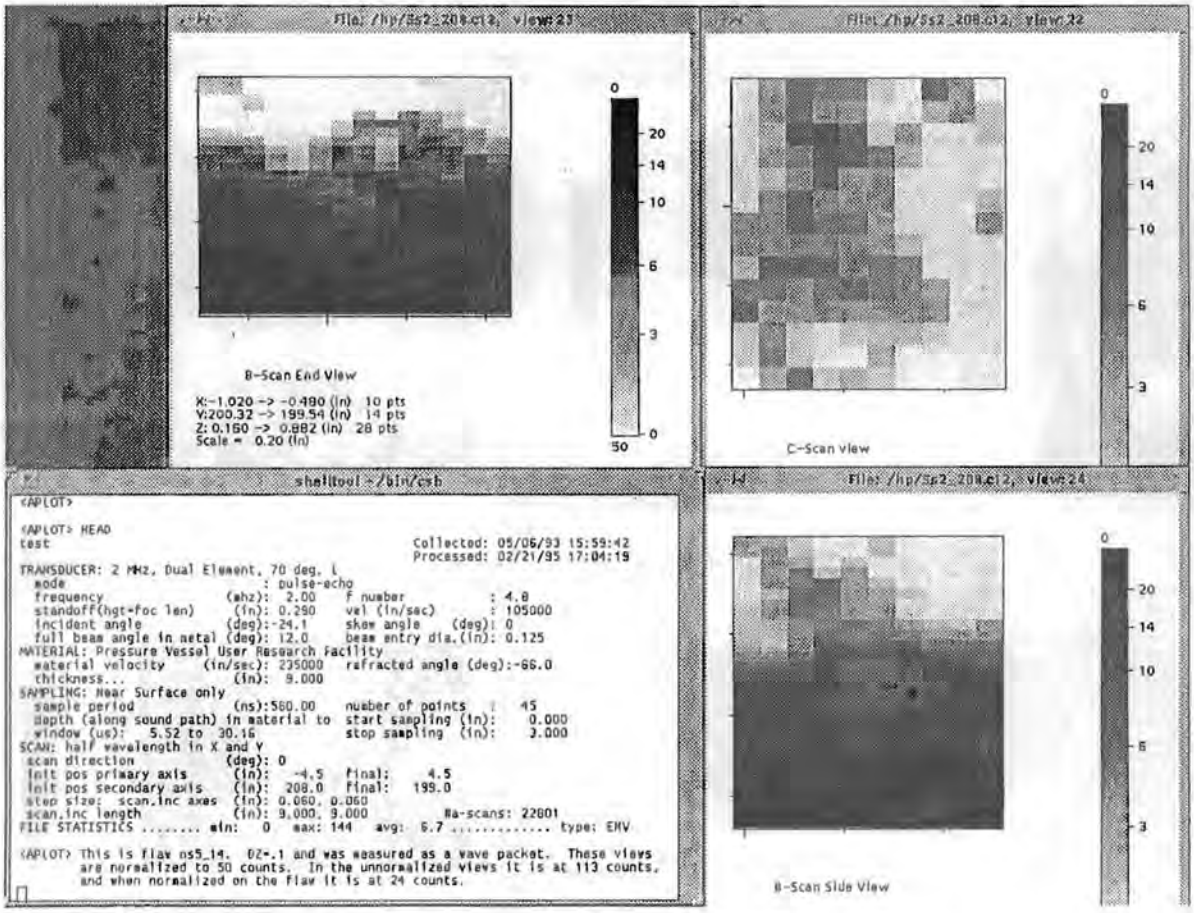
Figure A.24 shows planar indication #10 in the near surface base metal. This planar indication has a through-wall extent of 2.5 mm based on wave packet width. The detection was made in mode 2 where it had isolated TOF shape at a depth of 13 mm. There were no confirmations in other modes. The indication is characterized as planar based on lack of normal beam detection. There is no evidence of coin shape in the end view of modes 2. The length is 7 mm and was made to LOS in mode 2. The aspect ratio (length/depth) of this indication is 2.8 giving an orientation along the weld. The maximum amplitude-to-noise ratio is of medium range at 24 to 10. With an X coordinate of -18 mm, the indication is in the base metal, possibly in the HAZ. With a Z coordinate of 13 mm, the indication is below the cladding by 4 mm.

Figure A.24 - Planar indication #10 in the near surface base metal: mode 2

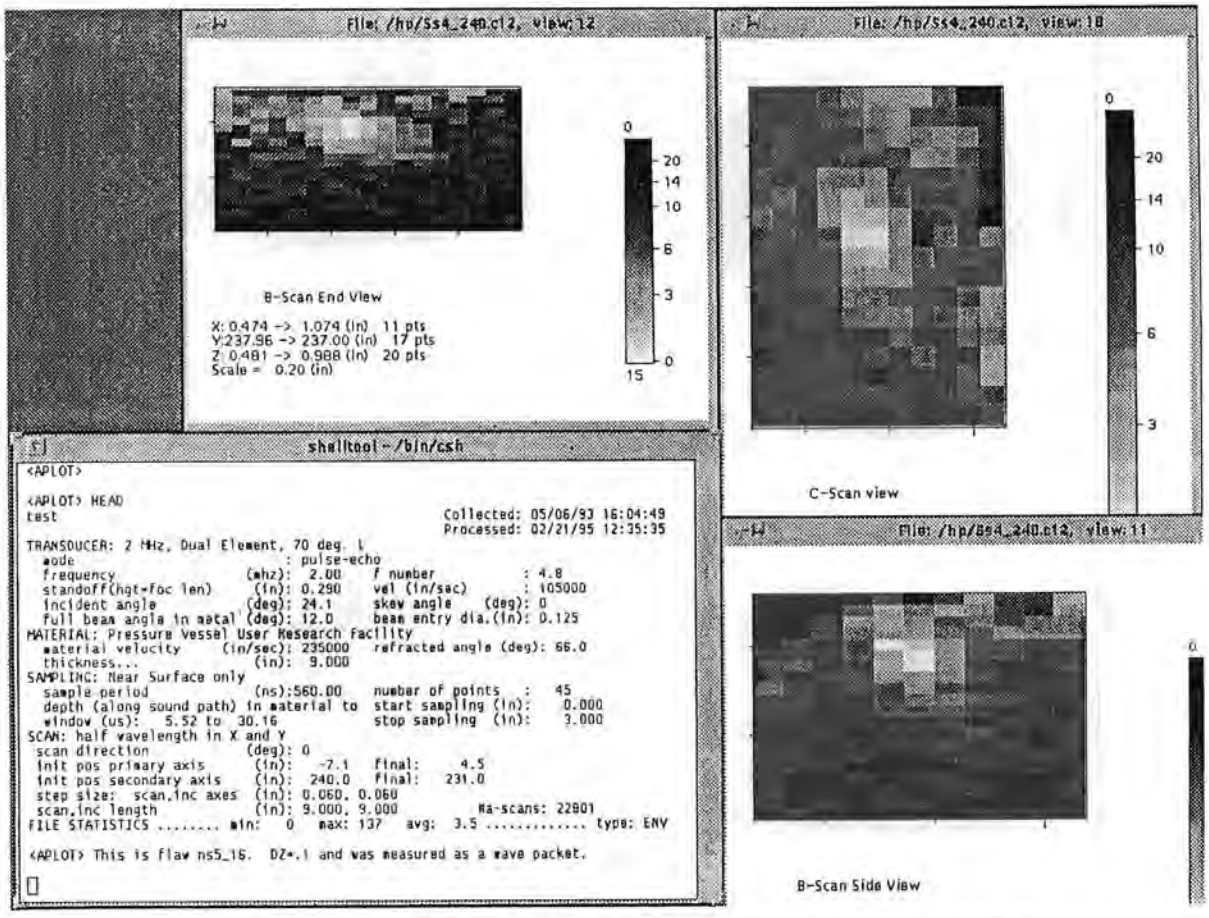
Figure A.25 shows planar indication #11 in the near surface base metal. This planar indication has a through-wall extent of 2.5 mm based on wave packet width. The detection was made in mode 4 where it had isolated TOF shape at a depth of 15 mm. The TOF shape may be artificial do to the limits of the scanning aperture; the shape quality is poor for this indication. There were no confirmations in other modes. The indication is characterized as planar based on lack of normal beam detection. There is no evidence of coin shape in the end view of mode 4. The length is 15 mm and was made to LOS in mode 4. The aspect ratio (length/depth) of this indication is 6 giving an orientation along the weld. The maximum amplitude-to-noise ratio is of medium range at 15 to 6. With an X coordinate of 20 mm, the indication is in the base metal. With a Z coordinate of 15 mm, the indication is clearly below the cladding.

Figure A.25 - Planar indication #11 in the near surface base metal: mode 4

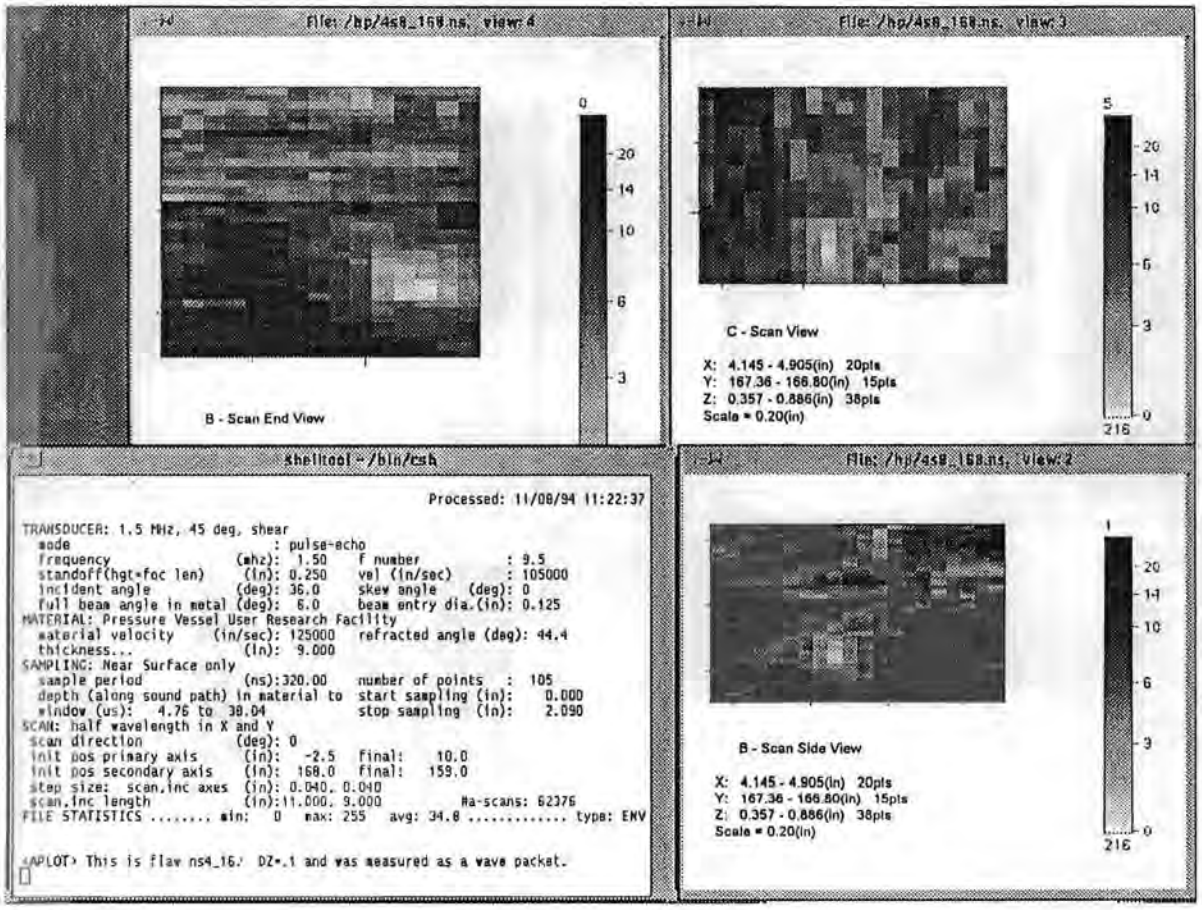
Figure A.26 shows planar indication #12 in the near surface base metal. This planar indication has a through-wall extent of 2.5 mm based on wave packet width. The detection was made in mode 8 where it had isolated TOF shape at a depth of 19 mm. There were no confirmations in other modes. The indication is characterized as planar based on lack of normal beam detection. There is some evidence of coin shape in the end view of mode 8. The length is 11 mm and was made to LOS in mode 8. The aspect ratio (length/depth) of this indication is 4 giving an orientation along the weld. The maximum amplitude-to-noise ratio is high at 216 to 45. With an X coordinate of 113 mm, the indication is clearly in the base metal. With a Z coordinate of 19 mm, the indication is clearly below the cladding.

Figure A.26 - Planar indication #12 in the near surface base metal: mode 8

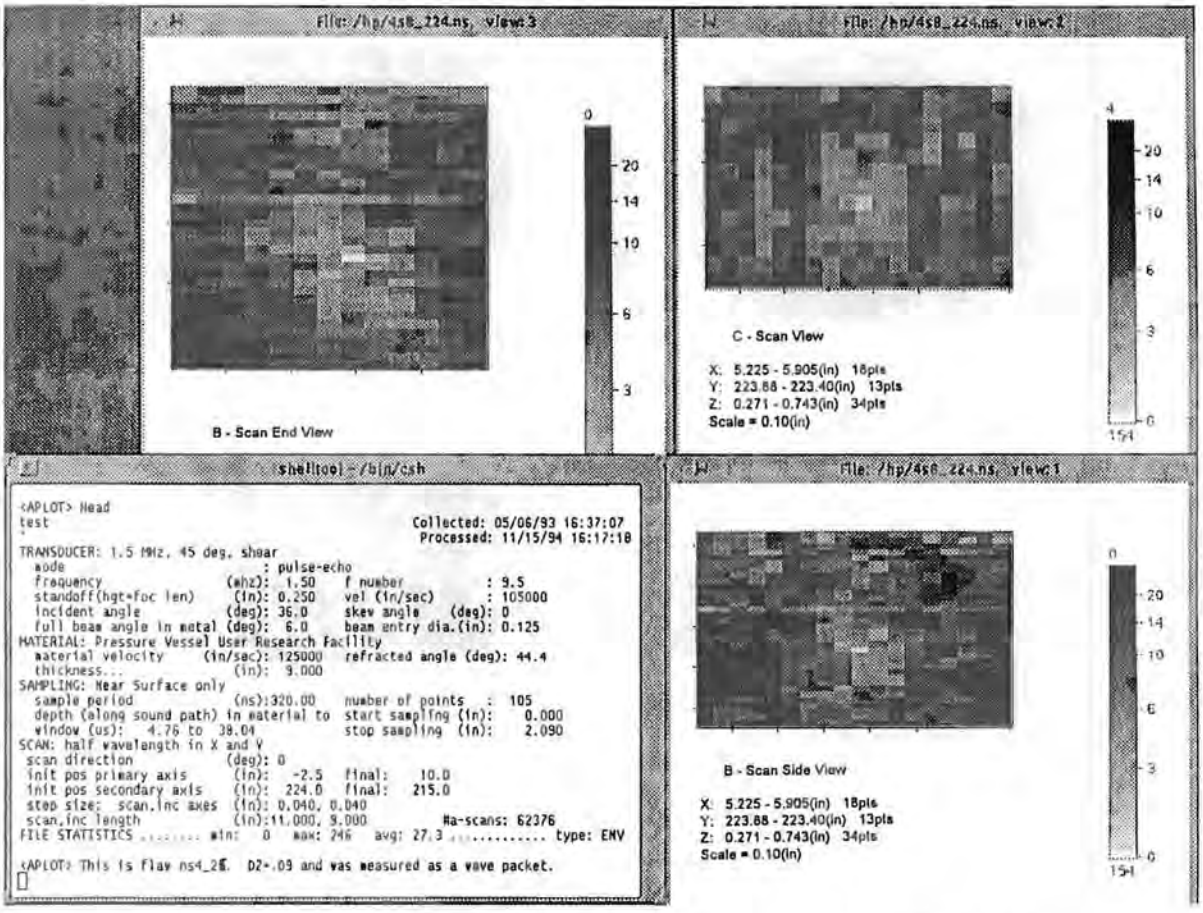
Figure A.27 shows planar indication #13 in the near surface base metal. This planar indication has a through-wall extent of 2.3 mm based on wave packet width, possibly 1.6 mm based on ring around pattern. The detection was made in mode 8 where it displayed TOF shape at a depth of 14 mm. The shape quality is good for this indication. There were no confirmations in other modes. The indication is characterized as planar based on lack of normal beam detection. There is no evidence of coin shape in the end view of mode 8. The length is 10 mm and was made to LOS in mode 8. The aspect ratio (length/depth) of this indication is 6 giving an orientation along the weld. The maximum amplitude-to-noise ratio is of medium range at 154 to 50. With an X coordinate of 142 mm, the indication is clearly in the base metal. With a Z coordinate of 14 mm, the indication is clearly below the cladding.

Figure A.27 - Planar indication #13 in the near surface base metal: mode 8

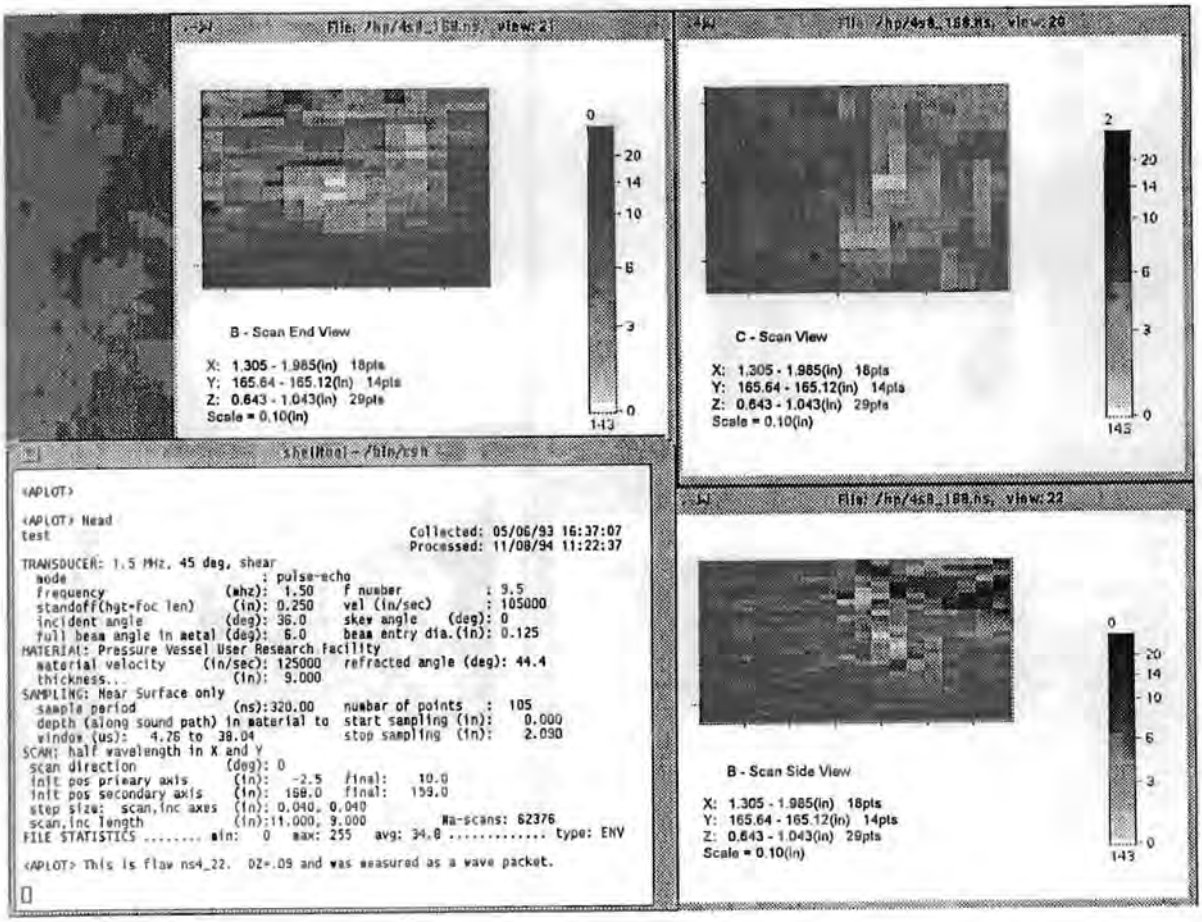
Figure A.28 shows planar indication #14 in the near surface base metal. This planar indication has a through-wall extent of 2.3 mm based on wave packet width. The detection was made in mode 8 where it had isolated TOF shape at a depth of 20 mm. The shape quality is good for this indication. There were no confirmations in other modes. The indication is characterized as planar based on lack of normal beam detection. There is some evidence of coin shape in the end view of mode 8. The length is 10 mm and was made to LOS in mode 8. The aspect ratio (length/depth) of this indication is 4 giving an orientation along the weld. The maximum amplitude-to-noise ratio is of medium range at 143 to 45. With an X coordinate of 43 mm, the indication is clearly in the base metal. With a Z coordinate of 20 mm, the indication is clearly below the cladding.

Figure A.28 - Planar indication #14 in the near surface base metal: mode 8

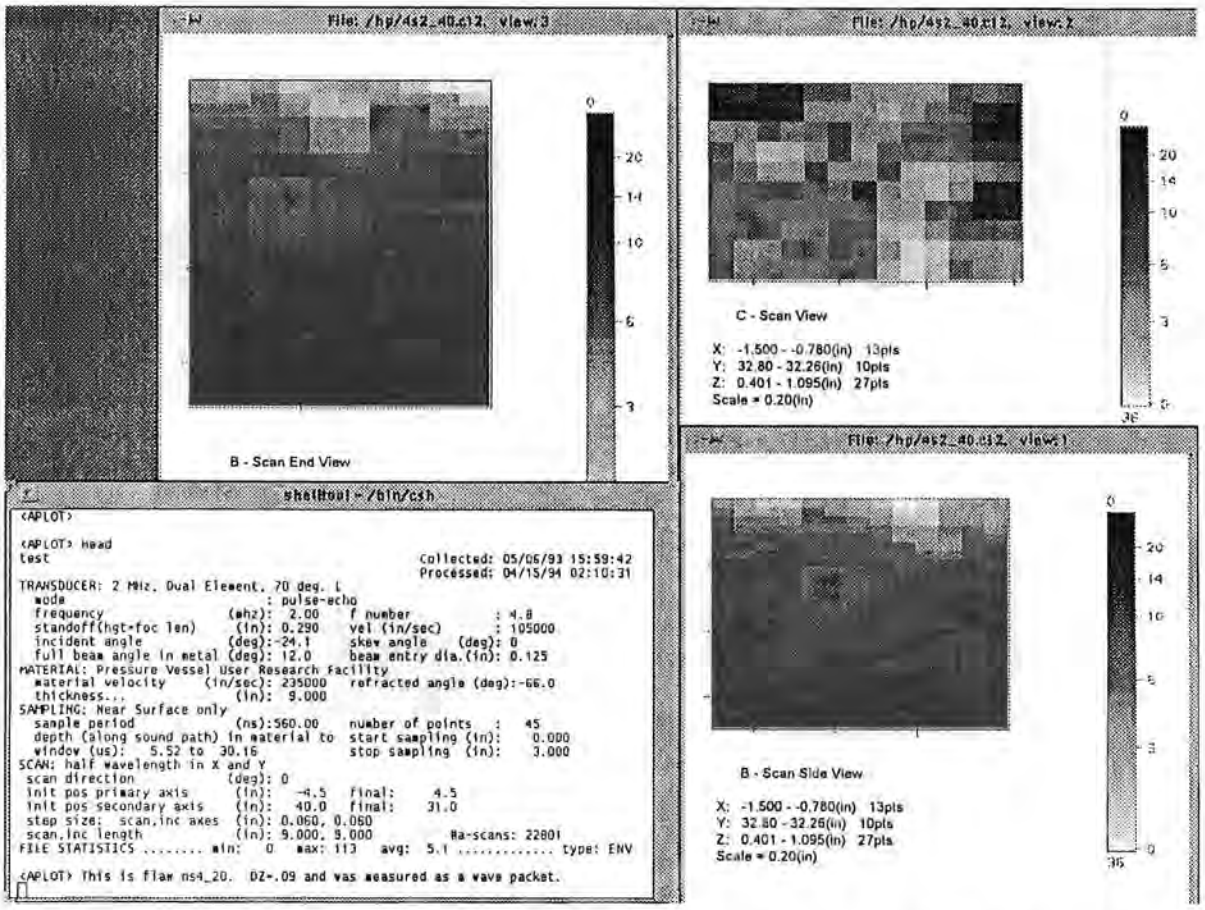
Figure A.29 shows planar indication #15 in the near surface base metal. This planar indication has a through-wall extent of 2.3 mm based on wave packet width. The detection was made in mode 2 where it had isolated TOF shape at a depth of 17 mm. The shape quality is good for this indication. There were no confirmations in other modes. The indication is characterized as planar based on lack of normal beam detection. There is no evidence of coin shape in the end view of mode 2. The length is 14 mm and was made to LOS in mode 2. The aspect ratio (length/depth) of this indication is 6 giving an orientation along the weld. The maximum amplitude-to-noise ratio is of medium range at 16 to 7. With an X coordinate of -30 mm, the indication is clearly in the base metal. With a Z coordinate of 17 mm, the indication is clearly below the cladding.

Figure A.29 - Planar indication #15 in the near surface base metal: mode 2
