NUREG/CR-6471, Vol. 1
PNNL-11143

Characterization of Flaws in U.S. Reactor Pressure Vessels

Density and Distribution of Flaw Indications in PVRUF

Pacific Northwest National Laboratory

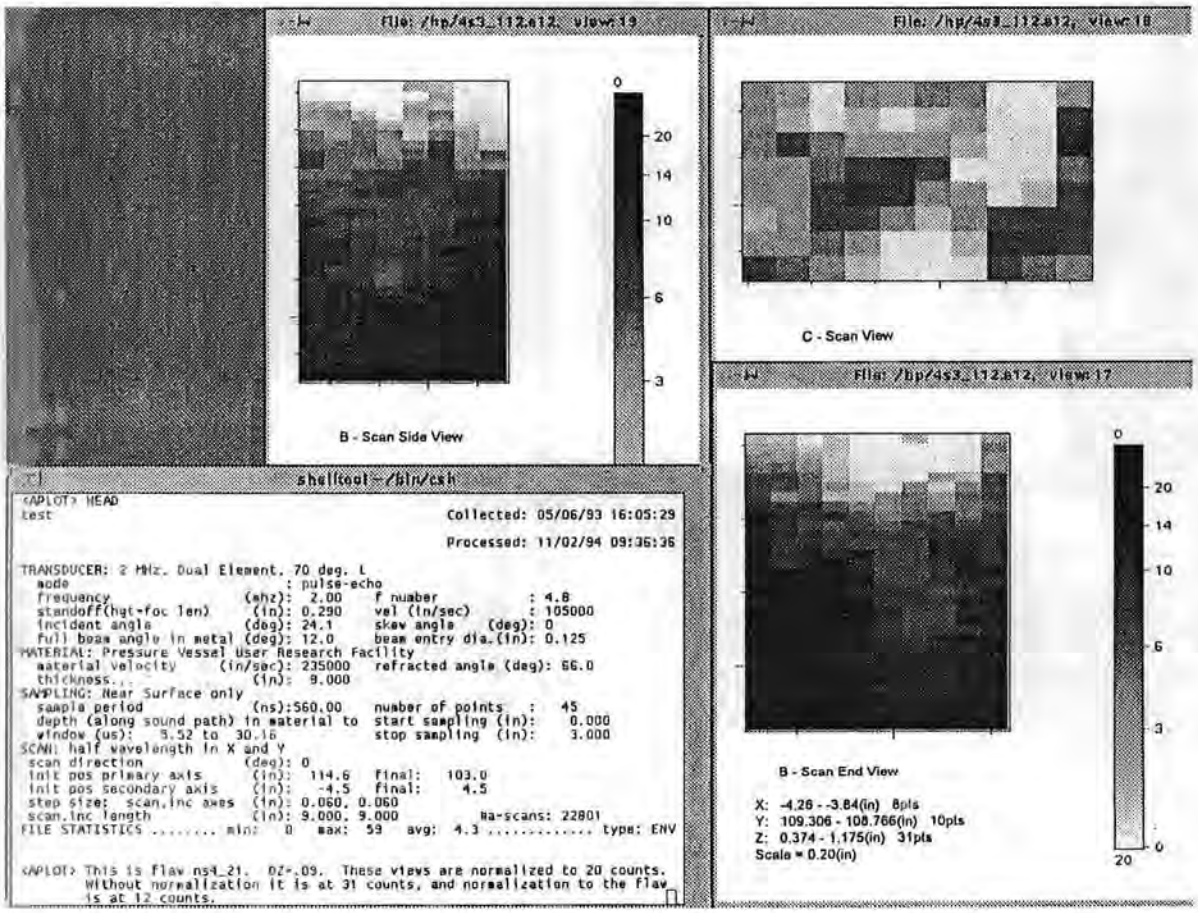
Figure A.30 shows planar indication #16 in the near surface base metal. This planar indication has a through-wall extent of 2.3 mm based on wave packet width. The detection was made in mode 3 where it had isolated TOF shape at a depth of 18 mm. The TOF shape may be artificial because of the limits of the scanning aperture; the shape quality is fair for this indication. There were no confirmations in other modes. The indication is characterized as planar based on lack of normal beam detection. There is no evidence of coin shape in the end view of mode 3. The width is 7 mm and was made to LOS in mode 3. The aspect ratio (width/depth) of this indication is 3 giving an orientation across the weld. The maximum amplitude-to-noise ratio is low at 12 to 6. With an X coordinate of -104 mm, the indication is clearly in the base metal. With a Z coordinate of 18 mm, the indication is clearly below the cladding.

Figure A.30 - Planar indication #16 in the near surface base metal: mode 3

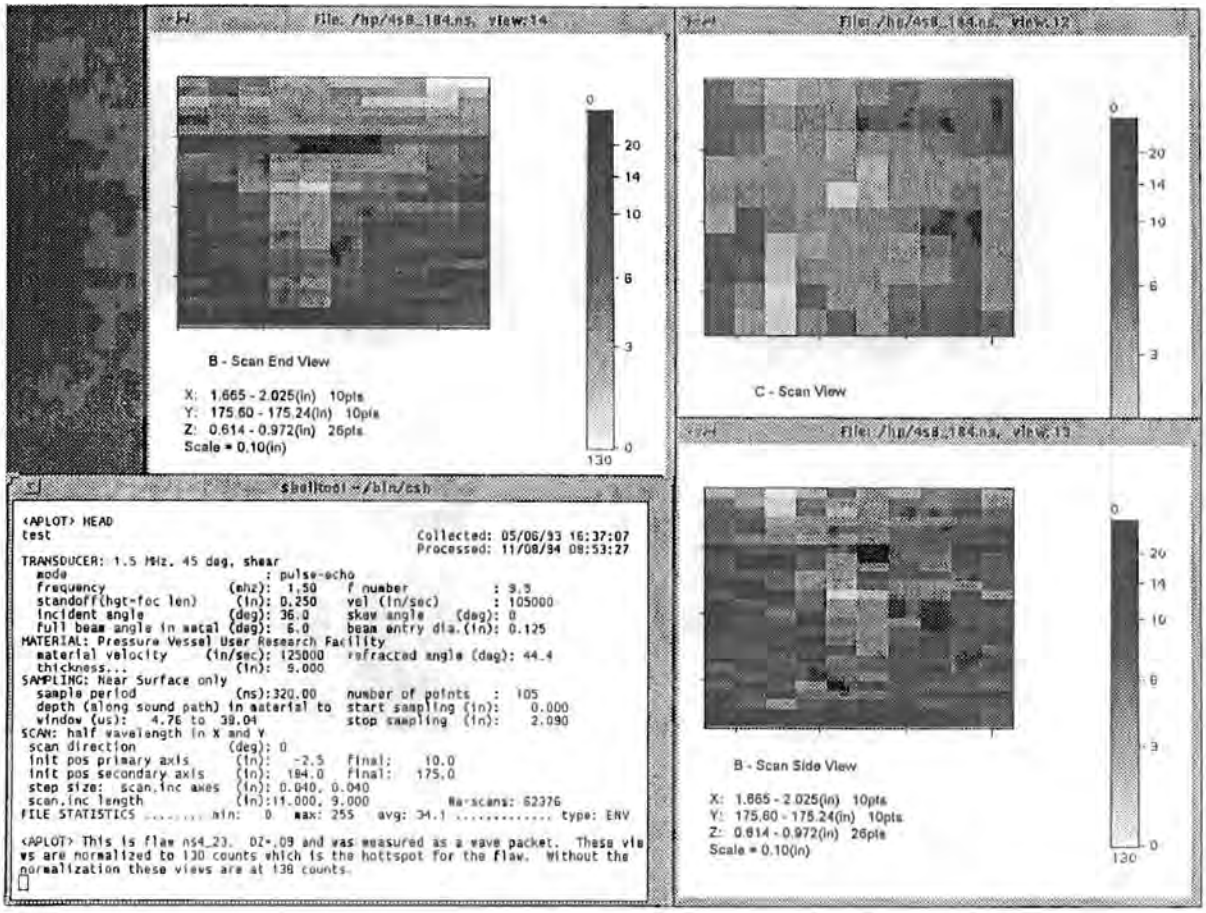
Figure A.31 - Planar indication #17 in the near surface base metal: mode 8

Figure A.31 shows planar indication #17 in the near surface base metal. This planar indication has a through-wall extent of 2.3 mm based on wave packet width. The detection was made in mode 8 where it had isolated TOF shape at a depth of 20 mm. The shape quality is poor for this indication. There were no confirmations in other modes. The indication is characterized as planar based on lack of normal beam detection. There is no evidence of coin shape in the end view of mode 8. The length is 8 mm and was made to LOS in mode 8. The aspect ratio (length/depth) of this indication is 3 giving an orientation along the weld. The maximum amplitude-to-noise ratio is of medium range at 130 to 50. With an X coordinate of 46 mm, the indication is clearly in the base metal. With a Z coordinate of 20 mm the indication is clearly below the cladding.

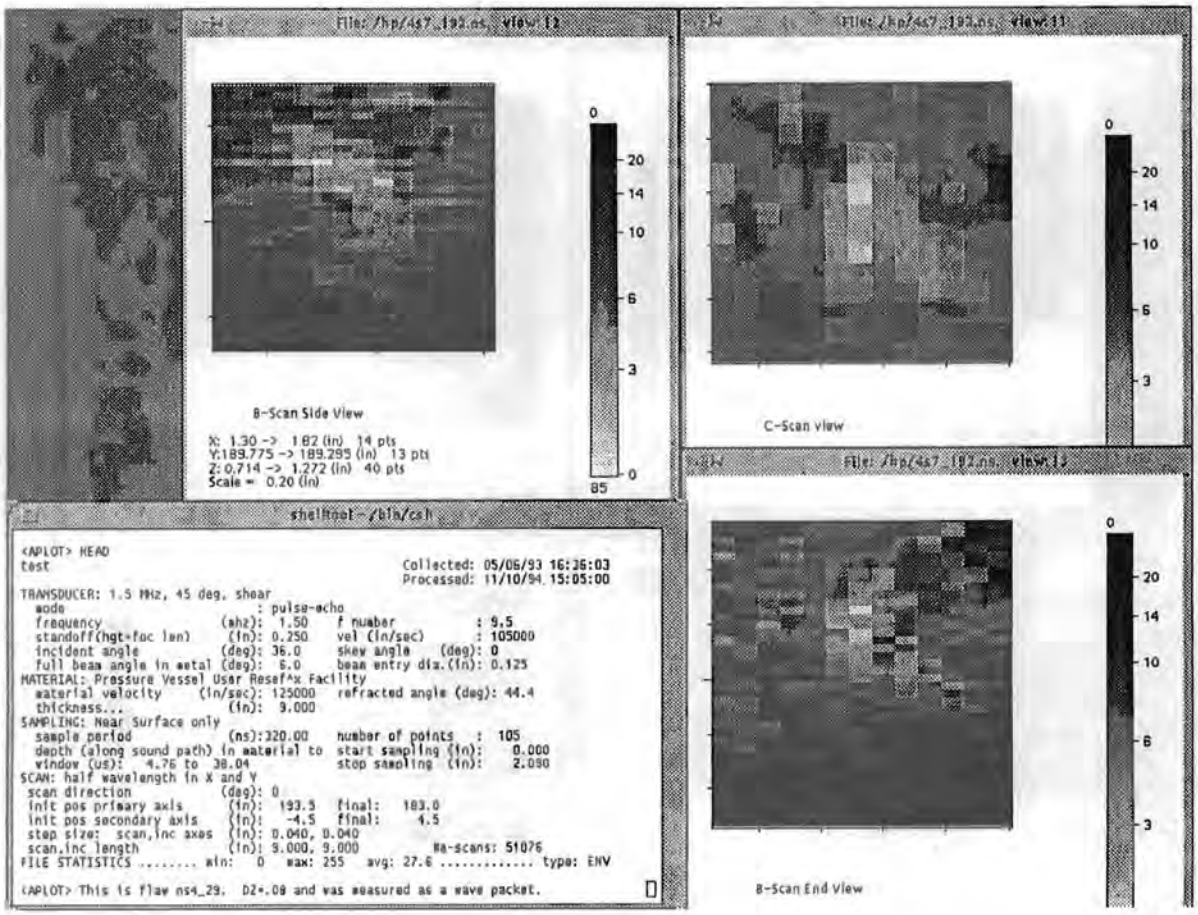
Figure A.32 shows planar indication #18 in the near surface base metal. This planar indication has a through-wall extent of 2 mm based on wave packet width. The detection was made in mode 7 where it had isolated TOF shape at a depth of 22 mm. The shape quality is fair for this indication. There were no confirmations in other modes. The indication is characterized as planar based on lack of normal beam detection. There is no evidence of coin shape in the side view of mode 7. The width is 11 mm and was made to LOS in mode 7. The aspect ratio (width/depth) of this indication is 6 giving an orientation across the weld. The maximum amplitude-to-noise ratio is of medium range at 85 to 30. With an X coordinate of 39 mm, the indication is clearly in the base metal. The Z coordinate of 22 mm shows that the indication is below the cladding.

Figure A.32 - Planar indication #18 in the near surface base metal: mode 7

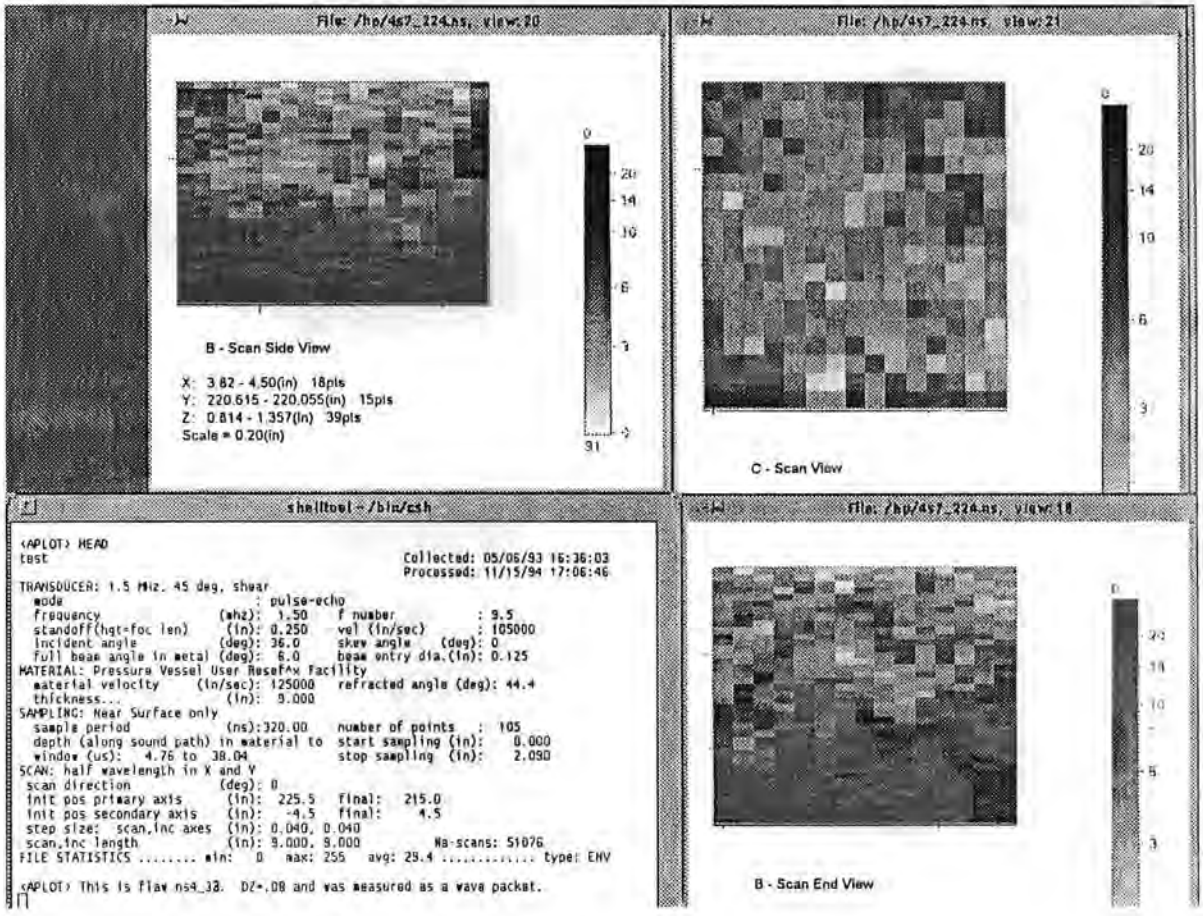
Figure A.33 shows planar indication #19 in the near surface base metal. This planar indication has a through-wall extent of 2 mm based on wave packet width. The detection was made in mode 7 where it had isolated TOF shape at a depth of 25 mm. The shape quality for this indication is poor and broken up, implying that more than one small flaw may be present There were no confirmations in other modes. The indication is characterized as planar based on lack of normal beam detection or detection of orthogonal modes. There is no evidence of coin shape in the side view of mode 7. The width is 16 mm and was made to LOS in mode 7. The aspect ratio (width/depth) of this indication is 8 which tends to confirm more than one small flaw. The maximum amplitude-to-noise ratio is of medium range at 91 to 40. With an X coordinate of 106 mm, the indication is clearly in the base metal. With a Z coordinate of 25 mm, the indication is clearly below the cladding.

Figure A.33 - Planar indication #19 in the near surface base metal: mode 7

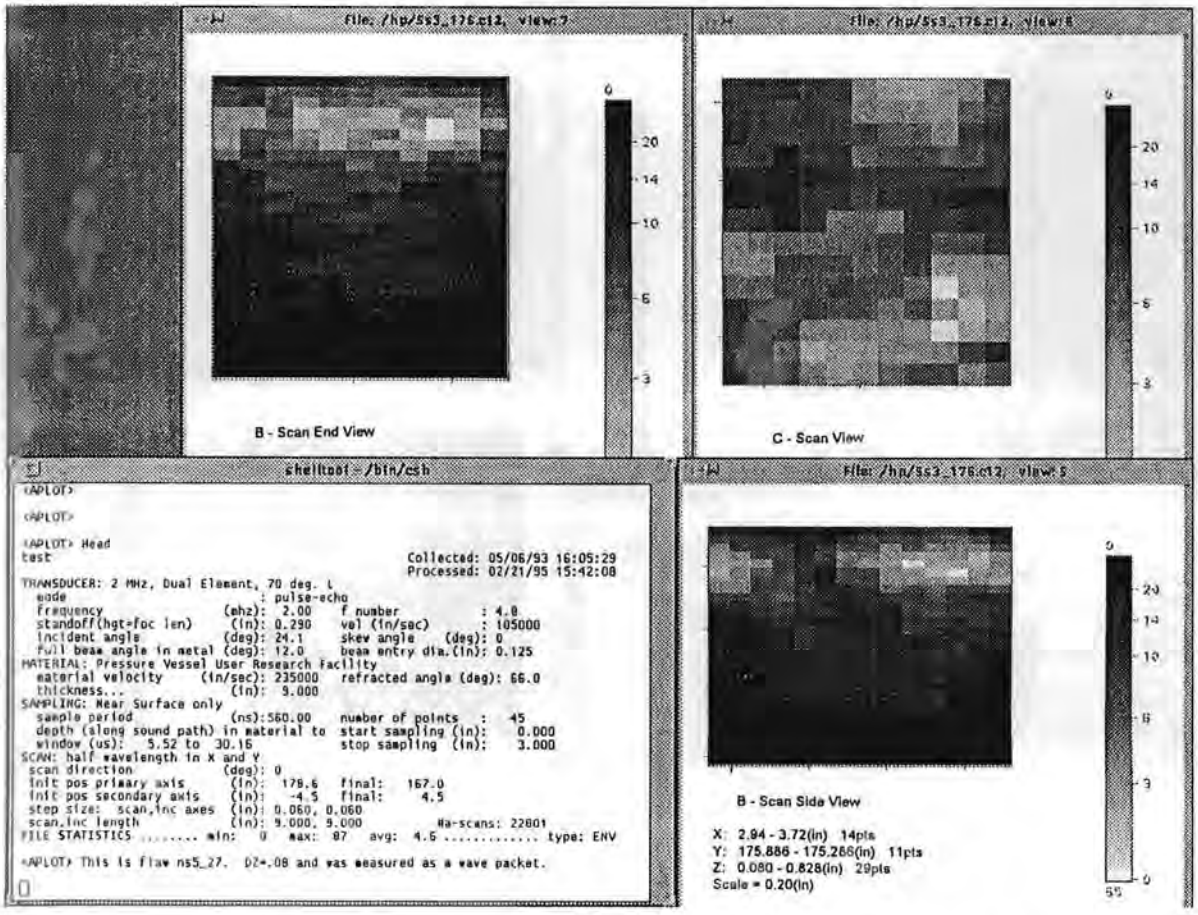
Figure A.34 - Planar indication #20 in the near surface base metal: mode 3

Figure A.34 shows planar indication #20 in the near surface base metal. This planar indication has a through-wall extent of 2 mm based on wave packet width. The detection was made in mode 3 where it had isolated TOF shape at a depth of 12 mm. The shape quality is fair for this indication. There were no confirmations in other modes. The indication is characterized as planar based on lack of detection in normal beam or orthogonal modes. There is no evidence of coin shape in the side view of mode 3. The width is 8 mm and was made to LOS in mode 3. The aspect ratio (width/depth) of this indication is 4 giving an orientation across the weld. The maximum amplitude-to-noise ratio is of medium range at 24 to 8. With an X coordinate of 81 mm, the indication is clearly in the base metal. With a Z coordinate of 12 mm, the indication is below the cladding by 3 mm.

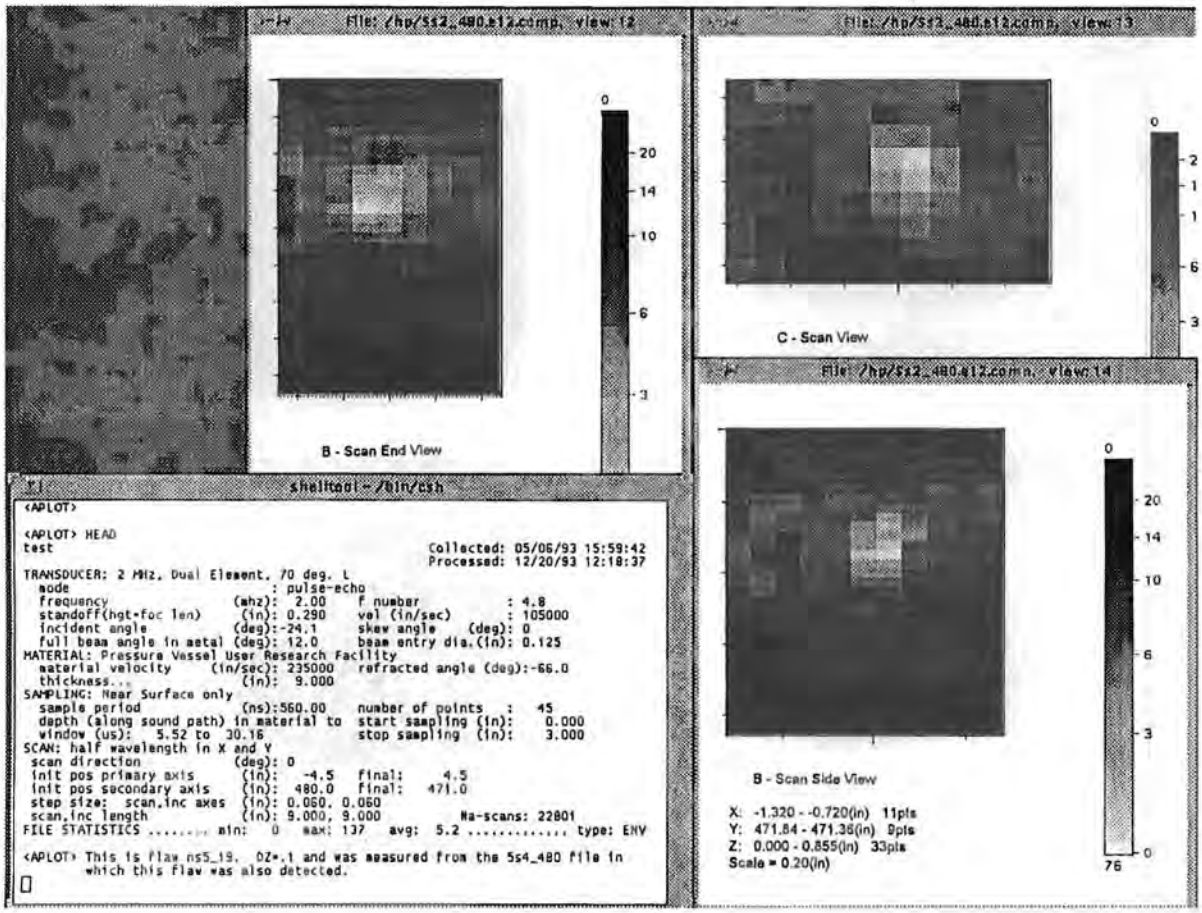
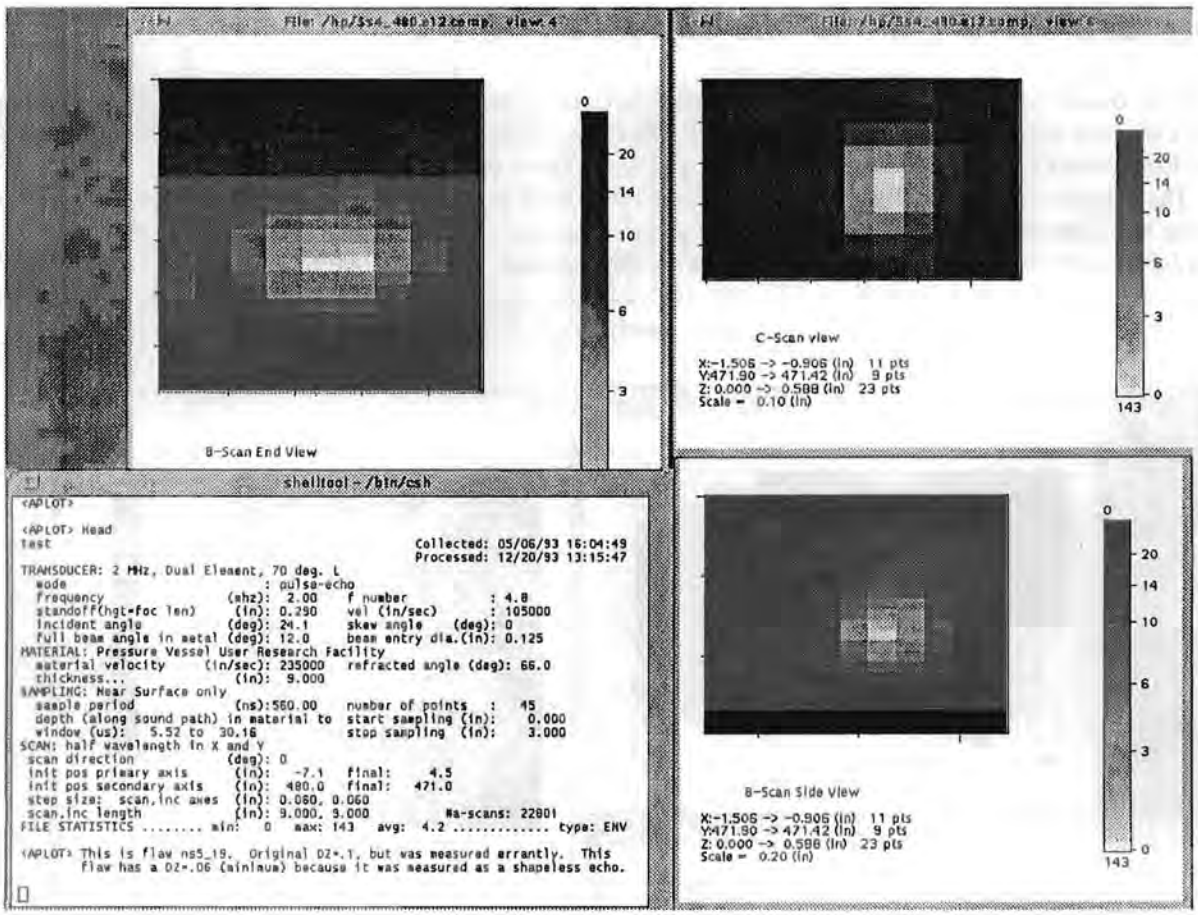
Figures A.35a-b show planar indication #21 in the near surface base metal. This planar indication has a through-wall extent of 1.5 mm based on wave packet width. The detections were made in modes 2 and 4 where they had isolated TOF shape at a depth of 8 mm. The TOF shape quality for this indication is fair. The indication is characterized as planar based on lack of normal beam detection. There is good evidence of coin shape in the end view of mode 4. The length is 8 mm and was made to LOS in mode 4. The aspect ratio (length/depth) of this indication is 5 giving an orientation along the weld. The maximum amplitude-to-noise ratio is high at 143 to 25. With an X coordinate of -24 mm, the indication is clearly in the base metal. The Z coordinate of 8 mm shows that the indication is in the base metal, possibly in the cladding.

Figure A.35a - Planar indication #21 in the near surface base metal: mode 2

Figure A.35b - Planar indication #21 in the near surface base metal: mode 4

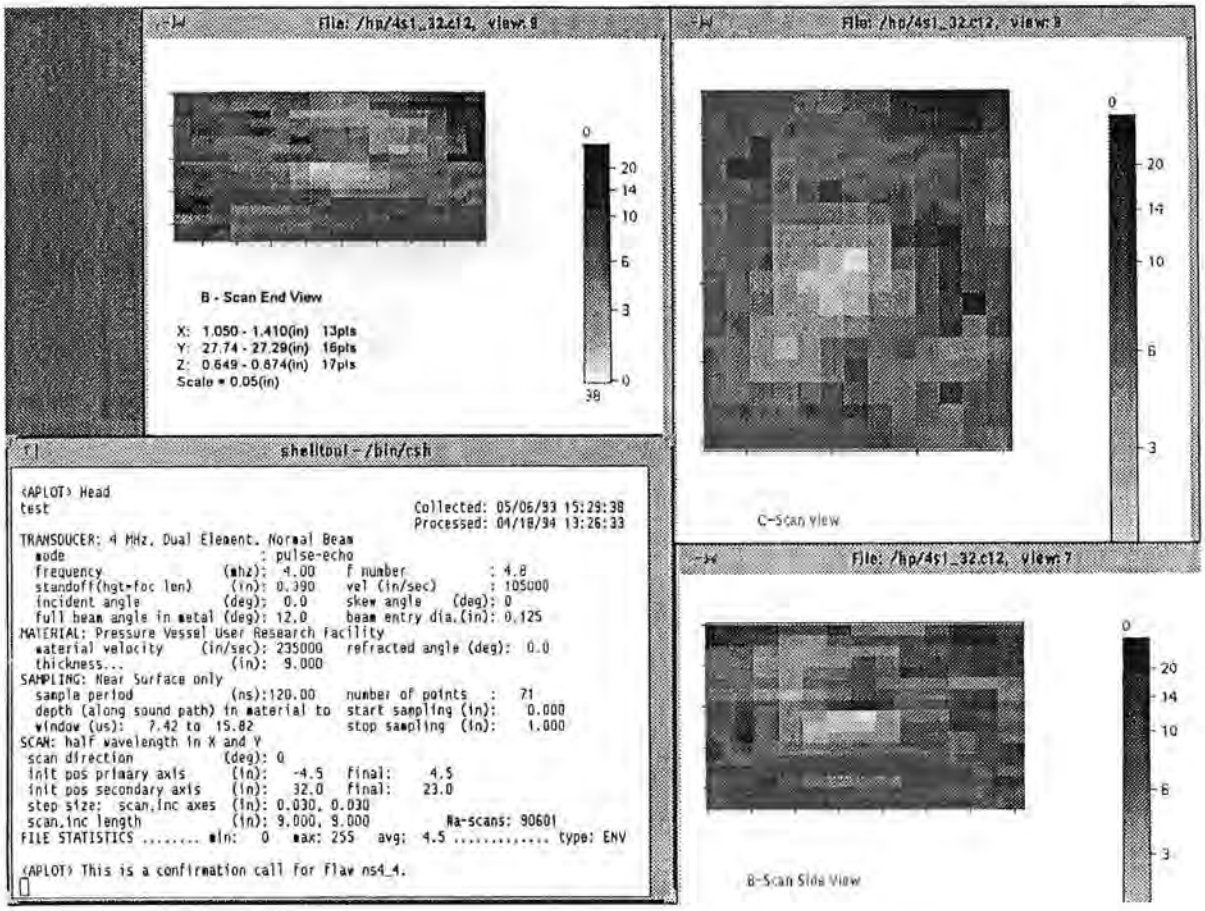
Figures A.36a-b show volumetric indication #1 in the near surface base metal. This volumetric indication has a through-wall extent of 6 mm based LOS in a cloud like pattern. The detection was made in mode 9 where it failed to display TOF shape but looked more cloud like in nature at a depth of 20 mm. There was a confirmation in mode 1 at a depth of 19 mm. The indication is characterized as volumetric based on normal beam detection. There is no evidence of coin shape in the side view of mode 9. The length is 6 mm and was made to LOS in mode 1. The width is 7 mm and was made to LOS in mode 9. The aspect ratio (width/depth) of this indication is 1.2, and the length-to-depth ratio is 1.0. The maximum amplitude-to-noise ratio is low at 88 to 40. With an X coordinate of 28 mm, the indication is clearly in the base metal. With a Z coordinate of 20 mm, the indication is clearly below the cladding.

Figure A.36a - Volumetric indication #1 in the near surface base metal: mode 1

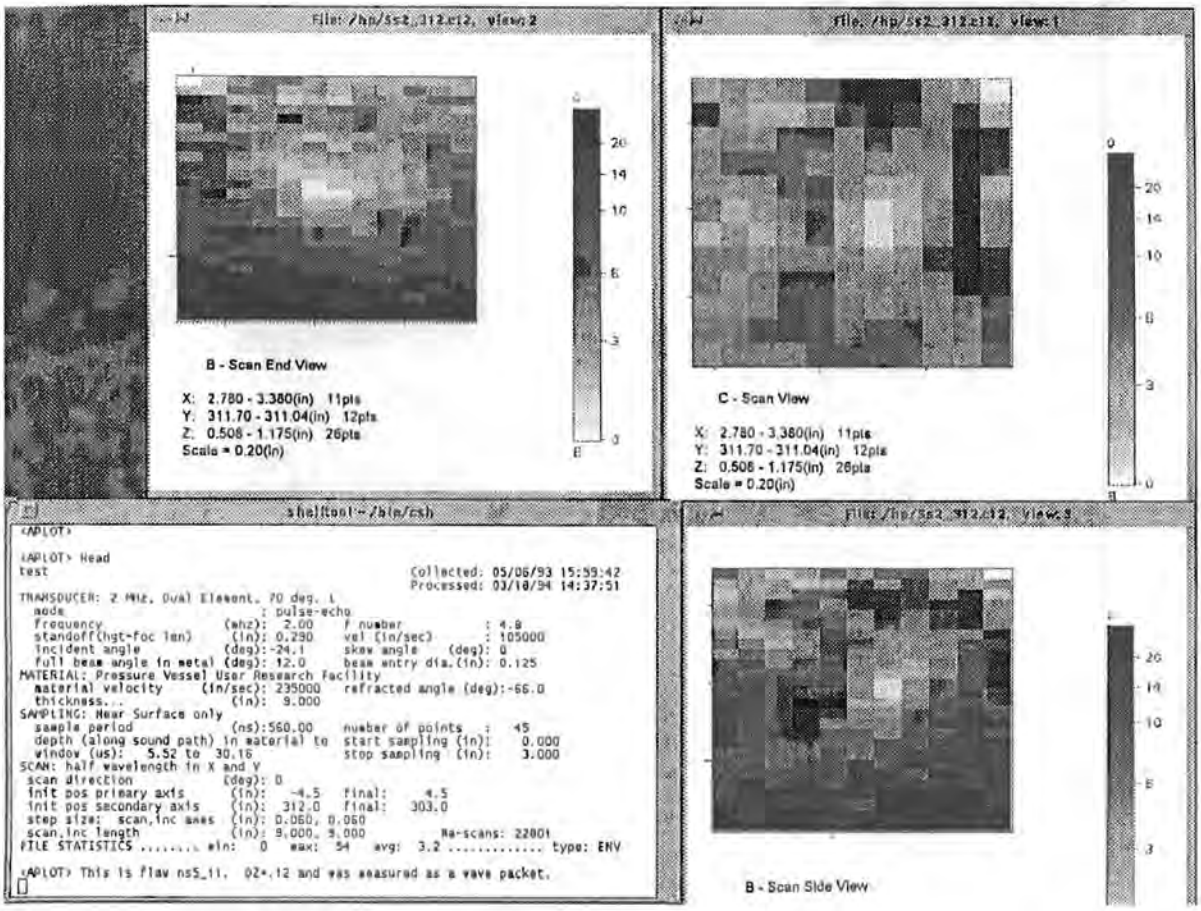
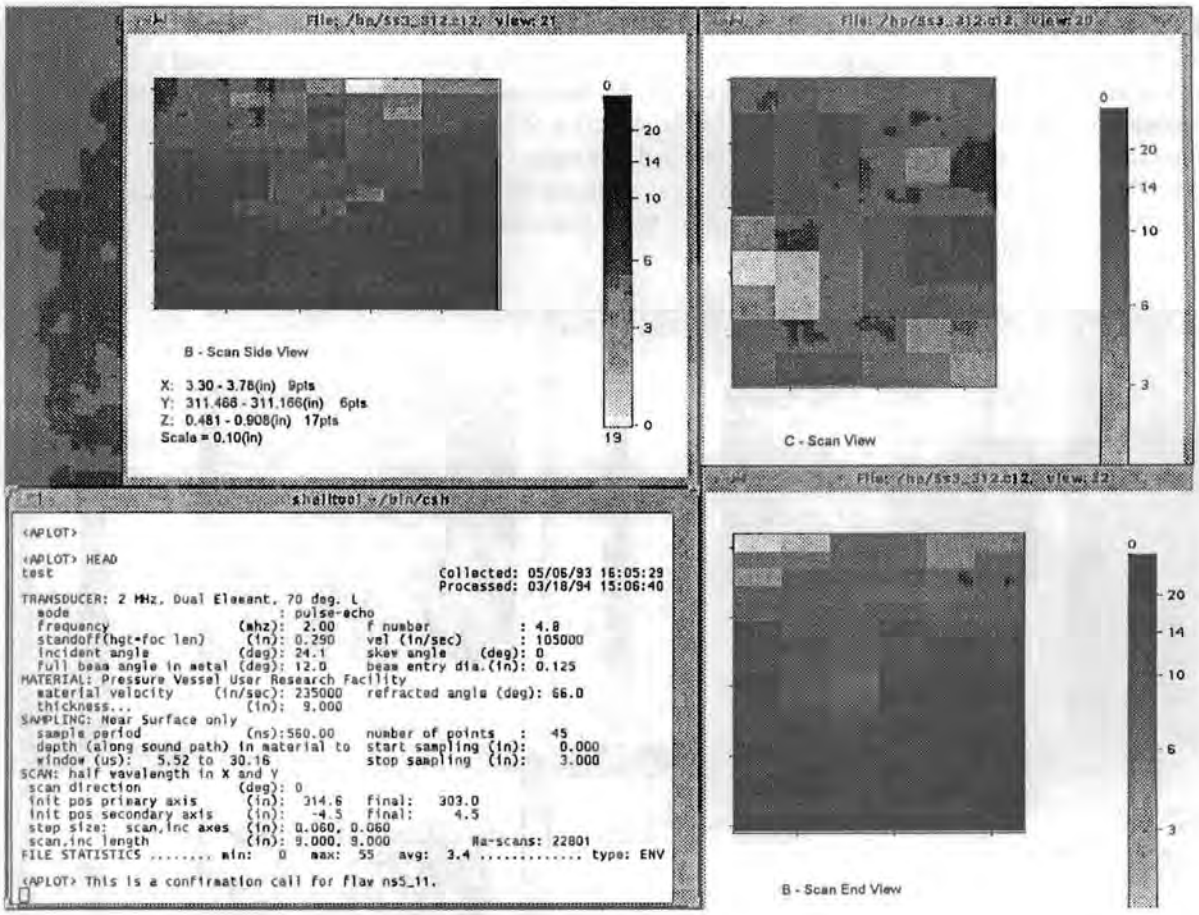
Figures A.37a-b show volumetric indication #2 in the near surface base metal. This volumetric indication has a through-wall extent of 3 mm based on wave packet width. The detection was made in mode 2 where it had isolated TOF shape at a depth of 20 mm. The shape quality is poor for this indication. There was a confirmation in mode 3 at a depth of 18 mm. The different Z values 18 to 20 give an alternate depth size of 2 mm. The indication is characterized as volumetric based on detection in orthogonal modes. There is no evidence of coin shape in the end view of mode 2 and side view of mode 3. The length is 13 mm and was made to LOS mode 2. The width is 7 mm and was made to LOS in mode 3. The aspect ratio (length/depth) of this indication is 4 giving an orientation along the weld. The maximum amplitude-to-noise ratio is of medium range at 8 to 3. With an X coordinate of 79 mm, the indication is clearly in the base metal. With a Z coordinate of 18 mm, the indication is clearly below the cladding.

Figure A.37a - Volumetric indication #2 in the near surface base metal: mode 2

Figure A.37b - Volumetric indication #2 in the near surface base metal: mode 3

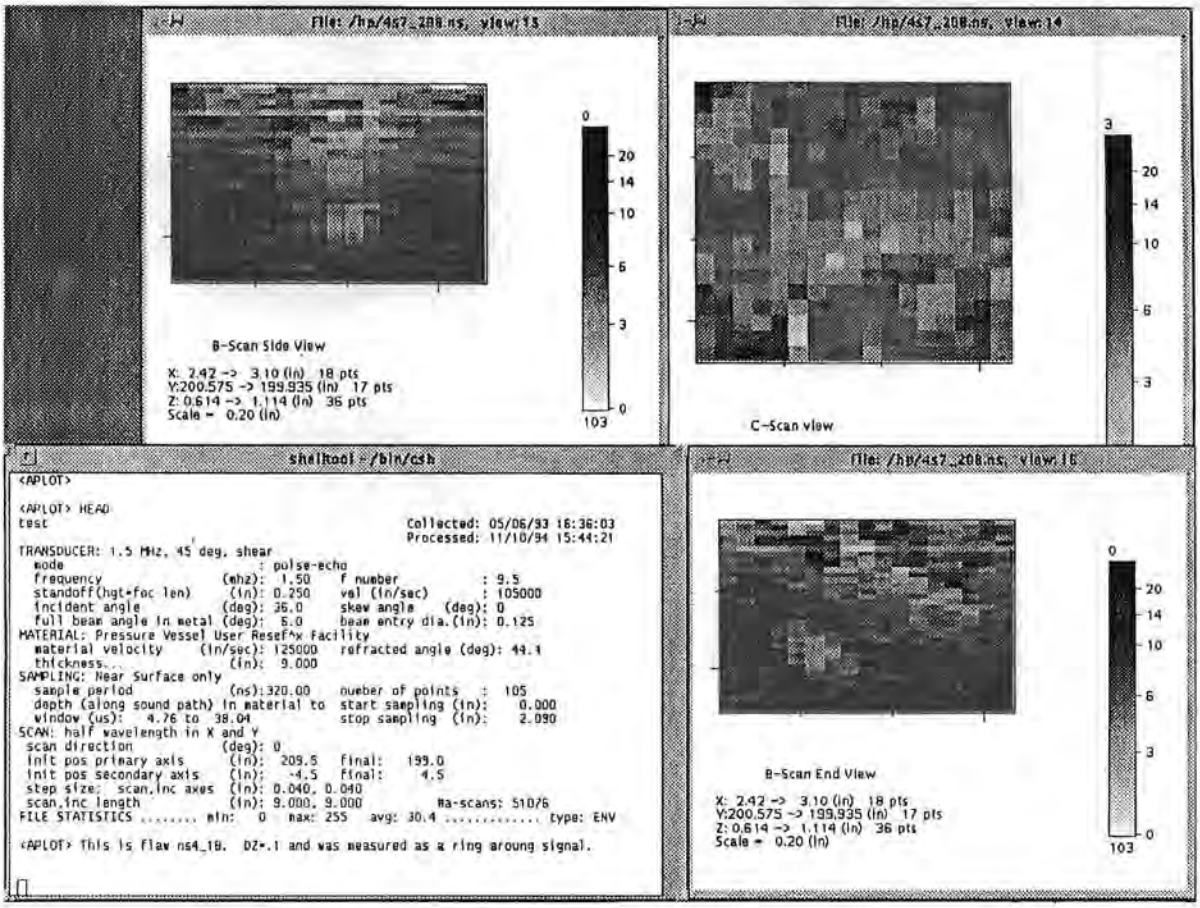
Figure A.38 - Volumetric indication #3 in the near surface base metal: mode 7

Figure A.38 shows volumetric indication #3 in the near surface base metal. This volumetric indication has a through-wall extent of 2.5 mm based on ring around pattern. The detection was made in mode 7 where it displayed a pair of TOF shapes at a depth of 20 mm. The shape quality is good for this indication. There were no confirmations in other modes. The indication is characterized as volumetric based on the detection of ring around shape. There is no evidence of coin shape in the side view of mode 7. The width is 12 mm and was made to LOS in mode 7. The aspect ratio (width/depth) of this indication is 5 giving an orientation across the weld. The maximum amplitude-to-noise ratio is high at 100 to 25. With an X coordinate of 71 mm, the indication is clearly in the base metal. With a Z coordinate of 20 mm, the indication is clearly below the cladding.

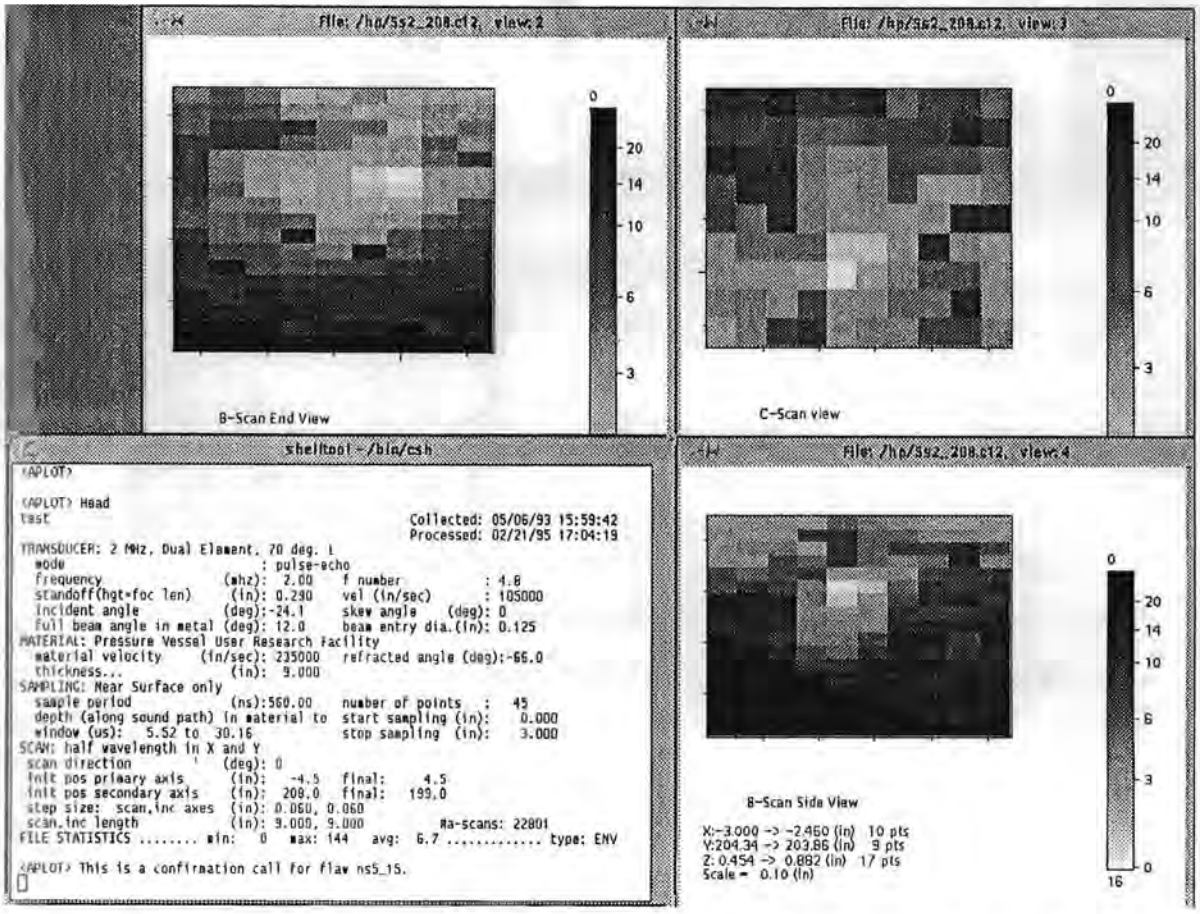
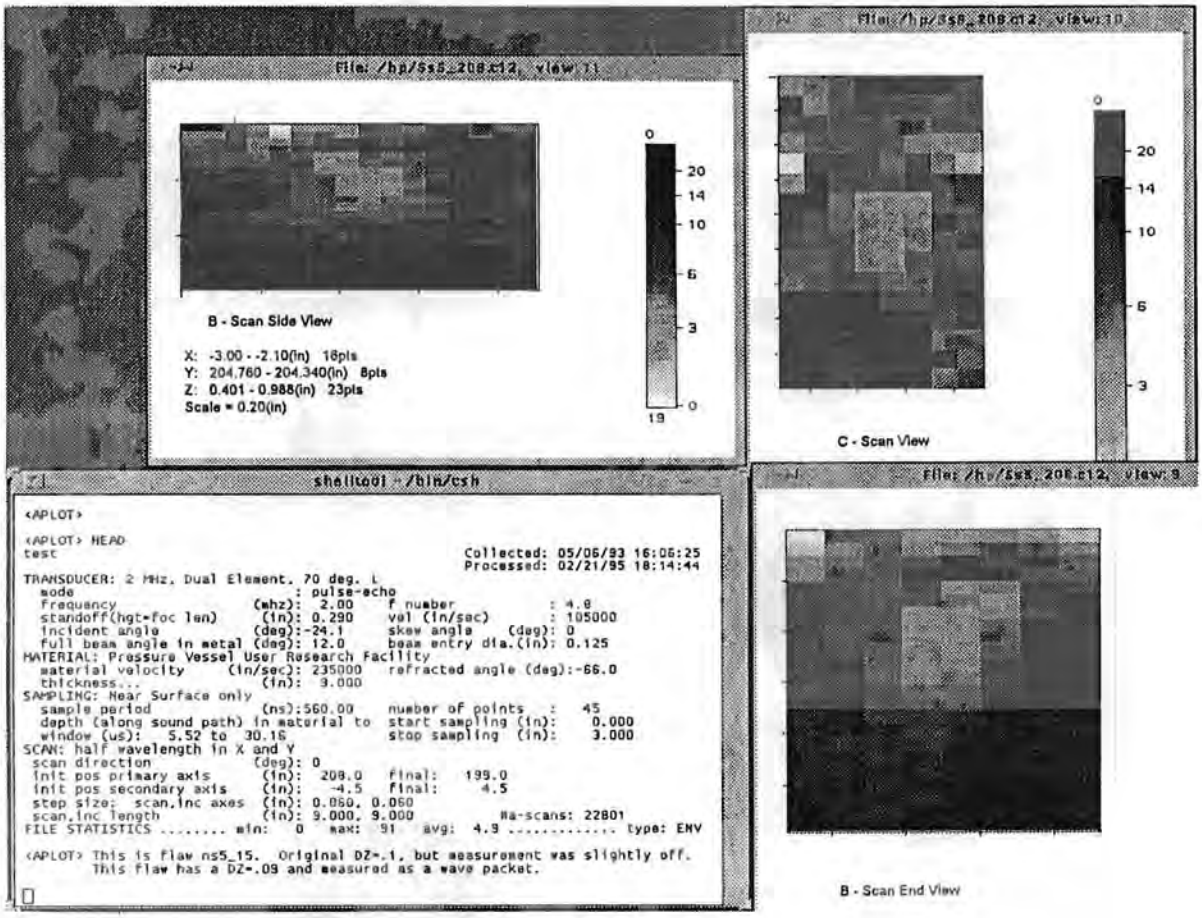
Figures A.39a-b show volumetric indication #4 in the near surface base metal. This volumetric indication has a through-wall extent of 2.3 mm based on wave packet width. The detection was made in mode 5 where it had isolated TOF shape at a depth of 16 mm. The shape quality is good for this indication. There was a confirmation in mode 2 at a depth of 16 mm. The two Z values of 16 mm give an alternate depth size of less than 1.5 mm. The indication is characterized as volumetric based on detection in orthogonal modes. There is no evidence of coin shape in the end view of mode 2 and side view of mode 5. The length is 12 mm and was made to LOS in mode 2. The width is 12 mm and was made to LOS in mode 5. The range of aspect ratios (length/depth) of this indication is 5 to 8. With an X coordinate of -64 mm, the indication is clearly in the base metal. With a Z coordinate of 16 mm, the indication is clearly below the cladding.

Figure A.39a - Volumetric indication #4 in the near surface base metal: mode 2

Figure A.39b - Volumetric indication #4 in the near surface base metal: mode 5

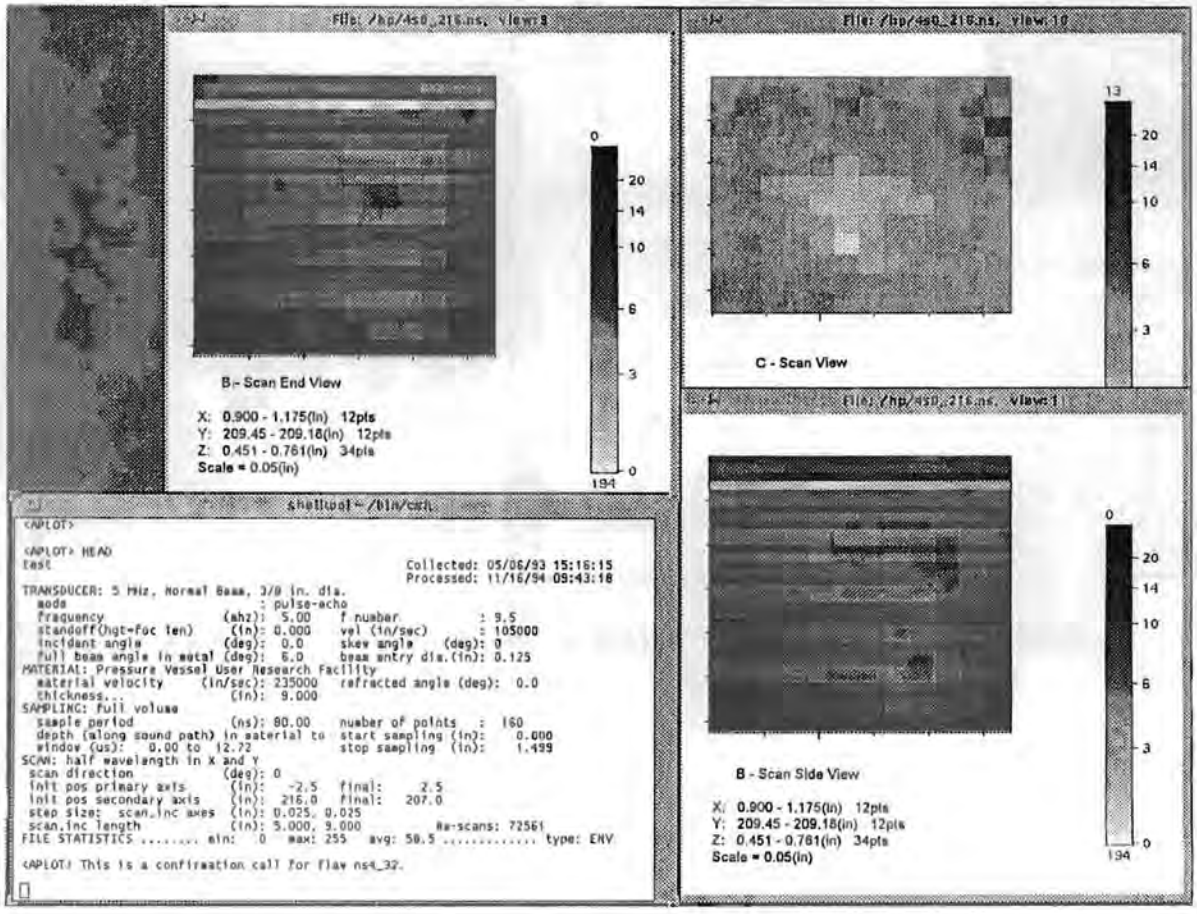
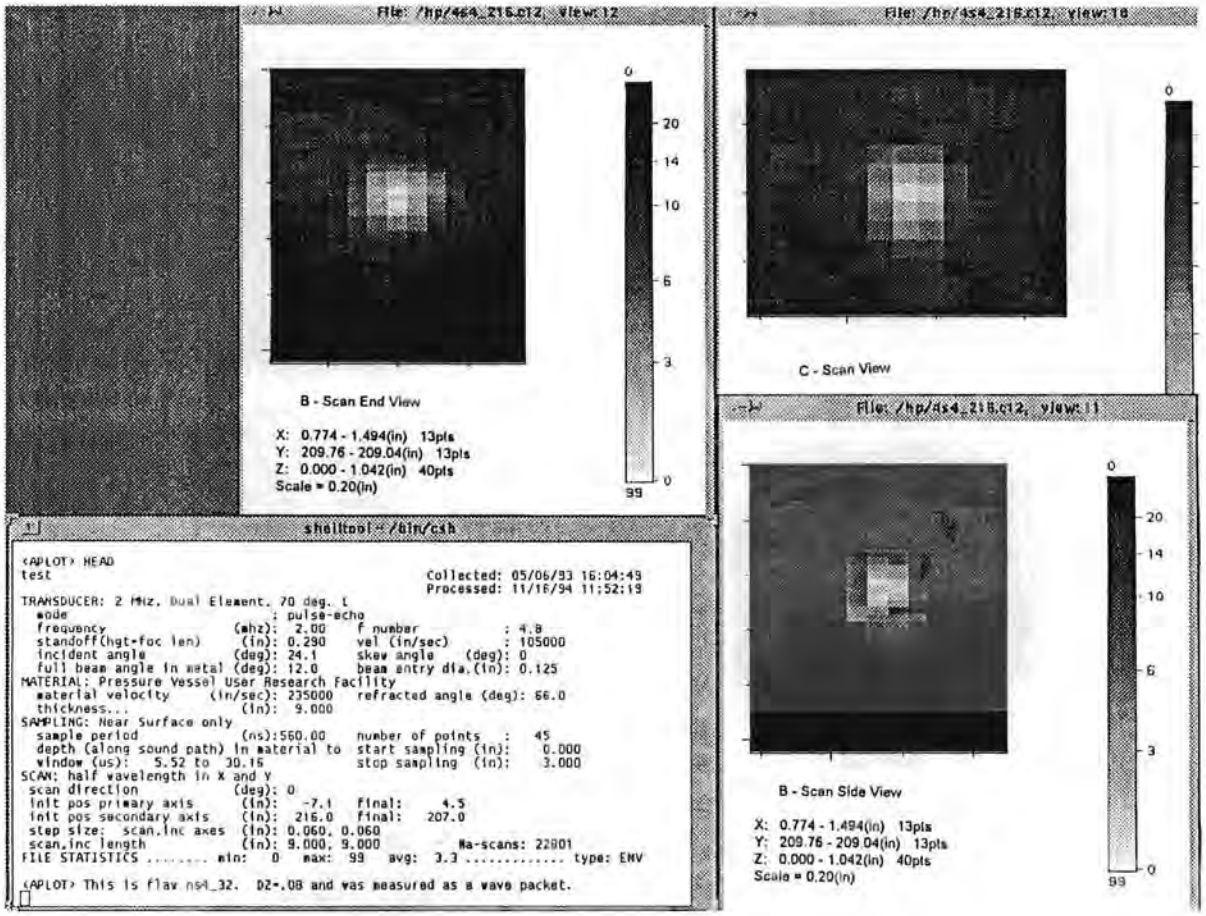
Figures A.40a-b show volumetric indication #5 in the near surface base metal. This volumetric indication has a through-wall extent of 2 mm based on wave packet width. The detection was made in mode 4 where it had isolated TOF shape at a depth of 11 mm. The shape quality is poor but not unusual for a shallow indication. There was a confirmation in mode 10 at a depth of 12 mm. The different Z values 10 to 11 mm give an alternate depth size of 1 mm. The indication is characterized as volumetric based on normal beam detection. There is no evidence of coin shape in the end view of mode 4. The length is 9 mm and was made to LOS in mode 4. The width is 5 mm and was made to LOS in mode 10. The aspect ratio (length/depth) of this indication is 4 giving an orientation along the weld. The maximum amplitude-to-noise ratio is high at 99 to 20. With an X coordinate of 26 mm, the indication is clearly in the base metal. With a Z coordinate of 10 to 11 mm, the indication is below the cladding by 1 to 2 mm.

Figure A.40-a - Volumetric indication #5 in the near surface base metal: mode 10

Figure A.40b - Volumetric indication #5 in the near surface base metal: mode 4

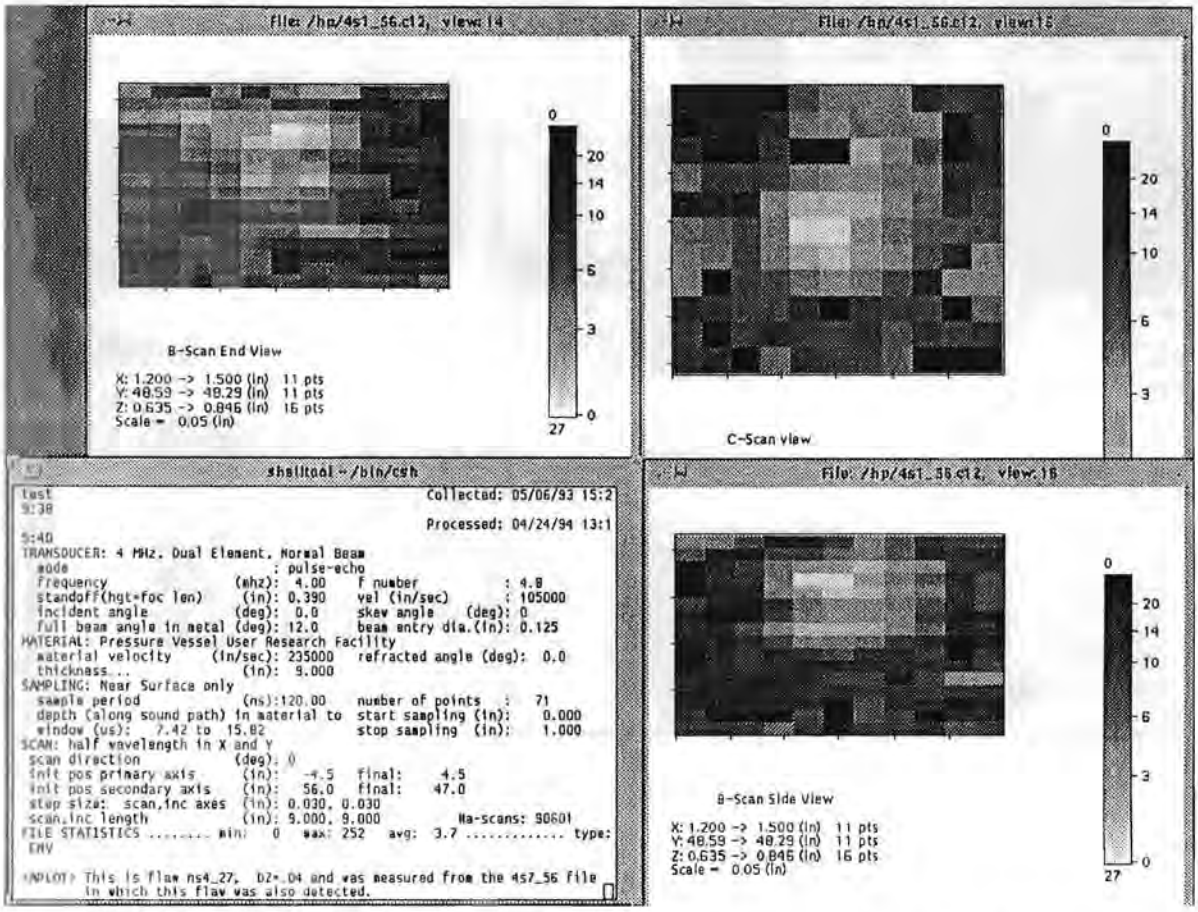
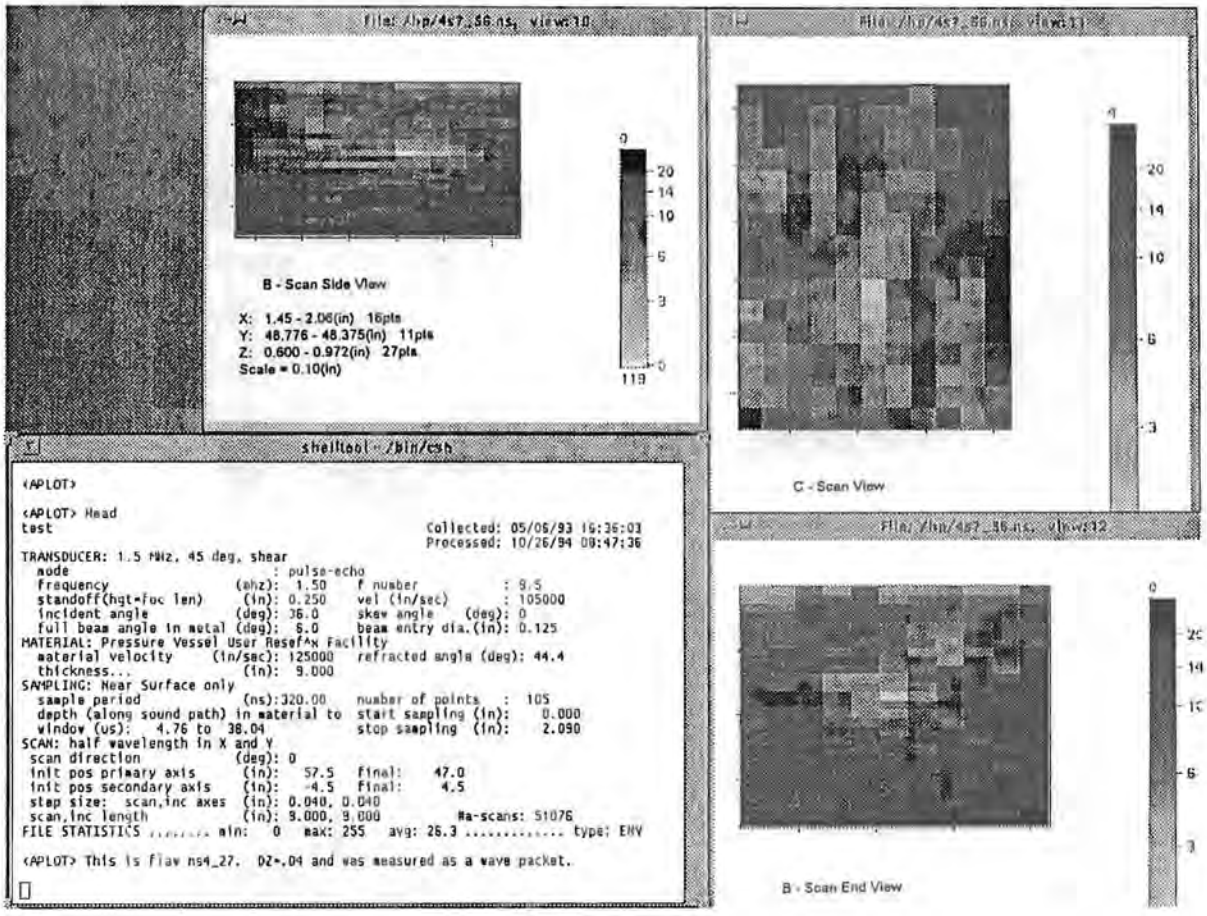
Figures A.4a-b show volumetric indication #6 in the near surface base metal. This volumetric indication has a through-wall extent of 2 mm based on different depth estimates, and an alternate size of 1 mm based on wave packet width. The detection was made in modes 1 and 7 where it had isolated TOF shape at depths of 17 and 19 mm. The shape quality is poor for this indication. There were no confirmations in other modes. The indication is characterized as volumetric based on normal beam detection. There is no evidence of coin shape in the side view of mode 7. The length is 5 mm and was made to LOS in mode 1. The width is 10 mm and was made to LOS in mode 7. The range of aspect ratios (width/depth) of this indication is 3 to 10. the maximum amplitude-to-noise ratio is of medium range at 119 to 30. With an X coordinate of 34 mm, the indication is clearly in the base metal. With a Z coordinate of 17 mm, the indication is clearly below the cladding.

Figure A.41a – Volumetric indication #6 in the near surface base metal: model 1

Figure A.41b - Volumetric indication #6 in the near surface base metal: mode 7
