NUREG/CR-6471, Vol. 1
PNNL-11143

Characterization of Flaws in U.S. Reactor Pressure Vessels

Density and Distribution of Flaw Indications in PVRUF

Pacific Northwest National Laboratory

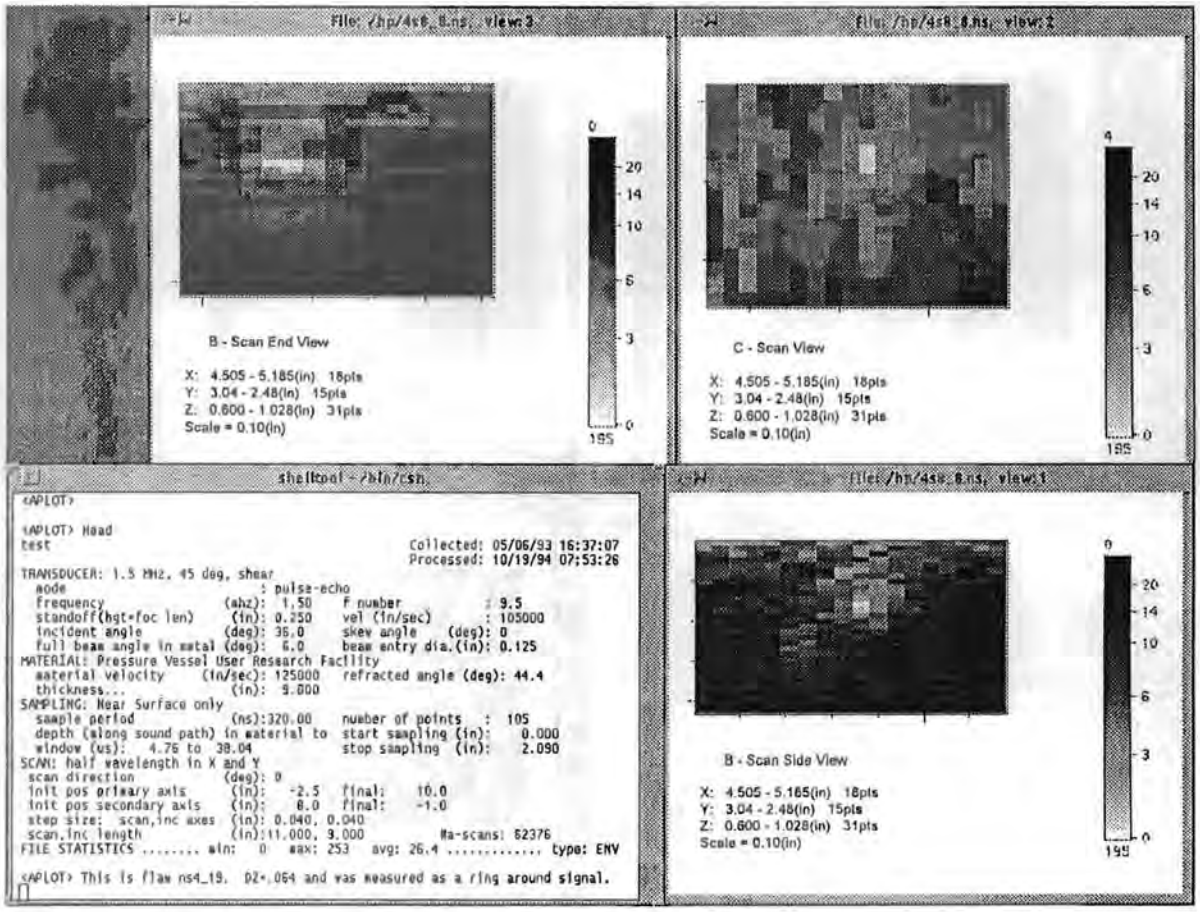
Figure A.42 - Volumetric indication #7 in the near surface base metal: mode 8

Figure A.42 shows volumetric indication #7 in the near surface base metal. This volumetric indication has a through-wall extent of 1.6 mm based on ring around pattern. The detection was made in mode 8 where it displayed a pair of TOF shapes at a depth of 19 mm. The shape quality is good for this indication. There were no confirmations in other modes. The indication is characterized as volumetric based on the detection of ring around shape. There is no evidence of coin shape in the end view of mode 8. The length is 8 mm and was made to LOS in mode 8. The aspect ratio (width/depth) of this indication is 5 giving an orientation along the weld. The maximum amplitude-to-noise ratio is high at 195 to 45. With an X coordinate of 123 mm, the indication is clearly in the base metal. With a Z coordinate of 19 mm, the indication is clearly below the cladding.

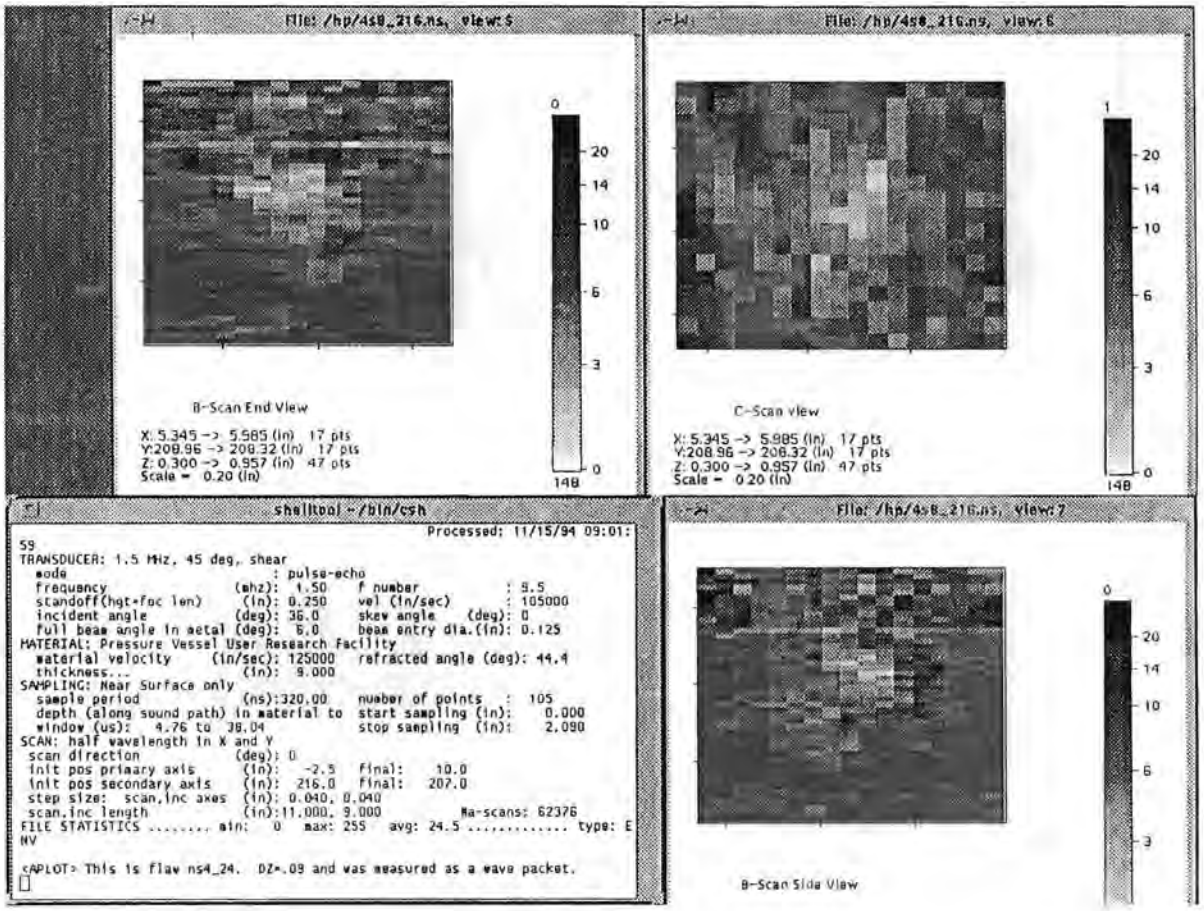
Figure A.43 - Volumetric indication #8 in the near surface base metal: mode 8

Figure A.43 shows volumetric indication #8 in the near surface base metal. This volumetric indication has a through-wall extent of 1.6 mm based on ring around pattern. The detection was made in mode 8 where it displayed a pair of TOF shapes at a depth of 14 mm. There were no confirmations in other modes. The indication is characterized as volumetric based on the detection of ring around shape. There is some evidence of coin shape in the end view of mode 8. The length is 12 mm and was made to LOS in mode 8. The aspect ratio (length/depth) of this indication is 3 giving an orientation along the weld. The maximum amplitude-to-noise ratio is of medium range at 148 to 40. With an X coordinate of 145 mm, the indication is clearly in the base metal. With a Z coordinate of 14 mm, the indication is clearly below the cladding.

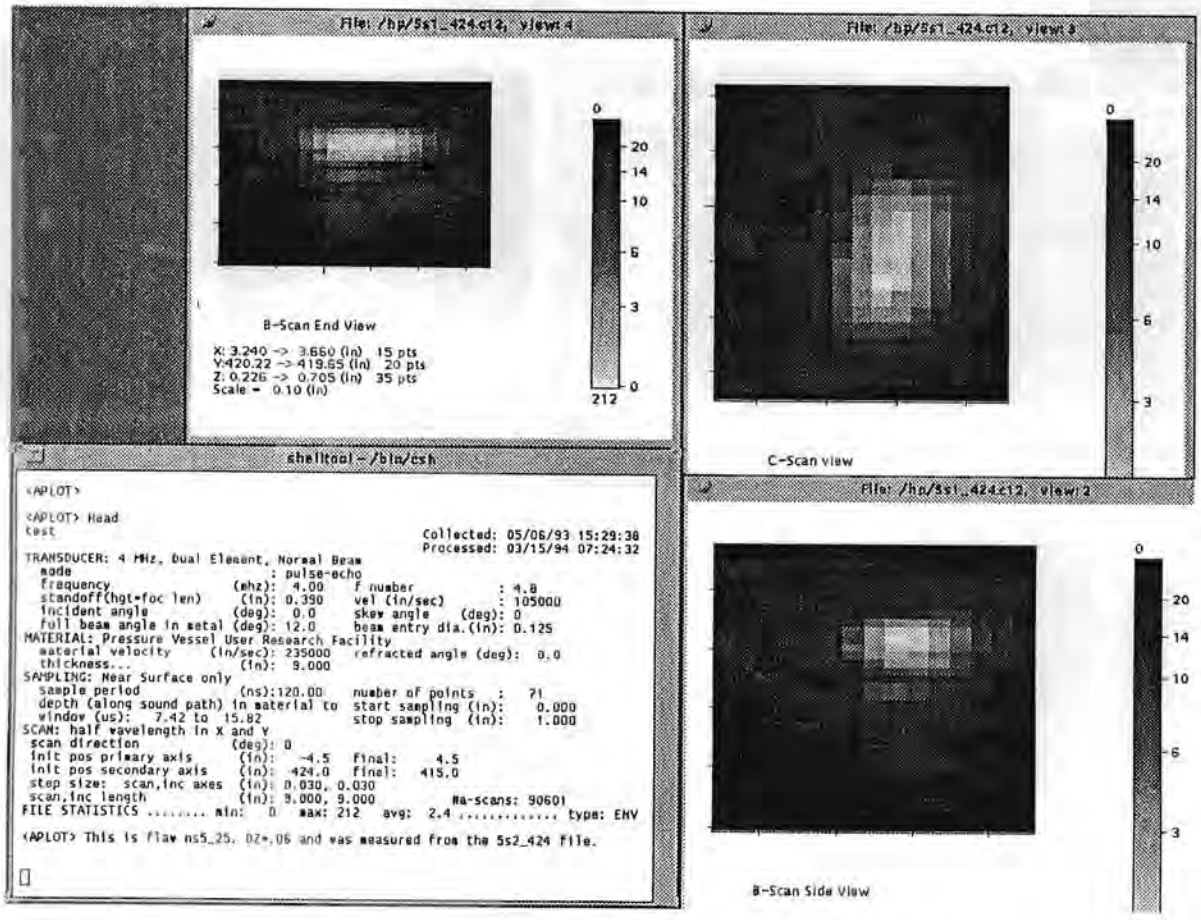
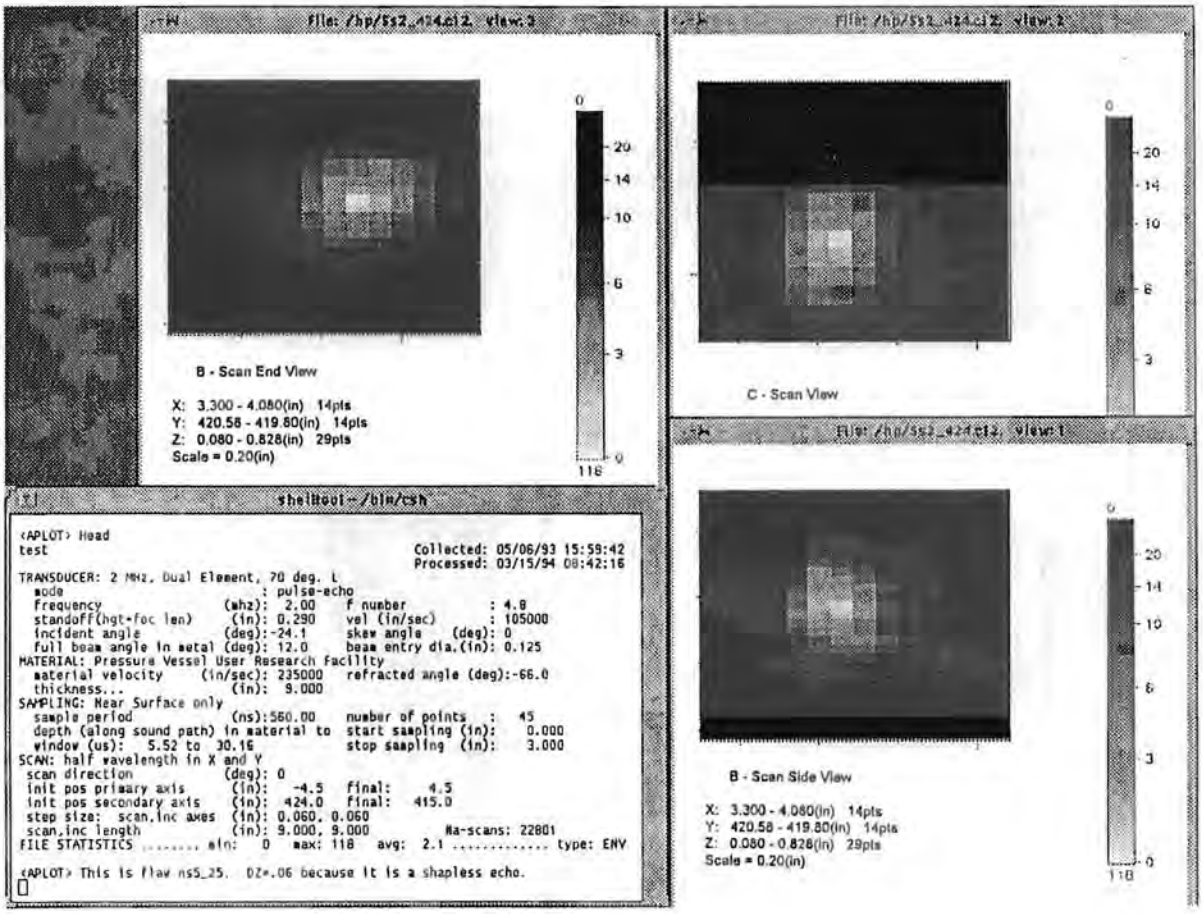
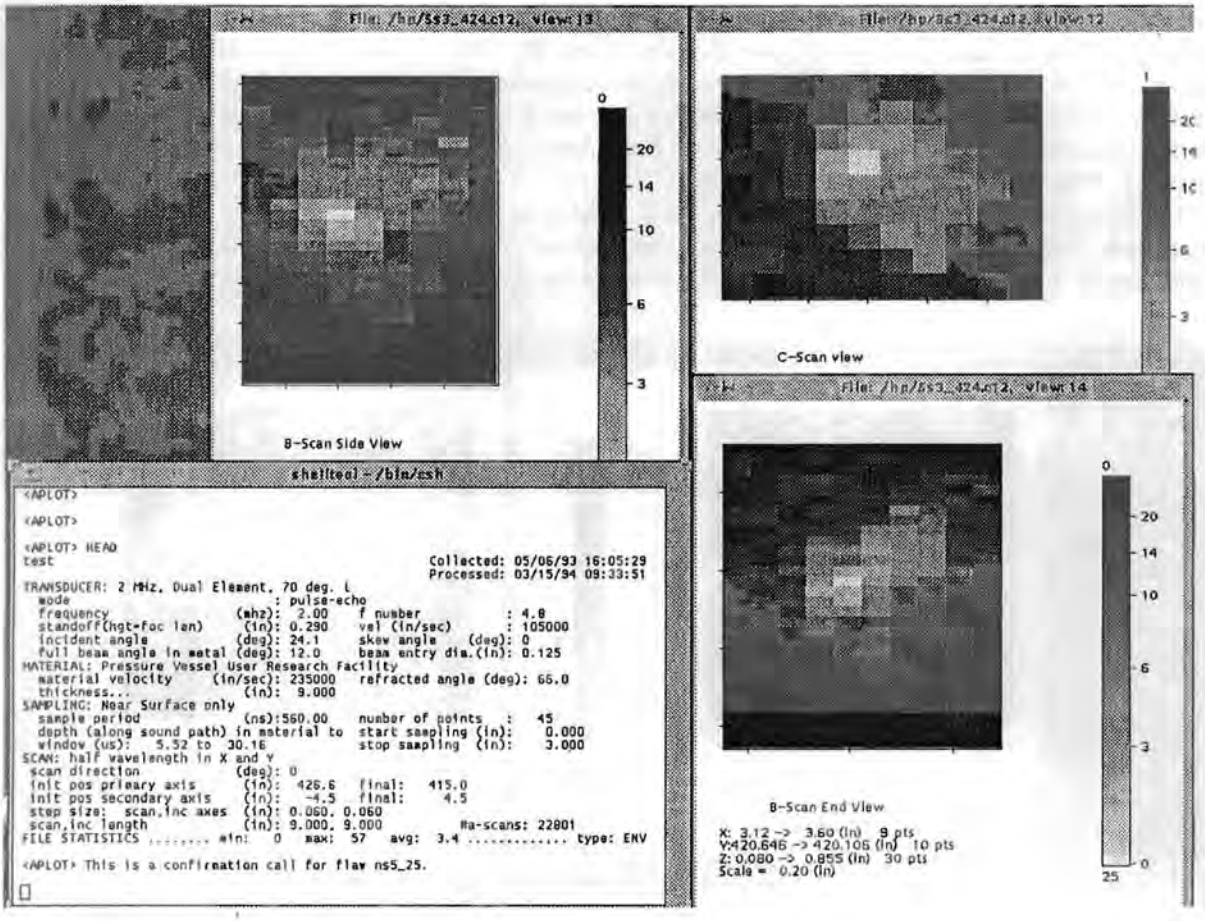
Figures A.44a-c show volumetric indication #10 in the near surface base metal. (Note: volumetric indication #9 in the near surface base metal was merged with volumetric indication #7). This volumetric indication has a through-wall extent of 1.5 mm based on wave packet width. Detections were made in modes 1 and 2. It had isolated TOF shape in mode 2 at a depth of 11 mm and normal beam shape in mode 1 at 10 mm. The shape quality is poor but not unusual for a shallow indication. There were confirmations in modes 3 and 4 at a depth of 11 mm. The different Z values 10 to 11 mm give an alternate depth size of 1 mm. The indication is characterized as volumetric based on normal beam detection. There is good evidence of coin shape in the end view of mode 2 which tends to characterize the indication as volumetric. The length is 11 mm and was made to LOS in mode 2. The width is 11 mm and was made to LOS in mode 3. The aspect ratio (length/depth) of this indication is 7 and the width-to-depth ratio is also 7 which tends to confirm volumetric orientation. The maximum amplitude-to-noise ratio is high at 212 to 25. With an X coordinate of 79 mm, the indication is clearly in the base metal. With a Z coordinate of 10 mm, the indication is below the cladding, and possibly connected to it.

Figure A.44a - Volumetric indication #10 in the near surface base metal: mode 1

Figure A.44b - Volumetric indication #10 in the near surface base metal: mode 2

Figure A.44c - Volumetric indication #10 in the near surface base metal: mode 3

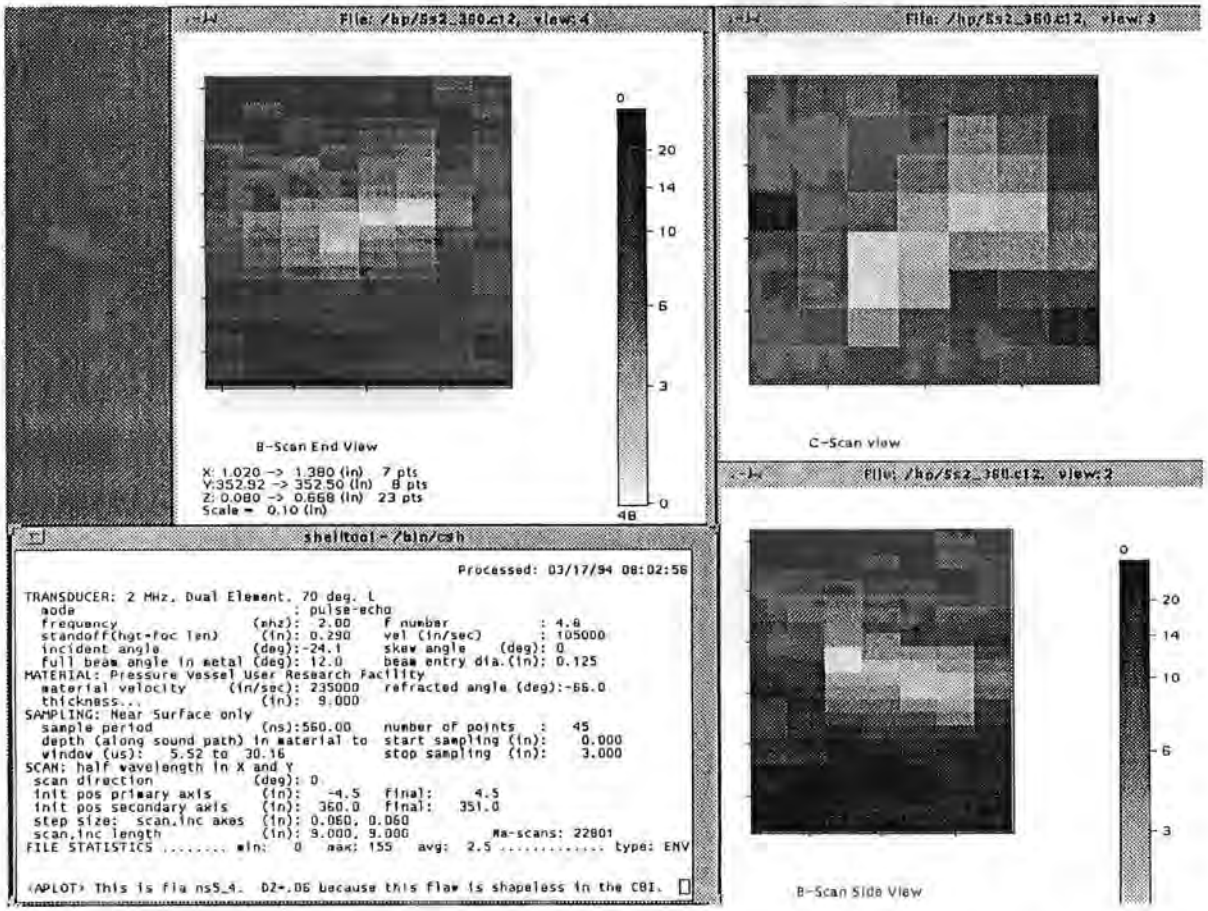
Figures A.45a-b show volumetric indication #11 in the near surface base metal. This volumetric indication has a through-wall extent of less than 1.5 mm based on a bright indication without TOF shape at depth of less than 10 mm. The detection was made in modes 1 and 2 where the bright, shallow indication failed to take shape at depths of 8 and 9 mm. There were no confirmations in other modes. The different Z values 8 to 9 give an alternate depth size of 1 mm. The indication is characterized as volumetric based on normal beam detection. There is no evidence of coin shape in the end view of mode 2. The length is 10 mm and was made to LOS in mode 2. The width is 7 mm and was made to LOS in mode 1. The aspect ratio (length/depth) of this indication is 7 giving an orientation along the weld. The maximum amplitude-to-noise ratio is high at 102 to 25. With an X coordinate of 24 mm, the indication is clearly in the base metal. The Z coordinate of 8 to 9 mm shows that the indication is below the cladding, and possibly connected to it.

Figure A.45a - Volumetric indication #11 in the near surface base metal: mode 2

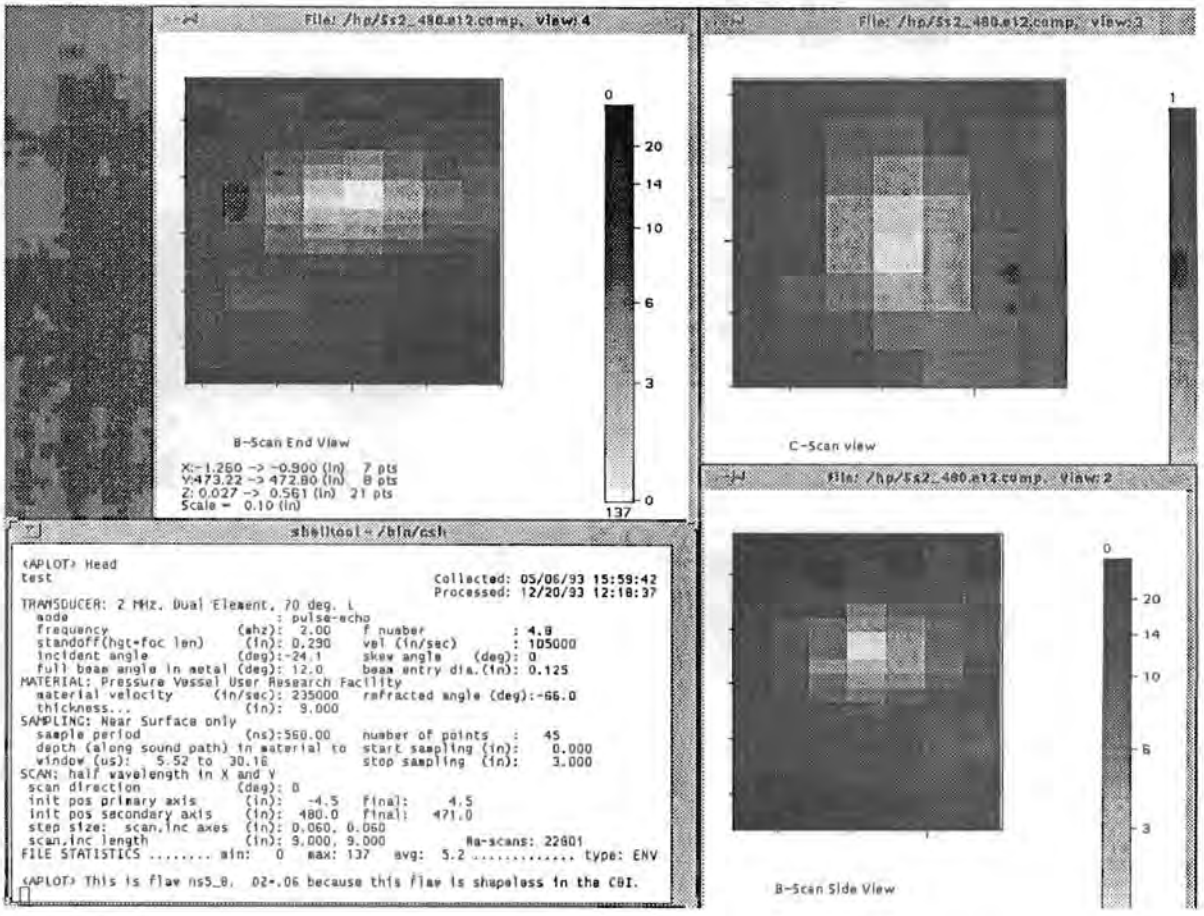
Figure A.46 - Planar indication #1 in the cladding: mode 2

Figure A.46 shows planar indication #1 in the cladding. This planar indication has a through-wall extent of less than 1.5 mm based on an indication without TOF shape at the clad to base metal interface. The detection was made in mode 2 where it lost TOF shape but remained brighter than 95 counts at a depth of 6 mm. There were no confirmations in other modes. The indication is characterized as planar based on lack of detection in normal beam or orthogonal modes. There is no evidence of coin shape in the end view of mode 2. The length is 14 mm and was made to LOS in mode 2. The aspect ratio (length/depth) of this indication is 9. The maximum amplitude-to-noise ratio is high at 130 to 30. The Z coordinate of 6 mm shows that the indication is in the clad-to-base metal interface.

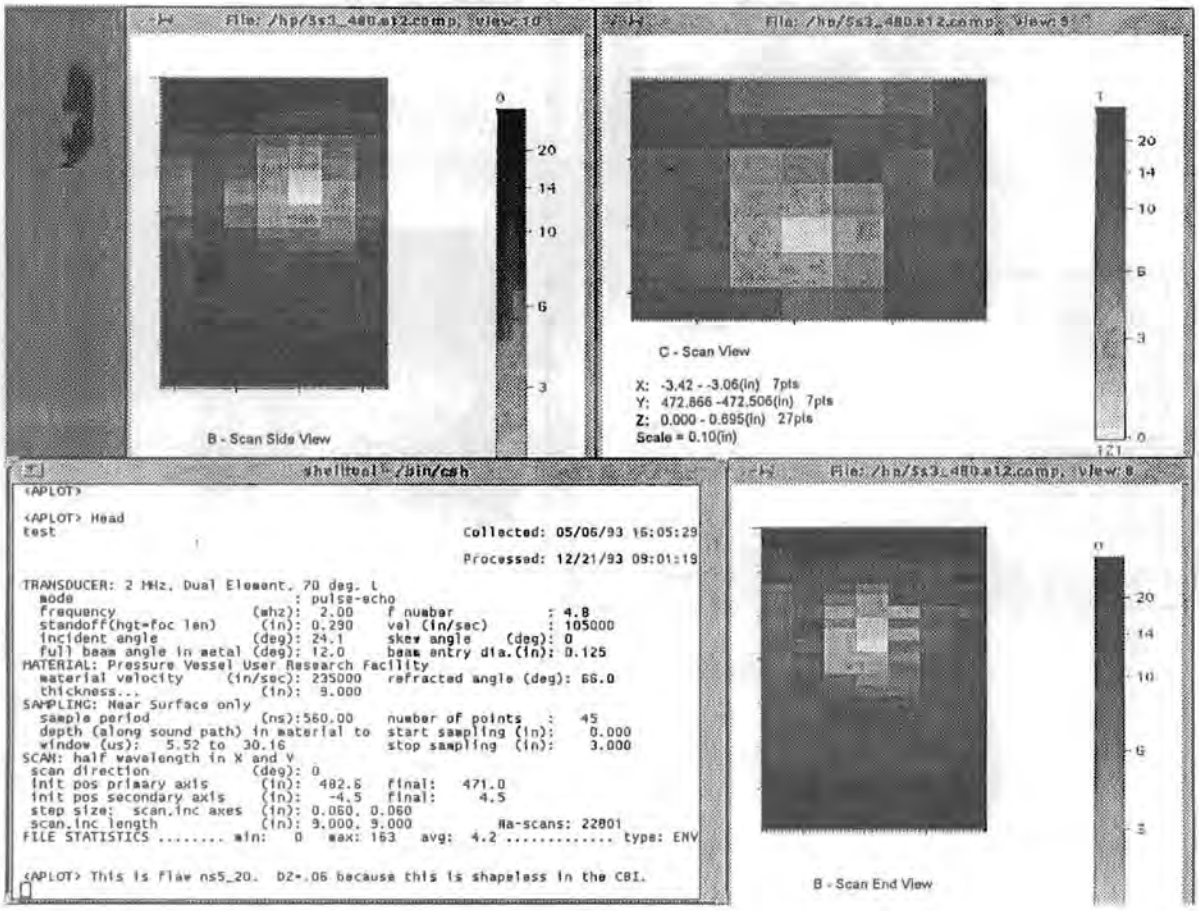
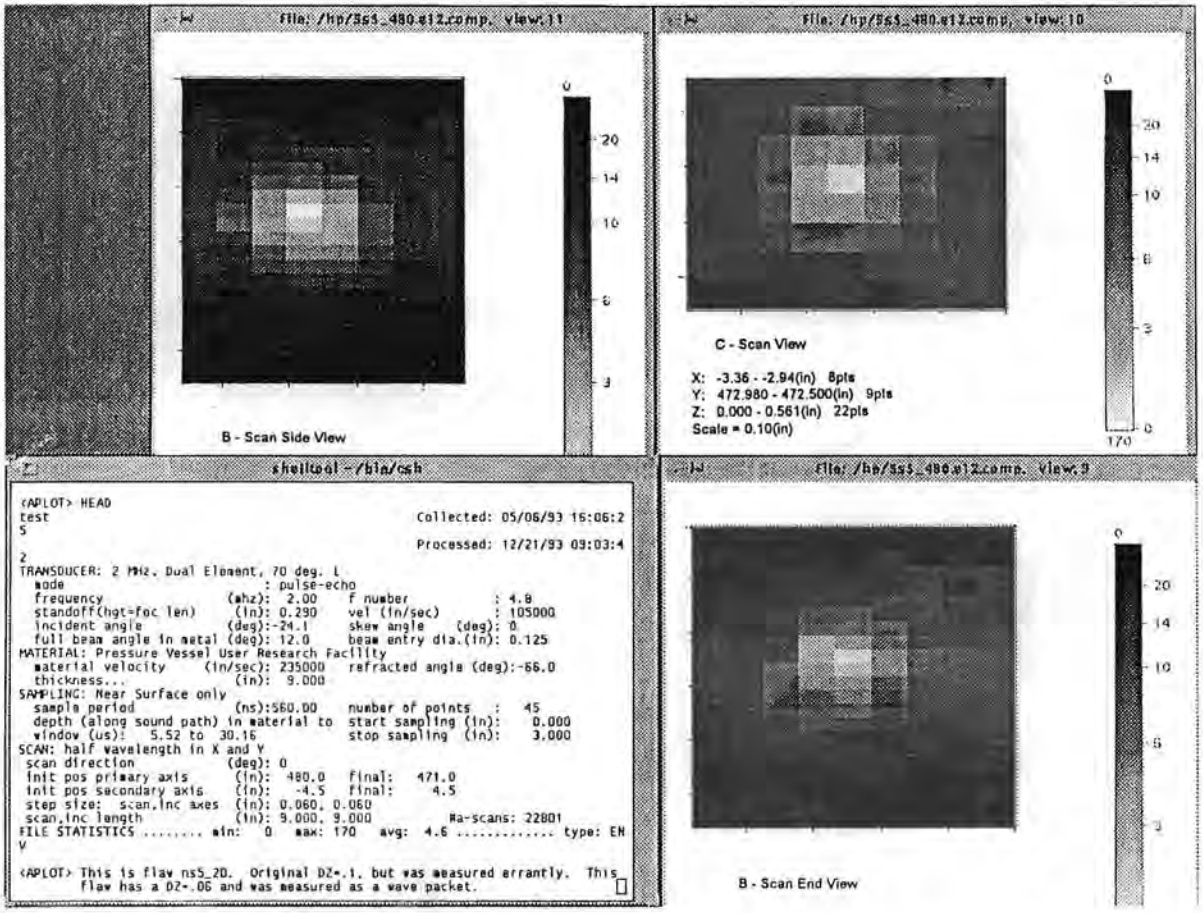
Figures A.47a-b show planar indication #2 in the cladding. This planar indication has a through-wall extent of less than 1.5 mm based on an indication without TOF shape at the clad to base metal interface. The detection was made in modes 3 and 5 where it lost TOF shape but remained brighter than 95 counts at depths of 6 and 7 mm. There were no confirmations in other modes. The two Z values of 6 to 7 mm give an alternate depth size of 1 mm. The indication is characterized as planar based on lack of detection in normal beam or orthogonal modes. There is no evidence of coin shape in the side view of modes 3 and 5. The width is 7 mm and was made to LOS in modes 3 and 5. The aspect ratio (width/depth) of this indication is 5. The maximum amplitude-to-noise ratio is high at 170 to 30. The Z coordinate of 6 to 7 mm shows that the indication is in the clad-to-base metal interface.

Figure A.47a - Planar indication #2 in the cladding: mode 3

Figure A.47b - Planar indication #2 in the cladding: mode 5

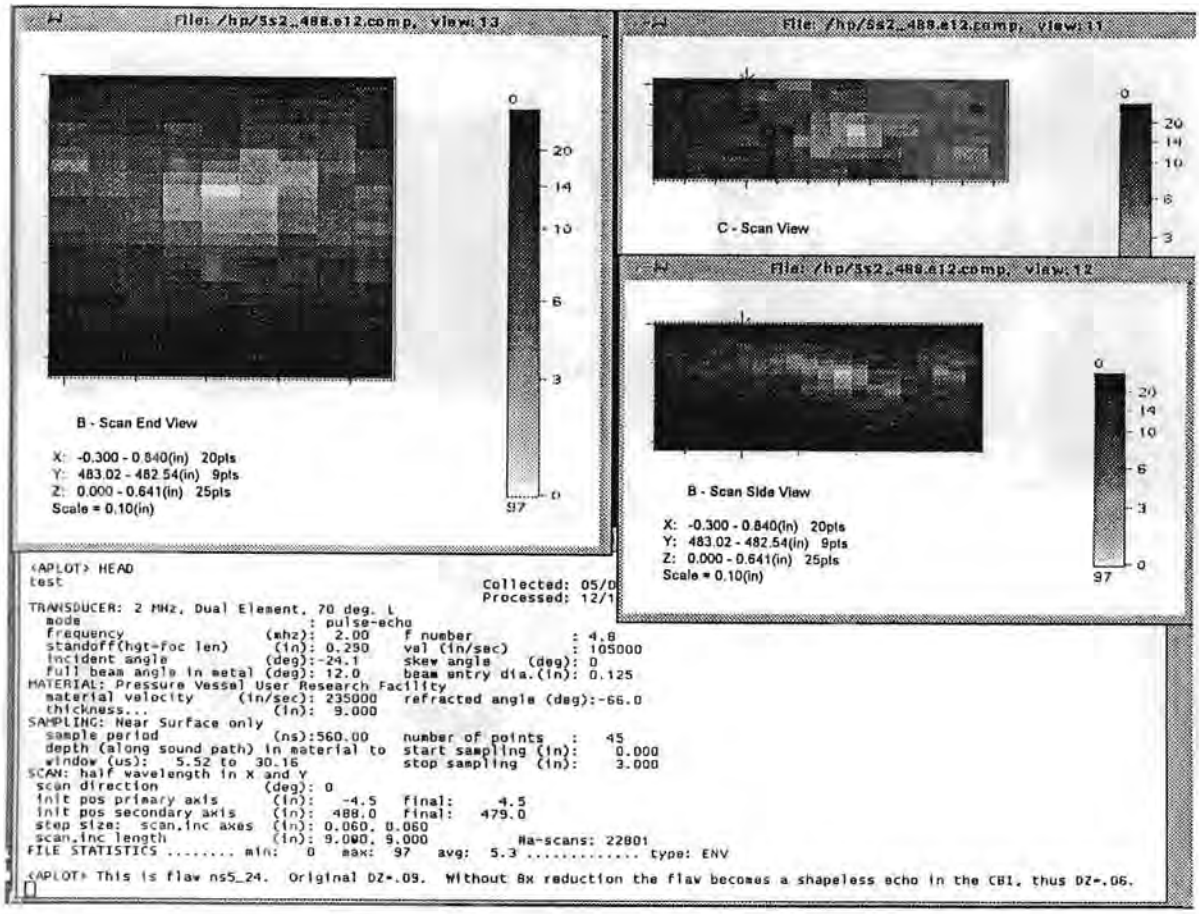
Figure A.48 shows planar indication #3 in the cladding. This planar indication has a through-wall extent of less than 1.5 mm based on an indication without TOF shape at the clad to base metal interface. The detection was made in mode 2 where it failed to display TOF shape but remained brighter than 95 counts at a depth of 6 mm. There were no confirmations in other modes. The indication is characterized as planar based on lack of detection in normal beam or orthogonal modes. There is no evidence of coin shape in the end view of mode 2. The length is 8 mm and was made to LOS in mode 2. The aspect ratio (length/depth) of this indication is 5 giving an orientation along the weld. The maximum amplitude-to-noise ratio is of medium range at 97 to 30. The Z coordinate of 6 mm shows that the indication is in the clad-to-base metal interface. The X coordinate of 9 mm shows that the indication is over the weld.

Figure A-48. Planar indication #3 in the cladding: mode 2

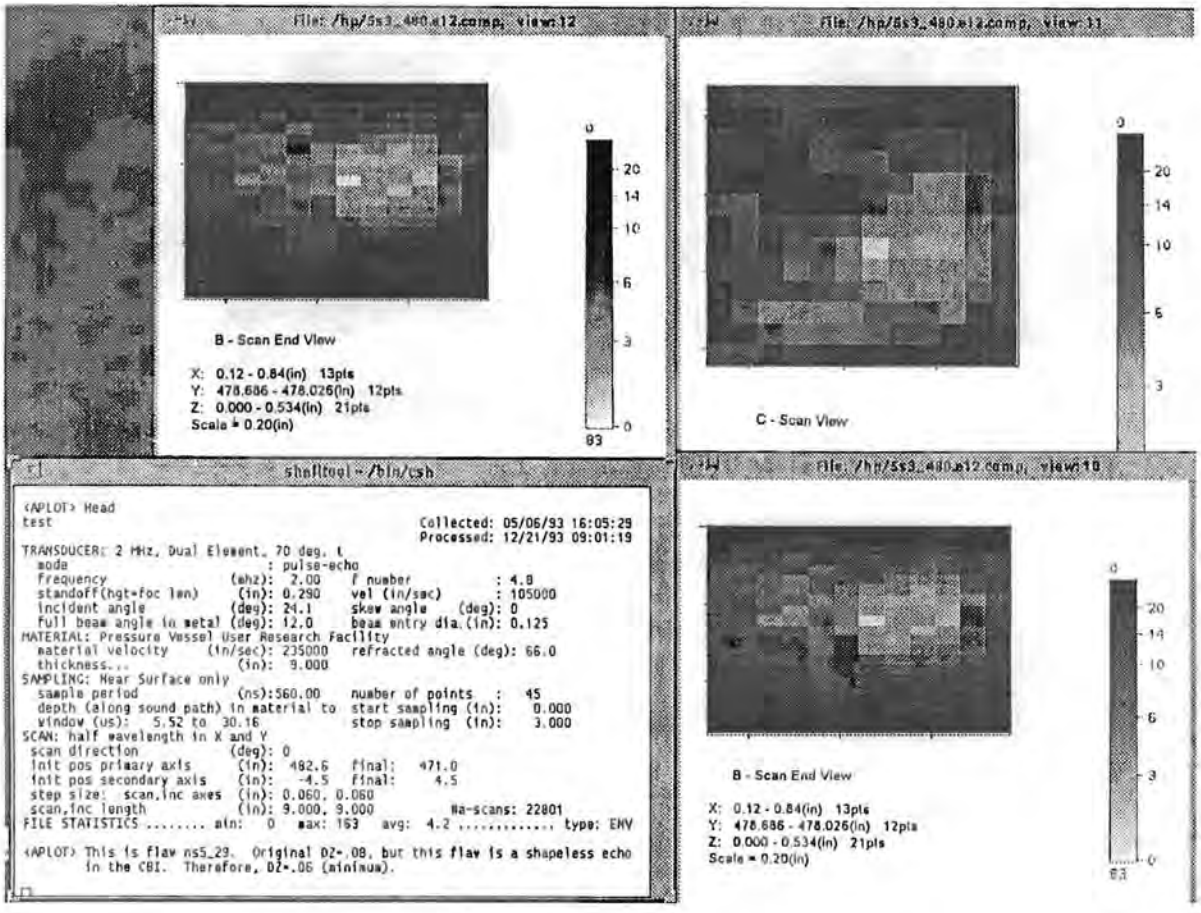
Figure A.49 - Planar indication #4 in the cladding: mode 3

Figure A.49 shows planar indication #4 in the cladding. This planar indication has a through-wall extent of less than 1.5 mm based on an indication without TOF shape at the clad to base metal interface. The detection was made in mode 3 where it displayed evidence of coin shape at a depth of 6 mm. There were no confirmations in other modes. The indication is characterized as planar based on lack of detection in normal beam or orthogonal modes. There is good evidence of coin shape in the side view of mode 3 which tends to confirm the indication as planar. The width is 16 mm and was made to LOS in mode 3. The aspect ratio (width/depth) of this indication is 11 which tends to indicate a larger through-wall extent than 1.5 mm. The maximum amplitude-to-noise ratio is high at 83 to 15. The Z coordinate of 6 mm shows that the indication is in the clad-to-base metal interface. The X coordinate of 14 mm shows that the indication is over the HAZ.

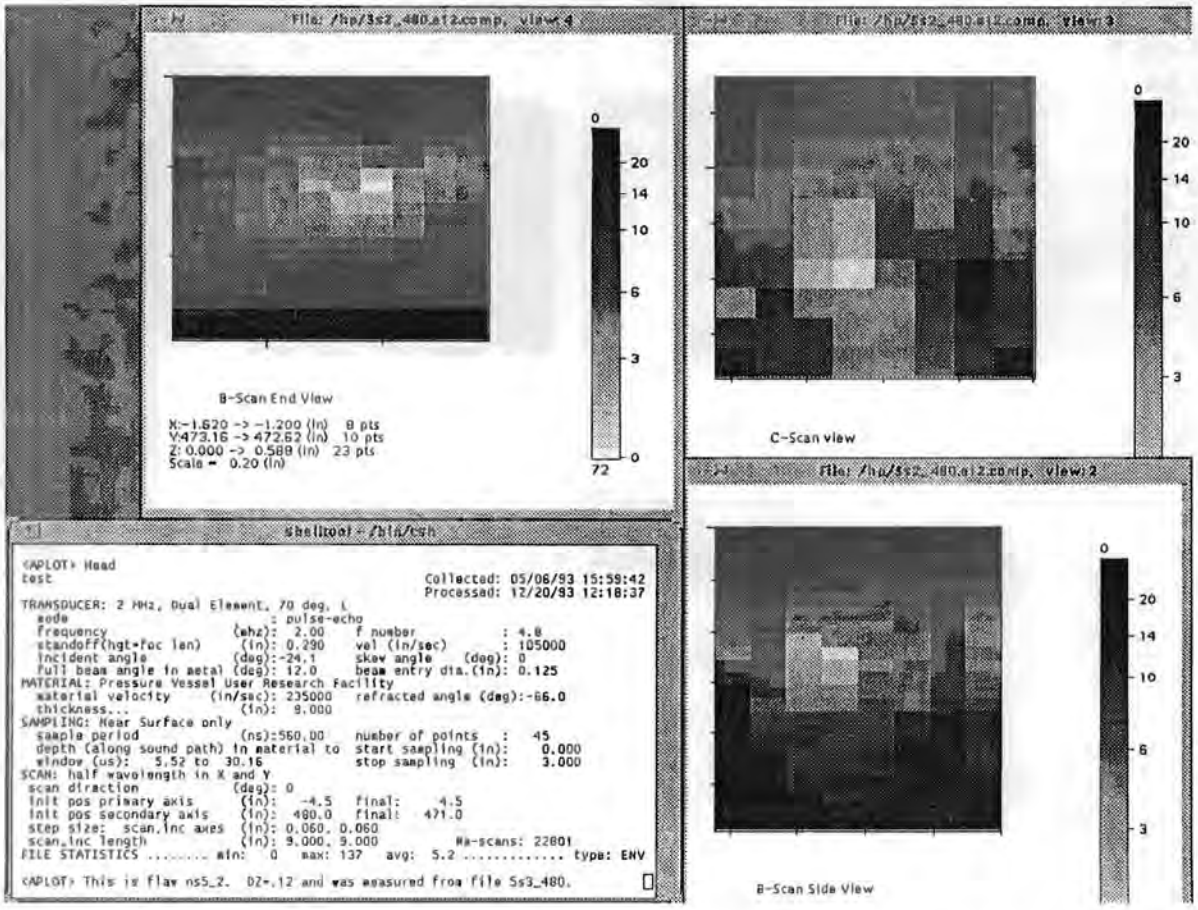
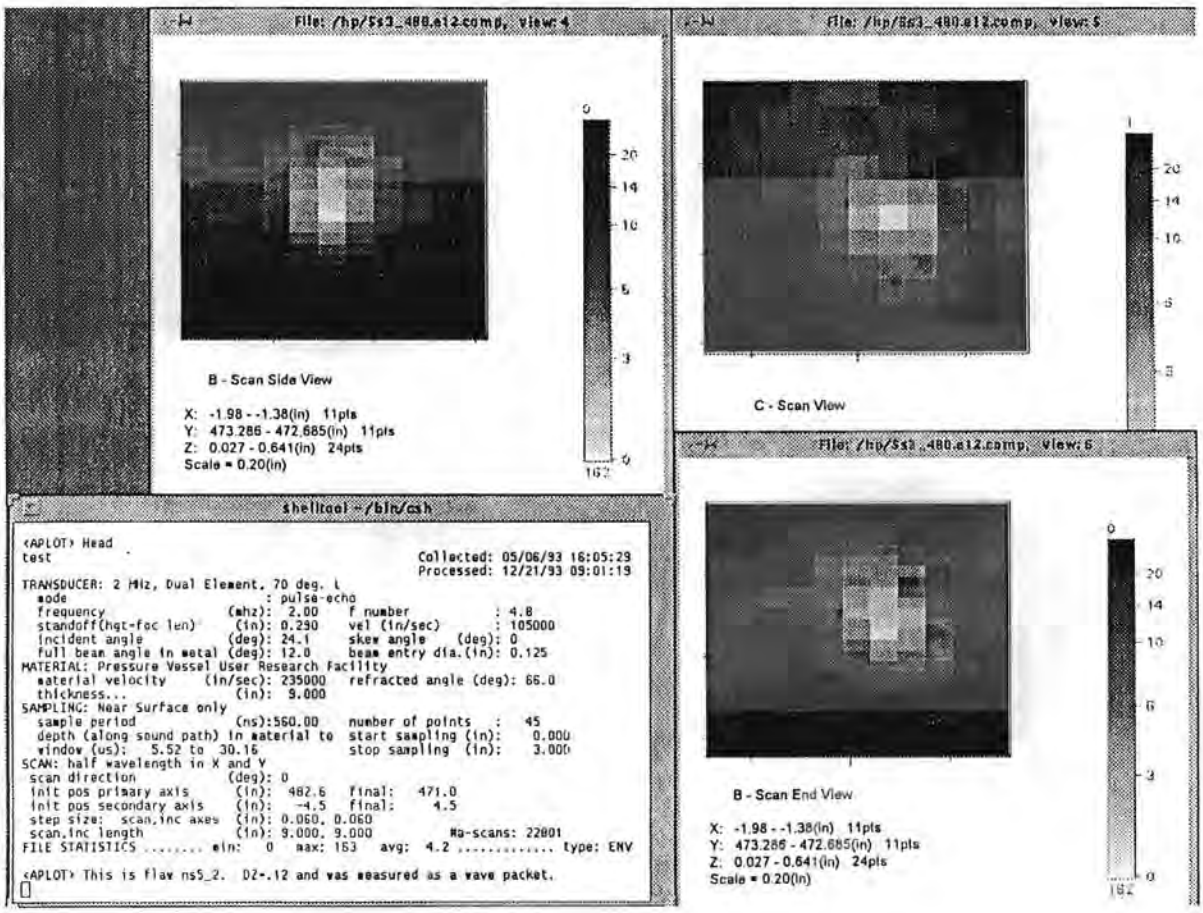
Figures A.50a-b show volumetric indication #1 in the cladding. This volumetric indication has a through-wall extent of 3 mm based on wave packet width. The detection was made in mode 2 where it had isolated TOF shape at a depth of 7 mm. The shape quality is good for this indication. There was a confirmation in mode 3 at a depth of 8 mm. The different Z values of 7 to 8 mm give an alternate depth size of 1 mm. The indication is characterized as volumetric based on detection in orthogonal modes. There is some evidence of coin shape in the end view of mode 2. The length is 12 mm and was made to LOS in mode 2. The width is 10 mm and was made to LOS in mode 3. The range of aspect ratios (length/depth) of this indication is 4 to 12 which tends to confirm the larger through-wall extent. The maximum amplitude-to-noise ratio is high at 162 to 20. The Z coordinate of 7 to 8 mm shows that the indication is in the clad-to-base metal interface. The X coordinate of -36 mm shows that the indication is over the base metal.

Figure A.50a - Volumetric indication #1 in the cladding: mode 2

Figure A.50b - Volumetric indication #1 in the cladding: mode 3

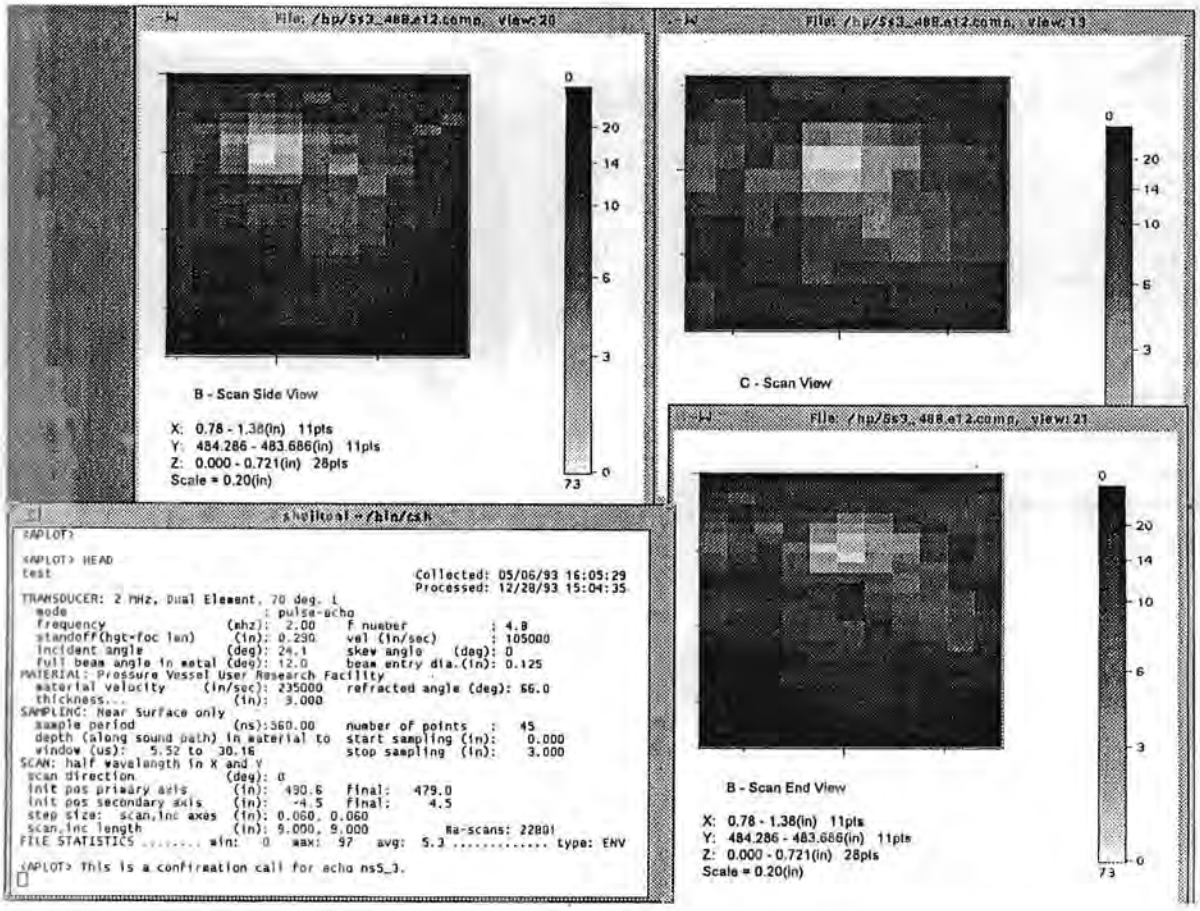
Figures A.51a-d show volumetric indication #2 in the cladding. This volumetric indication has a through-wall extent of 3 mm based on different depth estimates of 5 to 8 mm and a smaller size of 2.3 mm based on wave packet width. The detection was made in modes 2 and 5 where it had isolated TOF shape at depths of 5 and 6 mm. The shape quality is poor but not unusual for a shallow indication and is broken up indicating that more than one small flaw is present. There were confirmations in modes 1 and 3 at depths of 6 and 8 mm. The indication is characterized as volumetric based on normal beam detection. There is no evidence of coin shape in the end view of modes 2, the side view of mode 3, and the side view of mode 5. The length is 11 mm and was made to LOS in mode 2. The width is 12 mm and was made to LOS in mode 5. The aspect ratio (width/depth) of this indication is 5 and the length-to-depth ratio is 5 which tends to confirm volumetric orientation. The maximum amplitude-to-noise ratio is of medium range at 92 to 30. The Z coordinates of 5 to 8 mm show that the indication is in the clad-to-base metal interface. The X coordinate of 15 mm shows that the indication is over the HAZ.

Figure A.51a - Volumetric indication #2 in the cladding: mode 3

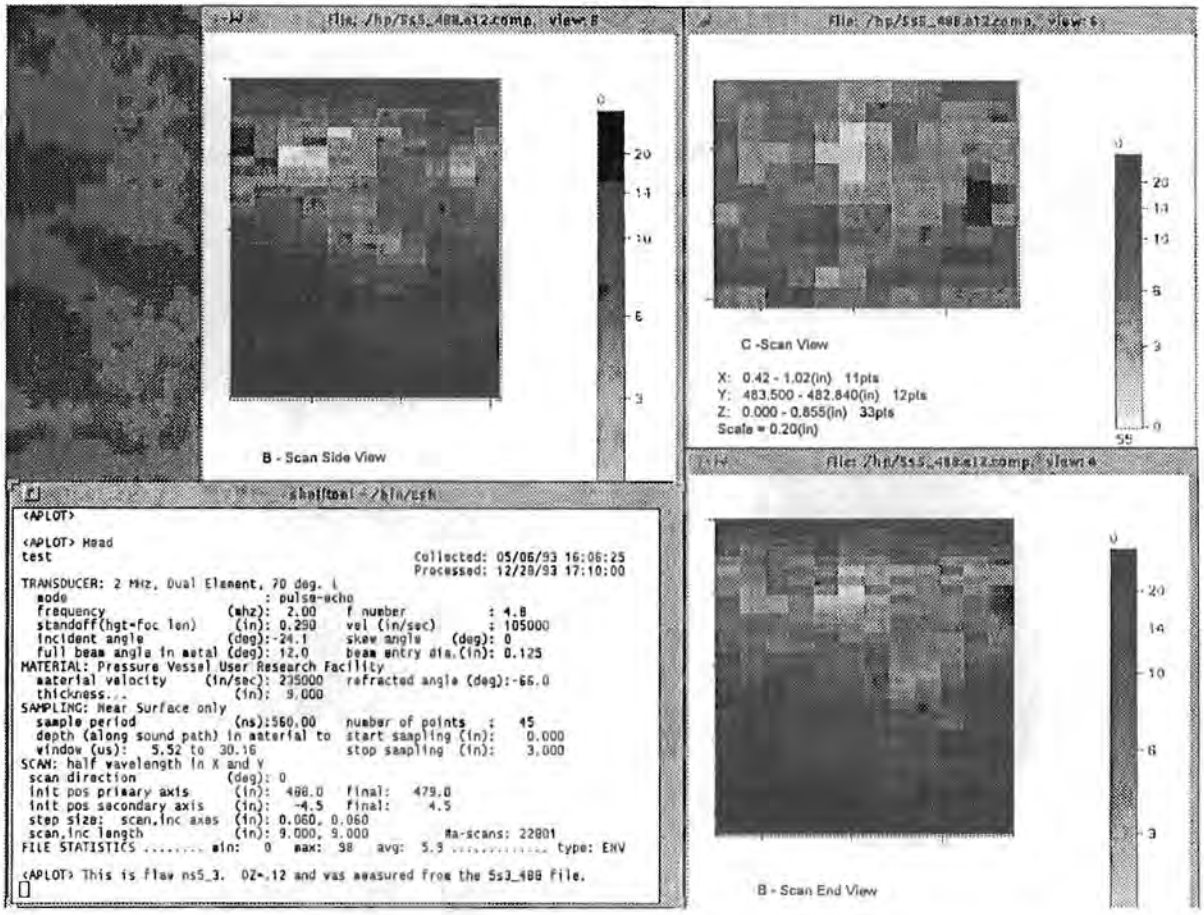
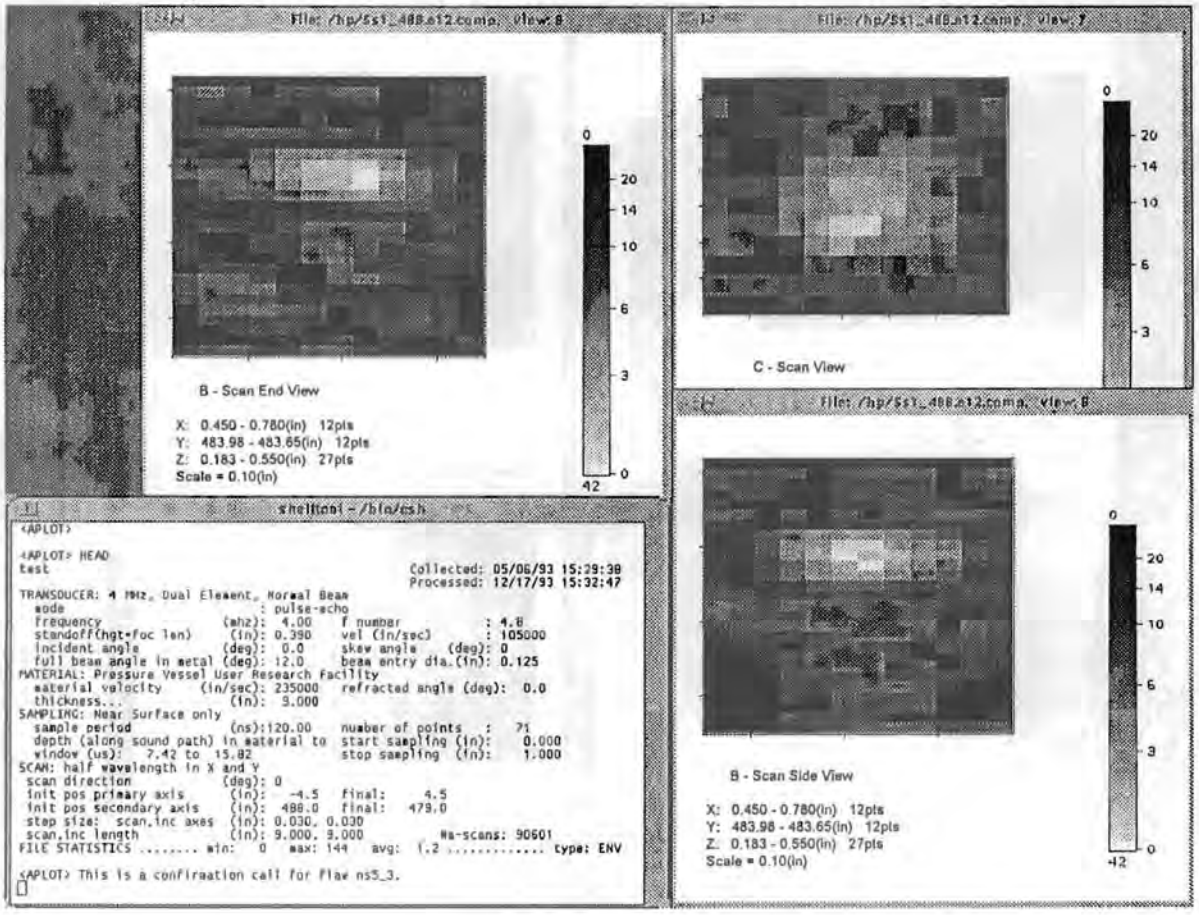
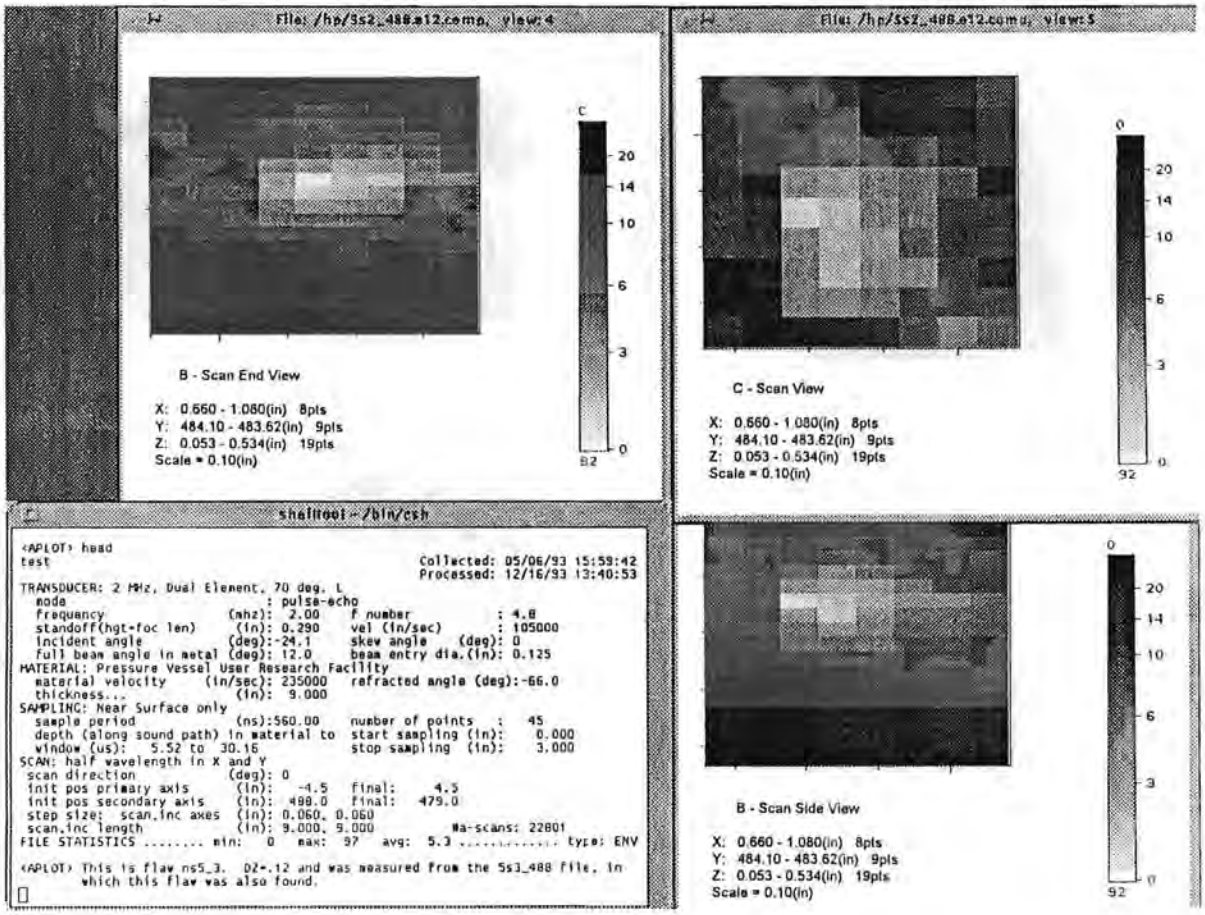
Figure A.51b - Volumetric indication #2 in the cladding: mode 5

Figure A.51c - Volumetric indication #2 in the cladding: mode 1

Figure A.51d - Volumetric indication #2 in the cladding: mode 2
