NUREG/CR-6471, Vol. 1
PNNL-11143

Characterization of Flaws in U.S. Reactor Pressure Vessels

Density and Distribution of Flaw Indications in PVRUF

Pacific Northwest National Laboratory

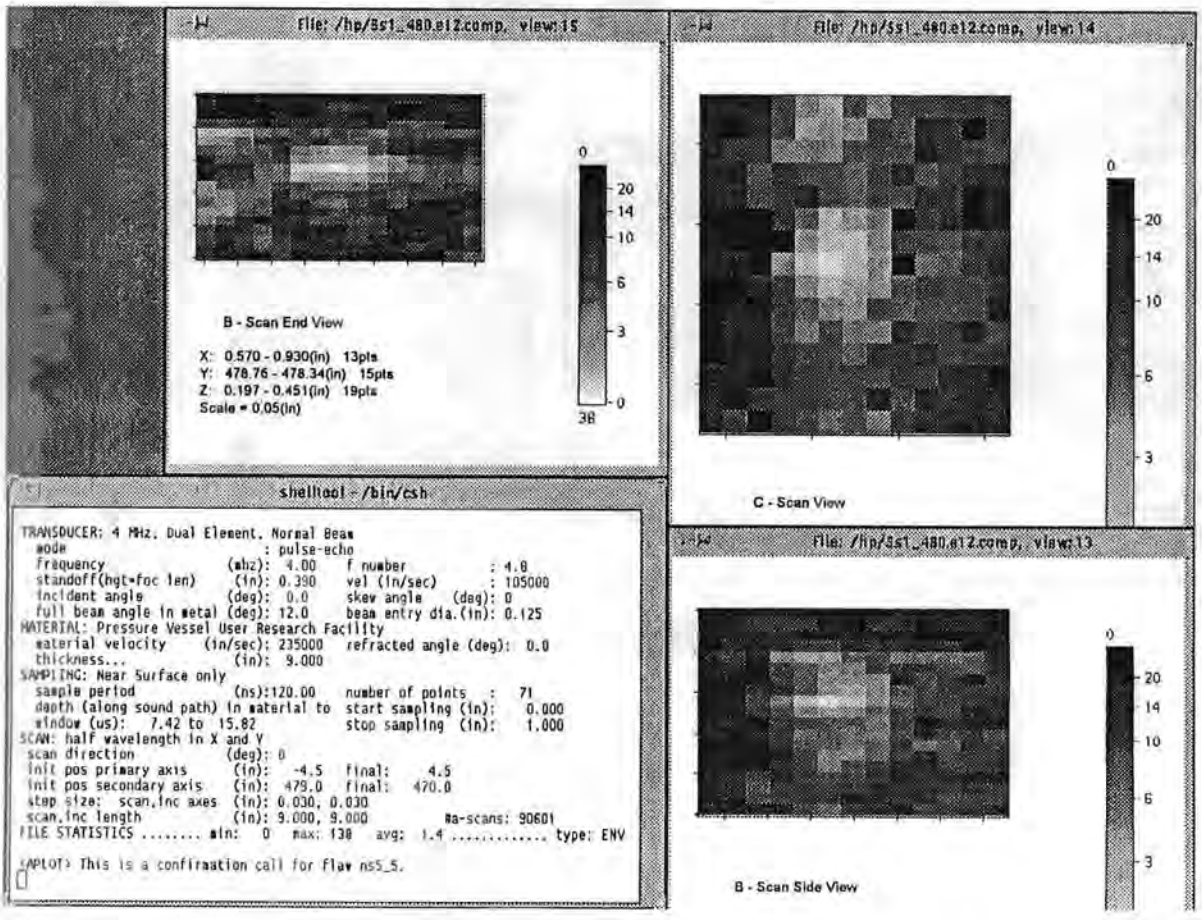
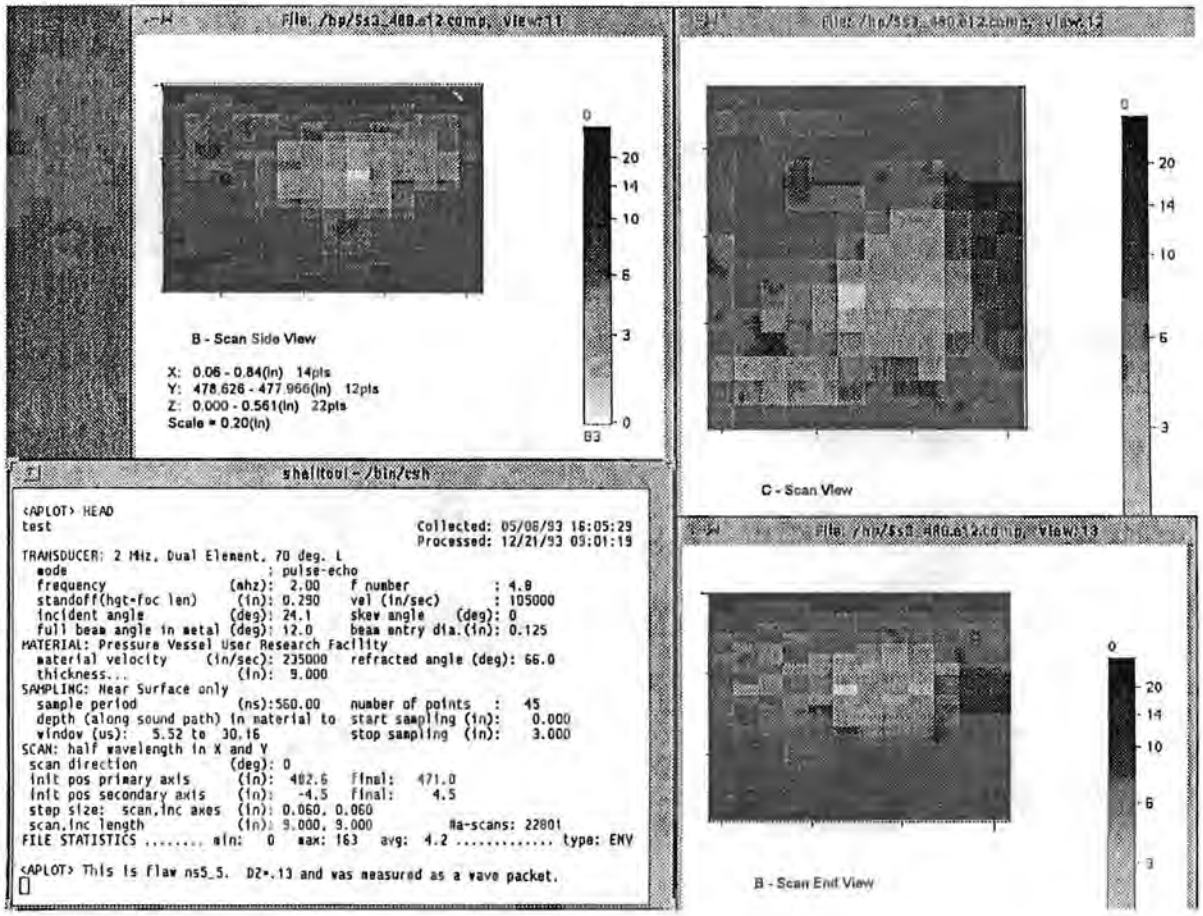
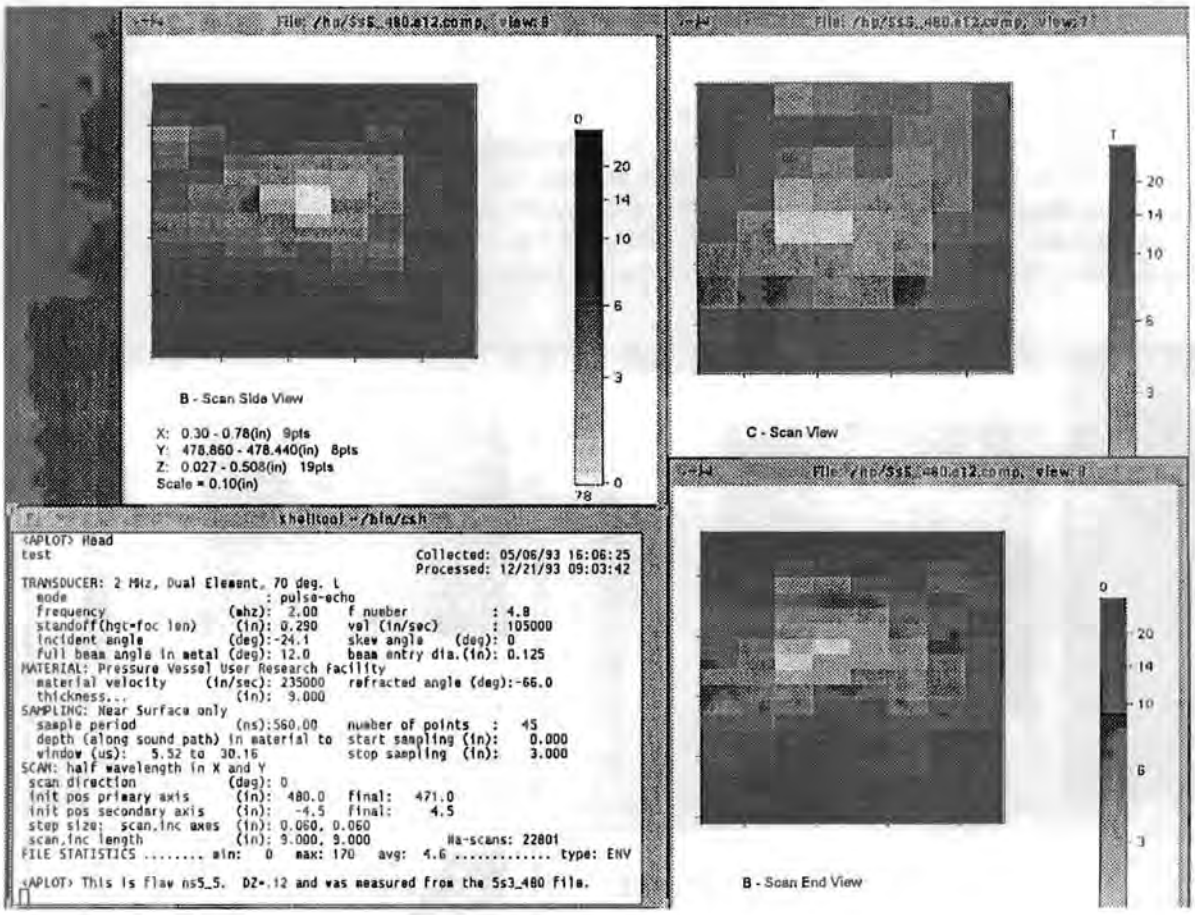
Figures A.52a-c show volumetric indication #3 in the cladding. This planar indication has a through-wall extent of 2 mm based on different depth estimates and less than 1.5 mm based on a coin shaped indication at the clad to base metal interface. The detection was made in mode 3 where it displayed coin shape at a depth of 6 mm. There were confirmations in modes 1 and 5 at depths of 6 and 8 mm. The different Z values of 6 to 8 mm give an alternate depth size of 2 mm. The indication is characterized as volumetric based on normal beam detection. There is good evidence of coin shape in the side view of mode 3. The length is 6 mm and was made to LOS in mode 1. The width is 18 mm and was made to LOS in mode 1. The range of aspect ratios (width/depth) of this indication is 9 to 12. The maximum amplitude-to-noise ratio is of medium range at 83 to 25. The Z coordinate of 6 to 8 mm shows that the indication is in the clad-to-base metal interface. The X coordinate of 18 mm shows that the indication is over the base metal.

Figure A.52a - Volumetric indication #3 in the cladding: mode 1

Figure A.52b - Volumetric indication #3 in the cladding: mode 3

Figure A.52c - Volumetric indication #3 in the cladding: mode 5

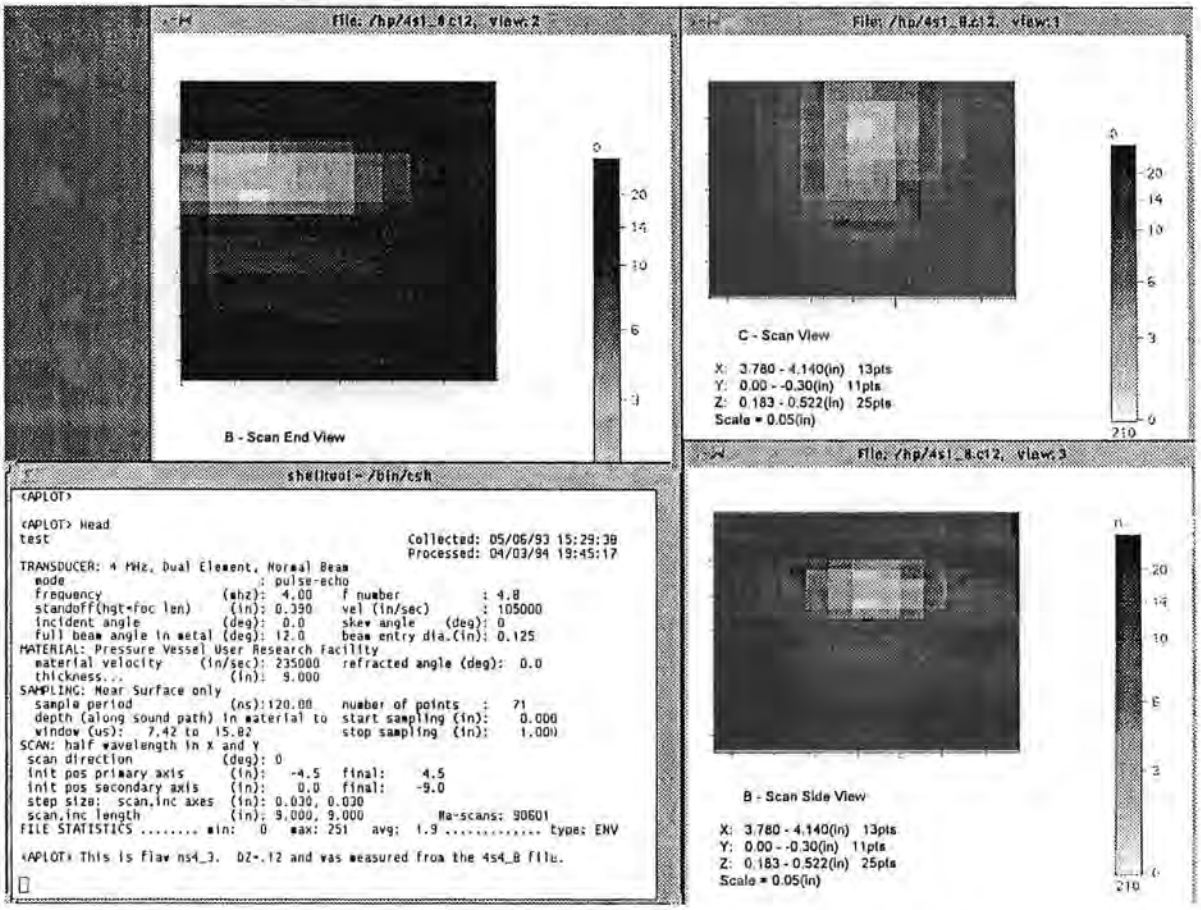
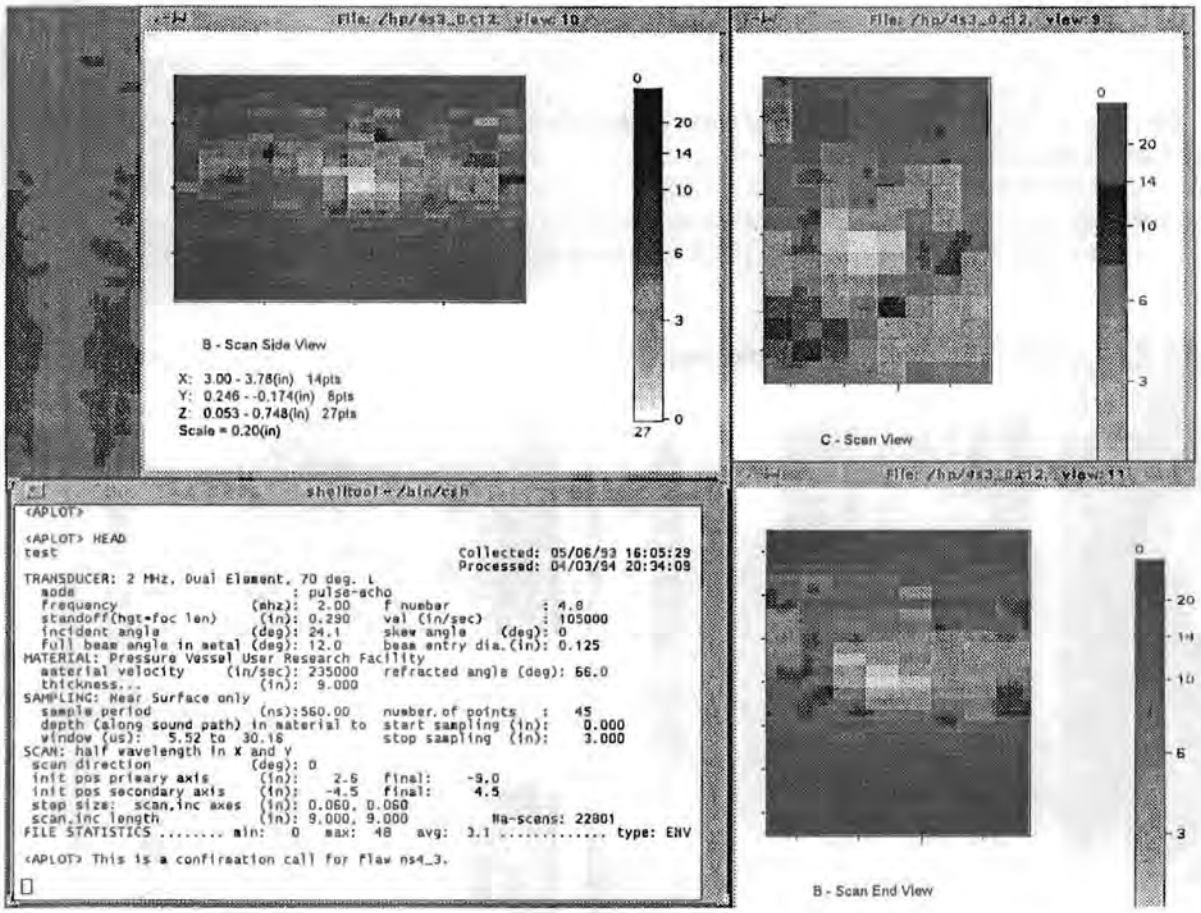
Figures A.53a-d show volumetric indication #4 in the cladding. This volumetric indication has a through-wall extent of 2 mm based on different depth estimates of 7 to 9 mm and less than 1.5 mm based on an indication without TOF shape at the clad to base metal interface. The detection was made in modes 1 and 4 where it failed to display TOF shape but remained brighter than 95 counts at depths of 7 and 8 mm. There was a confirmation in mode 3 at a depth of 9 mm. The indication is characterized as volumetric based on normal beam detection. There is no evidence of coin shape in the side view of mode 3 and end view of mode 4. The length is 16 mm and was made to LOS in mode 4. The width is 8 mm and was made to LOS in mode 3. The range of aspect ratios (width/depth) of this indication is 9 to 11. The maximum amplitude-to-noise ratio is high at 210 to 20. The Z coordinate of 7 to 9 mm shows that this indication is in the clad-to-base metal interface. The X coordinate of 98 mm shows that the indication is over the base metal.

Figure A.53d - Volumetric indication #4 in the cladding: mode 3

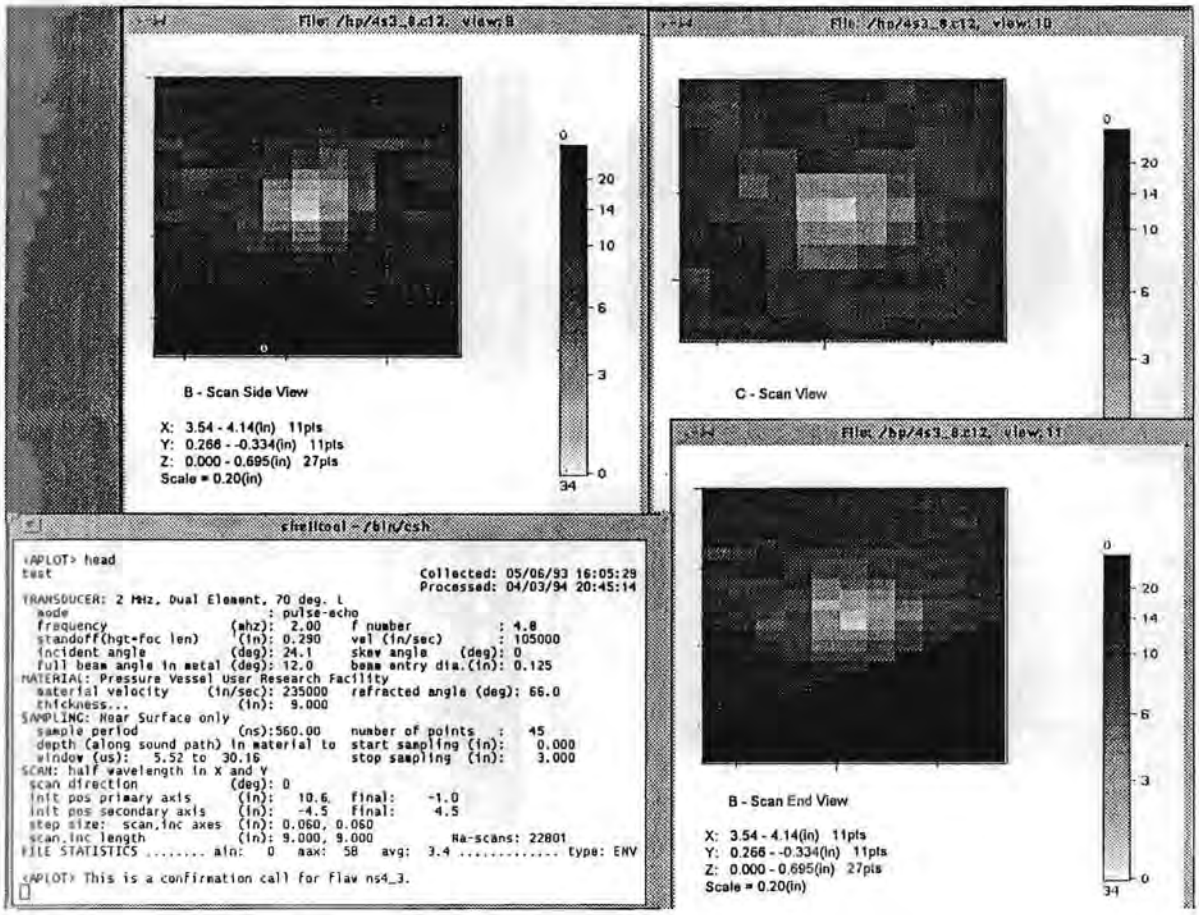
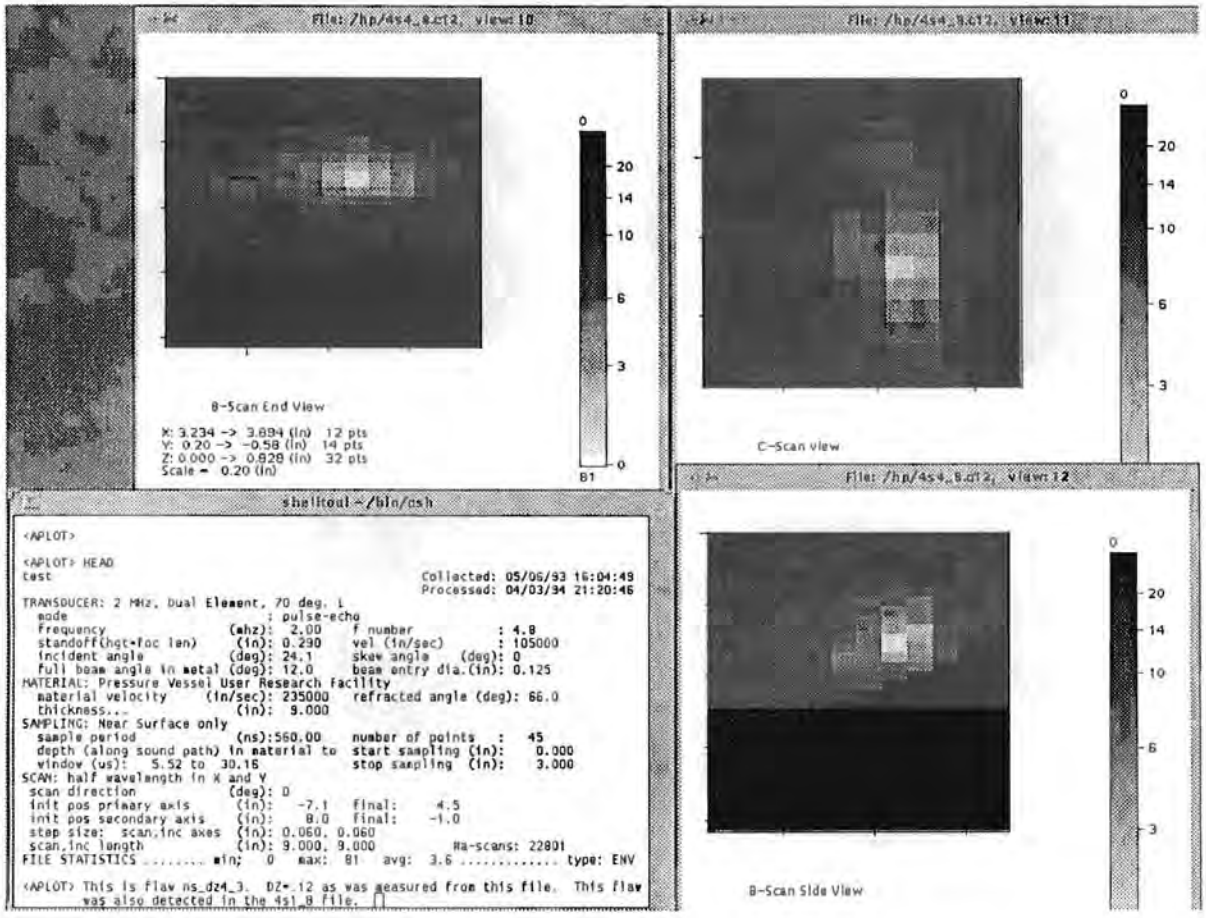
Figure A.53b - Volumetric indication #4 in the cladding: mode 3

Figure A.53c - Volumetric indication #4 in the cladding: mode 4

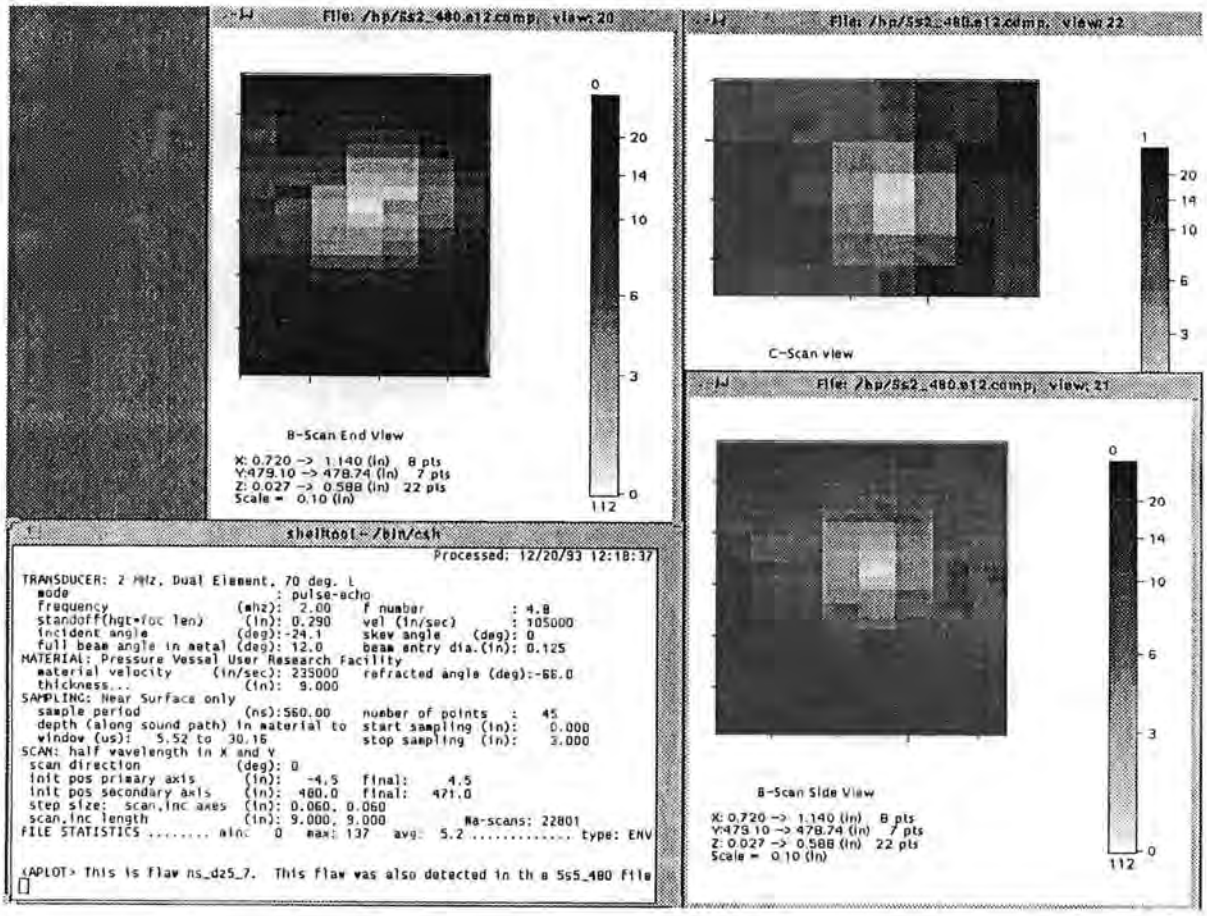
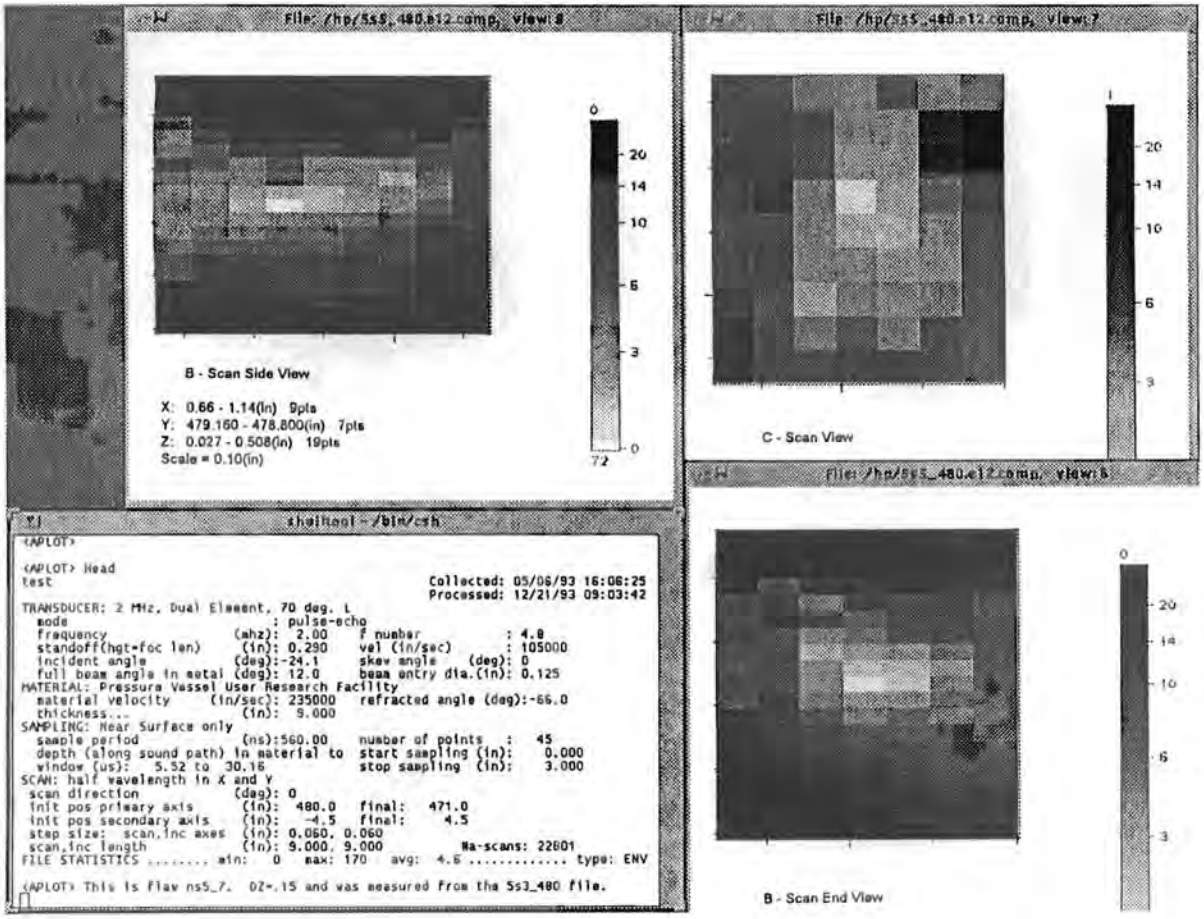
Figures A.54a-c show volumetric indication #5 in the cladding. This volumetric indication has a through-wall extent of less than 1.5 mm based a bright indication without TOF shape in the clad to base metal interface. The detection was made in modes 2 and 5 where the bright, shallow indication failed to take shape at a depth of 6 mm. There was a confirmation in mode 3 at a depth of 6 mm. The three Z values of 6 mm give an alternate depth size of less than 1 mm. The indication is characterized as volumetric based on detection in orthogonal modes. There is some evidence of coin shape in the side view of mode 3. The length is 12 mm and was made to LOS in mode 2. The width is 11 mm and was made to LOS in mode 3. The maximum amplitude-to-noise ratio is of medium range at 112 to 40. The Z coordinate of 6 mm shows that the indication is in the clad-to-base metal interface. The X coordinate of 21 mm shows that the indication is over the base metal.

Figure A.54b - Volumetric indication #5 in the cladding: mode 3

Figure A.54c - Volumetric indication #5 in the cladding: mode 5

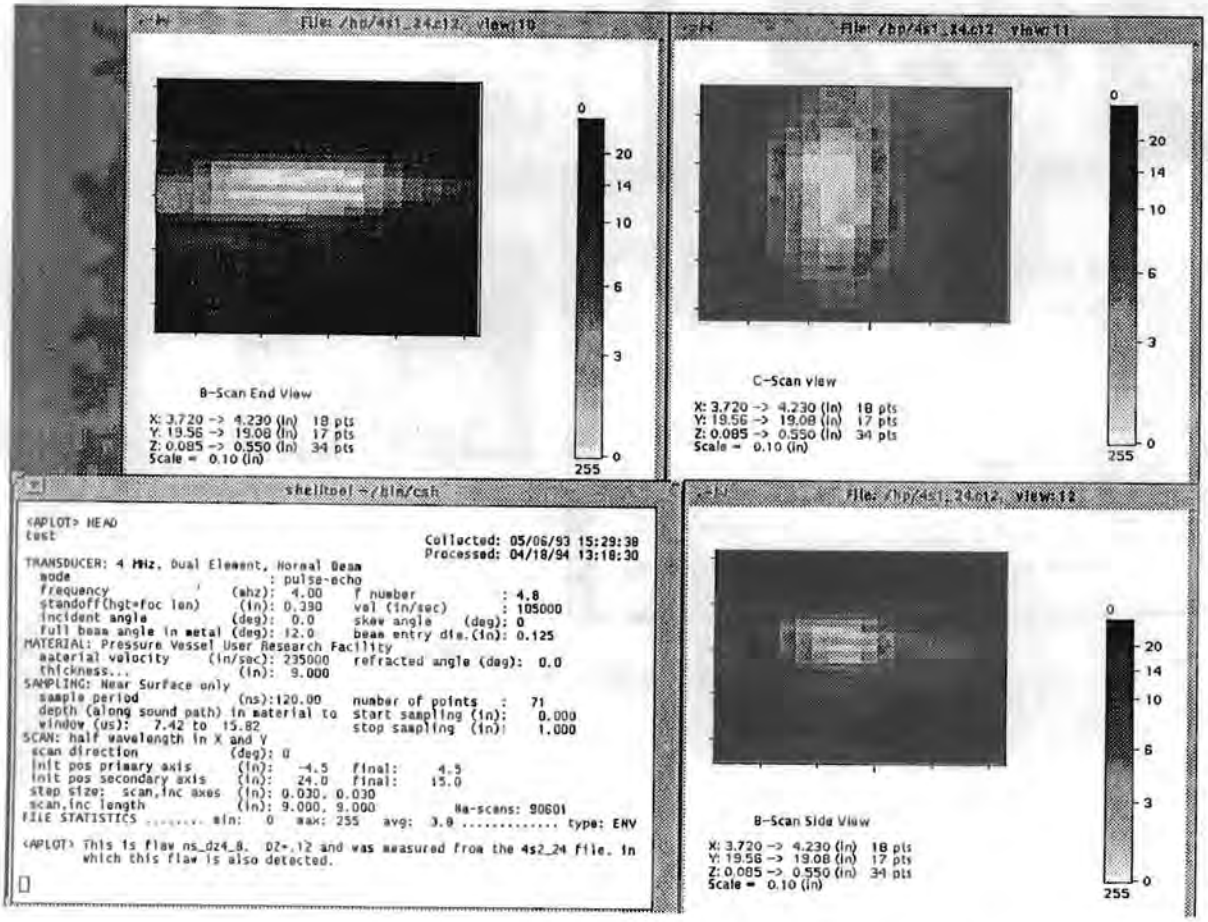
Figures A.55a-c show volumetric indication #6 in the cladding. This volumetric indication has a through-wall extent of less than 1.5 mm based on an indication without TOF shape at the clad to base metal interface. The detection was made in modes 1 and 2 where the bright, shallow indication failed to take shape at a depth of 7 mm. There was a confirmation in mode 3 at a depth of 9 mm. The different Z values of 7 to 9 mm give an alternate depth size of 2 mm. The indication is characterized as volumetric based on normal beam detection. There is no evidence of coin shape in the end view of modes 2 and the side view of mode 3. The maximum amplitude-to-noise ratio is high at 255 to 20. The Z coordinate of 7 to 9 mm shows that the indication is in the clad-to-base metal interface. The X coordinate of 94 mm shows that the indication is over the base metal.

Figure A.55a - Volumetric indication #6 in the cladding: mode 1

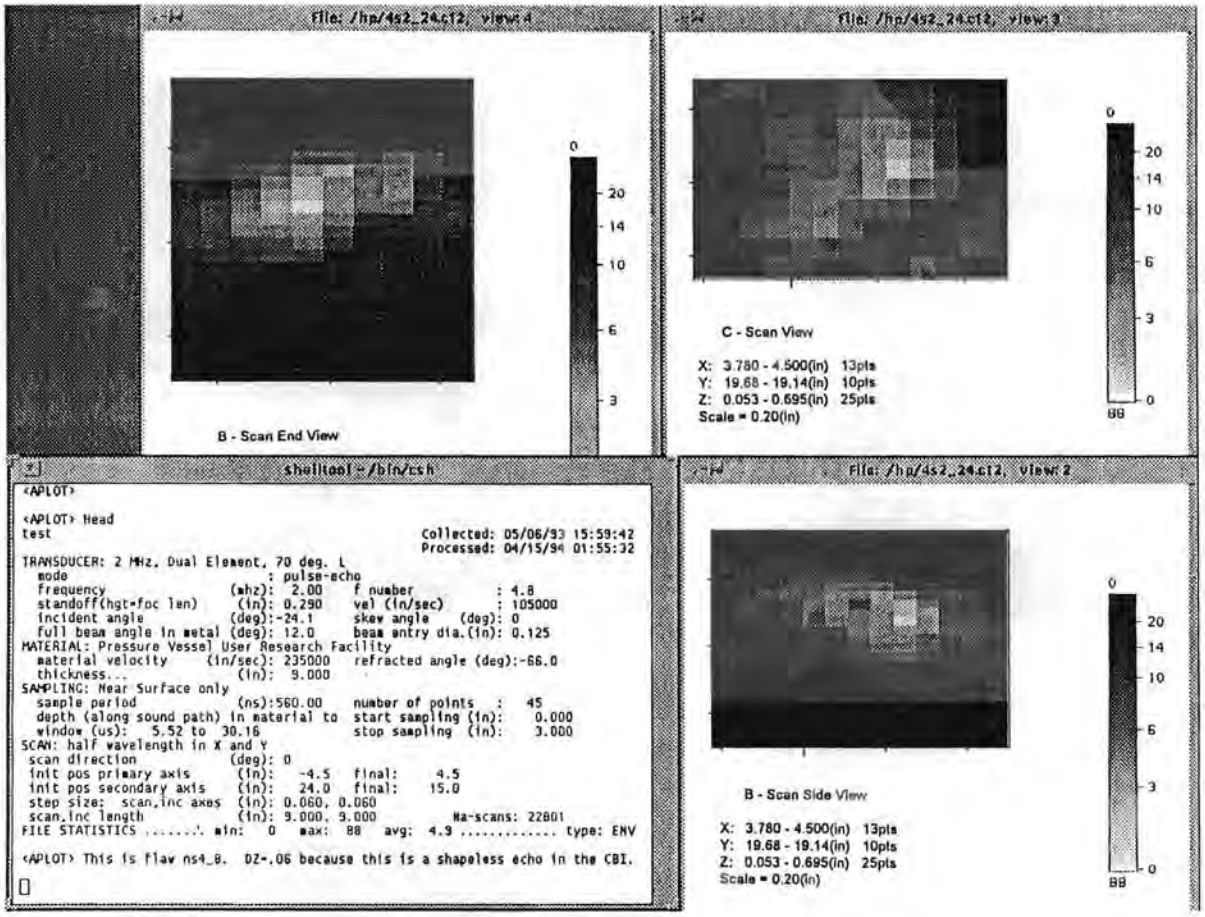
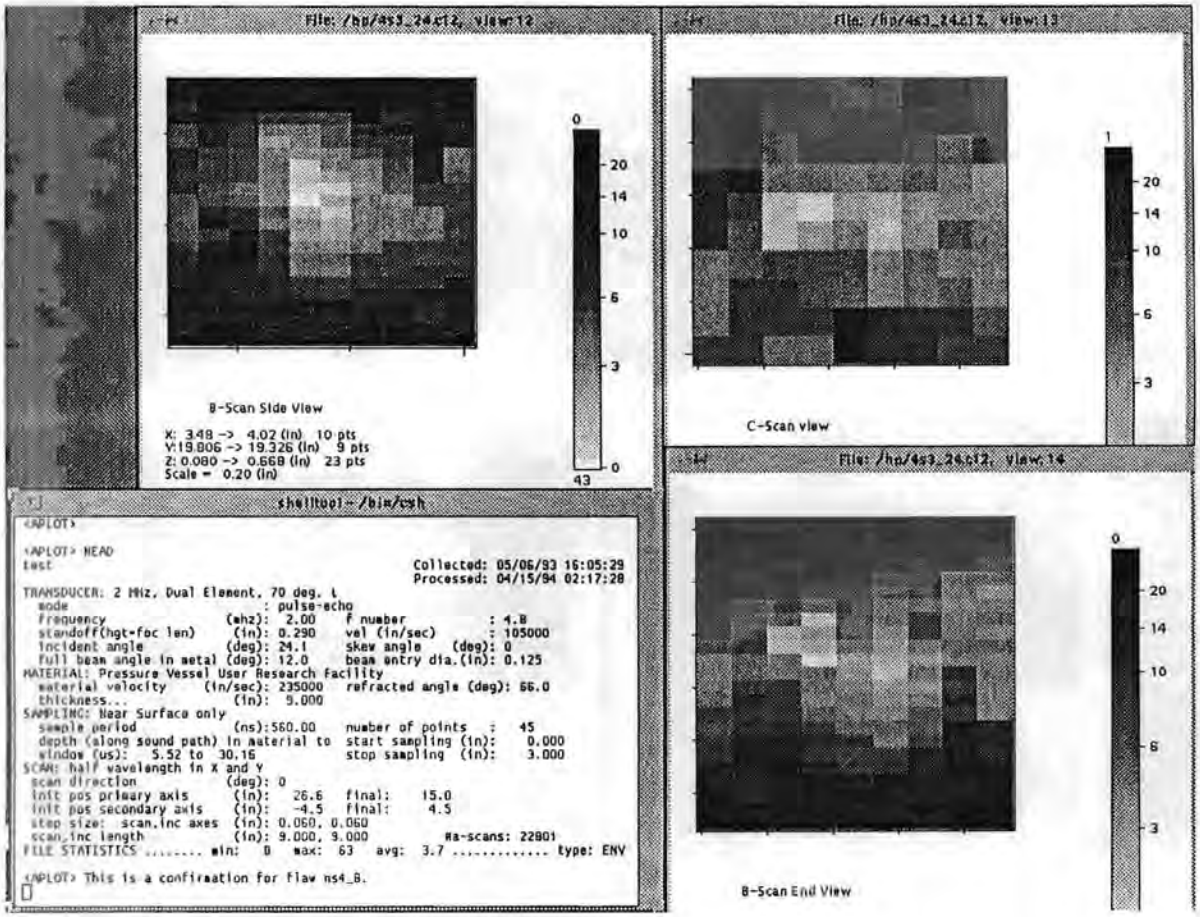
Figure A.55b - Volumetric indication #6 in the cladding: mode 2

Figure A.55c - Volumetric indication #6 in the cladding: mode 3

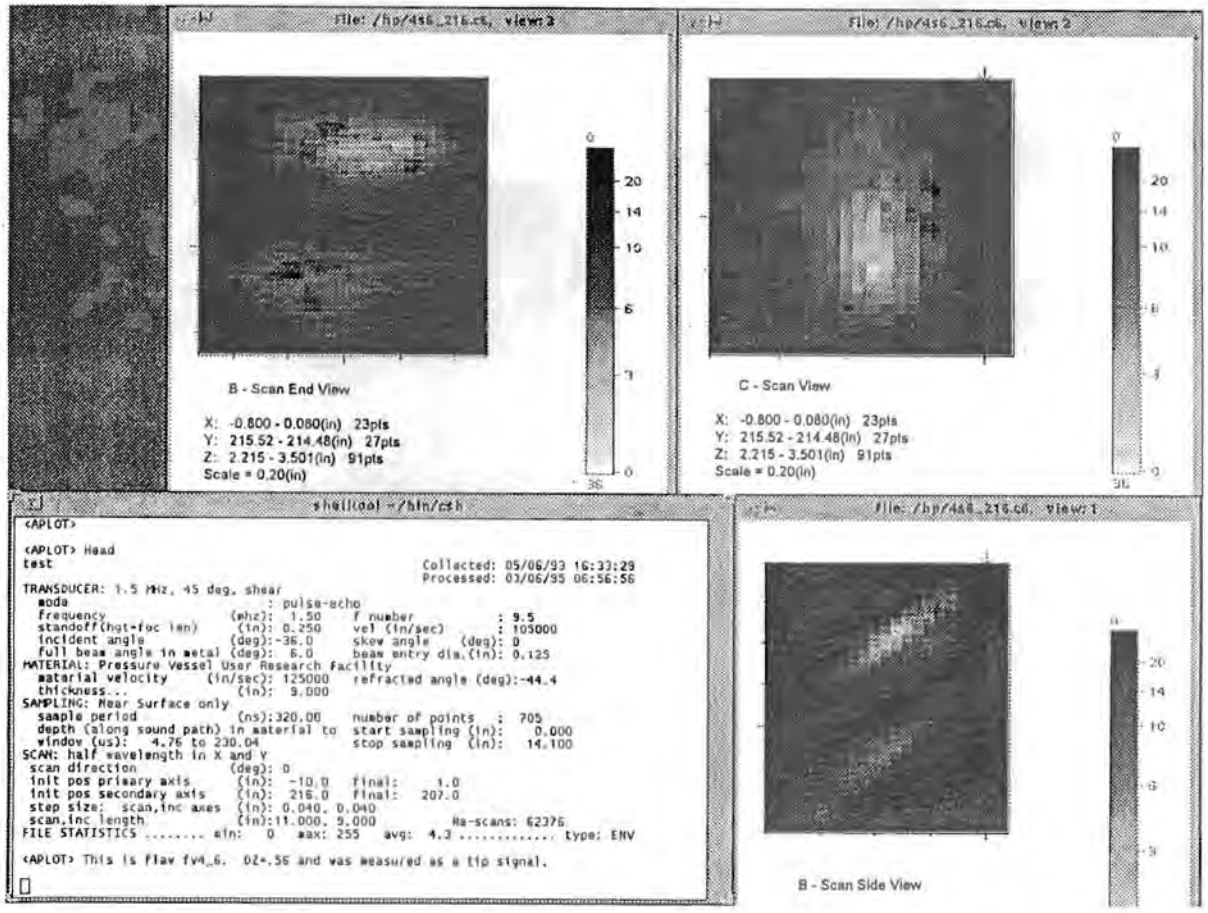
Figure A.56 - Planar indication #1 in the weldment below 25 mm: mode 6

Figure A.56 shows planar indication #1 in the weldment below 25 mm. This planar indication has a through-wall extent of 14 mm based on tip signal pattern. The detection was made in mode 6 where it displayed a pair of TOF shapes at a depth of 64 mm. The shape quality is good for this indication. There were no confirmations in other modes. The indication is characterized as planar based on the tip signal pattern. The length is 18 mm and was made to LOS in mode 6. The aspect ratio (length/depth) of this indication is 1.3. The maximum amplitude-to-noise ratio is high at 36 to 5. With an X coordinate of -8 mm, the indication is in the weld. With a Z coordinate of 64 mm, the indication is in the middle third of the vessel.

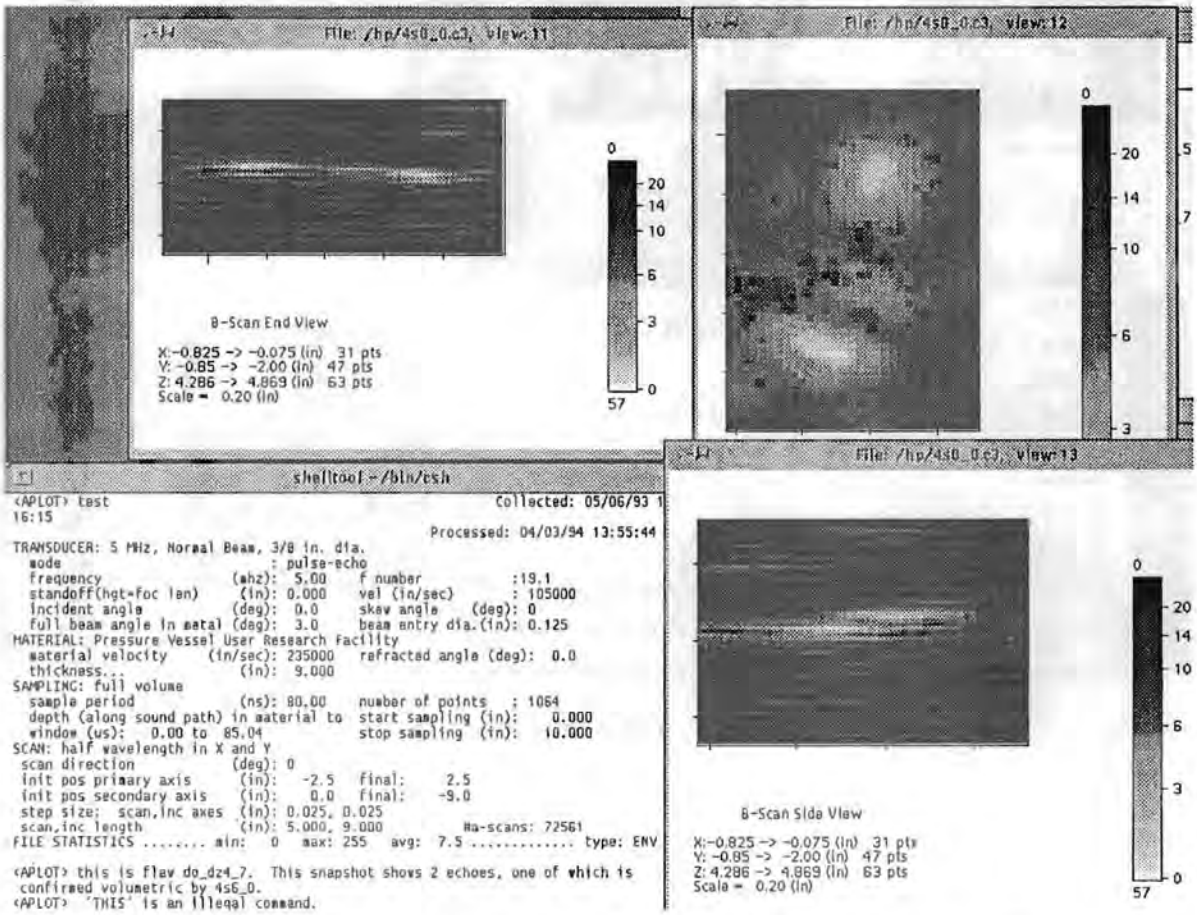
Figure A.57a - Planar indication #2 in the weldment below 25 mm: mode 10

Figures A.57a-b show planar indication #2 in the weldment below 25 mm. This planar indication has a through-wall extent of 13 mm based on tip signal pattern. The detection was made in mode 10 where it displayed normal beam shape at a depth of 115 mm. There was a confirmation in mode 6 at a depth of 112 mm. The confirmation mode detected the tip signal pattern. The indication is characterized as planar based on the tip pattern. The length is 25 mm and was made to LOS in mode 6. The width is 9 mm and was made to LOS in mode 10. The aspect ratio (length/depth) of this indication is 2. The maximum amplitude-to-noise ratio is high at 56 to 11. With an X coordinate of -8 mm, the indication is in the weld. With a Z coordinate of 115 mm, the indication is in the middle third of the vessel.

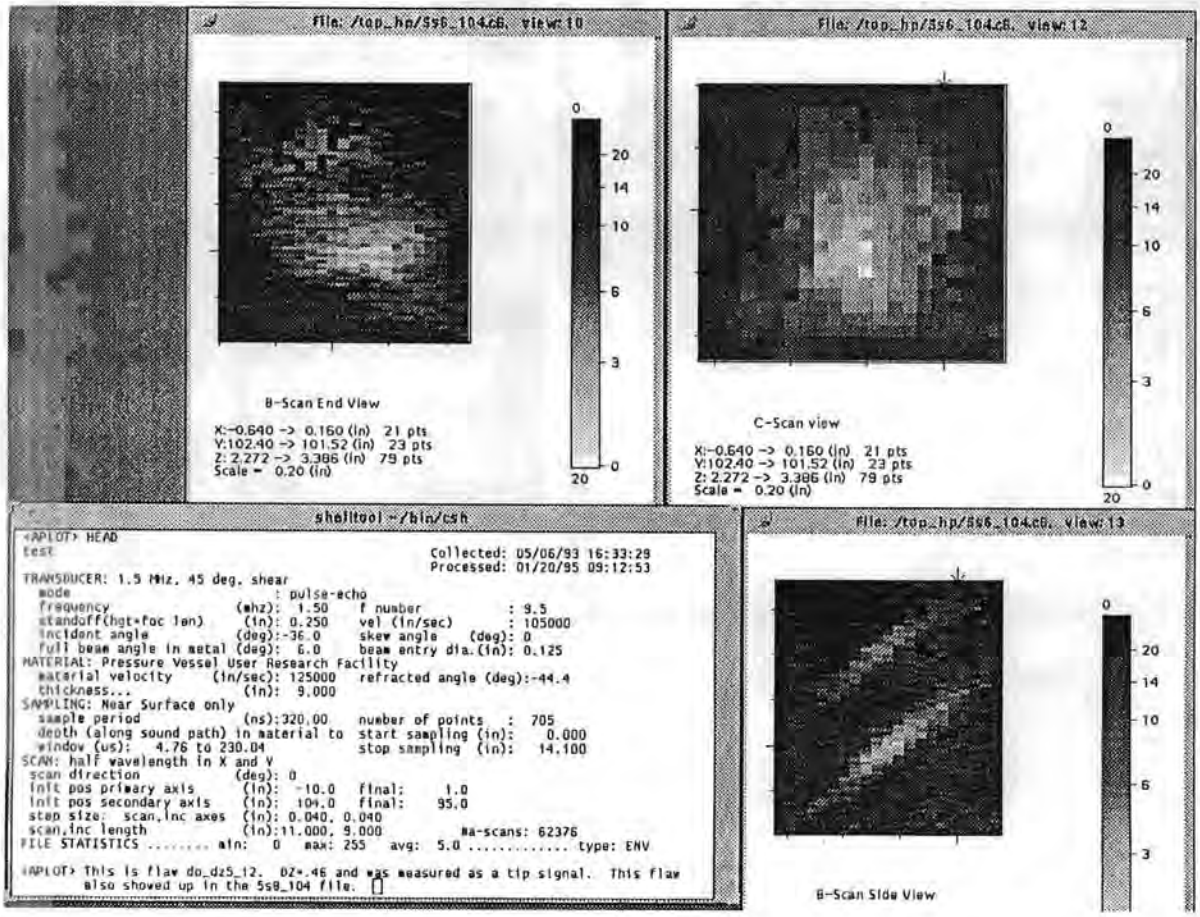
Figure A.58a - Planar indication #3 in the weldment below 25 mm: mode 6

Figures A.58a-b show planar indication #3 in the weldment below 25 mm. This planar indication has a through-wall extent of 11 mm based on tip signal pattern. The detection was made in mode 6 where it displayed a pair of TOF shapes at a depth of 75 mm. The shape quality is good for this indication. There was a confirmation in mode 8 at a depth of 74 mm. The different Z values of 74 to 75 mm give an alternate depth size of 1 mm. The indication is characterized as planar based on the tip signal pattern. The length is 18 mm and was made to LOS in mode 6. The range of aspect ratios (length/depth) of this indication is 1.6 to 18 which tends to confirm the larger through-wall extent. The maximum amplitude-to-noise ratio is high at 21 to 3. With an X coordinate of -7 mm, the indication is clearly in the weld. The Z coordinate of 75 mm shows that the indication is in the middle third of the vessel.

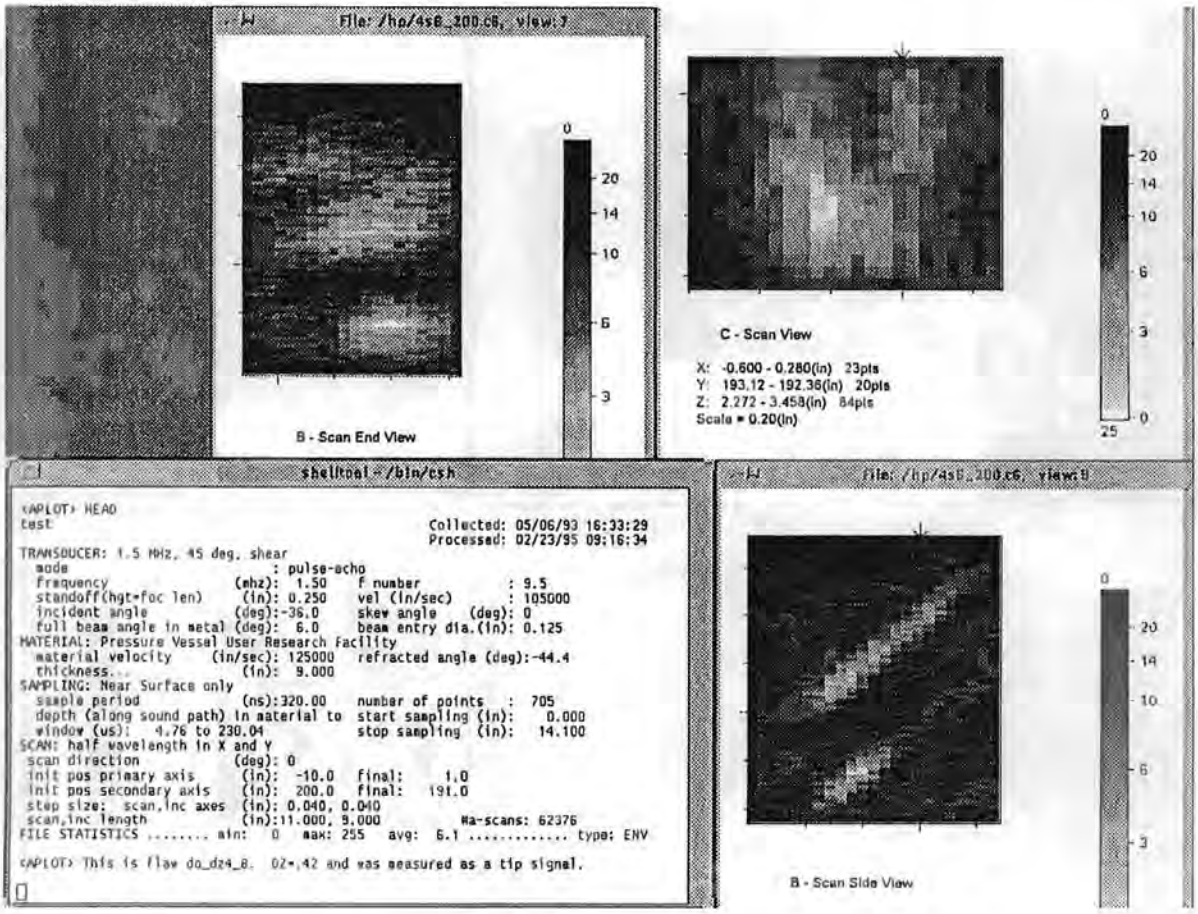
Figure A.59 shows planar indication #4 in the weldment below 25 mm. This planar indication has a through-wall extent of 11 mm based on tip signal pattern. The detection was made in mode 6 where it displayed a pair of TOF shapes at a depth of 73 mm. The shape quality is good for this indication. There were no confirmations in other modes. The indication is characterized as planar based on the tip signal pattern. The length is 18 mm and was made to LOS in mode 6. The aspect ratio (length/depth) of this indication is 1.6. The maximum amplitude-to-noise ratio is high at 25 to 5. The X coordinate of -7 mm shows that the indication is in the weld. The Z coordinate of 73 mm shows that the indication is in the middle third of the vessel.

Figure A.59 - Planar indication #4 in the weldment below 25 mm: mode 6

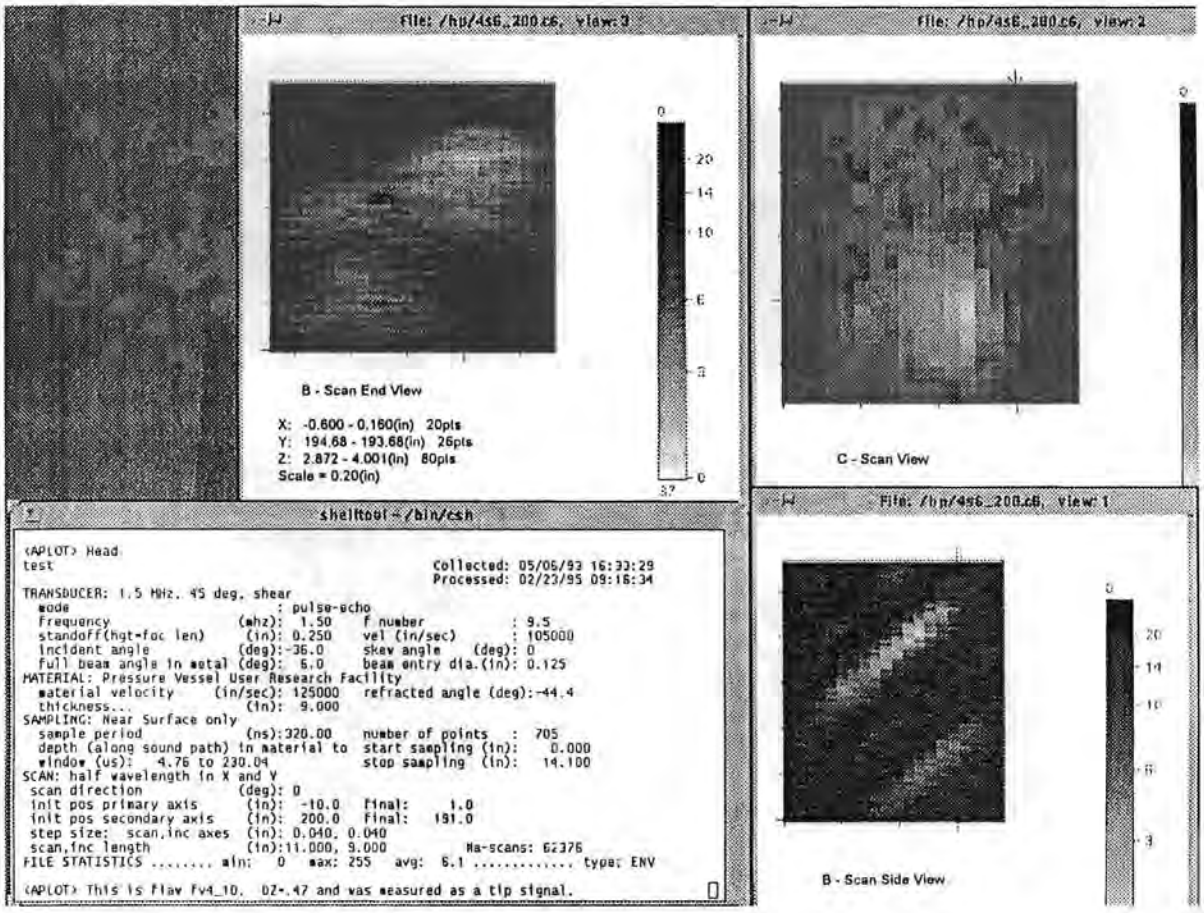
Figure A.60 shows planar indication #5 in the weldment below 25 mm. This planar indication has a through-wall extent of 9 mm based on tip signal pattern. The detection was made in mode 6 where it displayed a pair of TOF shapes at a depth of 81 mm. The shape quality for this indication is good but broken up, implying that more than one small flaw may be present. There were no confirmations in other modes. The indication is characterized as planar based on the tip signal pattern. The length is 16 mm and was made to LOS in mode 6. The aspect ratio (length/depth) of this indication is 1.8. The maximum amplitude-to-noise ratio is high at 37 to 6. The X coordinate of -6 mm shows that the indication is in the weld. The Z coordinate of 81 mm shows that the indication is in the middle third of the vessel.

Figure A.60 - Planar indication #5 in the weldment below 25 mm: mode 6

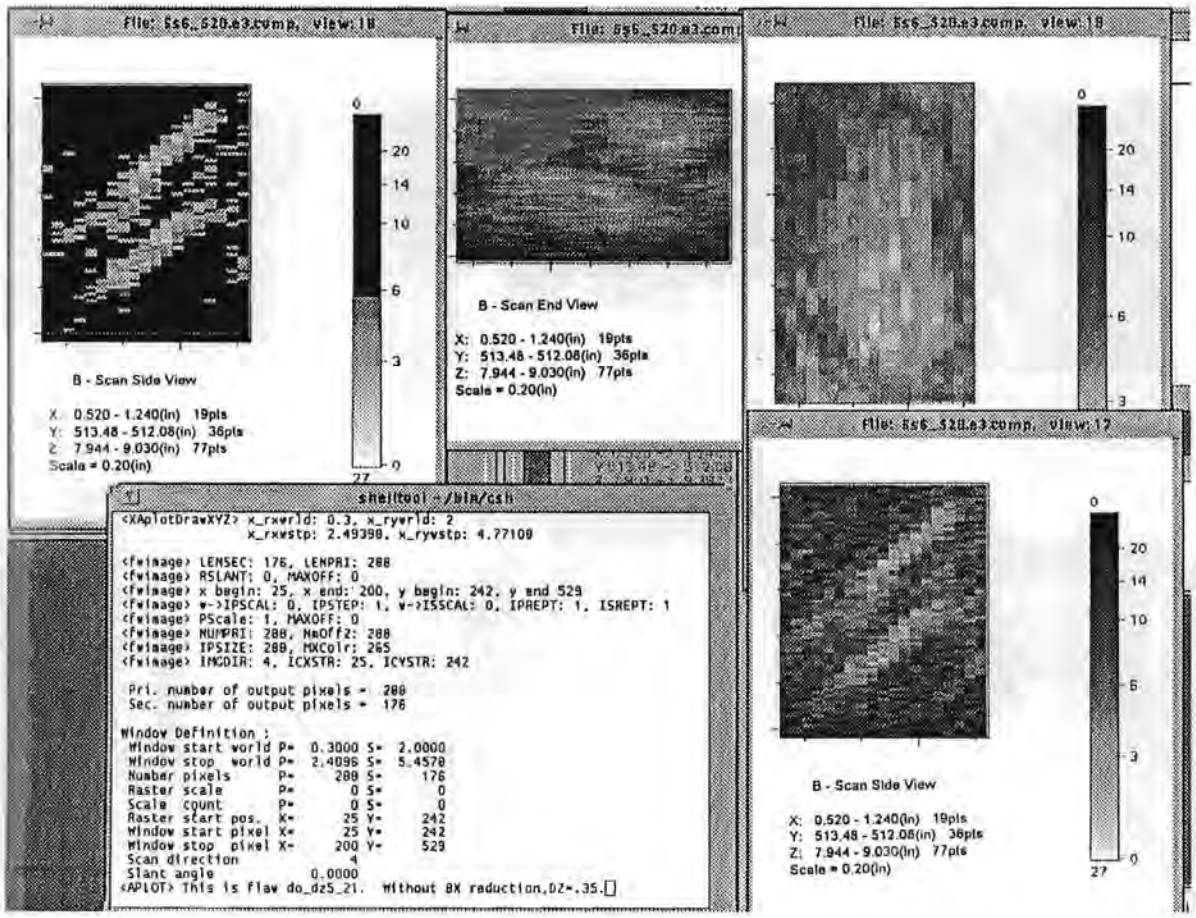
Figure A.61 - Planar indication #6 in the weldment below 25 mm: mode 6

Figure A.61 shows planar indication #6 in the weldment below 25 mm. This planar indication has a through-wall extent of 9 mm based on tip signal pattern. The detection was made in mode 6 where it displayed a pair of TOF shapes at a depth of 211 mm. The shape quality is good for this indication. There were no confirmations in other modes. The indication is characterized as planar based on the tip signal pattern. The length is 30 mm and was made to LOS in mode 6. The aspect ratio (length/depth) of this indication is 3. The maximum amplitude-to-noise ratio is of medium range at 27 to 11. The X coordinate of 23 mm shows that the indication is in the weld. The Z coordinate of 211 mm shows that the indication is near the outer wall of the vessel.
