NUREG/CR-6471, Vol. 1
PNNL-11143

Characterization of Flaws in U.S. Reactor Pressure Vessels

Density and Distribution of Flaw Indications in PVRUF

Pacific Northwest National Laboratory

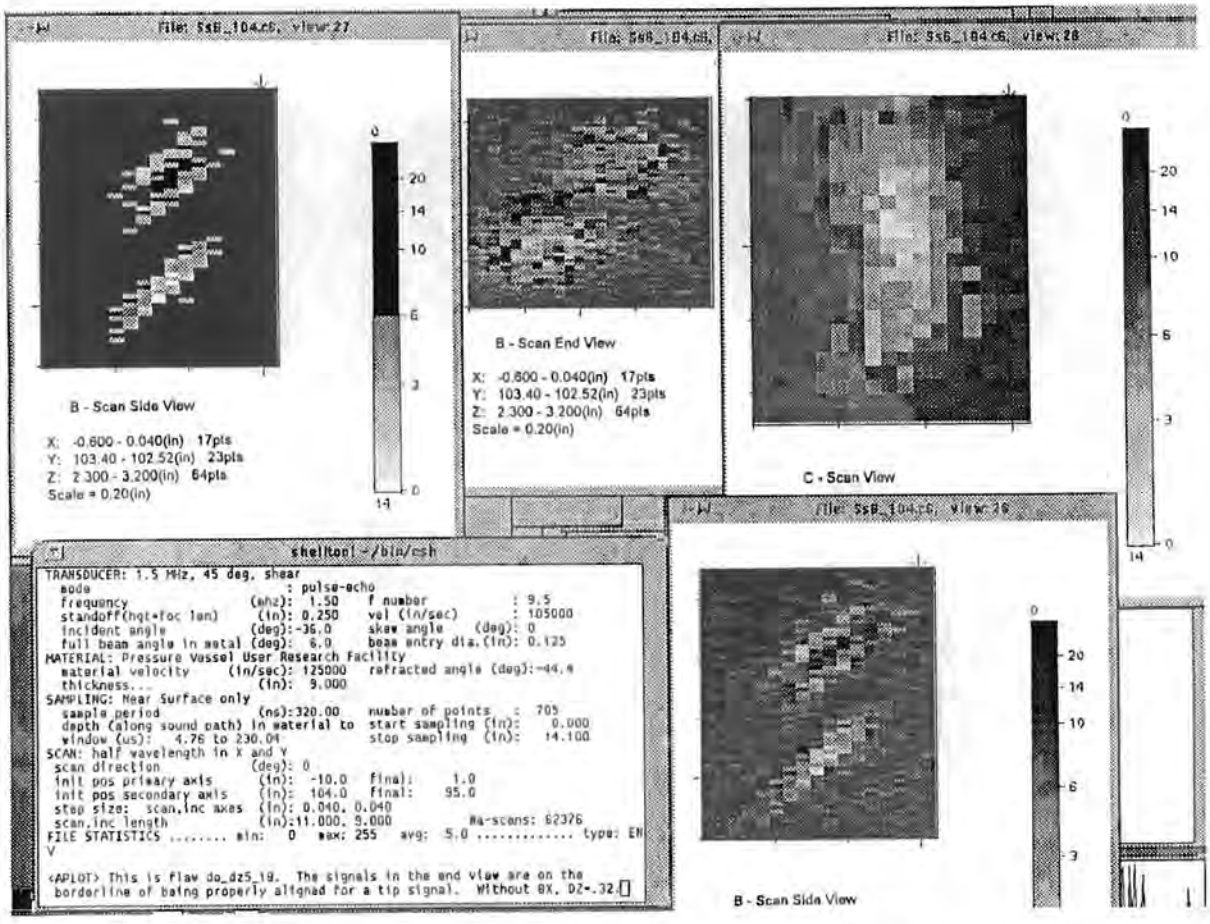
Figure A.62a - Planar indication #7 in the weldment below 25 mm: mode 6

Figures A.62a-b show planar indication #7 in the weldment below 25 mm. This planar indication has a through-wall extent of 9 mm based on tip signal pattern. The detection was made in modes 6 and 8 where it displayed a pair of TOF shapes at depths of 68 and 63 mm. The shape quality is good for this indication. There were no confirmations in other modes. The indication is characterized as planar based on the tip signal pattern. The length is 16 mm and was made to LOS in mode 8. The aspect ratio (length/depth) of this indication is 1.8. The maximum amplitude-to-noise ratio is high at 15 to 5. The X coordinate of -8 mm shows that the indication is in the weld. The Z coordinate of 63 to 68 mm shows that the indication is in the middle third of the vessel.

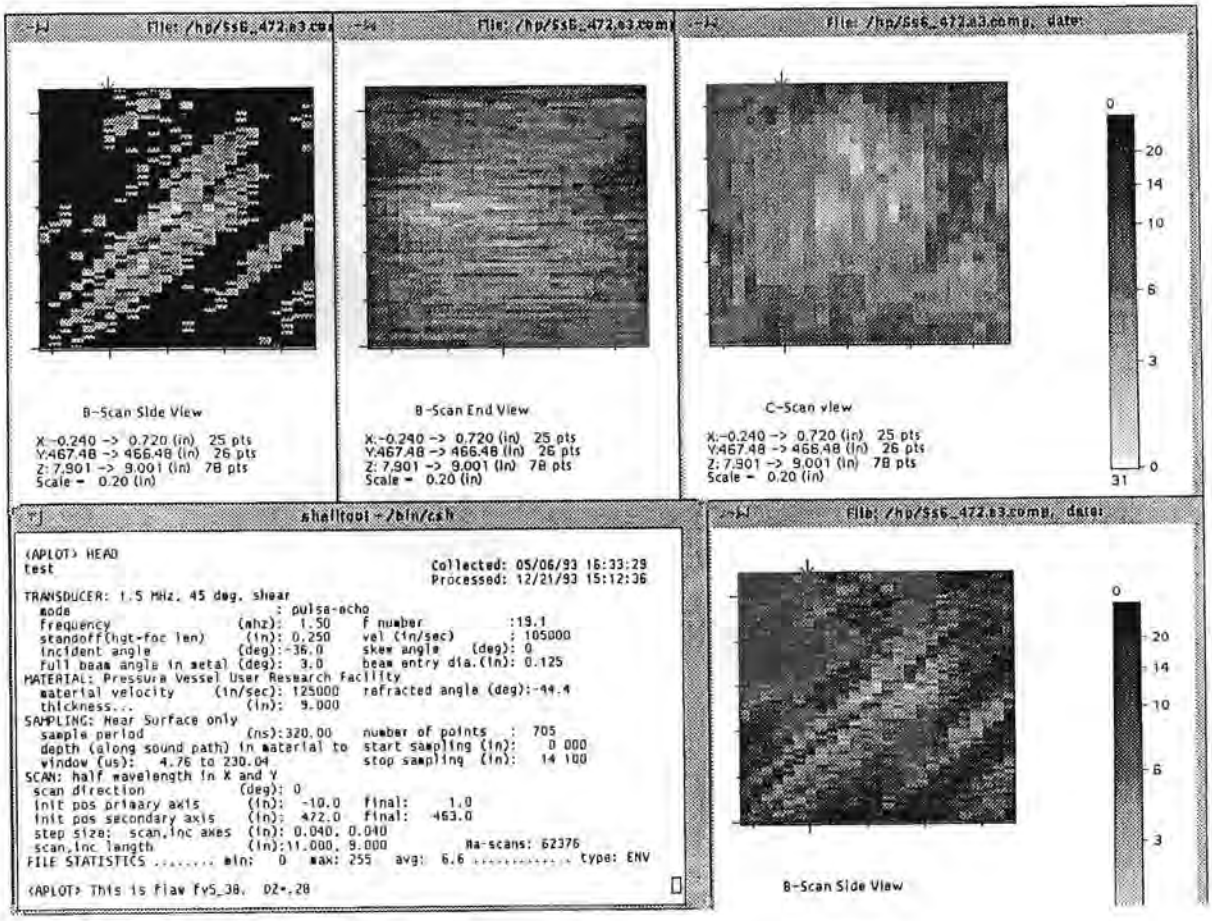
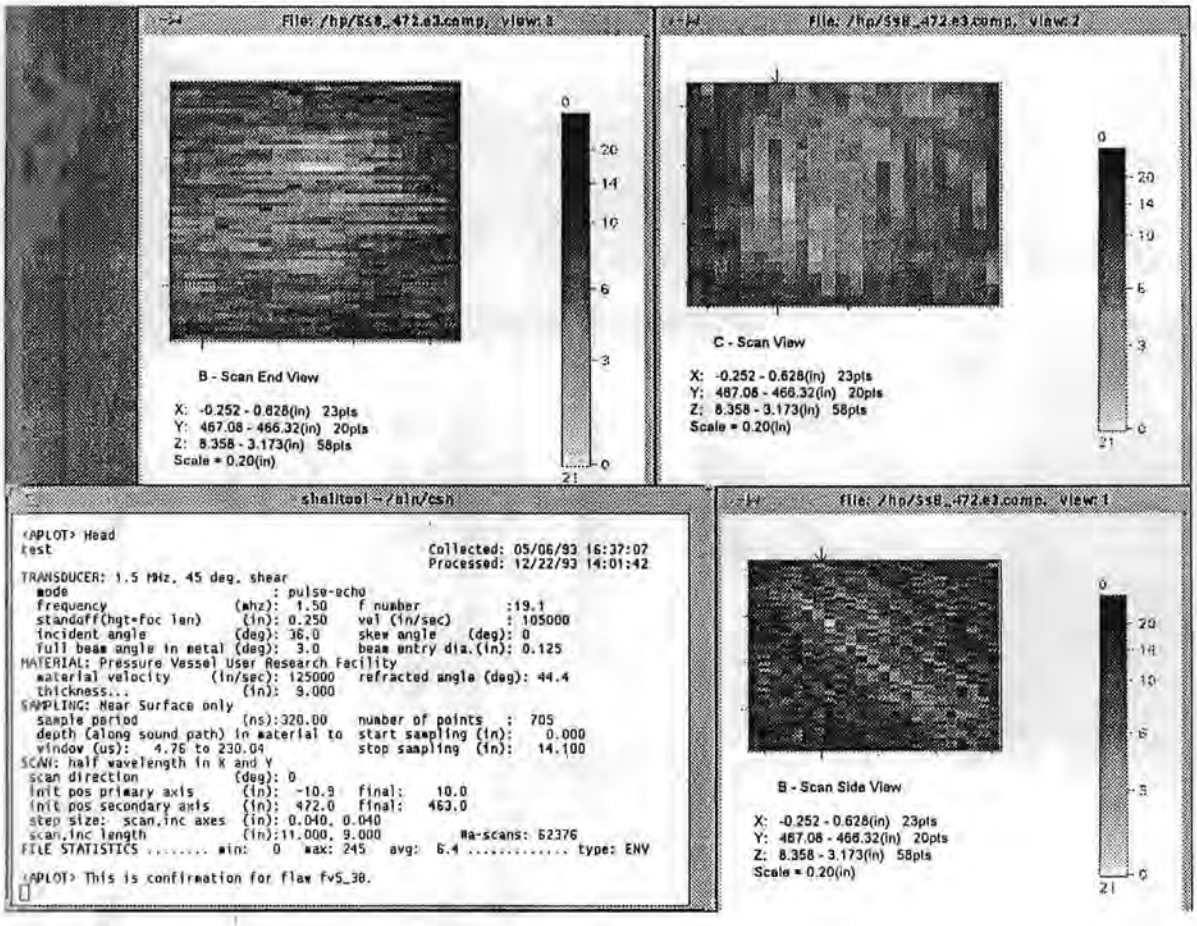
Figures A.63a-b show planar indication #8 in the weldment below 25 mm. This planar indication has a through-wall extent of 7 mm based on wave packet width. The detection was made in modes 6 and 8 where it had isolated TOF shapes at depths of 213 and 218 mm. The shape quality is good for this indication and is broken up indicating that more than one small flaw may be present. There were no confirmations in other modes. The two Z values of 213 to 218 mm give an alternate depth size of 5 mm. The indication is characterized as planar based on lack of detection in normal beam or orthogonal modes. The length is 24 mm and was made to LOS in mode 6. The aspect ratio (length/depth) of this indication is 3. The maximum amplitude-to-noise ratio is of medium range at 31 to 13. The X coordinate of 6 mm shows that the indication is in the weld. The Z coordinate of 213 to 218 mm shows that the indication is near the outer wall of the vessel.

Figure A.63a - Planar indication #8 in the weldment below 25 mm: mode 6

Figure A.63b - Planar indication #8 in the weldment below 25 mm: mode 8

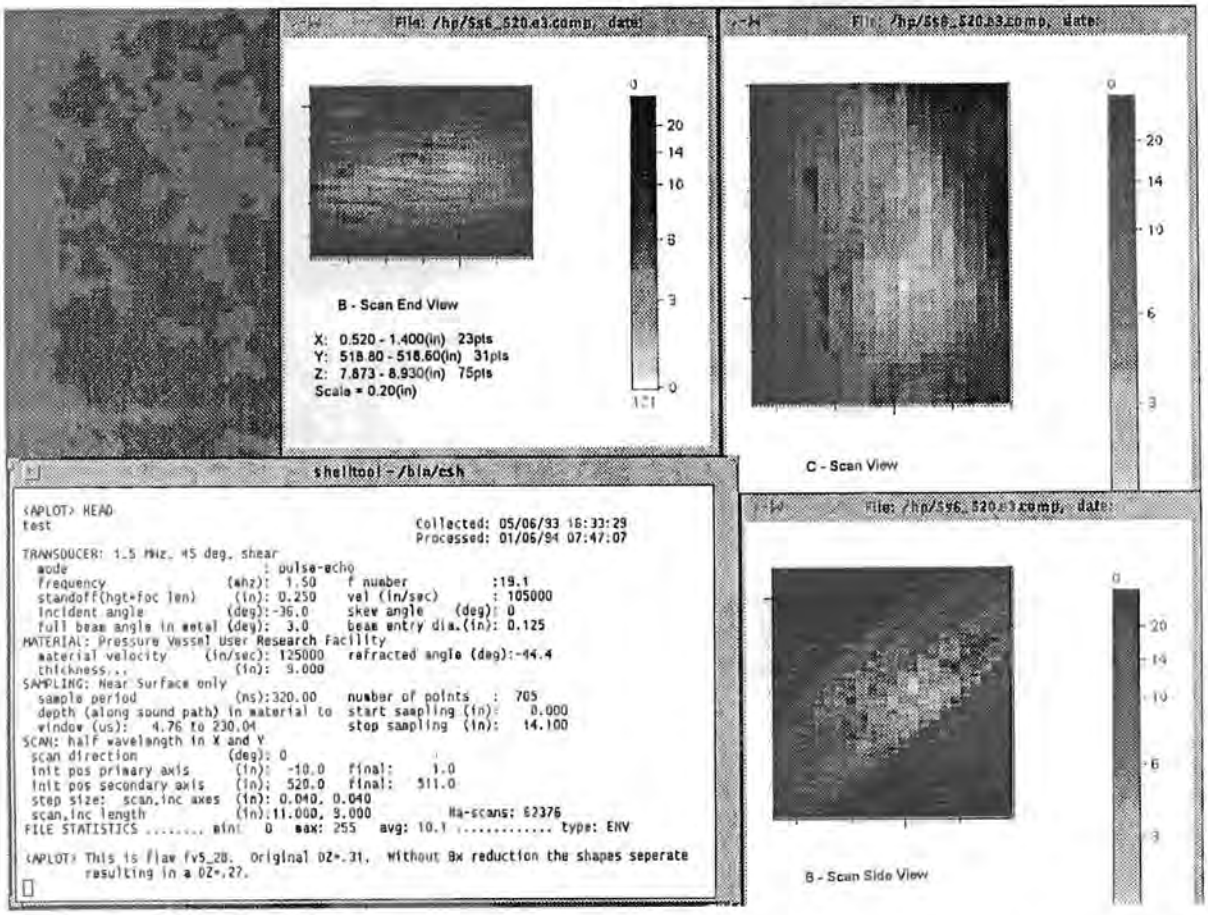
Figure A.64 shows planar indication #9 in the weldment below 25 mm. This planar indication has a through-wall extent of 7 mm based on wave packet width. The detection was made in mode 6 where it had isolated TOF shape at a depth of 213 mm. The shape quality for this indication is good but broken up, implying that more than one small flaw may be present. There were no confirmations in other modes. The indication is characterized as planar based on lack of detection in normal beam or orthogonal modes. The length is 30 mm and was made to LOS in mode 6. The aspect ratio (length/depth) of this indication is 4 which tends to confirm the large through-wall extent. The maximum amplitude-to-noise ratio is high at 121 to 15. The X coordinate of 24 mm shows that the indication is in the weld. The Z coordinate of 213 mm shows that the indication is near the outer wall of the vessel.

Figure A.64 - Planar indication #9 in the weldment below 25 mm: mode 6

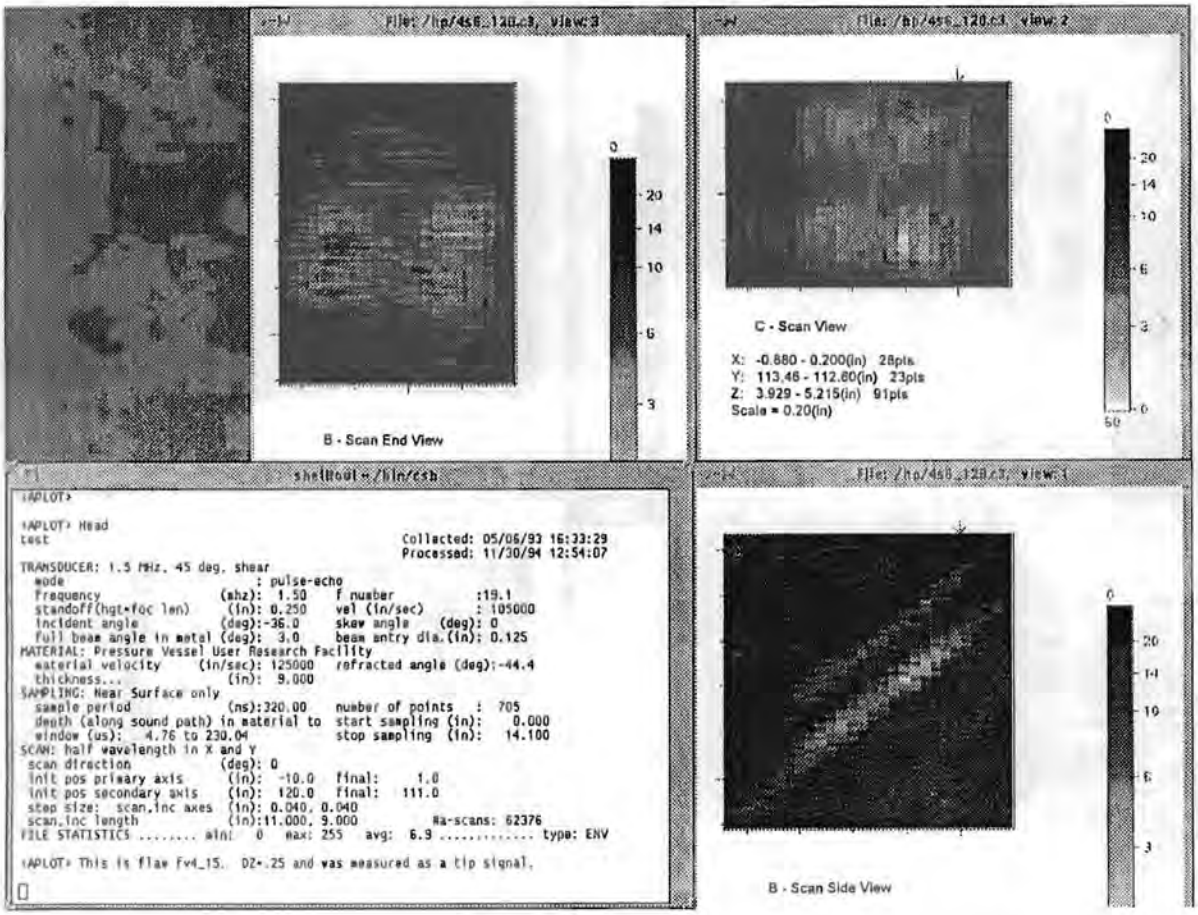
Figure A.65 - Planar indication #10 in the weldment below 25 mm: mode 6

Figure A.65 shows planar indication #10 in the weldment below 25 mm. This planar indication has a through-wall extent of 6 mm based on tip signal pattern. The detection was made in mode 6 where it displayed a pair of TOF shapes at a depth of 117 mm. The shape quality is good for this indication. There were no confirmations in other modes. The indication is characterized as planar based on lack of detection in normal beam or orthogonal modes. The length is 19 mm and was made to LOS in mode 6. The aspect ratio (length/depth) of this indication is 3. The maximum amplitude-to-noise ratio is high at 60 to 12. The X coordinate of -7 mm shows that the indication is in the weld. The Z coordinate of 117 mm shows that the indication is in the middle third of the vessel.

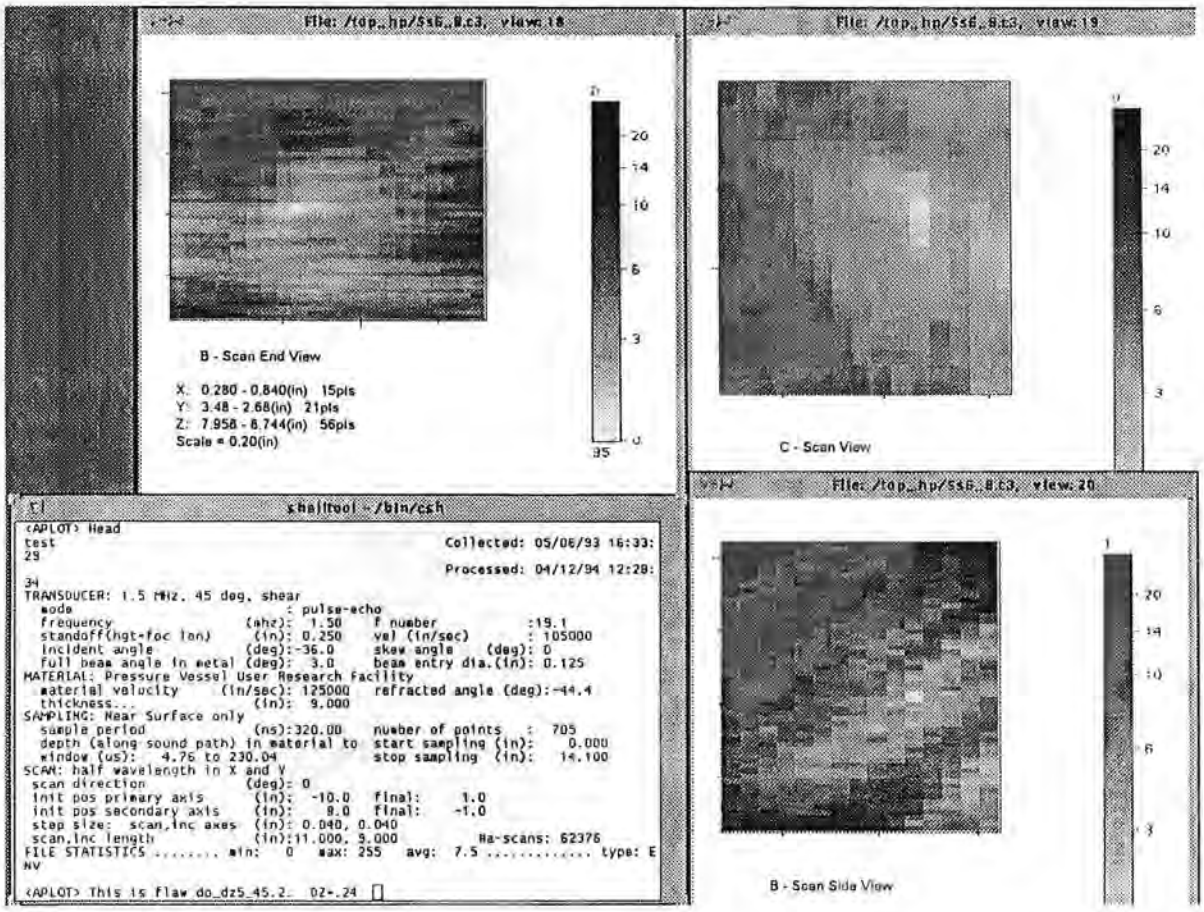
Figure A.66 - Planar indication #11 in the weldment below 25 mm: mode 6

Figure A.66 shows planar indication #11 in the weldment below 25 mm. This planar indication has a through-wall extent of 6 mm based on wave packet width. The detection was made in mode 6 where it had isolated TOF shape at a depth of 213 mm. The shape quality is good for this indication. There were no confirmations in other modes. The indication is characterized as planar based on lack of detection in normal beam or orthogonal modes. The length is 17 mm and was made to LOS in mode 6. The aspect ratio (length/depth) of this indication is 3. The maximum amplitude-to-noise ratio is low at 90 to 45. The X coordinate of 16 mm shows that the indication is in the weld. The Z coordinate of 213 mm shows that the indication is near the outer wall of the vessel.

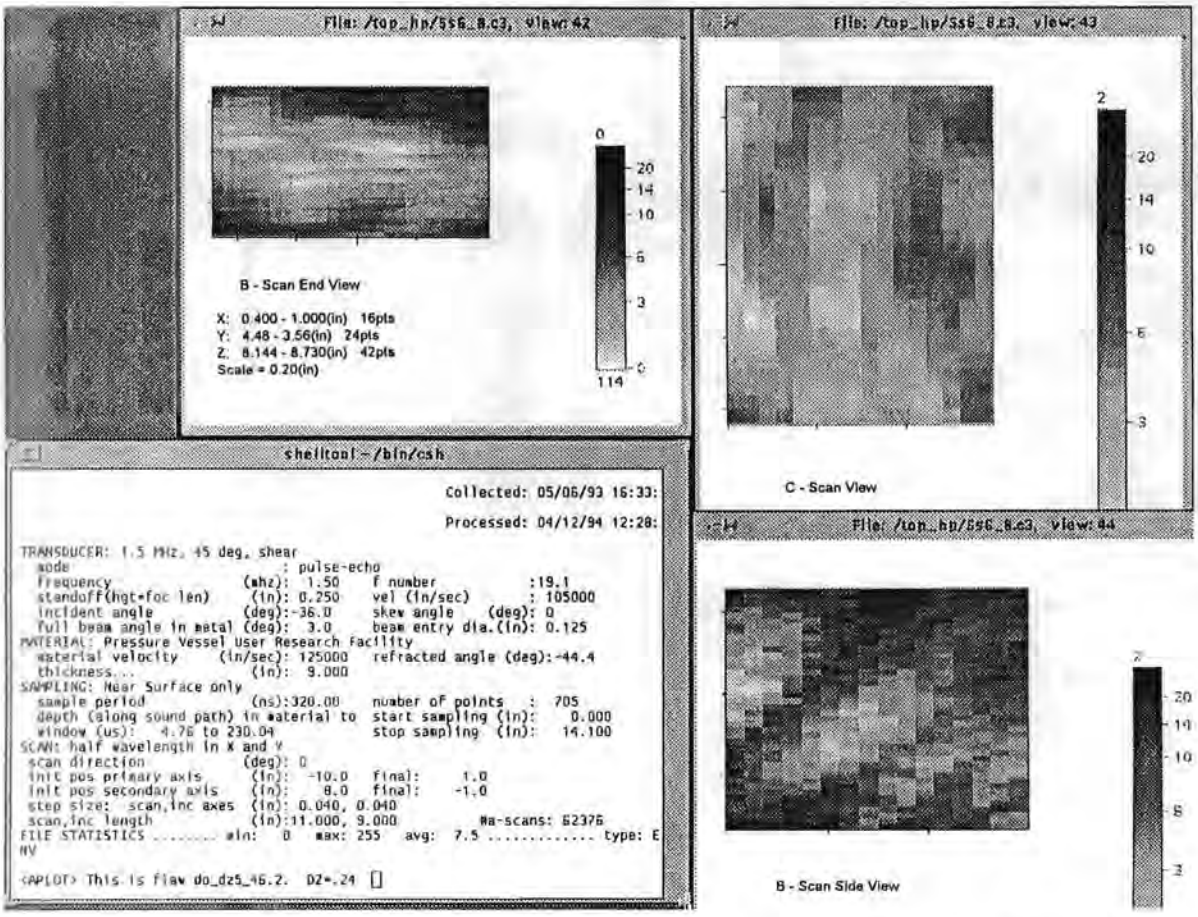
Figure A.67 - Planar indication #12 in the weldment below 25 mm: mode 6

Figures A.67a-b show planar indication #12 in the weldment below 25 mm. This planar indication has a through-wall extent of 6 mm based on wave packet width. The detection was made in mode 6 where it had isolated TOF shape at a depth of 215 mm. The shape quality is good for this indication. There was a confirmation in mode 8 at a depth of 213 mm. The two Z values of 213 to 215 mm give an alternate depth size of 2 mm. The indication is characterized as planar based on lack of normal beam detection or detection in orthogonal modes. The length is 25 mm and was made to LOS in mode 6. The aspect ratio (length/depth) of this indication is 4 which tends to confirm the large through-wall extent. The maximum amplitude-to-noise ratio is of medium range at 109 to 40. The X coordinate of 16 mm shows that the indication is in the weld. The Z coordinate of 213 to 215 mm shows that the indication is near the outer wall of the vessel.

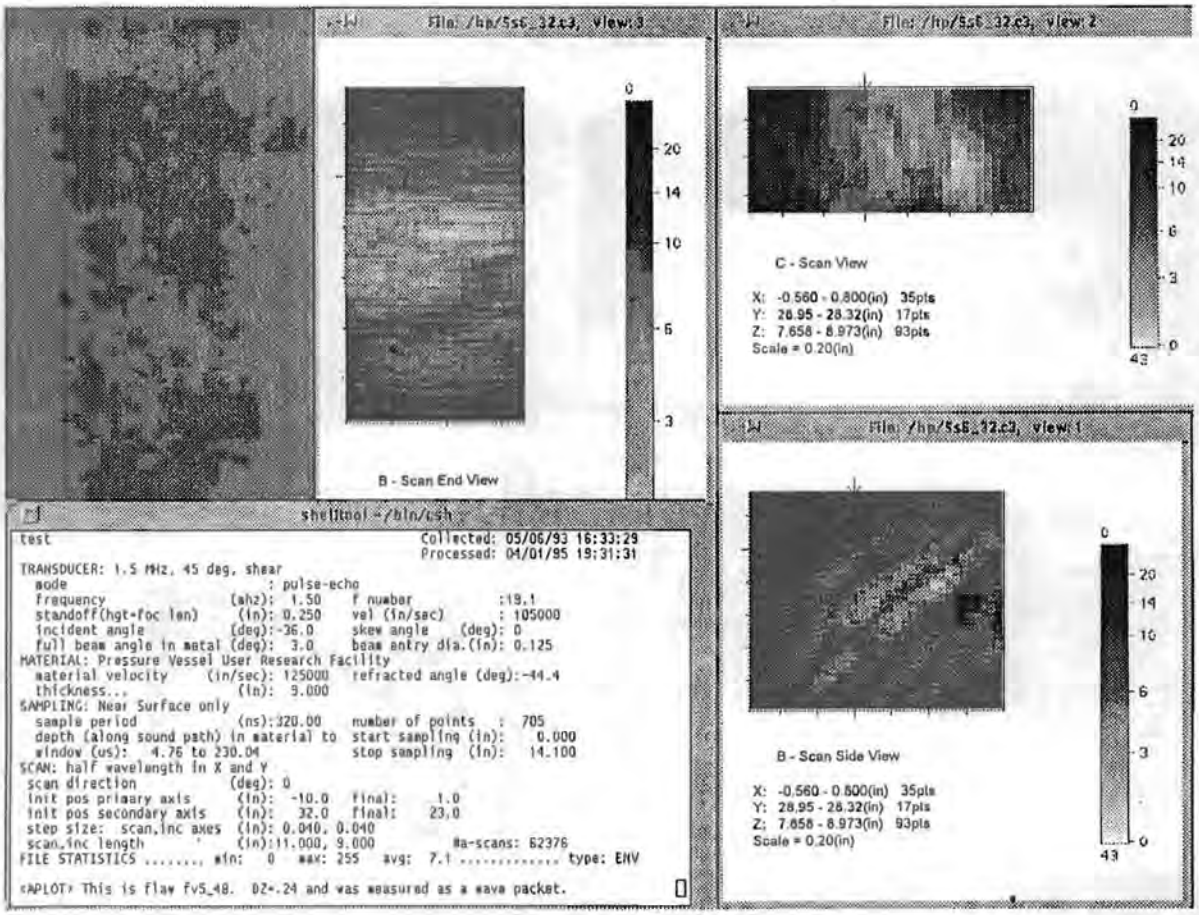
Figure A.68 - Planar indication #13 in the weldment below 25 mm: mode 6

Figure A.68 shows planar indication #13 in the weldment below 25 mm. This planar indication has a through-wall extent of 6 mm based on wave packet width. The detection was made in mode 6 where it had isolated TOF shape at a depth of 209 mm. The shape quality is good for this indication. There were no confirmations in other modes. The indication is characterized as planar based on lack of detection in normal beam or orthogonal modes. The length is 15 mm and was made to LOS in mode 6. The aspect ratio (length/depth) of this indication is 2.5. The maximum amplitude-to-noise ratio is high at 43 to 10. The X coordinate of 10 mm shows that the indication is in the weld. The Z coordinate of 209 mm shows that the indication is near the outer wall of the vessel.

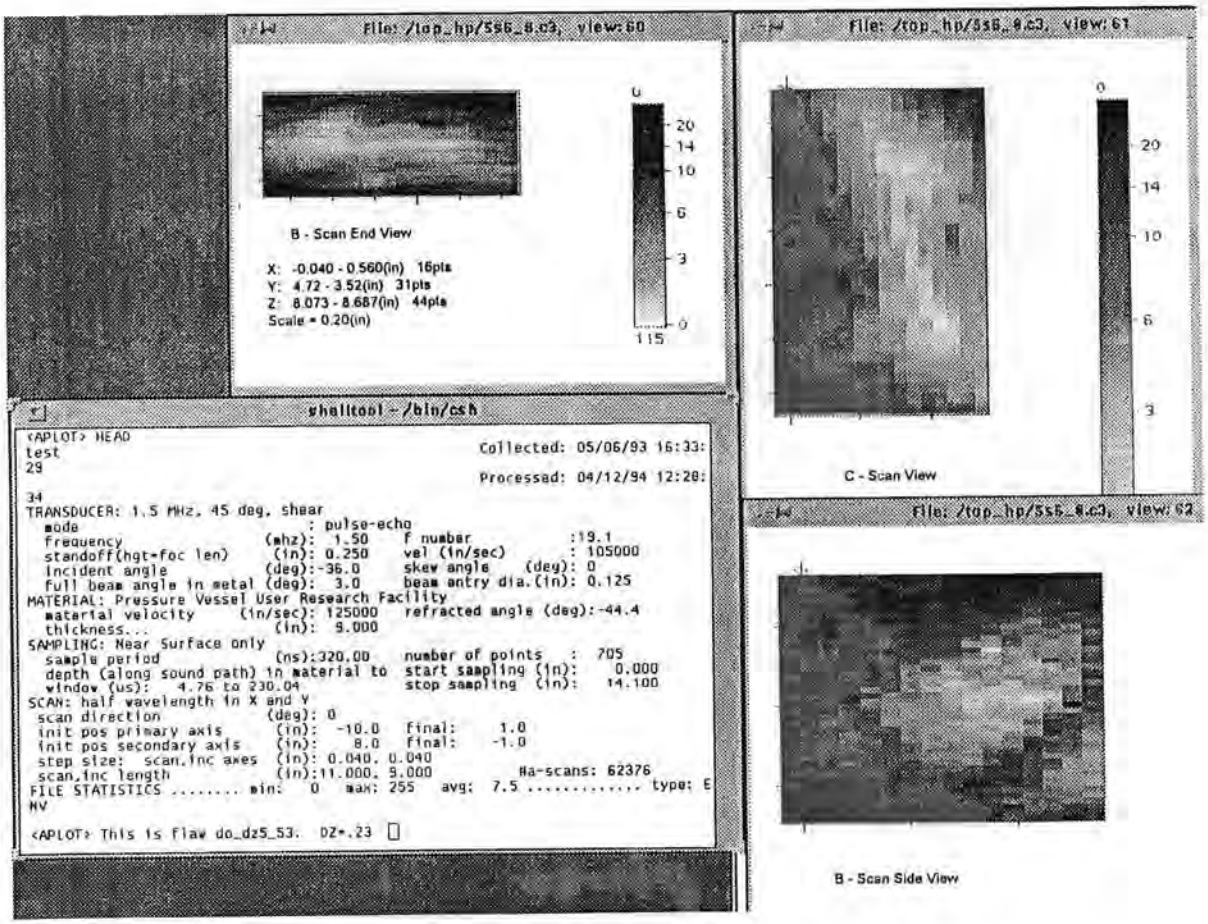
Figure A.69 - Planar indication #14 in the weldment below 25 mm: mode 6

Figure A.69 shows planar indication #14 in the weldment below 25 mm. This planar indication has a through-wall extent of 6 mm based on wave packet width. The detection was made in mode 6 where it had isolated TOF shape at a depth of 212 mm. The shape quality is good for this indication. There were no confirmations in modes. The indication is characterized as planar based on lack of detection in normal beam or orthogonal modes. The length is 27 mm and was made to LOS in mode 6. The aspect ratio (length/depth) of this indication is 4.5 which tends to confirm the large through-wall extent. The maximum amplitude-to-noise ratio is of medium range at 115 to 40. The X coordinate of 9 mm shows that the indication is in the weld. The Z coordinate of 212 mm shows that the indication is near the outer wall of the vessel.

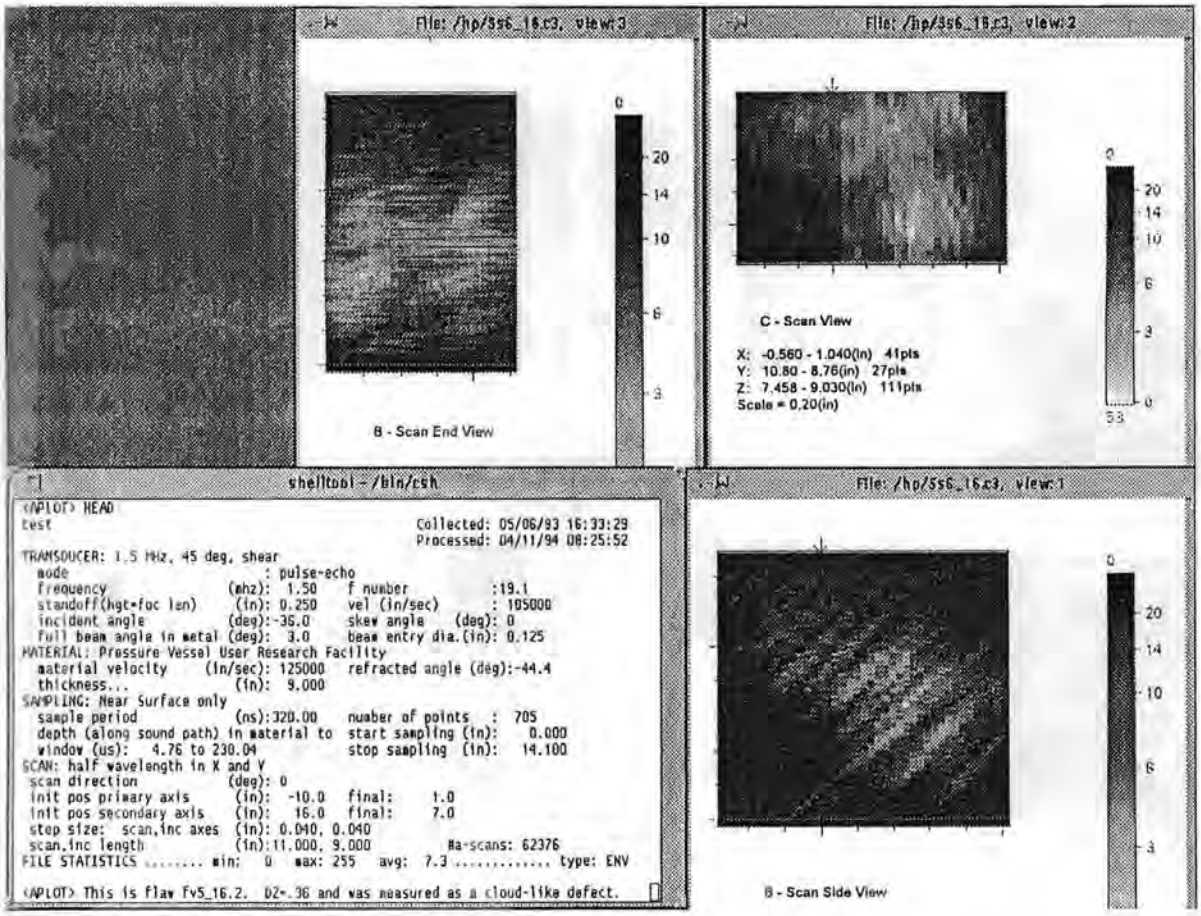
Figure A.70 - Planar indication #15 in the weldment below 25 mm: mode 6

Figure A.70 shows planar indication #15 in the weldment below 25 mm. This planar indication has a through-wall extent of 4 mm based on LOS in a cloud like pattern. The detection was made in mode 6 where the shape appeared cloud like in nature at a depth of 212 mm. The shape quality for this indication is fair but broken up, indicating that more than one small flaw may be present. There were no confirmations in other modes. The indication is characterized as planar based on lack of detection in normal beam or orthogonal modes. The length is 42 mm and was made to LOS in mode 6. The aspect ratio (length/depth) of this indication is 10. The maximum amplitude-to-noise ratio is high at 53 to 13. The X coordinate of 10 mm shows that the indication is in the weld. The Z coordinate of 212 mm shows that the indication is near the outer wall of the vessel.

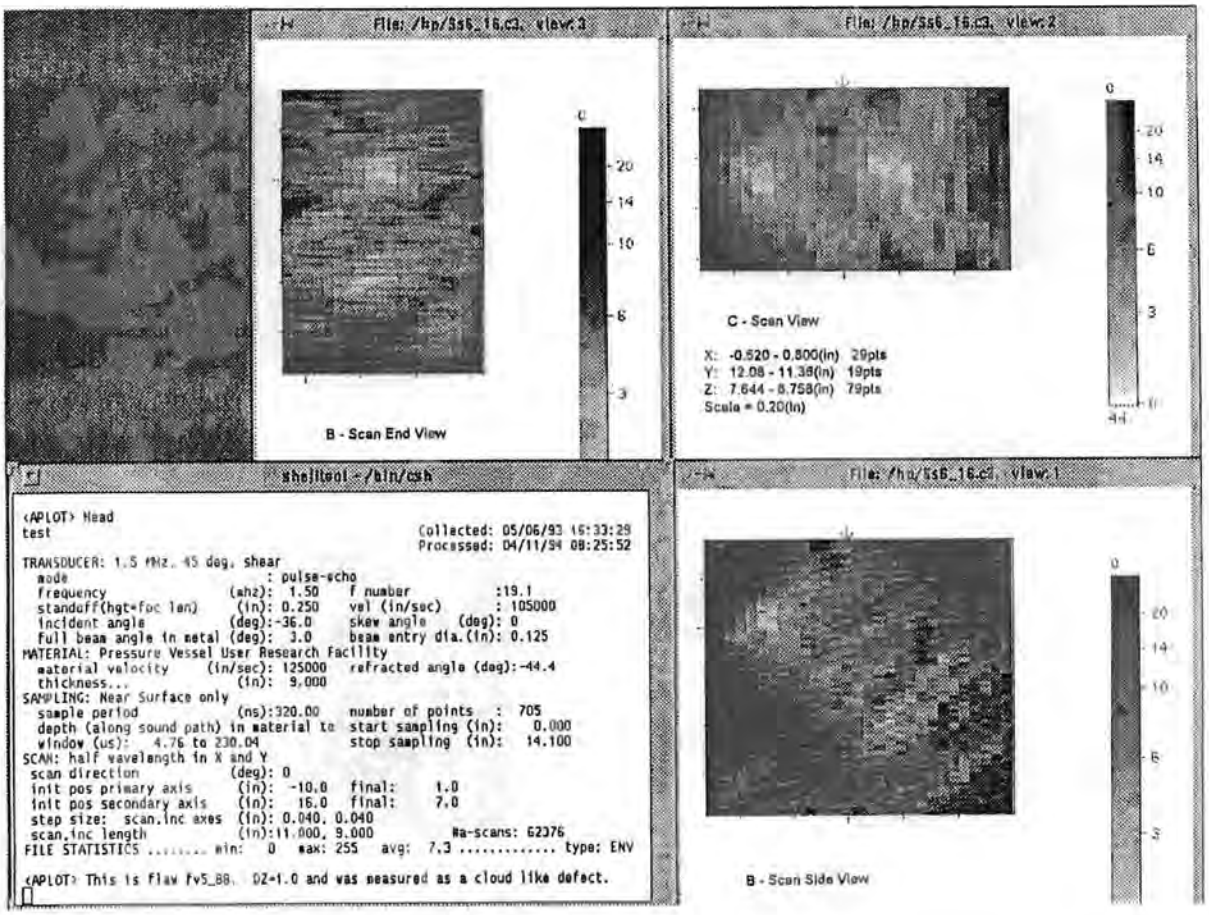
Figure A.71 - Planar indication #16 in the weldment below 25 mm: mode 6

Figure A.71 shows planar indication #16 in the weldment below 25 mm. This planar indication has a through-wall extent of 4 mm based on LOS in a cloud like pattern. The detection was made in mode 6 where the shape appeared cloud like in nature at a depth of 203 mm. The shape quality is poor and broken up indicating that more than one small flaw is present. There were no confirmations in other modes. The indication is characterized as planar based on lack of detection in normal beam or orthogonal modes. The length is 25 mm and was made to LOS in mode 6. The aspect ratio (length/depth) is 6 which tends to confirm the large through-wall extent. The maximum amplitude-to-noise ratio is high at 44 to 10. The X coordinate of -8 mm shows that the indication is clearly in the weld. The Z coordinate of 203 mm shows that the indication is near the vessel outer wall.

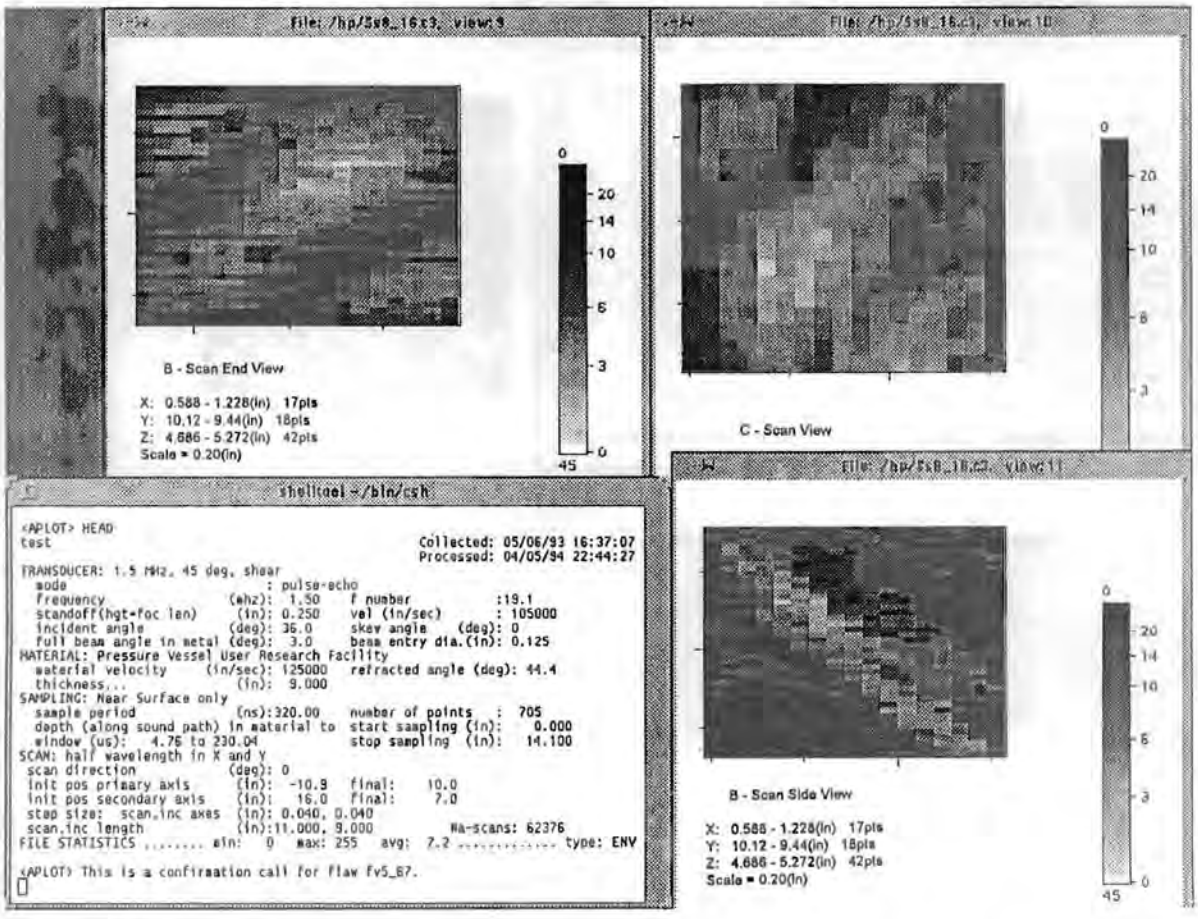
Figure A.72a - Volumetric indication #1 in the weldment below 25 mm: mode 8

Figures A.72a-b show volumetric indication #1 in the weldment below 25 mm. This volumetric indication has a through-wall extent of 5 mm based on ring around pattern. The detection was made in mode 9 where it displayed a pair of TOF shapes at a depth of 116 mm. The shape quality is good for this indication. There was a confirmation in mode 8 at a depth of 121 mm. The confirmation mode gave a through-wall extent of 5 mm based on wave packet width. The two Z values of 116 to 121 mm give an alternate depth size of 5 mm. The indication is characterized as volumetric based on the detection of ring around shape. The length is 23 mm and was made to LOS in mode 8. The width is 17 mm and was made to LOS in mode 9. The aspect ratio (length/depth) of this indication is 5 and the width-to-depth ratio is 3 which tends to confirm volumetric orientation. The maximum amplitude-to-noise ratio is high at 51 to 10. The X coordinate of 12 mm shows that the indication is in the weld. The Z coordinate of 116 to 121 mm shows that the indication is in the middle third of the vessel.

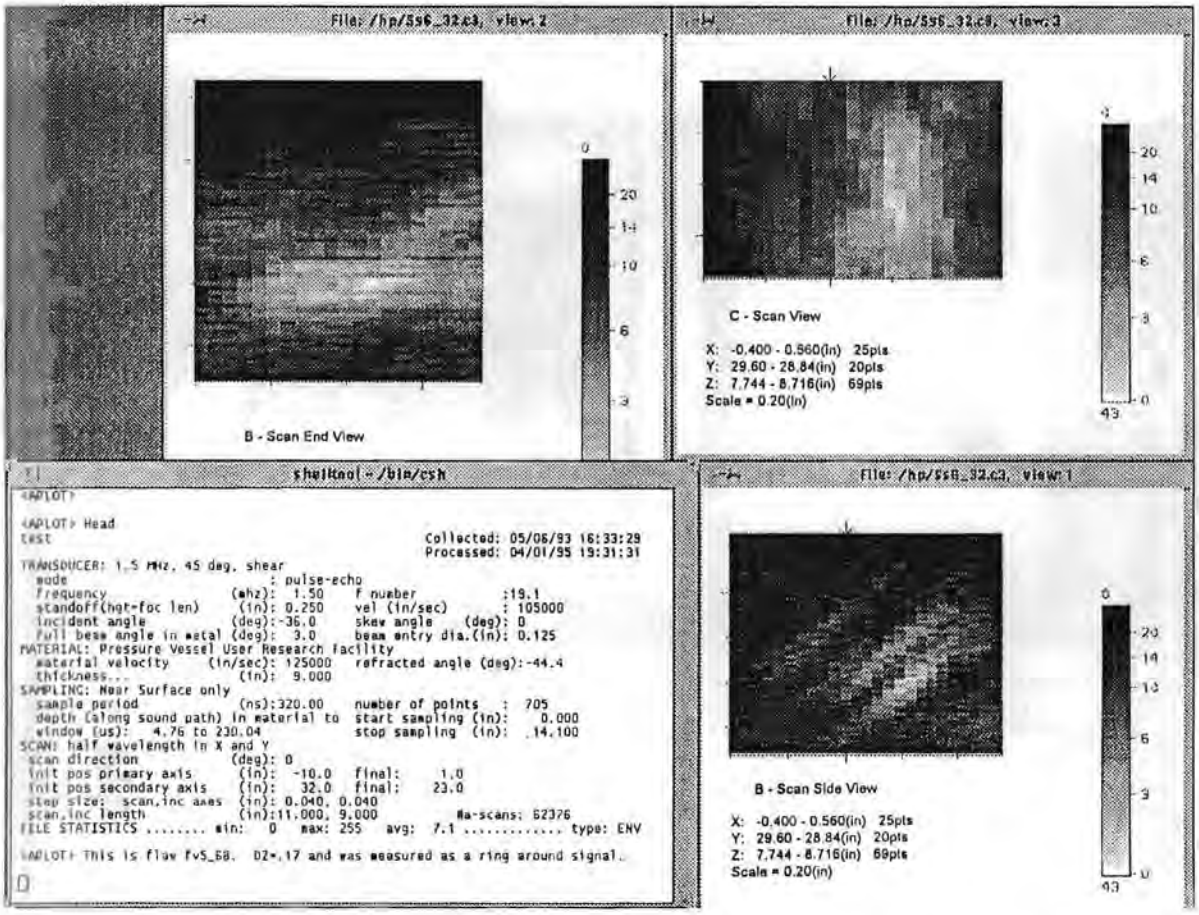
Figure A.73 - Volumetric indication #2 in the weldment below 25 mm: mode 6

Figure A.73 shows volumetric indication #2 in the weldment below 25 mm. This volumetric indication has a through-wall extent of 4 mm based on ring around pattern. The detection was made in mode 6 where it displayed a pair of TOF shapes at a depth of 213 mm. The shape quality is good for this indication. There were no confirmations in other modes. The indication is characterized as volumetric based on the detection of ring around shape. The length is 9 mm and was made to LOS in mode 6. The aspect ratio (length/depth) of this indication is 2. The maximum amplitude-to-noise ratio is of medium range at 43 to 13. The X coordinate of 6 mm shows that the indication is in the weld. The Z coordinate of 213 mm shows that the indication is near the outer wall of the vessel.

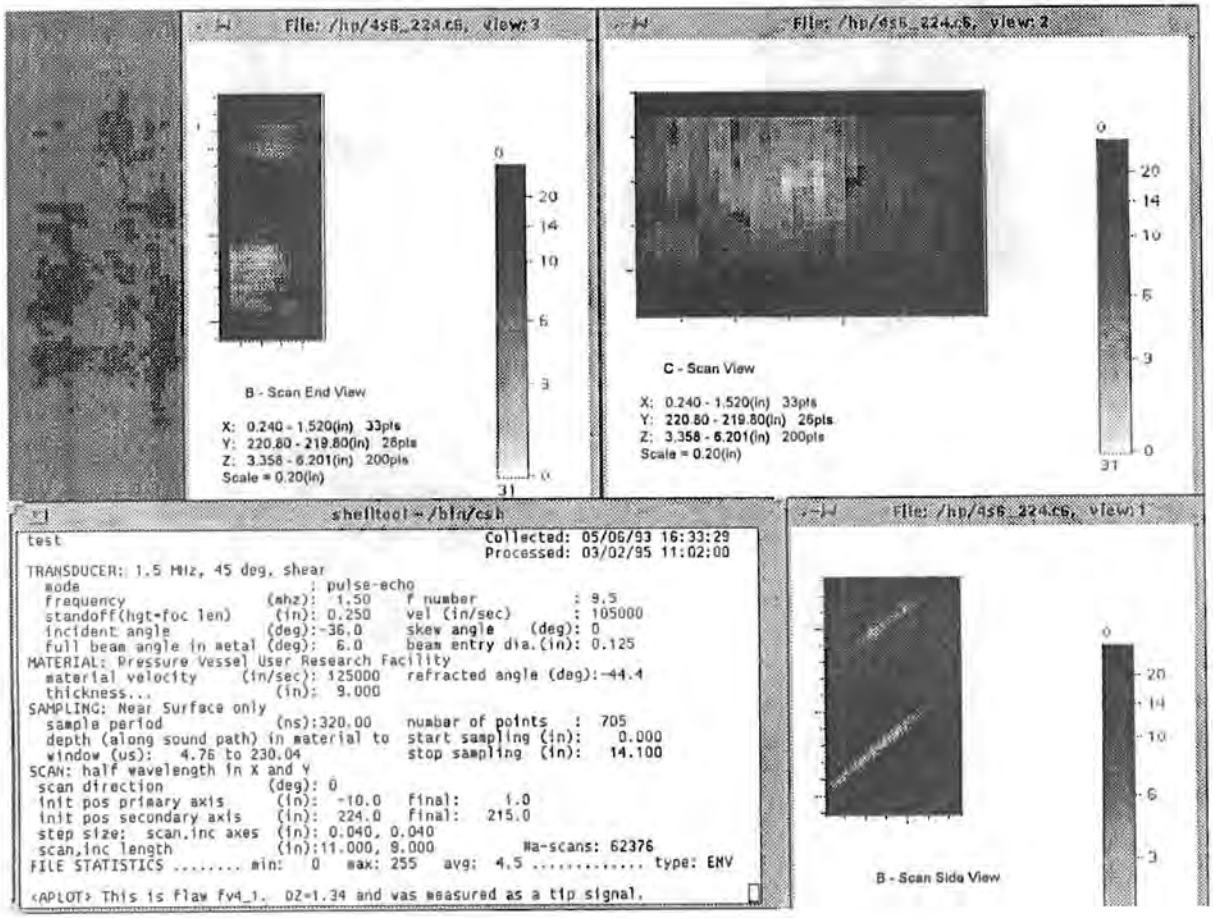
Figure A.74 - Planar indication #1 in the HAZ below 25 mm: mode 6

Figure A.74 shows planar indication #1 in the heat affected zone below 25 mm. This planar indication has a through-wall extent of 34 mm based on tip signal pattern. The detection was made in mode 6 where it displayed a pair of TOF shapes at a depth of 135 mm. The shape quality is good for this indication. There were no confirmations in other modes. The indication is characterized as planar based on the tip signal pattern. Using LOS in mode 6, the length was measured as greater than 15 mm but was limited by the edge of the available aperture (data). The aspect ratio (length/depth) of this indication is greater than 0.4; the loss of data probably limits the length measurement. The maximum amplitude-to-noise ratio is high at 31 to 4. The X coordinate of 20 mm shows that the indication is probably in the HAZ. The Z coordinate of 135 mm shows that the indication is in the middle third of the vessel.

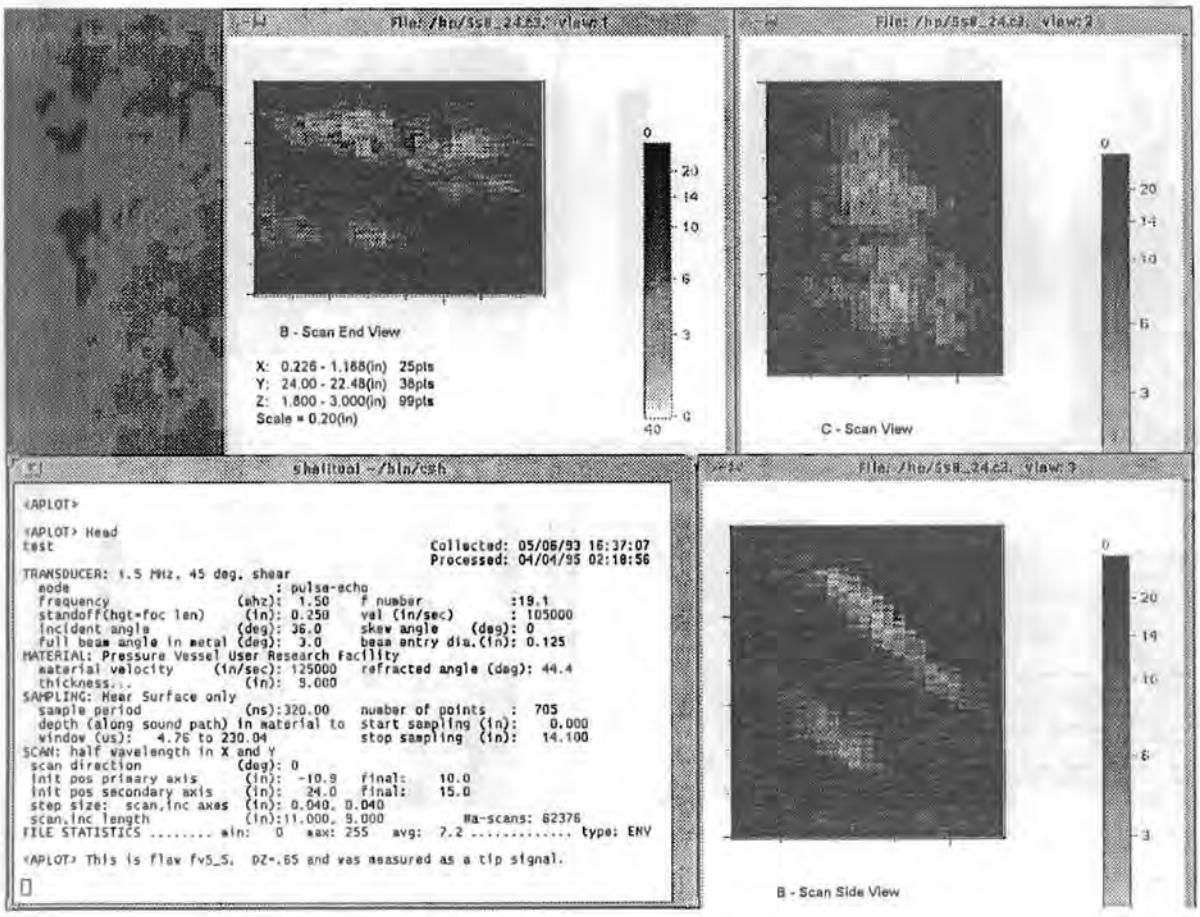
Figure A.75 - Planar indication #2 in the HAZ below 25 mm: mode 8

Figure A.75 shows planar indication #2 in the heat affected zone below 25 mm. This planar indication has a through-wall extent of 18 mm based on tip signal pattern. The detection was made in mode 8 where it displayed a pair of TOF shapes at a depth of 48 mm. The shape quality for this indication is good but broken up, implying that more than one small flaw may be present. There were no confirmations in other modes. The indication is characterized as planar based on the tip signal pattern. The length is 75 mm and was made to LOS in mode 6. The aspect ratio (length/depth) of this indication is 4 which tends to confirm the large through-wall extent. The maximum amplitude-to-noise ratio is high at 38 to 3. The X coordinate of 17 mm shows that the indication is probably in the HAZ. The Z coordinate of 48 mm shows that the indication is in the inner third of the vessel.

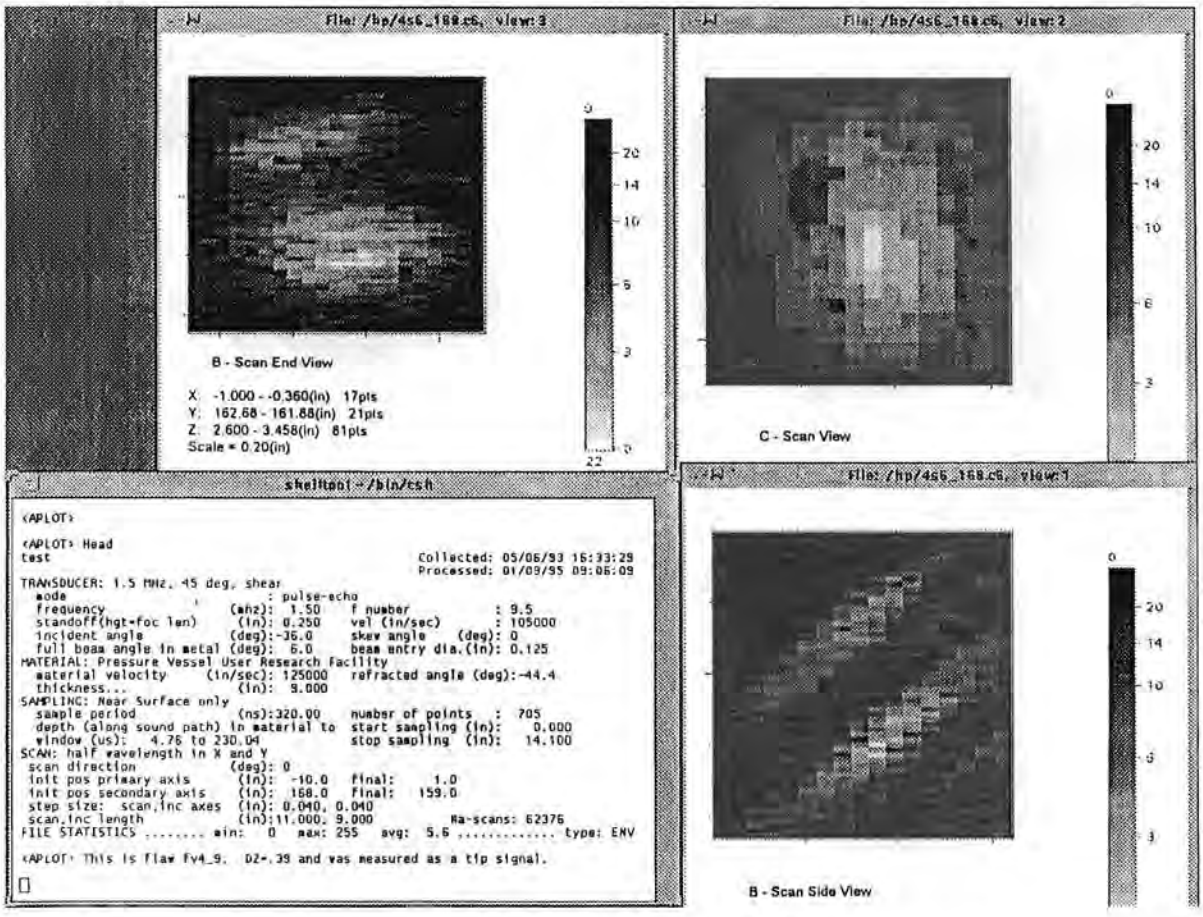
Figure A.76 - Planar indication #3 in the HAZ below 25 mm: mode 6

Figure A.76 shows planar indication #3 in the heat affected zone below 25 mm. This planar indication has a through-wall extent of 10 mm based on tip signal pattern. The detection was made in mode 6 where it displayed a pair of TOF shapes at a depth of 73 mm. The shape quality is good for this indication. There were no confirmations in other modes. The indication is characterized as planar based on the tip signal pattern. The length is 18 mm and was made to LOS in mode 6. The aspect ratio (length/depth) of this indication is 1.8. The maximum amplitude-to-noise ratio is high at 22 to 4. The X coordinate of -17 mm shows that the indication is probably in the HAZ. The Z coordinate of 73 mm shows that the indication is in the middle third of the vessel.

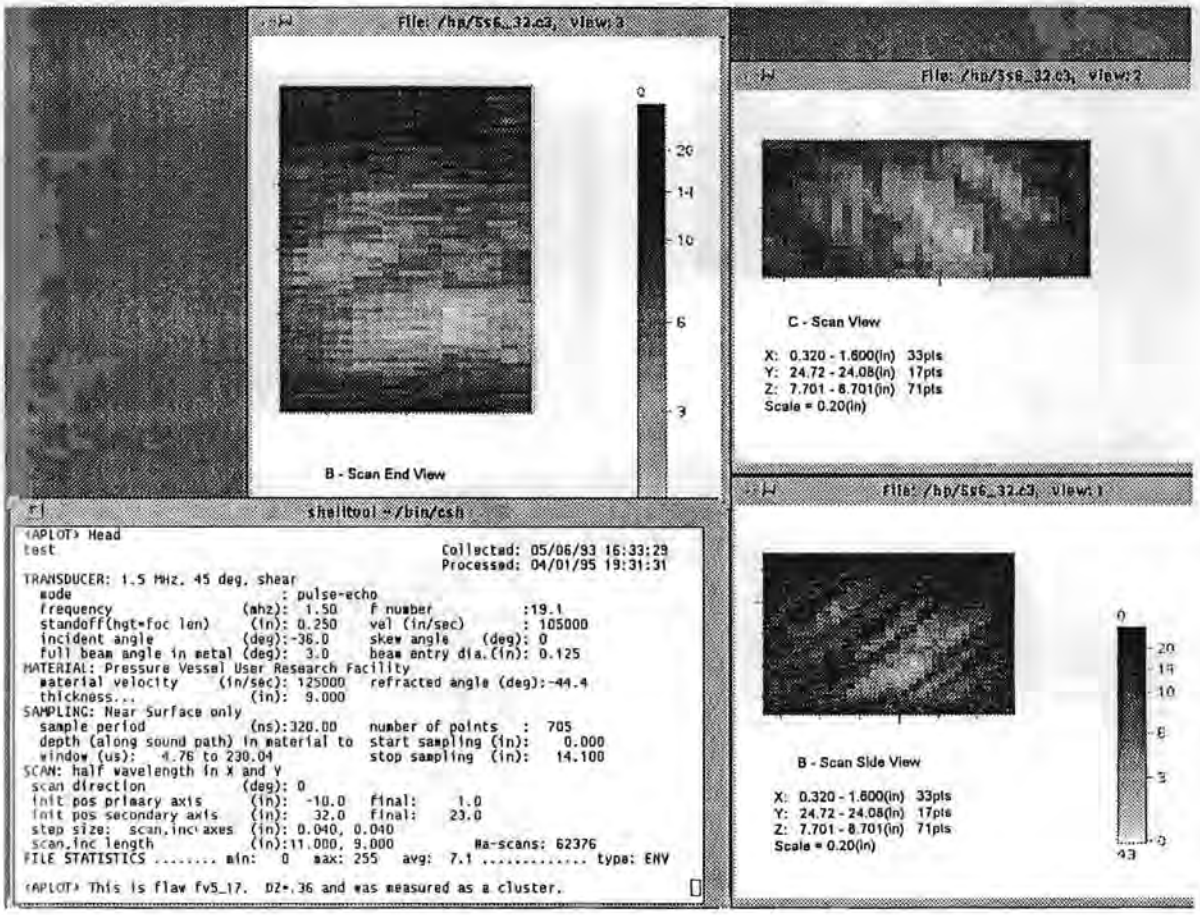
Figure A.77 - Planar indication #4 in the HAZ below 25 mm: mode 6

Figure A.77 shows planar indication #4 in the heat affected zone below 25 mm. This planar indication has a through-wall extent of 9 mm based on LOS in a cloud like pattern. The detection was made in mode 6 where the shape appeared cloud like in nature at a depth of 213 mm. The shape quality is good for this indication. There were no confirmations in other modes. The indication is characterized as planar based on lack of detection in normal beam or orthogonal modes. The length is 21 mm and was made to LOS in mode 6. The aspect ratio (length/depth) of this indication is 2. The maximum amplitude-to-noise ratio is of medium range at 43 to 15. The X coordinate of 26 mm shows that the indication is probably in the HAZ. The Z coordinate of 213 mm shows that the indication is near the outer wall of the vessel.
