NUREG/CR-6471, Vol. 1
PNNL-11143

Characterization of Flaws in U.S. Reactor Pressure Vessels

Density and Distribution of Flaw Indications in PVRUF

Pacific Northwest National Laboratory

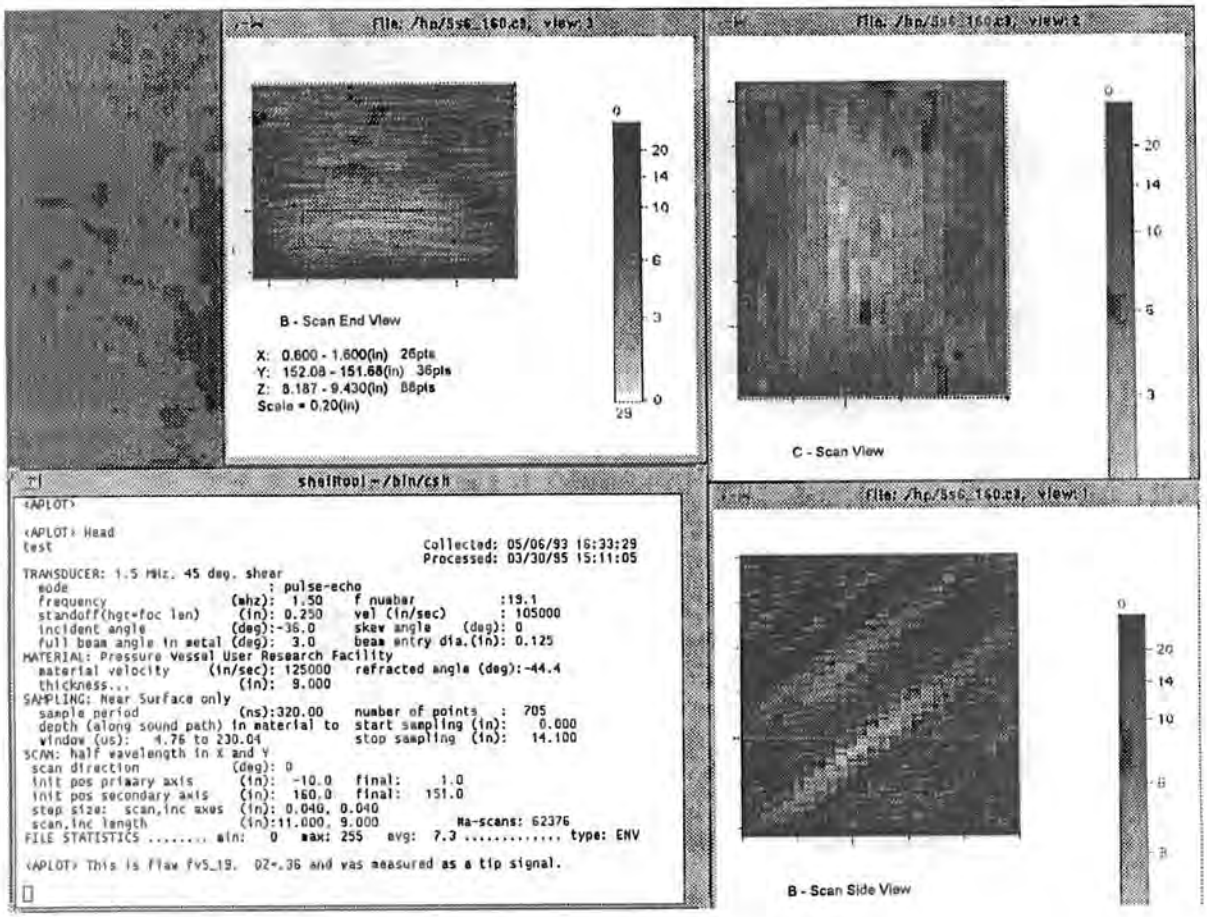
Figure A.78 - Planar indication #5 in the HAZ below 25 mm: mode 6

Figure A.78 shows planar indication #5 in the heat affected zone below 25 mm. This planar indication has a through-wall extent of 9 mm based on tip signal pattern. The detection was made in mode 6 where it displayed a pair of TOF shapes at a depth of 224 mm. The shape quality is good for this indication. There were no confirmations in other modes. The indication is characterized as planar based on the tip signal pattern. The length is 27 mm and was made to LOS in mode 6. The aspect ratio (length/depth) of this indication is 3. The maximum amplitude-to-noise ratio is of medium range at 29 to 8. The X coordinate of 24 mm shows that the indication is probably in the HAZ. The Z coordinate of 224 mm shows that the indication is near the outer wall.

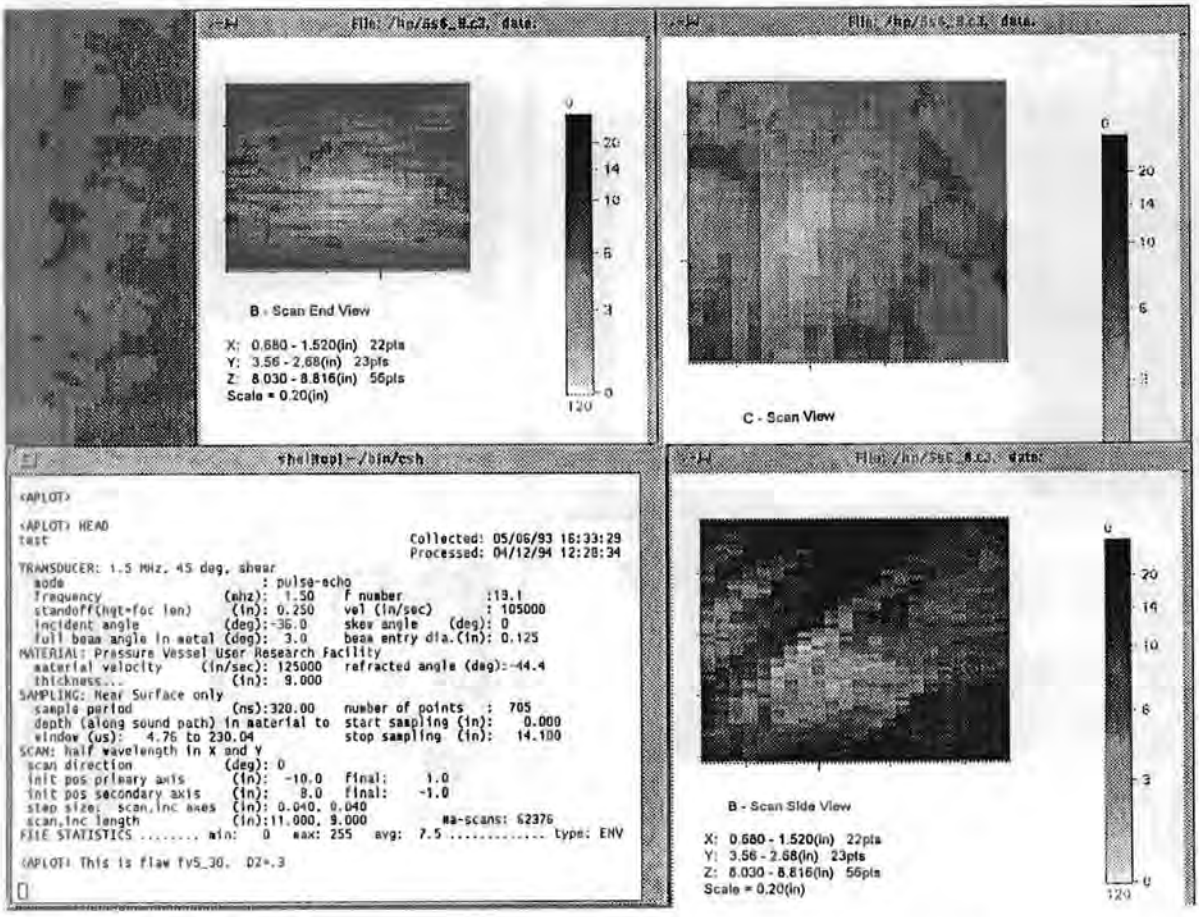
Figure A.79 - Planar indication #6 in the HAZ below 25 mm: mode 6

Figure A.79 shows planar indication #6 in the heat affected zone below 25 mm. This planar indication has a through-wall extent of 8 mm based on wave packet width. The detection was made in mode 6 at a depth of 216 mm. The shape has the appearance of a cluster or cloud. There were no confirmations in other modes. The indication is characterized as planar based on lack of detection in normal beam or orthogonal modes. The length is 22 mm and was made to LOS in mode 6. The aspect ratio (length/depth) of this indication is 3. The maximum amplitude-to-noise ratio is high at 120 to 25. The X coordinate of 26 mm shows that the indication is probably in the HAZ. The Z coordinate of 216 mm shows that the indication is near the outer wall of the vessel.

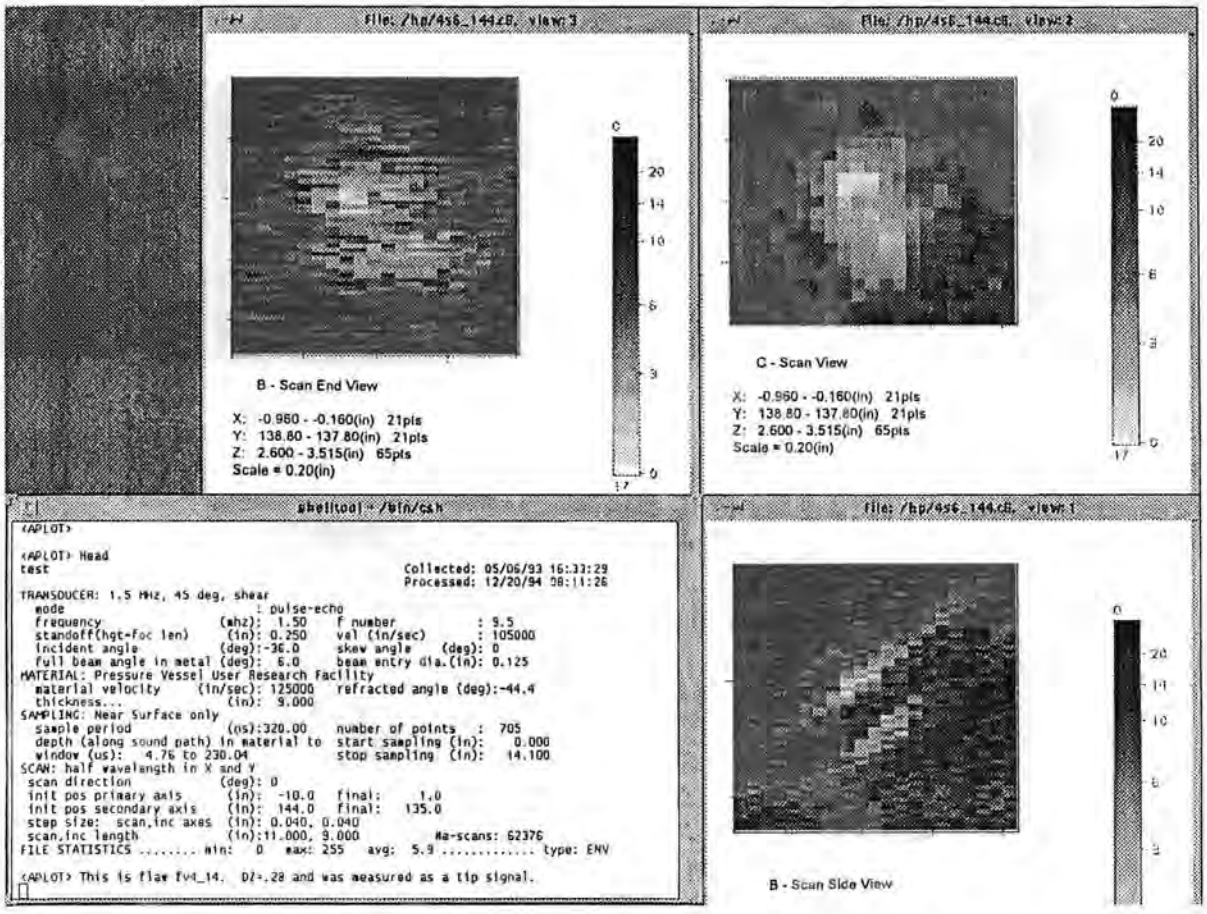
Figure A.80 - Planar indication #7 in the HAZ below 25 mm: mode 6

Figure A.80 shows planar indication #7 in the heat affected zone below 25 mm. This planar indication has a through-wall extent of 7 mm based on tip signal pattern. The detection was made in mode 6 where it displayed a pair of TOF shapes at a depth of 76 mm. The shape quality is good for this indication. There were no confirmations in modes. The indication is characterized as planar based on the tip signal pattern. The length is 14 mm and was made to LOS in mode 6. The aspect ratio (length/depth) of this indication is 2. The maximum amplitude-to-noise ratio is of medium range at 17 to 5. The X coordinate of 16 mm shows that the indication is probably in the HAZ. The Z coordinate of 76 mm shows that the indication is in the middle third of the vessel.

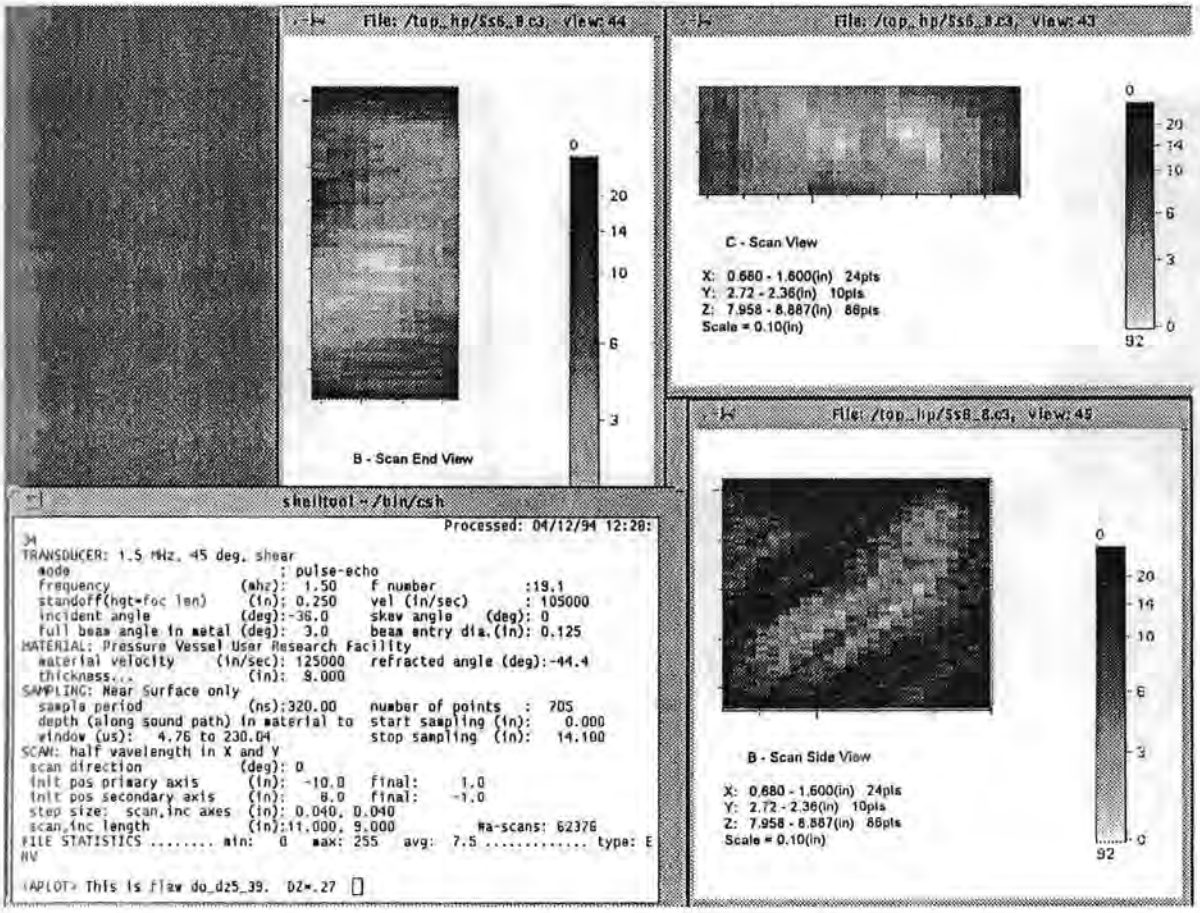
Figure A.81 - Planar indication #8 in the HAZ below 25 mm: mode 6

Figure A.81 shows planar indication #8 in the heat affected zone below 25 mm. This planar indication has a through-wall extent of 7 mm based on wave packet width. The detection was made in mode 6 where it had isolated TOF shape at a depth of 214 mm. The shape quality is good for this indication. There were no confirmations in other modes. The indication is characterized as planar based on lack of detection in normal beam or orthogonal modes. The length is 10 mm and was made to LOS in mode 6. The aspect ratio (length/depth) of this indication is 1.4. The maximum amplitude-to-noise ratio is of medium range at 92 to 25. The X coordinate of 30 mm shows that the indication is probably in the HAZ. The Z coordinate of 214 mm shows that the indication is near the outer wall of the vessel.

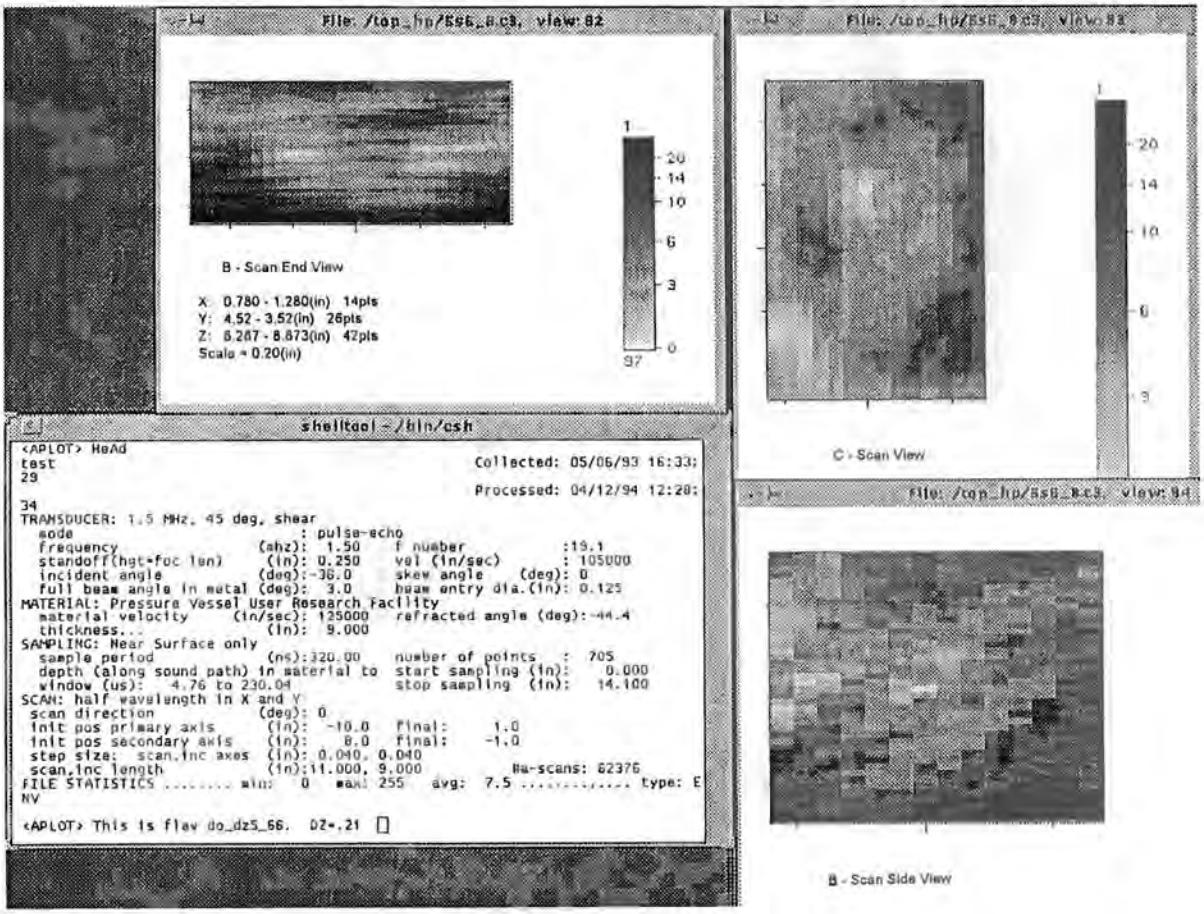
Figure A.82a - Planar indication #9 in the HAZ below 25 mm: mode 6

Figures A.82a-b show planar indication #9 in the heat affected zone below 25 mm. This planar indication has a through-wall extent of 5 mm based on wave packet width. The detection was made in mode 6 where it had isolated TOF shape at a depth of 218 mm. The shape quality is good but more than one TOF shape was present for this indication. There was a confirmation in mode 8 at depth of 216 mm. The confirmation mode gave a through-wall extent estimate of 4 mm based on wave packet width. The two Z values of 216 to 218 mm give an alternate depth size of 2 mm. The indication is characterized as planar based on lack of detection in normal beam or orthogonal modes. The length is 22 mm and was made to LOS in mode 6. The aspect ratio (length/depth) of this indication is 4 which tends to confirm the large through-wall extent. The maximum amplitude-to-noise ratio is of medium range at 88 to 35. The X coordinate of 24 mm shows that the indication is probably in the HAZ. The Z coordinate of 216 to 218 mm shows that the indication is near the outer wall of the vessel.

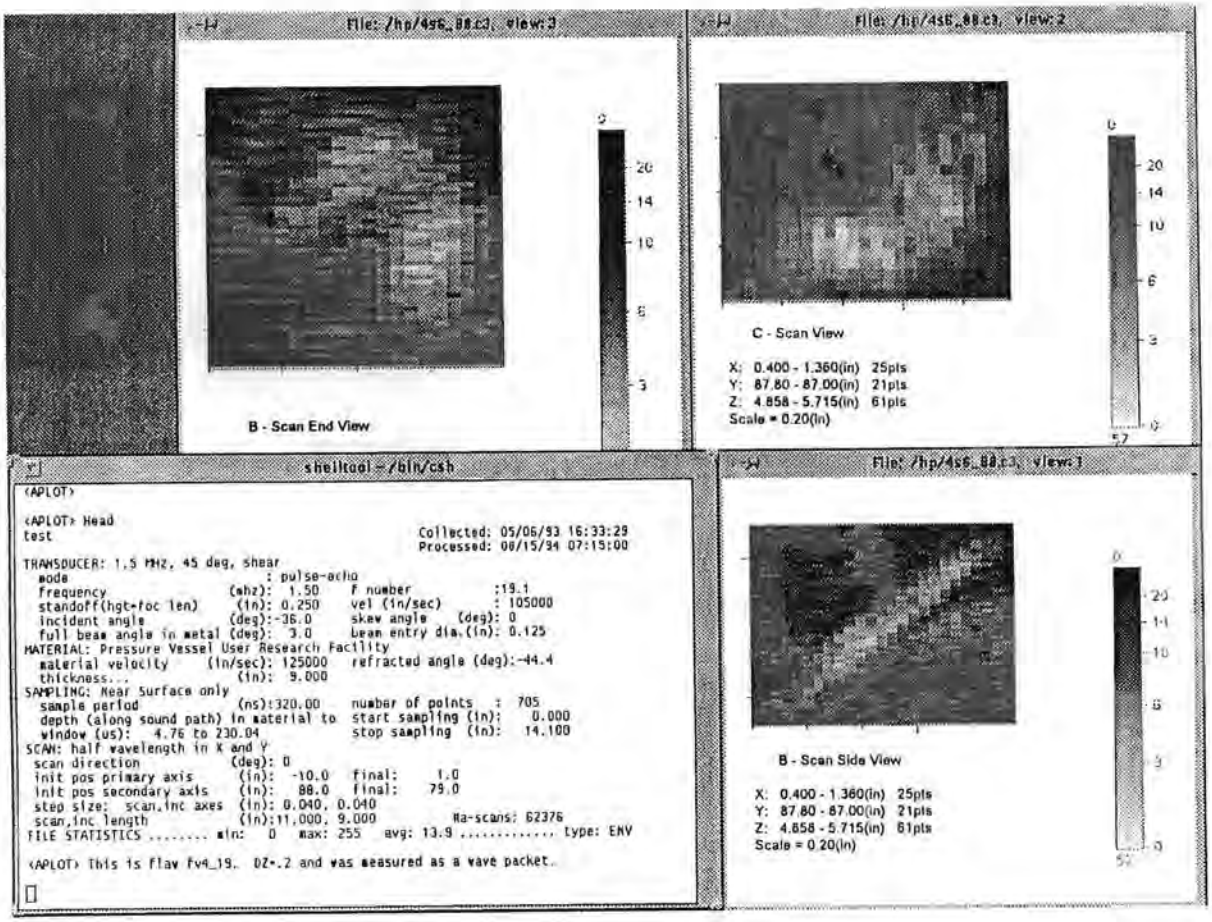
Figure A.83 shows planar indication #10 in the heat affected zone below 25 mm. This planar indication has a through-wall extent of 5 mm based on wave packet width. The detection was made in mode 6 where it had isolated TOF shape at a depth of 134 mm. The shape quality is good and more than one TOF shape was present for this indication. There were no confirmations in other modes. The indication is characterized as planar based on lack of detection in normal beam or orthogonal modes. The length is 19 mm and was made to LOS in mode 6. The aspect ratio (length/depth) of this indication is 4 which tends to confirm the large through-wall extent. The maximum amplitude-to-noise ratio is of medium range at 57 to 18. The X coordinate of 23 mm shows that the indication is probably in the HAZ. The Z coordinate of 134 mm shows that the indication is in the middle third of the vessel.

Figure A.83 - Planar indication #10 in the HAZ below 25 mm: mode 6

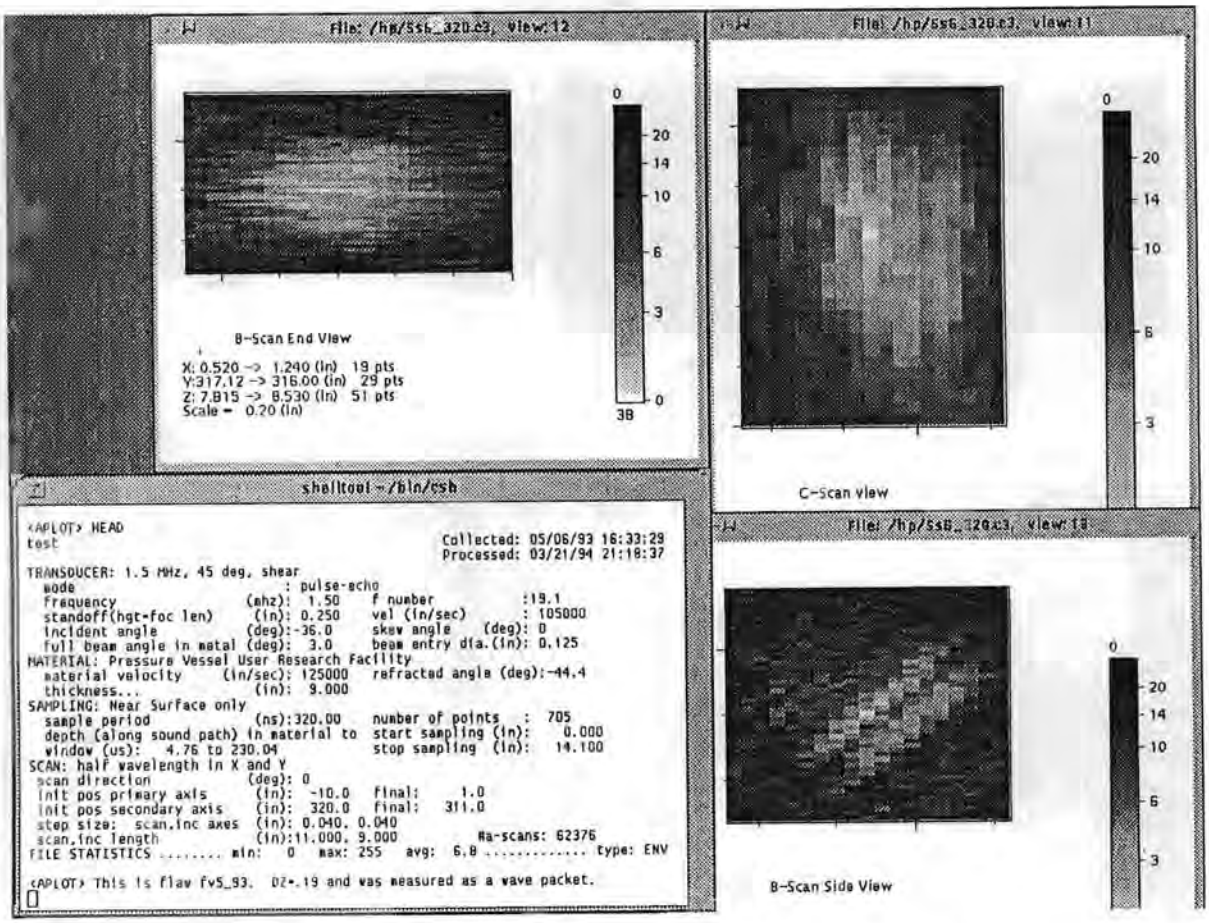
Figure A.84 shows planar indication #11 in the heat affected zone below 25 mm. This planar indication has a through-wall extent of 5 mm based on wave packet width. The detection was made in mode 6 where it had isolated TOF shape at a depth of 208 mm. The shape quality is good but more than one TOF shape was present for this indication. There were no confirmations in other modes. The indication is characterized as planar based on lack of detection in normal beam or orthogonal modes. The length is 26 mm and was made to LOS in mode 6. The aspect ratio (length/depth) of this indication is 5 which tends to confirm the large through-wall extent. The maximum amplitude-to-noise ratio is of medium range at 38 to 10. The X coordinate of 23 mm shows that the indication is probably in the HAZ. The Z coordinate of 21 mm shows that the indication is near the outer wall of the vessel.

Figure A.84 - Planar indication #11 in the HAZ below 25 mm: mode 6

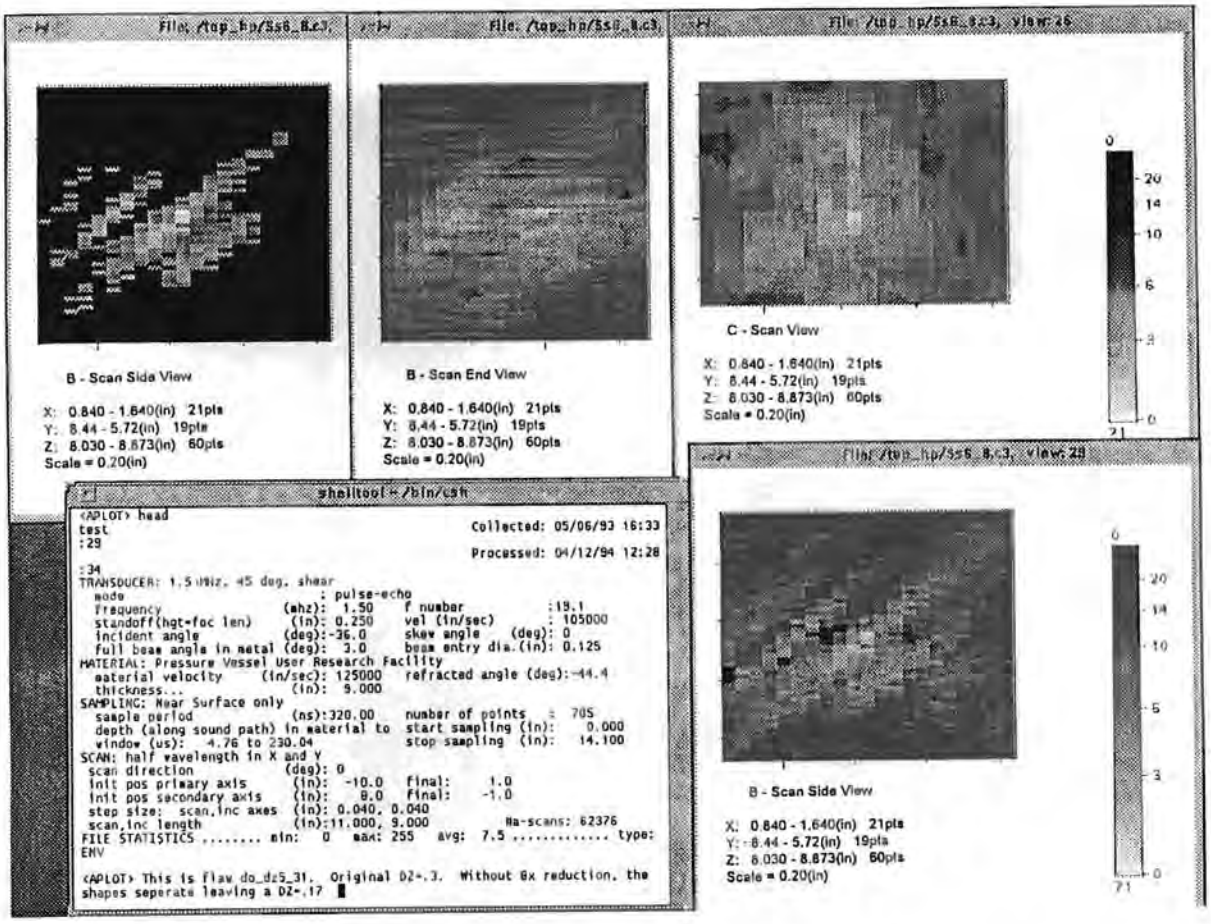
Figure A.85 shows planar indication #12 in the heat affected zone below 25 mm. This planar indication has a through-wall extent of 4 mm based on wave packet width. The detection was made in mode 6 where it had isolated TOF shape at a depth of 215 mm. The shape quality is good but more than one TOF shape was present for this indication. There were no confirmations in other modes. The indication is characterized as planar based on lack of detection in normal beam or orthogonal modes. The length is 20 mm and was made to LOS in mode 6. The aspect ratio (length/depth) of this indication is 5 which tends to confirm the large through-wall extent. The maximum amplitude-to-noise ratio is of medium range at 71 to 20. The X coordinate of 30 mm shows that the indication is probably in the HAZ. The Z coordinate of 215 mm shows that the indication near the outer wall of the vessel.

Figure A.85 - Planar indication #12 in the HAZ below 25 mm: mode 6

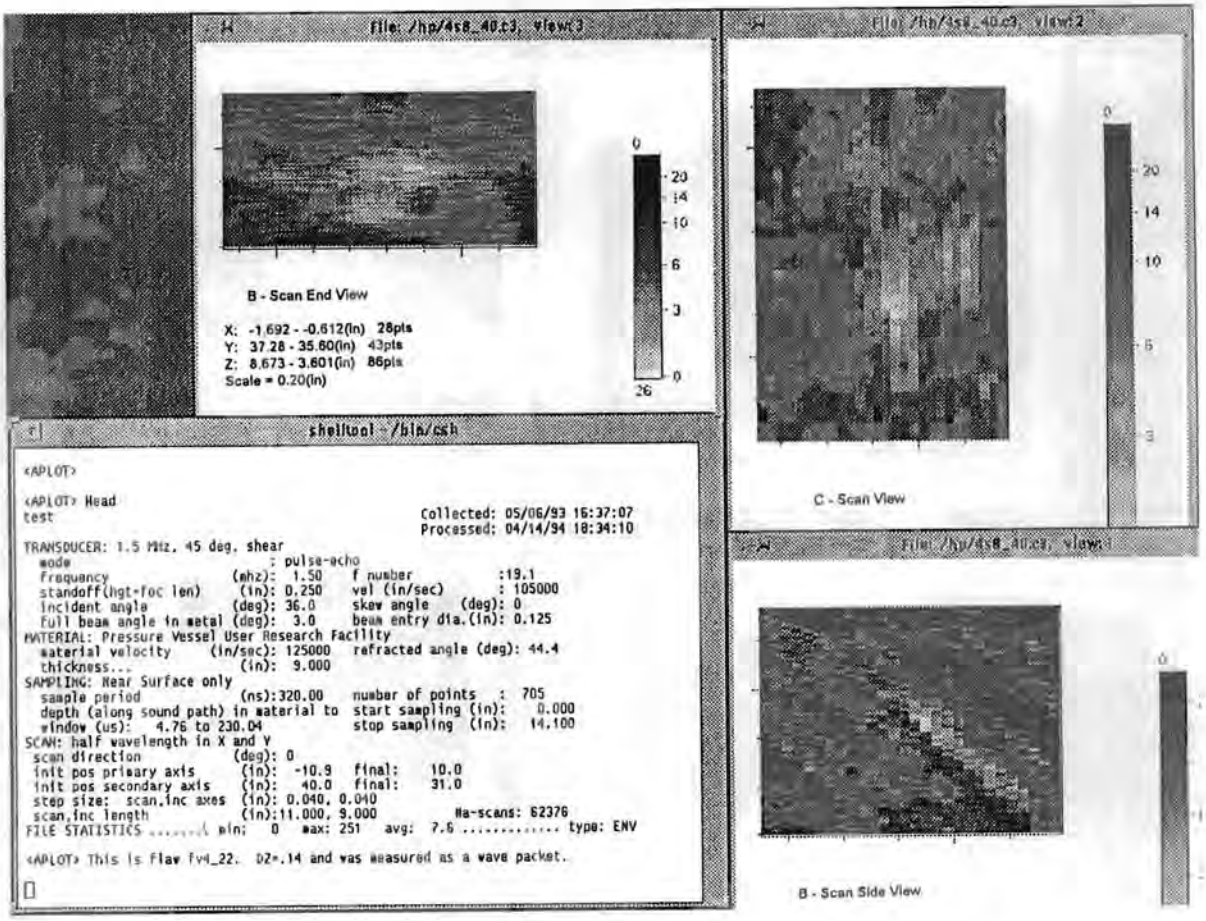
Figure A.86 shows planar indication #13 in the heat affected zone below 25 mm. This planar indication has a through-wall extent of 4 mm based on wave packet width. The detection was made in mode 6 where it had isolated TOF shape at a depth of 232 mm. The shape quality is good but more than one TOF shape was present for this indication. There were no confirmations in other modes. The indication is characterized as planar based on lack of detection in normal beam or orthogonal modes. The length is 33 mm and was made to LOS in mode 6. The aspect ratio (length/depth) of this indication is 8 which tends to confirm the large through-wall extent. The maximum amplitude-to-noise ratio is of medium range at 26 to 10. The X coordinate of -28 mm shows that the indication is probably in the HAZ. The Z coordinate of 232 mm shows that the indication is near the outer wall, possibly connected to the outer wall of the vessel.

Figure A.86 - Planar indication #13 in the HAZ below 25 mm: mode 8

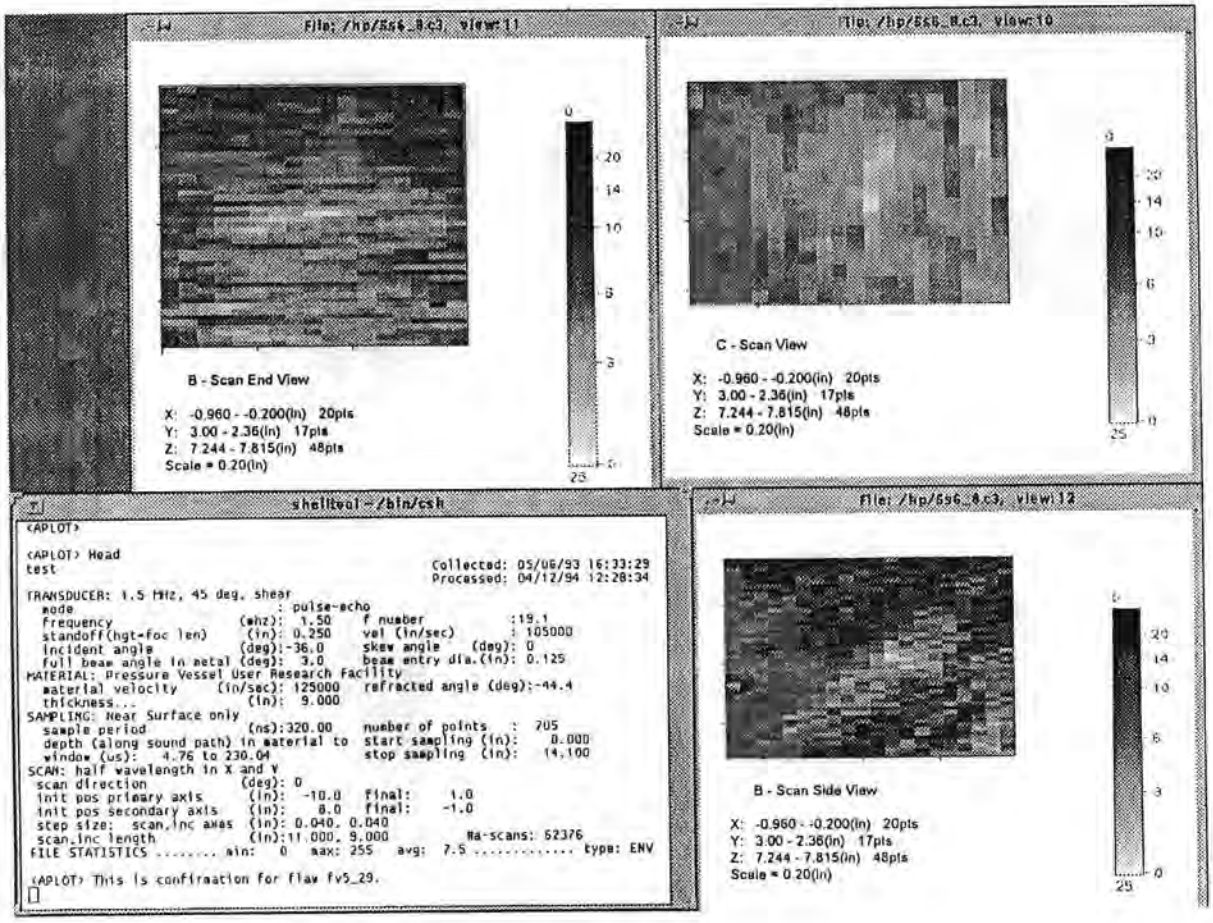
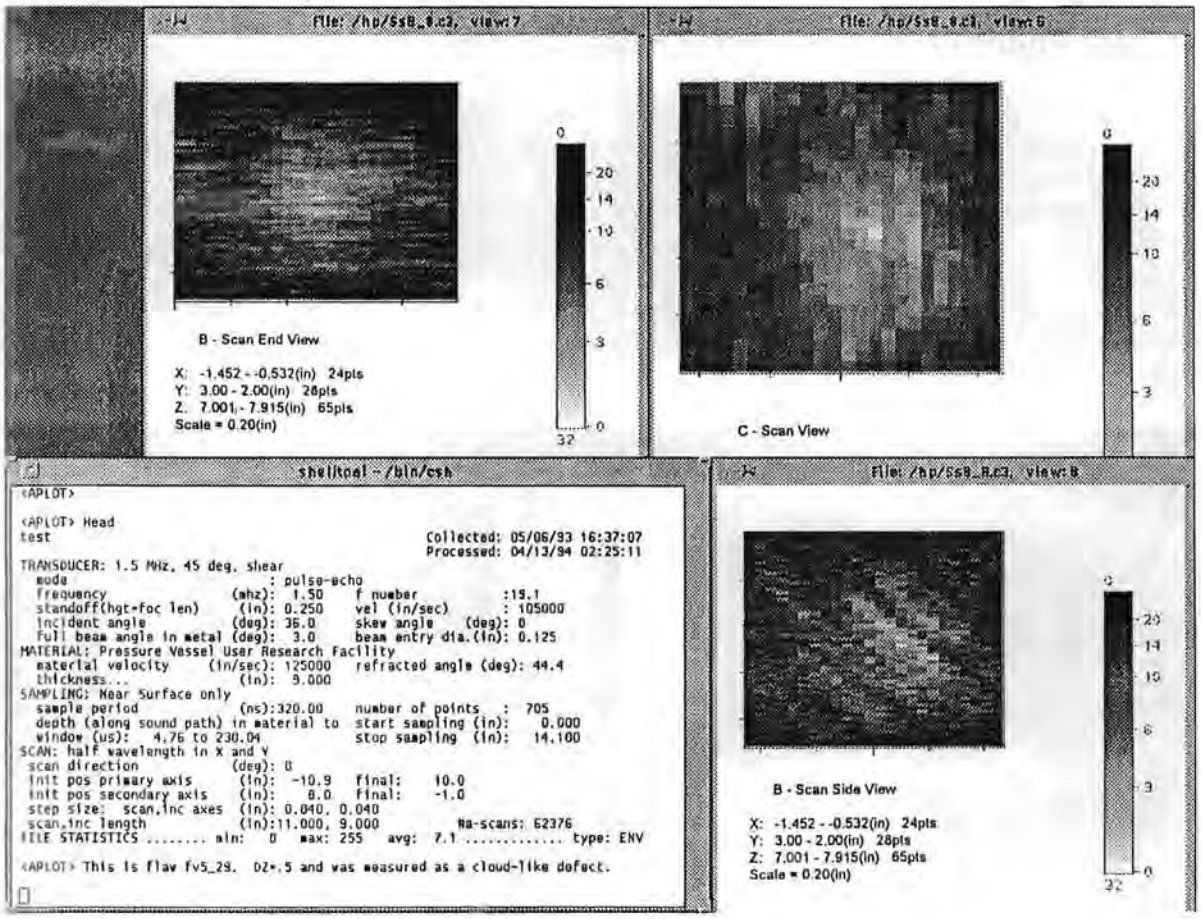
Figures A.87a-b show planar indication #14 in the heat affect zone below 25 mm. This planar indication has a through-wall extent of 4 mm based on LOS in a cloud like pattern. The detection was made in mode 8 where the shape appeared cloud like in nature at a depth of 189 mm. There was a confirmation in mode 6 at depth of 192 mm. The confirmation mode gave a through-wall extent estimate of 3 mm based on wave packet width. The two Z values of 189 to 192 mm give an alternate depth size of 3 mm. The indication is characterized as planar based on lack of detection in normal beam or orthogonal modes. The length is 18 mm and was made to LOS in mode 8. The aspect ratio (length/depth) of this indication is 4.5 which tends to confirm the large through-wall extent. The maximum amplitude-to-noise ratio is of medium range at 32 to 12. The X coordinate of -14 mm shows that the indication is probably in the HAZ. The Z coordinate of 189 to 192 mm shows that the indication is in the outer third of the vessel.

Figure A.87a - Planar indication #14 in the HAZ below 25 mm: mode 6

Figure A.87b - Planar indication #14 in the HAZ below 25 mm: mode 8

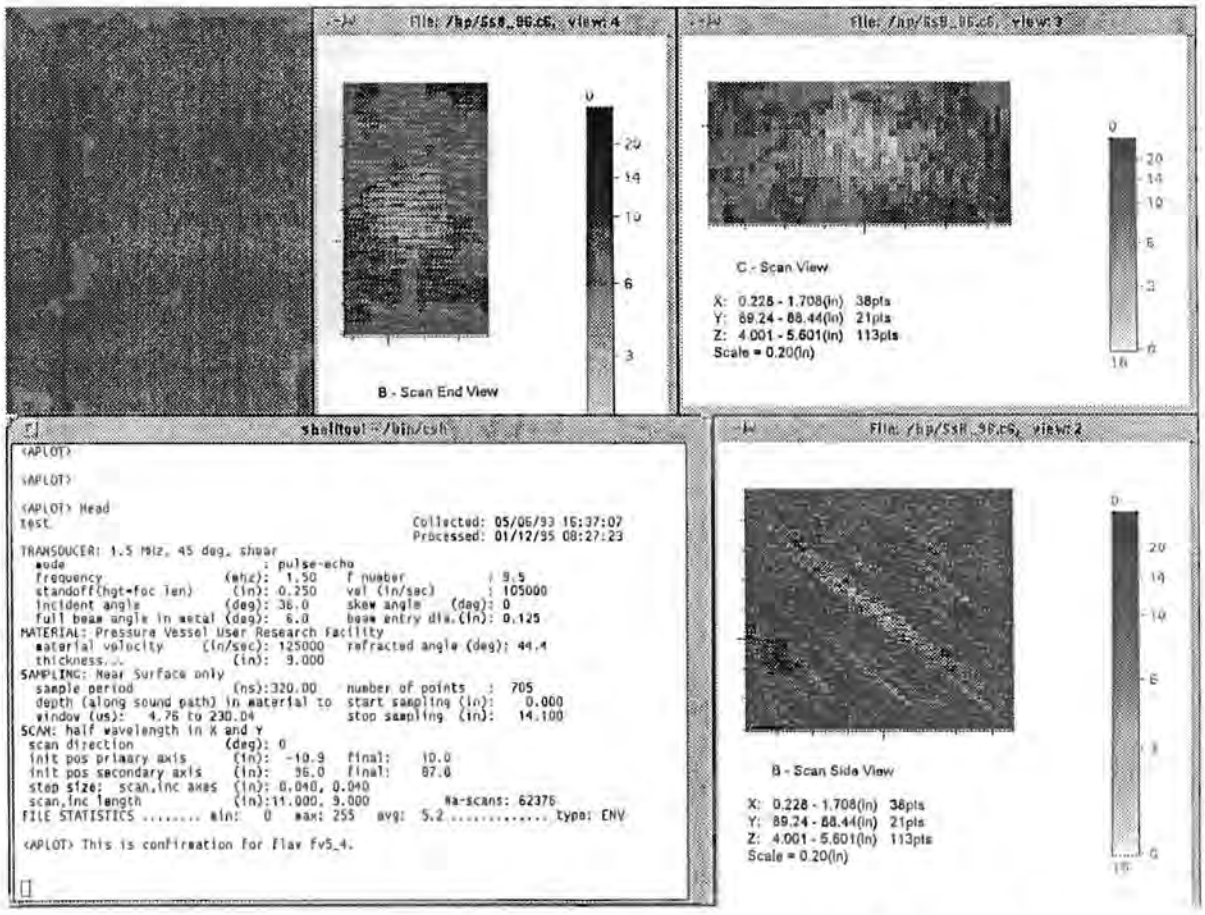
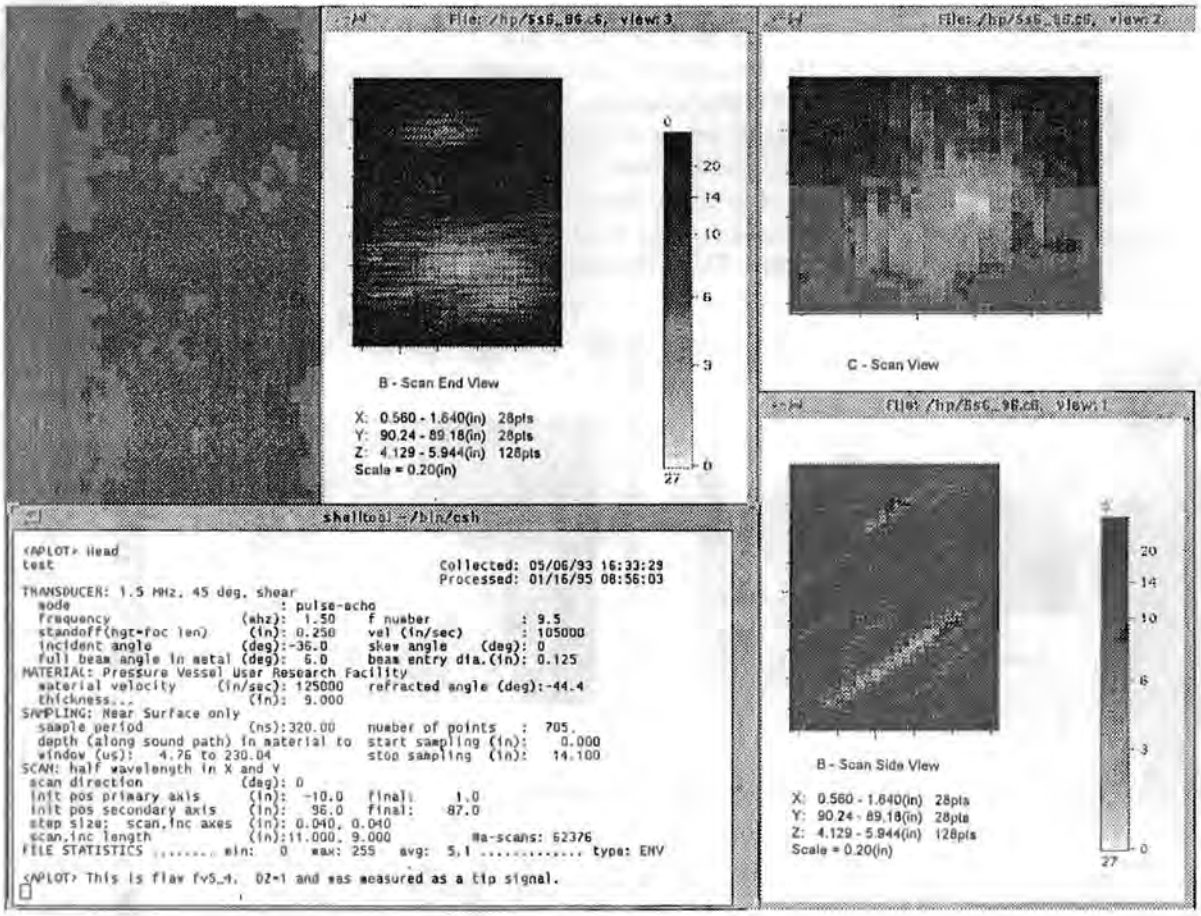
Figures A.88a-b show planar indication #1 in the base metal below 25 mm. This planar indication has a through-wall extent of 26 mm based on tip signal pattern. The detection was made in mode 6 where it displayed a pair of TOF shapes at a depth of 136 mm. The shape quality is good for this indication. There was a confirmation in mode 8 at depth of 123 mm. The confirmation mode gave a through-wall extent estimate of 1 mm based on wave packet width. The two Z values of 123 to 136 mm give an alternate depth size of 13 mm. The indication is characterized as planar based on the tip signal pattern. The length is 23 mm and was made to LOS in mode 6. The range of aspect ratios (length/depth) of this indication is 0.9 to 1.8. The maximum amplitude-to-noise ratio is high at 27 to 5. The X coordinate of 28 mm shows that the indication is in the base metal, possibly HAZ. The Z coordinate of 123 to 136 mm shows that the indication is in the middle third of the vessel.

Figure A.88a - Planar indication #1 in the base metal below 25 mm: mode 8

Figure A.88b - Planar indication #1 in the base metal below 25 mm: mode 6

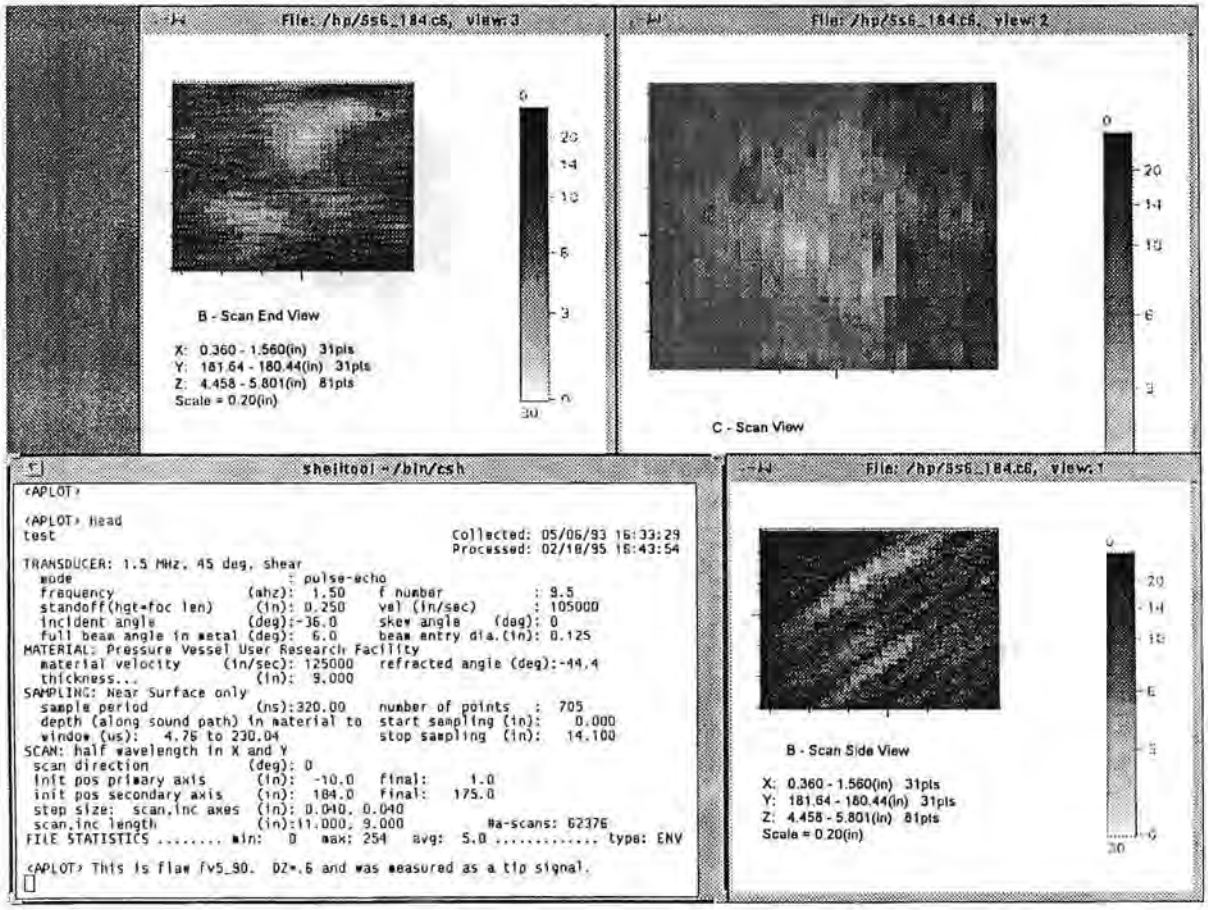
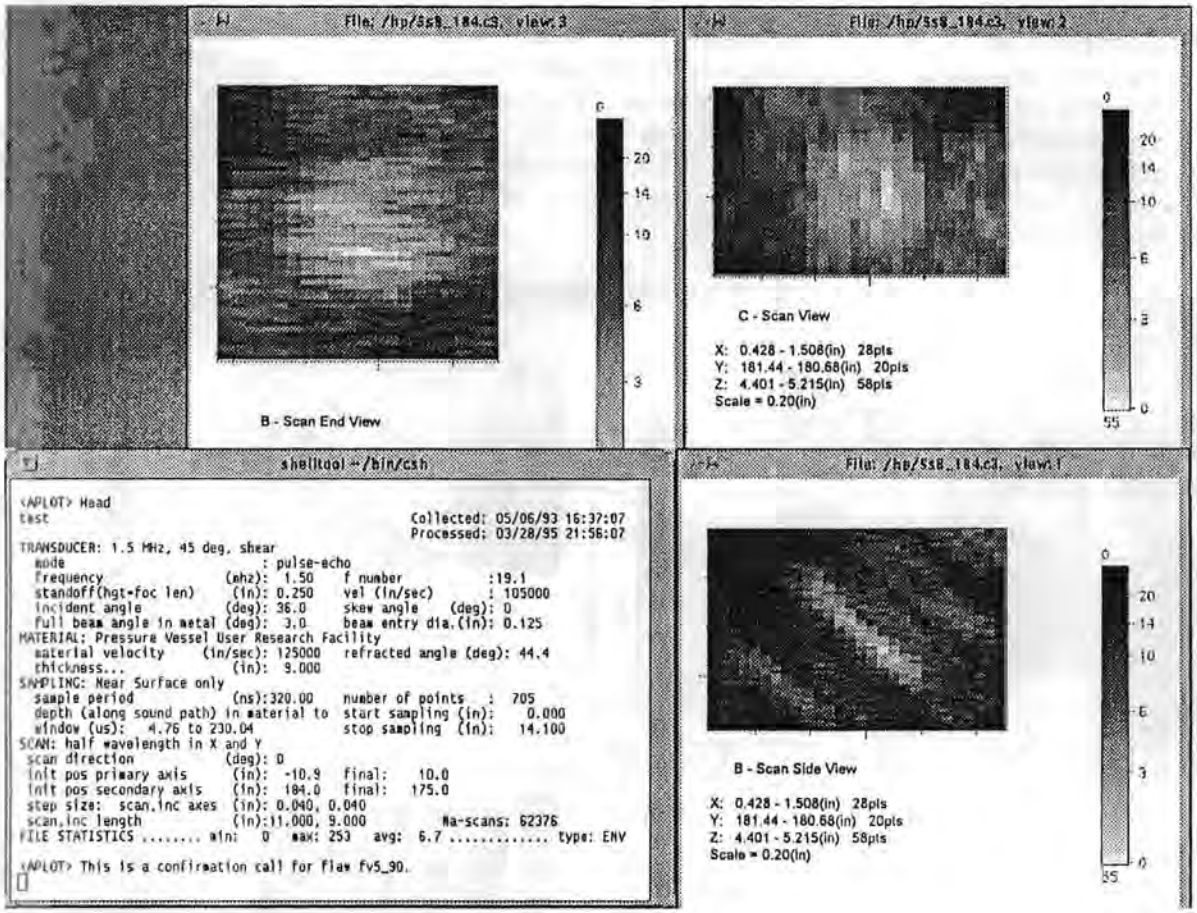
Figures A.89a-b show planar indication #2 in the base metal below 25 mm. This planar indication has a through-wall extent of 15 mm based on tip signal pattern. The detection was made in mode 6 where it displayed a pair of TOF shapes at a depth of 121 mm. The shape quality is good for this indication. There was a confirmation in mode 8 at a depth of 122 mm. The confirmation mode gave a through-wall extent estimate of 3 mm based on ring around pattern. The two Z values of 121 to 122 mm give an alternate depth size of 1 mm. The indication is characterized as planar based on the tip signal pattern. The length is 41 mm and was made to LOS in mode 6. The aspect ratio (length/depth) of this indication is 3. The maximum amplitude-to-noise ratio is of medium range at 30 to 8. The X coordinate of 24 mm shows that the indication is in the base metal, possibly in the HAZ. The Z coordinate of 121 to 122 mm shows that the indication is in the middle third of the vessel.

Figure A.89a - Planar indication #2 in the base metal below 25 mm: mode 6

Figure A.89b - Planar indication #2 in the base metal below 25 mm: mode 8

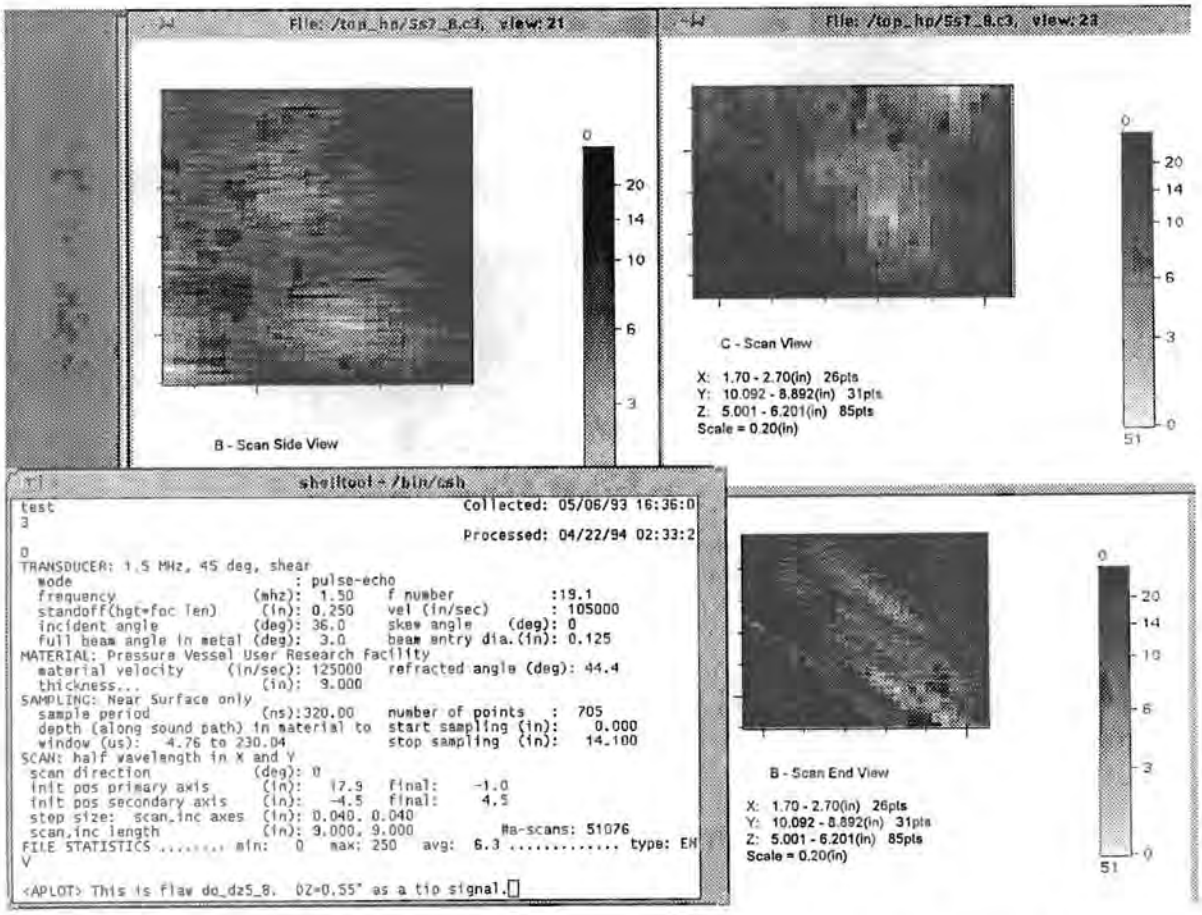
Figure A.90 shows planar indication #3 in the base metal below 25 mm. This planar indication has a through-wall extent of 13 mm based on tip signal pattern. The detection was made in mode 7 where it displayed a pair of TOF shapes at a depth of 145 mm. The shape quality is good for this indication. There were no confirmations in other modes. The indication is characterized as planar based on the tip signal pattern. The width is 15 mm and was made to LOS in mode 7. The aspect ratio (width/depth) of this indication is 1.2. The maximum amplitude-to-noise ratio is of medium range at 51 to 14. The X coordinate of 58 mm shows that the indication is clearly in the base metal. The Z coordinate of 145 mm shows that the indication is in the middle third of the vessel.

Figure A.90 - Planar indication #3 in the base metal below 25 mm: mode 7

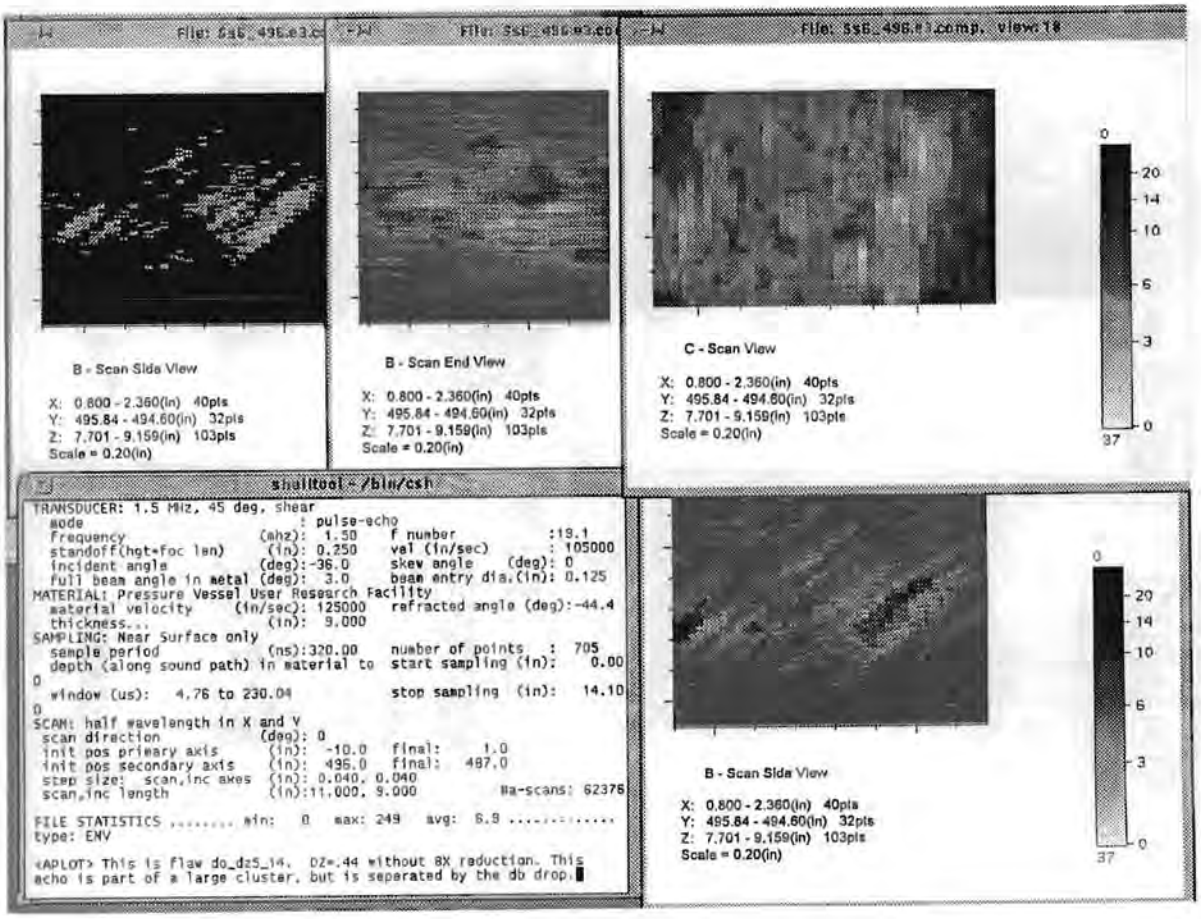
Figure A.91 shows planar indication #4 in the base metal below 25 mm. This planar indication has a through-wall extent of 11 mm based on wave packet width. The detection was made in mode 6 where it had isolated TOF shape at a depth of 214 mm. The shape quality for this indication is good. Because more than one TOF shape was present the indication is broken up, implying that more than one small flaw may be present. There were no confirmations in other modes. The indication is characterized as planar based on lack of detection in normal beam or orthogonal modes. The length is 30 mm and was made to LOS in mode 6. The aspect ratio (length/depth) of this indication is 3. The maximum amplitude-to-noise ratio is of medium range at 45 to 12. The X coordinate of 43 mm shows that the indication is clearly in the base metal. The Z coordinate of 214 mm shows that the indication is near the outer wall of the vessel.

Figure A.91 - Planar indication #4 in the base metal below 25 mm: mode 6
