NUREG/CR-6471, Vol. 1
PNNL-11143

Characterization of Flaws in U.S. Reactor Pressure Vessels

Density and Distribution of Flaw Indications in PVRUF

Pacific Northwest National Laboratory

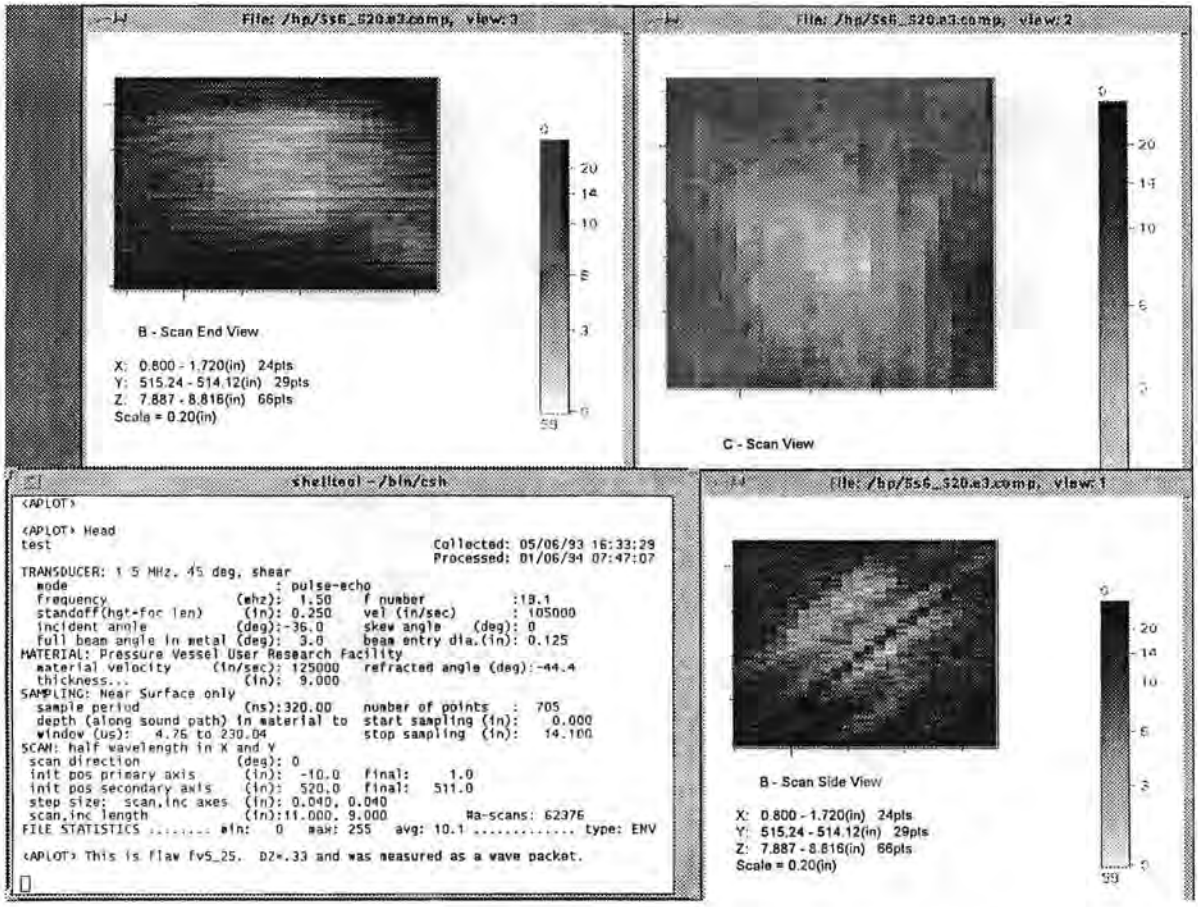
Figure A.92 shows planar indication #5 in the base metal below 25 mm. This planar indication has a through-wall extent of 8 mm based on wave packet width. The detection was made in mode 6 where it had isolated TOF shape at a depth of 211 mm. The shape quality is good. More than one TOF shape was present for this indication, implying that more than one small flaw may be present. There were no confirmations in other modes. The indication is characterized as planar based on lack of detection in normal beam or orthogonal modes. The length is 27 mm and was made to LOS in mode 6. The aspect ratio (length/depth) of this indication is 3. The maximum amplitude-to-noise ratio is high at 59 to 12. The X coordinate of 31 mm shows that the indication is in the base metal, possibly HAZ. The Z coordinate of 211 mm shows that the indication is near the outer wall of the vessel.

Figure A.92 - Planar indication #5 in the base metal below 25 mm: mode 6

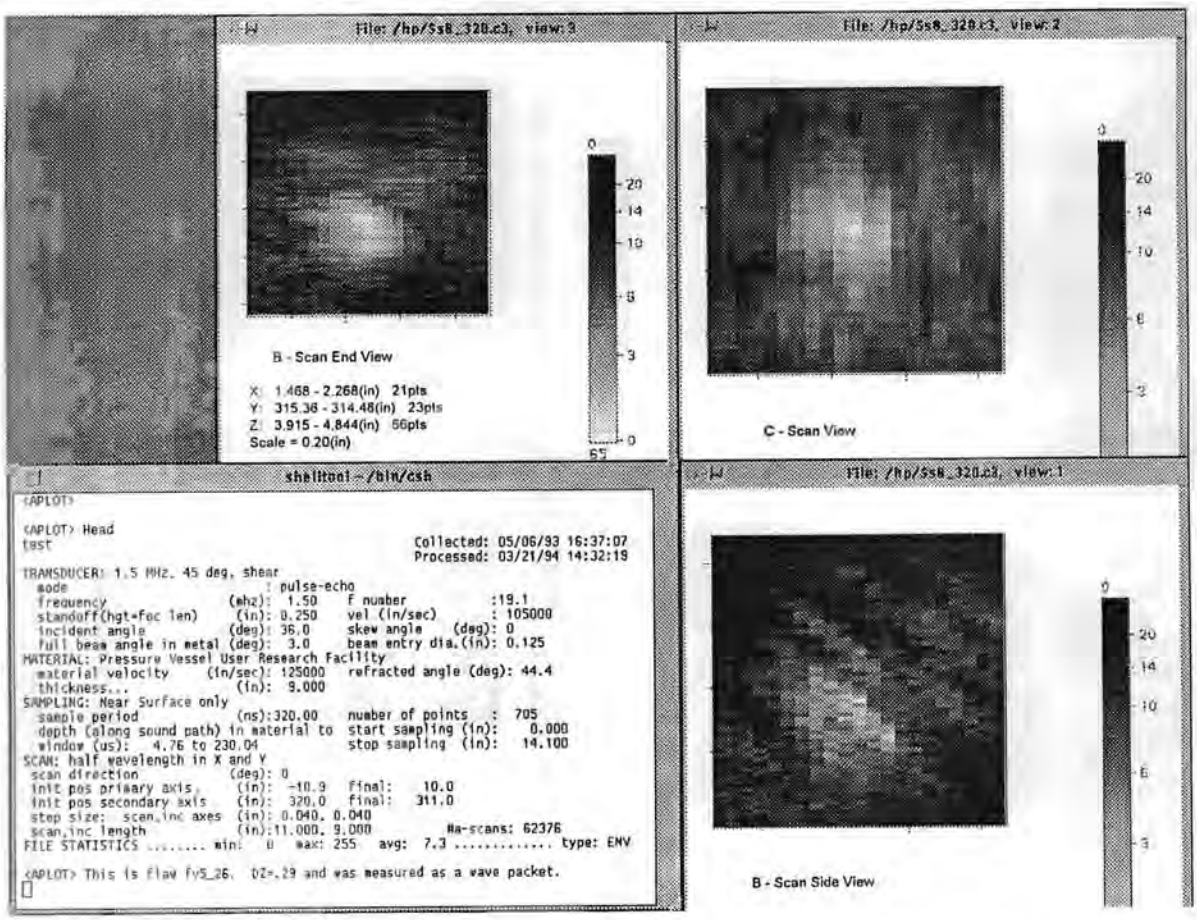
Figure A.93 shows planar indication #6 in the base metal below 25 mm. This planar indication has a through-wall extent of 7 mm based on wave packet width. The detection was made in mode 8 where it had isolated TOF shape at a depth of 113 mm. More than one TOF shape was present. The shape quality for this indication is good but broken up, implying that more than one small flaw may be present. There were no confirmations in other modes. The indication is characterized as planar based on lack of detection in normal beam or orthogonal modes. The length is 16 mm and was made to LOS in mode 6. The aspect ratio (length/depth) of this indication is 2. The maximum amplitude-to-noise ratio is high at 65 to 15. The X coordinate of 46 mm shows that the indication is clearly in the base metal. The Z coordinate of 113 mm shows that the indication is in the middle third of the vessel.

Figure A.93 - Planar indication #6 in the base metal below 25 mm: mode 8

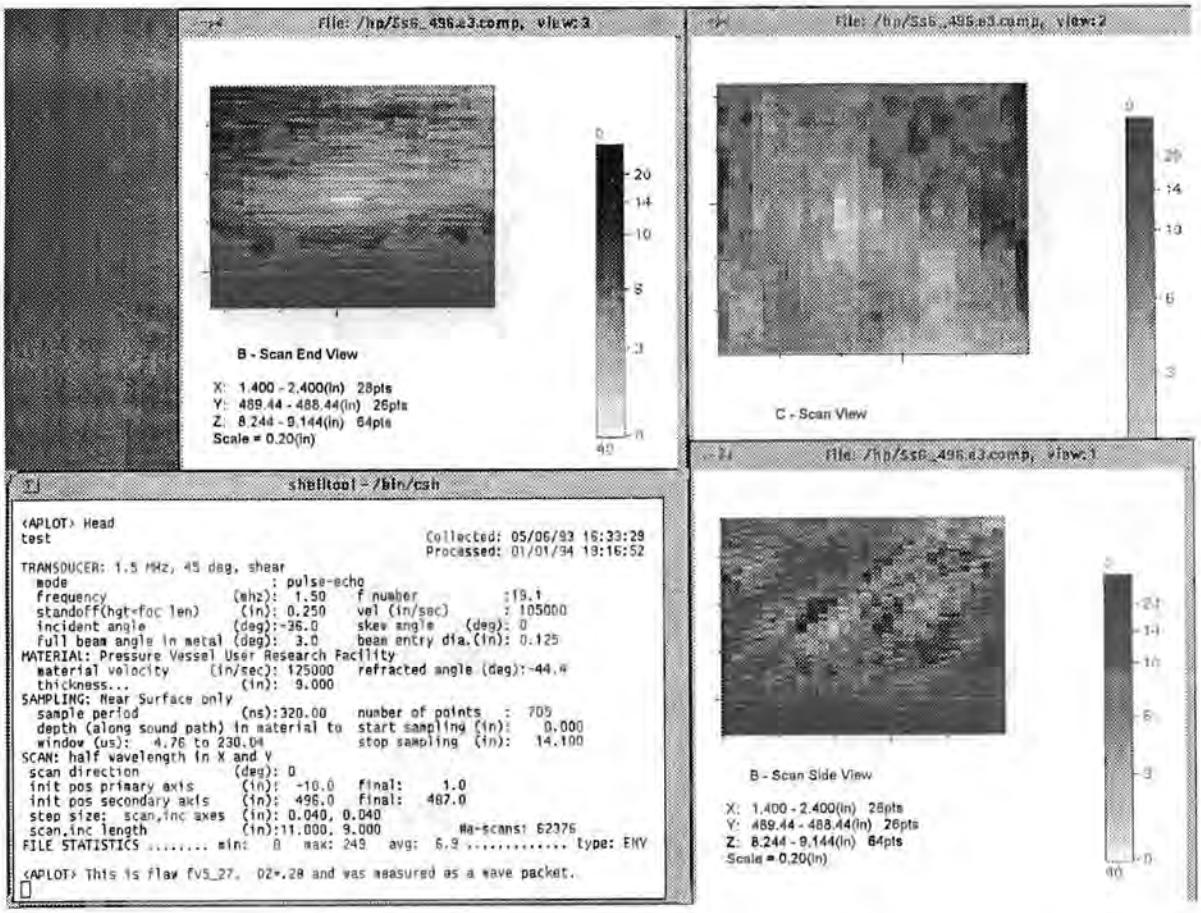
Figure A.94 shows planar indication #7 in the base metal below 25 mm. This planar indication has a through-wall extent of 7 mm based on wave packet width. The detection was made in mode 8 where it had isolated TOF shape at a depth of 113 mm. More than one TOF shape was present. The shape quality for this indication is good but broken up, implying that more than one small flaw may be present. There were no confirmations in other modes. The indication is characterized as planar based on lack of detection in normal beam or orthogonal modes. The length is 16 mm and was made to LOS in mode 6. The aspect ratio (length/depth) of this indication is 2. The maximum amplitude-to-noise ratio is high at 65 to 15. The X coordinate of 46 mm shows that the indication is clearly in the base metal. The Z coordinate of 113 mm shows that the indication is in the middle third of the vessel.

Figure A.94 - Planar indication #7 in the base metal below 25 mm: mode 6

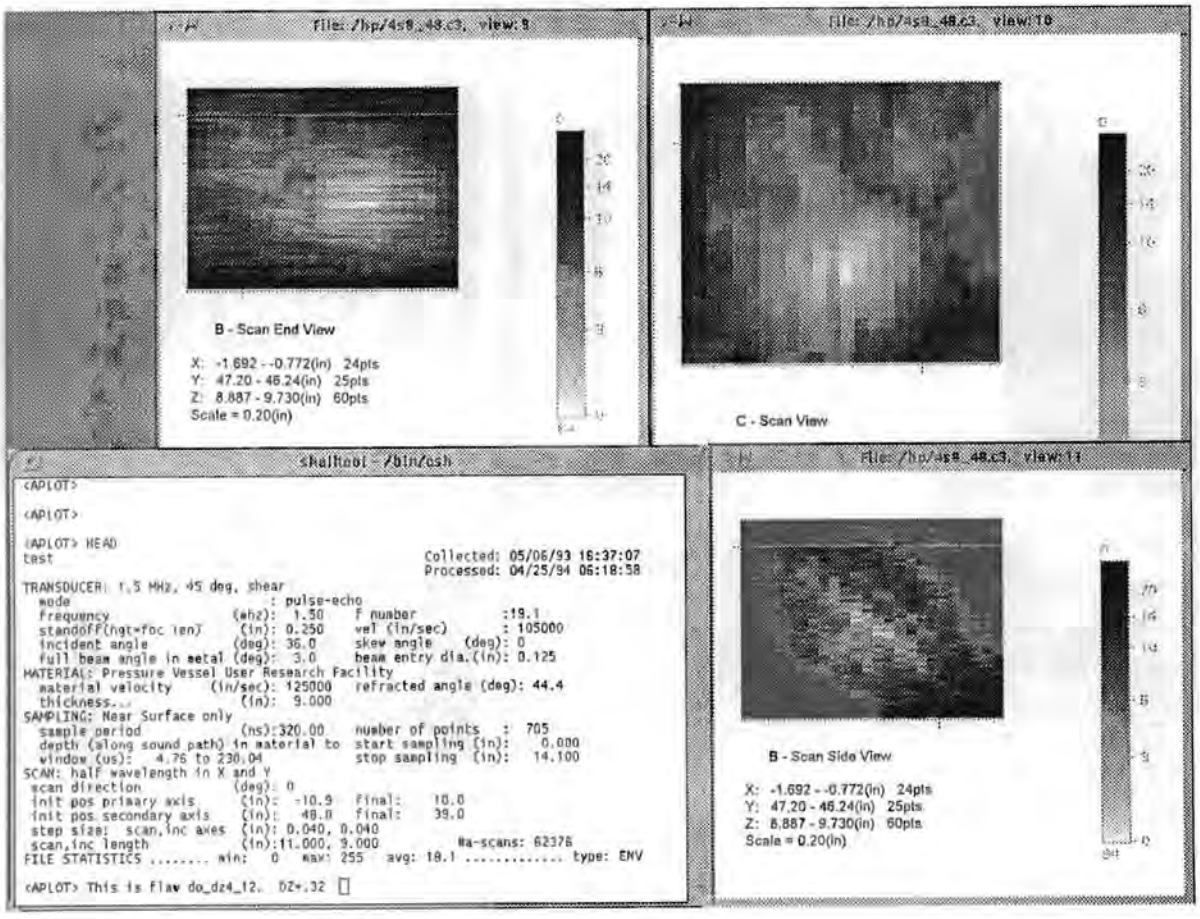
Figure A.95 shows planar indication #8 in the base metal below 25 mm. This planar indication has a through-wall extent of 7 mm based on wave packet width. The detection was made in mode 8 where it had isolated TOF shape at a depth of 238 mm. More than one TOF shape was present. The shape quality for this indication is good but broken up, implying that more than one small flaw may be present. There were no confirmations in other modes. The indication is characterized as planar based on lack of detection in normal beam or orthogonal modes. The length is 28 mm and was made to LOS in mode 8. The aspect ratio (length/depth) of this indication is 4 which tends to confirm the large through-wall extent. The maximum amplitude-to-noise ratio is high at 84 to 20. The X coordinate of 31 mm shows that the indication is in the base metal, possibly HAZ. The Z coordinate of 238 mm shows that the indication is near the outer wall, possibly connected to the outer wall of the vessel.

Figure A.95 - Planar indication #8 in the base metal below 25 mm: mode 8

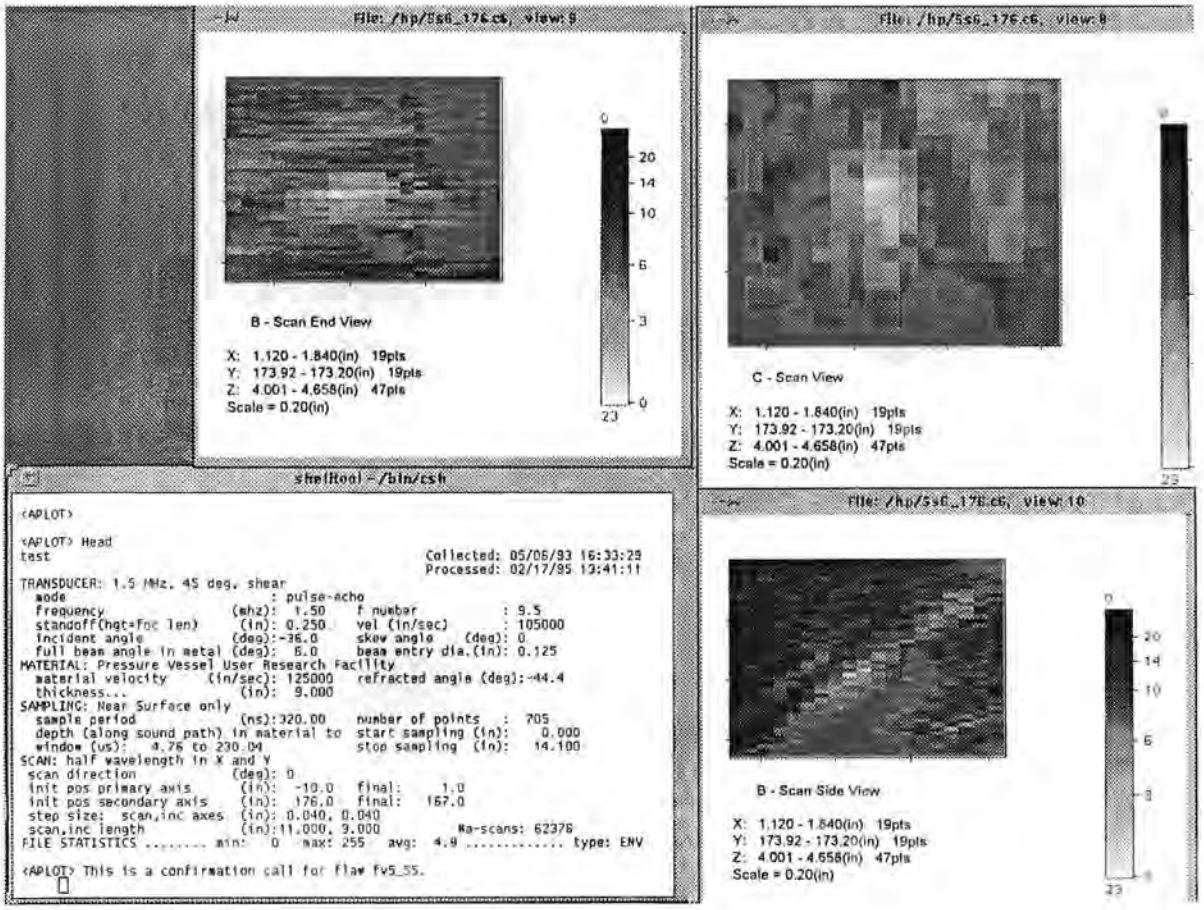
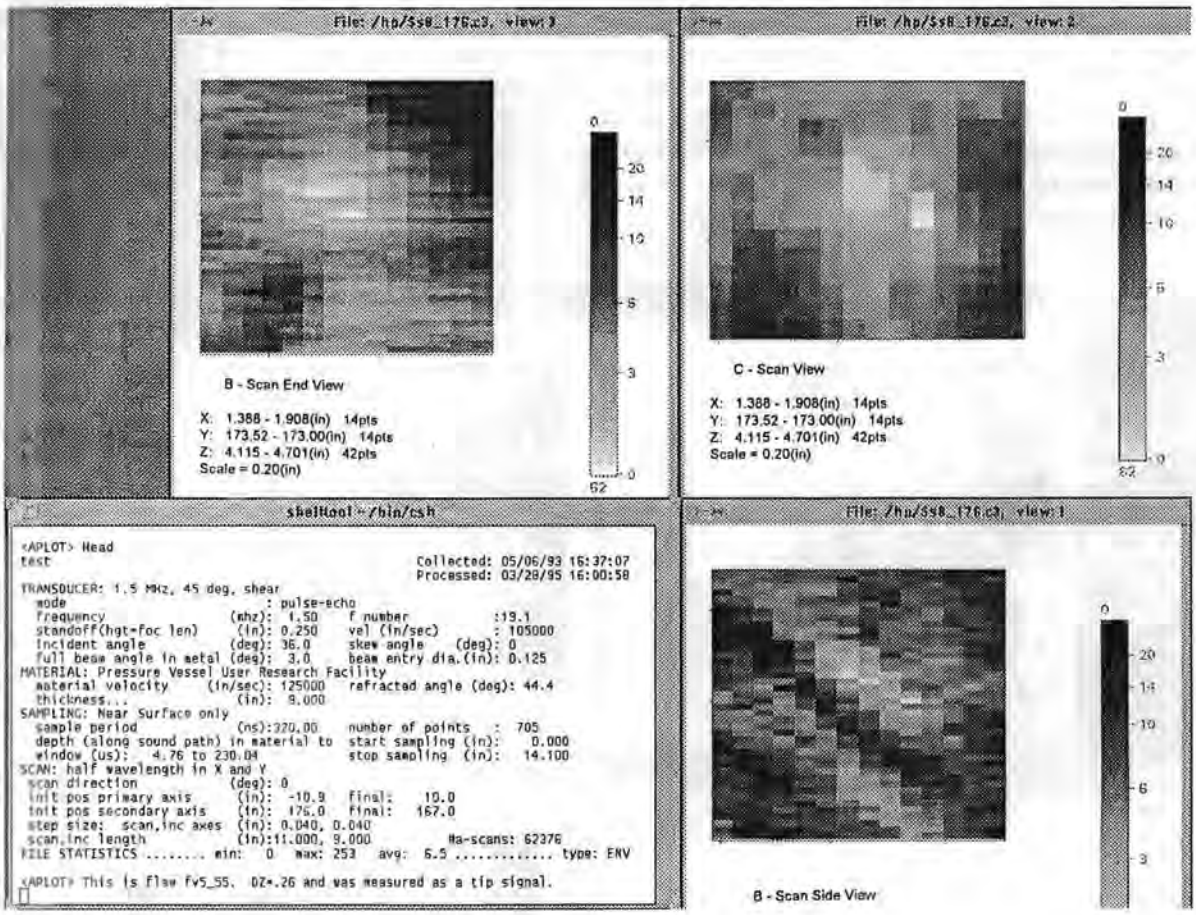
Figures A.96a-b show planar indication #9 in the base metal below 25 mm. This planar indication has a through-wall extent of 7 mm based on tip signal pattern. The detection was made in mode 8 where it displayed a pair of TOF shapes at a depth of 110 mm. The shape quality is good for this indication. There was a confirmation in mode 6 at a depth of 111 mm. The confirmation mode gave a through-wall extent estimate of 4 mm based on wave packet width. The two Z values of 110 to 111 mm give an alternate depth size of 1 mm. The indication is characterized as planar based on the tip signal pattern. The length is 16 mm and was made to LOS in mode 6. The aspect ratio (length/depth) of this indication is 2. The maximum amplitude-to-noise ratio is of medium range at 62 to 20. The X coordinate of 37 mm shows that the indication is clearly in the base metal. The Z coordinate of 110 mm shows that the indication is in the middle third of the vessel.

Figure A.96a - Planar indication #9 in the base metal below 25 mm: mode 6

Figure A.96b - Planar indication #9 in the base metal below 25 mm: mode 8

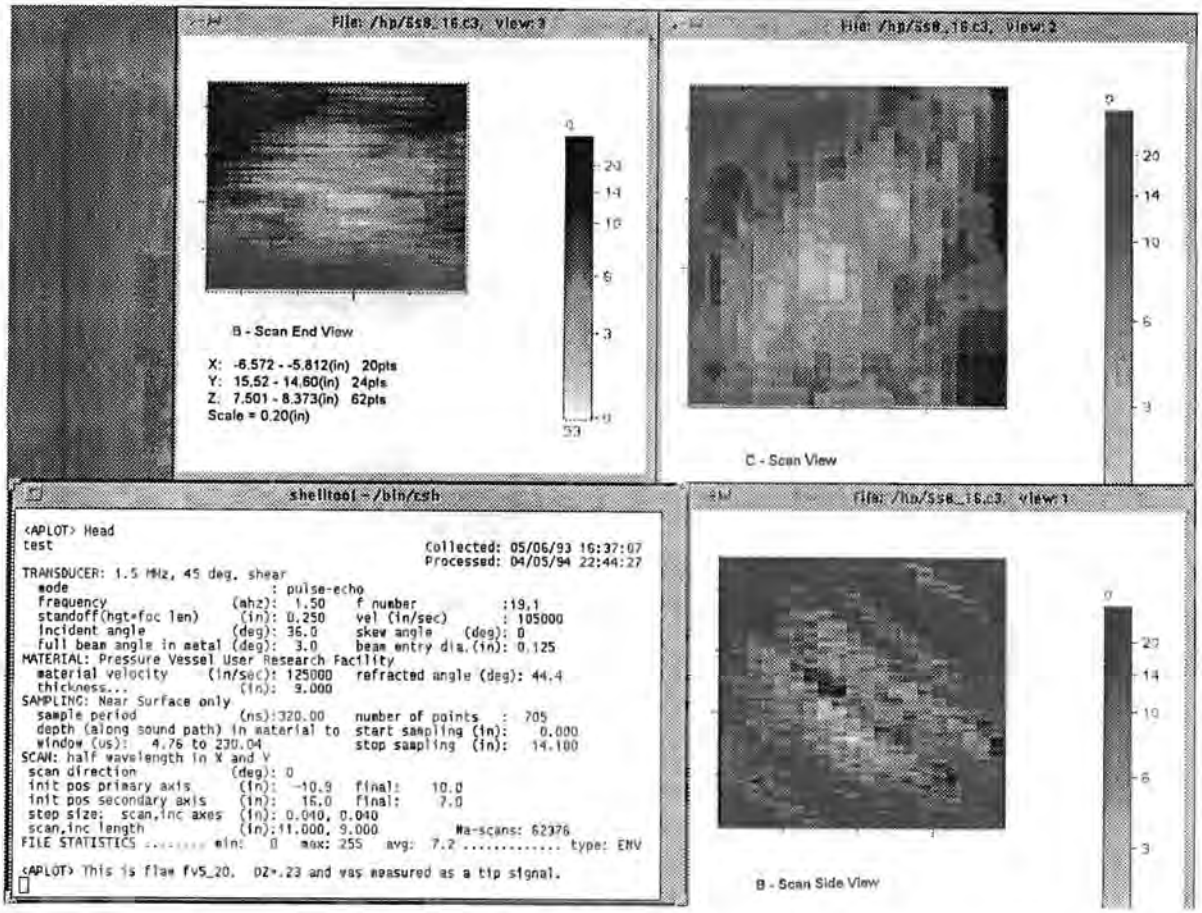
Figure A.97 shows planar indication #10 in the base metal below 25 mm. This planar indication has a through-wall extent of 6 mm based on tip signal pattern. The detection was made in mode 8 where it displayed a pair of TOF shapes at a depth of 201 mm. The shape quality is good for this indication. There were no confirmations in other modes. The indication is characterized as planar based on the tip signal pattern. The length is 20 mm and was made to LOS in mode 8. The aspect ratio (length/depth) of this indication is 3. The maximum amplitude-to-noise ratio is of medium range at 53 to 20. The X coordinate of -159 mm shows that the indication is clearly in the base metal. The Z coordinate of 201 mm shows that the indication is in the outer third of the vessel.

Figure A.97 - Planar indication #10 in the base metal below 25 mm: mode 8

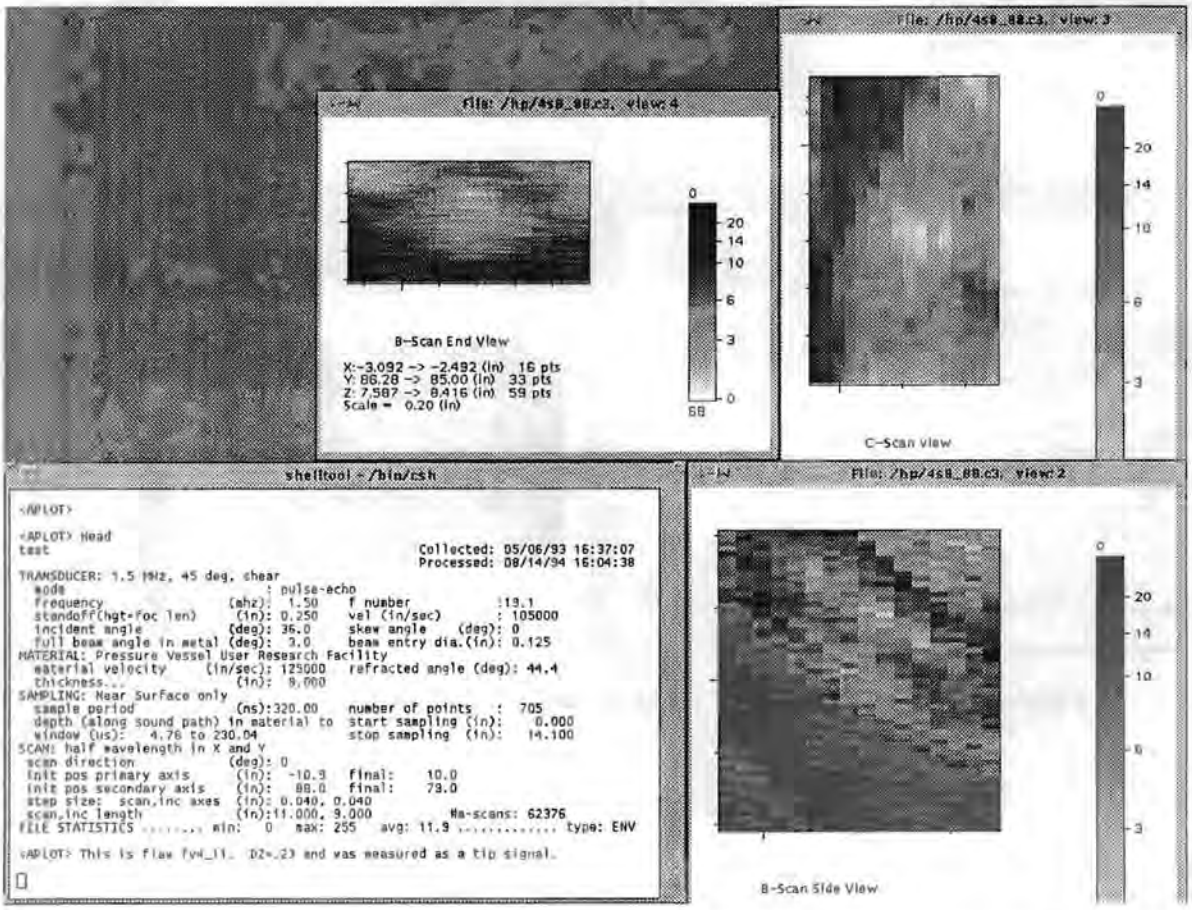
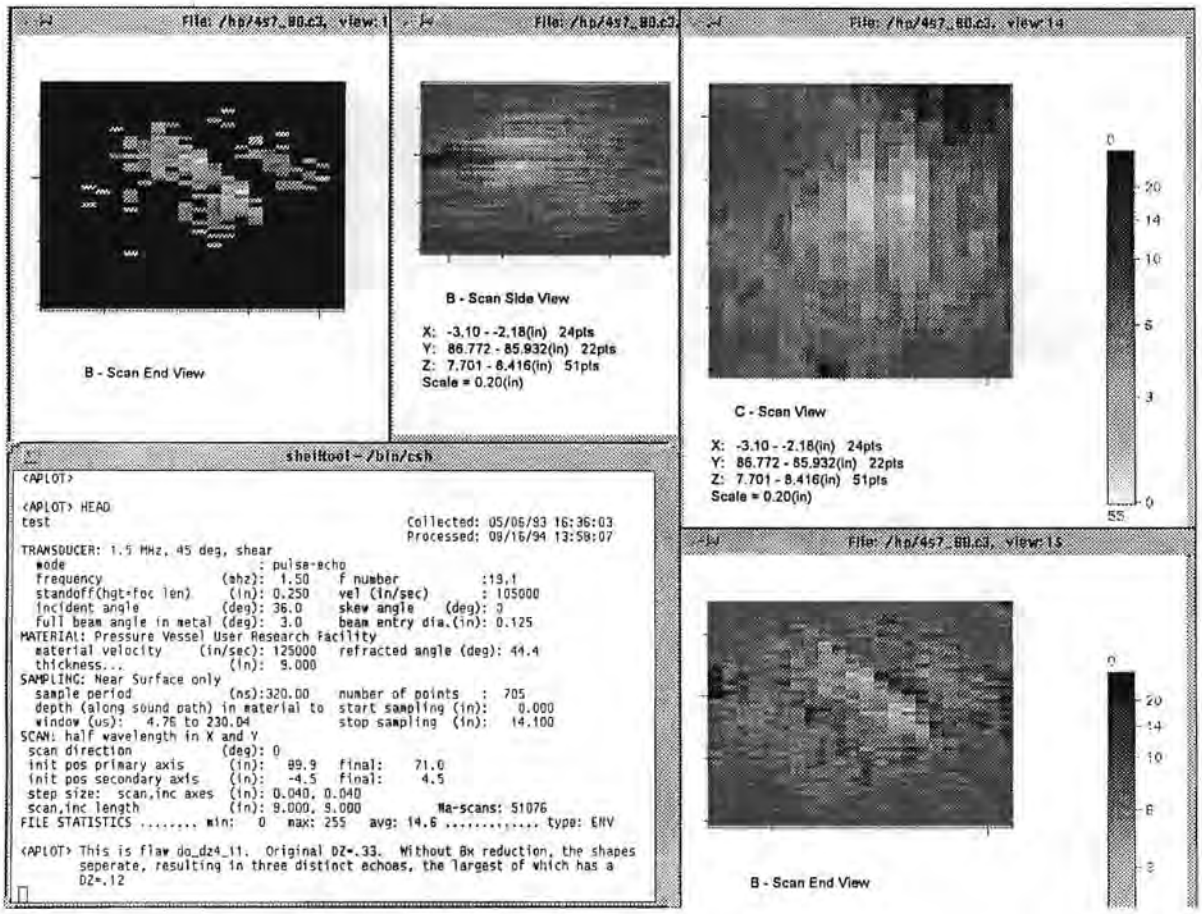
Figures A.98a-b show planar indication #11 in the base metal below 25 mm. This planar indication has a through-wall extent of 6 mm based on tip signal pattern. The detection was made in mode 8 where it displayed a pair of TOF shapes. The shape quality is good for this indication. There were no confirmations in other modes. The indication is characterized as planar based on the tip signal pattern. The length is 23 mm and was made to LOS in mode 8. The aspect ratio (length/depth) of this indication is 4 which tends to confirm the large through-wall extent. The maximum amplitude-to-noise ratio is of medium range at 68 to 25. The X coordinate of -70 mm shows that the indication is in the base metal. The Z coordinate of 203 mm shows that the indication is in the outer third of the vessel.

Figure A.98a - Planar indication #11 in the base metal below 25 mm: mode 8

Figure A.98b - Planar indication #11 in the base metal below 25 mm: mode 7

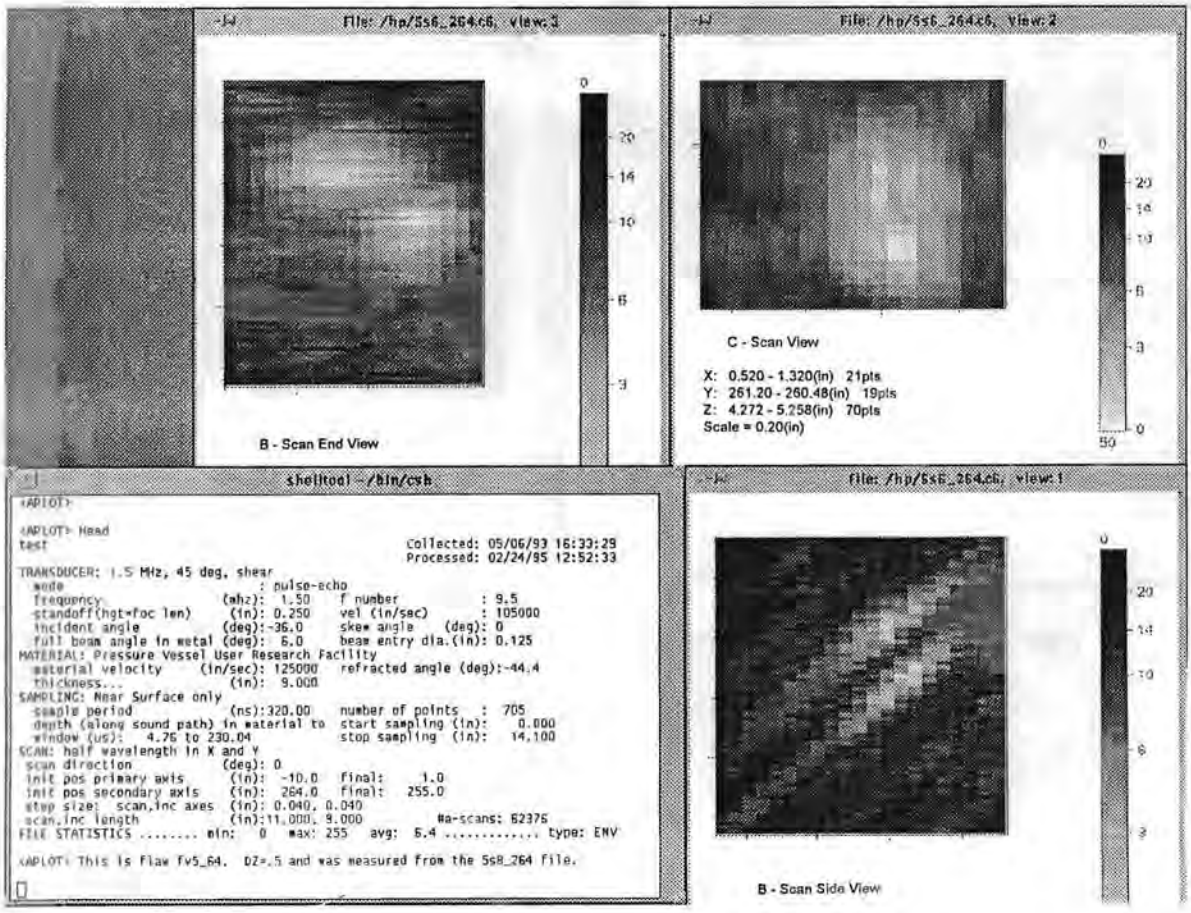
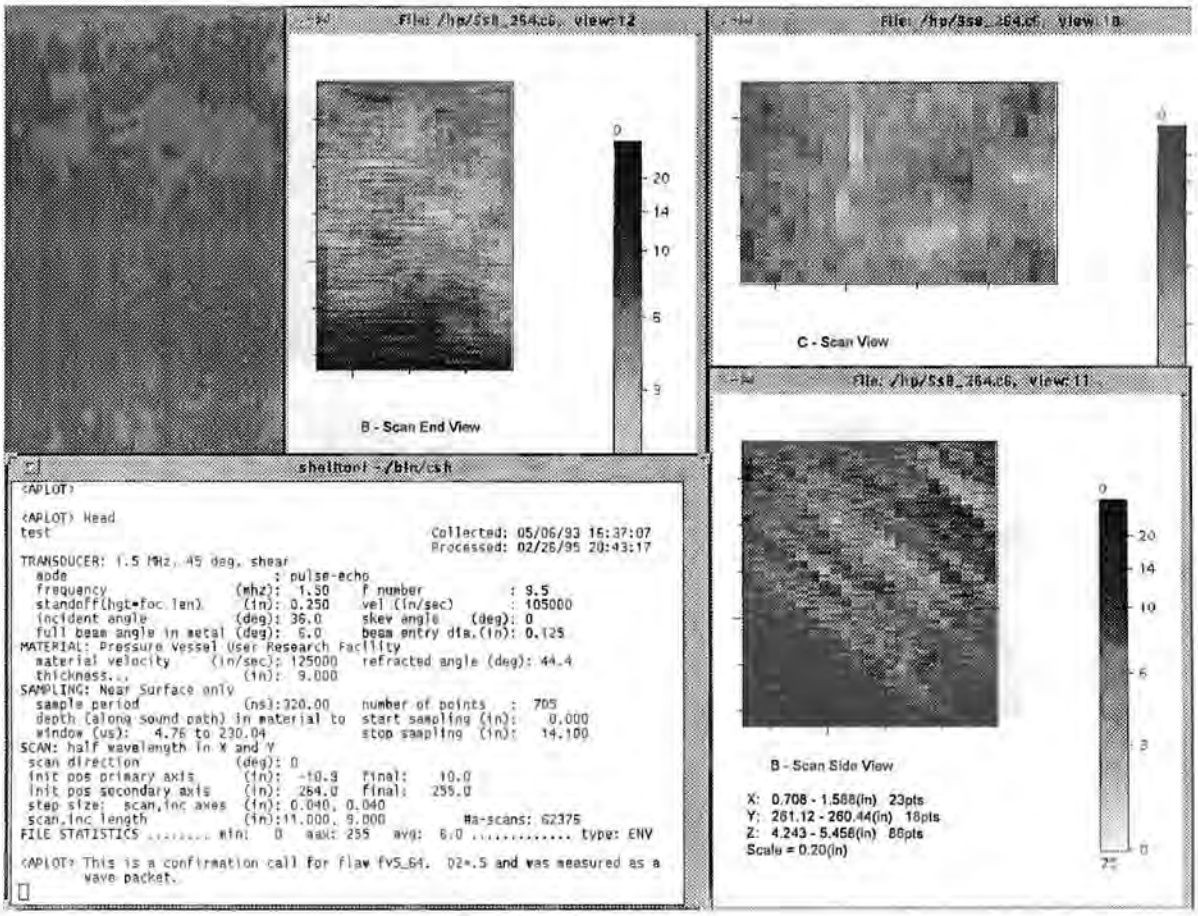
Figures A.99a-b show planar indication #12 in the base metal below 25 mm. This planar indication has a through-wall extent of 6 mm based on tip signal pattern. The detection was made in mode 6 where it displayed a pair of TOF shapes at a depth of 118 mm. The shape quality is good for this indication. There was a confirmation in mode 8 at a depth of 119 mm. Based on LOS in a cloud like shape, the confirmation mode gave a through-wall extent estimate of 13 mm. The two Z values of 118 to 119 mm give an alternate depth size of 1 mm. The indication is characterized as planar based on the tip signal pattern. The length is 17 mm and was made to LOS in mode 6. The range of aspect ratios (length/depth) of this indication is 1.3 to 2.8. The maximum amplitude-to-noise ratio is of medium range at 50 to 15. The X coordinate of 25 mm shows that the indication is in the base metal, possibly in the HAZ. The Z coordinate of 118 mm shows that the indication is in the middle third of the vessel.

Figure A.99a - Planar indication #12 in the base metal below 24 mm: mode 6

Figure A.99b - Planar indication #12 in the base metal below 25 mm: mode 8

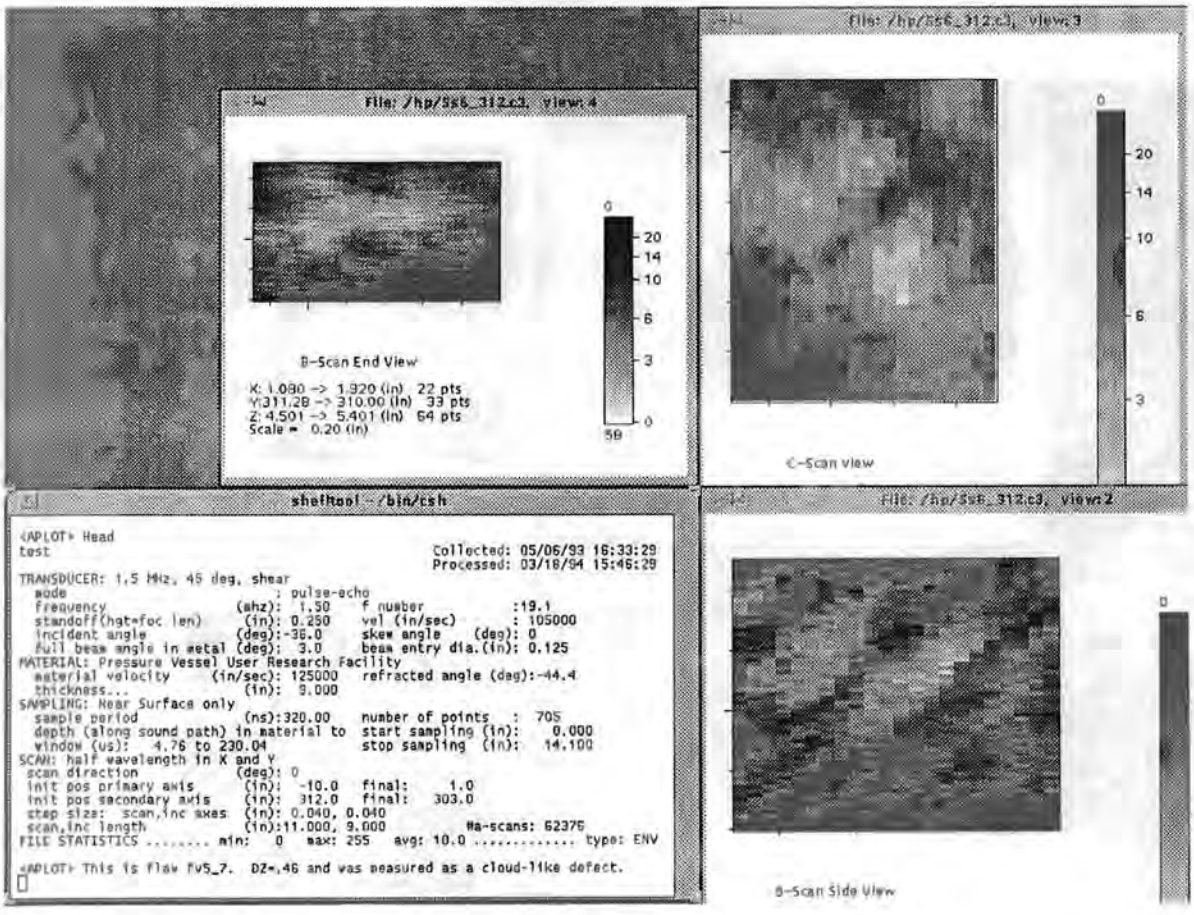
Figure A.100 shows planar indication #13 in the base metal below 25 mm. Based on LOS in a cloud like pattern, this planar indication has a through-wall extent of 4 mm. The detection was made in mode 6 where the shape was cloud like in nature at a depth of 123 mm. The shape quality for this indication is good but broken up, implying that more than one small flaw may be present. There were no confirmations in other modes. The indication is characterized as planar based on lack of detection in normal beam or orthogonal modes. The length is 30 mm and was made to LOS in mode 6. The aspect ratio (length/depth) of this indication is 8 which tends to confirm the large through-wall extent. The maximum amplitude-to-noise ratio is of medium range at 58 to 20. The X coordinate of 36 mm shows that the indication is clearly in the base metal. The Z coordinate of 123 mm shows that the indication is in the middle third of the vessel.

Figure A.100 - Planar indication #13 in the base metal below 25 mm: mode 6

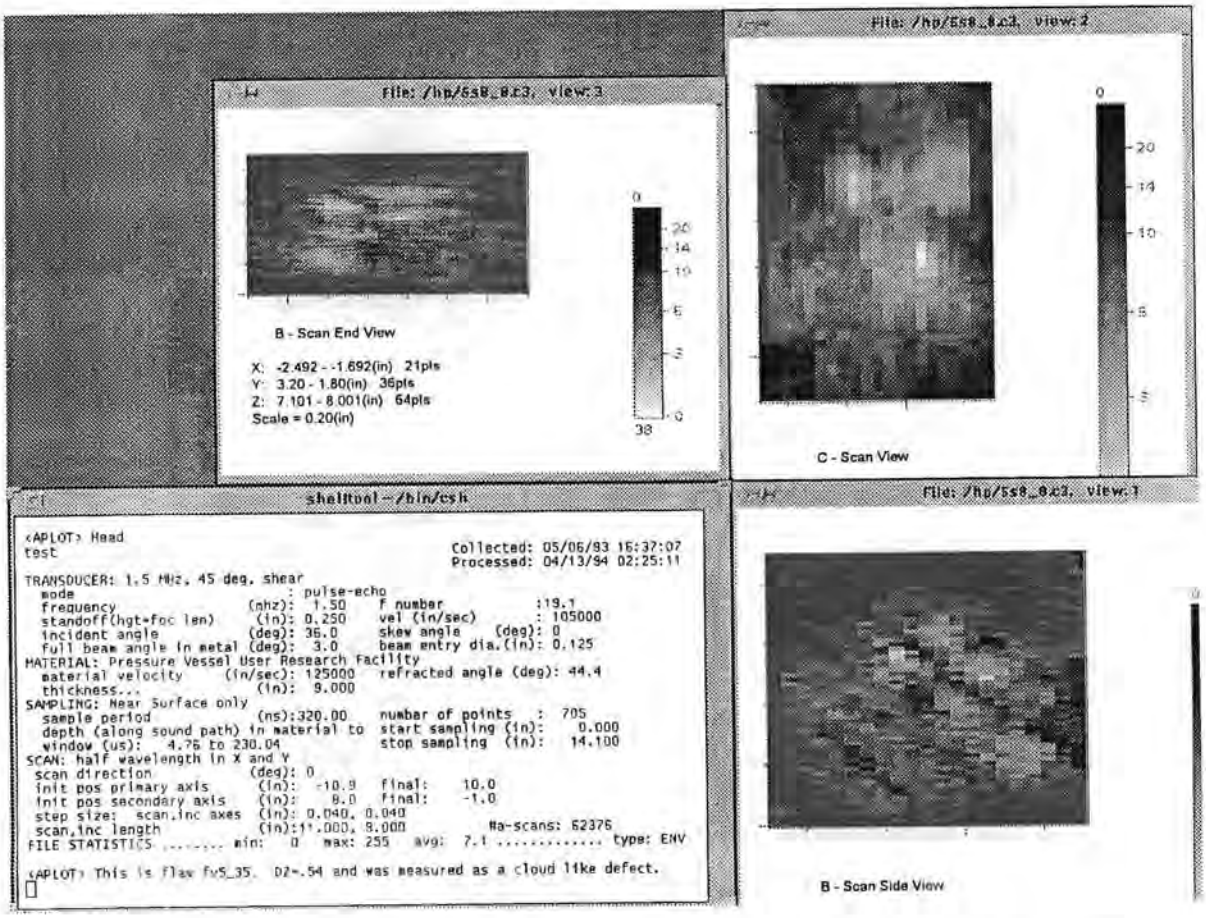
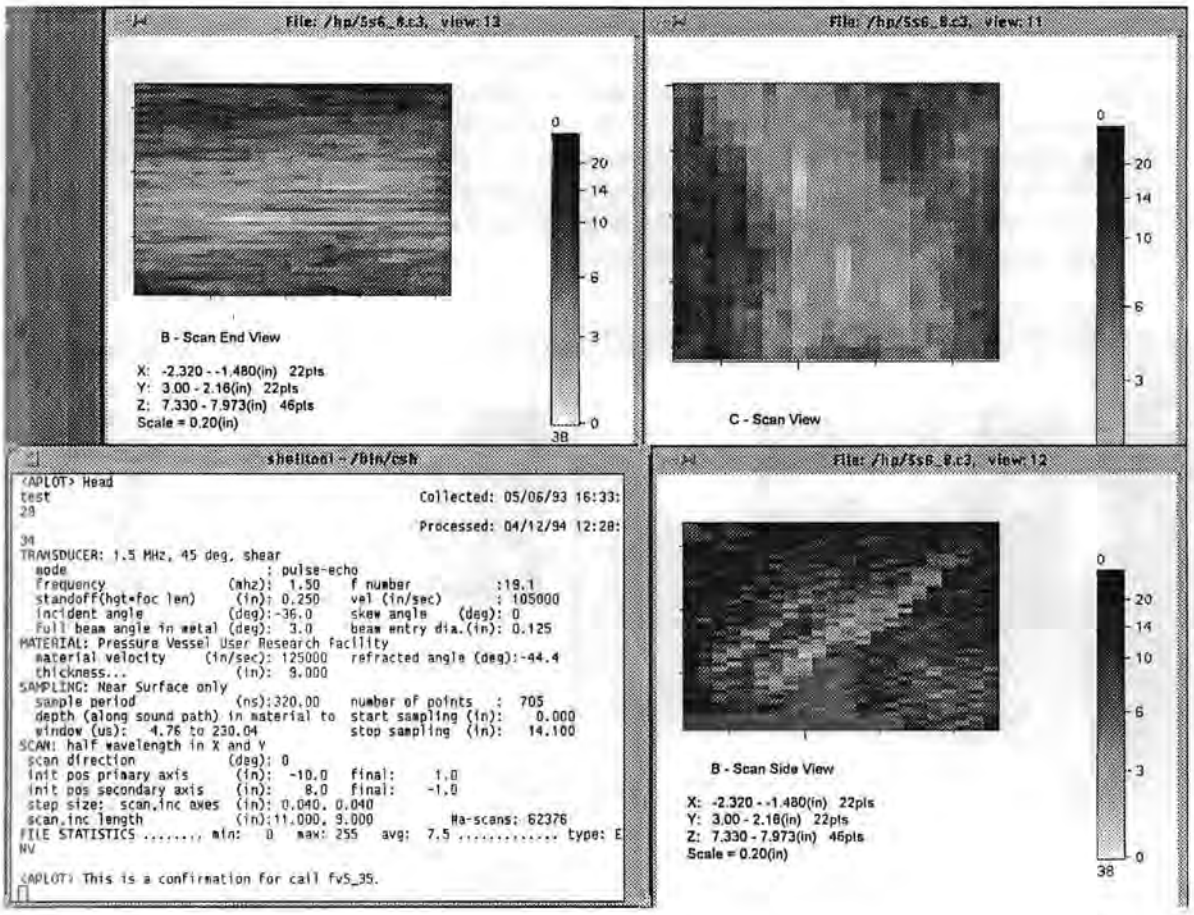
Figures A.101a-b show planar indication #14 in the base metal below 25 mm. Based on LOS in a cloud like pattern, this planar indication has a through-wall extent of 4 mm. The detection was made in mode 8 where the shape was cloud like in nature at a depth of 192 mm. The shape quality for this indication is good but broken up, implying that more than one small flaw may be present. There was a confirmation in mode 6 at a depth of 195 mm which gave a through-wall extent estimate of 4 mm based on wave packet width. The two Z values of 192 to 195 mm give an alternate depth size of 3 mm. The indication is characterized as planar based on lack of detection in normal beam or orthogonal modes. The length is 25 mm and was made to LOS in mode 8. The aspect ratio (length/depth) of this indication is 6 which tends to confirm the large through-wall extent. The maximum amplitude-to-noise ratio is of medium range at 38 to 10. The X coordinate of -49 mm shows that the indication is clearly in the base metal. The Z coordinate of 192 to 195 mm shows that the indication is in the outer third of the vessel.

Figure A.101a - Planar indication #14 in the base metal below 25 mm: mode 8

Figure A.101b - Planar indication #14 in the base metal below 25 mm: mode 6

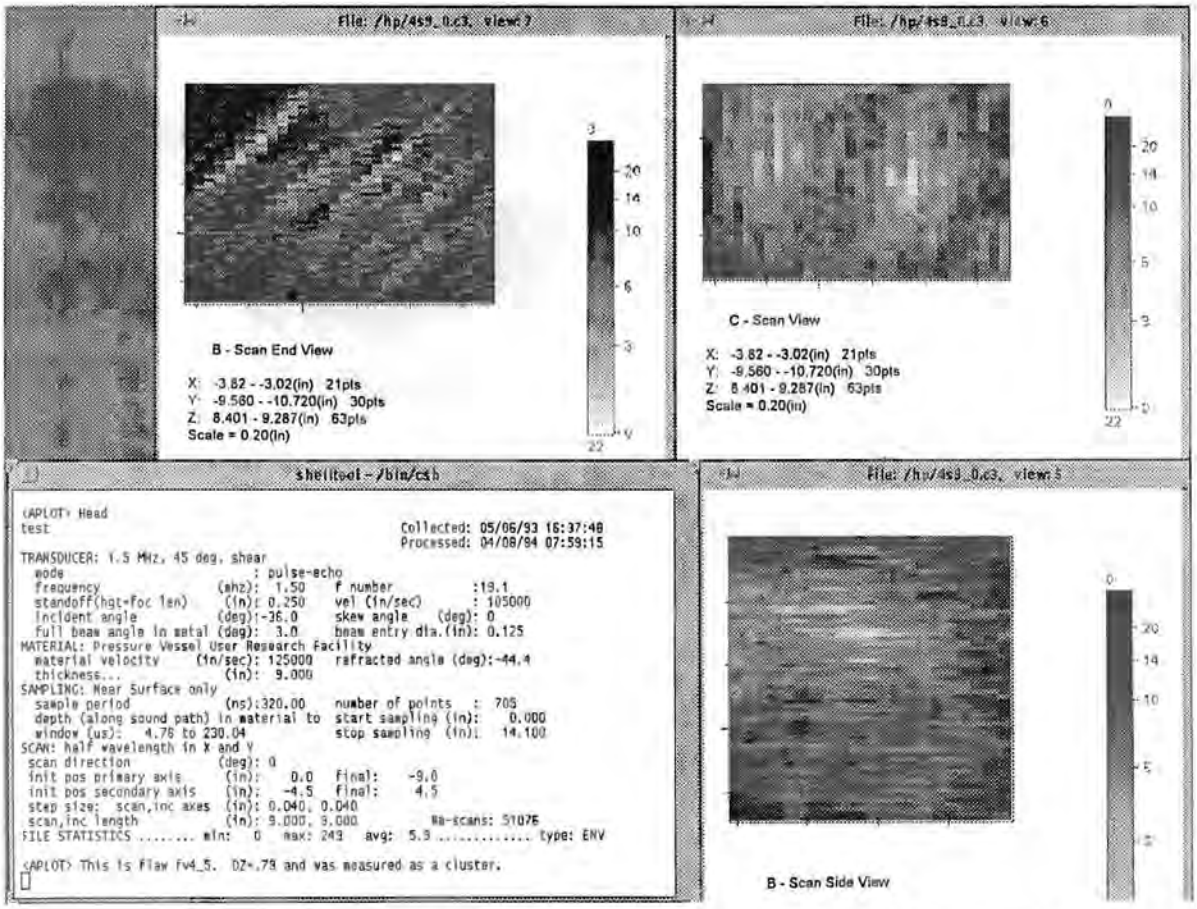
Figure A.102 shows planar indication #15 in the base metal below 25 mm. Based on LOS in a cloud like pattern, this planar indication has a through-wall extent of 4 mm. The detection was made in mode 9 where the shape was cloud like in nature at a depth of 220 mm. The shape quality for this indication is good but broken up, implying that more than one small flaw may be present. There were no confirmations in other modes. The indication is characterized as planar based on lack of detection in normal beam or orthogonal modes. The width is 18 mm and was made to LOS in mode 9. The aspect ratio (width/depth) of this indication is 4. The maximum amplitude-to-noise ratio is of medium range at 25 to 7. The X coordinate of 90 mm shows that the indication is clearly in the base metal. The Z coordinate of 220 mm shows that the indication is in the near the outer wall of the of the vessel.

Figure A.102 - Planar indication #15 in the base metal below 25 mm: mode 9

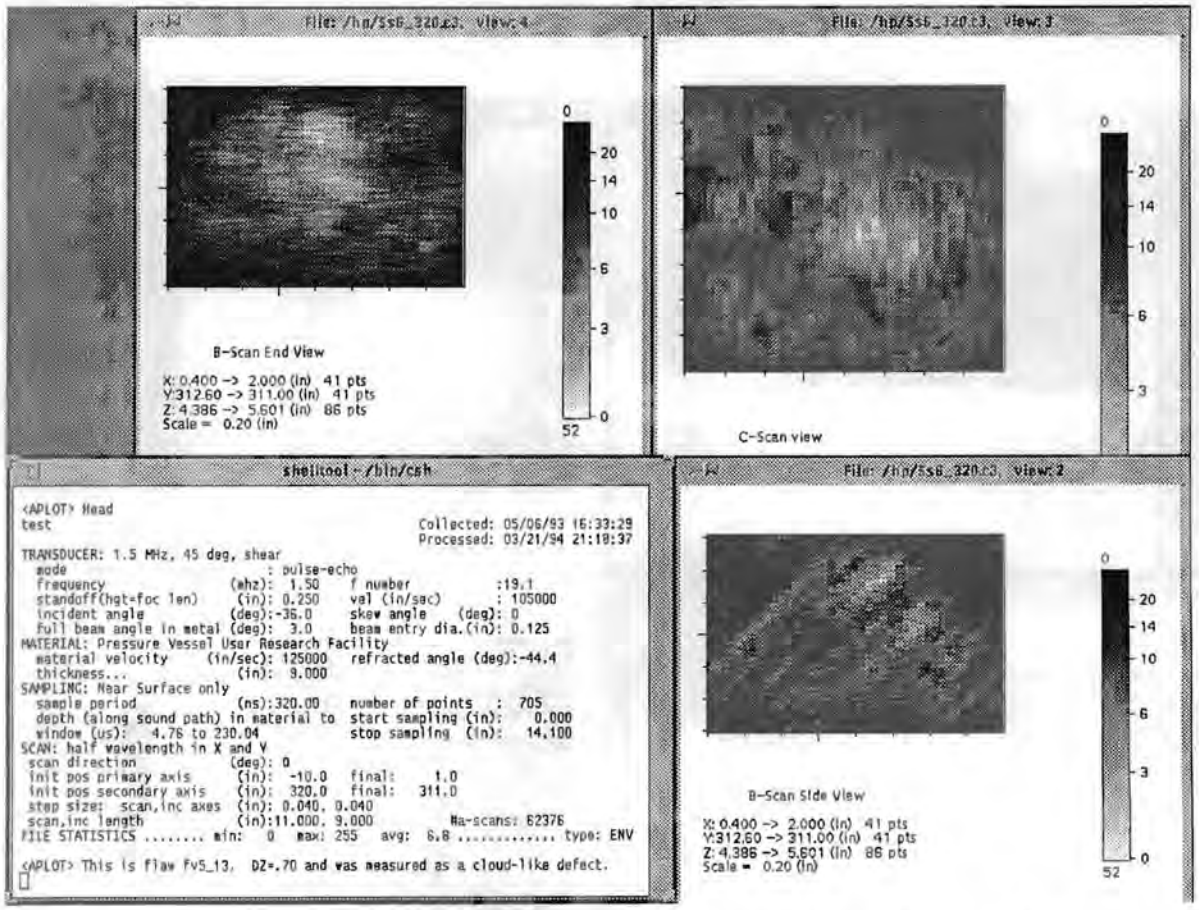
Figure A.103 shows planar indication #16 in the base metal below 25 mm. Based on LOS in a cloud like pattern, this planar indication has a through-wall extent of 4 mm. The detection was made in mode 6 where the shape was cloud like in nature at a depth of 122 mm. The shape quality for this indication is good but broken up, implying that more than one small flaw may be present. There were no confirmations in other modes. The indication is characterized as planar based on lack of detection in normal beam or orthogonal modes. The length is 15 mm and was made to LOS in mode 6. The aspect ratio (length/depth) of this indication is 4. The maximum amplitude-to-noise ratio is of medium range at 52 to 14. The X coordinate of 36 mm shows that the indication is clearly in the base metal. The Z coordinate of 122 mm shows that the indication is in the middle third of the vessel.

Figure A.103 - Planar indication #16 in the base metal below 25 mm: mode 6
