NUREG/CR-6471, Vol. 1
PNNL-11143

Characterization of Flaws in U.S. Reactor Pressure Vessels

Density and Distribution of Flaw Indications in PVRUF

Pacific Northwest National Laboratory

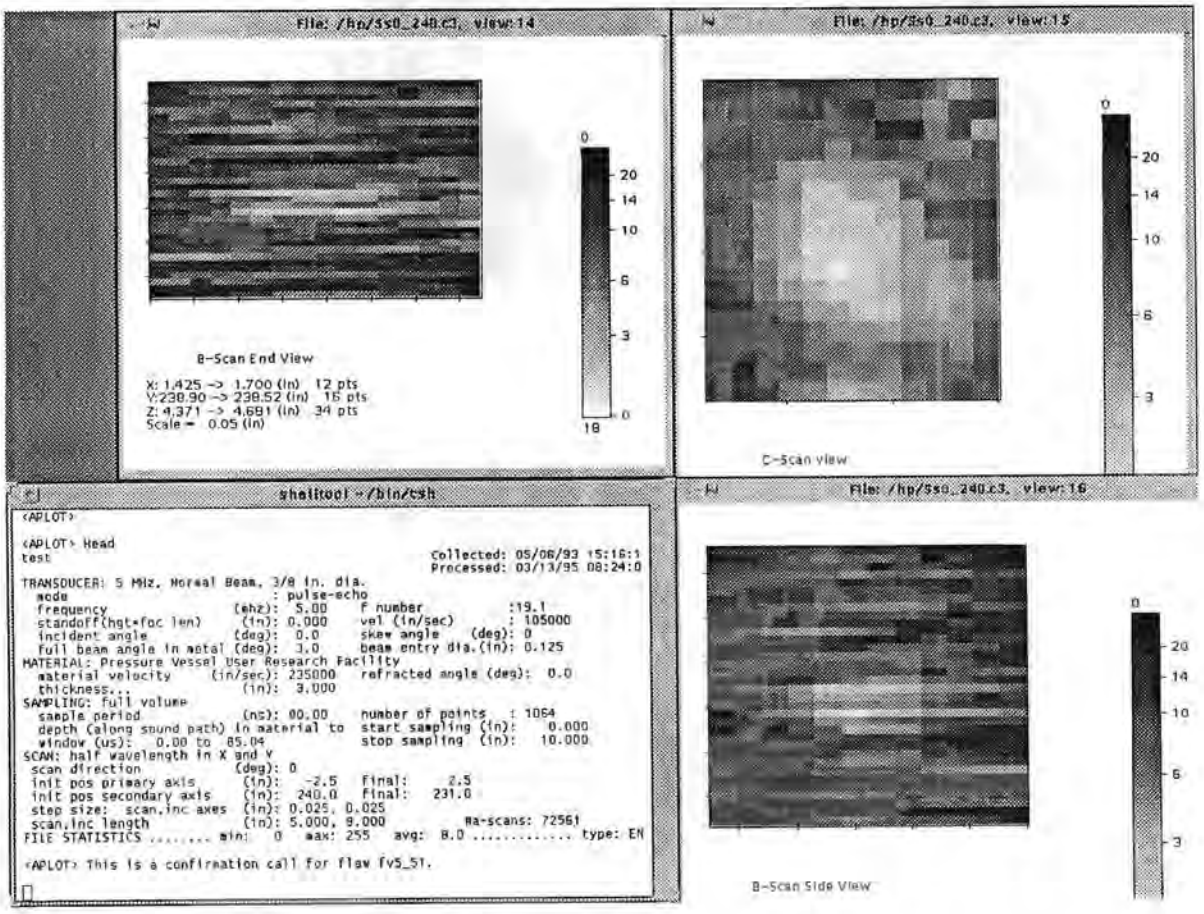
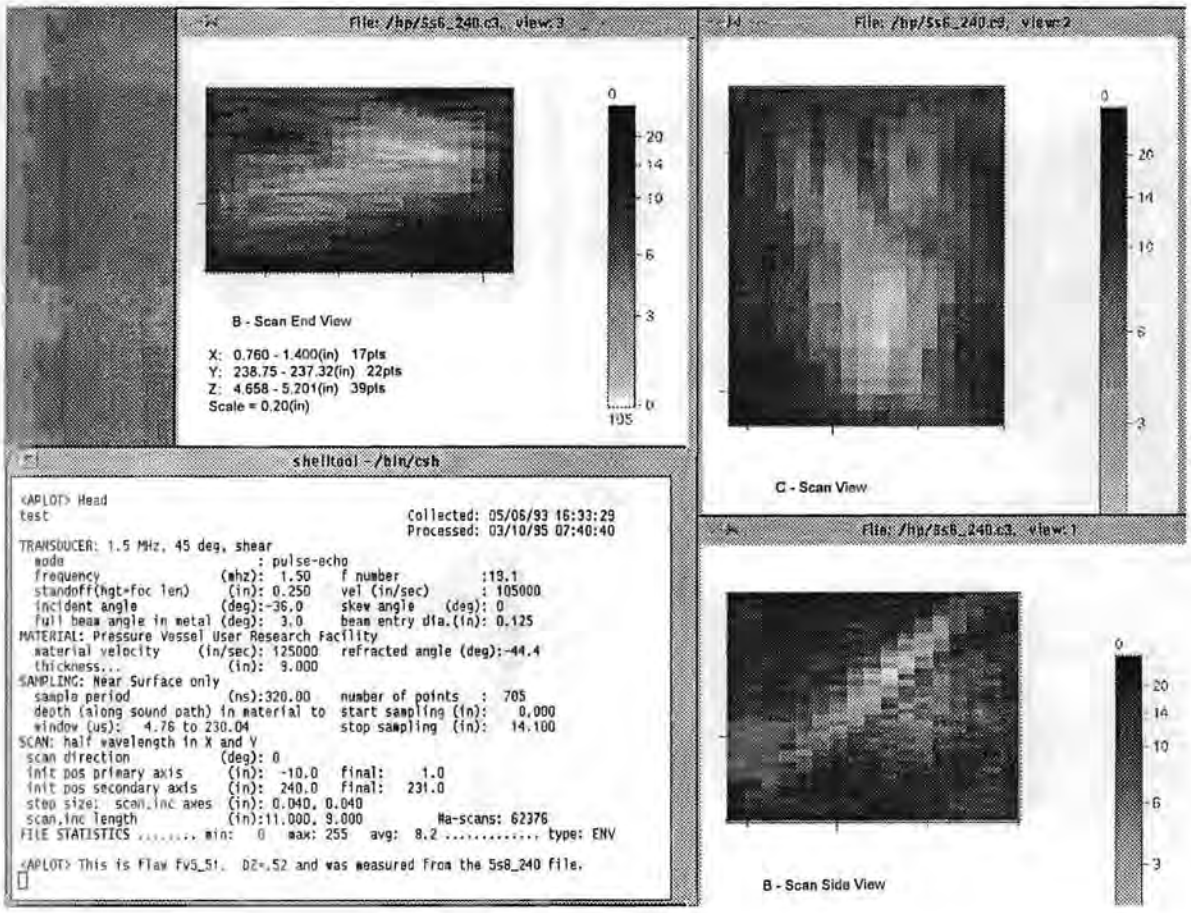
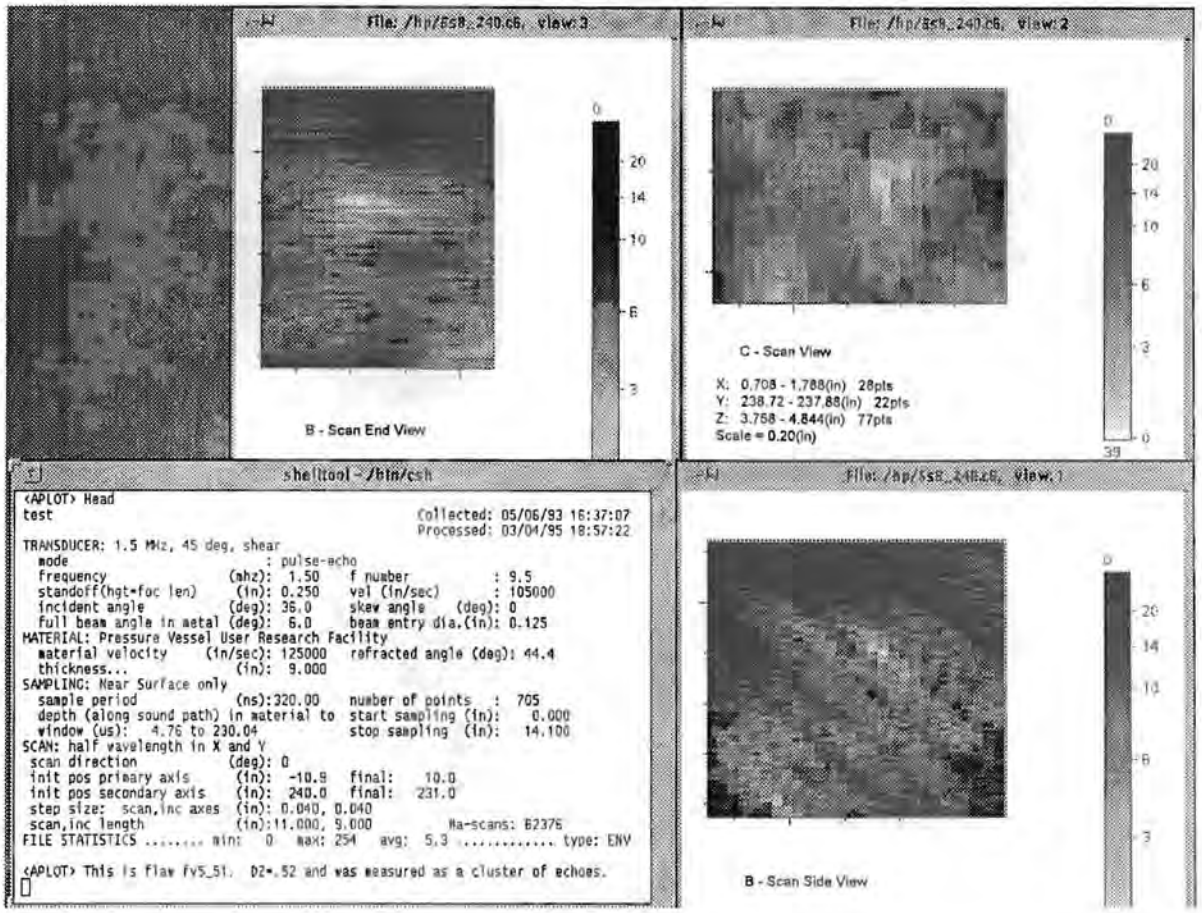
Figures A.104a-c show volumetric indication #1 in the base metal below 25 mm. Based on LOS in a cloud like pattern, this volumetric indication has a through-wall extent of 7 mm. The detection was made in modes 6 and 8. In mode 8 the shape was cloud like in nature at a depth of 108 mm. In mode 6 a through-wall extent estimate of 1 mm was obtained from a wave packet width. The shape quality is good for this indication. There was a confirmation in mode 10 at a depth of 115 mm. The two Z values of 108 to 115 mm give an alternate depth size of 7 mm. The indication is characterized as volumetric based on normal beam detection. The length is 19 mm and was made to LOS in mode 6. The width is 6 mm and was made to LOS in mode 10. The aspect ratio (length/depth) of this indication is 3. The maximum amplitude-to-noise ratio is high at 105 to 25. The X coordinate of 28 mm shows that the indication is in the base metal. The Z coordinate of 107 to 115 mm shows that the indication is in the middle third of the vessel.

Figure A.104a - Volumetric indication #1 in the base metal below 25 mm: mode 10

Figure A.104b - Volumetric indication #1 in the base metal below 25 mm: mode 6

Figure A.104c - Volumetric indication #1 in the base metal below 25 mm: mode 8

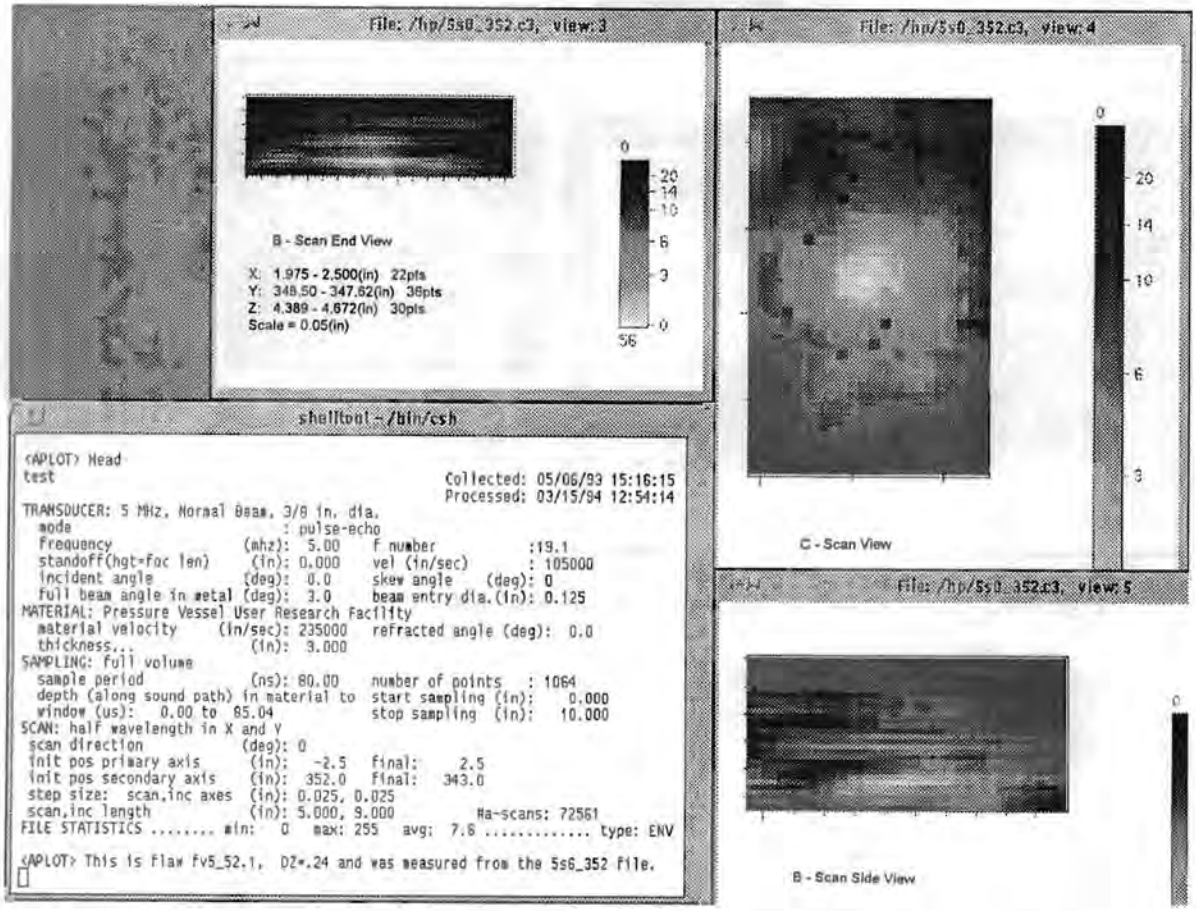
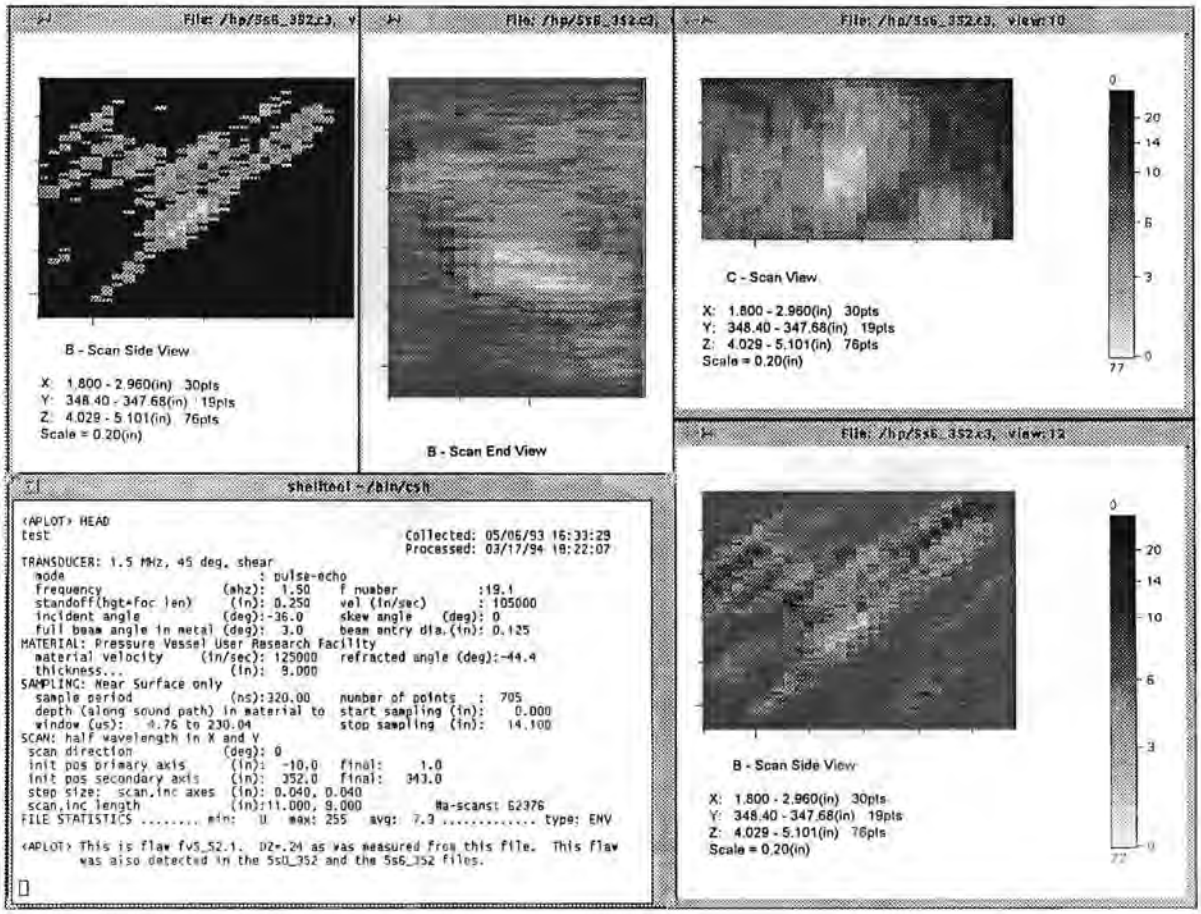
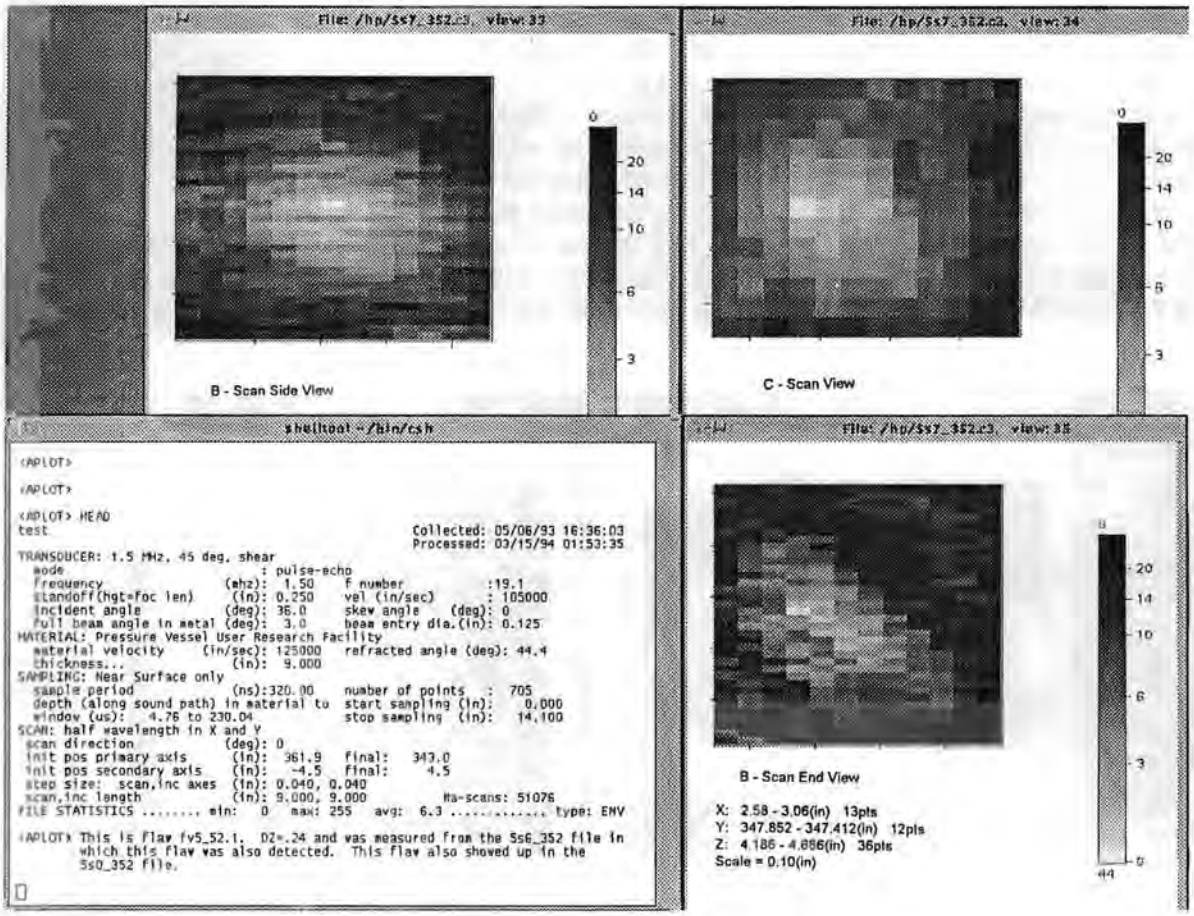
Figures A.105a-c show volumetric indication #2 in the base metal below 25 mm. Based on wave packet width in mode 6, this volumetric indication has a through-wall extent of 5 mm. The detection was made in modes 6,7, and 10. In mode 6 it displayed TOF shape at a depth of 118 mm, while in mode 7 it displayed TOF shape at a depth of 113 mm and gave a through-wall extent of 3 mm based on wave packet width. The detection in mode found the indication at a depth of 117 mm. The different Z values of 113 to 118 mm give an alternate depth size of 5 mm. The indication is characterized as volumetric based on normal beam detection. The length is 19 mm and was made to LOS in mode 10. The width is 11 mm and was made to LOS in mode 10. The aspect ratio (length/depth) of this indication is 4 which tends to confirm the large through-wall extent. The maximum amplitude-to-noise ratio is high at 77 to 17. The X coordinate of 58 mm shows that the indication is clearly in the base metal. The Z coordinate of 113 to 118 mm shows that the indication is in the middle third of the vessel.

Figure A.105a - Volumetric indication #2 in the base metal below 25 mm: mode 10

Figure A.105b - Volumetric indication #2 in the base metal below 25 mm: mode 6

Figure A.105c - Volumetric indication #2 in the base metal below 25 mm: mode 7

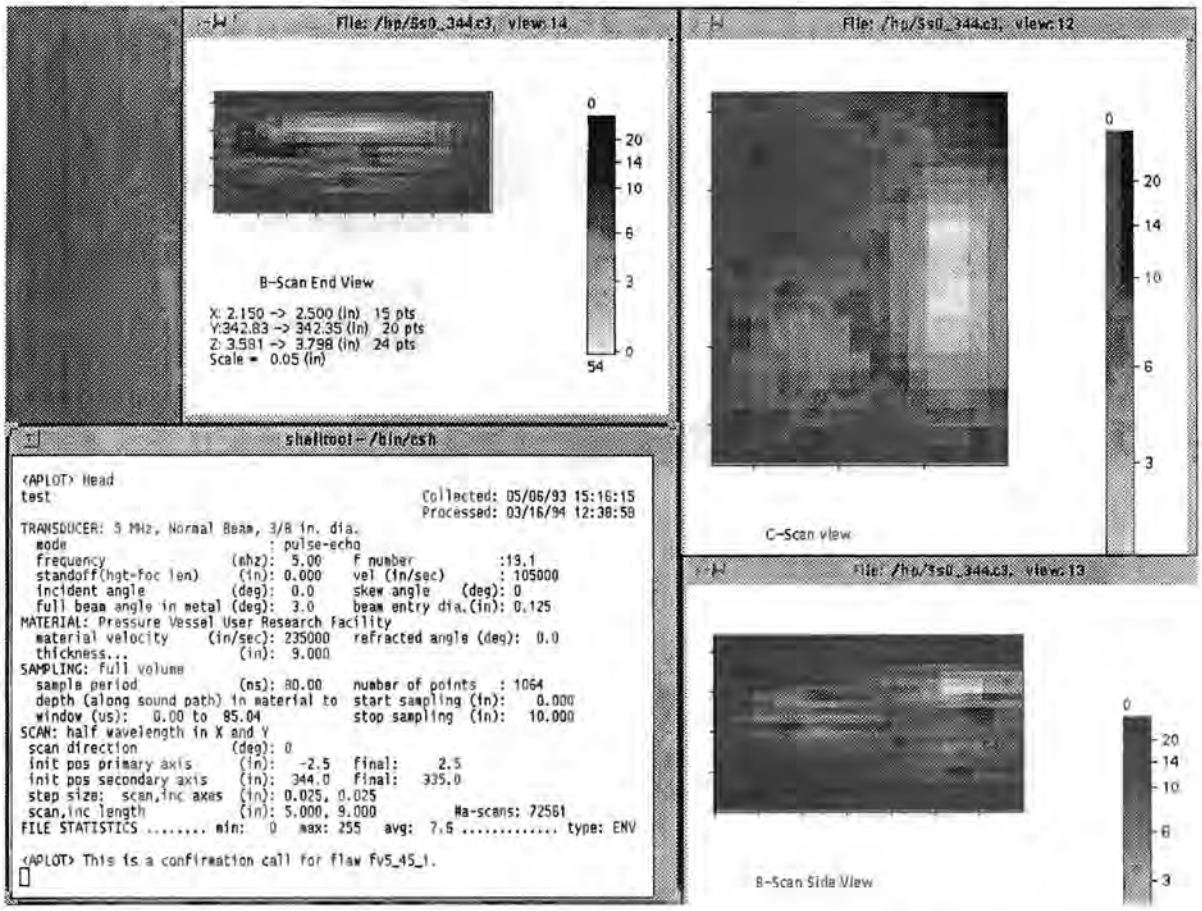
Figures A.106a-e show volumetric indication #3 in the base metal below 25 mm. This volumetric indication has a through-wall extent of 5 mm based on wave packet width. The detection was made in mode 8 where it had isolated TOF shape at a depth of 91 mm. More than one TOF shape was present. The shape quality for this indication is good but broken up, implying that more than one small flaw may be present. There were confirmations in modes 6,7,9, and 10 at depths of 86 to 96 mm. The confirmation modes gave a through-wall extent estimate of 3 to 4 mm based on wave packet width. The different Z values of 86 to 96 mm give an alternate depth size of 10 mm. The indication is characterized as volumetric based on normal beam detection and detection in orthogonal modes. The length is 12 mm and was made to LOS in mode 6. The width is 48 mm and was made to LOS in mode 9. The aspect ratio (width/depth) of this indication is 10. The maximum amplitude-to-noise ratio is of medium range at 35 to 10. The X coordinate of 56 mm shows that the indication is clearly in the base metal. The Z coordinate of 86 to 96 mm shows that the indication is in the middle third of the vessel.

Figure A.106a - Volumetric indication #3 in the base metal below 25 mm: mode 10

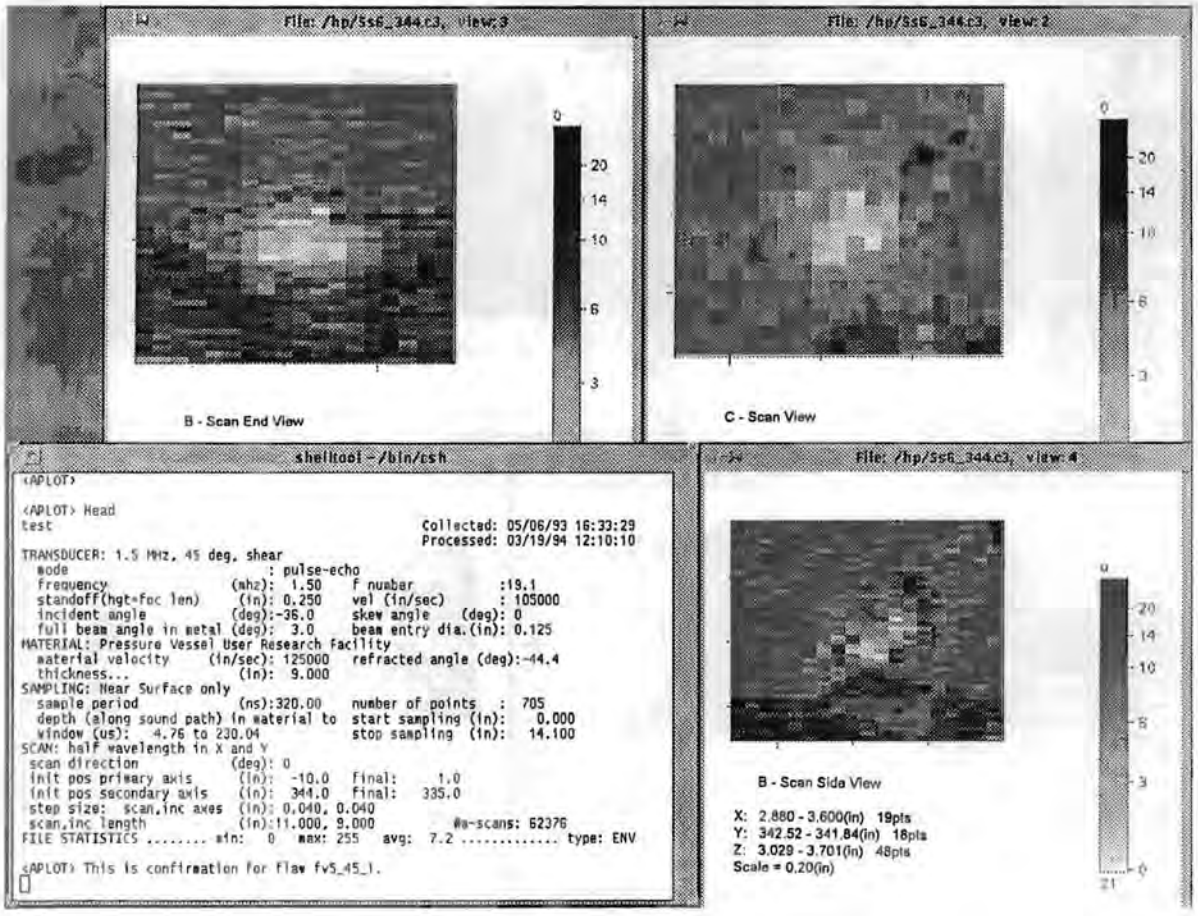
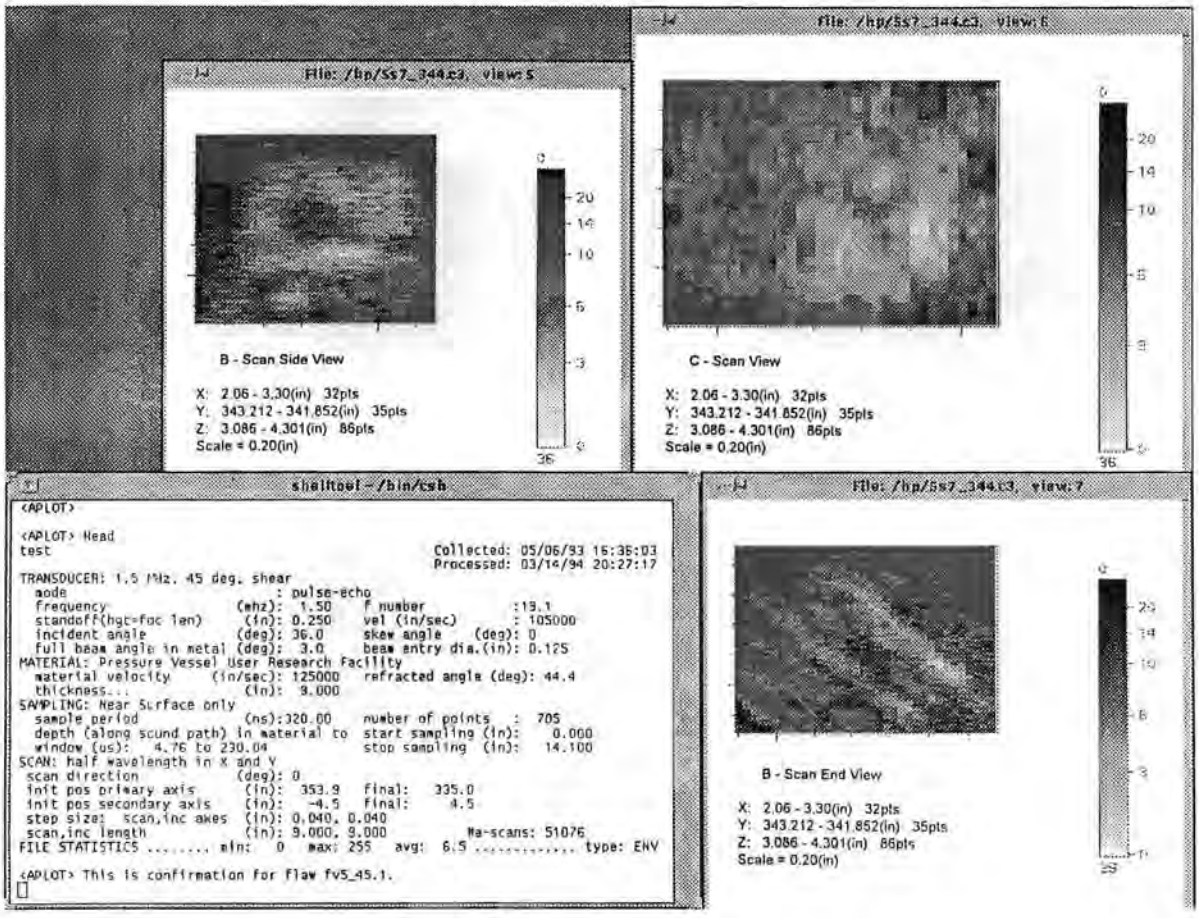
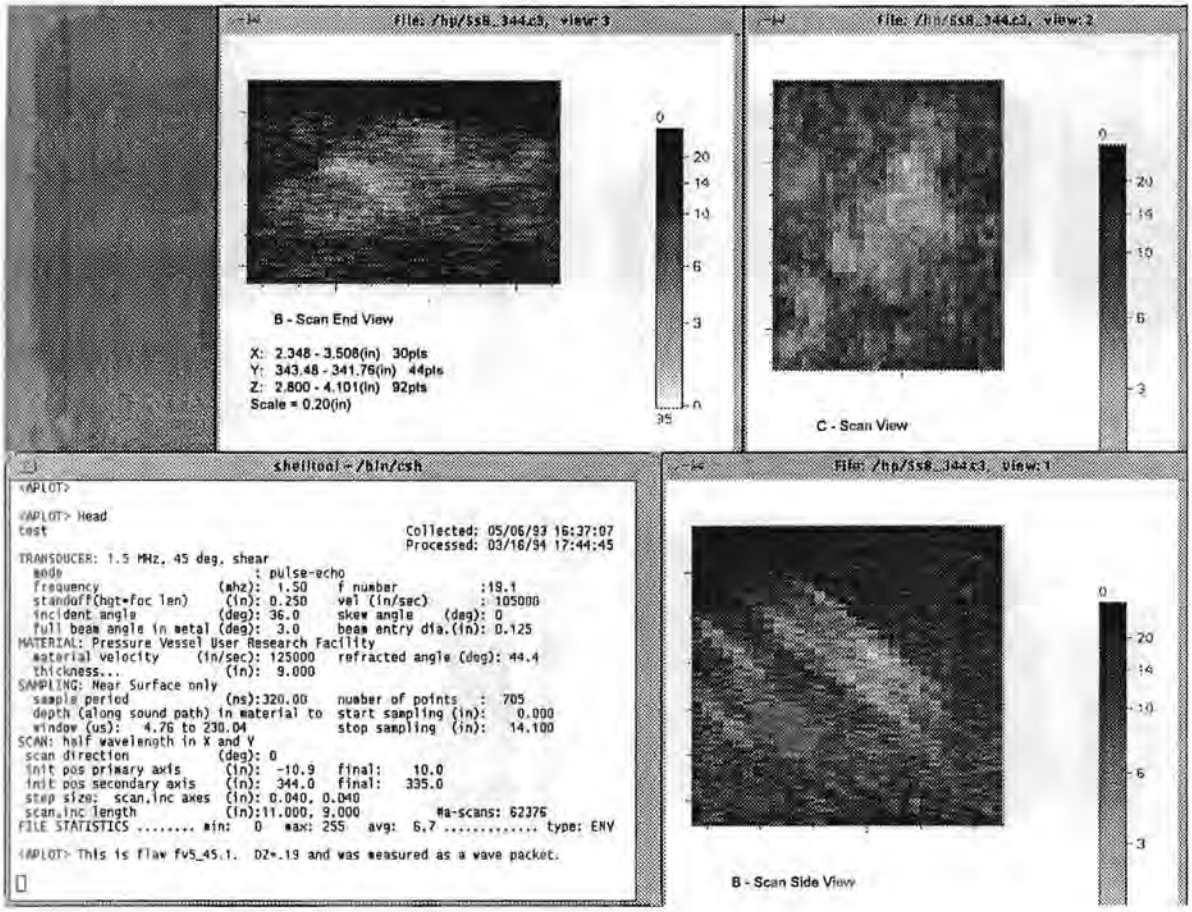
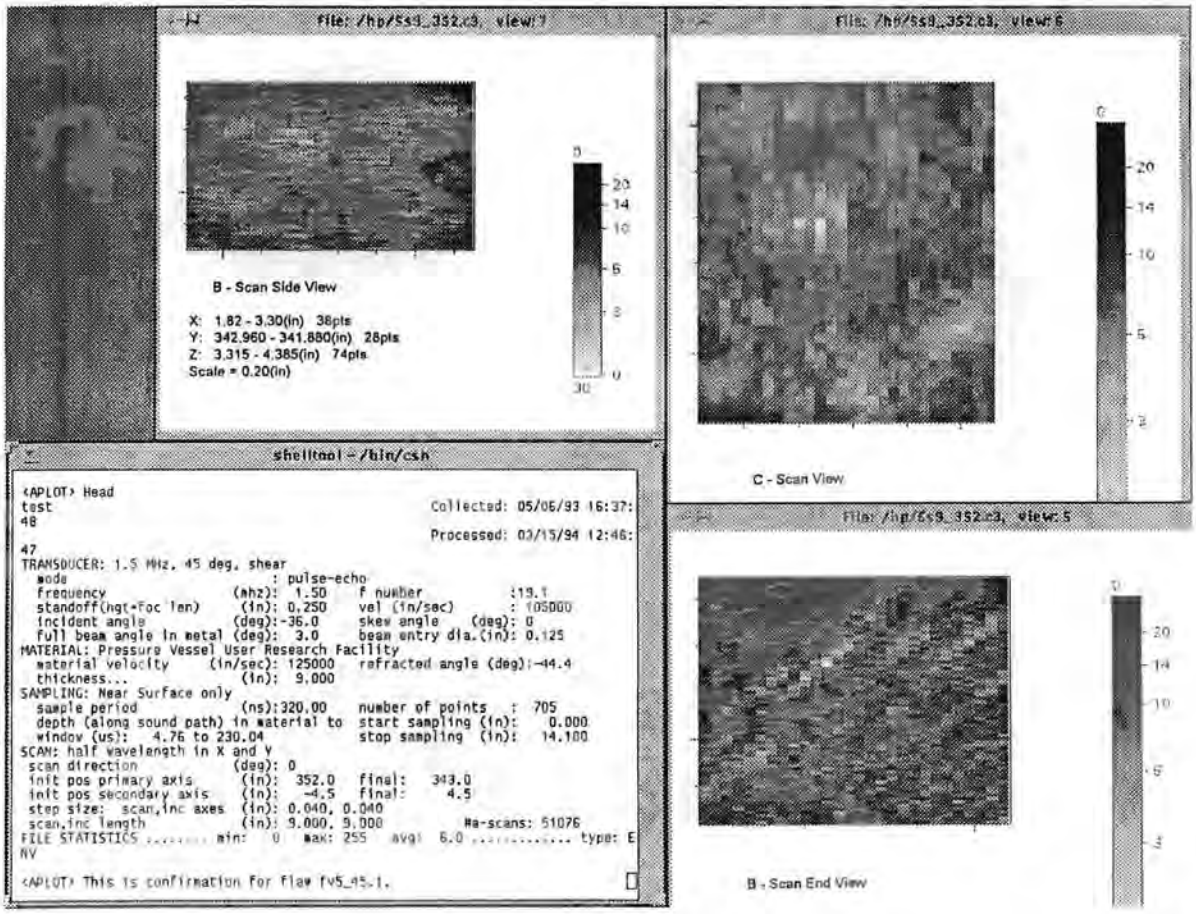
Figure A.106b - Volumetric indication #3 in the base metal below 25 mm: mode 6

Figure A.106c - Volumetric indication #3 in the base metal below 25 mm: mode 7

Figure A.106d - Volumetric indication #3 in the base metal below 25 mm: mode 8

Figure A.106e - Volumetric indication #3 in the base metal below 25 mm: mode 9

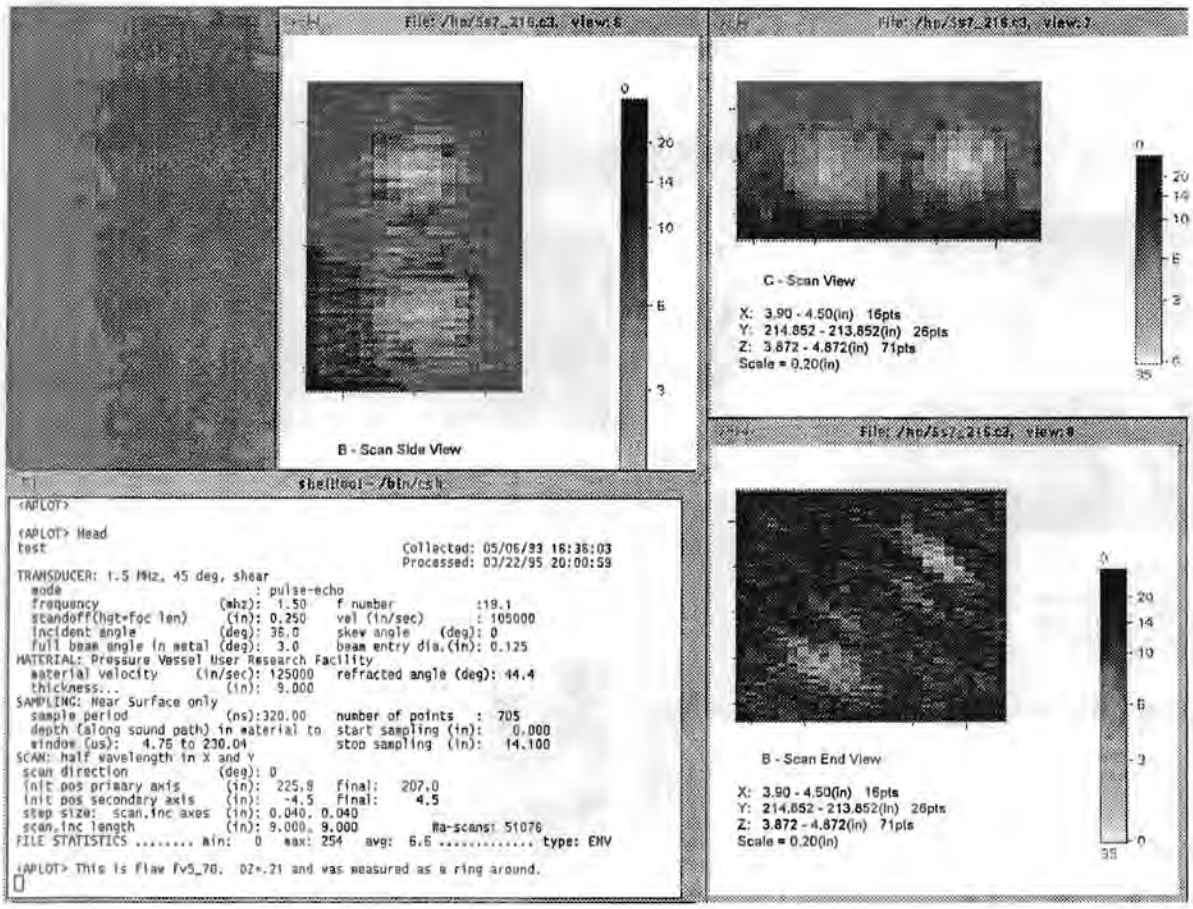
Figure A.107 shows volumetric indication #4 in the base metal below 25 mm. This volumetric indication has a through-wall extent of 5 mm based on ring around pattern. The detection was made in mode 7 where it displayed a pair of TOF shapes at a depth of 106 mm. The shape quality is good for this indication. There were no confirmations in other modes. The indication is characterized as volumetric based on the detection of ring around shape. The width is 9 mm and was made to LOS in mode 7. The aspect ratio (width/depth) of this indication is 1.8. The maximum amplitude-to-noise ratio is high at 35 to 8. The X coordinate of 108 mm shows that the indication is clearly in the base metal. The Z coordinate of 106 mm shows that the indication is in the middle third of the vessel.

Figure A.107 - Volumetric indication #4 in the base metal below 25 mm: mode 7

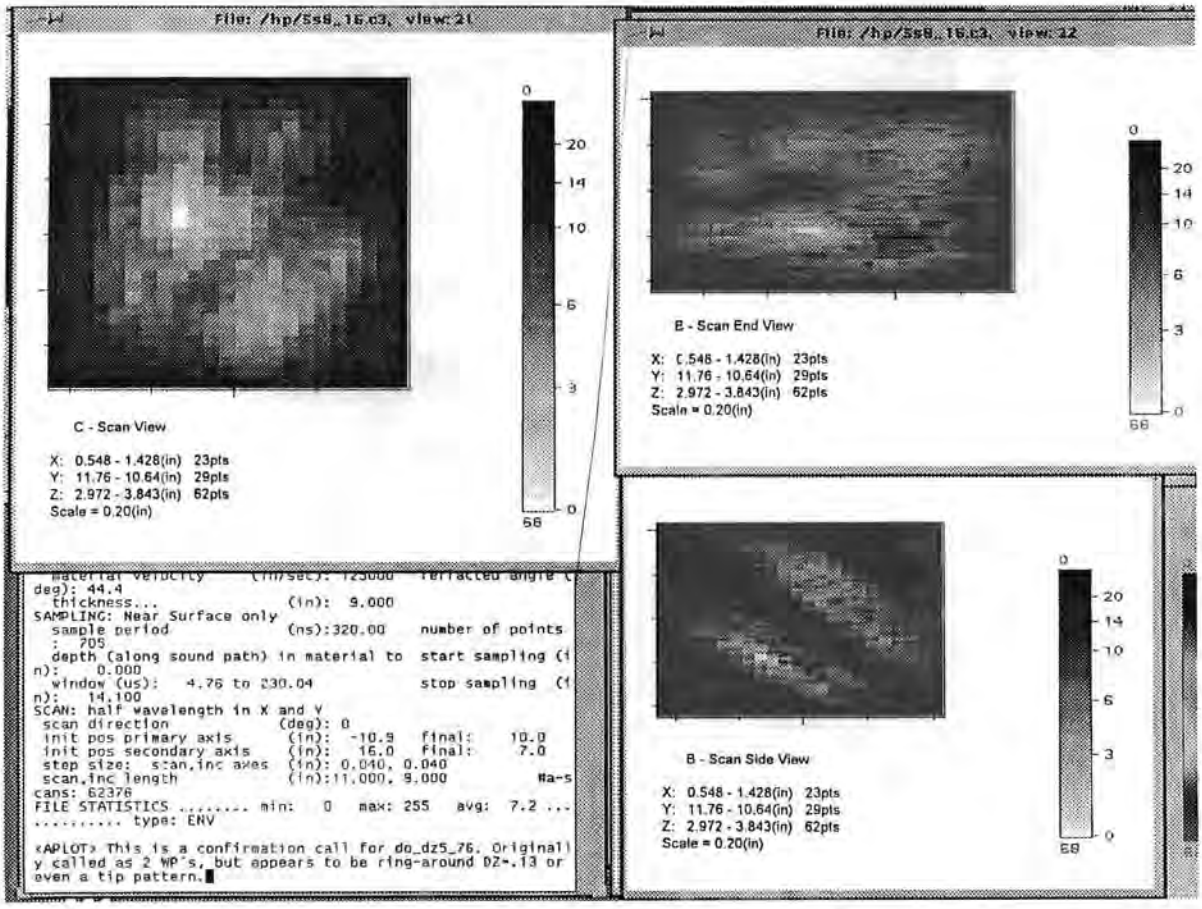
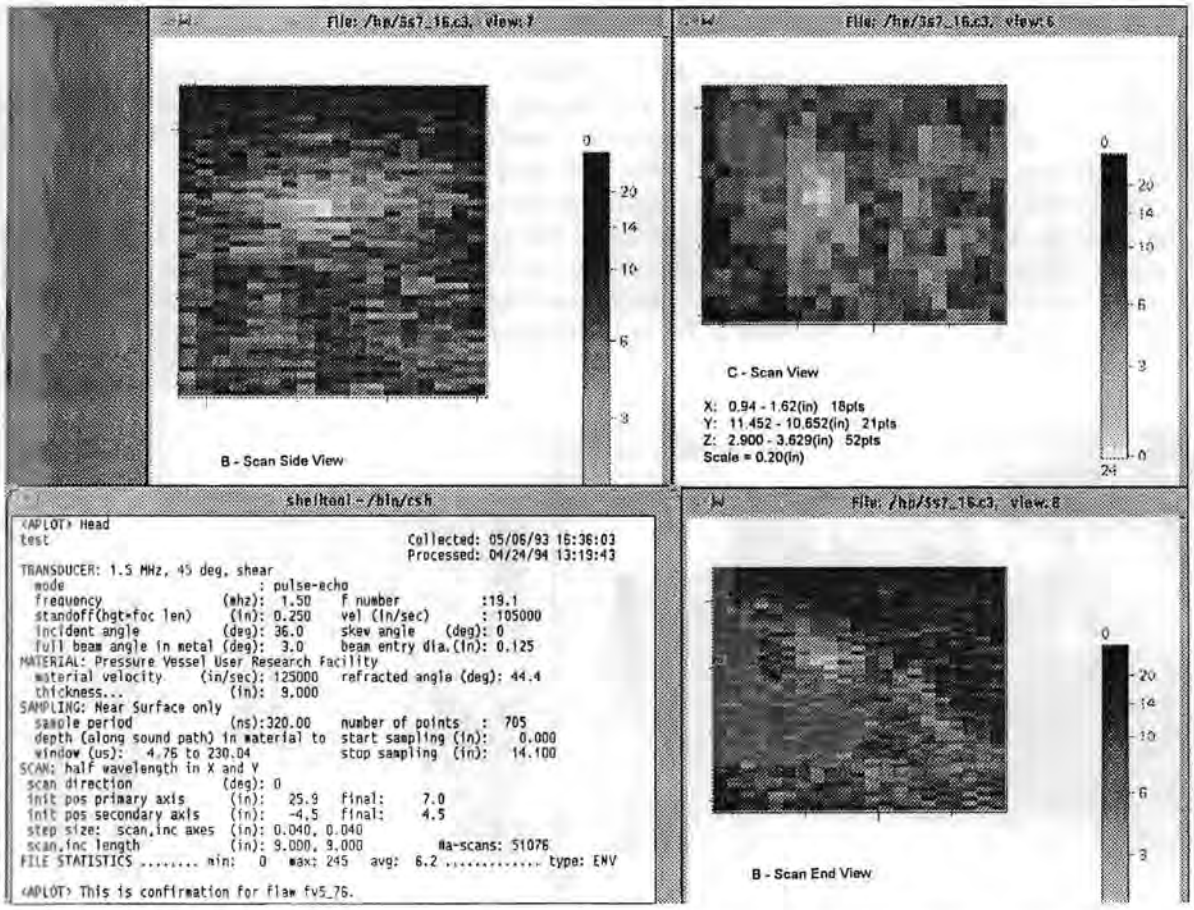
Figures A.108a-b show volumetric indication #5 in the base metal below 25 mm. This volumetric indication has a through-wall extent of 5 mm based on wave packet width. The detection was made in mode 6 where it had isolated TOF shape at a depth of 85 mm. The shape quality is good for this indication. There were confirmations in modes 7 and 8 at depths of 81 and 82 mm. The confirmation mode gave a through-wall extent estimate of 1 mm based on wave packet width and 4 mm based on ring around pattern. The different Z values of 81 to 85 mm give an alternate depth size of 4 mm. The indication is characterized as volumetric based on detection in orthogonal modes and the detection of ring around shape. The length is 28 mm and was made to LOS in mode 6. The width is 14 mm and was made to LOS in mode 7. The range of aspect ratios (length/depth) of this indication is 6 to 7 which tends to confirm the large through-wall extent. The maximum amplitude-to-noise ratio is high at 63 to 13. The X coordinate of 29 mm shows that the indication is in the base metal, possibly in the HAZ. The Z coordinate of 81 to 85 mm shows that the indication is in the middle third of the vessel.

Figure A.108a - Volumetric indication #5 in the base metal below 25 mm: mode 8

-Figure A.108b - Volumetric indication #5 in the base metal below 25 mm: mode 7

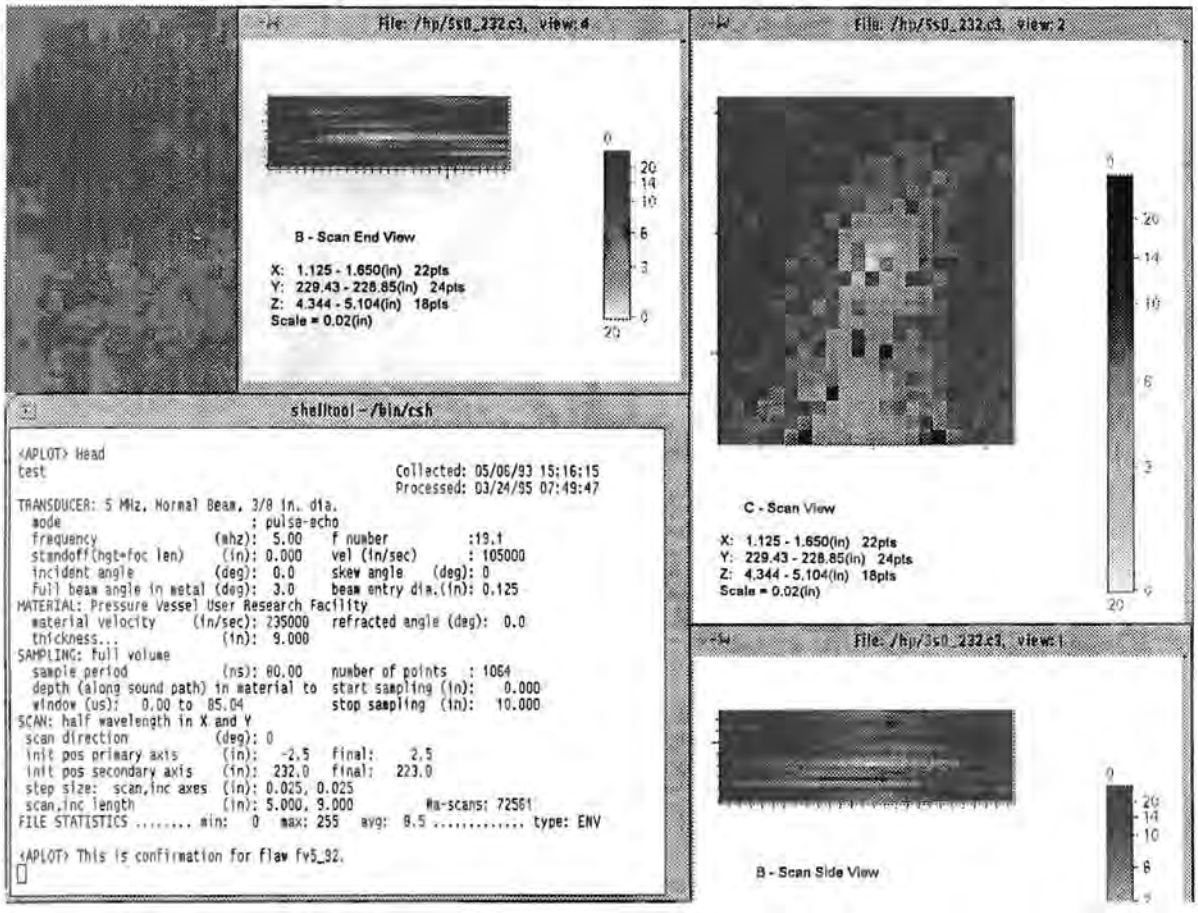
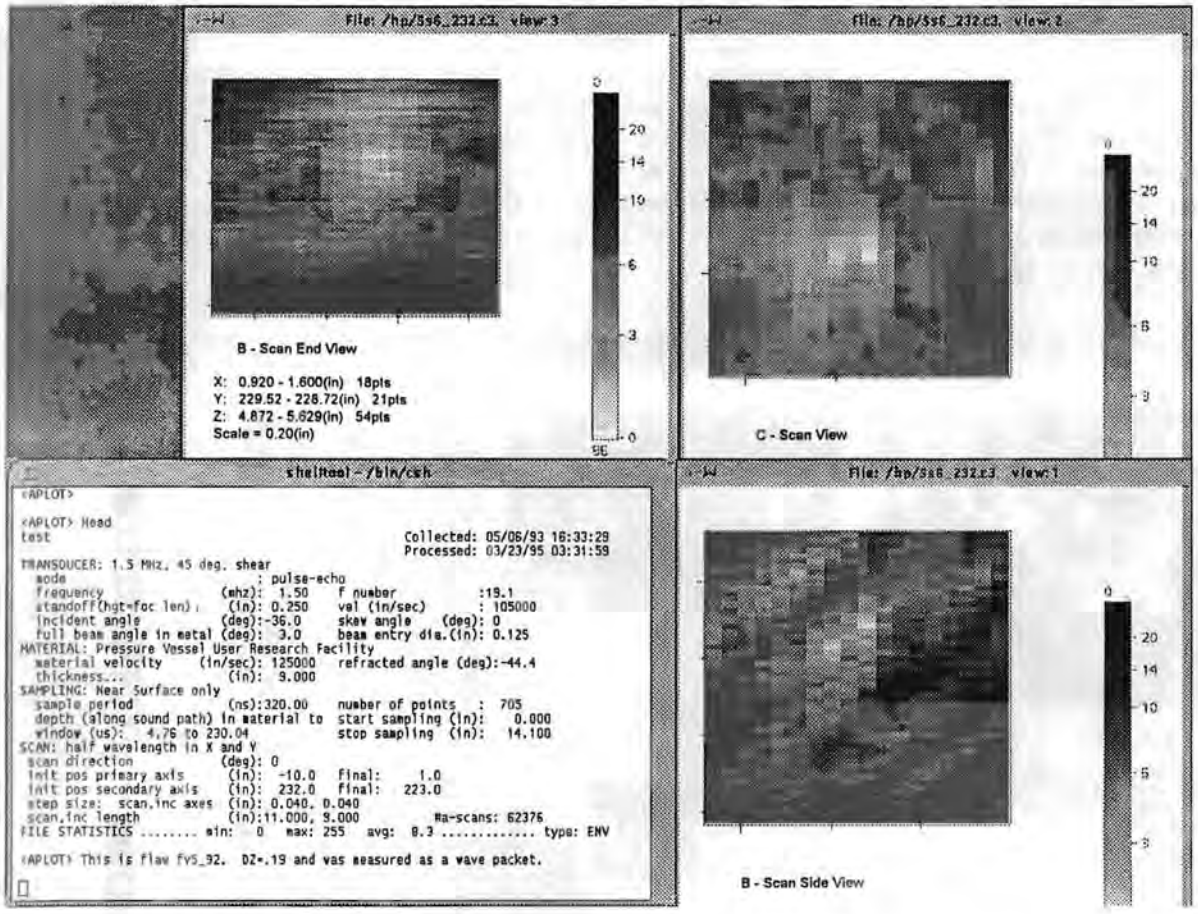
Figures A.109a-b show volumetric indication #6 in the base metal below 25 mm. This volumetric indication has a through-wall extent of 5 mm based on wave packet width. The detection was made in mode 6 where it had isolated TOF shape at a depth of 130 mm. The shape quality for this indication is good but broken up, implying that more than one small flaw may be present. There was a confirmation in mode 10 at a depth of 128 mm. The two Z values of 128 to 130 mm give an alternate depth size of 2 mm. The indication is characterized as volumetric based on normal beam detection. The length is 20 mm and was made to LOS in mode 6. The width is 9 mm and was made to LOS in mode 10. The aspect ratio (length/depth) of this indication is 4 which tends to confirm the large through-wall extent. The maximum amplitude-to-noise ratio is of medium range at 86 to 24. The X coordinate of 31 mm shows that the indication is in the base metal, possibly in the HAZ. The Z coordinate of 128 to 130 mm shows that the indication is in the middle third of the vessel.

Figure A.109a - Volumetric indication #6 in the base metal below 25 mm: mode 10

Figure A.109b - Volumetric indication #6 in the base metal below 25 mm: mode 6

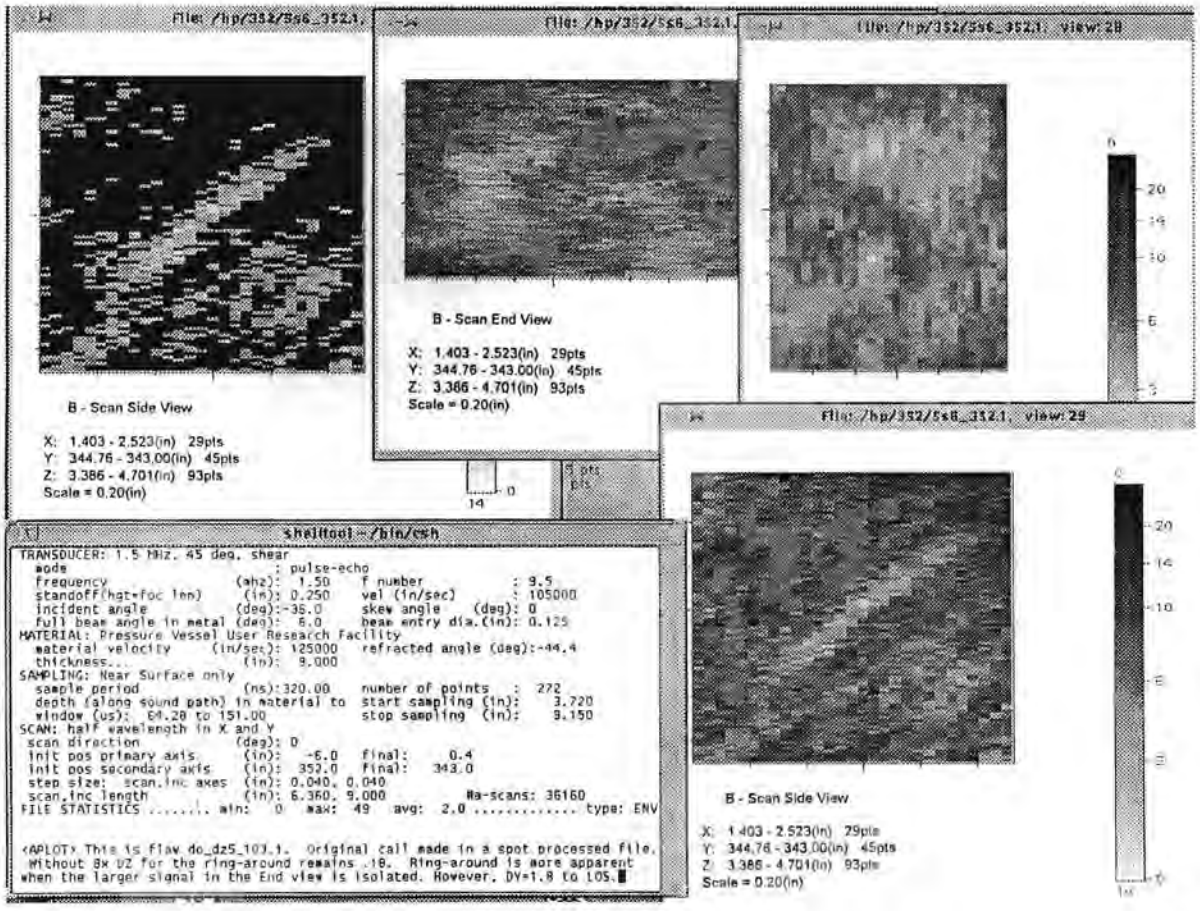
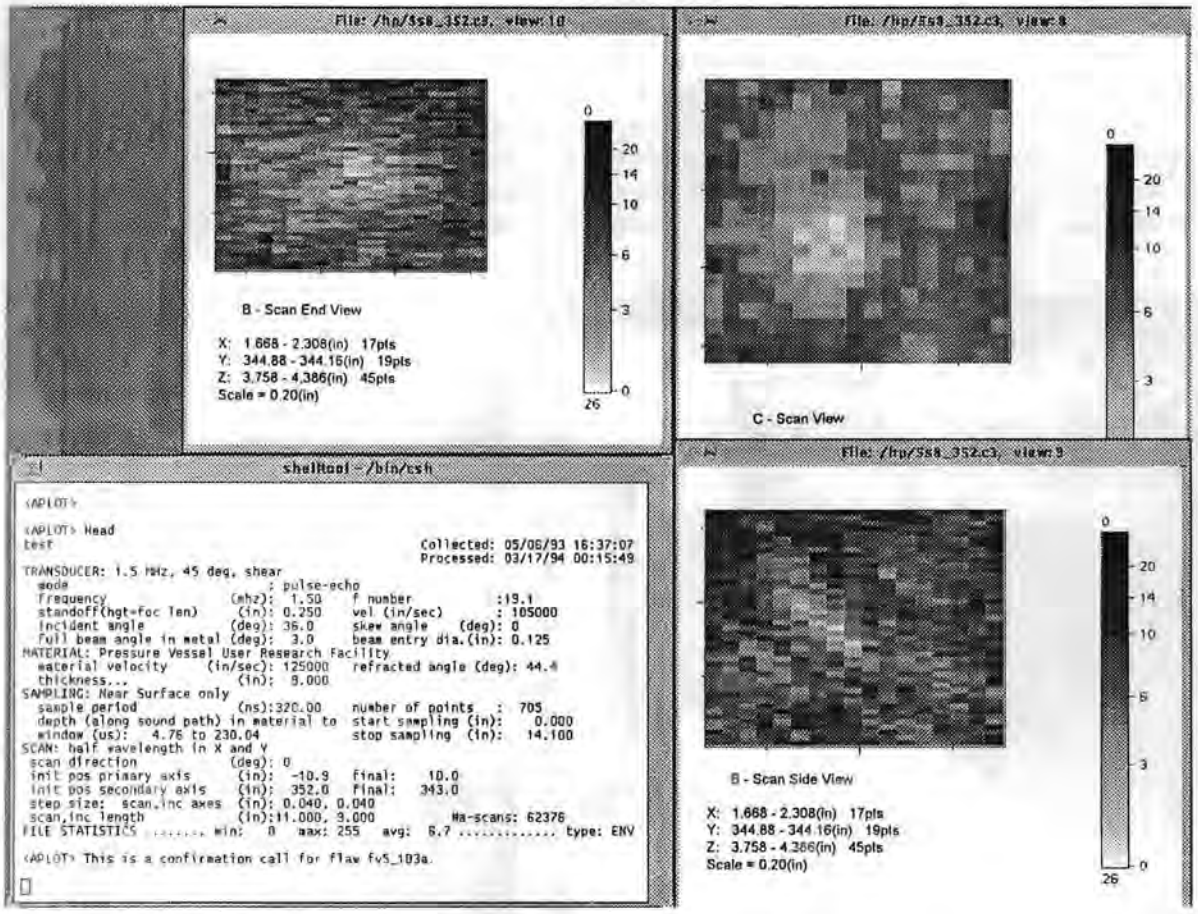
Figures A.110a-b show volumetric indication #7 in the base metal below 25 mm. This volumetric indication has a through-wall extent of 5 mm based on ring around pattern. The detection was made in mode 6 where it displayed a pair of TOF shapes at a depth of 103 mm. The shape quality is good for this indication. There was a confirmation in mode 8 at depth of 104 mm. The confirmation mode gave a through-wall extent estimate of 2.5 mm based on wave packet width. The two Z values of 103 to 104 mm give an alternate depth size of 1 mm. The indication is characterized as volumetric based on the detection of ring around shape. The length is 46 mm and was made to LOS in mode 6. The aspect ratio (length/depth) of this indication is 9. The maximum amplitude-to-noise ratio is low at 13 to 6. The X coordinate of 48 mm shows that the indication is clearly in the base metal. The Z coordinate of 103 to 104 mm shows that the indication is in the middle third of the vessel.

Figure A.110a - Volumetric indication #7 in the base metal below 25 mm: mode 6

Figure A.110b - Volumetric indication #7 in the base metal below 25 mm: mode 8
