NUREG/CR-6471, Vol. 1
PNNL-11143

Characterization of Flaws in U.S. Reactor Pressure Vessels

Density and Distribution of Flaw Indications in PVRUF

Pacific Northwest National Laboratory

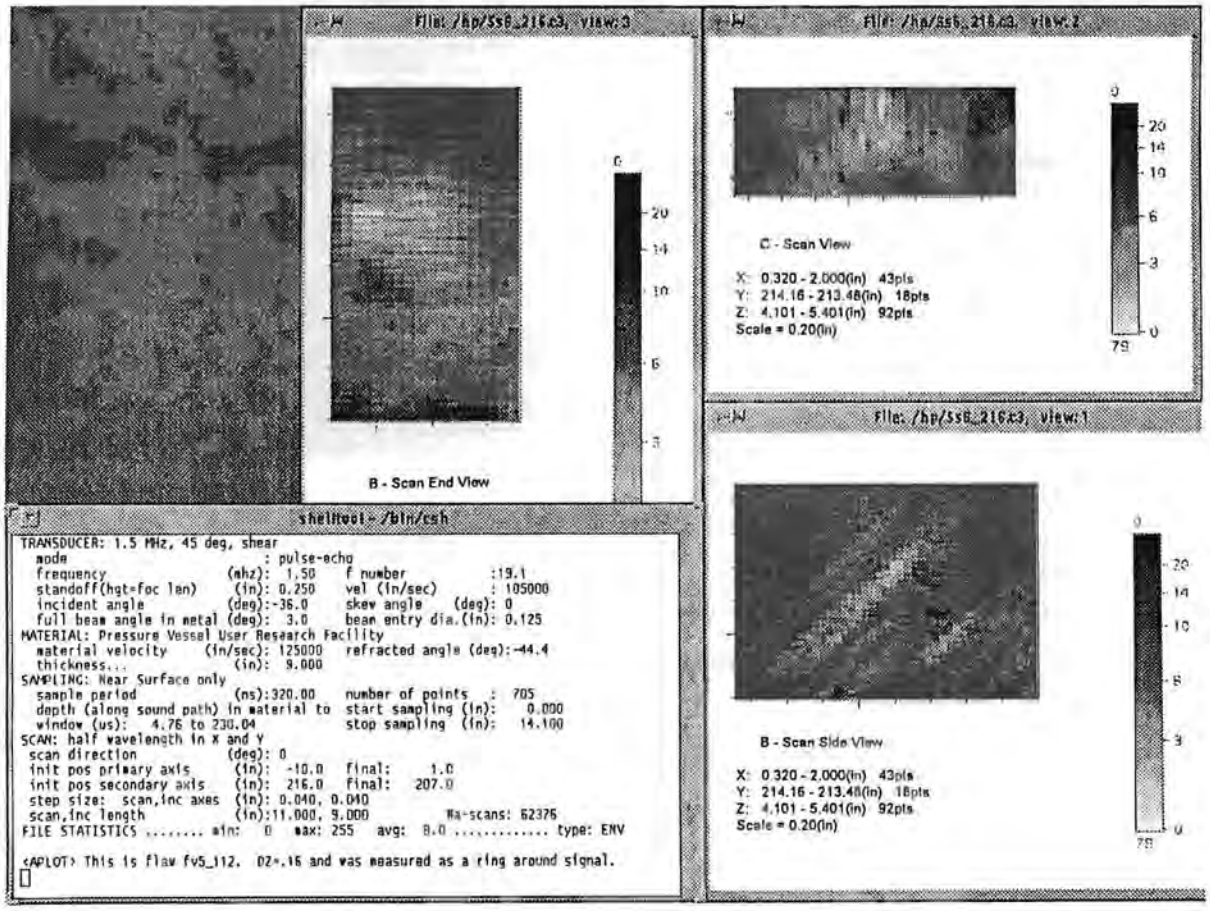
Figure A.111 shows volumetric indication #8 in the base metal below 25 mm. This volumetric indication has a through-wall extent of 4 mm based on ring around pattern. The detection was made in mode 6 where it displayed a pair of TOF shapes at a depth of 119 mm. The shape quality for this indication is good but broken up, implying that more than one small flaw may be present. There were no confirmations in other modes. The indication is characterized as volumetric based on the detection of ring around shape. The length is 41 mm and was made to LOS in mode 6. The aspect ratio (length/depth) of this indication is 10 which tends to confirm the large through-wall extent. The maximum amplitude-to-noise ratio is of medium range at 79 to 24. The X coordinate of 26 mm shows that the indication is in the base metal, possibly in the HAZ. The Z coordinate of 119 mm shows that the indication is in the middle third of the vessel.

Figure A.111 - Volumetric indication #8 in the base metal below 25 mm: mode 6

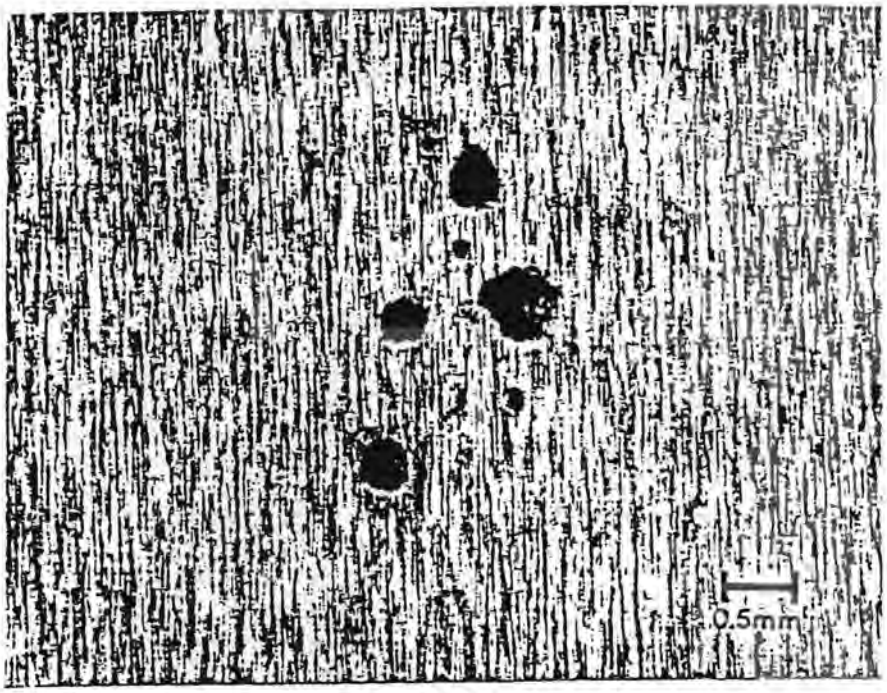
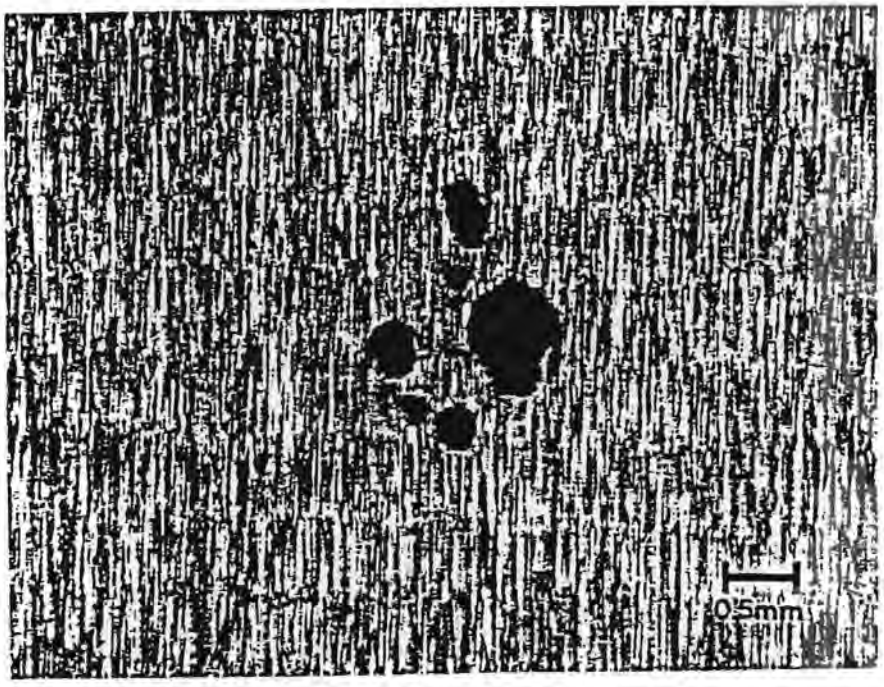
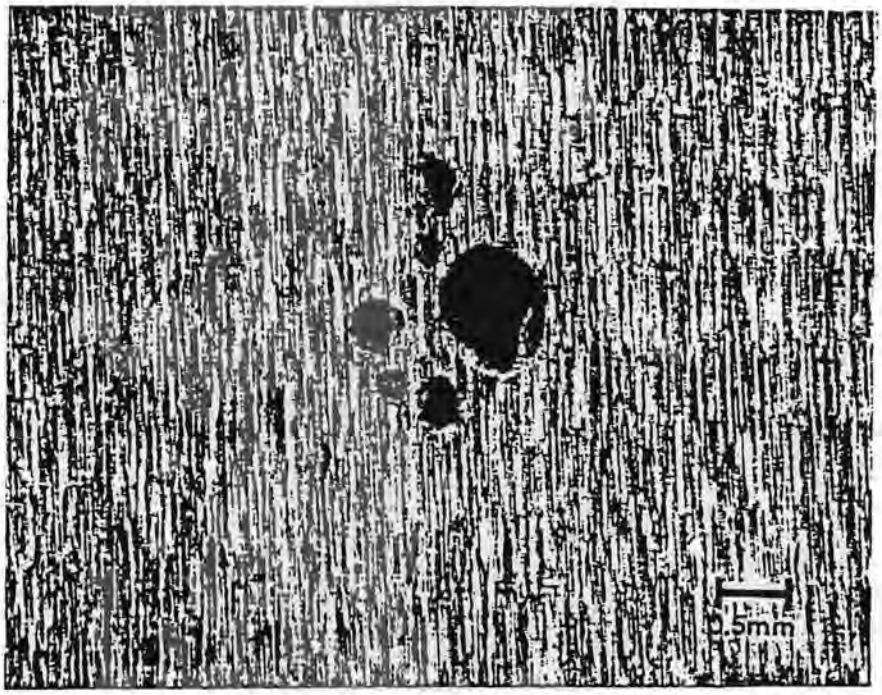
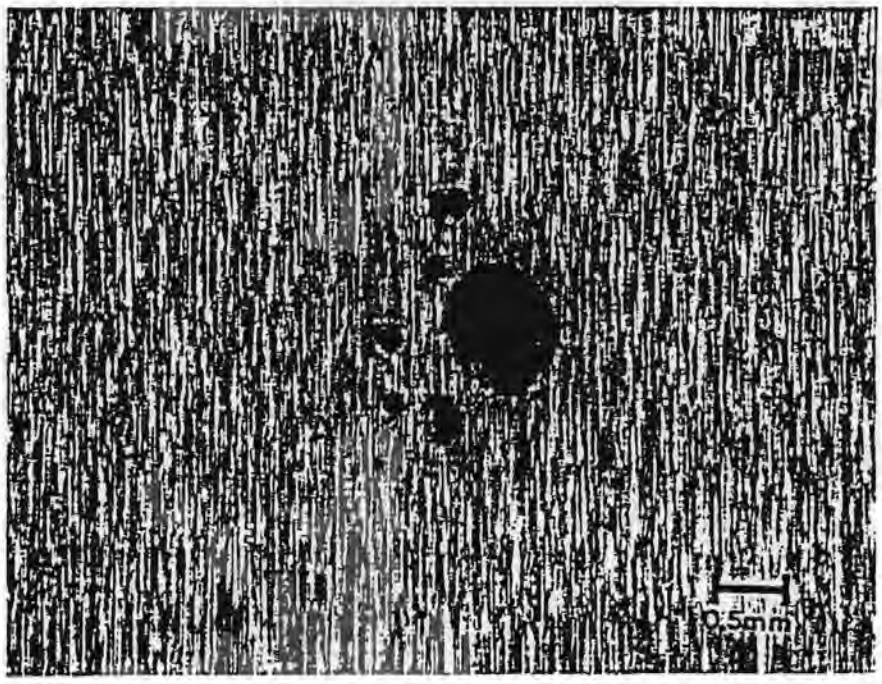
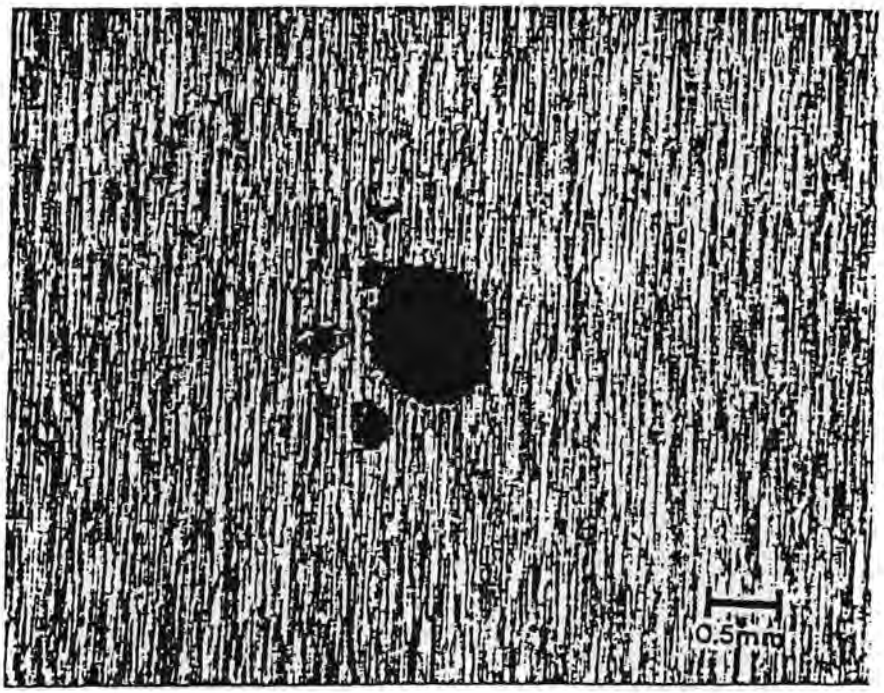
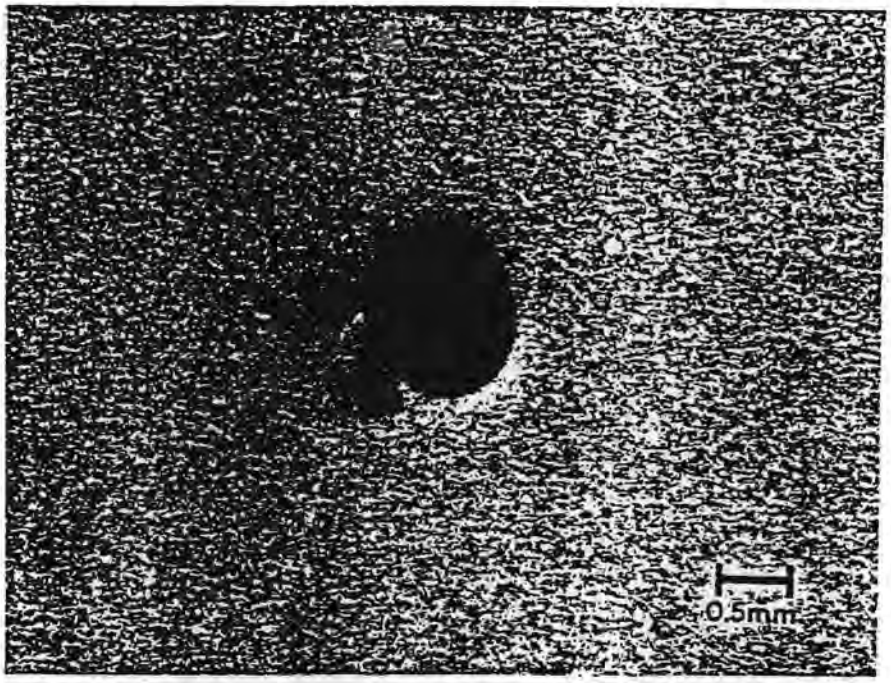
Figure 4.1 DA Photograph of Midland Flaw 1-8 #2
Photographs provided by the EPRI NDE Center

(a) Depth: 14.25 mm (0.561 in.), as machined

(b) Depth: 14.15 mm (0.557 in.), as machined

(c) Depth: 14.1 mm (0.555 in.), as machined

(d) Depth: 14.05 mm (0.553 in.), as machined

(e) Depth: 14.02 mm (0.552 in.), as machined

(f) Depth: 14.97 mm (0.550 in.), as polished and etched

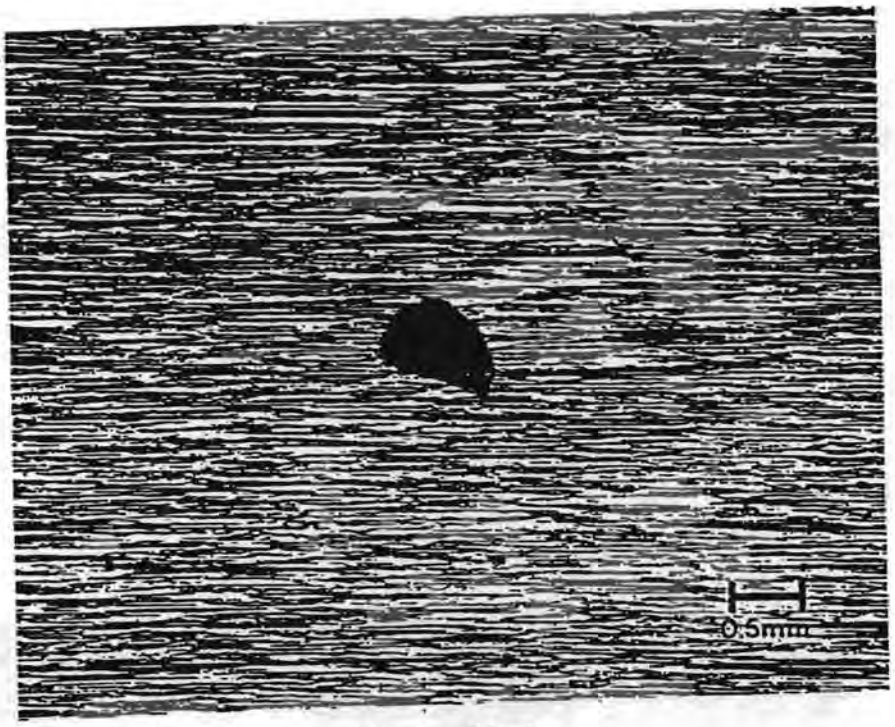
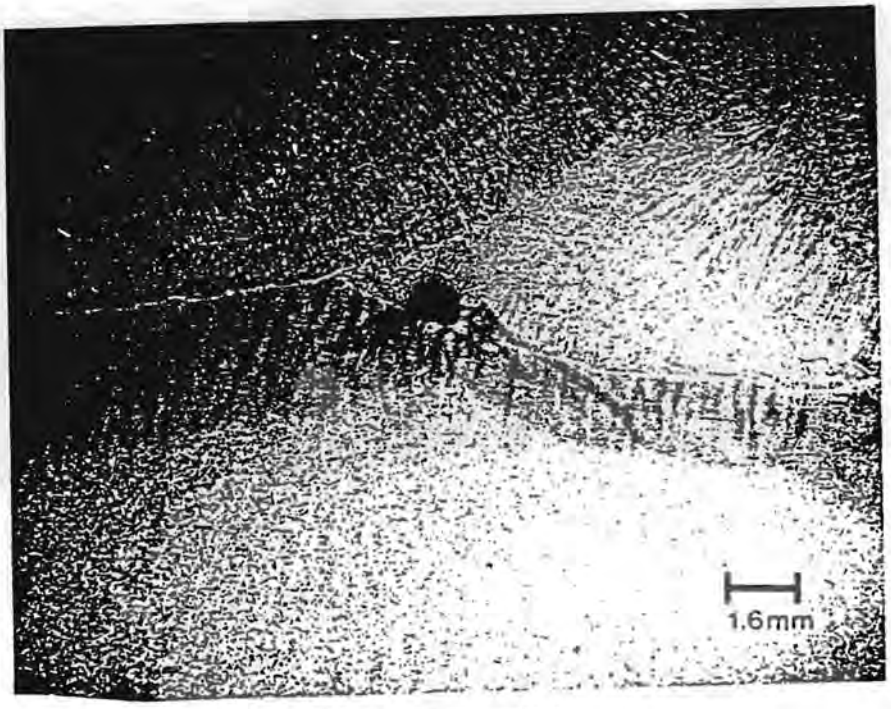
Figure 4.2 DA Photograph of Midland Flaw 1-8 #3b
Photographs provided by the EPRI NDE Center

(a) As machined

(b) Polished and etched

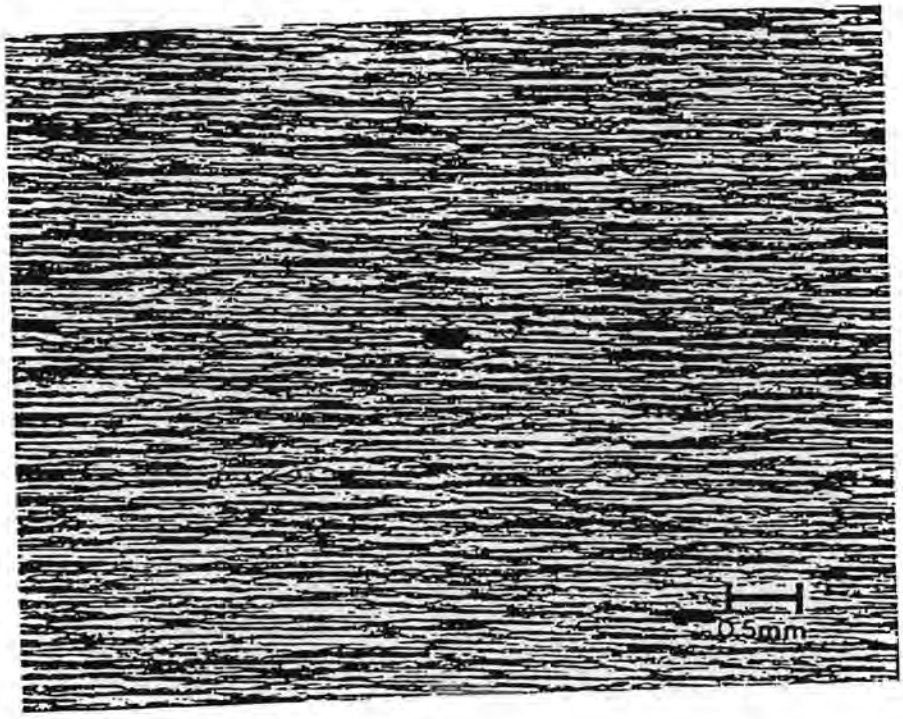
Figure 4.3 DA Photograph of Midland Flaw 1-8 #4b, as machined.
Photograph provided by the EPRI NDE Center

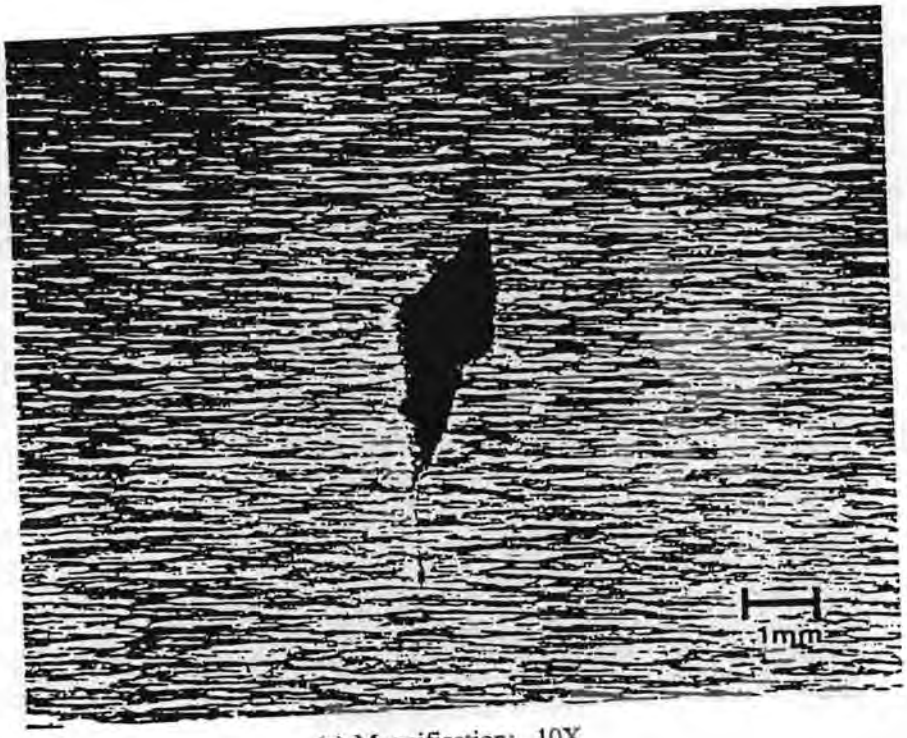
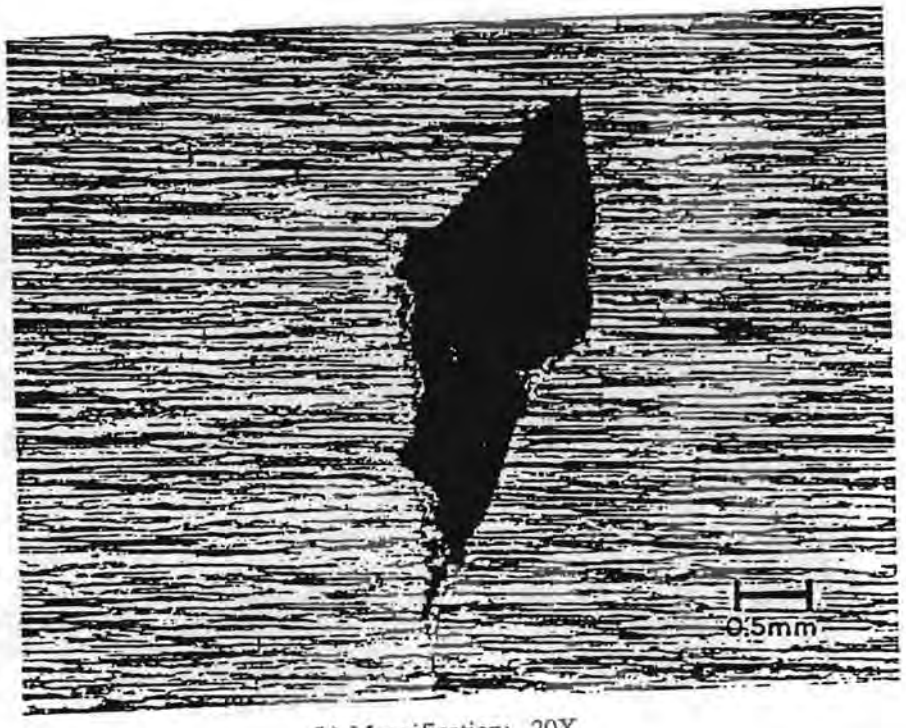
Figure 4.4 DA Photograph of Midland Flaw 1-8 #5t
Photographs provided by the EPRI NDE Center

Flaw #5	Y, mm (in.)	DY, mm (in.)	X, mm (in.)	DX, mm (in.)	Z, mm (in.)	DZ, mm (in.)	Notes
Destructive Data	380 (15.0)	5 (0.2)	--	--	89 (3.5)	2 (0.1)	X and DX not given but flaw is in the weldment so X is 0 ± 12.7 mm (0.5 in.). See Figure 4.4.
SAFT-UT	380 (15.0)	5 (0.2)	-5 (-0.2)	13 (0.5)	89 (3.5)	1.3 (0.05)	DZ is determined from 45°S inspection from the unclad side. See Figure 5.1d.
Flaw #6t & 6b	**Y, mm (in.)**	**DY, mm (in.)**	**X, mm (in.)**	**DX, mm (in.)**	**Z, mm (in.)**	**DZ, mm (in.)**	**Notes**
Destructive Data	350 (13.8)	2.0 (0.08) 3.5 (0.14)	--	--	99 (3.9)	1.5 (0.06) 2.5 (0.10)	See Figures 4.5 and 4.6.
SAFT-UT	350 (13.8)	10 (0.4)	-10 (-0.4)	18 (0.7)	91 (3.6)	1.3 (0.05)	DZ is determined from 45°S inspection from the unclad side. See Figure 5.2g.

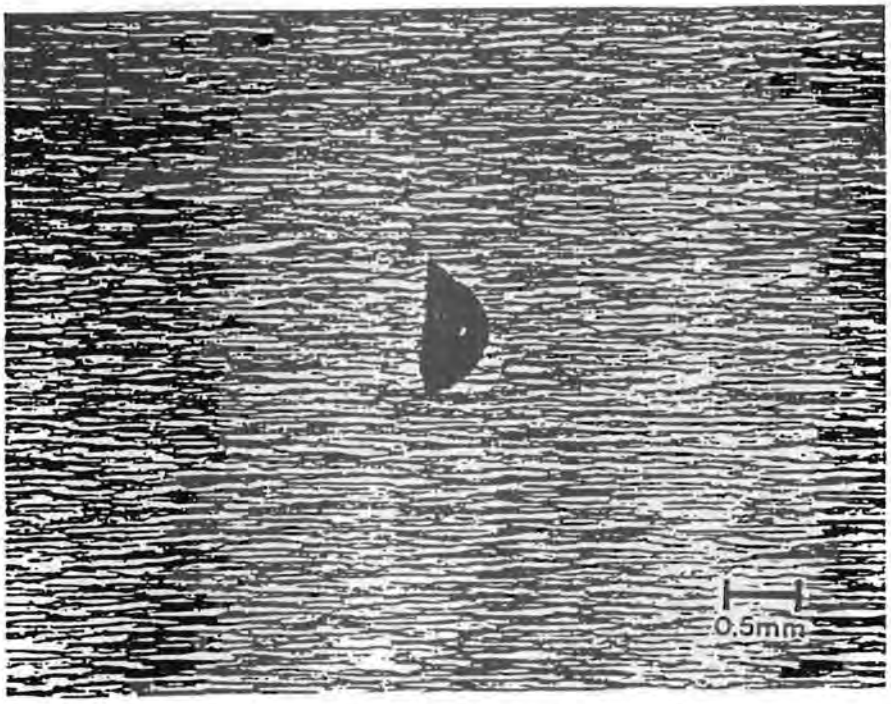
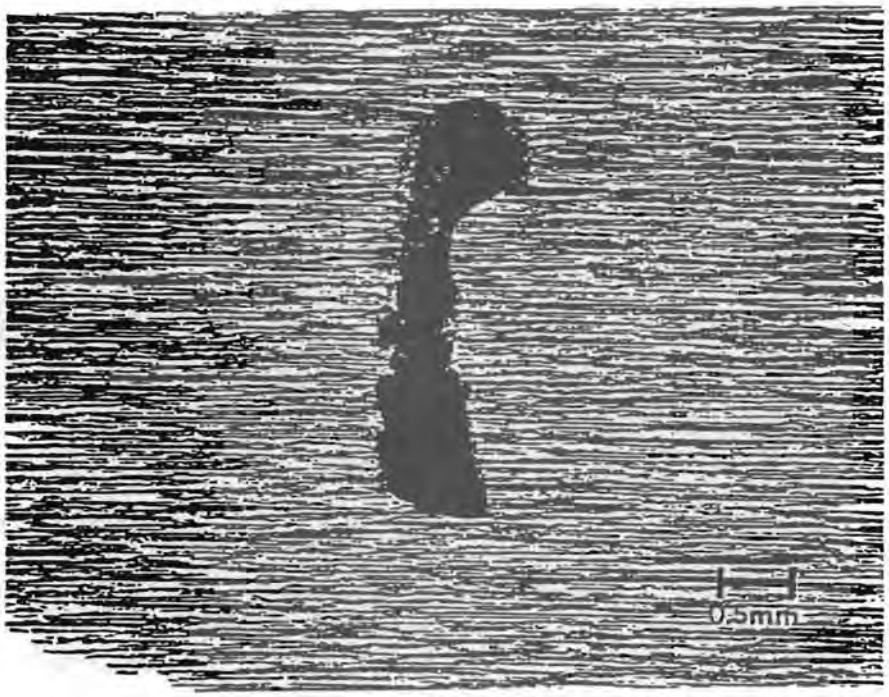
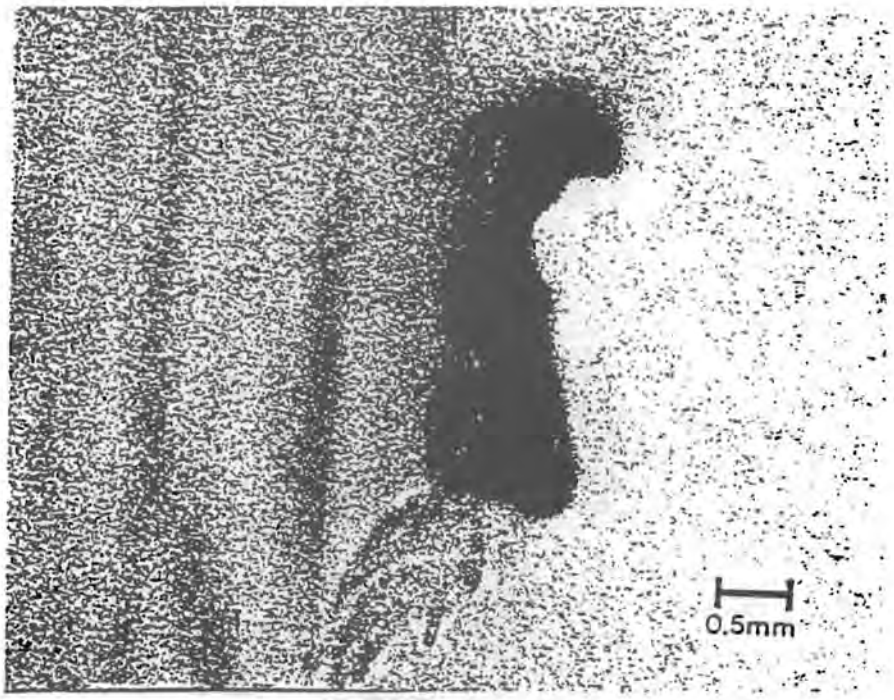
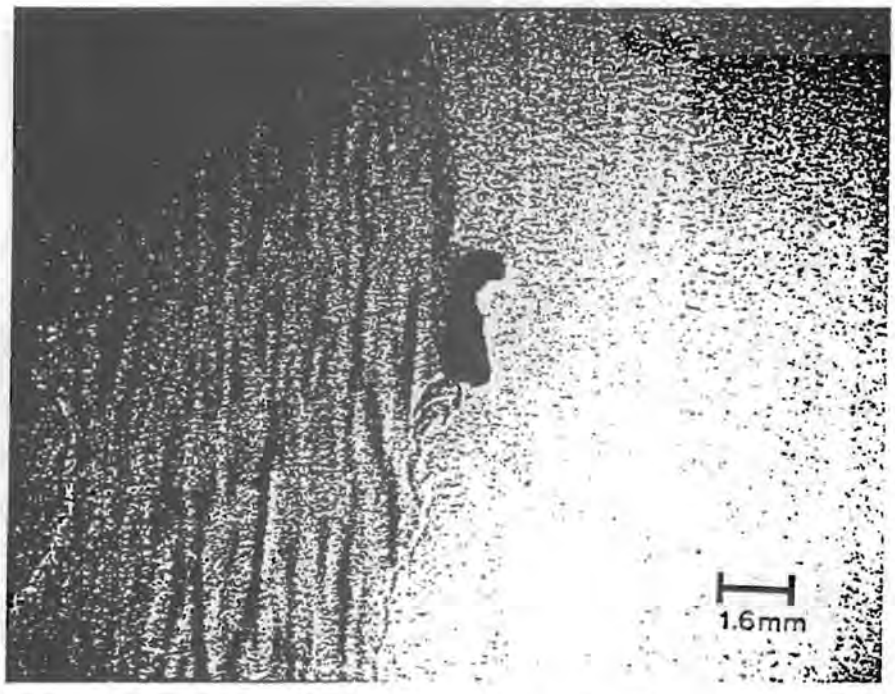
Figure 4.5 DA Photograph of Midland Flaw 1-8 #6b
Photographs provided by the EPRI NDE Center

(a) Depth: 6.32 mm (0.249 in.), as machined

(b) Depth: 5.82 mm (0.229 in.), as machined

(c) As polished and etched, magnification: 20X

(d) As polished and etched, magnification: 6.3X

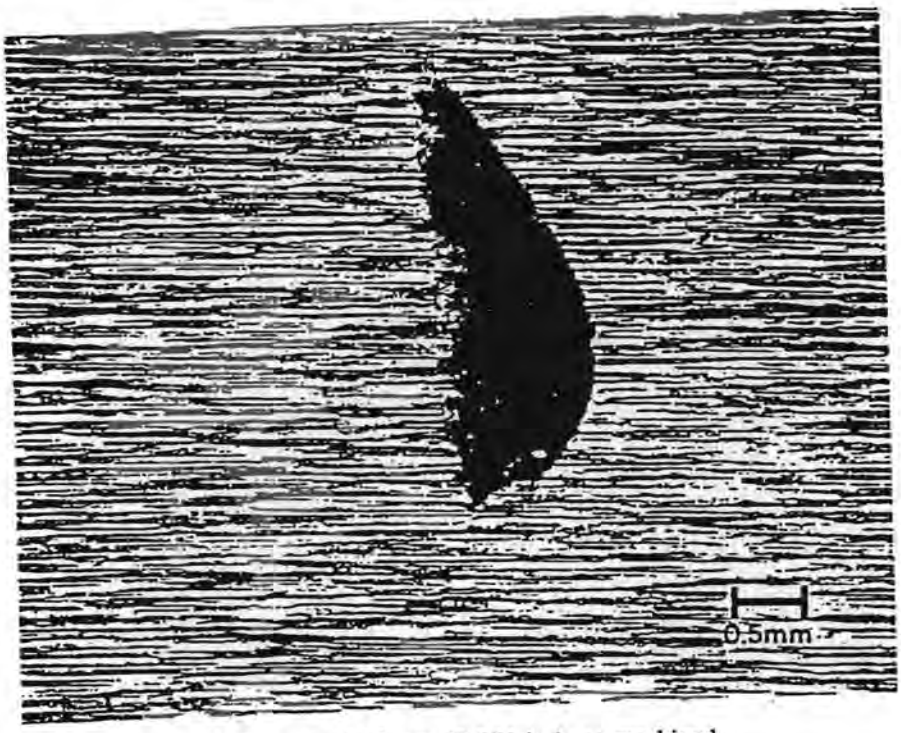
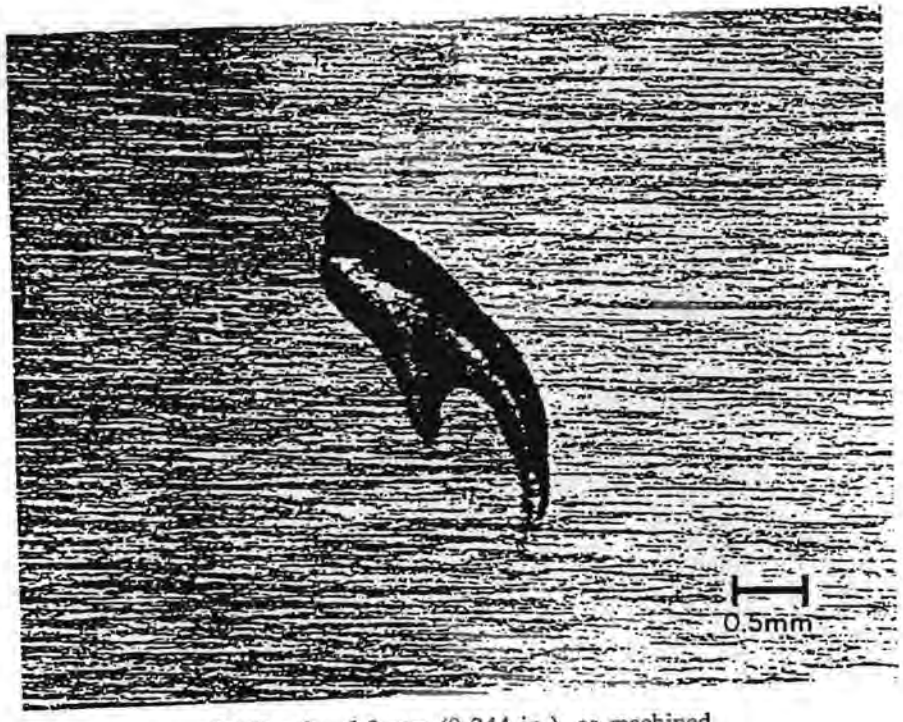
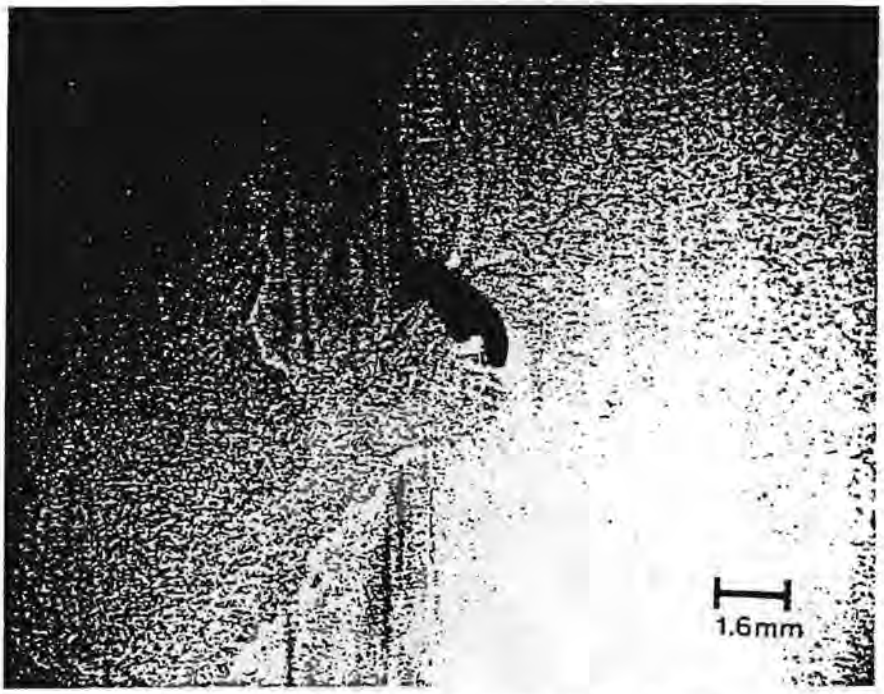
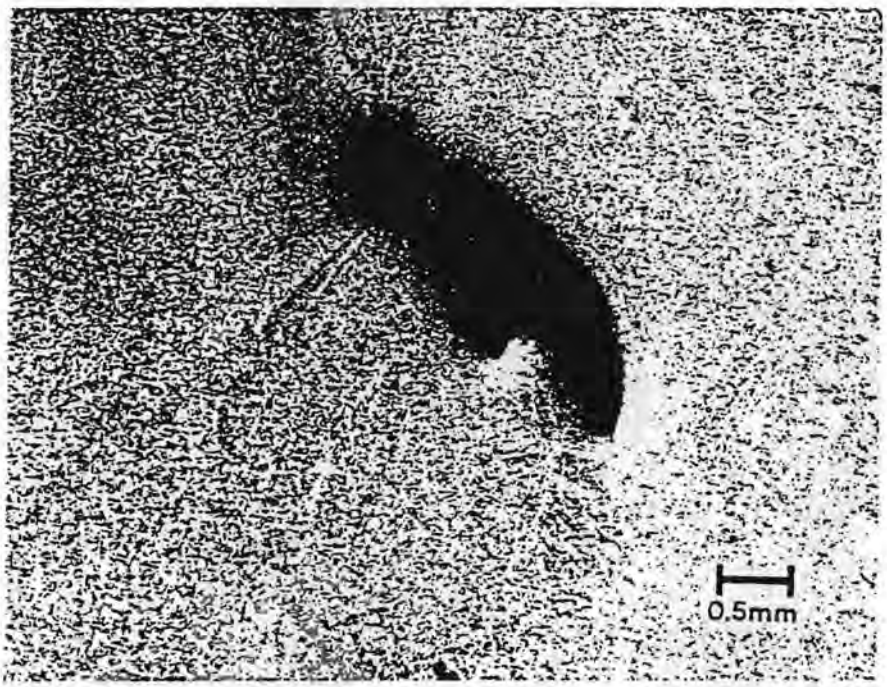
Figure 4.6 DA Photograph of Midland Flaw 1-8 #6t
Photographs provided by the EPRI NDE Center

(a) Depth: 6.45 mm (0.254 in.), as machined

(b) Depth: 6.2 mm (0.244 in.), as machined

(c) As polished and etched, magnification: 6.3X

(d) As polished and etched, magnification: 20X

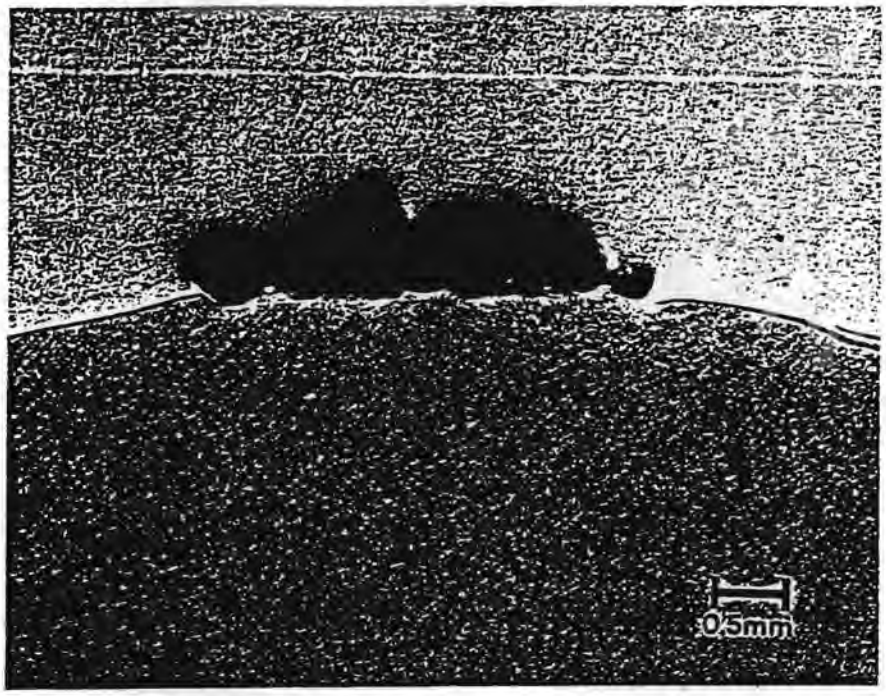
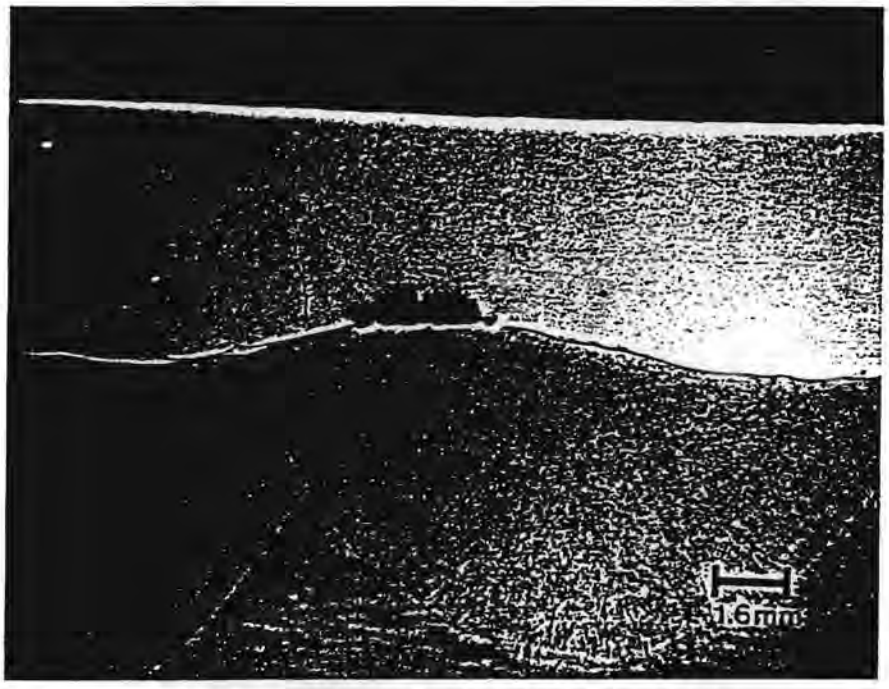
Figure 4.7 DA Photograph of Midland Flaw 1-8 #7b
Photographs provided by the EPRI NDE Center

Flaw #7	Y, mm (in.)	DY, mm (in.)	X, mm (in.)	DX, mm (in.)	Z, mm (in.)	DZ, mm (in.)	Notes
Destructive Data	81 (3.2)	--	-22 (-0.8)	4 (0.16)	7 (0.27)	1 (0.04)	See Figure 4.7.
SAFT-UT	89 (3.5)	5 (0.2)	8 (0.3)	5 (0.2)	8 (0.3)	<2.2 (<0.09)	See Figure 5.26. There is a sign difference between the destructive analysis and the SAFT-UT data for X. The origin of this difference is not known.
Flaw #8	**Y, mm (in.)**	**DY, mm (in.)**	**X, mm (in.)**	**DX, mm (in.)**	**Z, mm (in.)**	**DZ, mm (in.)**	**Notes**
Destructive Data	112 (4.4)	--	33 (1.3)	5 (0.2)	10 (0.4)	2 (0.08)	See Figure 4.8.
SAFT-UT	112 (4.4)	5 (0.2)	-33 (-1.3)	5 (0.2)	10 (0.4)	<2.2 (<0.09)	See Figure 5.27. There is a sign difference between the destructive analysis and the SAFT-UT data for X. The origin of this difference is not known.
Flaw #11	**Y, mm (in.)**	**DY, mm (in.)**	**X, mm (in.)**	**DX, mm (in.)**	**Z, mm (in.)**	**DZ, mm (in.)**	**Notes**

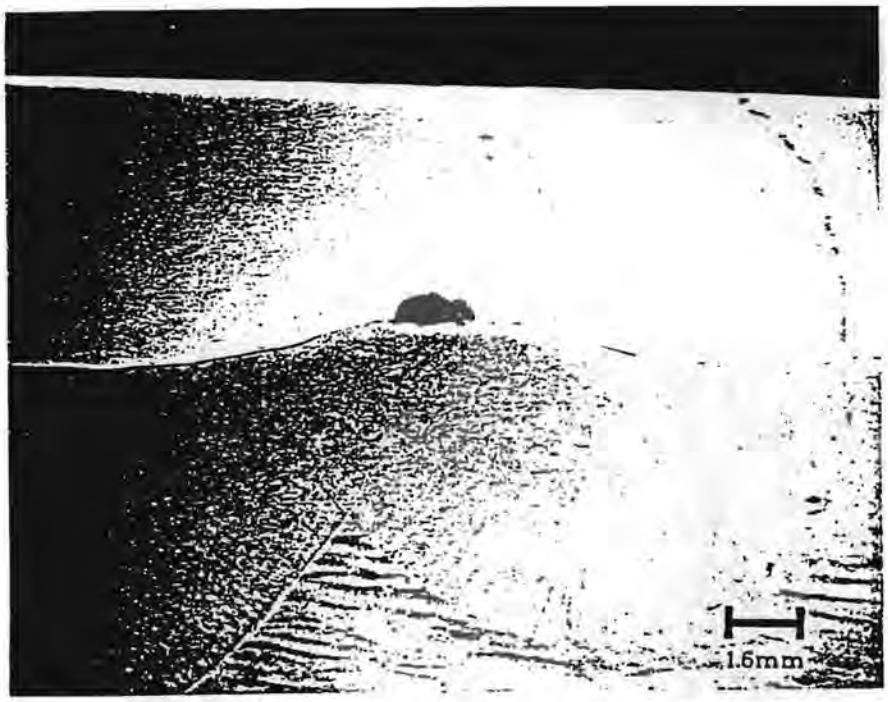
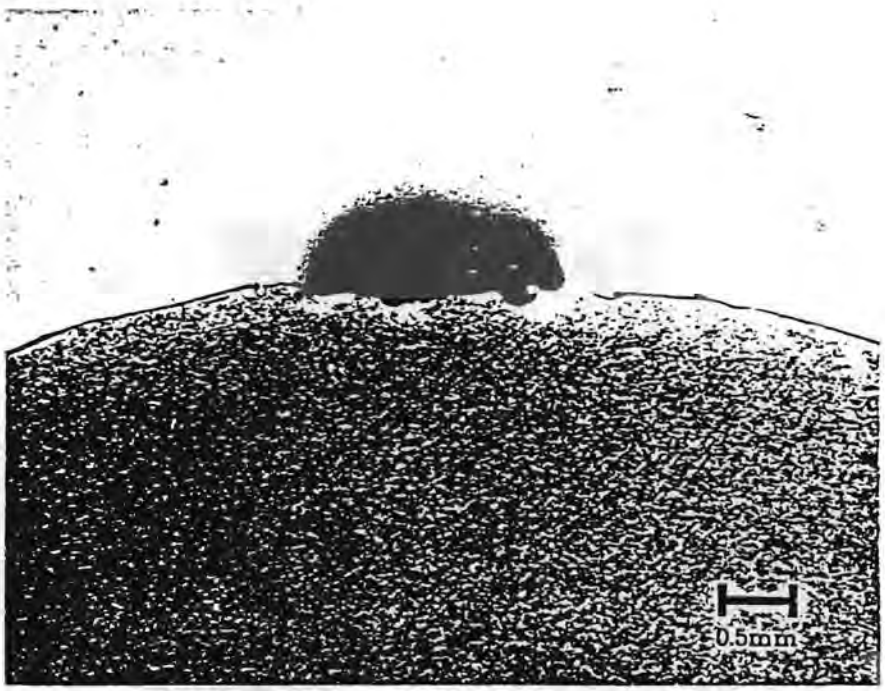
Figure 4.9 DA Photograph of Midland Flaw 1-8 #10a
Photographs provided by the EPRI NDE Center

(a) As polished and etched, magnification: 6.3X

(b) As polished and etched, magnification: 20X

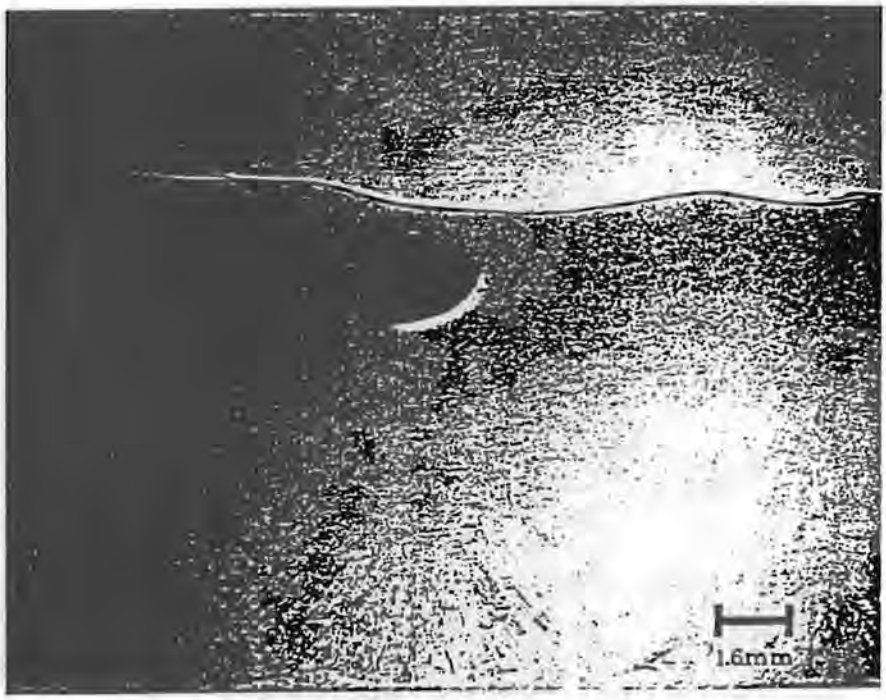
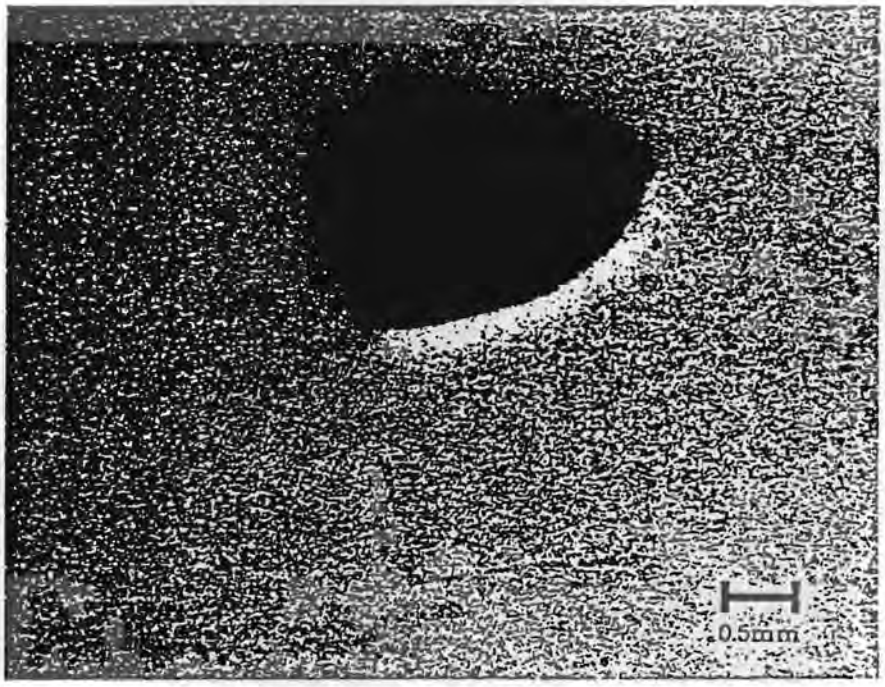
Figure 4.10 DA Photograph of Midland Flaw 1-8 #10b
Photographs provided by the EPRI NDE Center

(a) As polished and etched, magnification: 6.3X

(b) As polished and etched, magnification: 20X

236 (9.3)	5 (0.2)	18 (0.7)	5 (0.2)	5 (0.2)	<2.2 (<0.09)	Detected by SAFT-UT in 70° L-wave inspection in the -X direction only. See Figure 5.28. This is a volumetric defect. Destructive analysis shows one small defect labeled #11. See Table 4.1 and Figure 4.10 for DA results.
442 (17.4)	15 (0.6)	-23 (-0.9)	5 (0.2)	5 (0.2)	<2.2 (<0.09)	Detected by SAFT-UT in 70° L-wave inspection in the +X direction. See Figure 5.29. This is a volumetric defect.

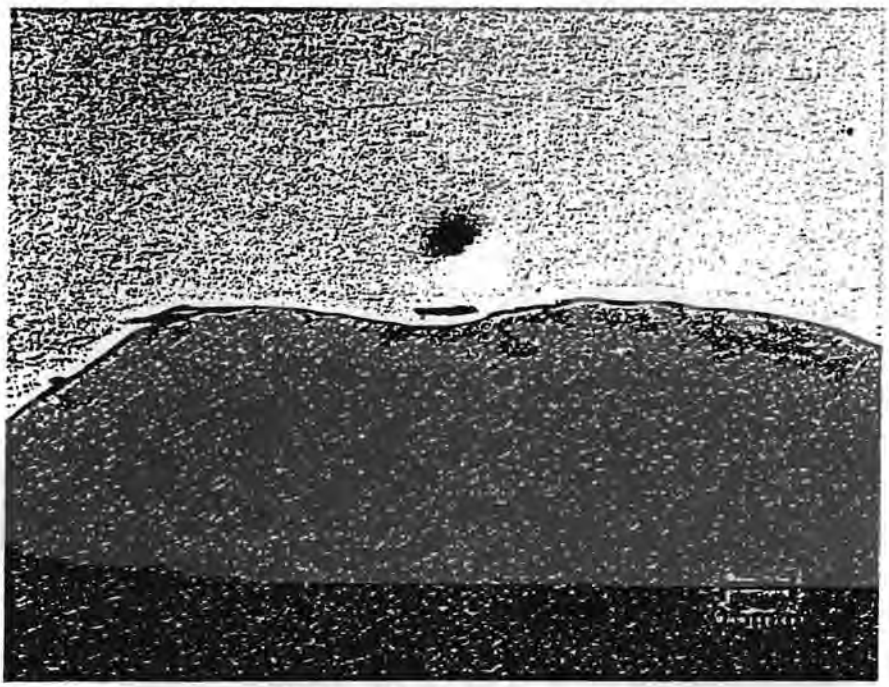
Figure 4.11 DA Photograph of Midland Flaw 1-8 #11
Photographs provided by EPRI NDE Center

(b) As polished and etched

Destructive Data	235 (9.2)	--	-15 (-0.6)	1.5 (0.06)	6 (0.24)	0.5 (0.02)	See Figure 4.11.
SAFT-UT	236 (9.3)	5 (0.2)	18 (0.7)	5 (0.2)	5 (0.2)	<2.2 (<0.09)	See Figure 5.28. There is a sign difference between the destructive analysis and the SAFT-UT data for X. The origin of this difference is not known.

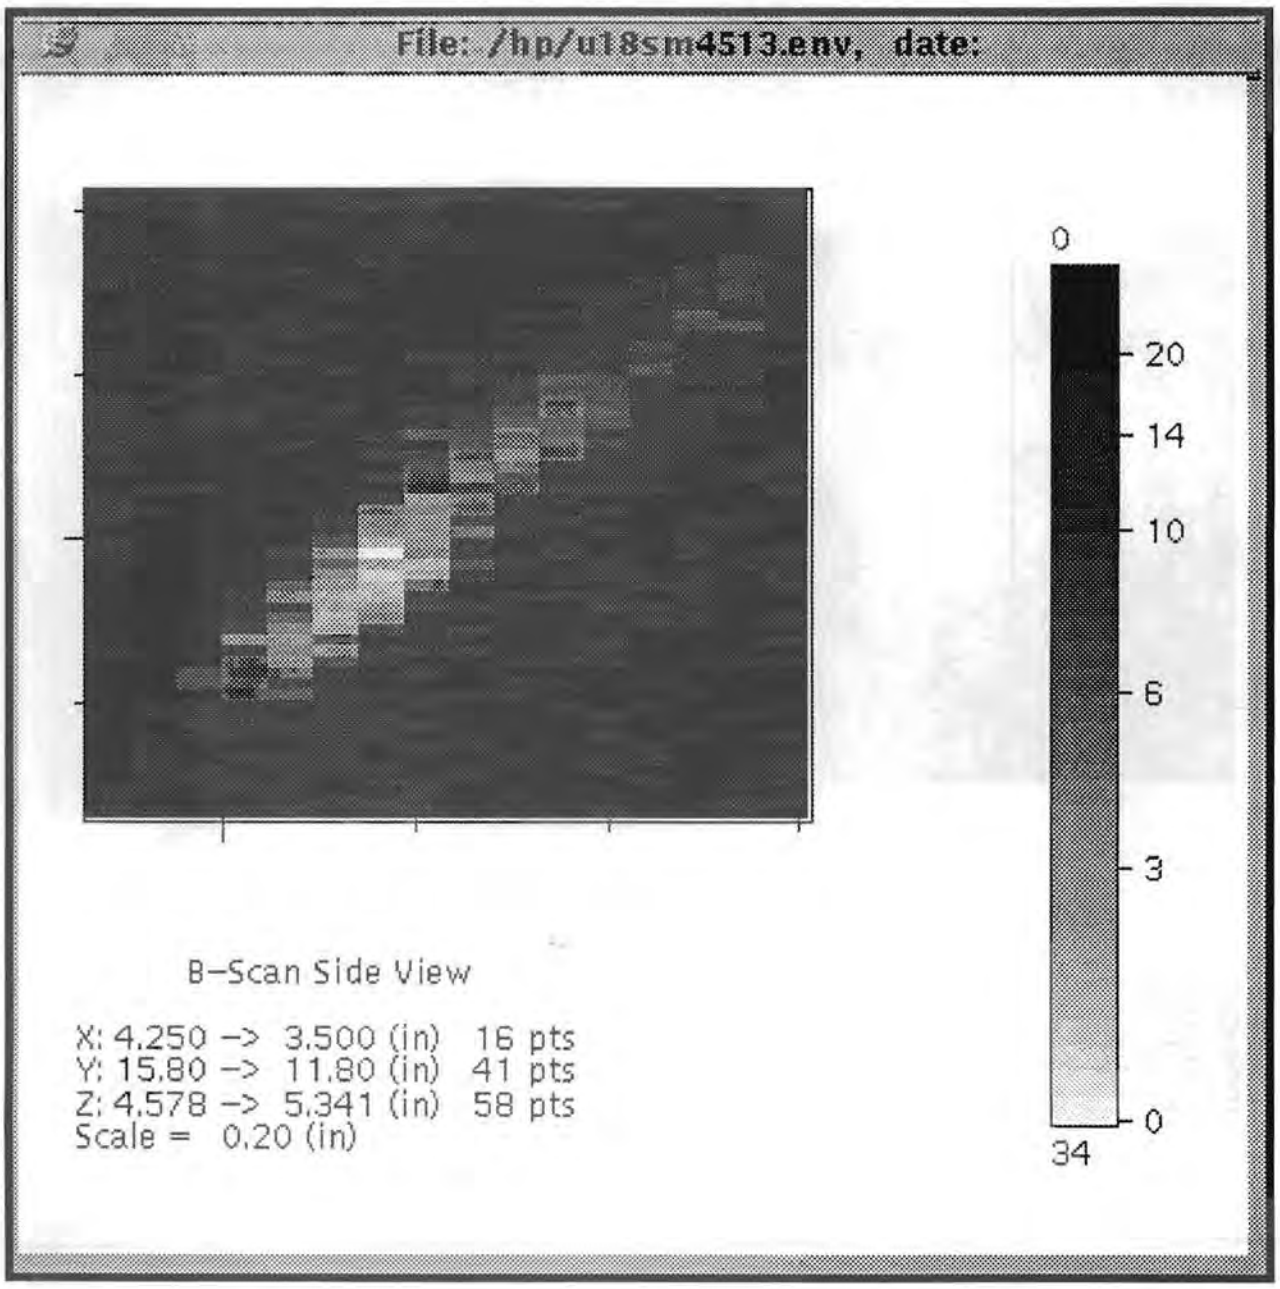
Figure 4.12 Typical Shape for a Reflector in the 45° Shear Inspections. Side View (XZ) of Base-Metal Indication in Block 1-8 at Y = 350 mm. 45° shear inspection from the unclad side. Beam direction is +X. Z values in the figure are measured from the unclad side.

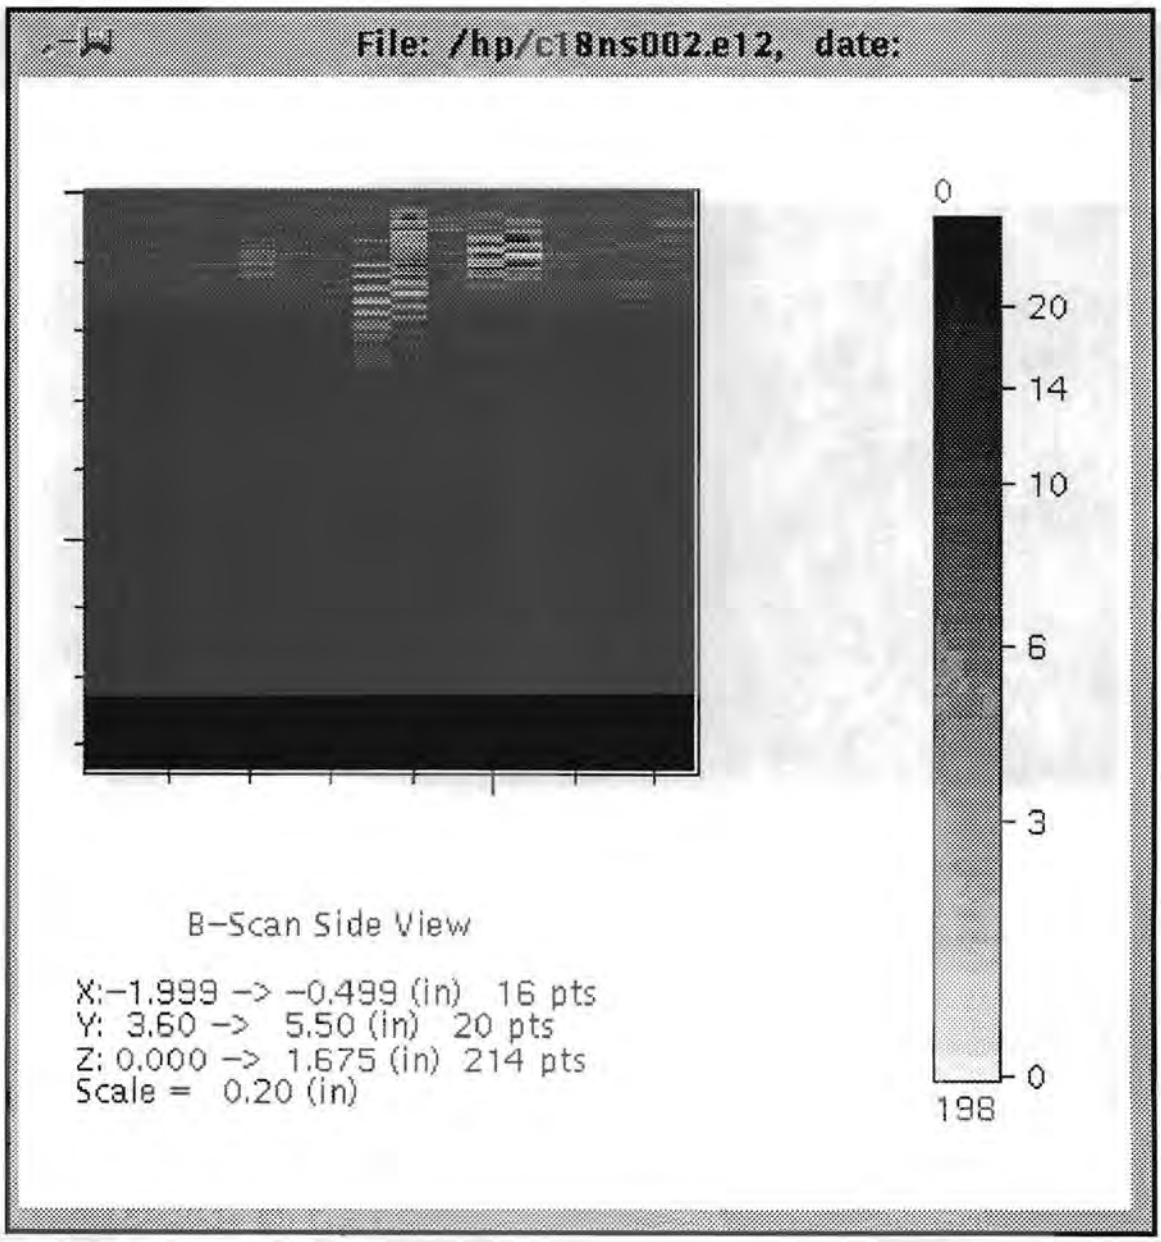
inspections is shown in Figure 4.14. This shape can be found only in the side view (B-scan) of the 70° L-wave data. The typical image for a reflector that is included based on amplitude alone is shown in Figure 4.15.

Figure 4.14 Typical Shape for a Reflector in the 70° L-Wave Inspections. Side View (XZ) of Clad to Base-Metal Indication in Block 1-8 at Y = 112 mm. 70° L-wave inspection with beam direction of +X.
