NUREG/CR-6471, Vol. 1
PNNL-11143

Characterization of Flaws in U.S. Reactor Pressure Vessels

Density and Distribution of Flaw Indications in PVRUF

Pacific Northwest National Laboratory

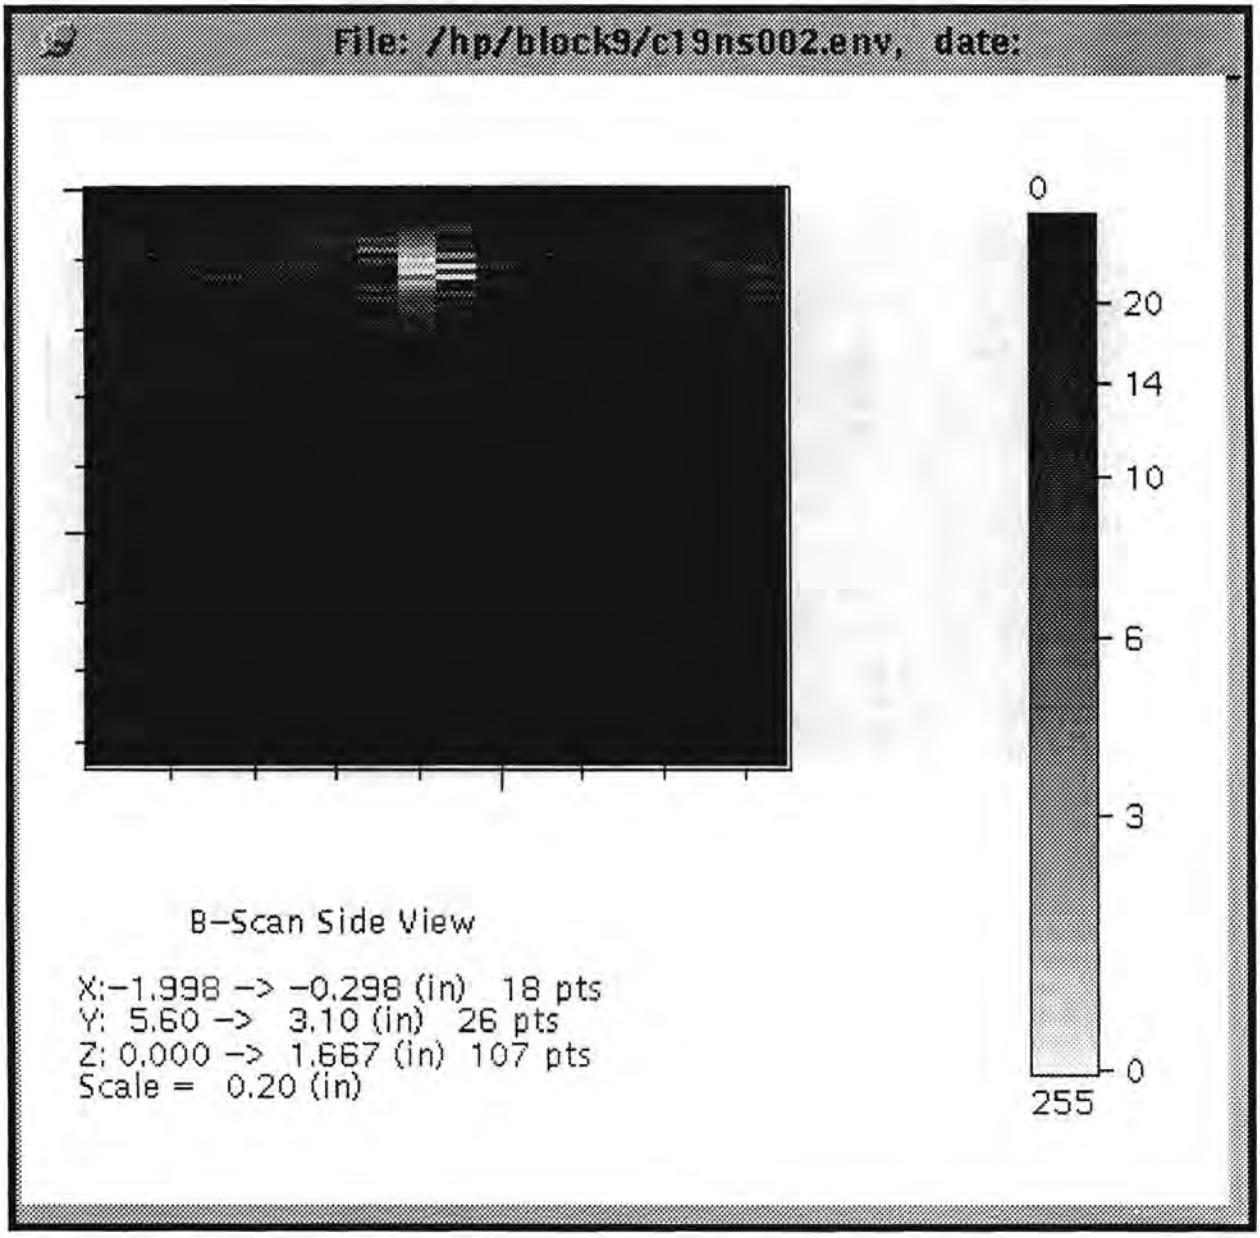
inspections is shown in Figure 4.14. This shape can be found only in the side view (B-scan) of the 70° L-wave data. The typical image for a reflector that is included based on amplitude alone is shown in Figure 4.15.

Figure 4.15 Typical Shapeless Image for a Bright Reflection in the 70° L-Wave Inspections. Side View (XZ) of Clad to Base-Metal Indication in Block 1-9 at Y = 117 mm. 70° L-wave inspection with beam direction of +X.

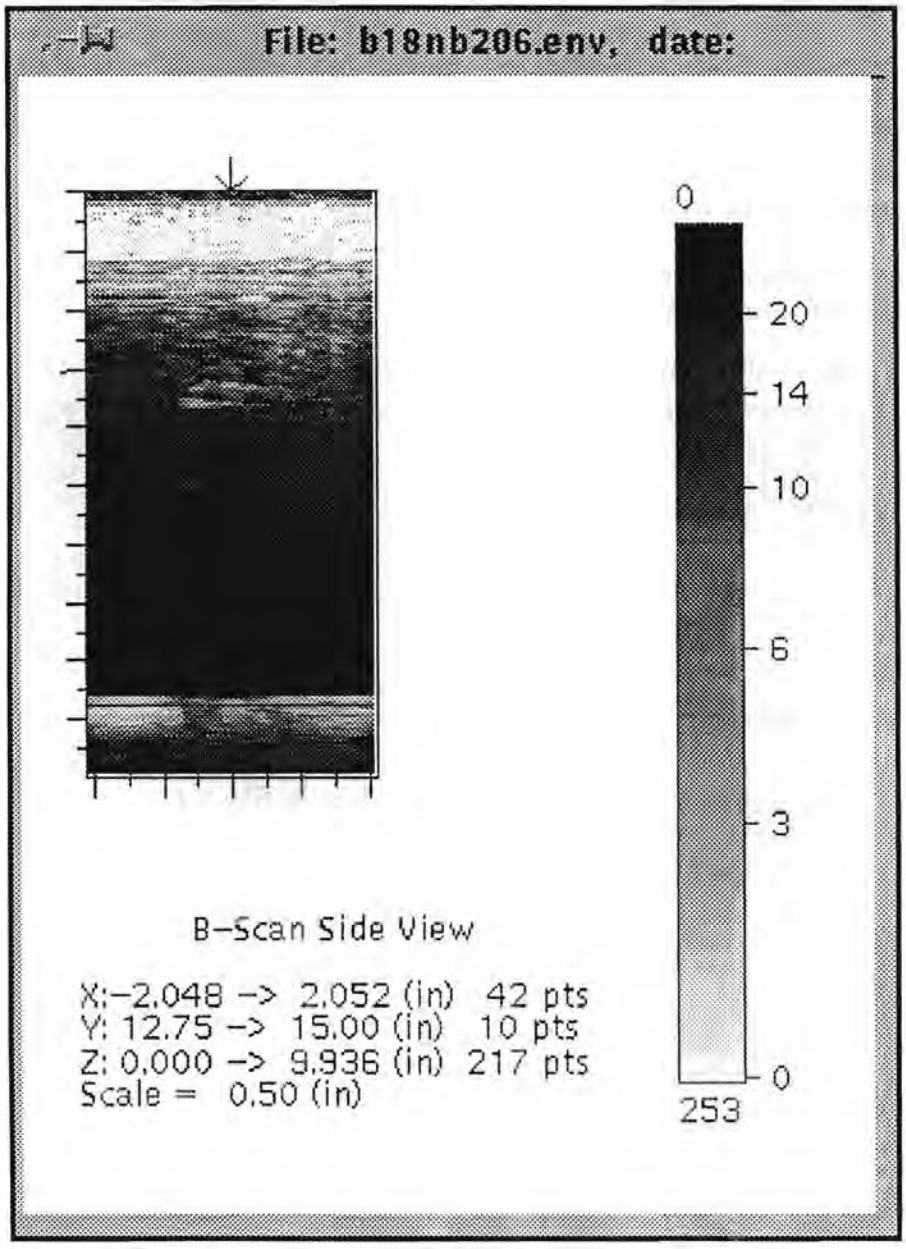
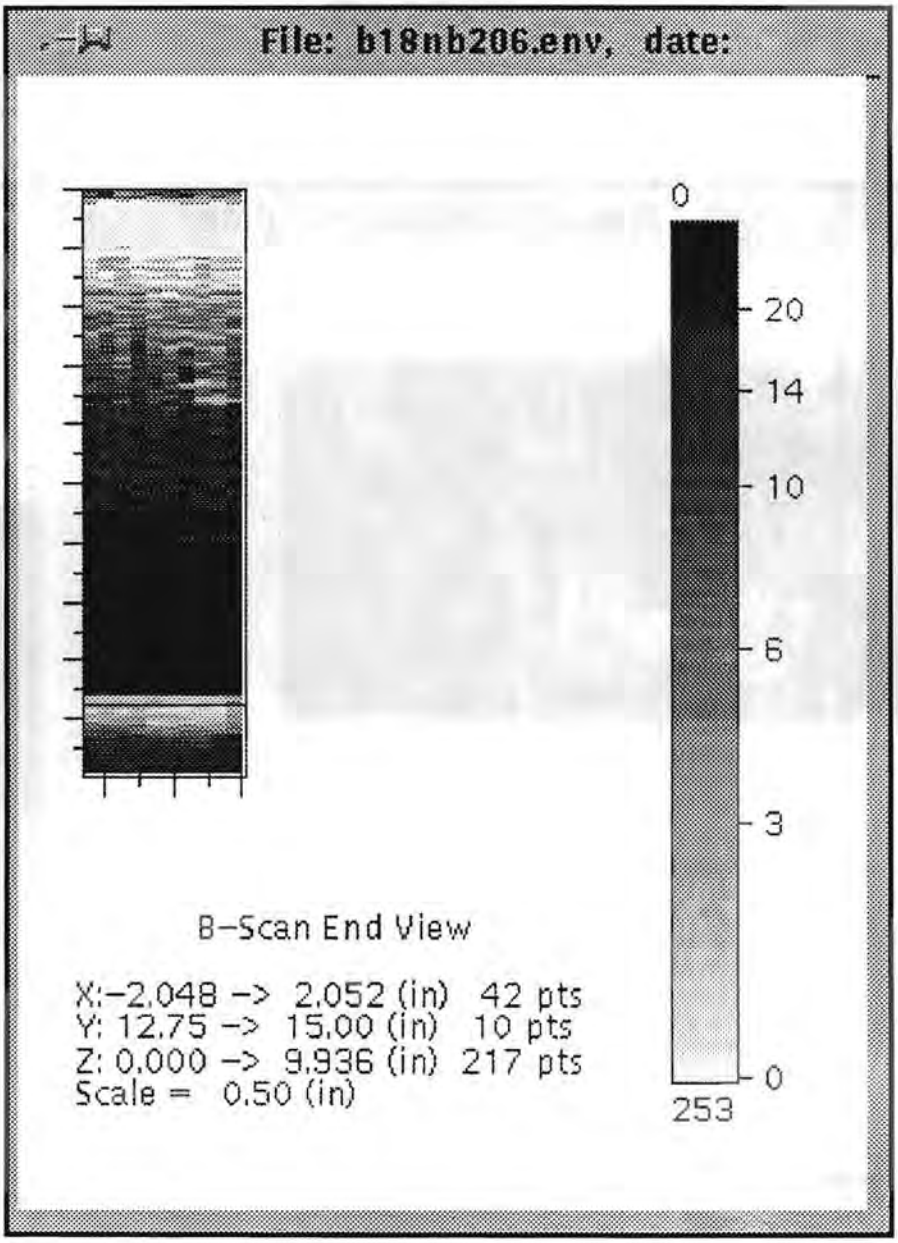
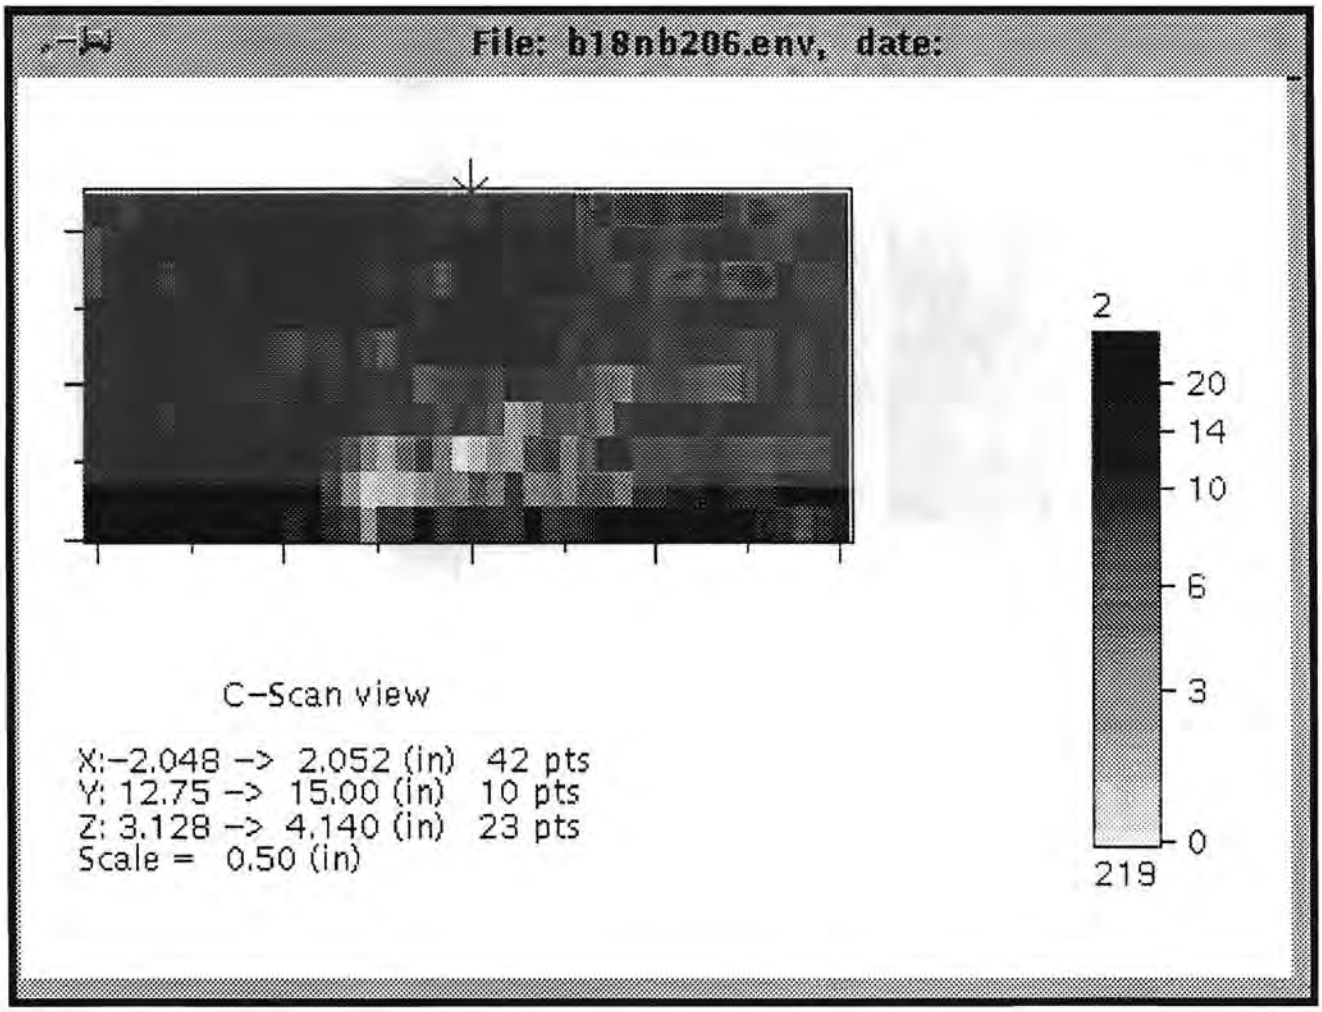
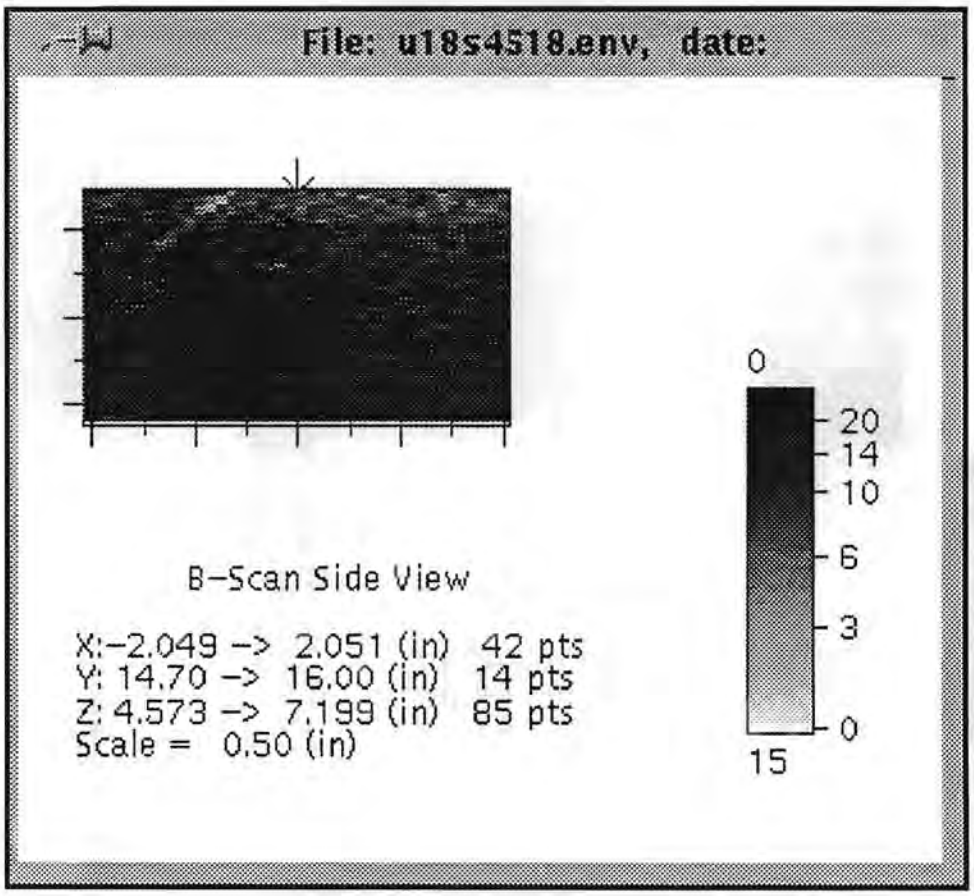
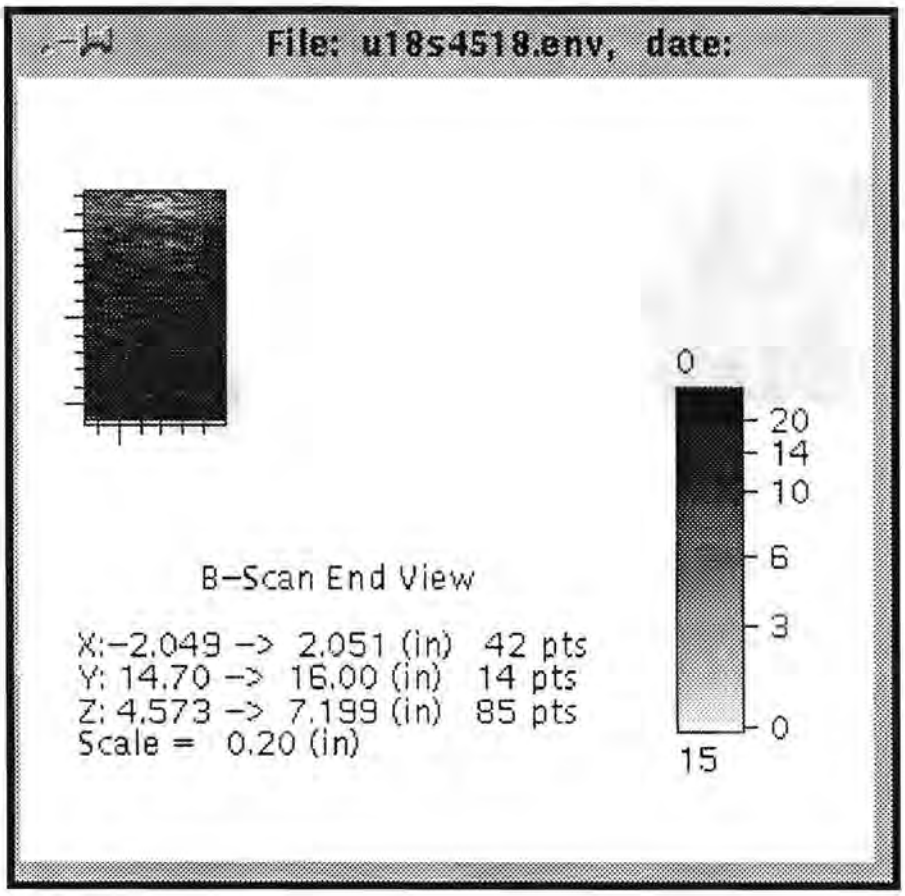
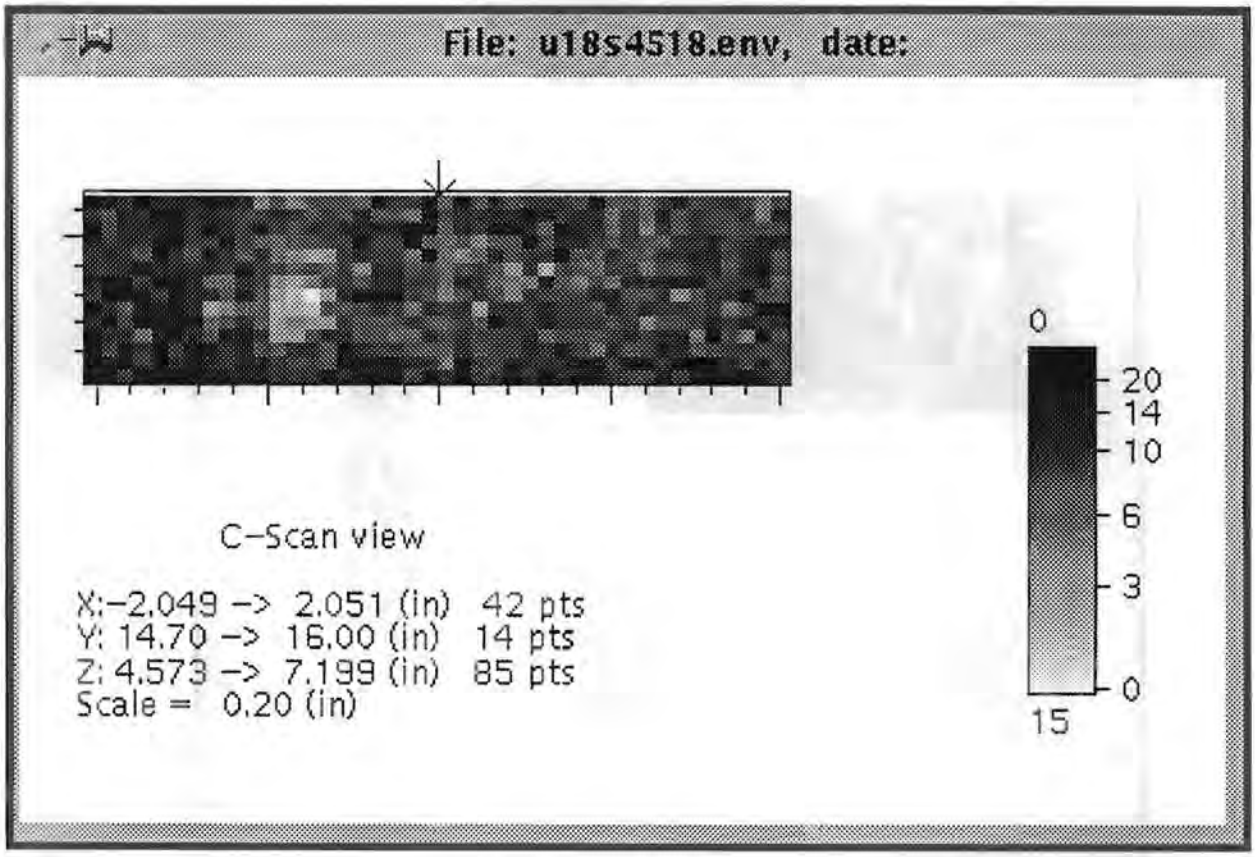
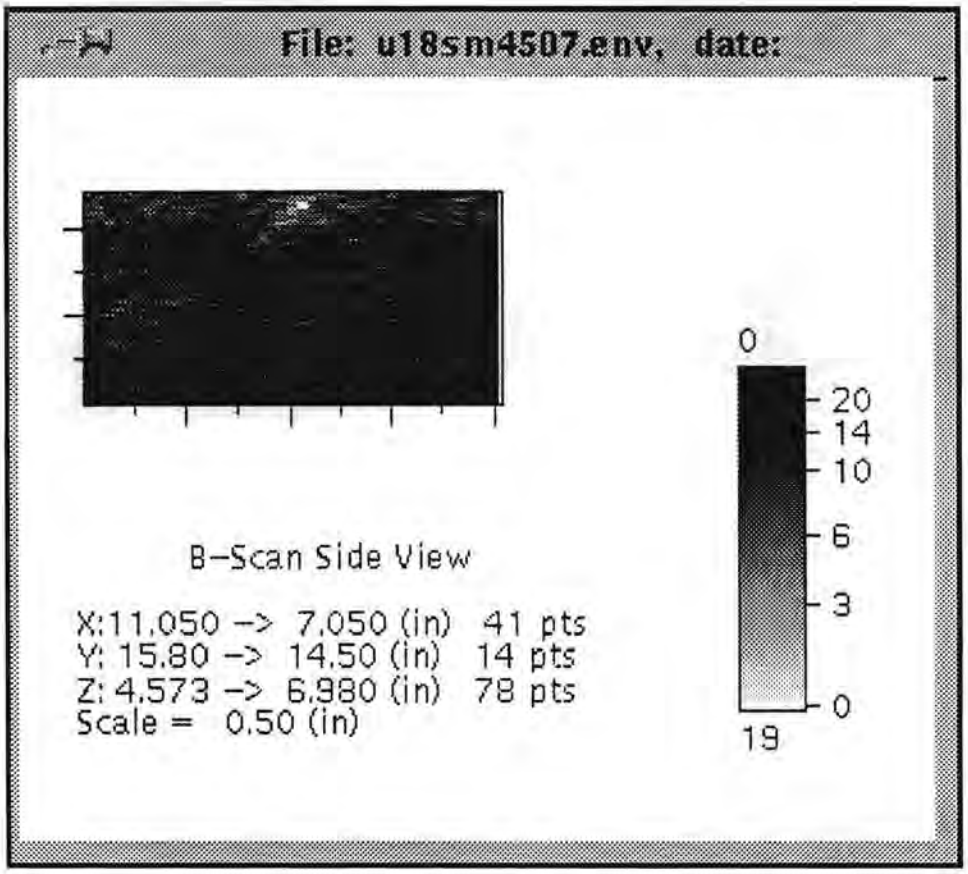
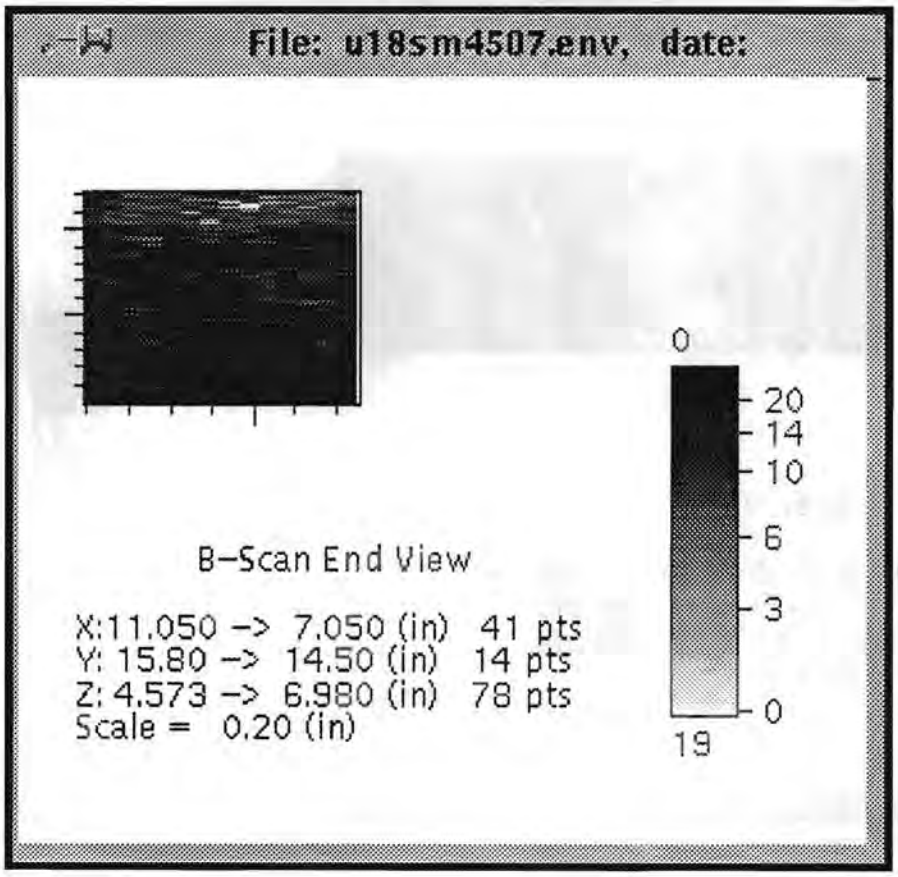
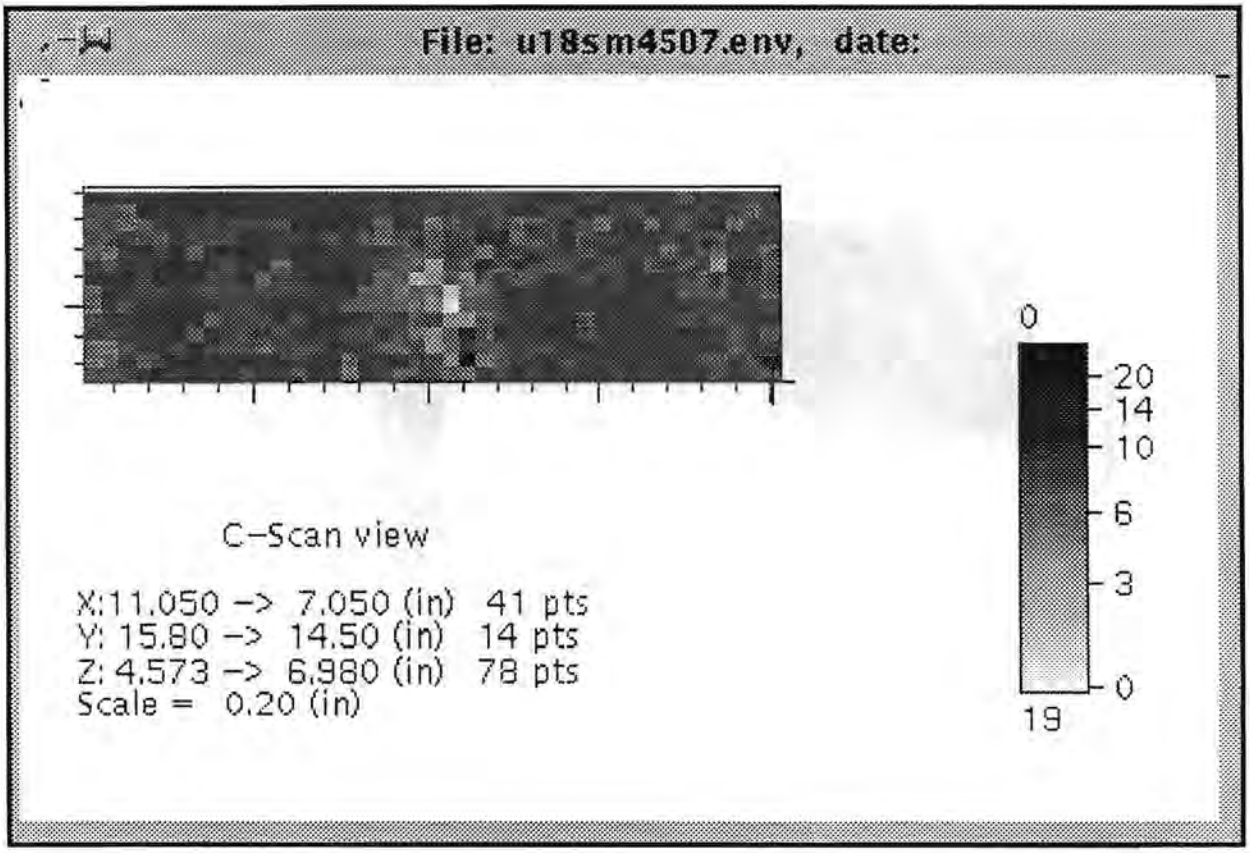
Y, mm (in.)	DY, mm (in.)	X, mm (in.)	DX, mm (in.)	Z, mm (in.)	DZ, mm (in.)	Characterization
380 (15.0)	5 (0.2)	-5 (-0.2)	13 (0.5)	89 (3.5)	1.3 (0.05)	Detected by SAFT-UT in normal beam from the clad side and in two different 45°S files from the unclad side. See Figure 5.1. DZ is determined from data shown in Figure 5.1d. This is one or more small volumetric defects. Destructive analysis shows one defect labeled 5T. See Table 4.1 and Figure 4.4 for DA results.
351 (13.8)	20 (0.8)	-10 (-0.4)	18 (0.7)	91 (3.6)	1.3 (0.05)	Detected by SAFT-UT in 45°S files from the unclad side. See Figure 5.2. DZ is determined from data shown in Figure 5.2g. This is one or more small planar defects. Destructive analysis shows two small defects label 6t and 6b. See Table 4.1 and Figure 4.5 for DA results.
318 (12.5)	15 (0.6)	-10 (-0.4)	13 (0.5)	91 (3.6)	1.3 (0.05)	Detected by SAFT-UT in normal beam from the clad side and in a 45°S inspection from the clad side. See Figure 5.3. This is a volumetric defect. DZ is estimated from Figure 5.3d.

Figure 5.1a Side View (XZ) of Base-Metal Indication in Block 1-8 at Y = 381 mm (15.0 in.). Normal beam inspection from the clad side. This indication corresponds to flaw #5 in the destructive analysis.

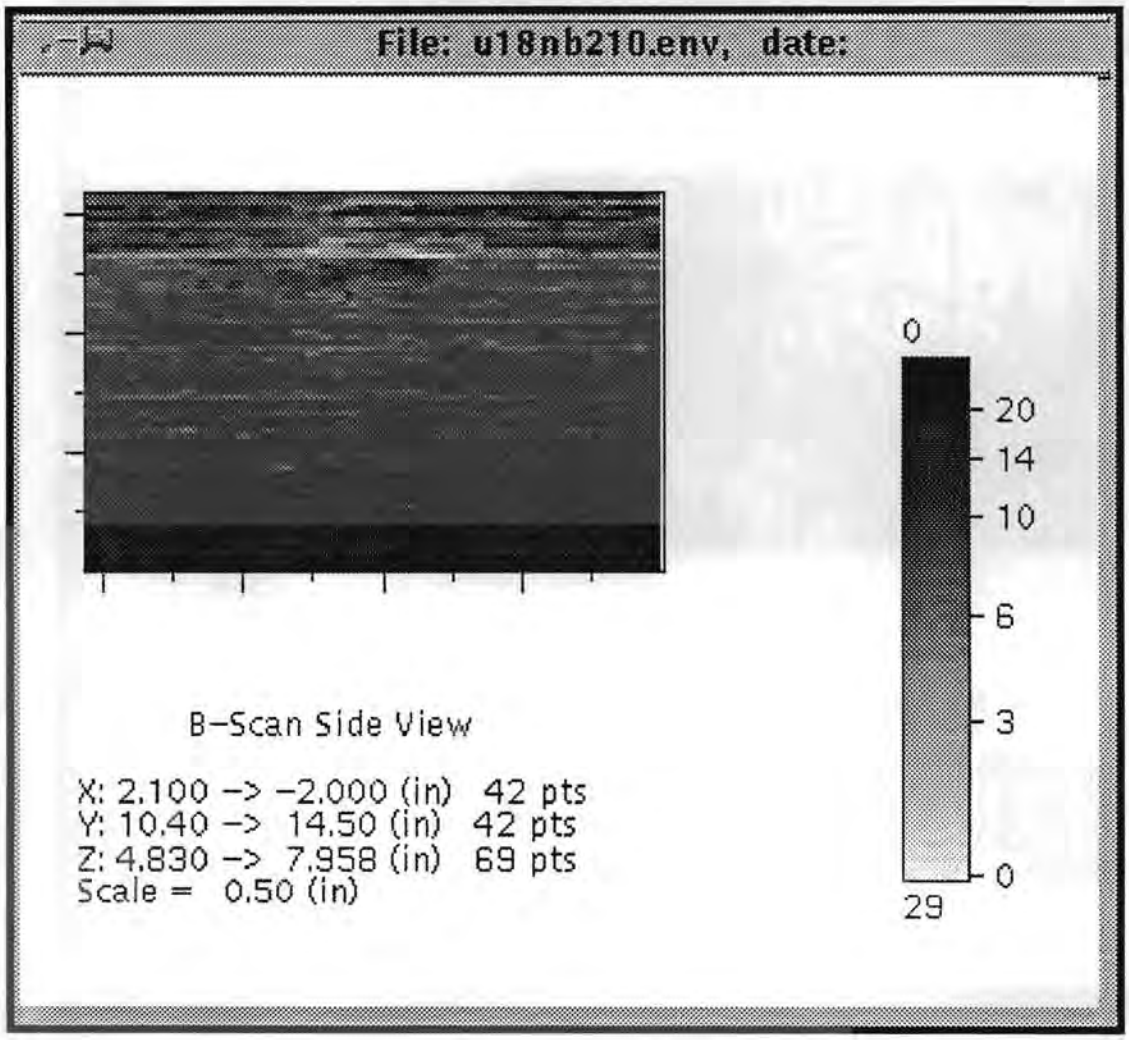
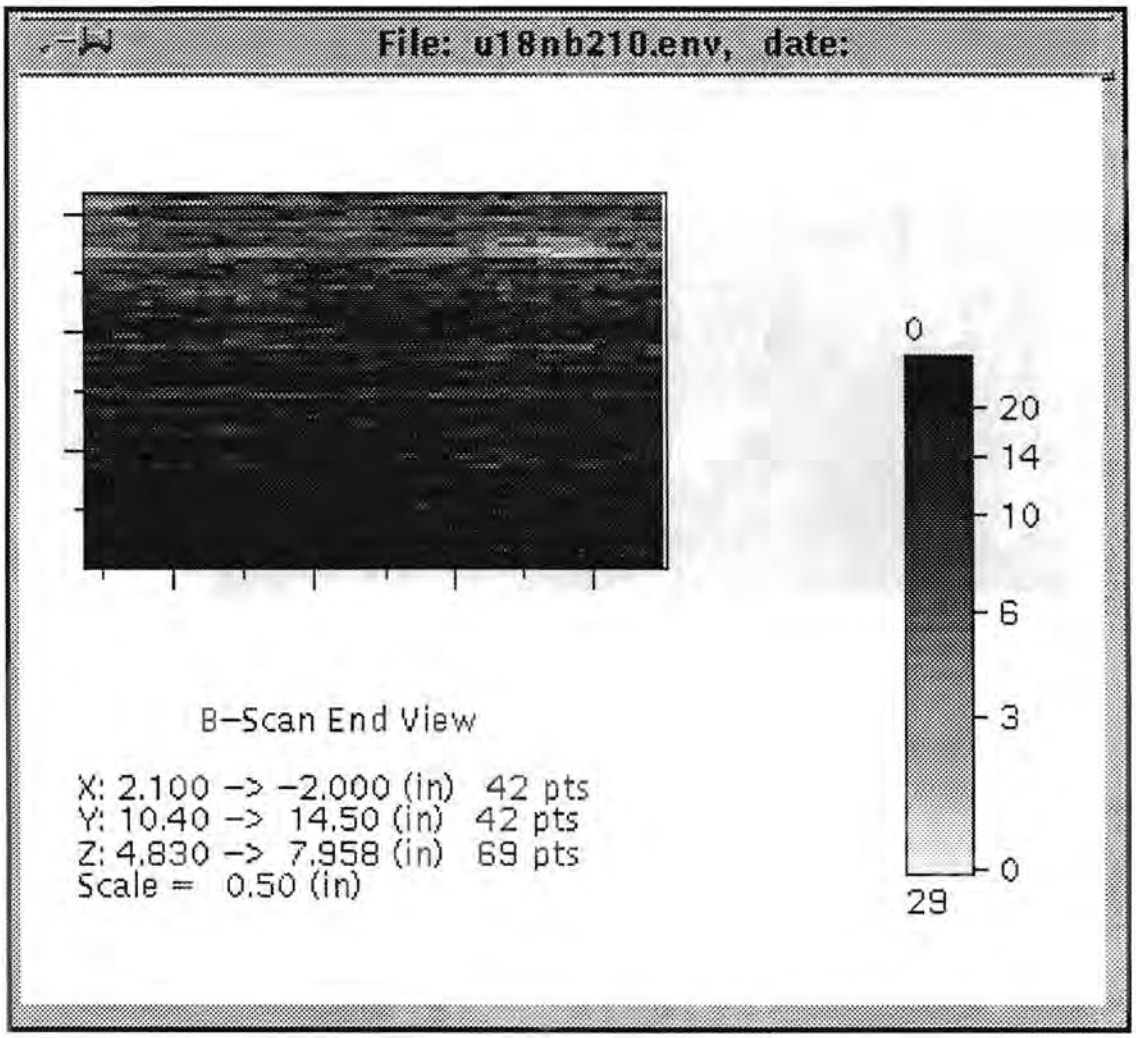
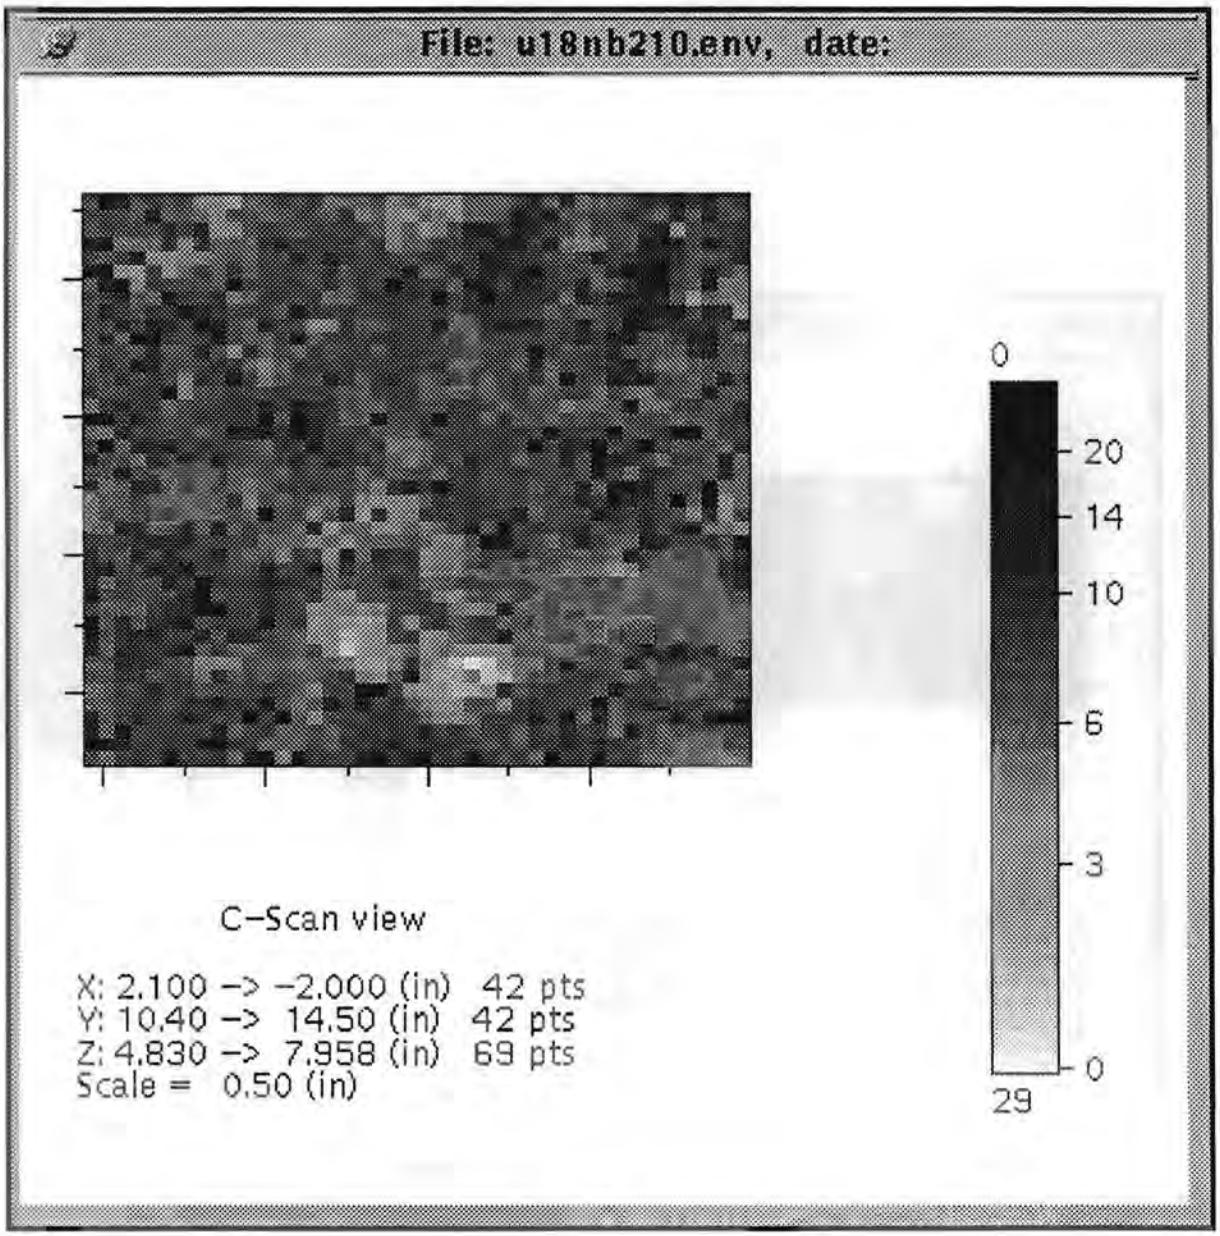
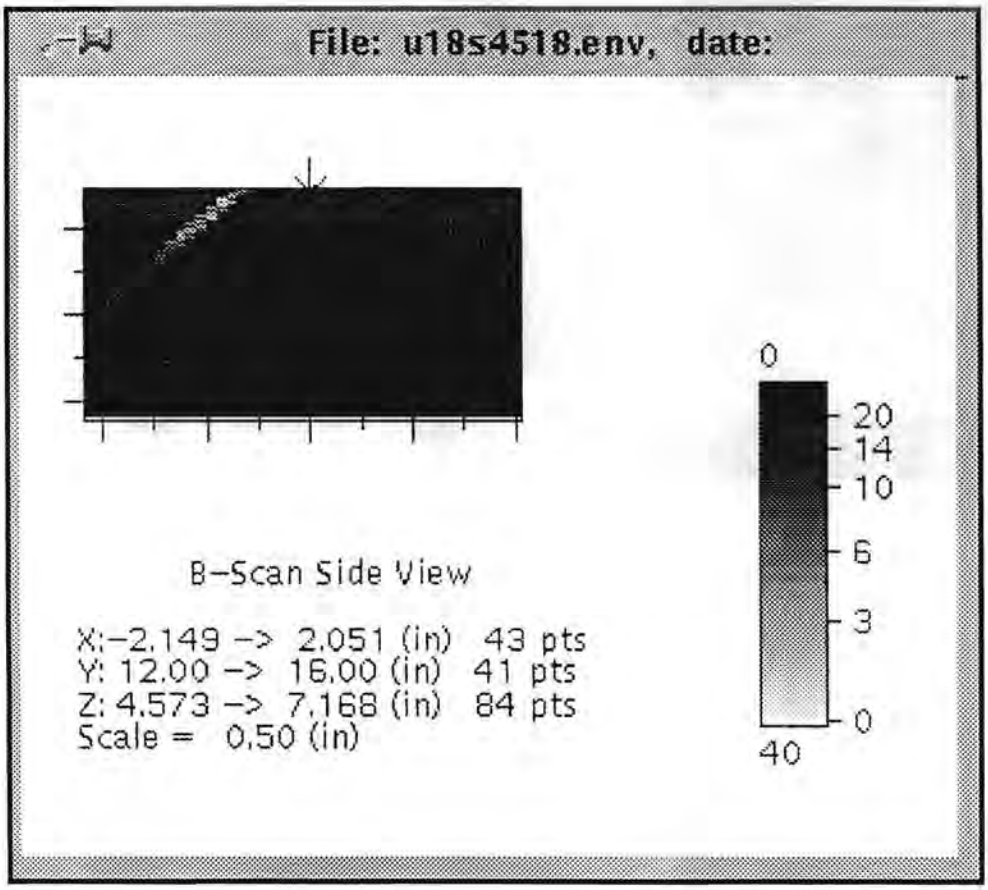
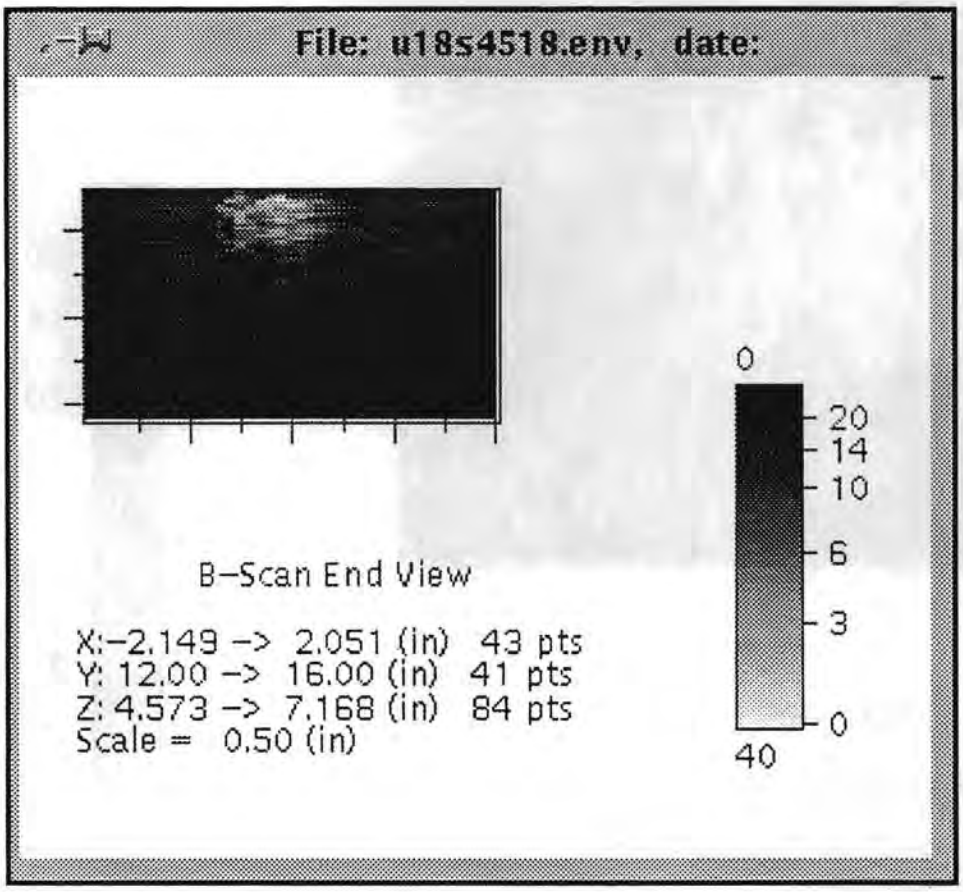
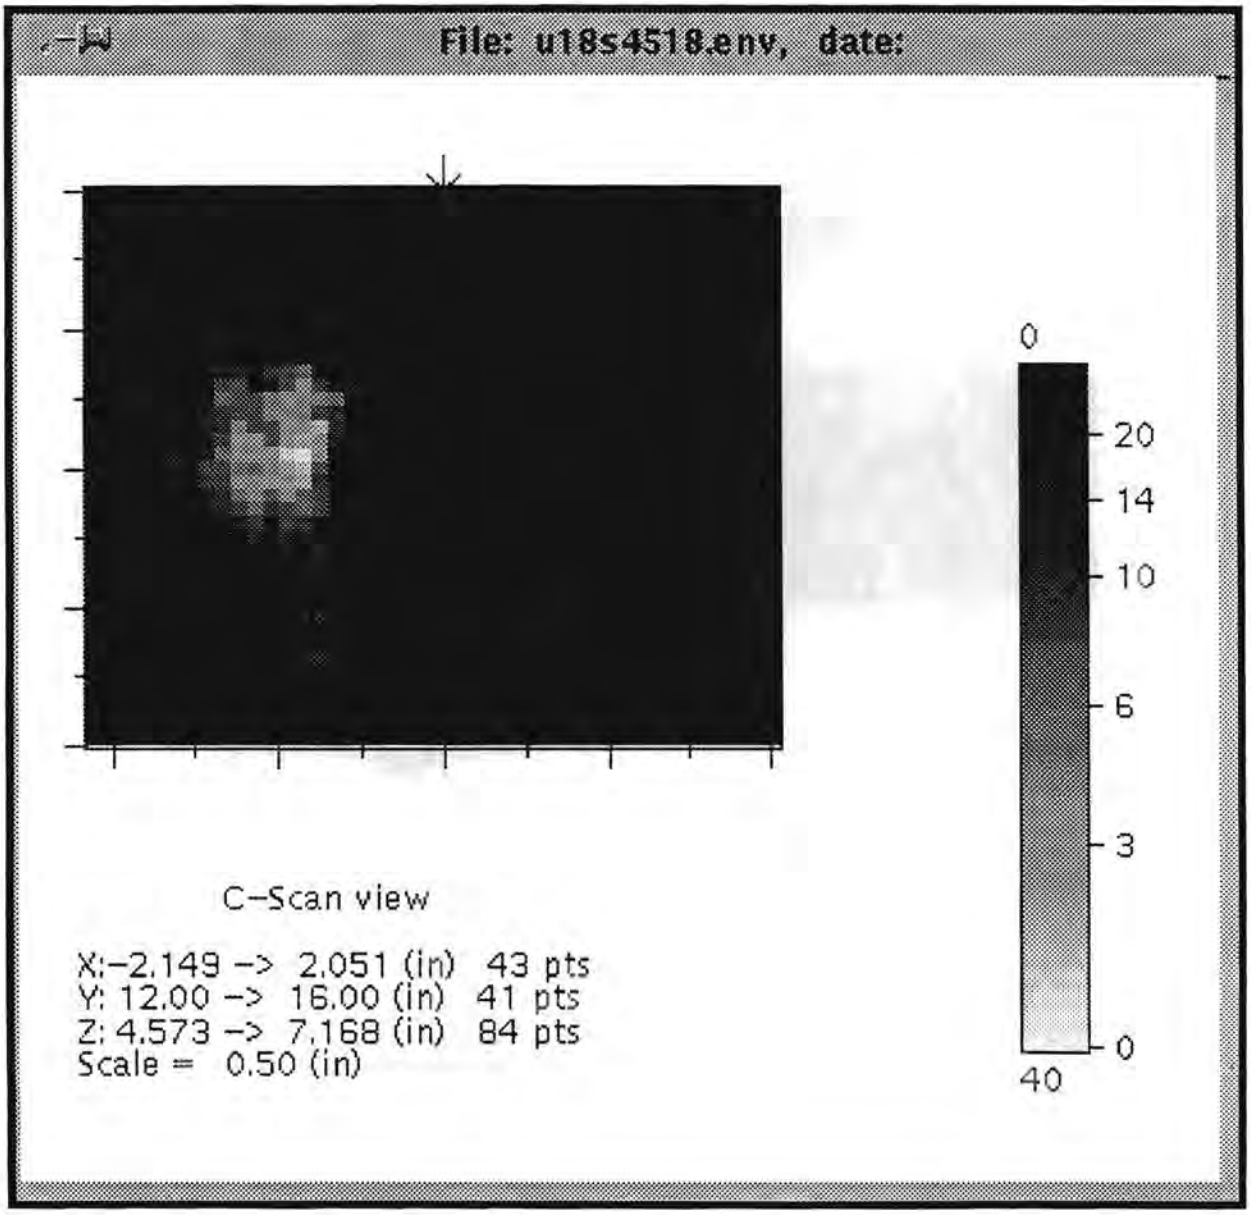
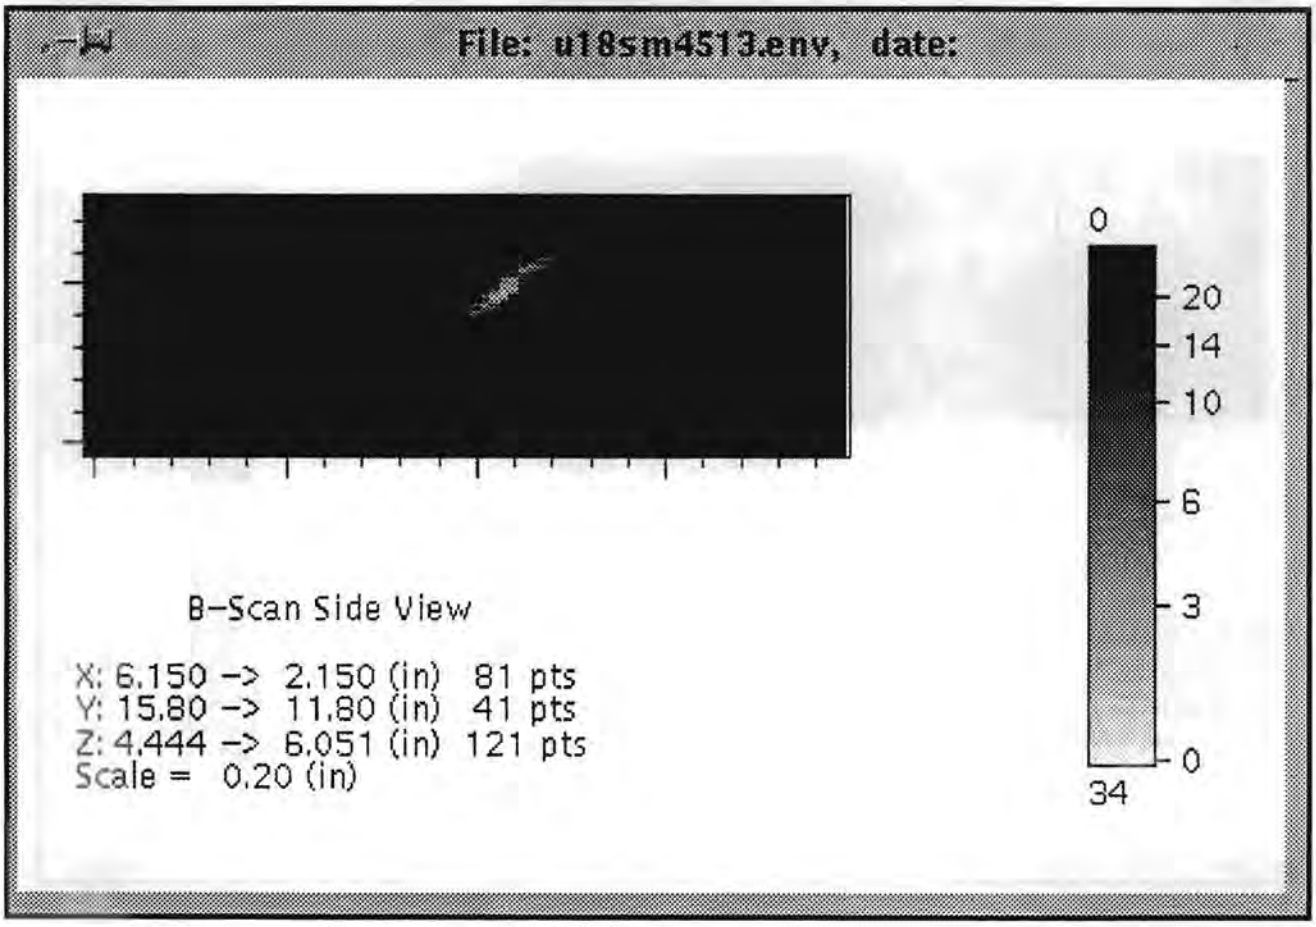
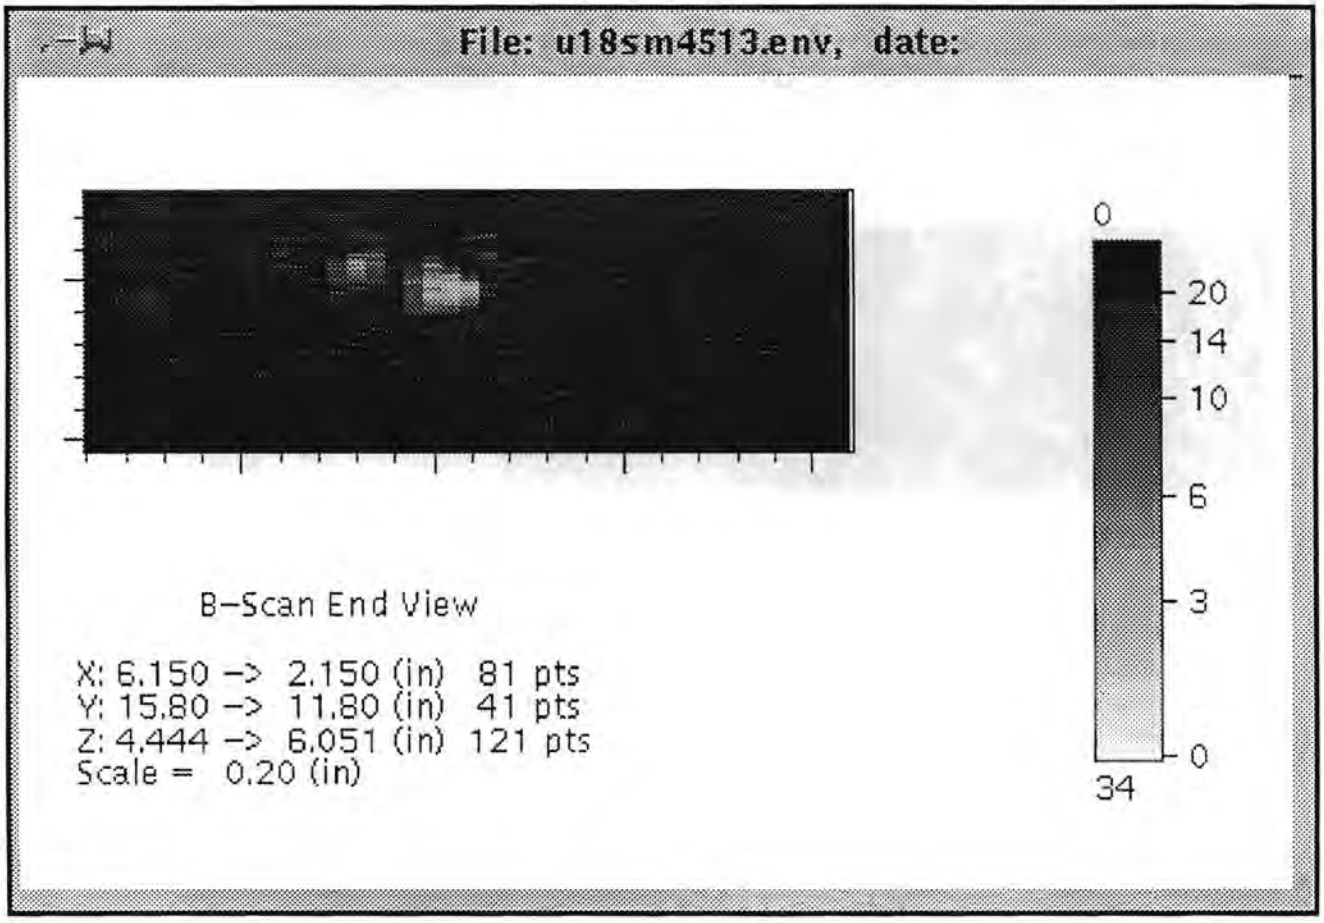
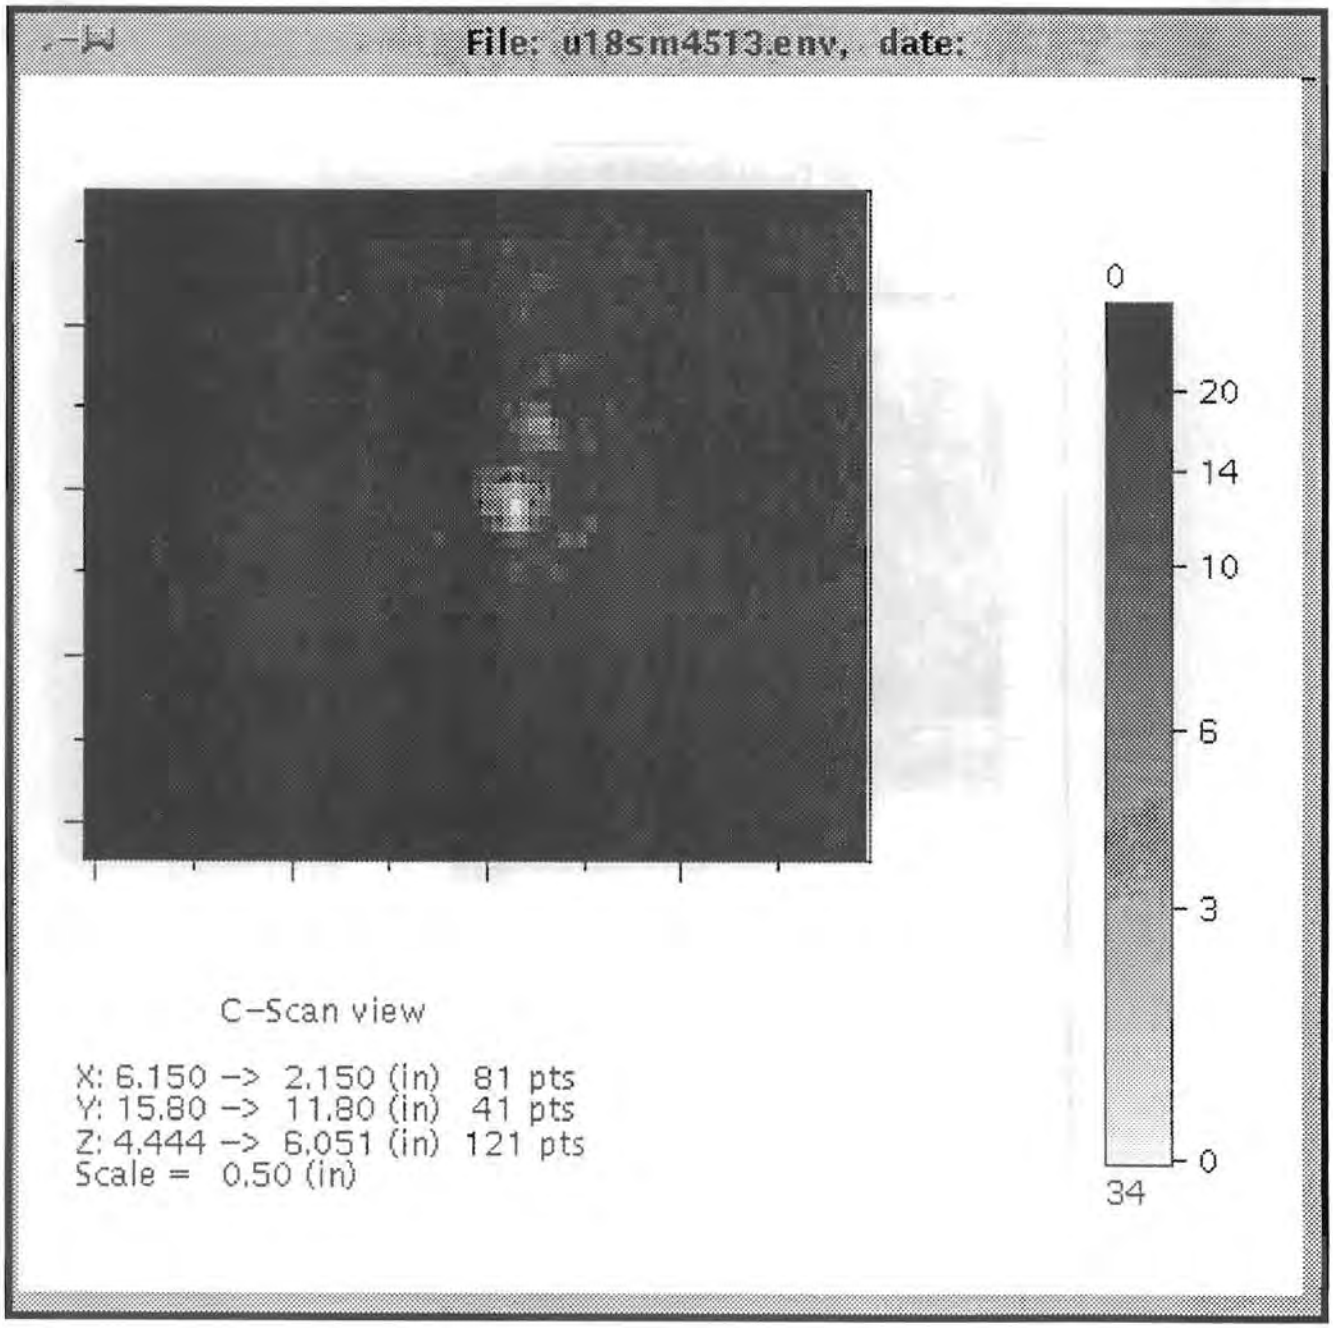
Flaw #5	Y, mm (in.)	DY, mm (in.)	X, mm (in.)	DX, mm (in.)	Z, mm (in.)	DZ, mm (in.)	Notes
Destructive Data	380 (15.0)	5 (0.2)	--	--	89 (3.5)	2 (0.1)	X and DX not given but flaw is in the weldment so X is 0 ± 12.7 mm (0.5 in.). See Figure 4.4.
SAFT-UT	380 (15.0)	5 (0.2)	-5 (-0.2)	13 (0.5)	89 (3.5)	1.3 (0.05)	DZ is determined from 45°S inspection from the unclad side. See Figure 5.1d.
Flaw #6t & 6b	**Y, mm (in.)**	**DY, mm (in.)**	**X, mm (in.)**	**DX, mm (in.)**	**Z, mm (in.)**	**DZ, mm (in.)**	**Notes**
Destructive Data	350 (13.8)	2.0 (0.08) 3.5 (0.14)	--	--	99 (3.9)	1.5 (0.06) 2.5 (0.10)	See Figures 4.5 and 4.6.
SAFT-UT	350 (13.8)	10 (0.4)	-10 (-0.4)	18 (0.7)	91 (3.6)	1.3 (0.05)	DZ is determined from 45°S inspection from the unclad side. See Figure 5.2g.

Figure 5.2a Side View (XZ) of Base-Metal Indication in Block 1-8 at Y = 351 mm (13.8 in.). Normal beam inspection from the unclad side. Z values in the figure are measured from the unclad side. This indication corresponds to flaw #6 in the destructive analysis.
