NUREG/CR-6471, Vol. 1
PNNL-11143

Characterization of Flaws in U.S. Reactor Pressure Vessels

Density and Distribution of Flaw Indications in PVRUF

Pacific Northwest National Laboratory

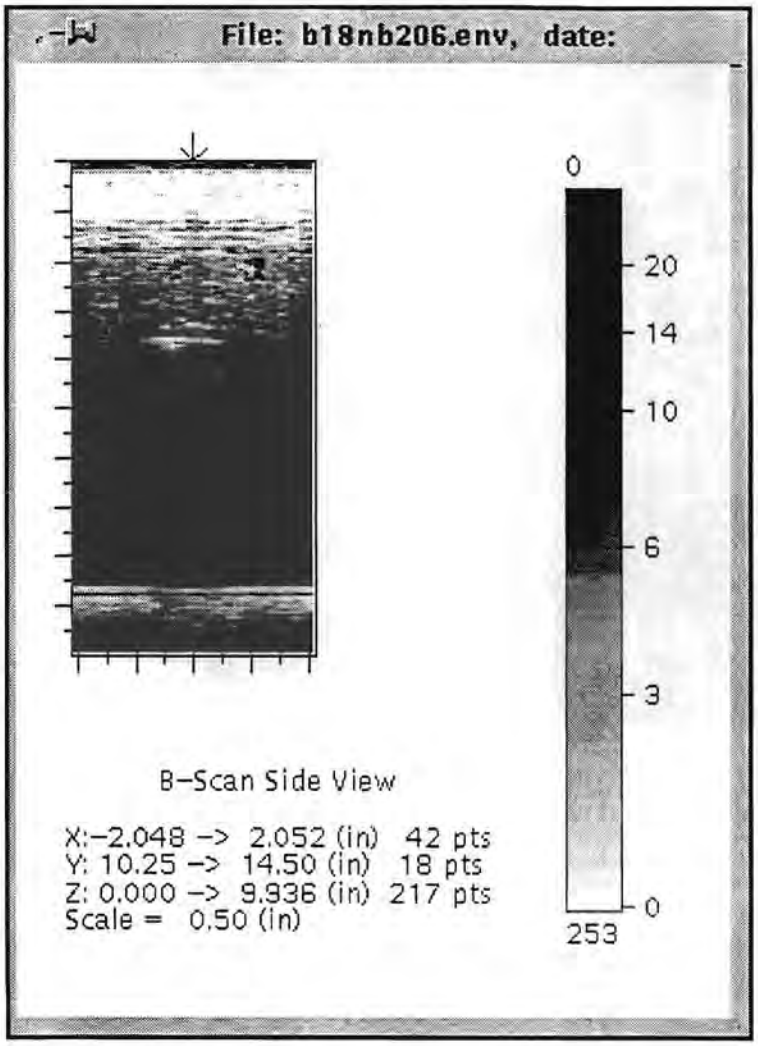
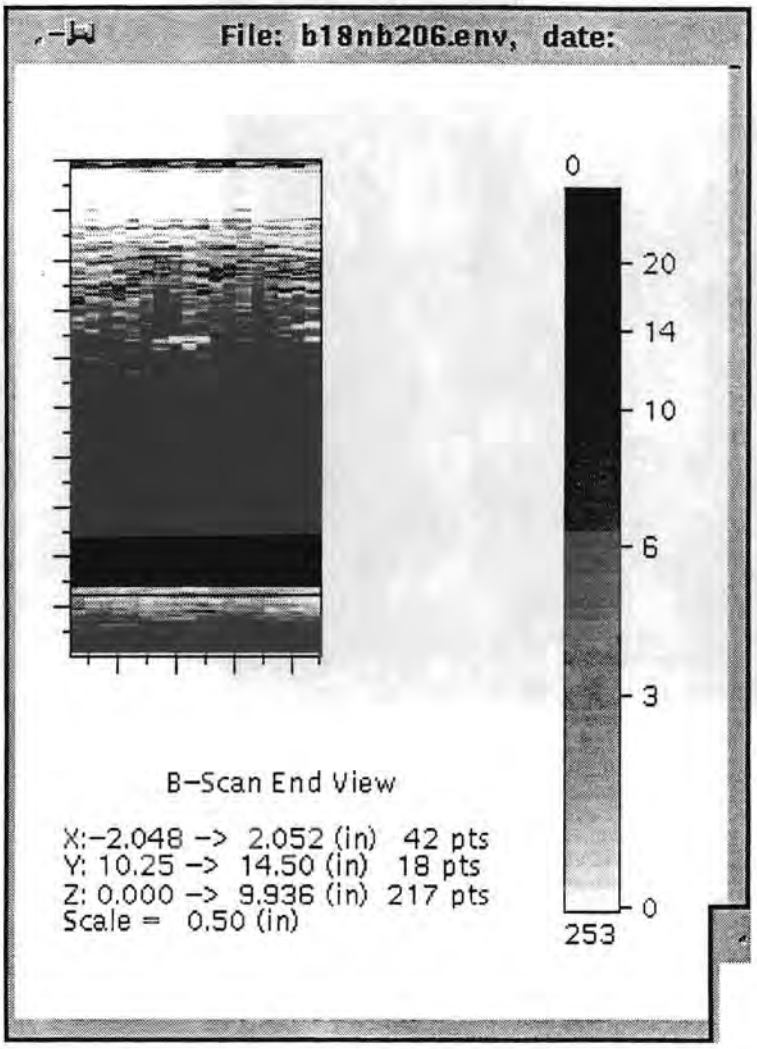
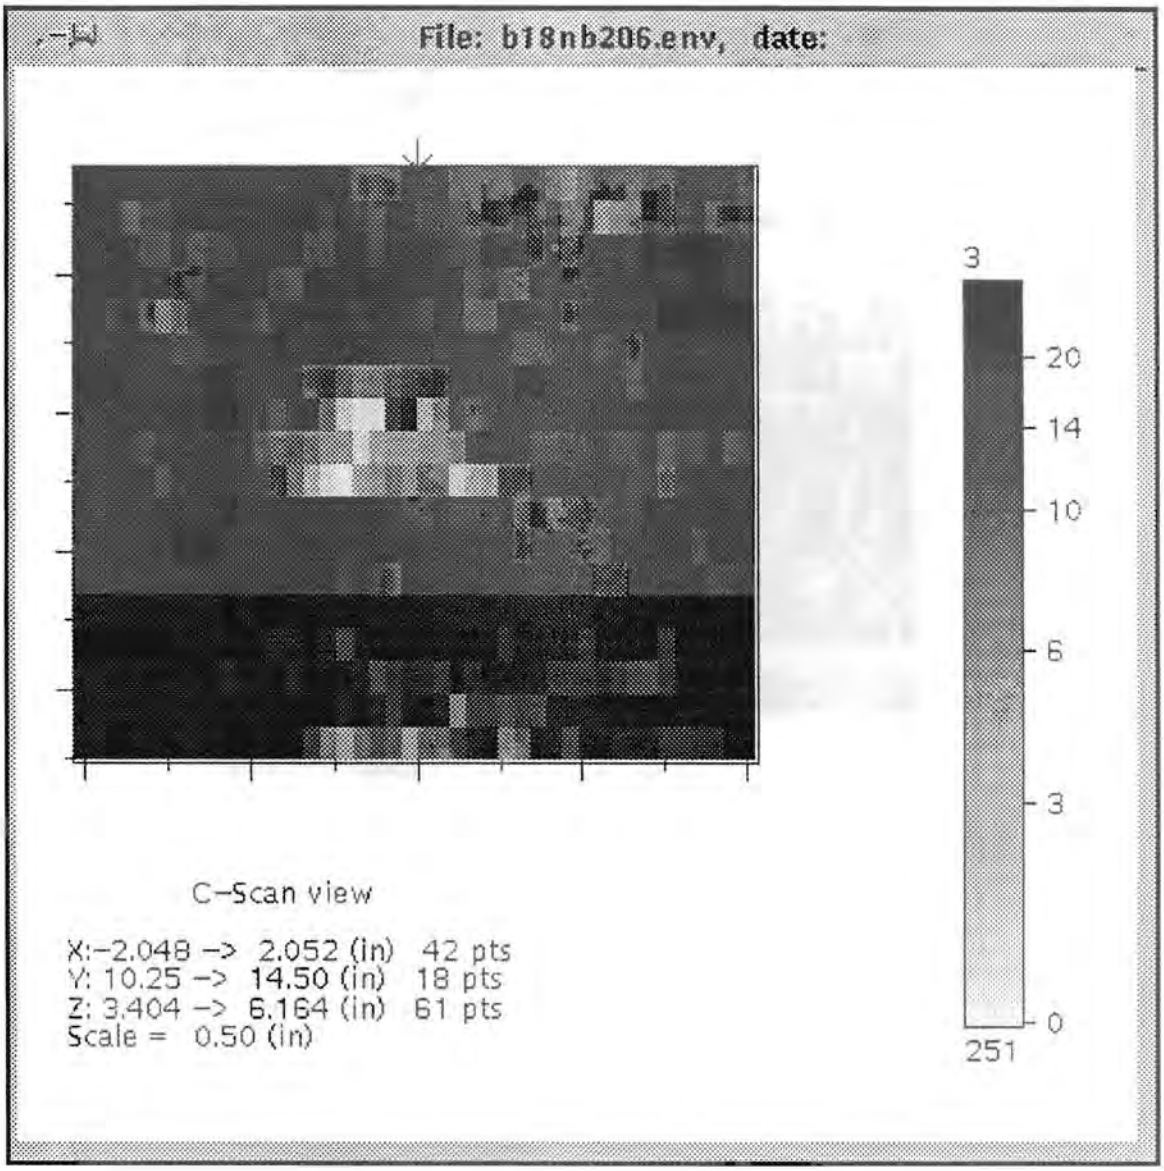
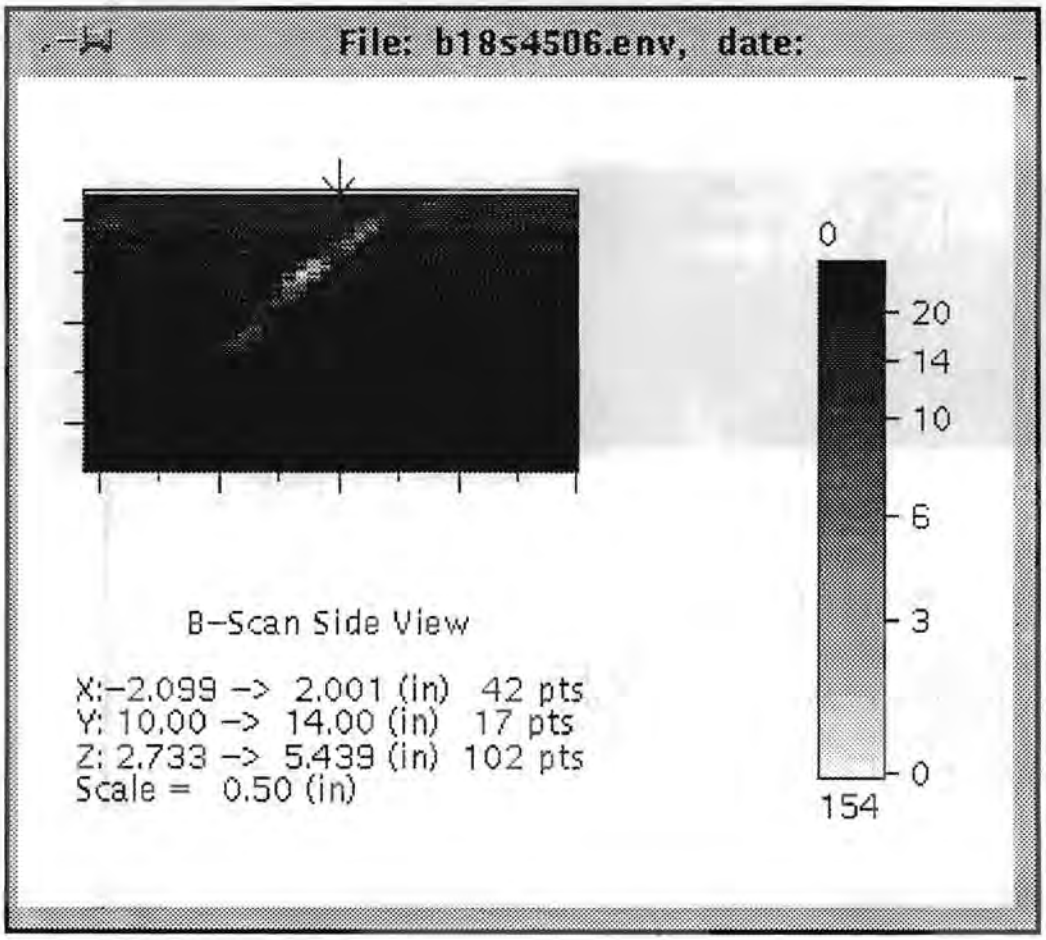
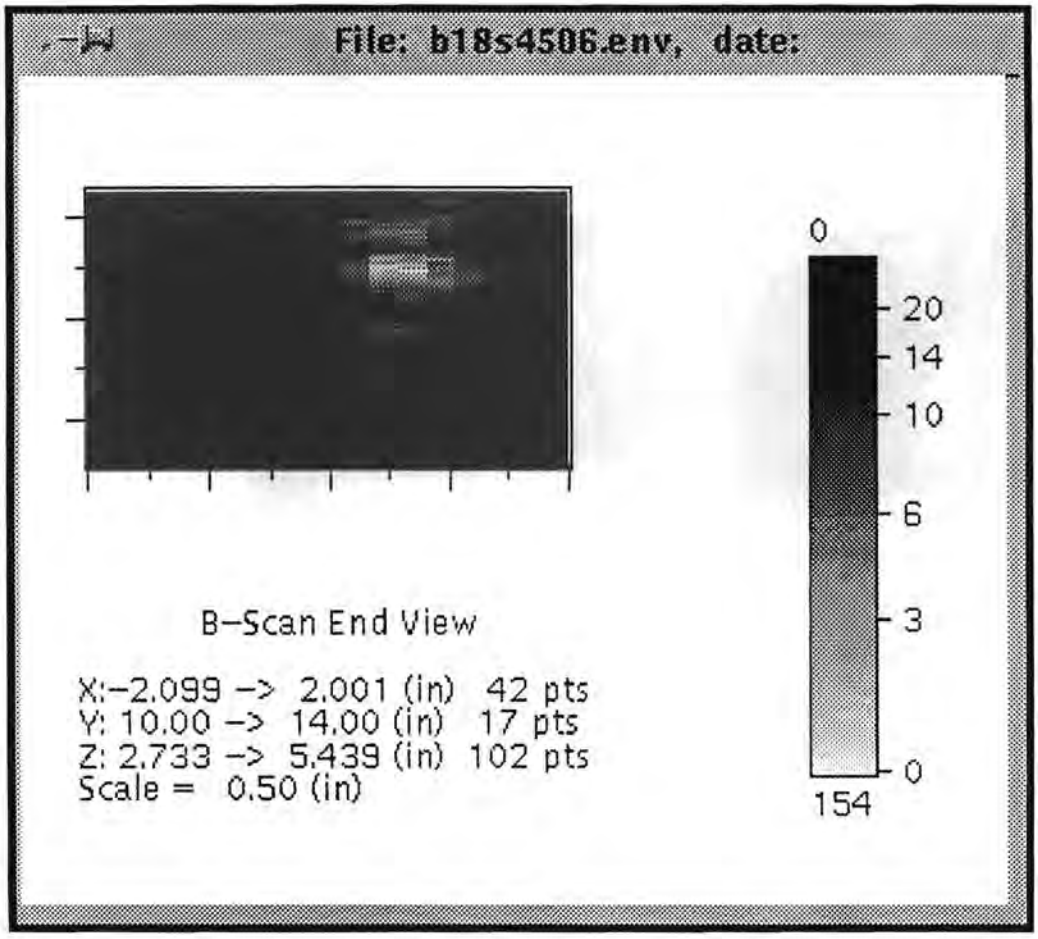
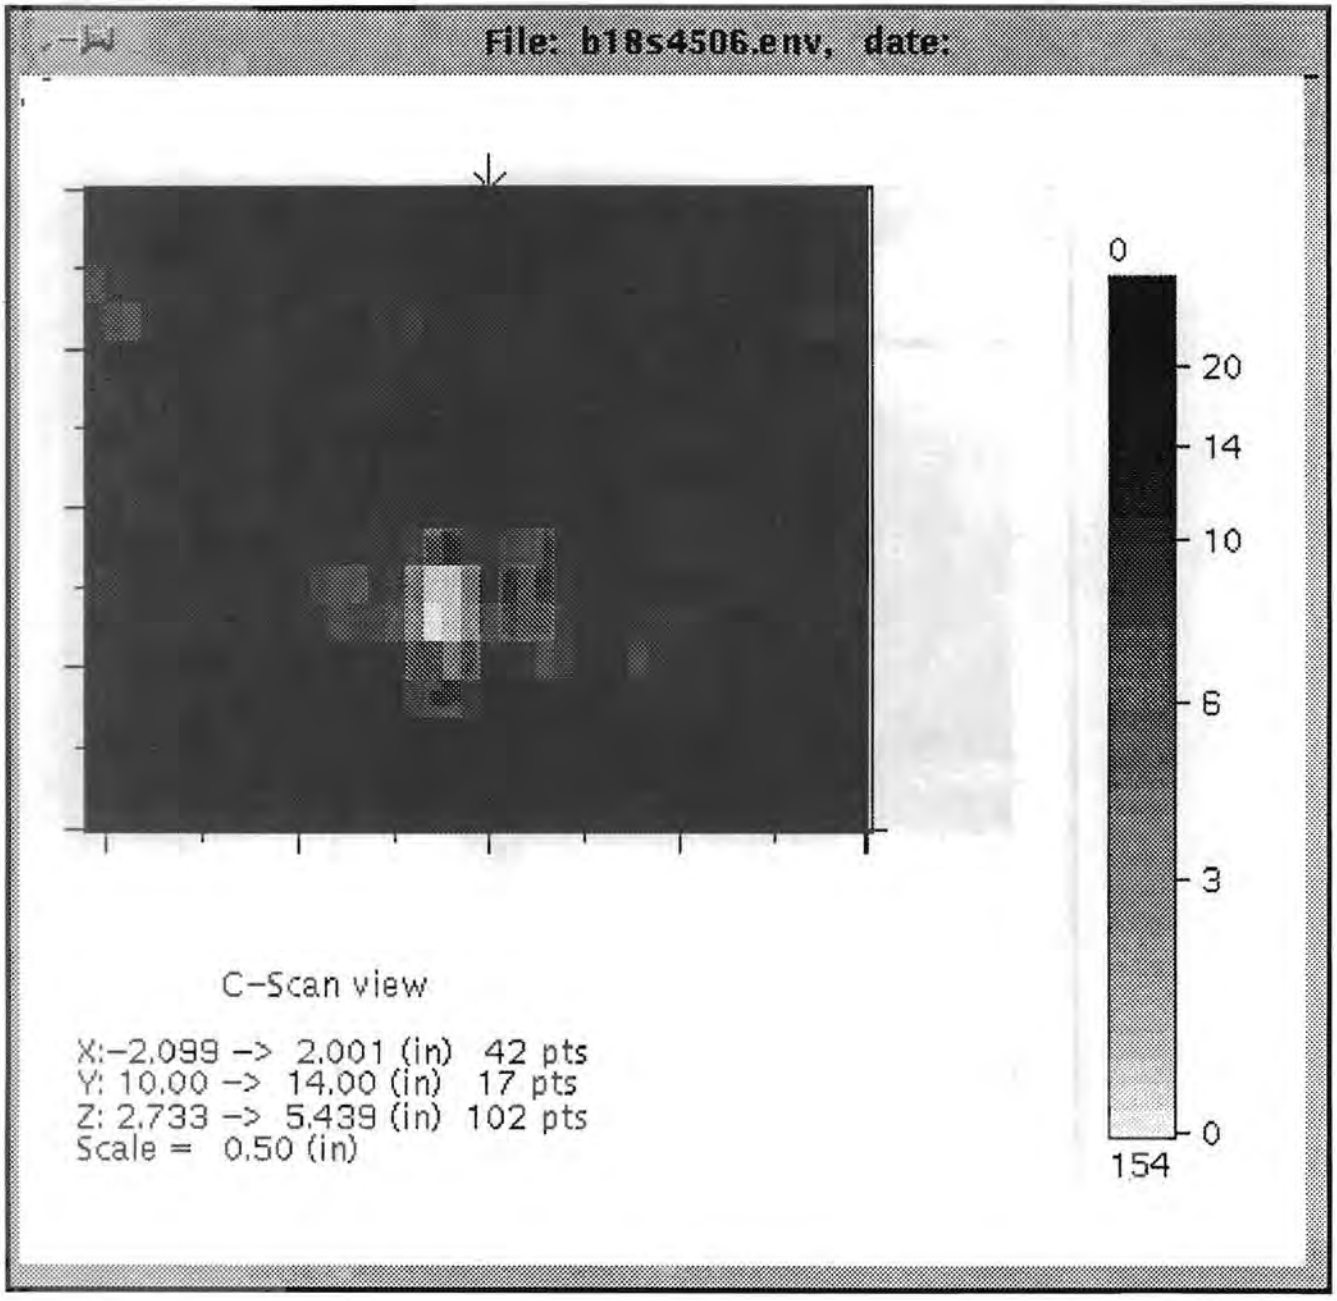
Y, mm (in.)	DY, mm (in.)	X, mm (in.)	DX, mm (in.)	Z, mm (in.)	DZ, mm (in.)	Characterization
380 (15.0)	5 (0.2)	-5 (-0.2)	13 (0.5)	89 (3.5)	1.3 (0.05)	Detected by SAFT-UT in normal beam from the clad side and in two different 45°S files from the unclad side. See Figure 5.1. DZ is determined from data shown in Figure 5.1d. This is one or more small volumetric defects. Destructive analysis shows one defect labeled 5T. See Table 4.1 and Figure 4.4 for DA results.
351 (13.8)	20 (0.8)	-10 (-0.4)	18 (0.7)	91 (3.6)	1.3 (0.05)	Detected by SAFT-UT in 45°S files from the unclad side. See Figure 5.2. DZ is determined from data shown in Figure 5.2g. This is one or more small planar defects. Destructive analysis shows two small defects label 6t and 6b. See Table 4.1 and Figure 4.5 for DA results.
318 (12.5)	15 (0.6)	-10 (-0.4)	13 (0.5)	91 (3.6)	1.3 (0.05)	Detected by SAFT-UT in normal beam from the clad side and in a 45°S inspection from the clad side. See Figure 5.3. This is a volumetric defect. DZ is estimated from Figure 5.3d.

Figure 5.3a Side View (XZ) of Base-Metal Indication in Block 1-8 at Y = 318 mm (12.5 in.). Normal beam inspection from the clad side.

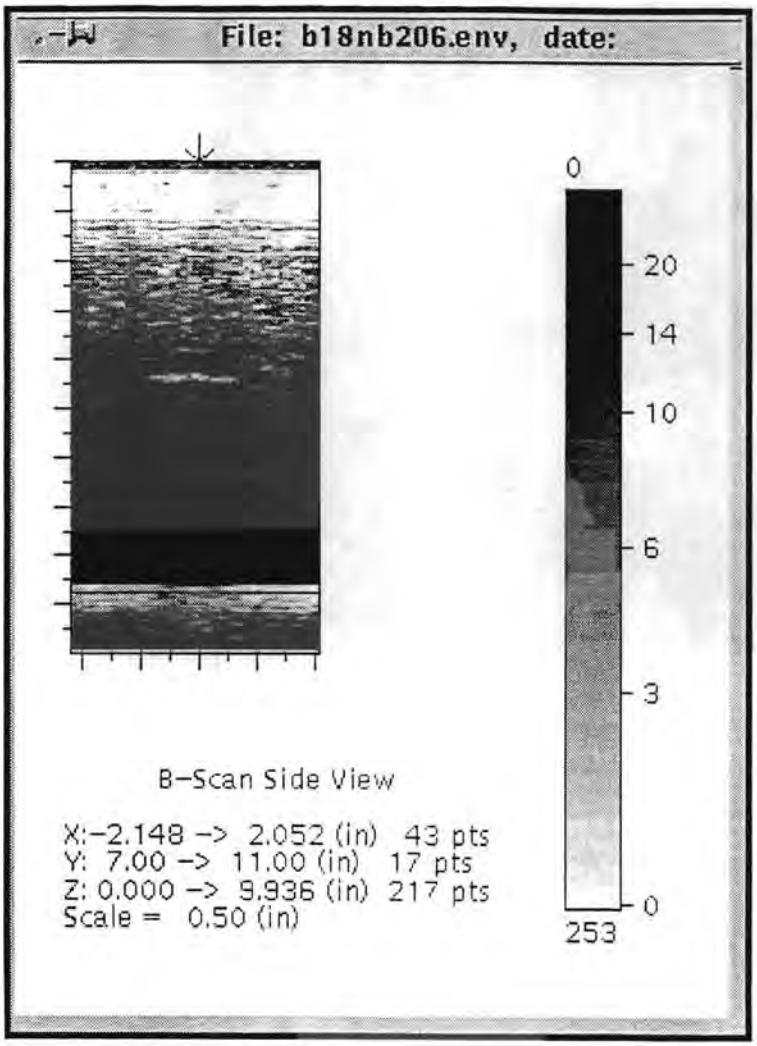
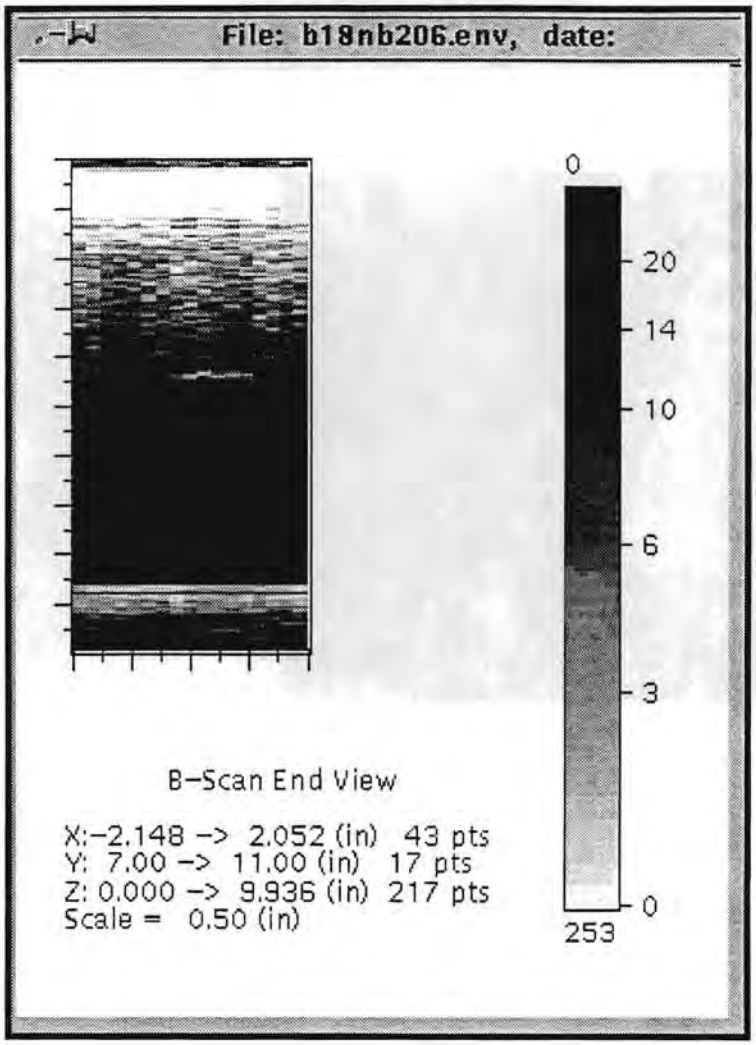
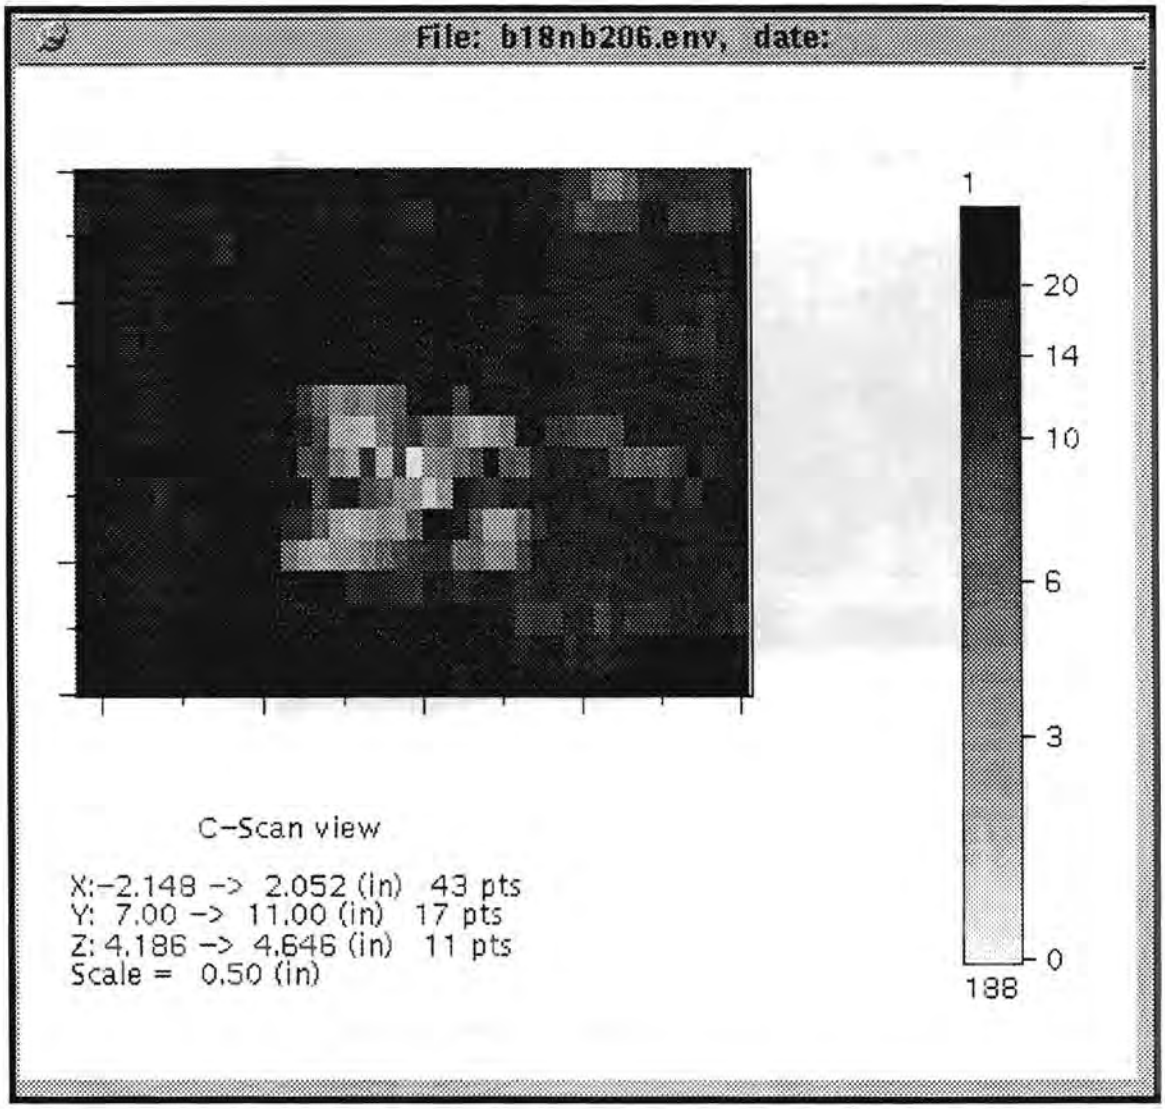
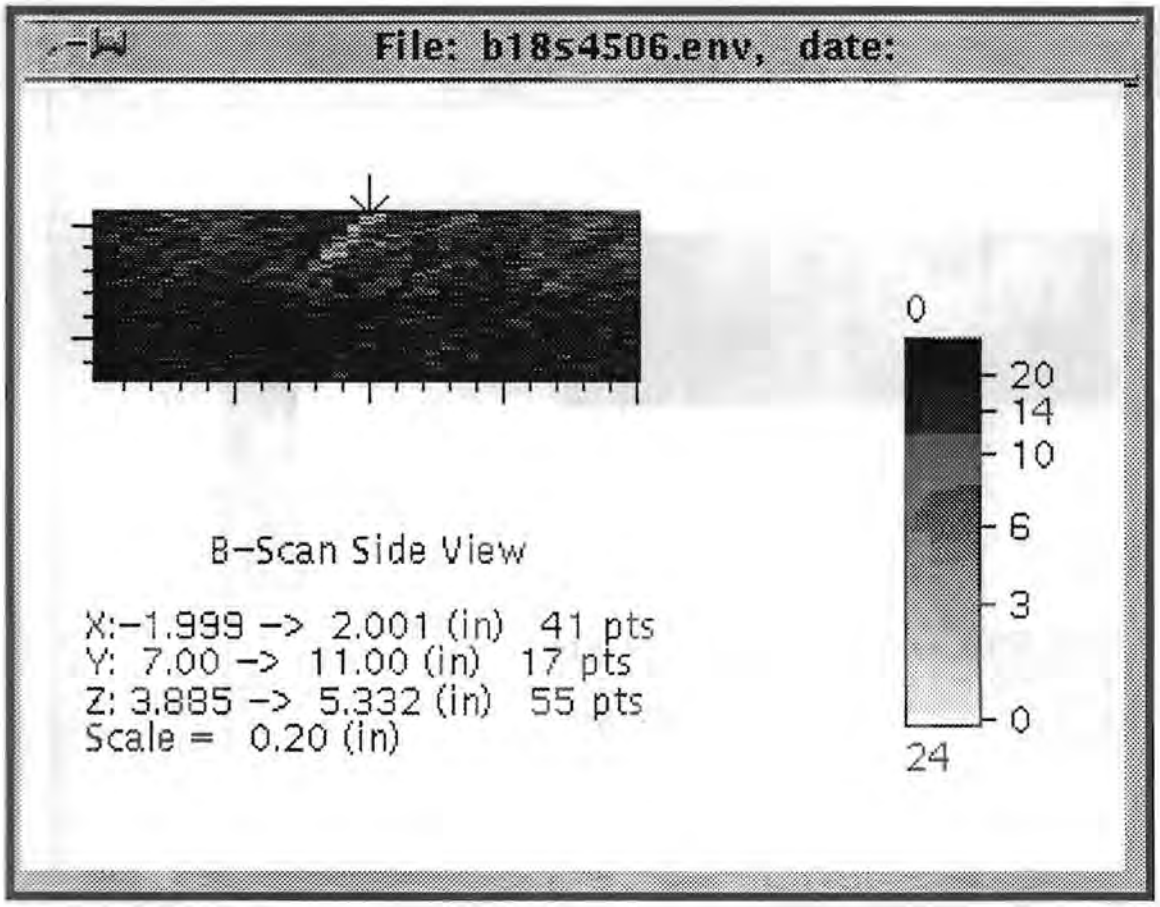
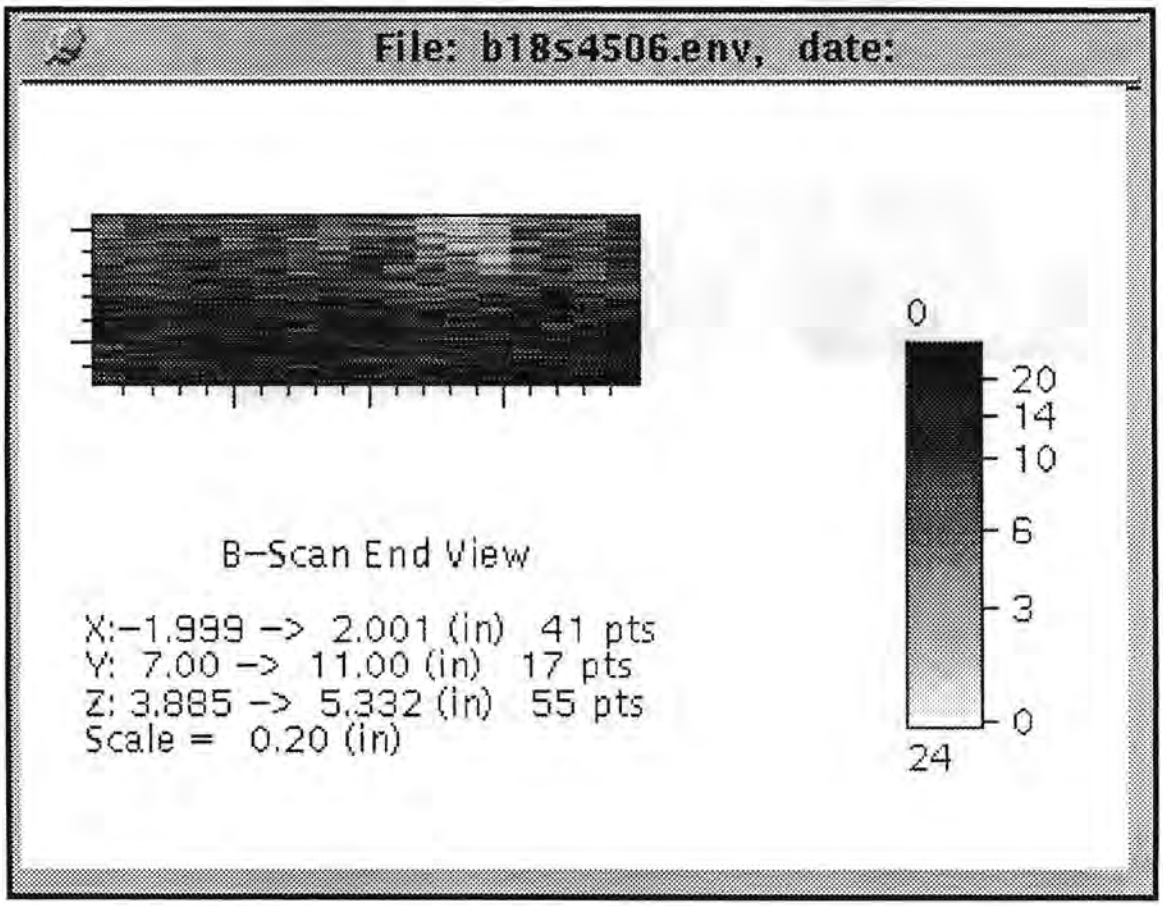
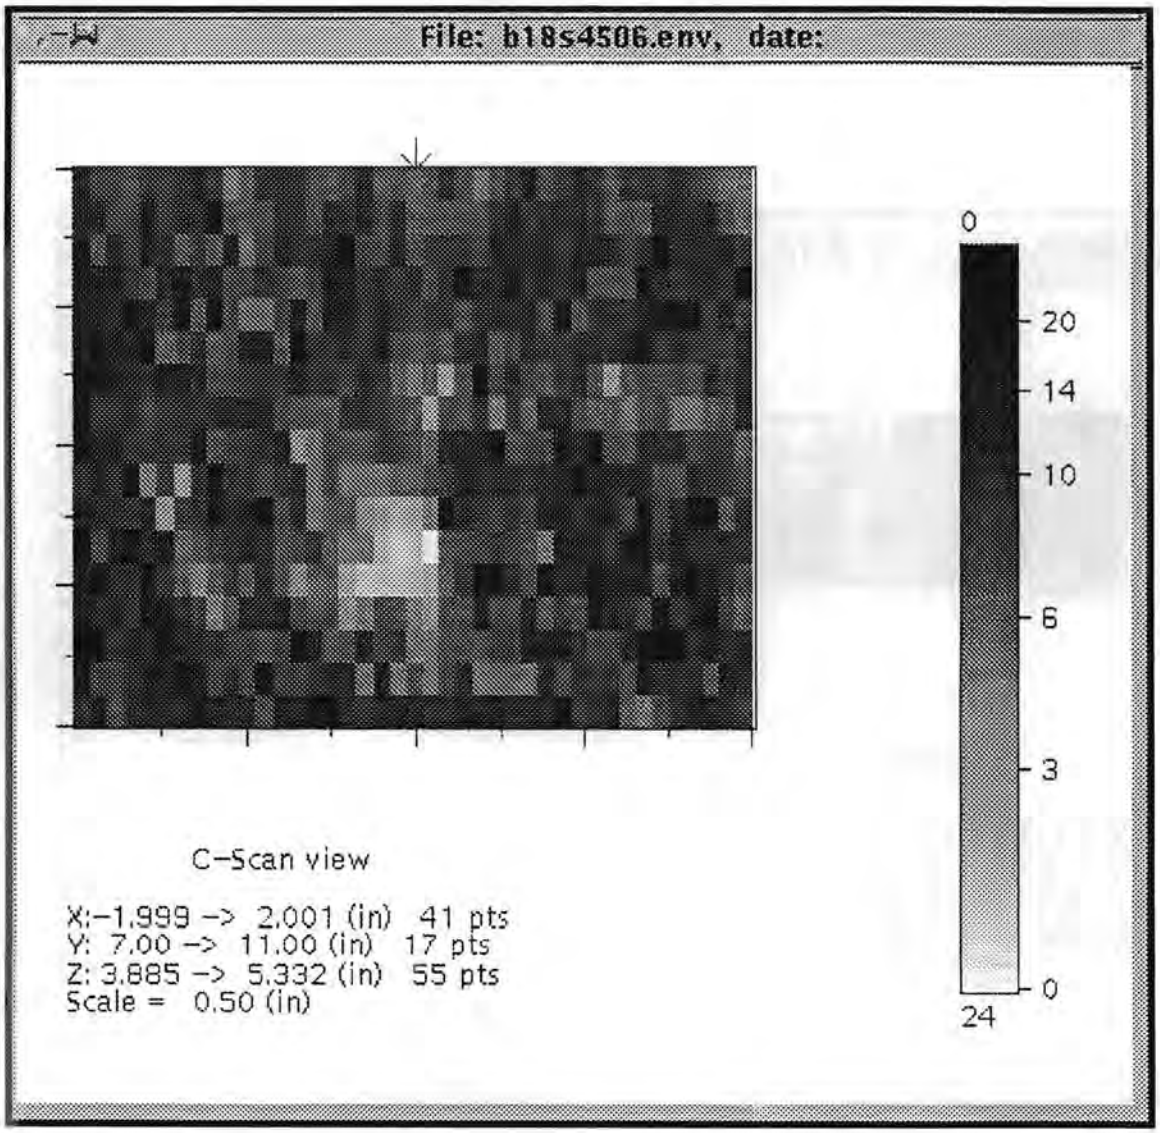
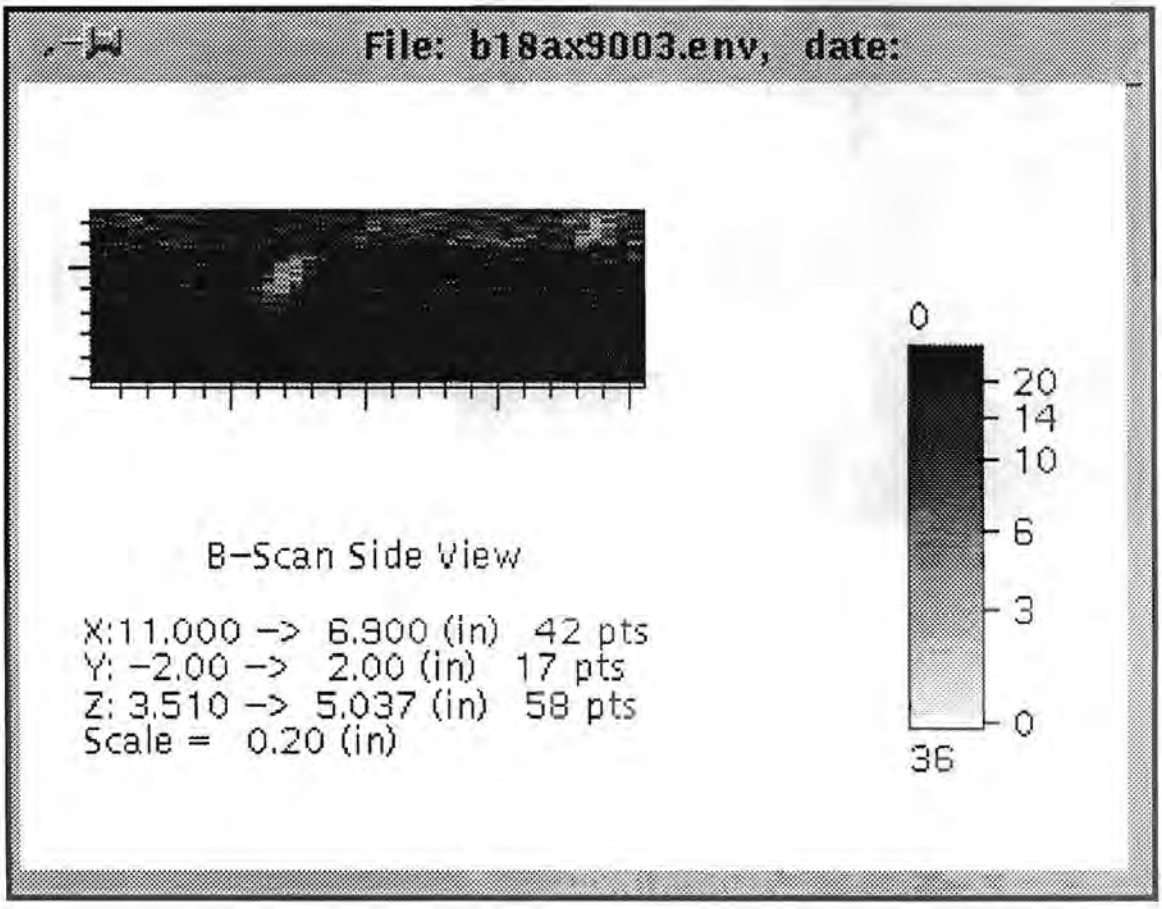
249 (9.8)	5 (0.2)	0.0 (0.0)	20 (0.8)	109 (4.3)	1.3 (0.05)	Detected by SAFT-UT in normal beam from clad and unclad side. Also detected in 45°S files from the clad side. See Figure 5.4. This is a small volumetric defect. DZ is estimated from Figures 5.4k and 5.4g. DX is estimated from Figure 5.4h, and DY is estimated from Figure 5.4e.
-127 (-5.0)	10 (0.4)	0.00 (0.0)	15 (0.6)	112 (4.4)	-	Detected by SAFT-UT in normal beam from the clad side. See Figure 5.5. No estimate is made for DZ since this reflector is only detected in normal beam from the clad side. This is one or more small volumetric defects.
-249 (-9.8)	10 (0.4)	13 (0.5)	8 (0.3)	79 (3.1)	-	Detected by SAFT-UT in normal beam from the clad side. See Figure 5.6. No estimate is made for DZ since this reflector is only detected in normal beam from the clad side. This is a small volumetric defect.
-391 (-15.4)	10 (0.4)	5 (0.2)	8 (0.3)	86 (3.4)	-	Detected by SAFT-UT in normal beam from the clad side. See Figure 5.7. No estimate is made for DZ since this reflector is only detected in normal beam from the clad side. This is a small volumetric defect.

Figure 5.4a Side View (XZ) of Base-Metal Indication in Block 1-8 at Y = 249 mm (9.8 in.). Normal beam inspection from the clad side.

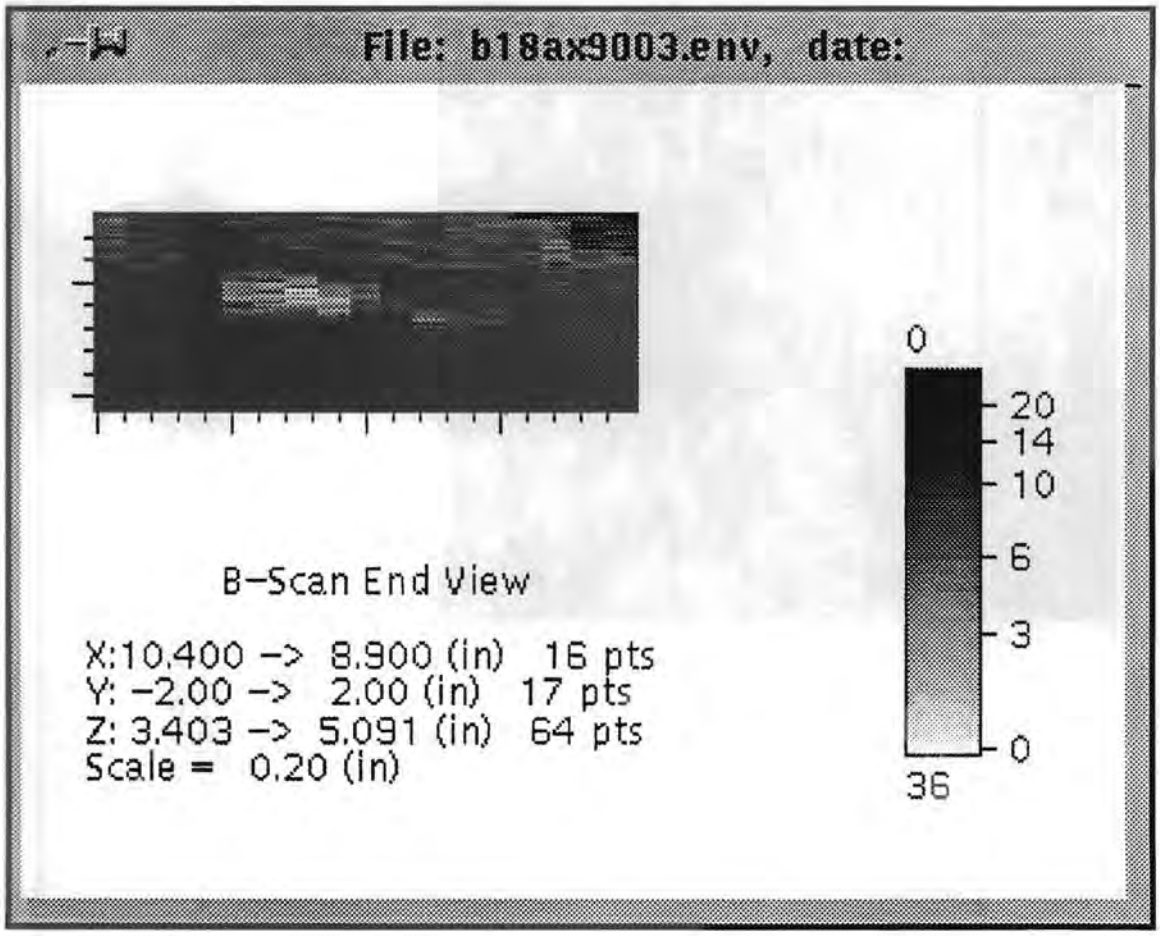
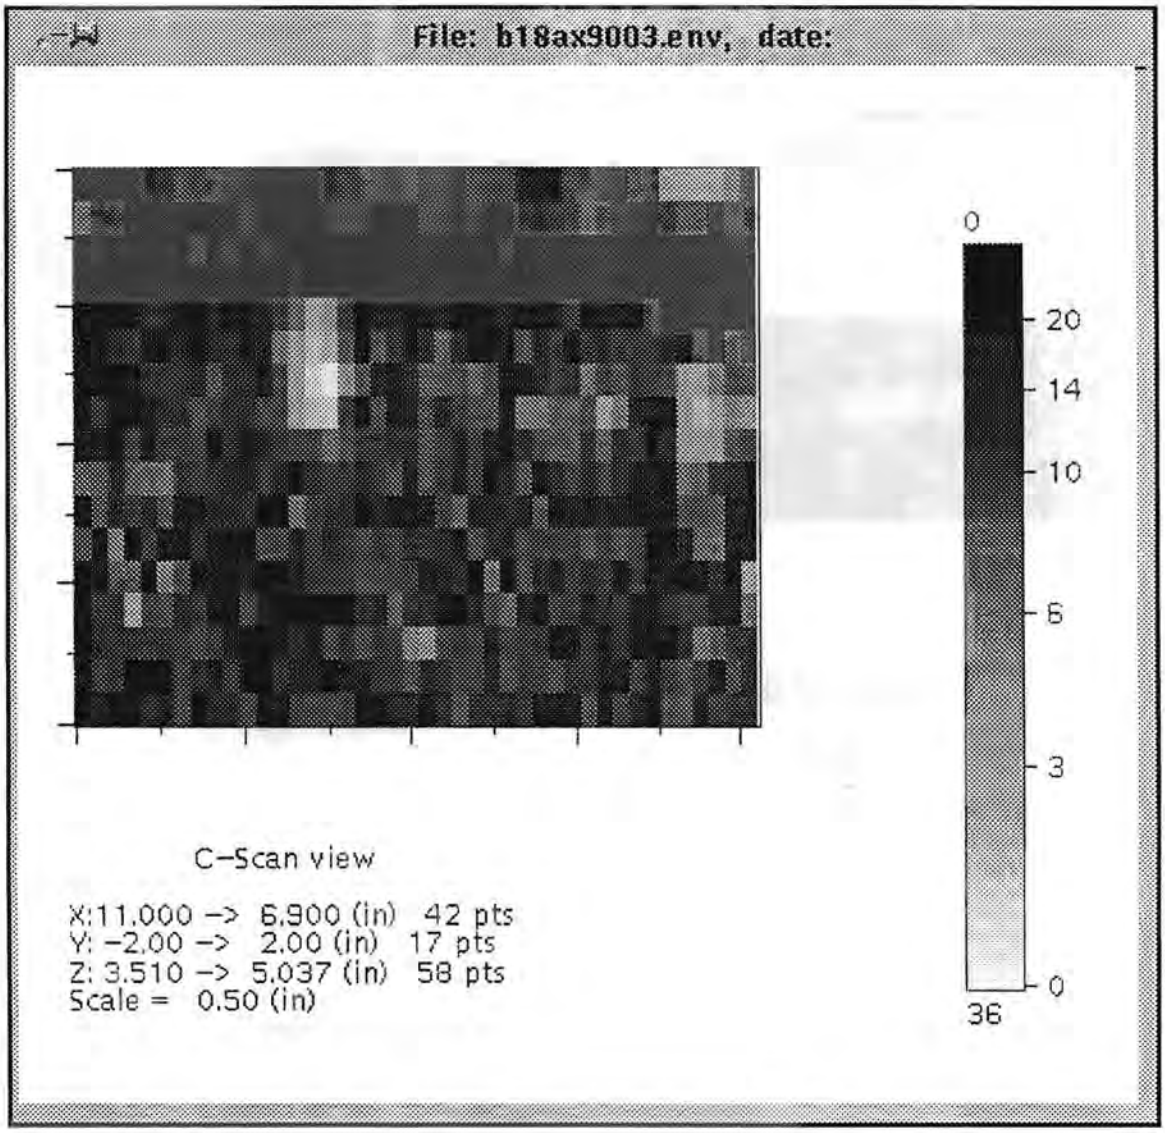
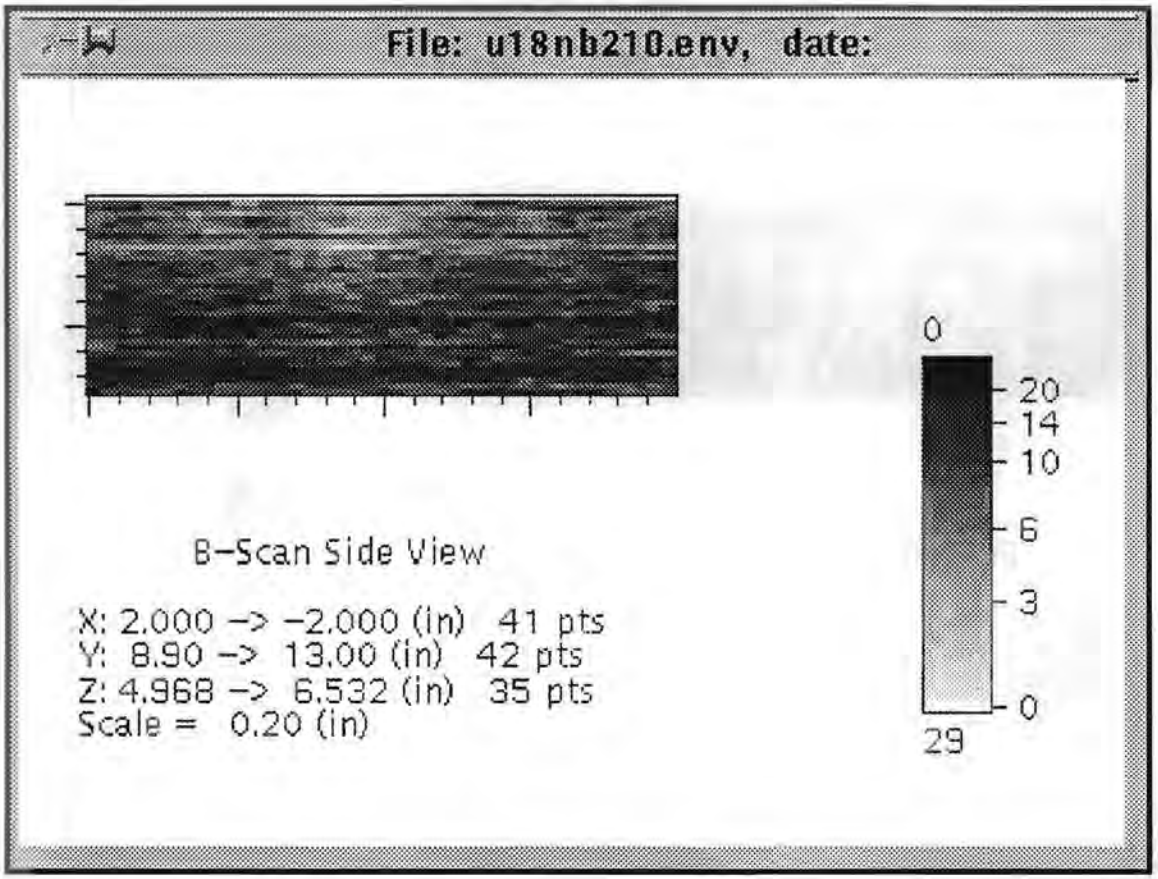
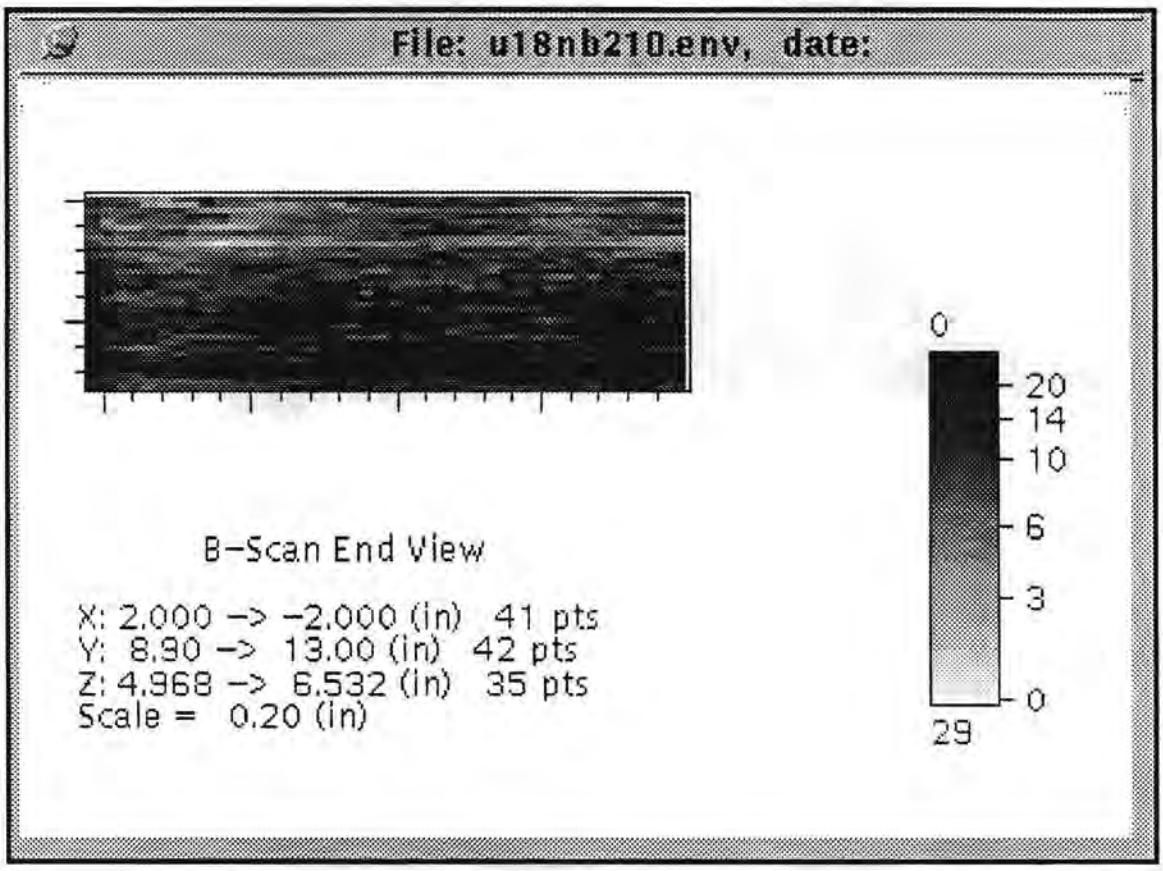
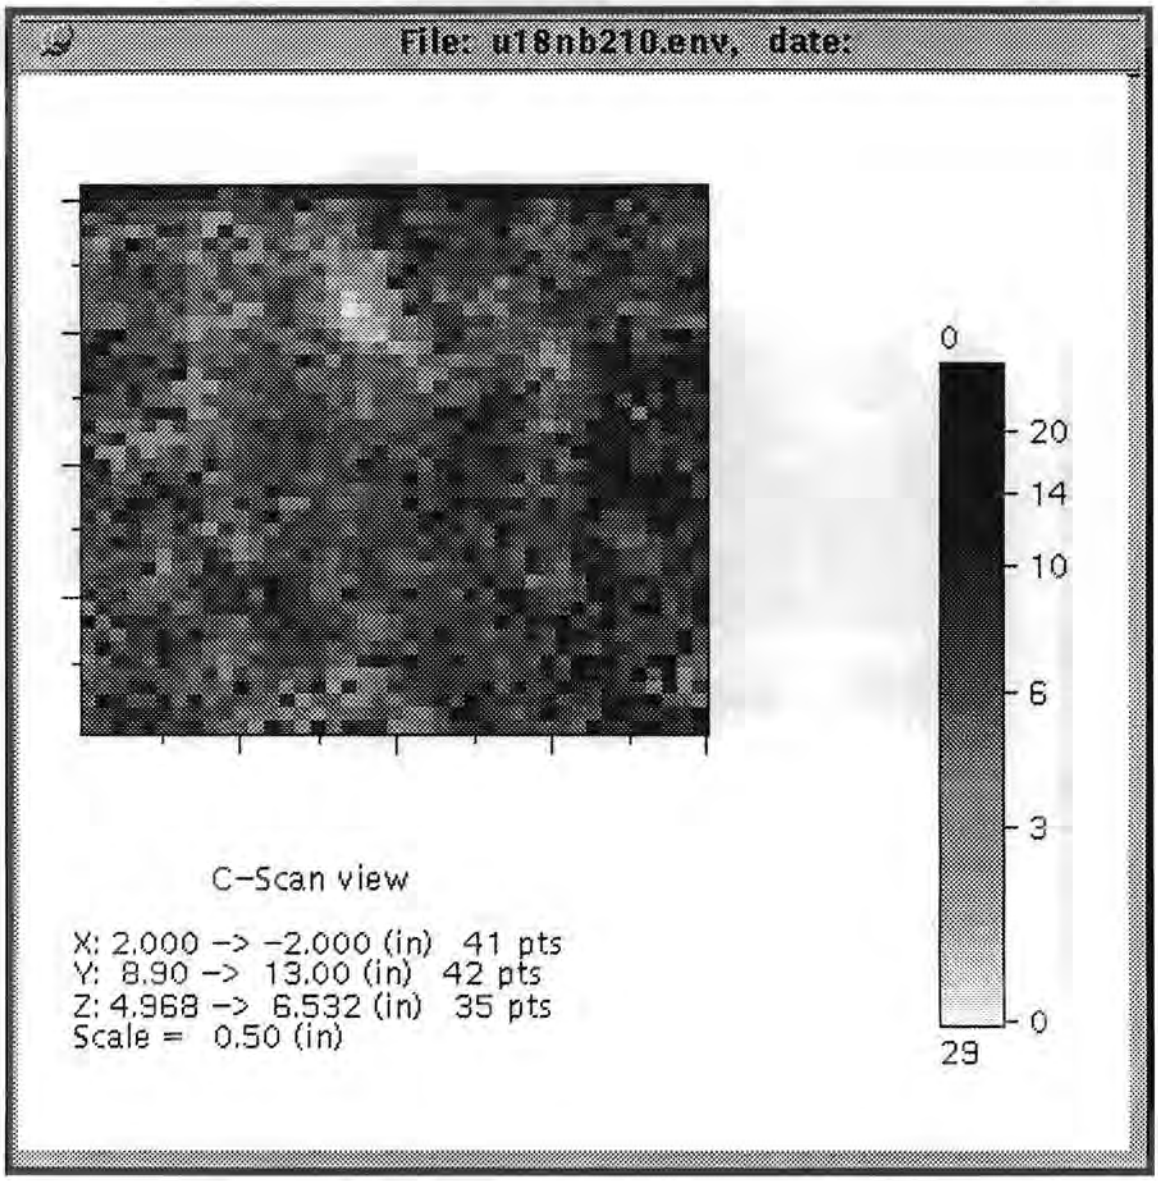
Figure 5.4h End View (in scanner coordinates) of Base-Metal Indication in Block 1-8 at Y = 249 mm (9.8 in.). 45° shear inspection from the clad side. Beam direction is -Y. Y coordinates shown in the figure correspond to X material coordinates.

Figure 5.4i C-scan View (in scanner coordinates) of Base-Metal Indication in Block 1-8 at Y = 249 mm (9.8 in.). 45° shear inspection from the clad side. Beam direction is -Y. Y coordinates shown in the figure correspond to X material coordinates.

Figure 5.4j Side View (XZ) of Base-Metal Indication in Block 1-8 at Y = 249 mm (9.8 in.). Normal beam inspection from the unclad side. Z values shown in figure are measured from the unclad side.

Figure 5.4k End View (YZ) of Base-Metal Indication in Block 1-8 at Y = 249 mm (9.8 in.). Normal beam inspection from the unclad side. Z values shown in figure are measured from the unclad side.

Figure 5.41 C-scan View (XY) of Base-Metal Indication in Block 1-8 at Y = 249 mm (9.8 in.). Normal beam inspection from the unclad side. Z values shown in figure are measured from the unclad side.
