NUREG/CR-6471, Vol. 1
PNNL-11143

Characterization of Flaws in U.S. Reactor Pressure Vessels

Density and Distribution of Flaw Indications in PVRUF

Pacific Northwest National Laboratory

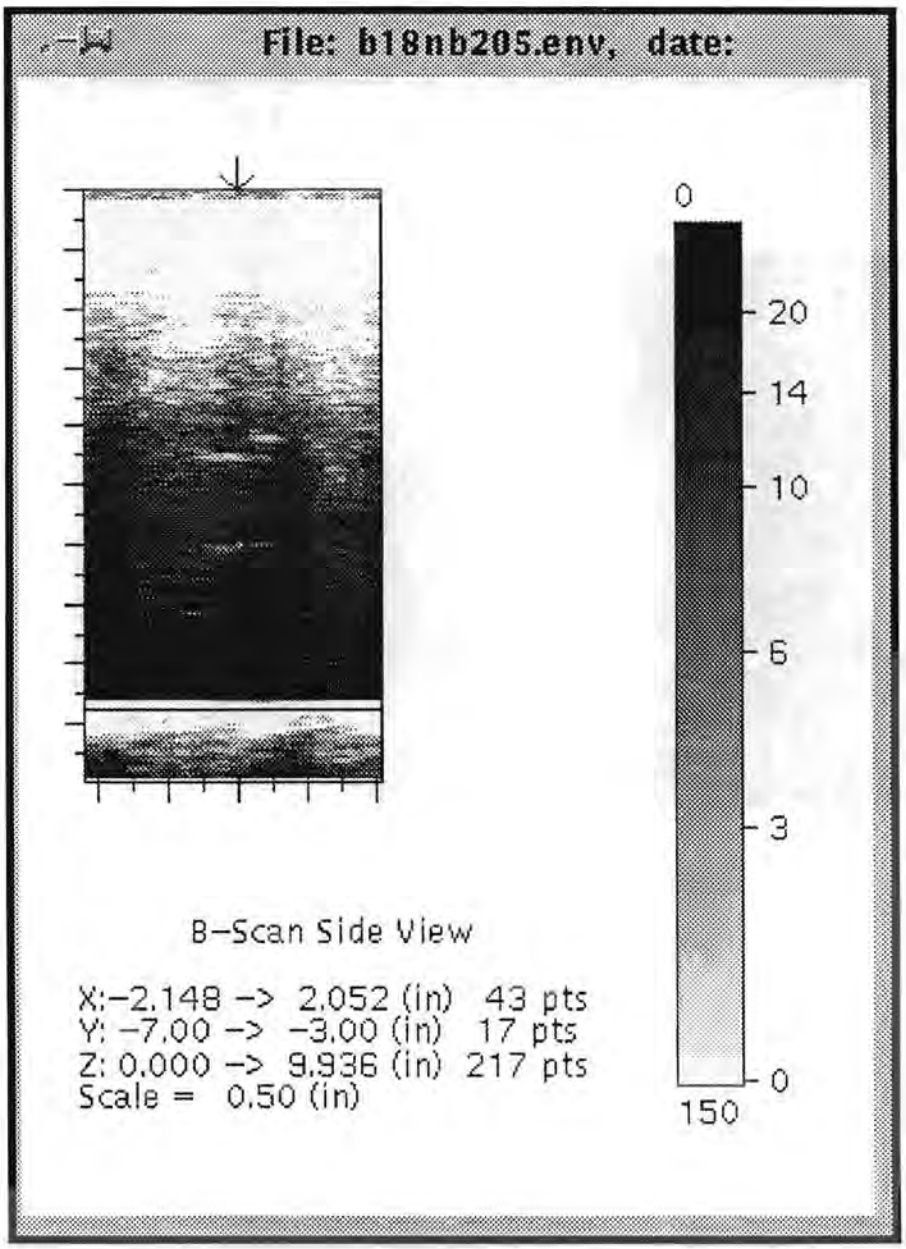
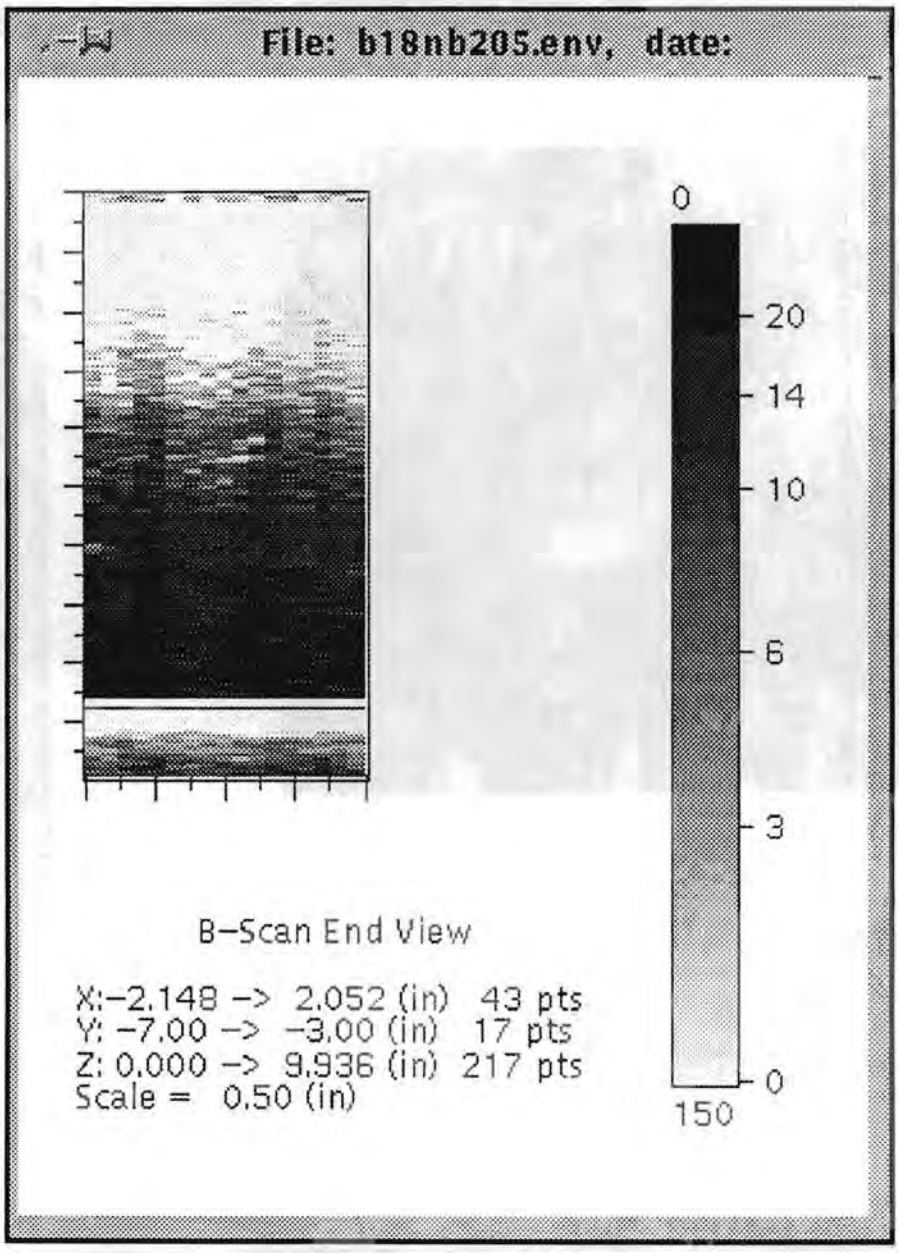
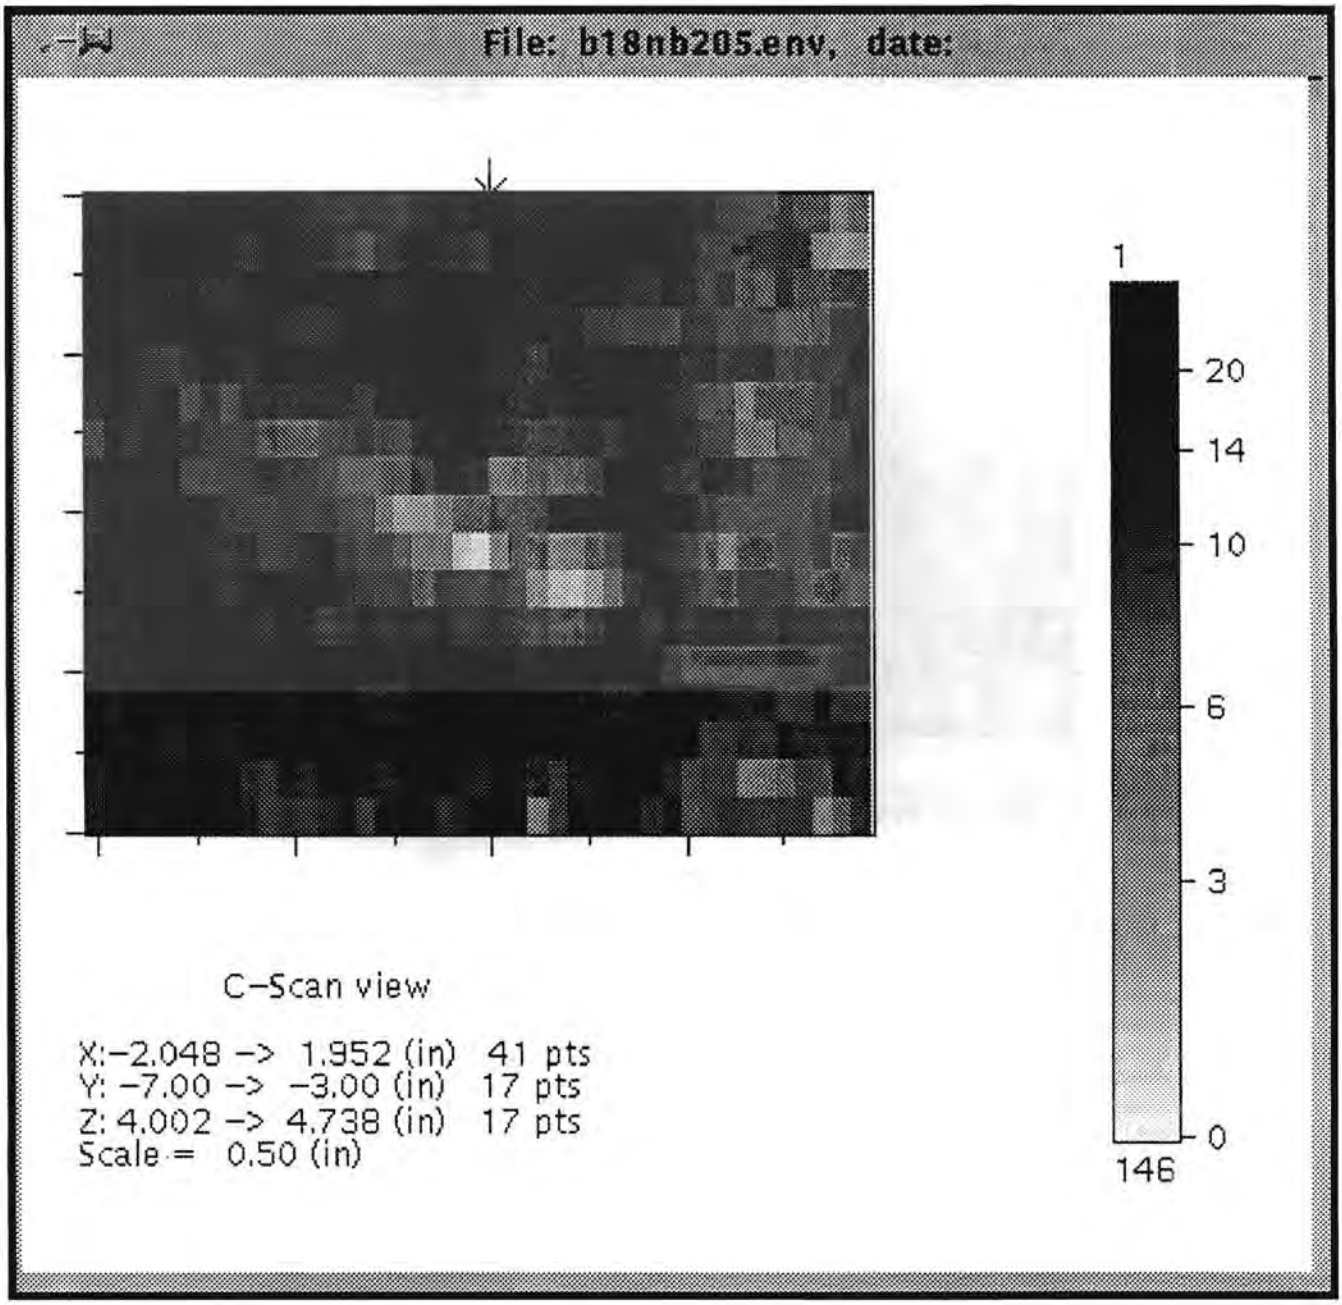
Figure 5.5a Side View (XZ) of Base-Metal Indication in Block 1-8 at Y = -127 mm (-5.0 in.). Normal beam inspection from the clad side.

Figure 5.5b End View (YZ) of Base-Metal Indication in Block 1-8 at Y = -127 mm (-5.0 in.). Normal beam inspection from the clad side.

Figure 5.5c C-scan View (XY) of Base-Metal Indication in Block 1-8 at Y = -127 mm (-5.0 in.). Normal beam inspection from the clad side.

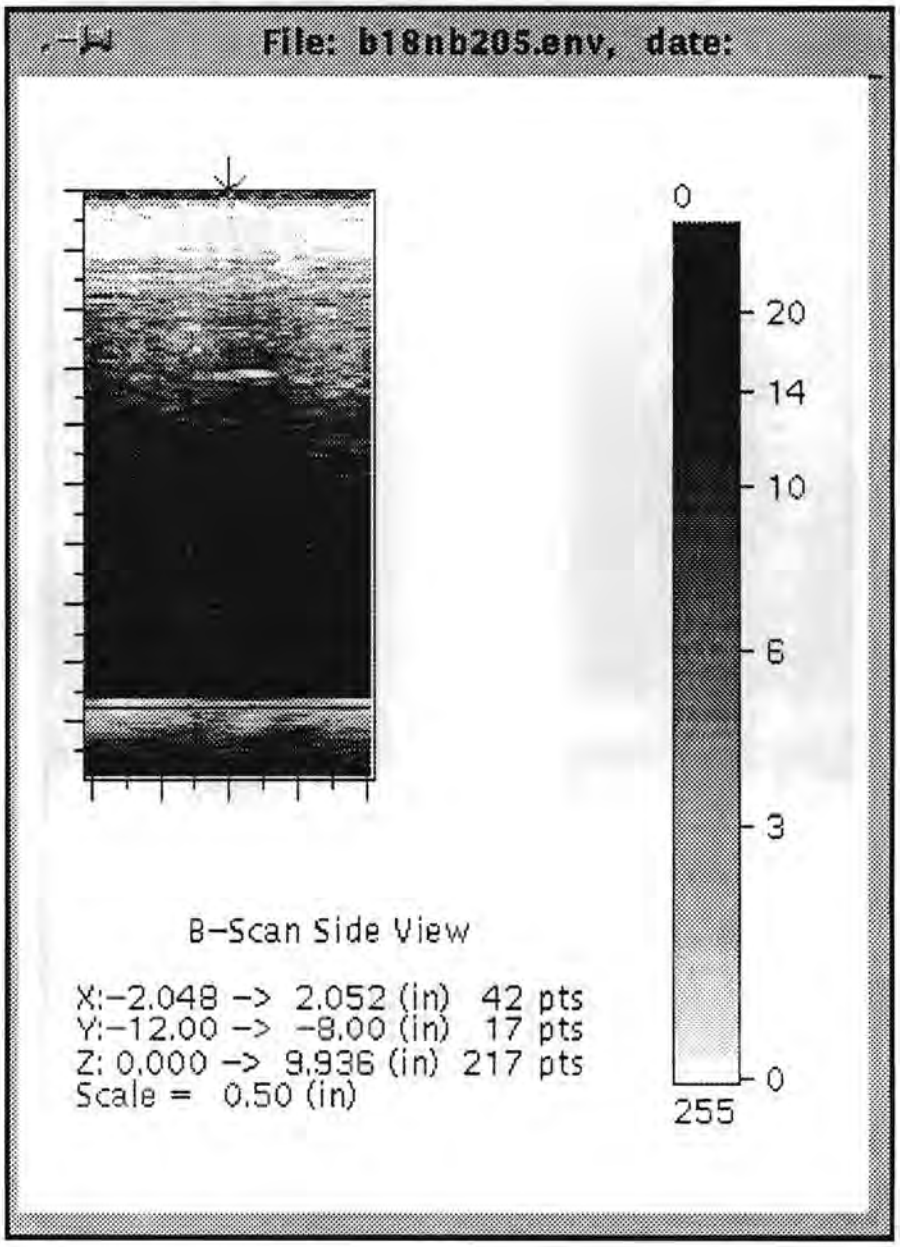
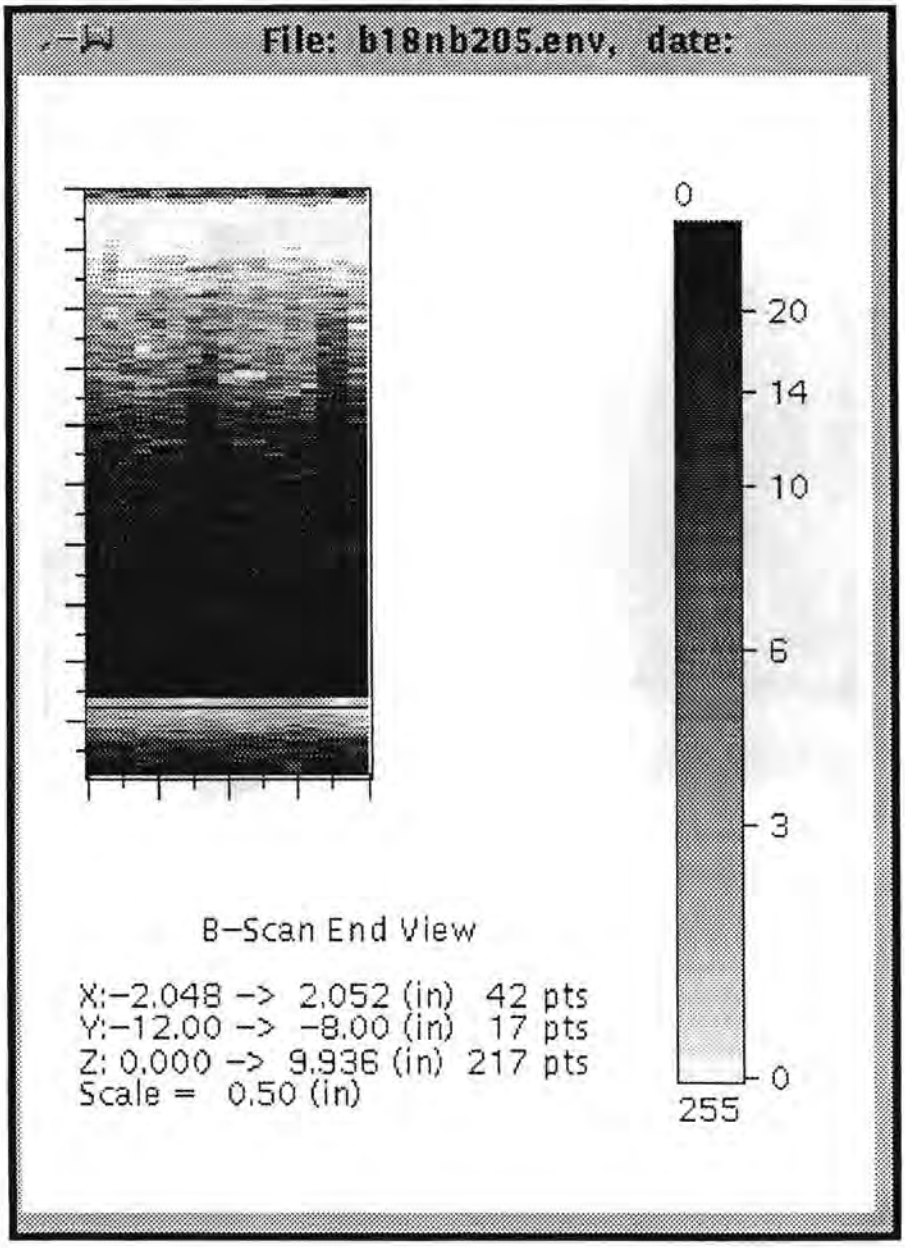
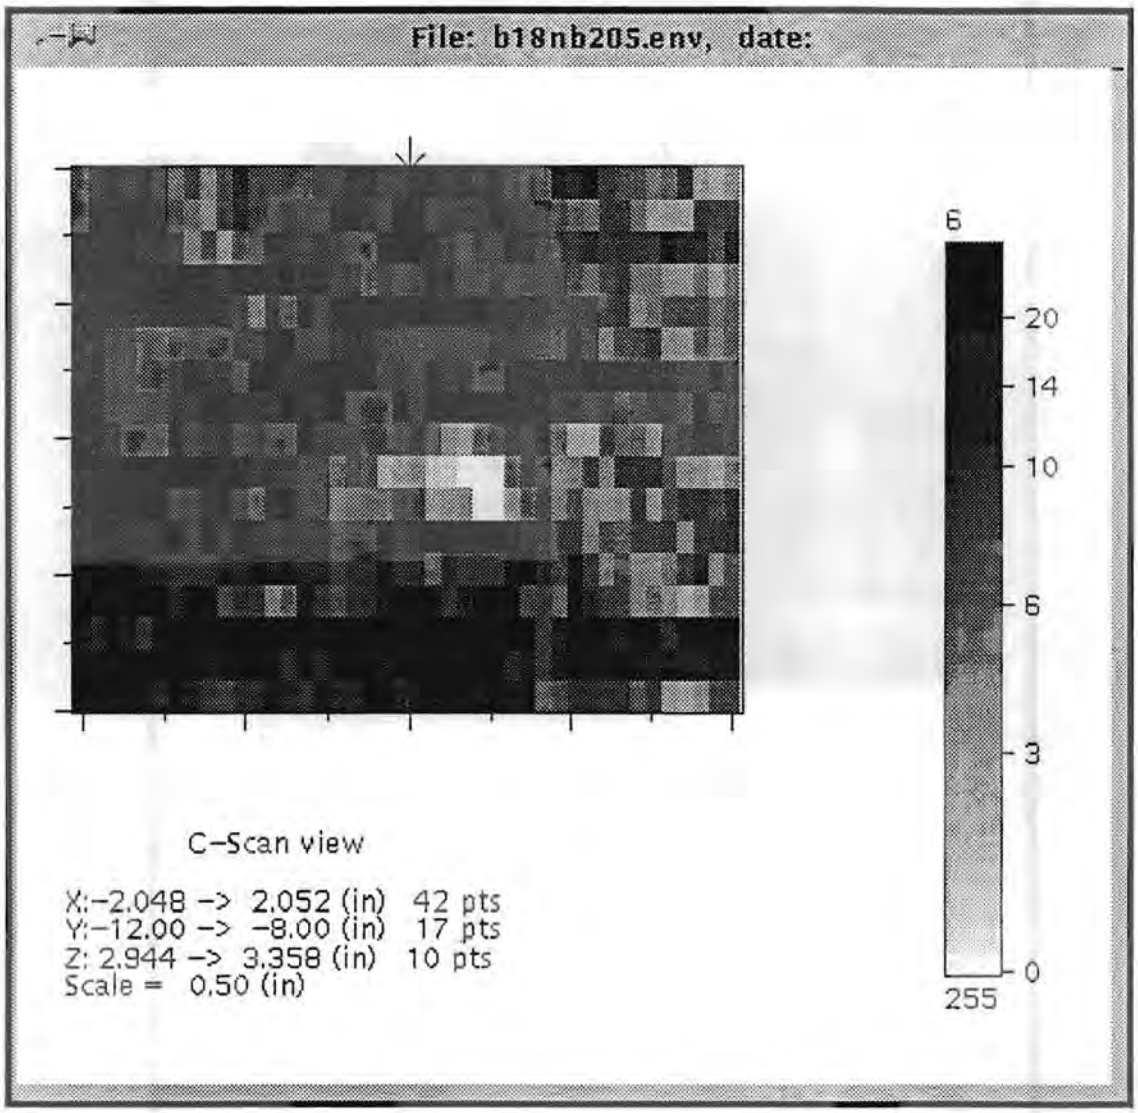
Figure 5.6a Side View (XZ) of Base-Metal Indication in Block 1-8 at Y = -249 mm (-9.8 in.). Normal beam inspection from the clad side.

Figure 5.6b End View (YZ) of Base-Metal Indication in Block 1-8 at Y = -249 mm (-9.8 in.). Normal beam inspection from the clad side.

Figure 5.6c C-scan View (XY) of Base-Metal Indication in Block 1-8 at Y = -249 mm (-9.8 in.). Normal beam inspection from the clad side.

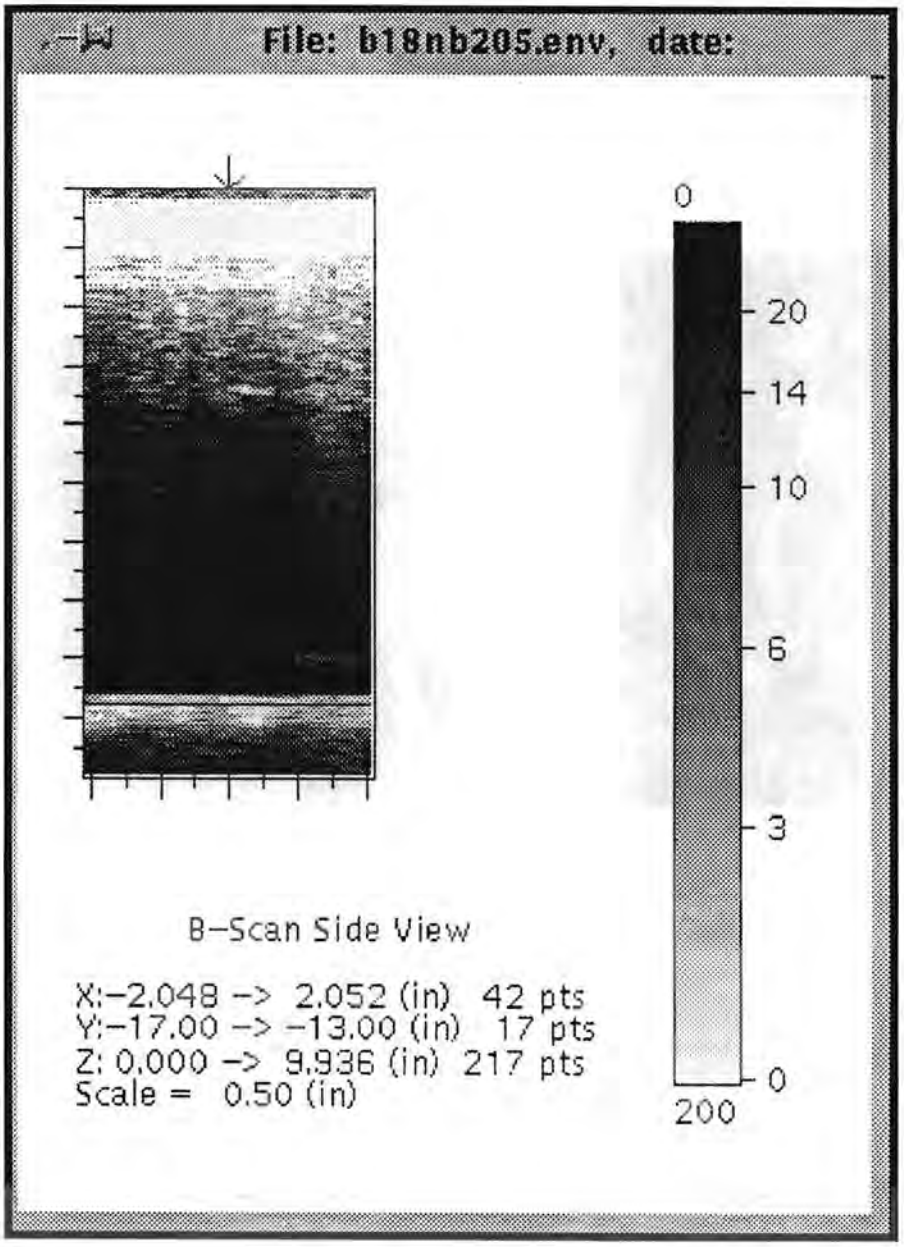
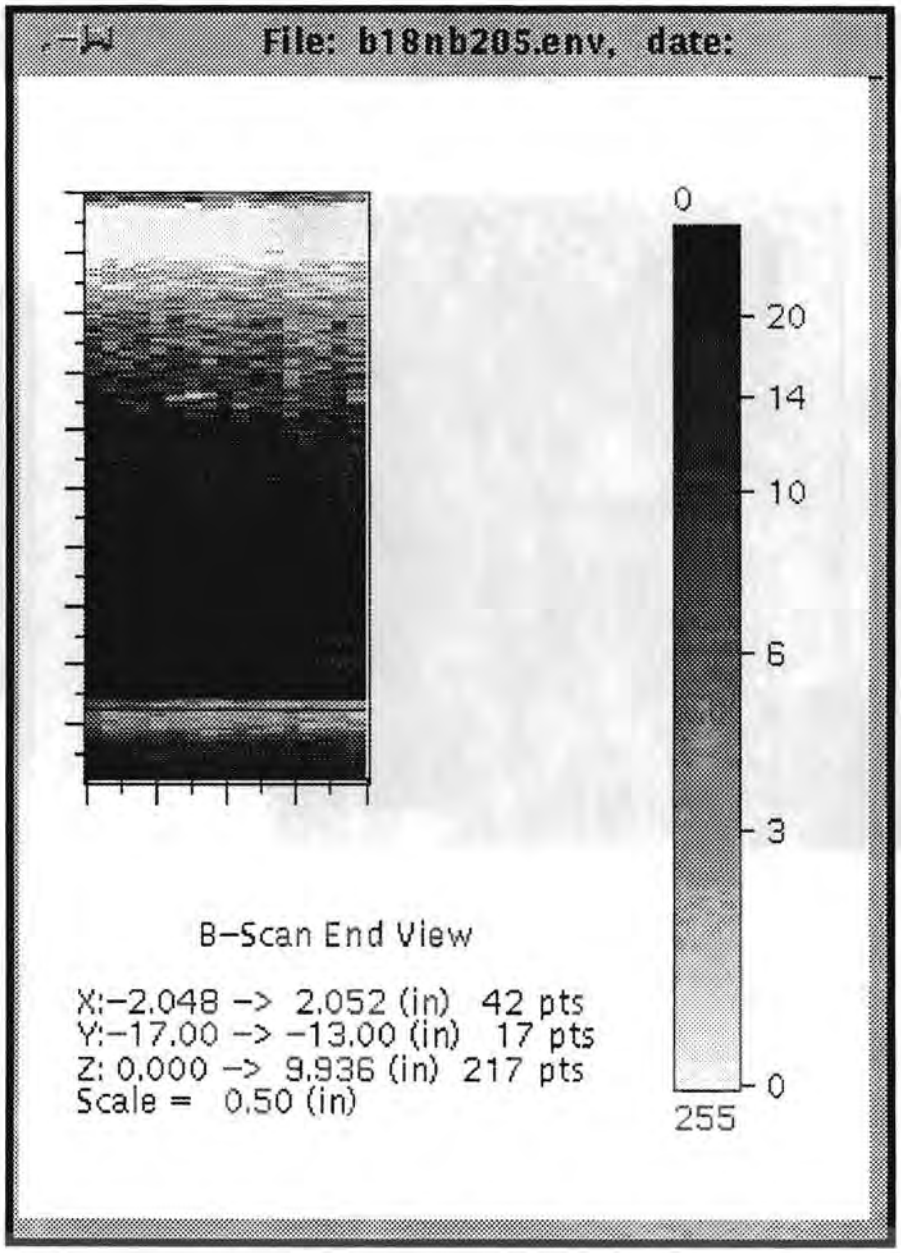
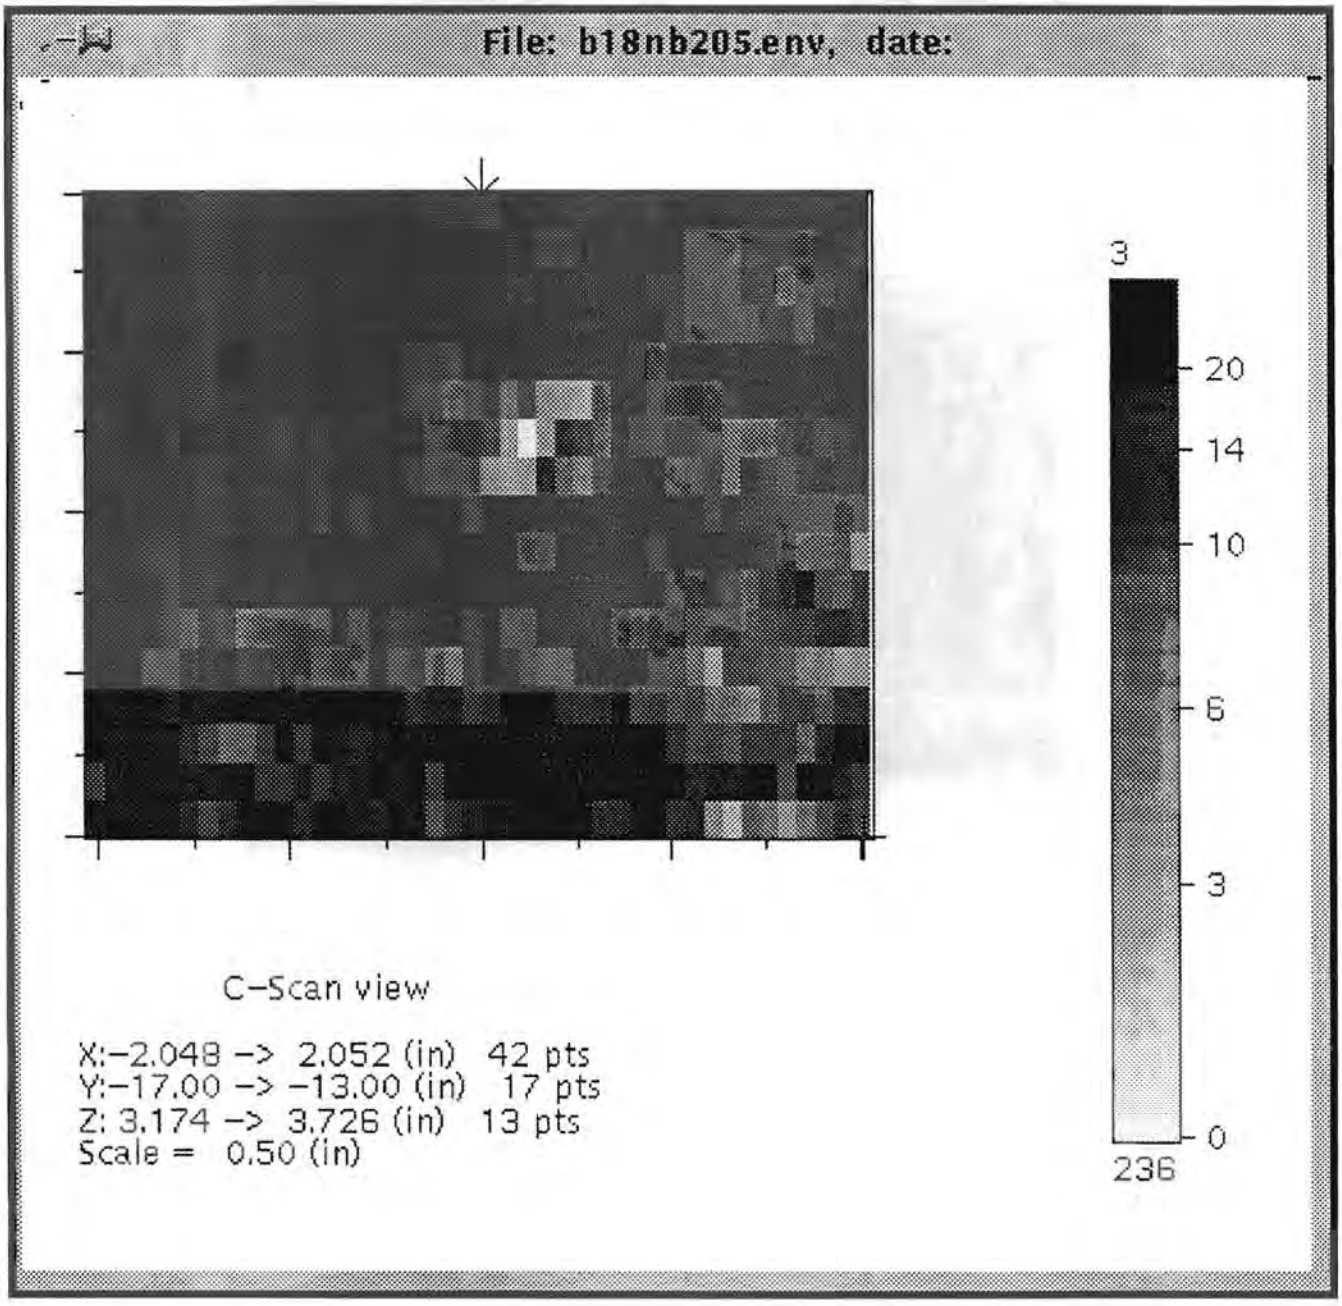
Figure 5.7a Side View (XZ) of Base-Metal Indication in Block 1-8 at Y = -391 mm (-15.4 in.). Normal beam inspection from the clad side.

Figure 5.7b End View (YZ) of Base-Metal Indication in Block 1-8 at Y = -391 mm (-15.4 in.). Normal beam inspection from the clad side.

Figure 5.7c C-scan View (XY) of Base-Metal Indication in Block 1-8 at Y = -391 mm (-15.4 in.). Normal beam inspection from the clad side.

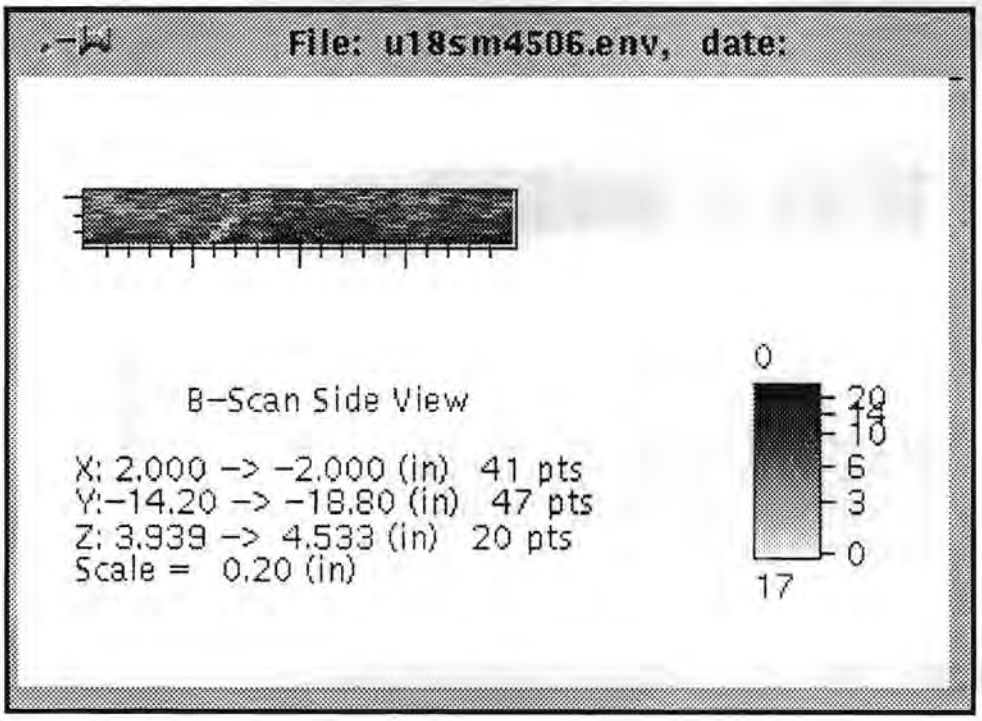
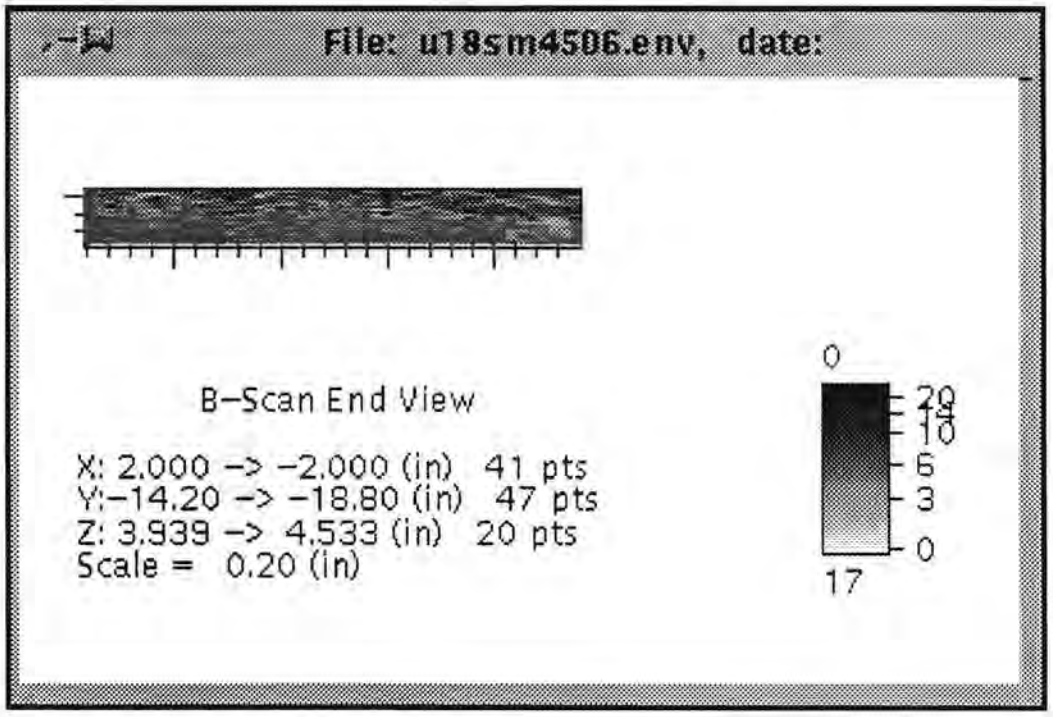
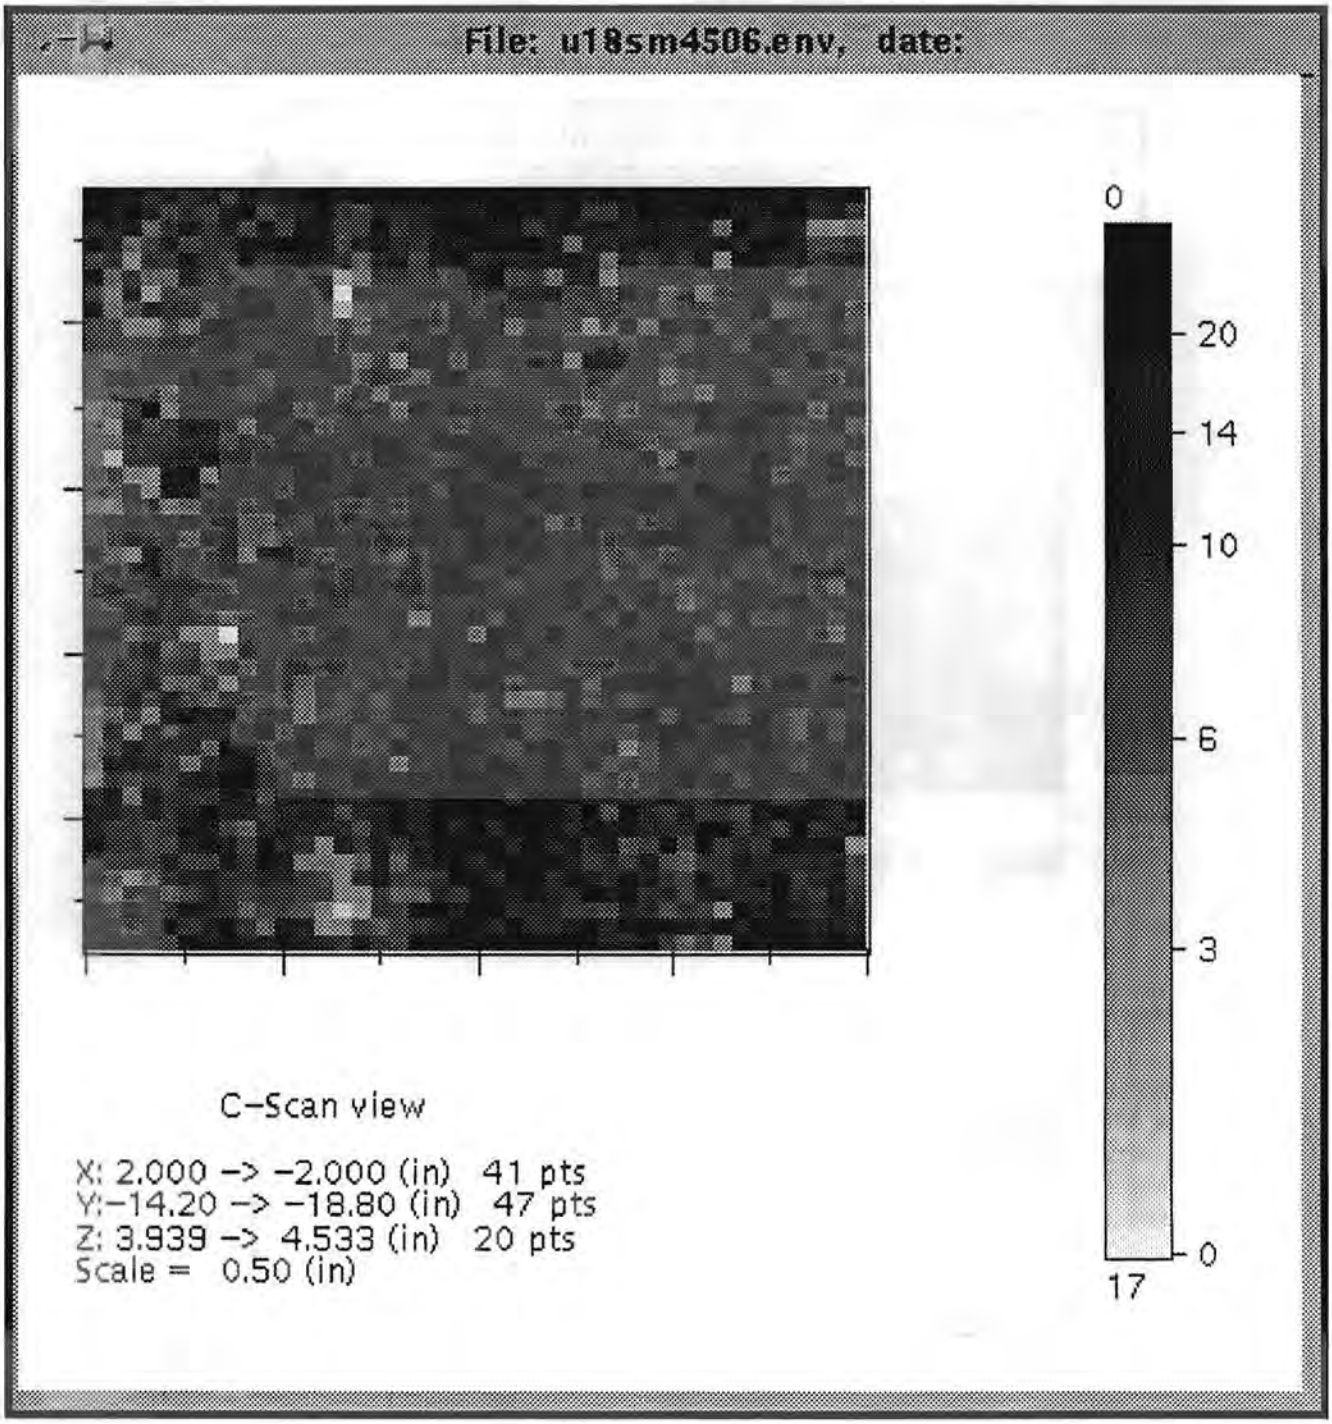
-465 (-18.3)	15 (0.6)	20 (0.8)	-	109 (4.3)	1.3 (0.05)	Detected by SAFT-UT in 45°S from the unclad side. See Figure 5.8. DZ is estimated from Figure 5.8a. No estimate is made for DX. DY is estimated from Figure 5.8b. This is a small defect, possibly planar since it was not detected in normal beam. But, confidence is

Figure 5.8a Side View (XZ) of Base-Metal Indication in Block 1-8 at Y = -465 mm (-18.3 in.). 45° shear inspection from the unclad side. Beam direction is -X. Z values in the figure are measured from the unclad side.

Figure 5.8b End View (YZ) of Base-Metal Indication in Block 1-8 at Y = -465 mm (-18.3 in.). 45° shear inspection from the unclad side. Beam direction is -X. Z values in the figure are measured from the unclad side.

Figure 5.8c C-scan View (XY) of Base-Metal Indication in Block 1-8 at Y = -465 mm (-18.3 in.). 45° shear inspection from the unclad side. Beam direction is -X. Z values in the figure are measured from the unclad side.

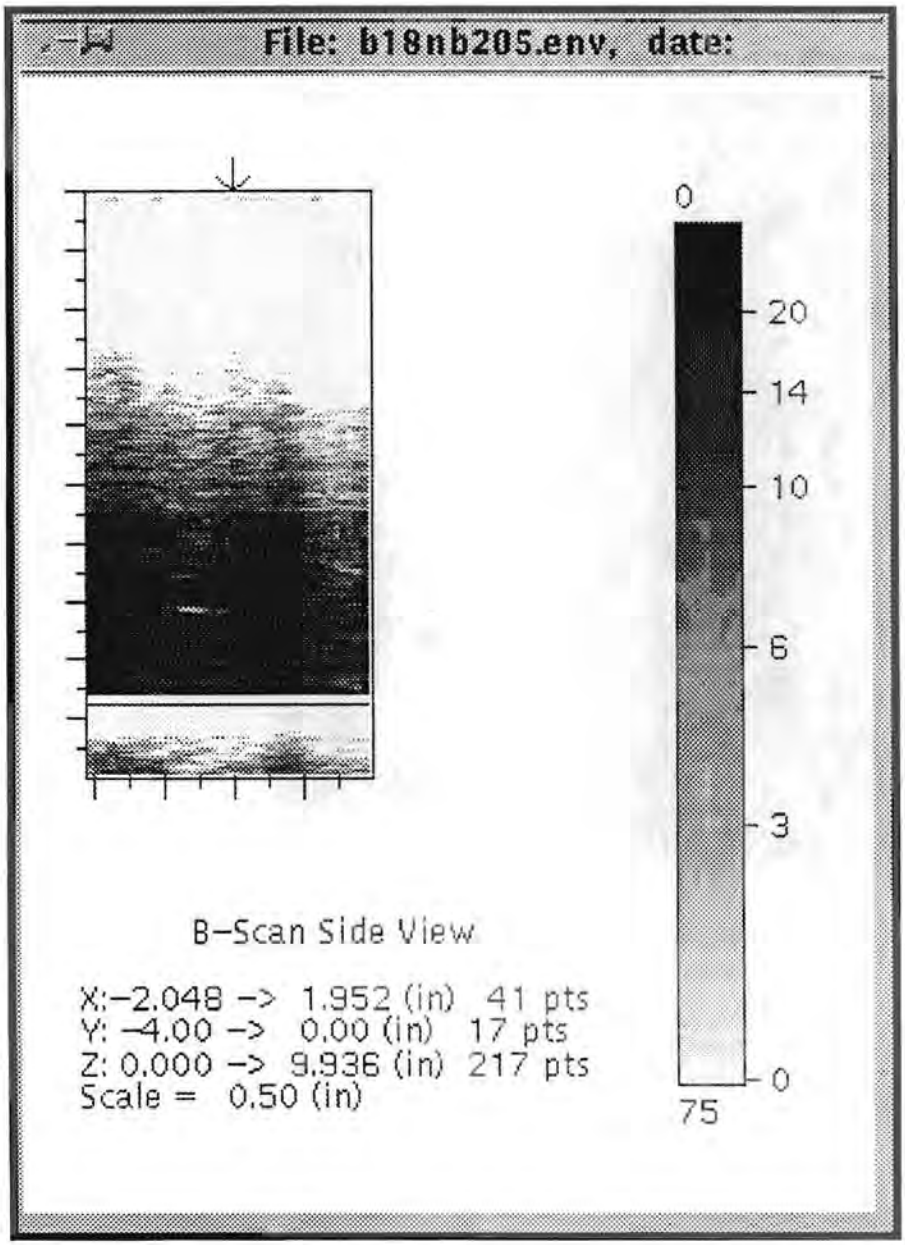
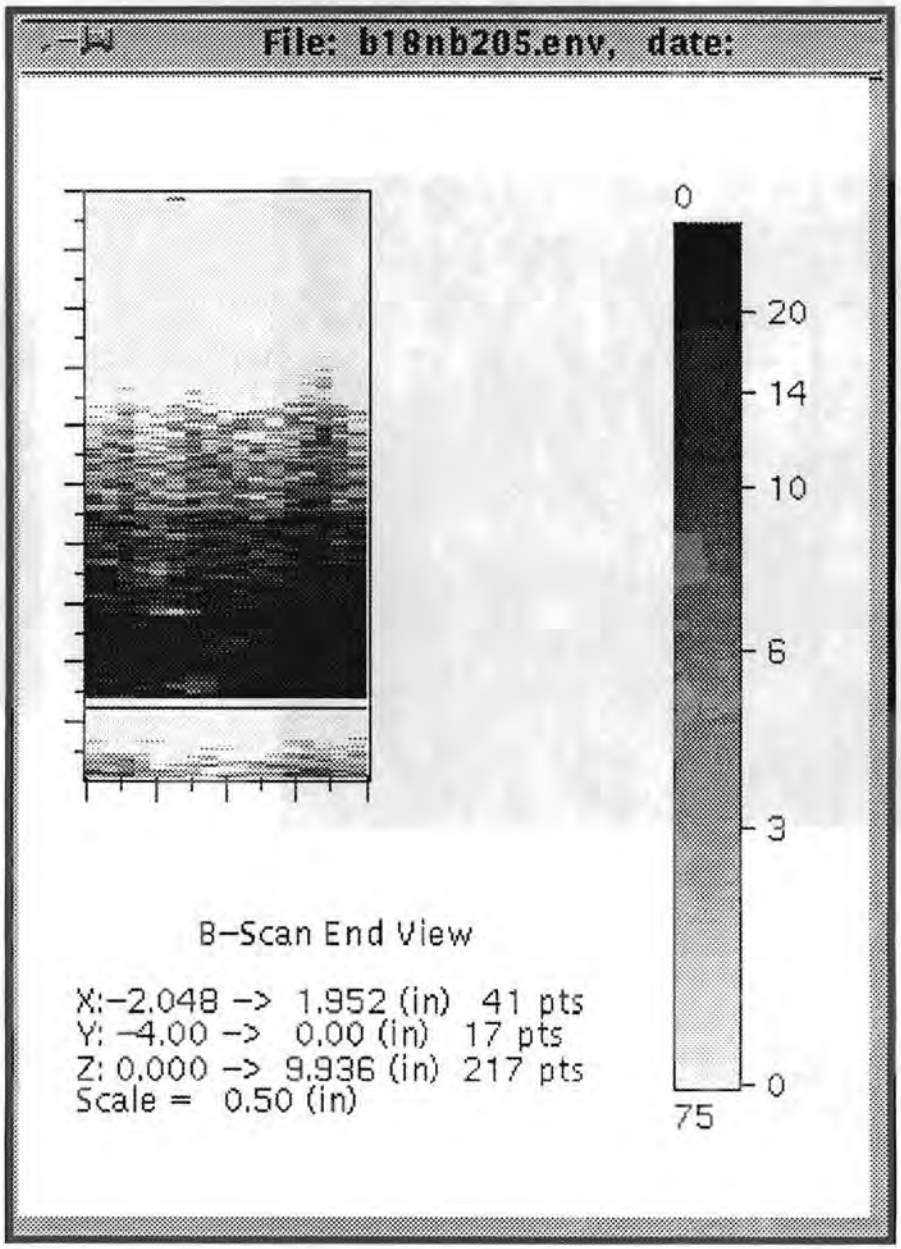
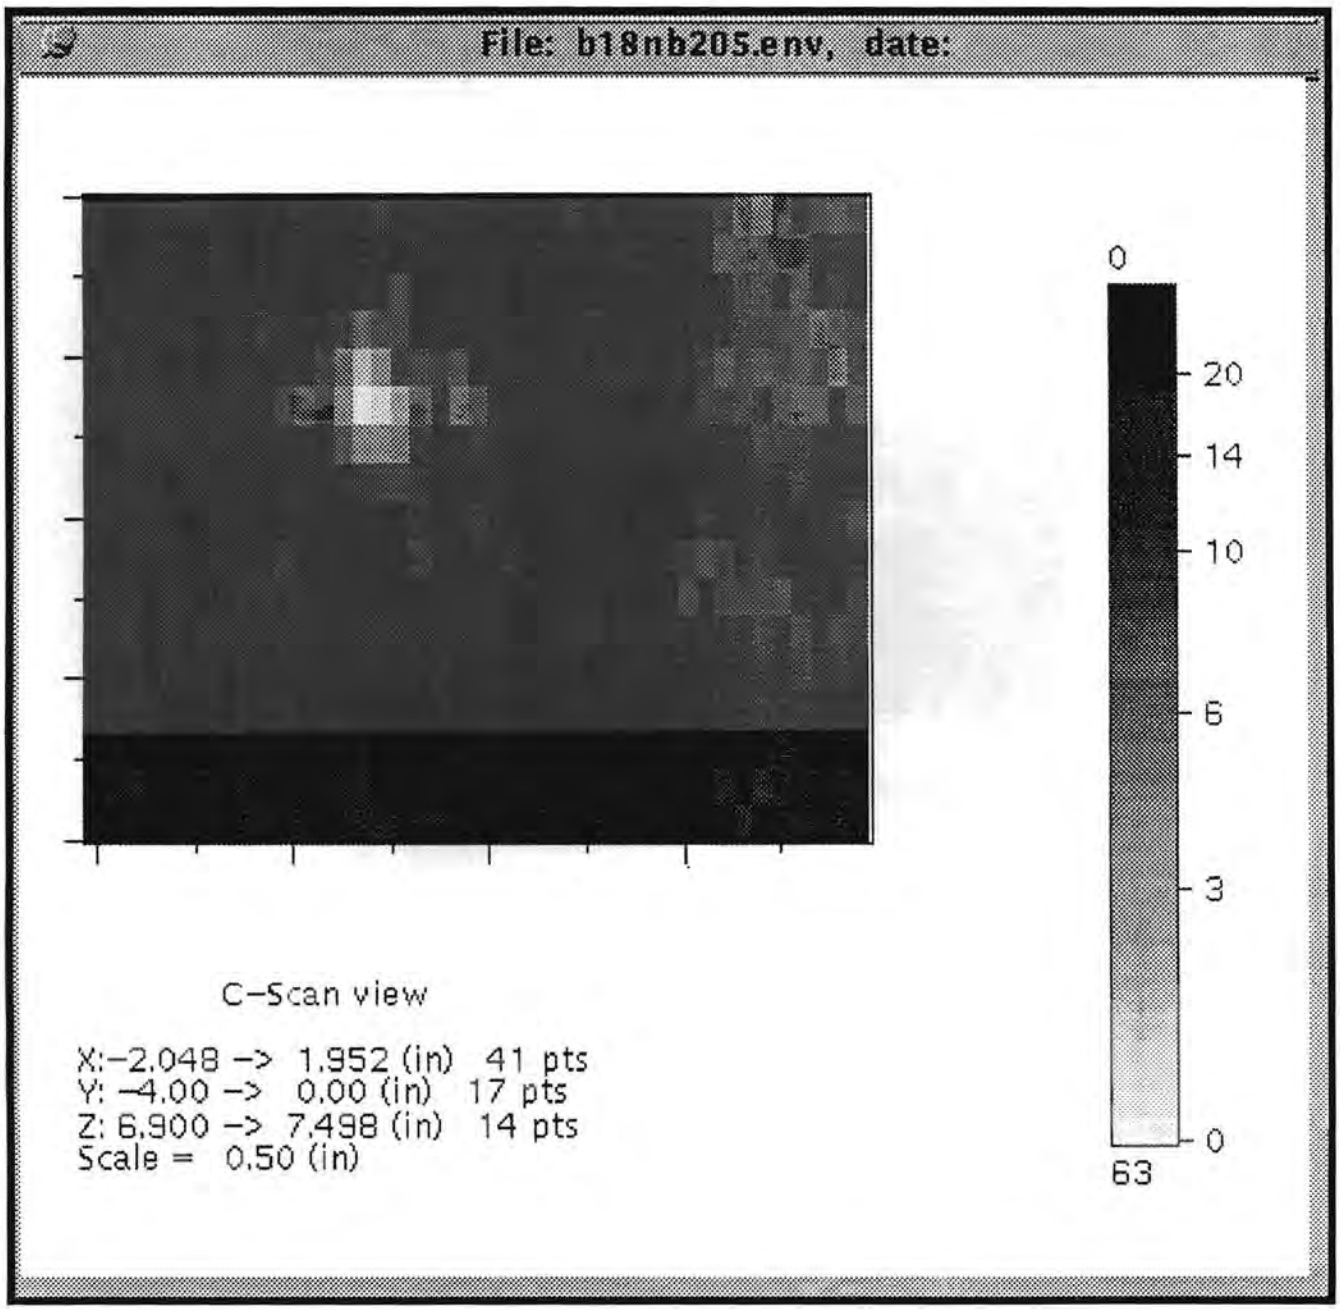
Y, mm (in.)	DY, mm (in.)	X, mm (in.)	DX, mm (in.)	Z, mm (in.)	DZ, mm (in.)	Characterization
						limited by the lack of coverage from the clad side. An indication was reported at this location by NDE center UT. Destructive analysis did not find a defect.
-71 (-2.8)	15 (0.6)	-15 (-0.6)	10 (0.4)	183 (7.2)	-	Detected by SAFT-UT in normal beam from the clad side. See Figure 5.9. No estimate is made for DZ since this reflector is only detected in normal beam from the clad side. This is a small volumetric defect.
-185 (-7.3)	25 (1.0)	2.5 (0.1)	51 (2.0)	155 (6.1)	-	Detected by SAFT-UT in normal beam from the clad side. See Figure 5.10. No estimate is made for DZ since this reflector is only detected in normal beam from the clad side. This is probably multiple volumetric defects.
-254 (-10.0)	20 (0.8)	-13 (-0.5)	13 (0.5)	183 (7.2)	-	Detected by SAFT-UT in normal beam from the clad side. See Figure 5.11. No estimate is made for DZ since this reflector is only detected in normal beam from the clad side. This is probably multiple small volumetric defects.

Figure 5.9a Side View (XZ) of Base-Metal Indication in Block 1-8 at Y = -71 mm (-2.8 in.). Normal beam inspection from the clad side.

Figure 5.9b End View (YZ) of Base-Metal Indication in Block 1-8 at Y = -71 mm (-2.8 in.). Normal beam inspection from the clad side.

Figure 5.9c C-scan View (XY) of Base-Metal Indication in Block 1-8 at Y = -71 mm (-2.8 in.). Normal beam inspection from the clad side.
