NUREG/CR-6471, Vol. 1
PNNL-11143

Characterization of Flaws in U.S. Reactor Pressure Vessels

Density and Distribution of Flaw Indications in PVRUF

Pacific Northwest National Laboratory

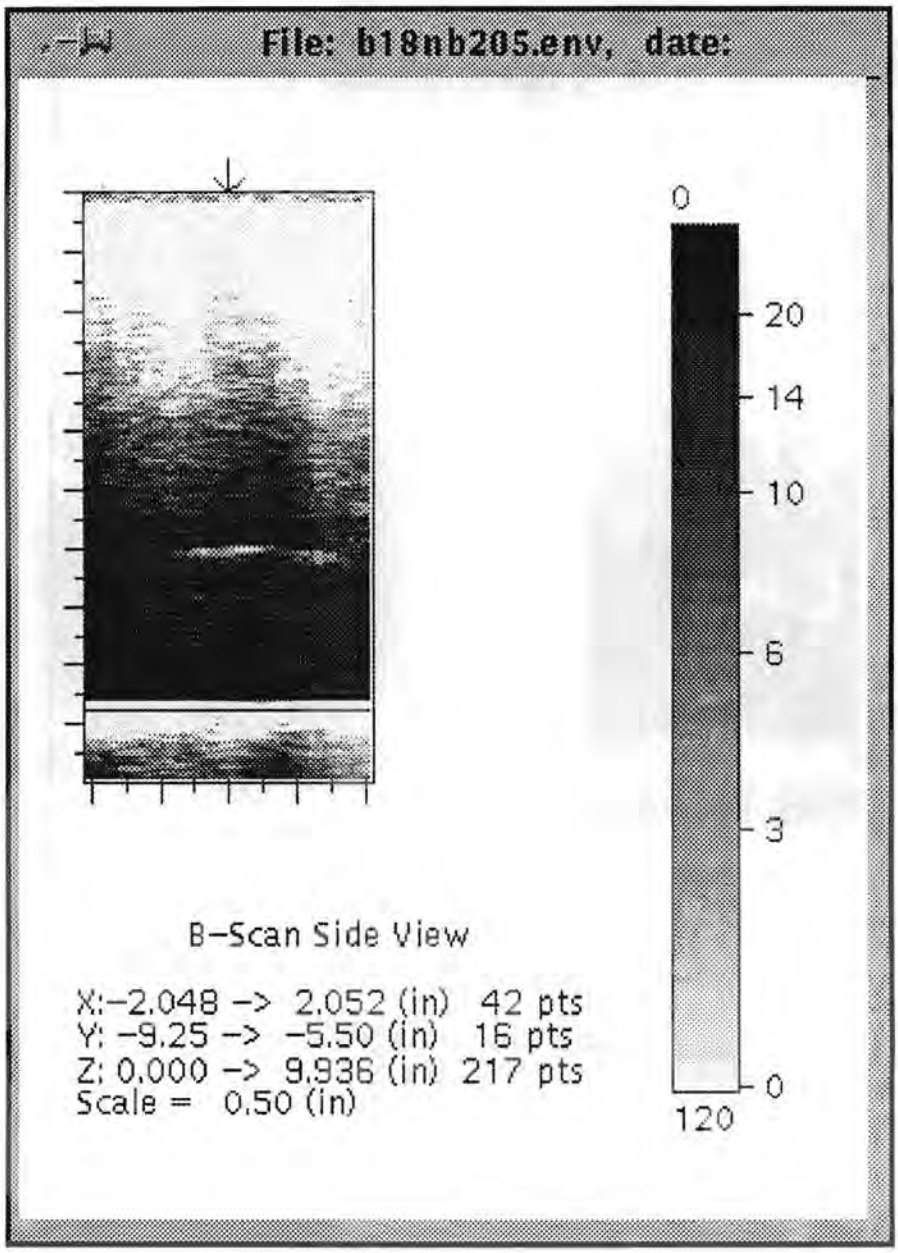
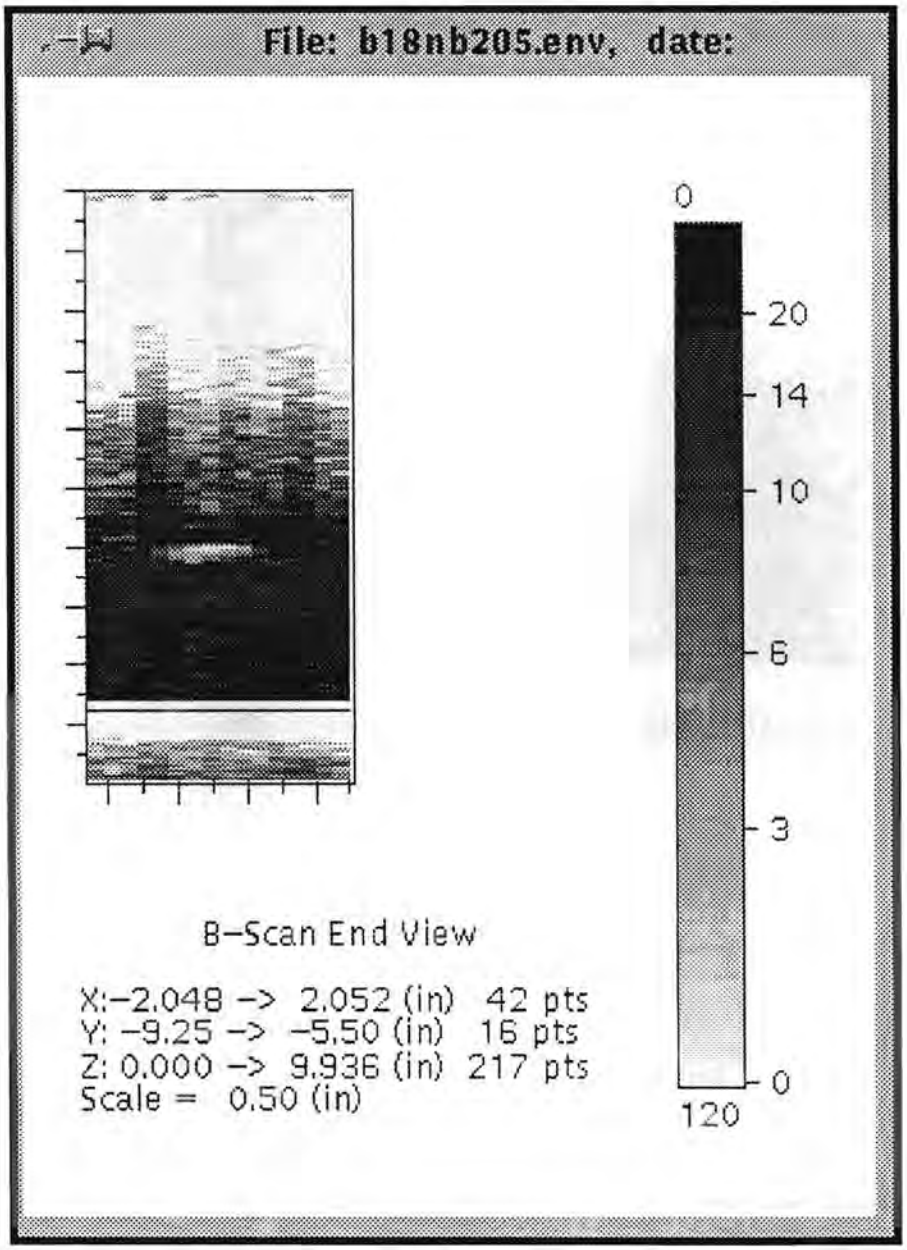
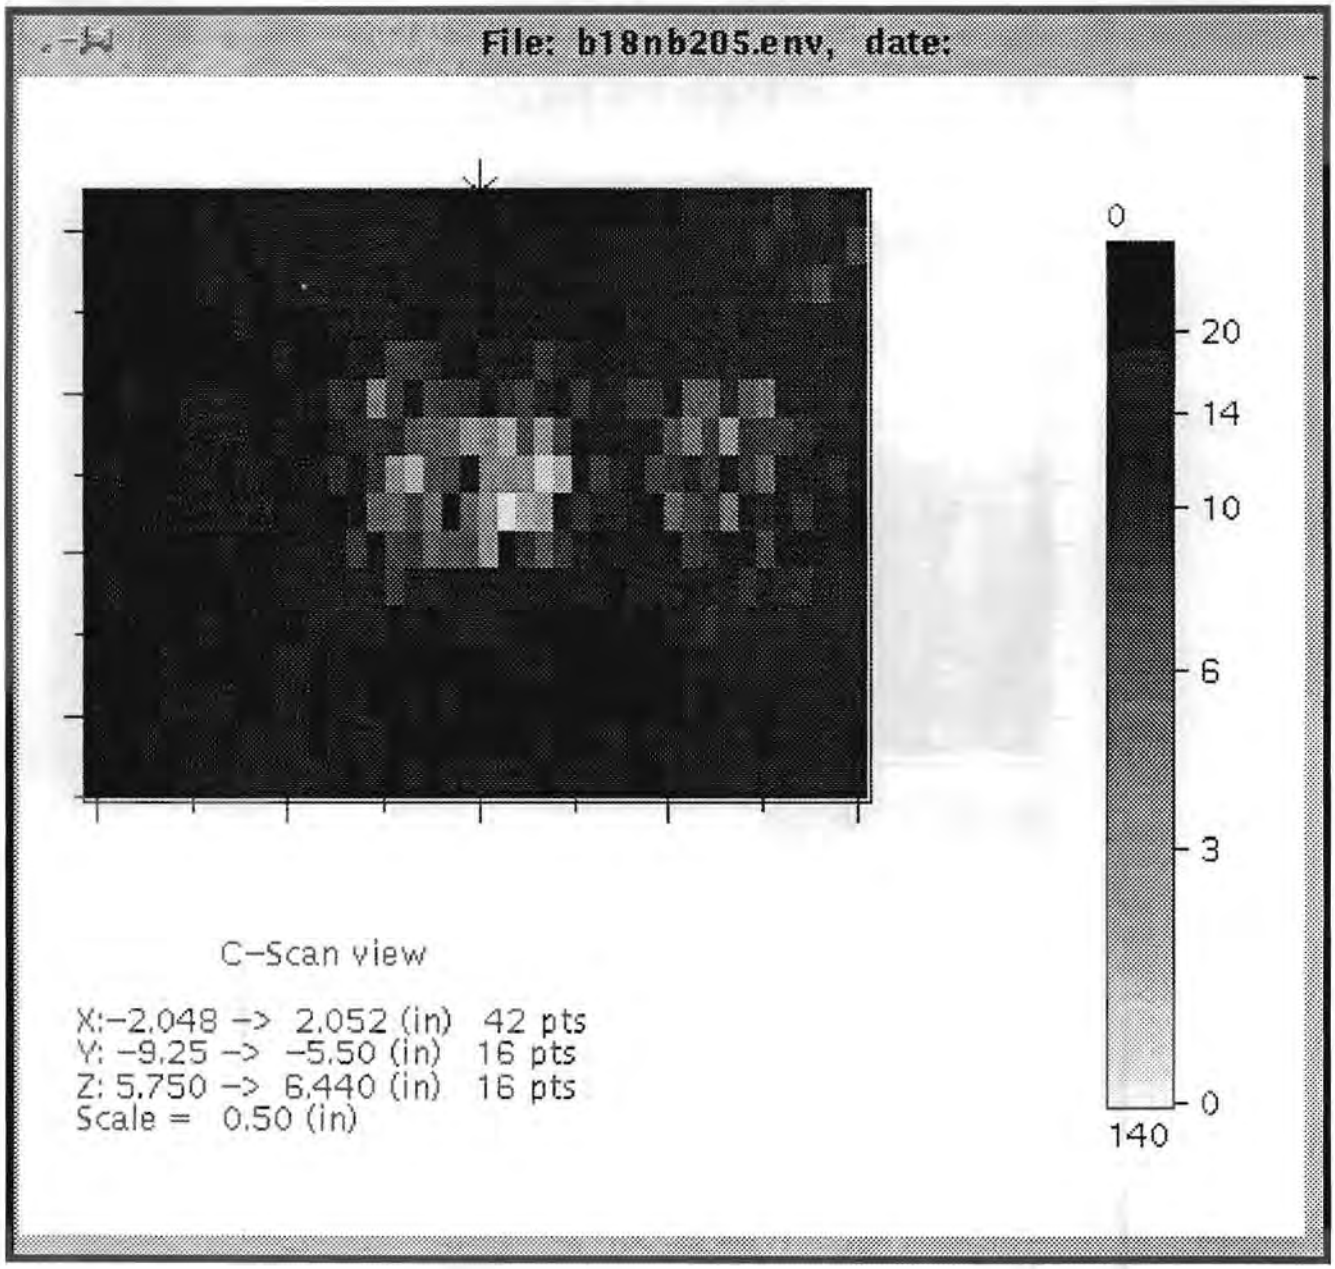
Figure 5.10a Side View (XZ) of Base-Metal Indication in Block 1-8 at Y = -185.4 mm (-7.3 in.). Normal beam inspection from the clad side.

Figure 5.10b End View (YZ) of Base-Metal Indication in Block 1-8 at Y = -185.4 mm (-7.3 in.). Normal beam inspection from the clad side.

Figure 5.10c C-scan View (XY) of Base-Metal Indication in Block 1-8 at Y = -185.4 mm (-7.3 in.). Normal beam inspection from the clad side.

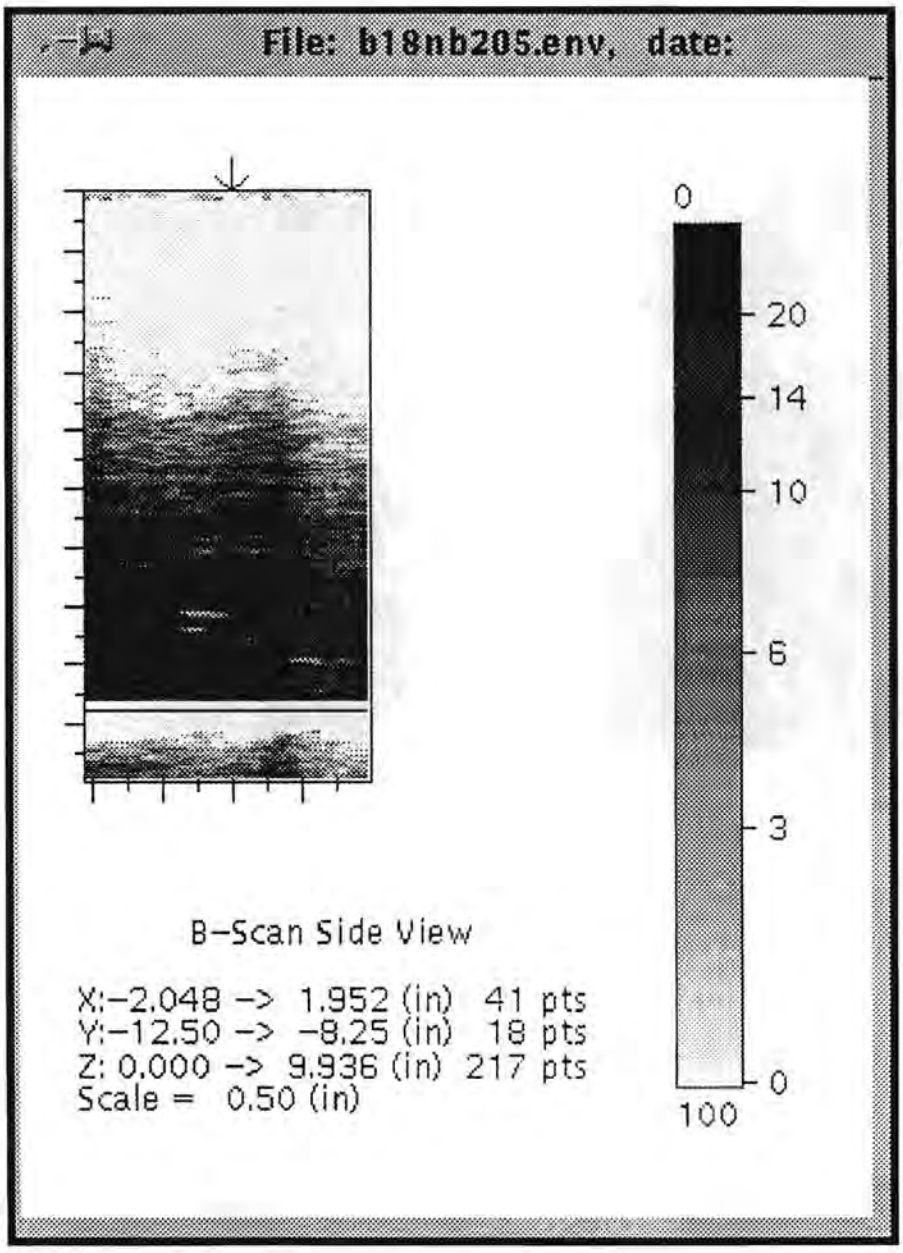
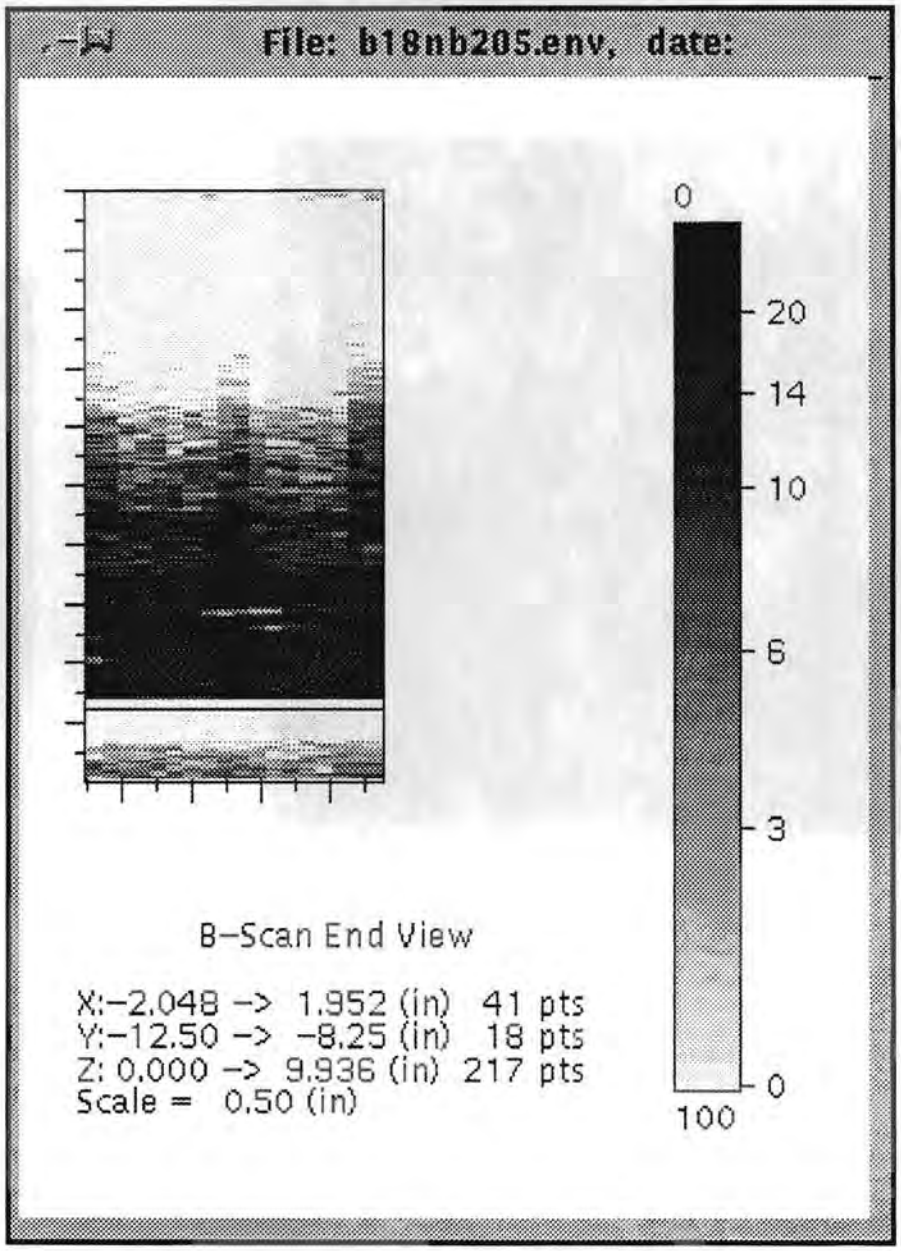
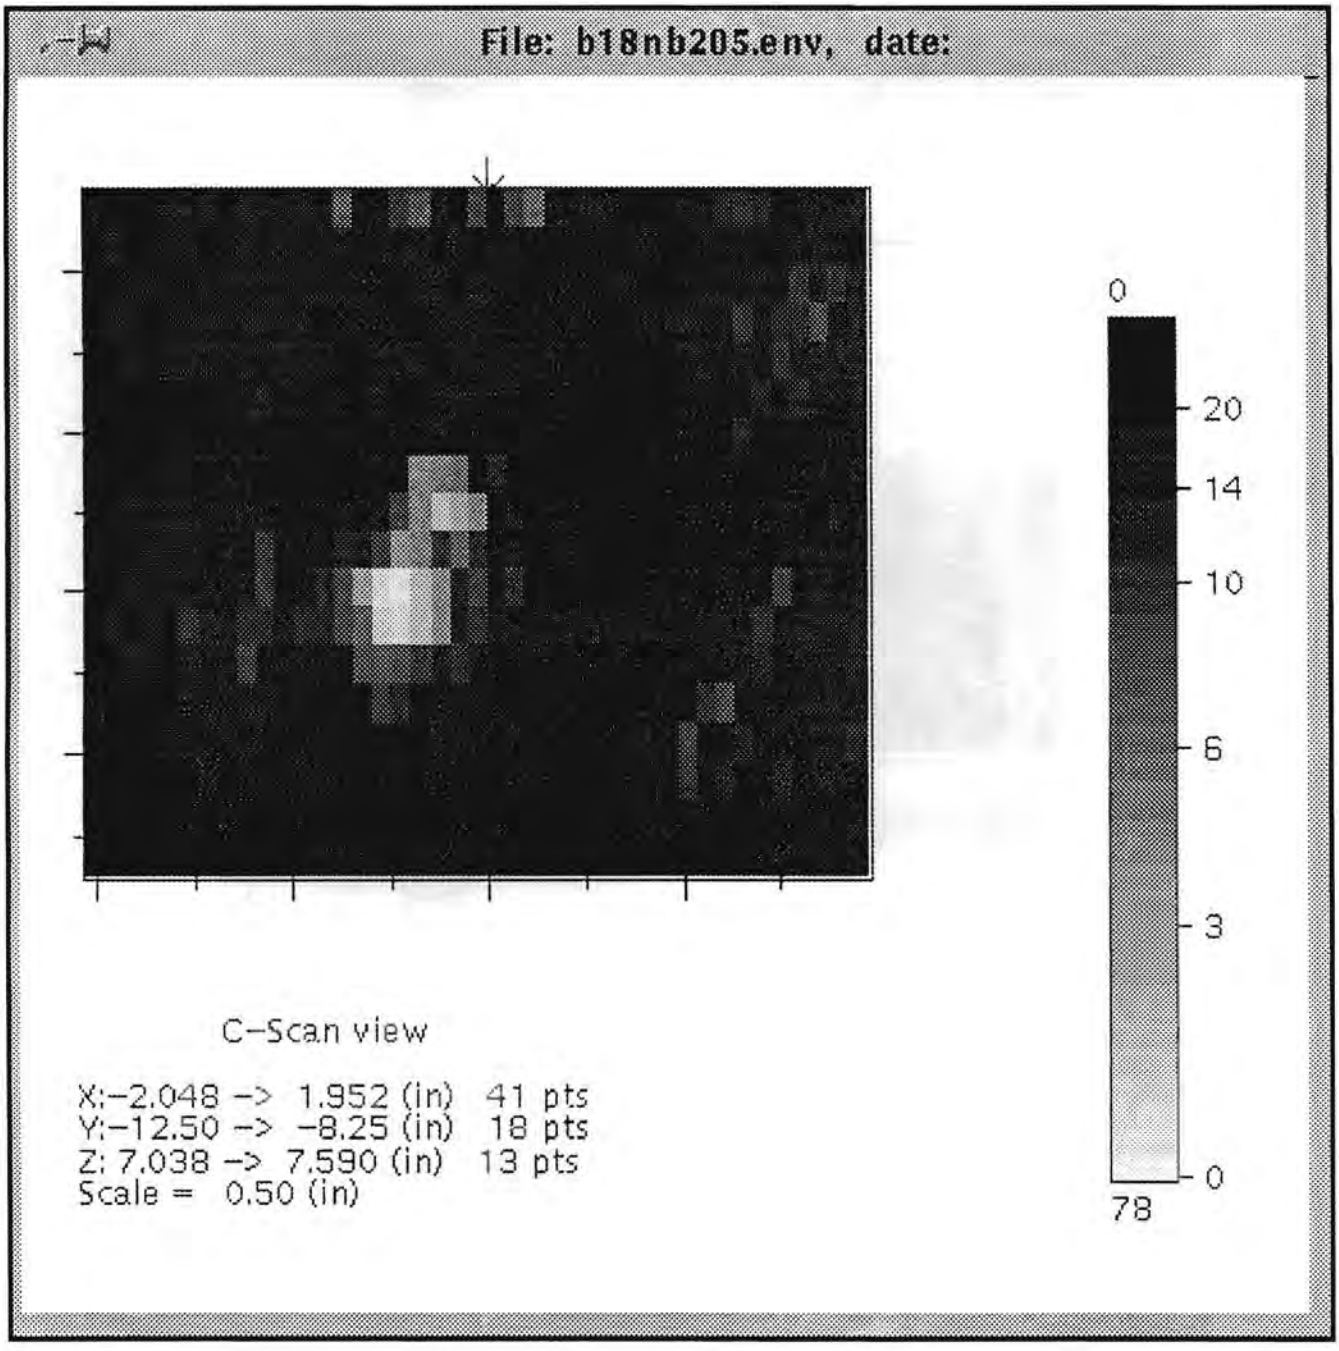
Figure 5.11a Side View (XZ) of Base-Metal Indication in Block 1-8 at Y = -254 mm (-10.0 in.). Normal beam inspection from the clad side.

Figure 5.11b End View (YZ) of Base-Metal Indication in Block 1-8 at Y = -254 mm (-10.0 in.). Normal beam inspection from the clad side.

Figure 5.11c C-scan View (XY) of Base-Metal Indication in Block 1-8 at Y = -254 mm (-10.0 in.). Normal beam inspection from the clad side.

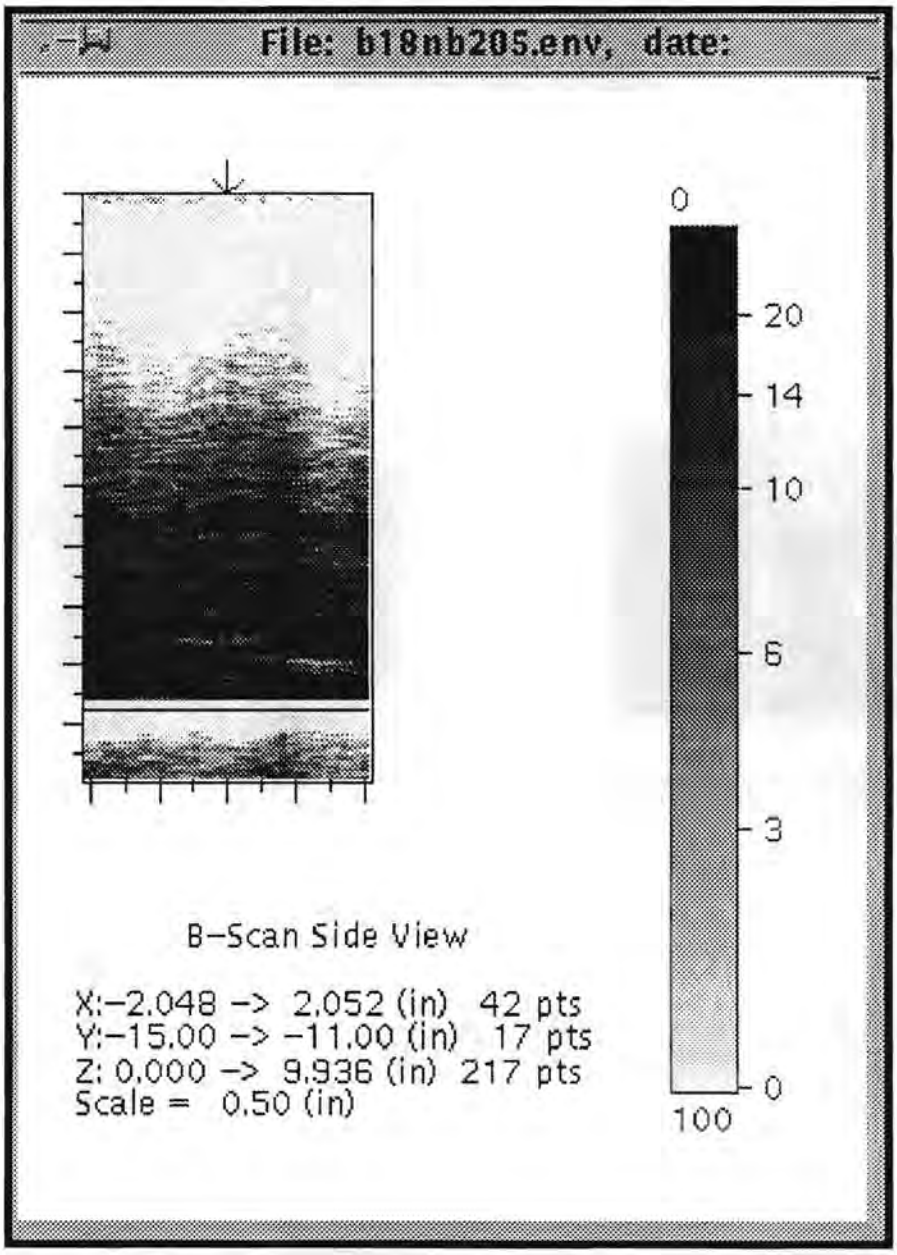
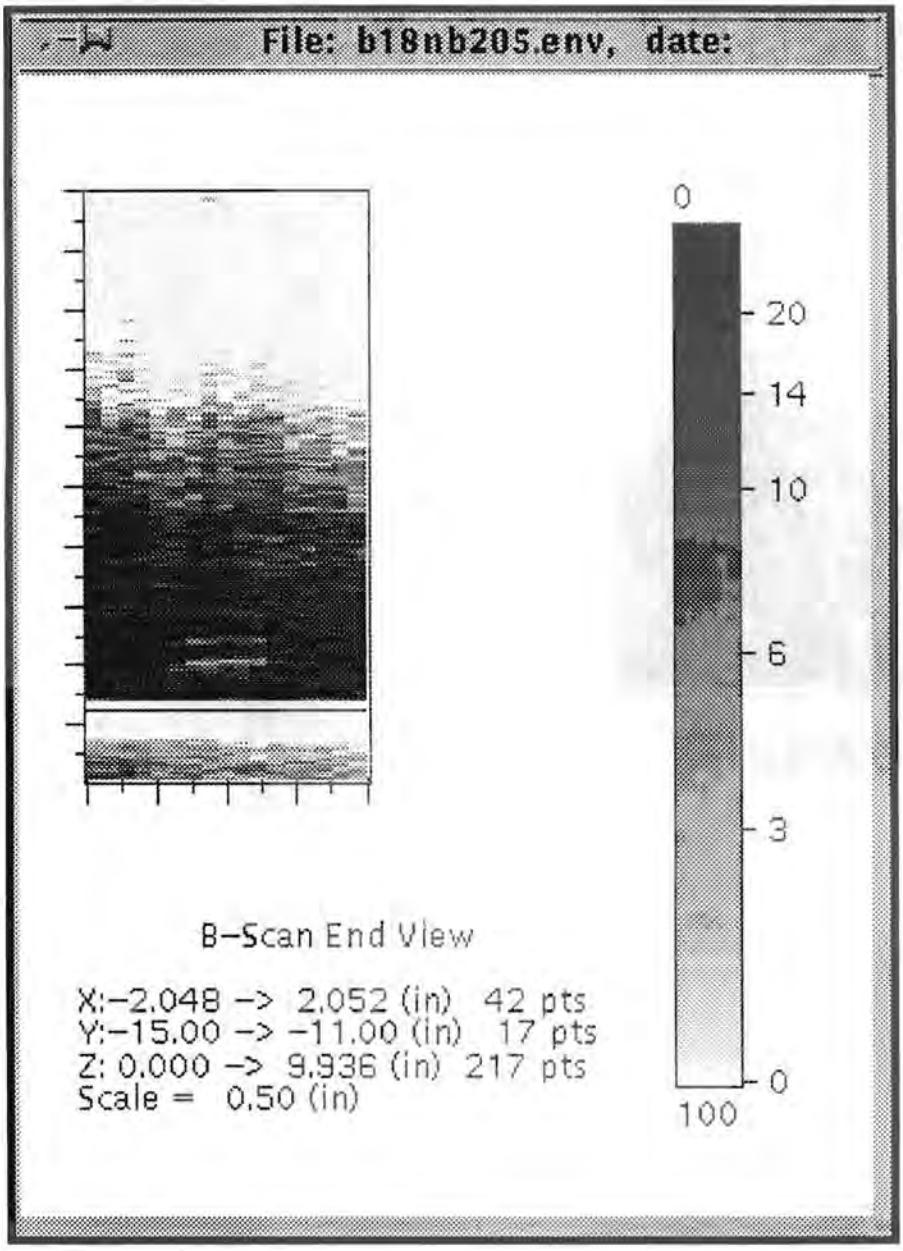
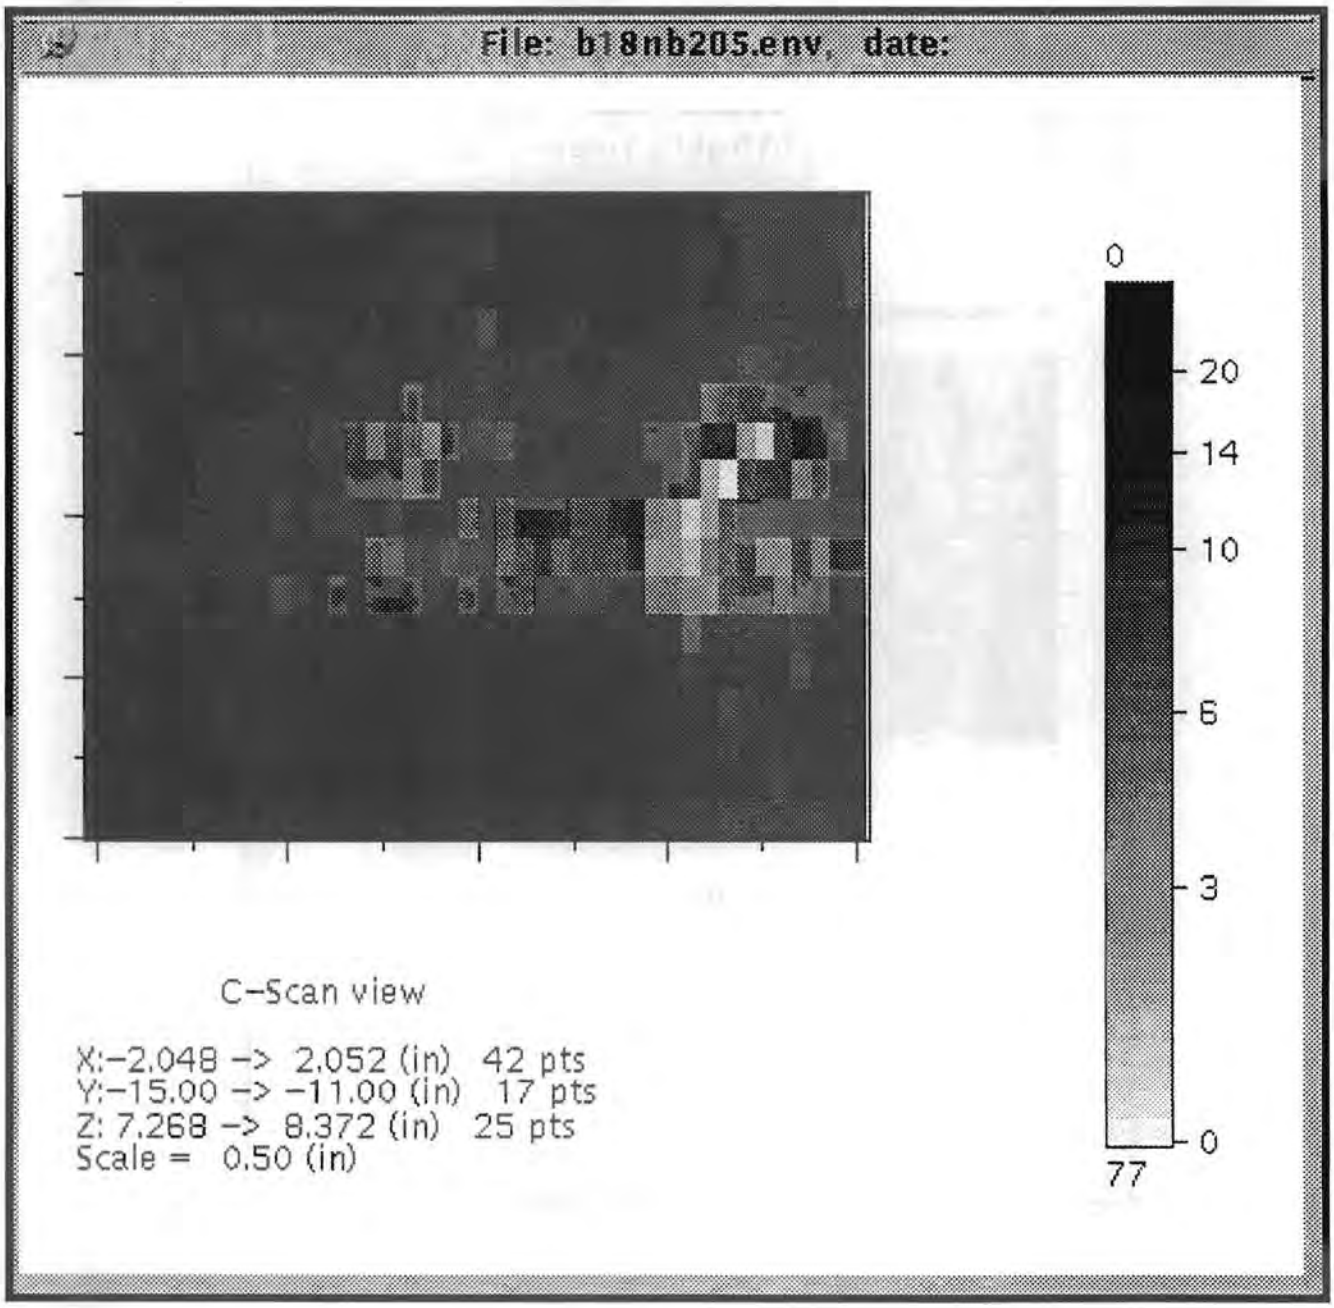
-325 (-12.8)	19 (0.75)	38 (1.5)	13 (0.5)	208 (8.2)	-	Detected by SAFT-UT in normal beam from the clad side. See Figure 5.12. No estimate is made for DZ since this reflector is only detected in normal beam from the clad side. This is probably multiple small volumetric defects.

Figure 5.12a Side View (XZ) of Base-Metal Indication in Block 1-8 at Y = -325 mm (-12.8 in.). Normal beam inspection from the clad side.

Figure 5.12b End View (YZ) of Base-Metal Indication in Block 1-8 at Y = -325 mm (-12.8 in.). Normal beam inspection from the clad side.

Figure 5.12c C-scan View (XY) of Base-Metal Indication in Block 1-8 at Y = -325 mm (-12.8 in.). Normal beam inspection from the clad side.

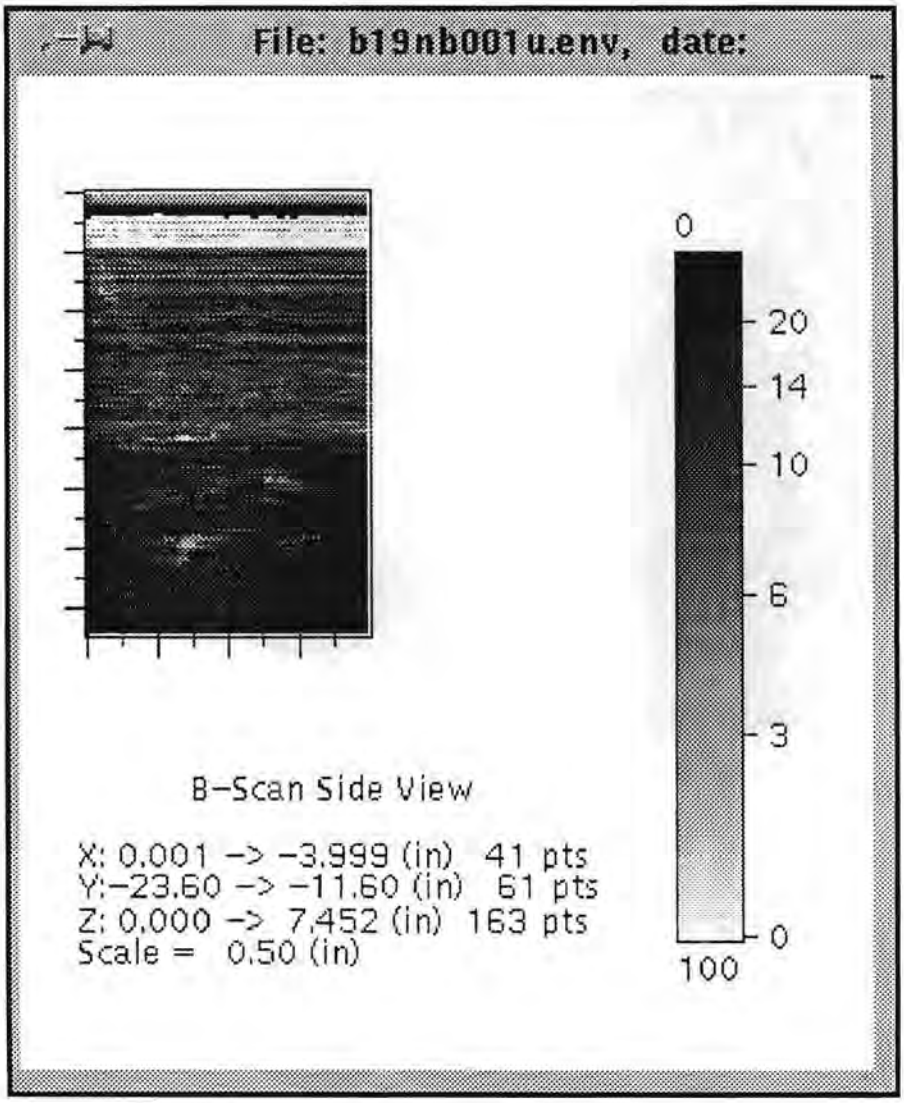
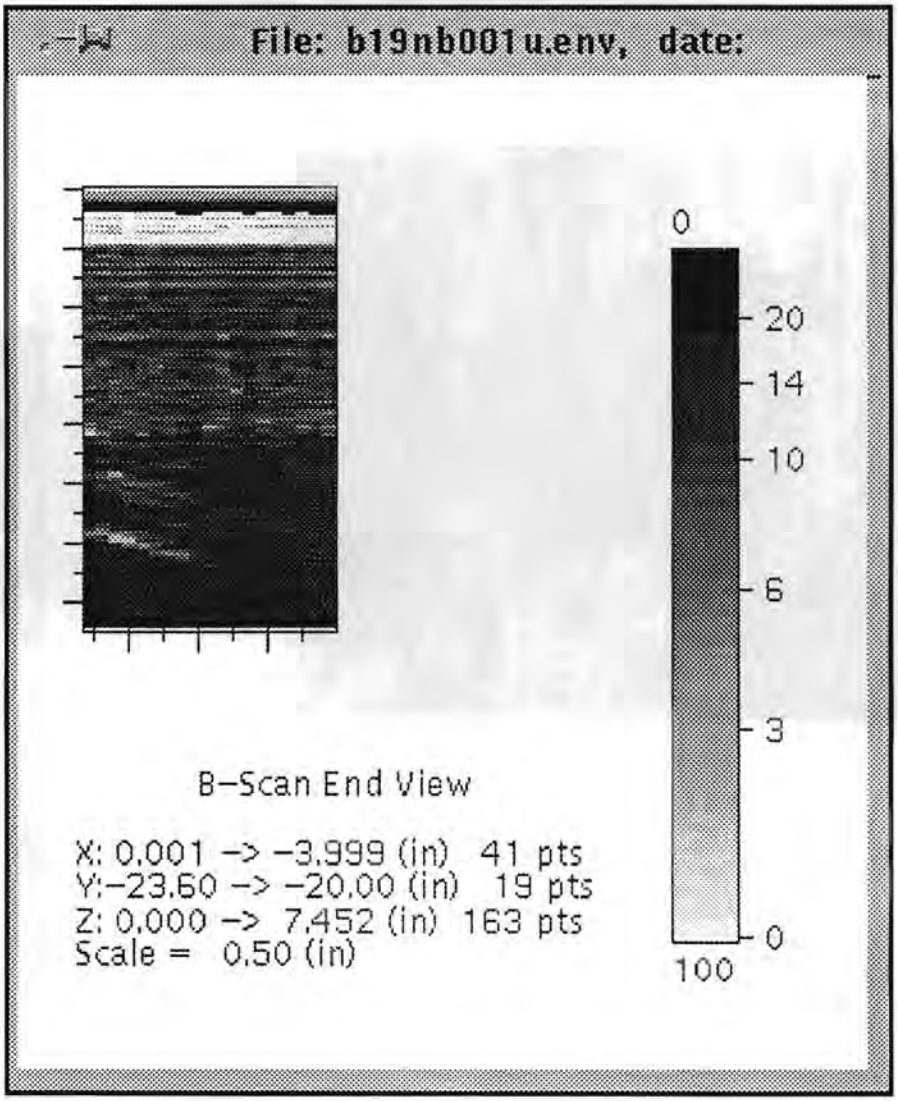
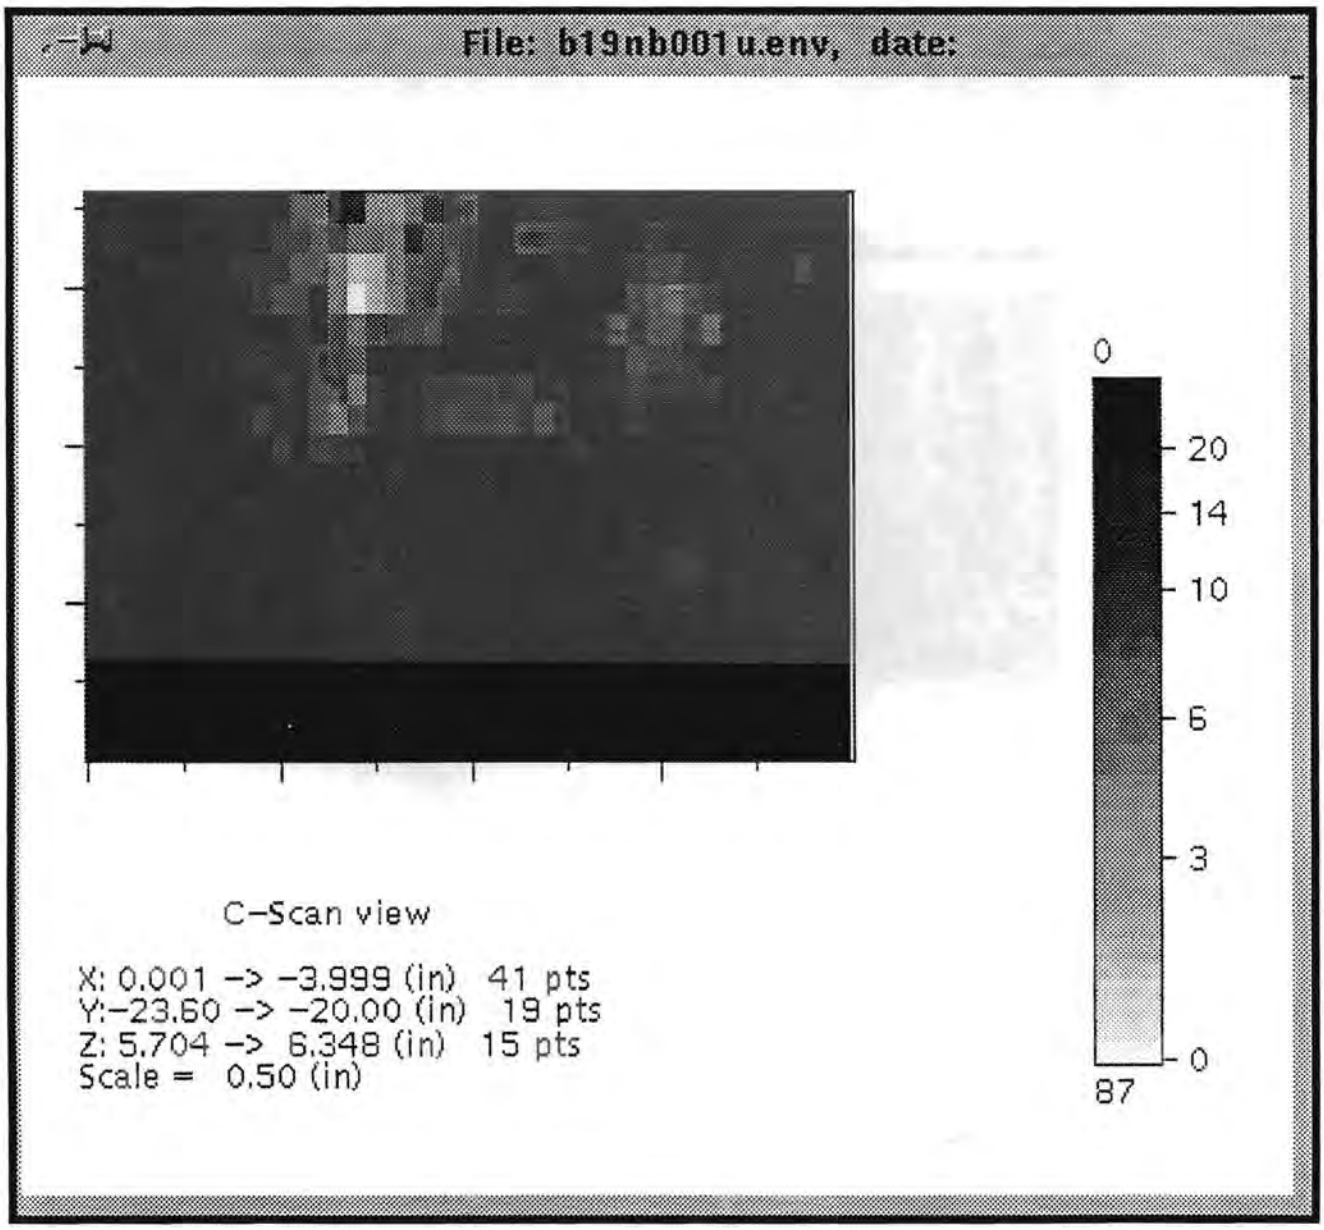
Y, mm (in.)	DY, mm (in.)	X, mm (in.)	DX, mm (in.)	Z, mm (in.)	DZ, mm (in.)	Characterization
Indications in and near the Weld of the Base Metal						
-582 (-22.9)	36 (1.4)	18 (-0.7)	-	178 (7.0)	18 (0.7)	Detected by SAFT-UT in normal beam from the bottom side. See Figure 5.13. This is probably multiple planar defects separated by 36 mm (1.4 in.) in Y.
-584 (-23.0)	23 (0.9)	-43 (-1.7)	-	145 (5.7)	<5 (<0.2)	Detected by SAFT-UT in normal beam from the bottom side. See Figure 5.14. This is either small planar defects separated by 23 mm (0.9 in.) in Y or a single planar defect of the size noted.
-597 (-23.5)	-	-66 (-2.6)	-	178 (7.0)	10 (0.4)	Detected by SAFT-UT in normal beam from bottom side. See Figure 5.15. Only part of the defect was insonified by SAFT-UT. This is probably a small planar defect of the size noted.
-221 (-8.7)	13 (0.5)	-30 (-1.2)	-	64 (2.5)	5 (0.2)	Detected by SAFT-UT in normal beam from the bottom side. See Figure 5.16. This is probably a single planar defect of the size noted.

Figure 5.13a Side View (scanner coordinates xz) of Base-Metal Indication in Block 1-9 at Y = -582 mm (-22.9 in.). Normal beam inspection from the bottom side. Z in the figure corresponds to material coordinates of X from -152 mm (-6 in.) to +36.8 mm (+1.45 in.). X in the figure corresponds to material coordinates of Z from 216 mm (8.5 in.) to 114.3 (4.5 in.).

Figure 5.13b End View (scanner coordinates yz) of Base-Metal Indication in Block 1-9 at Y = -582 mm (-22.9 in.). Normal beam inspection from the bottom side. Z in the figure corresponds to material coordinates of X from -152 mm (-6 in.) to +36.8 mm (+1.45 in.). X in the figure corresponds to material coordinates of Z from 216 mm (8.5 in.) to 114.3 (4.5 in.).

Figure 5.13c C-scan View (scanner coordinates xy) of Base-Metal Indication in Block 1-9 at Y = -582 mm (-22.9 in.). Normal beam inspection from the bottom side. Z in the figure corresponds to material coordinates of X from -152 mm (-6 in.) to +36.8 mm (+1.45 in.). X in the figure corresponds to material coordinates of Z from 216 mm (8.5 in.) to 114.3 (4.5 in.).

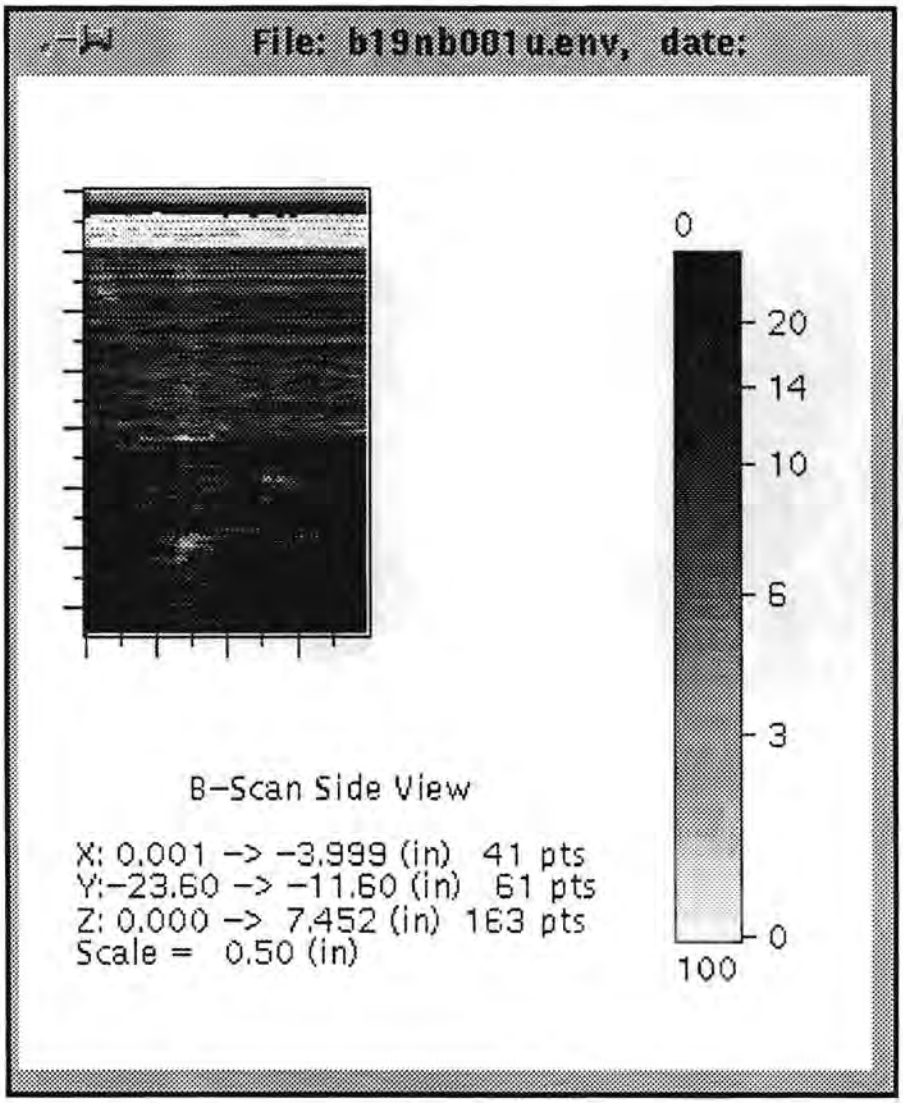
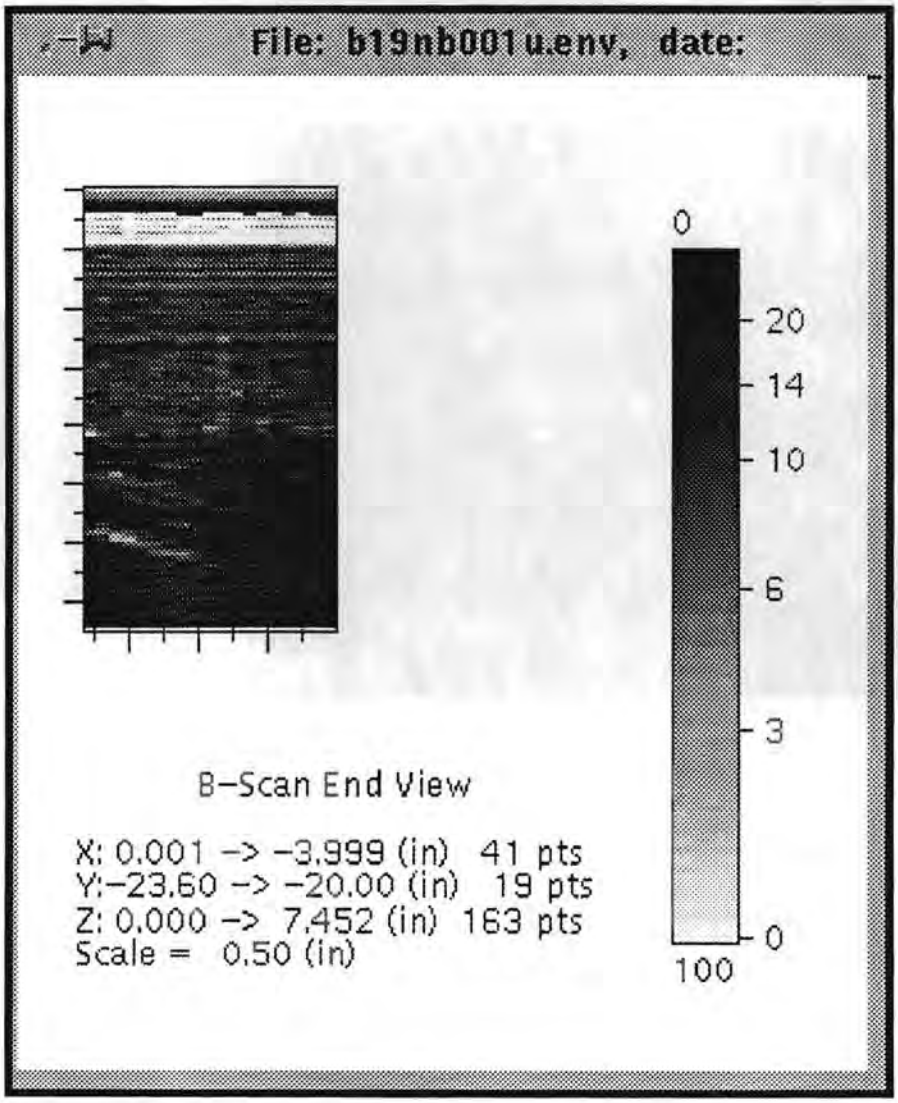
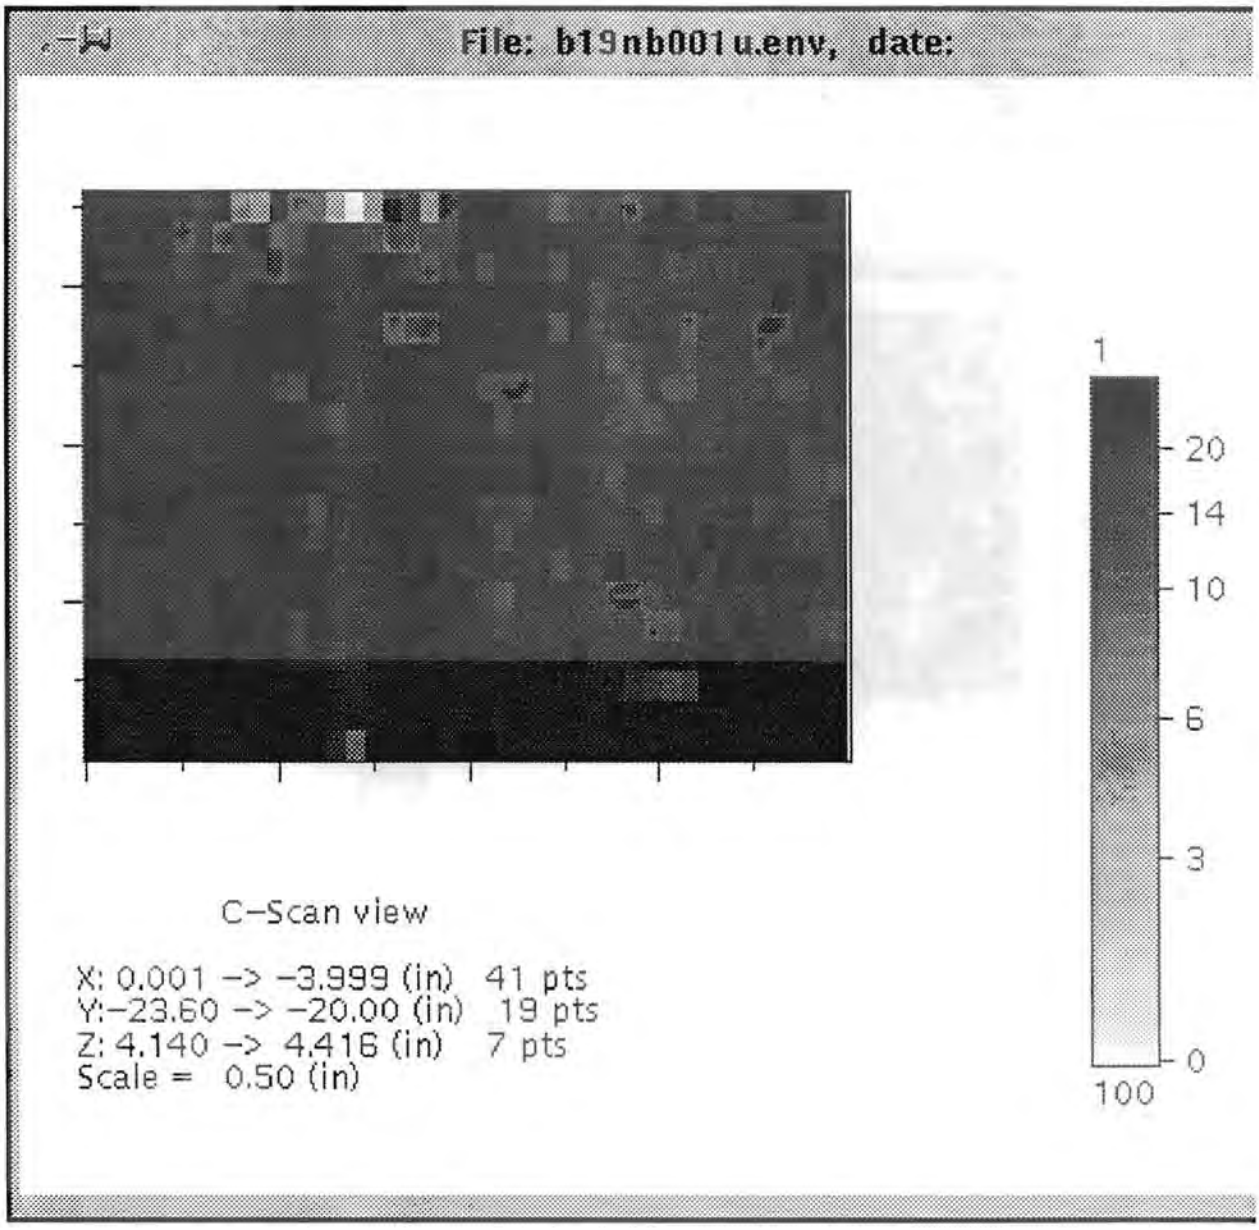
Figure 5.15a Side View (scanner coordinates xz) of Base-Metal Indication in Block 1-9 at Y = -597 mm (-23.5 in.). Normal beam inspection from the bottom side. Z in the figure corresponds to material coordinates of X from -152 mm (-6 in.) to +368 mm (+1.45 in.). X in the figure corresponds to material coordinates of Z from 216 mm (8.5 in.) to 114 mm (4.5 in.).

Figure 5.15b End View (scanner coordinates yz) of Base-Metal Indication in Block 1-9 at Y = -597 mm (-23.5 in.). Normal beam inspection from the bottom side. Z in the figure corresponds to material coordinates of X from -152 mm (-6 in.) to +368 mm (+1.45 in.). X in the figure corresponds to material coordinates of Z from 216 mm (8.5 in.) to 114 mm (4.5 in.).

Figure 5.15c C-scan View (scanner coordinates xy) of Base-Metal Indication in Block 1-9 at Y = -597 mm (-23.5 in.). Normal beam inspection from the bottom side. Z in the figure corresponds to material coordinates of X from -48 mm (-1.9 in.) to -41 mm (-1.6 in.). X in the figure corresponds to material coordinates of Z from 216 mm (8.5 in.) to 114 mm (4.5 in.).

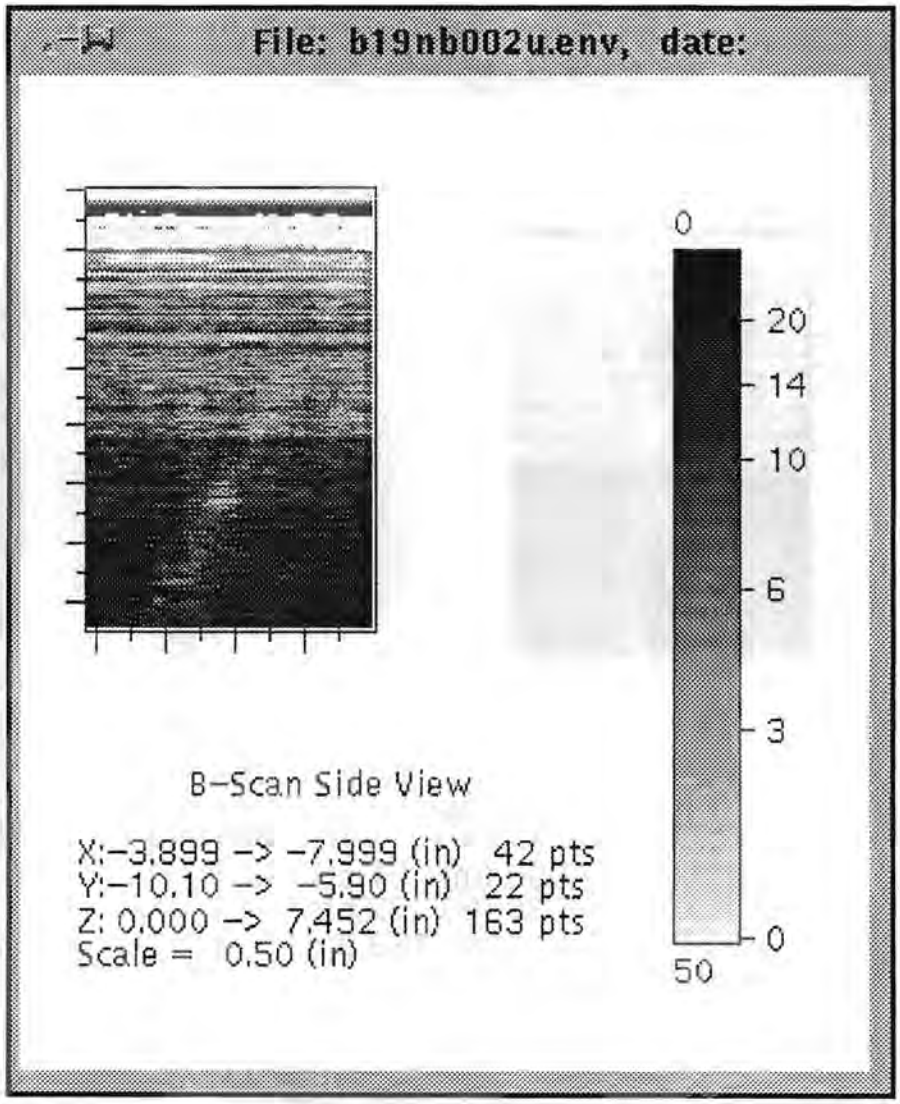
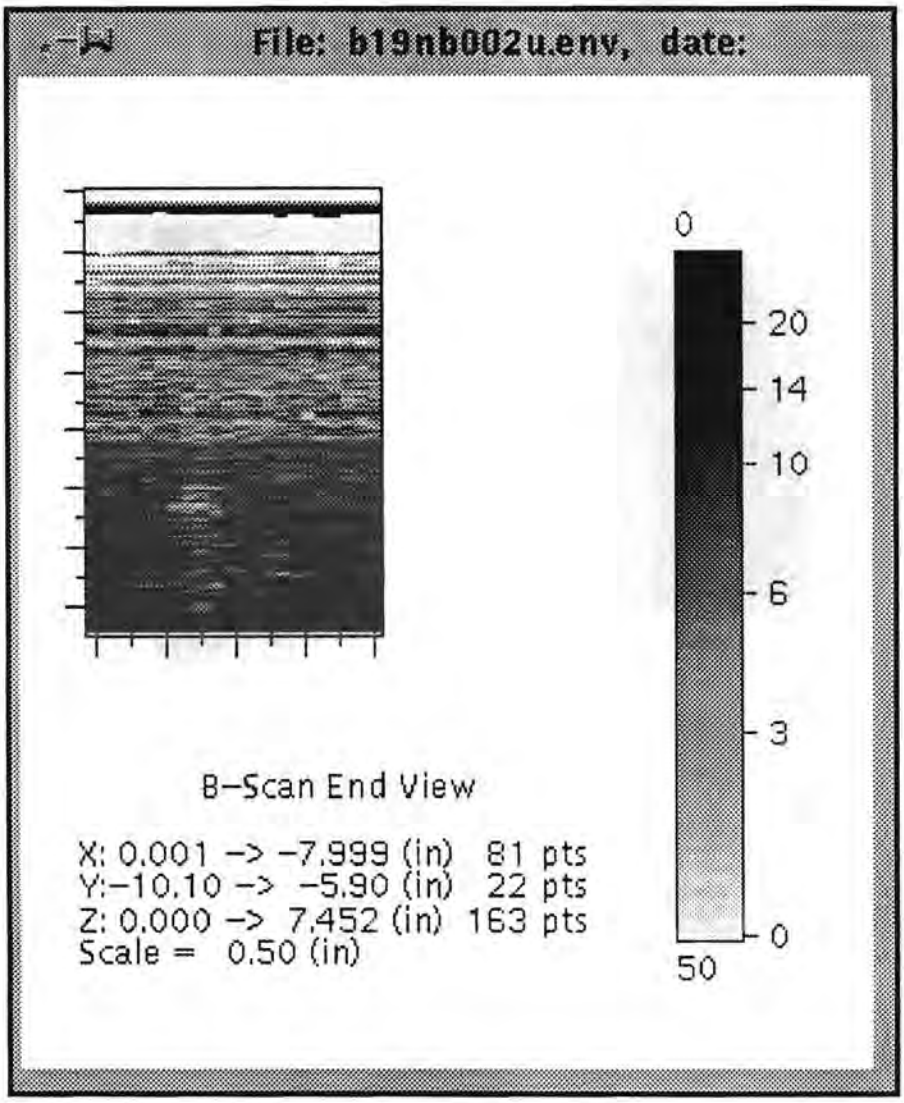
Figure 5.16a Side View (Scanner Coordinates XZ) of Base-Metal Indication in Block 1-9 at Y = -22.1 mm (-8.7 in.). Normal beam inspection from the bottom side. Z in the figure corresponds to material coordinates of X from -152 mm (-6 in.) to +368 mm (+1.45 in.). X in the figure corresponds to material coordinates of Z from 119 mm (4.7 in.) to 13 mm (0.5 in.).

Figure 5.16b End View (Scanner Coordinates YZ) of Base-Metal Indication in Block 1-9 at Y = -22.1 mm (-8.7 in.). Normal beam inspection from the bottom side. Z in the figure corresponds to material coordinates of X from -152 mm (-6 in.) to 368 mm (1.45 in.).
