NUREG/CR-6471, Vol. 1
PNNL-11143

Characterization of Flaws in U.S. Reactor Pressure Vessels

Density and Distribution of Flaw Indications in PVRUF

Pacific Northwest National Laboratory

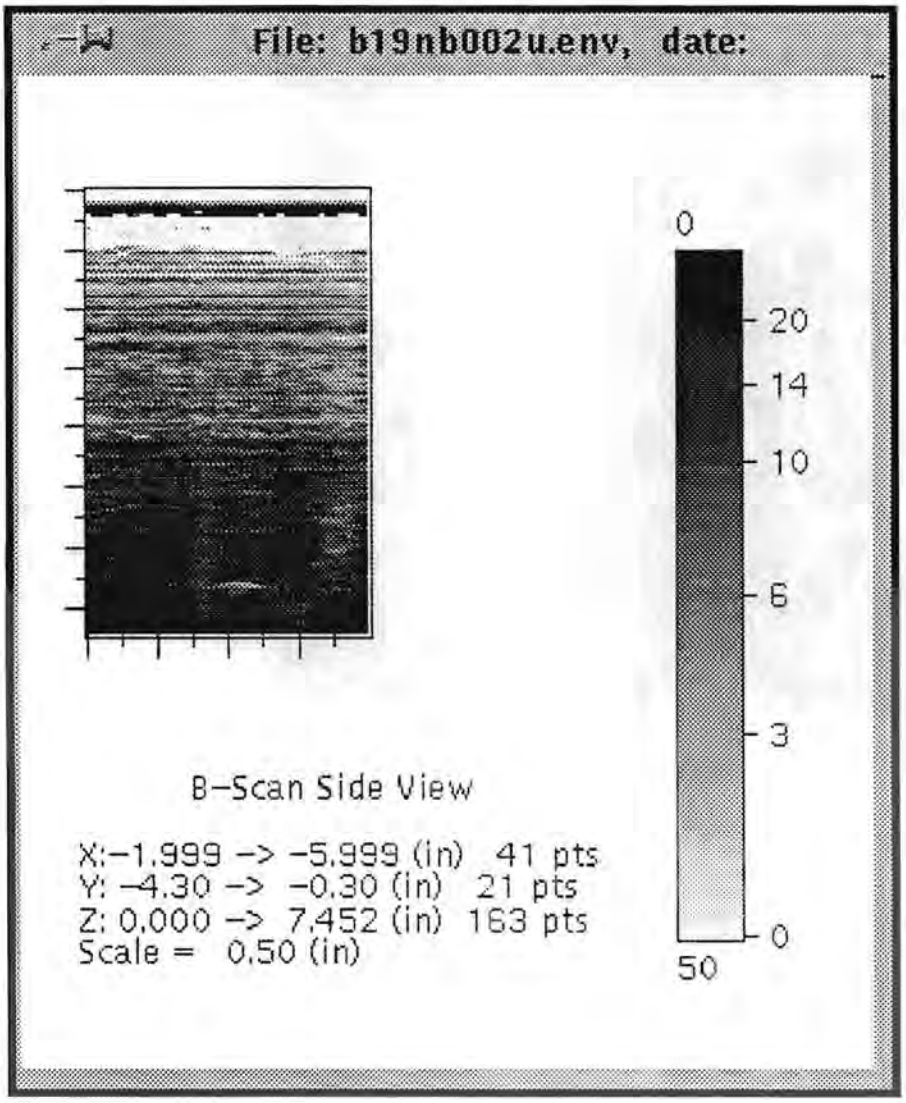
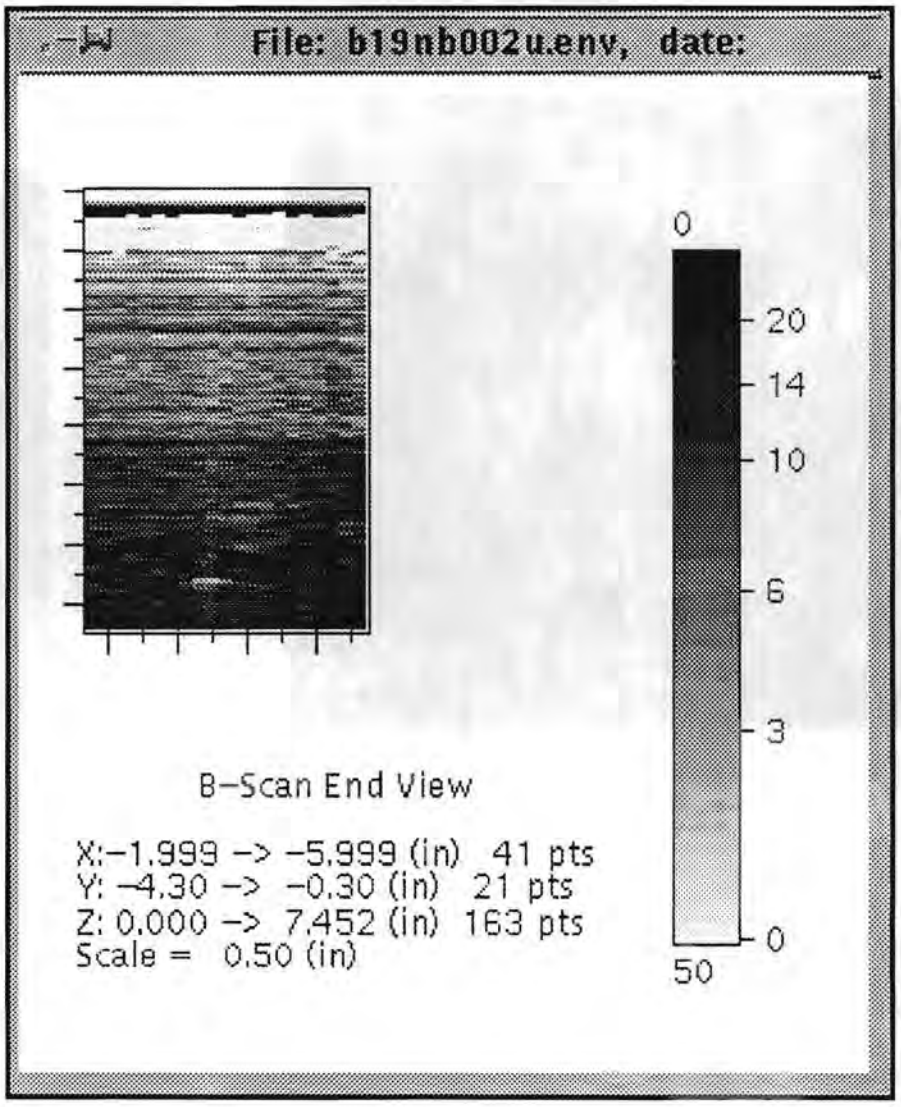
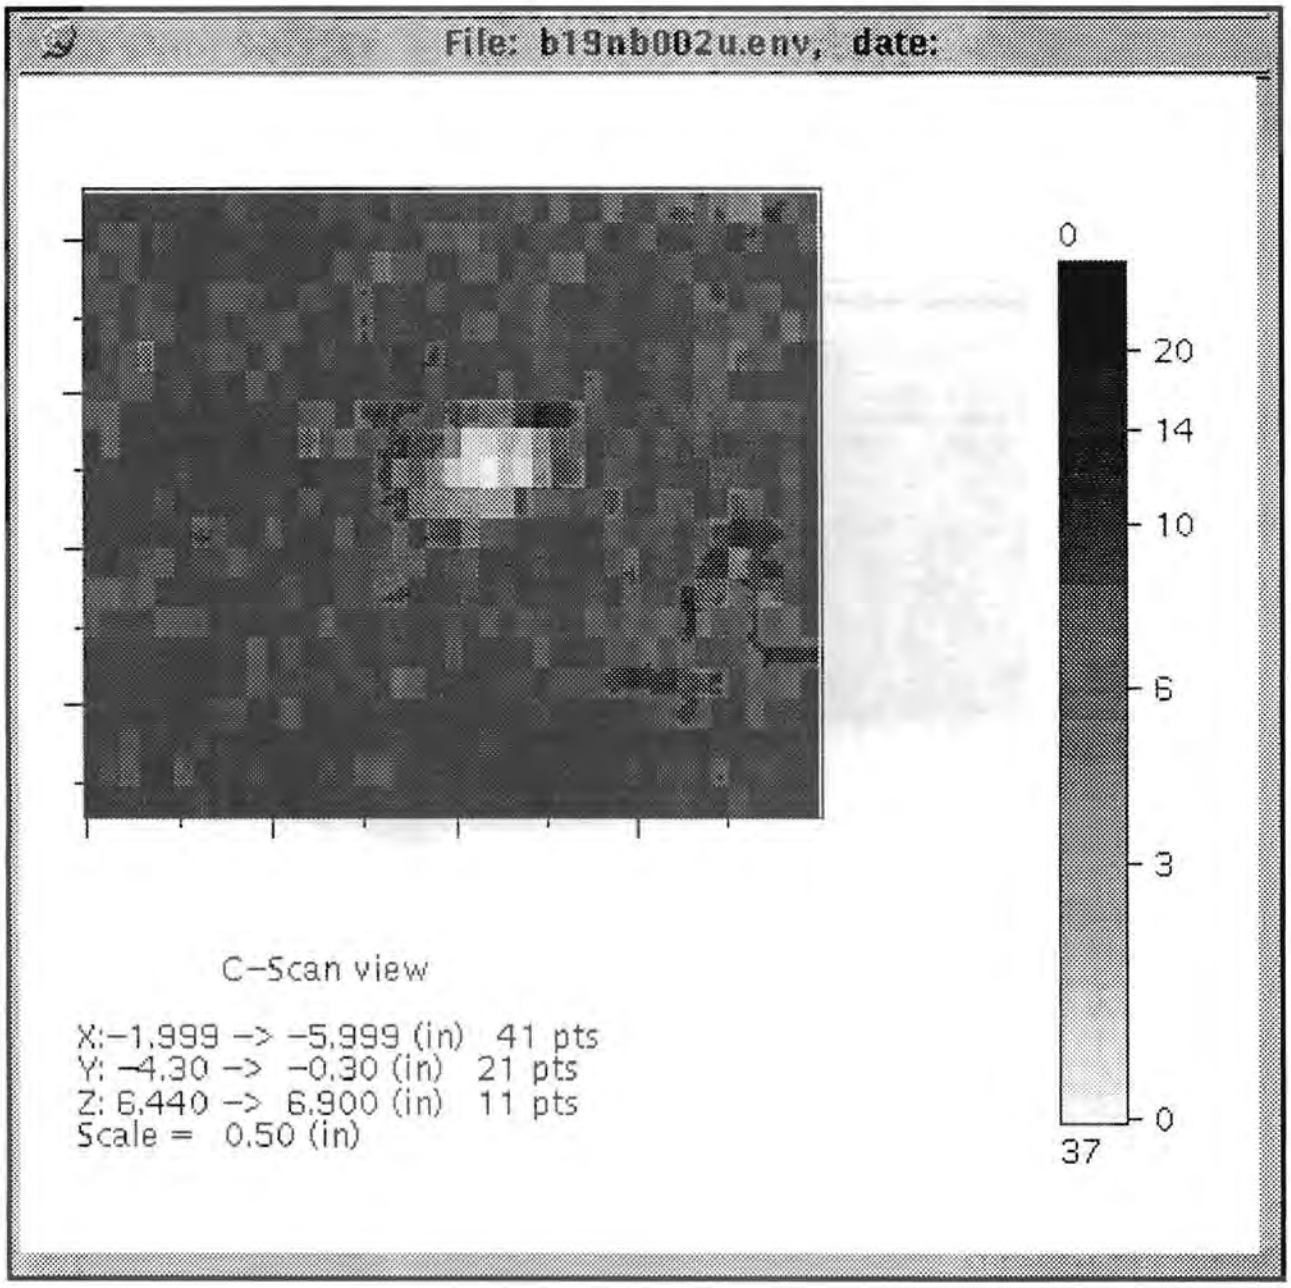
-69 (-2.7)	13 (0.5)	2 (0.1)	-	114 (4.5)	5 (0.2)	Detected by SAFT-UT in normal beam from the bottom side. See Figure 5.17. This is a small planar defect.
183 (7.2)	25 (1.0)	-2 (-0.1)	-	121 (4.8)	8 (0.3)	Detected by SAFT-UT in normal beam from the bottom side. See Figure 5.18. This is a small planar defect.
203 (8.0)	10 (0.4)	0 (0.0)	5 (0.2)	119 (4.7)	-	Detected by SAFT-UT in normal beam from the clad side. See Figure 5.19. No estimate is made for DZ since this reflector is only detected in normal beam from the clad side. This is a small volumetric defect.
185 (7.3)	23 (0.9)	76 (3.0)	5 (0.2)	206 (8.1)	-	Detected by SAFT-UT in normal beam from the clad side. See Figure 5.20. No estimate is made for DZ since this reflector is only detected in normal beam from the clad side. This is a small volumetric defect.

Figure 5.17a Side View (Scanner Coordinates XZ) of Base-Metal Indication in Block 1-9 at Y = -69 mm (-2.7 in.). Normal beam inspection from the bottom side. Z in the figure corresponds to material coordinates of X from -152 mm (-6 in.) to +368 mm (+1.45 in.). X in the figure corresponds to material coordinates of Z from 165 mm (6.5 in.) to 64 mm (2.5 in.).

Figure 5.17b End View (Scanner Coordinates YZ) of Base-Metal Indication in Block 1-9 at Y = -69 mm (2.7 in.). Normal beam inspection from the bottom side. Z in the figure corresponds to material coordinates of X from -152 mm (-6 in.) to +368 mm (+1.45 in.).

Figure 5.17c C-scan View (Scanner Coordinates XY) of Base-Metal Indication in Block 1-9 at Y = -69 mm (2.7 in.). Normal beam inspection from the bottom side. X in the figure corresponds to material coordinates of Z from 165 mm (6.5 in.) to 64 mm (2.5 in.).

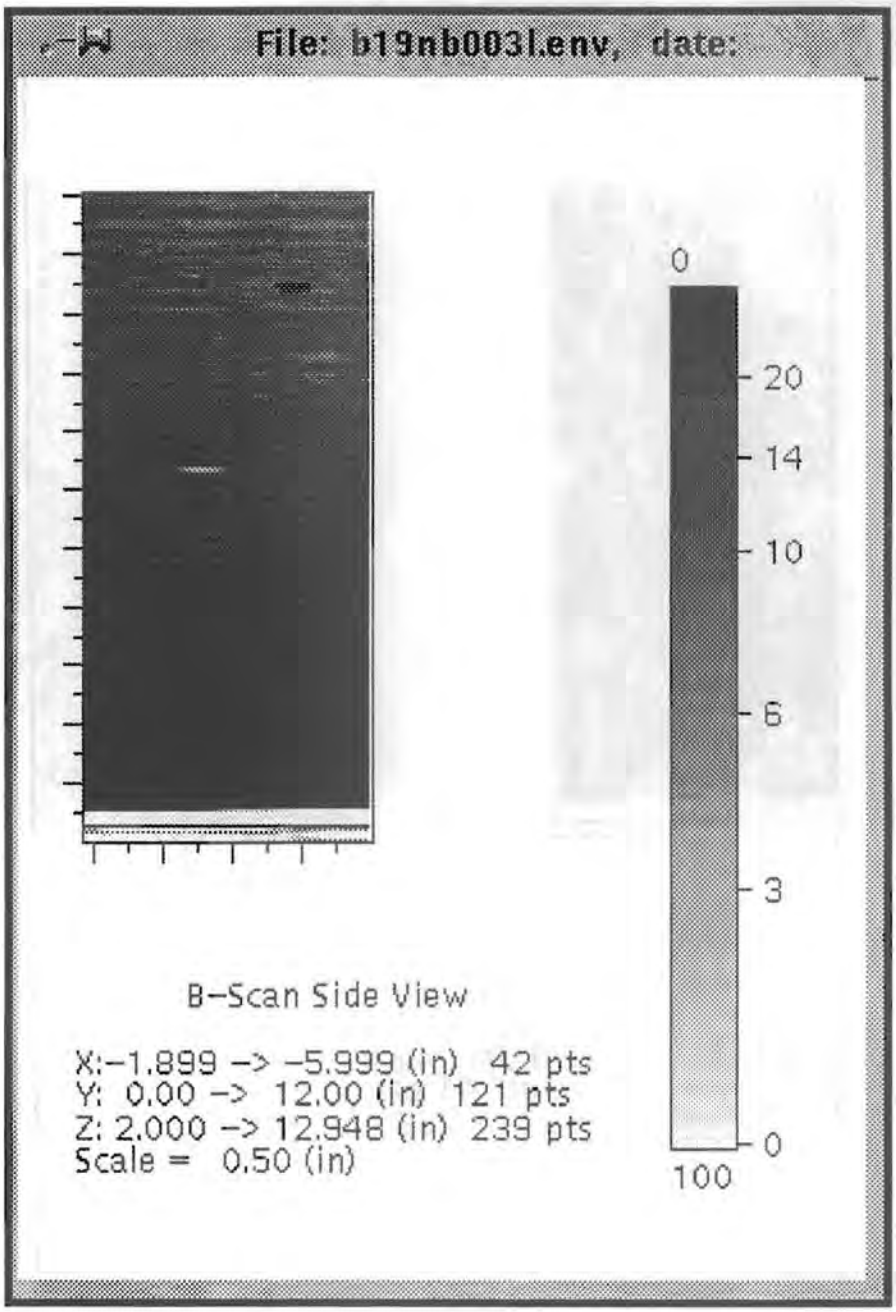
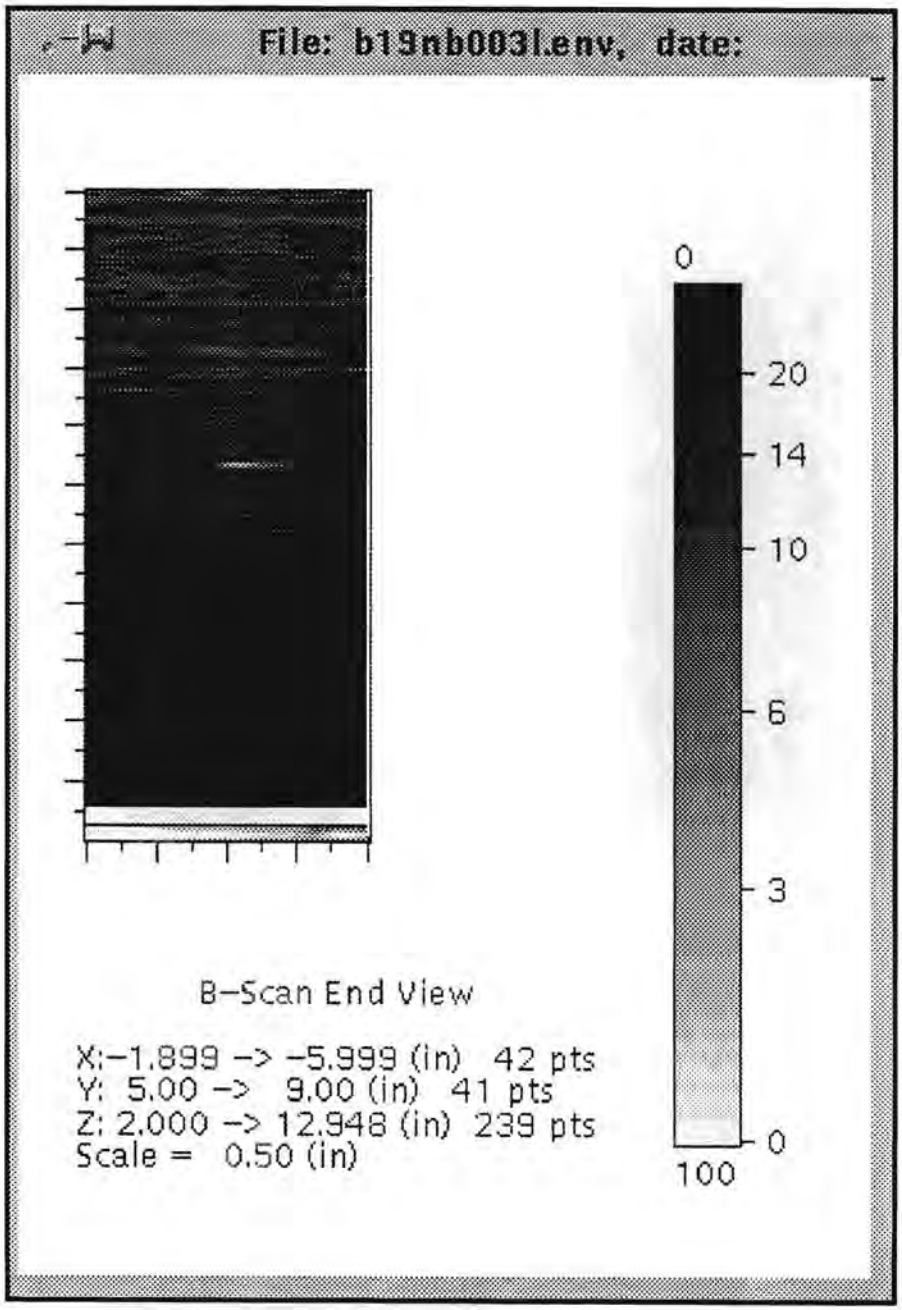
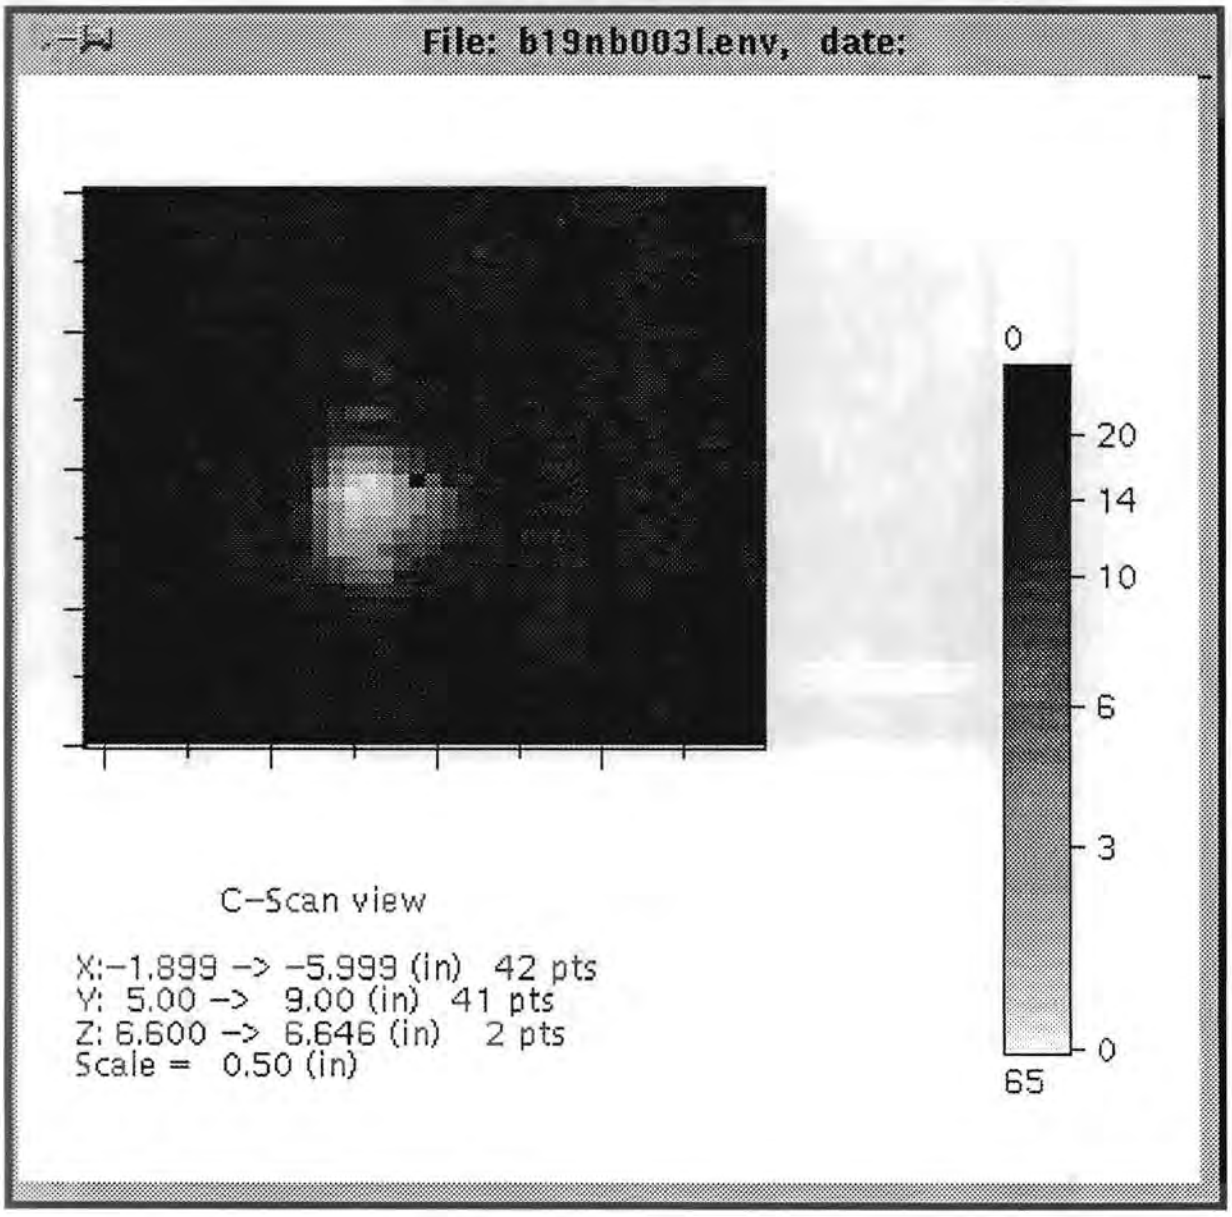
Figure 5.18a Side View (Scanner Coordinates XZ) of Base-Metal Indication in Block 1-9 at Y = 183 mm (7.2 in.). Normal beam inspection from the bottom side. Z in the figure corresponds to material coordinates of X from -102 mm (-4 in.) to 178 mm (7 in.). X in the figure corresponds to material coordinates of Z from 168 mm (6.6 in.) to 64 mm (2.5 in.).

Figure 5.18b End View (Scanner Coordinates YZ) of Base-Metal Indication in Block 1-9 at Y = 183 mm (7.2 in.). Normal beam inspection from the bottom side. Z in the figure corresponds to material coordinates of X from -102 mm (-4 in.) to 178 mm (7 in.).

Figure 5.18c C-scan View (Scanner Coordinates XY) of Base-Metal Indication in Block 1-9 at Y = 183 mm (7.2 in.). Normal beam inspection from the bottom side. X in the figure corresponds to material coordinates of Z from 168 mm (6.6 in.) to 64 mm (2.5 in.).

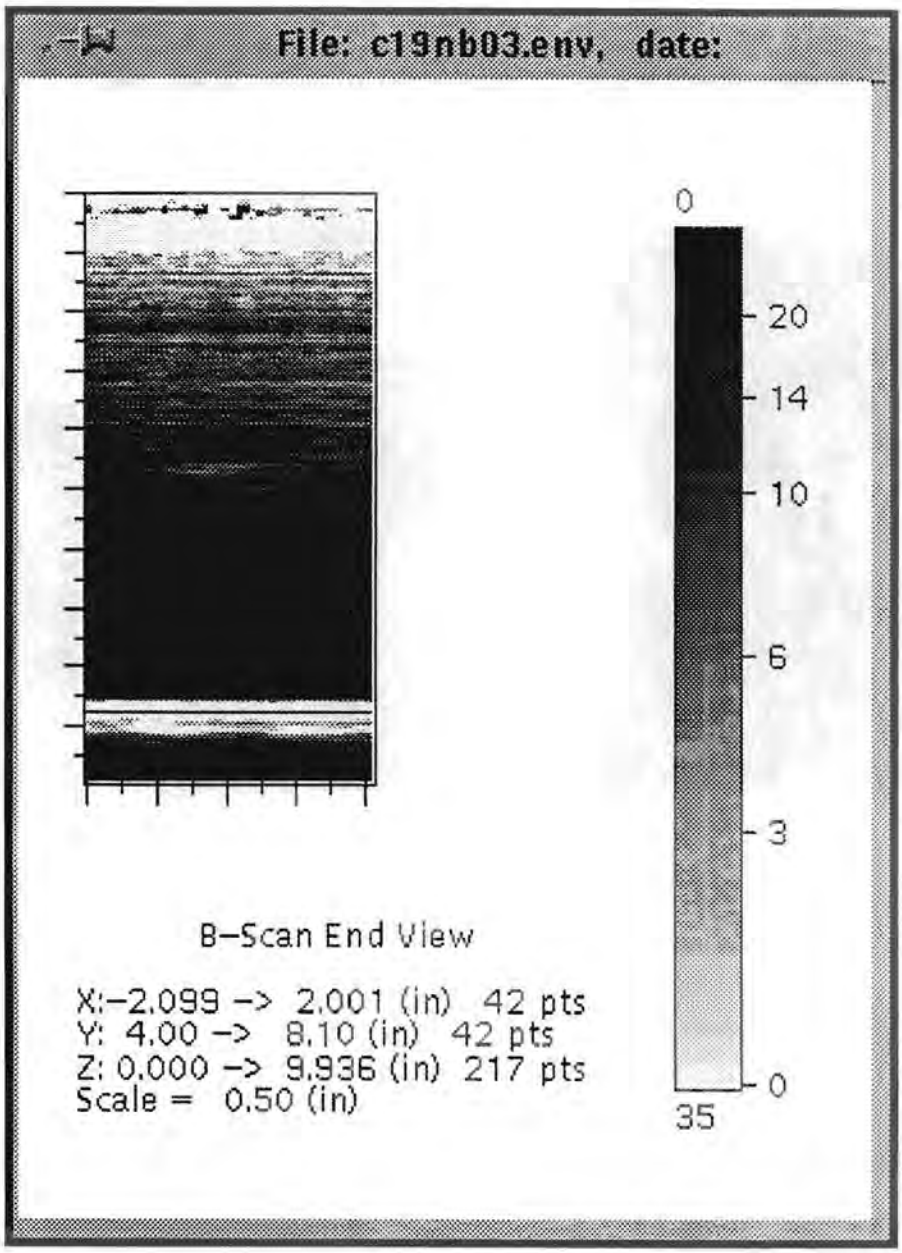
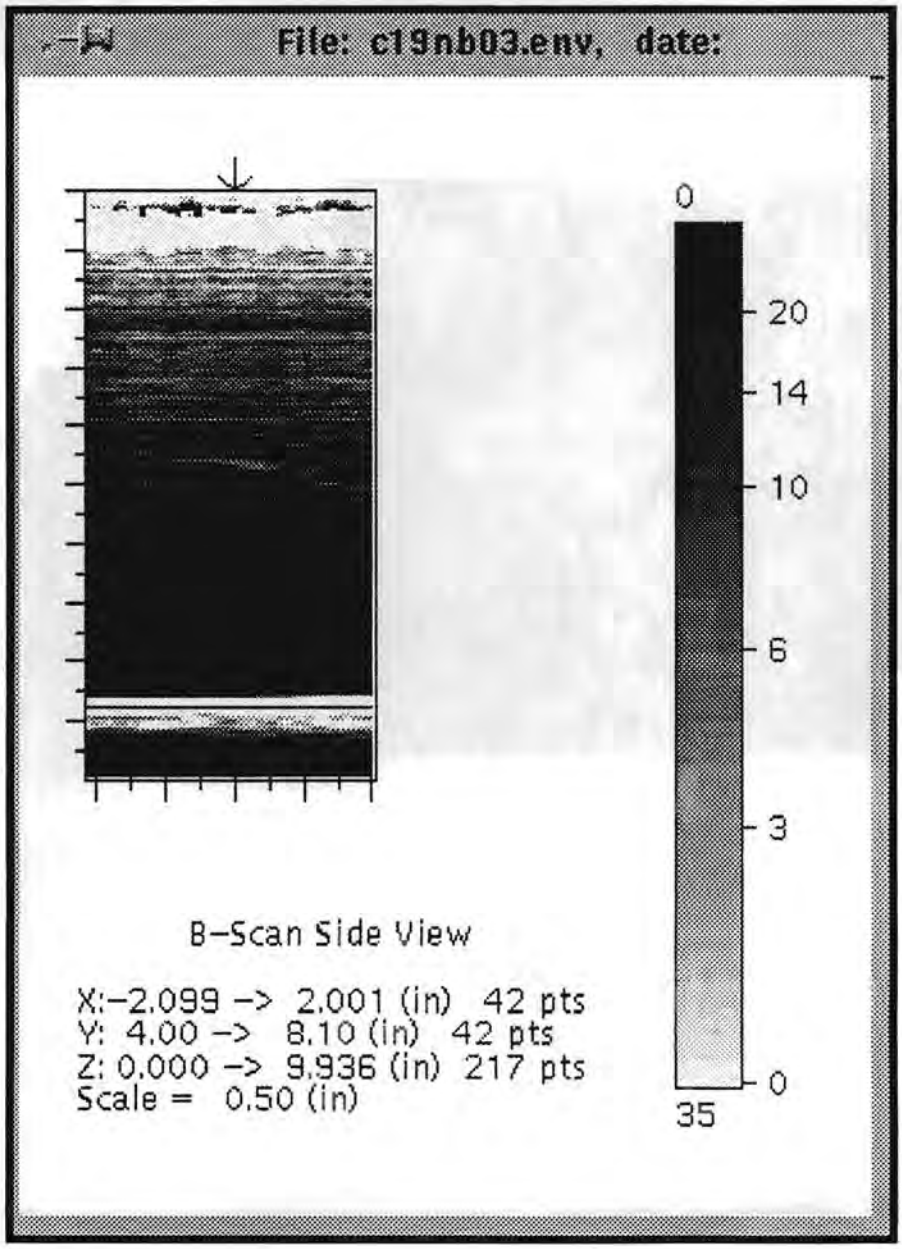
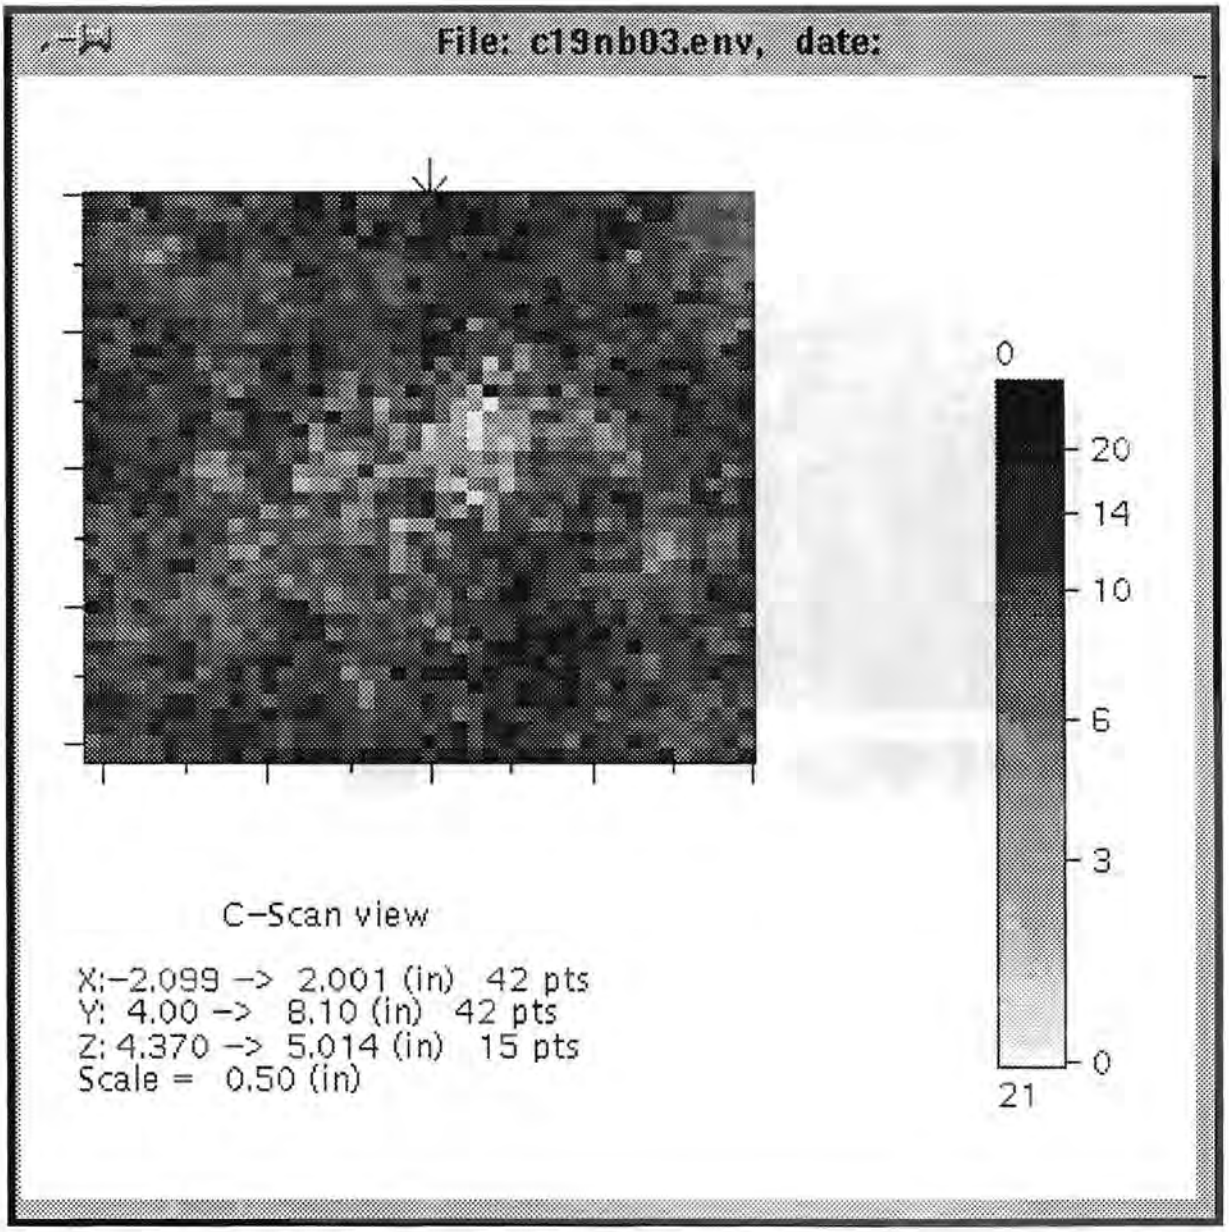
Figure 5.19a Side View (XZ) of Base-Metal Indication in Block 1-9 at Y = 203 mm (8.0 in.). Normal beam inspection from the clad side.

Figure 5.19b End View (YZ) of Base-Metal Indication in Block 1-9 at Y = 203 mm (8.0 in.). Normal beam inspection from the clad side.

Figure 5.19c C-scan View (XY) of Base-Metal Indication in Block 1-9 at Y = 203 mm (8.0 in.). Normal beam inspection from the clad side.

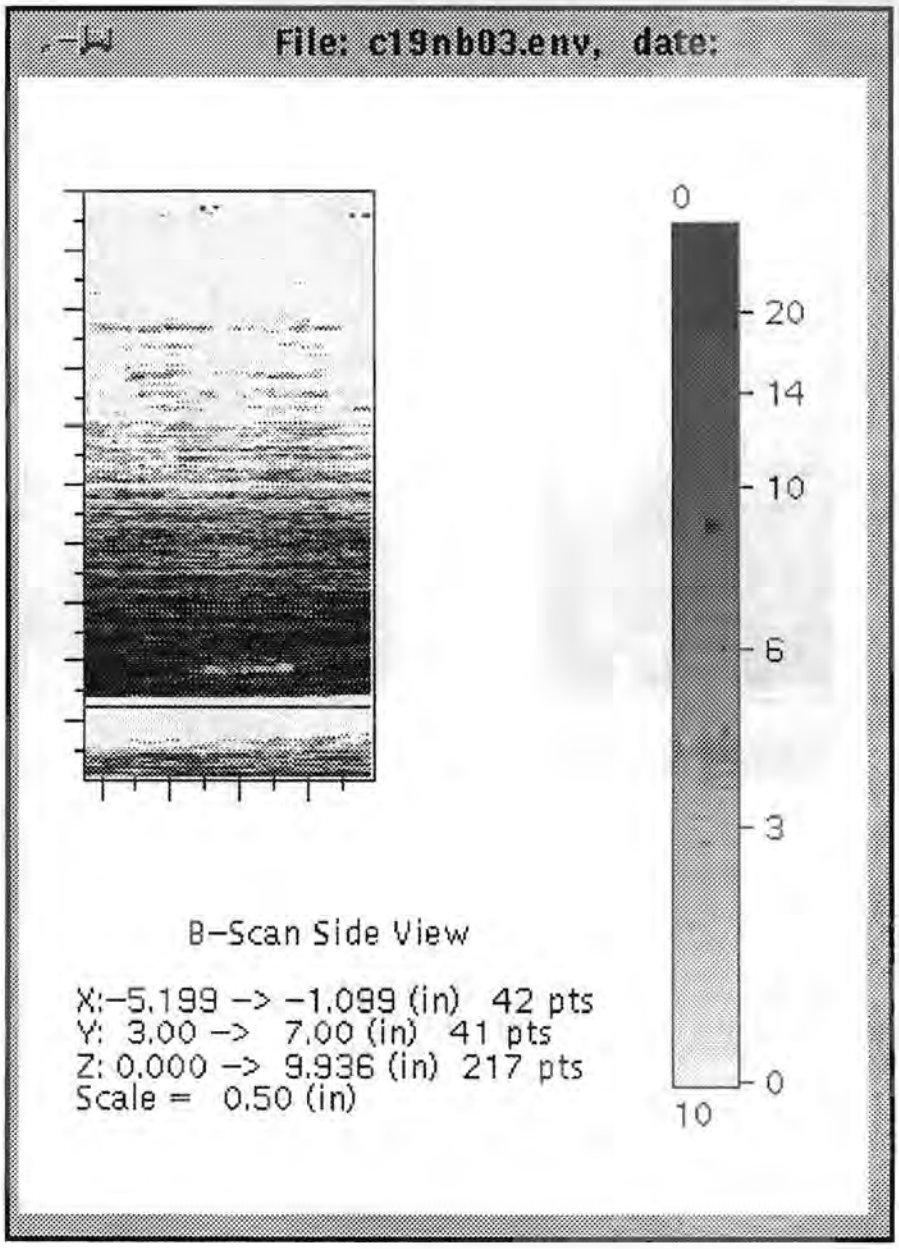
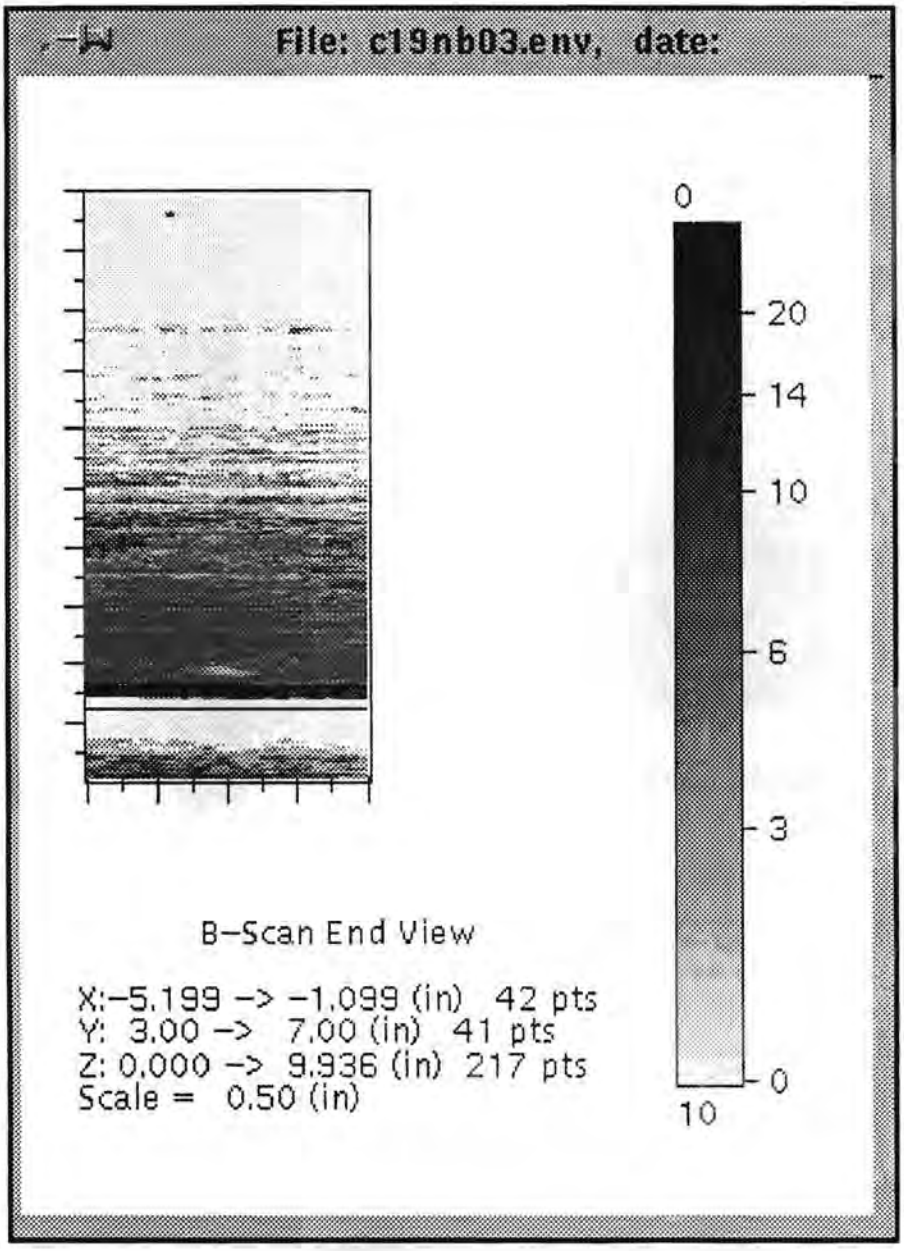
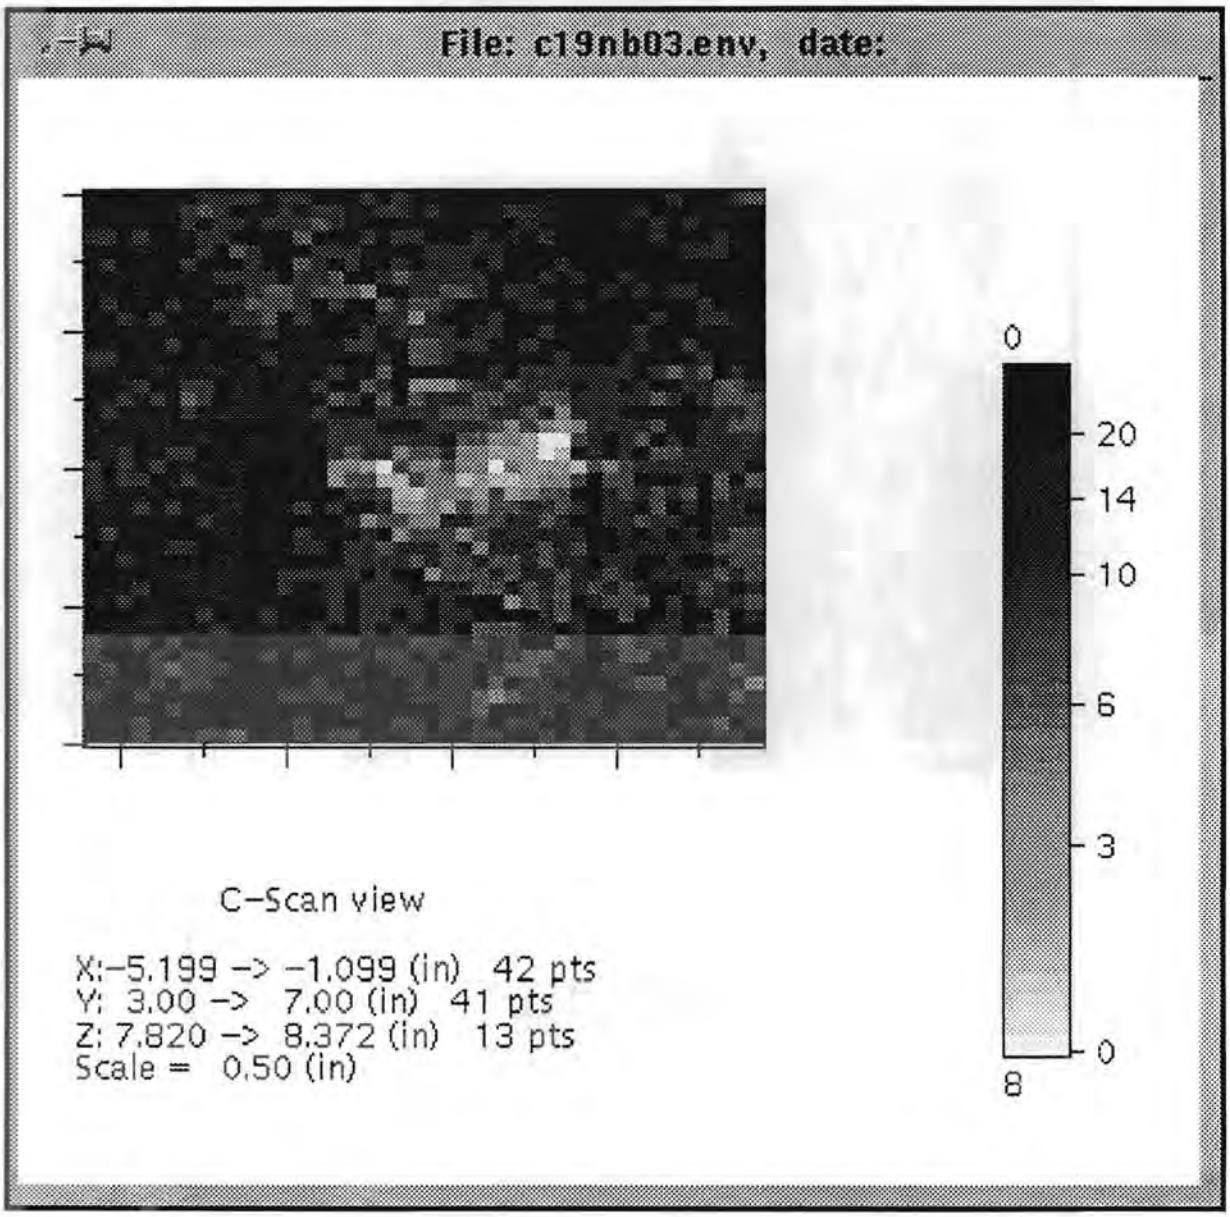
Figure 5.20a Side View (XZ) of Base-Metal Indication in Block 1-9 at Y = 185 mm (7.3 in.). Normal beam inspection from the clad side.

Figure 5.20b End View (YZ) of Base-Metal Indication in Block 1-9 at Y = 185 mm (7.3 in.). Normal beam inspection from the clad side.

Figure 5.20c C-scan View (XY) of Base-Metal Indication in Block 1-9 at Y = 185 mm (7.3 in.). Normal beam inspection from the clad side.

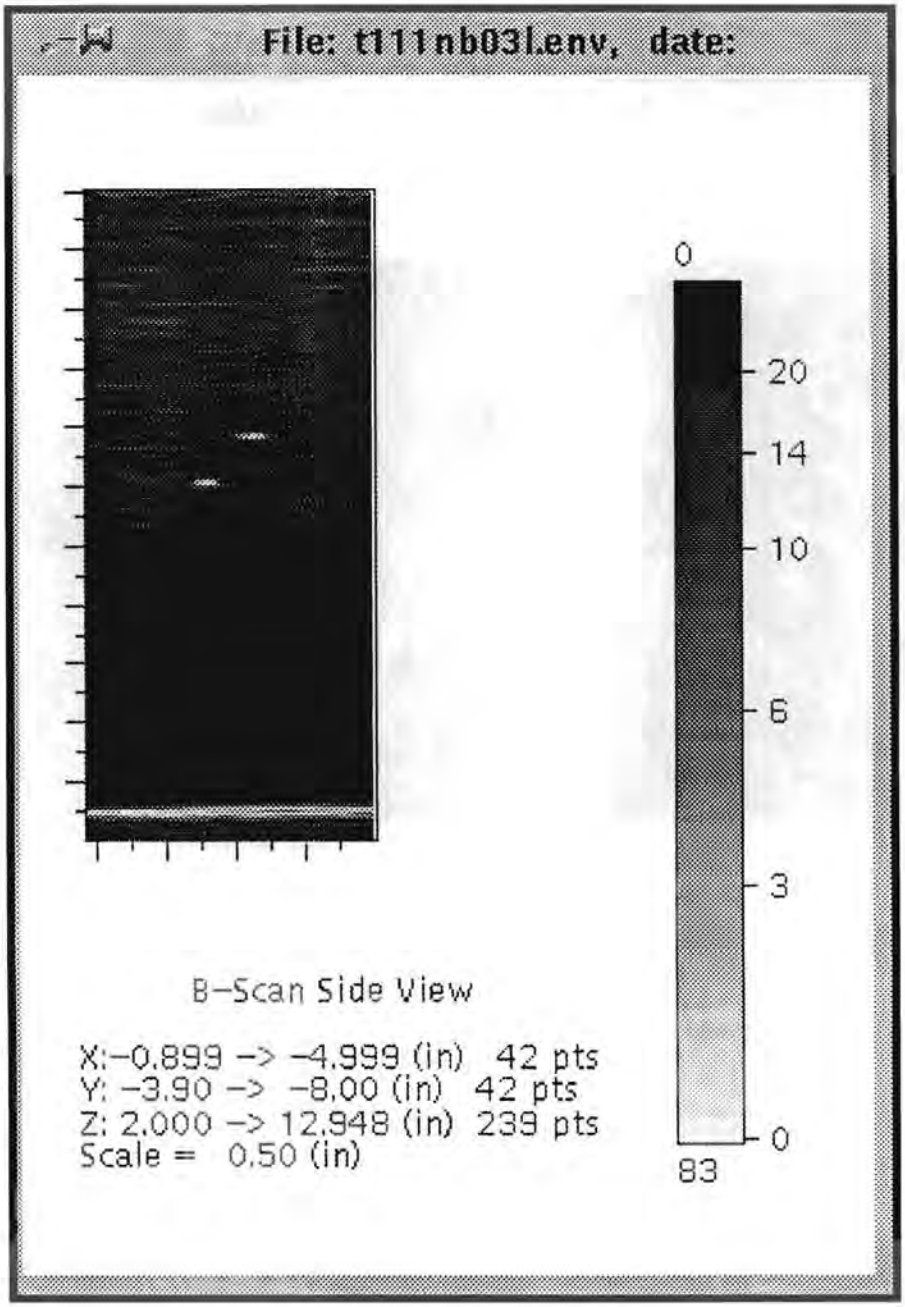
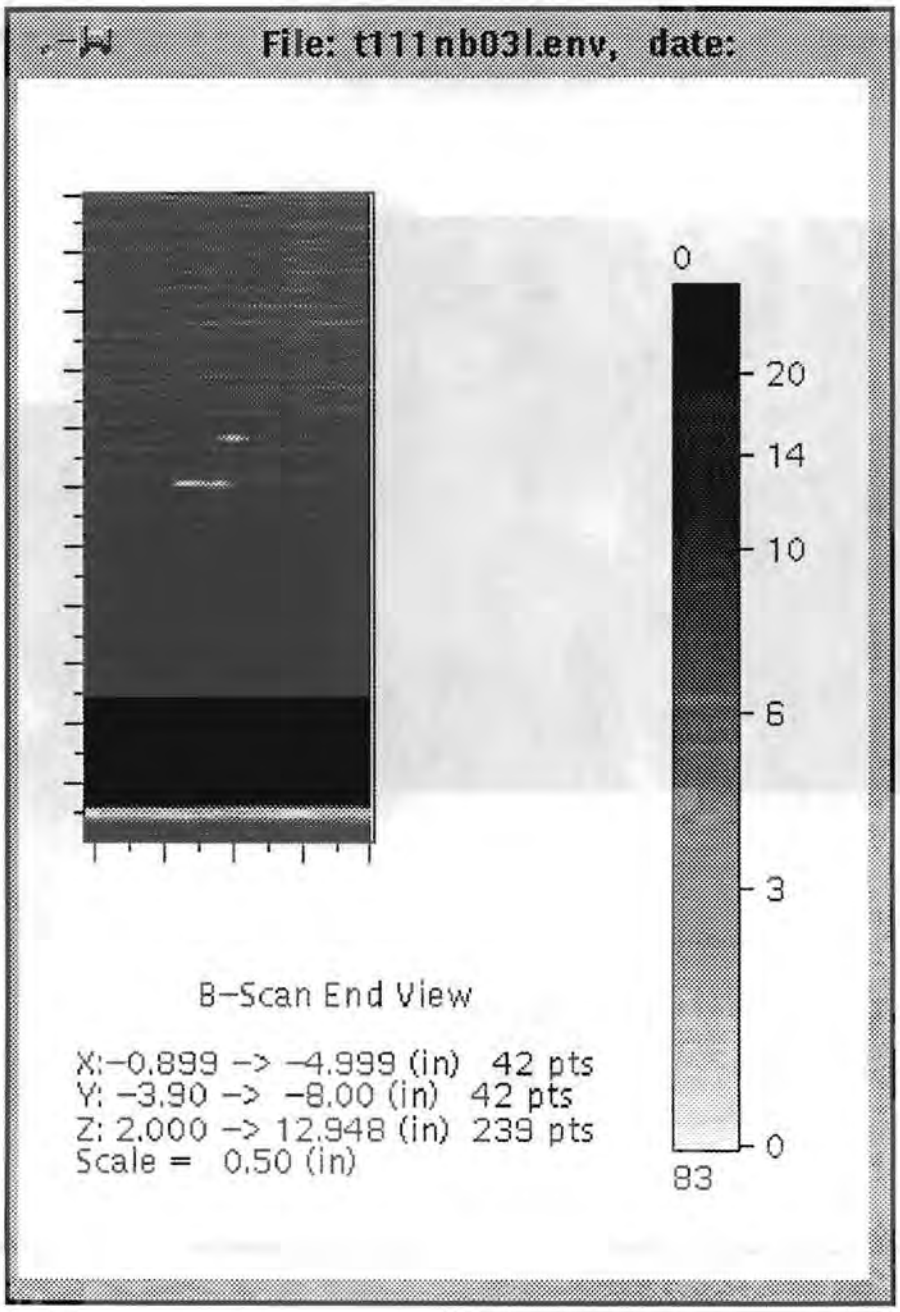
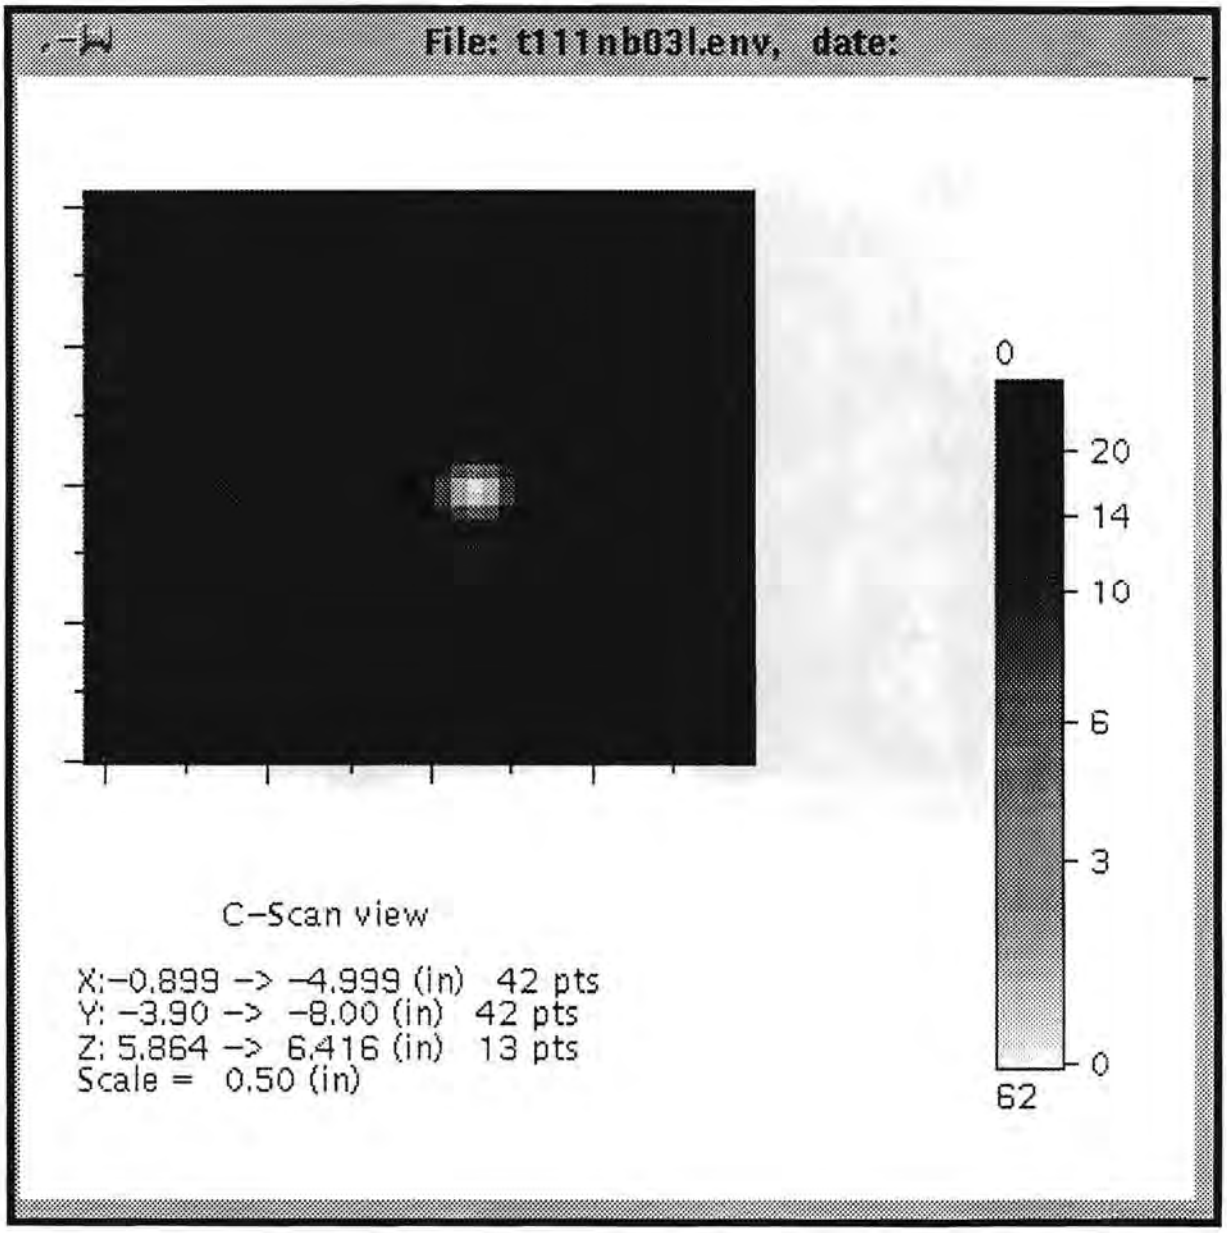
Y, mm (in.)	DY, mm (in.)	X, mm (in.)	DX, mm (in.)	Z, mm (in.)	DZ, mm (in.)	Characterization
-152 (-6.0)	10 (0.4)	8 (0.3)	-	132 (5.2)	2 (0.1)	Detected by SAFT-UT in normal beam from the top side. See Figure 5.21. This is a small planar defect.
-140 (-5.5)	20 (0.8)	-13 (-0.5)	-	150 (5.9)	2 (0.1)	Detected by SAFT-UT in normal beam from the top side. See Figure 5.22. This is either small planar defects separated by 20 mm or a single planar defect of the size noted.

Figure 5.21a Side View (Scanner Coordinates XZ) of Base-Metal Indication in Block 1-11 at Y = -152 mm (-6.0 in.). Normal beam inspection from the top side. Z in the figure corresponds to material coordinates of X from -102 mm (-4 in.) to 178 mm (7 in.). X in the figure corresponds to material coordinates of Z from 188 mm (7.4 in.) to 84 mm (3.3 in.).

Figure 5.21b End View (Scanner Coordinates YZ) of Base-Metal Indication in Block 1-11 at Y = -152 mm (-6.0 in.). Normal beam inspection from the top side. Z in the figure corresponds to material coordinates of X from -102 mm (-4 in.) to 178 mm (7 in.).

Figure 5.21c C-scan View (Scanner Coordinates XY) of Base-Metal Indication in Block 1-11 at Y = -152 mm (-6.0 in.). Normal beam inspection from the top side. X in the figure corresponds to material coordinates of Z from 188 mm (7.4 in.) to 84 mm (3.3 in.).
