NUREG/CR-6471, Vol. 1
PNNL-11143

Characterization of Flaws in U.S. Reactor Pressure Vessels

Density and Distribution of Flaw Indications in PVRUF

Pacific Northwest National Laboratory

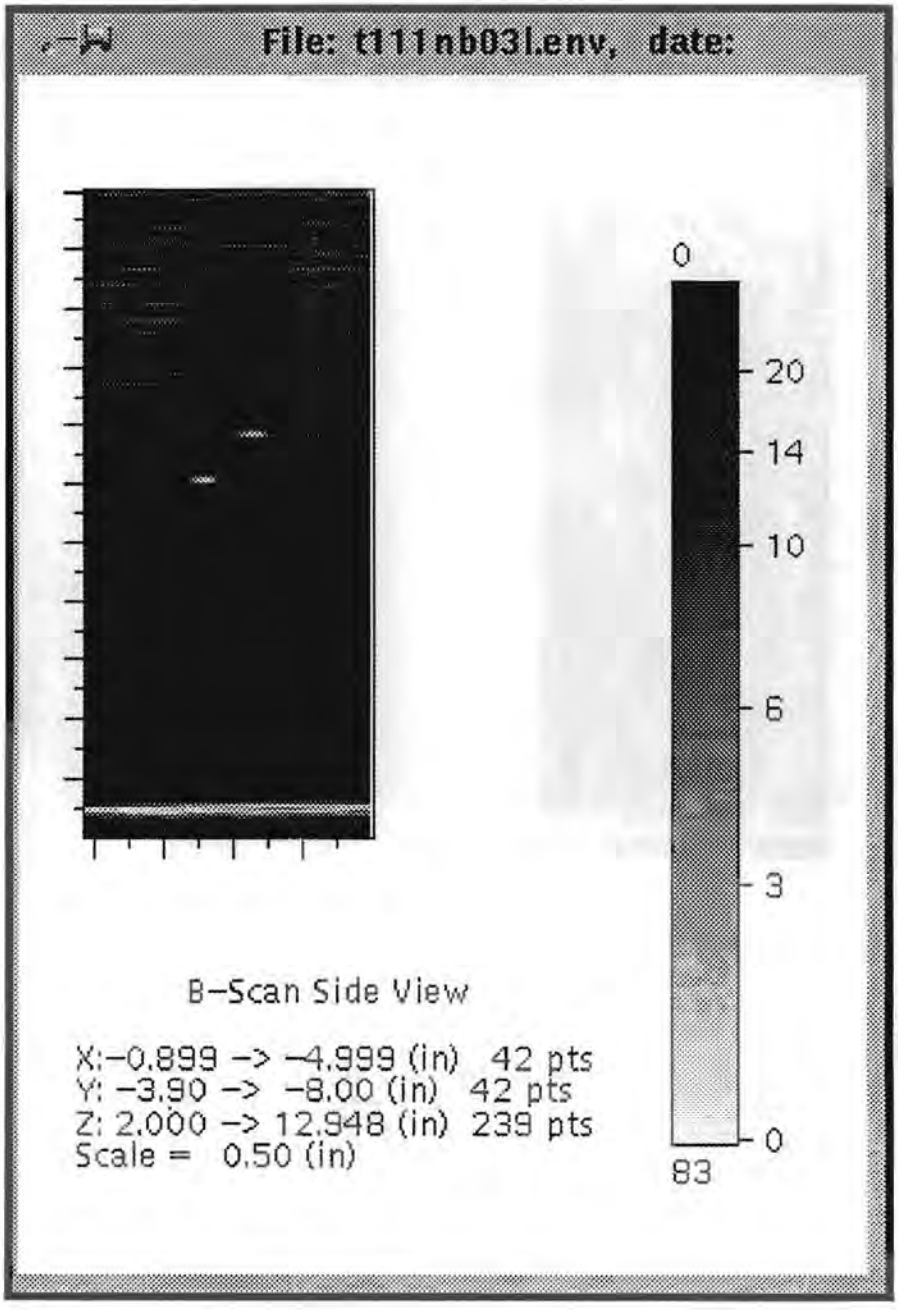
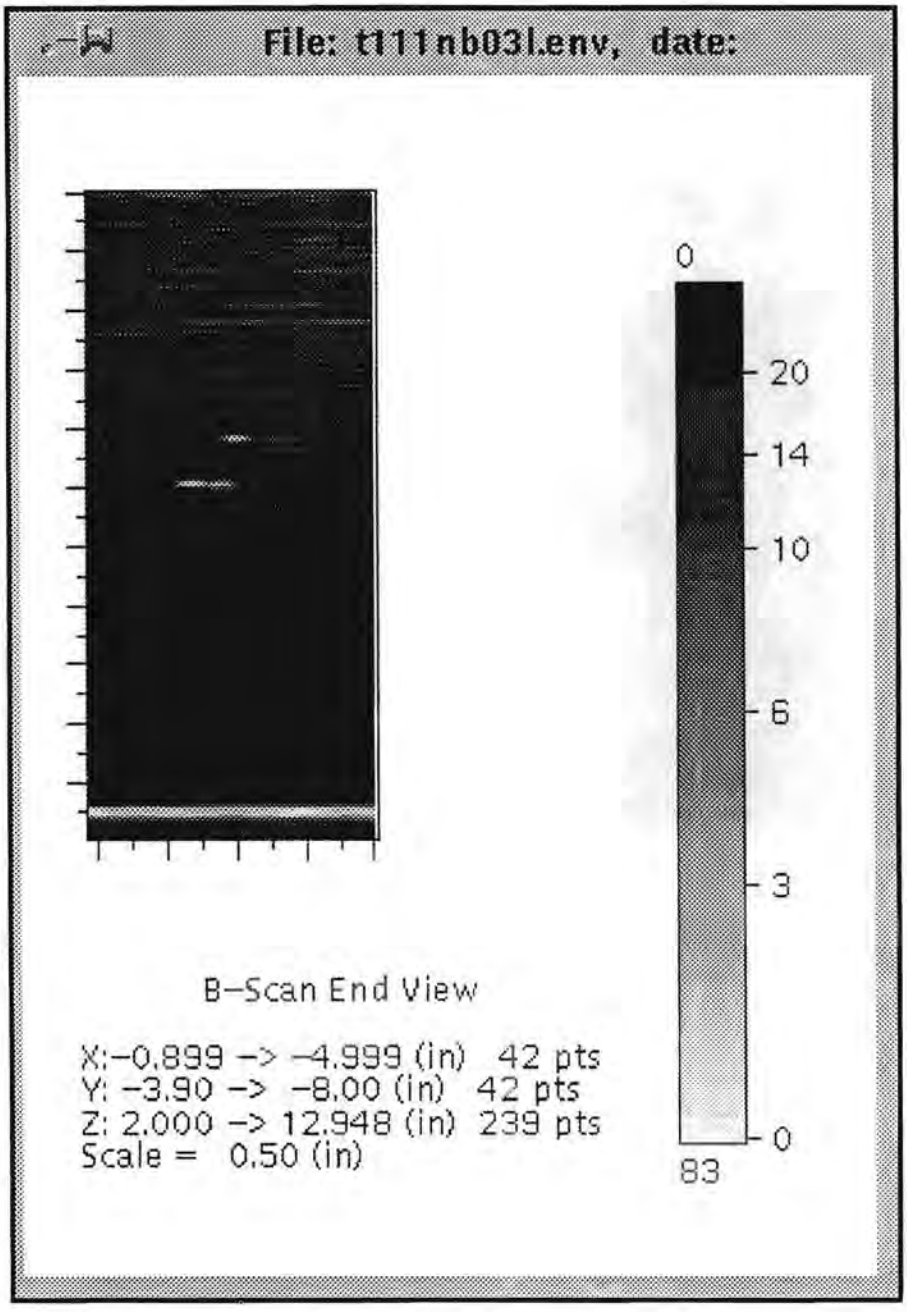
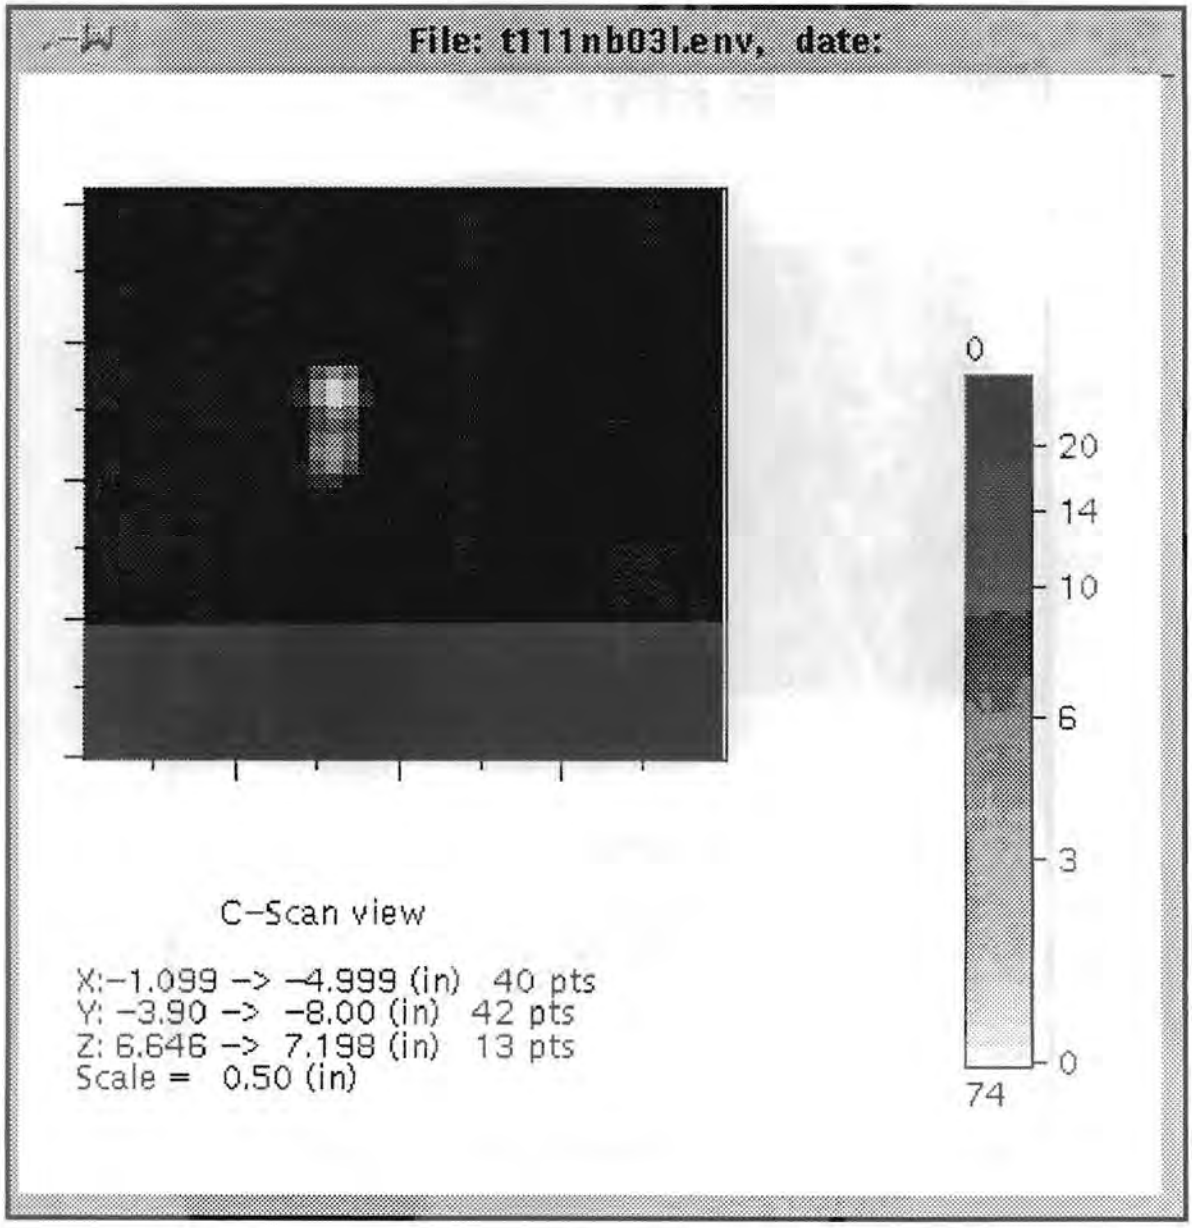
Y, mm (in.)	DY, mm (in.)	X, mm (in.)	DX, mm (in.)	Z, mm (in.)	DZ, mm (in.)	Characterization
-152 (-6.0)	10 (0.4)	8 (0.3)	-	132 (5.2)	2 (0.1)	Detected by SAFT-UT in normal beam from the top side. See Figure 5.21. This is a small planar defect.
-140 (-5.5)	20 (0.8)	-13 (-0.5)	-	150 (5.9)	2 (0.1)	Detected by SAFT-UT in normal beam from the top side. See Figure 5.22. This is either small planar defects separated by 20 mm or a single planar defect of the size noted.

Figure 5.22a Side View (Scanner Coordinates XZ) of Base-Metal Indication in Block 1-11 at Y = -140 mm (-5.5 in.). Normal beam inspection from the top side. Z in the figure corresponds to material coordinates of X from -102 mm (-4 in.) to 178 mm (7 in.). X in the figure corresponds to material coordinates of Z from 188 mm (7.4 in.) to 84 mm (3.3 in.).

Figure 5.22b End View (Scanner Coordinates YZ) of Base-Metal Indication in Block 1-11 at Y = -140 mm (-5.5 in.). Normal beam inspection from the top side. Z in the figure corresponds to material coordinates of X from -102 mm (-4 in.) to 178 mm (7 in.).

Figure 5.22c C-scan View (Scanner Coordinates XY) of Base-Metal Indication in Block 1-11 at Y = -140 mm (-5.5 in.). Normal beam inspection from the top side. X in the figure corresponds to material coordinates of Z from 188 mm (7.4 in.) to 84 mm (3.3 in.).

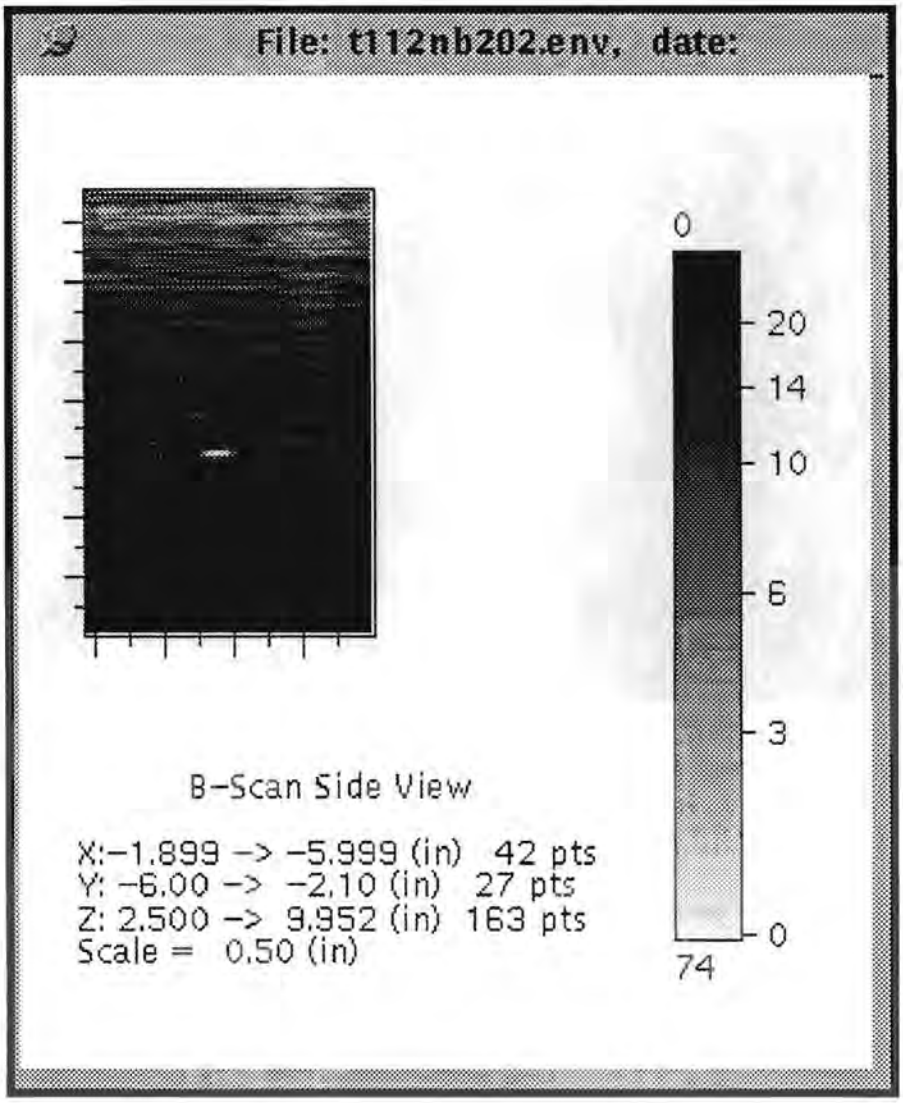
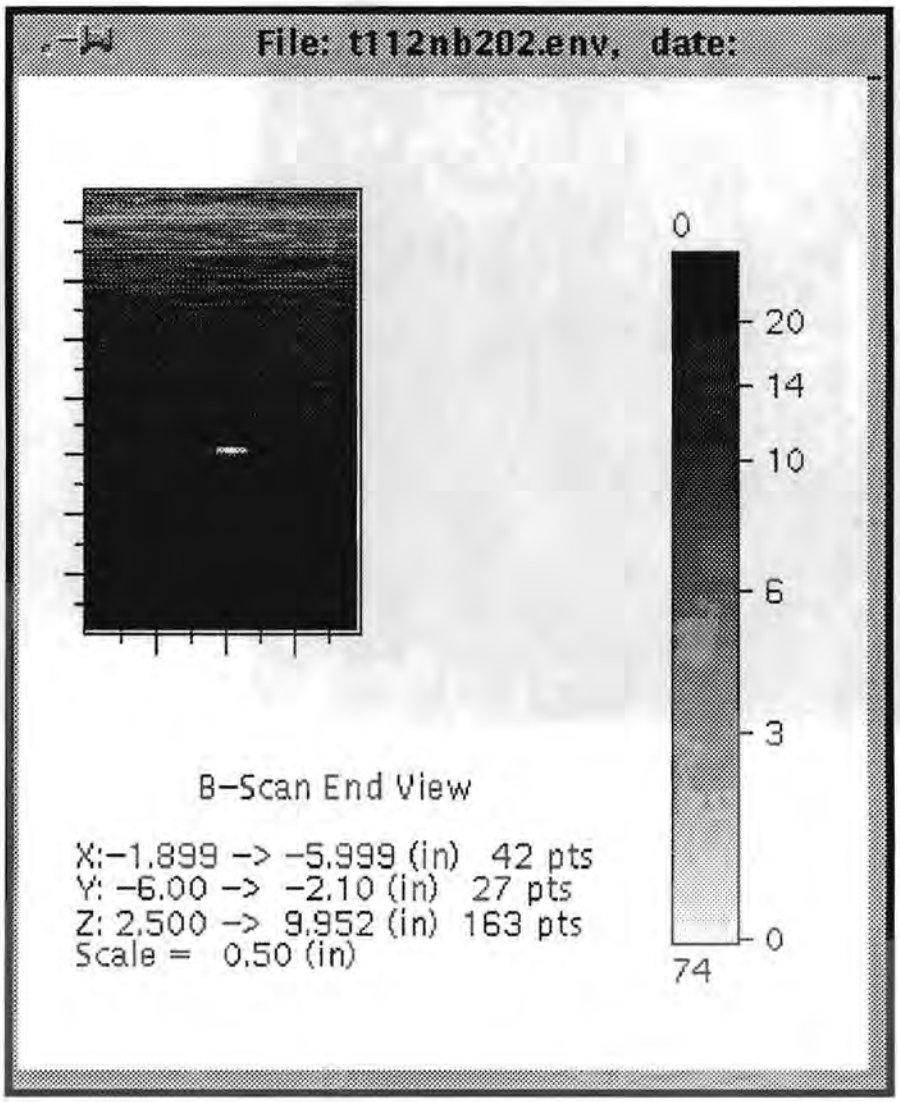
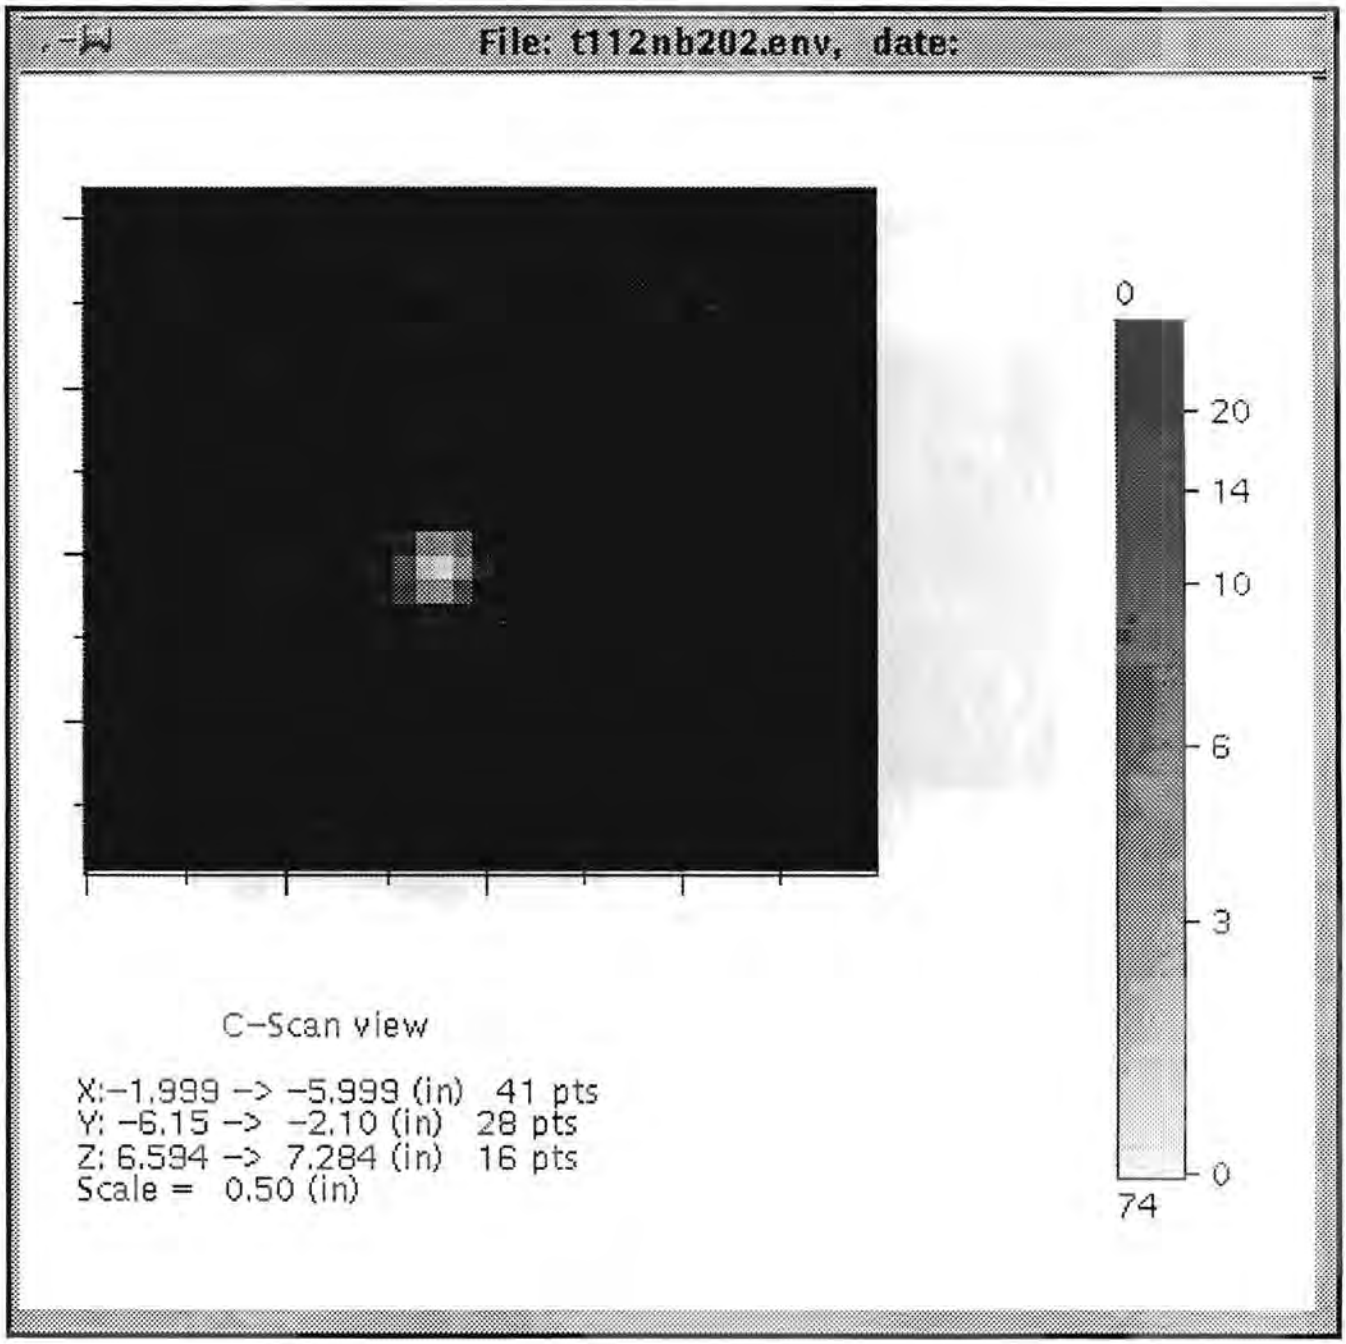
Y, mm (in.)	DY, mm (in.)	X, mm (in.)	DX, mm (in.)	Z, mm (in.)	DZ, mm (in.)	Characterization
-96 (-3.8)	10 (0.4)	-13 (-0.5)	-	119 (4.7)	2 (0.1)	Detected by SAFT-UT in normal beam from the top side. See Figure 5.23. This is a small planar defect.

Figure 5.23a Side View (Scanner Coordinates XZ) of Base-Metal Indication in Block 1-12 at Y = -96 mm (-3.8 in.). Normal beam inspection from the top side. Z in the figure corresponds to material coordinates of X from 89 mm (3.5 in.) to 76 mm (3.0 in.). X in the figure corresponds to material coordinates of Z from 168 mm (6.6 in.) to 64 mm (2.5 in.).

Figure 5.23b End View (Scanner Coordinates YZ) of Base-Metal Indication in Block 1-12 at Y = -96 mm (-3.8 in.). Normal beam inspection from the top side. Z in the figure corresponds to material coordinates of X from 89 mm (3.5 in.) to 76 mm (3.0 in.).

Figure 5.23c. C-scan View (Scanner Coordinates XY) of Base-Metal Indication in Block 1-12 at Y = -96 mm (-3.8 in.). Normal beam inspection from the top side. X in the figure corresponds to material coordinates of Z from 168 mm (6.6 in.) to 64 mm (2.5 in.).

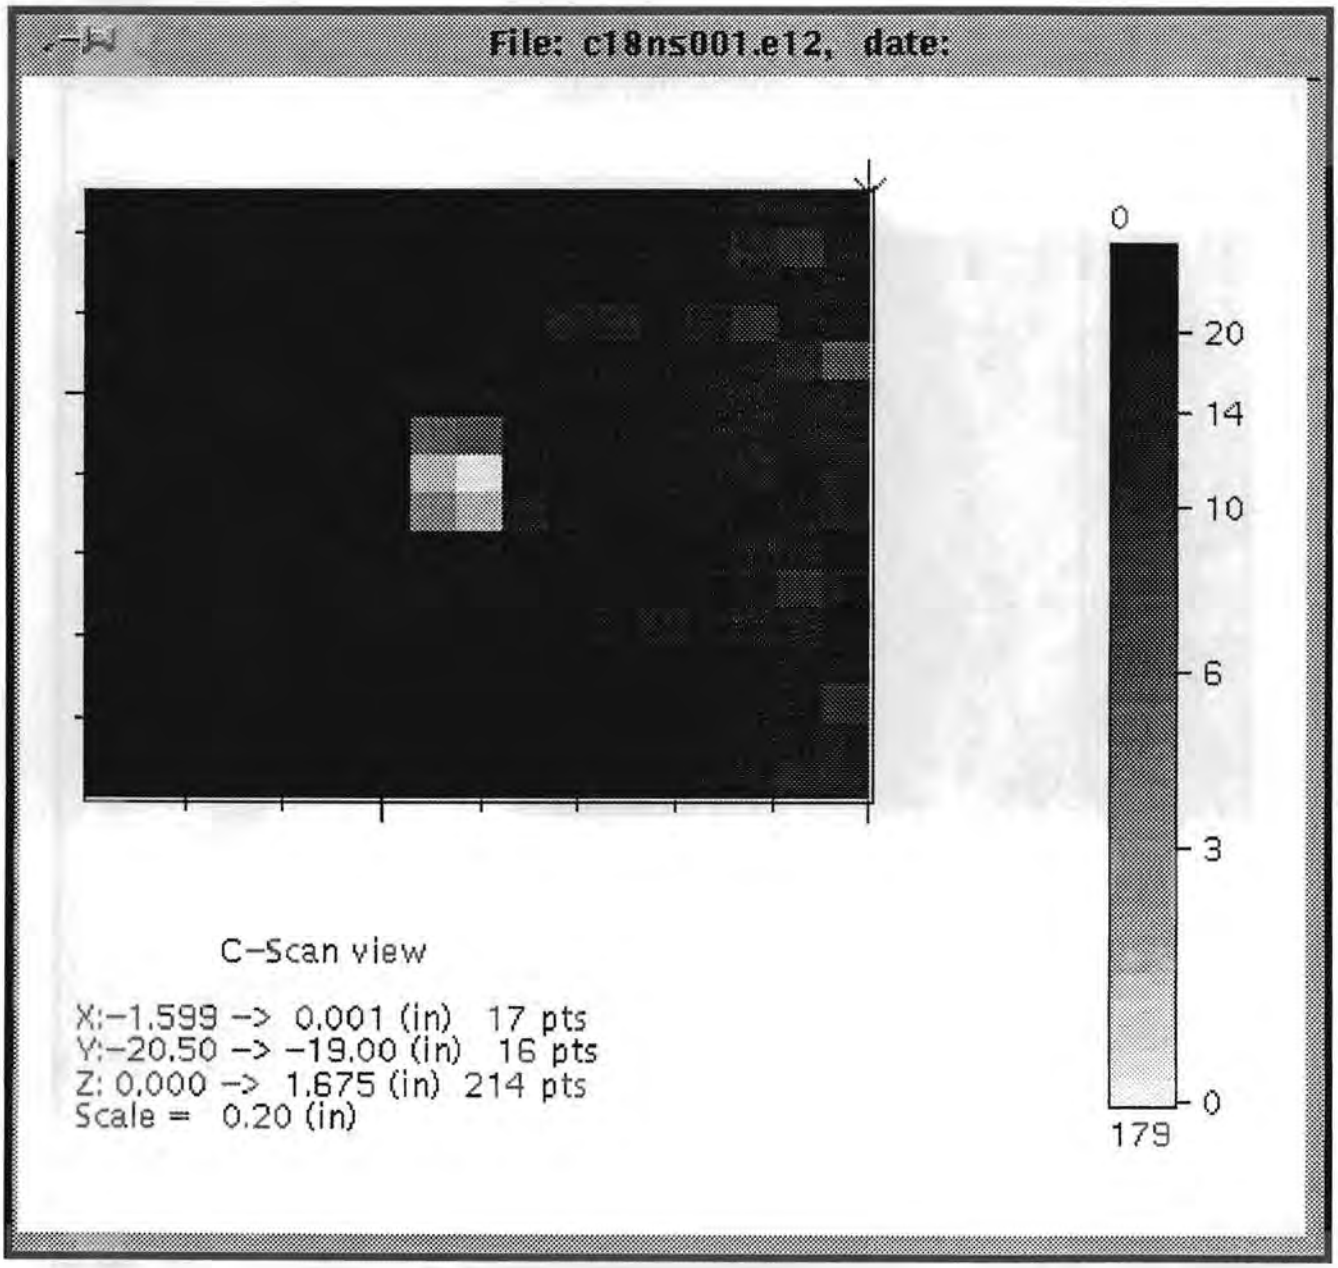
Figure 5.24c C-scan View (XY) of Clad to Base-Metal Indication in Block 1-8 at Y = -526 mm (-20.7 in.). 70° L-wave inspection with beam direction of +X.

Y, mm (in.)	DY, mm (in.)	X, mm (in.)	DX, mm (in.)	Z, mm (in.)	DZ, mm (in.)	Characterization
-526 (-20.7)	5 (0.2)	-20 (-0.8)	5 (0.2)	5 (0.2)	<2.2 (<0.09)	Detected by SAFT-UT in 70° L-wave inspection in the +X direction only. See Figure 5.24. This is a volumetric defect.
-211 (-8.3)	2 (0.1)	-20 (-0.8)	5 (0.2)	5 (0.2)	<2.2 (<0.09)	Detected by SAFT-UT in 70° L-wave inspection in the +X direction only. See Figure 5.25. This is a volumetric defect.
89 (3.5)	5 (0.2)	8 (0.3)	5 (0.2)	8 (0.3)	<2.2 (<0.09)	Detected by SAFT-UT in 70° L-wave inspection in the +X direction only. See Figure 5.26. This is a volumetric defect. Destructive analysis shows one small defect labeled #7. See Table 4.1 and Figure 4.6 for DA results.
112 (4.4)	5 (0.2)	-33 (-1.3)	5 (0.2)	10 (0.4)	<2.2 (<0.09)	Detected by SAFT-UT in 70° L-wave inspections in the +X and -X directions. See Figure 5.27. This is a volumetric defect. Destructive analysis shows one defect labeled #8. See Table 4.1 and Figure 4.7 for DA results. This indication had been conservatively called planar in Doctor (1991). DA confirms volumetric.

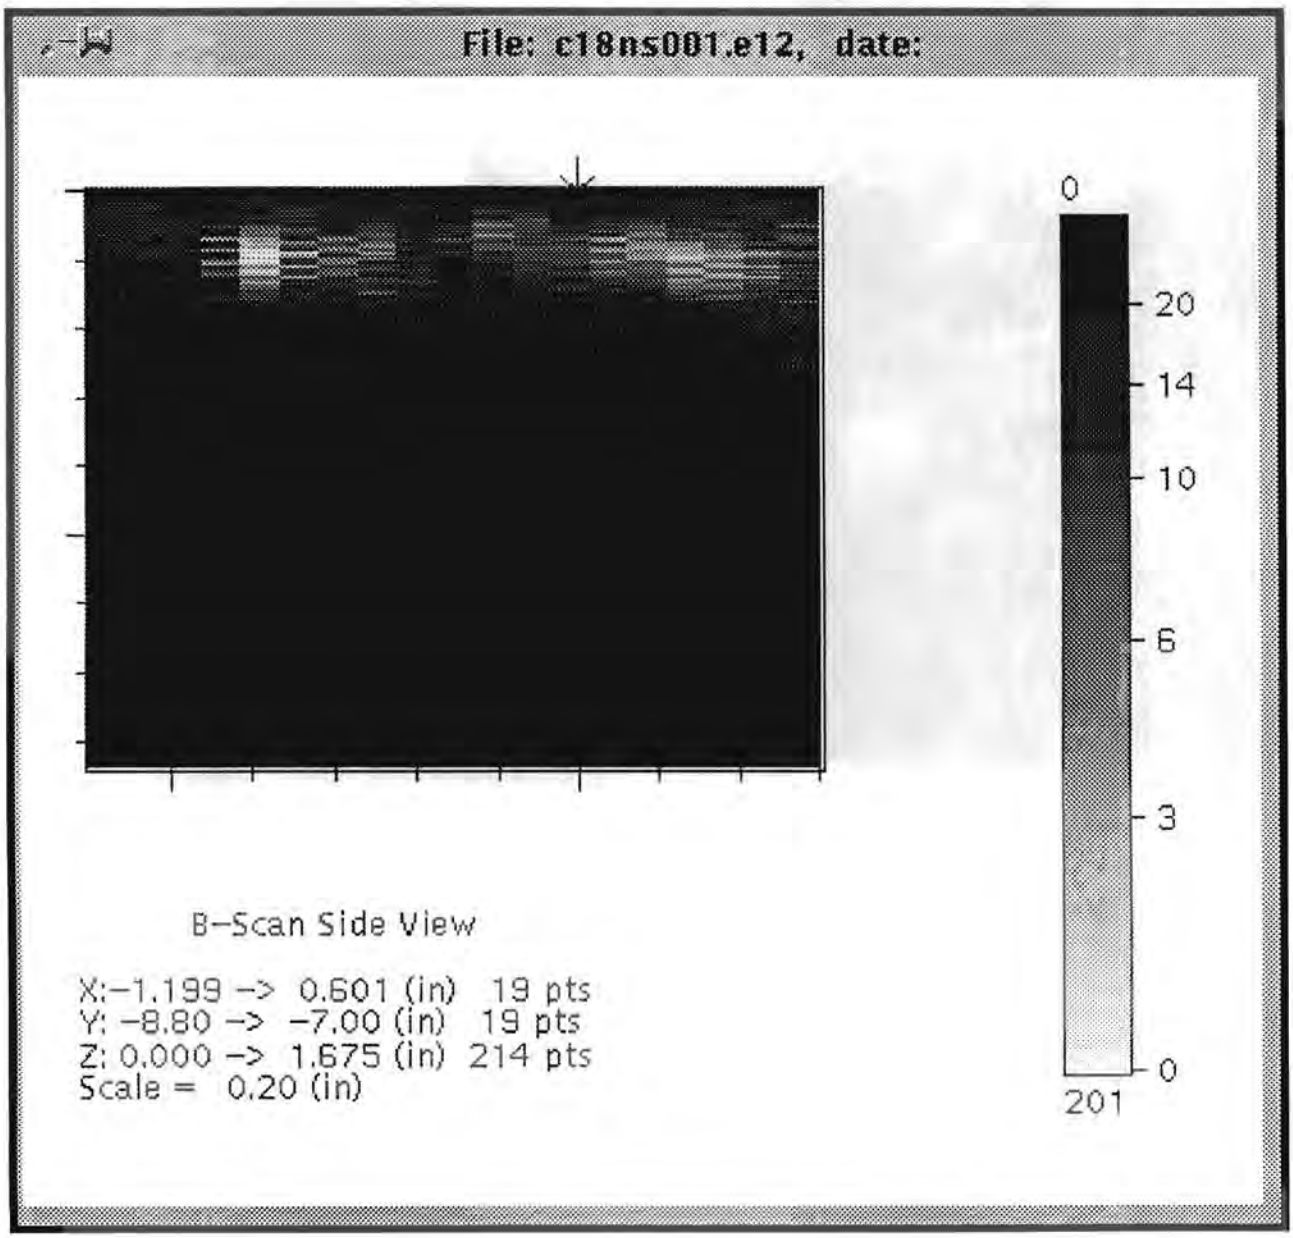
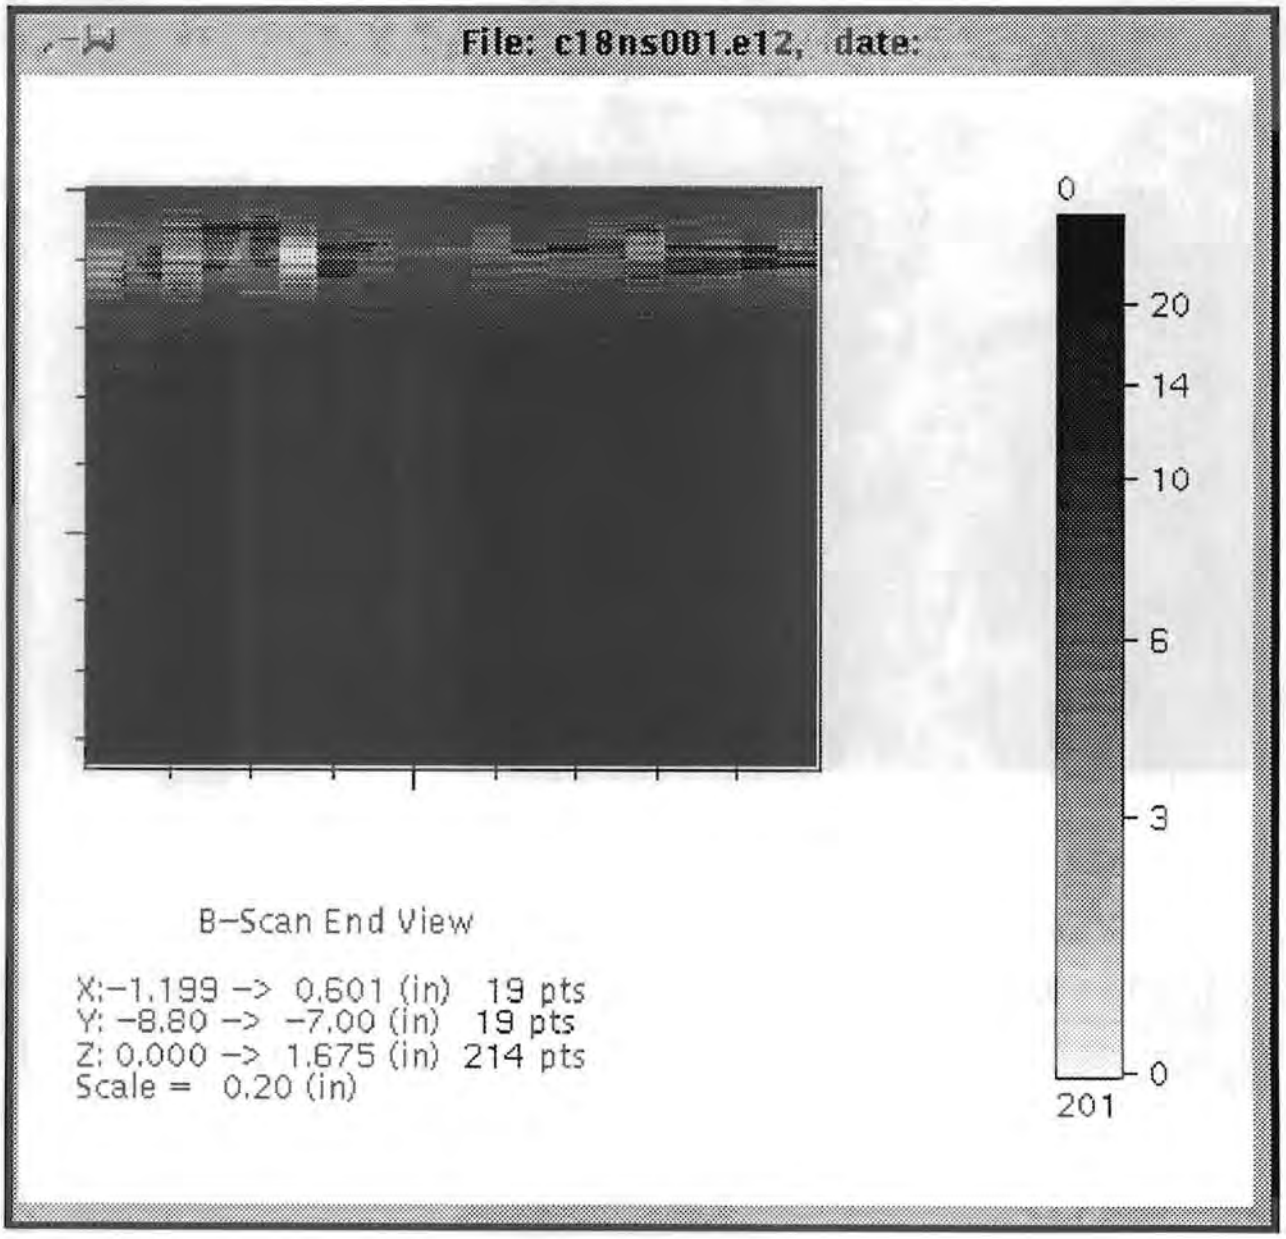
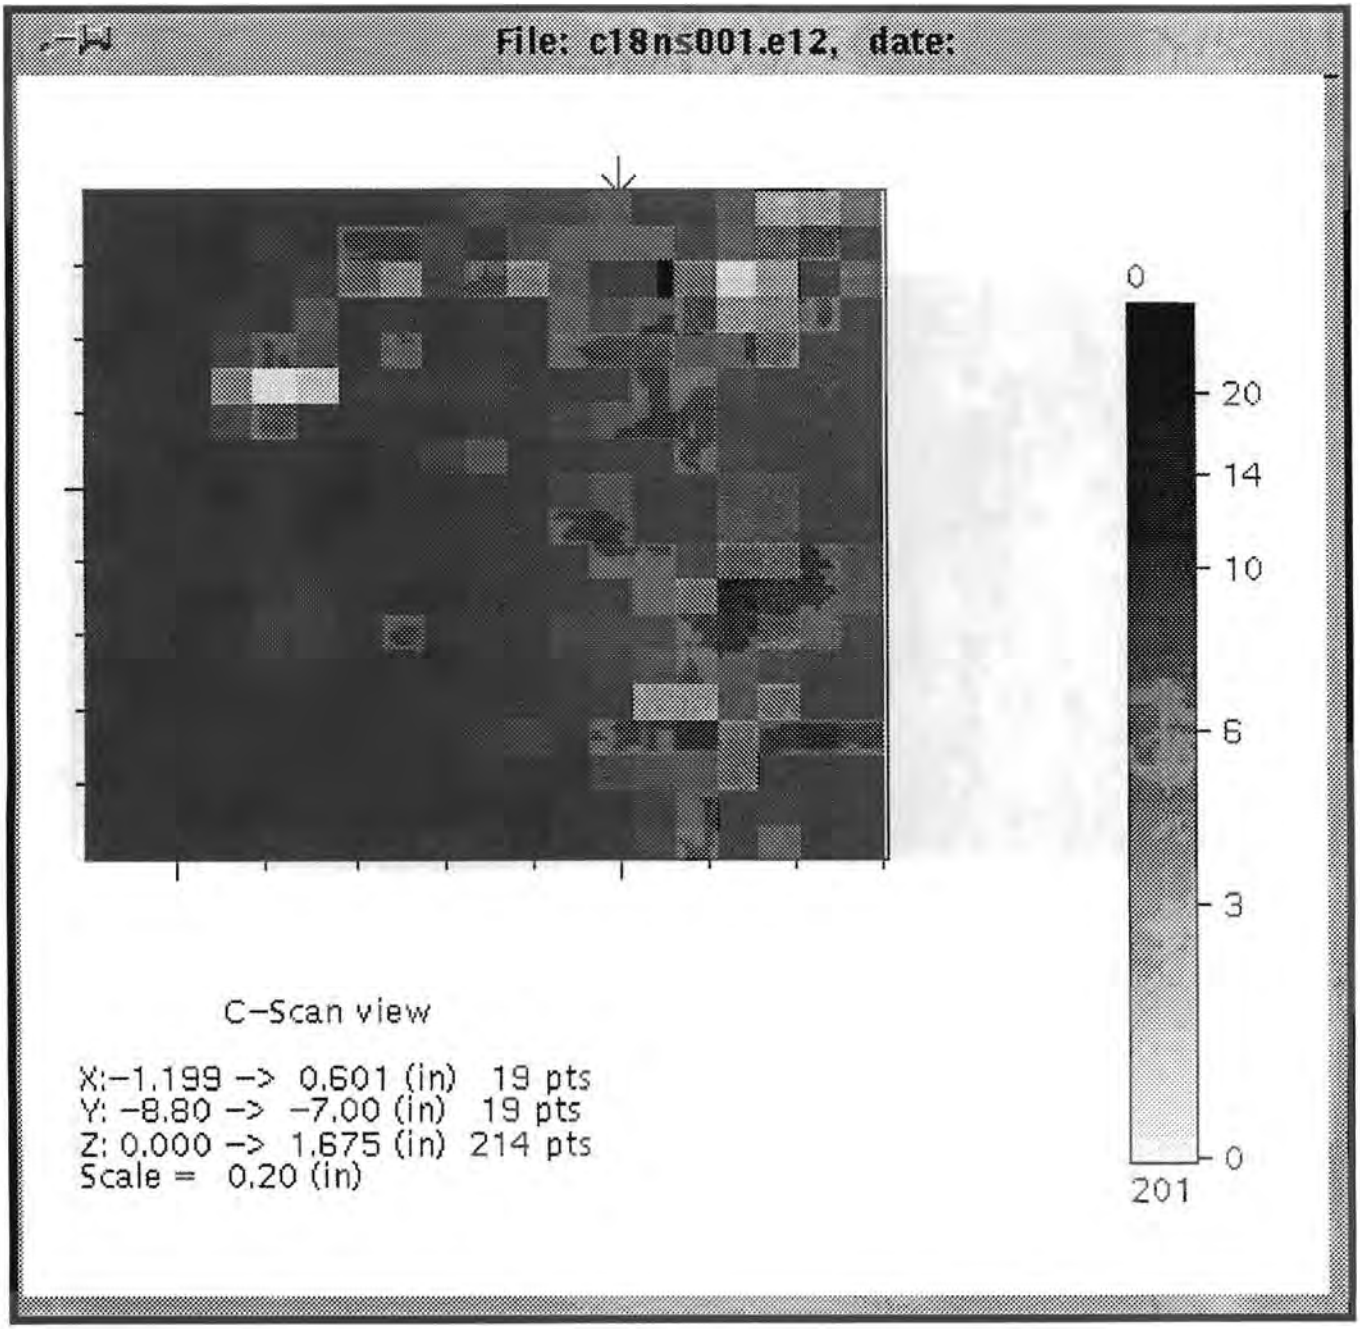
Figure 5.25a Side View (XZ) of Clad to Base-Metal Indication in Block 1-8 at Y = -211 mm (-8.3 in.). 70° L-wave inspection with beam direction of +X.

Figure 5.25b End View (YZ) of Clad to Base-Metal Indication in Block 1-8 at Y = -211 mm (-8.3 in.). 70° L-wave inspection with beam direction of +X.

Figure 5.25c C-scan View (XY) of Clad to Base-Metal Indication in Block 1-8 at Y = -211 mm (-8.3 in.). 70° L-wave inspection with beam direction of +X.

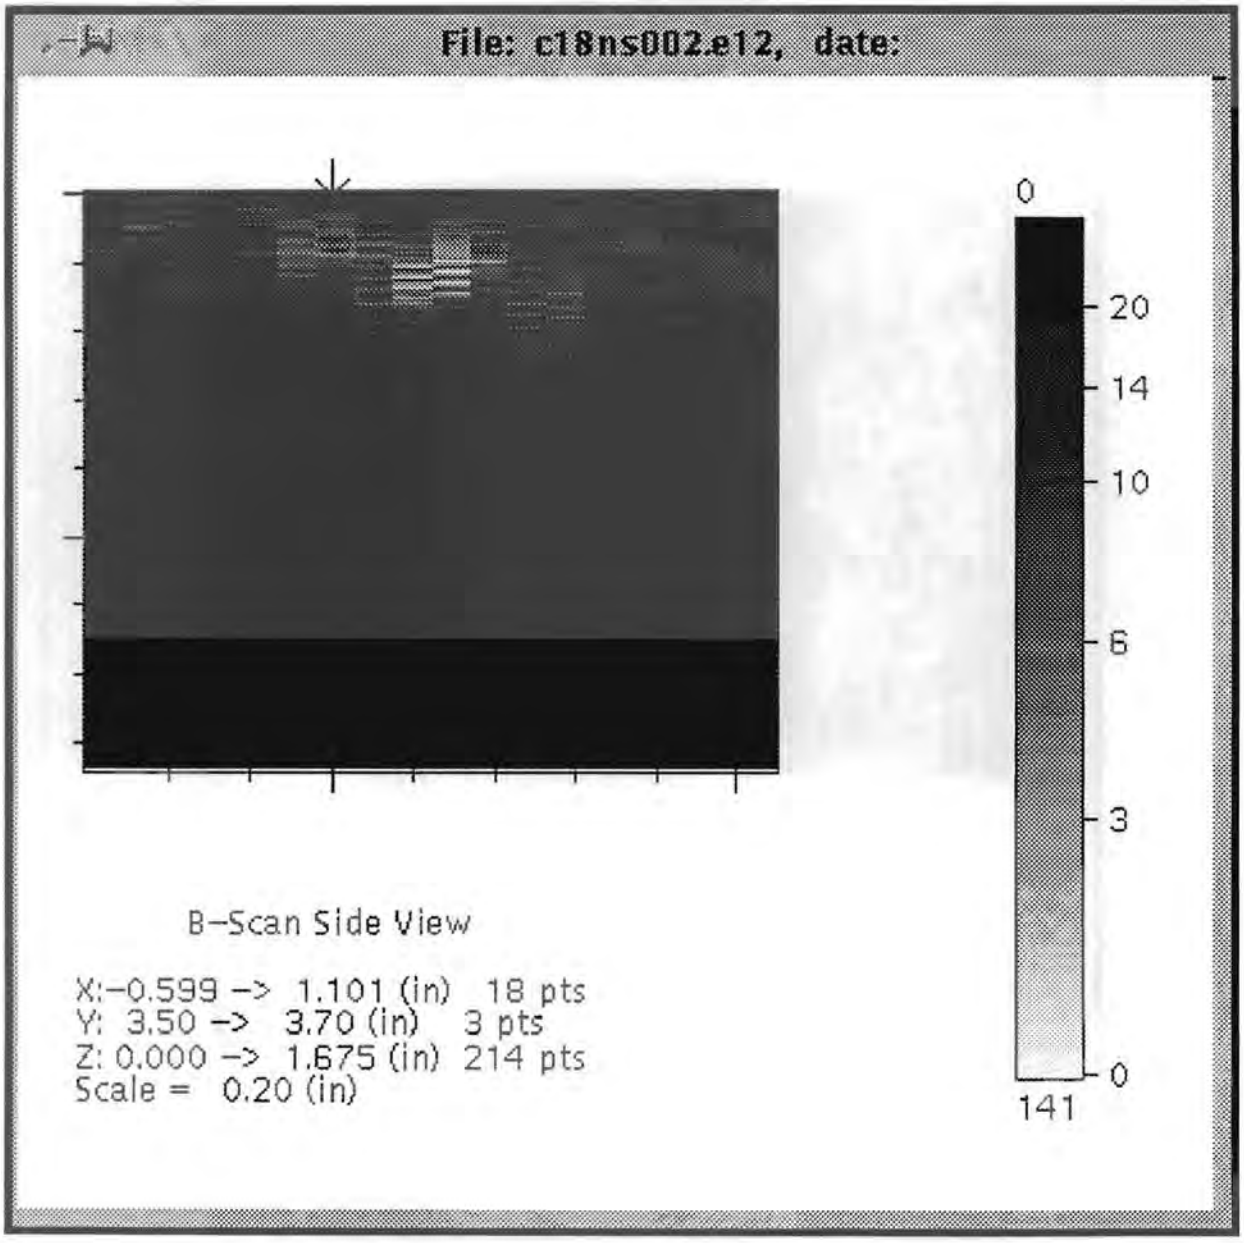
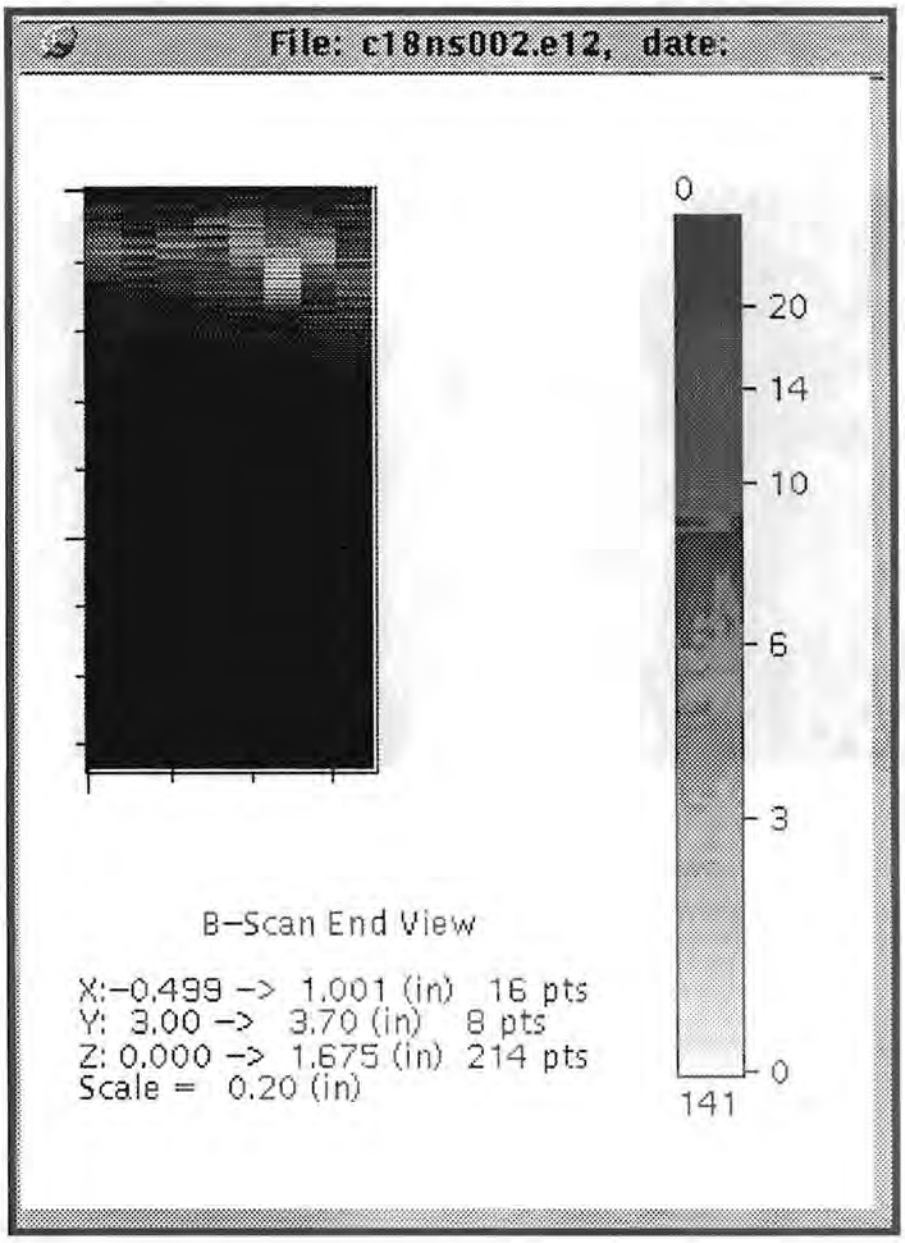
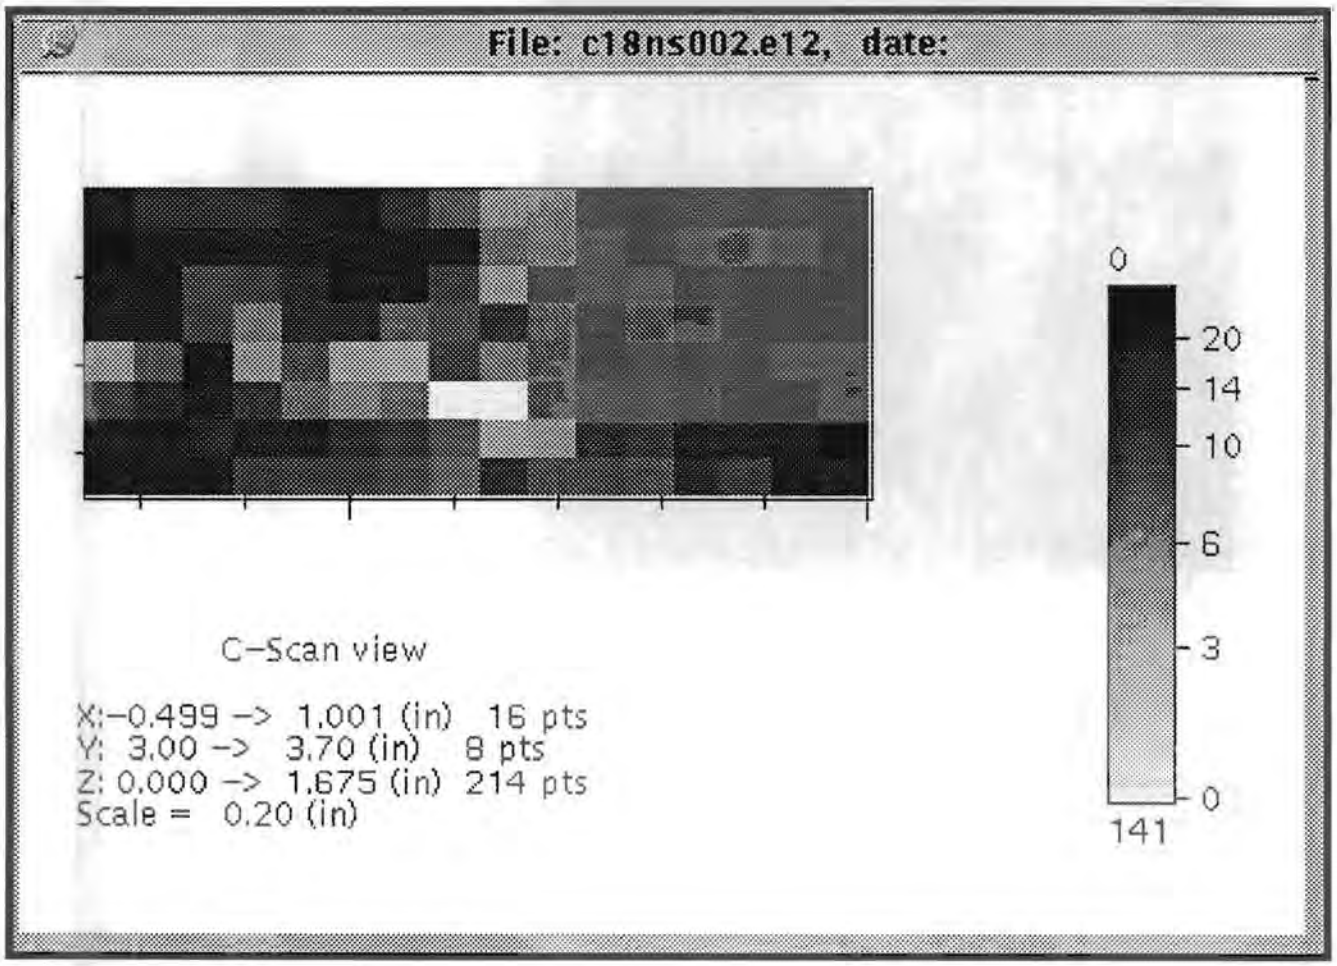
Flaw #7	Y, mm (in.)	DY, mm (in.)	X, mm (in.)	DX, mm (in.)	Z, mm (in.)	DZ, mm (in.)	Notes
Destructive Data	81 (3.2)	--	-22 (-0.8)	4 (0.16)	7 (0.27)	1 (0.04)	See Figure 4.7.
SAFT-UT	89 (3.5)	5 (0.2)	8 (0.3)	5 (0.2)	8 (0.3)	<2.2 (<0.09)	See Figure 5.26. There is a sign difference between the destructive analysis and the SAFT-UT data for X. The origin of this difference is not known.
Flaw #8	**Y, mm (in.)**	**DY, mm (in.)**	**X, mm (in.)**	**DX, mm (in.)**	**Z, mm (in.)**	**DZ, mm (in.)**	**Notes**
Destructive Data	112 (4.4)	--	33 (1.3)	5 (0.2)	10 (0.4)	2 (0.08)	See Figure 4.8.
SAFT-UT	112 (4.4)	5 (0.2)	-33 (-1.3)	5 (0.2)	10 (0.4)	<2.2 (<0.09)	See Figure 5.27. There is a sign difference between the destructive analysis and the SAFT-UT data for X. The origin of this difference is not known.
Flaw #11	**Y, mm (in.)**	**DY, mm (in.)**	**X, mm (in.)**	**DX, mm (in.)**	**Z, mm (in.)**	**DZ, mm (in.)**	**Notes**

Figure 5.26a Side View (XZ) of Clad to Base-Metal Indication in Block 1-8 at Y = 89 mm (3.5 in.). 70° L-wave inspection with beam direction of +X. This indication corresponds to flaw #7 in the destructive analysis.

Figure 5.26b End View (YZ) of Clad to Base-Metal Indication in Block 1-8 at Y = 89 mm (3.5 in.). 70° L-wave inspection with beam direction of +X. This indication corresponds to flaw #7 in the destructive analysis.

Figure 5.26c C-scan View (XY) of Clad to Base-Metal Indication in Block 1-8 at Y = 89 mm (3.5 in.). 70° L-wave inspection with beam direction of +X. This indication corresponds to flaw #7 in the destructive analysis.
