NUREG/CR-6471, Vol. 1
PNNL-11143

Characterization of Flaws in U.S. Reactor Pressure Vessels

Density and Distribution of Flaw Indications in PVRUF

Pacific Northwest National Laboratory

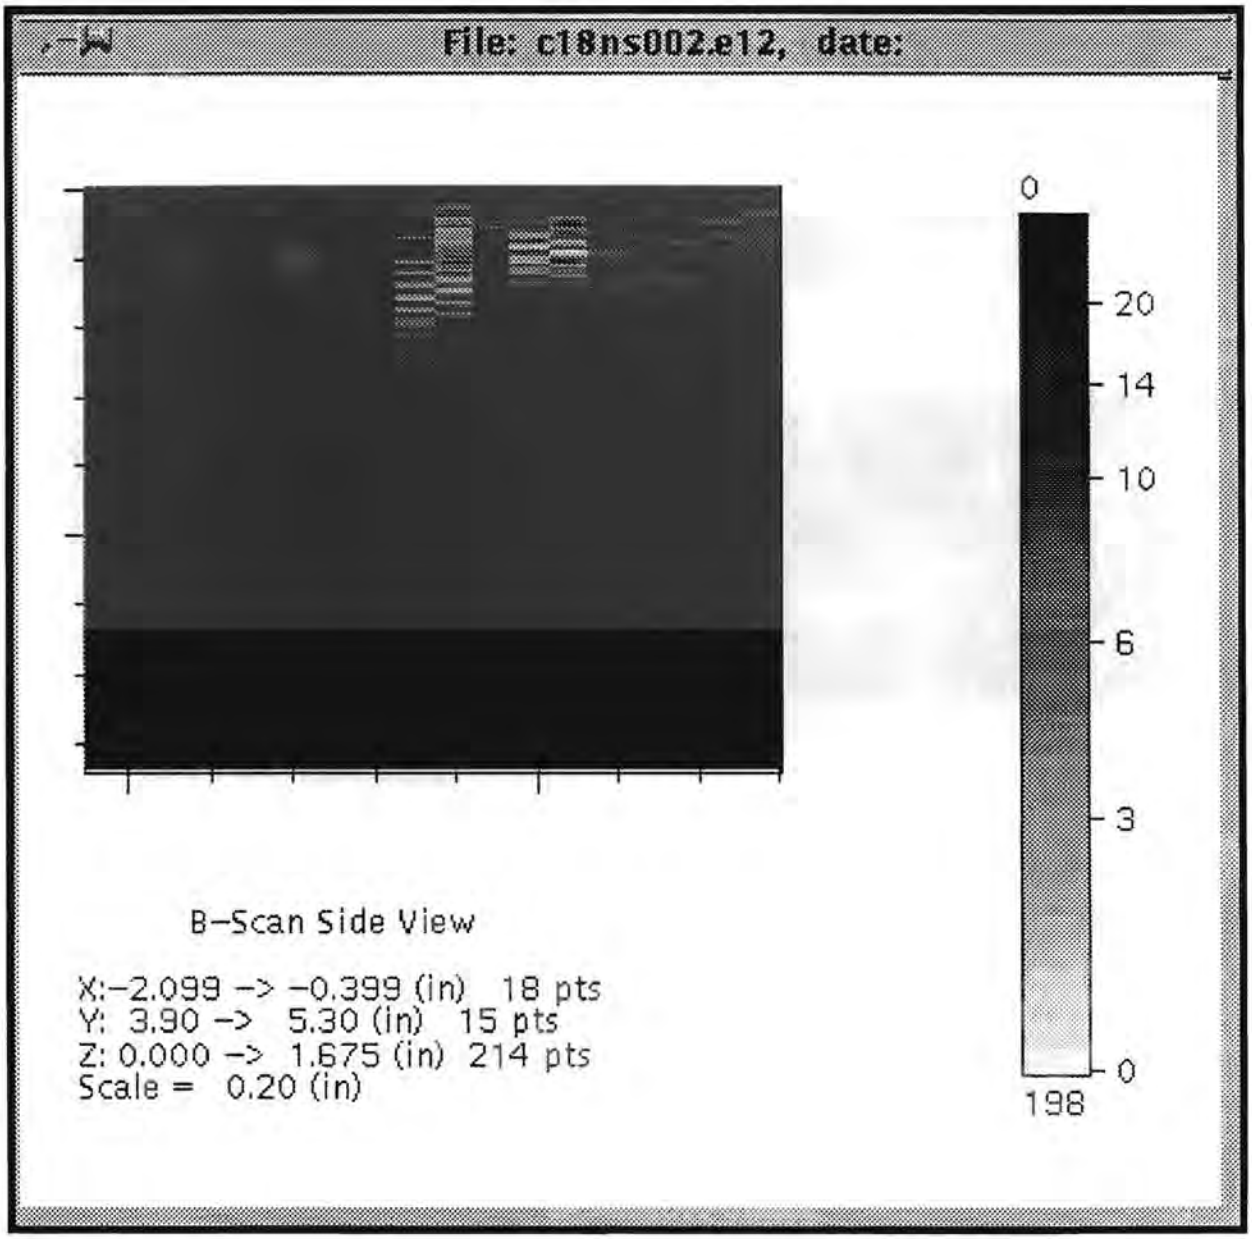
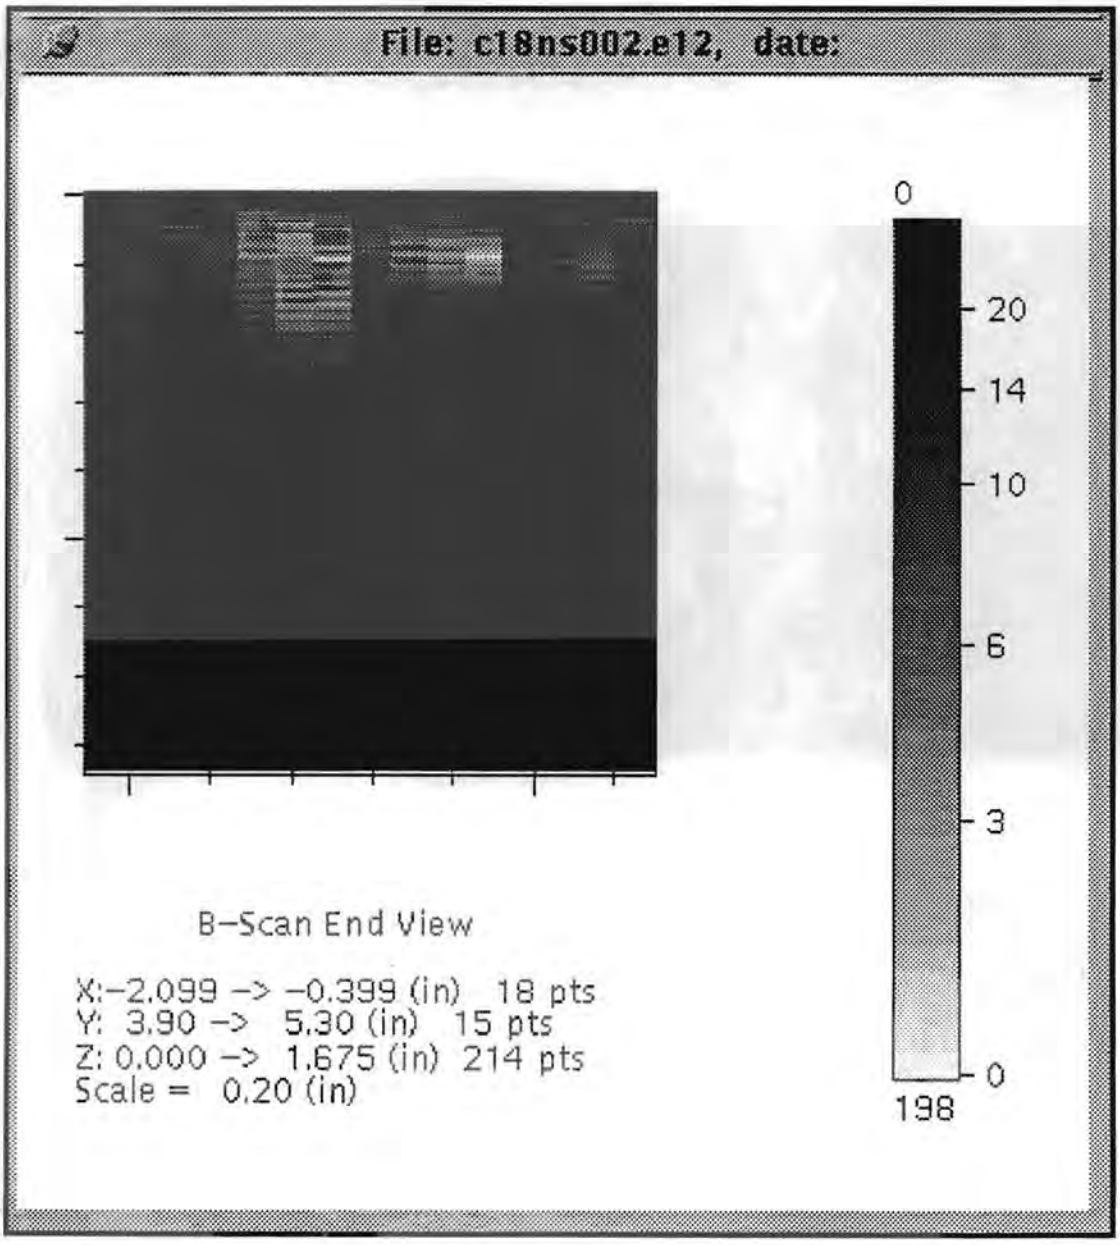
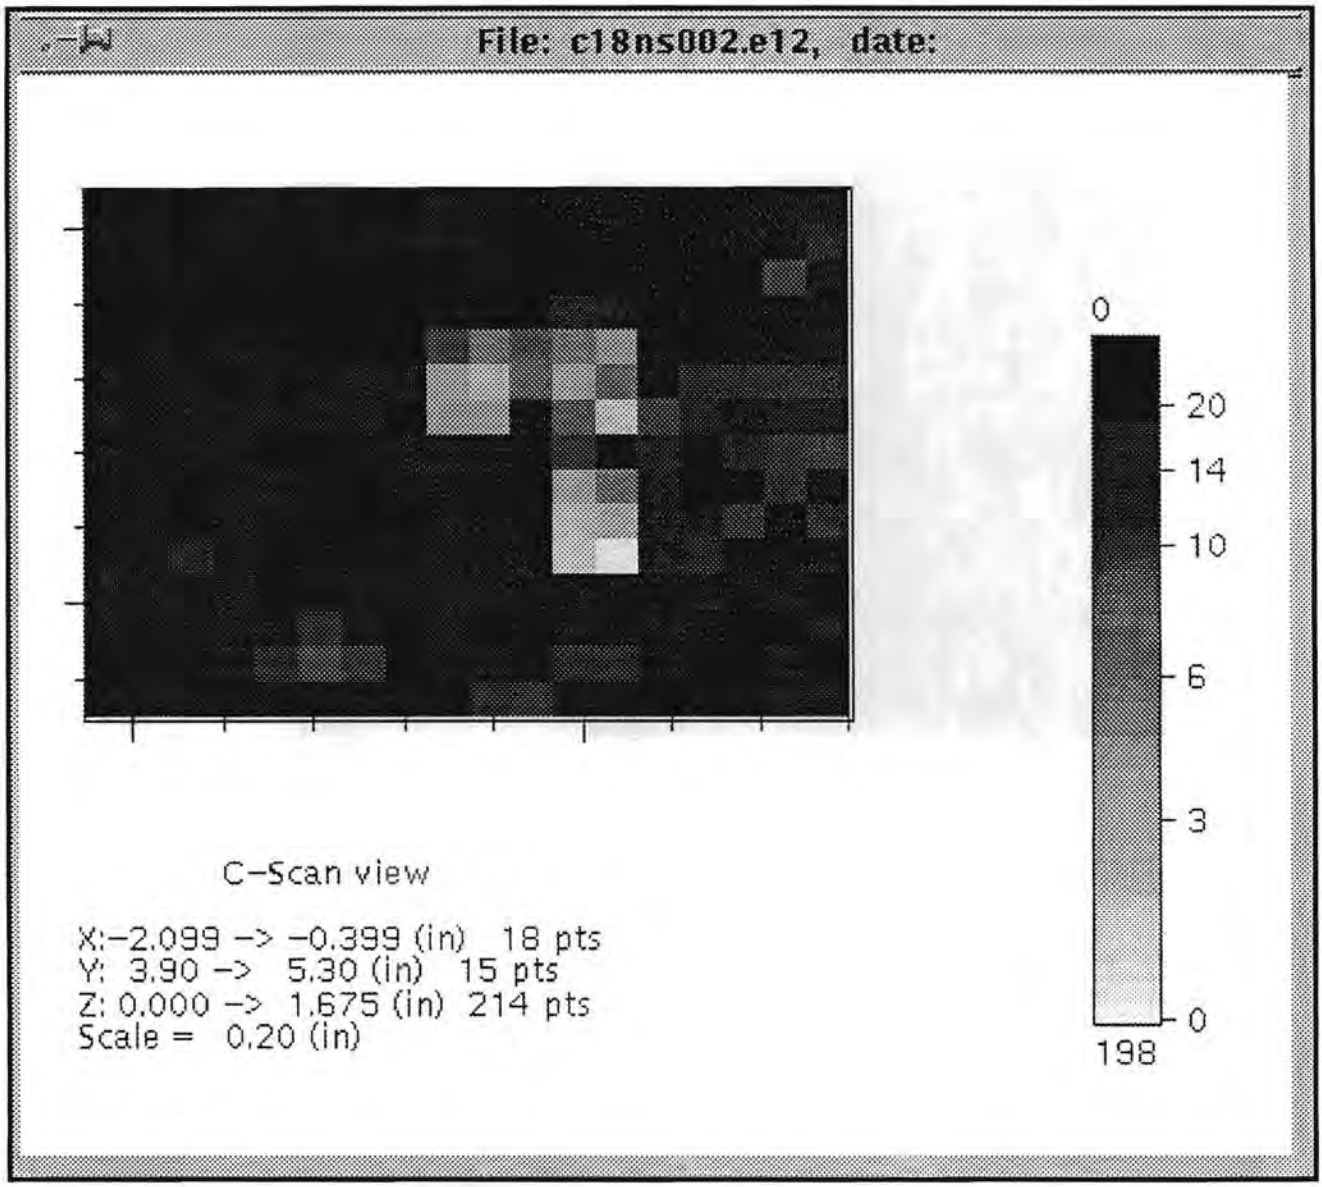
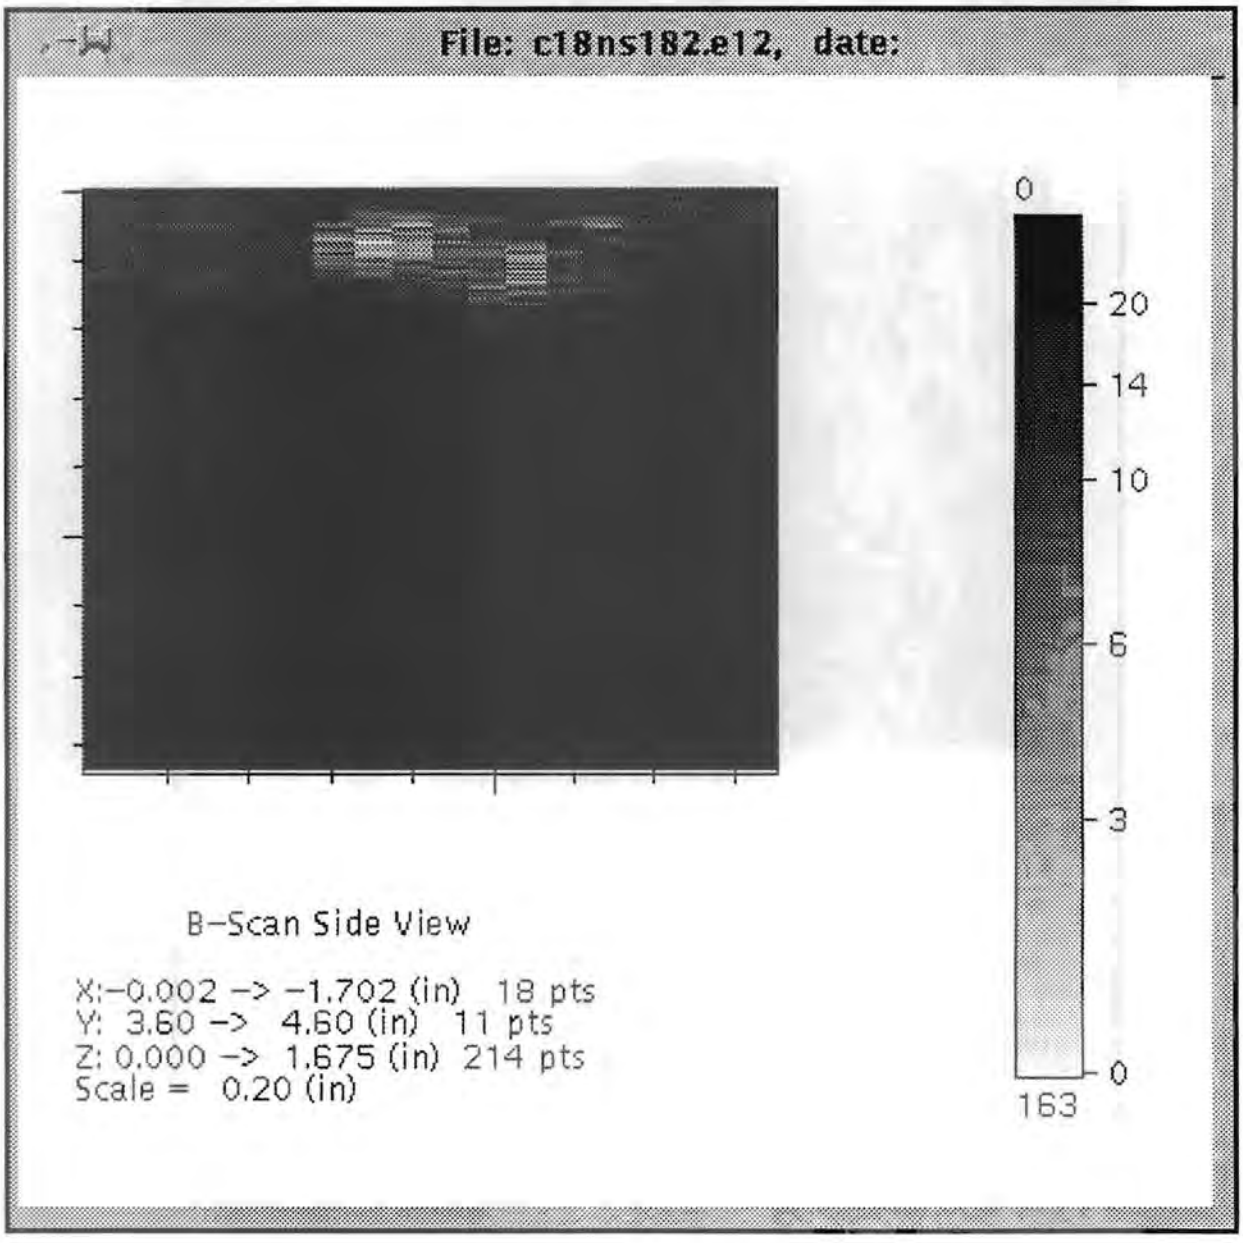
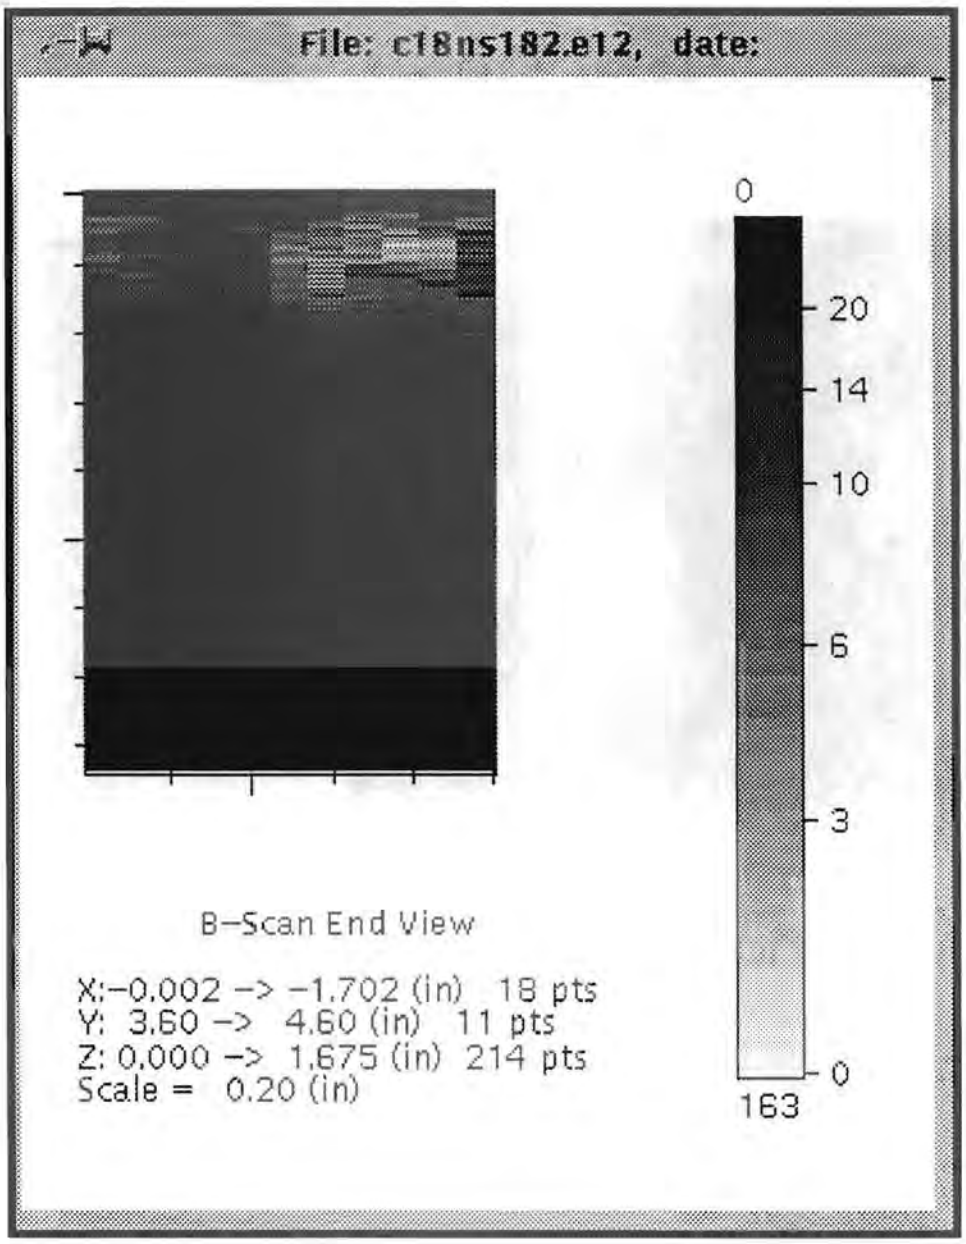
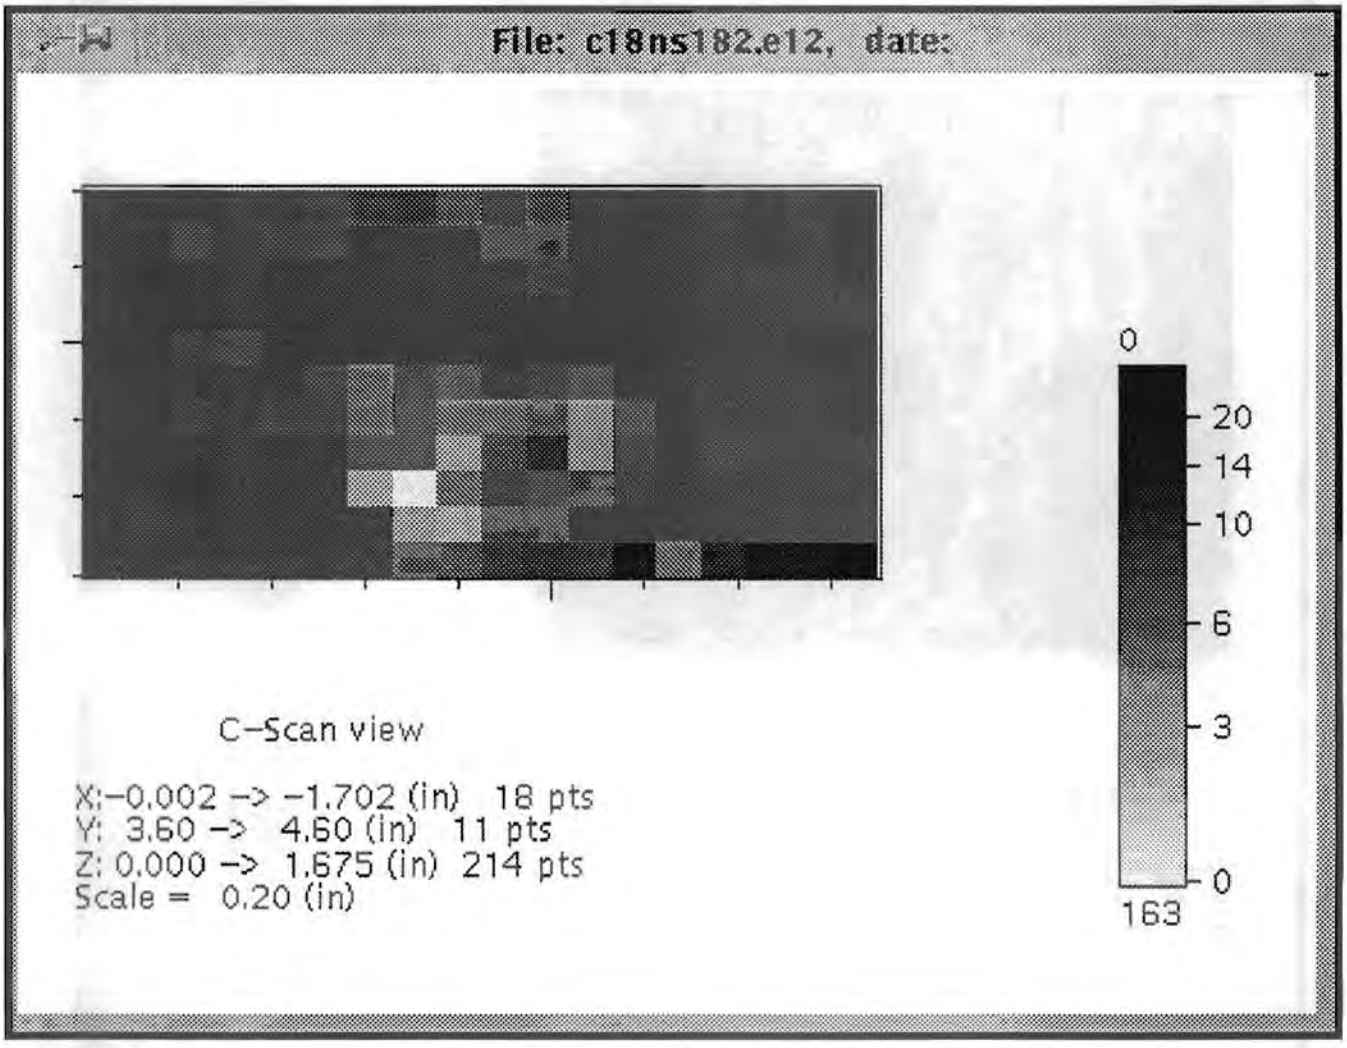
Figure 5.27a Side View (XZ) of Clad to Base-Metal Indication in Block 1-8 at Y = 112 mm (4.4 in.). 70° L-wave inspection with beam direction of +X. This indication corresponds to flaw #8 in the destructive analysis.

Figure 5.27b End View (YZ) of Clad to Base-Metal Indication in Block 1-8 at Y = 112 mm (4.4 in.). 70° L-wave inspection with beam direction of +X. This indication corresponds to flaw #8 in the destructive analysis.

Figure 5.27c C-scan View (XY) of Clad to Base-Metal Indication in Block 1-8 at Y = 112 mm (4.4 in.). 70° L-wave inspection with beam direction of +X. This indication corresponds to flaw #8 in the destructive analysis.

Figure 5.27d Side View (XZ) of Clad to Base-Metal Indication in Block 1-8 at Y = 112 mm (4.4 in.). 70° L-wave inspection with beam direction of -X. This indication corresponds to flaw #8 in the destructive analysis.

Figure 5.27e End View (YZ) of Clad to Base-Metal Indication in Block 1-8 at Y = 112 mm (4.4 in.). 70° L-wave inspection with beam direction of -X. This indication corresponds to flaw #8 in the destructive analysis.

Figure 5.27f C-scan View (XY) of Clad to Base-Metal Indication in Block 1-8 at Y = 112 mm (4.4 in.). 70° L-wave inspection with beam direction of -X. This indication corresponds to flaw #8 in the destructive analysis.

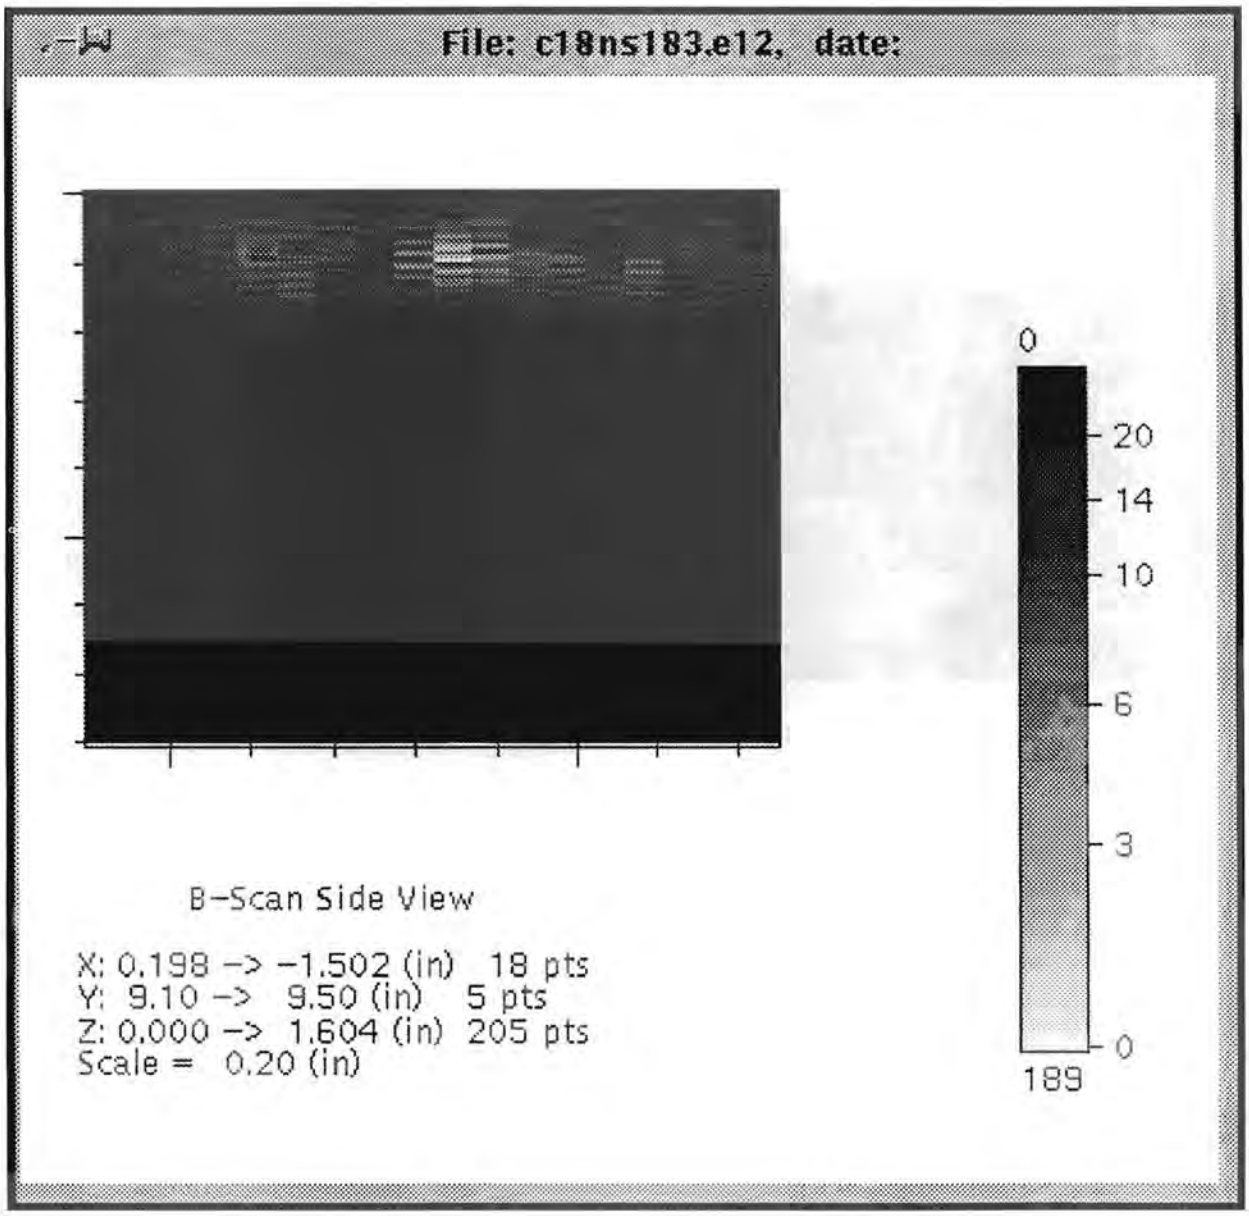
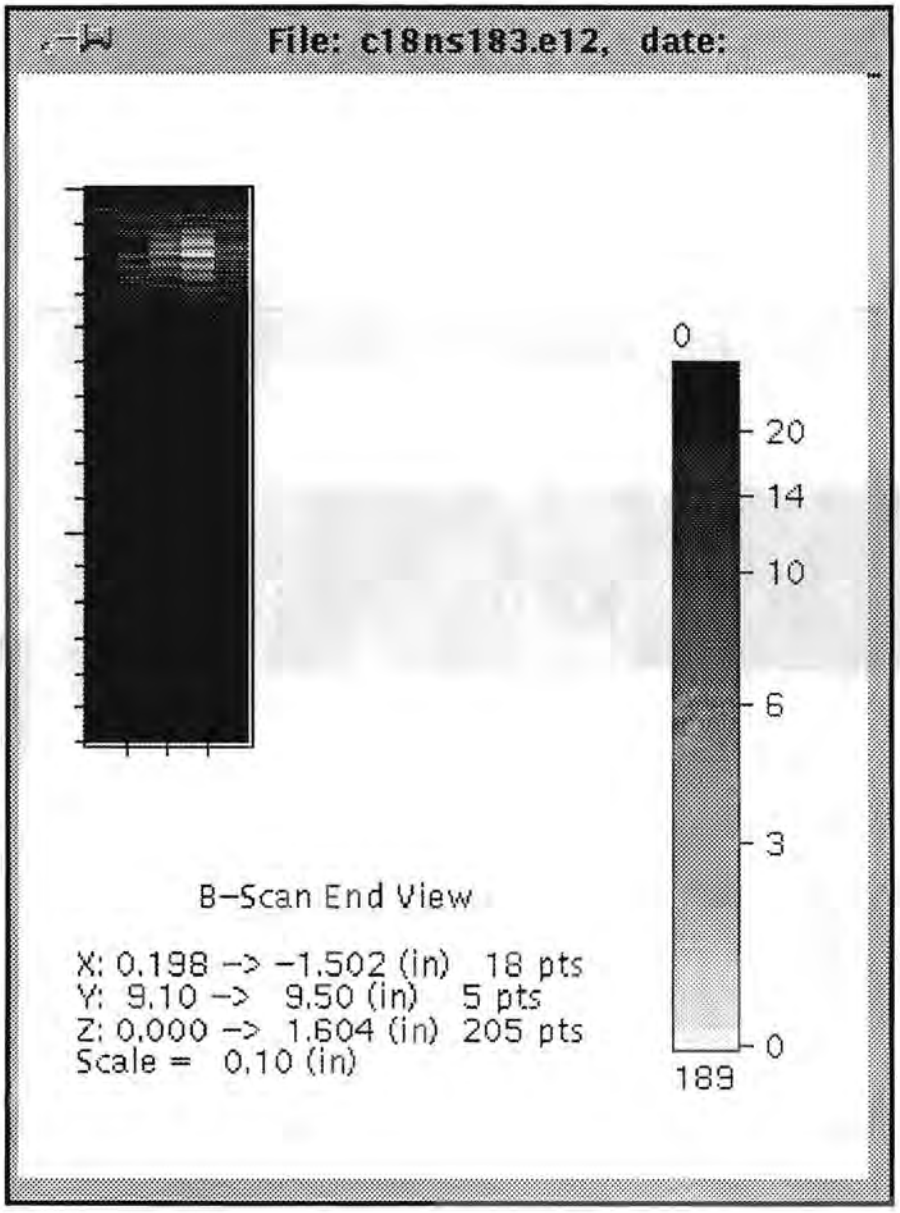
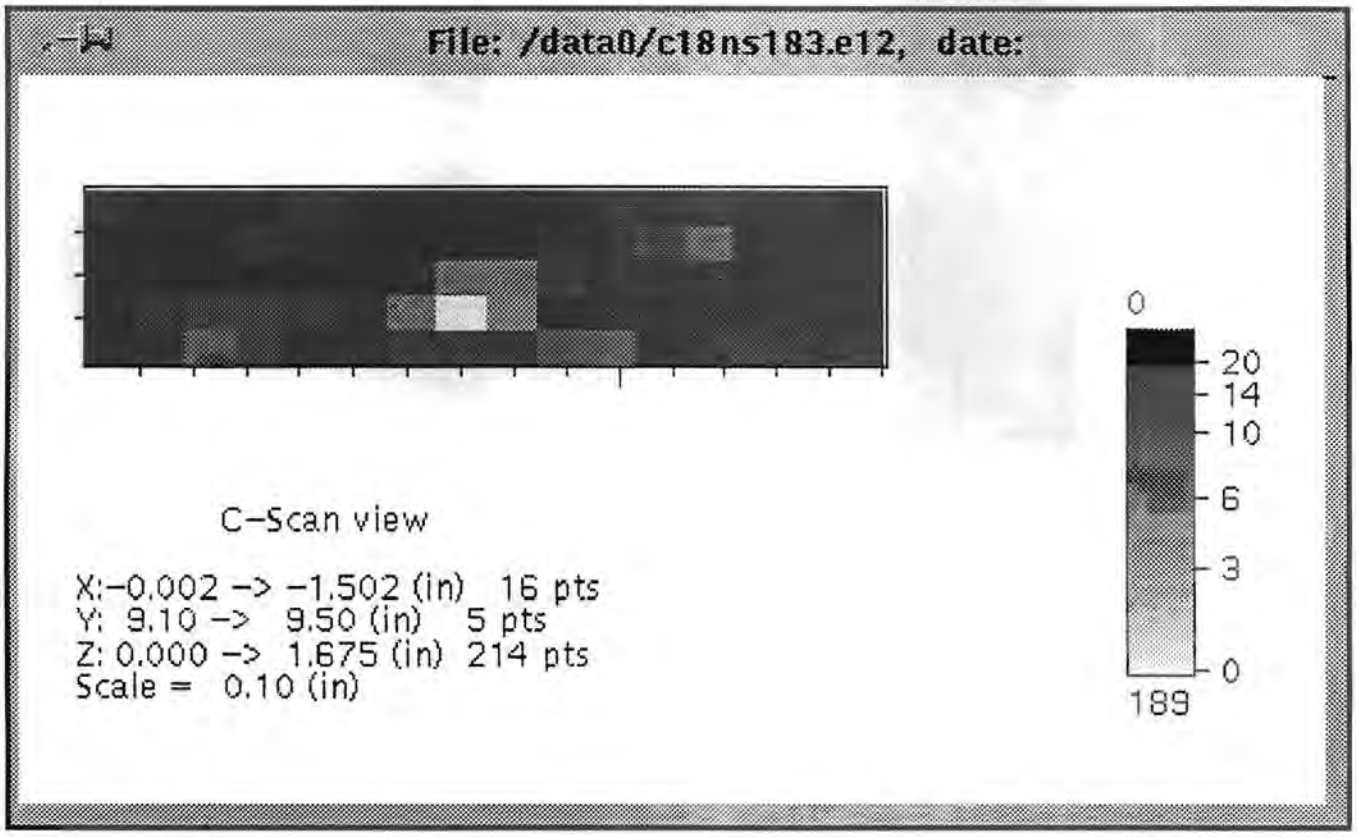
Destructive Data	235 (9.2)	--	-15 (-0.6)	1.5 (0.06)	6 (0.24)	0.5 (0.02)	See Figure 4.11.
SAFT-UT	236 (9.3)	5 (0.2)	18 (0.7)	5 (0.2)	5 (0.2)	<2.2 (<0.09)	See Figure 5.28. There is a sign difference between the destructive analysis and the SAFT-UT data for X. The origin of this difference is not known.

236 (9.3)	5 (0.2)	18 (0.7)	5 (0.2)	5 (0.2)	<2.2 (<0.09)	Detected by SAFT-UT in 70° L-wave inspection in the -X direction only. See Figure 5.28. This is a volumetric defect. Destructive analysis shows one small defect labeled #11. See Table 4.1 and Figure 4.10 for DA results.
442 (17.4)	15 (0.6)	-23 (-0.9)	5 (0.2)	5 (0.2)	<2.2 (<0.09)	Detected by SAFT-UT in 70° L-wave inspection in the +X direction. See Figure 5.29. This is a volumetric defect.

Figure 5.28a Side View (XZ) of Clad to Base-Metal Indication in Block 1-8 at Y = 236 mm (9.3 in.). 70° L-wave inspection with beam direction of -X. This indication corresponds to flaw #11 in the destructive analysis.

Figure 5.28b End View (YZ) of Clad to Base-Metal Indication in Block 1-8 at Y = 236 mm (9.3 in.). 70° L-wave inspection with beam direction of -X. This indication corresponds to flaw #11 in the destructive analysis.

Figure 5.28c C-scan View (XY) of Clad to Base-Metal Indication in Block 1-8 at Y = 236 mm (9.3 in.). 70° L-wave inspection with beam direction of -X. This indication corresponds to flaw #11 in the destructive analysis.

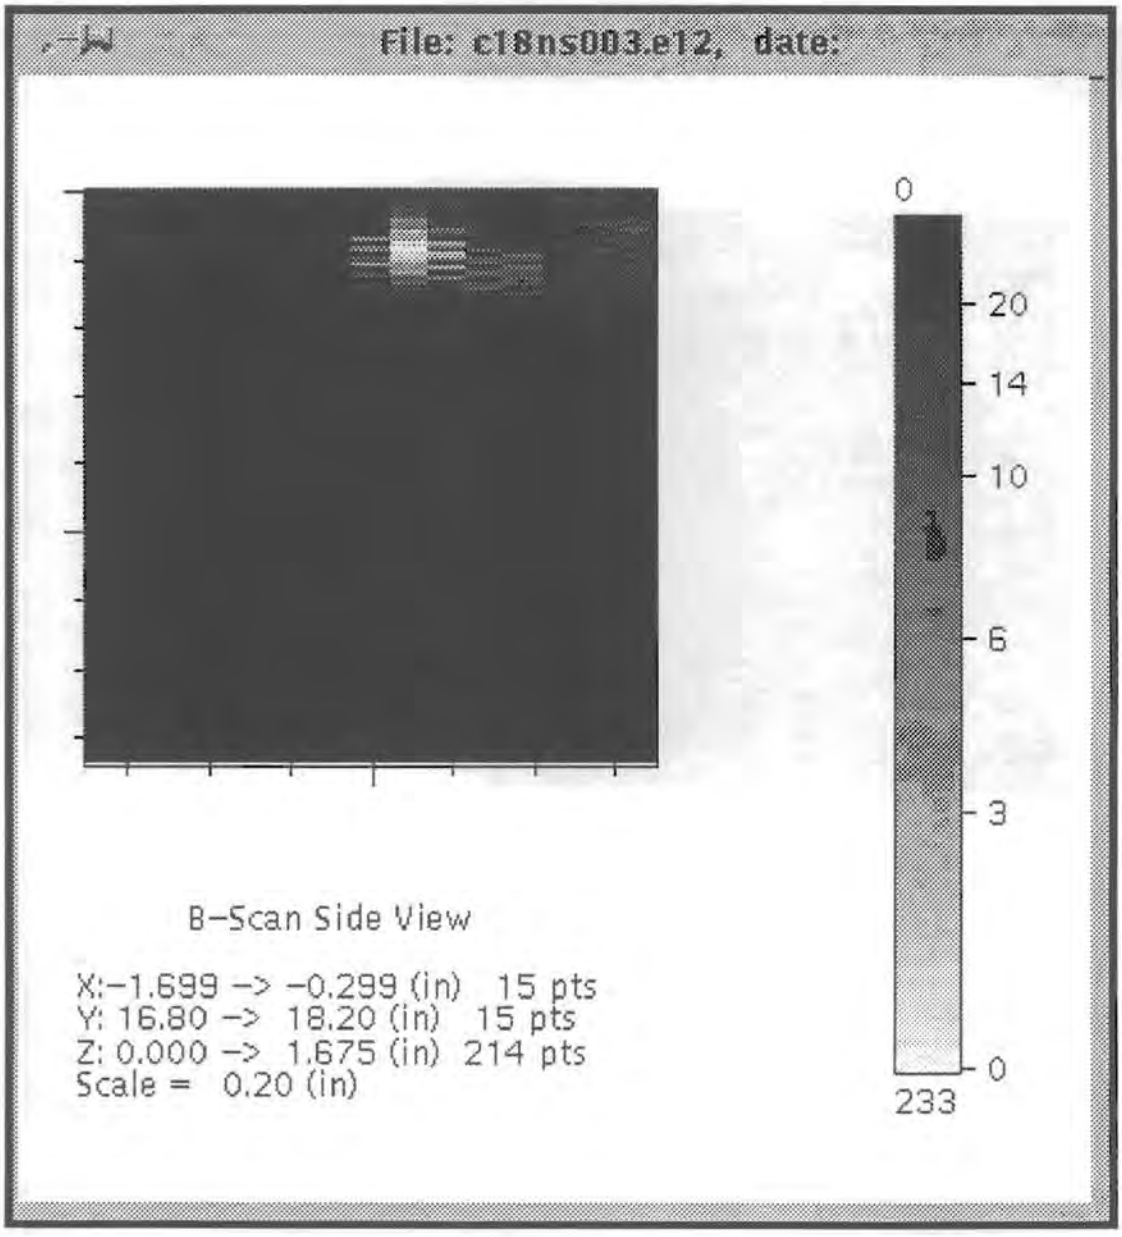
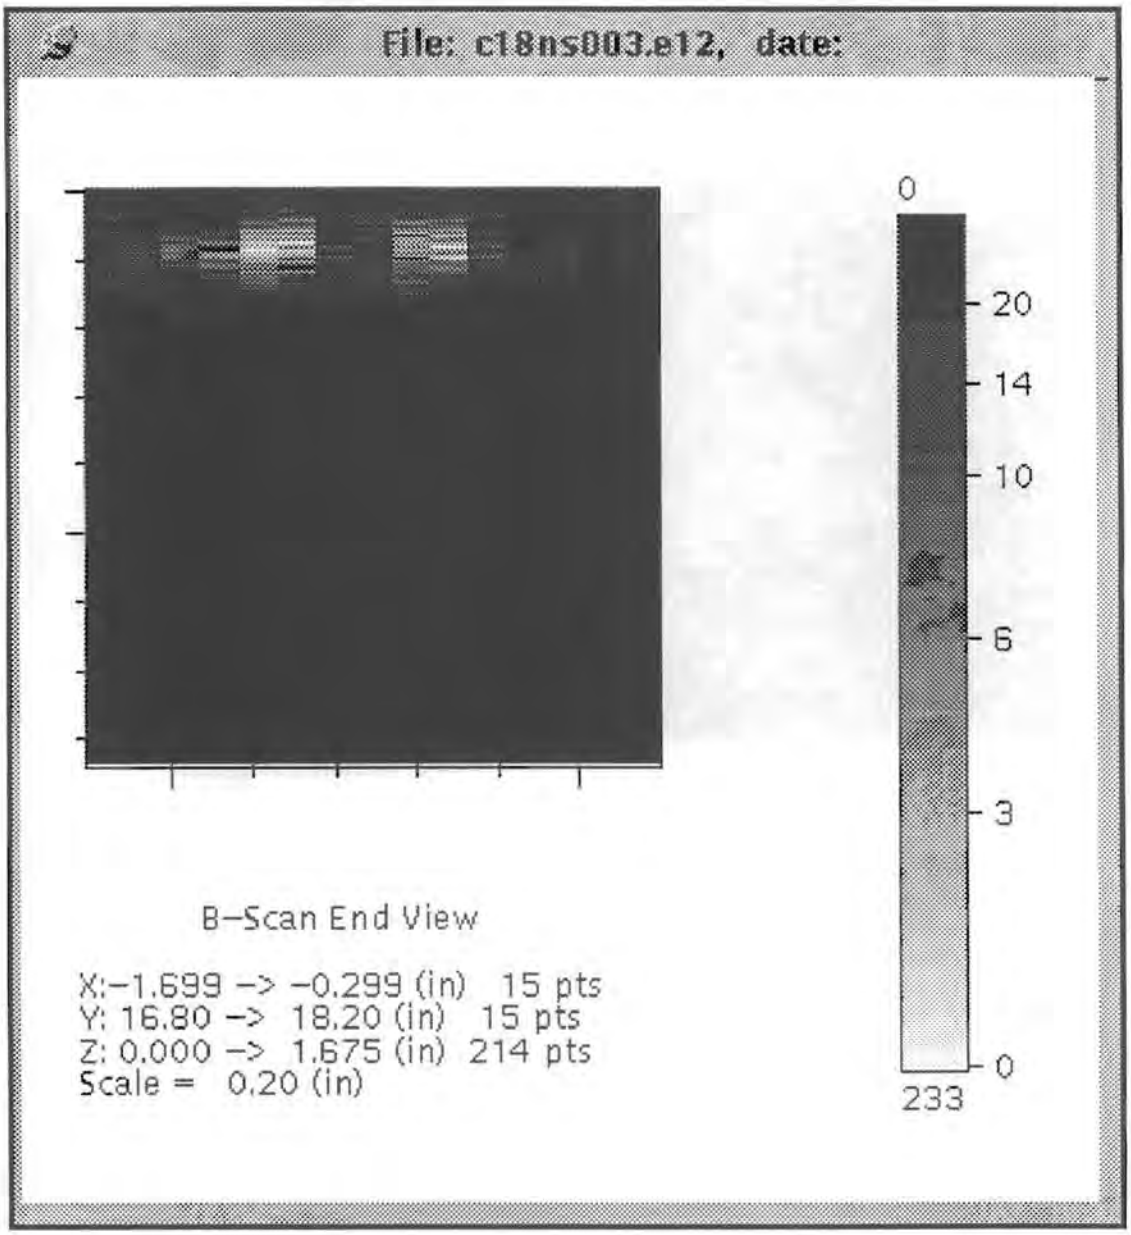
Figure 5.29a Side View (XZ) of Clad to Base-Metal Indication in Block 1-8 at Y = 442 mm (17.4 in.). 70° L-wave inspection with beam direction of +X.

Figure 5.29b End View (YZ) of Clad to Base-Metal Indication in Block 1-8 at Y = 442 mm (17.4 in.). 70° L-wave inspection with beam direction of +X.

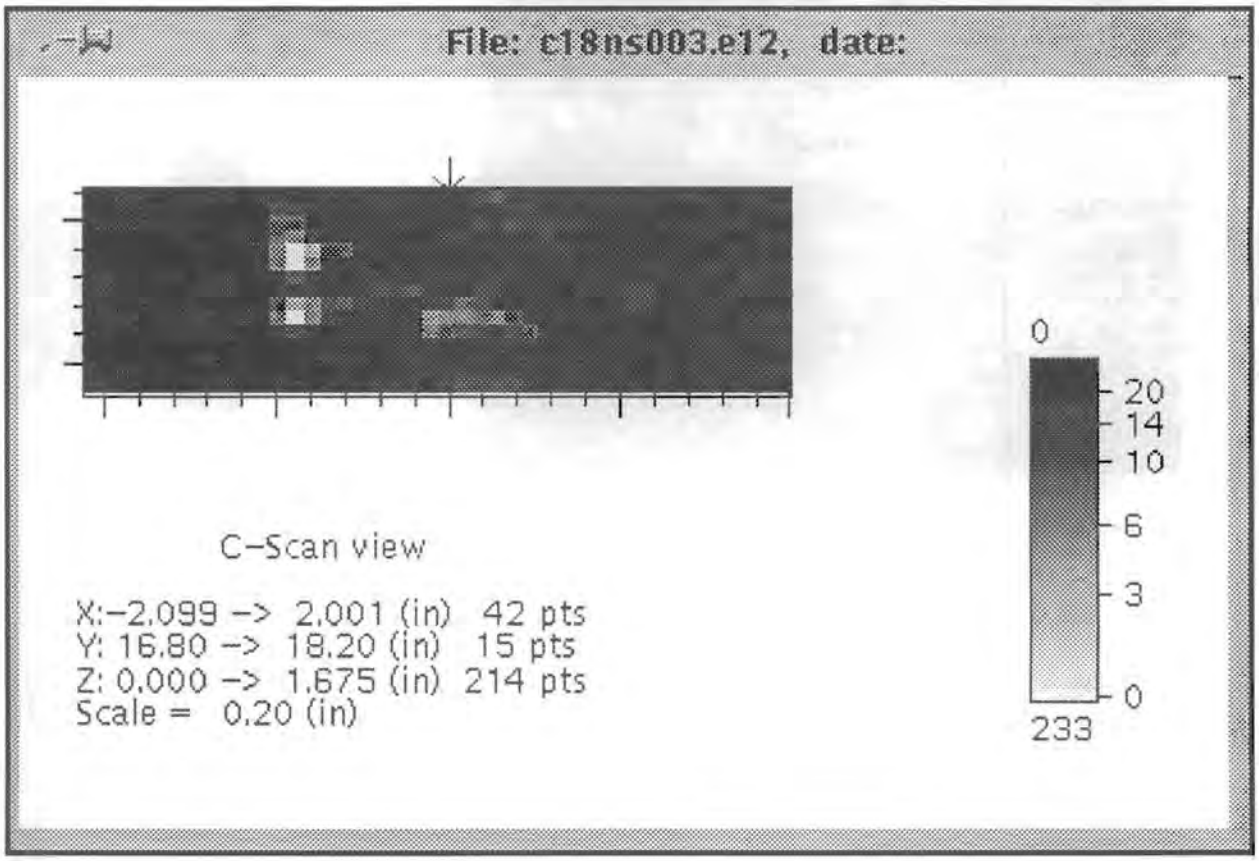
Figure 5.29c C-scan View (XY) of Clad to Base-Metal Indication in Block 1-8 at Y = 442 mm (17.4 in.). 70° L-wave inspection with beam direction of +X.

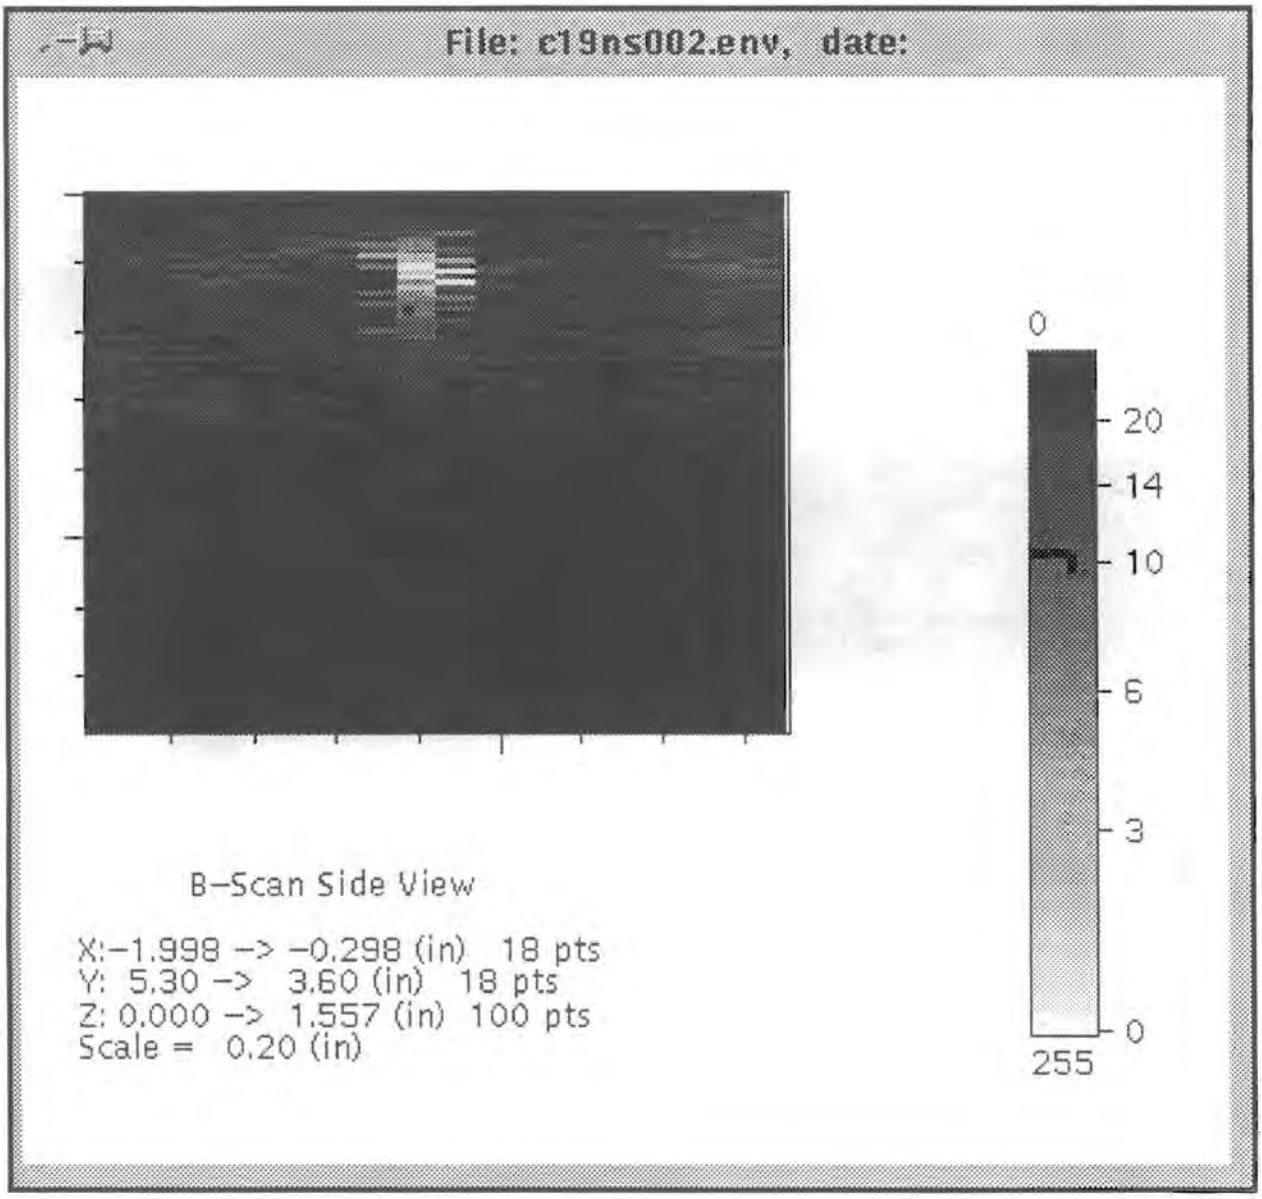
Y, mm (in.)	DY, mm (in.)	X, mmm (in.)	DX, mm (in.)	Z, mm (in.)	DZ, mm (in.)	Characterization
117 (4.6)	15 (0.6)	-30 (-1.2)	5 (0.2)	5 (0.2)	<2.2 (<0.09)	Detected by SAFT-UT in 70° L-wave inspection in the +X direction. See Figure 5.30. This is either two small volumetric defects or a larger defect of the size noted.

Figure 5.30a Side View (XZ) of Clad to Base-Metal Indication in Block 1-9 at Y = 117 mm (4.6 in.). 70° L-wave inspection with beam direction of +X.

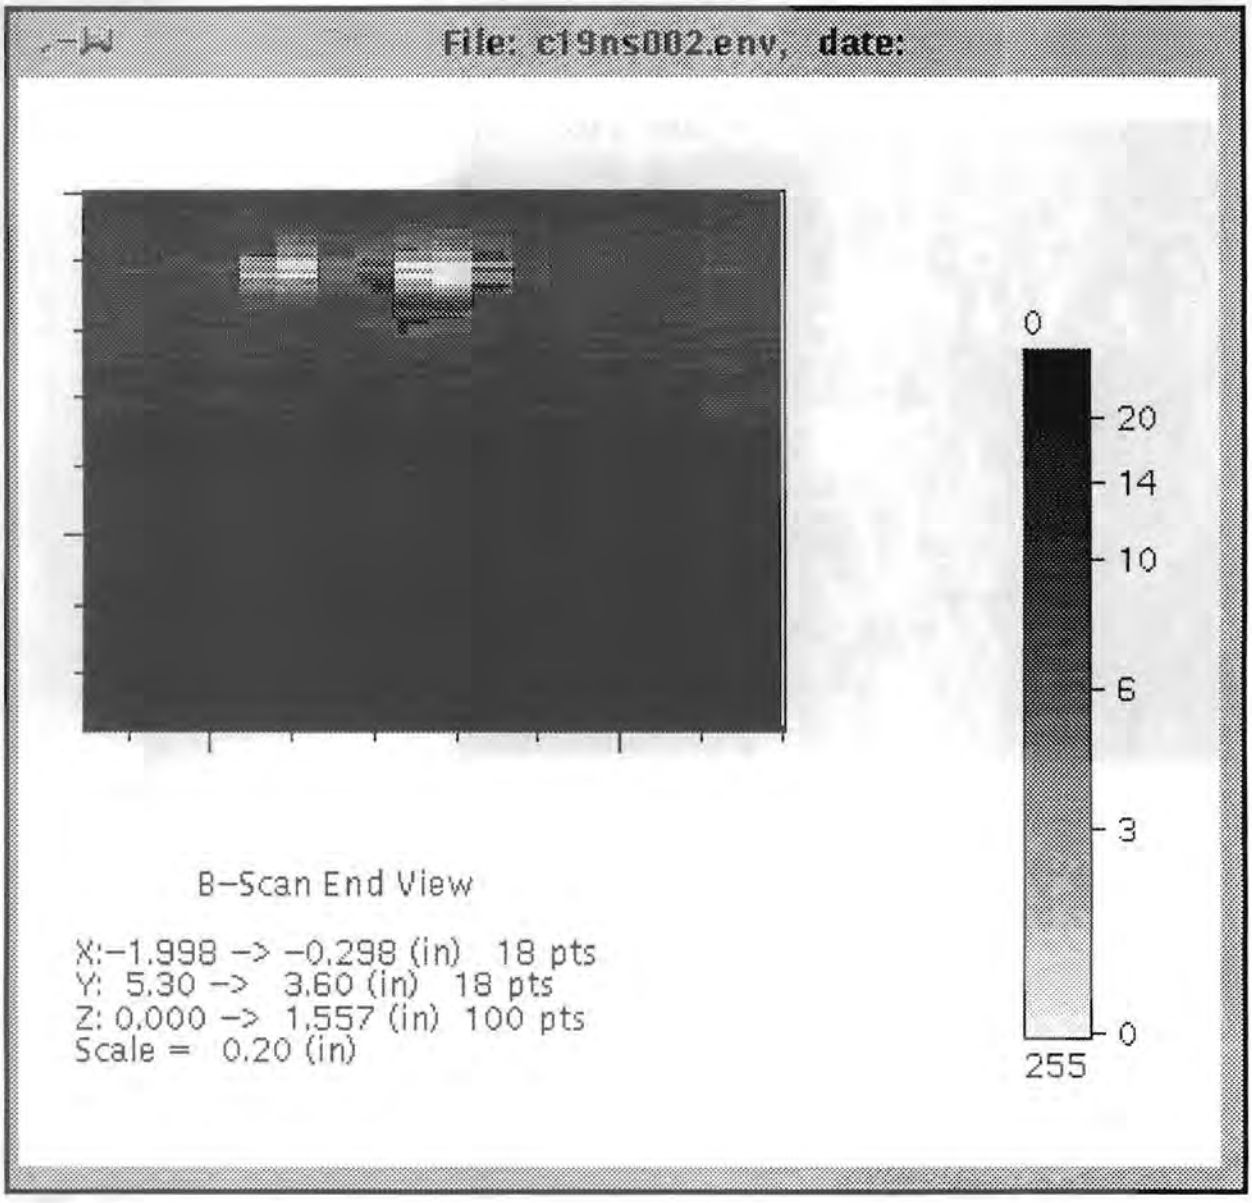
Figure 5.30b End View (YZ) of Clad to Base-Metal Indication in Block 1-9 at Y = 117 mm (4.6 in.). 70° L-wave inspection with beam direction of +X.

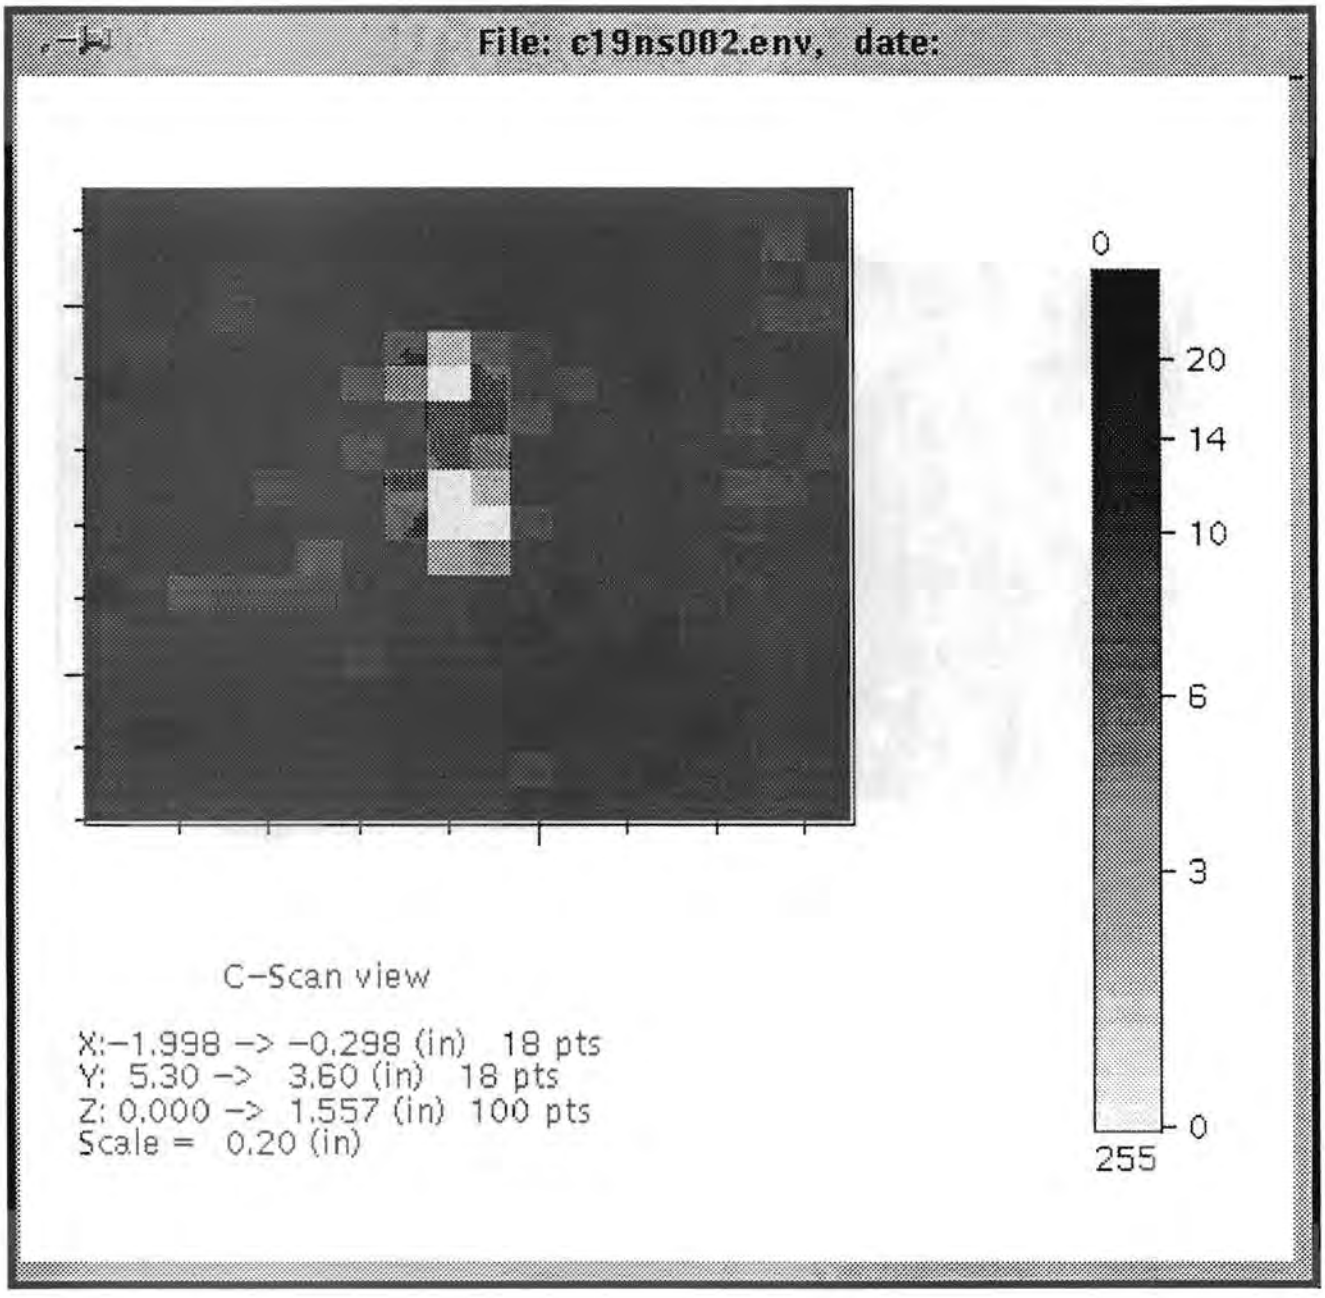
Figure 5.30c C-scan View (XY) of Clad to Base-Metal Indication in Block 1-9 at Y = 117 mm (4.6 in.). 70° L-wave inspection with beam direction of +X.

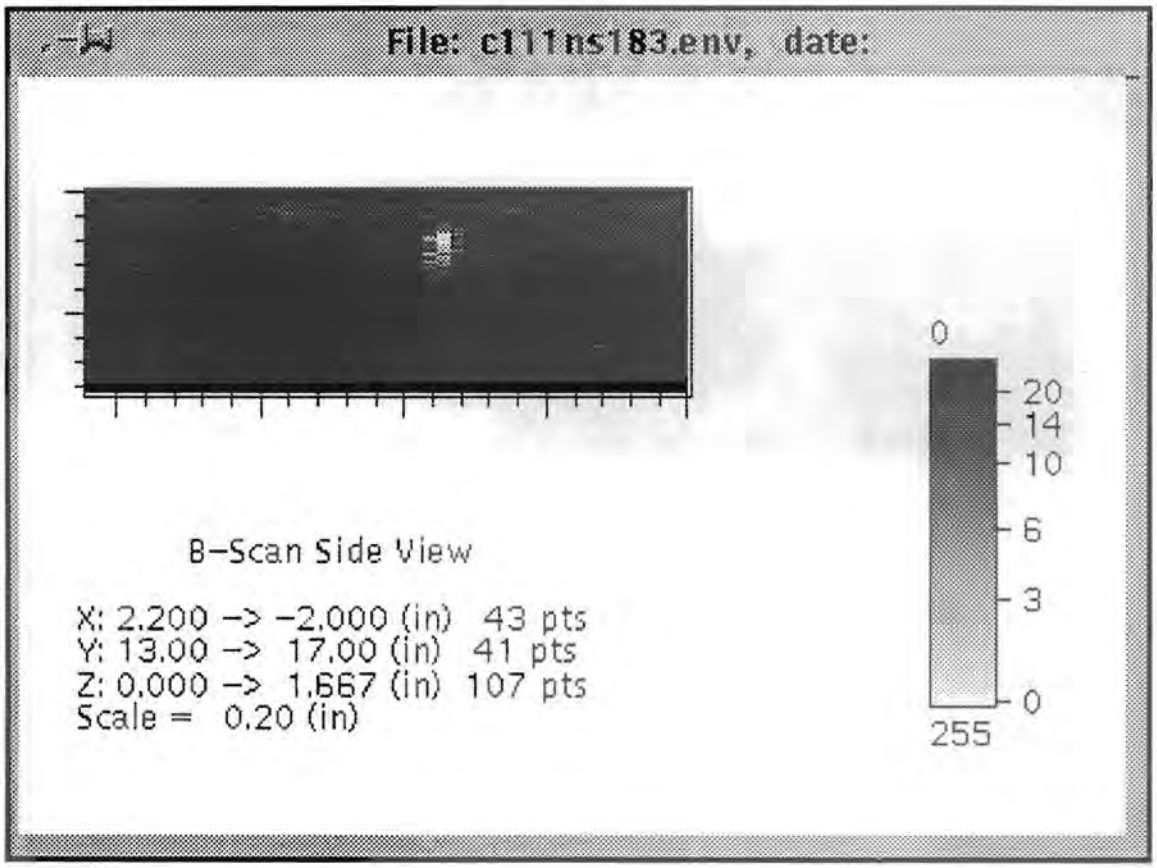
Y, mm (in.)	DY, Mm (in.)	X, mm (in.)	DX, mm (in.)	Z, mm (in.)	DZ, mm (in.)	Characterization
387 (15.3)	23 (0.9)	8 (0.3)	5 (0.2)	11 (0.45)	<2.2 (<0.09)	Detected by SAFT-UT in 70° L-wave inspection in the -X direction only. See Figure 5.31. This is the deepest of the 8 indications found in the near-surface zone. Because no destructive data exists to prove otherwise, this indication is conservatively assumed to be planar.

Figure 5.31a Side View (XZ) of Clad to Base-Metal Indication in Block 1-11 at Y = 387 mm (15.3 in.). 70° L-wave inspection with beam direction of -X.
