NUREG/CR-6471, Vol. 1
PNNL-11143

Characterization of Flaws in U.S. Reactor Pressure Vessels

Density and Distribution of Flaw Indications in PVRUF

Pacific Northwest National Laboratory

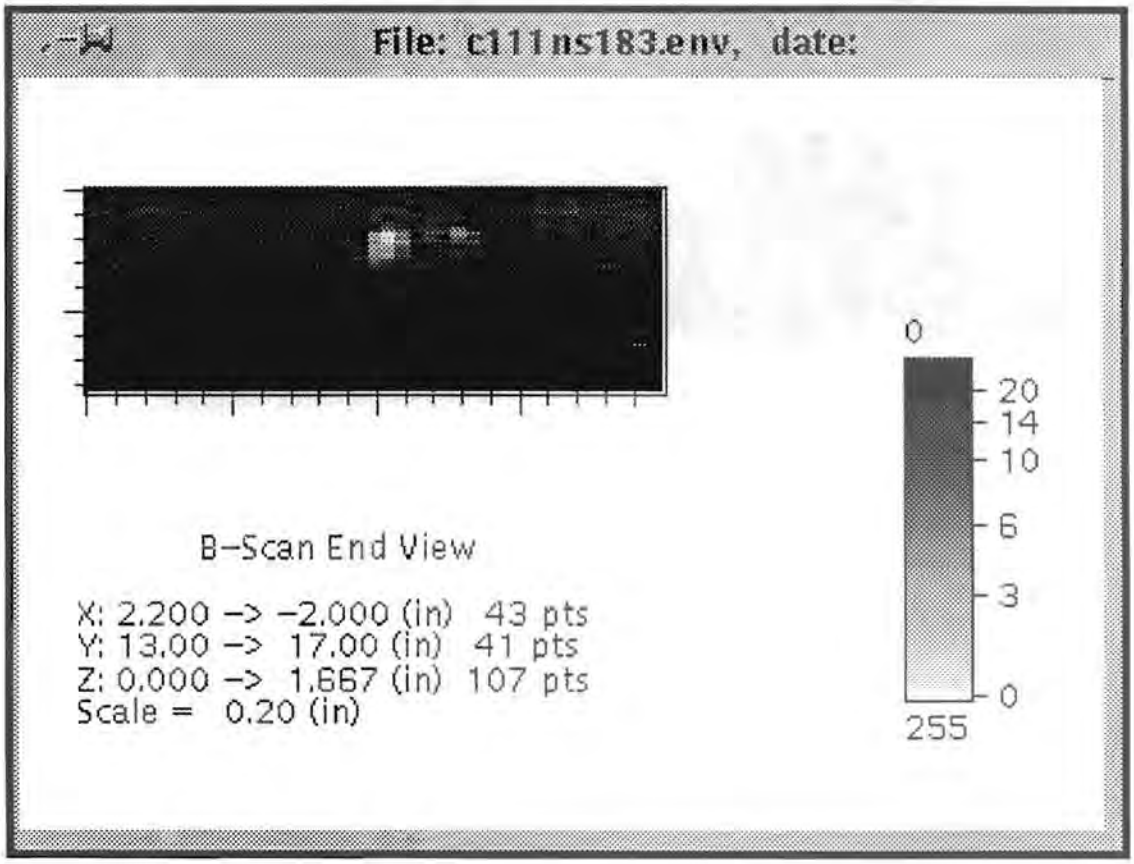
Y, mm (in.)	DY, Mm (in.)	X, mm (in.)	DX, mm (in.)	Z, mm (in.)	DZ, mm (in.)	Characterization
387 (15.3)	23 (0.9)	8 (0.3)	5 (0.2)	11 (0.45)	<2.2 (<0.09)	Detected by SAFT-UT in 70° L-wave inspection in the -X direction only. See Figure 5.31. This is the deepest of the 8 indications found in the near-surface zone. Because no destructive data exists to prove otherwise, this indication is conservatively assumed to be planar.

Figure 5.31b End View (YZ) of Clad to Base-Metal Indication in Block 1-11 at Y = 387 mm (15.3 in.). 70° L-wave inspection with beam direction of -X.

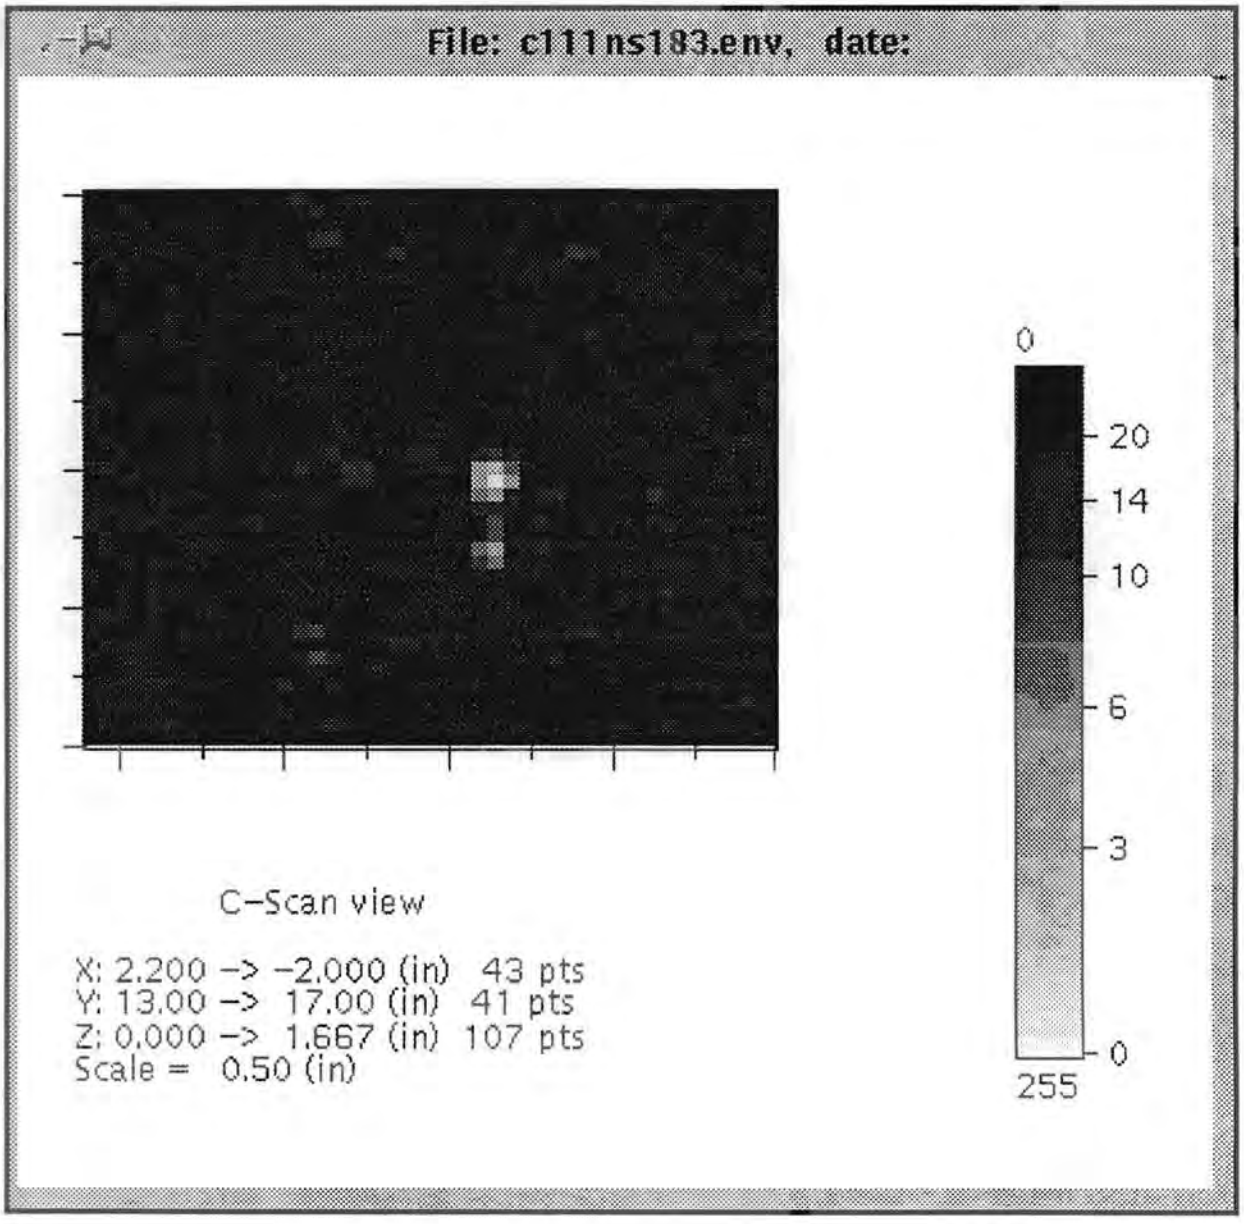
Figure 5.31c C-scan View (XY) of Clad to Base-Metal Indication in Block 1-11 at Y = 387 mm (15.3 in.). 70° L-wave inspection with beam direction of -X.

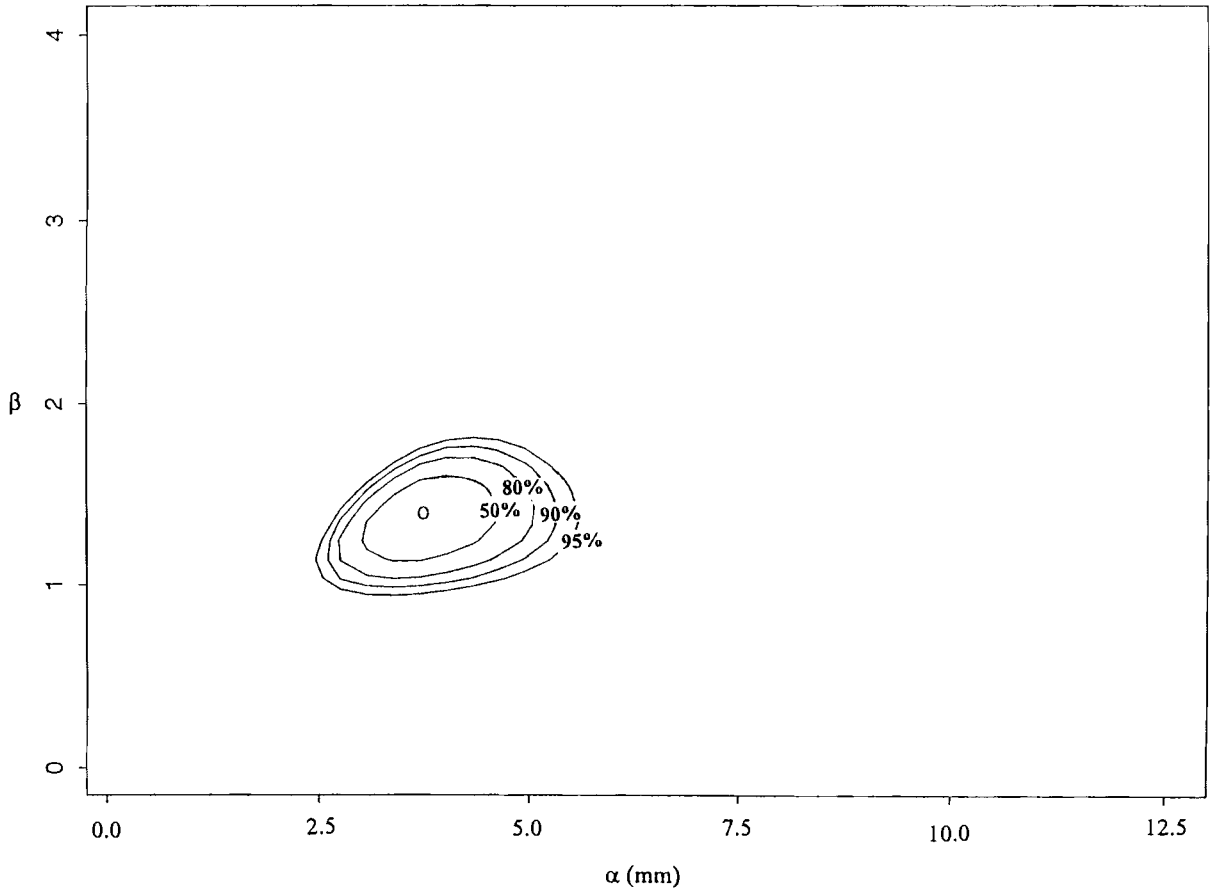
Figures 6.1 and 6.2 present the results of a maximum likelihood Weibull fit to the SAFT-UT data for the 31 flaws. Figure 6.1 displays the estimates and confidence bounds for the parameters α and β_1, which determine the shape of the cumulative flaw rate function. This plot shows the 50%, 80%, 90%, and 95% confidence bounds on these parameters. Figure 6.2 presents a plot of $\Lambda(s)$, surround by 95% confidence bounds.

Figure 6.1 Parameter Estimates with Confidence Bounds for Simple Weibull Fit to the SAFT-UT Data of 31 Flaws

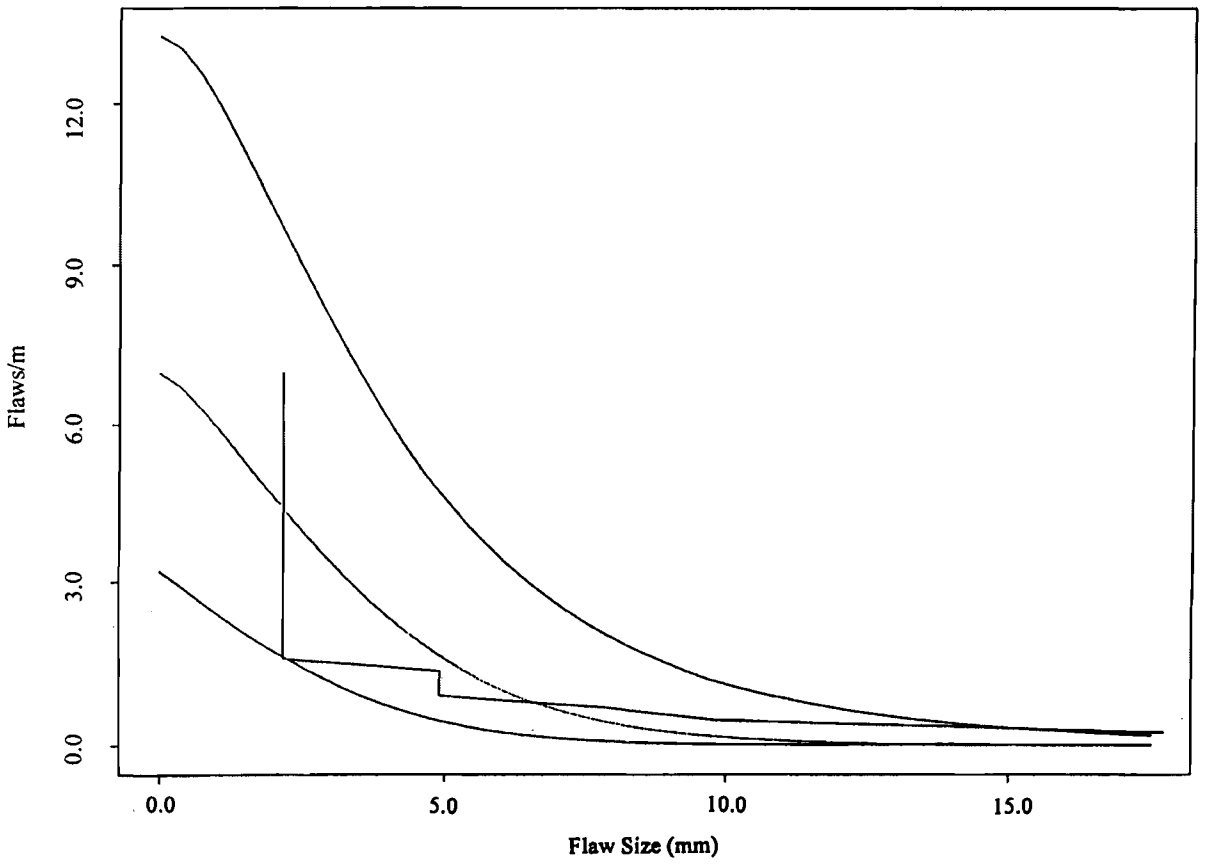
Figure 6.2 Estimate of Cumulative Flaw Rate Function with 95% Confidence Interval for Simple Weibull Fit to the SAFT-UT Data of 31 Flaws
