Field Installation and Performance of Sandbag Barrier

Field Installation and Performance of Hesco Bastion Concertainer

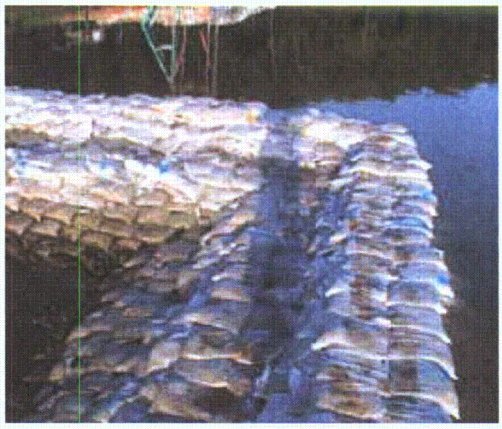
Figure 3-47. 6 June 2004, 3.3 ft of water against structure

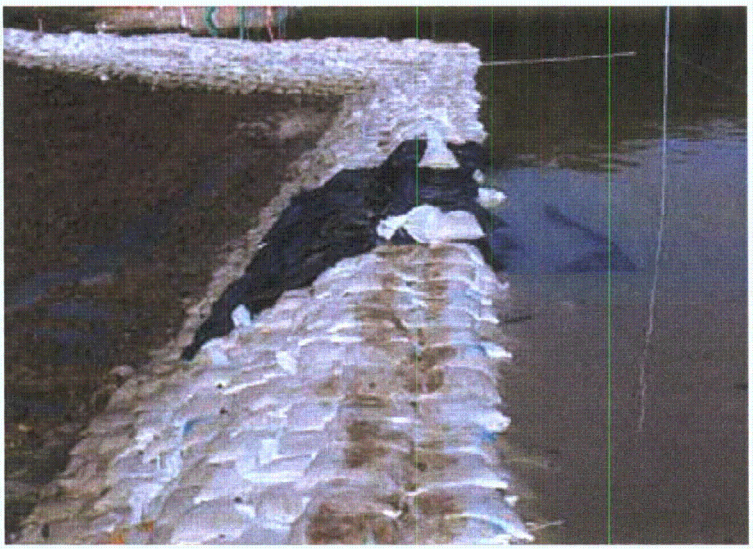
Figure 3-56. Plastic sheeting over riverward face

During the field test, seepage was collected in a buried concrete tank (Figure 3-51a, b). Seepage rates were determined by computing the change in volume in the tank over a specific time. As the water level against the structure rose, the seepage rates increased. The first photo was taken on 5 June 2004 while the seepage rate was low. The second photo was taken on 6 June 2004 when the seepage rate had increased. Figure 3-52 is a photo of the seepage observed through the overlapping sandbags. Figure 3-53 shows the seepage water on the protected side of the structure. To compare seepage rates for all four structures, the wetted area for each structure for given water surface elevations was computed (Figure 3-54). The seepage rate for the sandbag structure exceeded 4,500 gal/hr when the structure had almost 700 sq ft of wetted area. The rate of seepage increased markedly when the wetted area reached 500 sq ft. As the seepage rate increased, an attempt was made to reduce the seepage by draping the east tieback with plastic sheeting and weighting the sheeting with sandbags (Figure 3-55a, b). The draping of the sheeting did not decrease the flow of water through the structure. The plastic sheeting was also draped over a low section of the riverward face to protect against concentrated flow (Figure 3-56). These were the only modifications made to the sandbag structure.

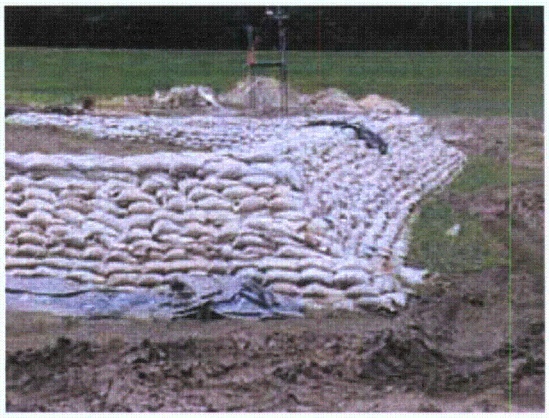
Figure 3-58. Riverward face

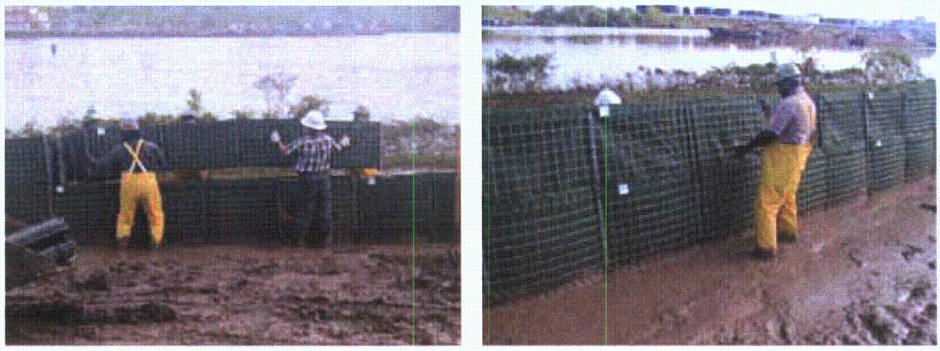
Figure 3-75. Installing top row units (required raise)

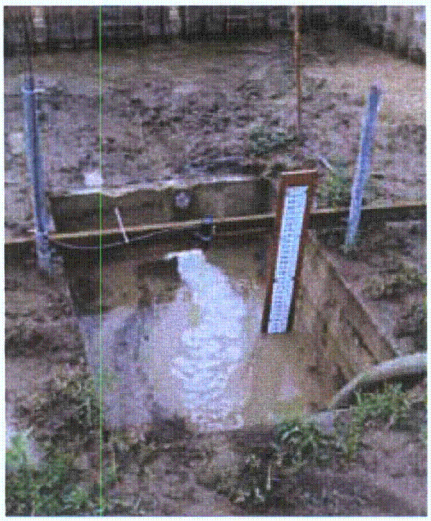
Figure 3-120. Seepage behind RDFW structure

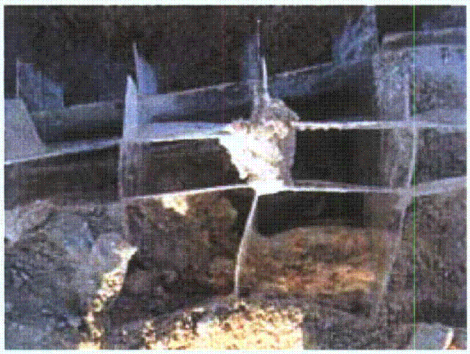
Figure 3-122. Fill material washed out of units (view down from top)

During testing, no major repairs were required to the RDFW structure. One minor repair performed by the RDFW representative was to refill units where the sand was washed out where the units had not been properly placed during construction (Figures 3-122 and 3-123). This repair was accomplished by adding sand to the washed-out compartments of the units (Figures 3-124 and 3-125). The repairs were completed by one RDFW representative, four government laborers, and one government equipment operator using shovels and a backhoe. Also during testing, a small sand boil (or pin boil) developed in the northeast corner of the structure near the sump tank. The boil was contained by placing a RDFW half unit over the boil (Figures 3-126 and 3-127).

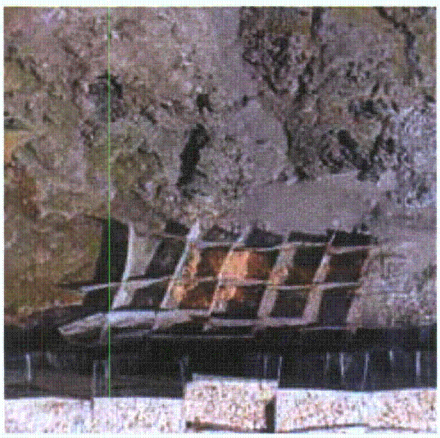
Figure 3-126. Using RDFW unit to contain sand boil

Figure 3-127. Contained sand boil

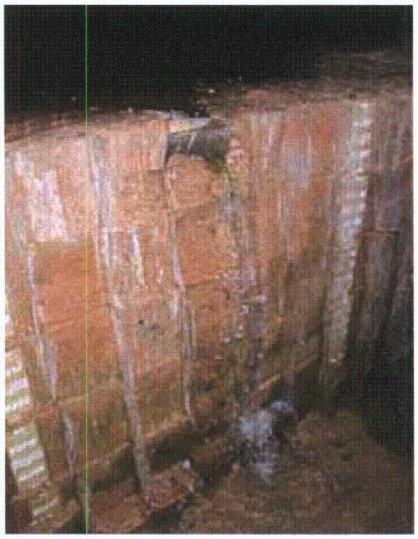
Figure 3-128. RDFW structure before overtopping

Figure 3-129. Overtopping of RDFW structure
