Official Transcript of Proceedings

NUCLEAR REGULATORY COMMISSION

Title: Advisory Committee on Reactor Safeguards
590th Meeting

Date: Friday, January 20, 2012

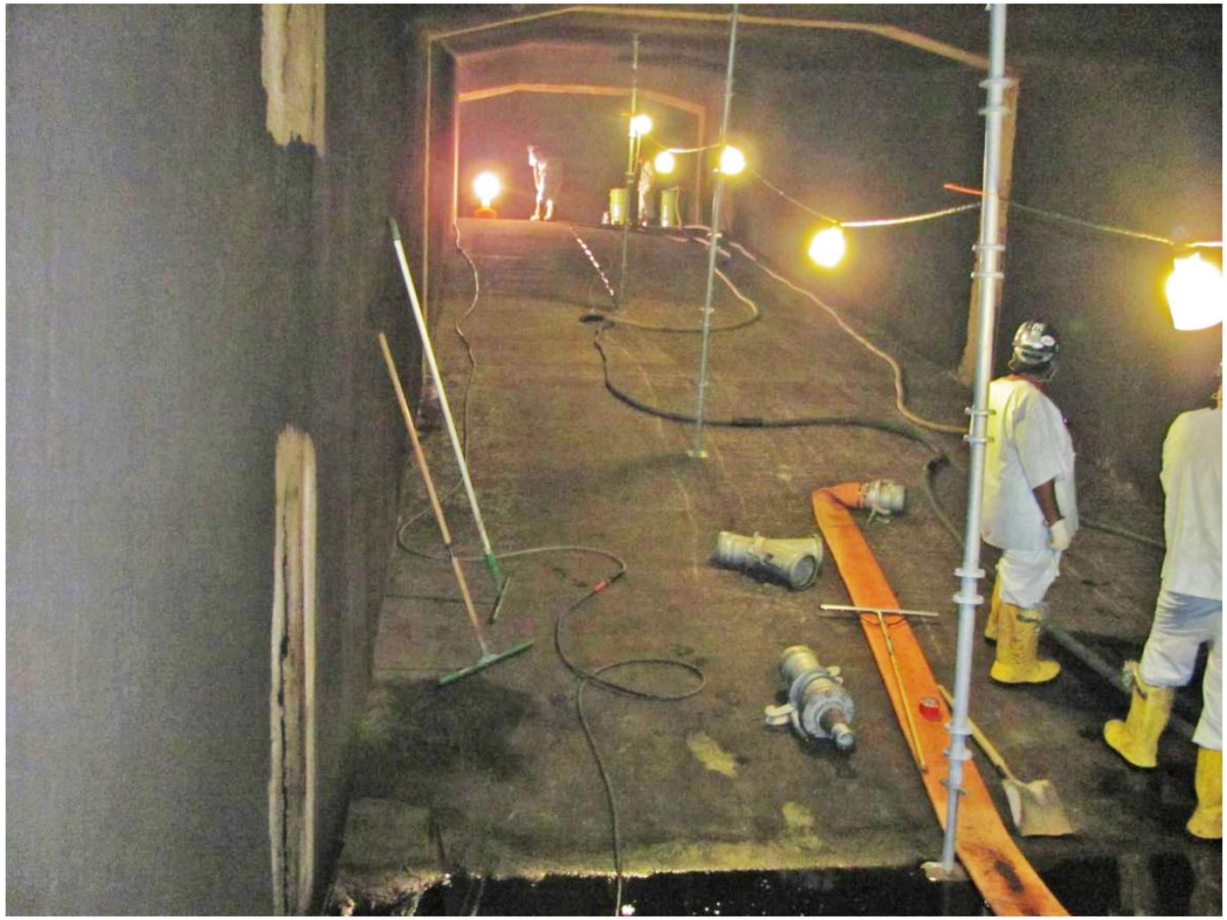
Unit 2 Tunnel Inspection

This is a picture of the Unit 2 circulating water tunnel. This is a picture that you're not going to often see because normally there's hundreds of millions of gallons a minute traveling through here. But this is basically a horizontal concrete box that is underground. Again, if there was going to be lateral motion you would see it here because you've got this rectangular box here that would be susceptible to damage. There was no damage found in this tunnel. But we did take the opportunity of the outage to be able to go in here and do a very extensive inspection of this tunnel.

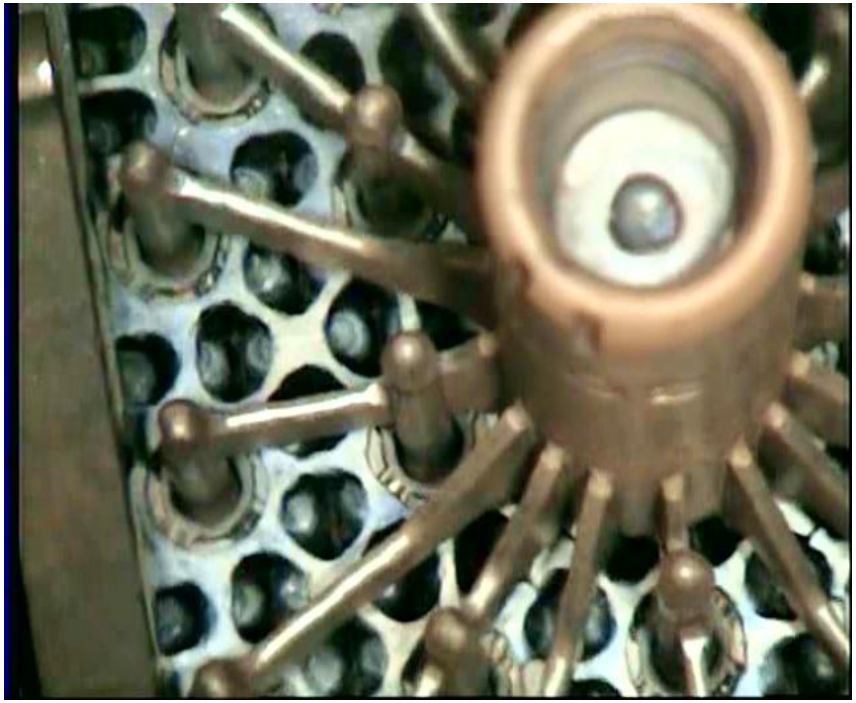
MR. GRECHECK: They had both units down. Unit 2 was scheduled for refueling -- a refueling outage about three weeks after the event, so we entered into the refueling outage early, defueled the Unit 2 reactor, looked at all the fuel assemblies as they came out. Looked at fuel assemblies in the spent fuel pool. Looked at new fuel assemblies which had been delivered to the site in anticipation of the refueling. Did not see any fuel damage.

Visual inspection of RCCA hubs

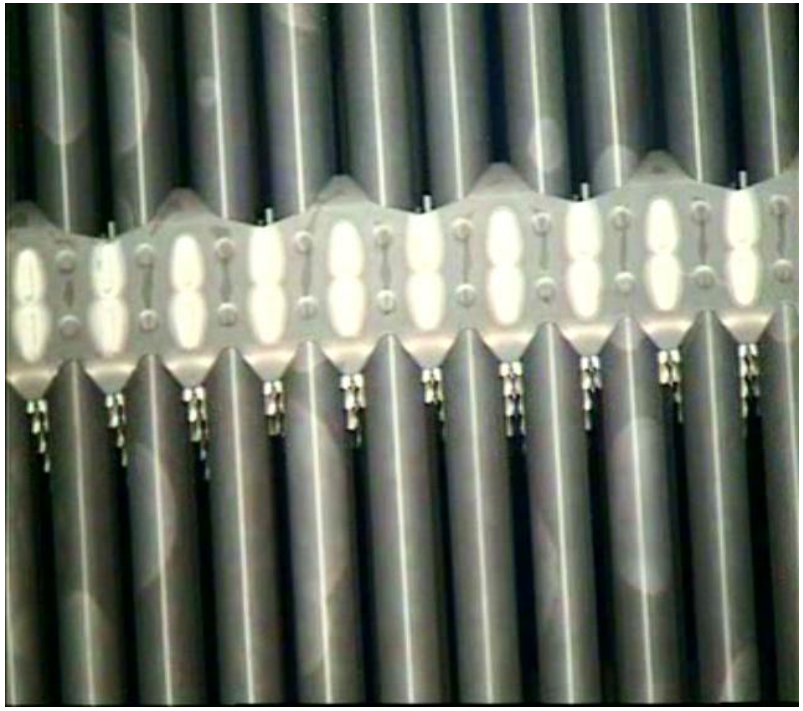
Examination of underside of a mid-span mixing grid
