NUREG/CR-7115

Performance of Metal and Polymeric O-Ring Seals in Beyond-Design-Basis Temperature Excursions

Office of Nuclear Regulatory Research

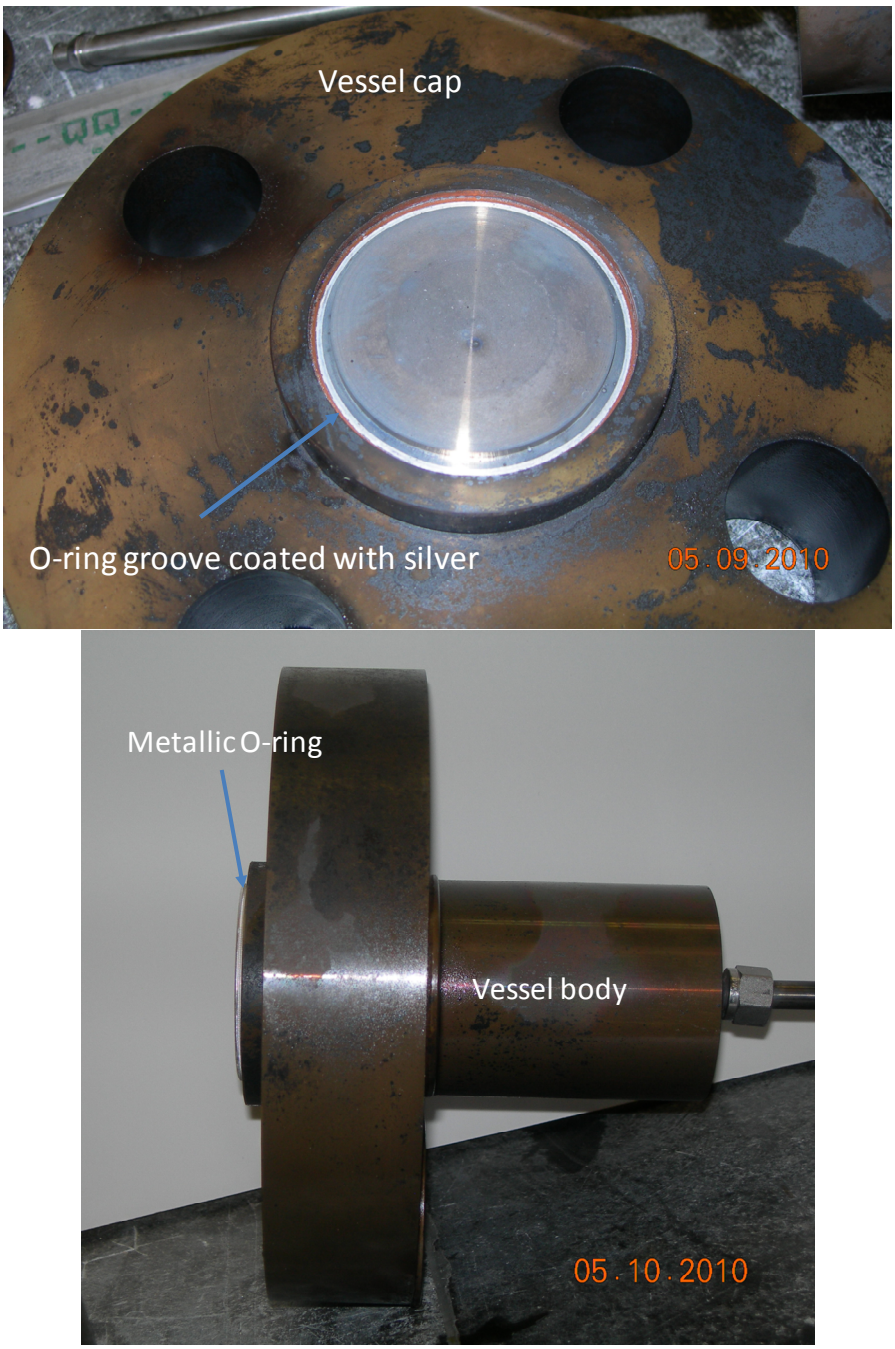
A post-test inspection of the test vessel revealed that the metallic seal was soldered to the flange of the vessel body and a silver-color coating was imprinted on the surface of the O-ring groove, as shown in Figure 3-1. The high-temperature exposure also discolored the test fixture.

Figure 3-1. Post-test photographs showing silver from the metallic O-ring deposited on the O-ring groove (above) and the O-ring bonded to the test vessel body (below).

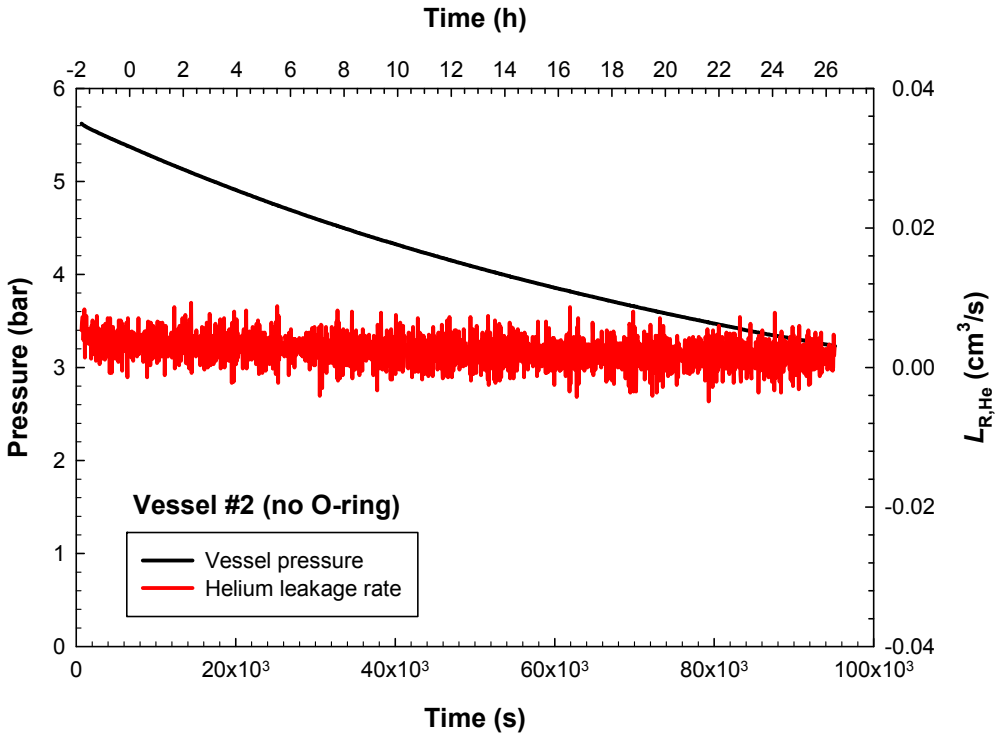
result, which indicates that the vessel pressure began to drop and leakage occurred immediately at the start of the test and continued slowly over the entire experimental run-time (26.43 h). The reference helium leakage rates $L_{R,He}$ (ref·cm^3/s) were estimated based on the method described in Appendix D. The time-averaged leakage rate is estimated to be 2.4×10^{-3} ref·cm^3/s.

Figure 3-2. Temporal variations of vessel pressure at 24 °C without metallic O-ring.

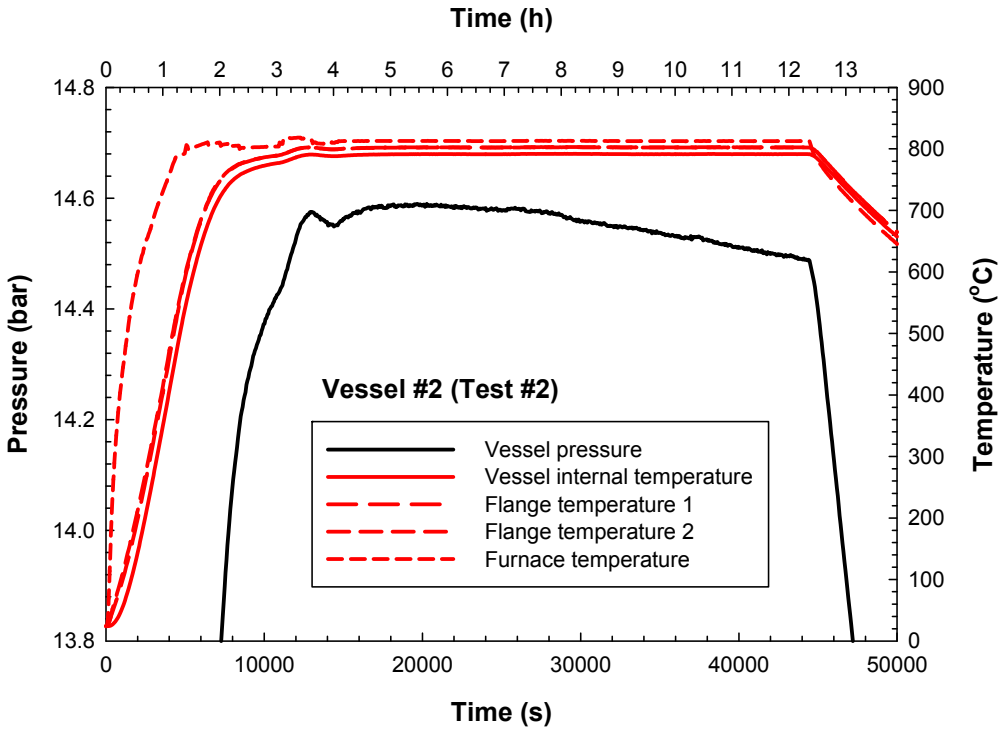
The vessel was disassembled and assembled again using a metallic seal to start Test #2. Figure 3-3 shows the temporal variations of the vessel internal pressure and temperature, two flange temperatures and furnace temperature during the heat-up, the constant-temperature heating (isothermal), and a portion of the cool-down phases for Test #2. The rapid decrease in the furnace temperature signifies turning-off the furnace and the beginning of the cool-down phase. Figure 3-4 shows a re-plot of Figure 3-3 with the time scale extended to include the entire cool-down phase, which normally takes more than several days to naturally cool the test vessel inside the powered-down furnace from 800 °C (1472 °F) to room temperature.

The scale of the ordinate for pressure in Figure 3-3 is magnified to show that the pressure starts to decrease shortly after the vessel temperature has reached 800 °C (1472 °F) and continues to decrease very slowly during the rest of the 9 h constant-temperature heating phase. Although the continuous downward trend does seem to imply the occurrence of a very tiny leak, the decrease in pressure is within the expanded measurement uncertainty of the pressure transducer (0.11 bar) and is not considered significant in this test. However, the complete thermal exposure history, shown in Figure 3-4, indicates that the vessel pressure is restored to its original charge pressure (≈ 5 bar) after the thermal exposure, indicating no leakage.

Figure 3-3. Temporal variations of vessel pressure and temperature in Test #2.

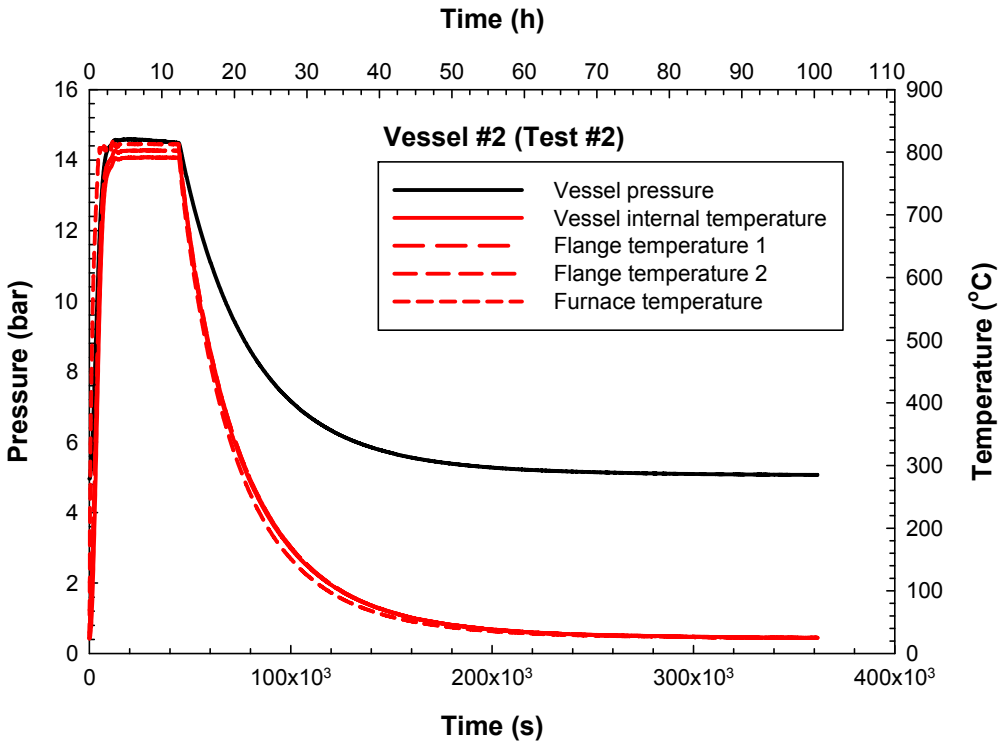
Figure 3-4. Temporal variations of vessel pressure and temperature in Test #2 (time scale extended, including the complete cool-down phase).

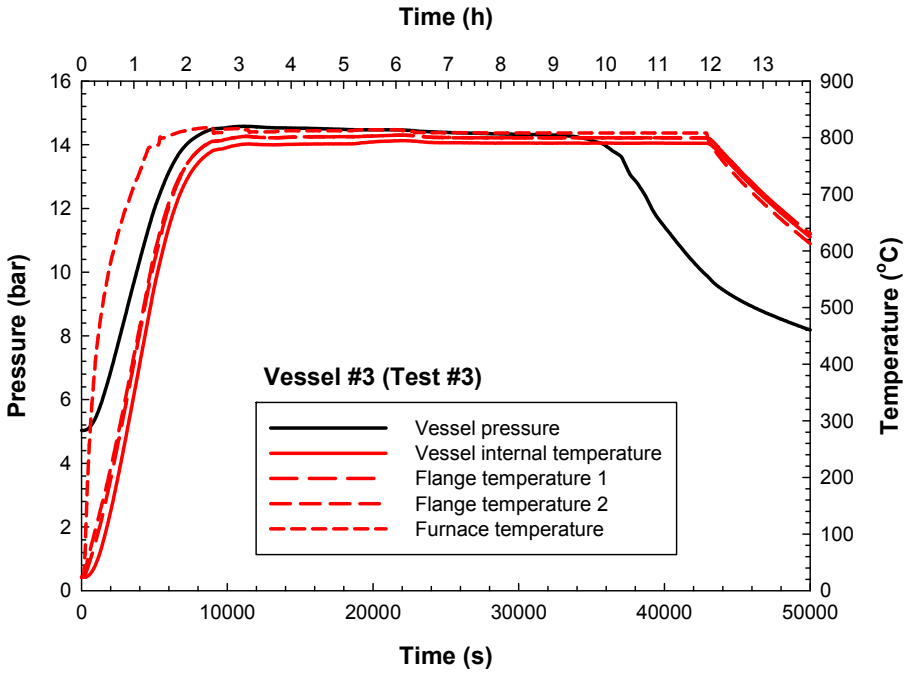
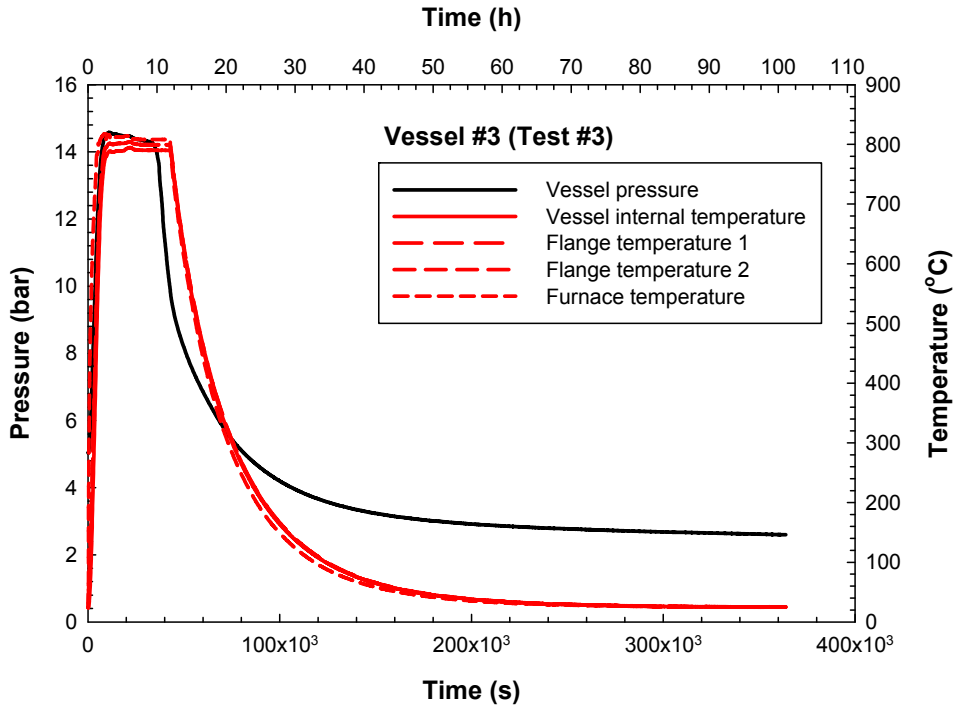
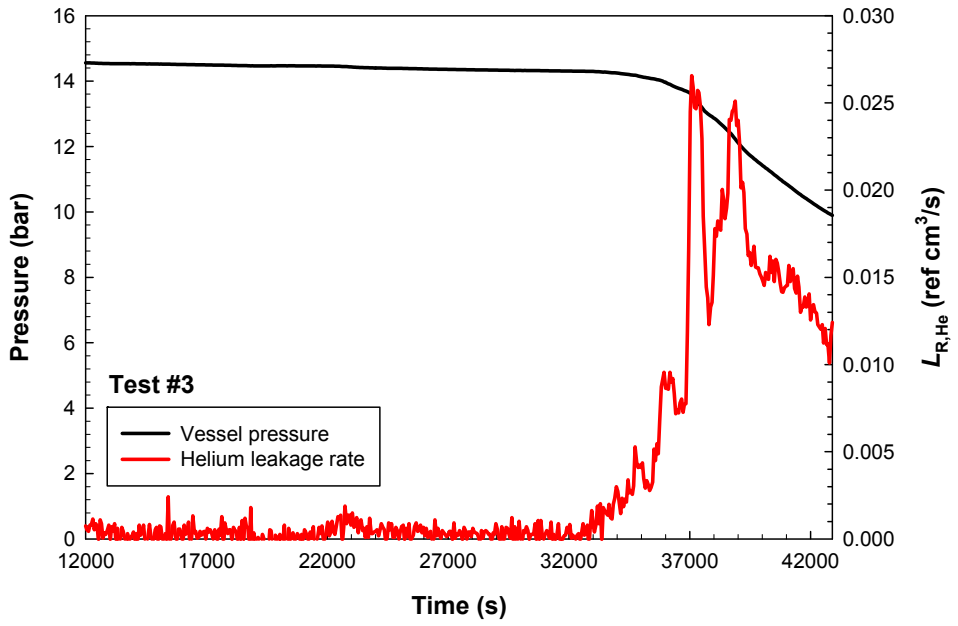
Tests #3 is a repeat of Test #2. Figure 3-5 presents the test results which show the occurrence of a leak during the 9 h constant-temperature heating phase at 800 °C (1472 °F). In Test #3, the vessel pressure decreases slowly initially and then significantly after about 25 000 s (6.9 h) at 800 °C (1472 °F). Since the leakage rate is directly proportional to the time rate of change of pressure, this two-stage decrease in pressure indicates a slower leak rate (small dP/dt) at first and then a faster leak rate (large dP/dt) at the end. Another leak indicator is revealed in Figure 3-6, which shows the entire time history of the test. After cooling to room temperature, the vessel does not recover its initial charge pressure of approximately 5 bar because of the leak. Isothermal reference helium leakage rates ($L_{R,He}$) during the 9 h heating in this test are shown in Figure 3-7.

Figure 3-5. Temporal variations of vessel pressure and temperature in Test #3.

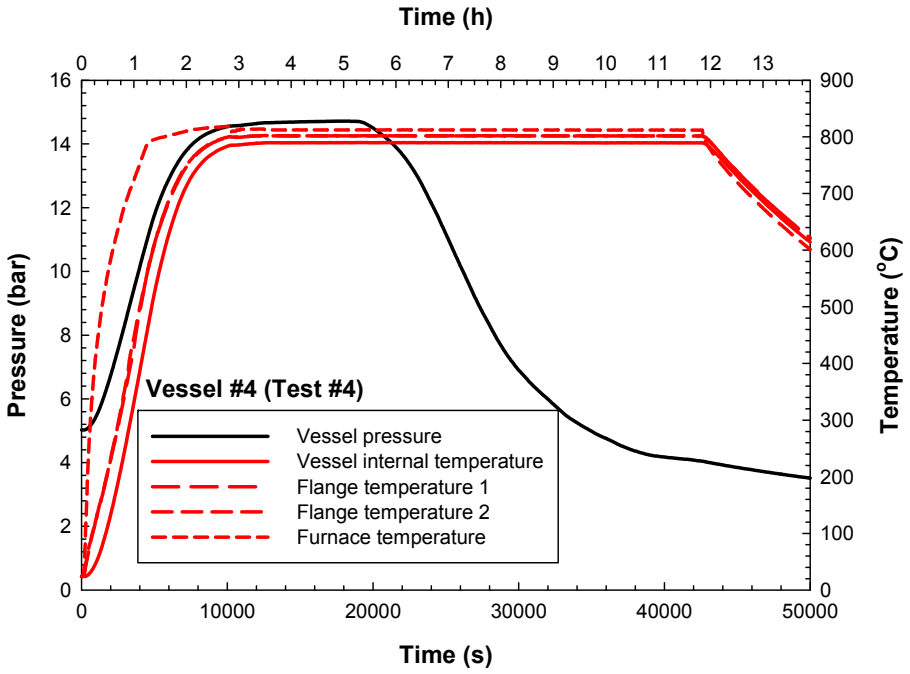
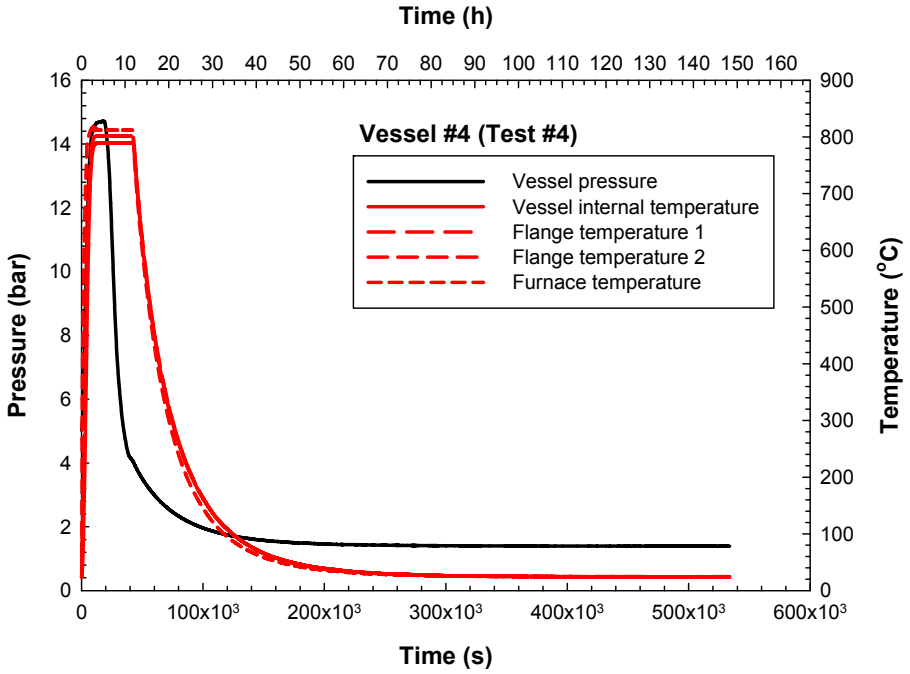
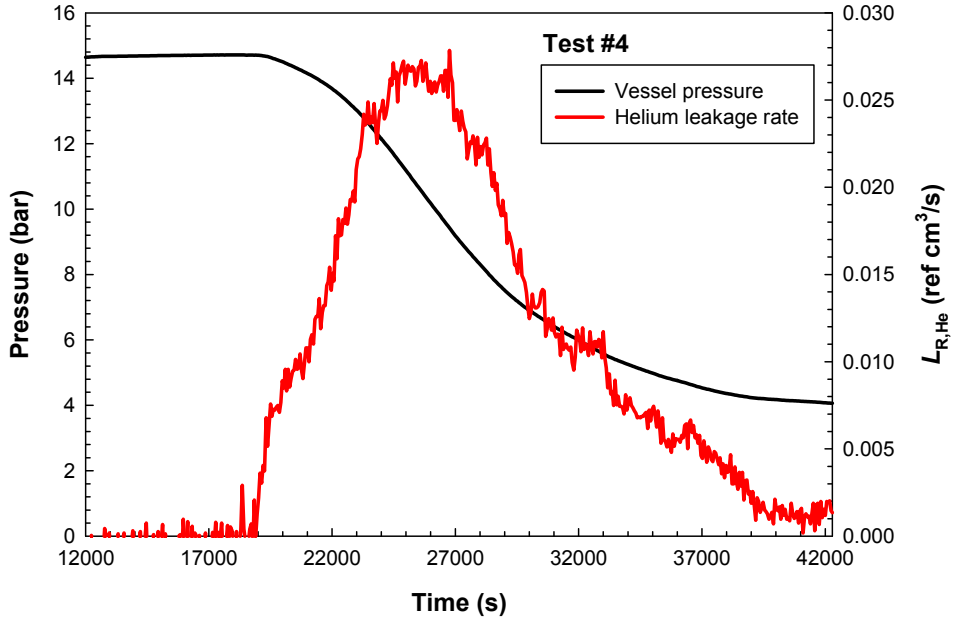
Test #4 is another repeat of the thermal exposure condition used in Test #2. Figure 3-8 shows the test results from Test #4. In this test, the pressure remained relatively constant for about 10 000 s (2.8 h) initially during the 9 h constant-temperature heating phase, begins to drop significantly for about 15 000 s (4.2 h) with large *dP*/*dt*, and decreases slowly with small *dP*/*dt* for the remaining duration. Figure 3-9 shows the complete time-pressure and time-temperature histories of the test. The calculated reference helium leakage rates are shown in Figure 3-10.

It is interesting to note that despite the occurrence of a leak in these two tests (Tests #3, and #4), the vessel pressure did not equilibrate to atmospheric pressure at the end of the cool-down-phase, which took several days. This observation indicated that re-sealing could potentially occur as the vessel was cooled down.

Figure 3-8. Temporal variations of vessel pressure and temperature in Test #4.

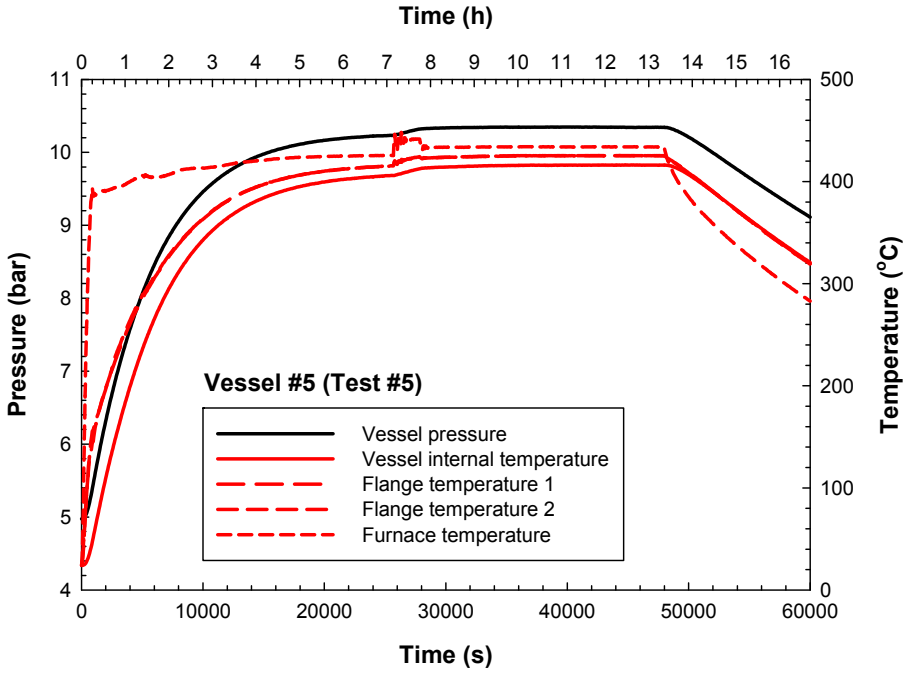
The results for Test #5 are shown in Figure 3-11. The vessel pressure remained constant during the entire 9 h constant-temperature heating period at 427 °C (800 °F). The seal held vessel pressure. This was confirmed as the initial pressure at room temperature was recovered after the cool-down phase. In addition, the pressure remained unchanged for over 140 h after the cool-down. Figure 3-12 shows the complete thermal exposure cycle of the test.

Figure 3-11. Temporal variations of vessel pressure and temperature in Test #5.

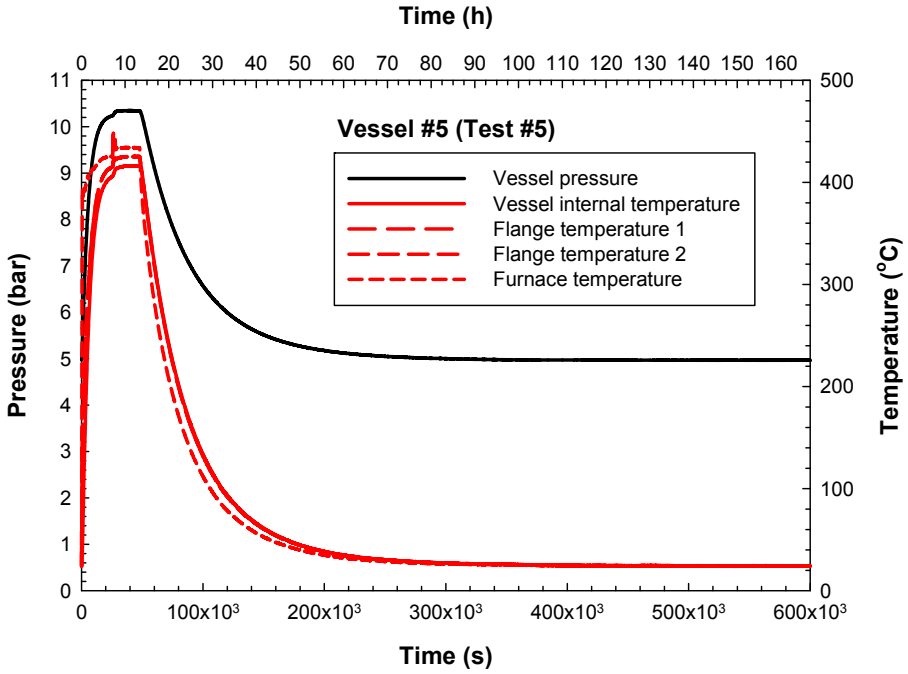
Figure 3-12. Temporal variations of vessel pressure and temperature in Test #5 (time scale extended, including the complete cool-down phase).

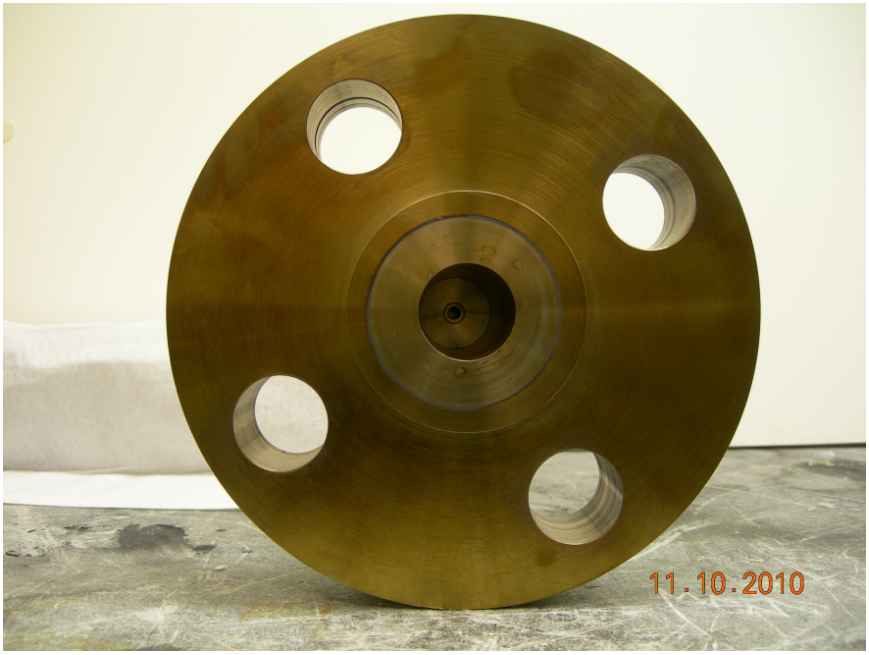
A photograph of the exposed vessel is shown in Figure 3-13. The extent of discoloration of the vessel depends on the test temperature (Figure 3-1 *vs*. Figure 3-13). A post-test inspection revealed that the metallic O-ring seal was not soldered to either flange surfaces, and no silver coating from the seal was transferred to the O-ring groove.

Figure 3-13. Post-test photograph of Vessel #5 (vessel body with O-ring removed) after exposure at 427 °C (800 °F) for 9 h.

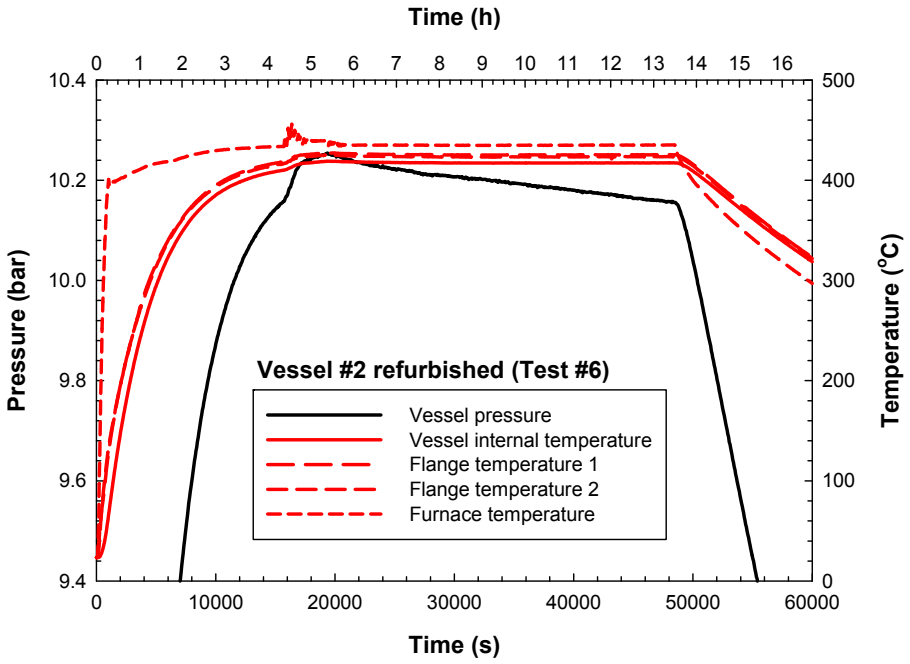
The results for Test #6 using the refurbished Vessel #2 are shown in Figure 3-14. The refurbishment only involved the re-facing of the surfaces of the flanges and O-ring groove to the specified tolerances. For this test, the vessel pressure started to decrease very slowly during the constant-temperature heating period. The scale of the ordinate is magnified in Figure 3-14 to elucidate the continuous decrease in pressure. However, the small pressure drop is within the pressure measurement uncertainty of 0.11 bar. Although the continuous decrease in pressure does seem to imply that a very small leak might have occurred during the test, the initial charge pressure was restored when the vessel was cooled to room temperature after the thermal exposure (as shown in Figure 3-15), an indication of no leakage.

Figure 3-14. Temporal variations of vessel pressure and temperature in Test #6.

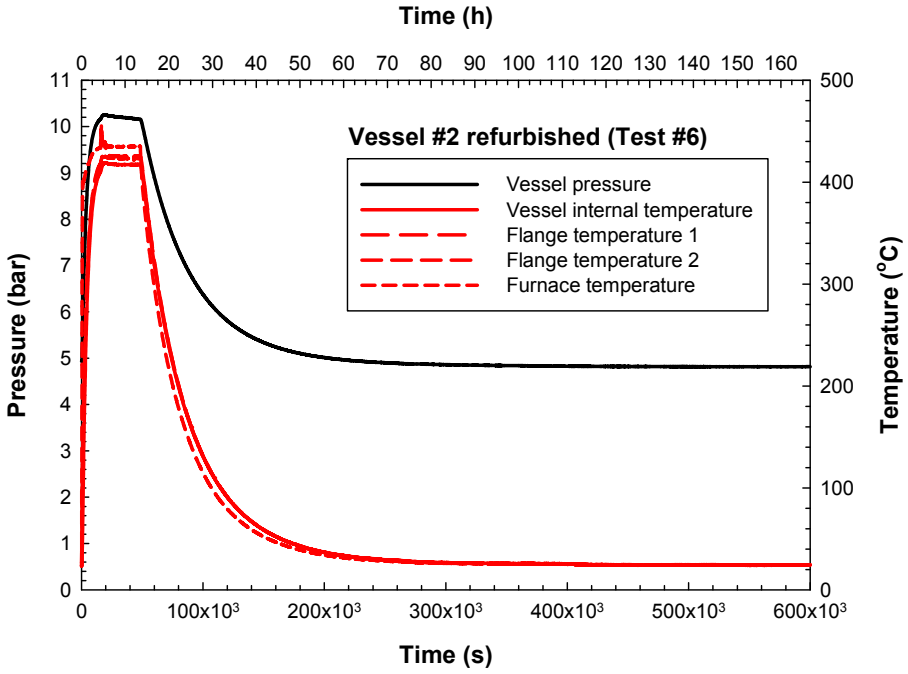
Figure 3-15. Temporal variations of vessel pressure and temperature in Test #6 (time scale extended, including the complete cool-down phase).

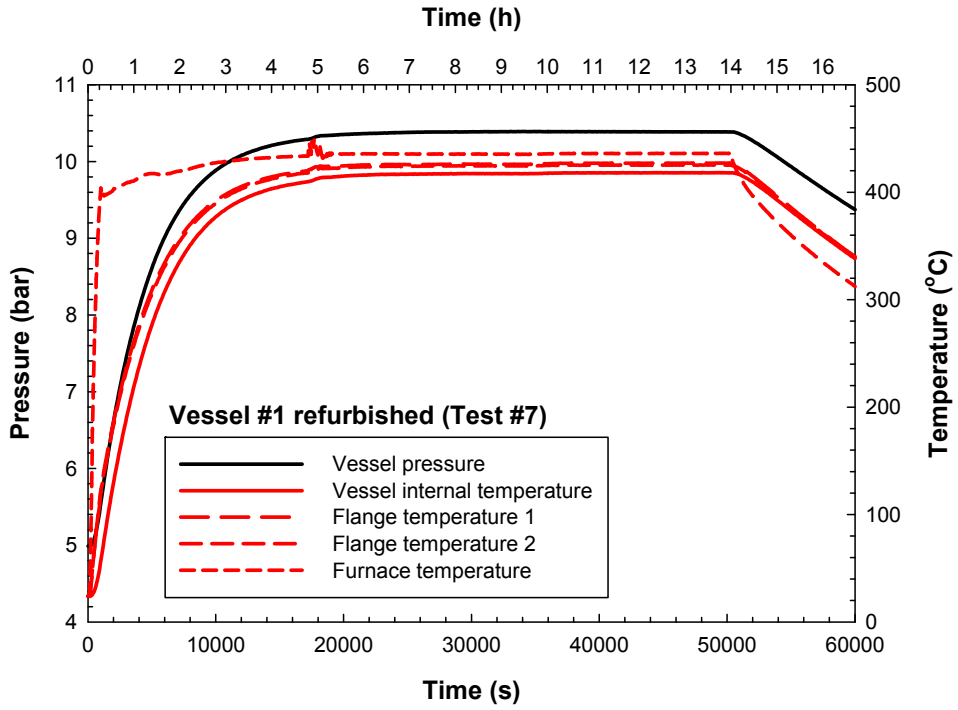
Figure 3-16 shows the results for Test #7 using the refurbished Vessel #1. The same refurbishing process used in Vessel #2 was applied to Vessel #1. As indicated in the figure, the vessel pressure remained unchanged during the 9-hour constant-temperature heating period. No leakage was observed during Test #7. Figure 3-17 is the complete thermal exposure history of Test #7.

Figure 3-16. Temporal variations of vessel pressure and temperature in Test #7.

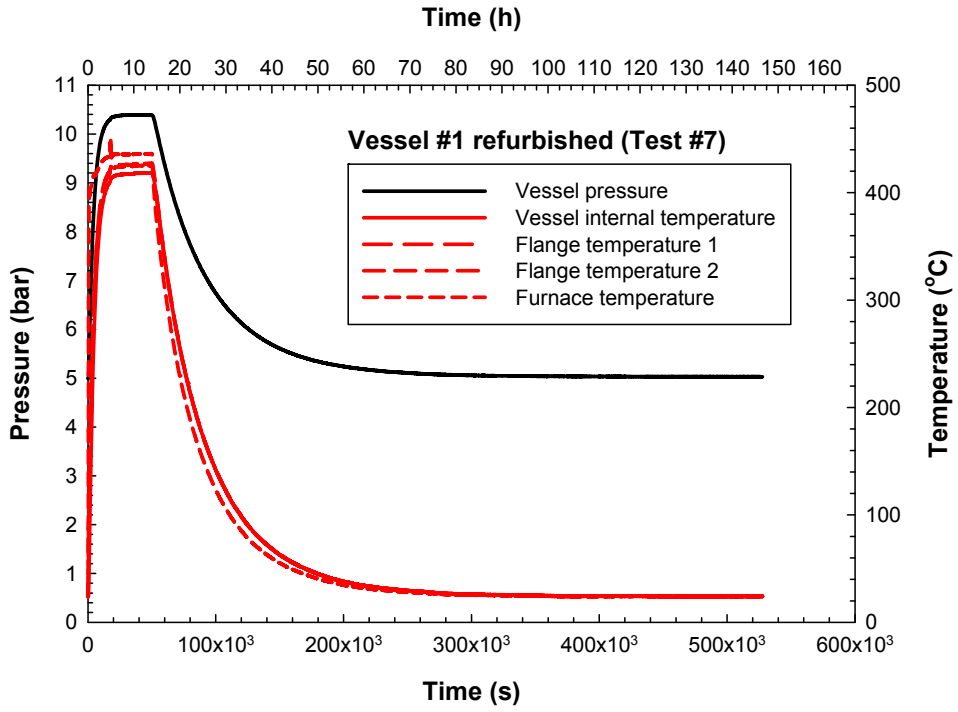
Figure 3-17. Temporal variations of vessel pressure and temperature in Test #7 (time scale extended, including the complete cool-down phase).

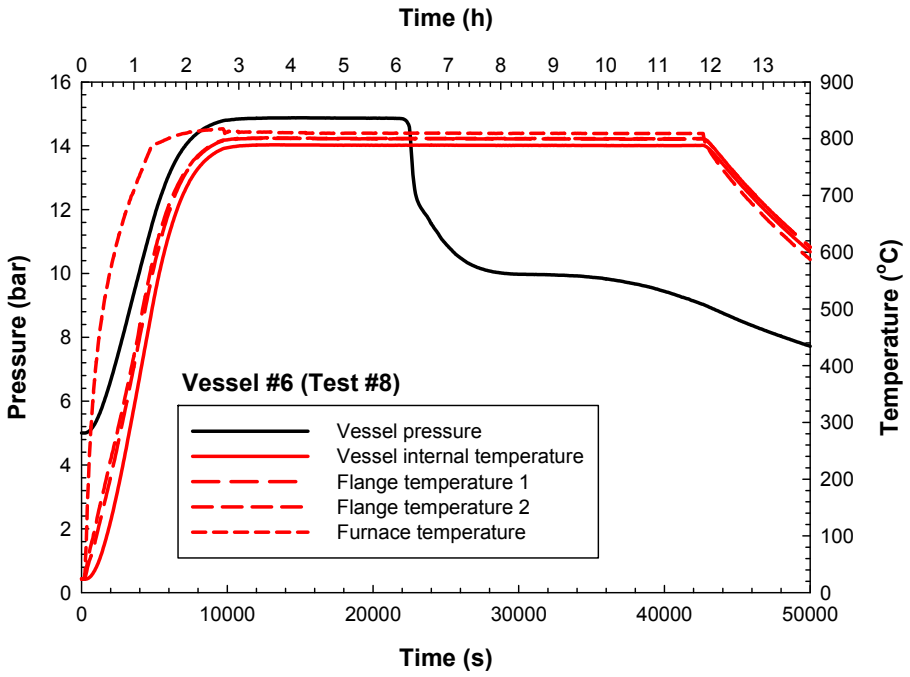
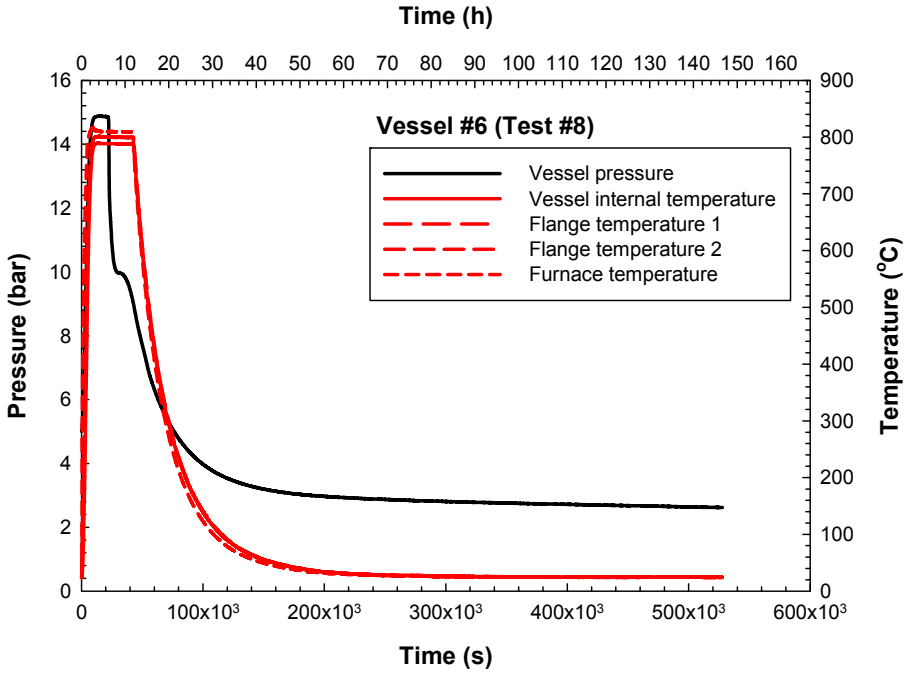
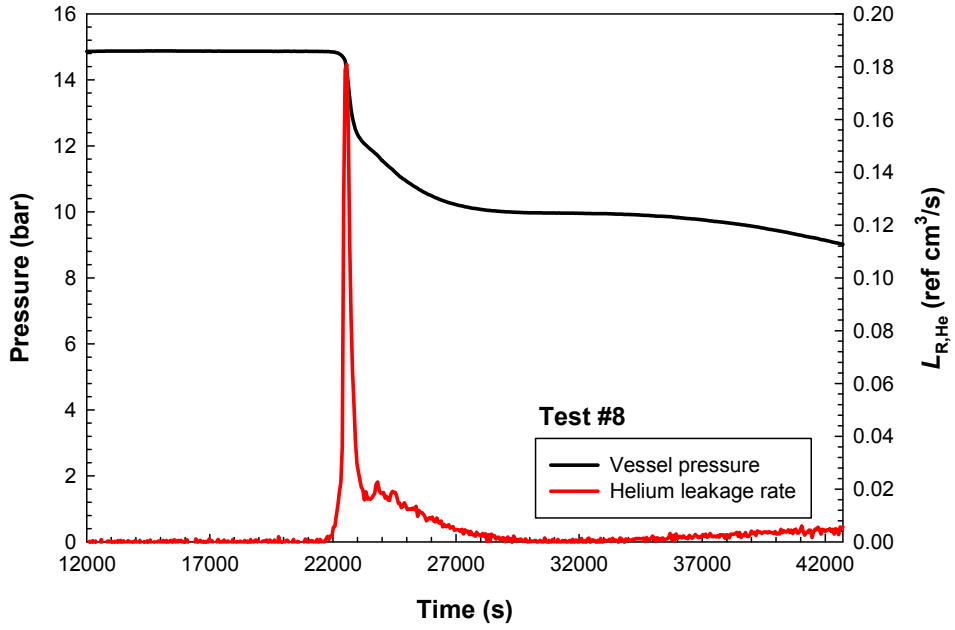
The test conditions were similar to Tests #2, 3, and 4. Figure 3-18 shows the thermal exposure results for Vessel #6. The pressure trace indicates that leakage occurs after about 3 h exposure to 800 °C (1472 °F). For this test, the pressure initially decreases very rapidly, followed by a gradual decrease in vessel pressure. However, the pressure never dropped below 2 bar, indicating that the seal had some residual sealing capacity. Figure 3-19 is the complete time-pressure and time-temperature histories of Test #8. Figure 3-20 shows the calculated isothermal reference helium leakage rates during the 9 h heating.

Figure 3-18. Temporal variations of vessel pressure and temperature in Test #8.

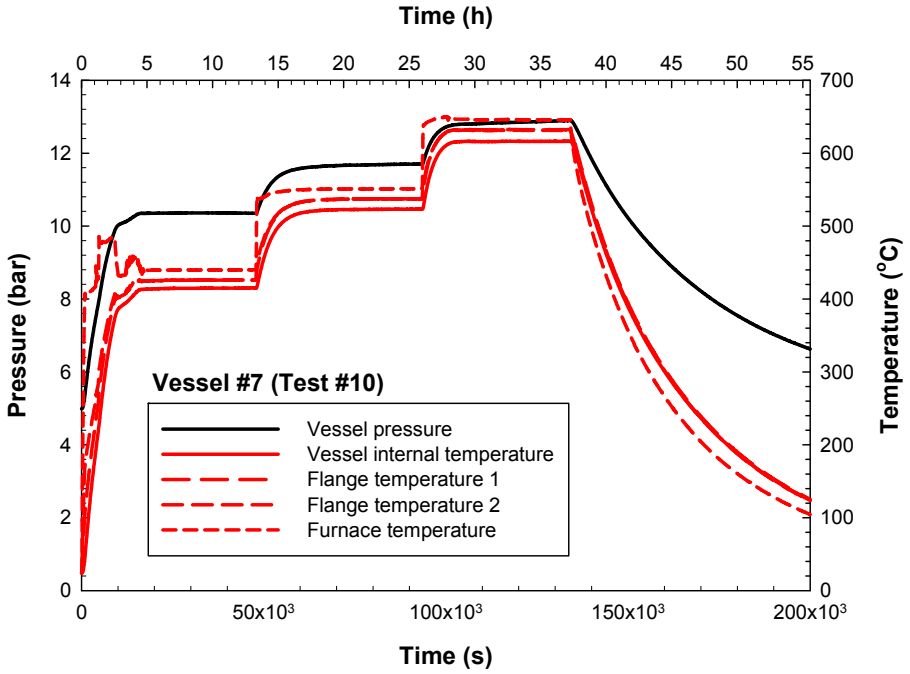
In Test #10, an incremental heating protocol was used to assess the metallic seal performance. The vessel was initially heated to 427 °C (800 °F) and held for 9 h at this temperature. Then, the furnace temperature was raised to 527 °C (981 °F), and the vessel was heated at 527 °C (981 °F) overnight (more than 9 h). The vessel was then heated to 627 °C (1161 °F) for 9 h. Figure 3-25 and Figure 3-26 show the test results. No leak was observed based on the pressure traces at the test temperatures, 427 °C (800 °F), 527 °C (981 °F), and 627 °C (1161 °F), and the recovery of the initial pressure at room temperature. Post-test removal of the O-ring from the groove was very easy. A post-test inspection of the vessel indicated that the metallic seal did not bond onto the O-ring groove.

Figure 3-25. Temporal variations of vessel pressure and temperature in Test #10.

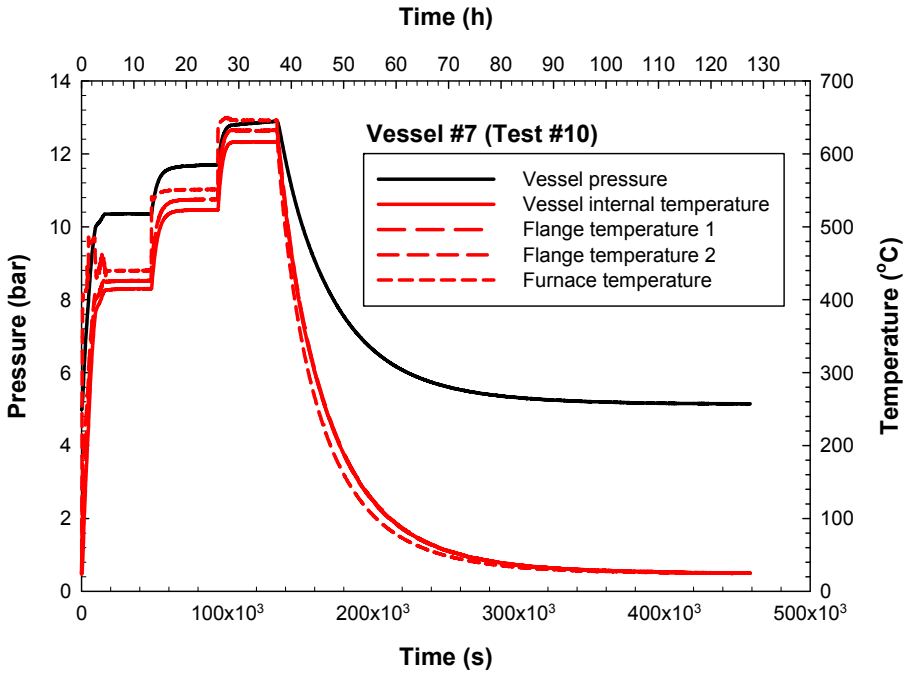
Figure 3-26. Temporal variations of vessel pressure and temperature in Test #10 (time scale extended, including the complete cool-down phase).

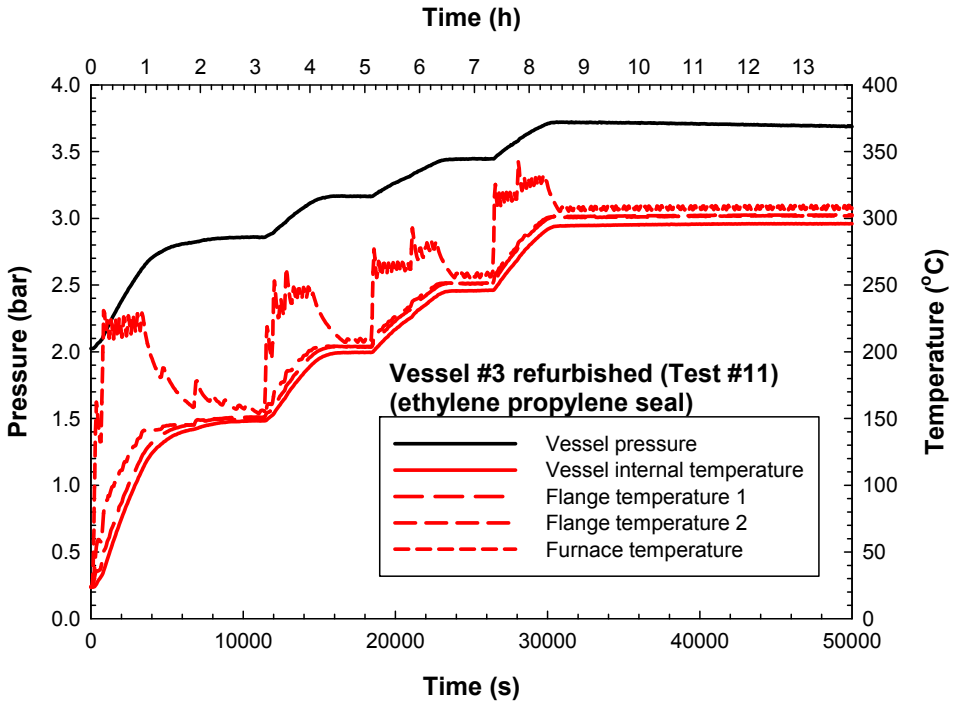
Figure 3-27 and Figure 3-28 are the test results plotted using different time scales. The spikes (overshoots) in the furnace temperature measurements reflect the way the furnace temperature was intentionally ramped and manipulated to accelerate the incremental heating of the vessel to the set temperatures. During the first 1 h heating at 150 °C (302 °F), the vessel pressure remained constant. The subsequent 1 h heating at 200 °C (392 °F) and the following 1 h heating at 250 °C (482 °F) also indicated the maintenance of vessel pressure. The final heating at 300 °C (572 °F) for more than 20 h shows a slow decrease in pressure, albeit within the pressure measurement uncertainty. However, the vessel pressure was restored to its initial value after the thermal exposure test, as shown in Figure 3-28. Post-test inspection of the exposed vessel revealed that the O-ring was still pliable and could be easily removed from the O-ring groove.

Figure 3-27. Temporal variations of vessel pressure and temperature in Test #11.

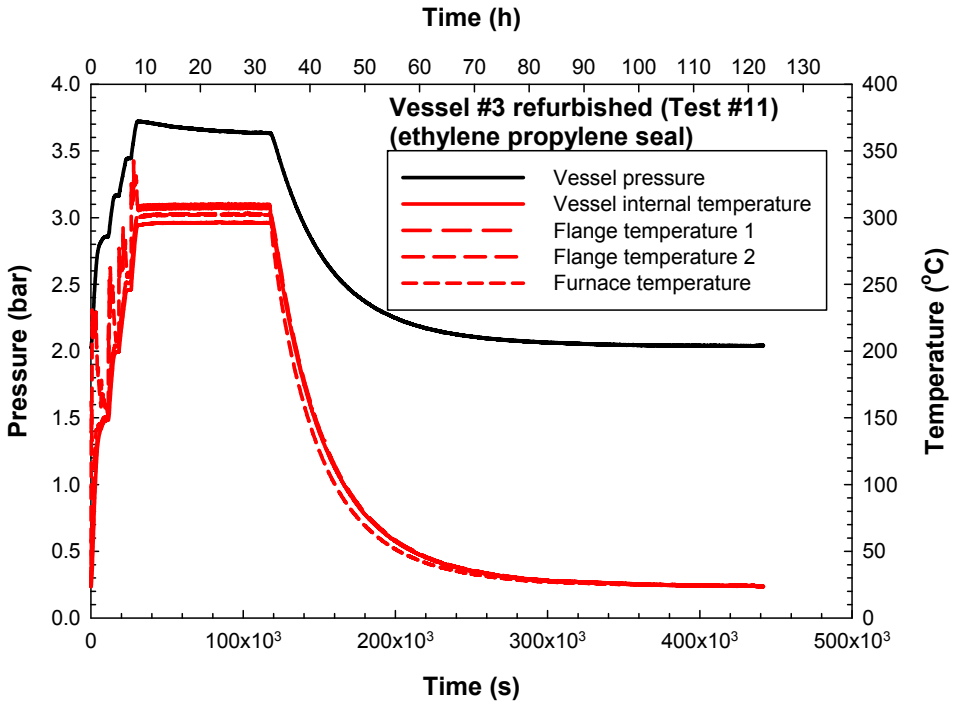
Figure 3-28. Temporal variations of vessel pressure and temperature in Test #11 (time scale extended, including the complete cool-down phase).

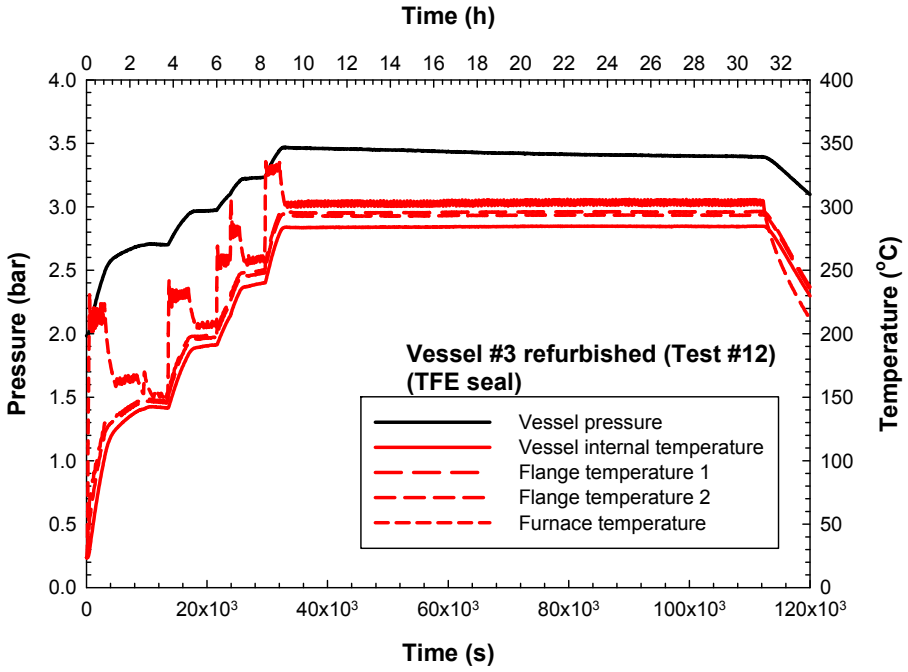
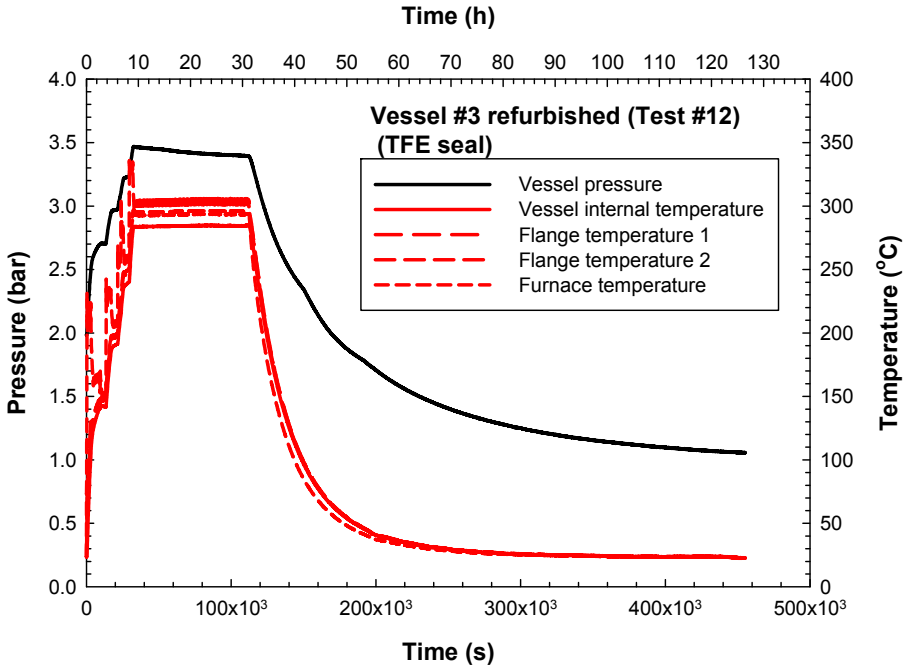
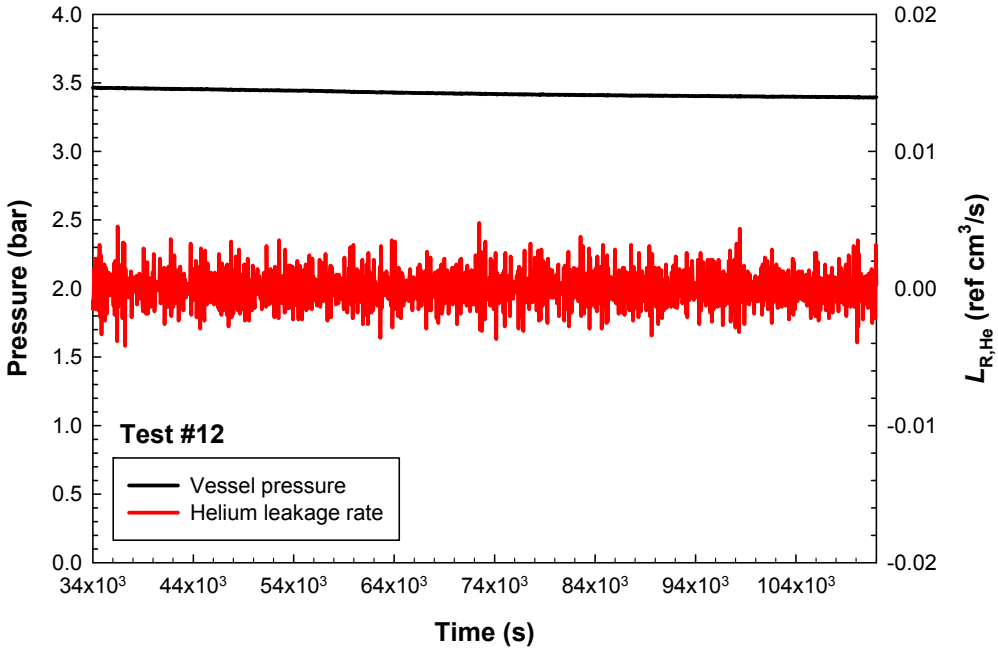
A PTFE O-ring (DBR Industries 228 PTFE, Lot #04/07 12730-1) with an outer diameter of 6.35 cm (2.5 in.) and a cross section of 0.32 cm (0.125 in.) and refurbished Vessel #3 was used for this test. The refurbishment of the vessel simply consisted of cleaning of the O-ring groove previously used for the ethylene propylene seal test (Test #11). Figure 3-29 and Figure 3-30 show the results during the heating phase and the complete heating-cooling history respectively. During the 22 h heating at 300 °C (572 °F), there was a slight drop in vessel pressure at the end of the isothermal heating phase; however, the pressure decrease was within the measurement uncertainty of the pressure transducer. Figure 3-31, which shows the calculated reference helium leakage rates during the 22 h heating period, indicates a time-averaged reference leakage rate of 4.5×10^{-5} ref·cm^3/s. The fluctuation in the leakage rate data was due to taking of numerical time derivatives of the unsmoothed pressure-time data. As indicated in the pressure trace, leakage was observed in this test during the cooling phase. The original pressure (≈ 2 bar) did not recover, and the vessel pressure dropped below the original pressure at room temperature. Post-test inspection of the exposed vessel revealed that the compressed O-ring was still intact and could be easily removed from the O-ring groove.

Figure 3-29. Temporal variations of vessel pressure and temperature in Test #12.

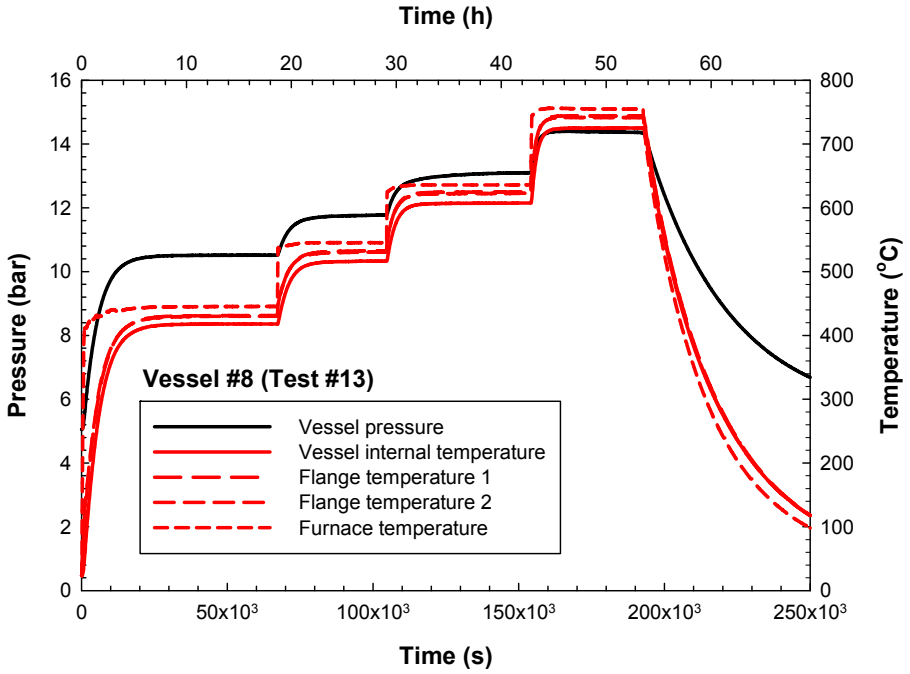
For Test #13, a metallic seal and a new vessel were used. The vessel was evacuated (for 1 min) and filled with helium (to 5 bar) and then evacuated and filled again twice. Contrary to the previous vessel filling process used in Tests #1 to #12, two additional evacuating and filling cycles were applied in order to determine if the evacuation process had any effect on the results.[9] In this test, an incremental heating protocol was used. The test vessel was first heated at 427 °C for more than 10 h, then at 527 °C for 9 h, then at 627 °C for more than 10 h, and finally at 727 °C for 9 h. Figure 3-32 and Figure 3-33 show the results. No leakage was observed during the entire incremental heating processes. However, after the vessel was cooled down to room temperature, the vessel pressure did not recover to its original (starting) value (≈ 5 bar) but remained at a slightly higher constant value of ≈ 5.2 bar over a duration of more than 50 h, albeit within the uncertainty of the transducer. This was not due to the drift of the pressure transducer because when the vessel content was vented to the atmosphere, the pressure transducer showed an atmospheric pressure reading.

Figure 3-32. Temporal variations of vessel pressure and temperature in Test #13.

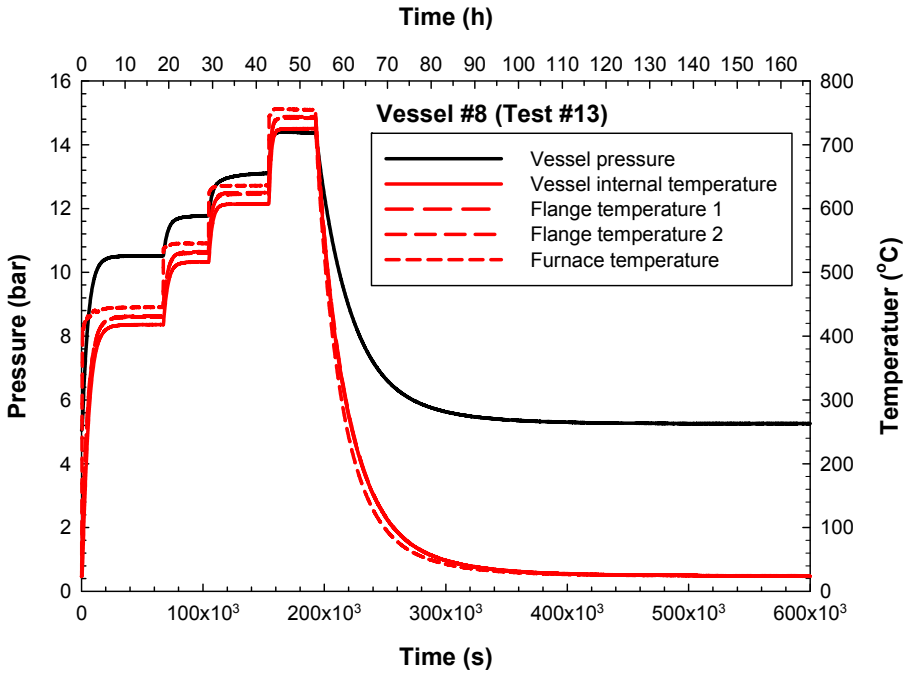
Figure 3-33. Temporal variations of vessel pressure and temperature in Test #13 (time scale extended, including the complete cool-down phase).
