NUREG/CR-7115

Performance of Metal and Polymeric O-Ring Seals in Beyond-Design-Basis Temperature Excursions

Office of Nuclear Regulatory Research

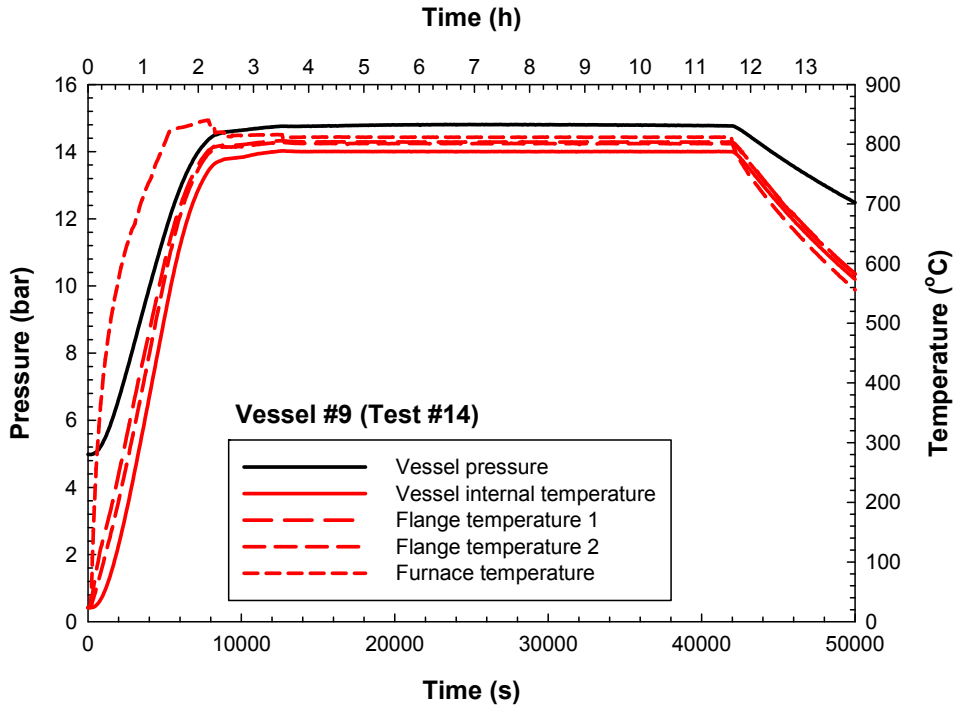
In Test #14, a new vessel with a metallic seal was used. The vessel was evacuated and charged with helium three times to prepare for the test. This test was a repeat of Tests #2, #3, and #4. Figure 3-34 shows the first 50 000 s (≈ 14 h) of the pressure-time and temperature-time histories to illustrate the absence of a leak (constant pressure at constant temperature). The pressure-time and temperature-histories during the complete heating and cooling cycle is shown in Figure 3-35. However, similar to the observation in Test #13, after the test vessel was cooled down to room temperature, the vessel pressure did not recover to its starting value (≈ 5 bar) but remained at a slightly higher constant value of ≈ 5.2 bar over a duration of more than 50 h. Again, this was not due to the drift of the pressure transducer because when the vessel content was released to the atmosphere, the pressure transducer gave an atmospheric pressure reading.

Figure 3-34. Temporal variations of vessel pressure and temperature in Test #14.

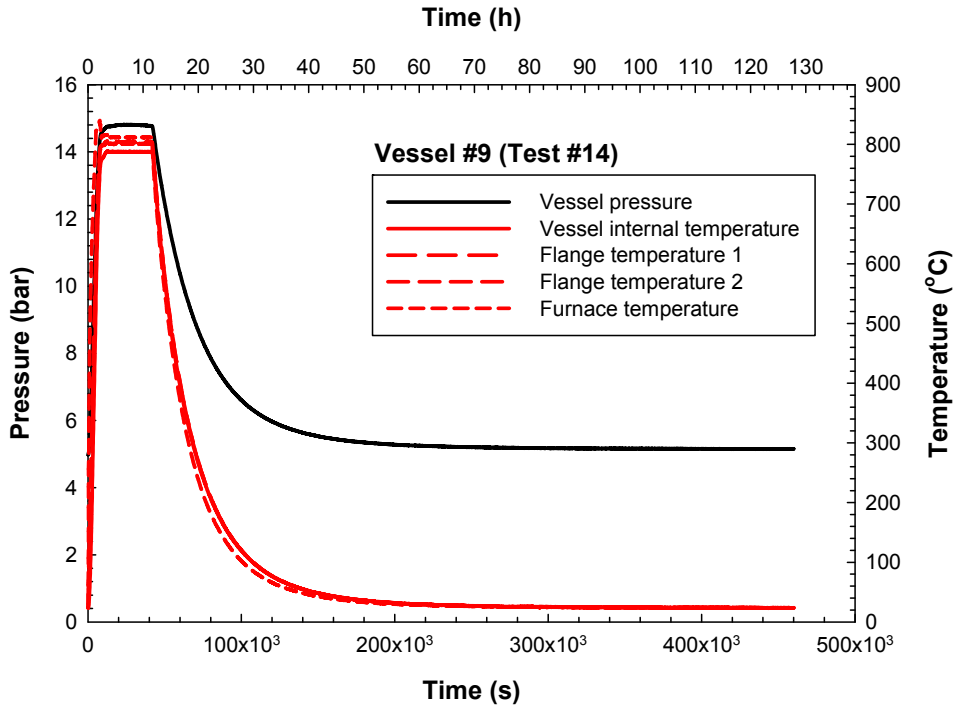
Figure 3-35. Temporal variations of vessel pressure and temperature in Test #14 (time scale extended, including the complete cool-down phase).

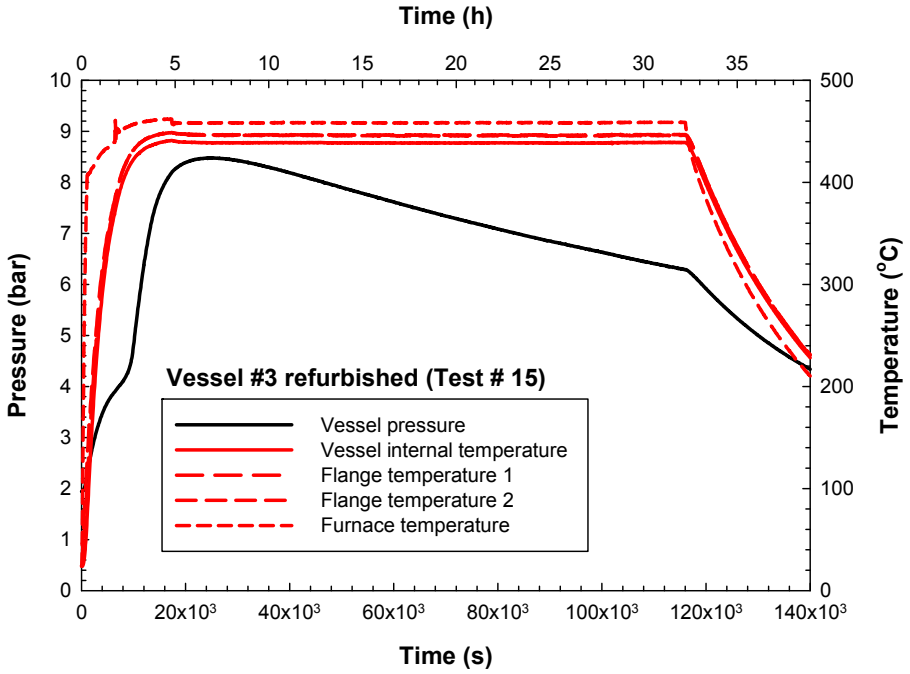
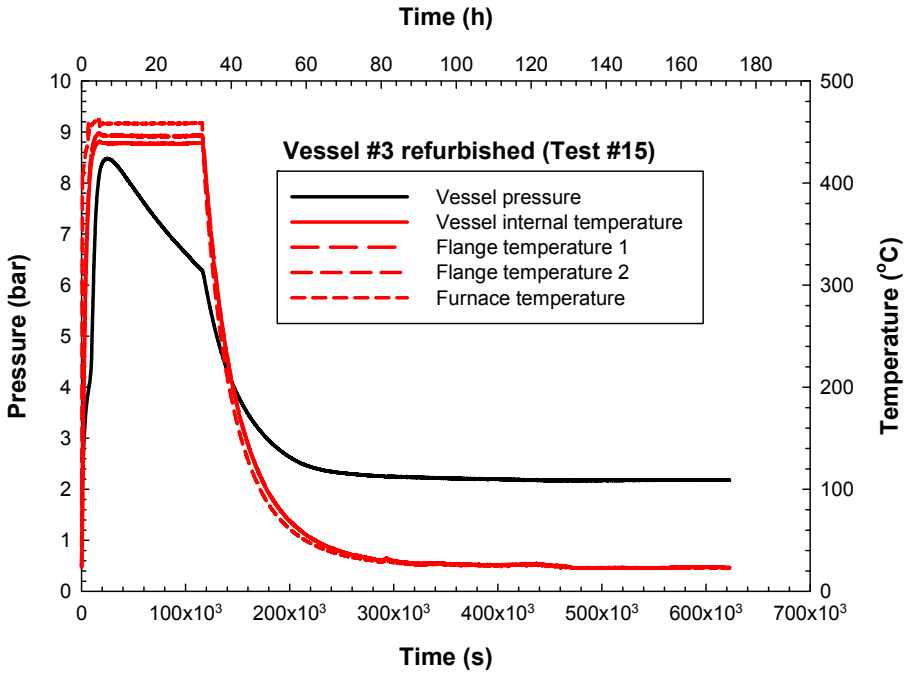
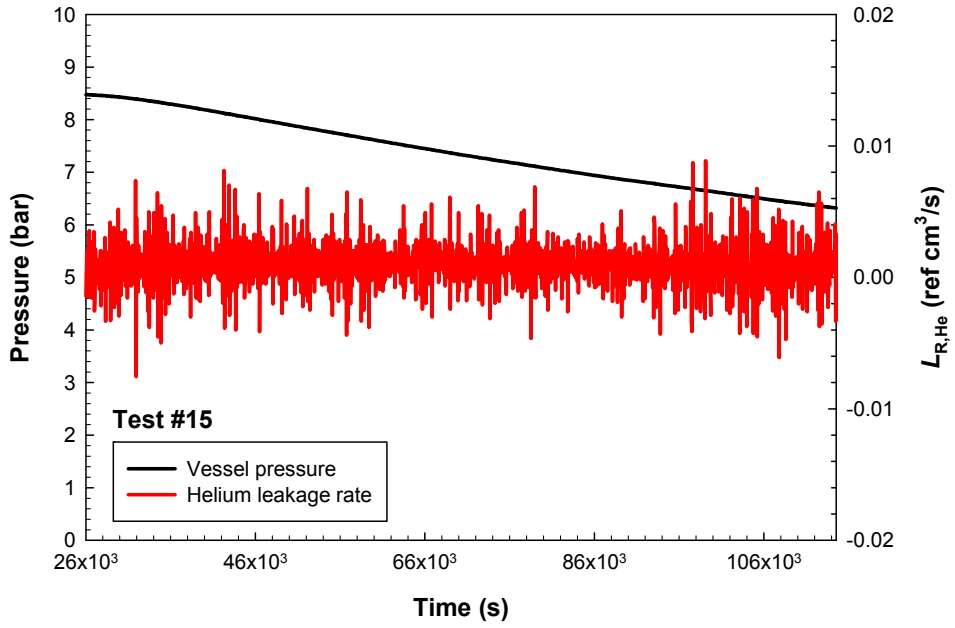
Figure 3-36 shows the first 39 h of the pressure-time and temperature-time histories obtained from this test. The pressure and temperature histories for the complete heating and cooling cycle are given in Figure 3-37. The pressure trace in Figure 3-36 clearly indicates a leak occurred soon after the vessel had attained the nominal target temperature of 450 °C (842 °F). Figure 3-38 shows the calculated reference helium leakage rates over the 25 h isothermal heating period at 450 °C (842 °F) with a time-averaged reference leakage rate of 9.2×10^{-4} ref·cm^3/s.

Figure 3-36. Temporal variations of vessel pressure and temperature in Test #15.

From Figure 3-36 and Figure 3-37, a peculiarity is noted. The measured attainable pressure (≈ 8.5 bar) at 450 °C (842 °F) before the leak occurred is noticeably higher than the pressure calculated using the ideal gas law (≈ 4.9 bar), even assuming no thermal expansion of the vessel volume. The addition of vapor mass from the potential thermal decomposition and off-gas of the O-ring and the lubricant used at 450 °C (842 °F) is conjectured to be the cause for this unusually high pressure. Another abnormality is that after the vessel was cooled down to room temperature, the pressure never recovered to its original value (≈ 2 bar) but remained relatively constant at ≈ 2.16 bar over a duration of more than 100 h, implying the O-ring still possessed some residual sealing capability. A post-test inspection of the tested vessel revealed that the interior vessel wall and the thermocouple inserted into the vessel interior were coated with a thin layer of black substance. Although the O-ring was still properly seated in the groove (see Figure 3-39), it had turned into a packed layer of powdery charred material and could not be removed from the groove without destroying its structural integrity (see Figure 3-40). Additional tests would be needed to further examine this finding.
