NUCLEAR REGULATORY COMMISSION

Title: Advisory Committee on Reactor Safeguards
595th Meeting

Date: Thursday, June 7, 2012

Brunswick Unit 2 - Failure to Properly Tension the Reactor Vessel Head Following Maintenance Outage

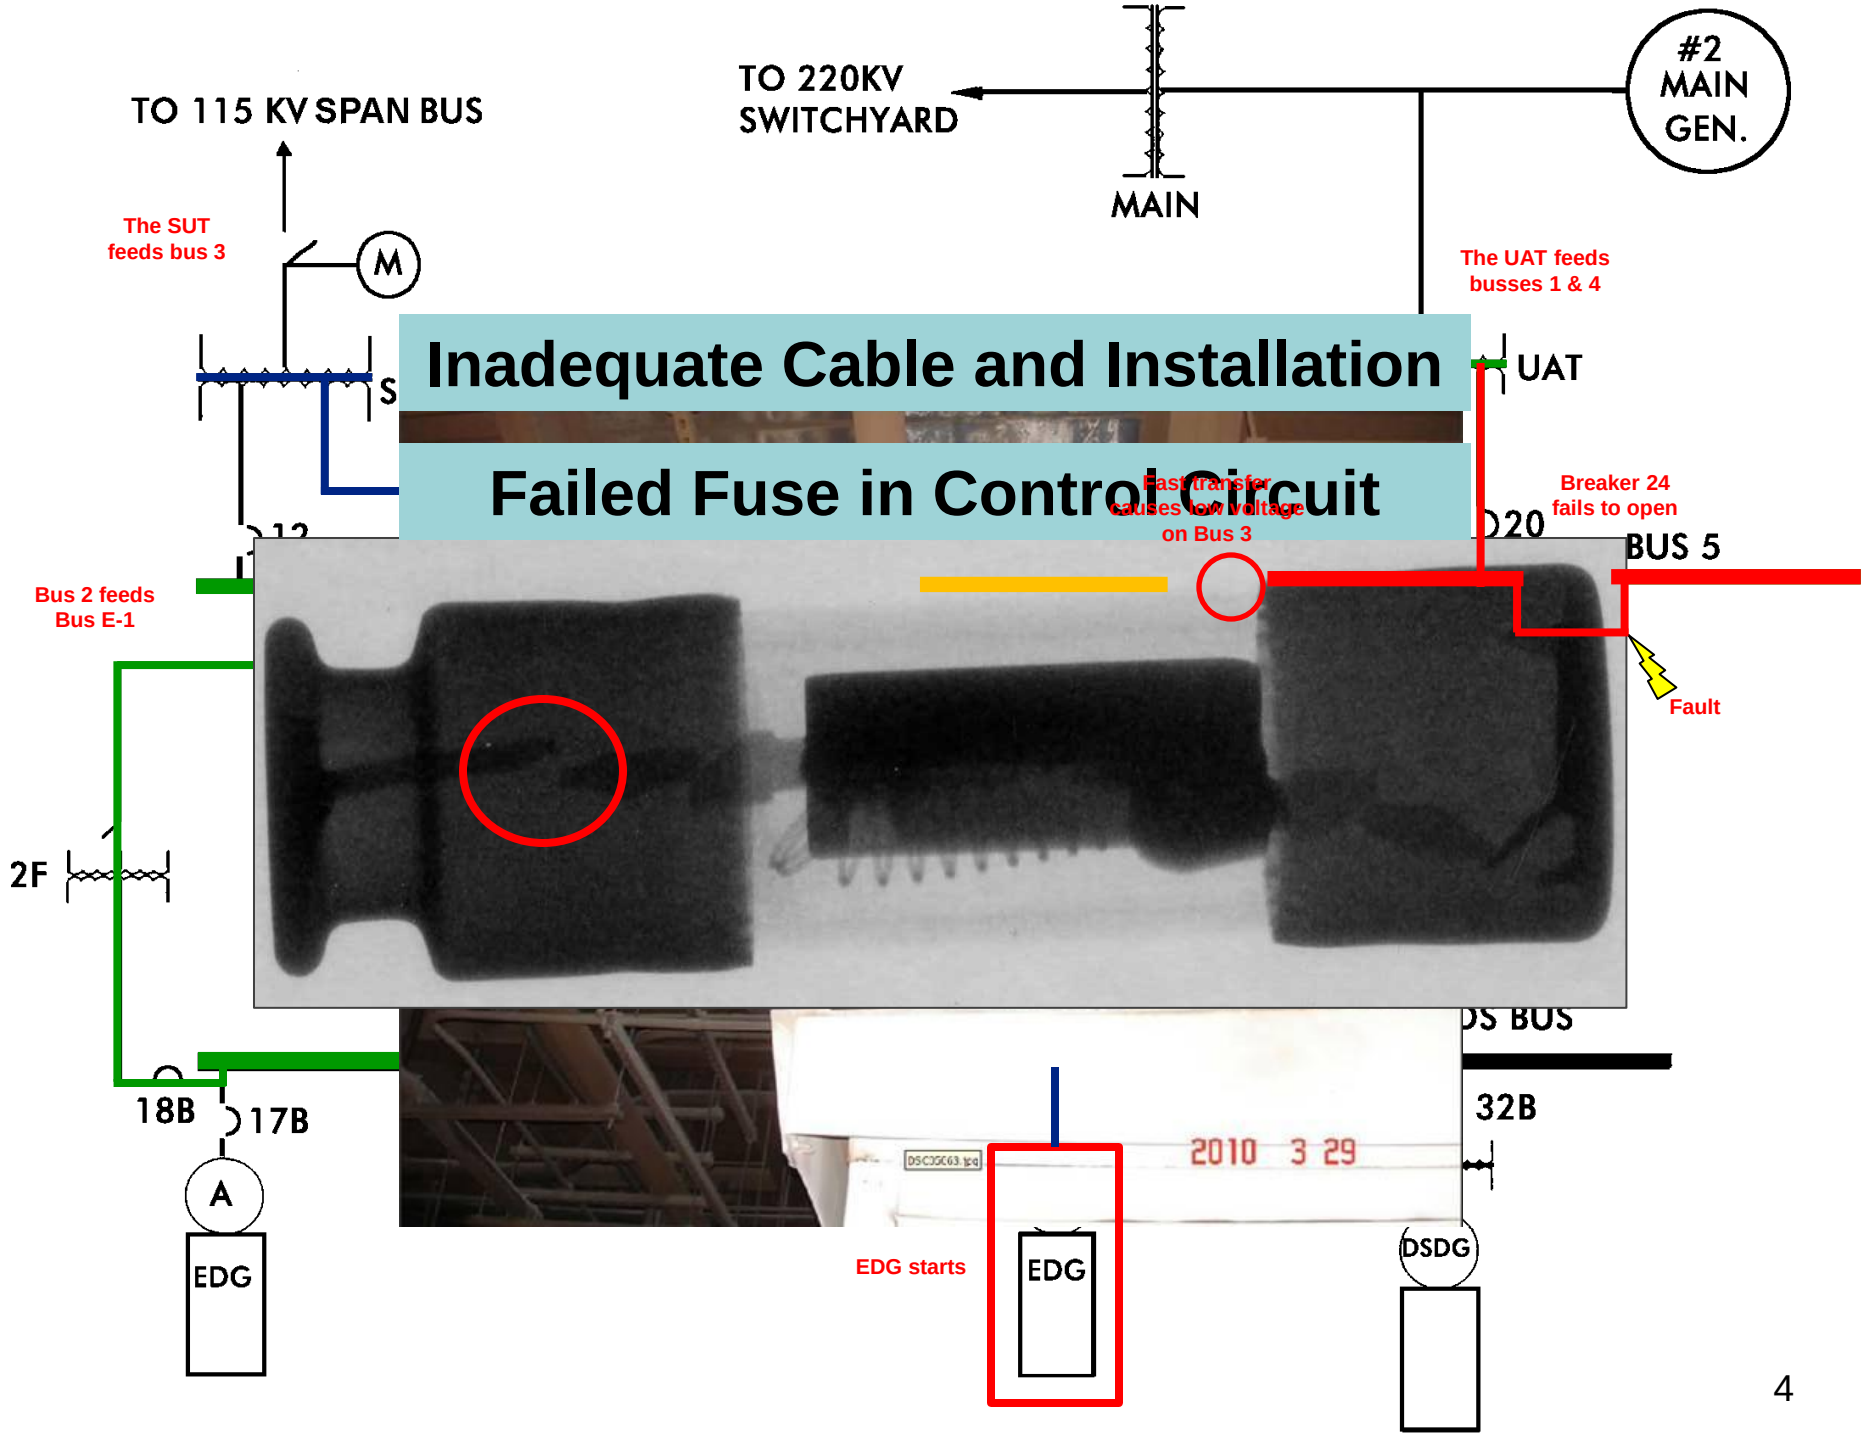
Inadequate Cable and Installation

Failed Fuse in Control Circuit

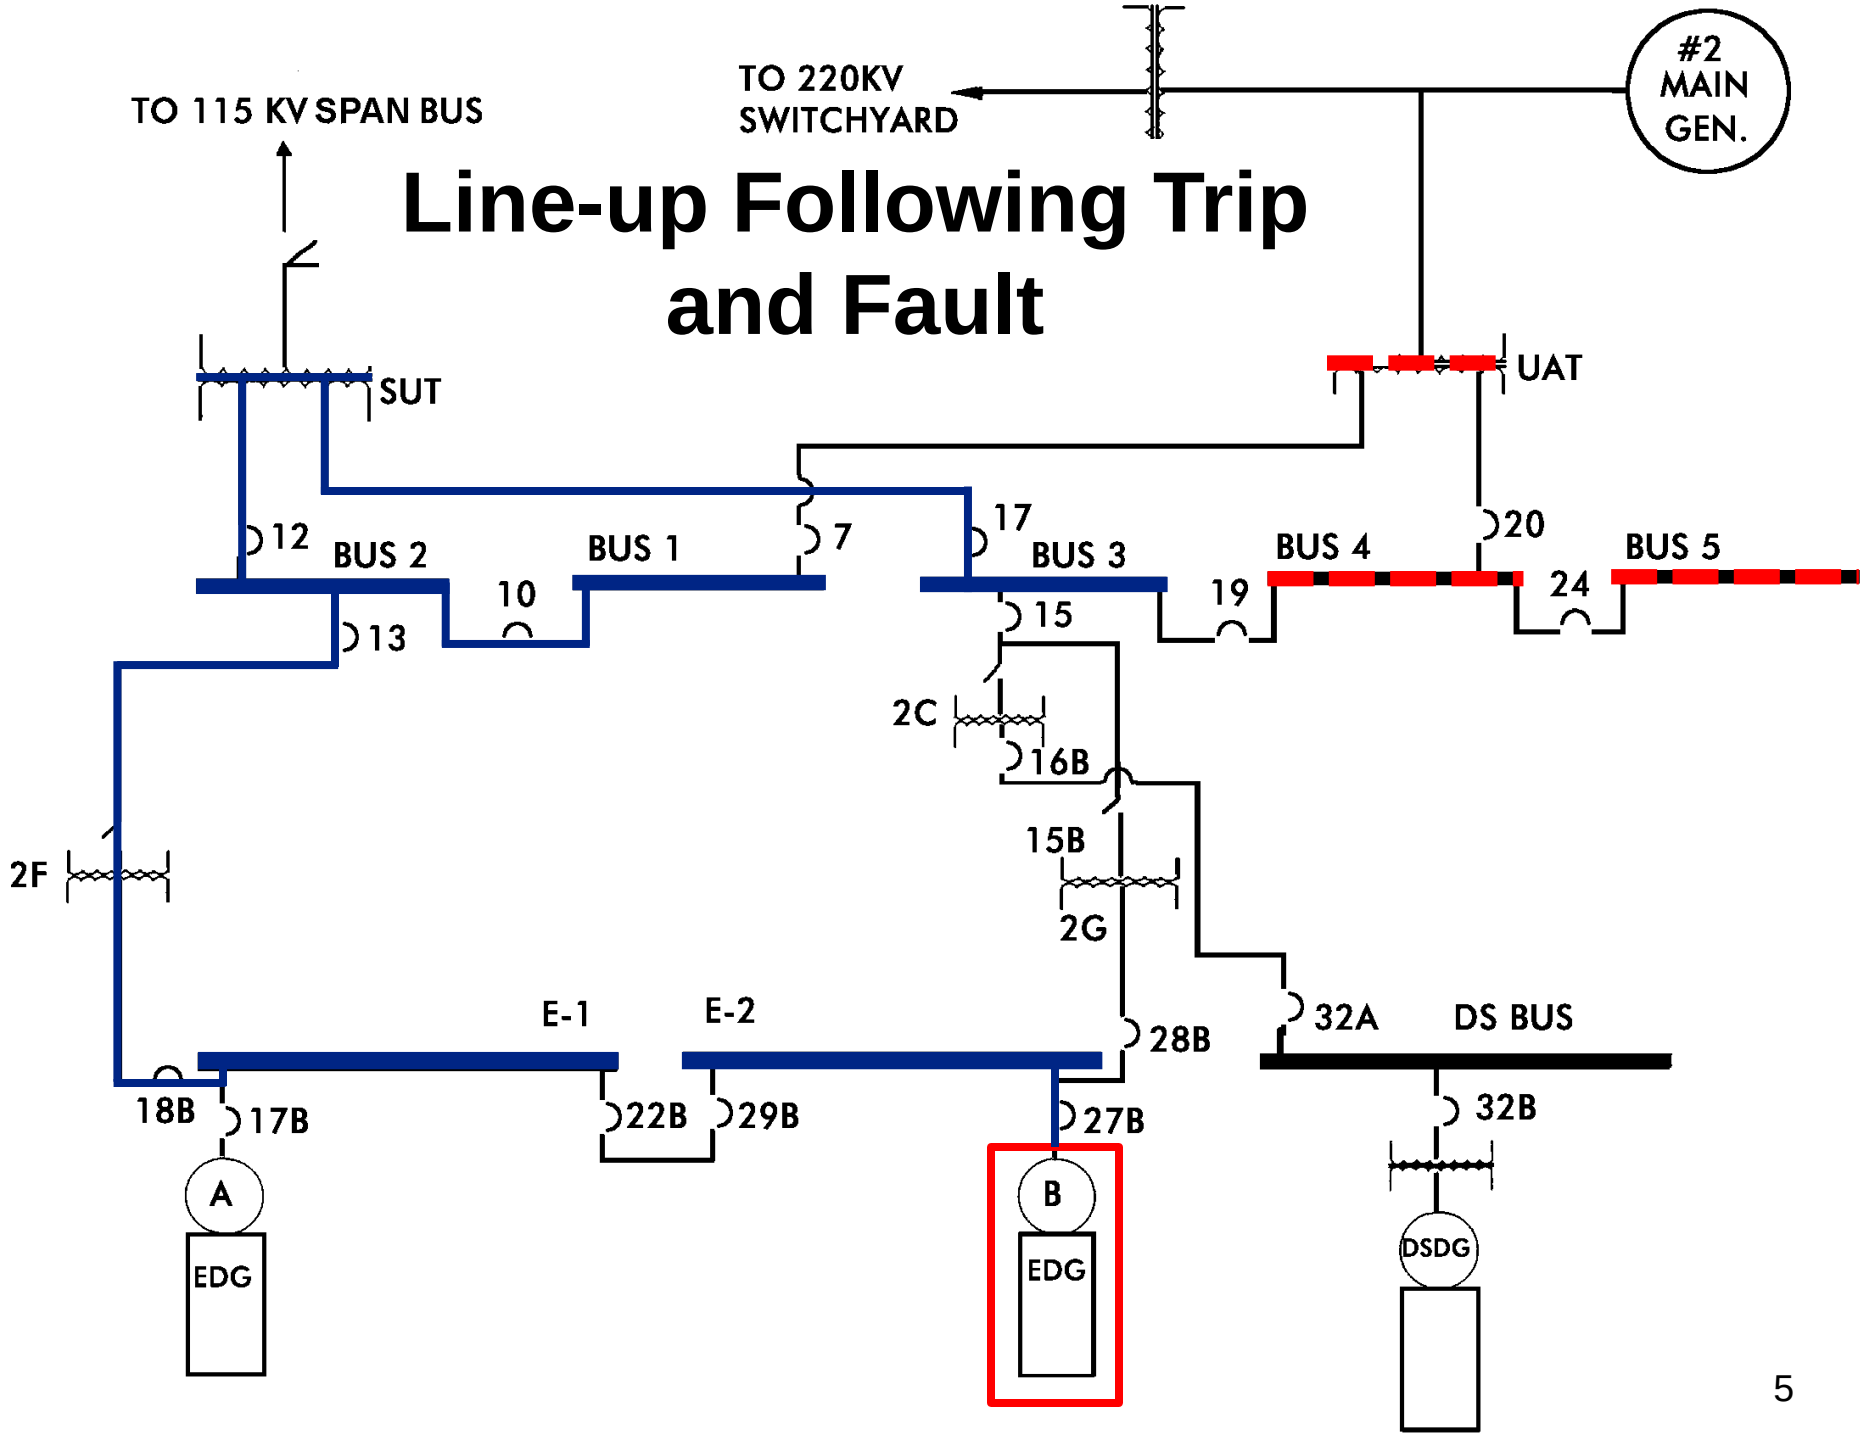
Line-up Following Trip and Fault

MR. ROBLES: Okay. So, the line up following the trip and fault is the unit auxiliary transformer failed, buses 4 and 5 are de-energized, breaker 24 is still closed because it doesn't have control power to open, breaker 20 open, 19 initially tried to close for the fast transfer but it ended up opening, so the start up transformers feeding buses 1, 2, and 3 and bus E-1 is fed by bus 2 as the normal line up, but bus E-2 is being fed by the emergency diesel generator.

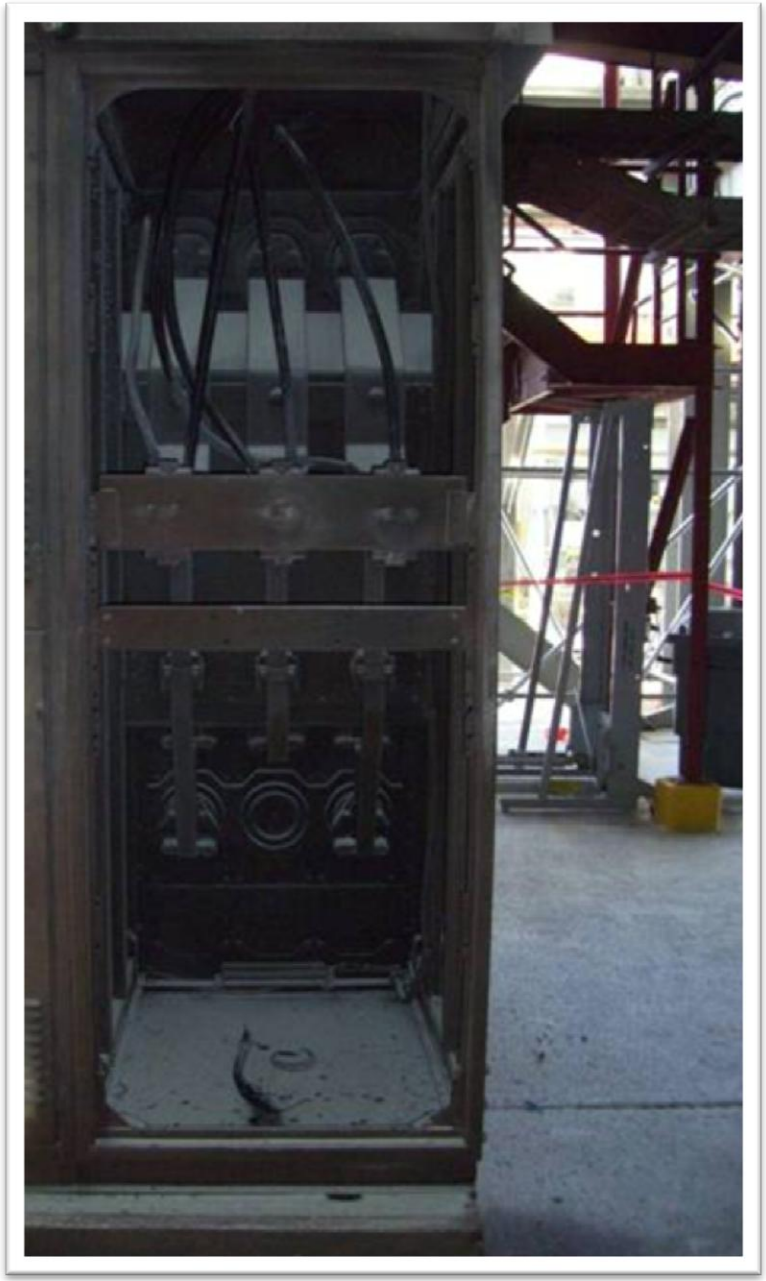
4160V Bus 5

This is a picture of bus 5, which is -- up here is where the fault started. That's where the cable failed and burned. And these are just from two different angles. This is basically showing the damage of all the smoke and soot. And this picture is the back of bus 4 where breaker 24 is, the breaker that failed to open. That breaker -- that panel blew up and caused damage on an adjacent panel that caused one of the trains of DC got grounded because of this, and the

damage to the other one got the grounds on the other train of DC. And these two pictures just show the top of 4160 plus 5, and the cable trays on top of that, some of the soot and fire damage. And this is an actual closeup of the conduit of the cable that failed that started the initial faults.

Side of bus 5

Back of bus 5

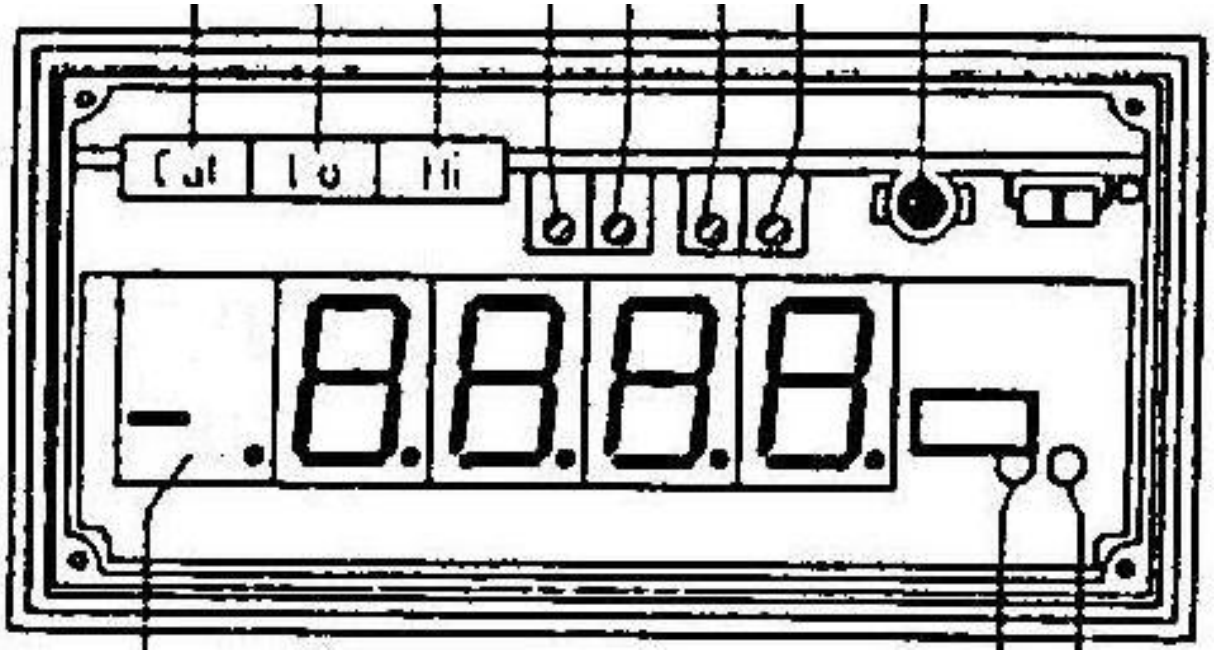
Hydraulic Tensioner Display

MR. GARMON: The immediate cause of the event is that the -- obviously, the operator did not tension the head properly onto the vessel. This happened because they misinterpreted readings on the hydraulic tensioner display.

- Personnel misinterpreted the readings on the hydraulic tensioner
  - Instead of applying the required 13,000 psi, the operators only applied 1,300 psi
