THE ACCIDENT AT THREE MILE ISLAND

Reports Of The Technical Assessment Task Force, Vol. IV

REPORTS OF THE
TECHNICAL ASSESSMENT TASK FORCE

QUALITY ASSURANCE

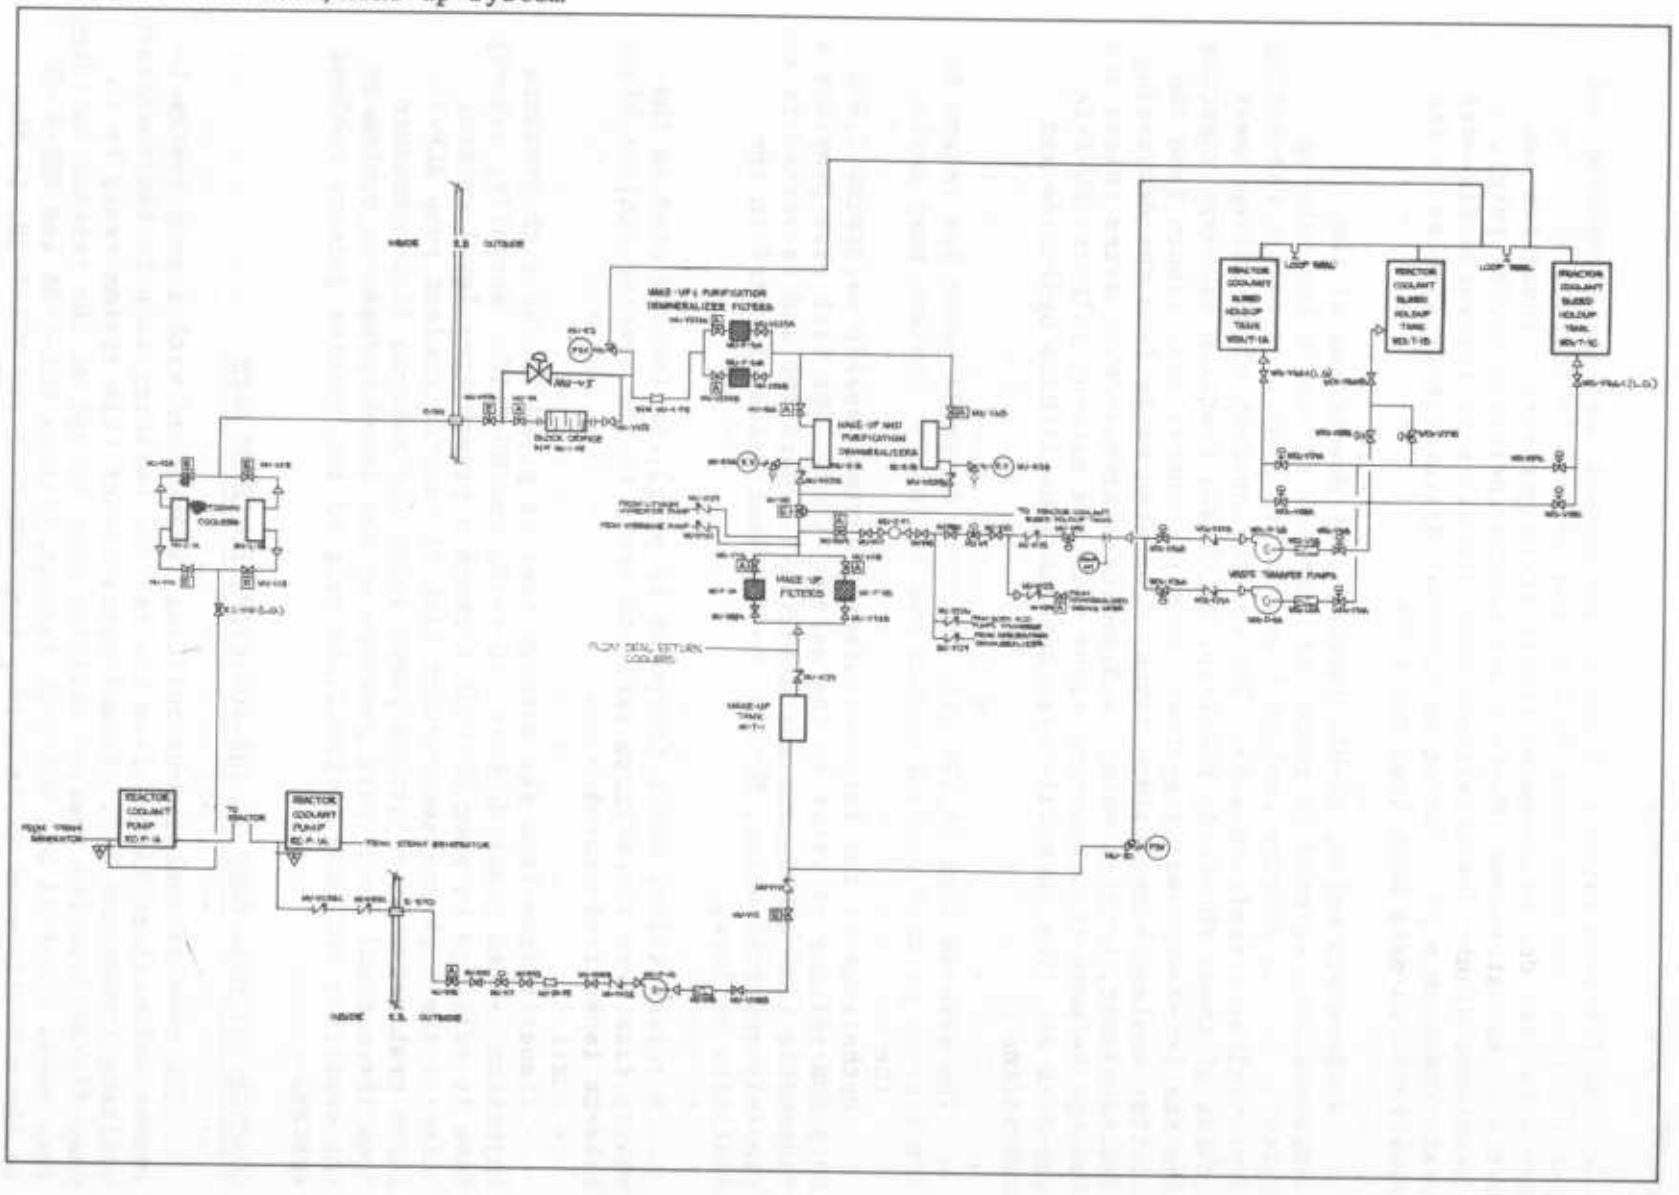
FIGURE 1: Let-Down/Make-up System

It is important to note that if the let-down/make-up system is in operation with the valves open upstream of the block orifice valve and a block or obstruction is effected downstream, this pressure relief valve MU-R3 relieves pressure by venting to the reactor coolant bleed holdup tanks (reference 6). The same relief is provided if the overpressure is caused by dissolved gases.

A remotely operated diaphragm bypass valve is installed parallel to the block orifice valve and is used to maintian adequate flows at reduced reactor coolant pressures.

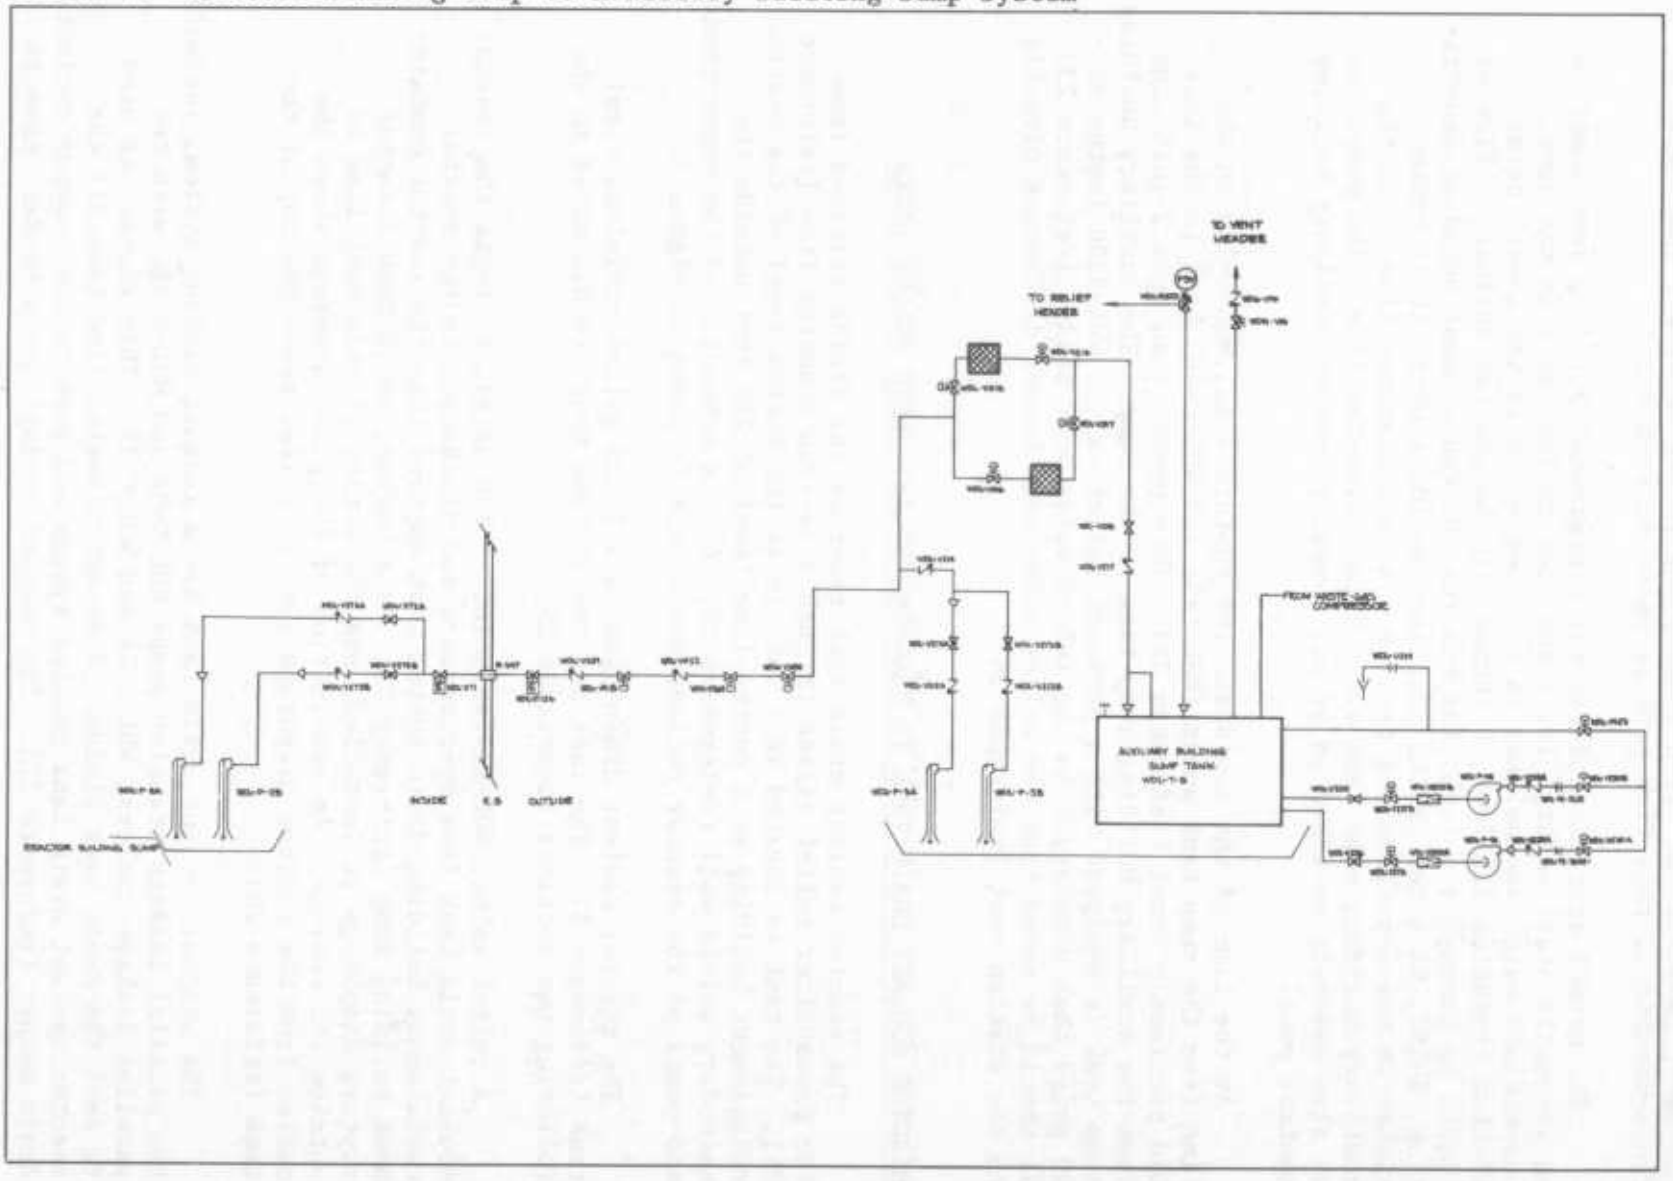
FIGURE 2: Reactor Building Sump to Auxiliary Building Sump System

auxiliary building sump tank. Consensus of operating personnel and level readings of the miscellaneous waste holdup tank before and after the event indicate the valve line-up was to the auxiliary sump tank. The schematic of this flow path is shown in Figure 2.

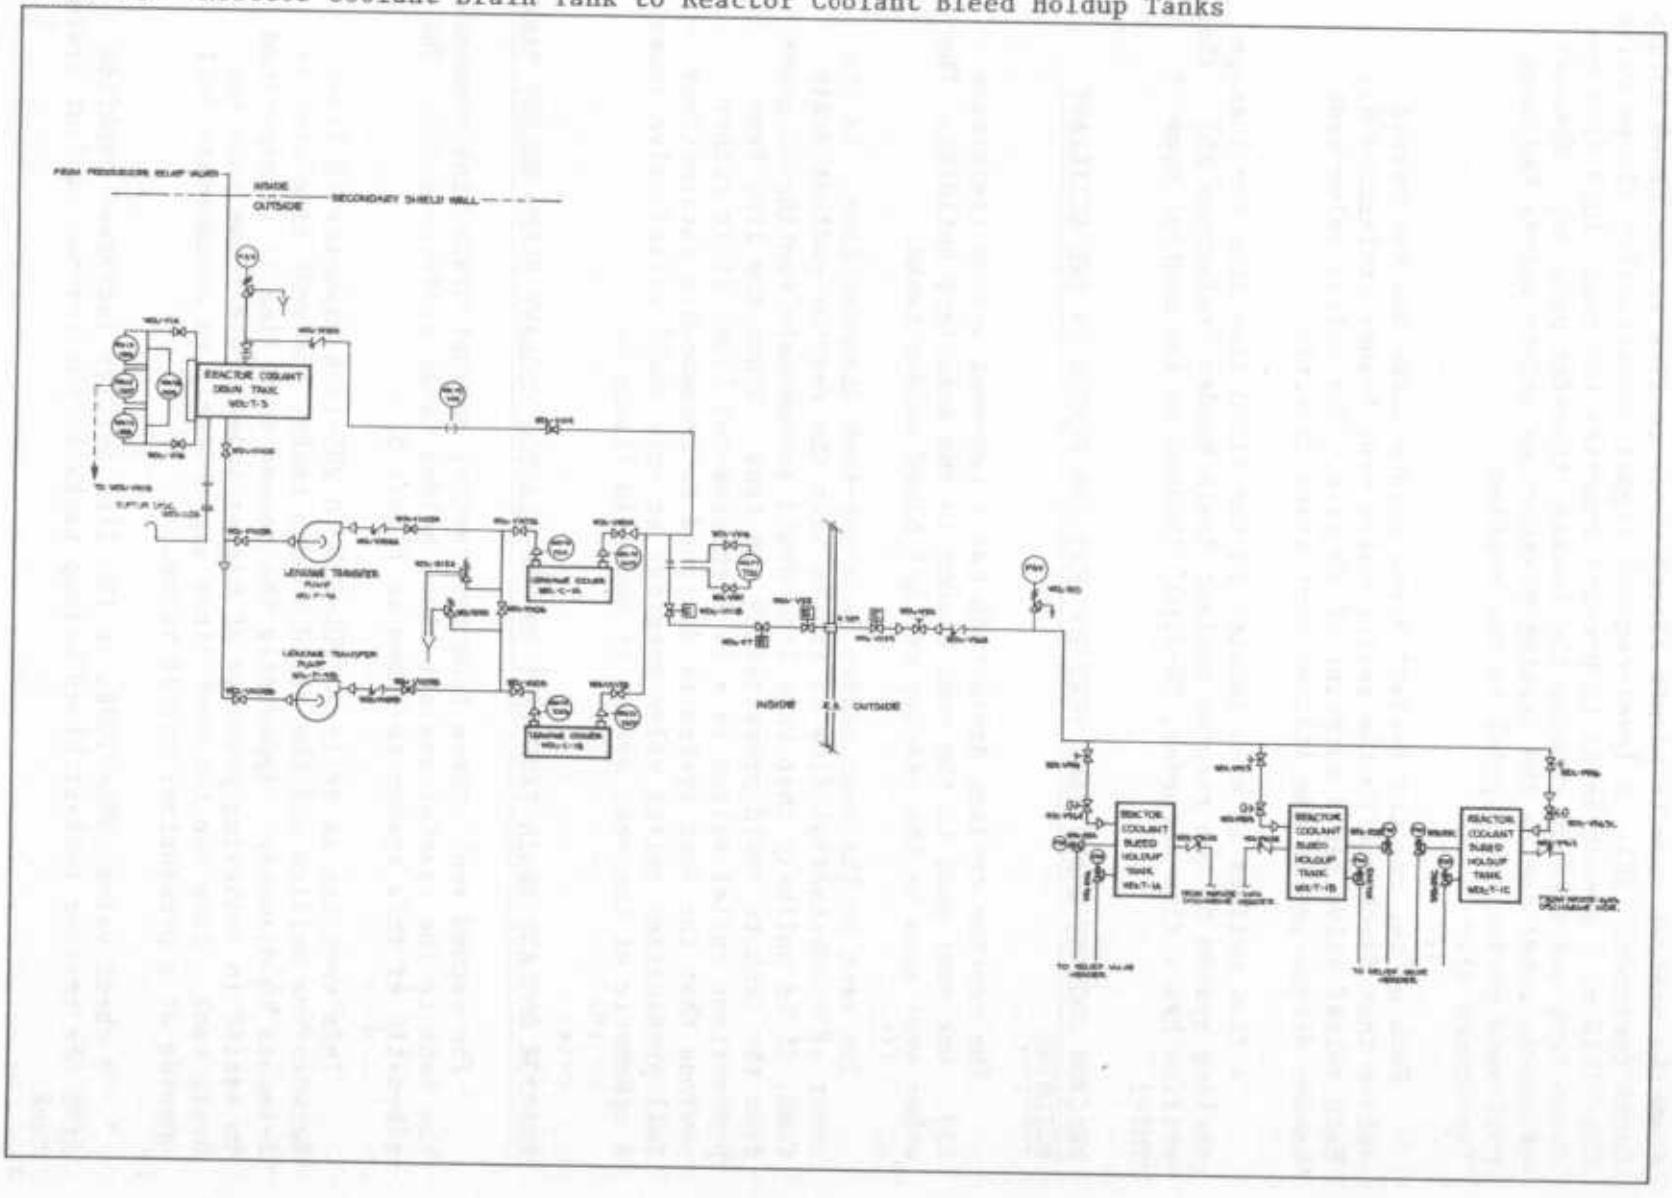
FIGURE 3: Reactor Coolant Drain Tank to Reactor Coolant Bleed Holdup Tanks

to the reactor coolant bleed holdup tanks. To remove fluids from the reactor coolant drain tank, normally a valve, WDL-V1118, is open remotely from the control room to permit excess water to flow to the bleed holdup tanks (reference 28). A level-control signal automatically closes valve WDL-V1118 at a preset level to prevent removing too much fluid from the drain tank and thereby running the leakage transfer pump dry. Removal of excess water due to the leaking pressurizer safety valves had been performed periodically prior to the accident (reference 4).

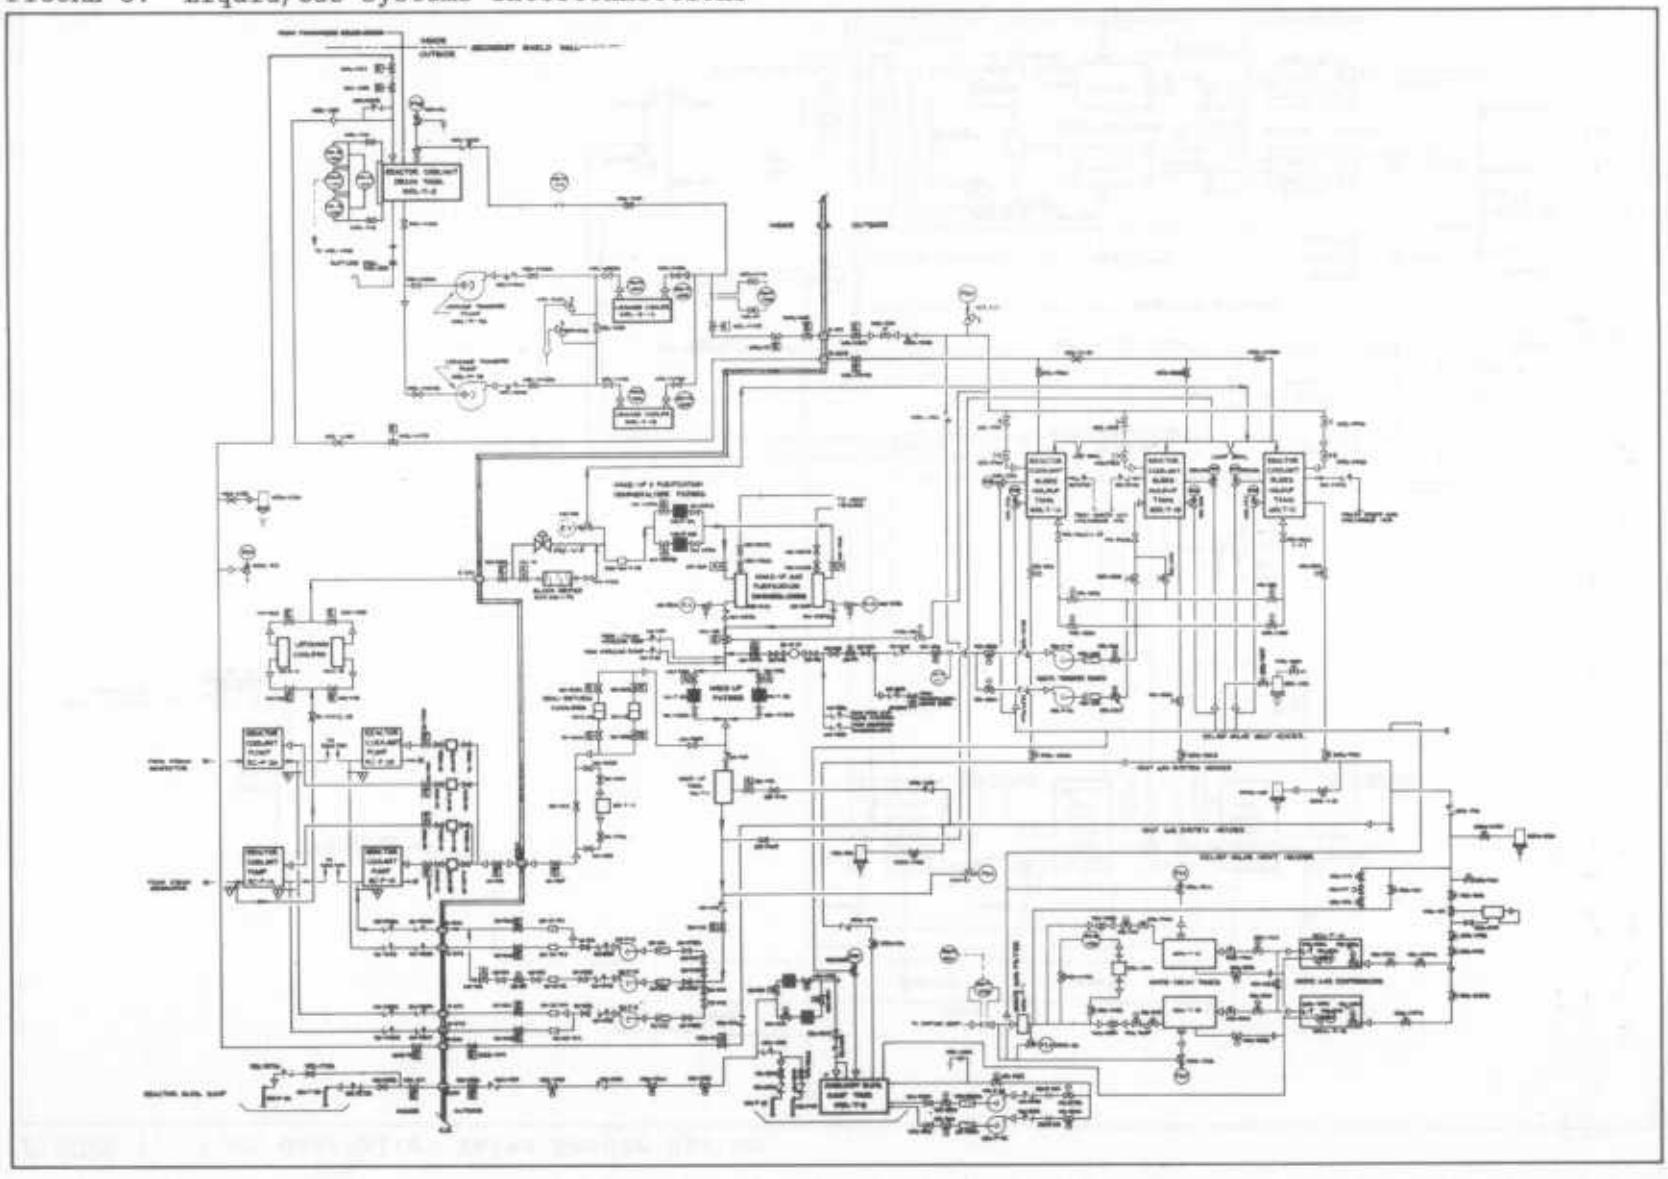
FIGURE 8: Liquid/Gas Systems Interconnections

The interconnections of the liquid system with the gas systems make it difficult to diagnose the release points of the radioactive gas from the auxiliary building.
