| United States Nuclear Regulatory Commission Official Hearing Exhibit	
In the Matter of:	Entergy Nuclear Operations, Inc. (Indian Point Nuclear Generating Units 2 and 3)

ASLBP #: 07-858-03-LR-BD01
Docket #: 05000247 | 05000286
Exhibit #: ENT00331B-00-BD01   **Identified:** 10/15/2012
Admitted: 10/15/2012   **Withdrawn:**
Rejected: **Stricken:**
Other:

ENT00331B
Submitted: March 29, 2012

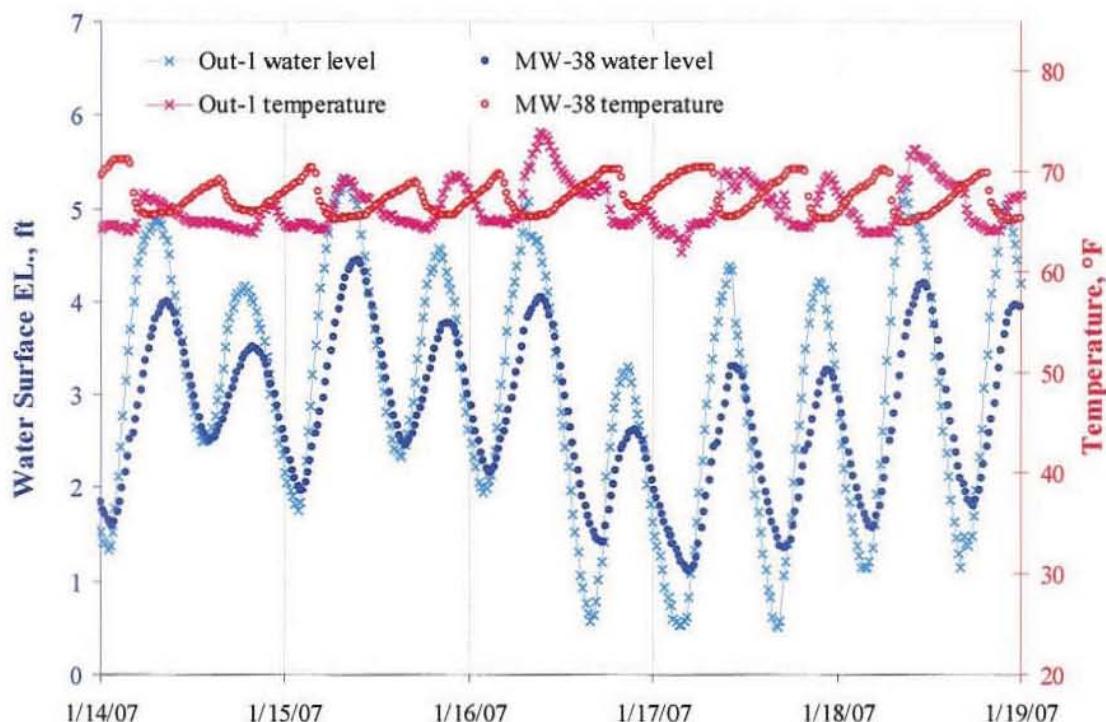
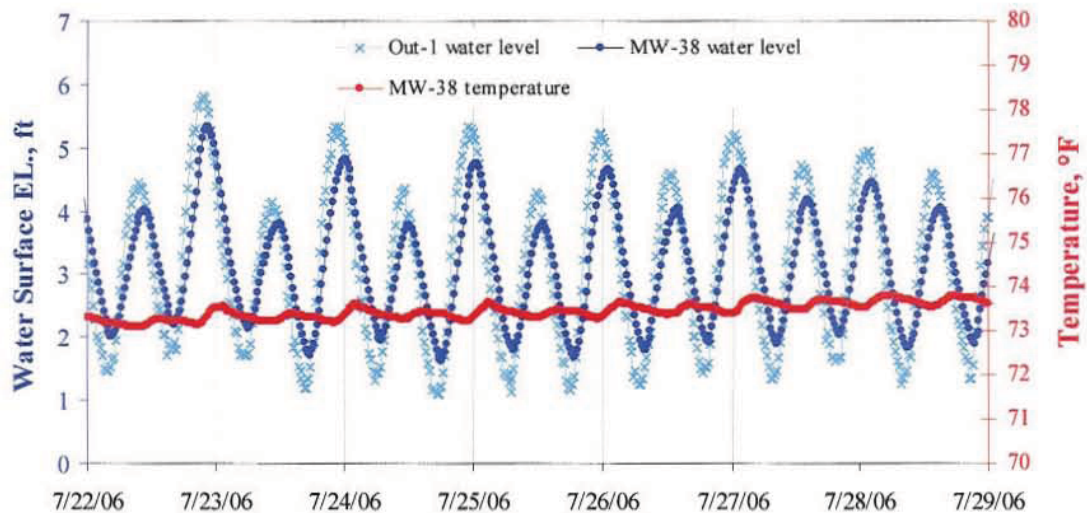
**WATER LEVEL AND TEMPERATURE RELATIONSHIPS FOR DISCHARGE CANAL AND MW-38 (JAN. 07)**

Additionally, at high tide the canal level is above the water level in MW-38 and at low tide the water level in MW-38 is above the level of the canal (see above graph). These data demonstrate the potential for water in the canal to migrate to the proximity of MW-38 during periods of high tide.

which shows water levels and temperatures collected in January 2007. In reviewing this graph, note that the temperature of groundwater in MW-38 is: 1) warmed significantly above ambient ground water temperatures (averaging approximately 70° F as compared to an ambient temperature of approximately 55° F); 2) on average, during this period, warmer than the canal water; 3) at its lowest temperature near high tide; and 4) increases in temperature while water levels in the well decline. These observations are consistent with groundwater discharge to the canal at low tide and canal water flow to the vicinity of well MW-38 during high tide.

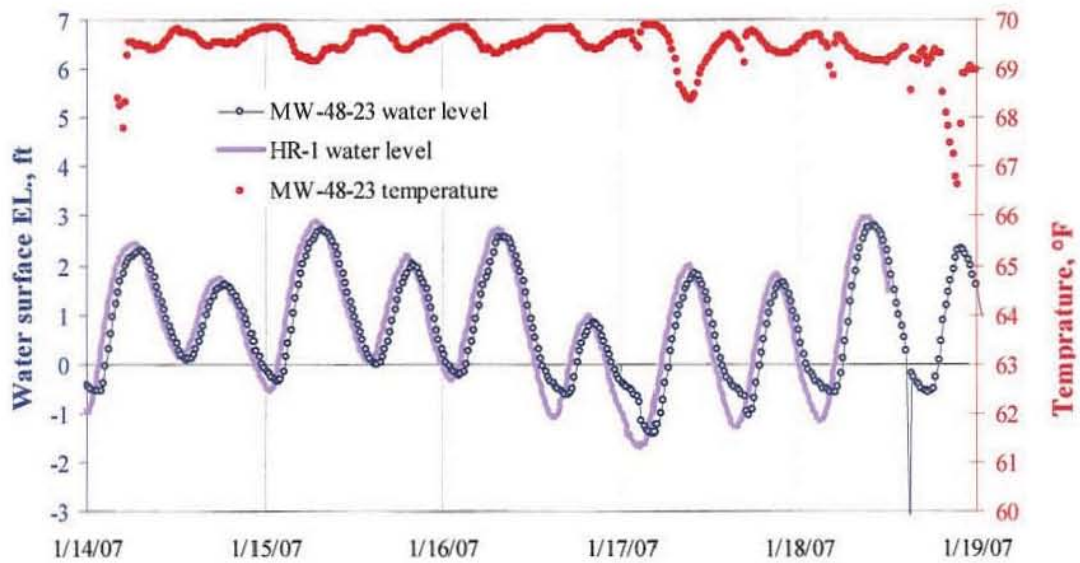
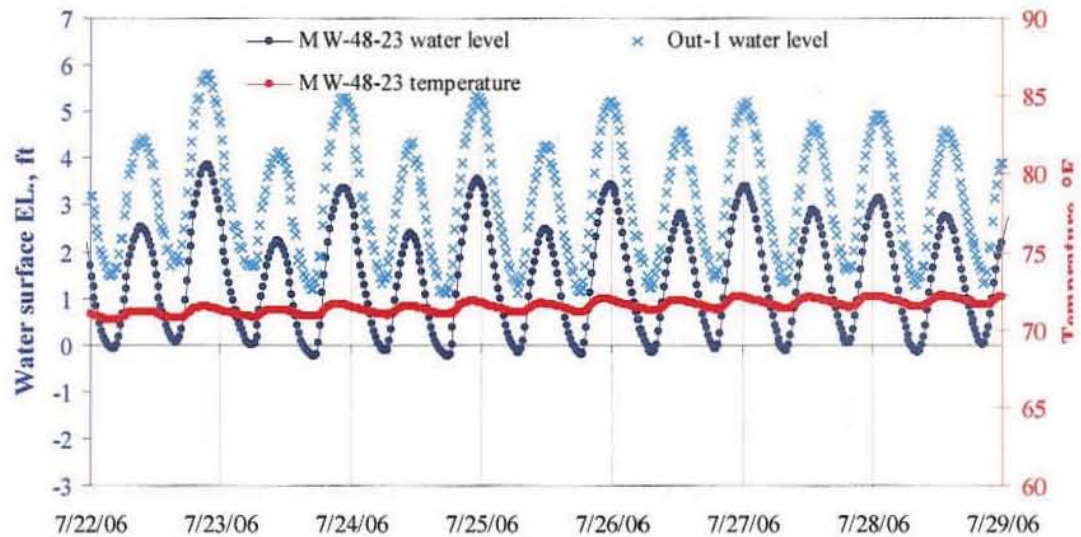
**WATER LEVEL AND TEMPERATURE RELATIONSHIPS FOR DISCHARGE CANAL AND MW-38 (JULY 06)**

Data presented above, which is for MW-38 in the summer of 2006, while not as dramatic, supports our conclusion that groundwater in MW-38 is mixed, at times, with canal water. In reviewing this graph, note the canal water is significantly warmer than the groundwater, and that water temperature in the well water increases while the canal water level is above the level of water in the well.

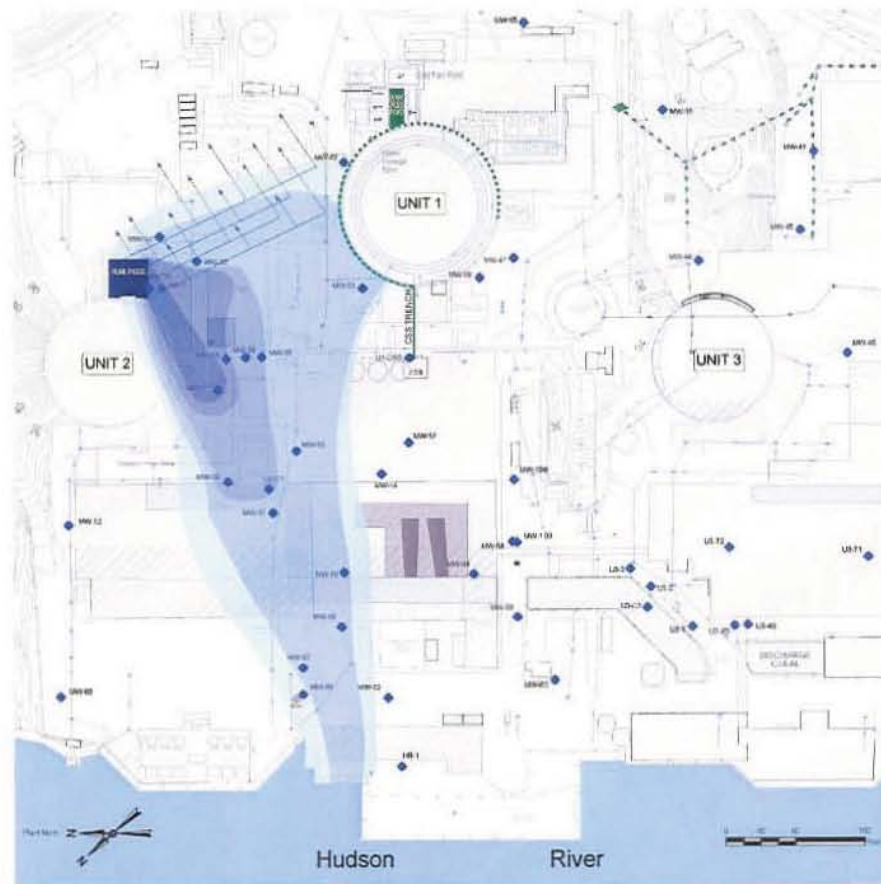
UNIT 2 BOUNDING ACTIVITY ISOPLETHS

[65] It is recognized that low concentrations of Tritium likely extend to the South, all the way to Unit 1. This conclusion is supported by: 1) the low Tritium concentrations remaining in IP1-SFPs (250,000pCi/L); 2) the data from MW-42 and MW-53; and 3) the Tritium balance between that released by the IP1-SFPs leak and that collected by the NCD. The transport mechanism is through *unsaturated* zone flow which follows bedrock fracture strike/dip directions rather than groundwater flow direction (see schematic of unsaturated zone flow mechanism included below). The levels of Tritium detected *upgradient* of IP2-SFP in monitoring wells MW-31 and MW-32 are also due to unsaturated zone transport from IP2-SFP along the generally southerly striking and easterly dipping bedrock fractures (see structural geology analysis in **Section 6.0** and tracer test discussions in **Section 7.0**).

[66] As the Tritium moves under the Discharge Canal, a significant amount discharges directly to the canal before the plume reaches the Hudson River.

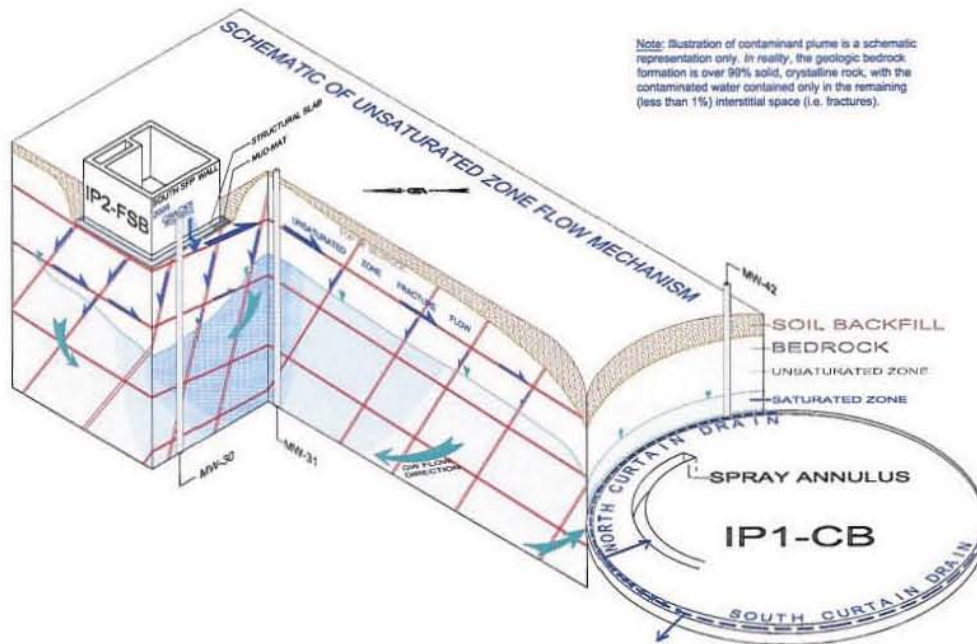
IP2-SFP UNSATURATED ZONE FLOW MECHANISM

The IP2-SFP contains both the fuel pool itself as well as its integral Transfer Canal. IP2-SFP is founded directly on bedrock which was excavated to elevation 51.6 feet for construction of this structure. As such, this pool's concrete bottom slab is located approximately 40 feet above the groundwater (as measured directly below the pool in MW-30[67]). During construction, a grid of steel "T-beams" was embedded in the interior surface of the 4-to 6-foot-thick concrete pool walls. These T-beams provided linear weld points for the 6 by 20 foot stainless steel liner plates. Given this construction method, an interstitial space exists between the back of the ¼-inch-thick stainless steel pool liner and the concrete walls. The space is expected to be irregular[68] and its exact width is unknown, but nominal estimates of a $\frac{1}{8}$ to ¼ inch are not unreasonable for assessing potential interstitial volume. Using these estimates, the volume of the space behind the liner could be on the order of 1500 gallons. In addition, the degree of interconnection between the spaces behind the individual liner plates is also expected to be highly variable given the likely variability of weld penetration into the "T beams." Therefore, the travel path for pool water that may penetrate through a leak in the liner is likely to be highly circuitous.

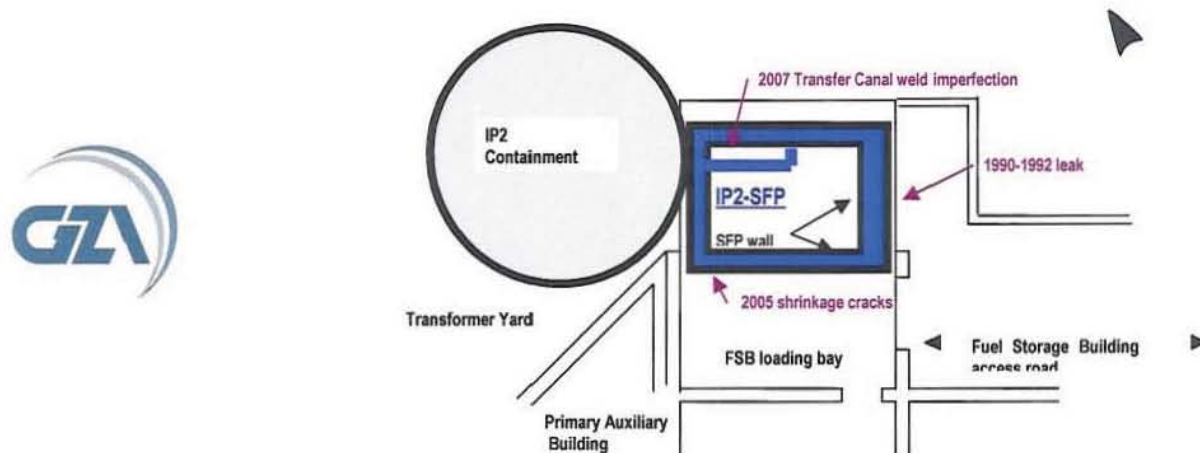
UNIT 2 FUEL POOL DIRECT SOURCE LOCATIONS

The three identified direct sources are discussed individually in the following paragraphs and shown on the figure below.

IP2-SFP 1990-1992 Legacy Liner Leak – This leak was first documented on May 7, 1992 when a small area of white radioactive precipitate was discovered above the ground surface on the outside of the IP2-SFP East concrete wall. This boron deposit exhibited radiological characteristics consistent with a potential leak from the pool. A camera survey was then conducted within the IP2-SFP to identify the location of the associated leak(s) in the liner. The survey initially revealed no damage to the liner. However, to further investigatory efforts, divers were utilized to visually inspect accessible portions of the liner. The divers found indications that the liner had been gouged when an internal rack had been removed on October 1, 1990. Two hundred and forty linear feet of the North and West IP2-SFP wall welds were then inspected and vacuum-tested to verify that the identified damage was isolated to this one case. No other leaks were identified, and on June 9, 1992, the leak was repaired.

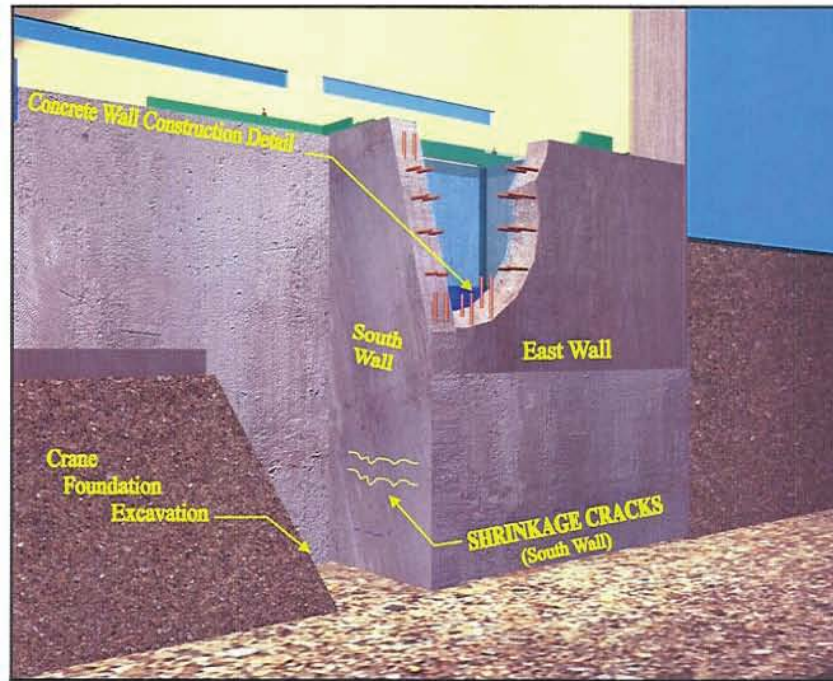
**UNIT 2 SFP 2005 SHRINKAGE CRACKS
IDENTIFIED IN SEPTEMBER 2005**

Initially, the two cracks were found to be leaking at a combined average rate typically as high as 1.5 l/day (peak of about 2 l/day) from the time of crack discovery/initial containment through the fall of 2005. In early 2006, a permanent stainless steel leak containment and collection device was installed. This containment was also piped to a permanent collection point such that any future leakage from the crack could be monitored and prevented from reaching the groundwater. Subsequent monitoring through 2006 and into 2007 has indicated that the leakage rate had fallen off rapidly and become intermittent with an average flow rate of approximately 0.02 l/day, when flowing (see figure below presenting shrinkage crack flow rate and Tritium concentration over time). This small amount of leakage is permanently being contained and it therefore is not impacting the groundwater.

Based upon two years of flow and radiological and chemical sample data, it appears that excavation of the backfill from behind the pool wall caused the shrinkage cracks to

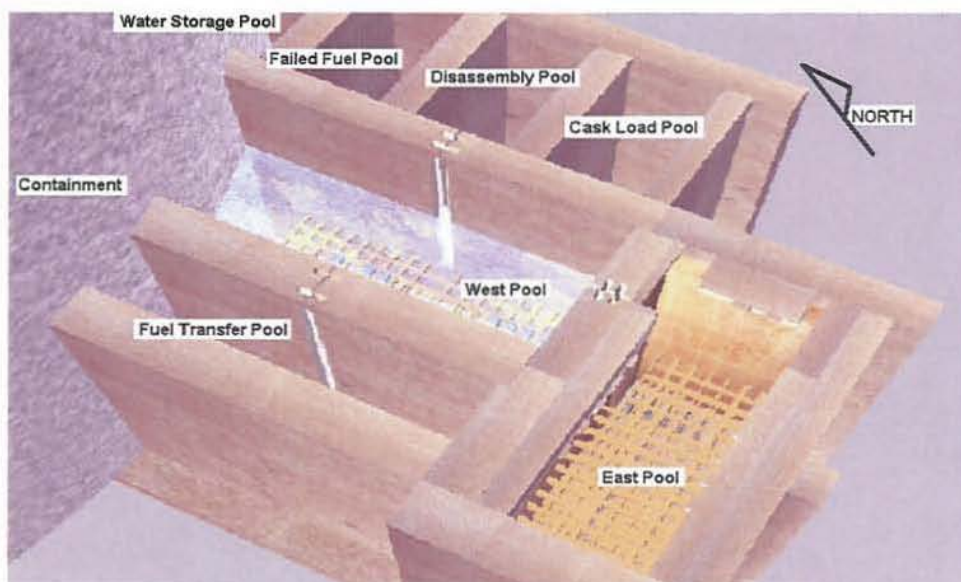
UNIT 1 FUEL POOL COMPLEX

The source of all the Strontium contamination detected in groundwater beneath the Site has been established as the IP1-SFPs. The IP1-SFPs were identified by the prior owner as leaking in the mid-1990's, and are estimated to currently be leaking at a rate of up to 70 gallons/day. A schematic of this pool complex is included below.

The IP1-SFPs were constructed of reinforced concrete with an internal low permeability coating[90]; stainless steel liners were not included in the design of these early fuel pools. The pool wall thickness ranges from 3 to 5.5 feet thick. The bottom of the IP1-SFPs is

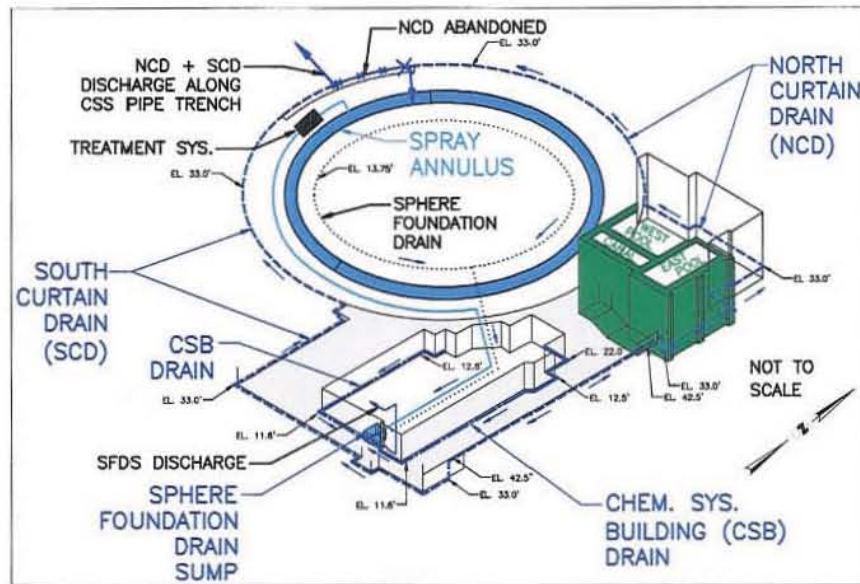
UNIT 1 FOOTING DRAINS AND DISCHARGE SUMP

Sphere Foundation Drain - The third foundation drain below the IP1-FHB and IP1-CB complex is the SFD. This drain is located directly around the bottom portion of the Sphere and consists of: 1) nine perforated pipe risers spaced around the sphere and tied into a circumferential drain line at elevation 13.75 feet; 2) each vertical riser is surrounded by a graded crushed stone filter; and 3) all of which are within a clean washed sand which encompasses the Sphere from elevation 25 to 16.5 feet (the "sand cushion"). The sand cushion is "sandwiched" between the concrete foundation wall, the Sphere and the grout below the Sphere; it is open at the top, proximate to the annulus. As such, it appears that this drain does not interface with the groundwater, except to the extent that some leakage may occur through imperfections in joint seals. This drain is also connected to the SFDS through a valve.

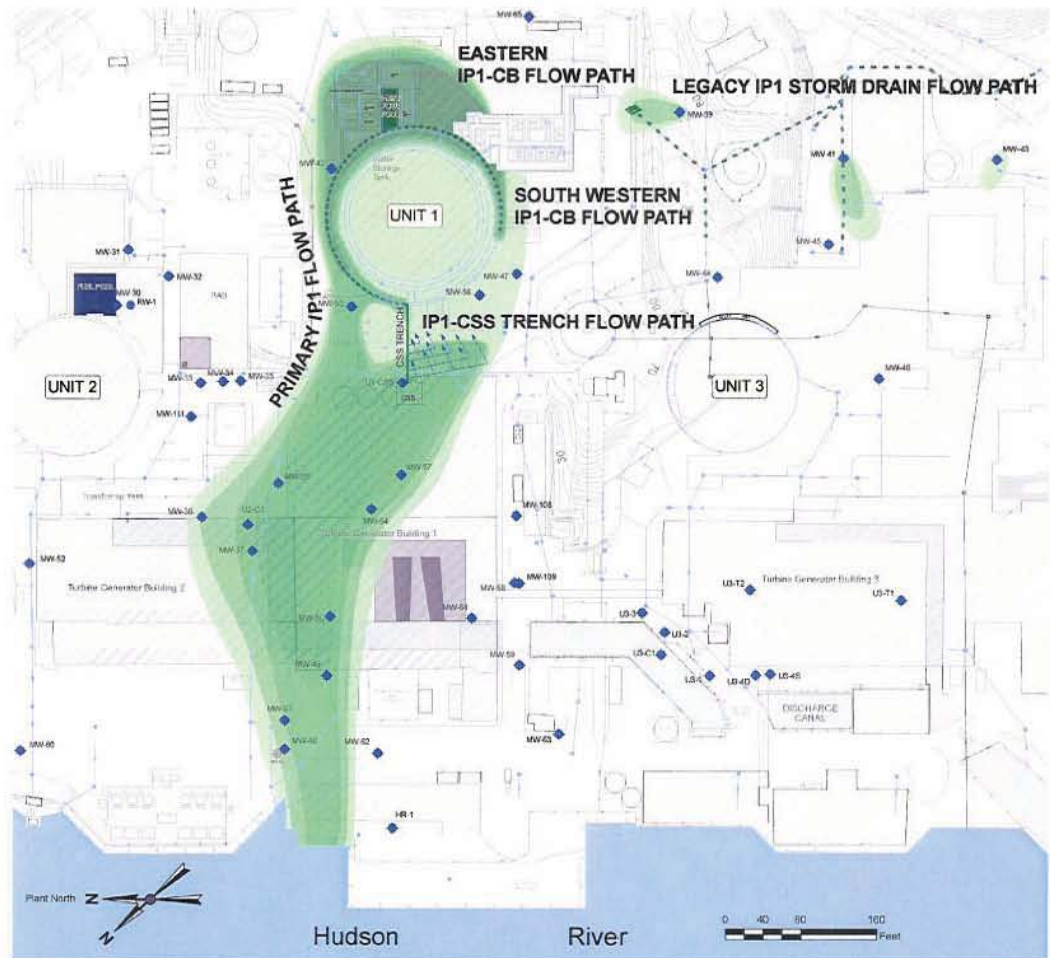
INDIVIDUAL UNIT 1 STRONTIUM FLOW PATH LOCATIONS

The discussions below are focused on the discovery and characterization of these individual flow paths, and the final mechanisms that best explain their existence. Other initially plausible mechanisms were also investigated as part of the Observational Method approach employed[102], but they did not remain plausible in light of the subsequently developed data and analyses, and are therefore not discussed herein. In addition, portions of the discussions below also relate to the concurrent investigation of other potential source areas across the Site. During review of the following sections, it is important to recognize that only small quantities of leakage are required to result in the groundwater plumes observed on the Site.

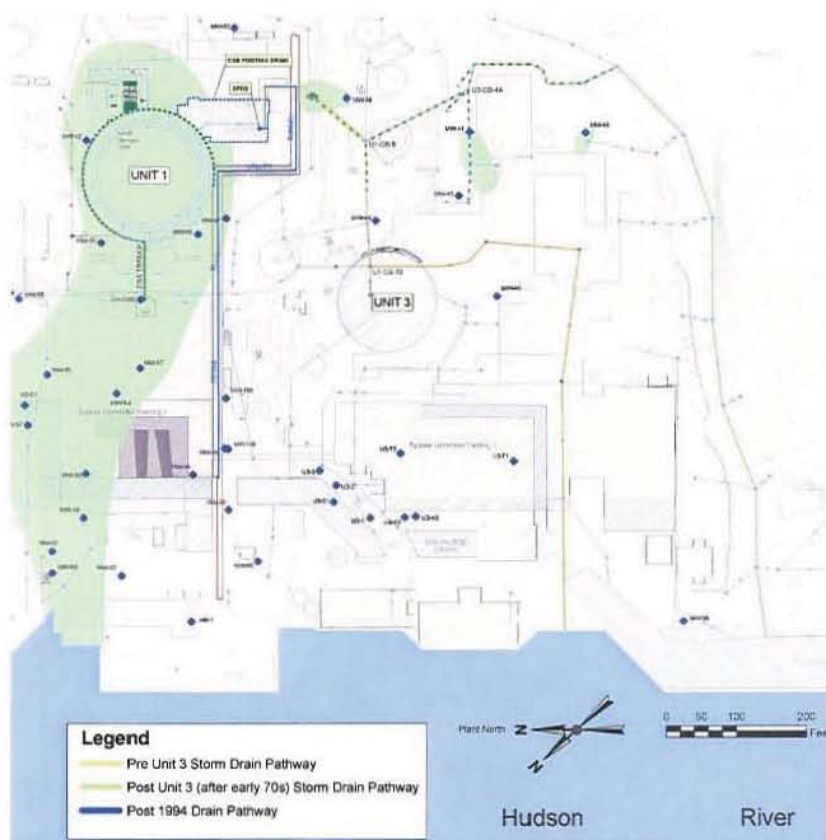
DIFFERING SPHERE FOUNDATION DRAIN SUMP DISCHARGE PATHWAYS OVER TIME

E-Series storm drains. (See figure included below and **Figure 8.2** where these pathways are also highlighted.)

A recent inspection of the storm drain system, including smoke tests and water flushing, has revealed that a number of pipes along these sections have been compromised and are leaking. Strontium found in groundwater on the South side of the Unit 1 FSB, and upgradient of Unit 3, is coincident with the locations of these stormwater pipes. Therefore, we concluded that some of the contaminated water discharged into these pipes exfiltrated, and then migrated downward through the unsaturated zone and contaminated the groundwater, thus resulting in the "legacy" storm drain flow path[114] shown on **Figure 8.2**.

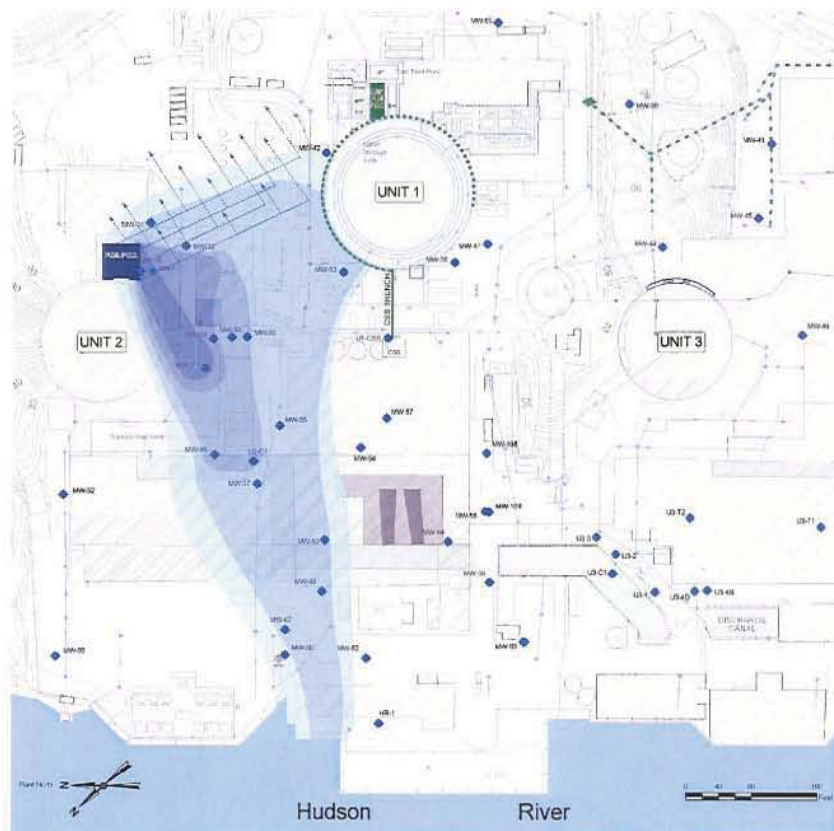
BOUNDING UNIT 2 ACTIVITY ISOPLETHS

pool area so as to include the location of the shrinkage crack leak in the South pool wall, the location of the 1992 leak on the East wall, and the location of the weld imperfection in the North wall of the IP2 Transfer Canal. We believe the core of the plume, as shown, is relatively narrow where Tritium flows downgradient (westerly) to MW-33 and MW-111 in the Transformer yard[117]. This delineation is based on: 1) the degree of connection[118] observed from MW-30 to MW-33 (as compared with that from MW-30 to MW-31 and/or MW-32) as being indicative of a zone of higher hydraulic conductivity limiting lateral dispersion; and 2) the localized increased thickness of the saturated soil in the vicinity of MW-111 (see **Figure 1.3**) which likely behaves as a local groundwater sink/source for westerly bedrock groundwater flow, prior to entering the associated backfill of the Discharge Canal.

occurrence involves gravity flow along bedrock fractures in the unsaturated portion of the bedrock beneath the IP2-SFP. This unsaturated flow direction is consistent with the dominant foliations (which strike to the Northeast and dip to the Northwest). This behavior is shown on the figure by dashed arrows and the isometric insert (see **Section 8.1**). This mechanism also accounts for some of the Tritium found near Unit 1 and is also supported by the results of the tracer test (see **Section 7.3**). However, once the contaminated water enters the local groundwater flow field, it migrates via advection in a direction generally perpendicular to the groundwater contours (i.e., with the groundwater flow).

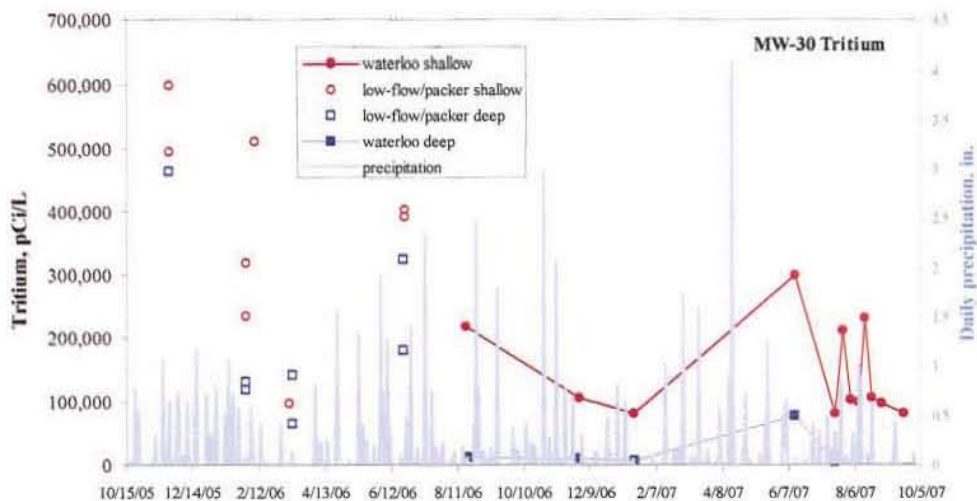
TRITIUM CONCENTRATIONS AND PRECIPITATION VS TIME FOR MW-30

[119] In addition, our review of sampling procedures and laboratory methods did not explain the variations observed in samples collected from monitoring well MW-30.

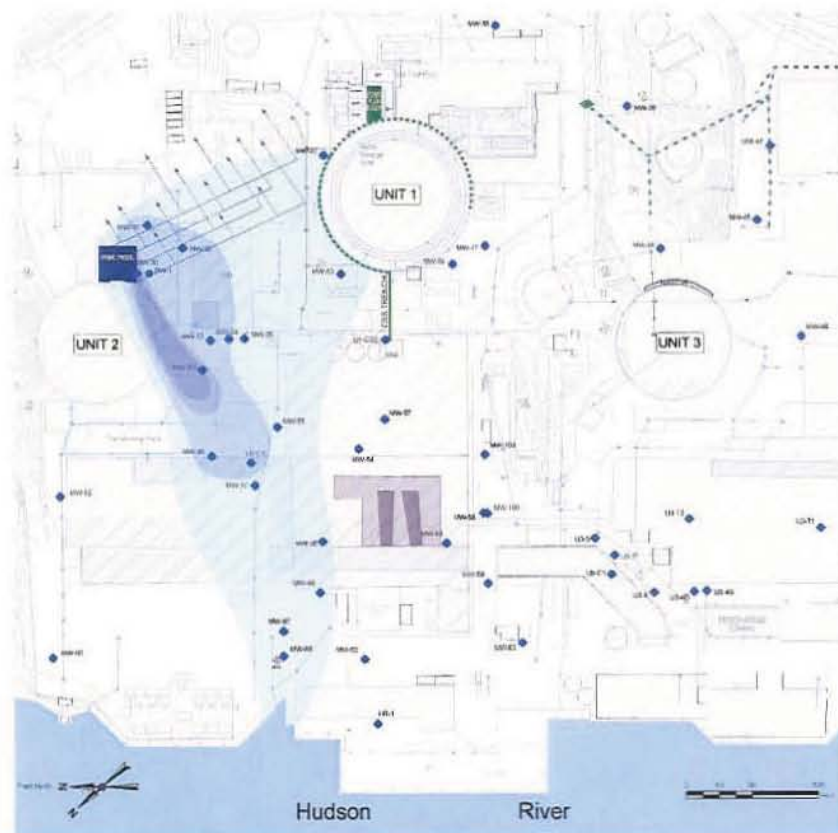
CURRENT UNIT 2 PLUME

Recognizing the limitations posed by short term fluctuations, we constructed **Figure 9.3**, which shows the lateral extent of Tritium contamination in the late summer of 2007 ("current conditions").
