Seismic Walkdown Checklist (SWC)

Equipment ID No. Q1R43E001A Equip. Class[1] 20

Equipment Description SEQUENCER B1F

Location: Bldg. AUXILIARY Floor El. 139 Room, Area 335

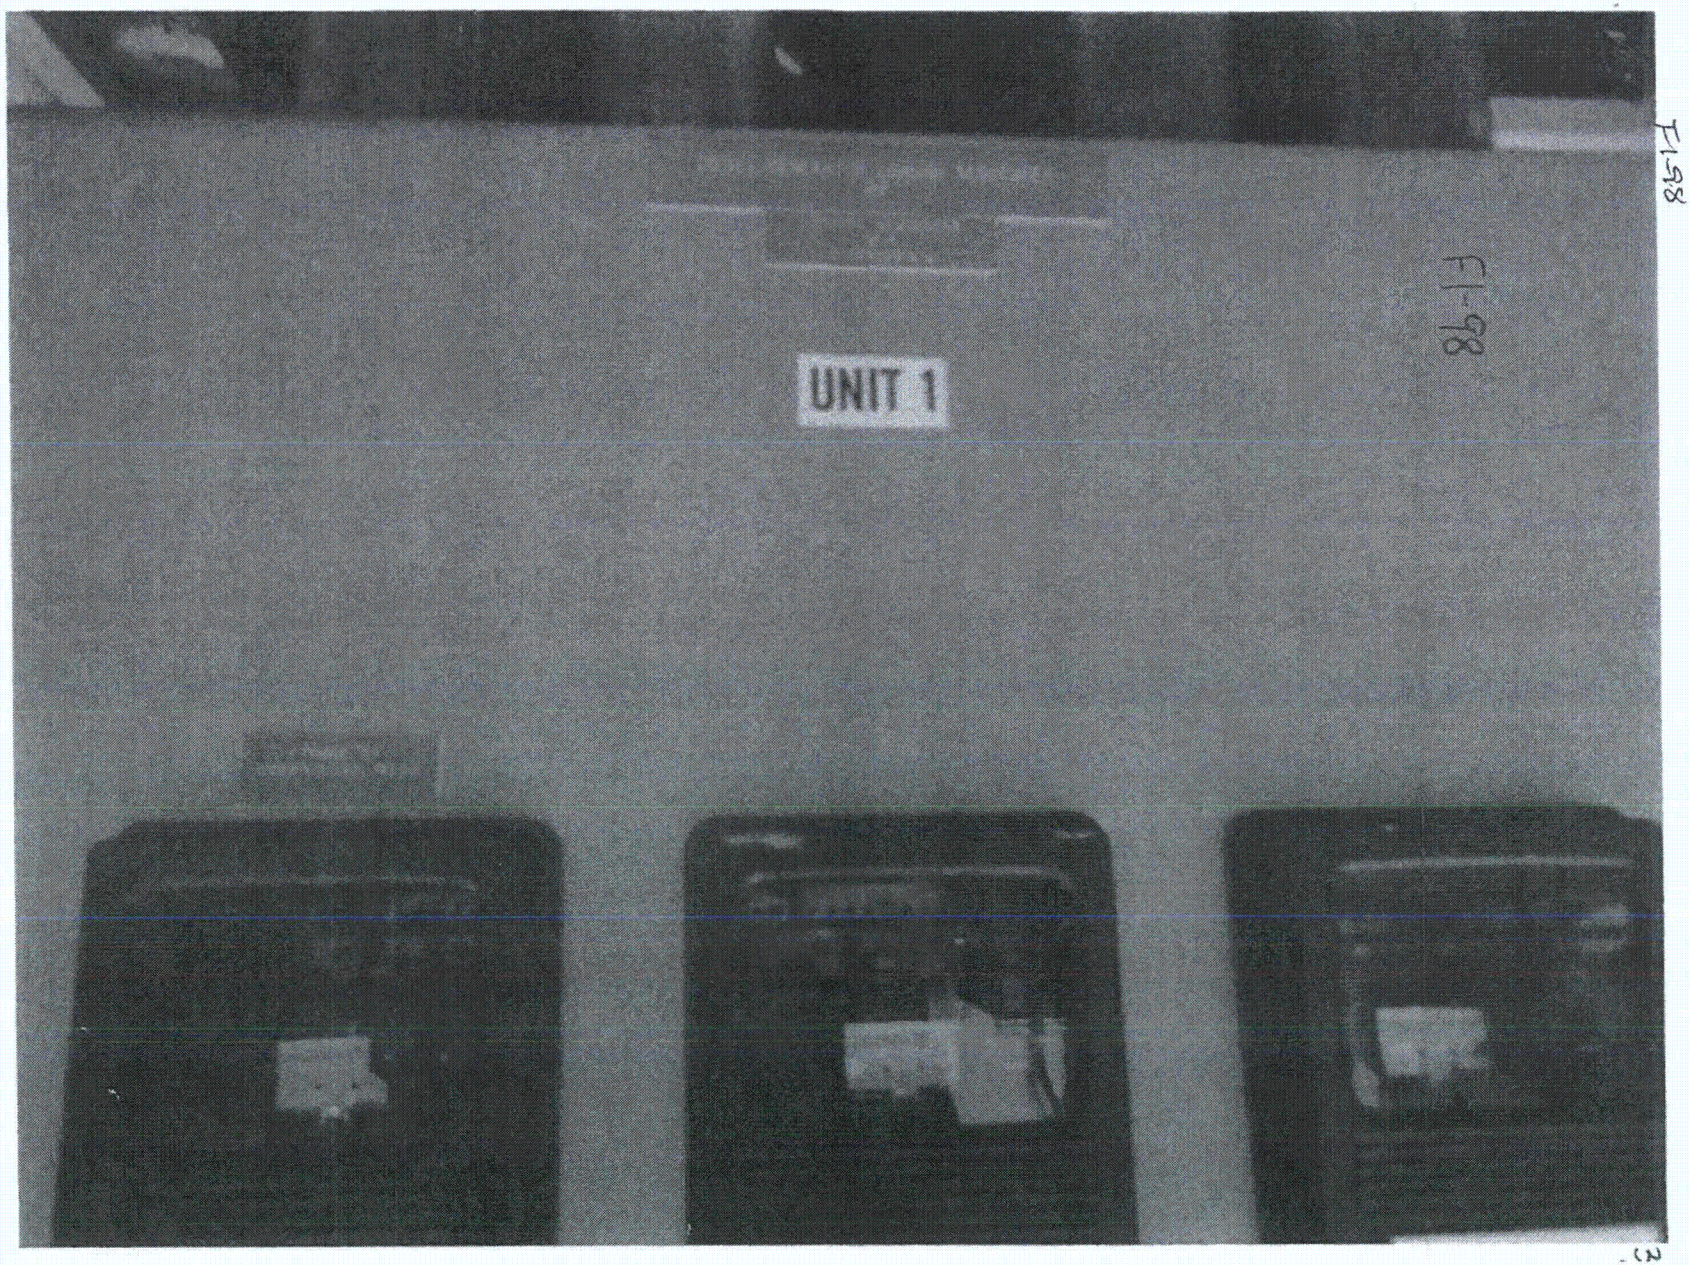
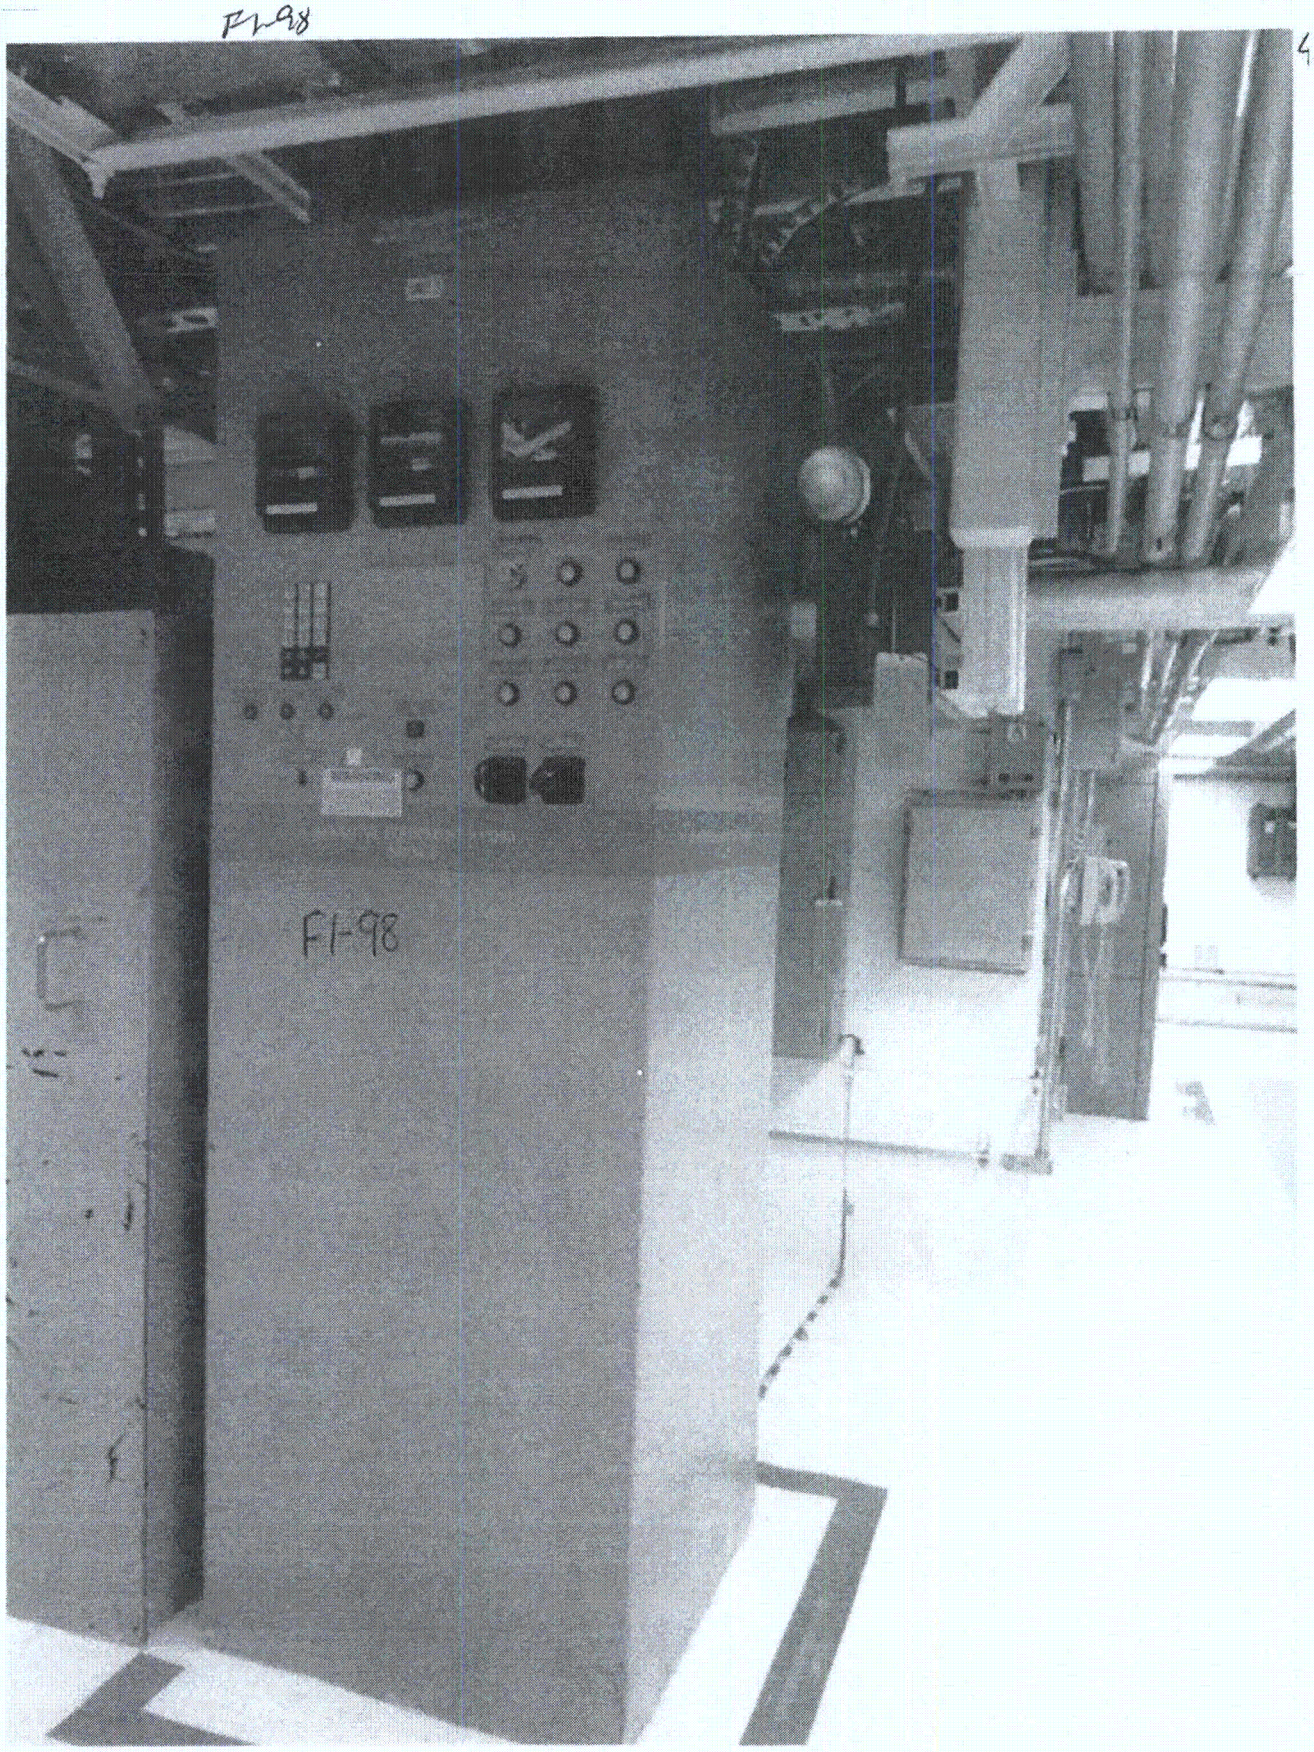
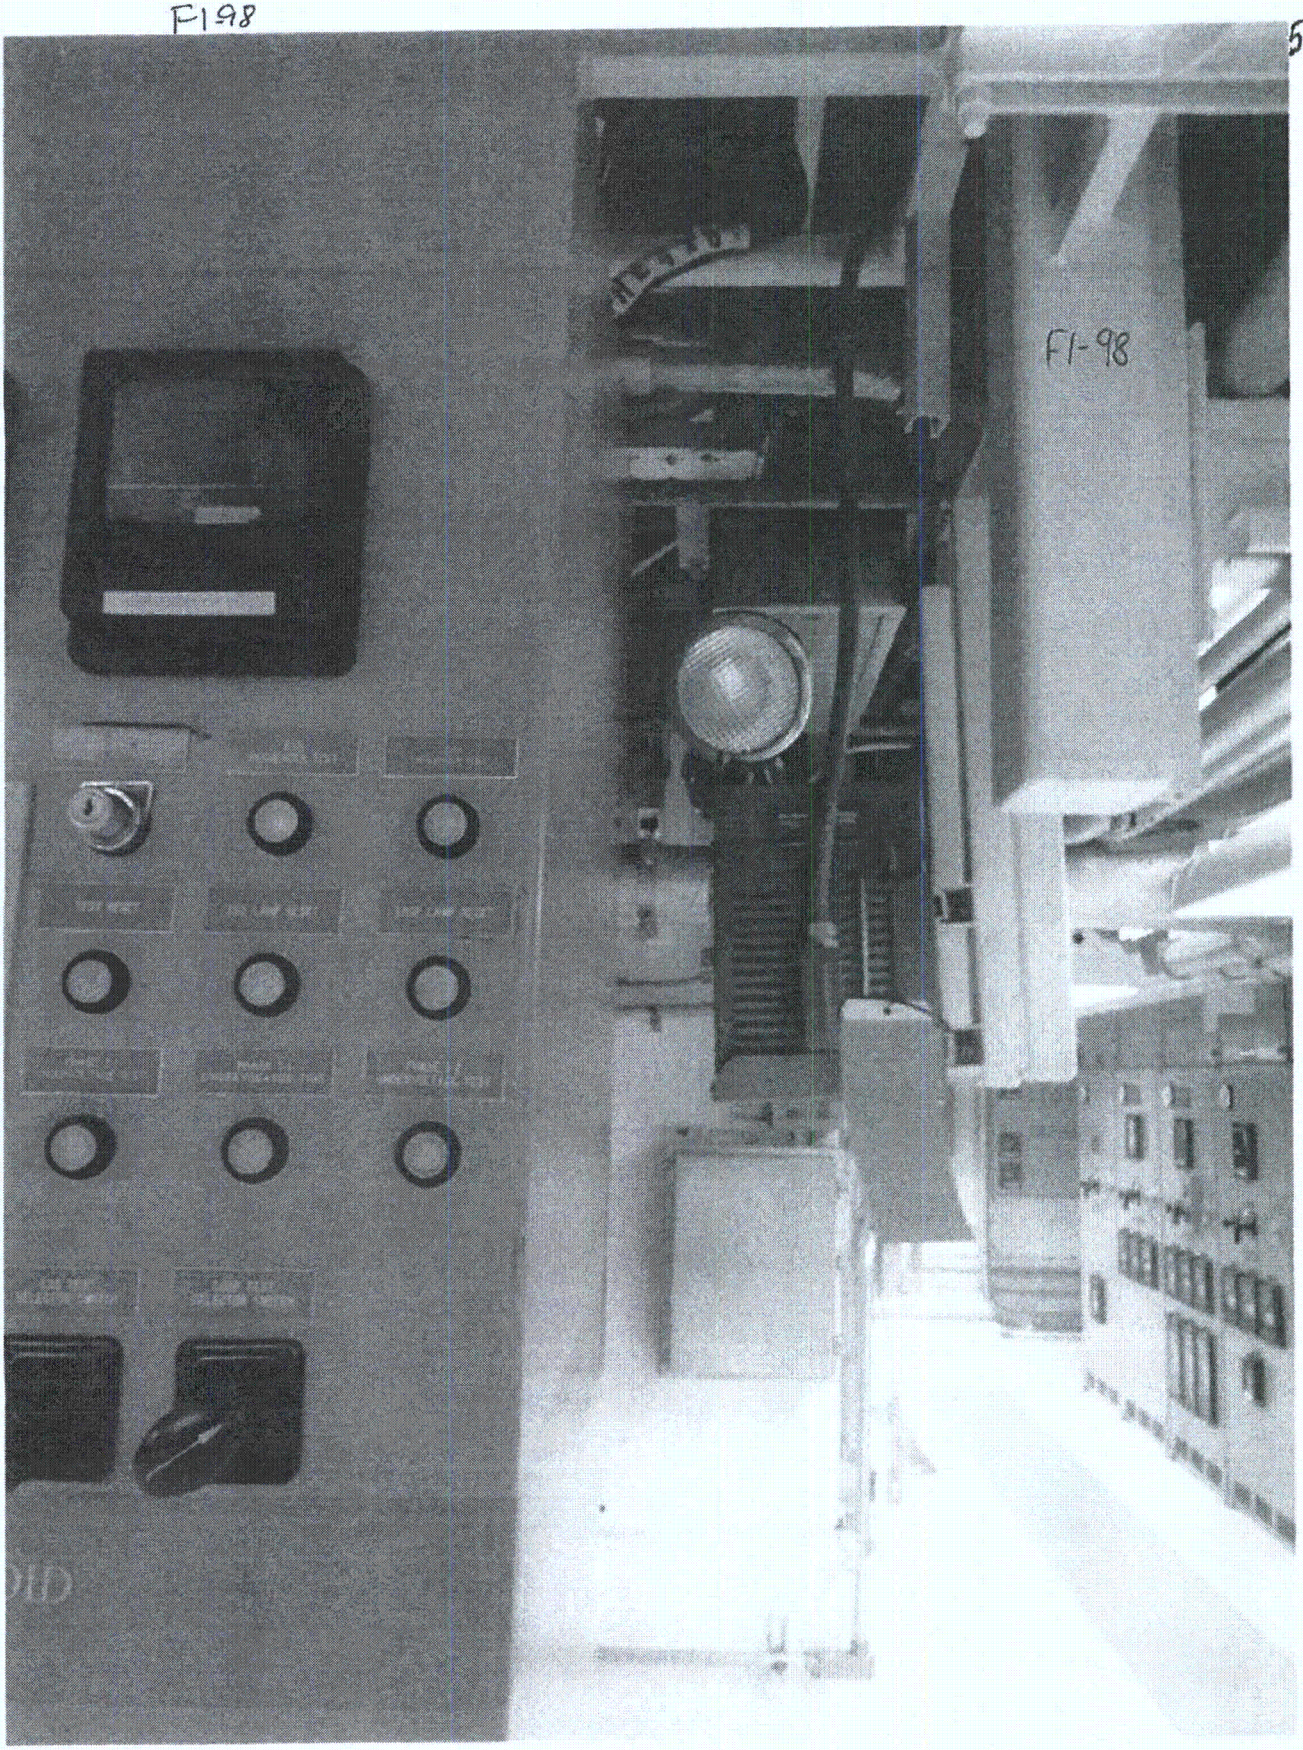
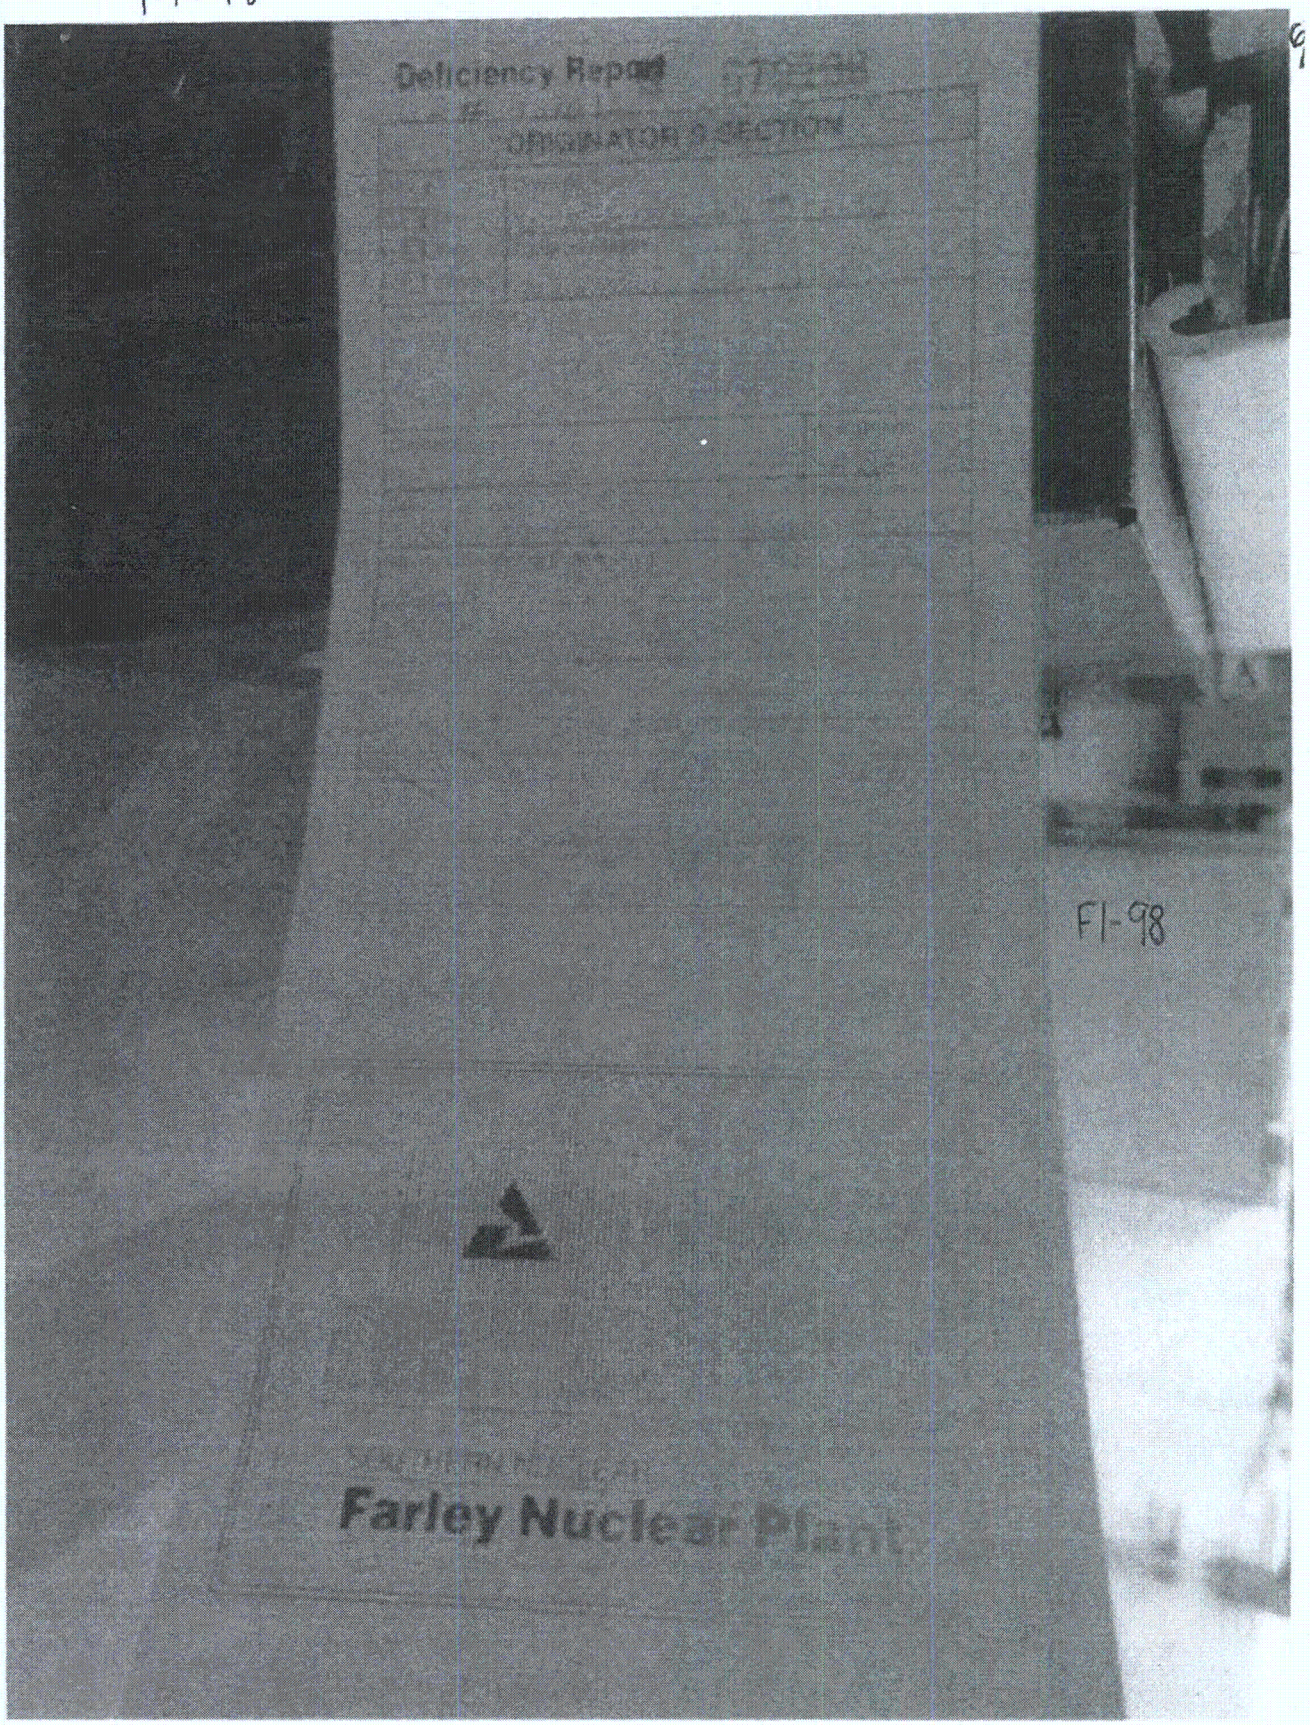
UNE 8/26 ~~Refer to Area Walkdown~~ As documented in CR# 497075 Emergency Light #1115 (N5R45EL001) is within 3" and could bump DG Load Sequencer B1F (Q1R43E001A) during normal maintenance or a seismic event. This CR was written prior to the walkdown.

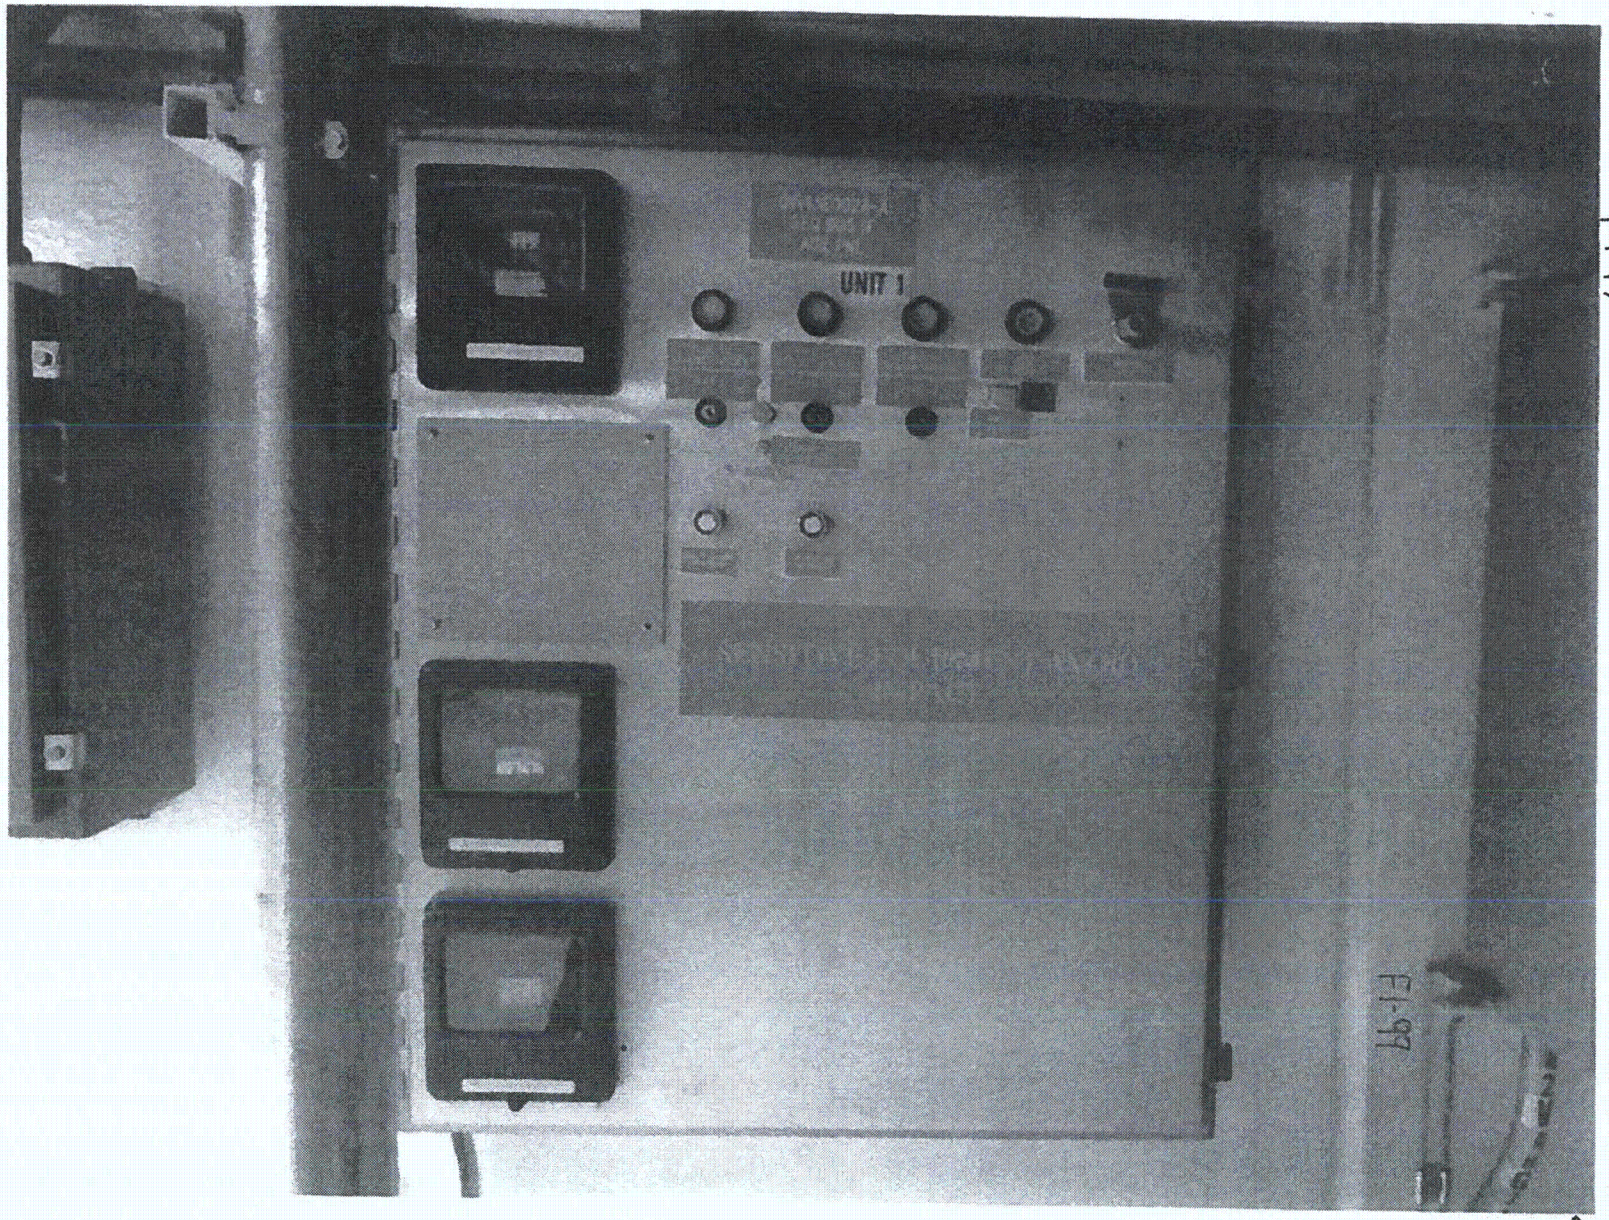
QIR43E002A-A
SEQ BUS IF
AUX PNL
UNIT 1
PHASE 3-1
DEGRADED GRID TEST
PHASE 2-3
DEGRADED GRID TEST
PHASE 1-2
DEGRADED GRID TEST
PHASE 2-3
PHASE 1-2

7. Are soft targets free from impact by nearby equipment or structures? Y☒ N☐ U☐ N/A☐
   Three two inch conduits are supported on the East side of the cabinet. The gap between the conduits and panel is about 1", but due to the rigid conduit support (welded to an embedded wall plate), the cabinet is judged to be free from impact during a seismic event.

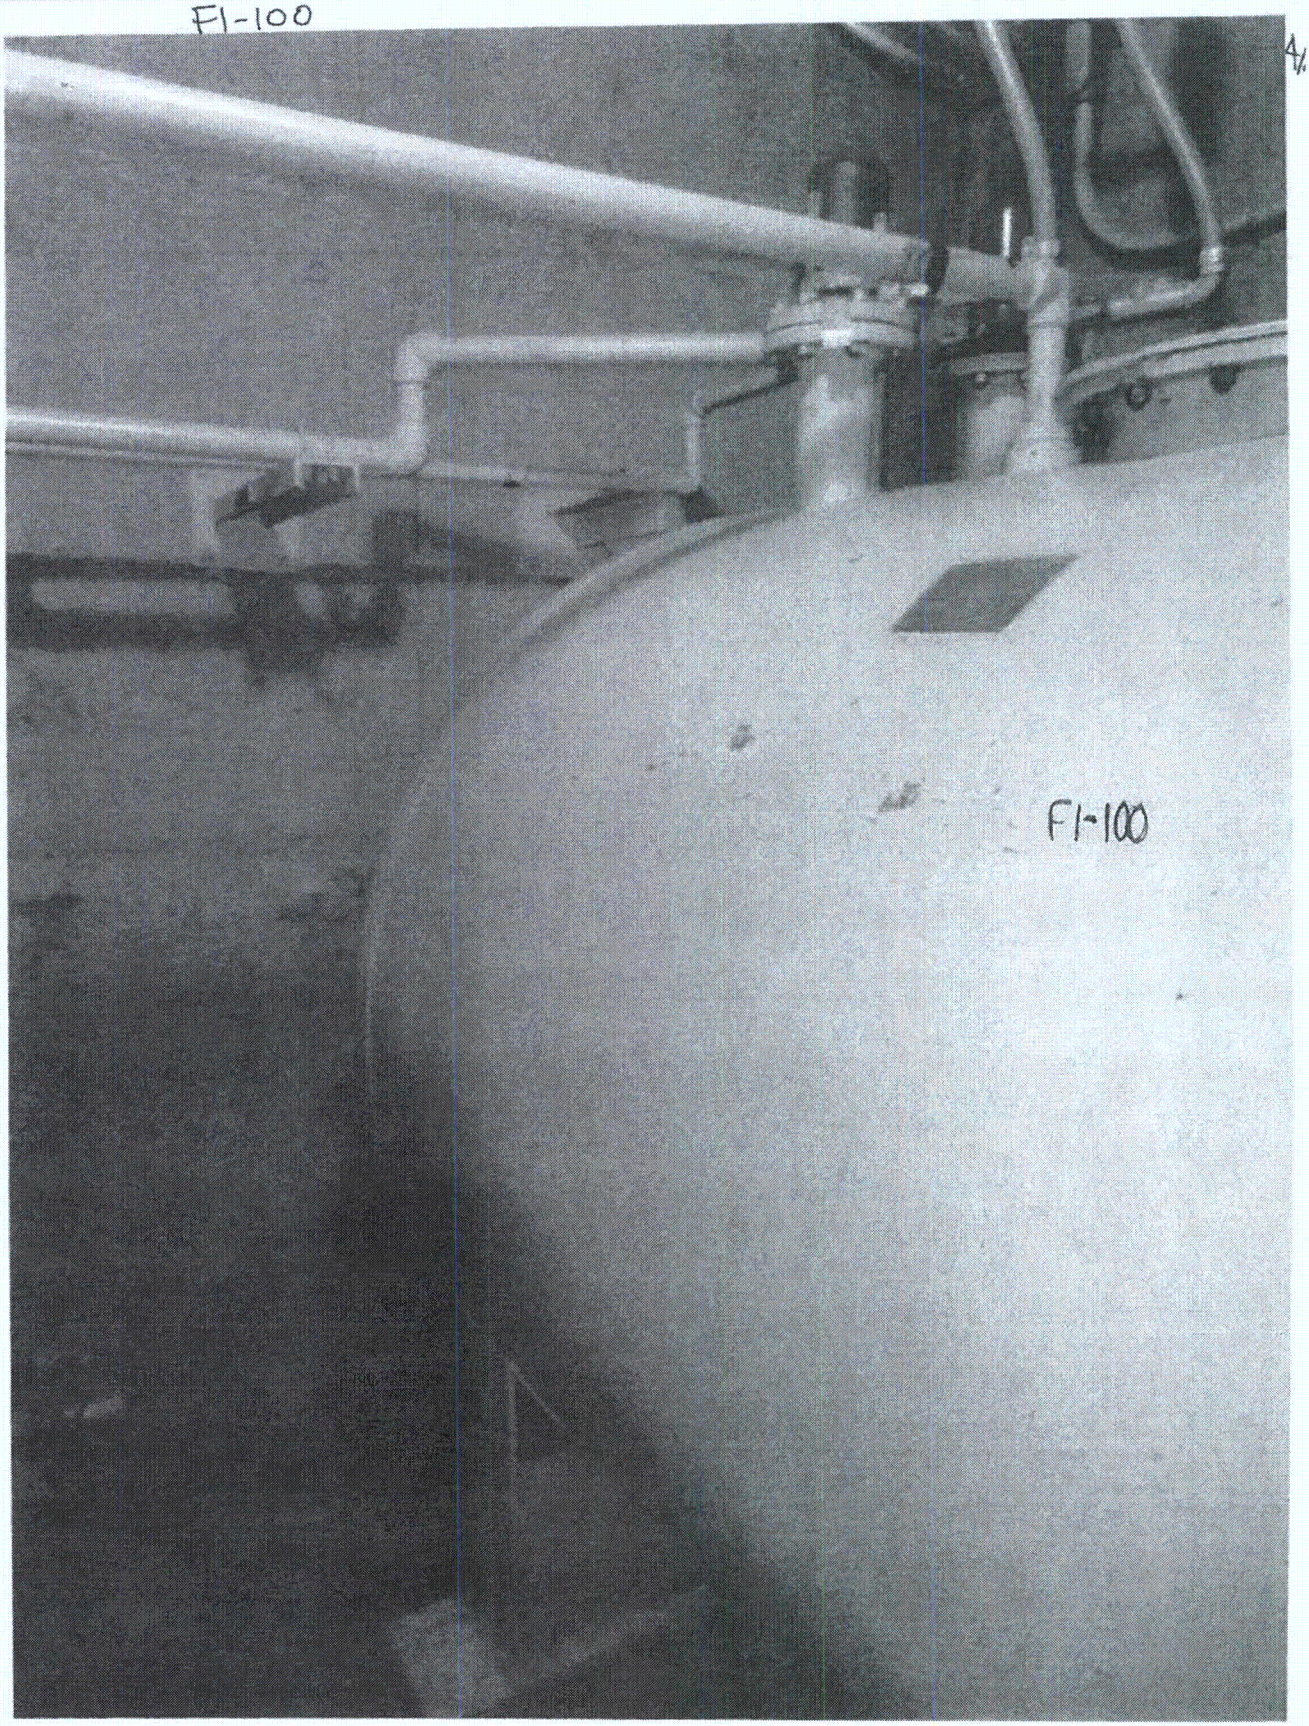
FI-101

7. Are soft targets free from impact by nearby equipment or structures? Y☒ N☐ U☐ N/A☐
   Small gap was noted between tank and cantilevered unistrut. This was previously noted in A-46 walkdowns and determined to be acceptable.

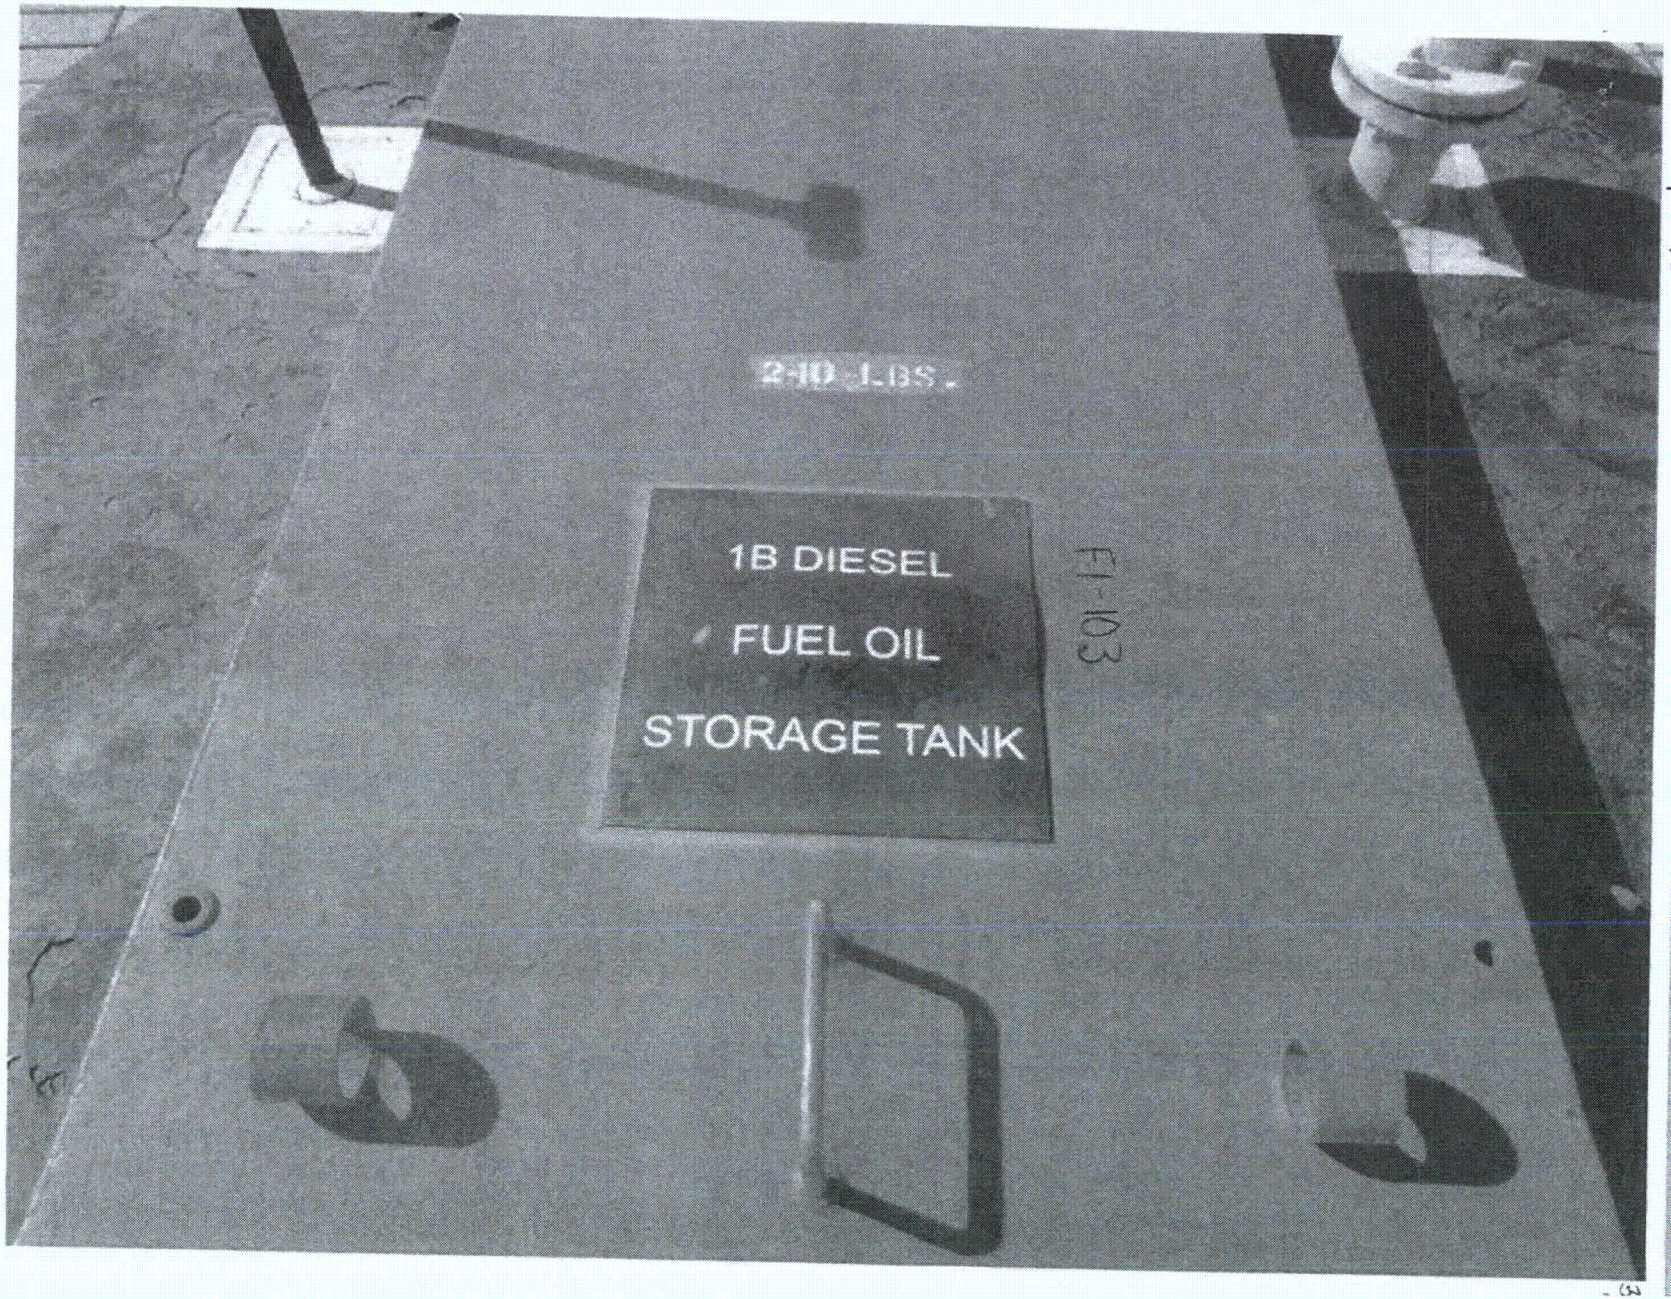
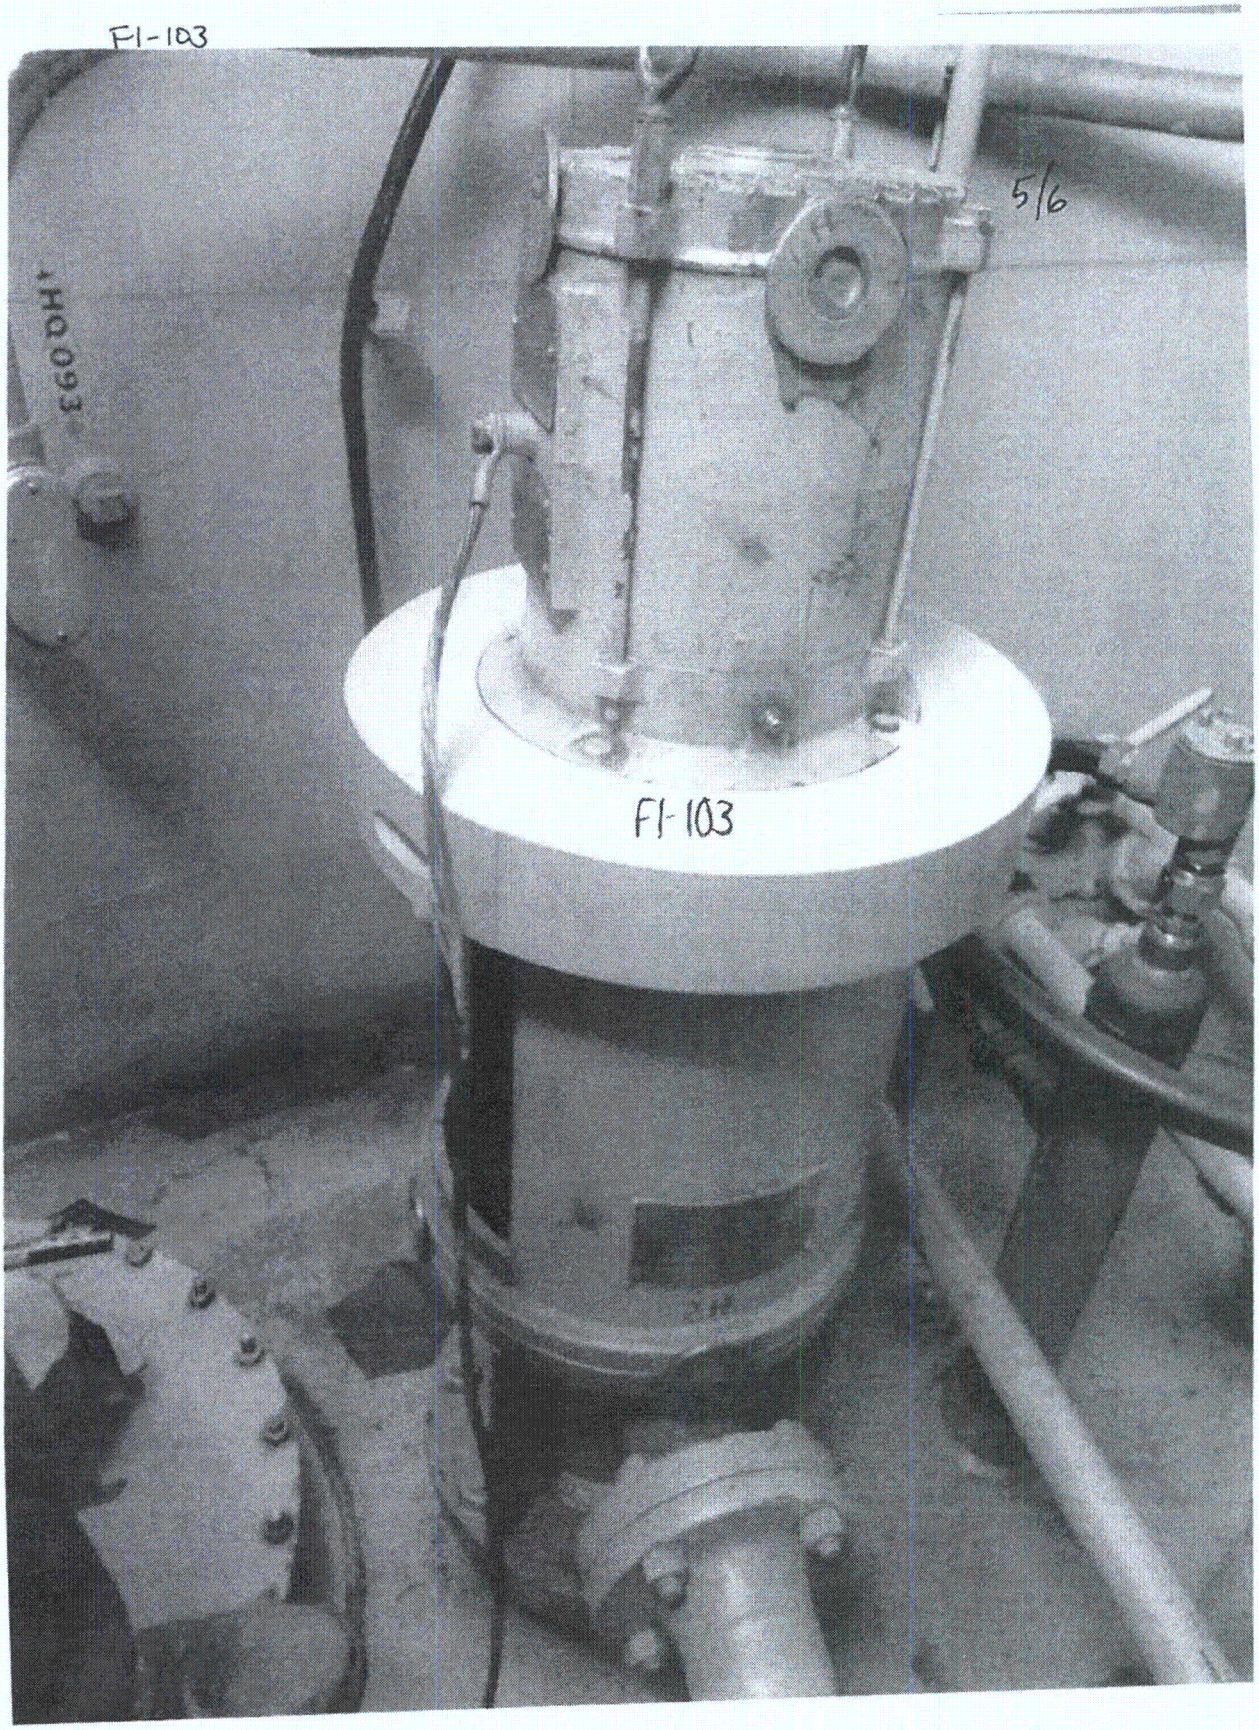
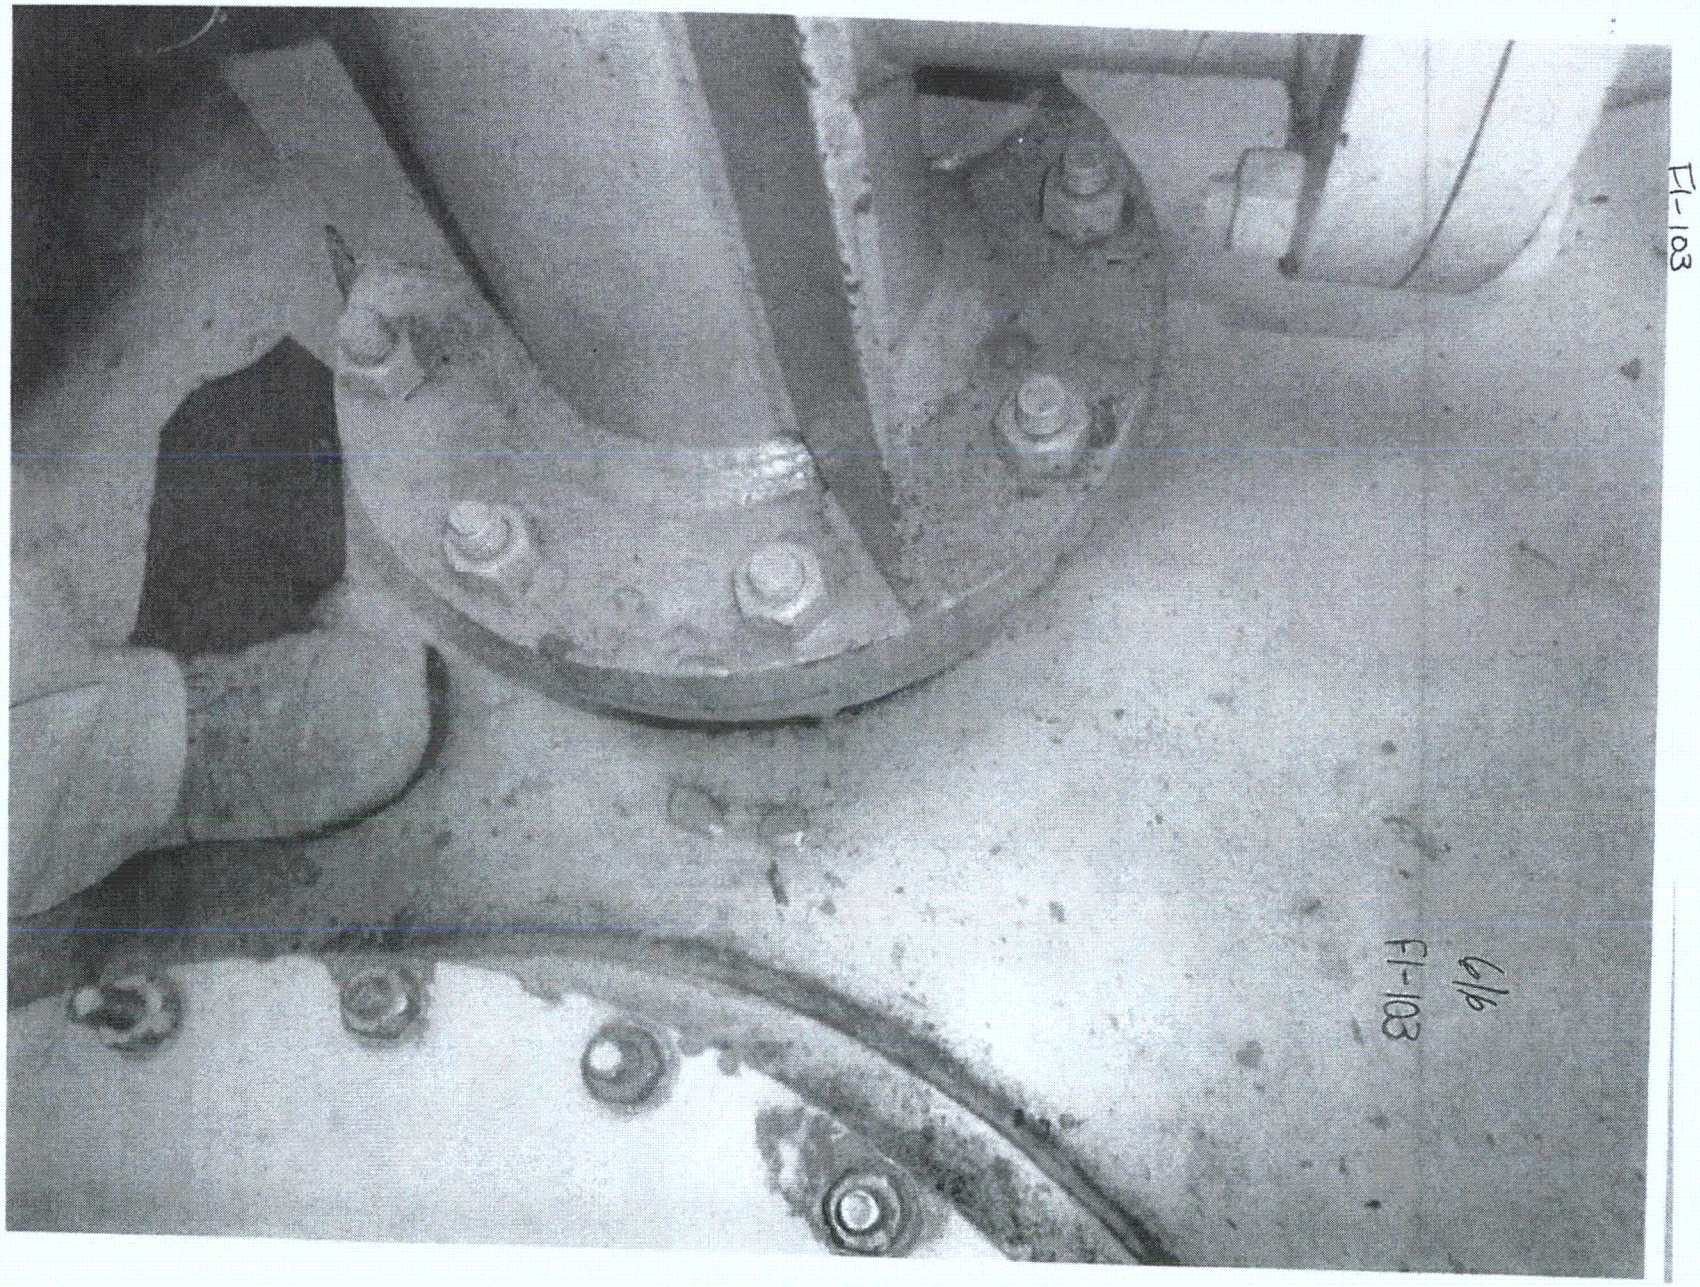
Mass added to pump to attenuate vibrations per MDC S98053790I and the effect on the pump/motor is evaluated ~~for~~ in S98053790IC005.
