Seismic Walkdown Checklist (SWC)

Equipment ID No. QSR42B516 Equip. Class[1] 20

Equipment Description UNIT 1 SERVICE WATER BATTERY FUSE BOX TRAIN A

Location: Bldg. SWIS Floor El. 188 Room, Area 74

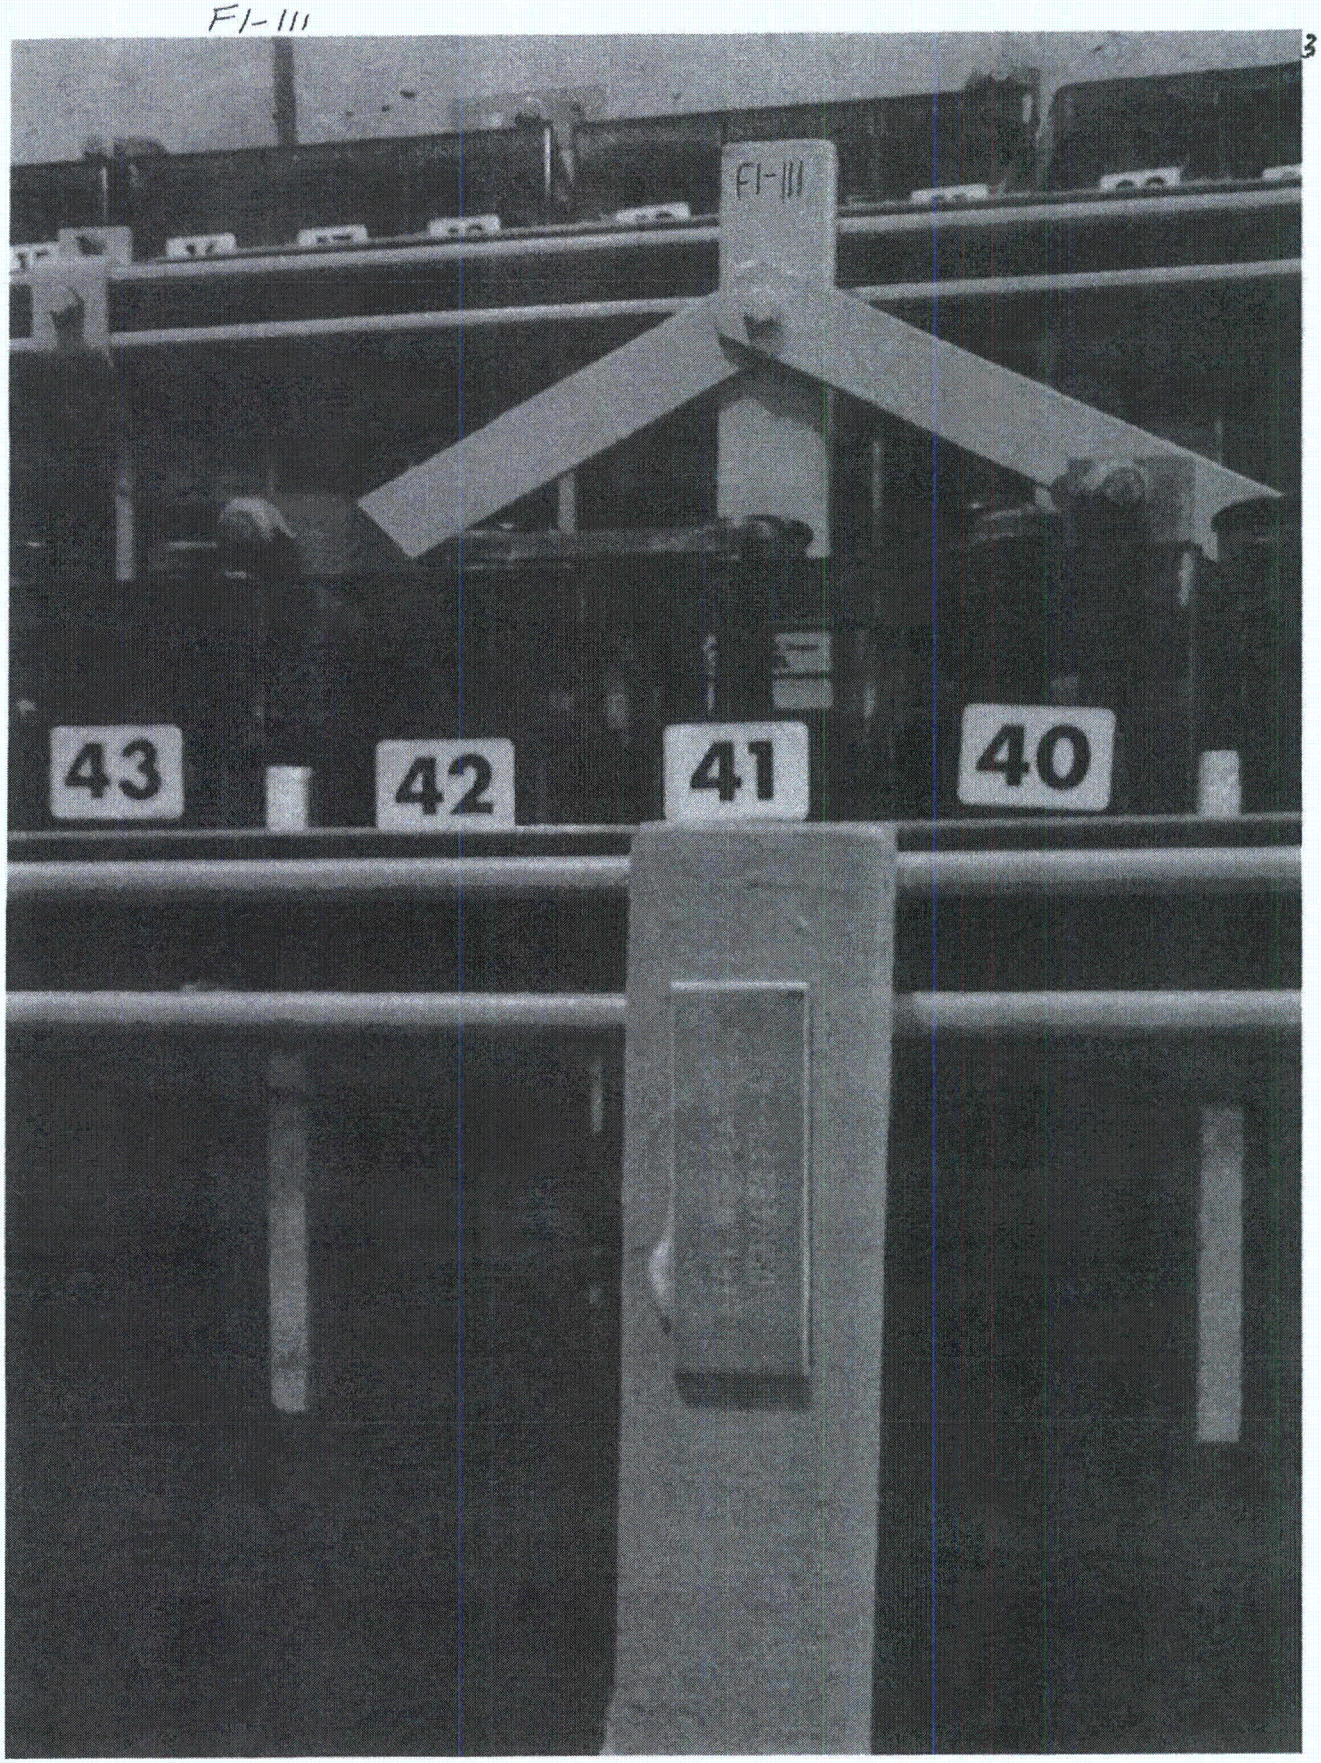
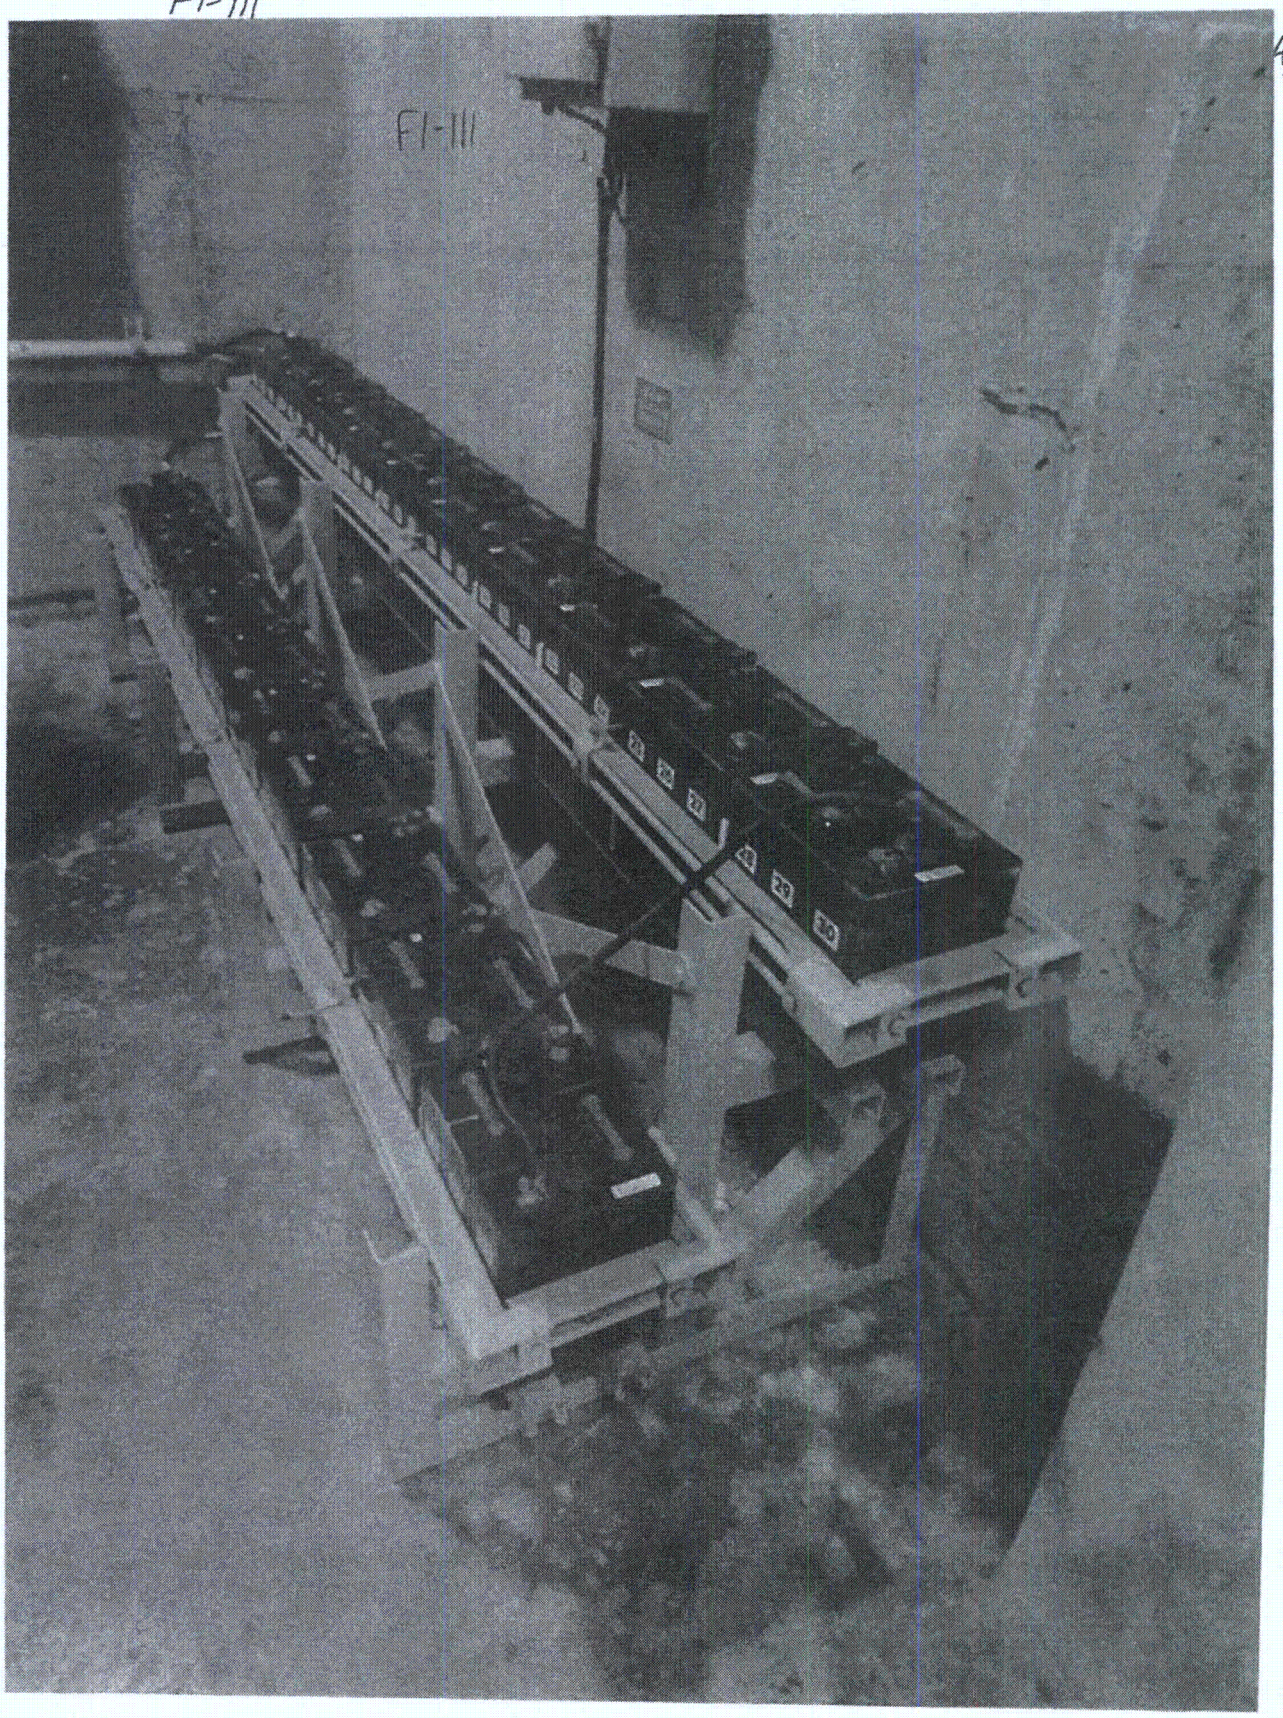
F1-111

SENS package dated 4/94 indicates 16 mounting bolts based on the photo on the last page, with rows of four.
6. Based on the above anchorage evaluations, is the anchorage free of potentially adverse seismic conditions? Y☒ N☐ U☐

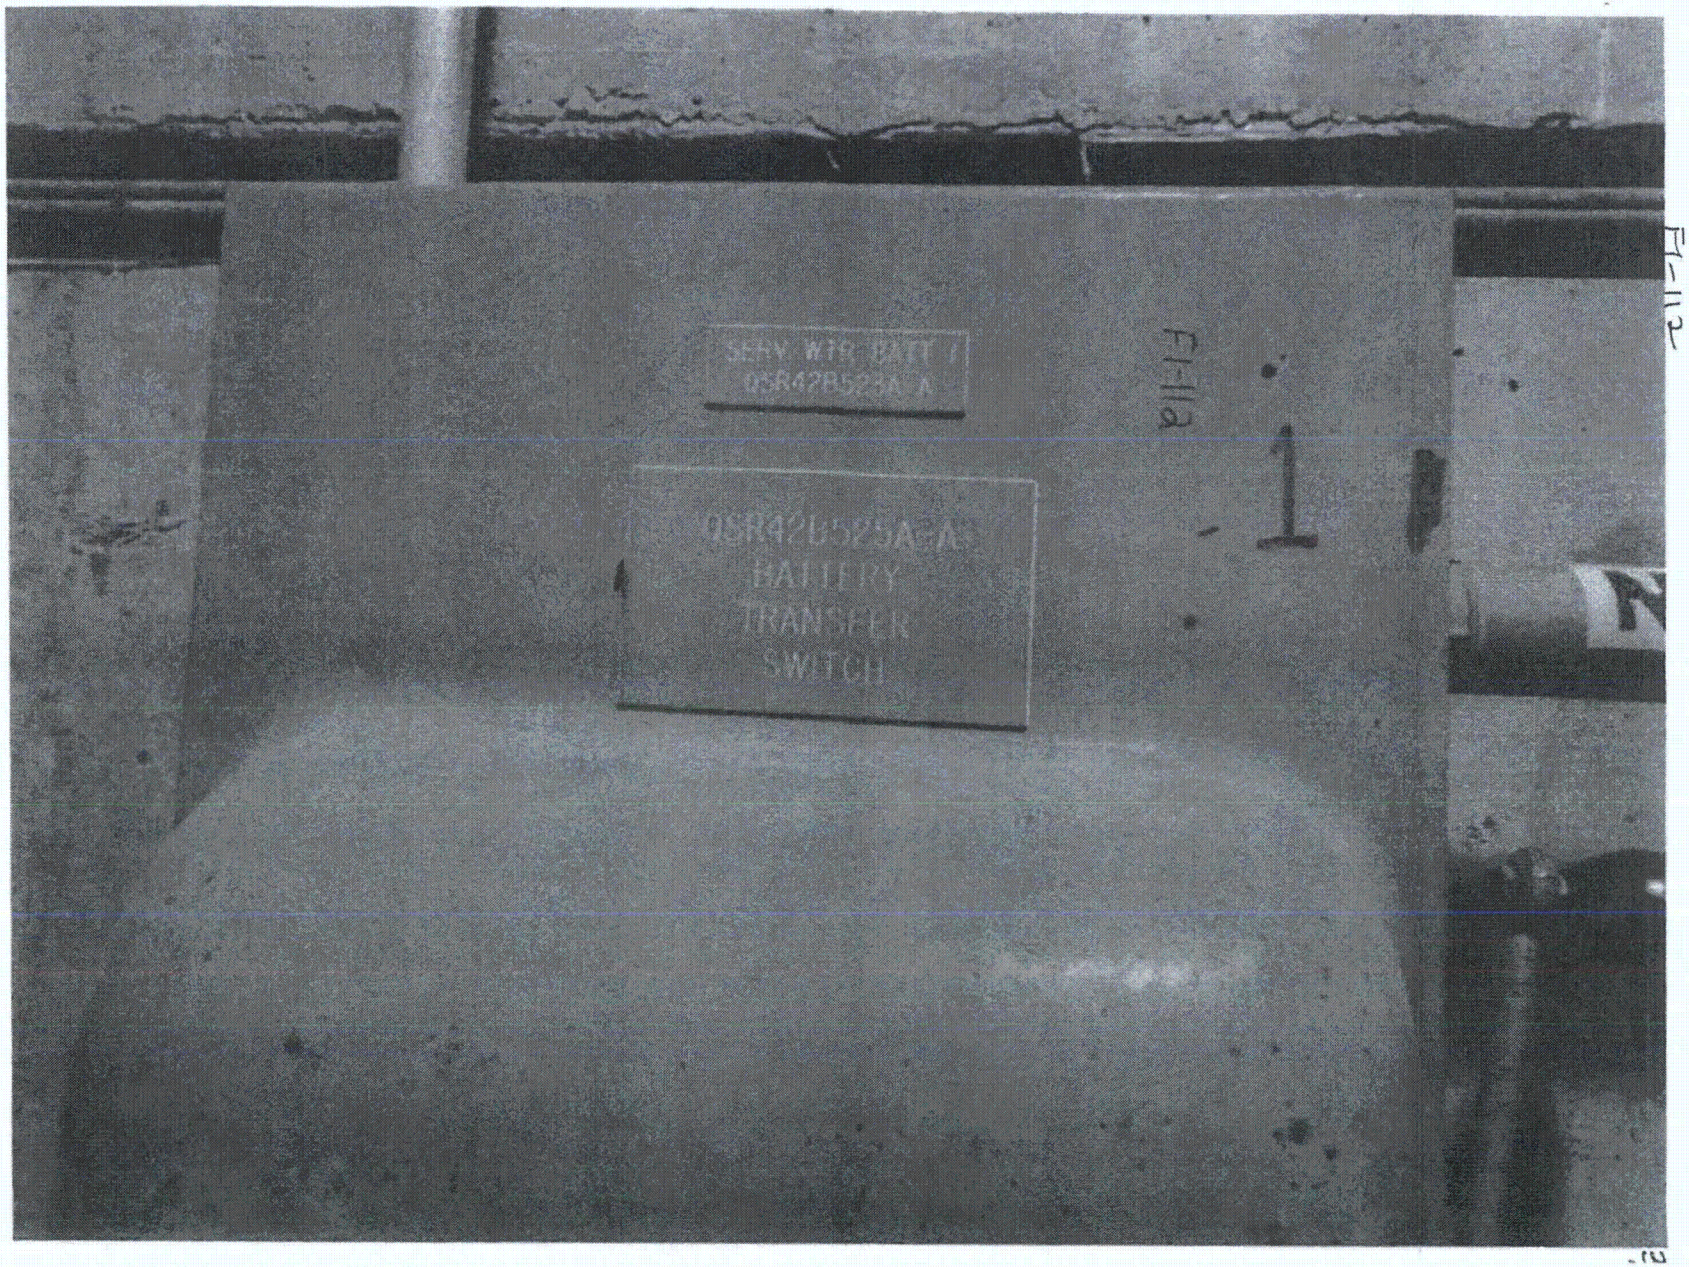
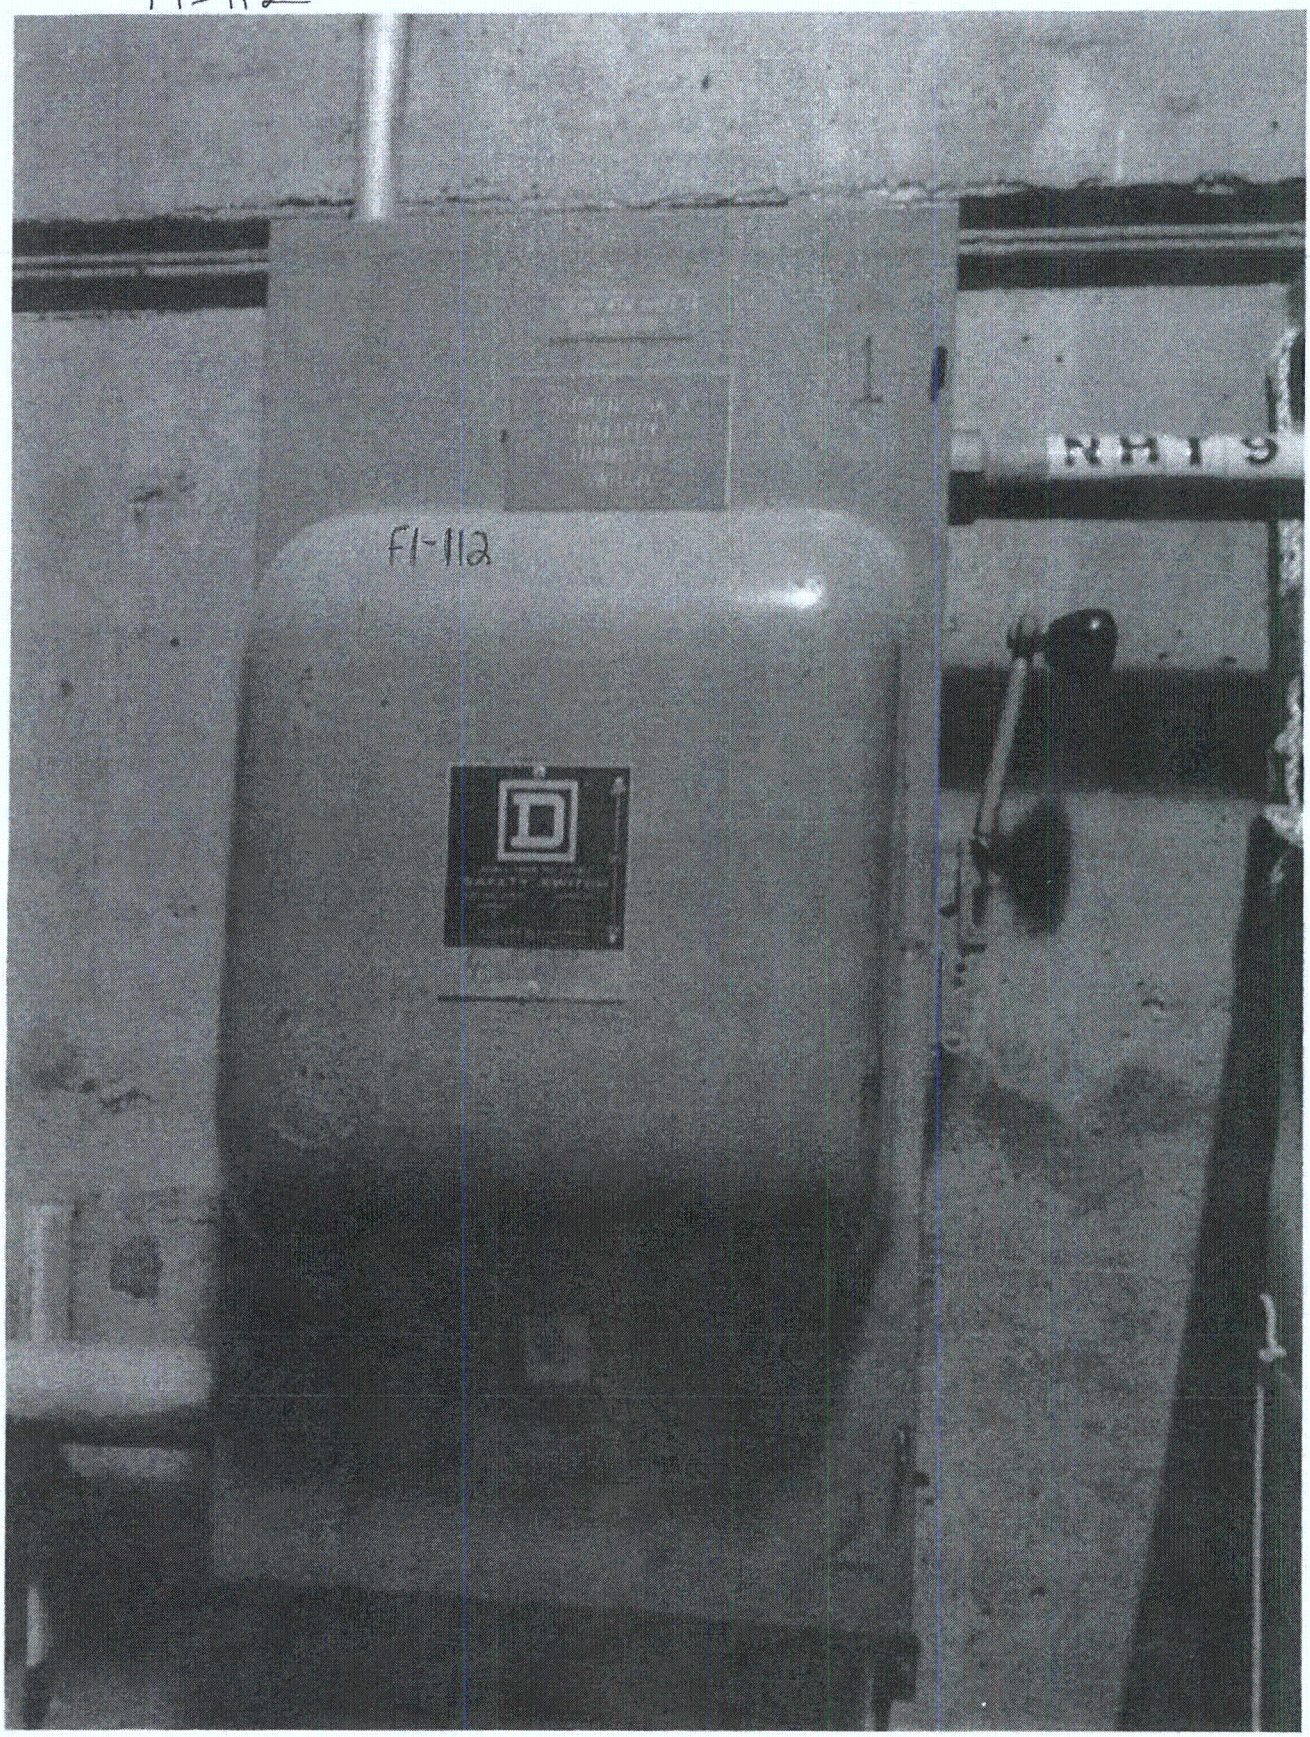
SERV WTR BATT 1
05R42B525A A
05R42B525A-A
BATTERY
TRANSFER
SWITCH
F1-112
1

two lengths of horizontal unistrut attached to concrete wall. The Battery Transfer Switch is attached to unistrut with four spring nuts. See SEWS Package dated 4/1994

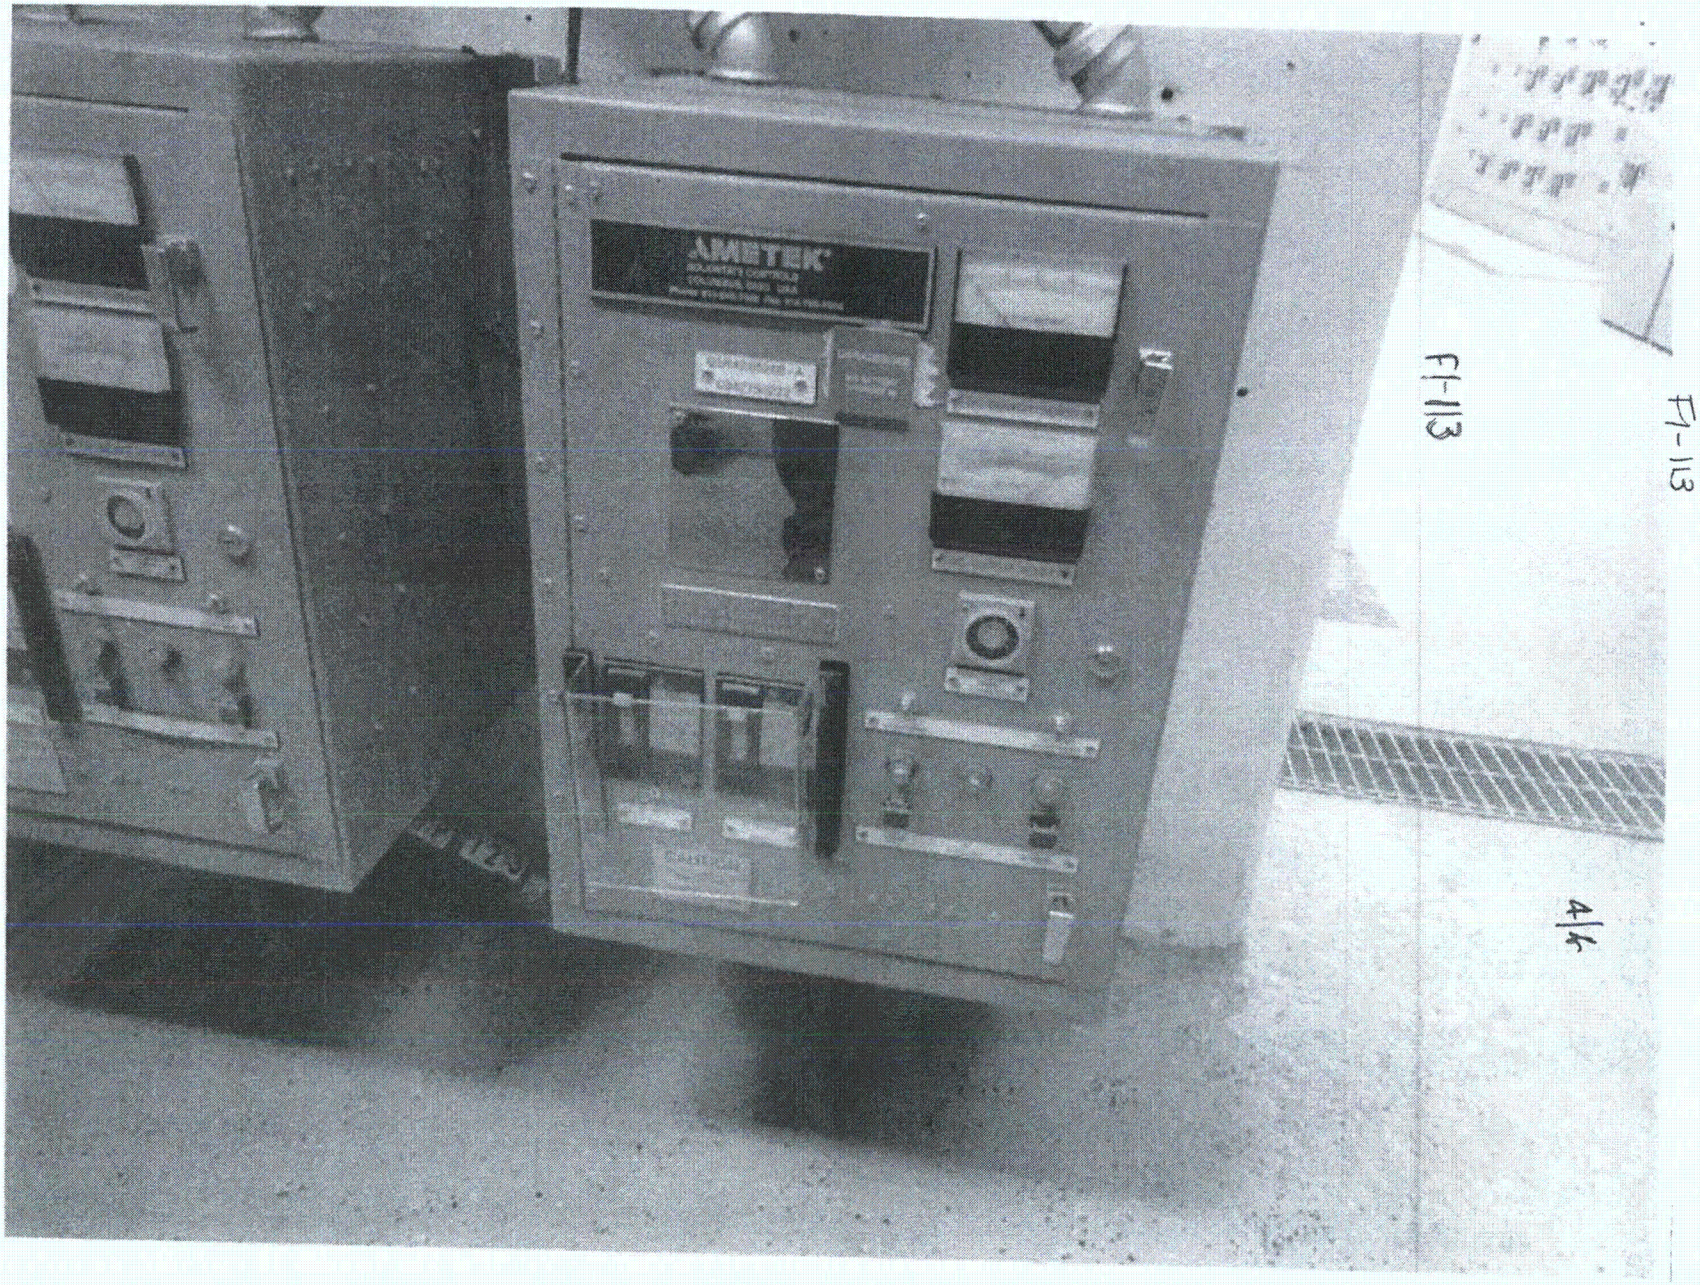
FI-113

8. Are overhead equipment, distribution systems, ceiling tiles and lighting, and masonry block walls not likely to collapse onto the equipment? Y☒ N☐ U☐ N/A☐
   Overhead lighting is attached by conduit and hooks which does not meet the requirement for a positive end connection. However decking above prevents hooks from coming disengaged. This is judged to not collapseon any equipment.

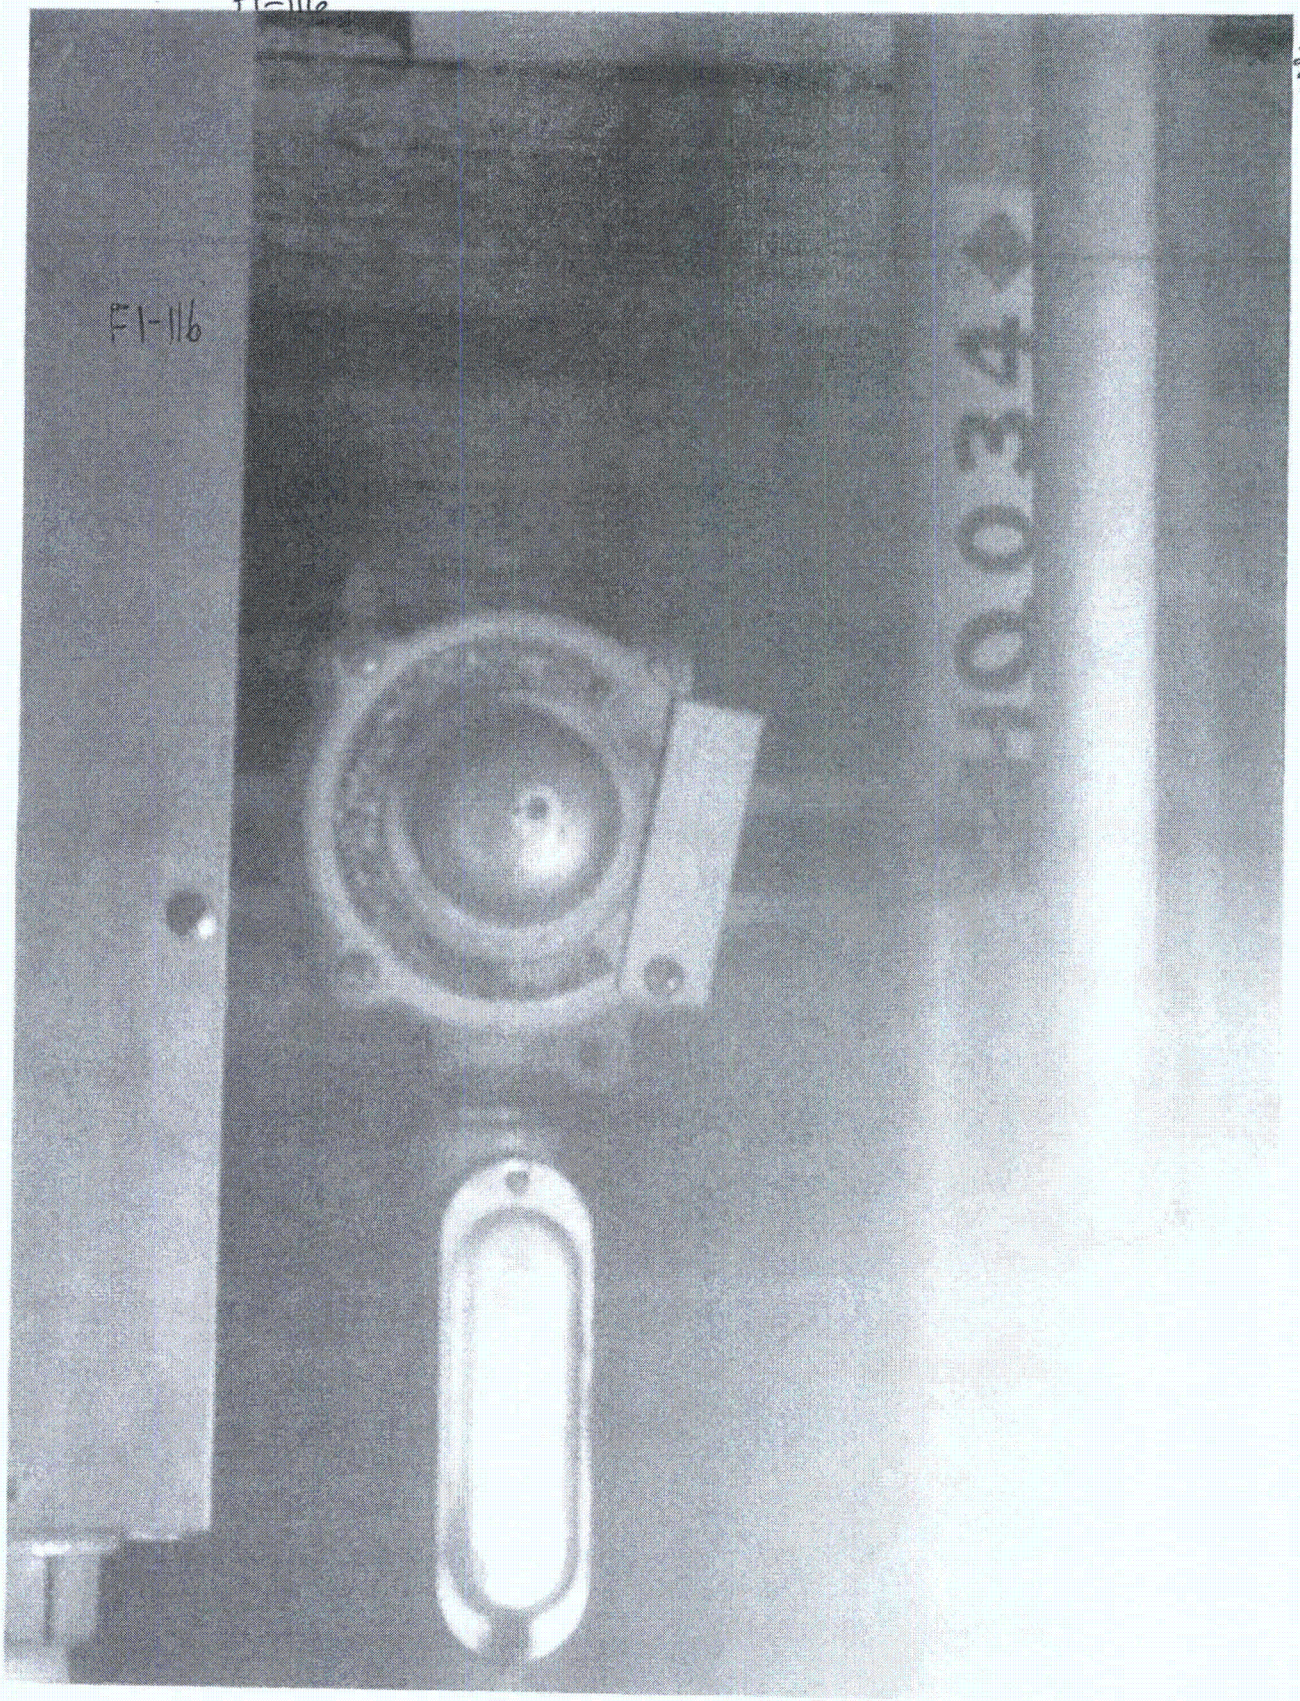
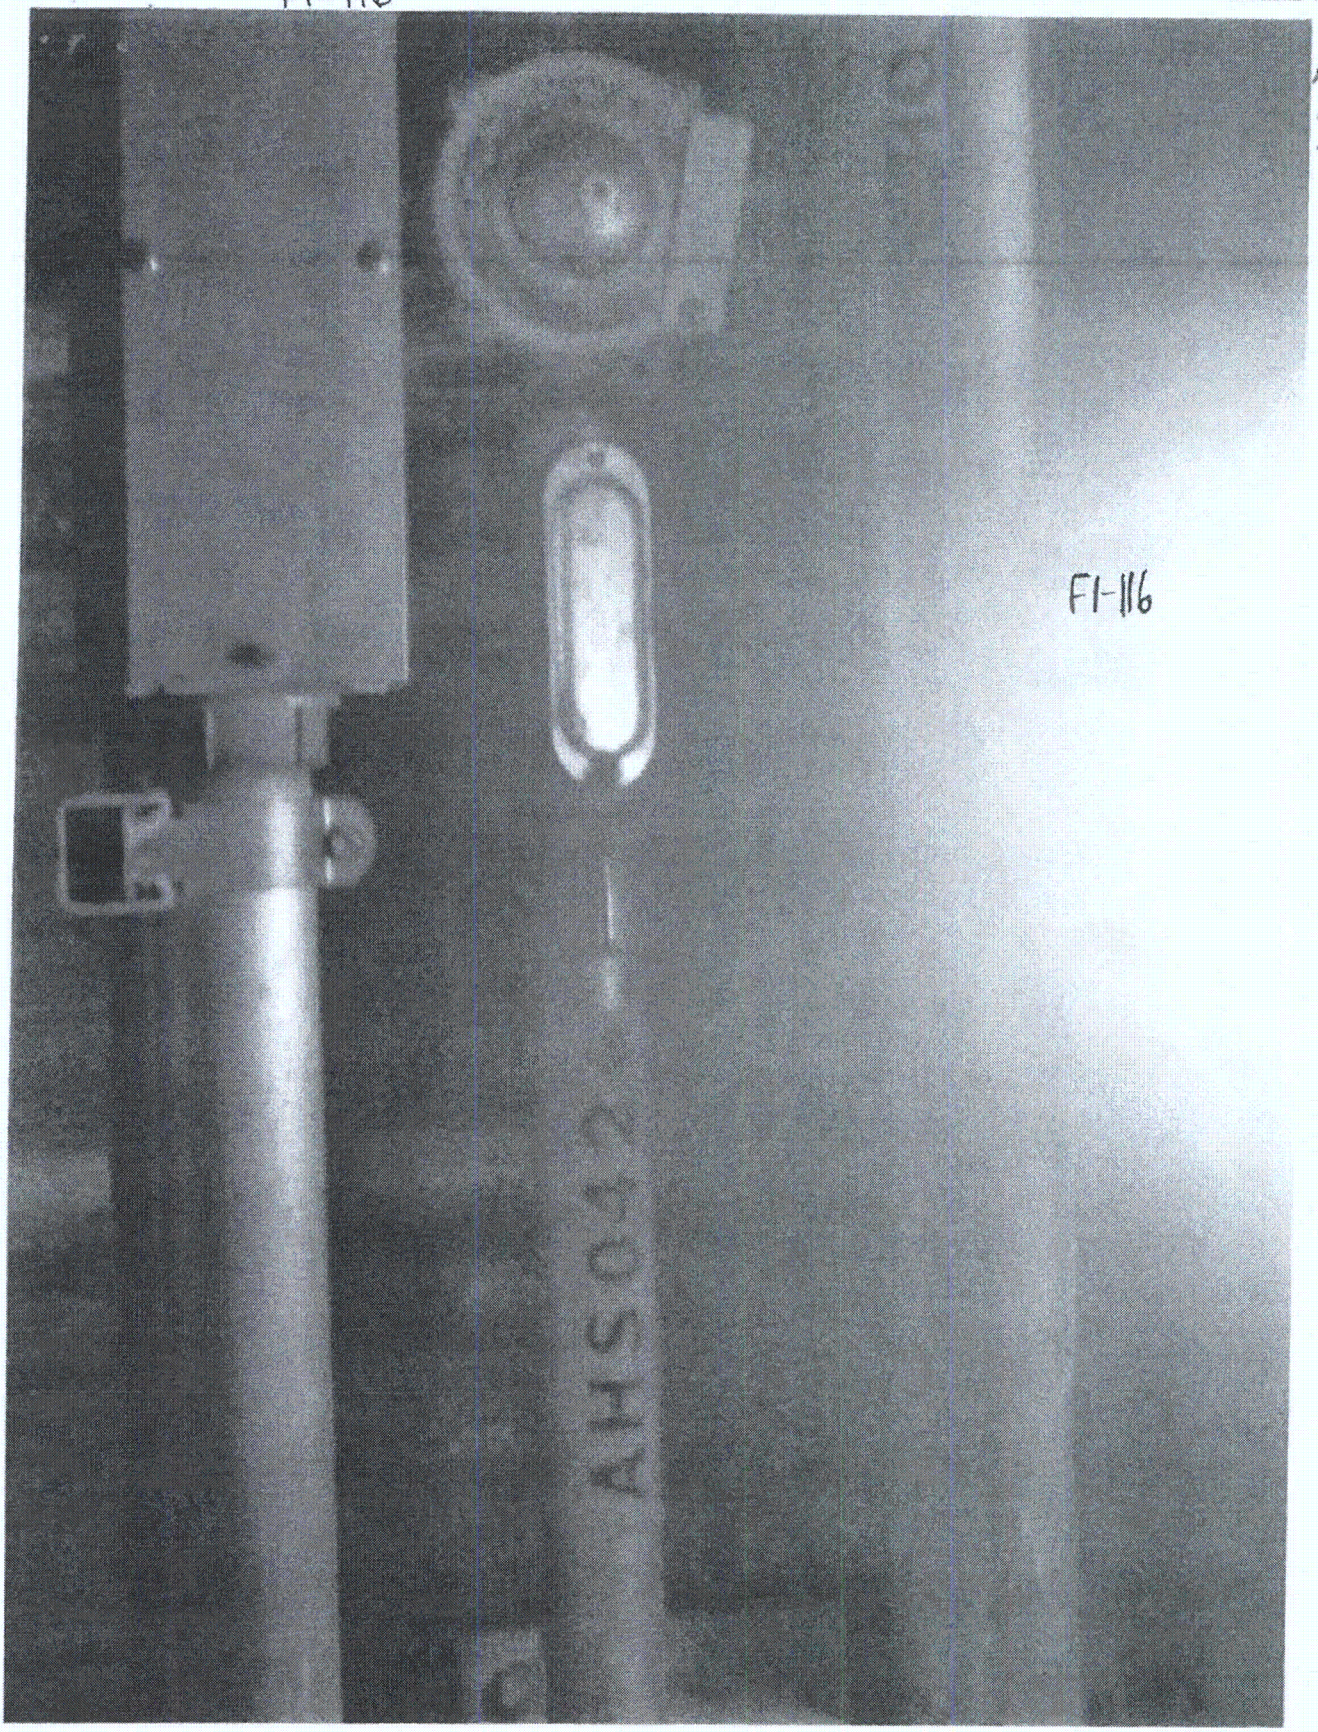
F1-116

8. Are overhead equipment, distribution systems, ceiling tiles and lighting, and masonry block walls not likely to collapse onto the equipment? Y☒ N☐ U☐ N/A☐
   nothing noted overhead that can collapse, see #7.

9. Do attached lines have adequate flexibility to avoid damage? Y☒ N☐ U☐ N/A☐
   electrical, tubing, ppg insp;ected
