Technical Report

STEAM GENERATOR WATER HAMMER EVALUATION
H. B. ROBINSON STEAM ELECTRIC PLANT UNIT NO. 2

Report No. 6-2

March 13, 1980

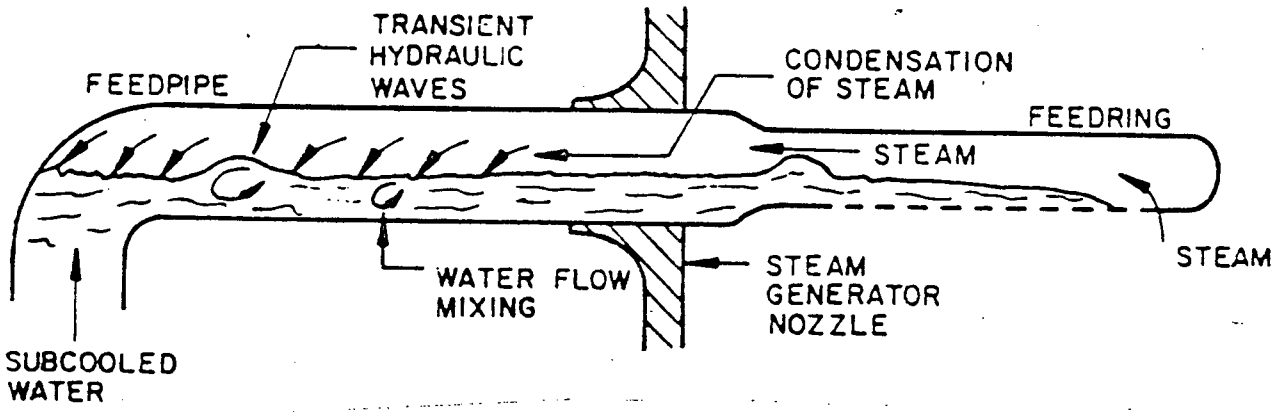
Figure 2. Counter-current Flow into Piping [2]

(1) The flow of steam into the feedring through the discharge holes which are not flowing water and around the feedring into feedwater piping is counter to the flow of water toward the holes. This counter-current flow can cause waves on the surface which can build up to block the ring and isolate a steam pocket in the upstream portion of piping.

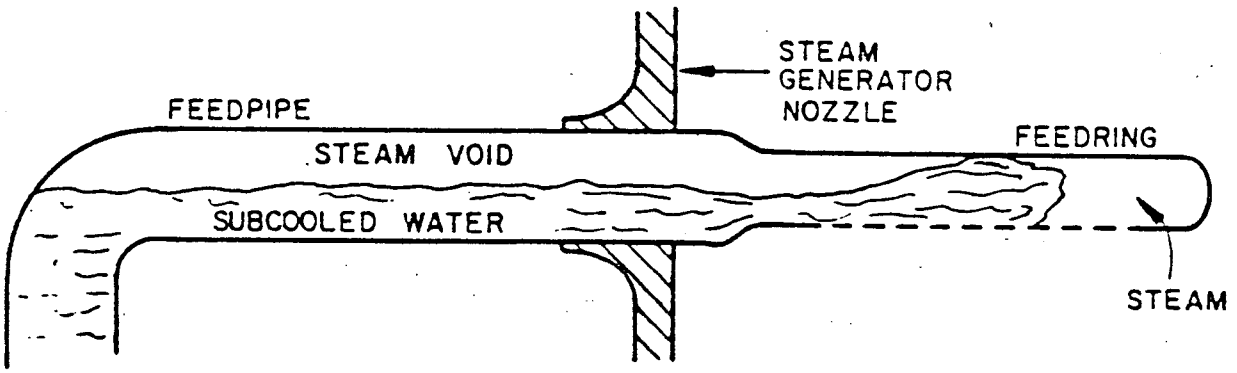
Figure 3. Isolation of Steam Void [2]

The event is typically initiated by a turbine trip which causes the water level to fall in the steam generators to a point below the feedring. Feedwater flow is discontinuous as a result of the trip and then the feedwater quickly drains from the ring through bottom discharge holes so that when the cold auxiliary feedwater arrives, the ring runs only partially full of water during recovery. The auxiliary feedwater flow rate at HBR is not sufficient to fill the ring while it is draining. As steam generator water level recovery proceeds, at least three mechanisms have been cited which could lead to the aforementioned steam void isolation and collapse:

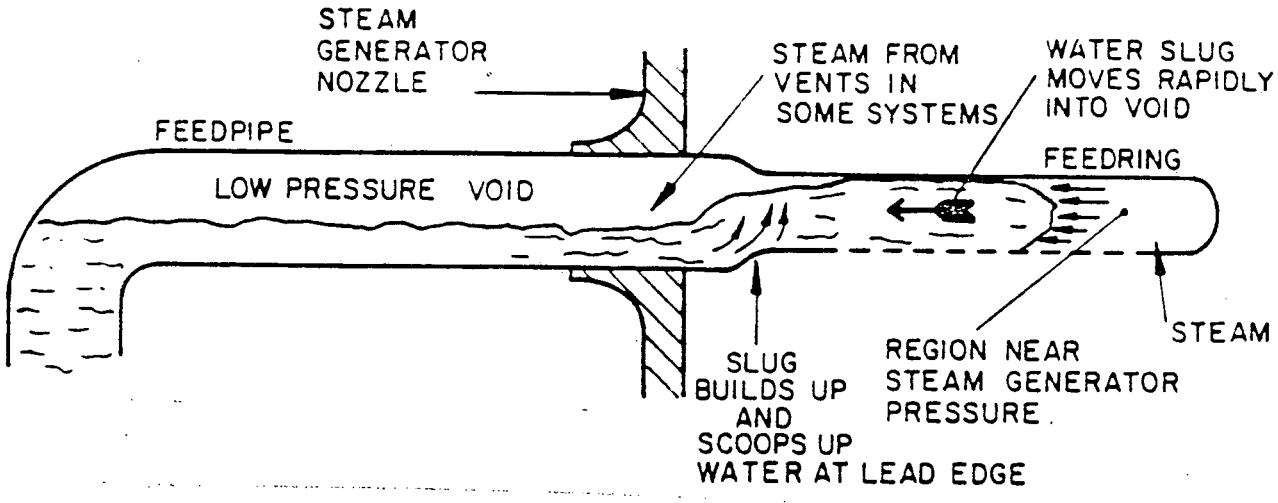
Figure 4. Acceleration of Water Slug [2]

The dynamic event considered here is that occurrence which has been observed several times in PWR's both in the United States and abroad in which a water slug is accelerated by the differential pressure caused by the condensation of an isolated steam pocket. The accelerated water slug can impact the piping or water and cause damage to the piping system. Reported cases in other units (there have been no reported cases at HBR) have led to associated damages such as bent piping supports and a cracked feedwater line.

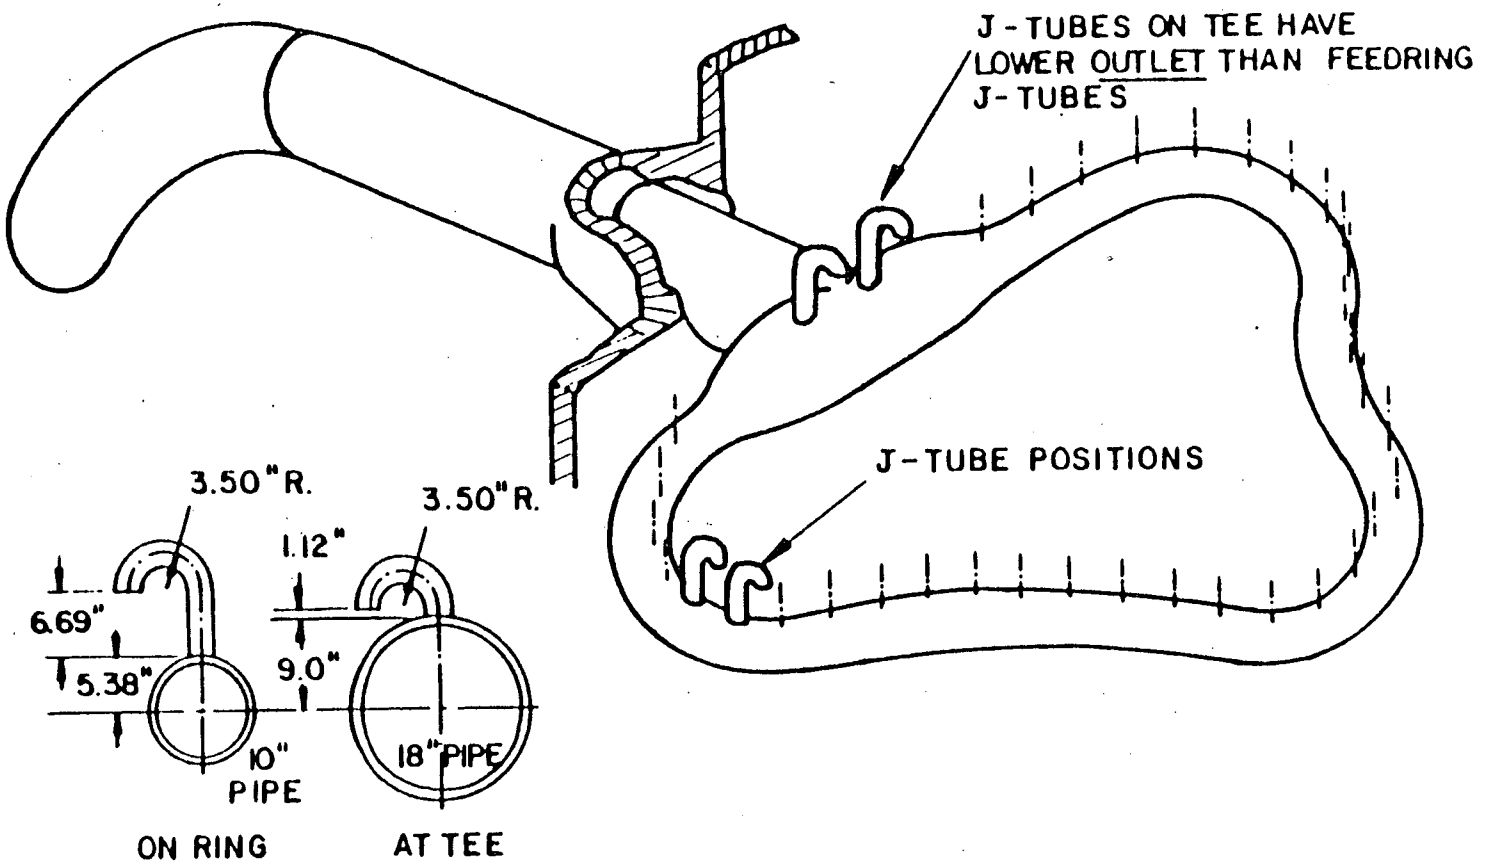
Figure 6. J-tubes Similar to those used at Indian Point Unit 2. [2]

In the interest of helping to keep the feedring from draining it has been recommended in the Creare Report [2] to install "J-tubes" similar to those shown in Figure 6. Currently, HBR does not plan to do this because of other mitigating features of the plant and the absence of any damaging hammer in the plant history [4].

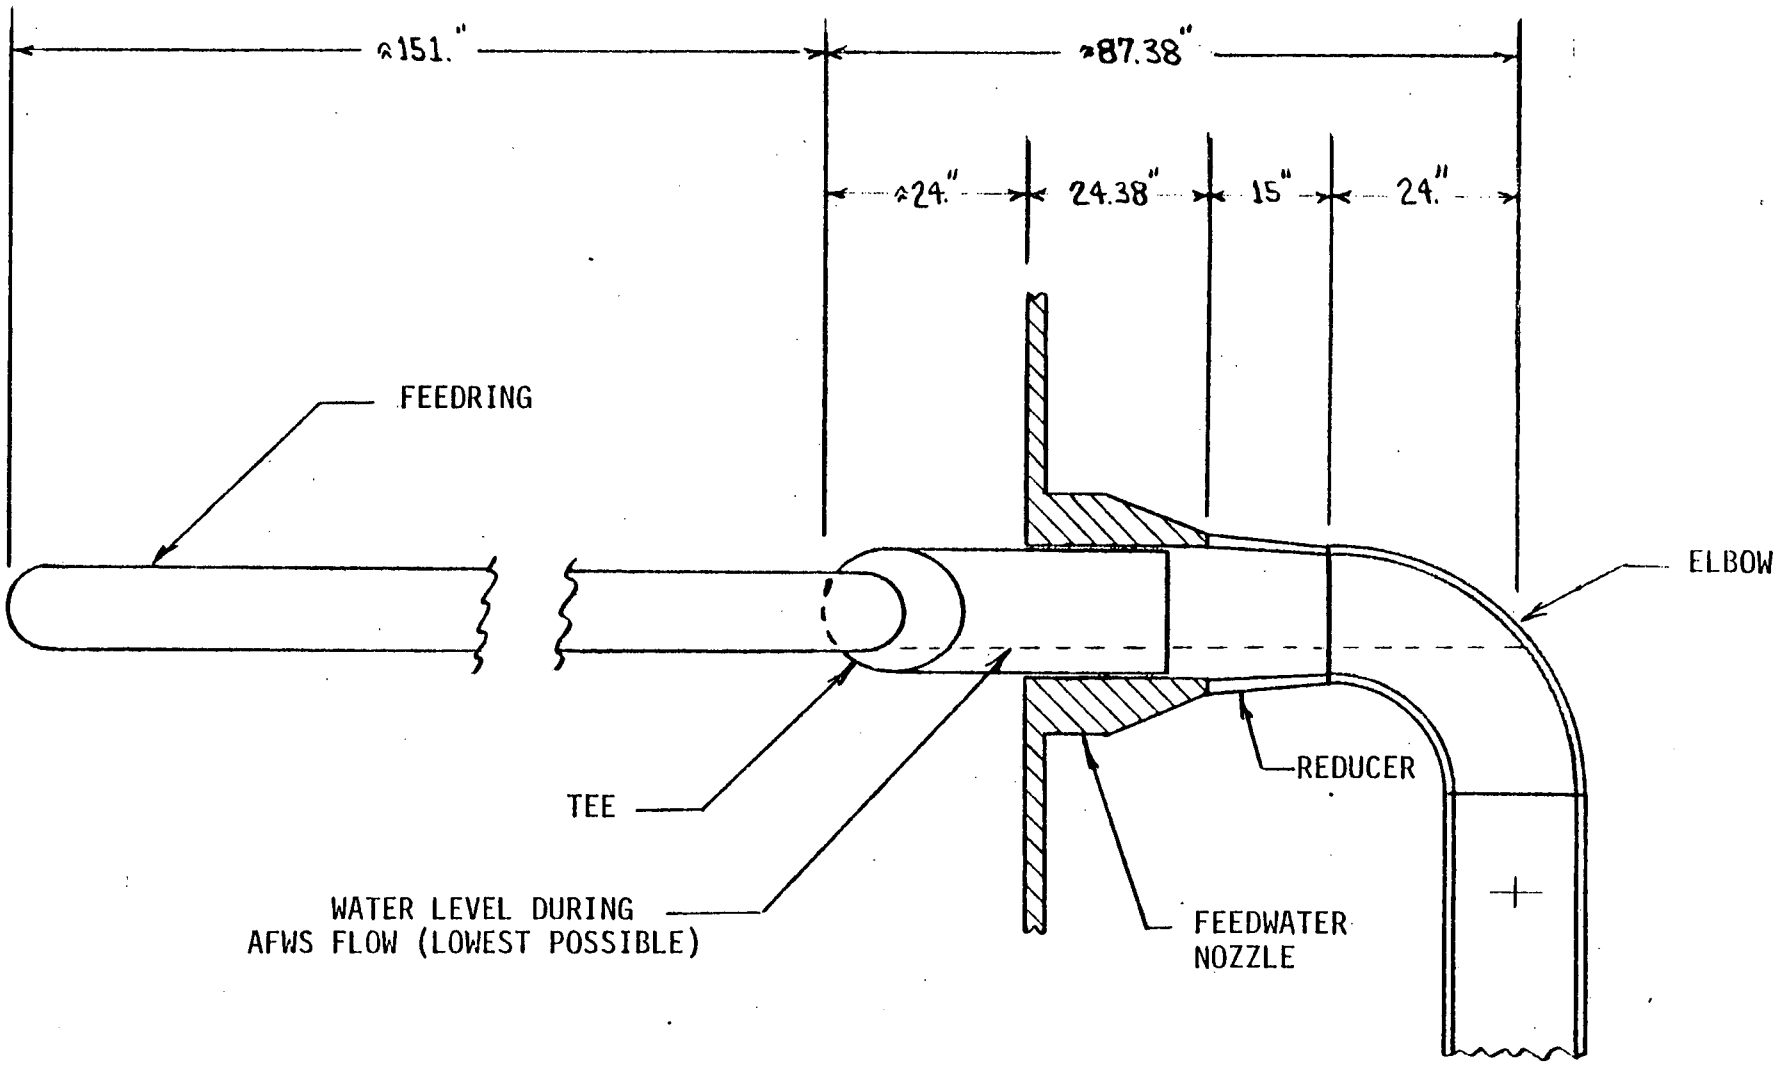
Figure 7. HBR Feedring and Piping Sketch

In the Creare Report [2] mention is made of adding the length of the feedring itself to the total "horizontal" run of drainable pipe when considering the water hammer potential. We have concluded that this is not correct. Steam void collapse (should any occur in the feedring) would accelerate a slug of water to produce only internal momentum transfer. While external pressure pulses could occur they would be much less than those generated by a water hammer in an external feedwater pipe section. Also, no known damage has been traced to water hammers originating in the feedring sparger.

The model test results reported do not show a reduced likelihood of water hammer occurrence with decreasing external piping horizontal length. However, the over-pressure did decrease. Also, these model tests did not accurately simulate the feedring geometry. A simple straight pipe was used to model the feedring which allowed its total length to act as a direct extension of the external "horizontal" piping. Thus, it can be seen how in this case the simulated feedring length contributed to the mechanisms initiating water hammer and allowed a direct linear communication between feedring and external piping facilitating momentum transfer.
