CAROLINA POWER AND LIGHT COMPANY

H. B. ROBINSON SEG PLANT, UNIT NO. 2

STEAM GENERATOR INSPECTION

SEPTEMBER, 1982

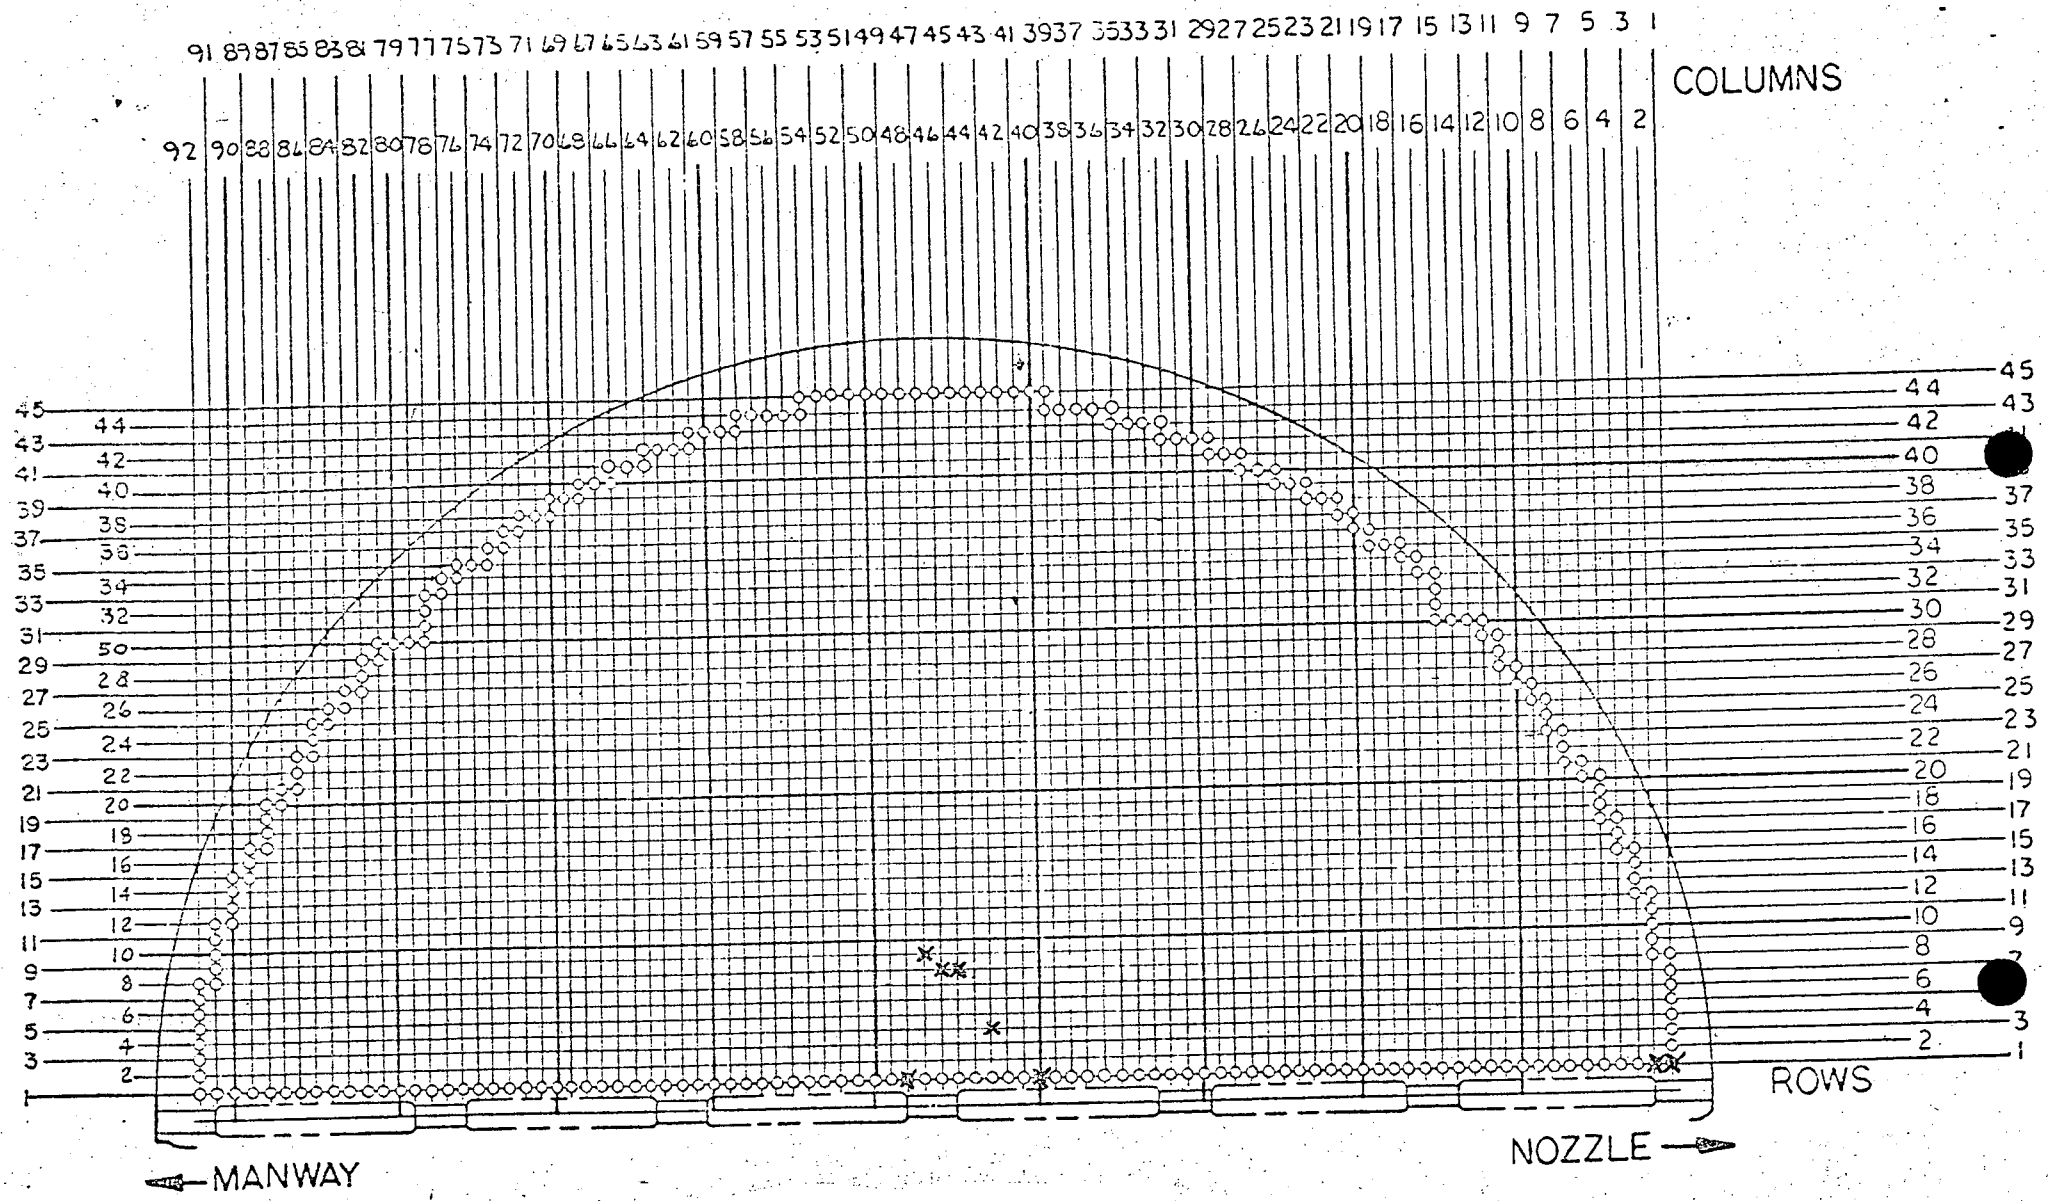
FIGURE I.1.1-1

The initial inspection sample selected consisted of all unplugged tubes in each S/G. Each tube was to be inspected full length (tube end to tube end). This was accomplished with the exception of eight tubes in "B" S/G which were inspected through the top support plate from each side but not through the U-bend region. These tubes, R1C1, R1C2, R1C40, R4C43, R8C45, R8C46, R9C47 and R1C48 are plotted on Figure I.1.1-1. These tubes were hand probed at the end of the inspection period, and the difficulty encountered due to probe friction did not warrant the radiation exposure required for the full length inspections. Also, these tubes are all located in a region which has never experienced U-bend degradation in any H. B. Robinson S/G. In addition, one tube in "C" S/G (R9C29) would not pass an eddy current probe thru the full tube length. (See Section II.1)

PLOT OF "B" S/G TUBES NOT INSPECTED THROUGH U-BEND

X = Denotes tubes not inspected through U-bend region.

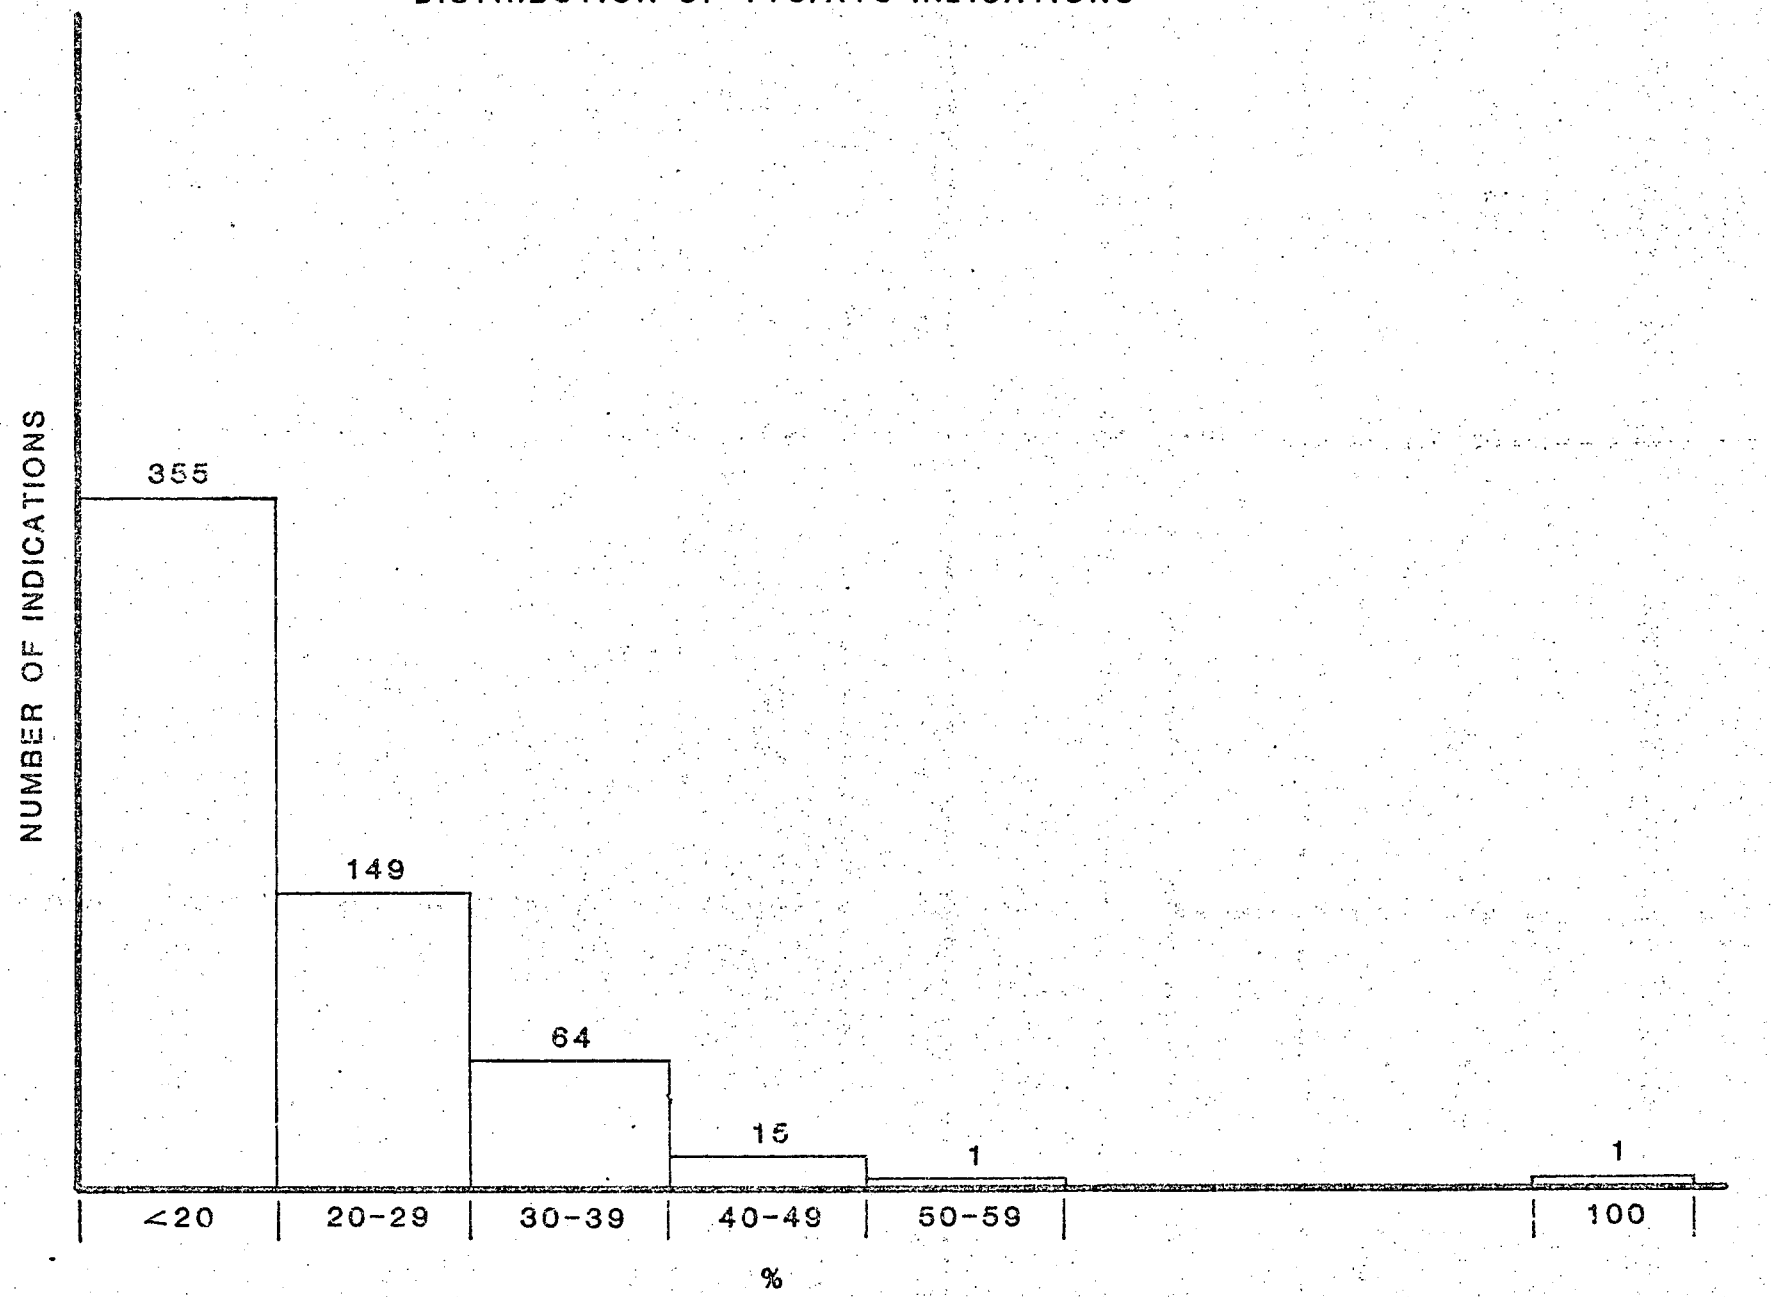
FIGURE I.1.4-1

(as outlined in our submittal dated August 21, 1981). This conclusion is supported by the distribution of the eddy current indications with respect to number and size. This distribution is depicted in Figures I.1.4-1 through I.1.4-6.

A S/G INLET

DISTRIBUTION OF TTS/ATS INDICATIONS

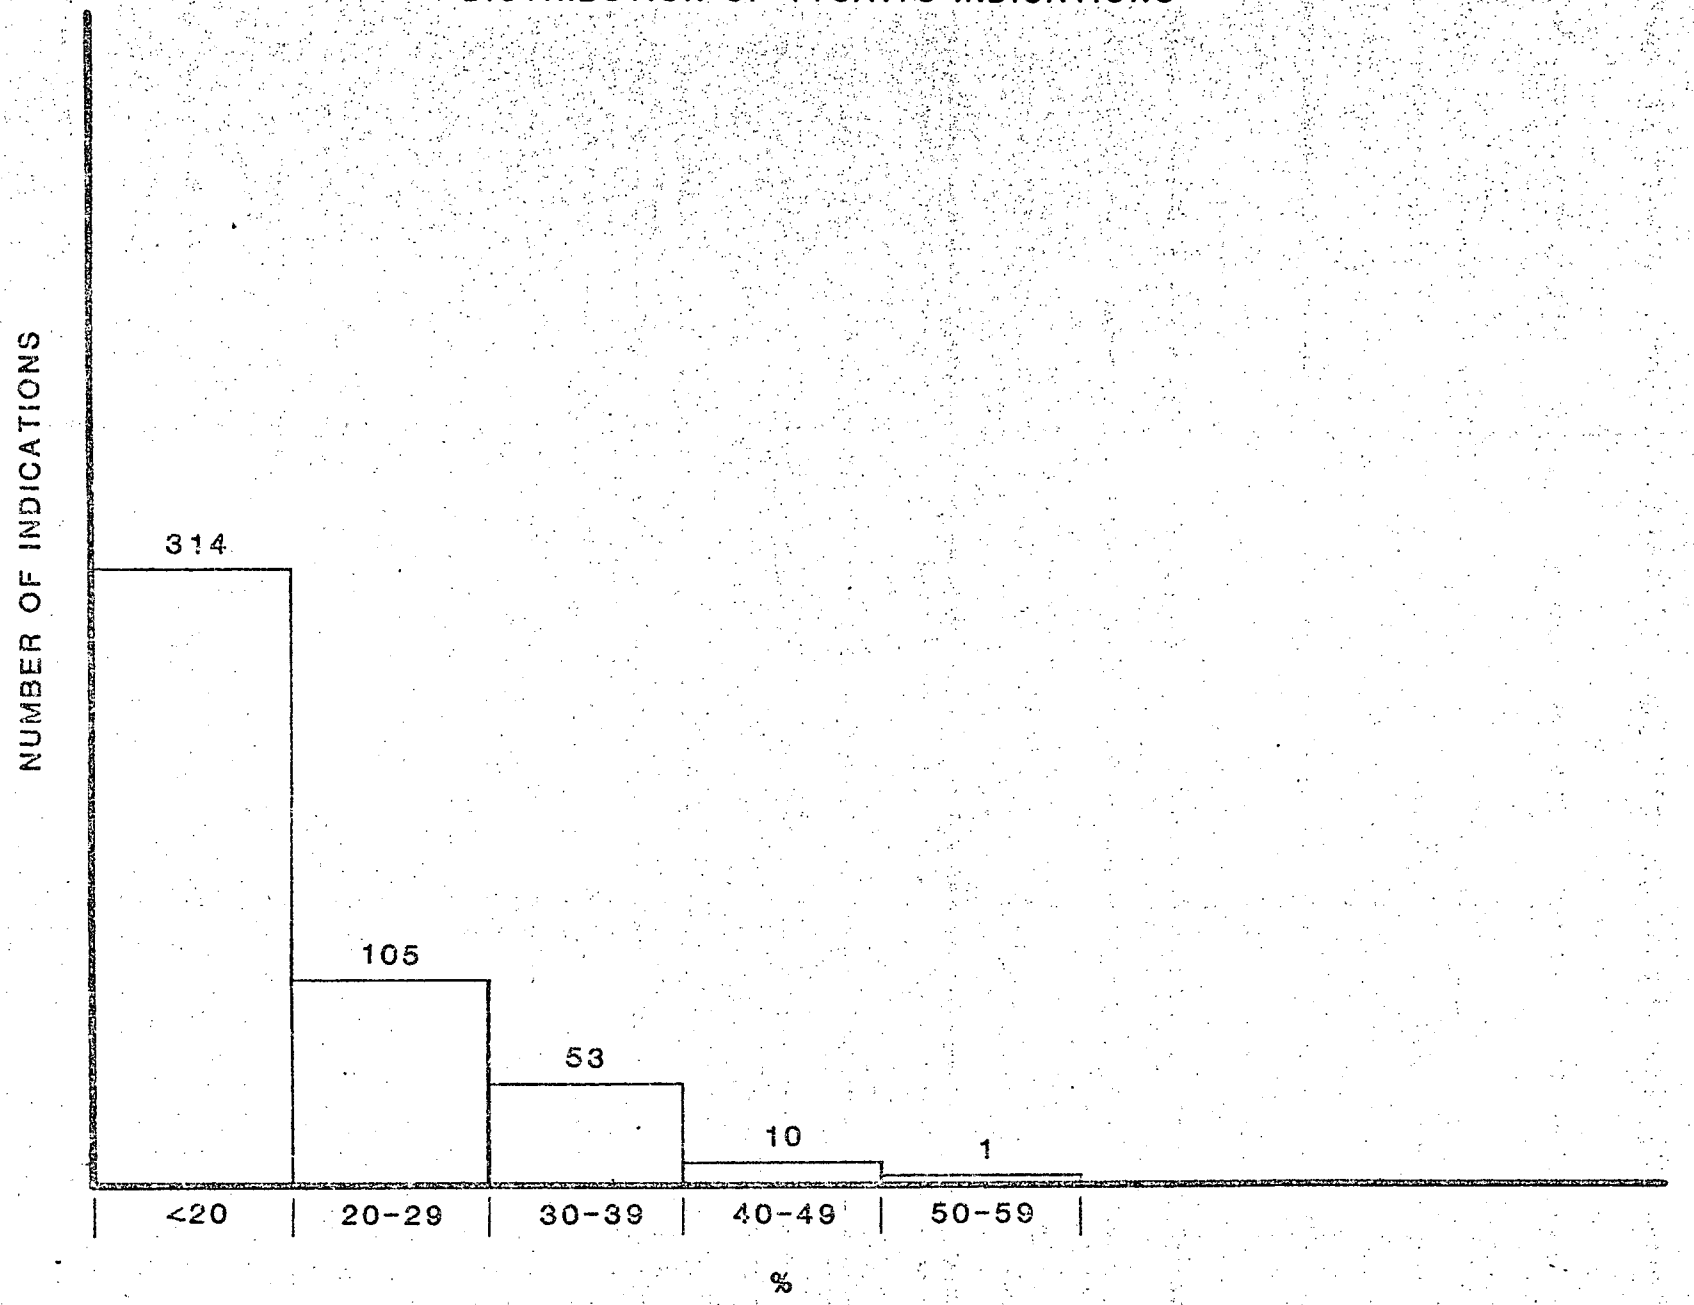
FIGURE I.1.4-2

A S/G OUTLET

DISTRIBUTION OF TTS/ATS INDICATIONS

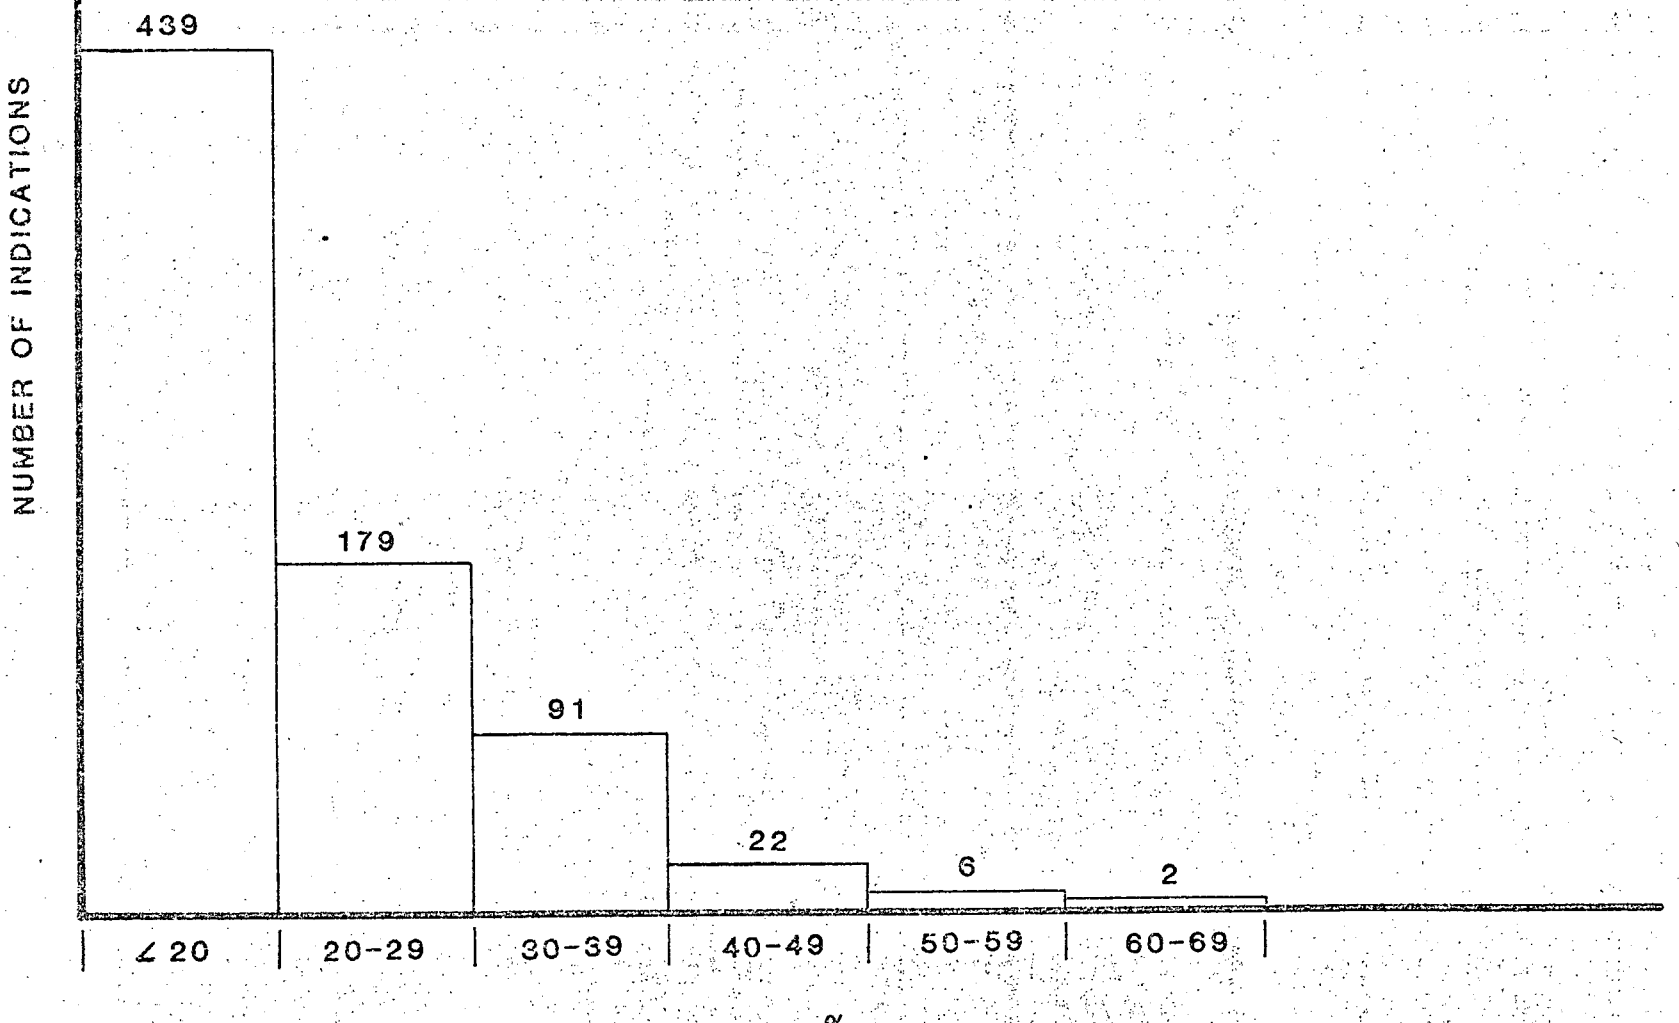
FIGURE I.1.4-3

B S/G INLET

DISTRIBUTION OF TTS/ATS INDICATIONS

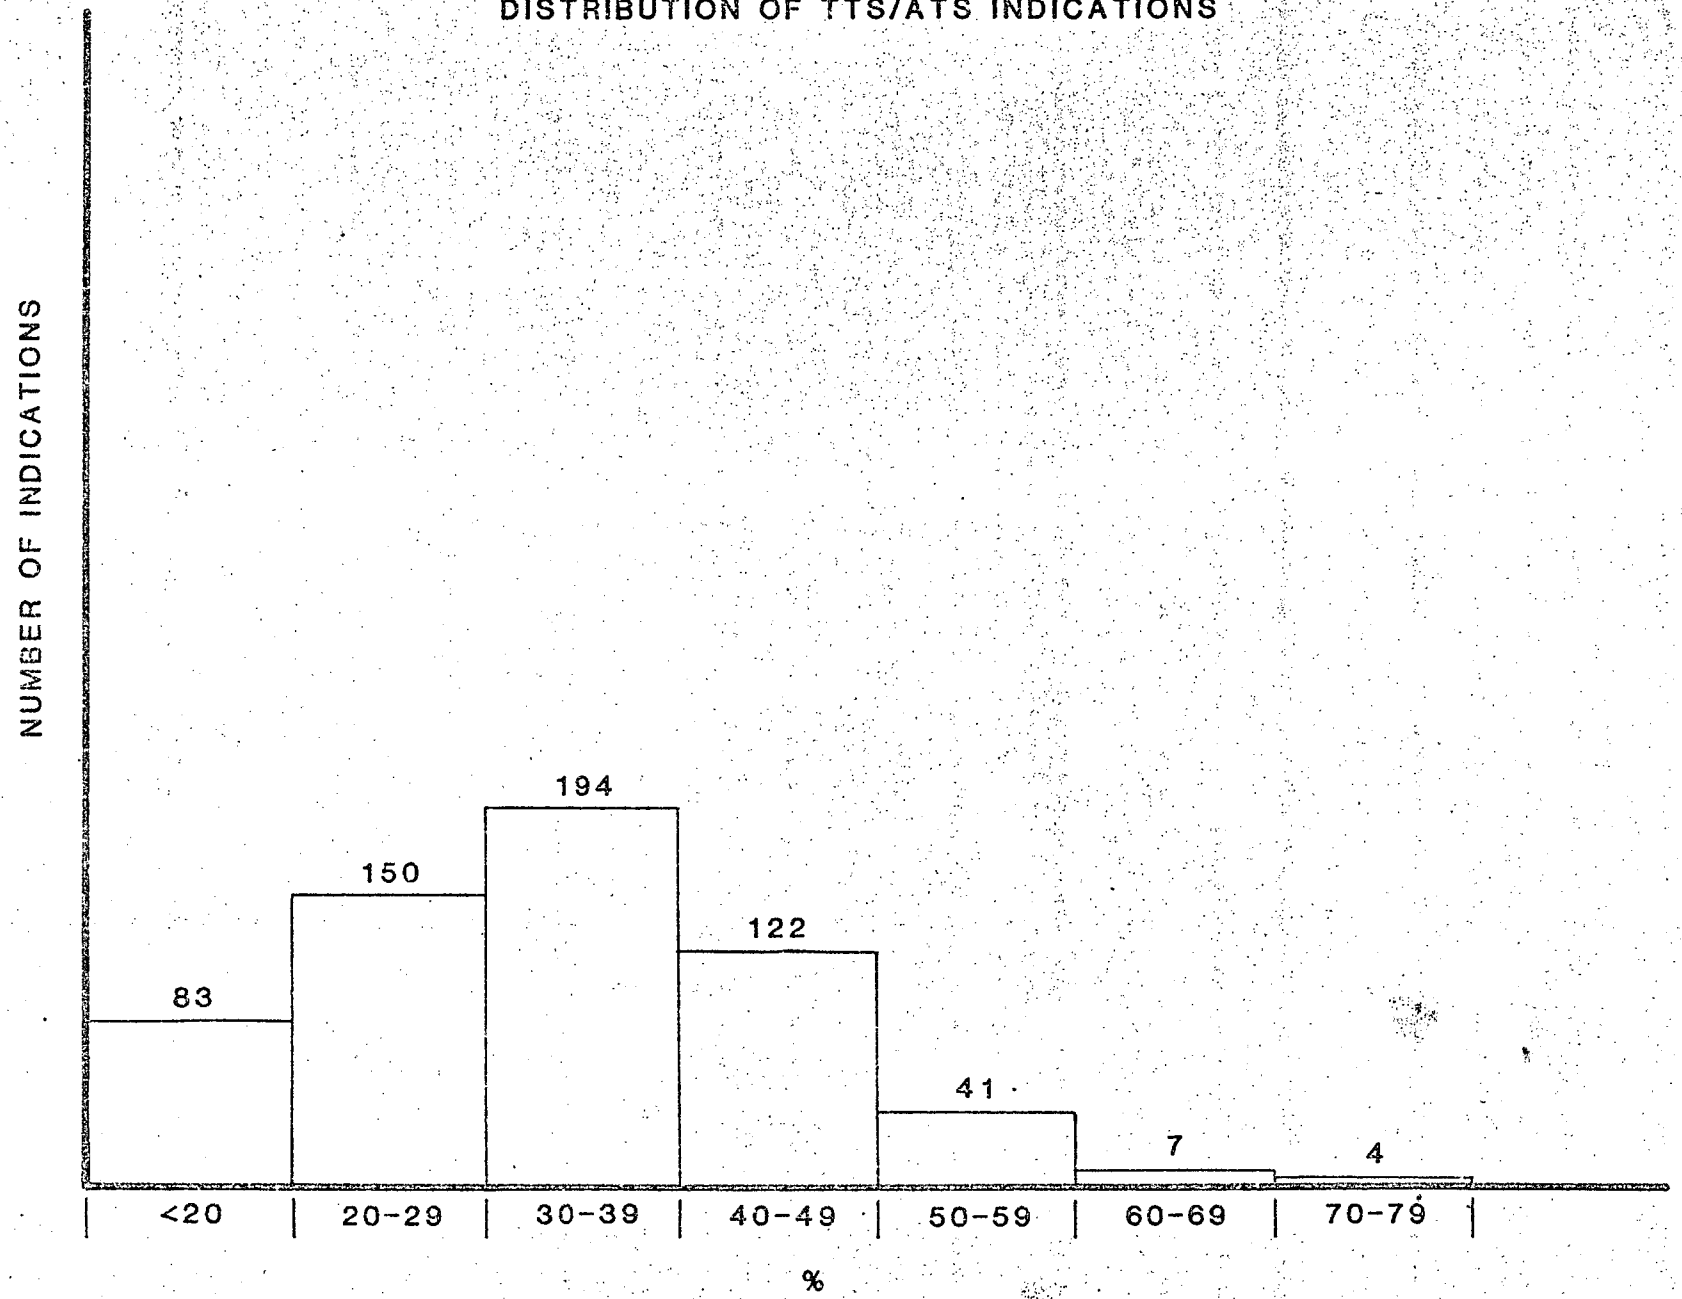
FIGURE I.1.4-4

B S/G OUTLET
DISTRIBUTION OF TTS/ATS INDICATIONS

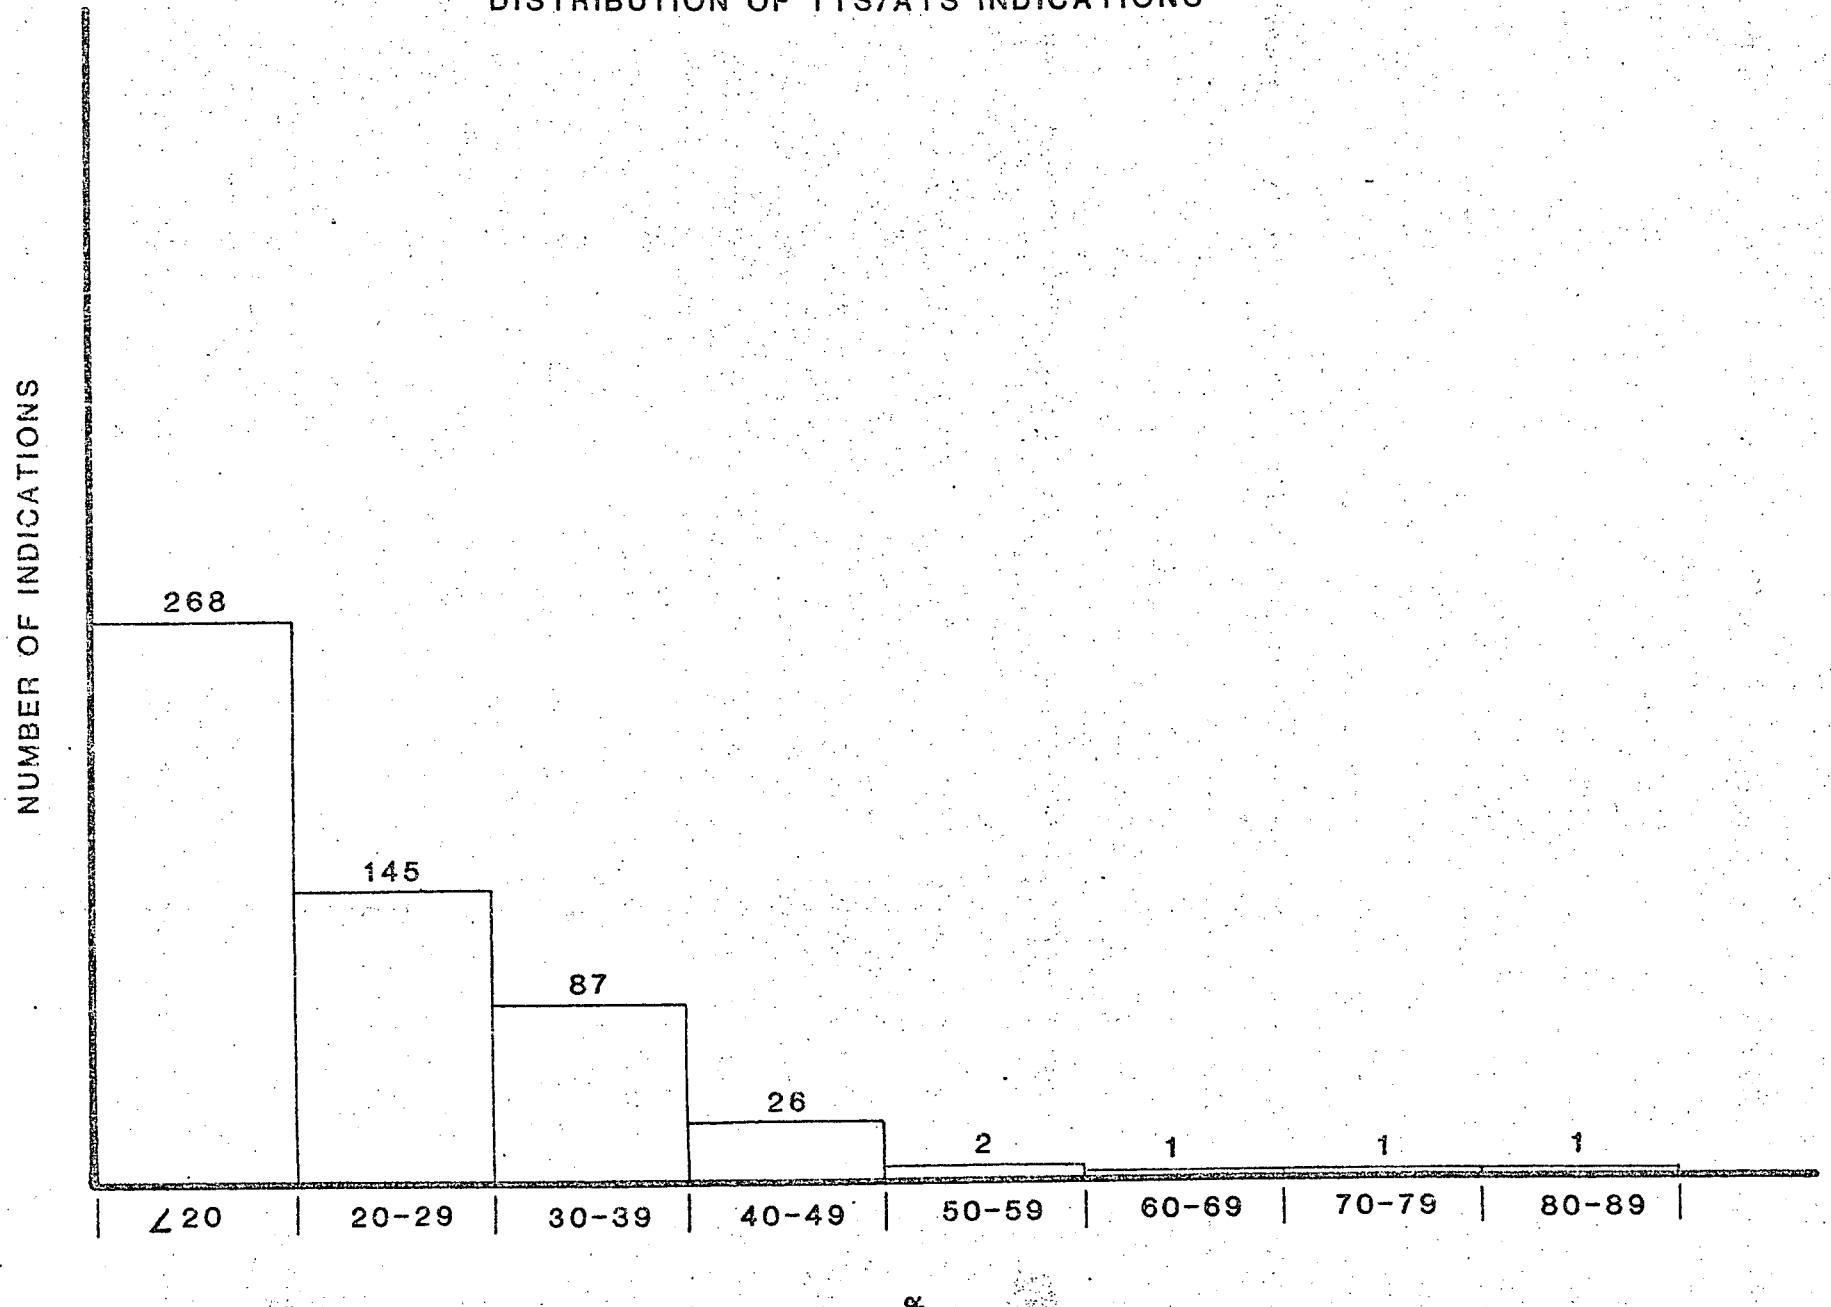
FIGURE I.1.4-5

C S/G INLET

DISTRIBUTION OF TTS/ATS INDICATIONS

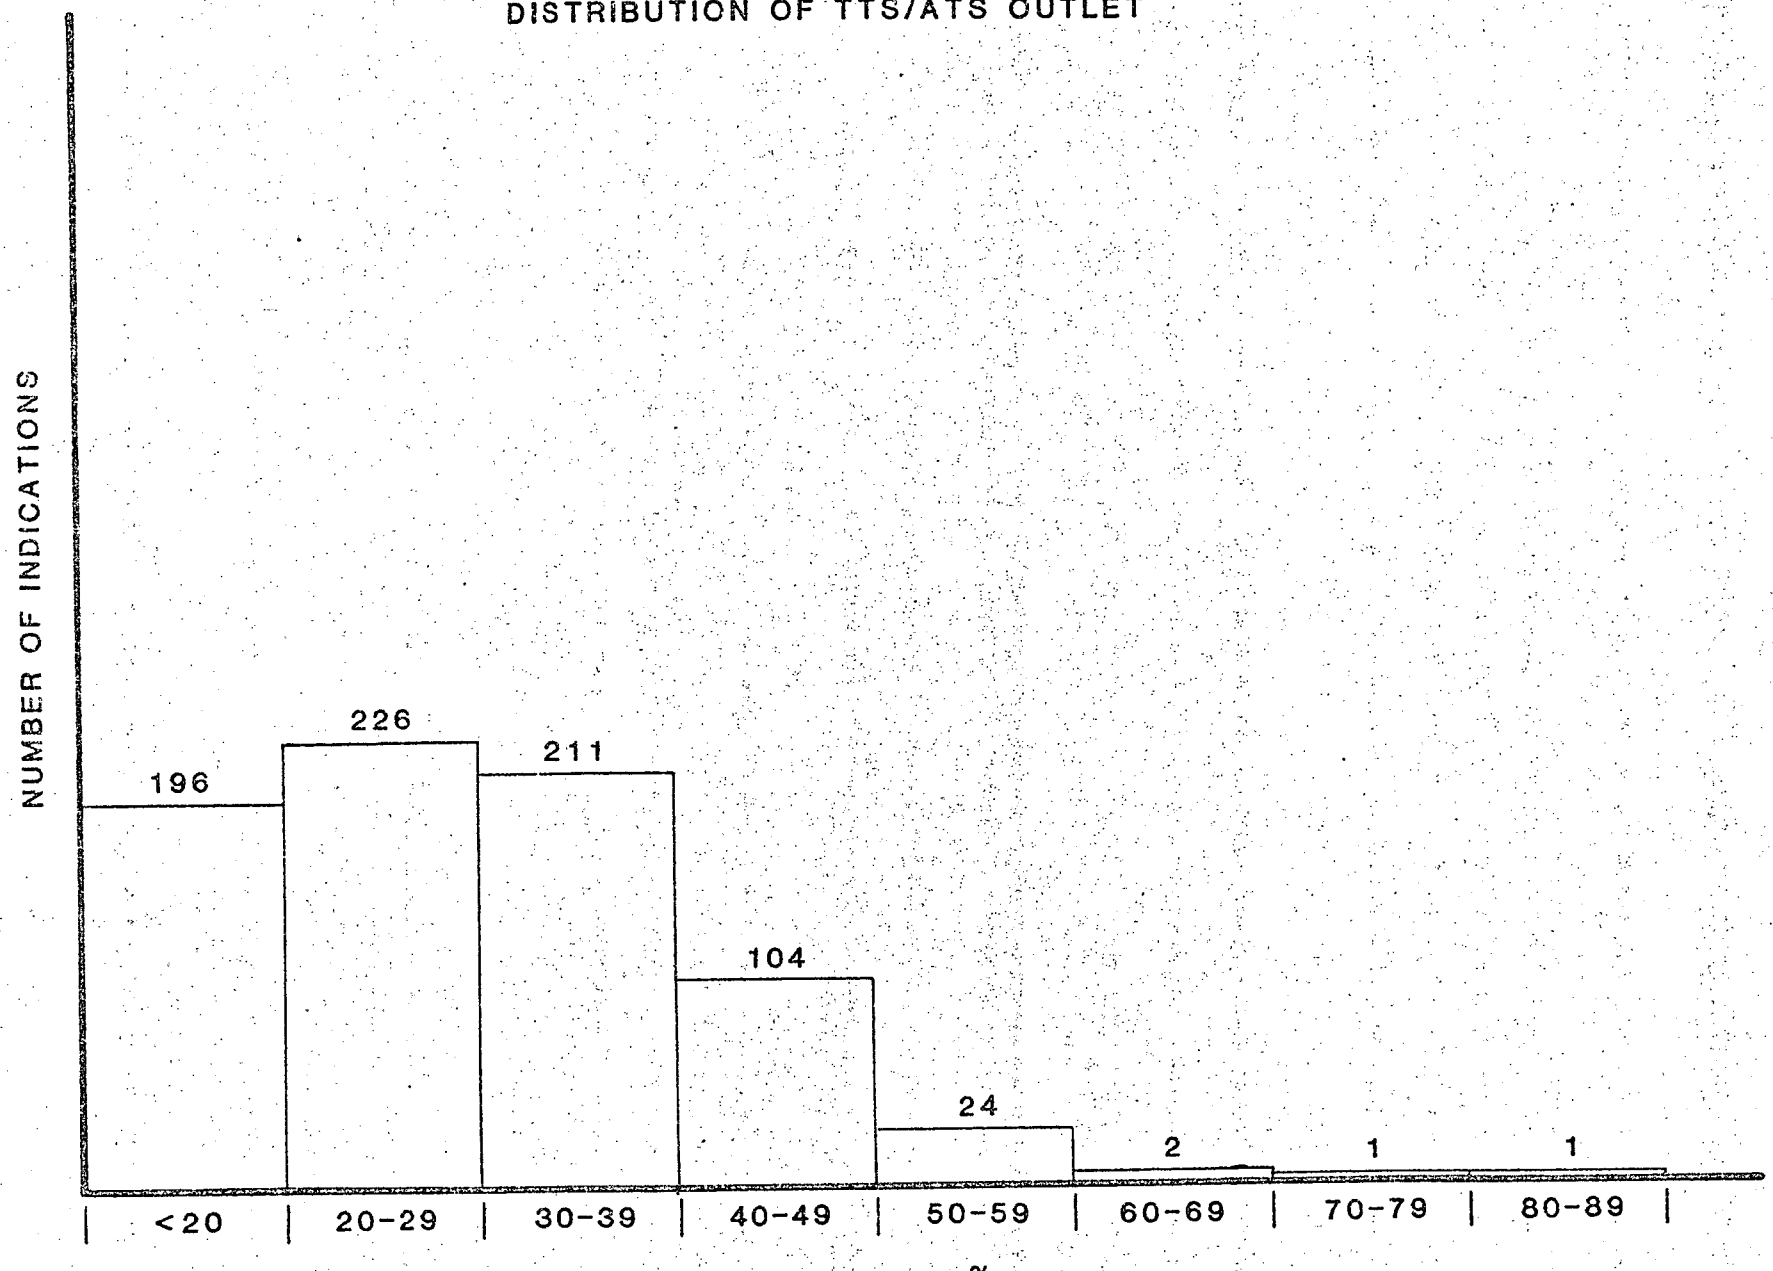
FIGURE I.1.4-6

However, the thinning corrosion rates for some of the TTS/ATS regions are higher than those observed for recent past operating periods. This is believed to be due to the reduced temperature program which results in lower secondary temperature and correspondingly higher phosphate concentrations.

C S/G OUTLET

DISTRIBUTION OF TTS/ATS OUTLET

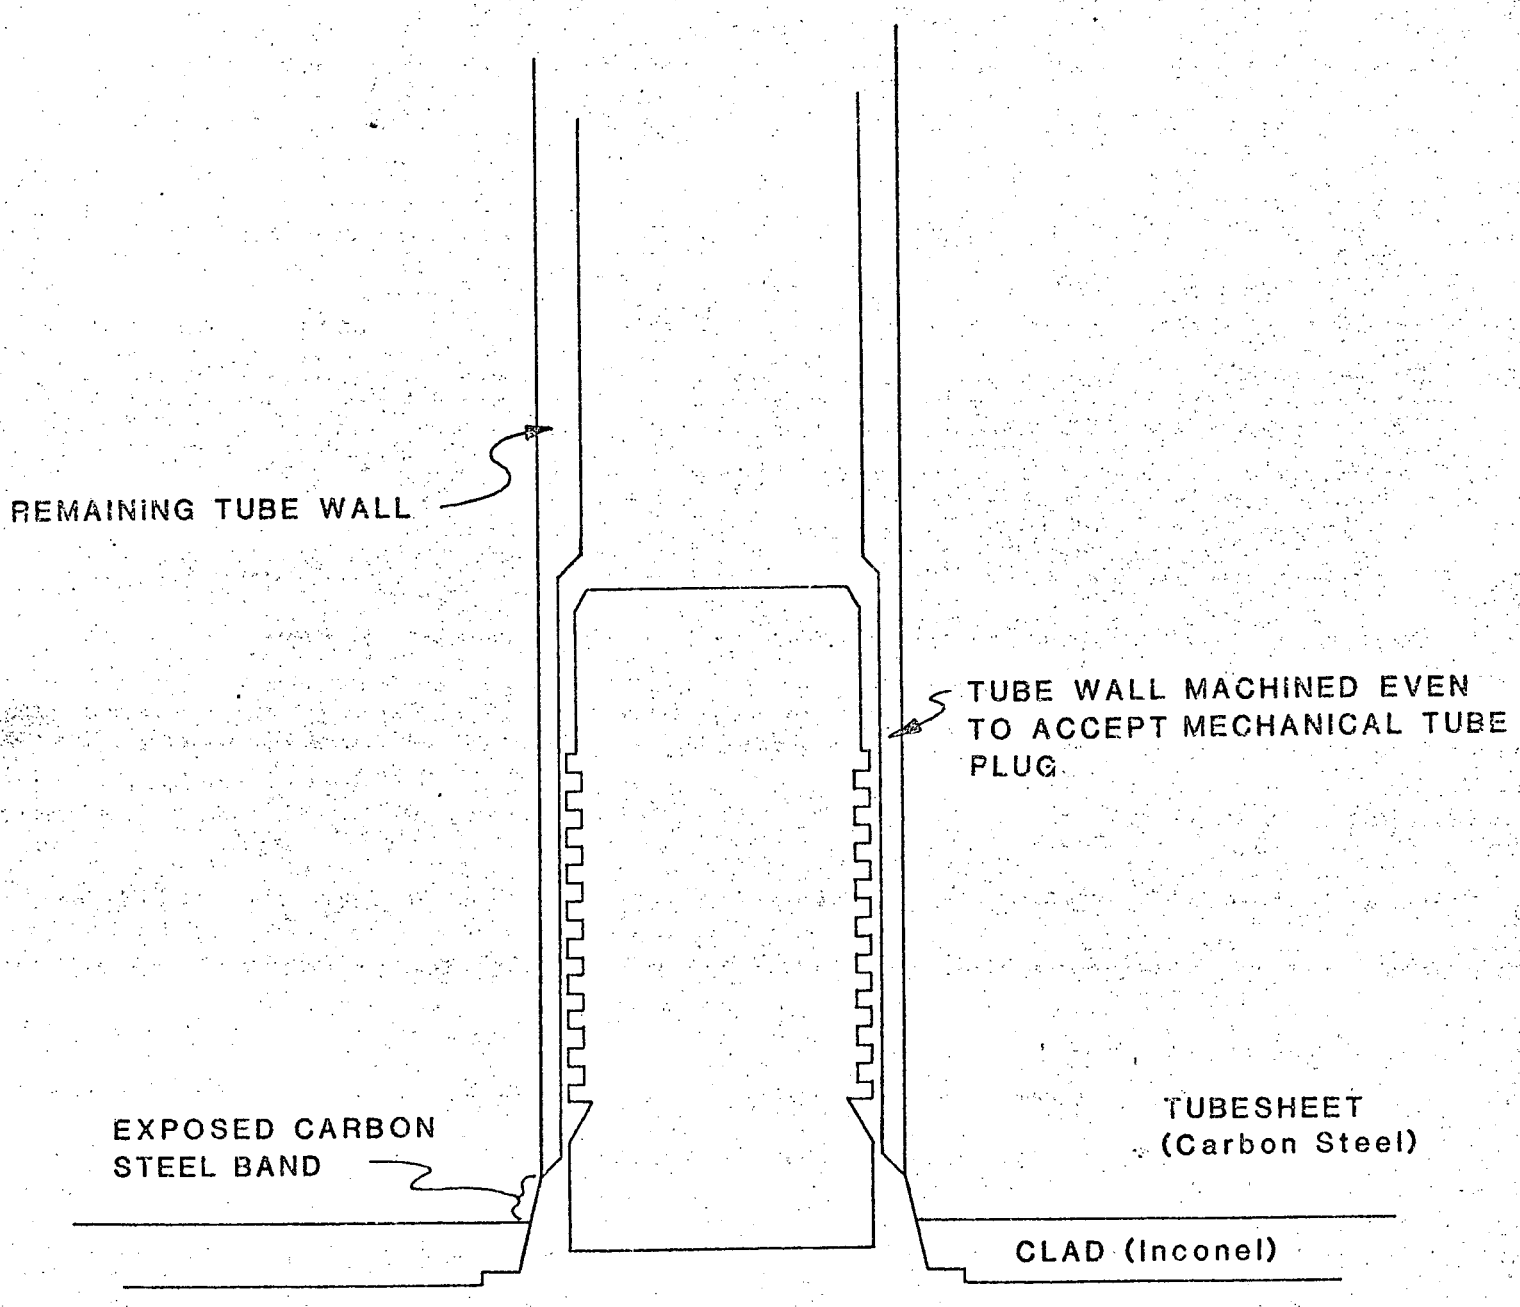
FIGURE II.3-1

Due to difficulties encountered in the performance of weld repairs on tube R8C52, a special repair technique was developed by CP&L and the S/G vendor and applied to this tube. The weld repair problems are attributed to the inclusion of contaminates in the weld. The source of these contaminates is assumed to be the tubesheet clad to tubesheet crevice. Additional weld repair attempts were not considered viable as the contaminated material could not be completely removed. Therefore, the repair technique applied was installation of a mechanical tube plug. The tube end was initially prepared in the same manner as for a weld repair. The remaining tube wall was then machined to accept the mechanical plug. A mechanical plug was then installed in the remaining rolled region of the tube sealing off both the inside of the tube and the tube to tubesheet interface. This eliminated all potential leak paths from R8C52.

This repair technique resulted in a small band (less than 3/16 inches wide) of carbon steel tubesheet material being exposed to primary coolant. The potential for corrosion of the carbon steel was evaluated via review of corrosion data. This evaluation performed from a primary coolant chemistry as well as tubesheet integrity standpoint revealed the following:

TUBE / TUBESHEET COUNTERBORE CONFIGURATION FOR MECHANICAL PLUG REPAIR

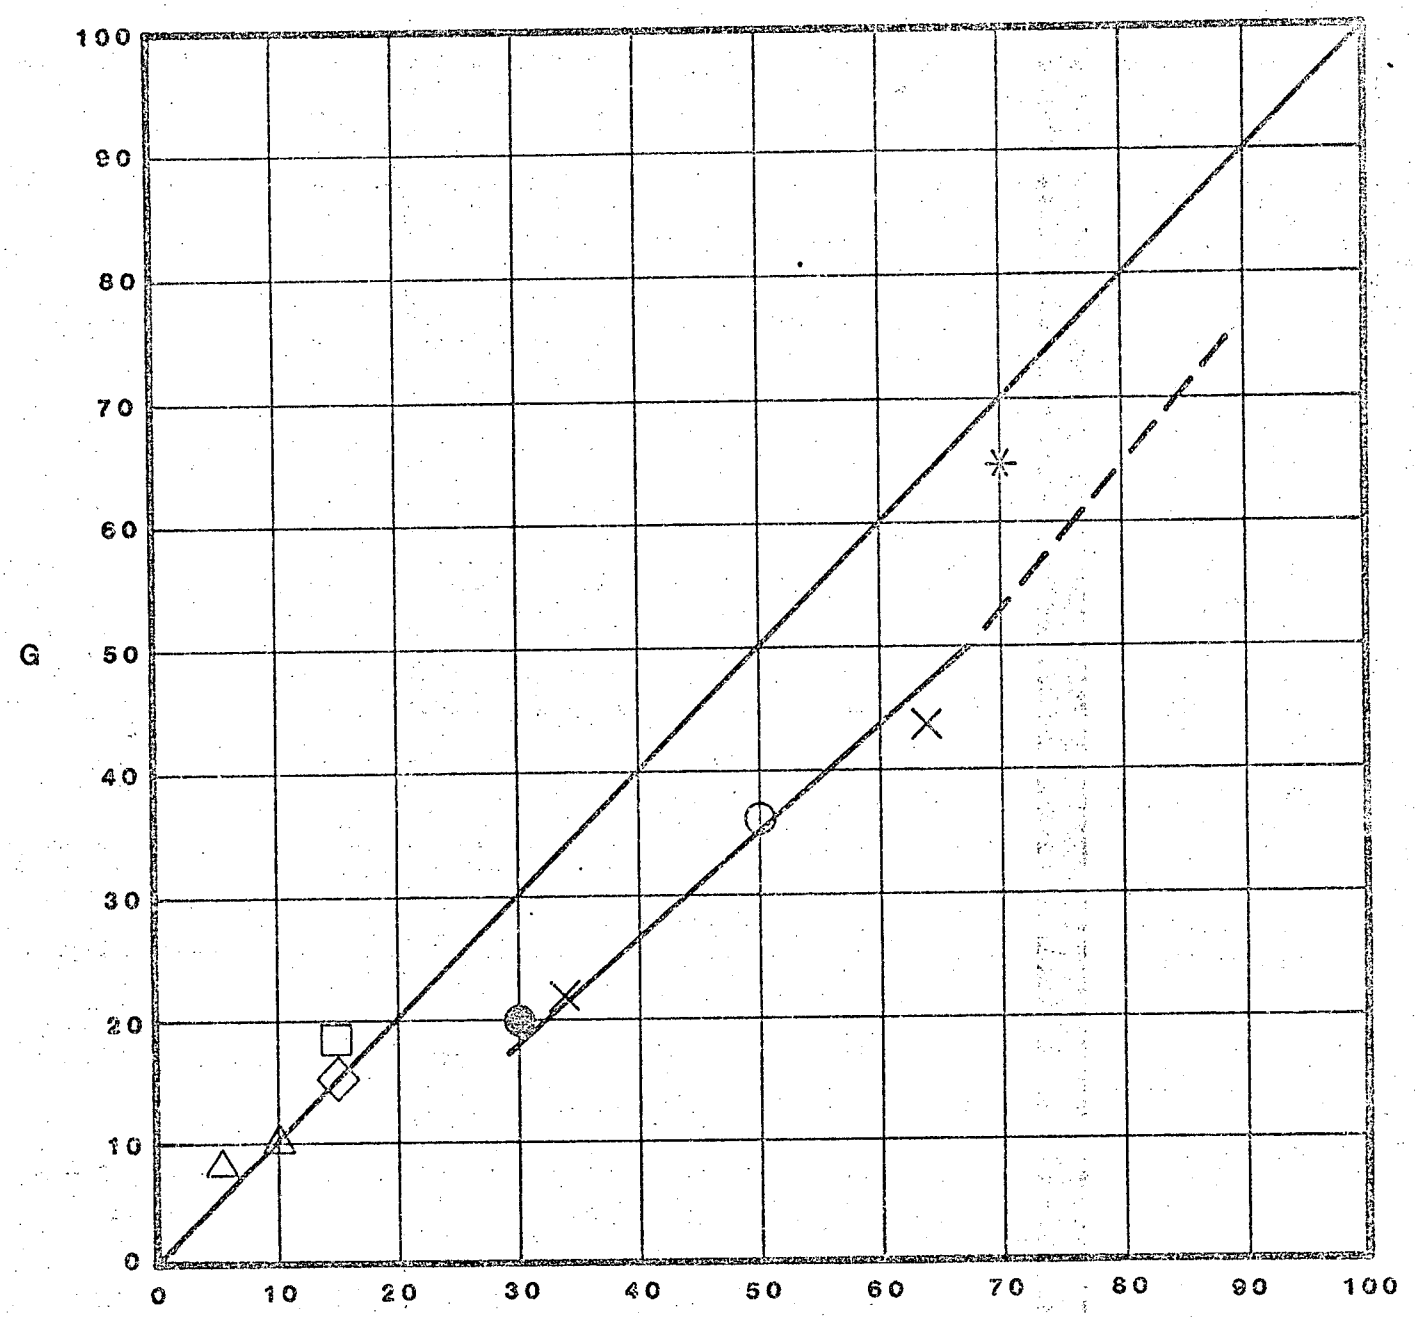
FIGURE 1

The data derived from the examination of tubes pulled from operating plants during several years shows that the eddy current technique, using the ASME calibration standard, yields overestimates of penetration depth when wastage type penetrations are involved. Figure 1 compares the depths measured by metallugraphic method with the estimated depths by EC data for steam generator tube exhibiting wastage type penetrations. These tubes were pulled from several plants. The eddy current estimates for penetrations in the range of $\pm$ 20% should be ignored since the confidence level here is very low. Excluding the $\pm$ 20% signals, the data shows an overestimate of about 10 to 15% in the indicated signal range of 30 to 60% penetration. The experimental

1. The large uncertainty in using the $\pm$ 9% error band for interpreting data, using the ASME standard is not valid in those cases of wastage flaws where penetrations of approximately $\pm$ 40% are present.
2. The evidence of significant overestimation of penetrations due to wastage by EC procedures used in the field at this time as shown in Figure 1.

SUMMARY OF ACTUAL MEASUREMENTS OF WALL - THINNED
STEAM GENERATOR TUBES FROM OPERATING PLANTS

It is recommended that the 9% conversatism factored into estimations of the margin for tube corrosion be elimated when tube wastage is involved.

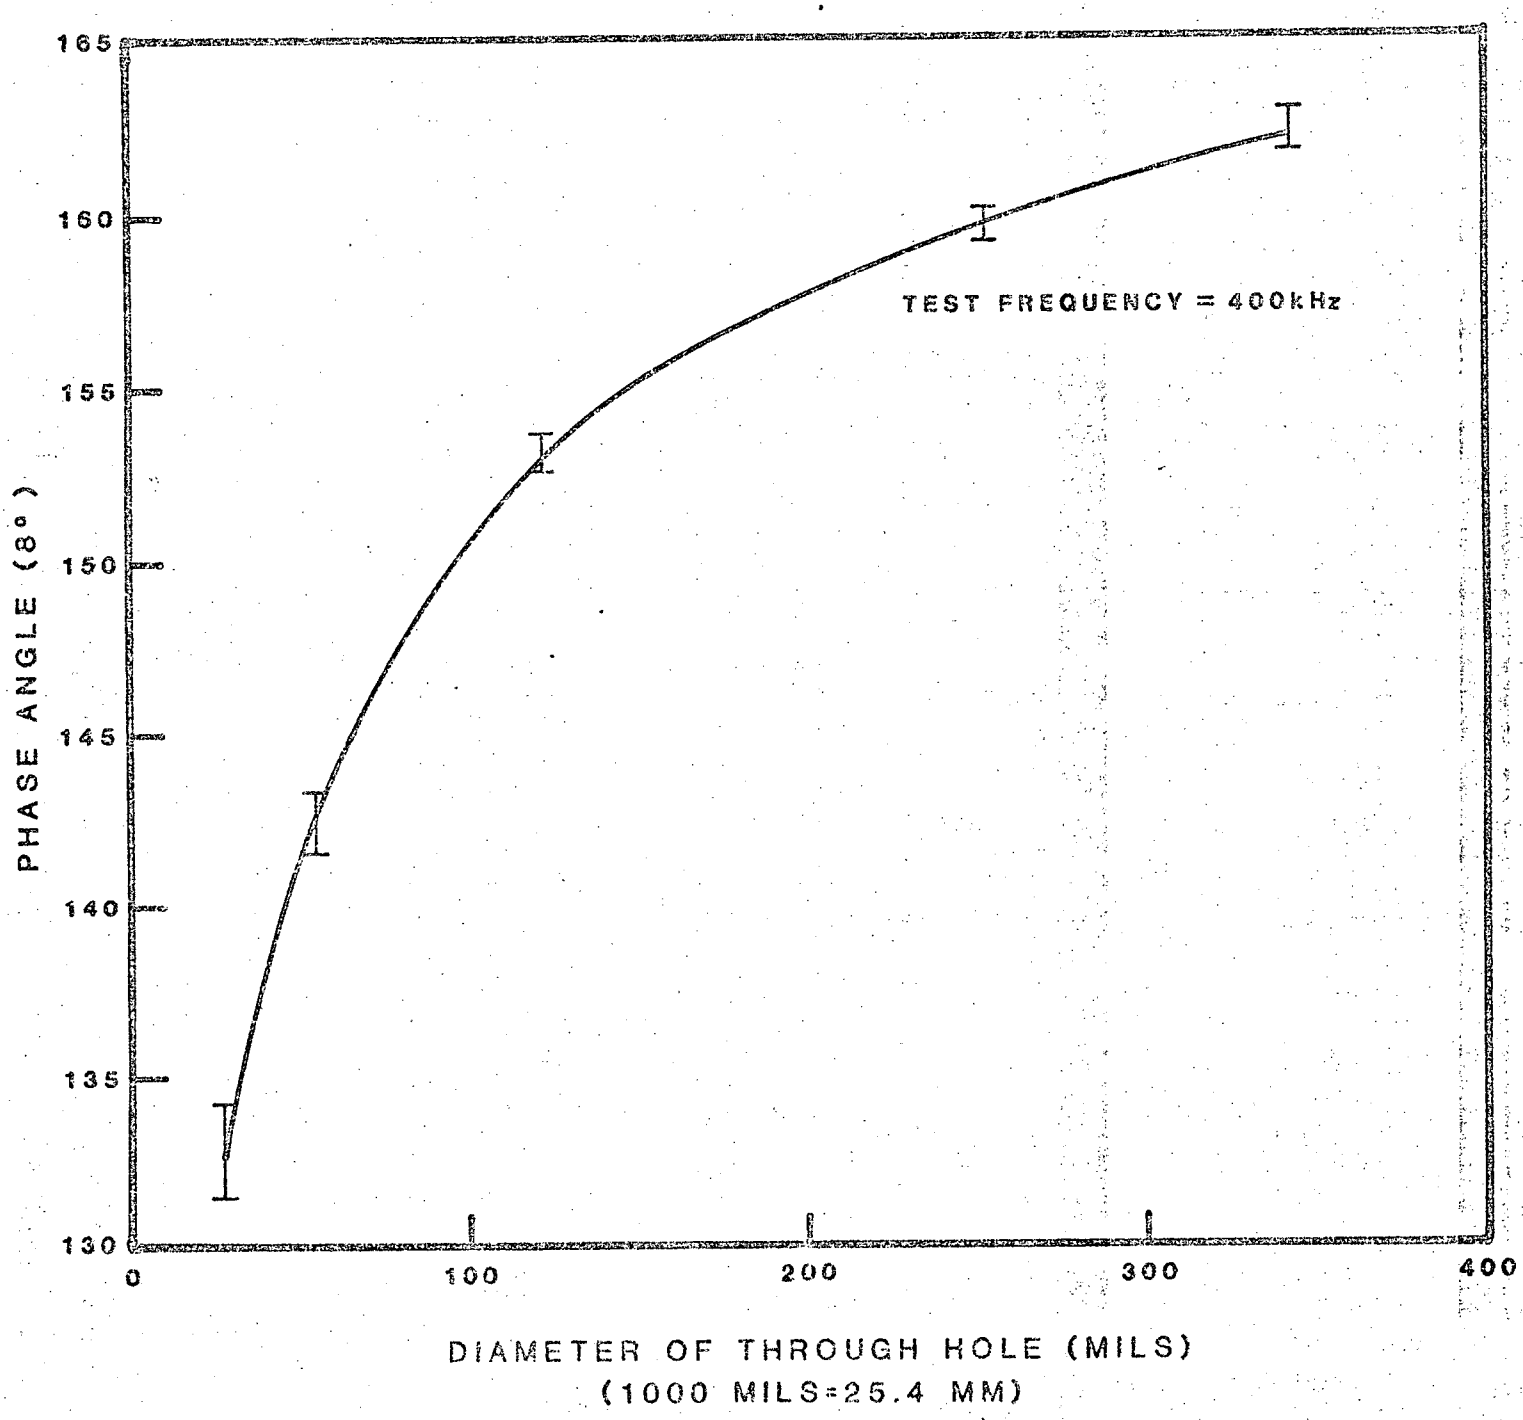
work performed at various laboratories to investigate the evaluation of wastage type penetrations fully support this field experience. The error results from the use of ASME drilled hole standard for calibration of EC data. Wastage penetrations do not resemble drilled holes and generally involve larger areas of the tube than the drilled hole. The influence of the larger surface area involvement results in higher depth estimates by EC data than the actual depths measured by metallugraphy.
