CAROLINA POWER AND LIGHT COMPANY

H. B. ROBINSON SEG PLANT, UNIT NO. 2

STEAM GENERATOR INSPECTION

SEPTEMBER, 1982

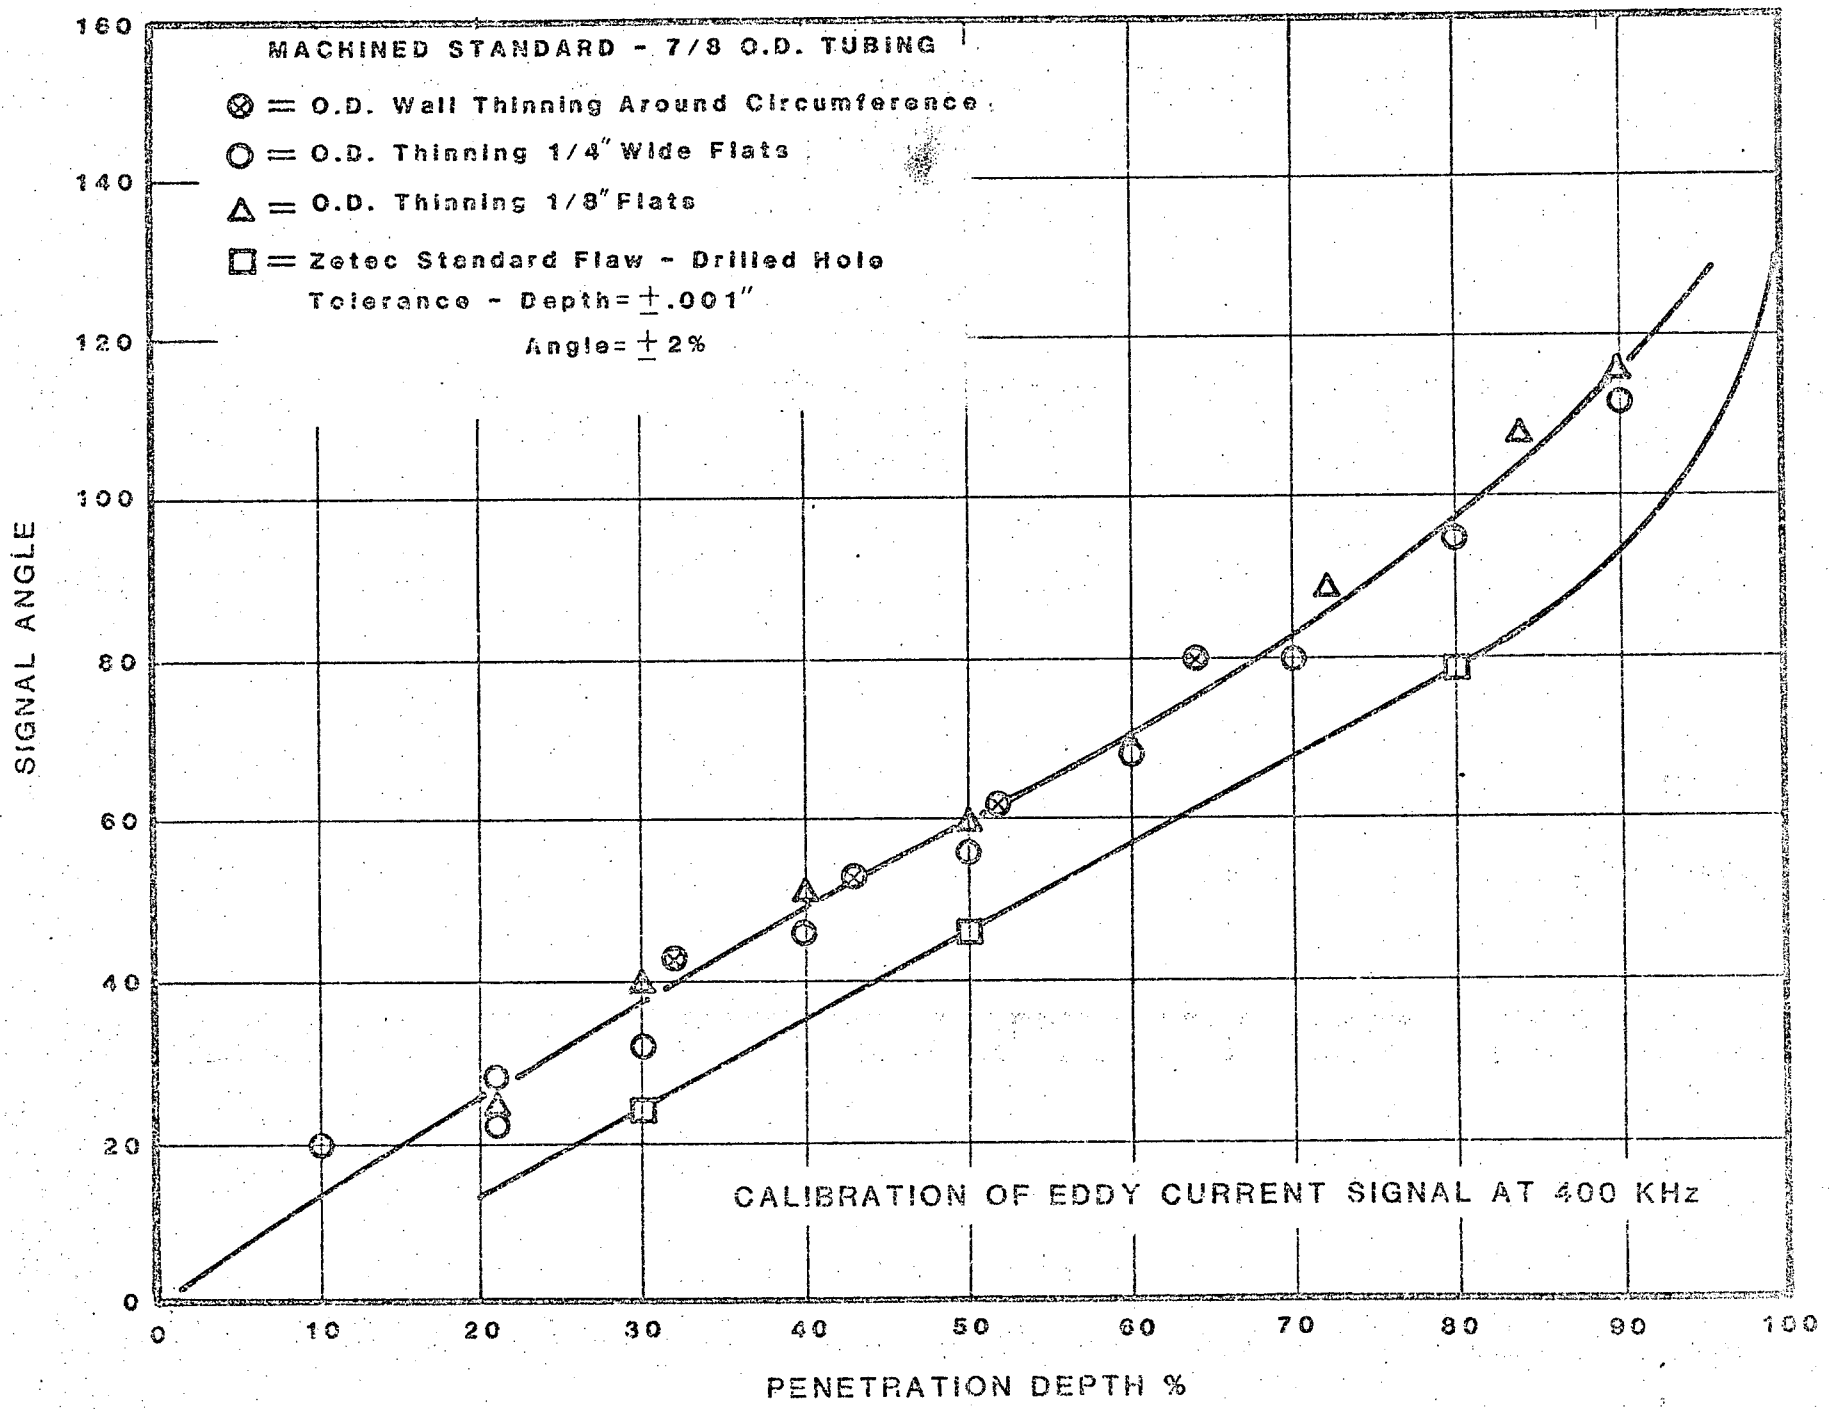
FIGURE 2

The often quoted uncertainty of ± 9% of the depth estimates for eddy current data is based on the use of the ASME drilled hole standard. The standard consists of flat-bottom holes of different depths. The diameters of the holes are adjusted such that the amplitudes of the EC signals from these different depth holes are approximately equal. For instance, the diameter of the 40% hole is 3/16" while those for 60% and 80% are 7/64" and 5/64" respectively. The volumes of these machined holes is quite small compared with the volumes involving wastage type penetrations of comparable depth and thus the amplitude of signals expected from wastage type penetrations of approximately ± 40% would be much larger than the amplitude of the signals from the drilled hole ASME standard. Thus, the uncertainty of ± 9% in EC data becomes a factor when wastage type penetrations of approximately ± 40% are involved. Furthermore, there is a built-in conservatism for the evaluation of wastage type penetrations if one uses the ASME standard for calibration. This observation has a theoretical basis and is supported by

both laboratory data and actual plant data on pulled tubes. The signal phase angle is not only a function of the depth, it is also a function of the area of the flaw. The phase angle is a monotonically proportional function of the area of the flaw at constant depth. The experimental data for the case of 100% through holes of different diameters is shown in Figure 2. If the area of the flaw is larger than the area of the same depth hole of the ASME standard, the flaw would yield a larger phase angle than the standard hole of same depth. This results in an overestimate of the depth of penetration of the large area flaws. The data of Figure 2 shows the affect of phase dependence on flaw area if the diameter of the hole is larger than of the ASME standard, the precise use of a calibration based on the standard becomes unrealistic since it results in an estimate the depth of penetration of over 100%. These observations are further supported by the experimental work on machined flaws of different geometries performed at different laboratories.

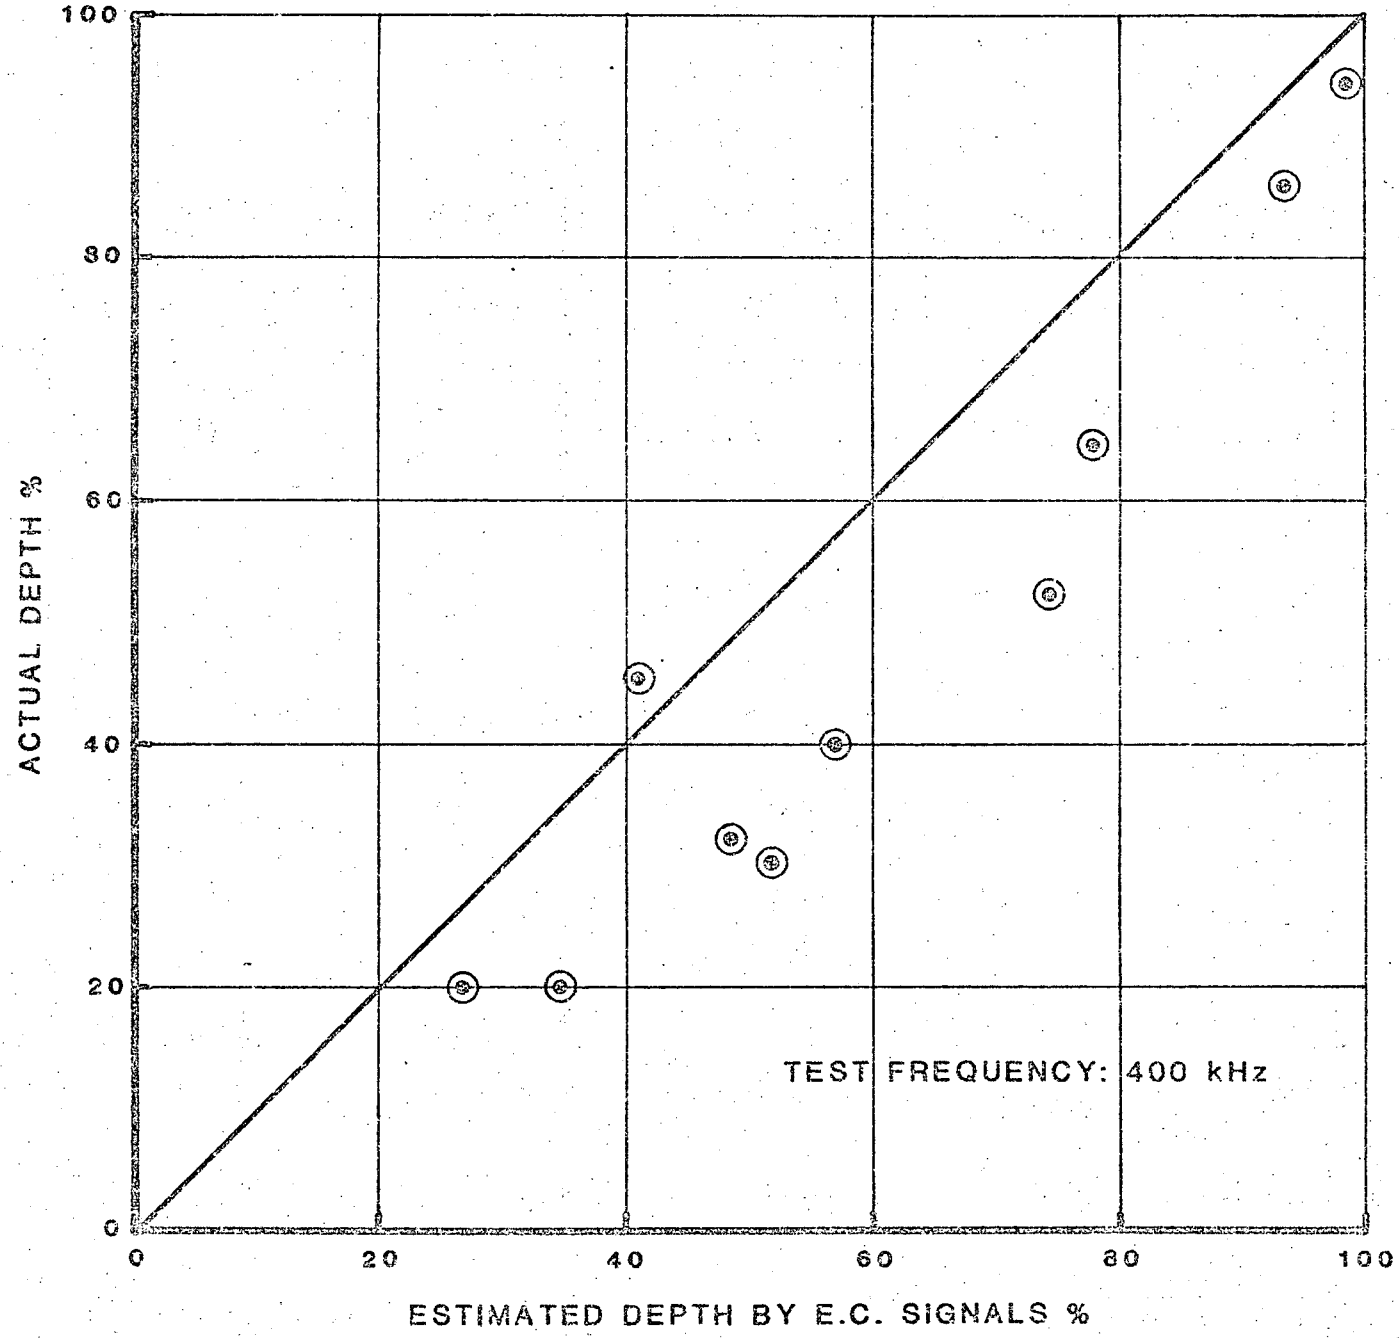
FIGURE 3

Figure 3 shows the signal phase angle vs. actual depth of penetration for various wastage type machined flaws along with the data on the ASME drilled hole calibration standard. These data indicate a consistent overestimate of depth on the basis of the ASME calibration standard. The results of the work done at Battelle Institute is shown in Figure 4. Here the actual depths are plotted against the depths estimated from the phase of the EC signals - again on the basis of calibration using the ASME standards. The geometry of the machined flaws simulated elliptical type wastage and the "compound wastage"

consisting of about 180 degrees band of uniform wastage followed by tapered type wastage. The data again shows significant overestimates of depths by EC technique when estimating wastage type penetrations.

COMPARISON OF DEPTH ESTIMATES BY E.C. TECHNIQUE AND
THE ACTUAL DEPTHS OF MACHINED WASTAGE TYPE PENETRATIONS

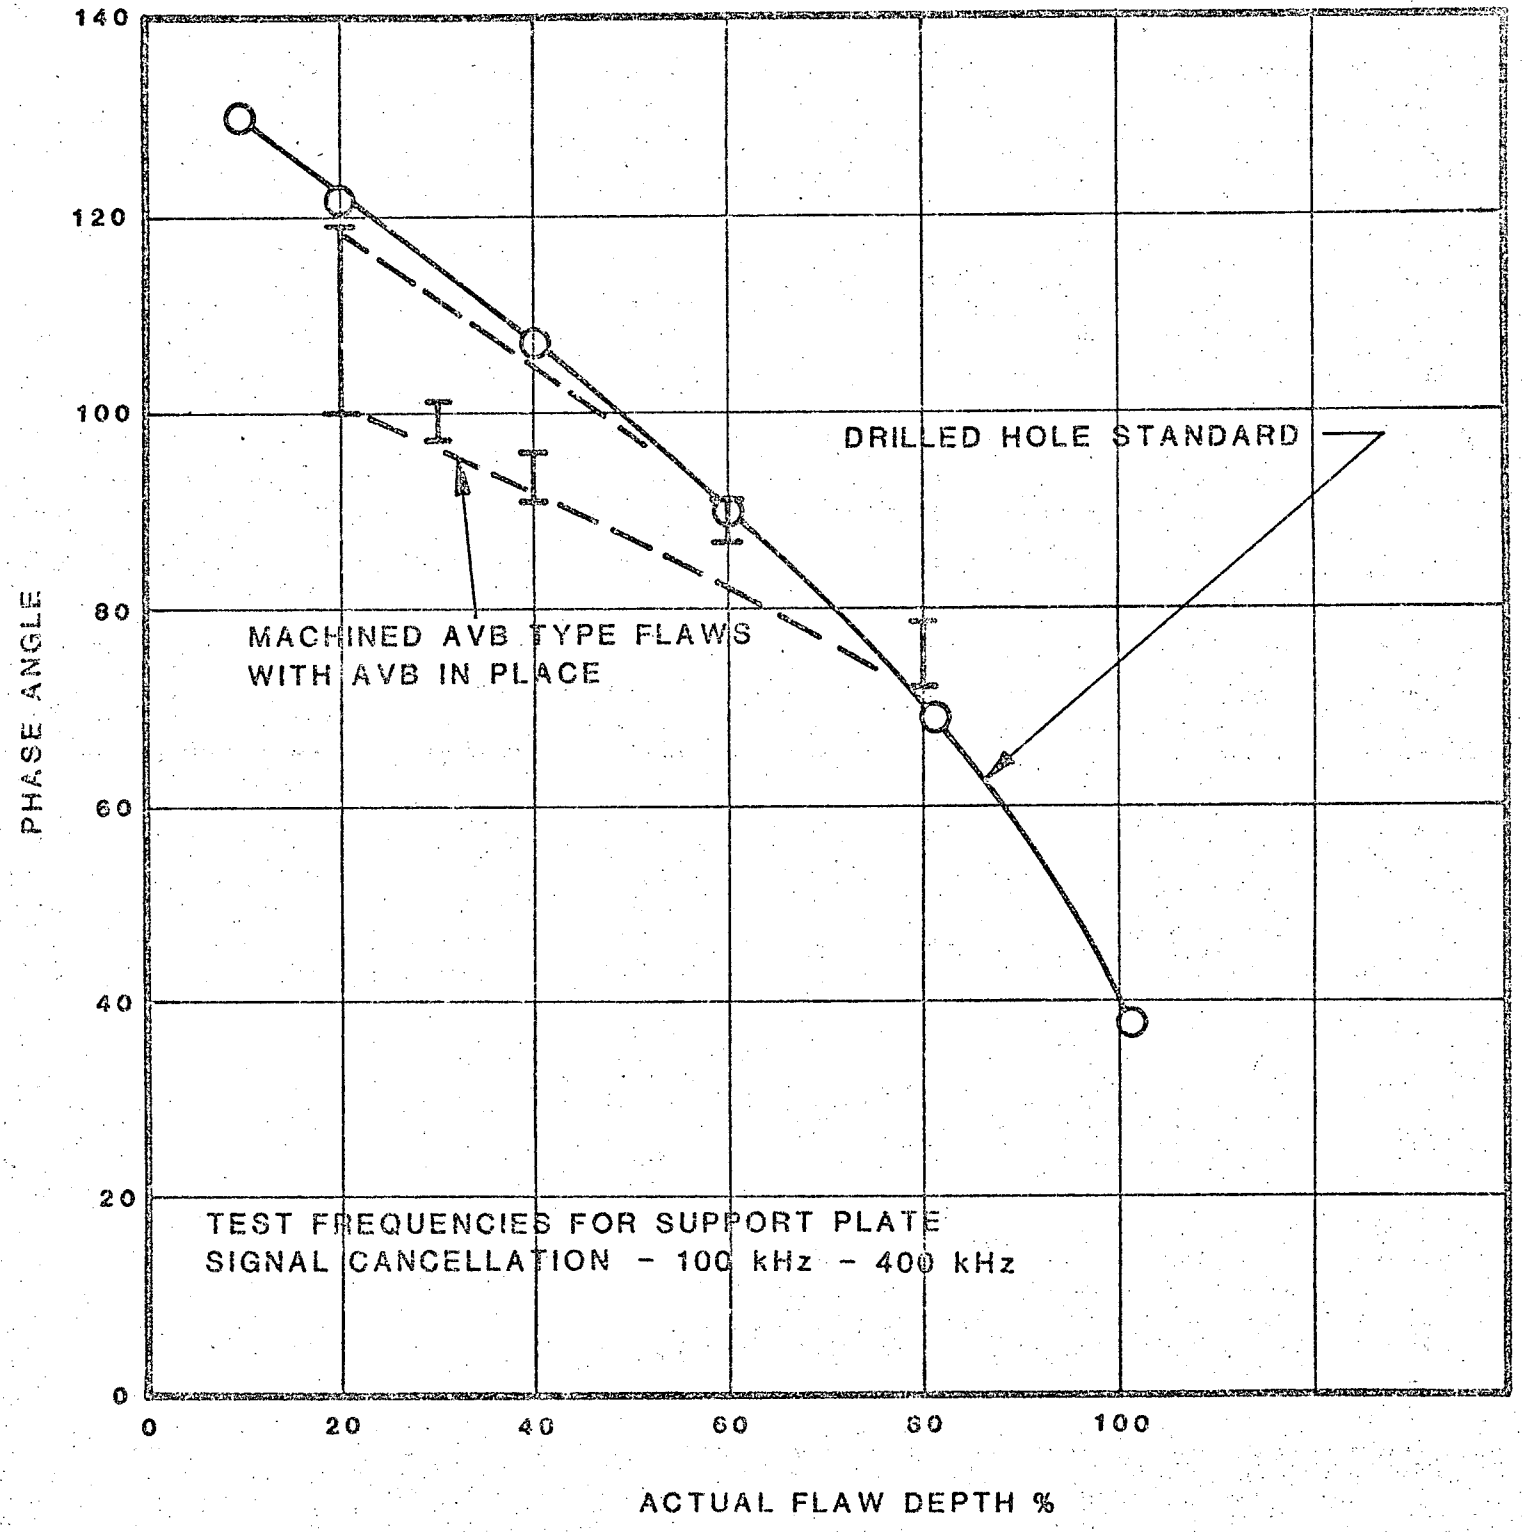
FIGURE 5

The above observations are valid for data taken at single frequency. If one uses the technique of mixing data taken at two frequencies the results are more complicated. For example, when the 400 kHz and 100 kHz data are mixed to cancel the interfering signals from support plates or Anti-Vibration Bars (AVB's) for estimating the depths of large area wear type penetrations resulting from vibrations or fretting, interpretation of the results is more complicated. Figure 5 shows laboratory data taken on wear type flaws at AVB locations. The data shows a cross-over near 60% wall penetration. The phenomenon of cross-over shown in Figure 5 is not relevant to the case where only 400 kHz data is used for depth estimation.

CALIBRATION CURVE BASED ON PHASE ANGLES FOR THE AVB TYPE FLAWS
