## LIST OF ITEMS OPENED, CLOSED AND DISCUSSED

Unit 3 had been operating for approximately one year following replacement of the steam generators when control room operators received alarms on January 31, 2012, that indicated reactor coolant was leaking into steam generator 3E0-88. The leak was unexpected, and the control room operators responded in accordance with their procedures to perform a rapid shutdown, since the leak, although small, had increased enough in a short period of time to warrant the precautionary shutdown. The estimated leak rate was 75 gallons per day. The facility license allows full power operation with a steady leak rate of less than 150 gallons per day.

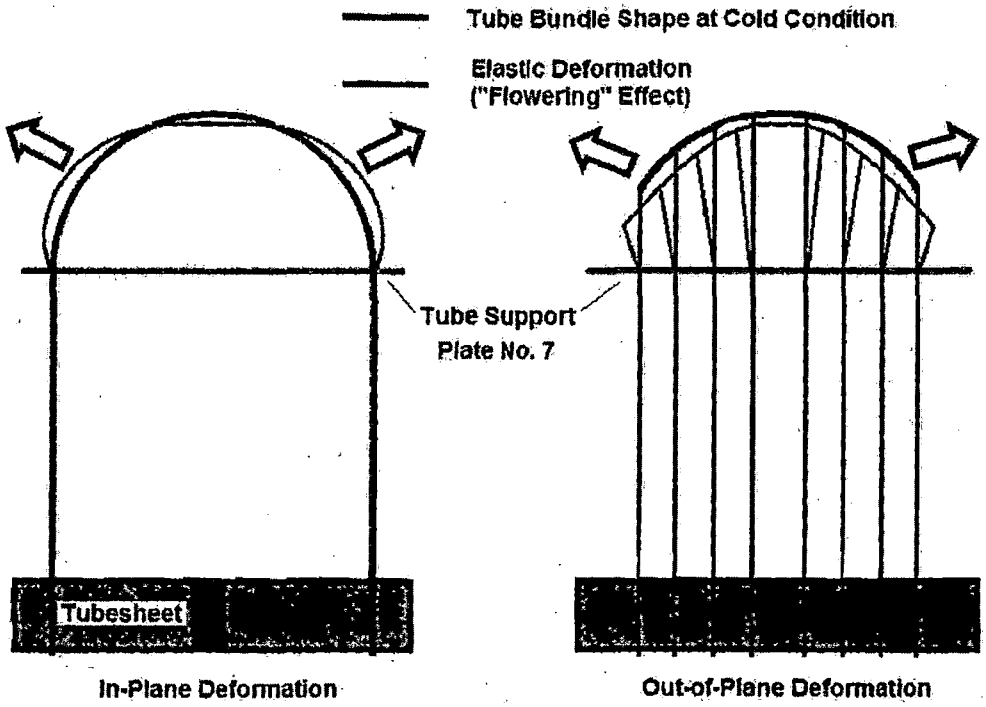
The failure mechanism model also considered a fluid dynamic effect associated with the spreading of the tubes in the U-bend region during normal operating conditions. This effect was informally referred to as "flowering," due to the characteristic shape in which the tube bundle spreads transverse to the plane of the u-bends at normal operating conditions. "Flowering" was described as the elastic deformation of the anti-vibration bar structure and the tube bundle in the U-bend region, as a result of thermal expansion and fluid dynamic pressure acting on the secondary side of the tubes (see figure below). The deformation caused by the "flowering" effect was believed to result in multiple areas of no contact between the anti-vibration bars and the tubes, which minimized resistance to in-plane motion of the u-bend area of the tubes.

Description of "Flowering" Effect (Conceptual Drawing – For Illustration Purposes Only)

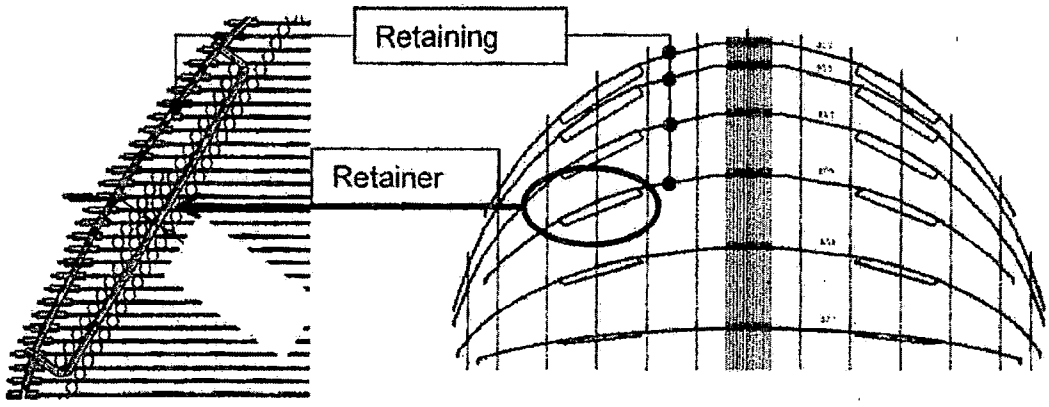
Description: In February 2012, the licensee identified wear indications in Unit 2 replacement steam generators at the tube locations in contact with the retainer bars (see figure below). Some of the indications showed excessive wear with a maximum degradation of 90 percent through wall.

**Retainer Bar Design and Location of Affected Tubes (For Illustration Purposes Only)**

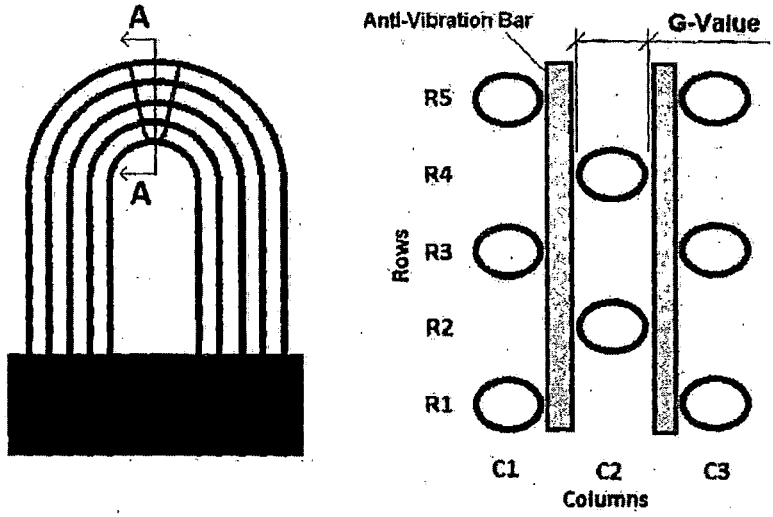
**Section A-A**

were installed. The acceptance criteria also remained the same throughout the fabrication of Unit 2 and Unit 3 replacement steam generators.

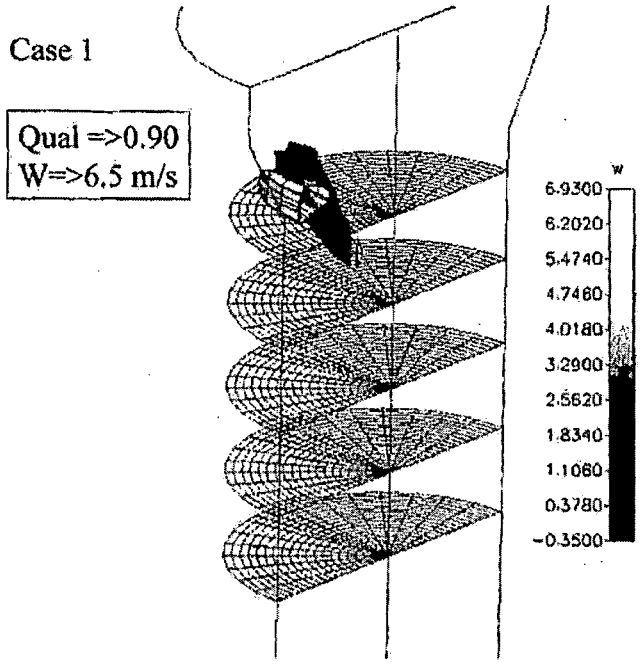
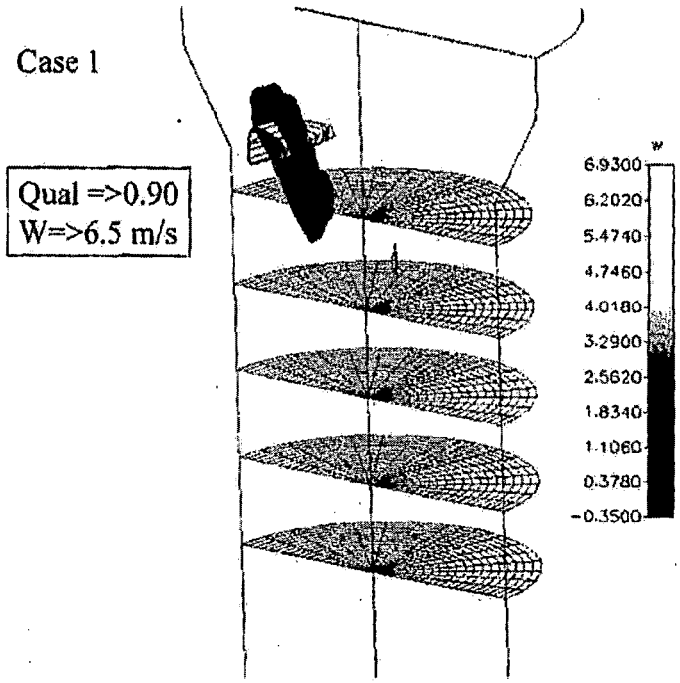
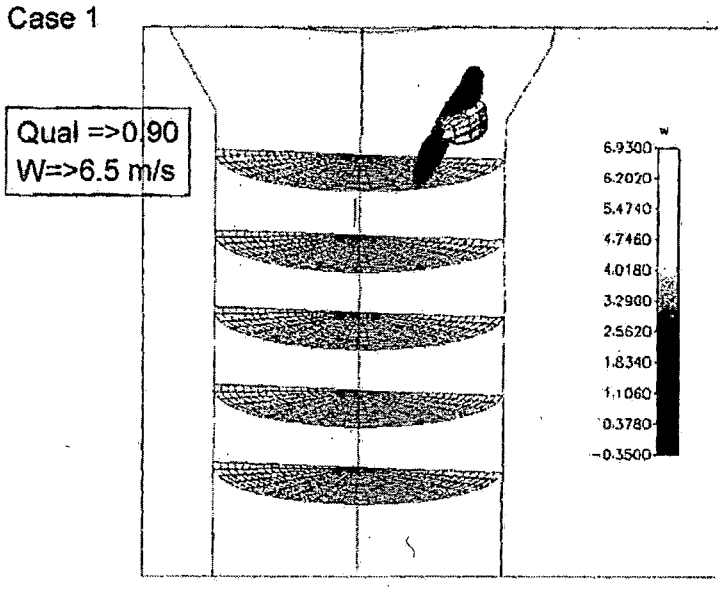
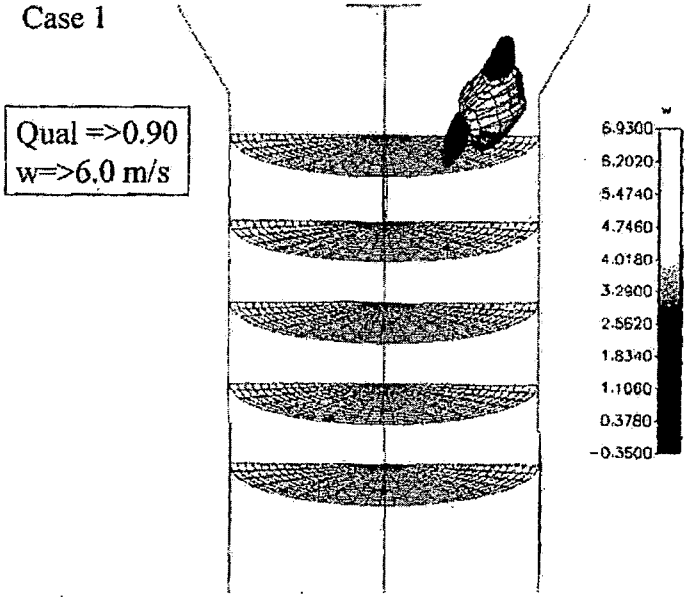
The tube-to-tube wear indications align with anti-vibration bar wear indication trends; however, the anti-vibration bar wear patterns appear to indicate a more square-like, essentially rectangular behavior that suggests that there may also be a mechanical, fabrication, assembly, and/or material contribution to the tube-to-tube wear degradation.

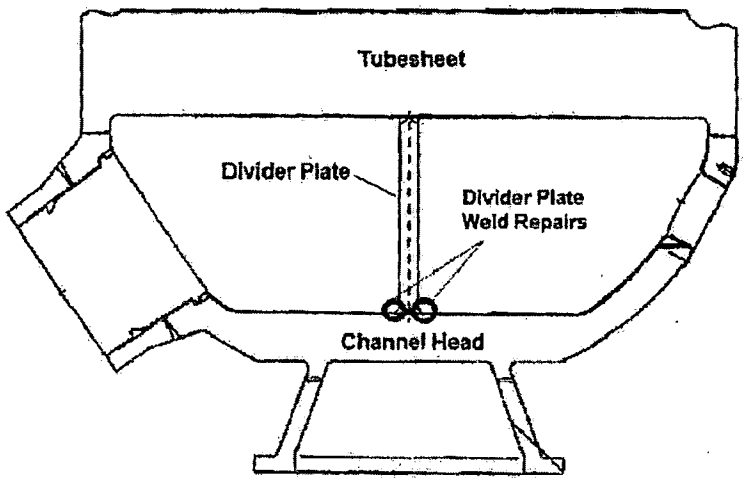
On March 18, 2009, Mitsubishi identified cracking indications in the weld between the divider plate and the channel head of Unit 3 replacement steam generator 3E0-88 (see figure below), after completion of the ASME Section III hydrostatic test on the secondary side. The extent of condition investigation also identified similar cracking indications in Unit 3 replacement steam generator 3E0-89. As discussed in Section 4 of this report, the cause of the cracking was attributed to the air carbon-arc gouging process used to remove the clad weld from the channel head. The team reviewed information associated with the repair of the cracking indications to assess whether the repair activities resulted in relevant differences in design and fabrication that could be considered as contributing factors for the cause of the tube-to-tube wear issue in Unit 3.

Location of Divider Plate Weld Repairs in Unit 3 Steam Generators (For Illustration Purposes Only)

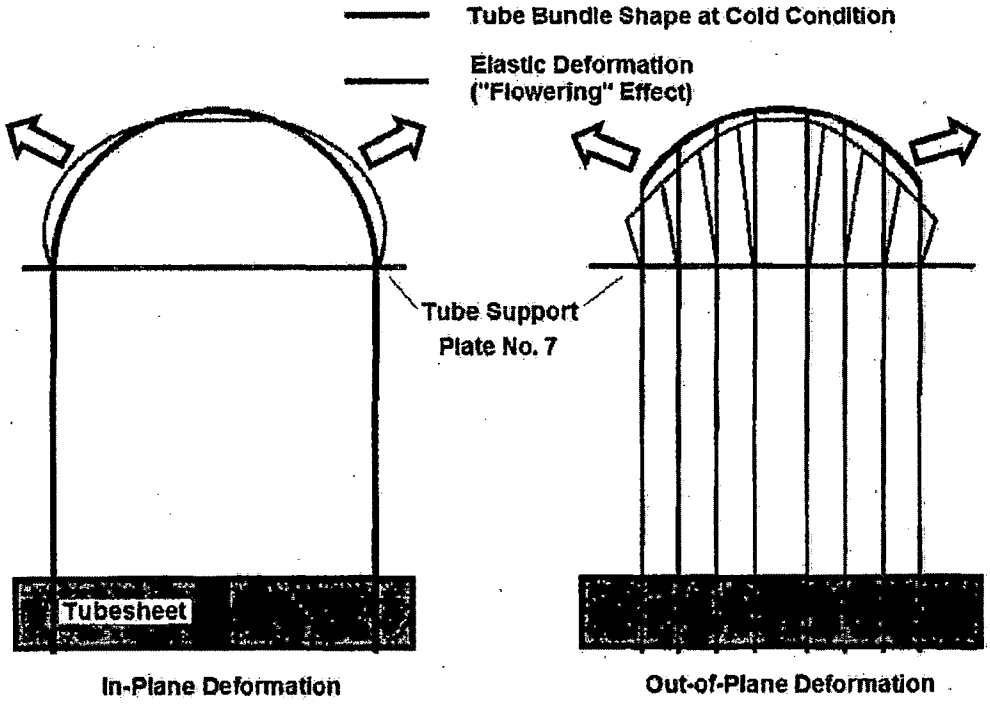
Description of "Flowering" Effect (Conceptual Drawing – For Illustration Purposes Only)

The failure mechanism model also considered a fluid dynamic effect associated with the spreading of the tubes in the U-bend region during normal operating conditions. This effect was informally referred to as "flowering," due to the characteristic shape in which the tube bundle spreads transverse to the plane of the u-bends at normal operating conditions. "Flowering" was described as the elastic deformation of the anti-vibration bar structure and the tube bundle in the U-bend region, as a result of thermal expansion and fluid dynamic pressure acting on the secondary side of the tubes (see figure below). The deformation caused by the "flowering" effect was believed to result in multiple areas of no contact between the anti-vibration bars and the tubes, which minimized resistance to in-plane motion of the u-bend area of the tubes.

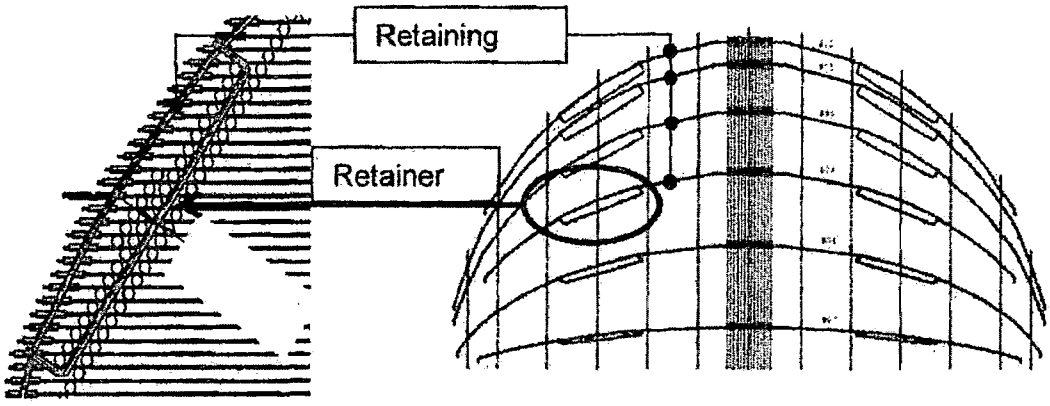
Retainer Bar Design and Location of Affected Tubes (For Illustration Purposes Only)

Description: In February 2012, the licensee identified wear indications in Unit 2 replacement steam generators at the tube locations in contact with the retainer bars (see figure below). Some of the indications showed excessive wear with a maximum degradation of 90 percent through wall.

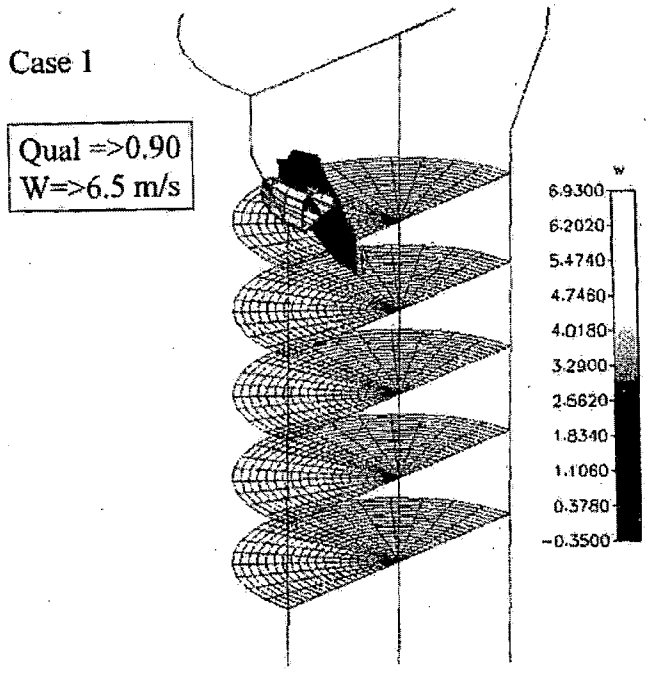
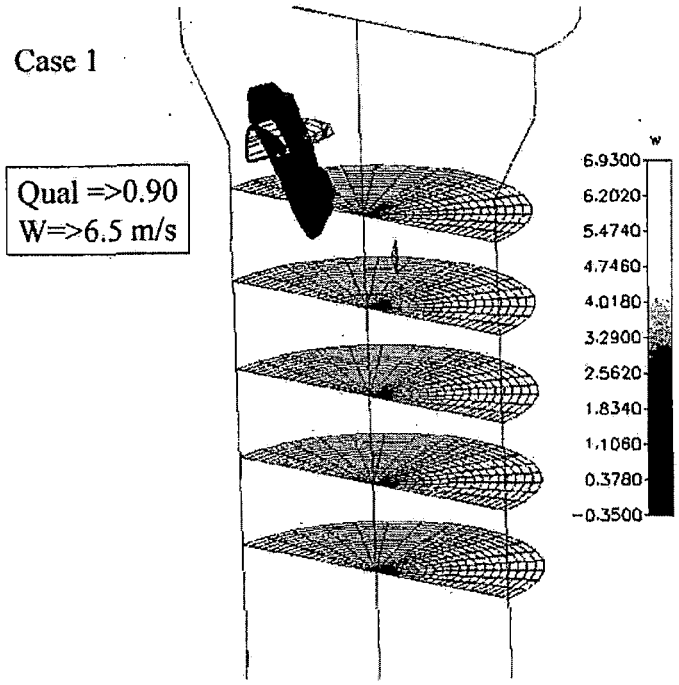
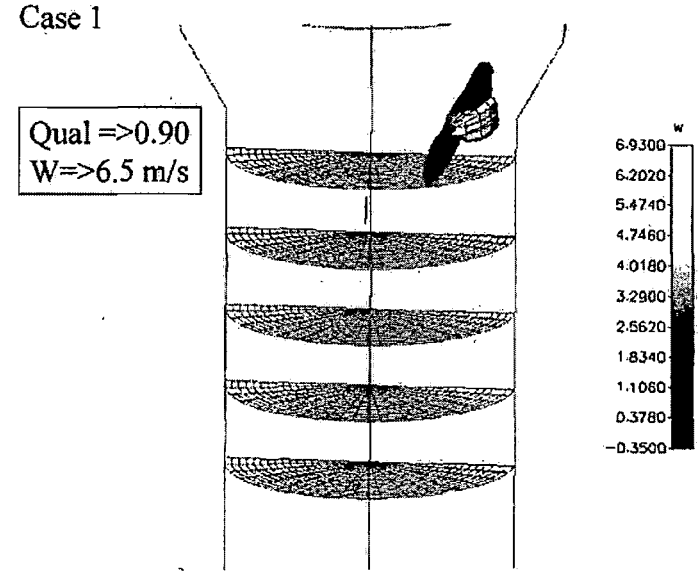
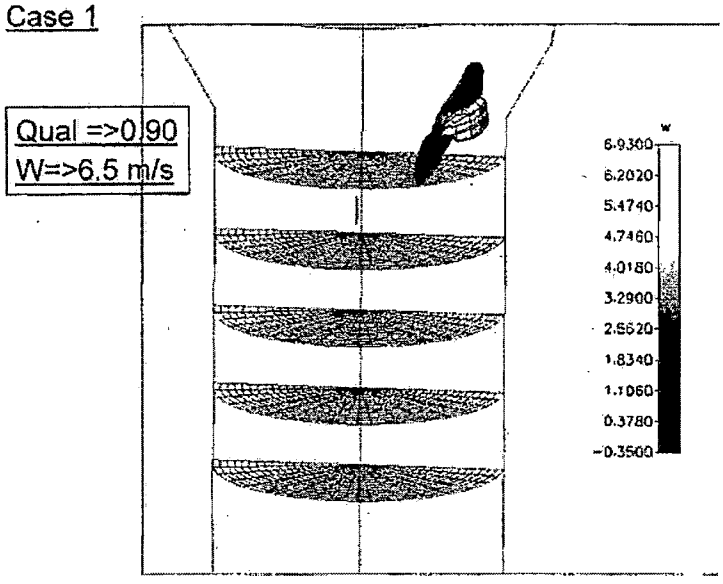
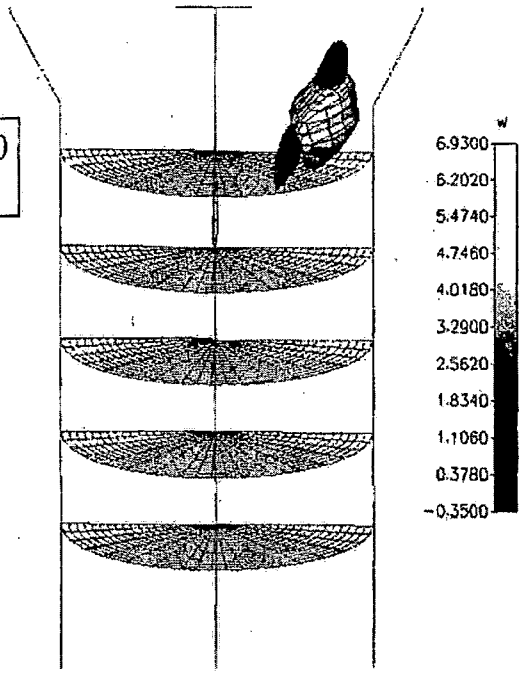
The tube-to-tube wear indications align with anti-vibration bar wear indication trends; however, the anti-vibration bar wear patterns appear to indicate a more square-like, essentially rectangular behavior that suggests that there may also be a mechanical, fabrication, assembly, and/or material contribution to the tube-to-tube wear degradation.

~~The ATHOS code predicted regions of high void fraction and high steam velocities are superimposed with tube-to-tube wear indications from Unit 3 steam generator 3E0 88~~

The NRC analysis indicated a correlation with the tube-to-tube wear based on a combination of high void fraction and high steam velocities. It should be noted that the traditional forcing function, fluid velocity squared times density, does not show good agreement with the tube-to-tube wear patterns. This indicated that the high quality steam fluid velocities and high void fraction may be sufficiently high to cause conditions in the generators conducive for onset of fluid-elastic instability.

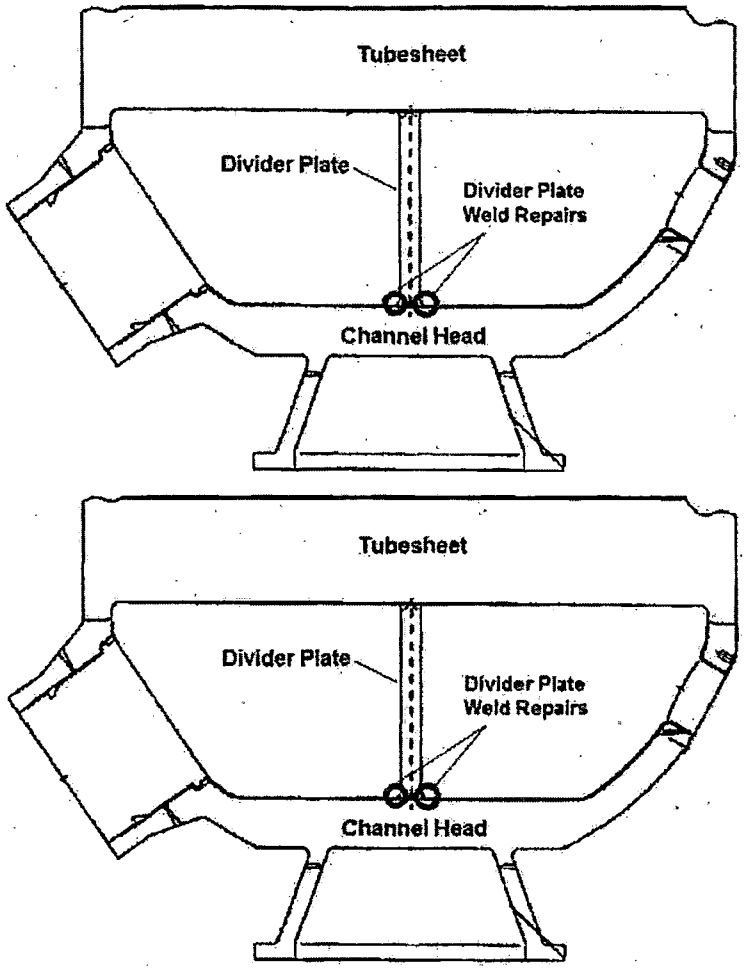
Location of Divider Plate Weld Repairs in Unit 3 Steam Generators (For Illustration Purposes Only)

On March 18, 2009, Mitsubishi identified cracking indications in the weld between the divider plate and the channel head of Unit 3 replacement steam generator 3E0-88 (see figure below), after completion of the ASME Section III hydrostatic test on the secondary side. The extent of condition investigation also identified similar cracking indications in Unit 3 replacement steam generator 3E0-89. As discussed in Section 4 of this report, the cause of the cracking was attributed to the air carbon-arc gouging process used to remove the clad weld from the channel head. The team reviewed information associated with the repair of the cracking indications to assess whether the repair activities resulted in relevant differences in design and fabrication that could be considered as contributing factors for the cause of the tube-to-tube wear issue in Unit 3.

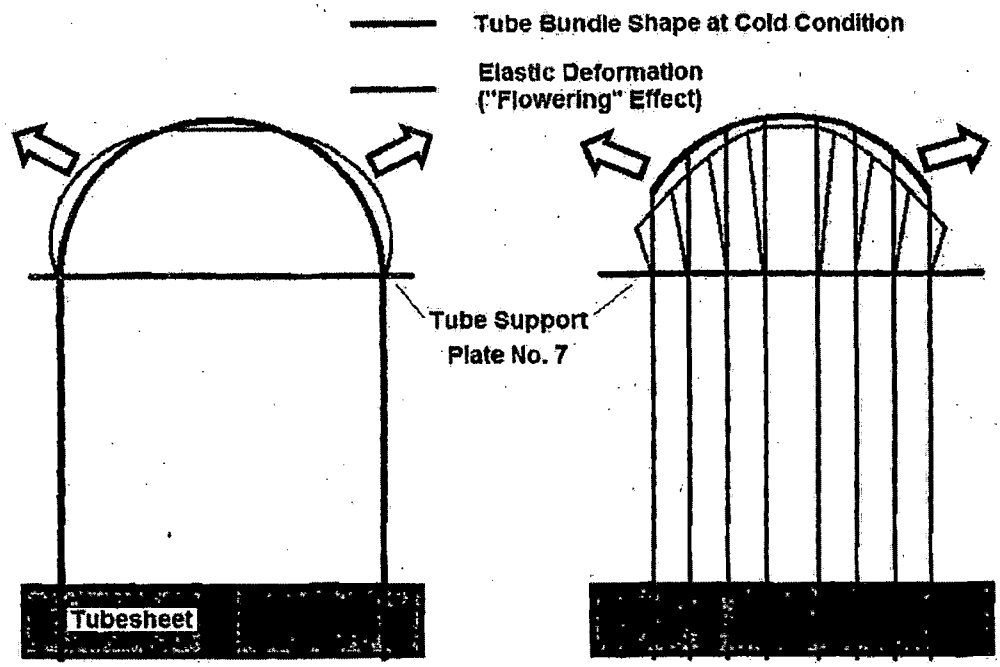
Description of "Flowering" Effect (Conceptual Drawing – For Illustration Purposes Only)

The failure mechanism model also considered a fluid dynamic effect associated with the spreading of the tubes in the U-bend region during normal operating conditions. This effect was informally referred to as "flowering," due to the characteristic shape in which the tube bundle spreads transverse to the plane of the u-bends at normal operating conditions. "Flowering" was described as the elastic deformation of the anti-vibration bar structure and the tube bundle in the U-bend region, as a result of thermal expansion and fluid dynamic pressure acting on the secondary side of the tubes (see figure below). The deformation caused by the "flowering" effect was believed to result in multiple areas of no contact between the anti-vibration bars and the tubes, which minimized resistance to in-plane motion of the u-bend area of the tubes.

Mitsubishi considered that the collective contribution of the factors described above resulted in conditions in the U-bend that were highly susceptible to excessive tube vibration. The in-plane vibration of the tubes in the U-bend region allowed direct contact between free-span sections of the tubes, resulting in the unanticipated tube-to-tube wear.

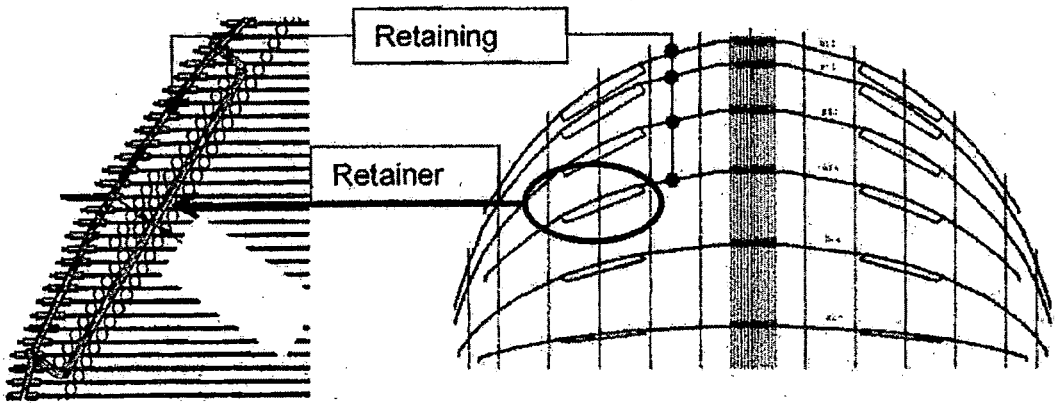
**Retainer Bar Design and Location of Affected Tubes (For Illustration Purposes Only)**

Description: In February 2012, the licensee identified wear indications in Unit 2 replacement steam generators at the tube locations in contact with the retainer bars (see figure below). Some of the indications showed excessive wear with a maximum degradation of 90 percent through wall.

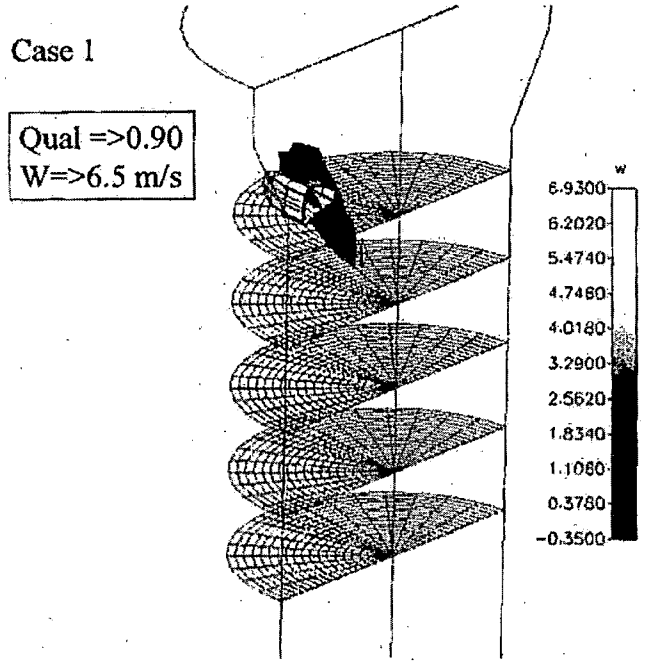
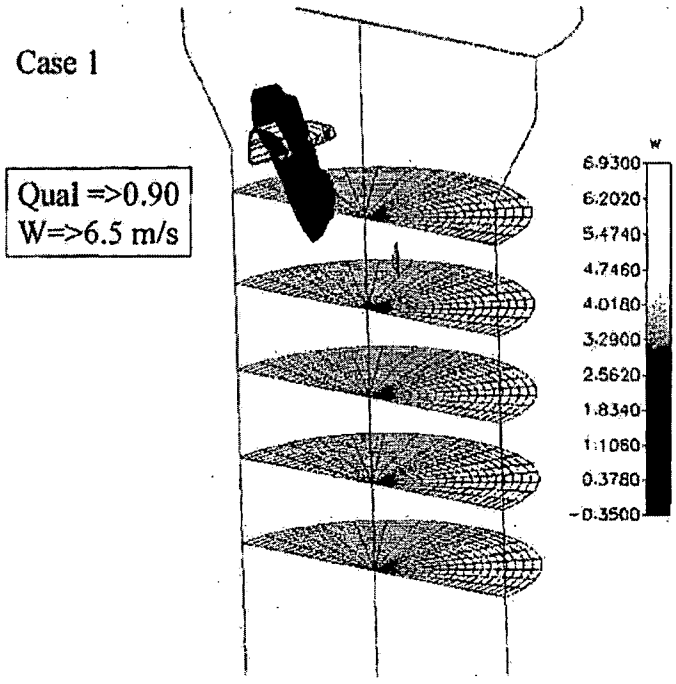
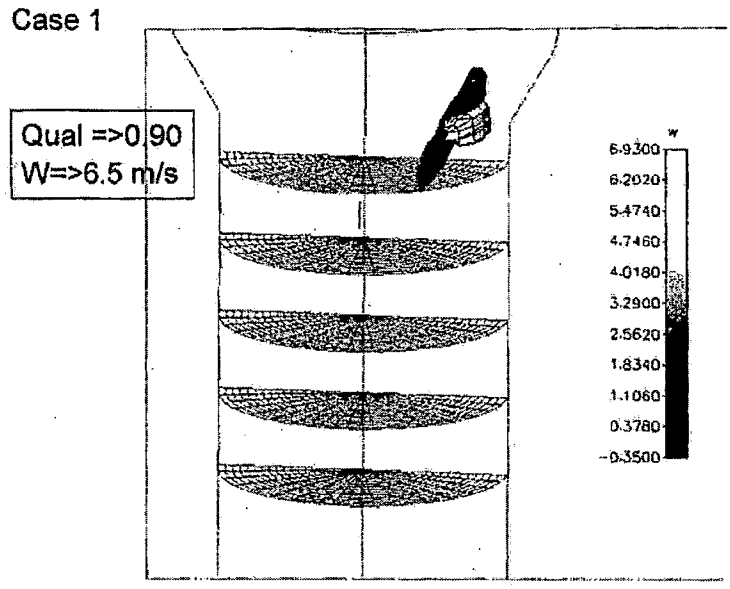
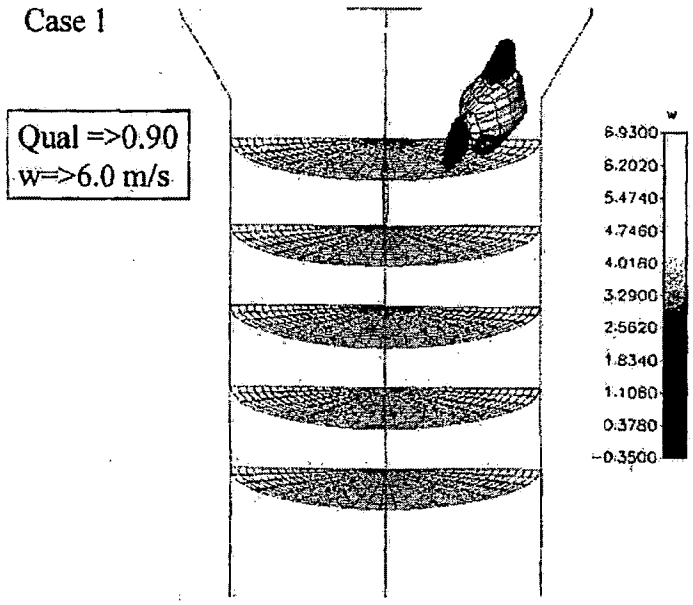
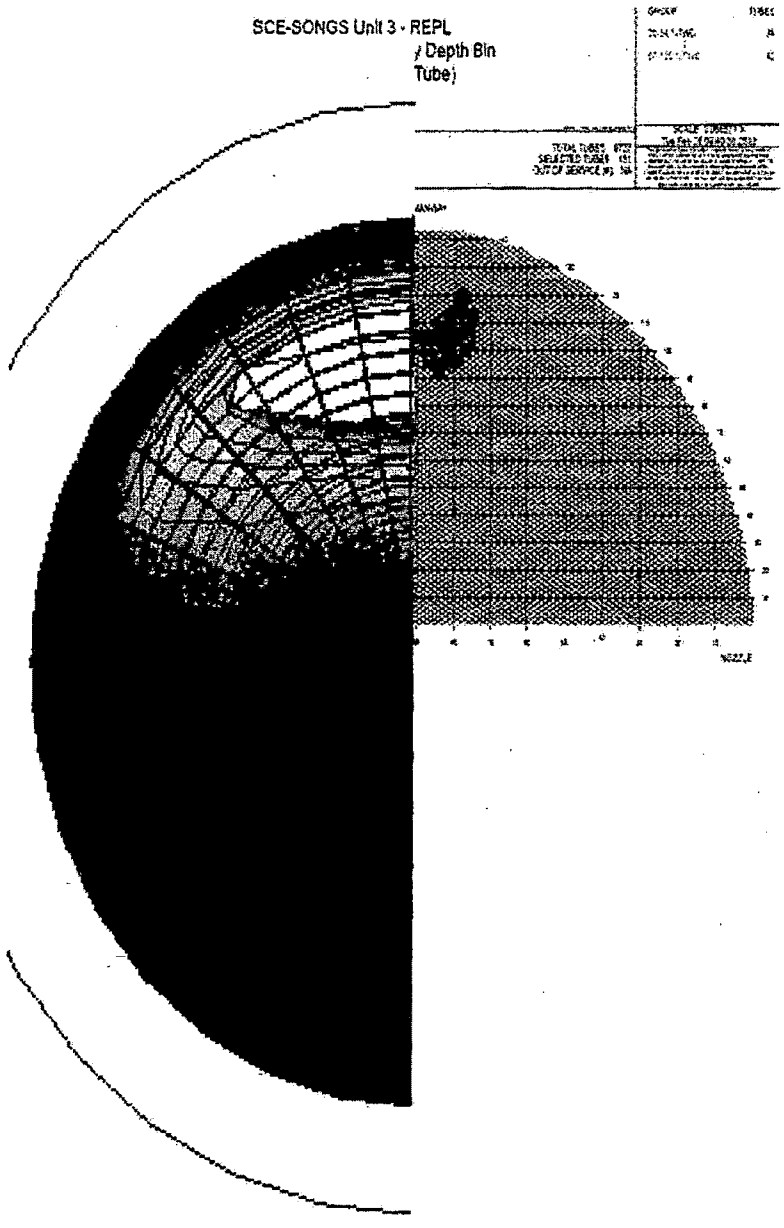
The tube-to-tube wear indications align with anti-vibration bar wear indication trends; however, the anti-vibration bar wear patterns appear to indicate a more square-like, essentially rectangular behavior that suggests that there may also be a mechanical, fabrication, assembly, and/or material contribution to the tube-to-tube wear degradation.

The NRC analysis indicated a correlation with the tube-to-tube wear based on a combination of high void fraction and high steam velocities. It should be noted that

the traditional forcing function, fluid velocity squared times density, does not show good agreement with the tube-to-tube wear patterns. This indicated that the high quality steam fluid velocities and high void fraction may be sufficiently high to cause conditions in the generators conducive for onset of fluid-elastic instability.

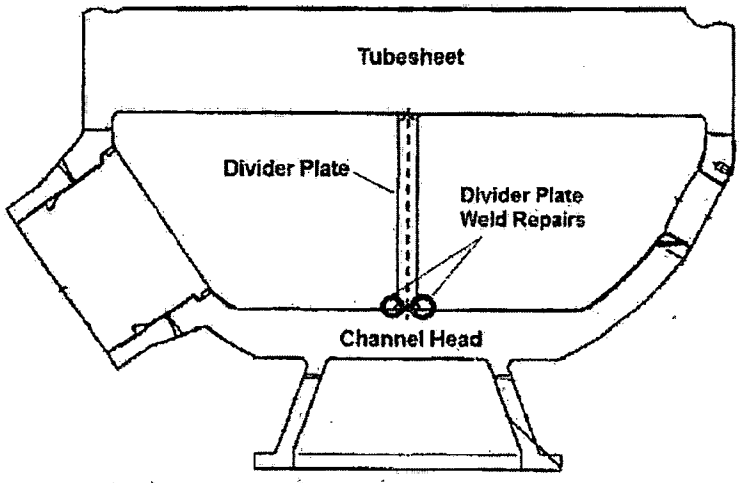
On March 18, 2009, Mitsubishi identified cracking indications in the weld between the divider plate and the channel head of Unit 3 replacement steam generator 3E0-88 (see figure below), after completion of the ASME Section III hydrostatic test on the secondary side. The extent of condition investigation also identified similar cracking indications in Unit 3 replacement steam generator 3E0-89. As discussed in Section 4 of this report, the cause of the cracking was attributed to the air carbon-arc gouging process used to remove the clad weld from the channel head. The team reviewed information associated with the repair of the cracking indications to assess whether the repair activities resulted in relevant differences in design and fabrication that could be considered as contributing factors for the cause of the tube-to-tube wear issue in Unit 3.

Location of Divider Plate Weld Repairs in Unit 3 Steam Generators (For Illustration Purposes Only)

Description: The cracking of the divider plate weld in both Unit 3 replacement steam generators required extensive repairs affecting the channel head, divider plate, and tubesheet. Based on interviews with licensee personnel and the review of documentation for the repairs, the team determined that Mitsubishi did not perform a comprehensive evaluation to assess the impact of the divider plate repairs on the integrity of the tube bundle. The team determined that the areas listed below were not considered or evaluated in sufficient depth to identify the potential adverse effects of the planned weld repairs.

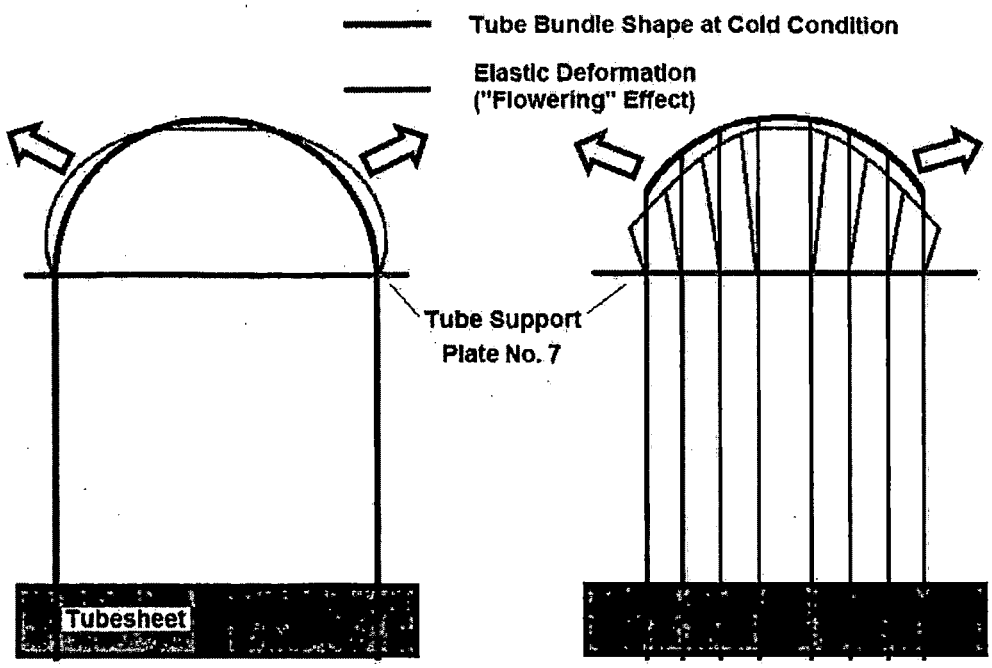
The failure mechanism model also considered a fluid dynamic effect associated with the spreading of the tubes in the U-bend region during normal operating conditions. This effect was informally referred to as "flowering," due to the characteristic shape in which the tube bundle spreads transverse to the plane of the u-bends at normal operating conditions. "Flowering" was described as the elastic deformation of the anti-vibration bar structure and the tube bundle in the U-bend region, as a result of thermal expansion and fluid dynamic pressure acting on the secondary side of the tubes (see figure below). The deformation caused by the "flowering" effect was believed to result in multiple areas of no contact between the anti-vibration bars and the tubes, which minimized resistance to in-plane motion of the u-bend area of the tubes.

Description of "Flowering" Effect (Conceptual Drawing – For Illustration Purposes Only) Form

Mitsubishi considered that the collective contribution of the factors described above resulted in conditions in the U-bend that were highly susceptible to excessive tube vibration. The in-plane vibration of the tubes in the U-bend region allowed direct contact between free-span sections of the tubes, resulting in the unanticipated tube-to-tube wear.

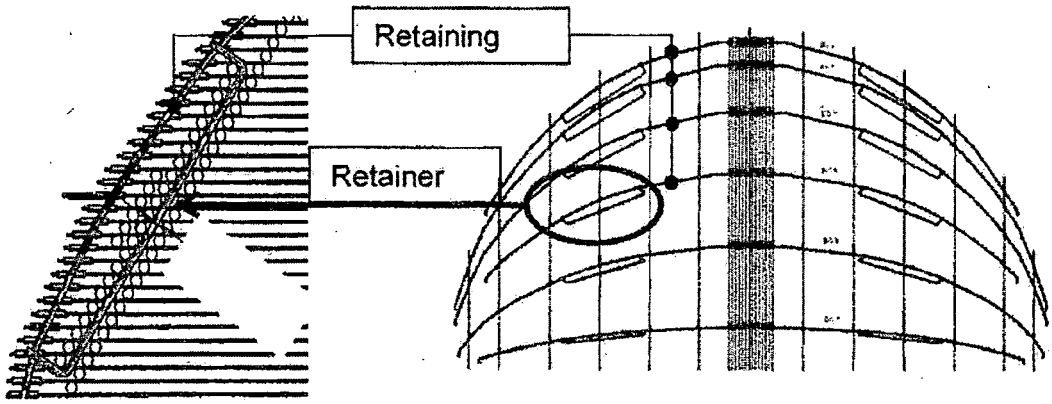
Description: In February 2012, the licensee identified wear indications in Unit 2 replacement steam generators at the tube locations in contact with the retainer bars (see figure below). Some of the indications showed excessive wear with a maximum degradation of 90 percent through wall.

Retainer Bar Design and Location of Affected Tubes (For Illustration Purposes Only)

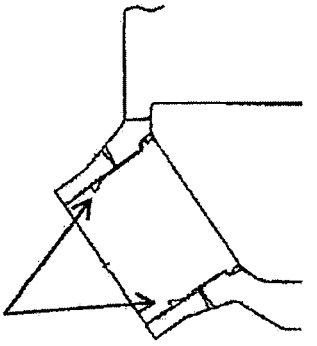
- Flow Limiter for Primary Inlet Nozzles – The replacement steam generators were designed with a flow limiter located in the primary inlet nozzle (see figure below) in order to make the reactor coolant system flow similar to the flow rate of the original steam generator and not exceed the maximum allowable reactor coolant system flow rate. The licensee's evaluation for the engineering design package determined that although the original steam generators had a number of plugged tubes, the reactor coolant system flow rate of the original steam generators was near the design requirement. Because the replacement steam generators has 377 more tubes than the original steam generators, and contained tubes with u-bends versus "square bends", the pressure drop of the replacement steam generators with no plugged tubes would be much less than the original steam generators resulting in a higher flowrate.

Replacement Steam Generator Primary Inlet Nozzle (For Illustration Purposes Only)

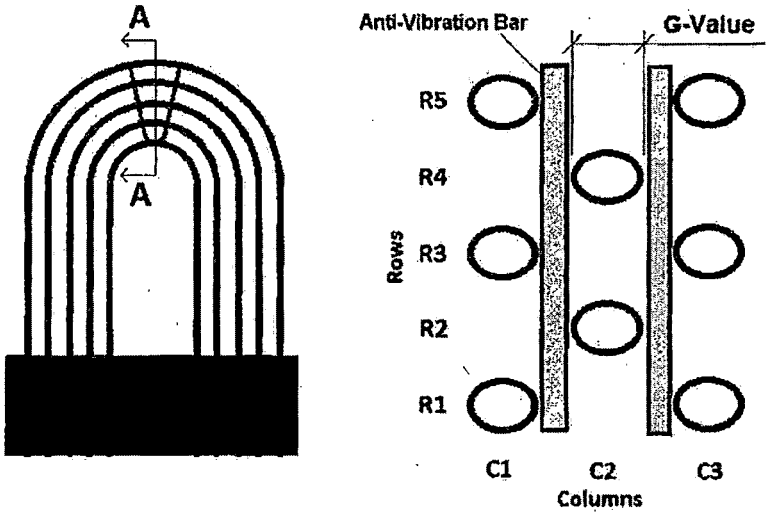
**Section A-A**

rejections. The G-value was a measure of departure from roundness, or "ovality," after the tubes were bent and it was controlled in order to control the gap between tubes and anti-vibration bars (see figure below). The G-values were measured at different locations along the U-bend section of the tubes for a selected number of tubes per row, as established in Mitsubishi's procedure. The acceptance criteria for G-value varied depending on the row where the tubes were installed. The acceptance criteria also remained the same throughout the fabrication of Unit 2 and Unit 3 replacement steam generators.

Description of G-Value Parameter (Conceptual Drawing – For Illustration Purposes Only)

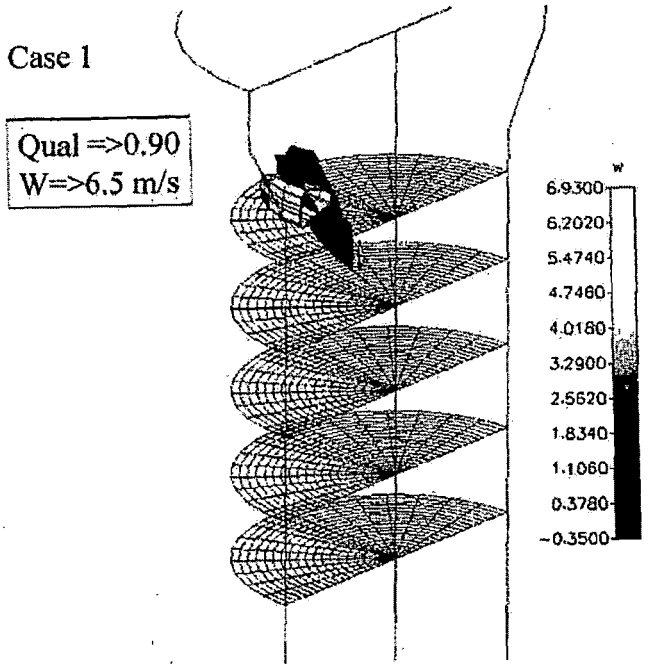
**Figure 1**

The tube-to-tube wear indications align with anti-vibration bar wear indication trends; however, the anti-vibration bar wear patterns appear to indicate a more square-like, essentially rectangular behavior that suggests that there may also be a mechanical, fabrication, assembly, and/or material contribution to the tube-to-tube wear degradation.

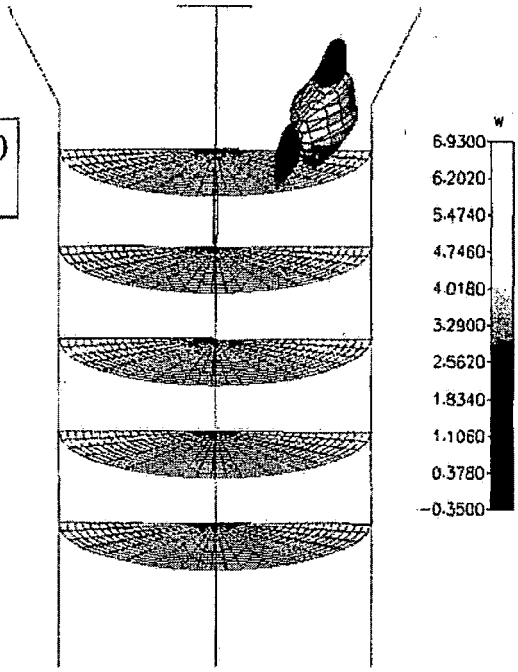
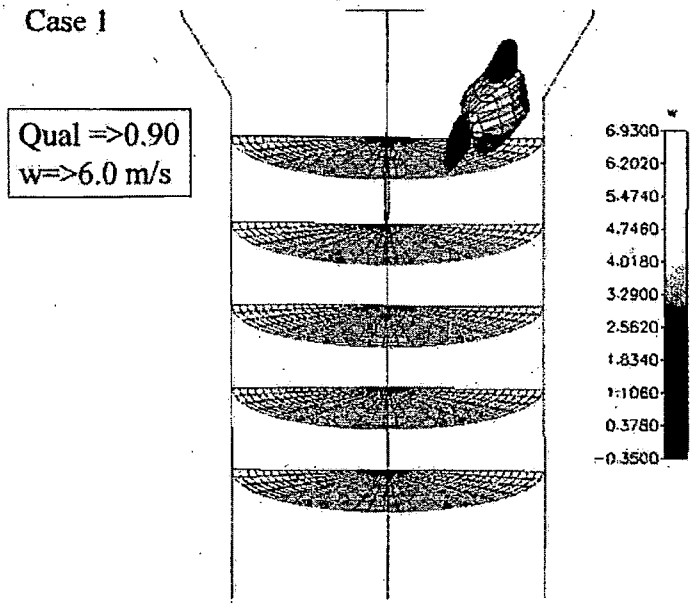
**Figure 4**

~~The ATHOS code predicted regions of high void fraction and high steam velocities are superimposed with tube-to-tube wear indications from Unit 3 steam generator 3E0-88~~

The NRC analysis indicated a correlation with the tube-to-tube wear based on a combination of high void fraction and high steam velocities. It should be noted that the traditional forcing function, fluid velocity squared times density, does not show good agreement with the tube-to-tube wear patterns. This indicated that the high quality steam fluid velocities and high void fraction may be sufficiently high to cause conditions in the generators conducive for onset of fluid-elastic instability.

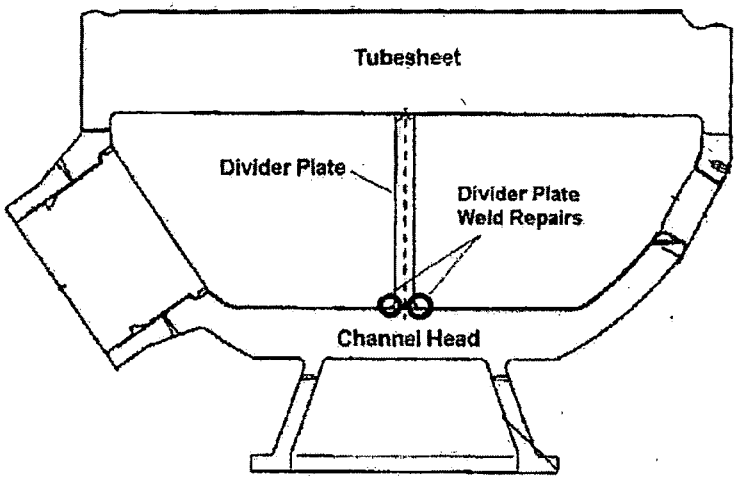
On March 18, 2009, Mitsubishi identified cracking indications in the weld between the divider plate and the channel head of Unit 3 replacement steam generator 3E0-88 (see figure below), after completion of the ASME Section III hydrostatic test on the secondary side. The extent of condition investigation also identified similar cracking indications in Unit 3 replacement steam generator 3E0-89. As discussed in Section 4 of this report, the cause of the cracking was attributed to the air carbon-arc gouging process used to remove the clad weld from the channel head. The team reviewed information associated with the repair of the cracking indications to assess whether the repair activities resulted in relevant differences in design and fabrication that could be considered as contributing factors for the cause of the tube-to-tube wear issue in Unit 3.

Location of Divider Plate Weld Repairs in Unit 3 Steam Generators (For Illustration Purposes Only)

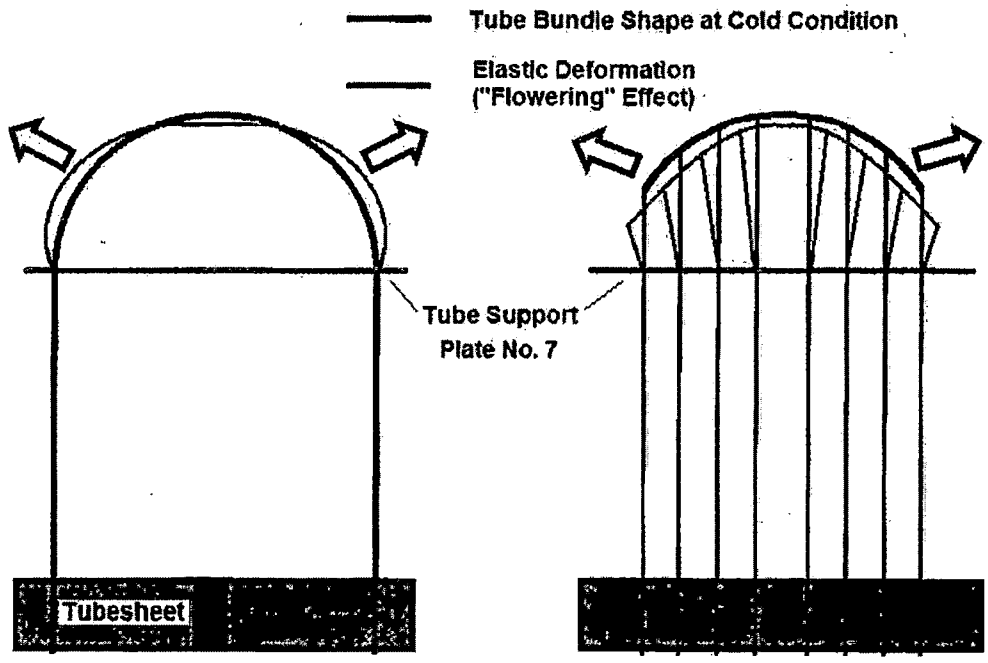
The failure mechanism model also considered a fluid dynamic effect associated with the spreading of the tubes in the U-bend region during normal operating conditions. This effect was informally referred to as "flowering," due to the characteristic shape in which the tube bundle spreads transverse to the plane of the u-bends at normal operating conditions. "Flowering" was described as the elastic deformation of the anti-vibration bar structure and the tube bundle in the U-bend region, as a result of thermal expansion and fluid dynamic pressure acting on the secondary side of the tubes (see figure below). The deformation caused by the "flowering" effect was believed to result in multiple areas of no contact between the anti-vibration bars and the tubes, which minimized resistance to in-plane motion of the u-bend area of the tubes.

Description of "Flowering" Effect (Conceptual Drawing – For Illustration Purposes Only)

Mitsubishi considered that the collective contribution of the factors described above resulted in conditions in the U-bend that were highly susceptible to excessive tube vibration. The in-plane vibration of the tubes in the U-bend region allowed direct contact between free-span sections of the tubes, resulting in the unanticipated tube-to-tube wear.

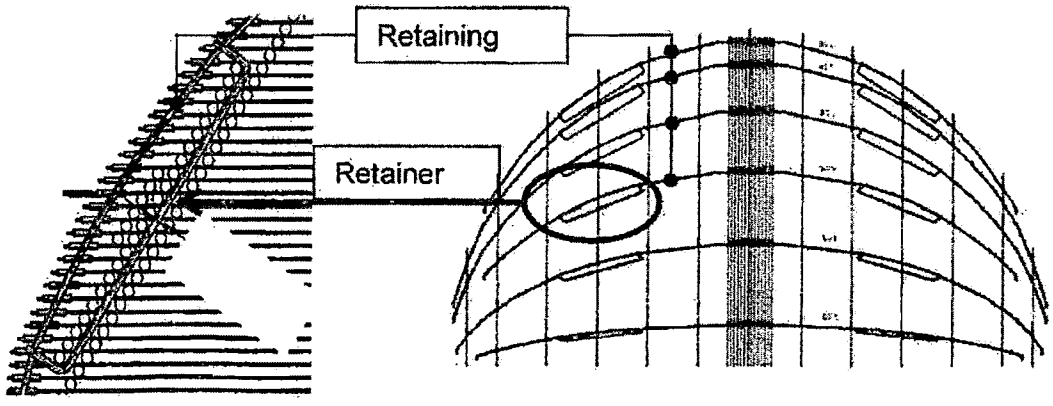
Description: In February 2012, the licensee identified wear indications in Unit 2 replacement steam generators at the tube locations in contact with the retainer bars (see figure below). Some of the indications showed excessive wear with a maximum degradation of 90 percent through wall.

Retainer Bar Design and Location of Affected Tubes (For Illustration Purposes Only)

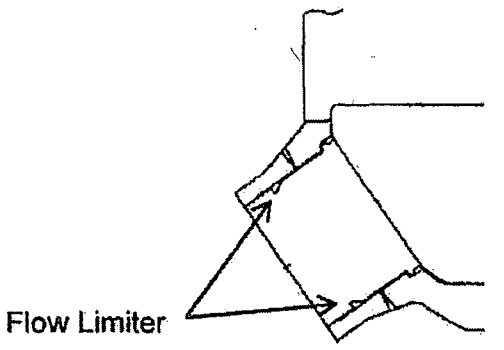
- Flow Limiter for Primary Inlet Nozzles – The replacement steam generators were designed with a flow limiter located in the primary inlet nozzle (see figure below) in order to make the reactor coolant system flow similar to the flow rate of the original steam generator and not exceed the maximum allowable reactor coolant system flow rate. The licensee's evaluation for the engineering design package determined that although the original steam generators had a number of plugged tubes, the reactor coolant system flow rate of the original steam generators was near the design requirement. Because the replacement steam generators has 377 more tubes than the original steam generators, and contained tubes with u-bends versus "square bends", the pressure drop of the replacement steam generators with no plugged tubes would be much less than the original steam generators resulting in a higher flowrate.

Replacement Steam Generator Primary Inlet Nozzle (For Illustration Purposes Only)

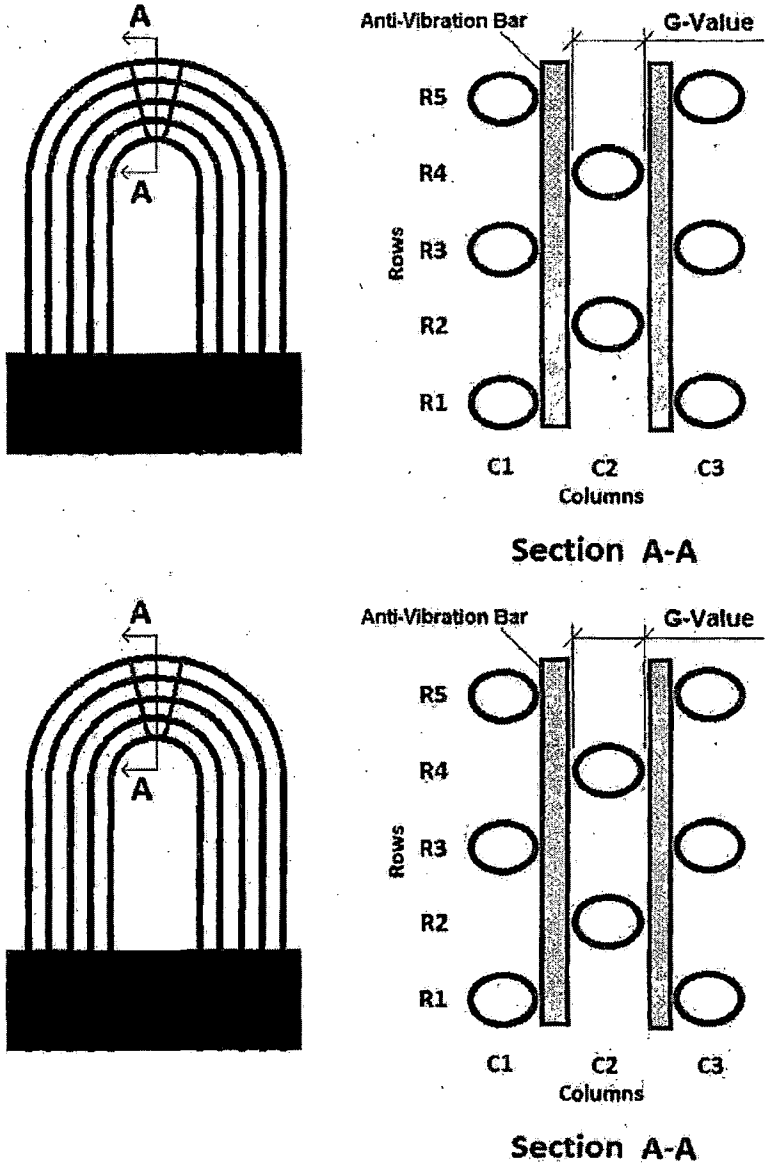
The first dimensional control under consideration was the improvement of tube roundness in the section of the tubes that was bent to form the U-bend shape. During fabrication of Unit 2 steam generator 2E0-89, the supplier of tubular product for Mitsubishi (i.e. Sumitomo), experienced quality issues to meet the G-values established in the design specifications, resulting in a high number of tube rejections. The G-value was a measure of departure from roundness, or "ovality," after the tubes were bent and it was controlled in order to control the gap between tubes and anti-vibration bars (see figure below). The G-values were measured at different locations along the U-bend section of the tubes for a selected number of tubes per row, as established in Mitsubishi's procedure. The acceptance criteria for G-value varied depending on the row where the tubes were installed. The acceptance criteria also remained the same throughout the fabrication of Unit 2 and Unit 3 replacement steam generators.

Description of G-Value Parameter (Conceptual Drawing – For Illustration Purposes Only)

Based on discussions with licensee personnel and documentation reviews, the team noted that Sumitomo implemented measures to improve the quality of the tube bending process which resulted in less deviation of G-values and a reduction in the amount and variability of tubing "ovality." Based on the statistical analysis of G-value data collected during fabrication of the Unit 2 and Unit 3 steam generators, Mitsubishi concluded that the G-values ~~standard deviation~~ gradually decreased since the fabrication of the first steam generator.
