## LIST OF ITEMS OPENED, CLOSED AND DISCUSSED

Unit 3 had been operating for approximately one year following replacement of the steam generators when control room operators received alarms on January 31, 2012, that indicated reactor coolant was leaking into steam generator 3E0-88. The leak was unexpected, and the control room operators responded in accordance with their procedures to perform a rapid shutdown, since the leak, although small, had increased enough in a short period of time to warrant the precautionary shutdown. The estimated leak rate was 75 gallons per day. The facility license allows full power operation with a steady leak rate of less than 150 gallons per day.

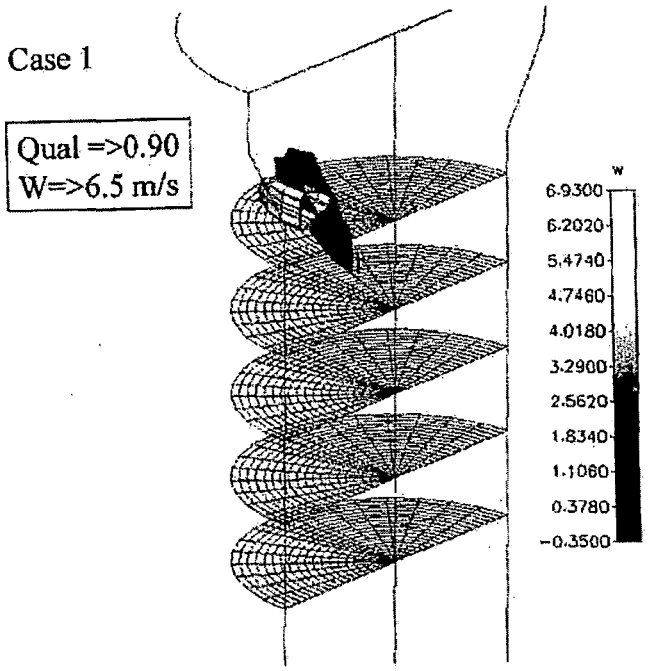
**Figure 1**

The tube-to-tube wear indications align with anti-vibration bar wear indication trends; however, the anti-vibration bar wear patterns appear to indicate a more square-like, essentially rectangular behavior that suggests that there may also be a mechanical, fabrication, assembly, and/or material contribution to the tube-to-tube wear degradation.

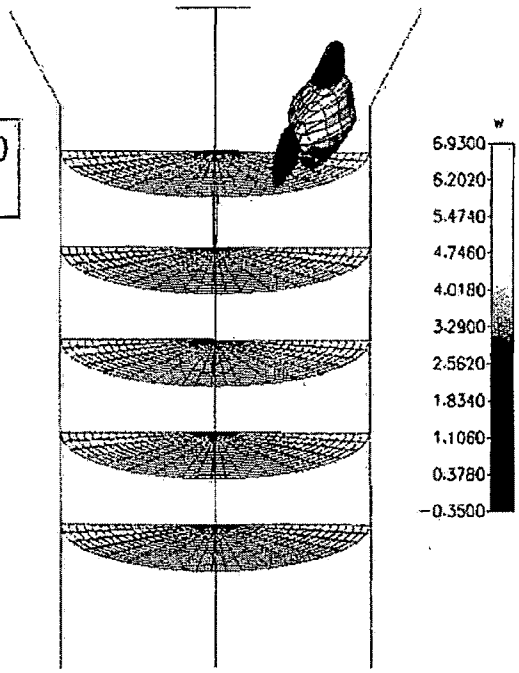
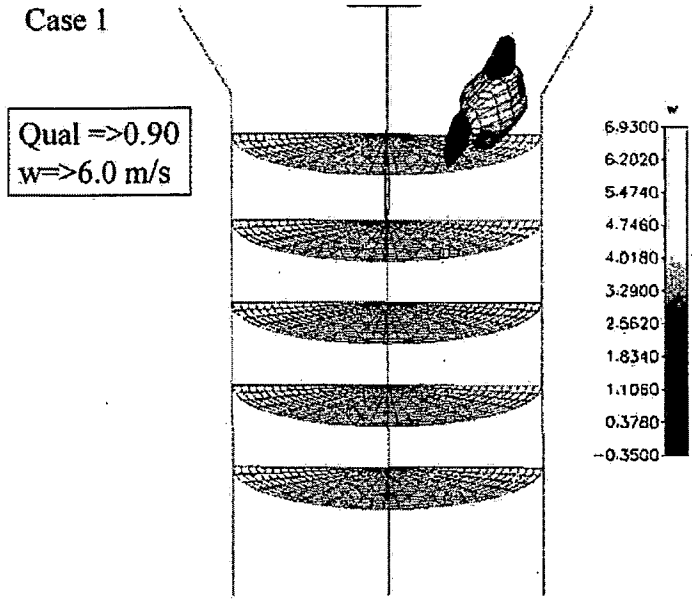
**Figure 4**

~~The ATHOS code predicted regions of high void fraction and high steam velocities are superimposed with tube-to-tube wear indications from Unit 3 steam generator 3E0-88~~

The NRC analysis indicated a correlation with the tube-to-tube wear based on a combination of high void fraction and high steam velocities. It should be noted that the traditional forcing function, fluid velocity squared times density, does not show good agreement with the tube-to-tube wear patterns. This indicated that the high quality steam fluid velocities and high void fraction may be sufficiently high to cause conditions in the generators conducive for onset of fluid-elastic instability.

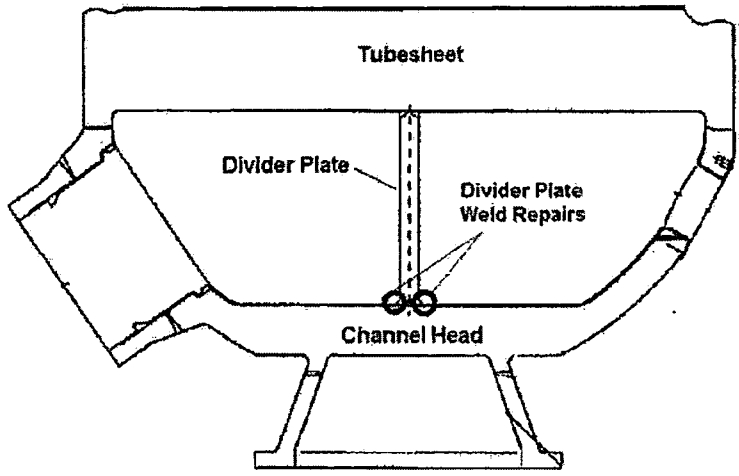
On March 18, 2009, Mitsubishi identified cracking indications in the weld between the divider plate and the channel head of Unit 3 replacement steam generator 3E0-88 (see figure below), after completion of the ASME Section III hydrostatic test on the secondary side. The extent of condition investigation also identified similar cracking indications in Unit 3 replacement steam generator 3E0-89. As discussed in Section 4 of this report, the cause of the cracking was attributed to the air carbon-arc gouging process used to remove the clad weld from the channel head. The team reviewed information associated with the repair of the cracking indications to assess whether the repair activities resulted in relevant differences in design and fabrication that could be considered as contributing factors for the cause of the tube-to-tube wear issue in Unit 3.

Location of Divider Plate Weld Repairs in Unit 3 Steam Generators (For Illustration Purposes Only)

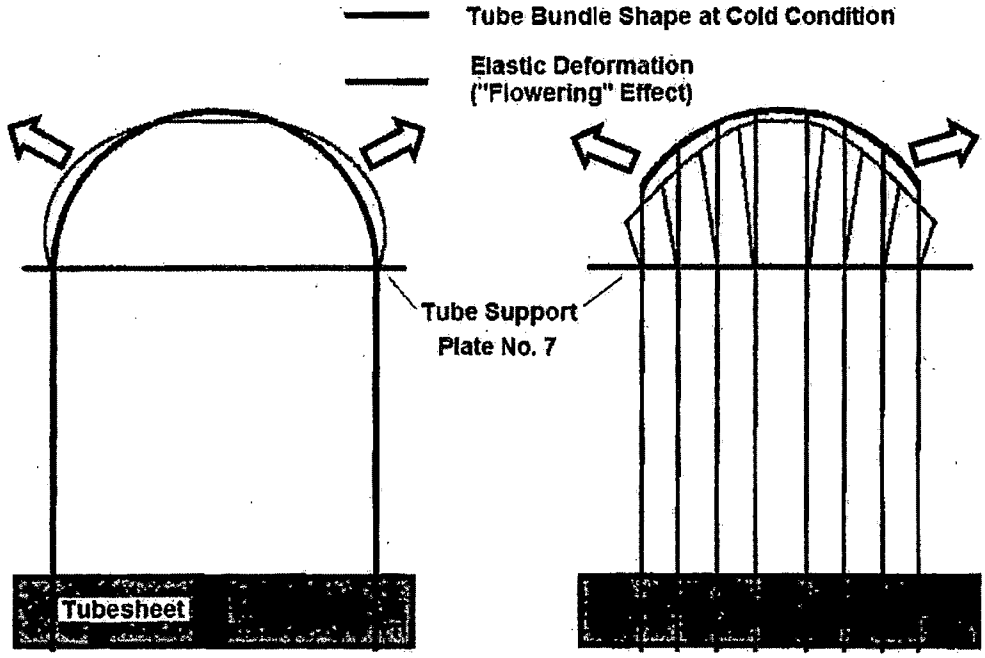
The failure mechanism model also considered a fluid dynamic effect associated with the spreading of the tubes in the U-bend region during normal operating conditions. This effect was informally referred to as "flowering," due to the characteristic shape in which the tube bundle spreads transverse to the plane of the u-bends at normal operating conditions. "Flowering" was described as the elastic deformation of the anti-vibration bar structure and the tube bundle in the U-bend region, as a result of thermal expansion and fluid dynamic pressure acting on the secondary side of the tubes (see figure below). The deformation caused by the "flowering" effect was believed to result in multiple areas of no contact between the anti-vibration bars and the tubes, which minimized resistance to in-plane motion of the u-bend area of the tubes.

Description of "Flowering" Effect (Conceptual Drawing – For Illustration Purposes Only)

Mitsubishi considered that the collective contribution of the factors described above resulted in conditions in the U-bend that were highly susceptible to excessive tube vibration. The in-plane vibration of the tubes in the U-bend region allowed direct contact between free-span sections of the tubes, resulting in the unanticipated tube-to-tube wear.

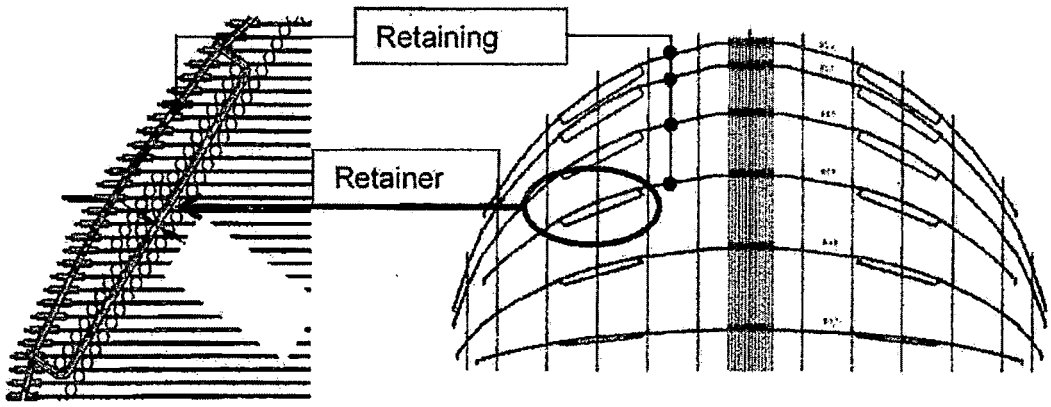
Description: In February 2012, the licensee identified wear indications in Unit 2 replacement steam generators at the tube locations in contact with the retainer bars (see figure below). Some of the indications showed excessive wear with a maximum degradation of 90 percent through wall.

Retainer Bar Design and Location of Affected Tubes (For Illustration Purposes Only)

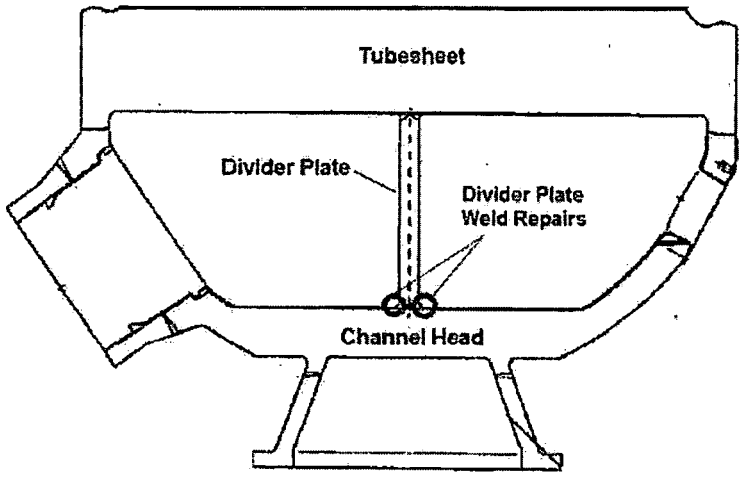
On March 18, 2009, Mitsubishi identified cracking indications in the weld between the divider plate and the channel head of Unit 3 replacement steam generator 3E0-88 (see figure below), after completion of the ASME Section III hydrostatic test on the secondary side. The extent of condition investigation also identified similar cracking indications in Unit 3 replacement steam generator 3E0-89. As discussed in Section 4 of this report, the cause of the cracking was attributed to the air carbon-arc gouging process used to remove the clad weld from the channel head. The team reviewed information associated with the repair of the cracking indications to assess whether the repair activities resulted in relevant differences in design and fabrication that could be considered as contributing factors for the cause of the tube-to-tube wear issue in Unit 3.

Location of Divider Plate Weld Repairs in Unit 3 Steam Generators (For Illustration Purposes Only)

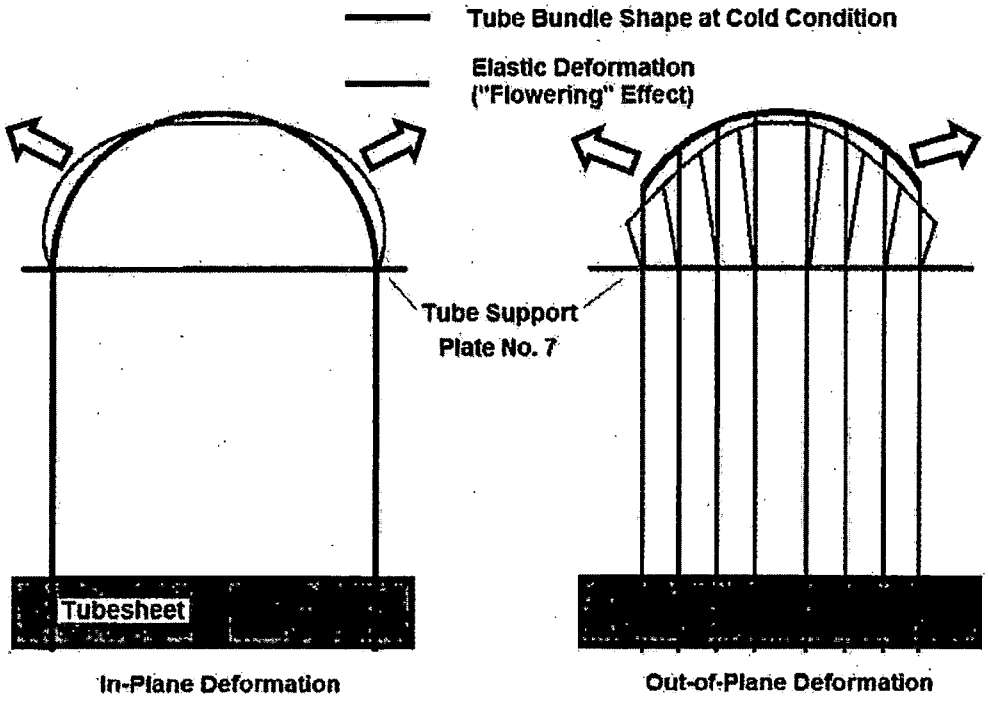
The failure mechanism model also considered a fluid dynamic effect associated with the spreading of the tubes in the U-bend region during normal operating conditions. This effect was informally referred to as "flowering," due to the characteristic shape in which the tube bundle spreads transverse to the plane of the u-bends at normal operating conditions. "Flowering" was described as the elastic deformation of the anti-vibration bar structure and the tube bundle in the U-bend region, as a result of thermal expansion and fluid dynamic pressure acting on the secondary side of the tubes (see figure below). The deformation caused by the "flowering" effect was believed to result in multiple areas of no contact between the anti-vibration bars and the tubes, which minimized resistance to in-plane motion of the u-bend area of the tubes.

Description of "Flowering" Effect (Conceptual Drawing – For Illustration Purposes Only)

Mitsubishi considered that the collective contribution of the factors described above resulted in conditions in the U-bend that were highly susceptible to excessive tube vibration. The in-plane vibration of the tubes in the U-bend region allowed direct contact between free-span sections of the tubes, resulting in the unanticipated tube-to-tube wear.

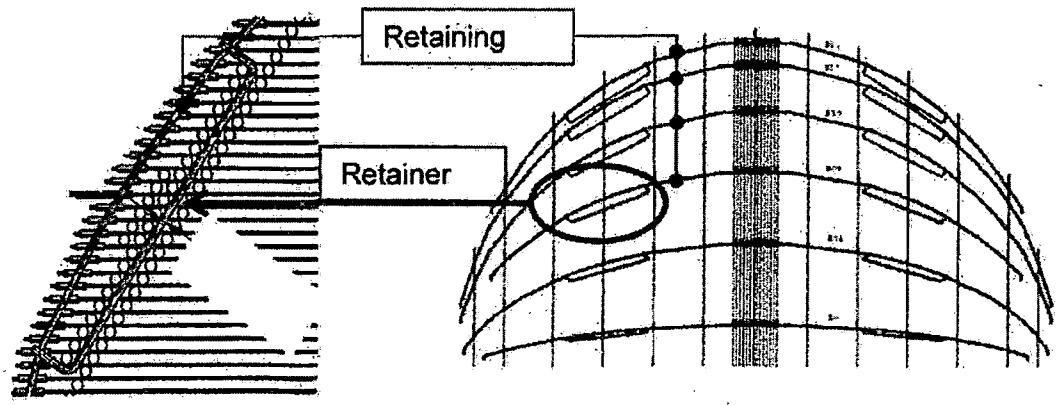
Description: In February 2012, the licensee identified wear indications in Unit 2 replacement steam generators at the tube locations in contact with the retainer bars (see figure below). Some of the indications showed excessive wear with a maximum degradation of 90 percent through wall.

Retainer Bar Design and Location of Affected Tubes (For Illustration Purposes Only) Form

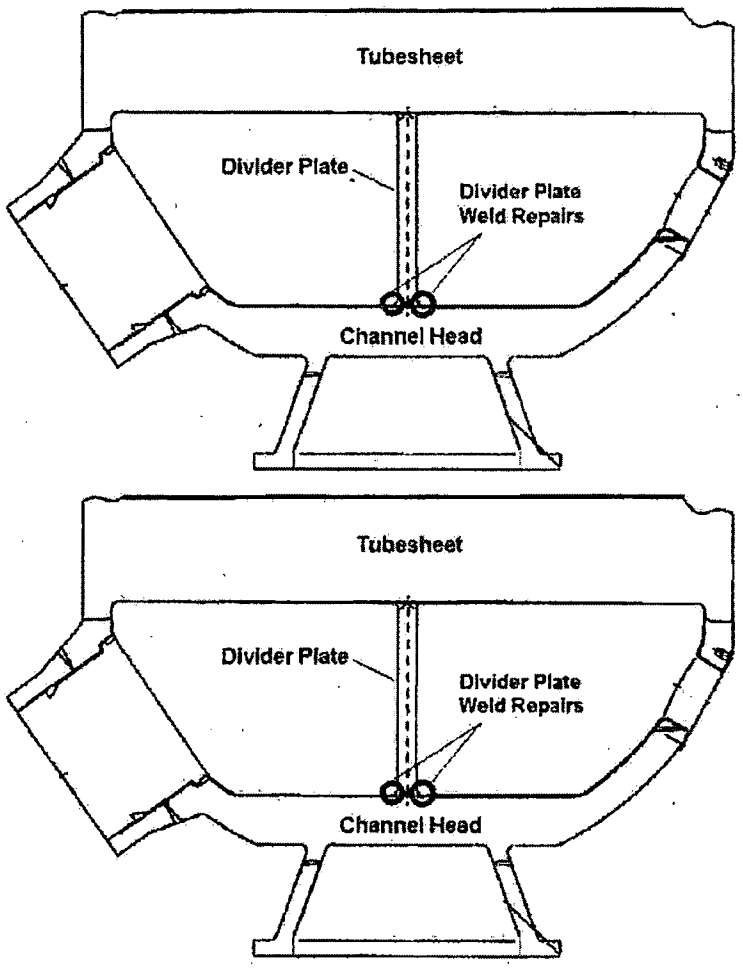
On March 18, 2009, Mitsubishi identified cracking indications in the weld between the divider plate and the channel head of Unit 3 replacement steam generator 3E0-88 (see figure below), after completion of the ASME Section III hydrostatic test on the secondary side. The extent of condition investigation also identified similar cracking indications in Unit 3 replacement steam generator 3E0-89. As discussed in Section 4 of this report, the cause of the cracking was attributed to the air carbon-arc gouging process used to remove the clad weld from the channel head. The team reviewed information associated with the repair of the cracking indications to assess whether the repair activities resulted in relevant differences in design and fabrication that could be considered as contributing factors for the cause of the tube-to-tube wear issue in Unit 3.

Location of Divider Plate Weld Repairs in Unit 3 Steam Generators (For Illustration Purposes Only)

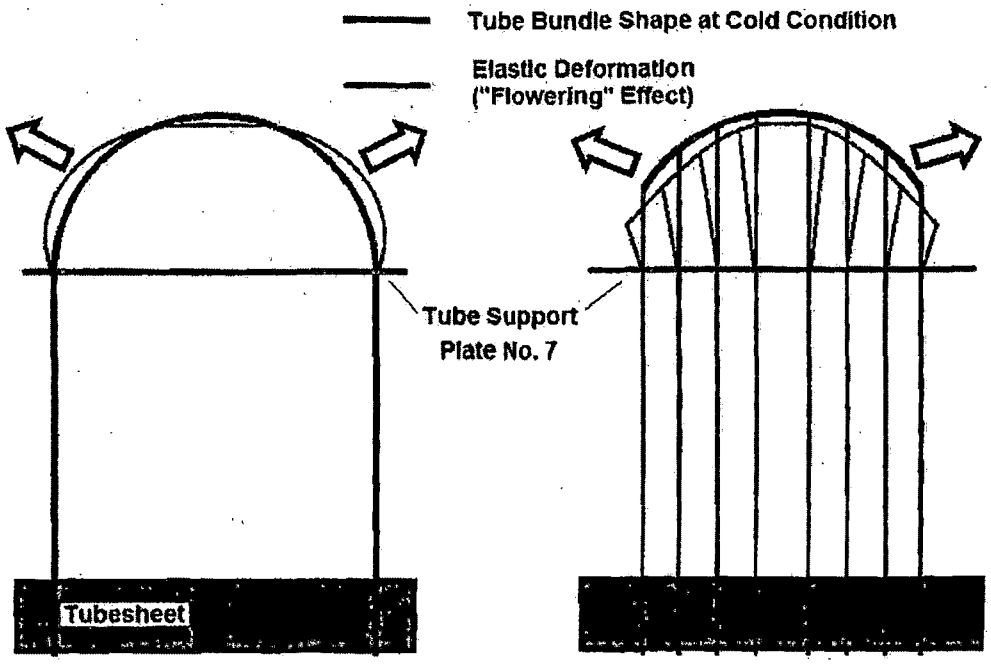
The failure mechanism model also considered a fluid dynamic effect associated with the spreading of the tubes in the U-bend region during normal operating conditions. This effect was informally referred to as "flowering," due to the characteristic shape in which the tube bundle spreads transverse to the plane of the u-bends at normal operating conditions. "Flowering" was described as the elastic deformation of the anti-vibration bar structure and the tube bundle in the U-bend region, as a result of thermal expansion and fluid dynamic pressure acting on the secondary side of the tubes (see figure below). The deformation caused by the "flowering" effect was believed to result in multiple areas of no contact between the anti-vibration bars and the tubes, which minimized resistance to in-plane motion of the u-bend area of the tubes.

Description of "Flowering" Effect (Conceptual Drawing – For Illustration Purposes Only)

Mitsubishi considered that the collective contribution of the factors described above resulted in conditions in the U-bend that were highly susceptible to excessive tube vibration. The in-plane vibration of the tubes in the U-bend region allowed direct contact between free-span sections of the tubes, resulting in the unanticipated tube-to-tube wear.

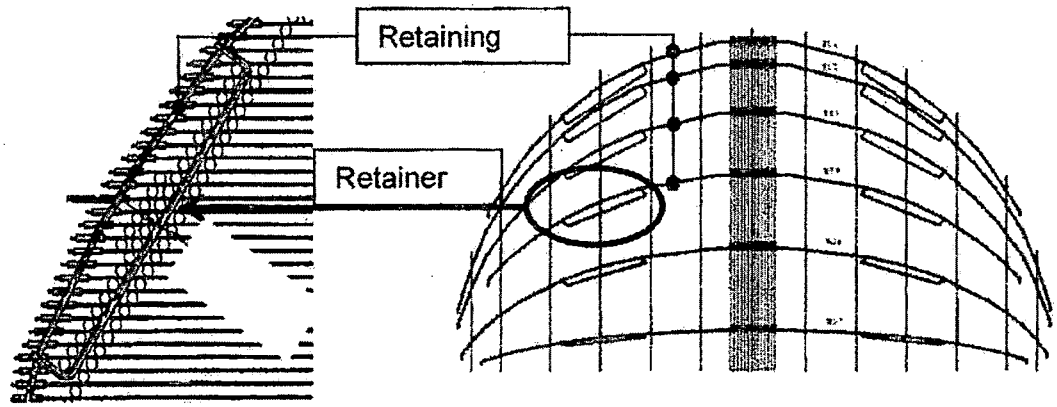
Description: In February 2012, the licensee identified wear indications in Unit 2 replacement steam generators at the tube locations in contact with the retainer bars (see figure below). Some of the indications showed excessive wear with a maximum degradation of 90 percent through wall.

**Retainer Bar Design and Location of Affected Tubes (For Illustration Purposes Only)**

- Fluid-elastic instability was found not applicable to the retainer bar because this mechanism did not apply to a single tube in cross flow.
- Vortex-induced vibration was found not applicable to the retainer bar because it was considered a vibration mode applicable to a single cylinder in uniform cross flow in a large area and the flow condition around the retainer bars was considered slug-froth two phase flow.

excessive wear. The analysis considered three vibration mechanisms: fluid-elastic instability, vortex-induced vibration, and turbulence-induced vibration (random vibration). The analysis for turbulence-induced vibration determined that random vibration was the possible cause of the retainer vibration, based on the peculiar flow around the retainer bar, combined with the rather low natural frequency of the retainer bar. The analysis used the two phase flow conditions around the retainer bars and identified various modes of vibration at those flow conditions that could lead to retainer bar vibration and consequently to tube wear.

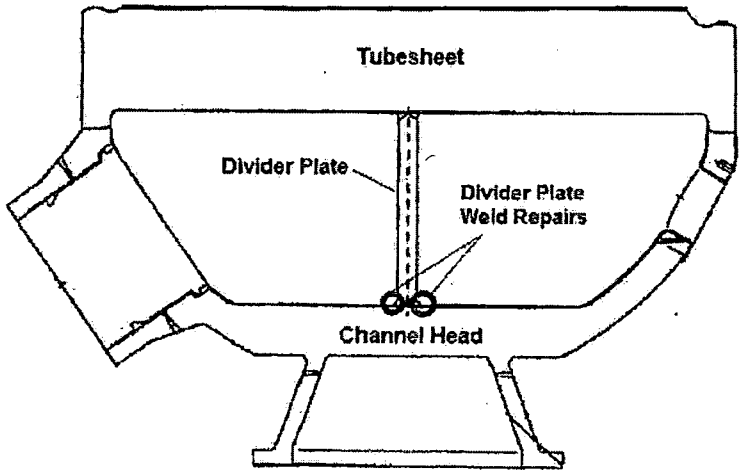
On March 18, 2009, Mitsubishi identified cracking indications in the weld between the divider plate and the channel head of Unit 3 replacement steam generator 3E0-88 (see figure below), after completion of the ASME Section III hydrostatic test on the secondary side. The extent of condition investigation also identified similar cracking indications in Unit 3 replacement steam generator 3E0-89. As discussed in Section 4 of this report, the cause of the cracking was attributed to the air carbon-arc gouging process used to remove the clad weld from the channel head. The team reviewed information associated with the repair of the cracking indications to assess whether the repair activities resulted in relevant differences in design and fabrication that could be considered as contributing factors for the cause of the tube-to-tube wear issue in Unit 3.

Location of Divider Plate Weld Repairs in Unit 3 Steam Generators (For Illustration Purposes Only)

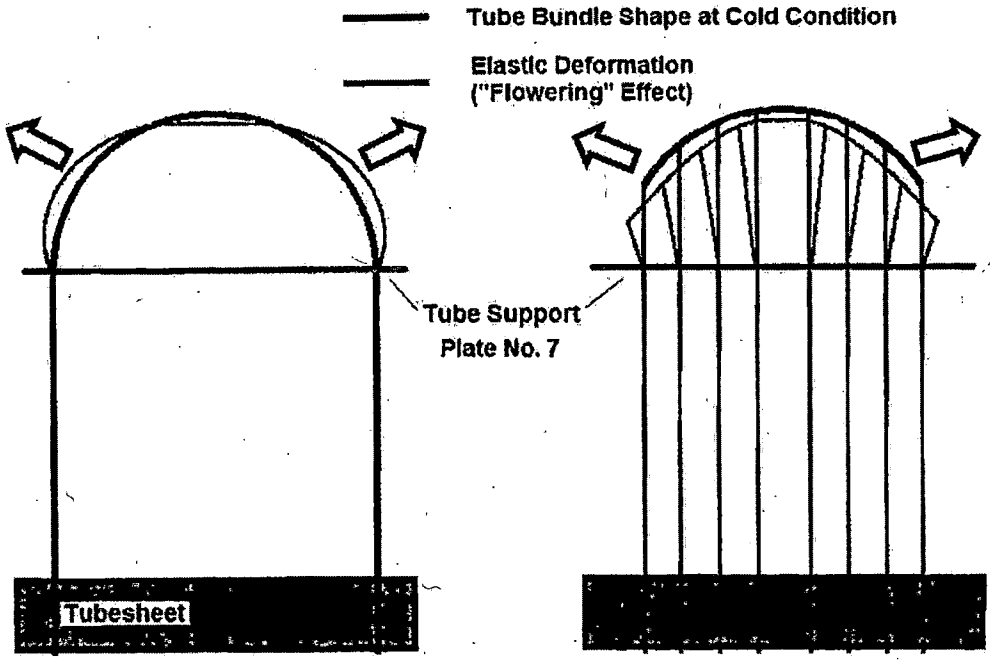
The failure mechanism model also considered a fluid dynamic effect associated with the spreading of the tubes in the U-bend region during normal operating conditions. This effect was informally referred to as "flowering," due to the characteristic shape in which the tube bundle spreads transverse to the plane of the u-bends at normal operating conditions. "Flowering" was described as the elastic deformation of the anti-vibration bar structure and the tube bundle in the U-bend region, as a result of thermal expansion and fluid dynamic pressure acting on the secondary side of the tubes (see figure below). The deformation caused by the "flowering" effect was believed to result in multiple areas of no contact between the anti-vibration bars and the tubes, which minimized resistance to in-plane motion of the u-bend area of the tubes.

Description of "Flowering" Effect (Conceptual Drawing – For Illustration Purposes Only)

Mitsubishi considered that the collective contribution of the factors described above resulted in conditions in the U-bend that were highly susceptible to excessive tube vibration. The in-plane vibration of the tubes in the U-bend region allowed direct contact between free-span sections of the tubes, resulting in the unanticipated tube-to-tube wear.

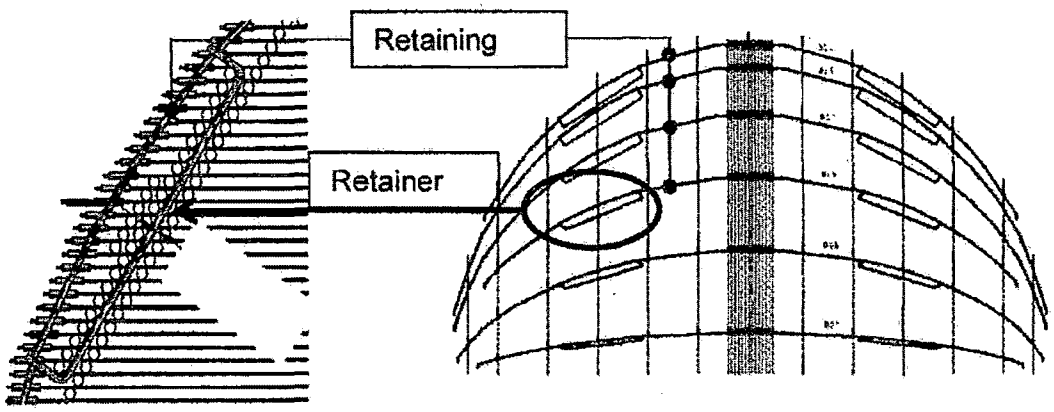
Description: In February 2012, the licensee identified wear indications in Unit 2 replacement steam generators at the tube locations in contact with the retainer bars (see figure below). Some of the indications showed excessive wear with a maximum degradation of 90 percent through wall.

**Retainer Bar Design and Location of Affected Tubes (For Illustration Purposes Only)**

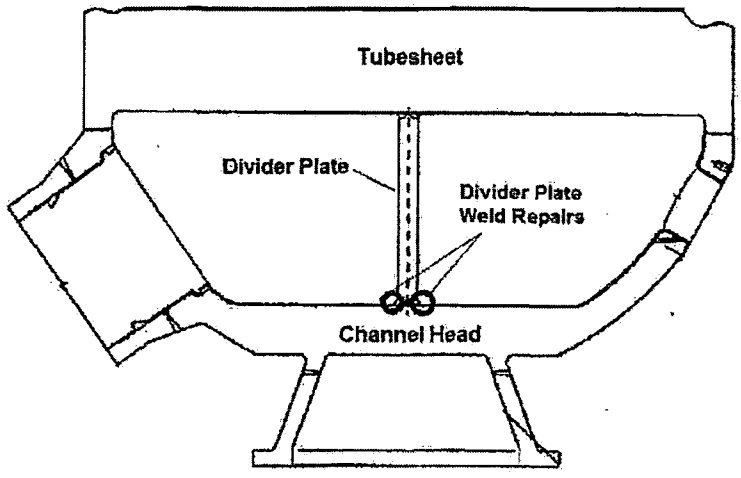
On March 18, 2009, Mitsubishi identified cracking indications in the weld between the divider plate and the channel head of Unit 3 replacement steam generator 3E0-88 (see figure below), after completion of the ASME Section III hydrostatic test on the secondary side. The extent of condition investigation also identified similar cracking indications in Unit 3 replacement steam generator 3E0-89. As discussed in Section 4 of this report, the cause of the cracking was attributed to the air carbon-arc gouging process used to remove the clad weld from the channel head. The team reviewed information associated with the repair of the cracking indications to assess whether the repair activities resulted in relevant differences in design and fabrication that could be considered as contributing factors for the cause of the tube-to-tube wear issue in Unit 3.

Location of Divider Plate Weld Repairs in Unit 3 Steam Generators (For Illustration Purposes Only)

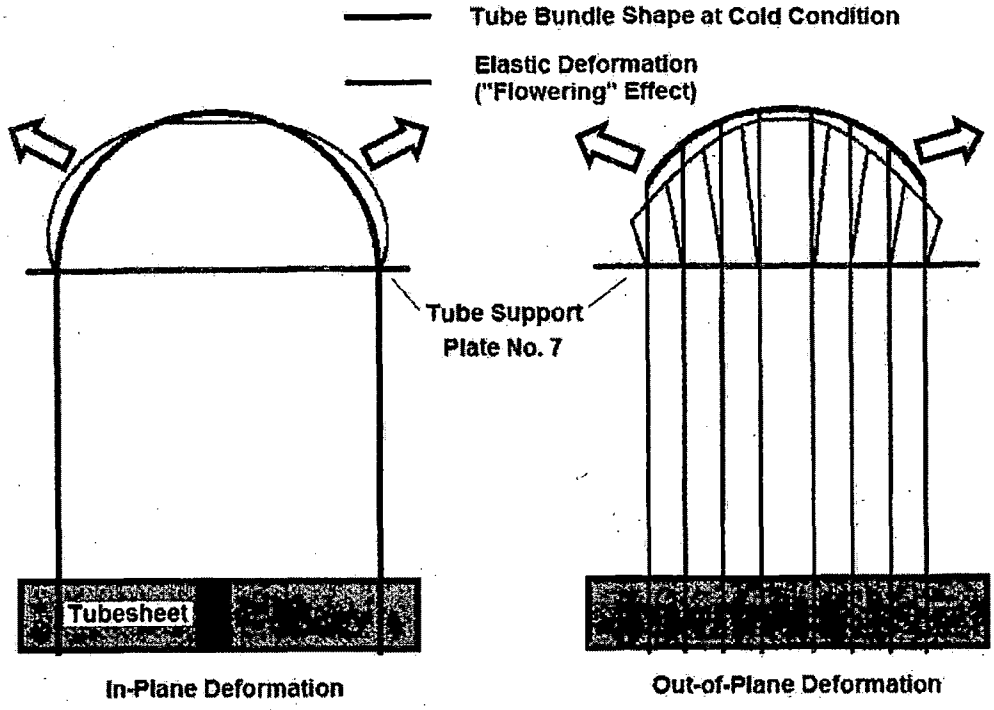
The failure mechanism model also considered a fluid dynamic effect associated with the spreading of the tubes in the U-bend region during normal operating conditions. This effect was informally referred to as "flowering," due to the characteristic shape in which the tube bundle spreads transverse to the plane of the u-bends at normal operating conditions. "Flowering" was described as the elastic deformation of the anti-vibration bar structure and the tube bundle in the U-bend region, as a result of thermal expansion and fluid dynamic pressure acting on the secondary side of the tubes (see figure below). The deformation caused by the "flowering" effect was believed to result in multiple areas of no contact between the anti-vibration bars and the tubes, which minimized resistance to in-plane motion of the u-bend area of the tubes.

Description of "Flowering" Effect (Conceptual Drawing – For Illustration Purposes Only)

Mitsubishi considered that the collective contribution of the factors described above resulted in conditions in the U-bend that were highly susceptible to excessive tube vibration. The in-plane vibration of the tubes in the U-bend region allowed direct contact between free-span sections of the tubes, resulting in the unanticipated tube-to-tube wear.

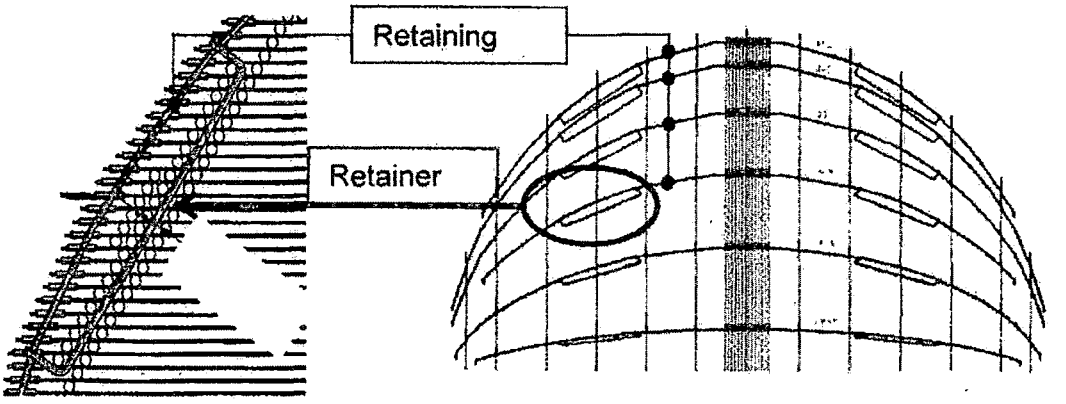
Description: In February 2012, the licensee identified wear indications in Unit 2 replacement steam generators at the tube locations in contact with the retainer bars (see figure below). Some of the indications showed excessive wear with a maximum degradation of 90 percent through wall.

**Retainer Bar Design and Location of Affected Tubes (For Illustration Purposes Only)**

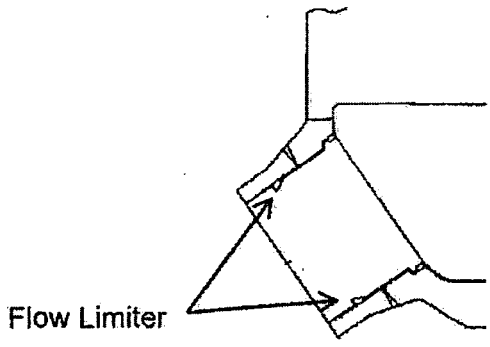
- Flow Limiter for Primary Inlet Nozzles – The replacement steam generators were designed with a flow limiter located in the primary inlet nozzle (see figure below) in order to make the reactor coolant system flow similar to the flow rate of the original steam generator and not exceed the maximum allowable reactor coolant system flow rate. The licensee's evaluation for the engineering design package determined that although the original steam generators had a number of plugged tubes, the reactor coolant system flow rate of the original steam generators was near the design requirement. Because the replacement steam generators has 377 more tubes than the original steam generators, and contained tubes with u-bends versus "square bends", the pressure drop of the replacement steam generators with no plugged tubes would be much less than the original steam generators resulting in a higher flowrate.

Replacement Steam Generator Primary Inlet Nozzle (For Illustration Purposes Only)

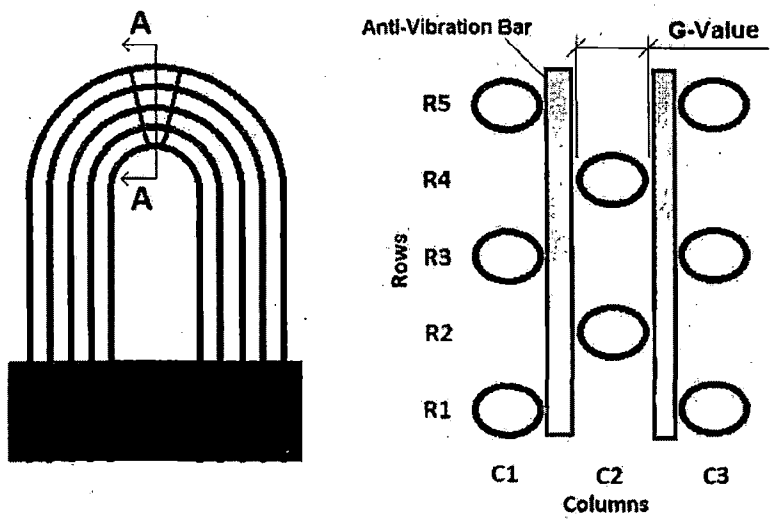
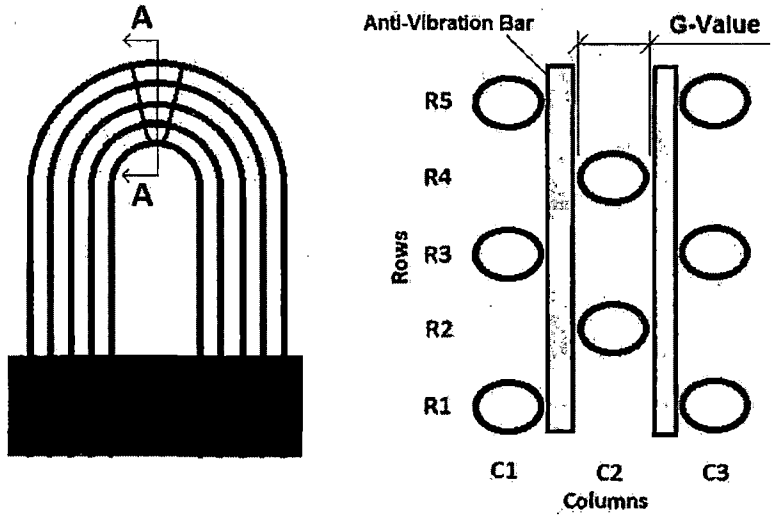
The first dimensional control under consideration was the improvement of tube roundness in the section of the tubes that was bent to form the U-bend shape. During fabrication of Unit 2 steam generator 2E0-89, the supplier of tubular product for Mitsubishi (i.e. Sumitomo), experienced quality issues to meet the G-values established in the design specifications, resulting in a high number of tube rejections. The G-value was a measure of departure from roundness, or "ovality," after the tubes were bent and it was controlled in order to control the gap between tubes and anti-vibration bars (see figure below). The G-values were measured at different locations along the U-bend section of the tubes for a selected number of tubes per row, as established in Mitsubishi's procedure. The acceptance criteria for G-value varied depending on the row where the tubes were installed. The acceptance criteria also remained the same throughout the fabrication of Unit 2 and Unit 3 replacement steam generators.

Description of G-Value Parameter (Conceptual Drawing – For Illustration Purposes Only)

Based on discussions with licensee personnel and documentation reviews, the team noted that Sumitomo implemented measures to improve the quality of the tube bending process which resulted in less deviation of G-values and a reduction in the amount and variability of tubing "ovality." Based on the statistical analysis of G-value data collected during fabrication of the Unit 2 and Unit 3 steam generators, Mitsubishi concluded that the G-values standard deviation gradually decreased since the fabrication of the first steam generator.

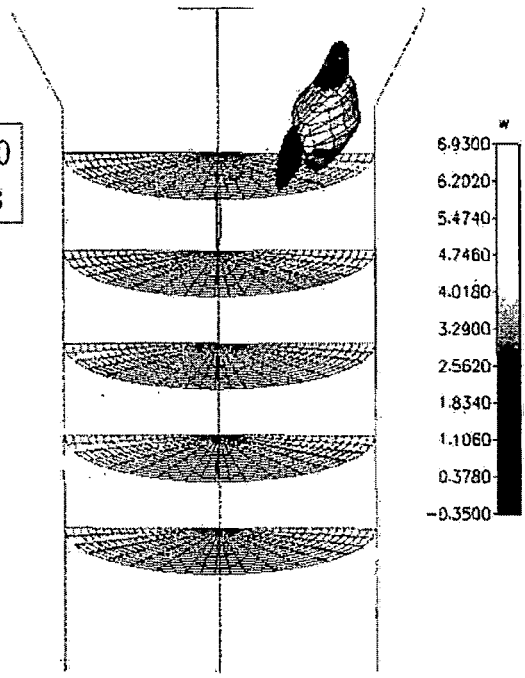
**Figure 5** The ATHOS code predicted regions of high void fraction and high steam velocities are superimposed with tube-to-tube wear indications from Unit 3 steam generator 3E0-88

The NRC analysis indicated a correlation with the tube-to-tube wear based on a combination of high void fraction and high steam velocities. It should be noted that the traditional forcing function, fluid velocity squared times density, does not show good agreement with the tube-to-tube wear patterns. This indicated that the high quality steam fluid velocities and high void fraction may be sufficiently high to cause conditions in the generators conducive for onset of fluid-elastic instability.

The above analyses apply equally to Units 2 and 3, so it does not explain why the accelerated fluid-elastic instability wear damage was significantly greater in Unit 3 steam generators. The ATHOS thermal-hydraulic model predicts bulk fluid behavior based on first principals and empirical correlations and as a result it is not able to evaluate mechanical, fabrication, or structural material differences or other phenomena that may be unique to each steam generator. Therefore this analysis cannot account for these mechanical factors and differences which could very likely also be contributing to the tube degradation.

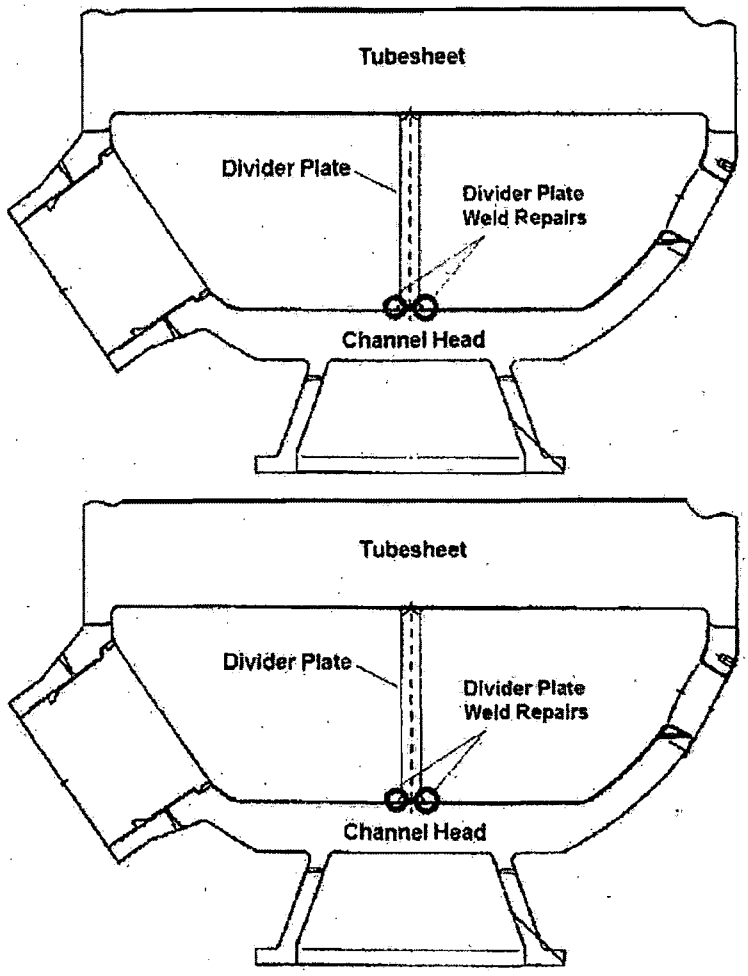
On March 18, 2009, Mitsubishi identified cracking indications in the weld between the divider plate and the channel head of Unit 3 replacement steam generator 3E0-88 (see figure below), after completion of the ASME Section III hydrostatic test on the secondary side. The extent of condition investigation also identified similar cracking indications in Unit 3 replacement steam generator 3E0-89. As discussed in Section 4 of this report, the cause of the cracking was attributed to the air carbon-arc gouging process used to remove the clad weld from the channel head. The team reviewed information associated with the repair of the cracking indications to assess whether the repair activities resulted in relevant differences in design and fabrication that could be considered as contributing factors for the cause of the tube-to-tube wear issue in Unit 3.

Location of Divider Plate Weld Repairs in Unit 3 Steam Generators (For Illustration Purposes Only)
