SUSQUEHANNA STEAM ELECTRIC STATION

INVESTIGATION OF UNIT ONE

SMALL PIPING SYSTEM DESIGN

SUSQUEHANNA STEAM ELECTRIC STATION - UNIT 1
REPORT - INVESTIGATION OF SMALL PIPING SYSTEM DESIGN
INSTALLATION AND INSPECTION - PROGRAM ADEQUACY
AND IMPLEMENTATION
AUGUST 3 - 12, 1982

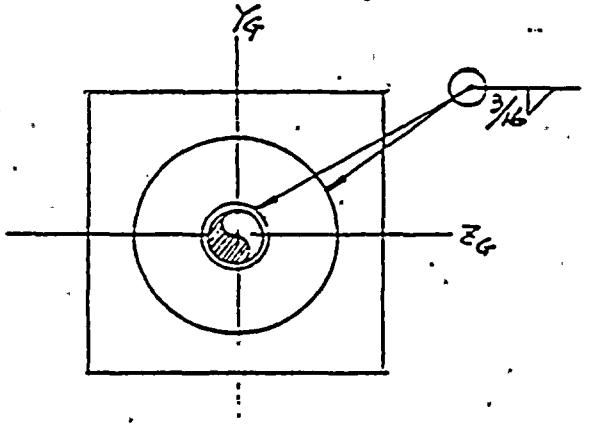
THE MAJOR DIFFERENCE BETWEEN THE AS-BUILT HANGER & SPA 720 IS THAT THE AS-BUILT USES A SMALLER & THINNER Æ THAN THE SPA. PRELIMINARY CALCS. USING THE ORIGINAL LOADS SHOW THAT THE SUPPORT WOULD FAIL, THUS THE FOLLOWING LESS CONSERVATIVE LOADS WERE GIVEN BY STRESS.

$$\frac{f_a}{F_a} = \frac{(0.2^K / 2.5791\ IN^2)}{19.11} = 0.004 < 0.15$$

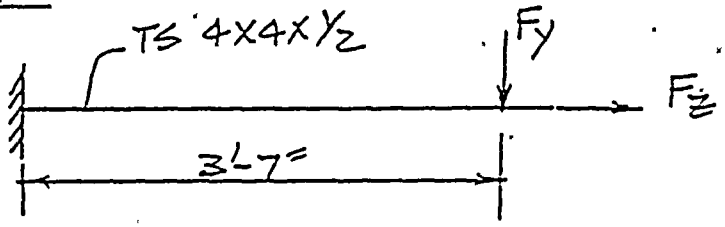
HZ004

SUBJECT SP-HCB-133-HZ004 SHEET NO. 2

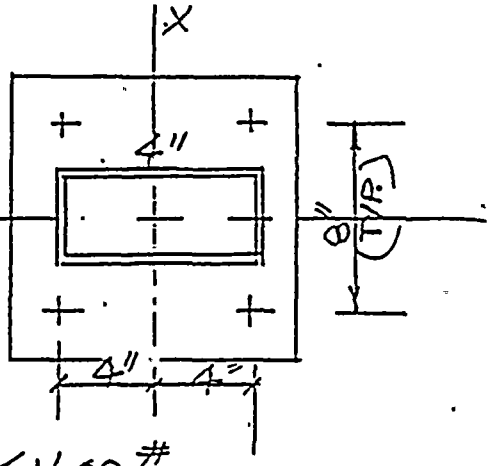
APPROX. PULLOUT

$\frac{13445}{2 \times 8} = 840^{\#}/\text{BOLT}$

$\text{SHEAR} = \frac{511}{4} = 128^{\#}$

$968^{\#}/\text{BOLT} < 1600^{\#}$

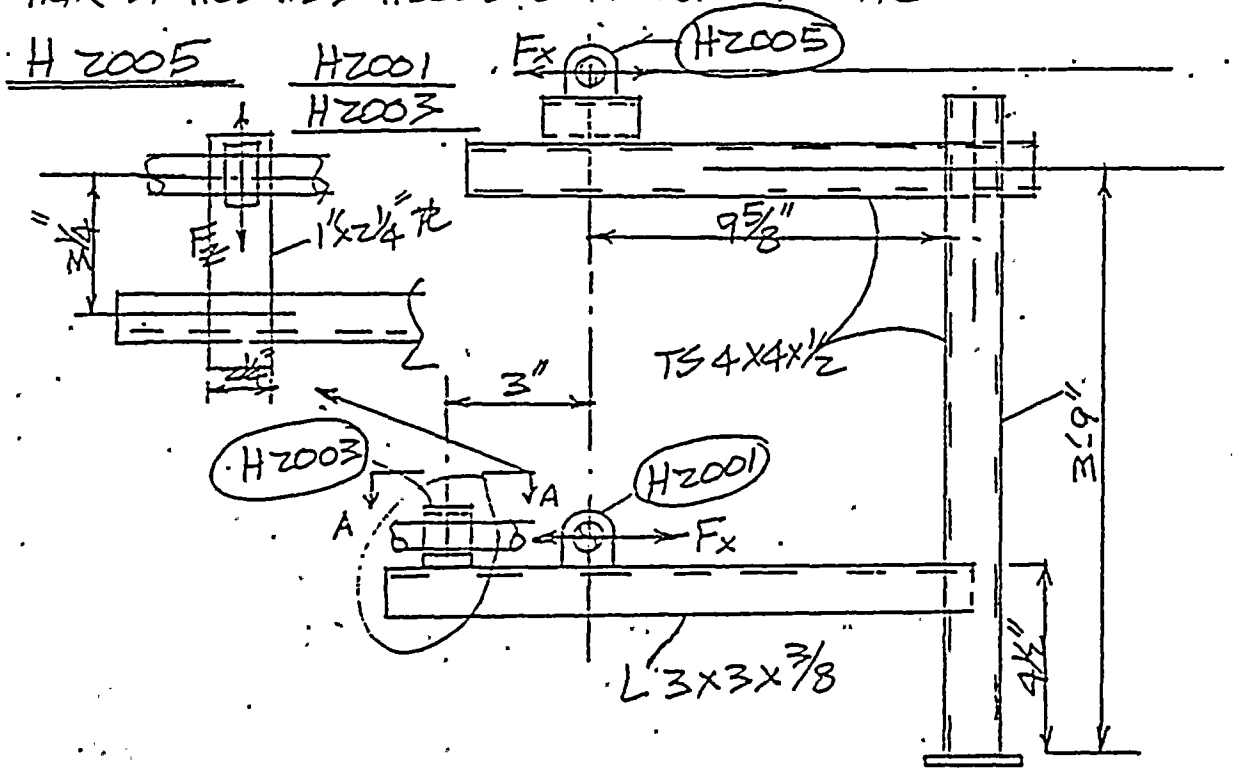
SUBJECT SP-HCB-133-H2005 SHEET NO. 4

HGRS, SP-HCB-133-H2001 & H2003 ARE ATTACHED TO HGR SP-HCB-133-H2005 SUPPORT FRAME

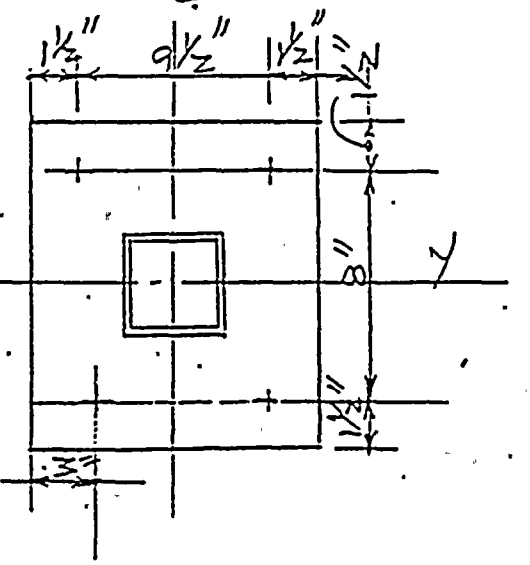
$= 0.259 < 1.0$

∴ 3/4" PL & 3/4" ϕ HILTI KWIK BOLTS O.K

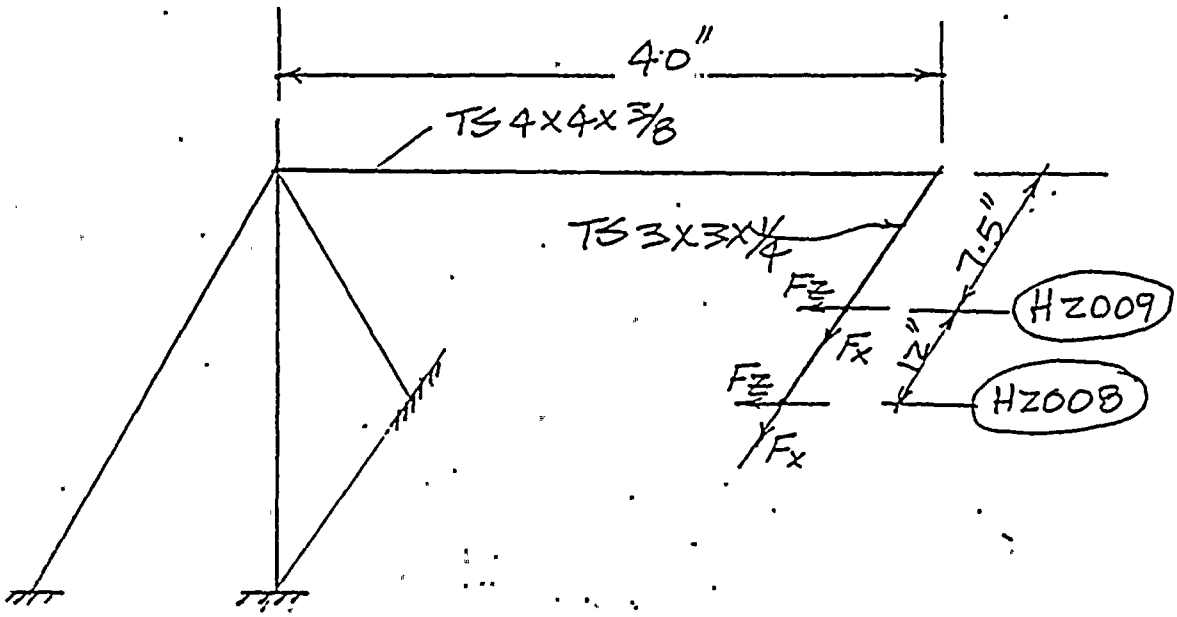
HZ009 HZ008

SUBJECT SP-HCB-133-HZ009 SHEET NO. 7

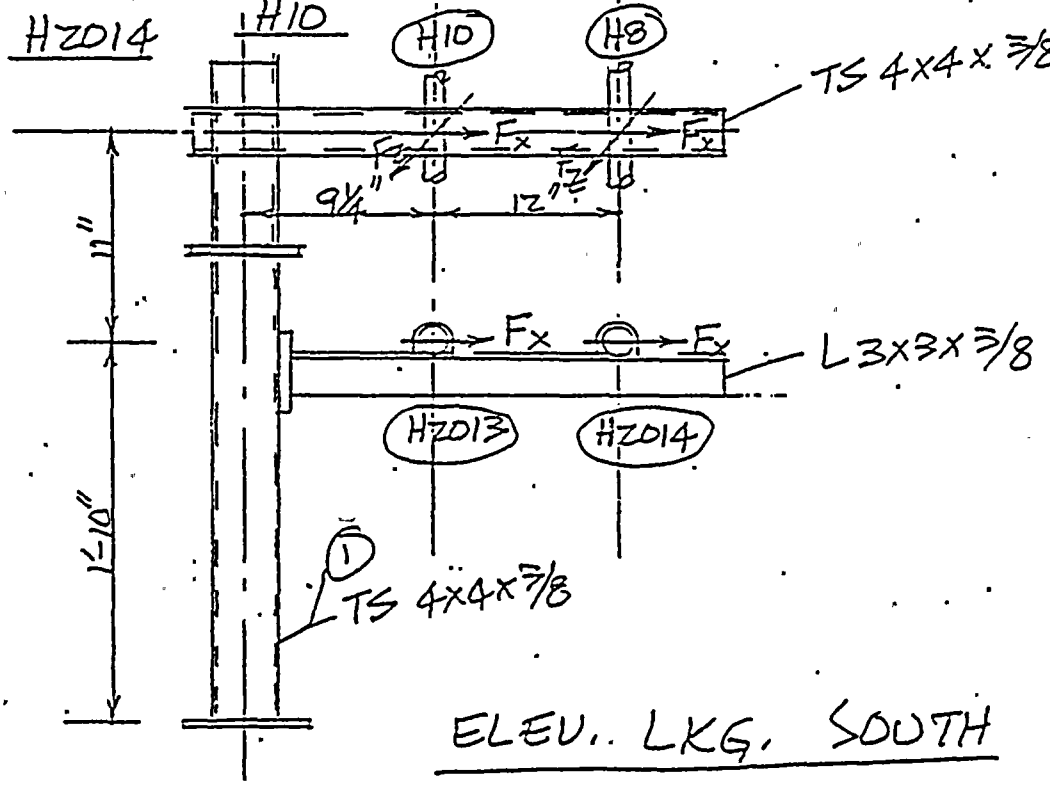
SUBJECT SP-HCB-133-H2013 SHEET NO. 9

HGR's SP-HCB-133-H8, H10 & H2014 ARE SUPPORTED FROM HGR. FRAME OF SP-HCB-133-H2013

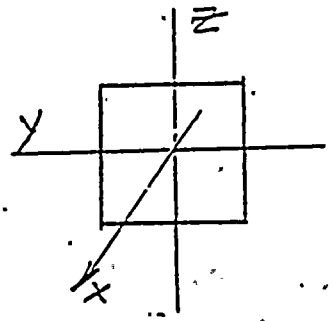
$M_y = 2(278)\times33$
$= 18348''\#$

$M_z = 2(33\times33 + 141\times22)$
$= 8382''\#$

M_x (TORSION) $= 278(9.25 + 21.25)$
$= 8480''\#$

$F_y = 2(141+33) = 348\ \#$

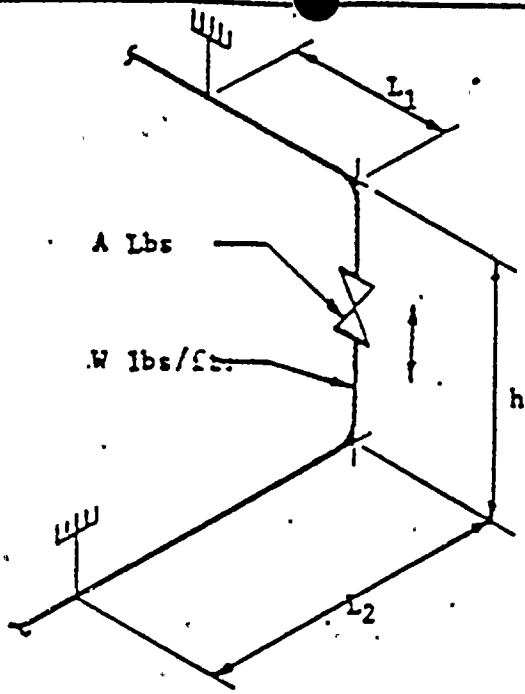
interpolation of the values for F presented in Figure A-3.15 are not authorized within the specification. Application of this larger value for F, obtained by interpolation, resulted in acceptance of a 2'-5½" span, which should have been identified as being 4½" overlength, by spec M-241 criteria.

There appears to be no adverse safety impact resulting from this action.

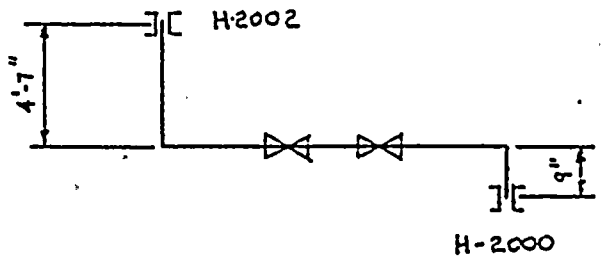
The span between H2000 and H2002 can be represented as shown below.

The calculations indicate that all of the dynamic loads associated with the concentrated pipe and valve weights is taken by H2000. Strict interpretation of Spec. M-241, Rev. 3 would indicate that the load should be split up between the both supports and the span adjusted accordingly.

Spec. M-241, Rev. 4 provides direction for this type of condition, that is, when all the load can be lumped on one support and not split up. The calculations noted above appear to go beyond these guidelines also.
