# 2016 ANNUAL MONITORING REPORT / PERFORMANCE REVIEW
# FOR
# HOMESTAKE'S GRANTS PROJECT
# PURSUANT TO
# NRC LICENSE SUA-1471 AND DISCHARGE PLAN DP-200

**U.S. NUCLEAR REGULATORY COMMISSION**
**AND**
**NEW MEXICO ENVIRONMENT DEPARTMENT**

**HOMESTAKE MINING COMPANY OF CALIFORNIA**
**GRANTS, NEW MEXICO**

**MARCH, 2017**

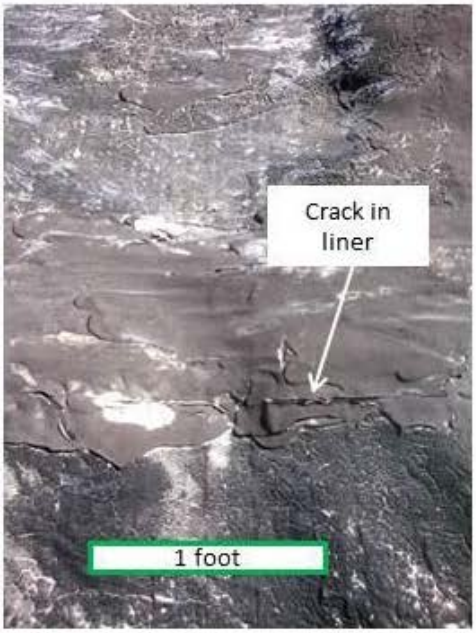
Figure 2 – Cracks in liner at east end of south inslope, EP1

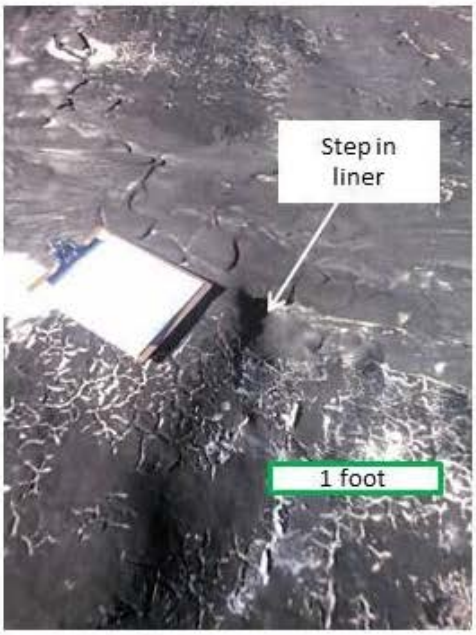
Figure 3 – Small step in liner related to lumps below liner at east end of south inslope, EP1
