FLORIDA POWER & LIGHT COMPANY

Re: Turkey Point Unit 4
Docket No. 50-251
Steam Generator Tube Wastage Information

TURKEY POINT UNIT 4

S/G TUBE WALL THINNING

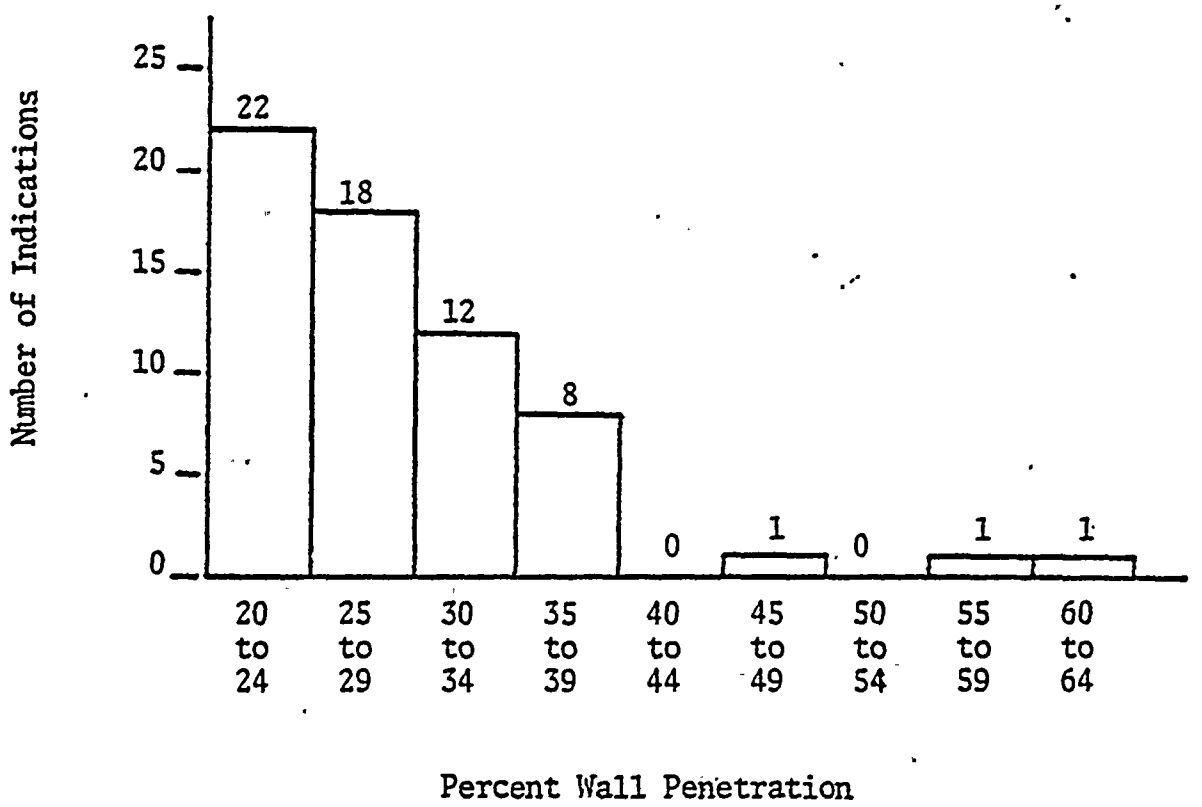
S/G A HOT LEG

Figures A-1 to A-6 show the distribution of eddy current indication $\geq 20\%$ for each leg of the three steam generators. The preponderance of indications at low percentages, i.e. less than 40%, strongly suggests thinning as the nature of the tube degradation since detection of cracking by eddy current techniques is insensitive below about 40% wall penetration.

DISTRIBUTION OF EDDY CURRENT INDICATIONS ≥ 20%
NOVEMBER 1980 INSPECTION

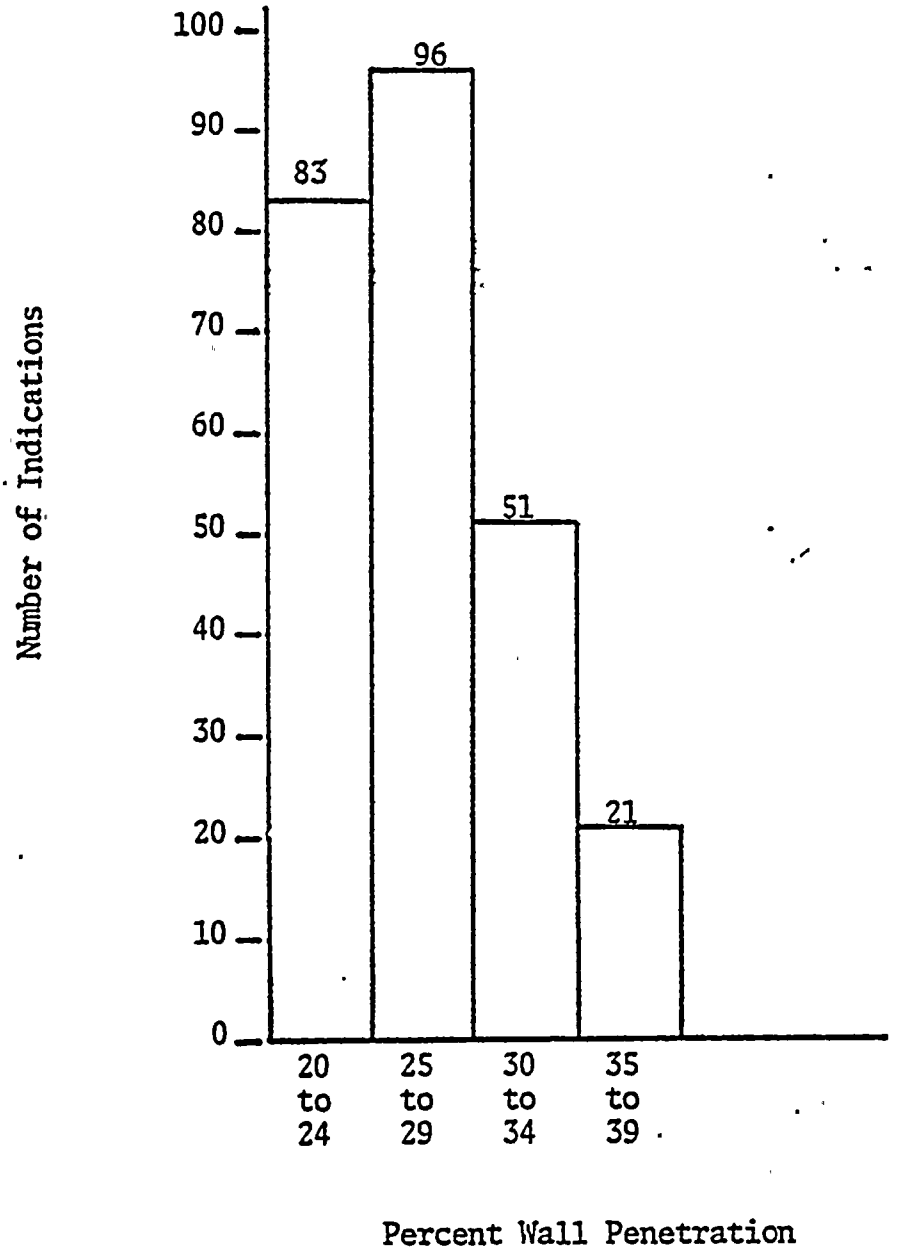
S/G A COLD LEG

DISTRIBUTION OF EDDY CURRENT INDICATIONS $\geq$ 20%

NOVEMBER 1980 INSPECTION

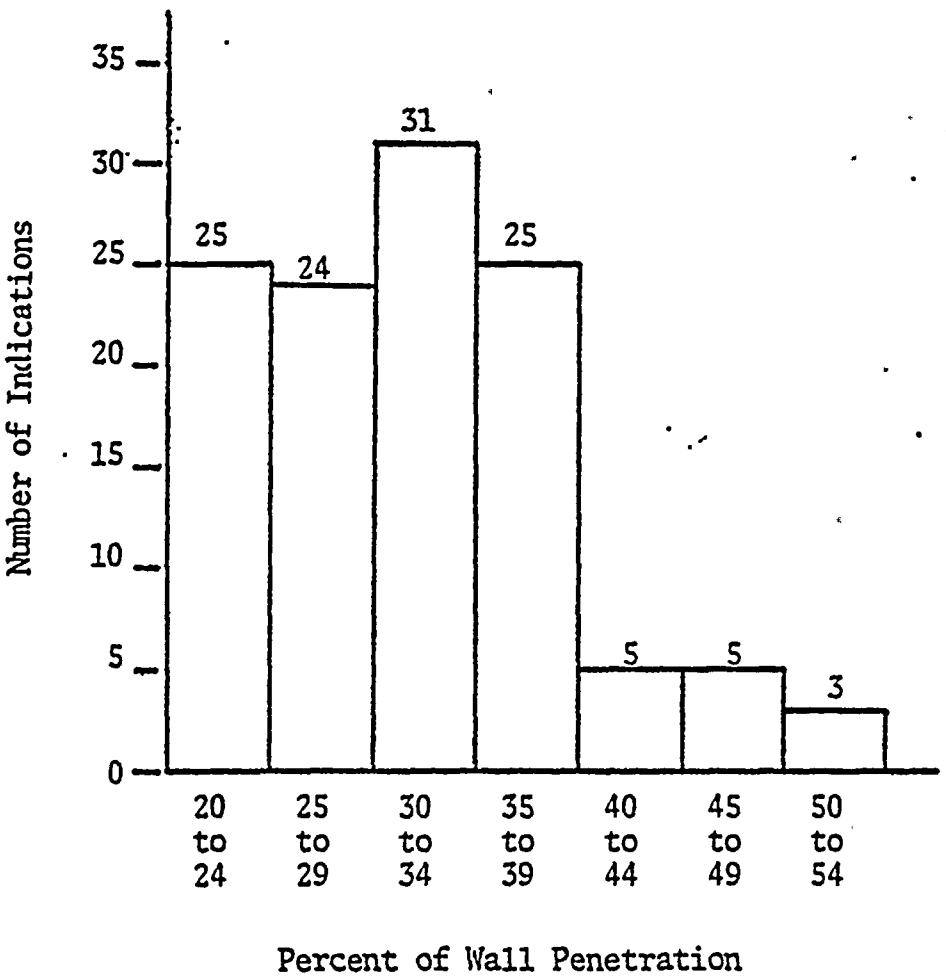
S/G B COLD LEG

DISTRIBUTION OF EDDY CURRENT INDICATIONS ≥ 20%
NOVEMBER 1980 INSPECTION

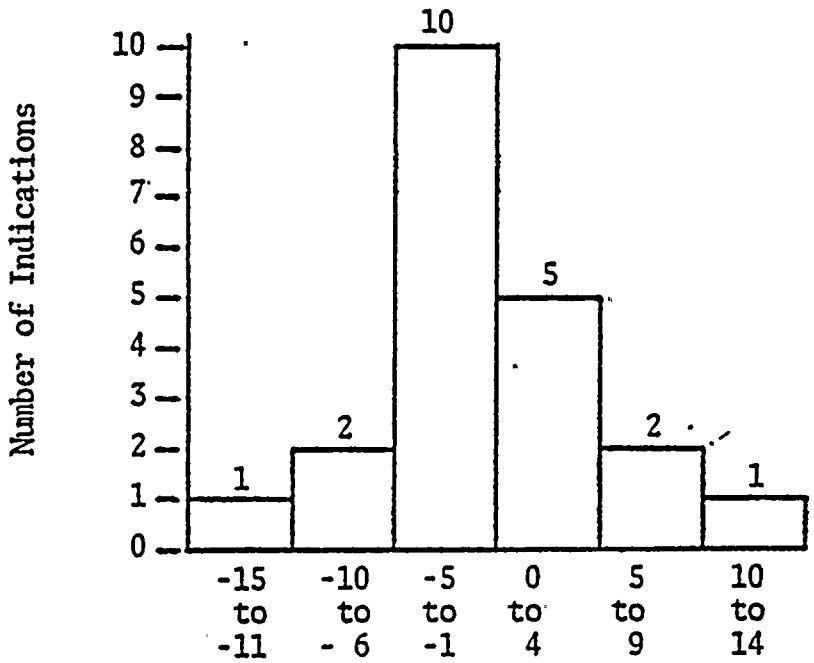
FIGURE A - 10

The average incremental wall thinning increase (in terms of percent of wall penetration) was calculated for each steam generator hot and cold leg, relative to the May, 1980 inspection for all tubes exhibiting thinning indications equal to or greater than 20% in December, 1980 and for which indications equal to or greater than 20% were observed in the May, 1980 inspection. The indications were observed at tube elevations from just above the top of the tubesheet to about 3 inches above the top of the tubesheet. No tubesheet crevice indications were observed in either the hot or cold legs of any of the generators inspected. The pertinent statistics are summarized in TAble A-2. For the case where

On the basis of the highest calculated average incremental change from May, 1980 to December, 1980, 8.41% in SG/B cold leg, the apparent degradation for this period of operation consisting of 4.75 Effective Full Power Months (EFPM) is 1.77%/EFPM. Assuming the same rate of thinning over the present operating period, a tube operating with the largest unplugged indication of 39% might experience further wall loss of 10.6% over an additional operating period of 6 EFPM. Allowing for the staff's

DISTRIBUTION OF THE CHANGE IN EDDY CURRENT INDICATIONS AT THE TUBESHEET BETWEEN THE MAY 1980 AND NOVEMBER 1980 INSPECTIONS

Total Number of Points	46
Average Change	8.41

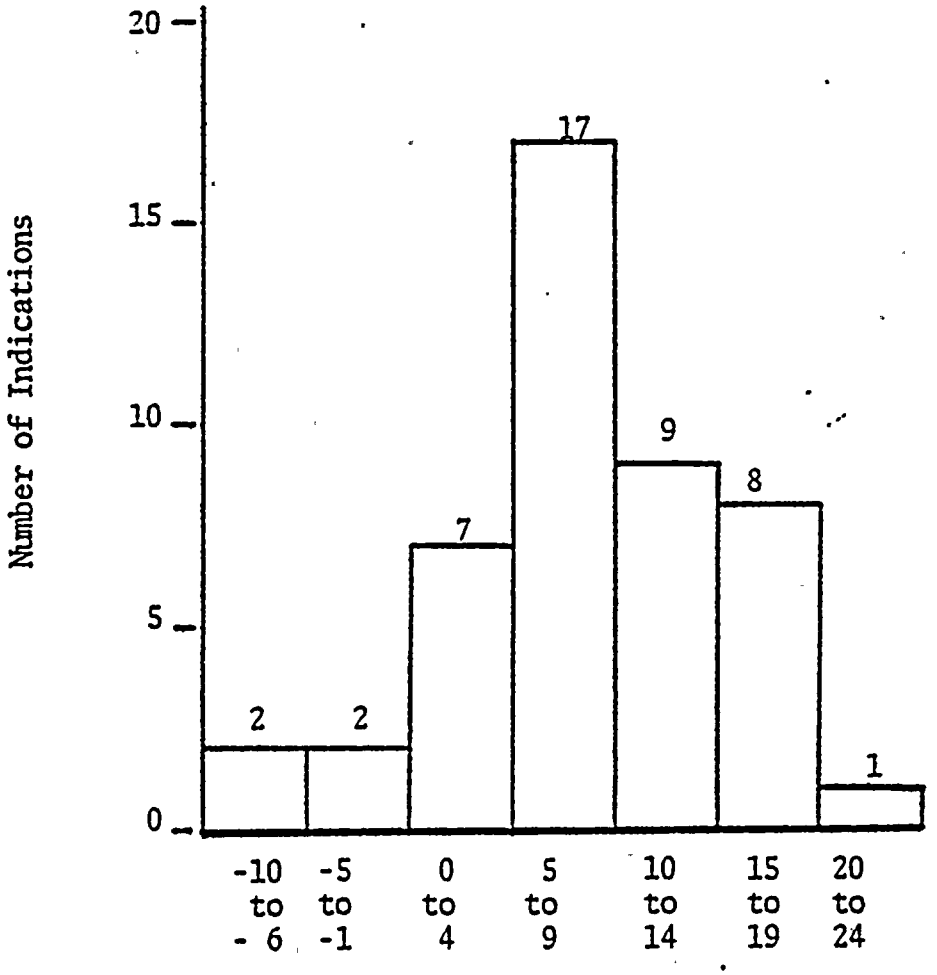
FIGURE A - 11

the only positive average incremental thinning increase was observed (steam generator B cold leg) the actual data from which the average was calculated are given in Table A-3.

From Table A-2, it is noted that except for the cold leg of steam generator B, where a positive average increment was calculated, and the hot leg of steam generator C, where only a single comparison was possible, the remaining four comparisons yielded apparently negative average incremental thinning for the period from May, 1980 to November, 1980. This result is not indicative of an actual decrease in tube thinning. Rather, it reflects the variability in the eddy current method itself as well as possible human factors involved in evaluating the eddy current signals. However, in each case (Steam Generator A, hot and cold leg; Steam Generator B, hot leg; and Steam Generator C, Cold Leg), these results suggest little or no thinning has occurred in the time period studied.

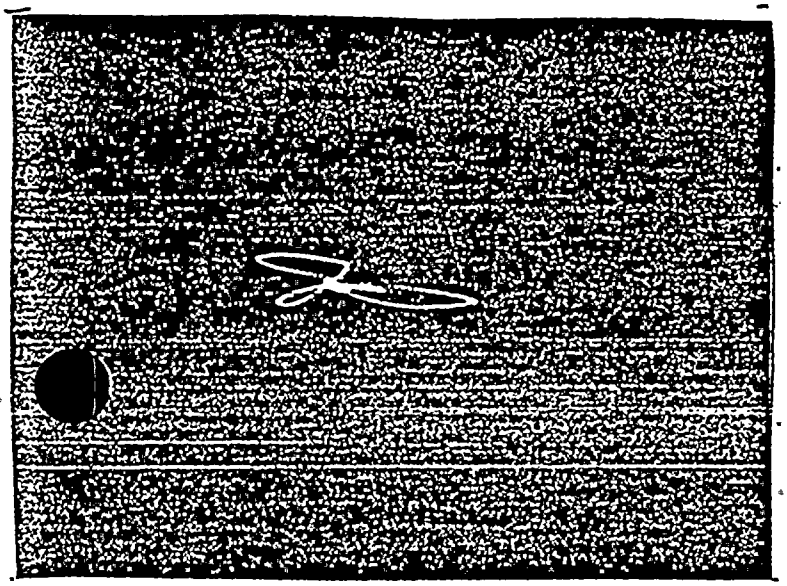
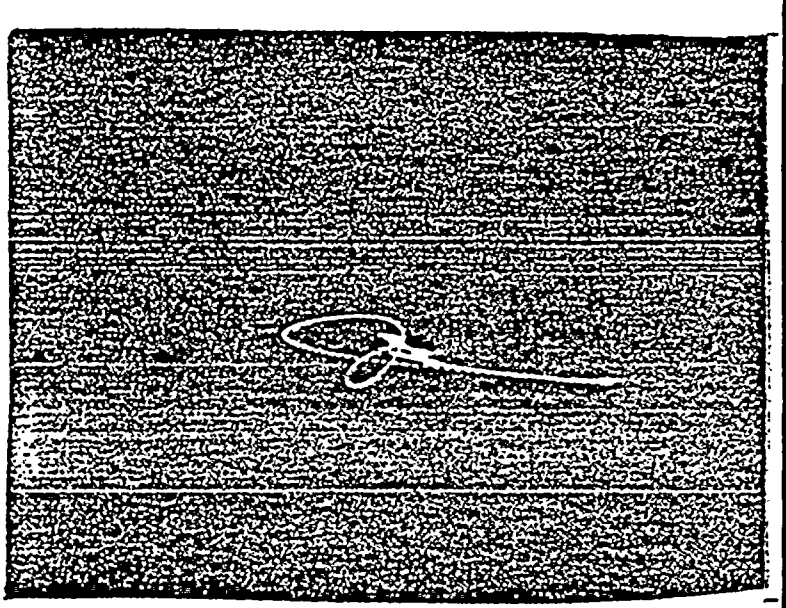
FIG. A-14

Not Quantified R9C81

51% 1" ATS

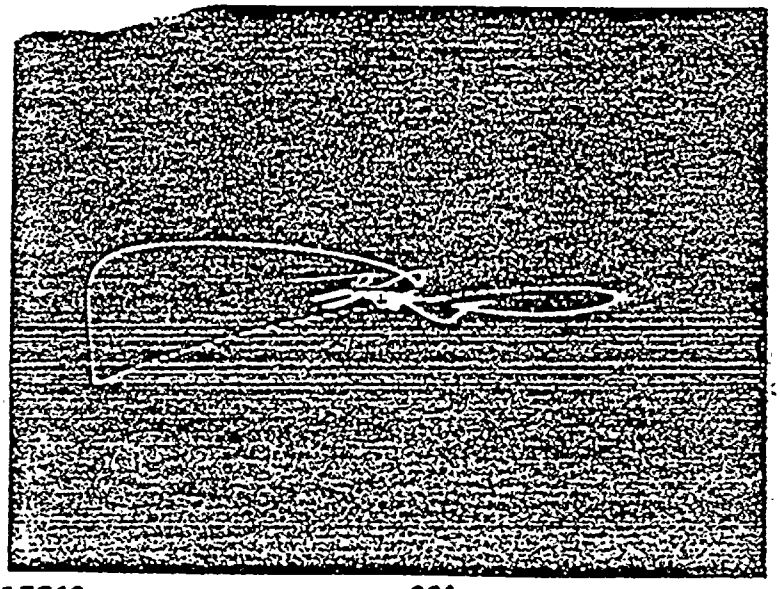
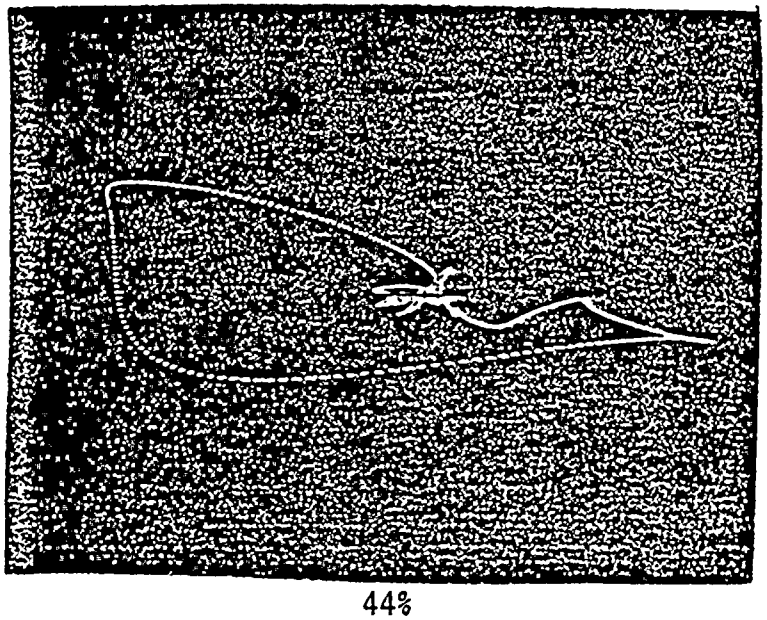
R17C69

Similar effects were observed for at least 12 of the 16 pluggable tubes in this leg of Steam Generator B, including R17-C69, for which the largest apparent increase of wall thinning was calculated from the reported field data, as well as for the pluggable tubes found in the other two steam generators.

20%

22%

3" ATS

44%

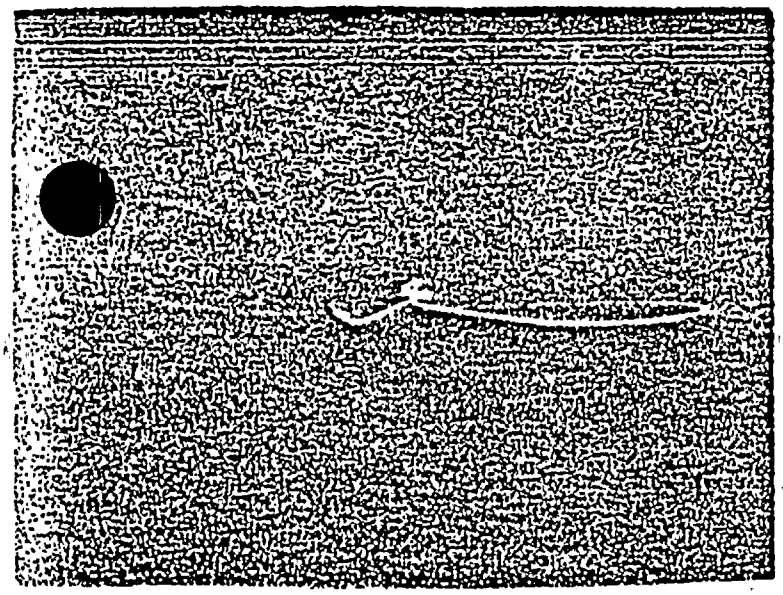
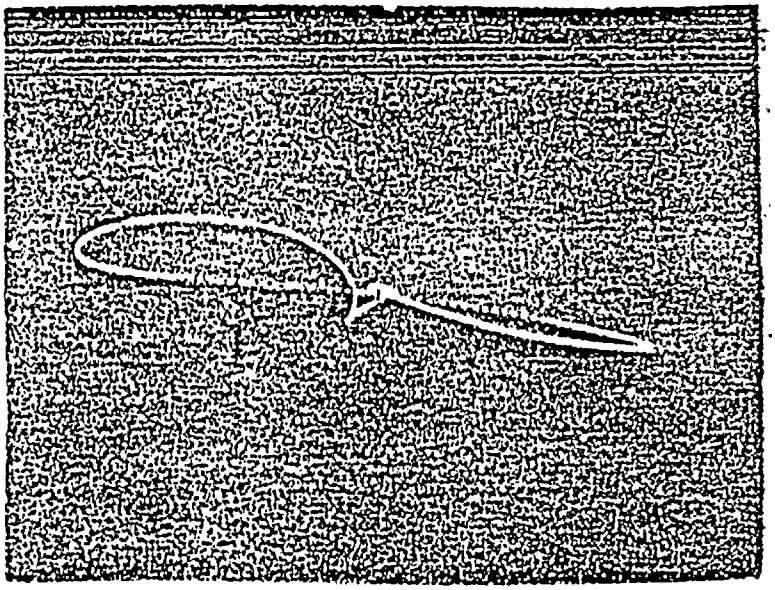
R11C22

Not Quantified

58% TTS

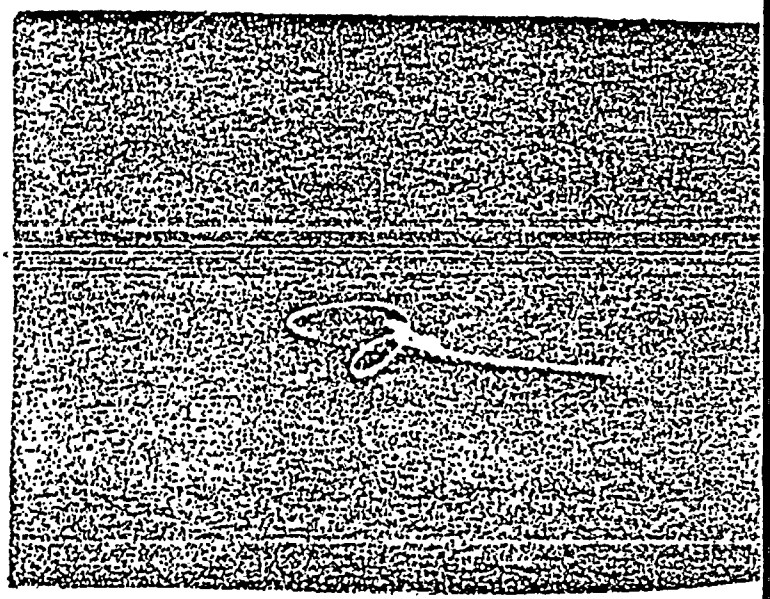
Not Quantified R9C81

51% 1" ATS

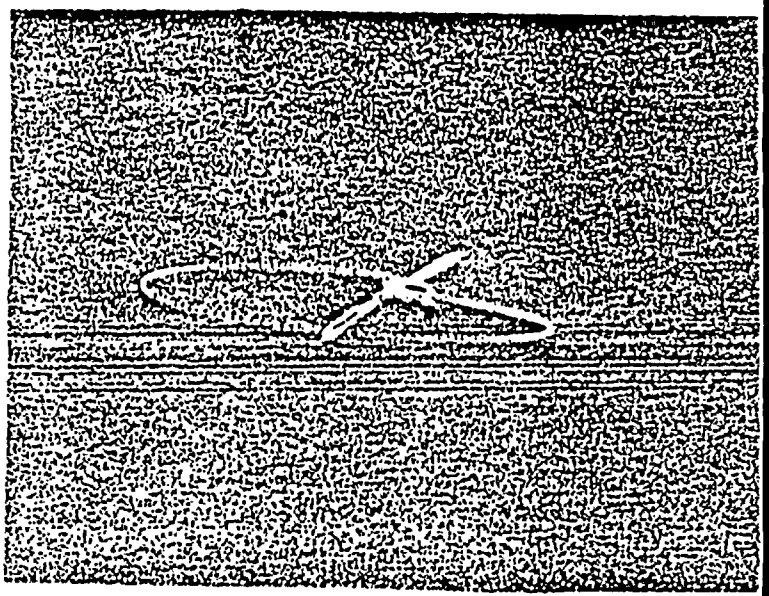
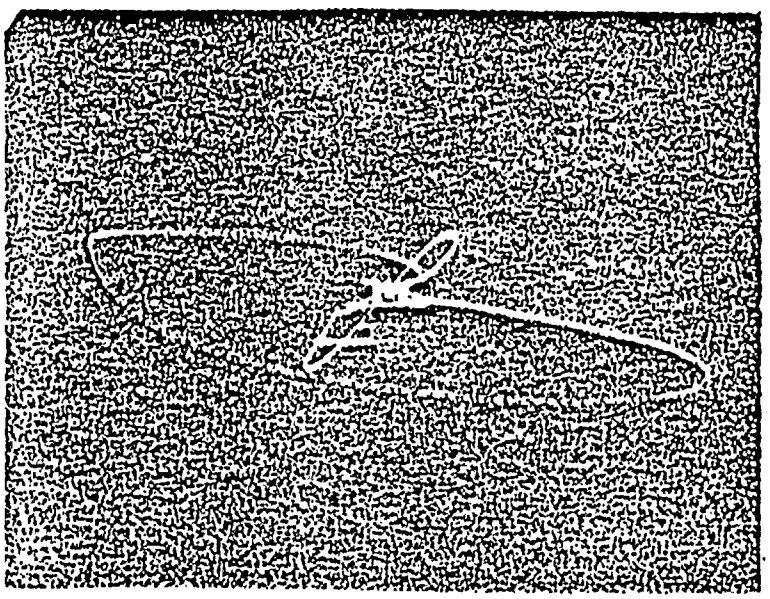
R14C29

50%

55%

46%

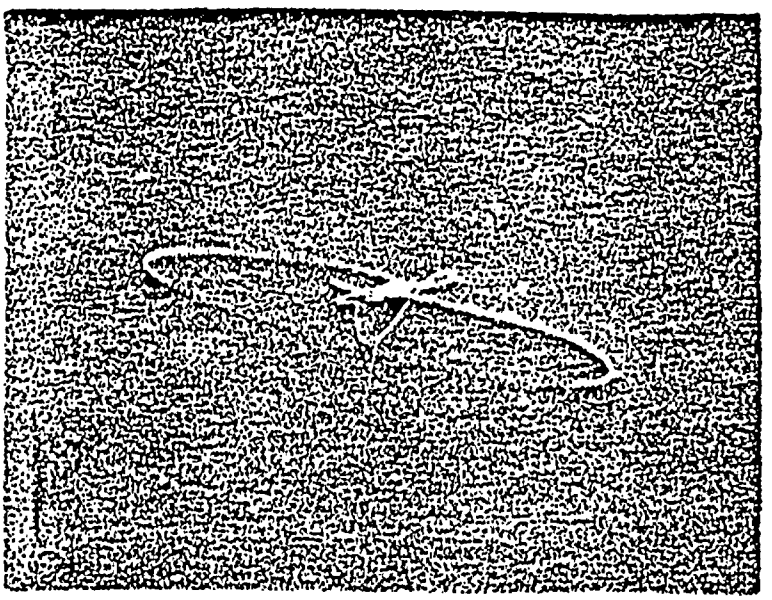
R12C30

5S%

2" ATS

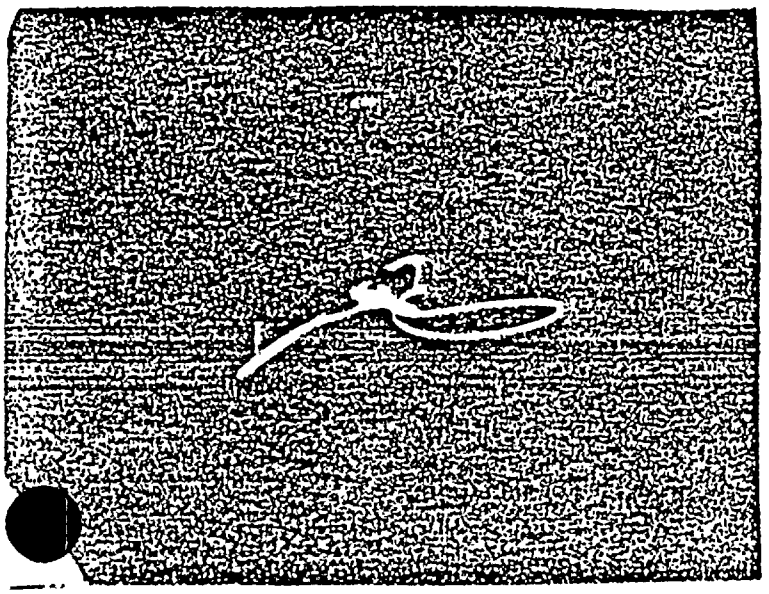
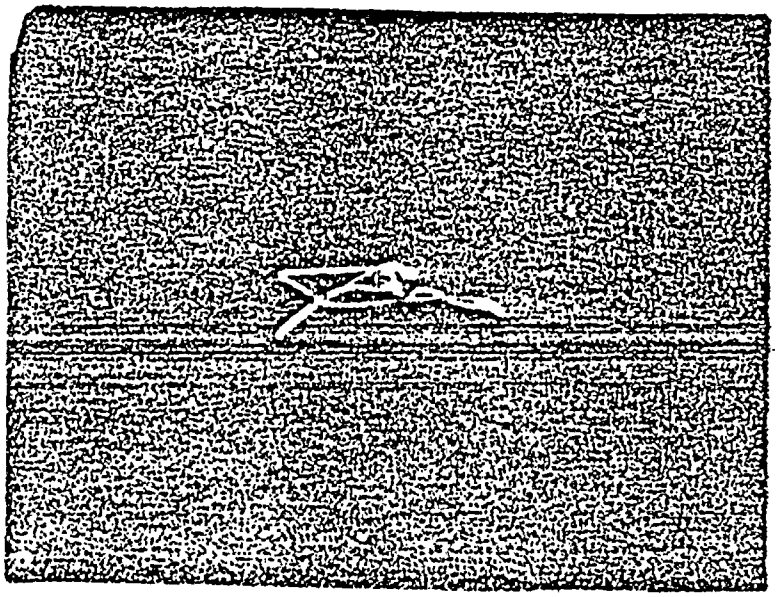
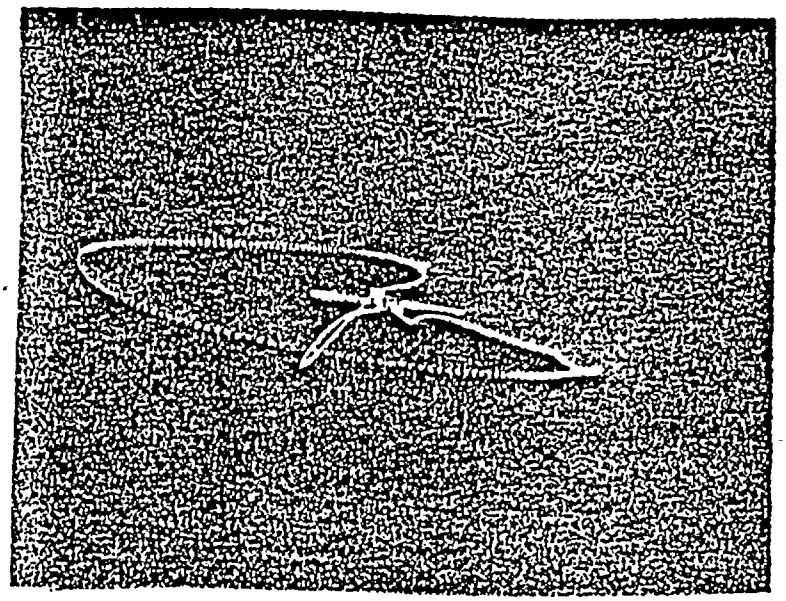
R24C39

38%

31 %

44%

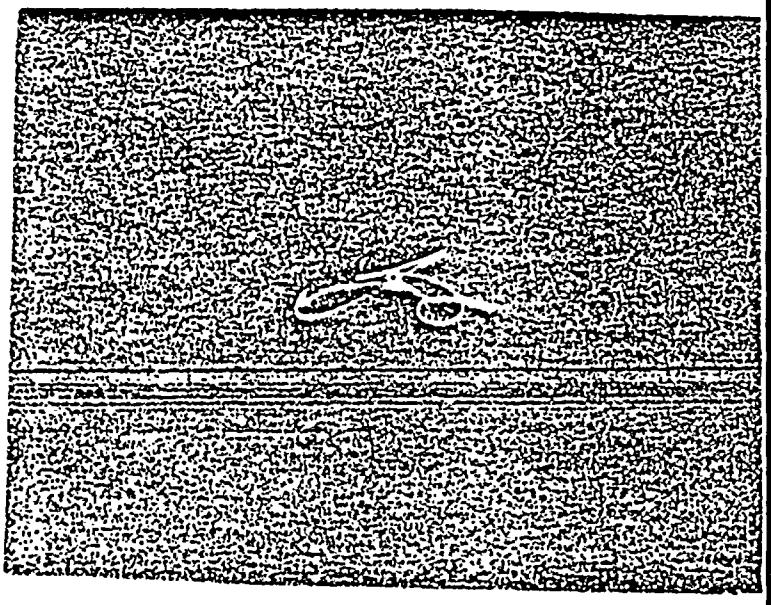
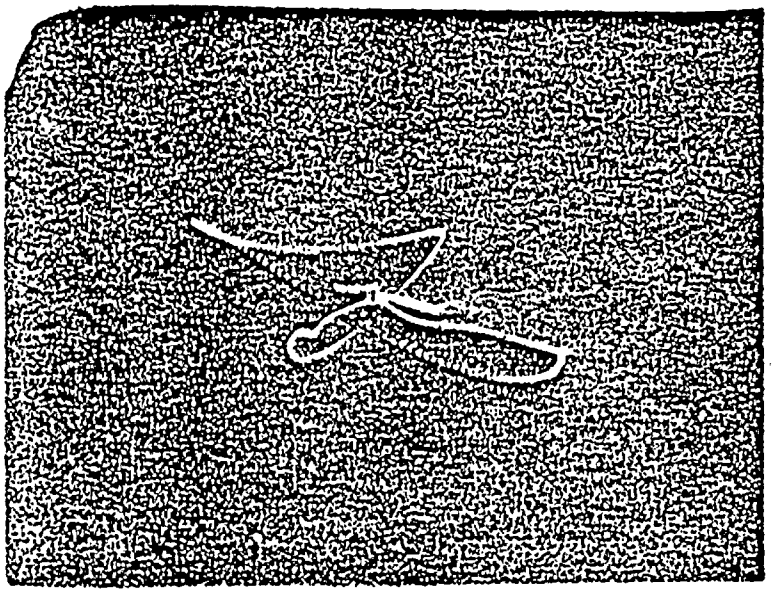
R24C40

< 20%

24%

41%

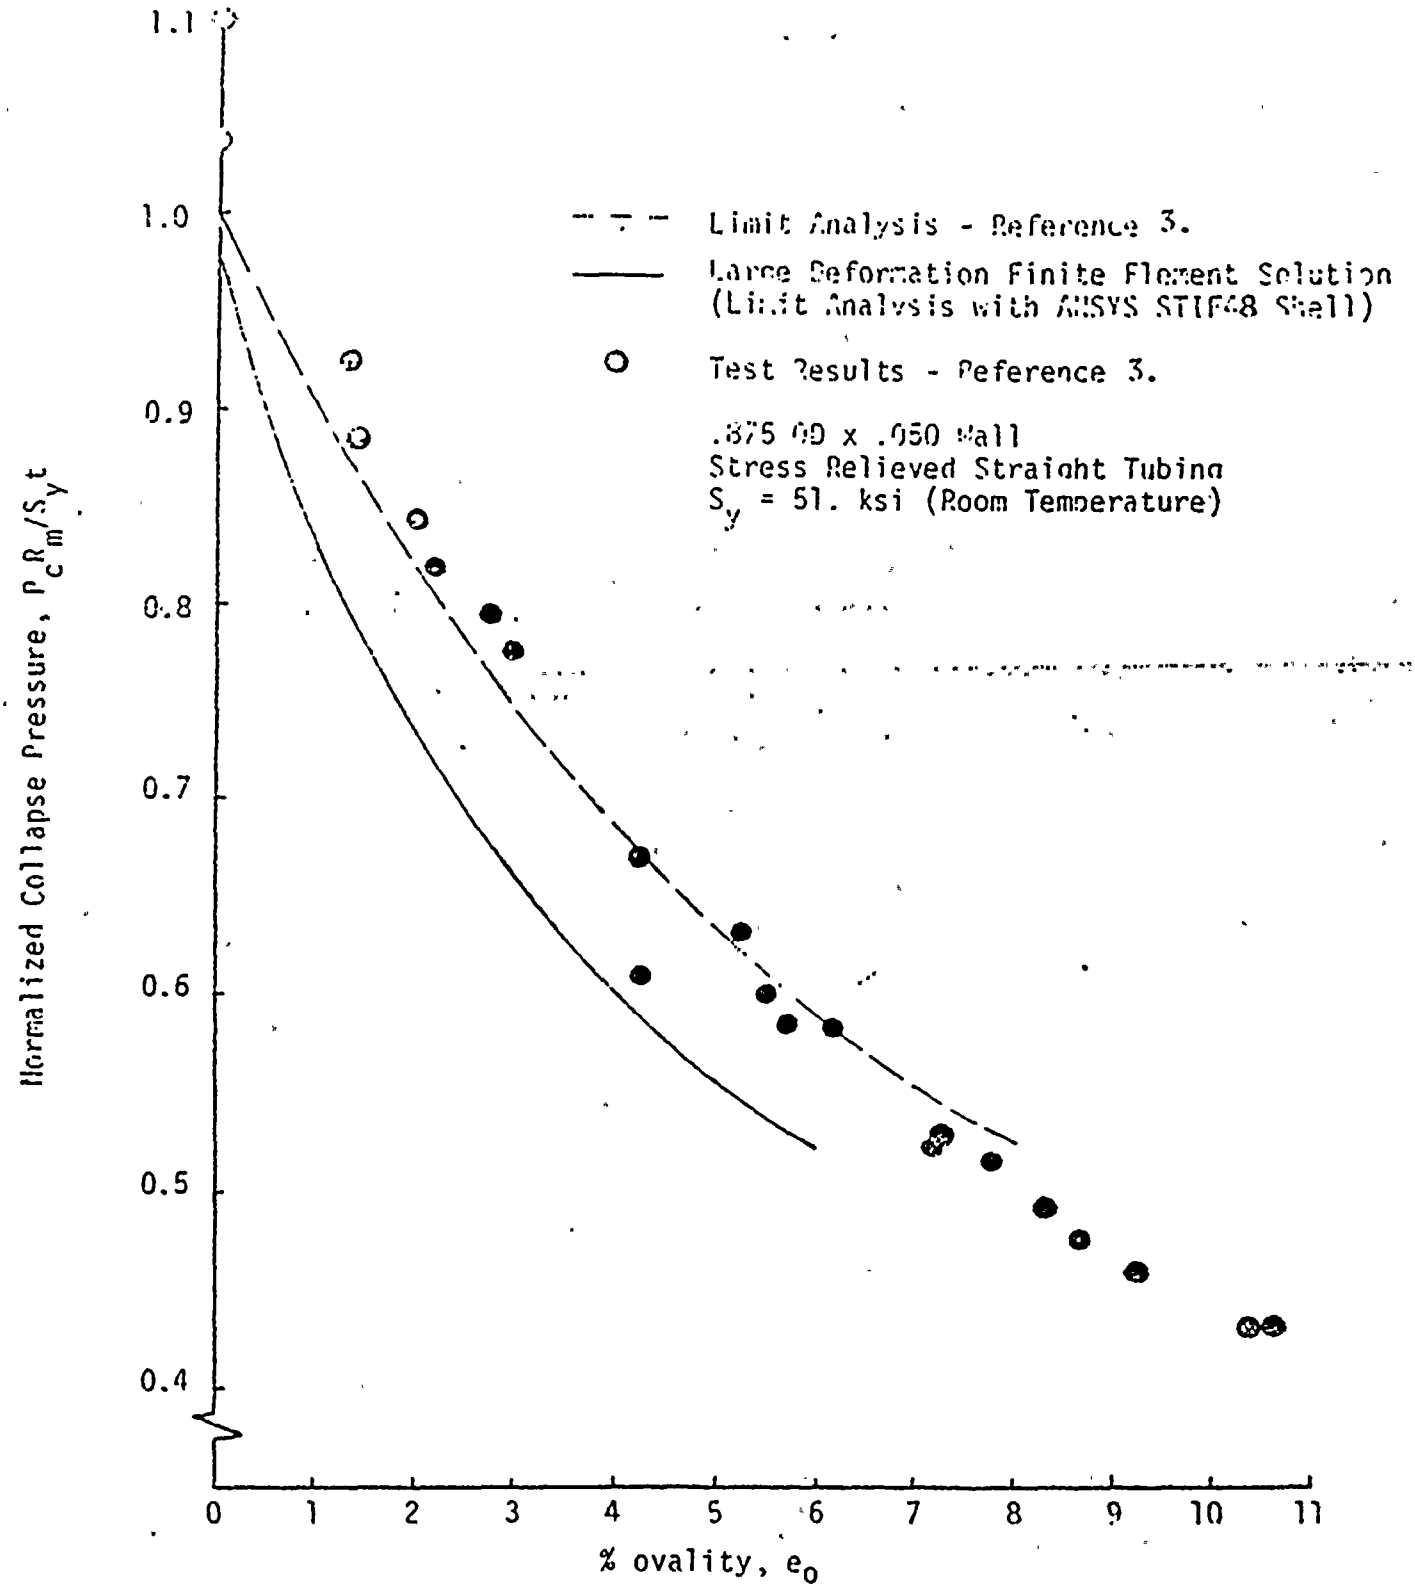
FIGURE B-1 COLLAPSE PRESSURE OF STRAIGHT OVALIZED TUBES - CORRELATION BETWEEN TEST AND ANALYSES

From the results in Reference (3), it is observed that the limit analysis theory correlates well with the test results of stress-relieved tubing which is believed to have less anisotropic yield properties than as-manufactured tubing. The theoretical prediction is rather excellent for speciments with small initial ovalities. Nevertheless, in order to account for continued increase in ovality under the external pressure loading, a large-deformation finite element solution (ANSYS STIF48) using elastic-perfectly plastic shell behavior is utilized for the actual verification. The finite element solution along with the limit analysis theory and actual test results is shown in Figure B-1.

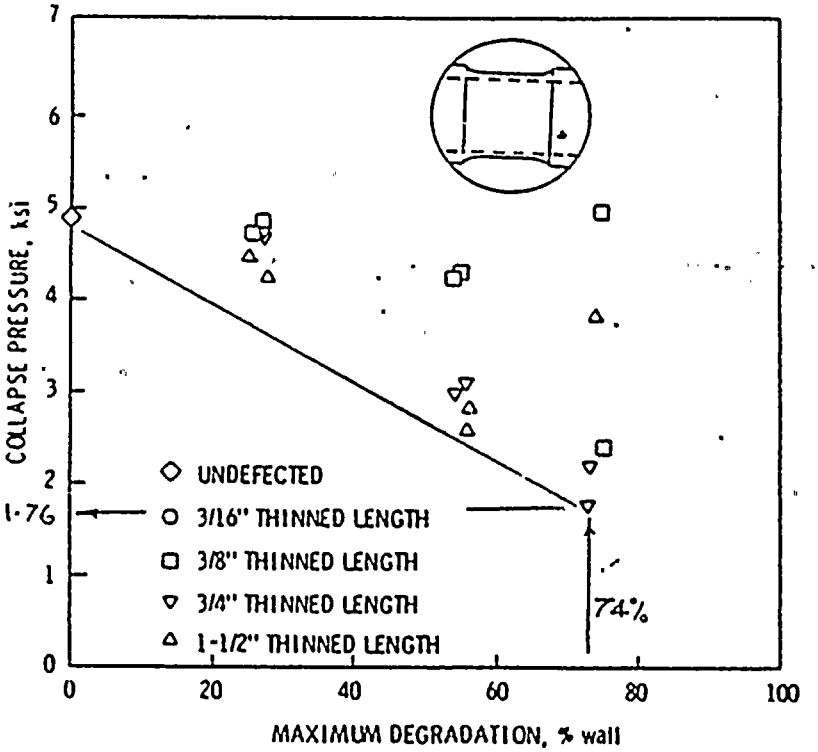
FIGURE B-2 Collapse Pressure Data for 0.875 x 0.050 Uniform Thinning Specimens – Ref. [1]

Corresponding to a 74% wall degradation, (t_{min} = .013 inch) the minimum collapse pressure P_c from Figure B-2 is obtained to be 1760 psi (for a defect length of .75 inch). This value is used as the reference collapse pressure of a perfectly round, (this is a conservative assumption) as-manufactured tube thinned uniformly to .013 inch ligament. This value is then adjusted for the actual FPL tubing yield strength of 30,100 psi and ovality of 1.5% using the ANSYS solution discussed above.

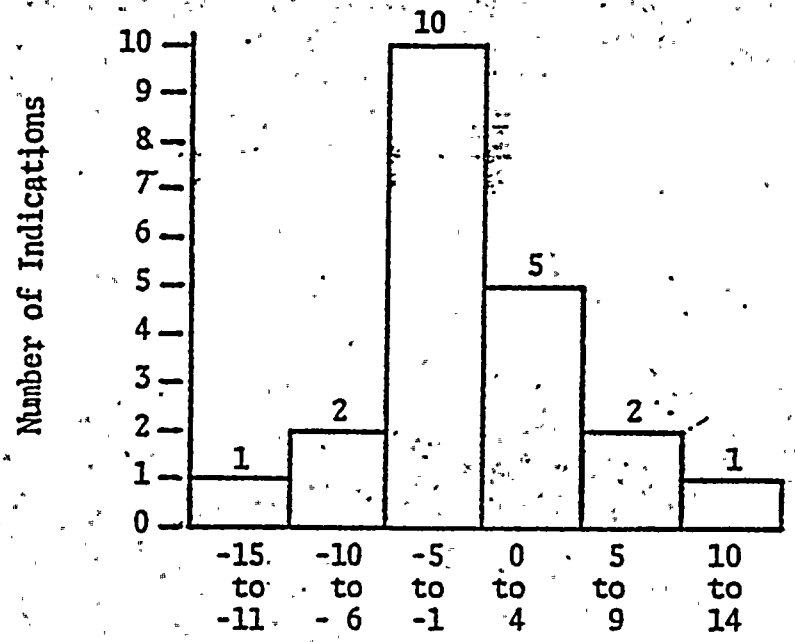
S/G B OUTLET

DISTRIBUTION OF THE CHANGE IN EDDY CURRENT INDICATIONS AT THE TUBESHEET BETWEEN THE MAY 1980 AND NOVEMBER 1980 INSPECTIONS

Total Number of Points	46
Average Change	8.41

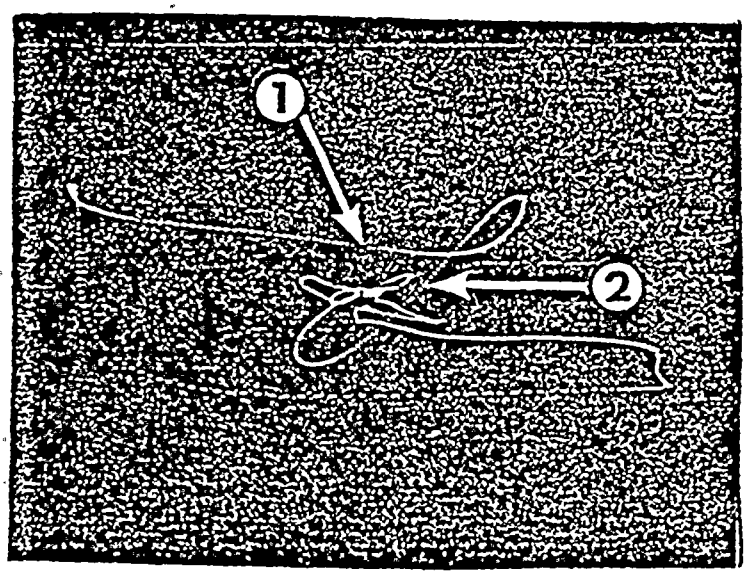
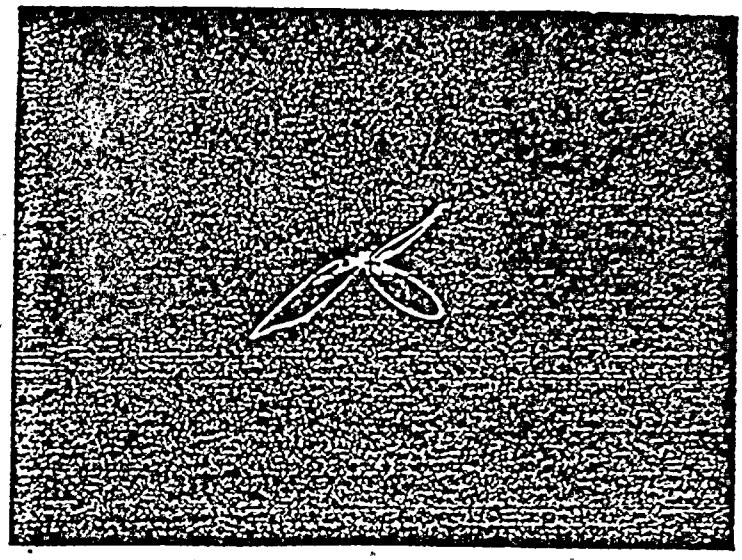
R22C44
1" ATS

45%

Not Tested

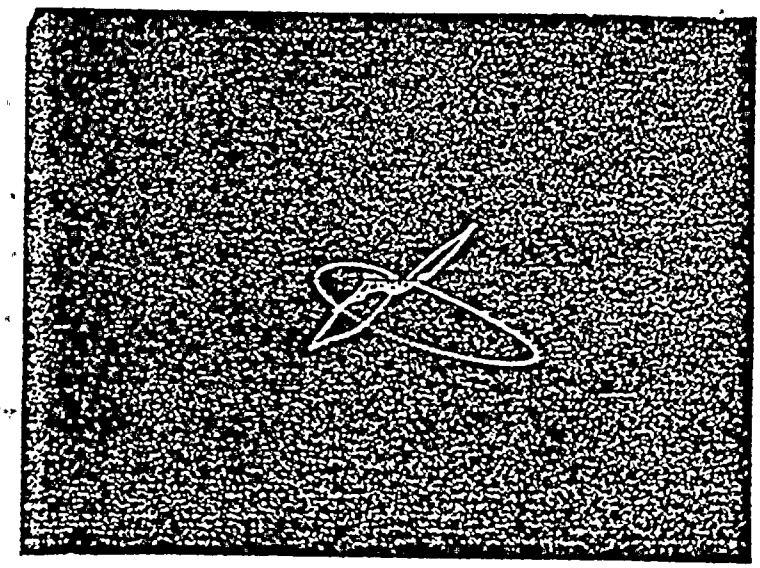
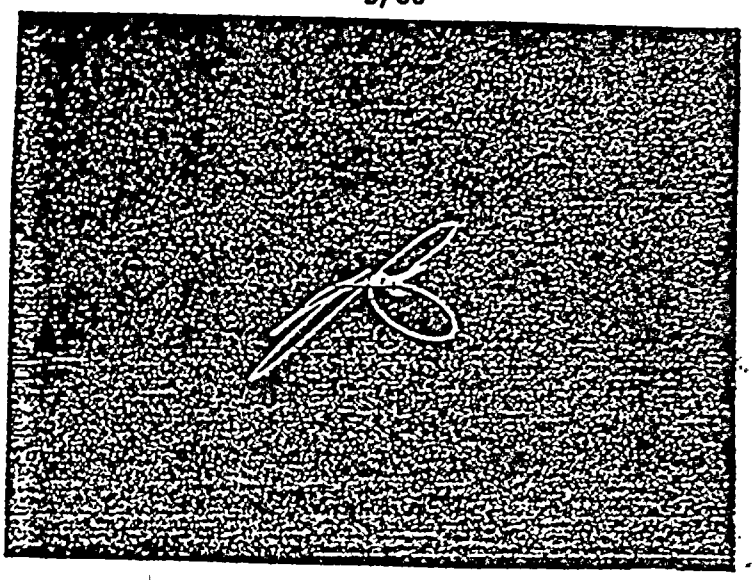
R10C46

37%

45%

Not Tested

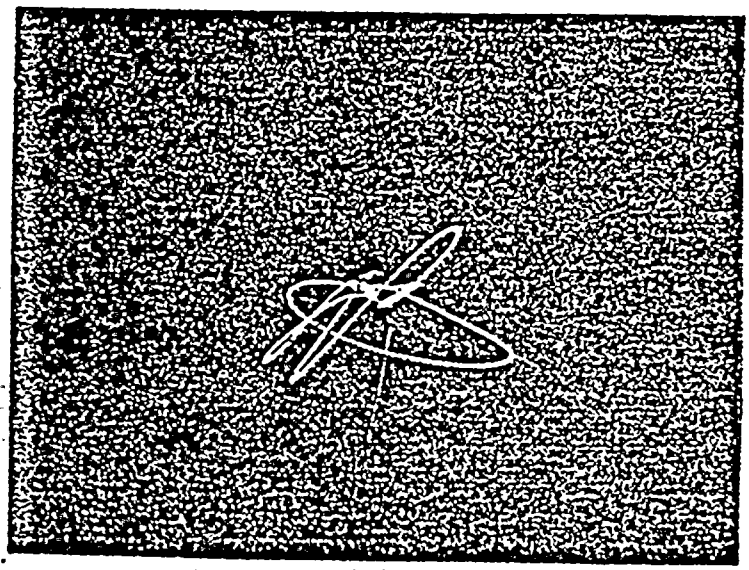
R11C46

39%

43%

NOT TESTED

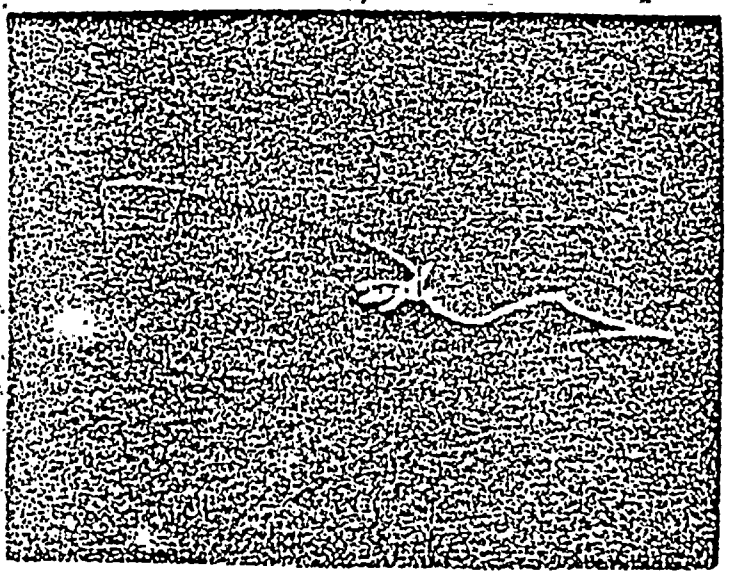
R17C69

Similar effects were observed for at least 12 of the 16 pluggable tubes in this leg of Steam Generator B, including R17-C69, for which the largest apparent increase of wall thinning was calculated from the reported field data, as well as for the pluggable tubes found in the other two steam generators.

3" ATS

44%

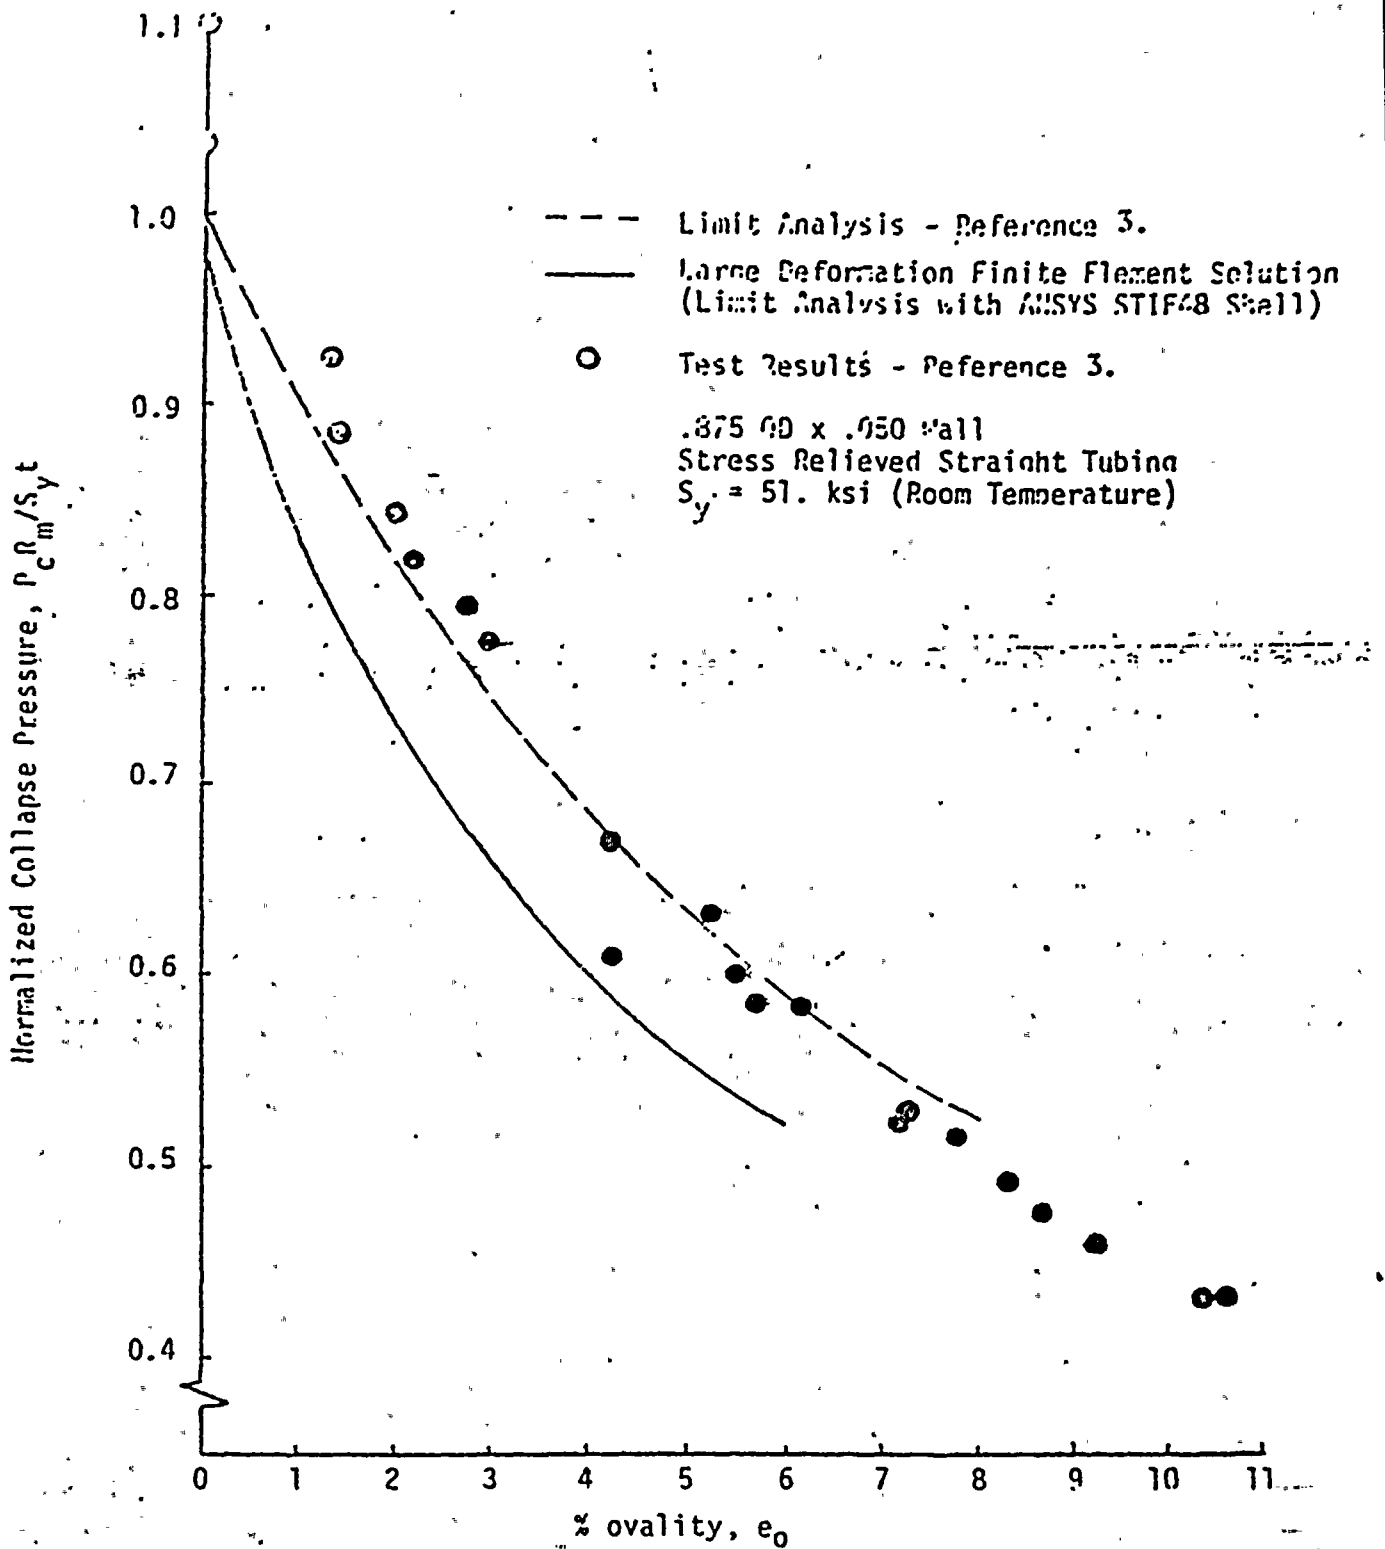
FIGURE B-1 COLLAPSE PRESSURE OF STRAIGHT OVALIZED TUBES - CORRELATION BETWEEN TEST AND ANALYSES

From the results in Reference (3), it is observed that the limit analysis theory correlates well with the test results of stress-relieved tubing which is believed to have less anisotropic yield properties than as-manufactured tubing. The theoretical prediction is rather excellent for speciments with small initial ovalities. Nevertheless, in order to account for continued increase in ovality under the external pressure loading, a large-deformation finite element solution (ANSYS STIF48) using elastic-perfectly plastic shell behavior is utilized for the actual verification. The finite element solution along with the limit analysis theory and actual test results is shown in Figure B-1.

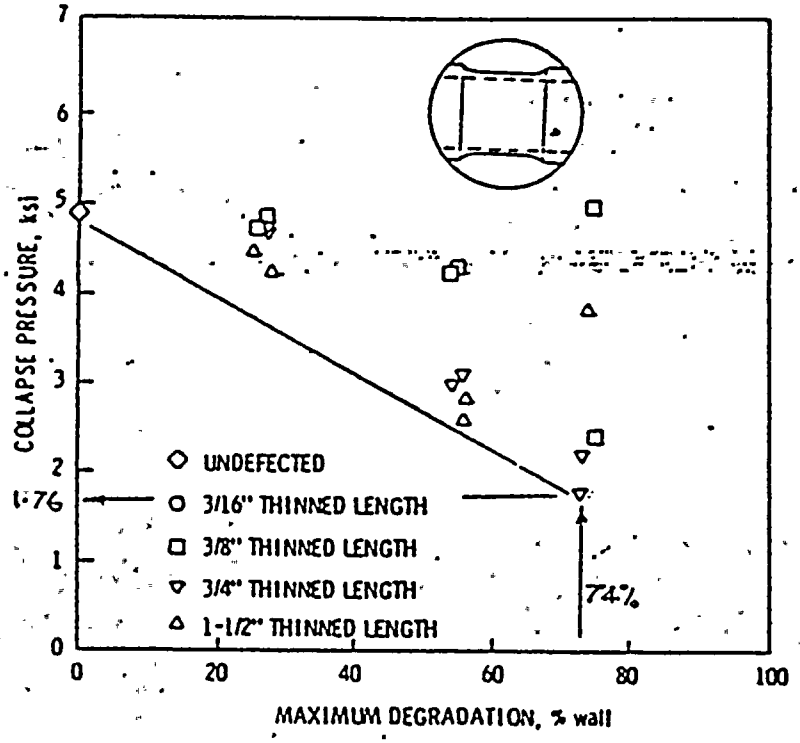
FIGURE B-2 Collapse Pressure Data for 0.875 x 0.050 Uniform Thinning Specimens - R<[.5]

Corresponding to a 74% wall degradation, (t_{min} = .013 inch) the minimum collapse pressure P_c from Figure B-2 is obtained to be 1760 psi (for a defect length of .75 inch). This value is used as the reference collapse pressure of a perfectly round, (this is a conservative assumption) as-manufactured tube thinned uniformly to .013 inch ligament. This value is then adjusted for the actual FPL tubing yield strength of 30,100 psi and ovality of 1.5% using the ANSYS solution discussed above.
