Rancho Seco ISFSI
License Renewal Application,
Revision 1 (non-proprietary version)

Sacramento Municipal Utility District (SMUD)

Revision 1

June 2018

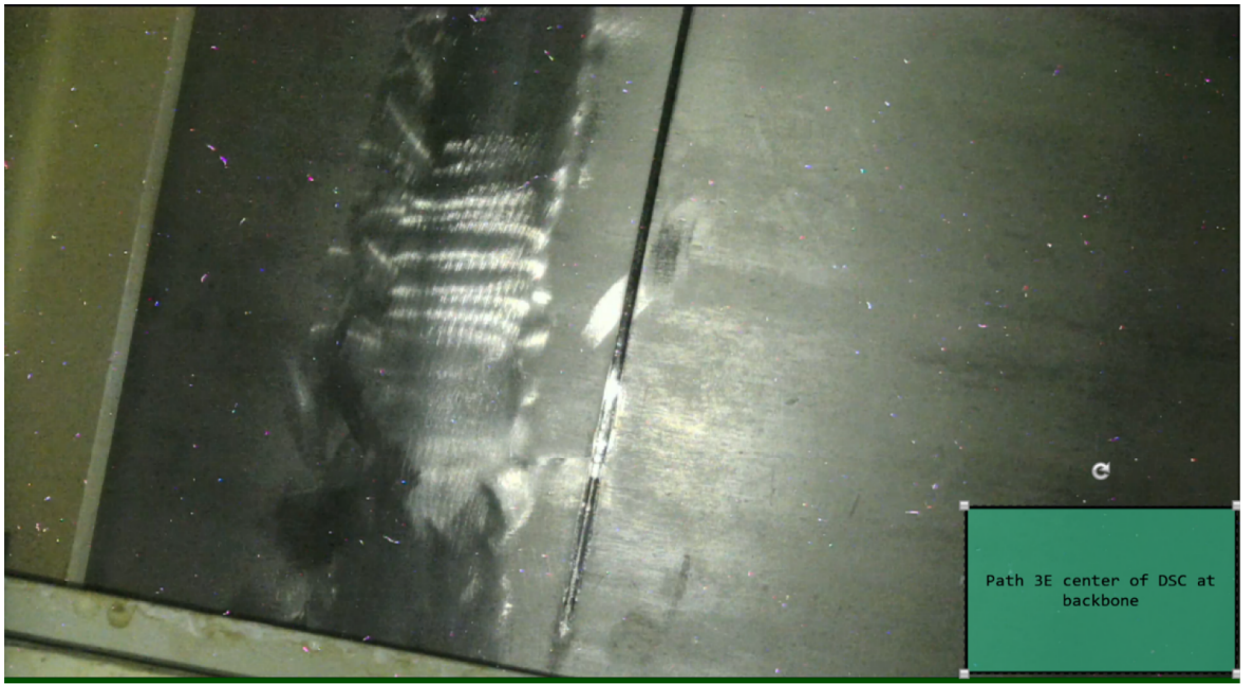
Figure 3-5
DSC Bottom Scrape at Northern Terminus

Note: The scrape extends from approximately 6 inches from the south HSM door to the middle of the DSC along an axial line. No indication of deterioration is observed.

As noted in DQ No. 01-0052, DSC P01 had received a scrape along the bottom due to contact with the TC during its insertion test performance in 2001. As shown, this scrape is clearly evident.

This picture shows a zoomed-in view of the scrape. There is no visible rust in the scrape observed. There are no sharp raised metal surfaces along the edges observed.

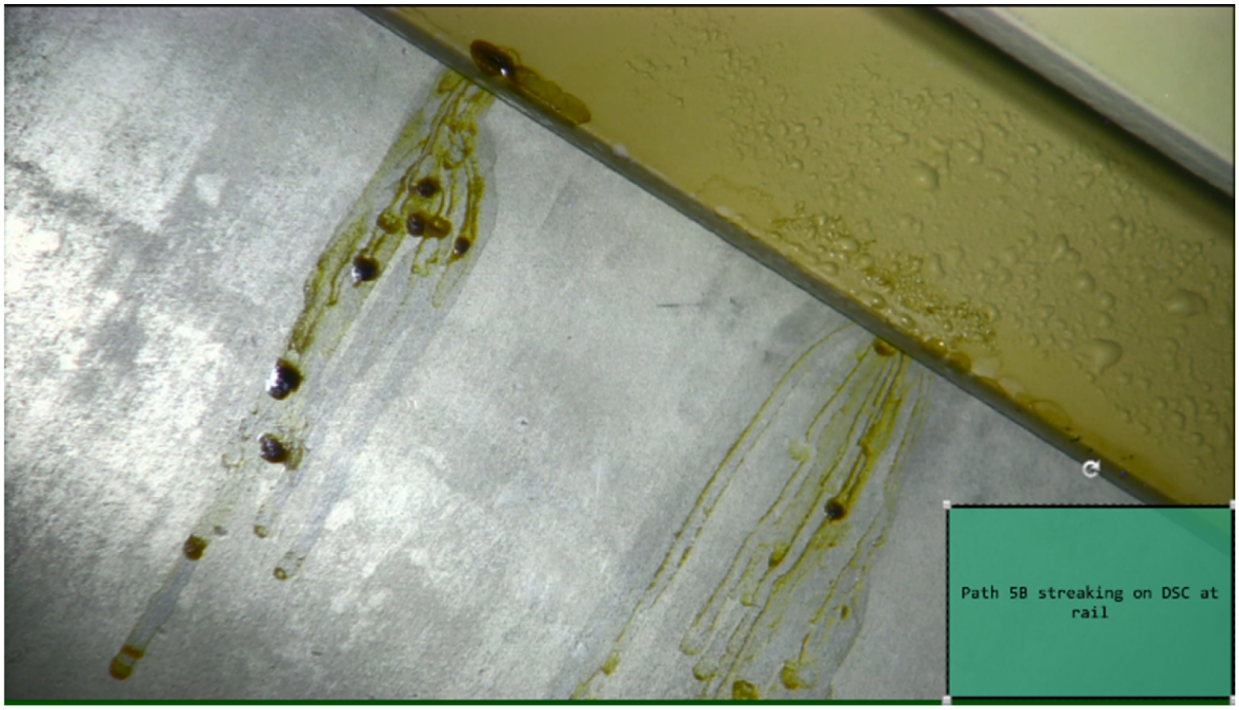
Figure 3-6
DSC Bottom and Support Rail, East Side, between Support #2 and Support #3

The scrape terminus is about 7 feet north of the interior face of the front wall. The middle crossbeam is at the lower portion of the picture. East rail flange is along the left portion of the picture.

Note discoloration streaks can be seen on the DSC that appear to be rail lubricant carried by rainwater intrusion. The streaks appear to be dry with no indication of active water intrusion. *Paint blisters were also observed on the Support Rail*

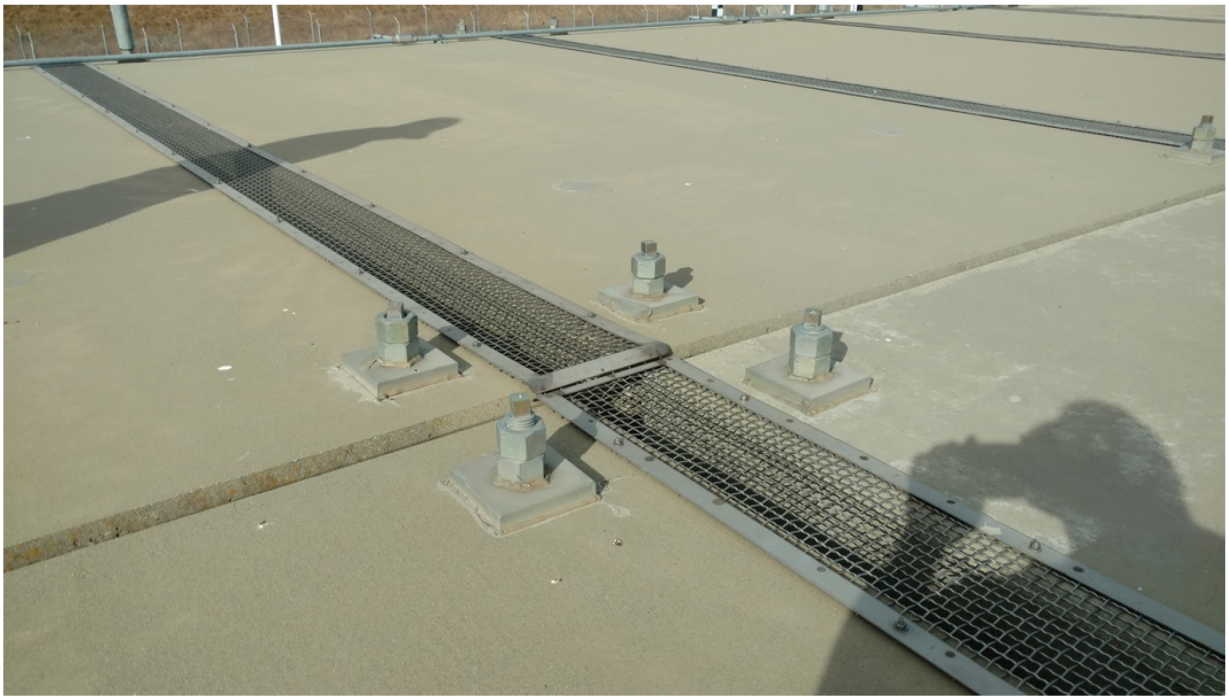
Figure 3-8
HSM-20 Roof

The HSM roof surface has the original finish with no indications of map cracking, scale, or abrasion. The four grout patches that fill the lift embeds are sound and free of deleterious cracks.

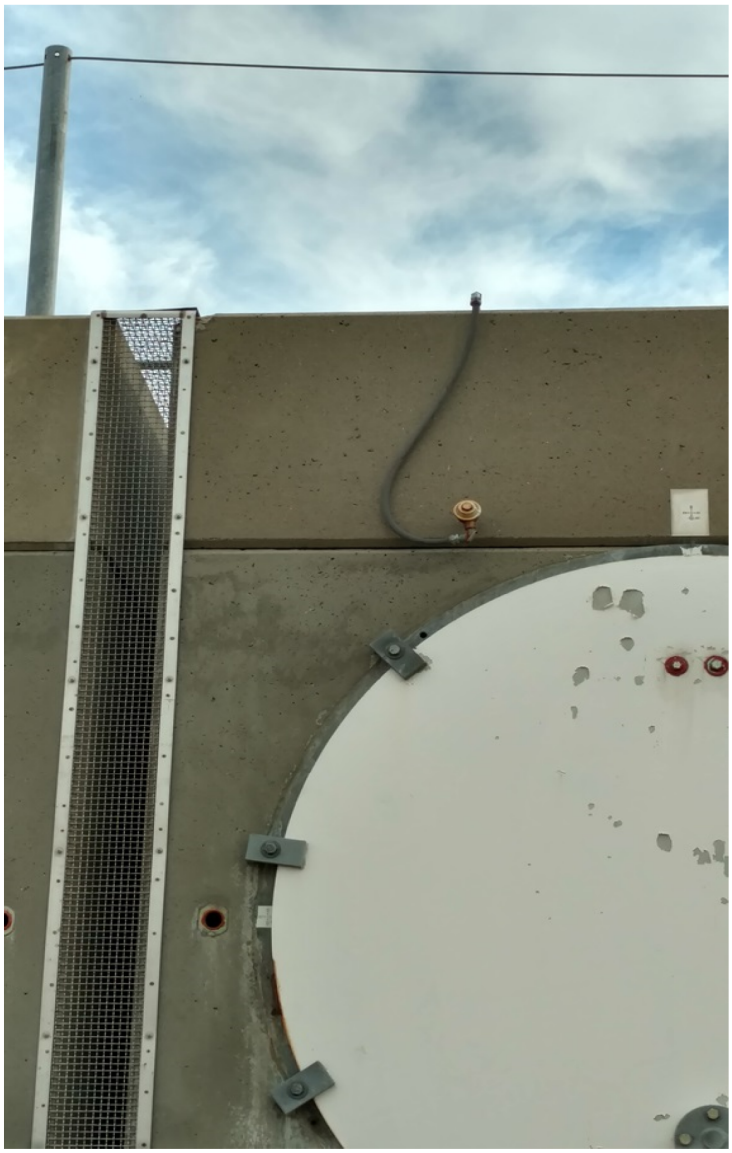
Figure 3-12
HSM-16 Spall at Roof Left Corner

HSM-16 had a spall at the upper left corner. The spall likely occurred during transport and assembly of the HSMs. The spall did not appear to be associated with active deterioration.
