DAILY FIELD LOGS

MWH	Project: NERC JETTY GEOTECH INVESTIGATION	DAILY FIELD ACTIVITY LOG	Date: 8-Nov-2016 Project Number: 1050

APPENDIX B FIELD PHOTOS

APPENDIX C LABORATORY DATA

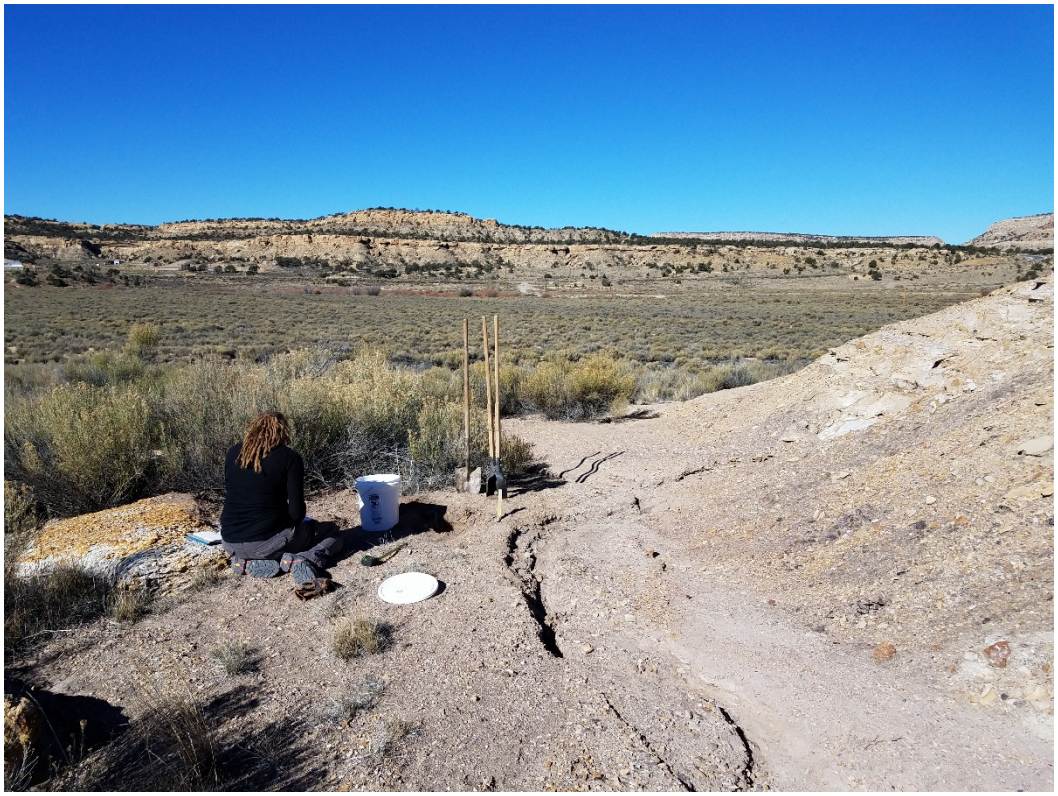
12. GENERAL LOCATION OF TEST PIT 3, LOOKING SOUTHEAST

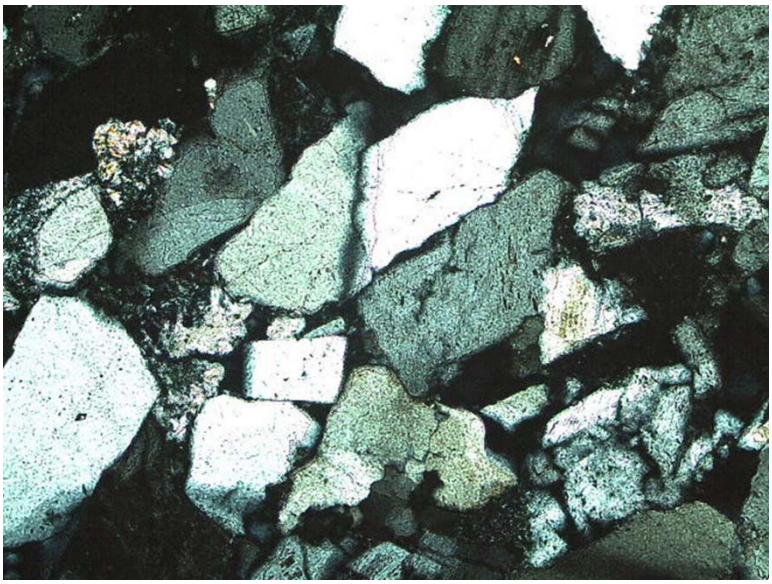
Photograph 1. Grain-supported quartz matrix, feldspar grain and calcite grains. XP, 100x, FL 1.0 mm.

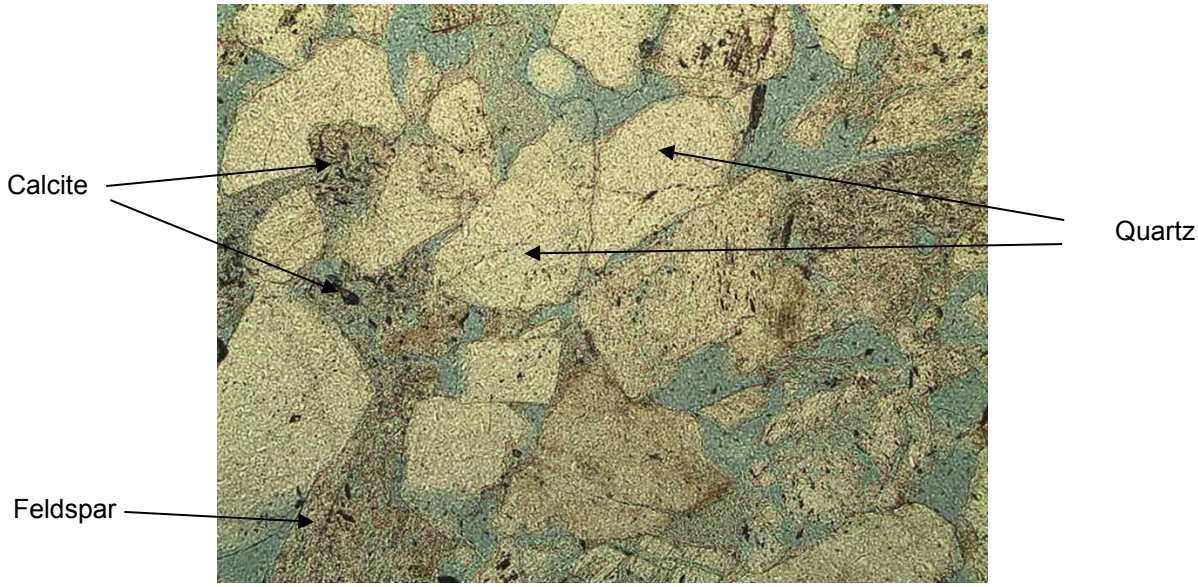
Photograph 2. Grain-supported quartz matrix (same field of view as Figure 1); feldspar grain and calcite grains identified all other grains are quartz. Blue is epoxy showing pore spaces. LP, 100x, FL 1.0 mm.

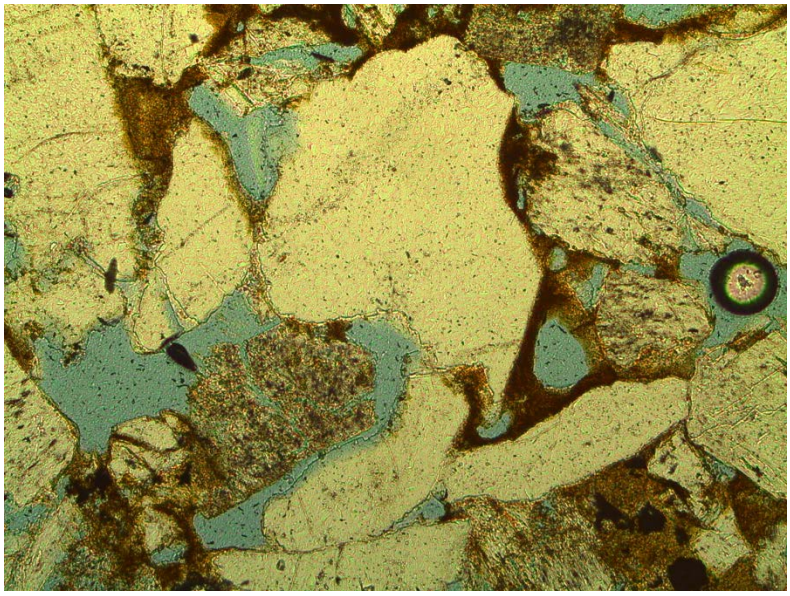
Photograph 3. Quartz showing abundant porosity and cementation by iron oxides and clays. PL, 100x, FL 1.0 mm.

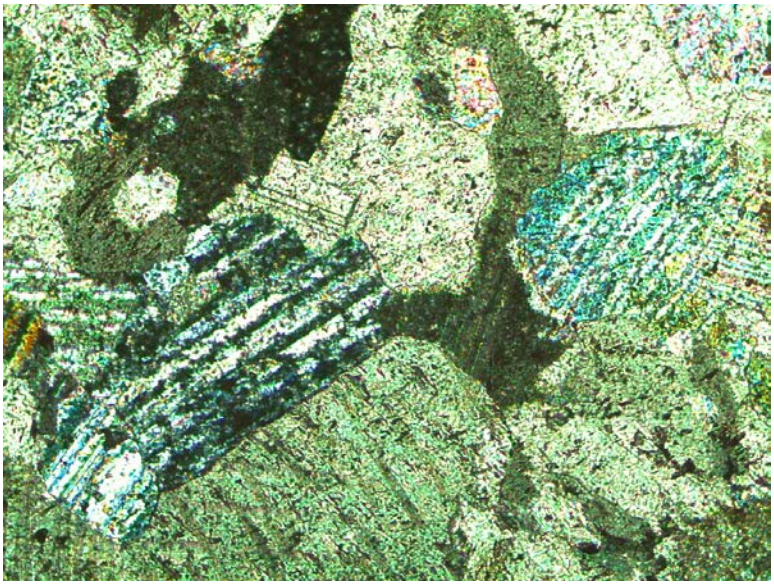
Photograph 4. Interlocking and intergrown carbonate minerals.

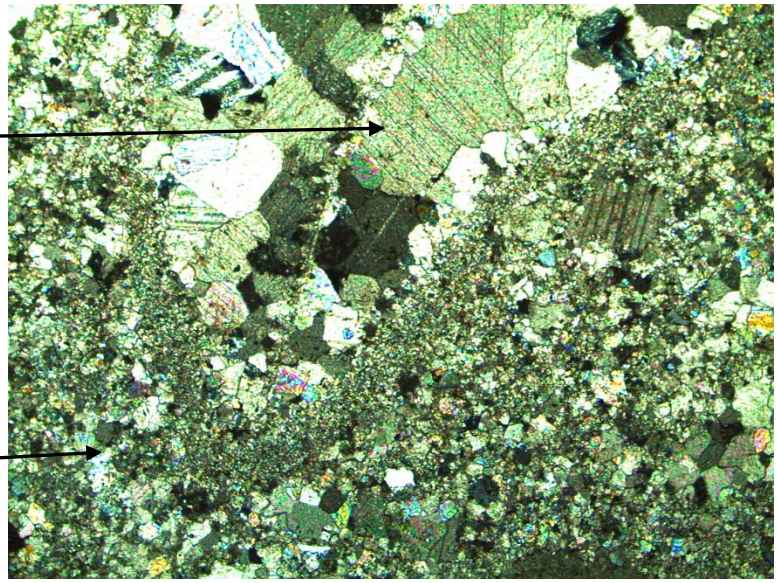
Photograph 5. Very fine grained calcite fracture filling.

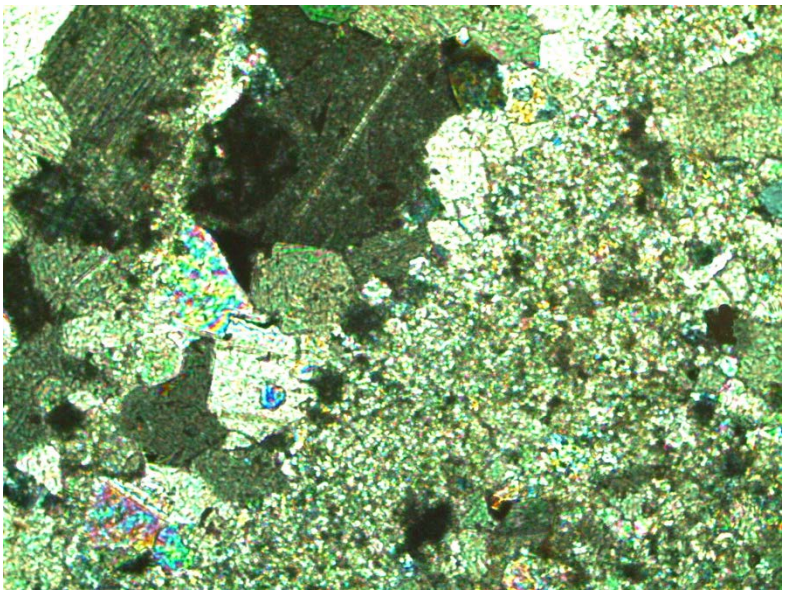
Photograph 6. Close-up of Figure 5. Note intergrown crystals.

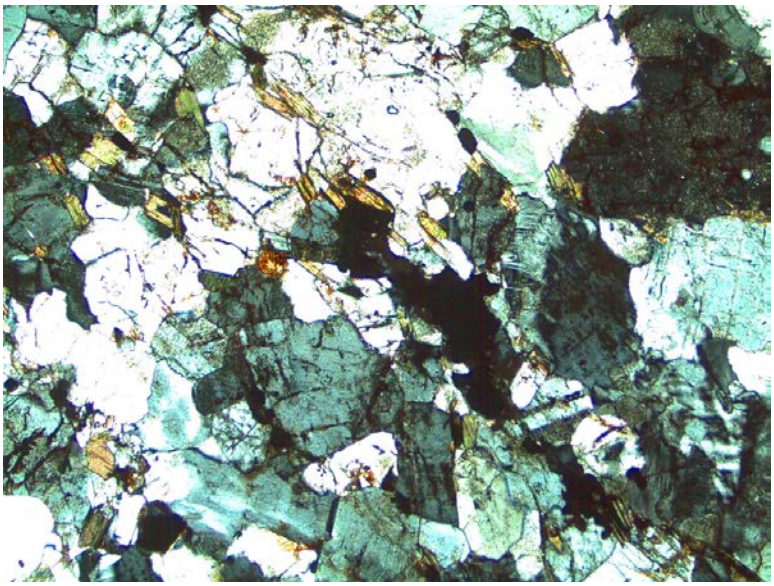
Photograph 7. Granite, showing interlocking euhedral grains. XP, 100x, FL 1mm.

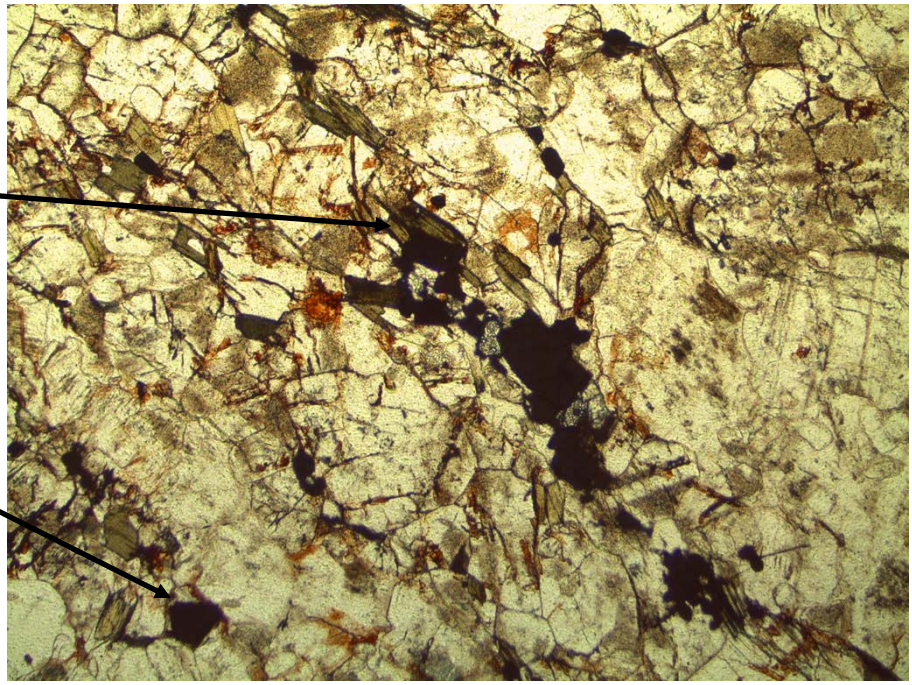
Photograph 8. Granite, showing interlocking euhedral grains. Note: Opaque hematite and associated hornblende, PL, 100x, FL 1mm.
