Citizens' Oversight Projects (COPs)
771 Jamacha Rd #148
El Cajon, CA 92019
CitizensOversight.org
619-820-5321

August 30, 2018

The NRC announced a "Special Inspection" at San Onofre Nuclear Generating Station to review events surrounding the Aug 3, 2018, fuel-loading "near miss" incident. Through this letter we hope to provide guidance to this investigation by the NRC from our standpoint of providing public oversight, including a request for expanding the scope of your investigation. Please distribute this letter appropriately within the NRC so our concerns will be known by the inspection team.

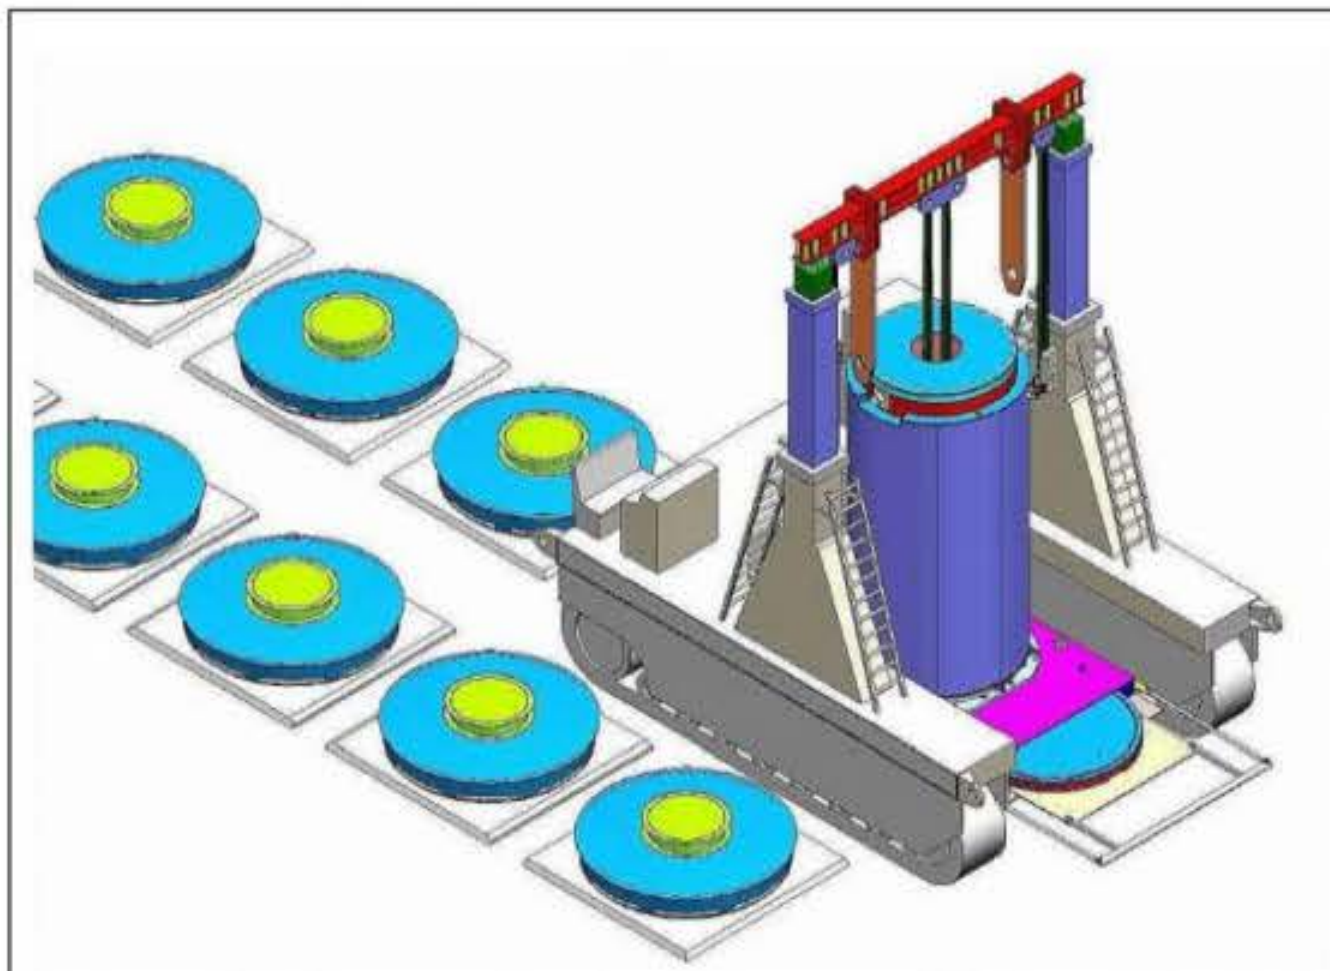
Figure 1: Transporter lowering an MPC canister into an underground vault protected by Transfer Cask

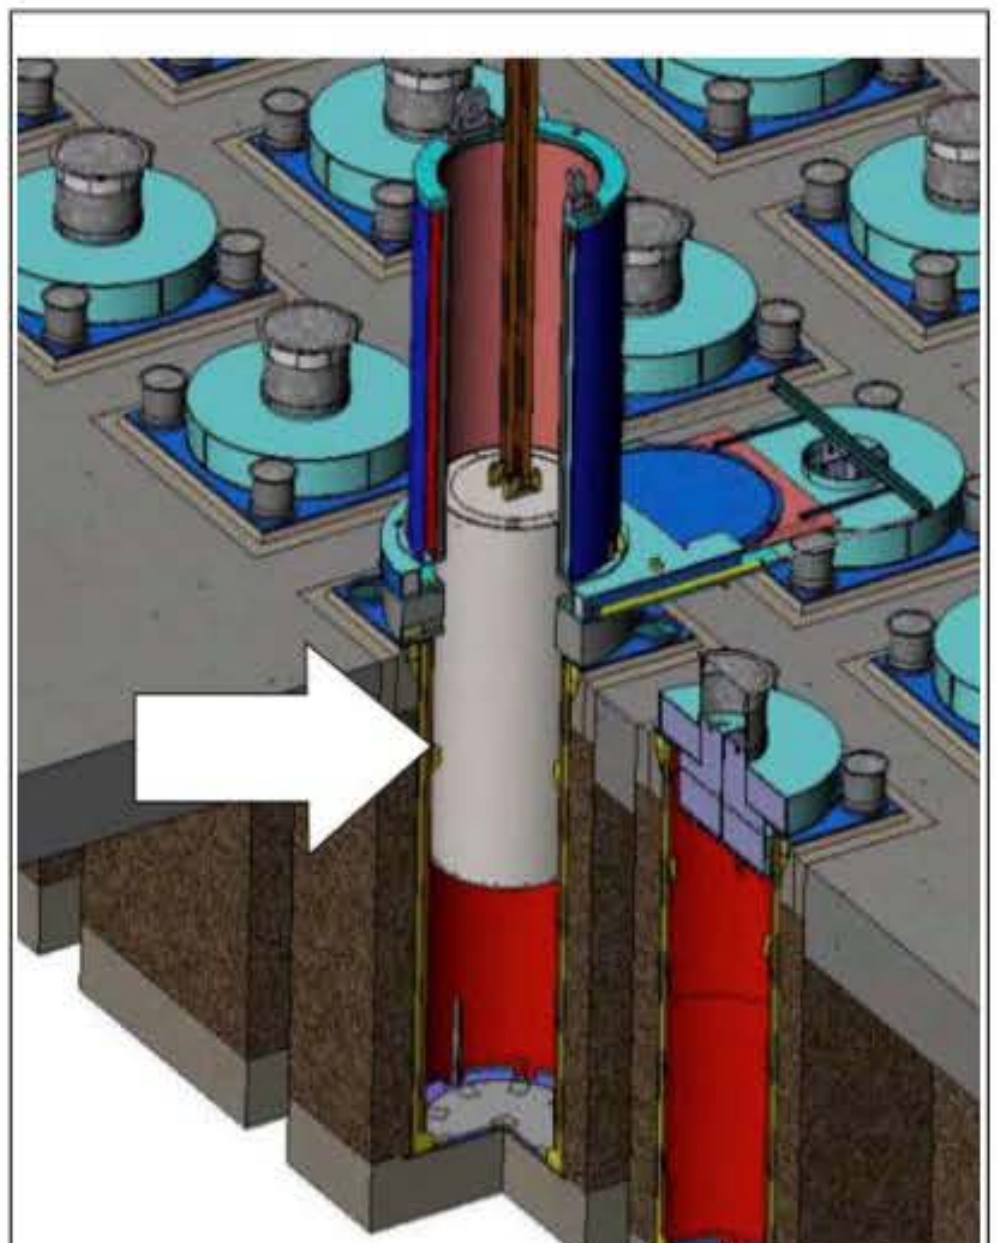
Figure 2: Arrow shows location of alignment ring which was supporting the entire ~45 ton mass on about 1/4" from falling about 18 feet into the vault.

Although the model devised above included a drop of the canister inside the HI-STORM (above-ground) shell, this analysis was limited to a drop of **only 12 inches, not 18 feet.** The other aspects of that report concerned drops of the HI-TRAC transfer cask holding a canister. Those models considered larger drops of up to 100 feet. But in those modeled drops, they considered that the contained canister was a "rigid cylinder" and they did not consider the damage to the MPC itself. If you've heard of drop tests of "30 feet", these tests include the transportation cask or transfer cask. These casks provide structural support and/or impact limiters, and those tests do not consider damage to the contained canister either.

As a trained engineer, my thoughts are as follows. First, models can be wrong, as they have never been validated by any actual drops of fully loaded MPC-37 canisters to see what would happen. But intuition says that if the fully loaded, (~45 tons) 5/8" thick stainless steel canister had fallen the 18 feet, it would have suffered substantial damage, particularly at the bottom which takes the full weight of the rest of the cylinder. The containment of the canister may have been breached (most likely at the weld to the base plate), and it very likely would have become wedged in the bottom of the vault (because the sides of the cylinder may have bent in and out or bent to one side). The concrete would be damaged by the falling canister and the shock wave produced by the fall may damage other nearby canisters. The canister spreading to the sides would likely damage the air vents of the underground vault, perhaps crushing them and eliminating any circulating air. Then, the fuel may quickly overheat. If the fuel assemblies inside were also compromised, there is a risk that a critical reaction would have been sustained. It could have resulted in a meltdown or explosive scenario, contaminating the coastal area for many miles. It is unclear how anyone could then get the crumpled canister back out of the underground vault even if the canister containment boundary is not compromised.

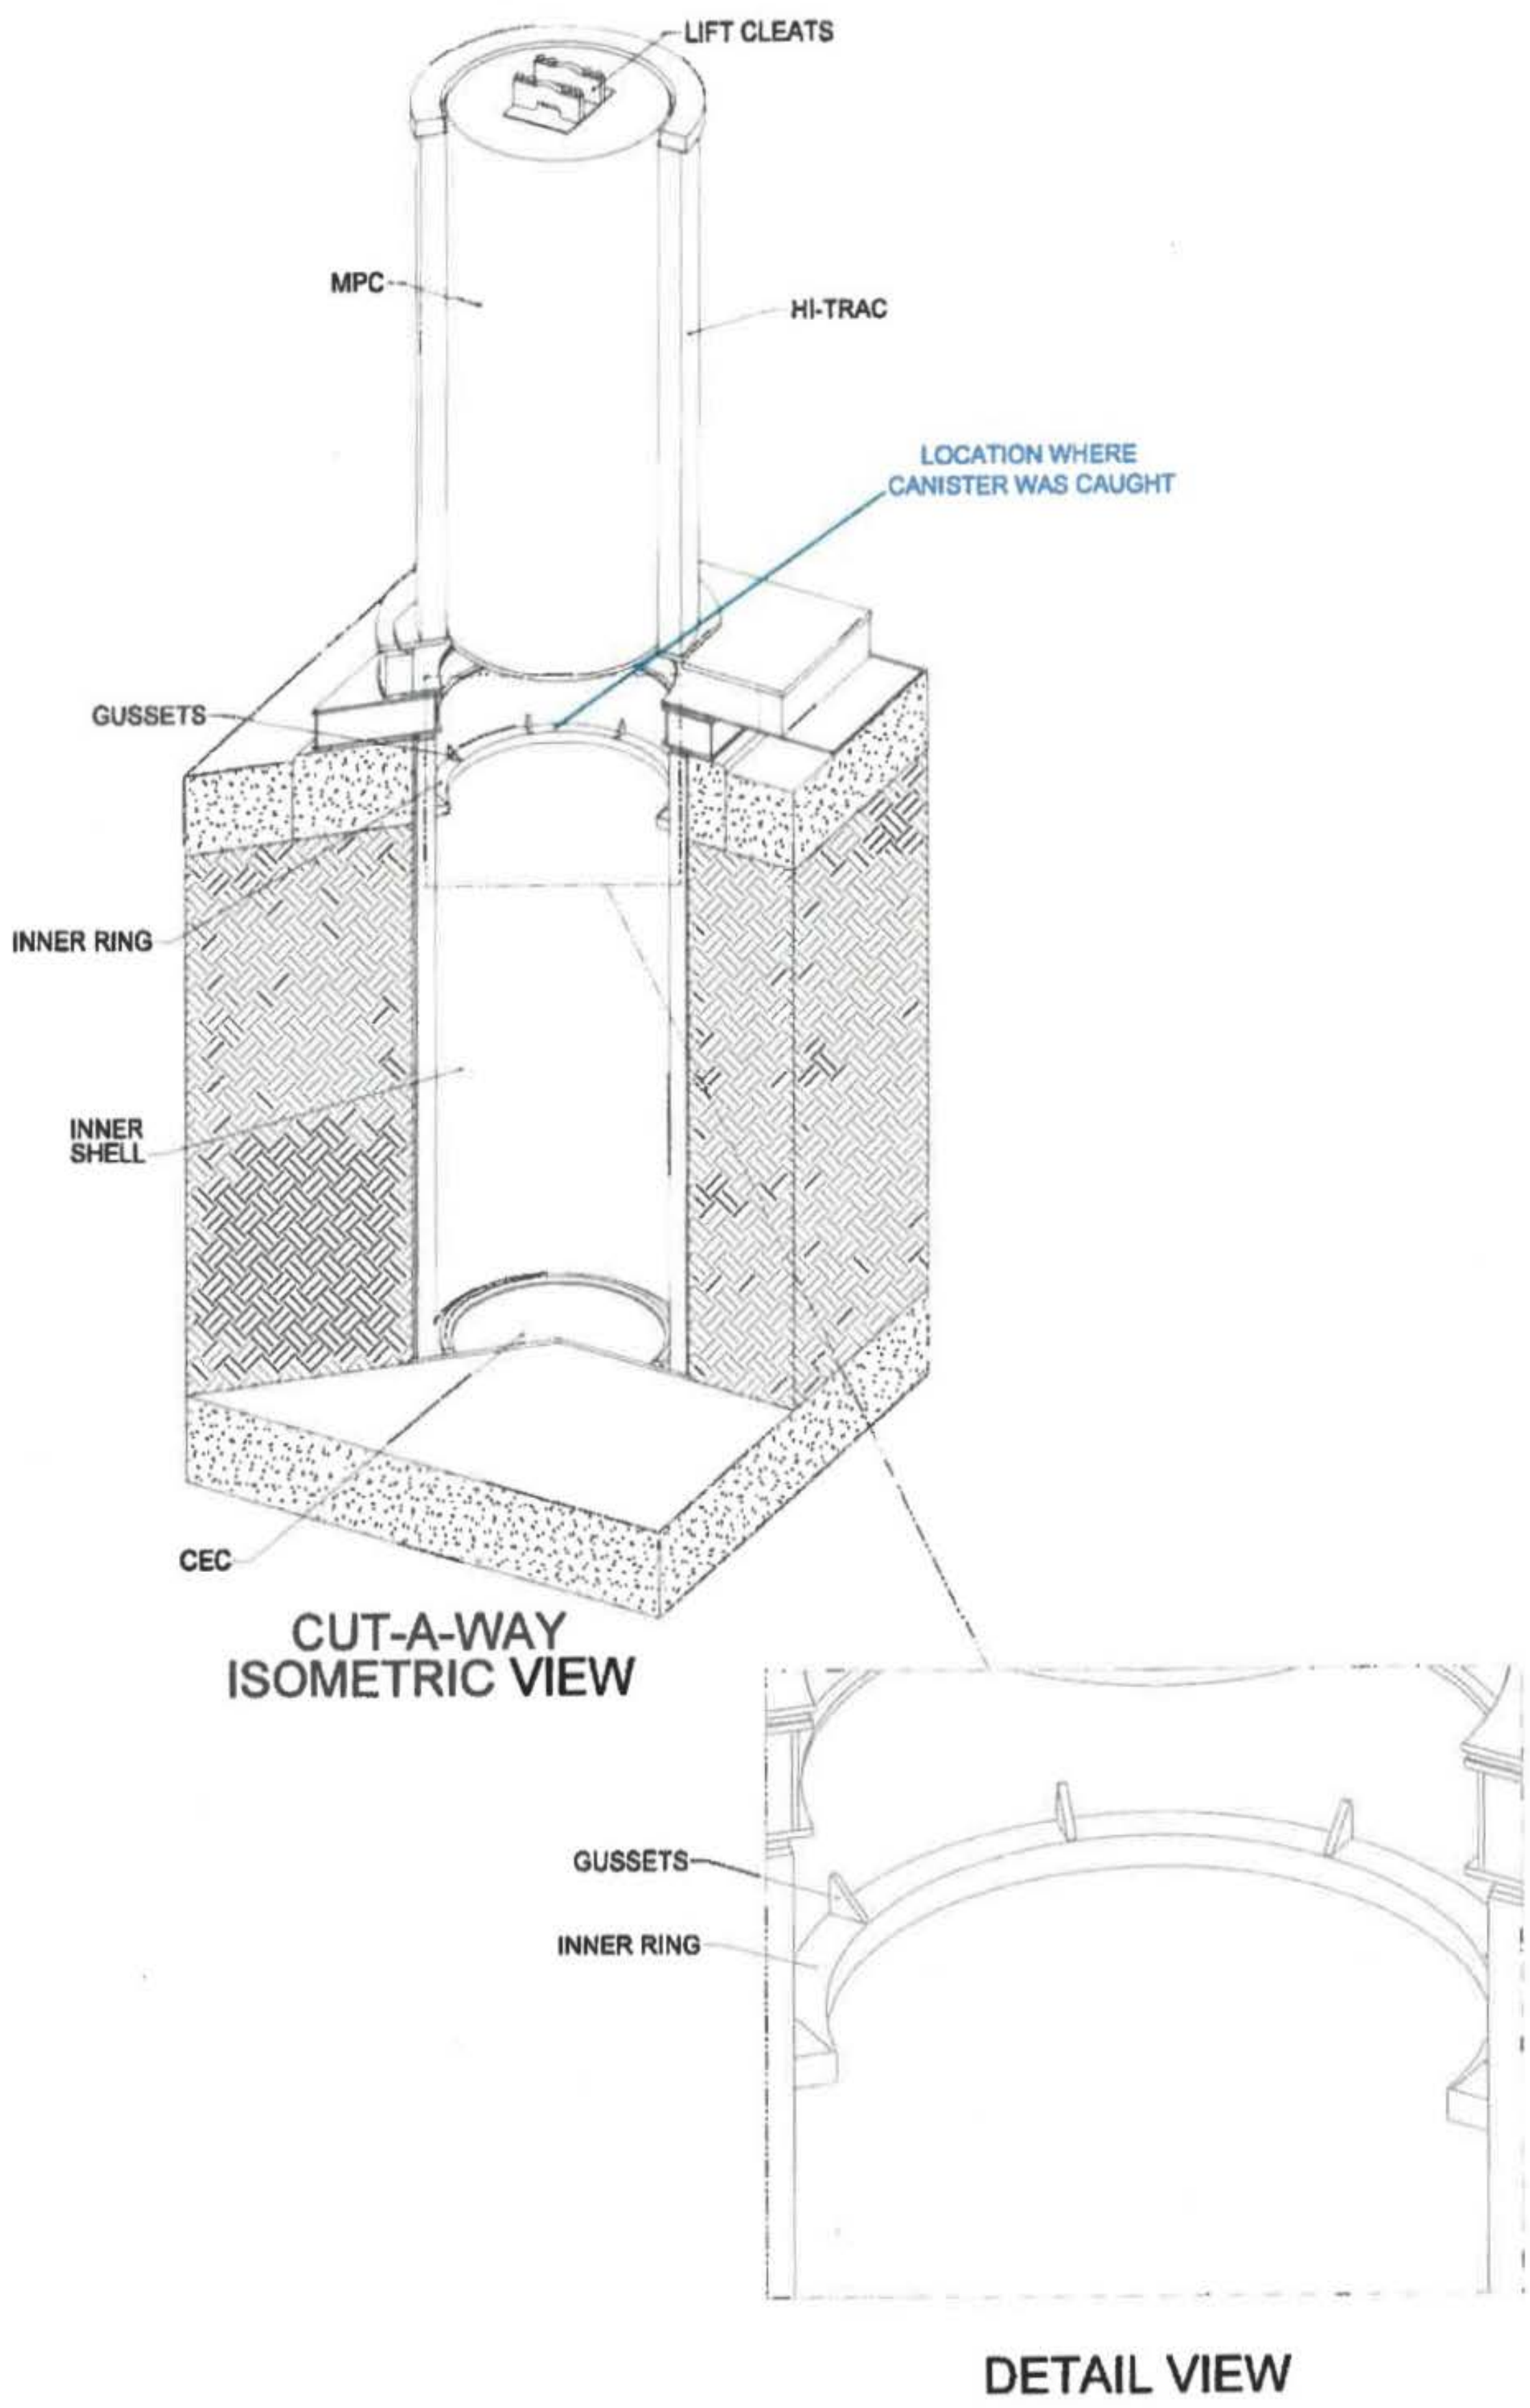
Attachment: SONGS UMAX Isometric Diagram

LIFT CLEATS
MPC
HI-TRAC
LOCATION WHERE CANISTER WAS CAUGHT
GUSSETS
INNER RING
INNER SHELL
CEC
CUT-A-WAY ISOMETRIC VIEW
GUSSETS
INNER RING
DETAIL VIEW

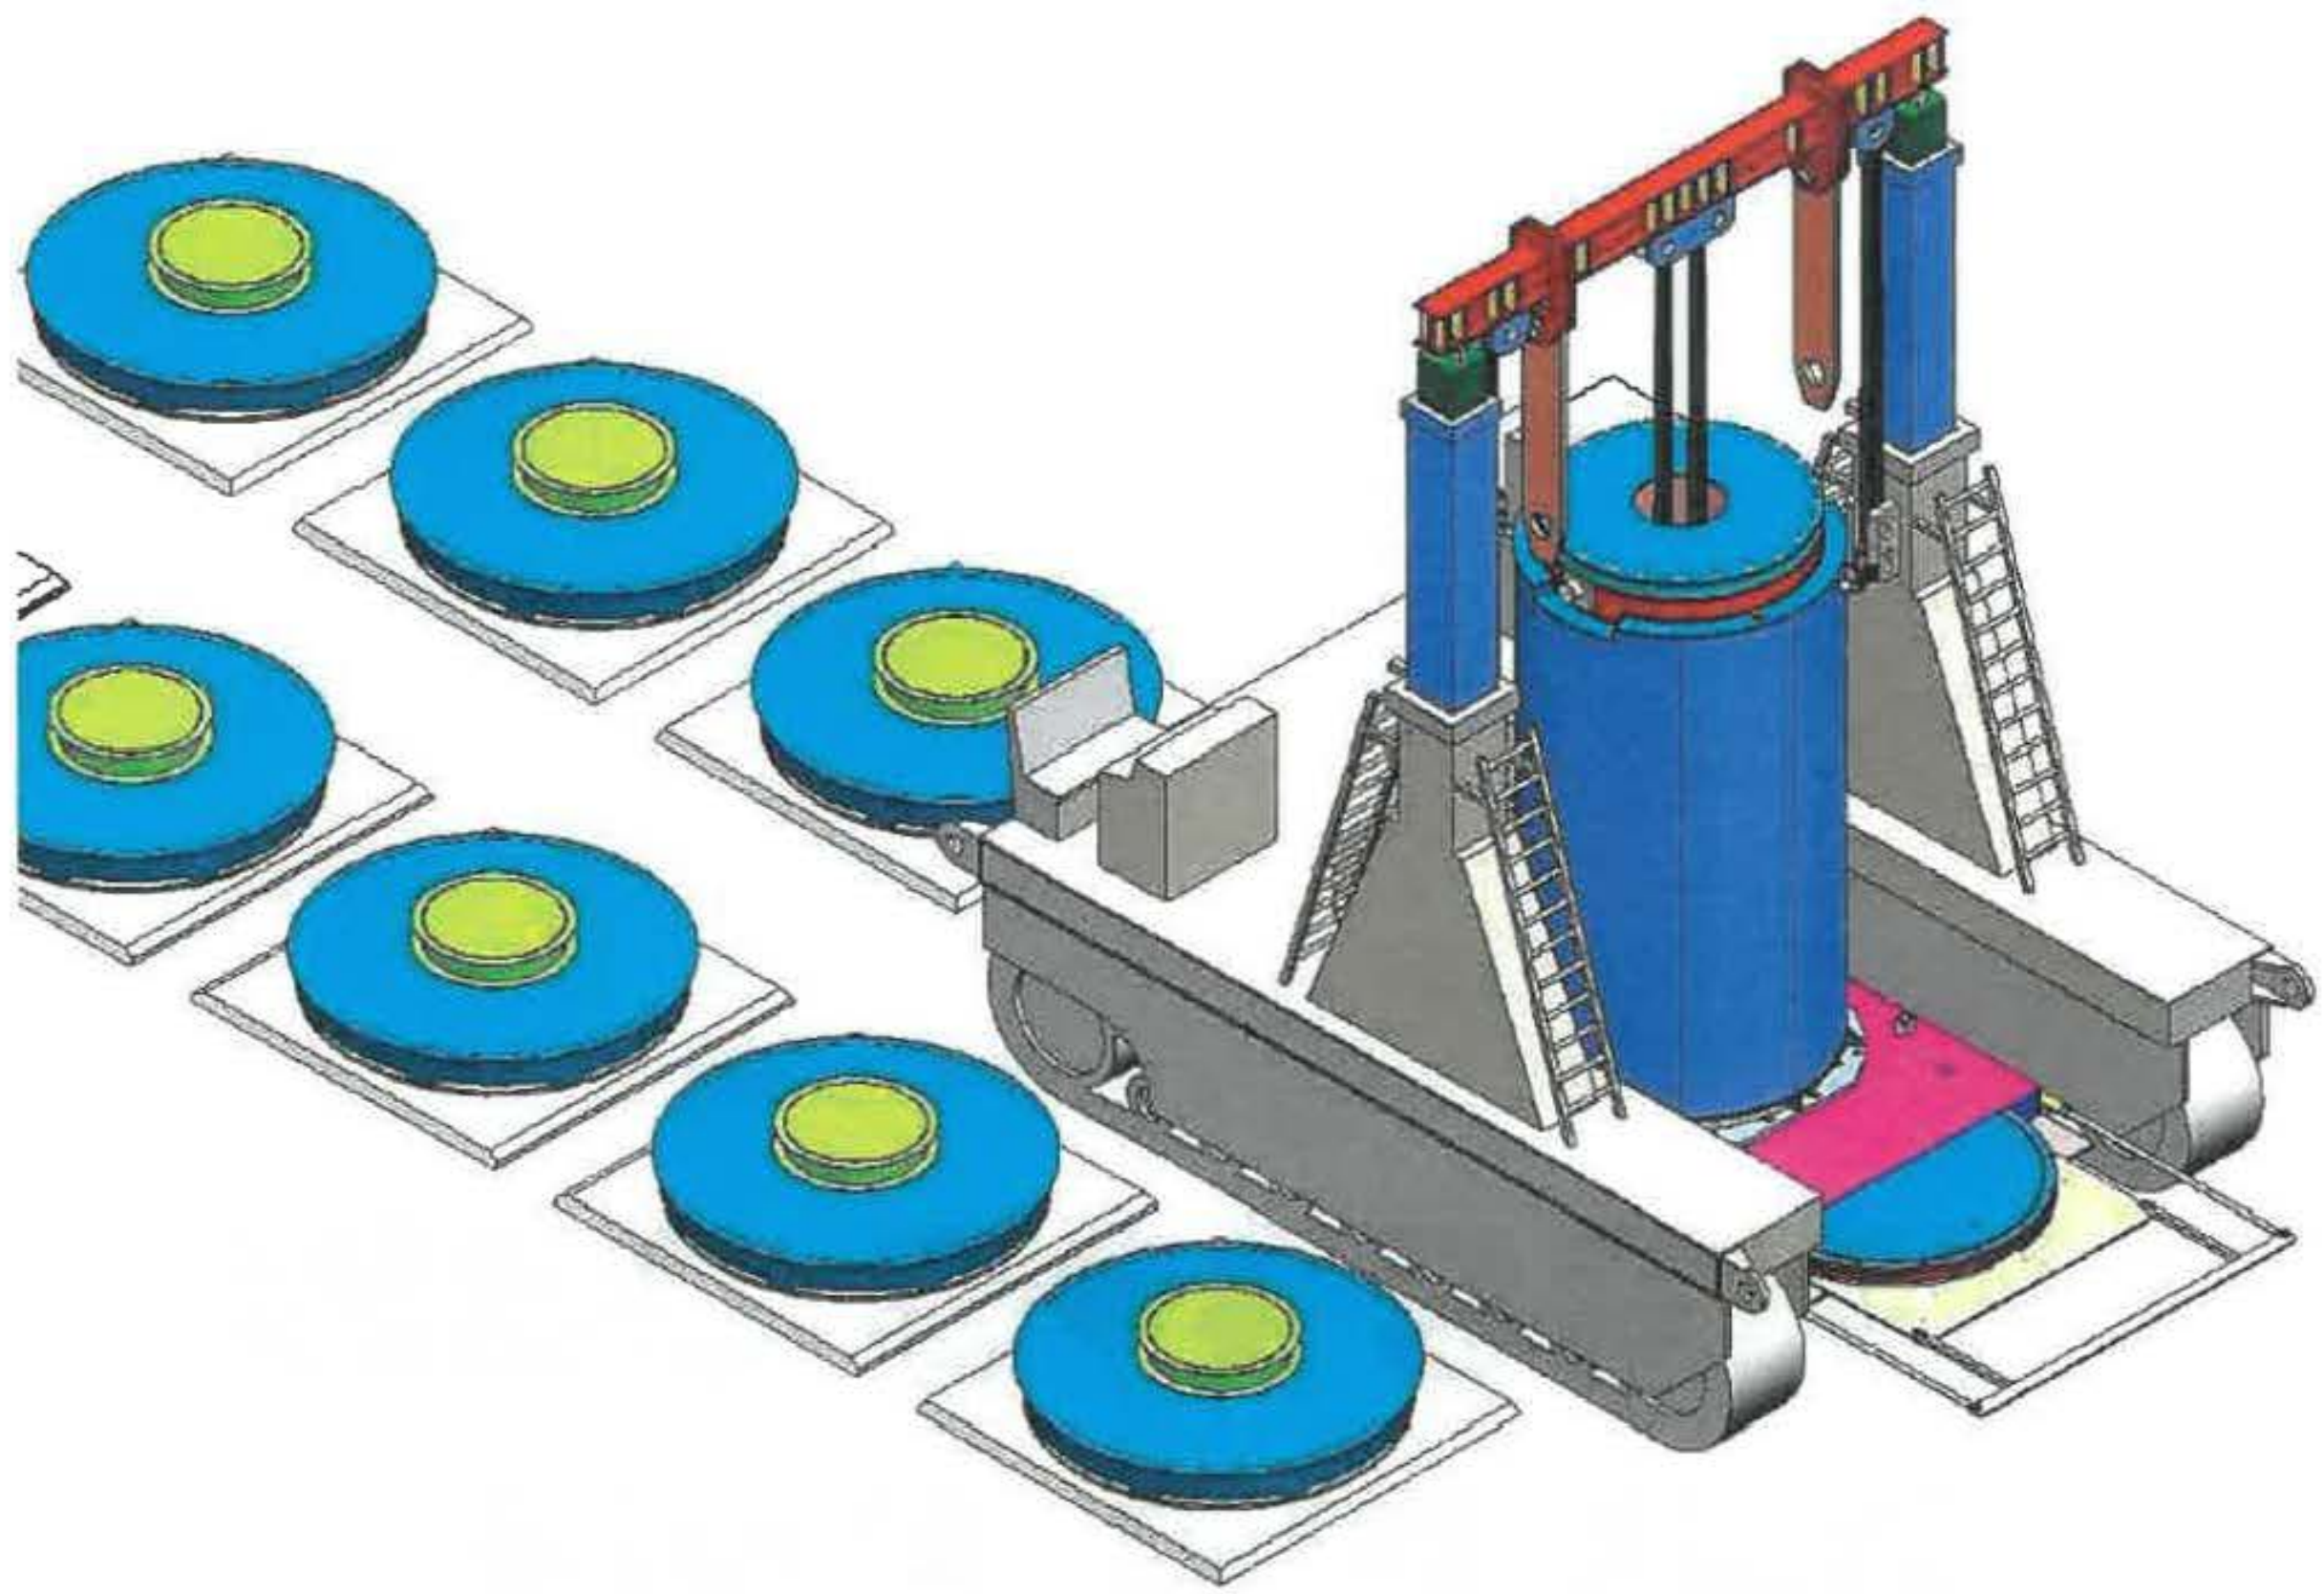
On August 3, 2018, an MPC was not properly aligned for placement into the CEC. As workers manipulated controls on the special transport rig to lower the MPC, the rigging lowered. But the MPC got stuck and stopped moving. During the Community Engagement Panel meeting on August 9, 2018, a worker stated that the rigging was lowered another 18 feet before the MPC's non-movement was noticed.

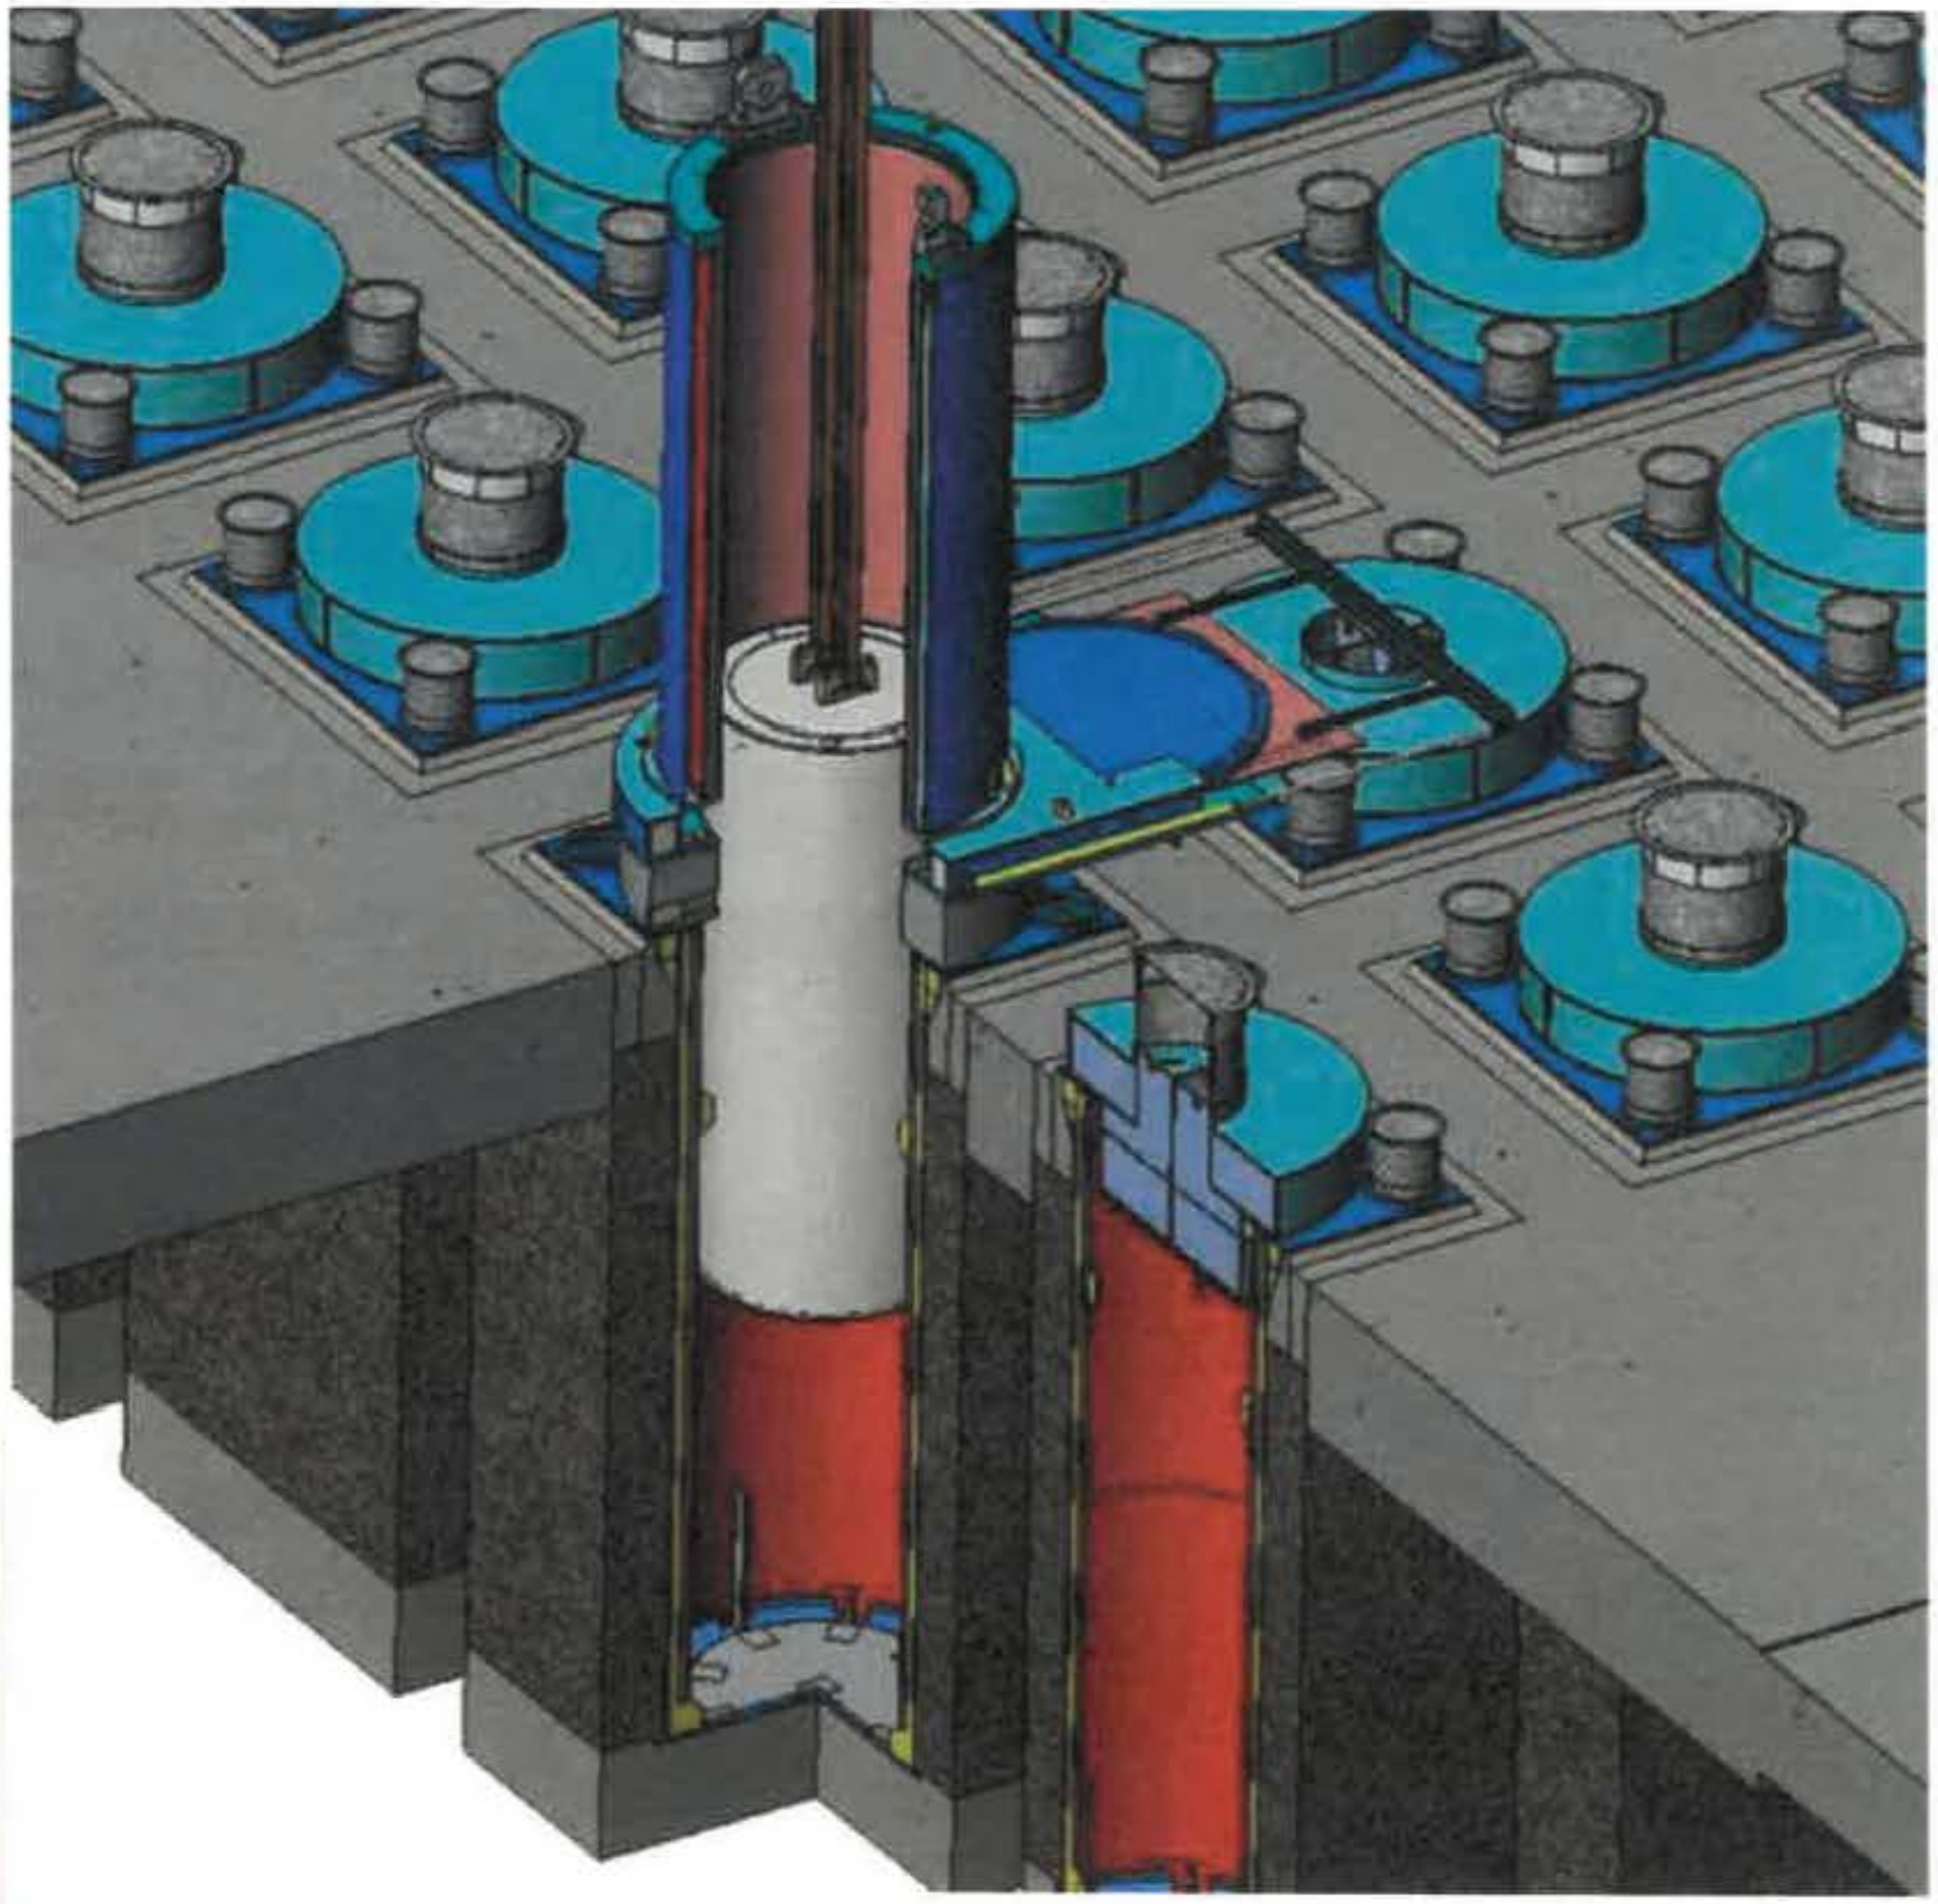
How Did the MPC Get Stuck?

The bottom end of the MPC got caught on an edge with the CEC instead of sliding smoothing into it. Consequently, the rigging kept lowering but the stuck MPC did not.

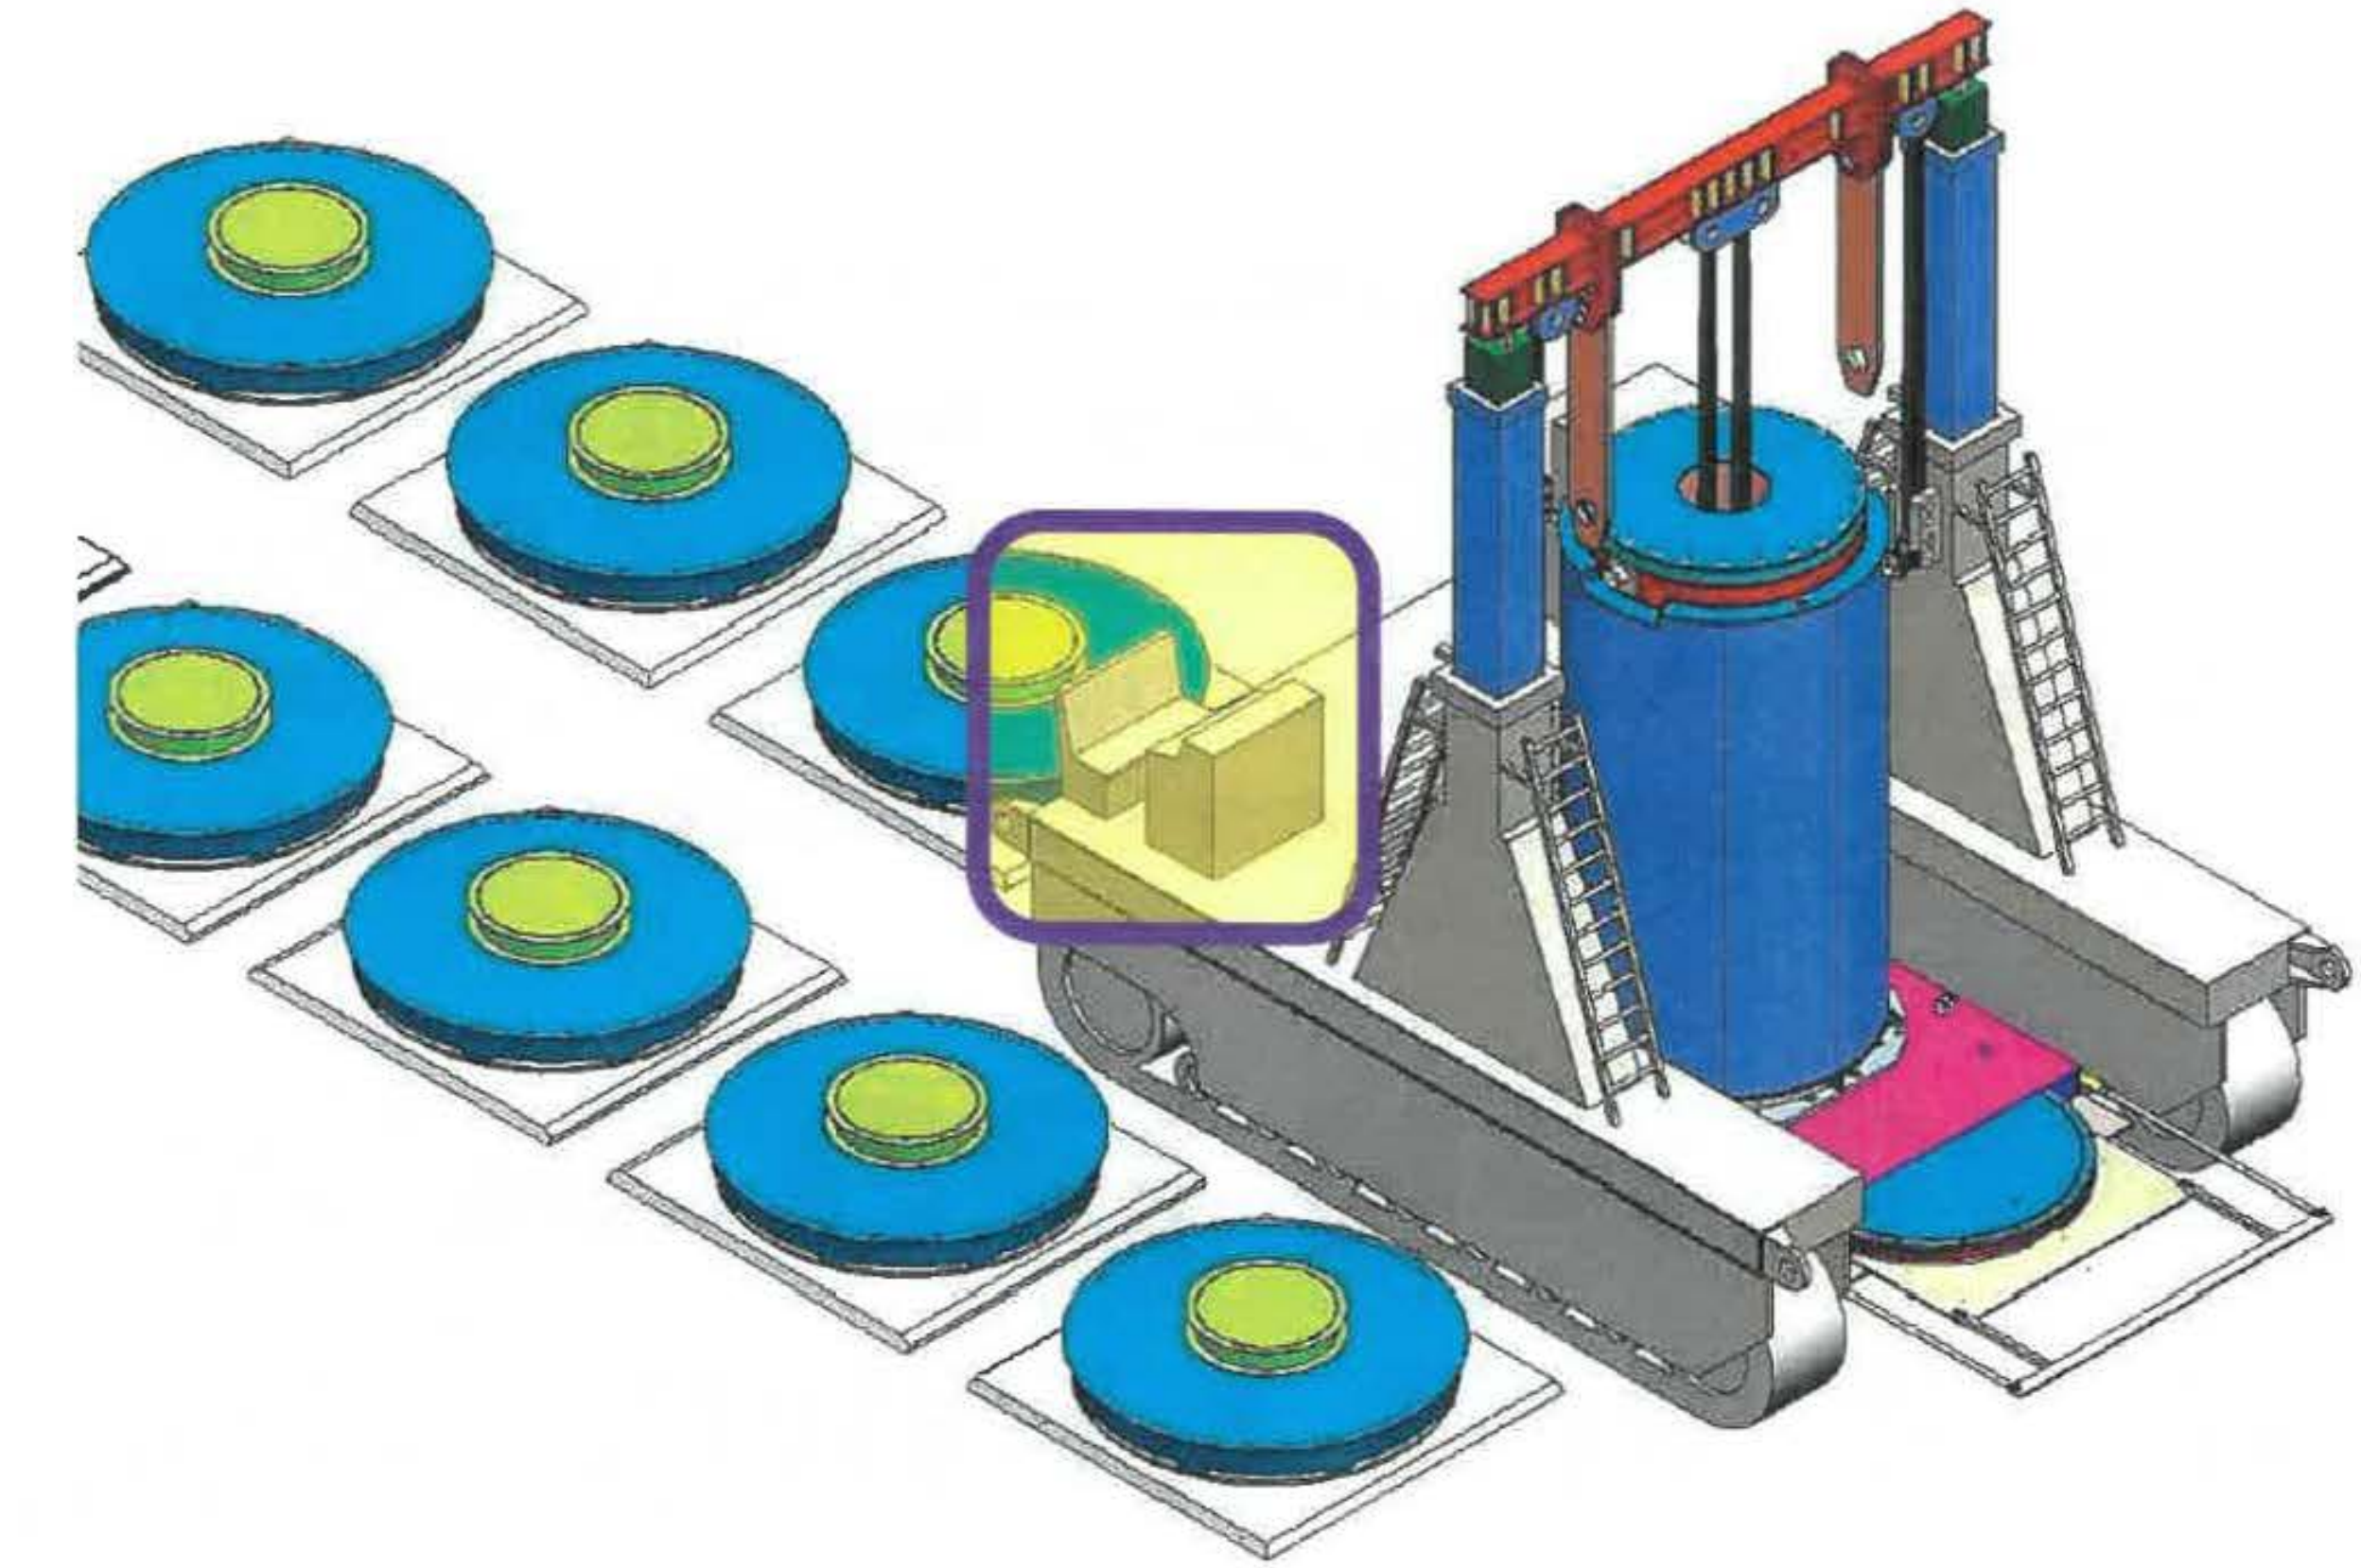
Once the MPC began moving, the "eyeball" worker retreated to a safer distance to reduce radiation dose. The worker at the controls fixated on ensuring both sides of the rigging remained level. After about 30 seconds, the worker saw that the MPC was not moving, but mistakenly thought the indication meant it had reached the bottom of the CEC. It had not.

Workers juggling competing concerns (i.e., dose reduction and rigging performance) let the ball drop by failing to notice that the MPC was <u>not</u> dropping.

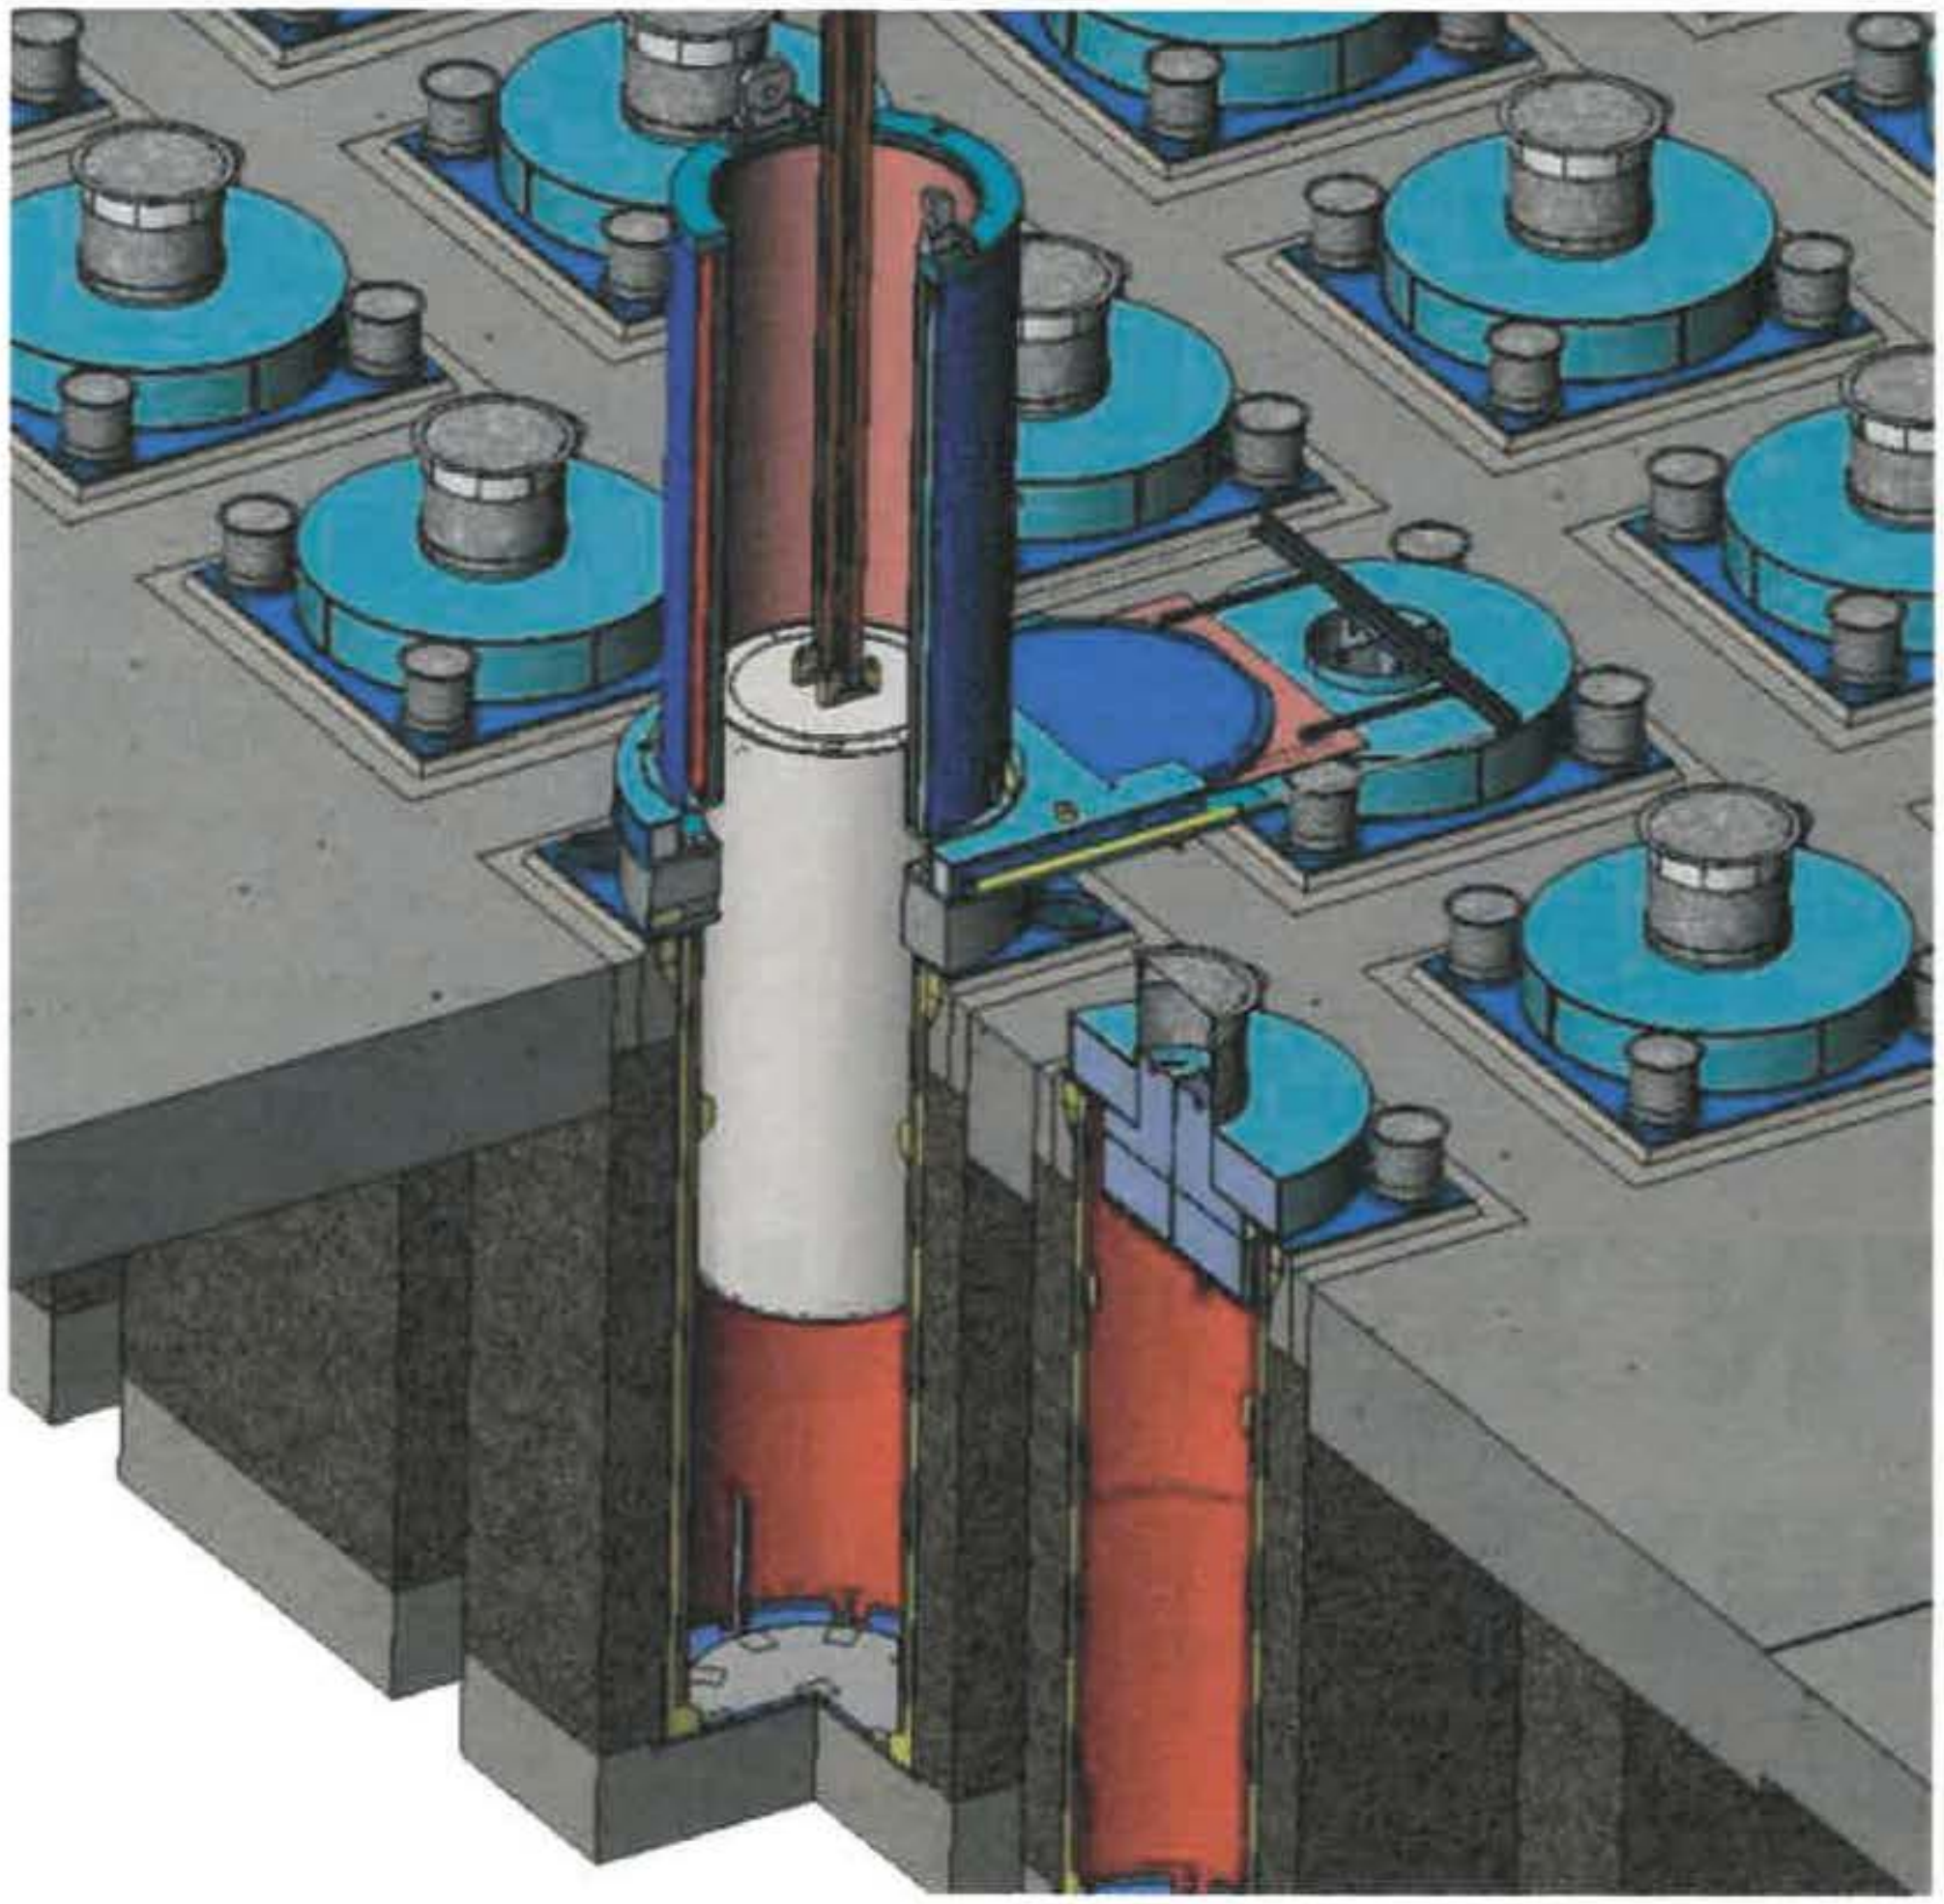
How Did the Stuck MPC Get Noticed?

A Radiation Protection technician surveyed the Cavity Enclosure Container and detected radiation levels higher than expected for a properly loaded MPC.

A worked looked into the transport sleeve and observed the top of the MPC at a higher level than desired.
