Citizens' Oversight Projects (COPs)
771 Jamacha Rd #148
El Cajon, CA 92019
CitizensOversight.org
619-820-5321

August 30, 2018

The NRC announced a "Special Inspection" at San Onofre Nuclear Generating Station to review events surrounding the Aug 3, 2018, fuel-loading "near miss" incident. Through this letter we hope to provide guidance to this investigation by the NRC from our standpoint of providing public oversight, including a request for expanding the scope of your investigation. Please distribute this letter appropriately within the NRC so our concerns will be known by the inspection team.

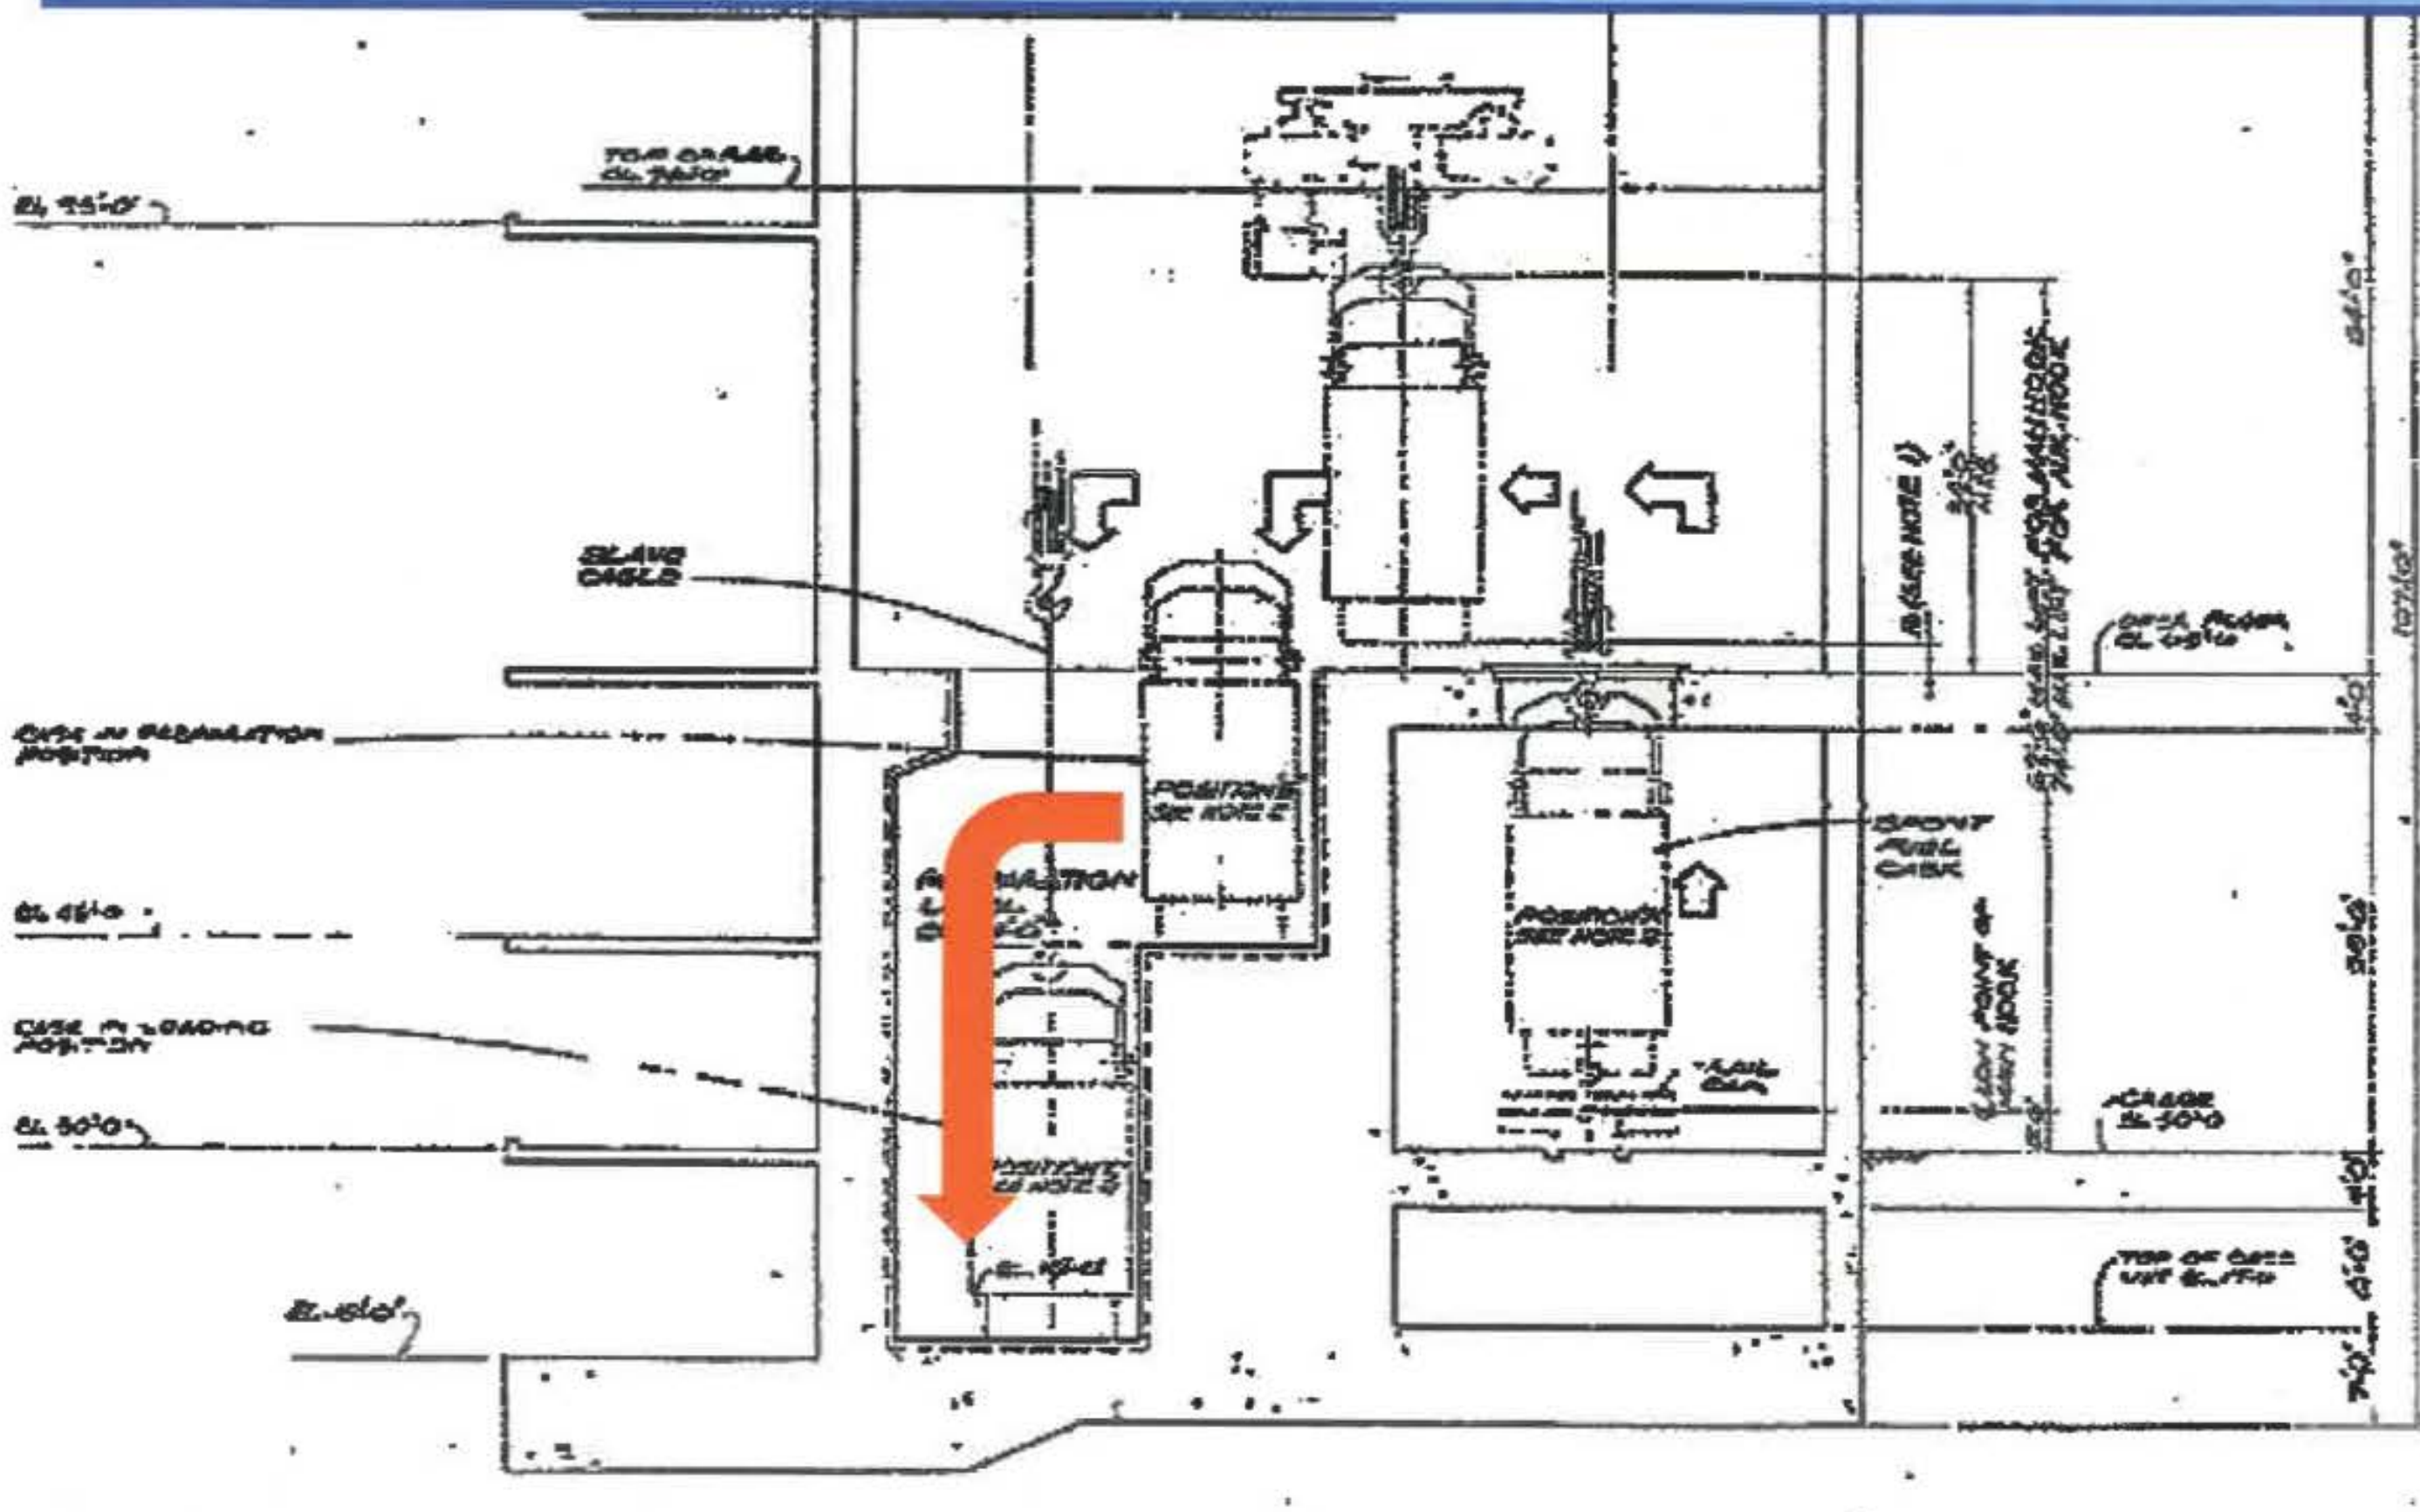
An earthquake could shake an MPC off the "step" in the Spent Fuel Cask Storage Pool. An analysis of a drop from the "step" concluded that irradiated fuel inside the MPC might be damaged, but the MPC would remain intact. No radioactivity would be released into the Fuel Handling Building.

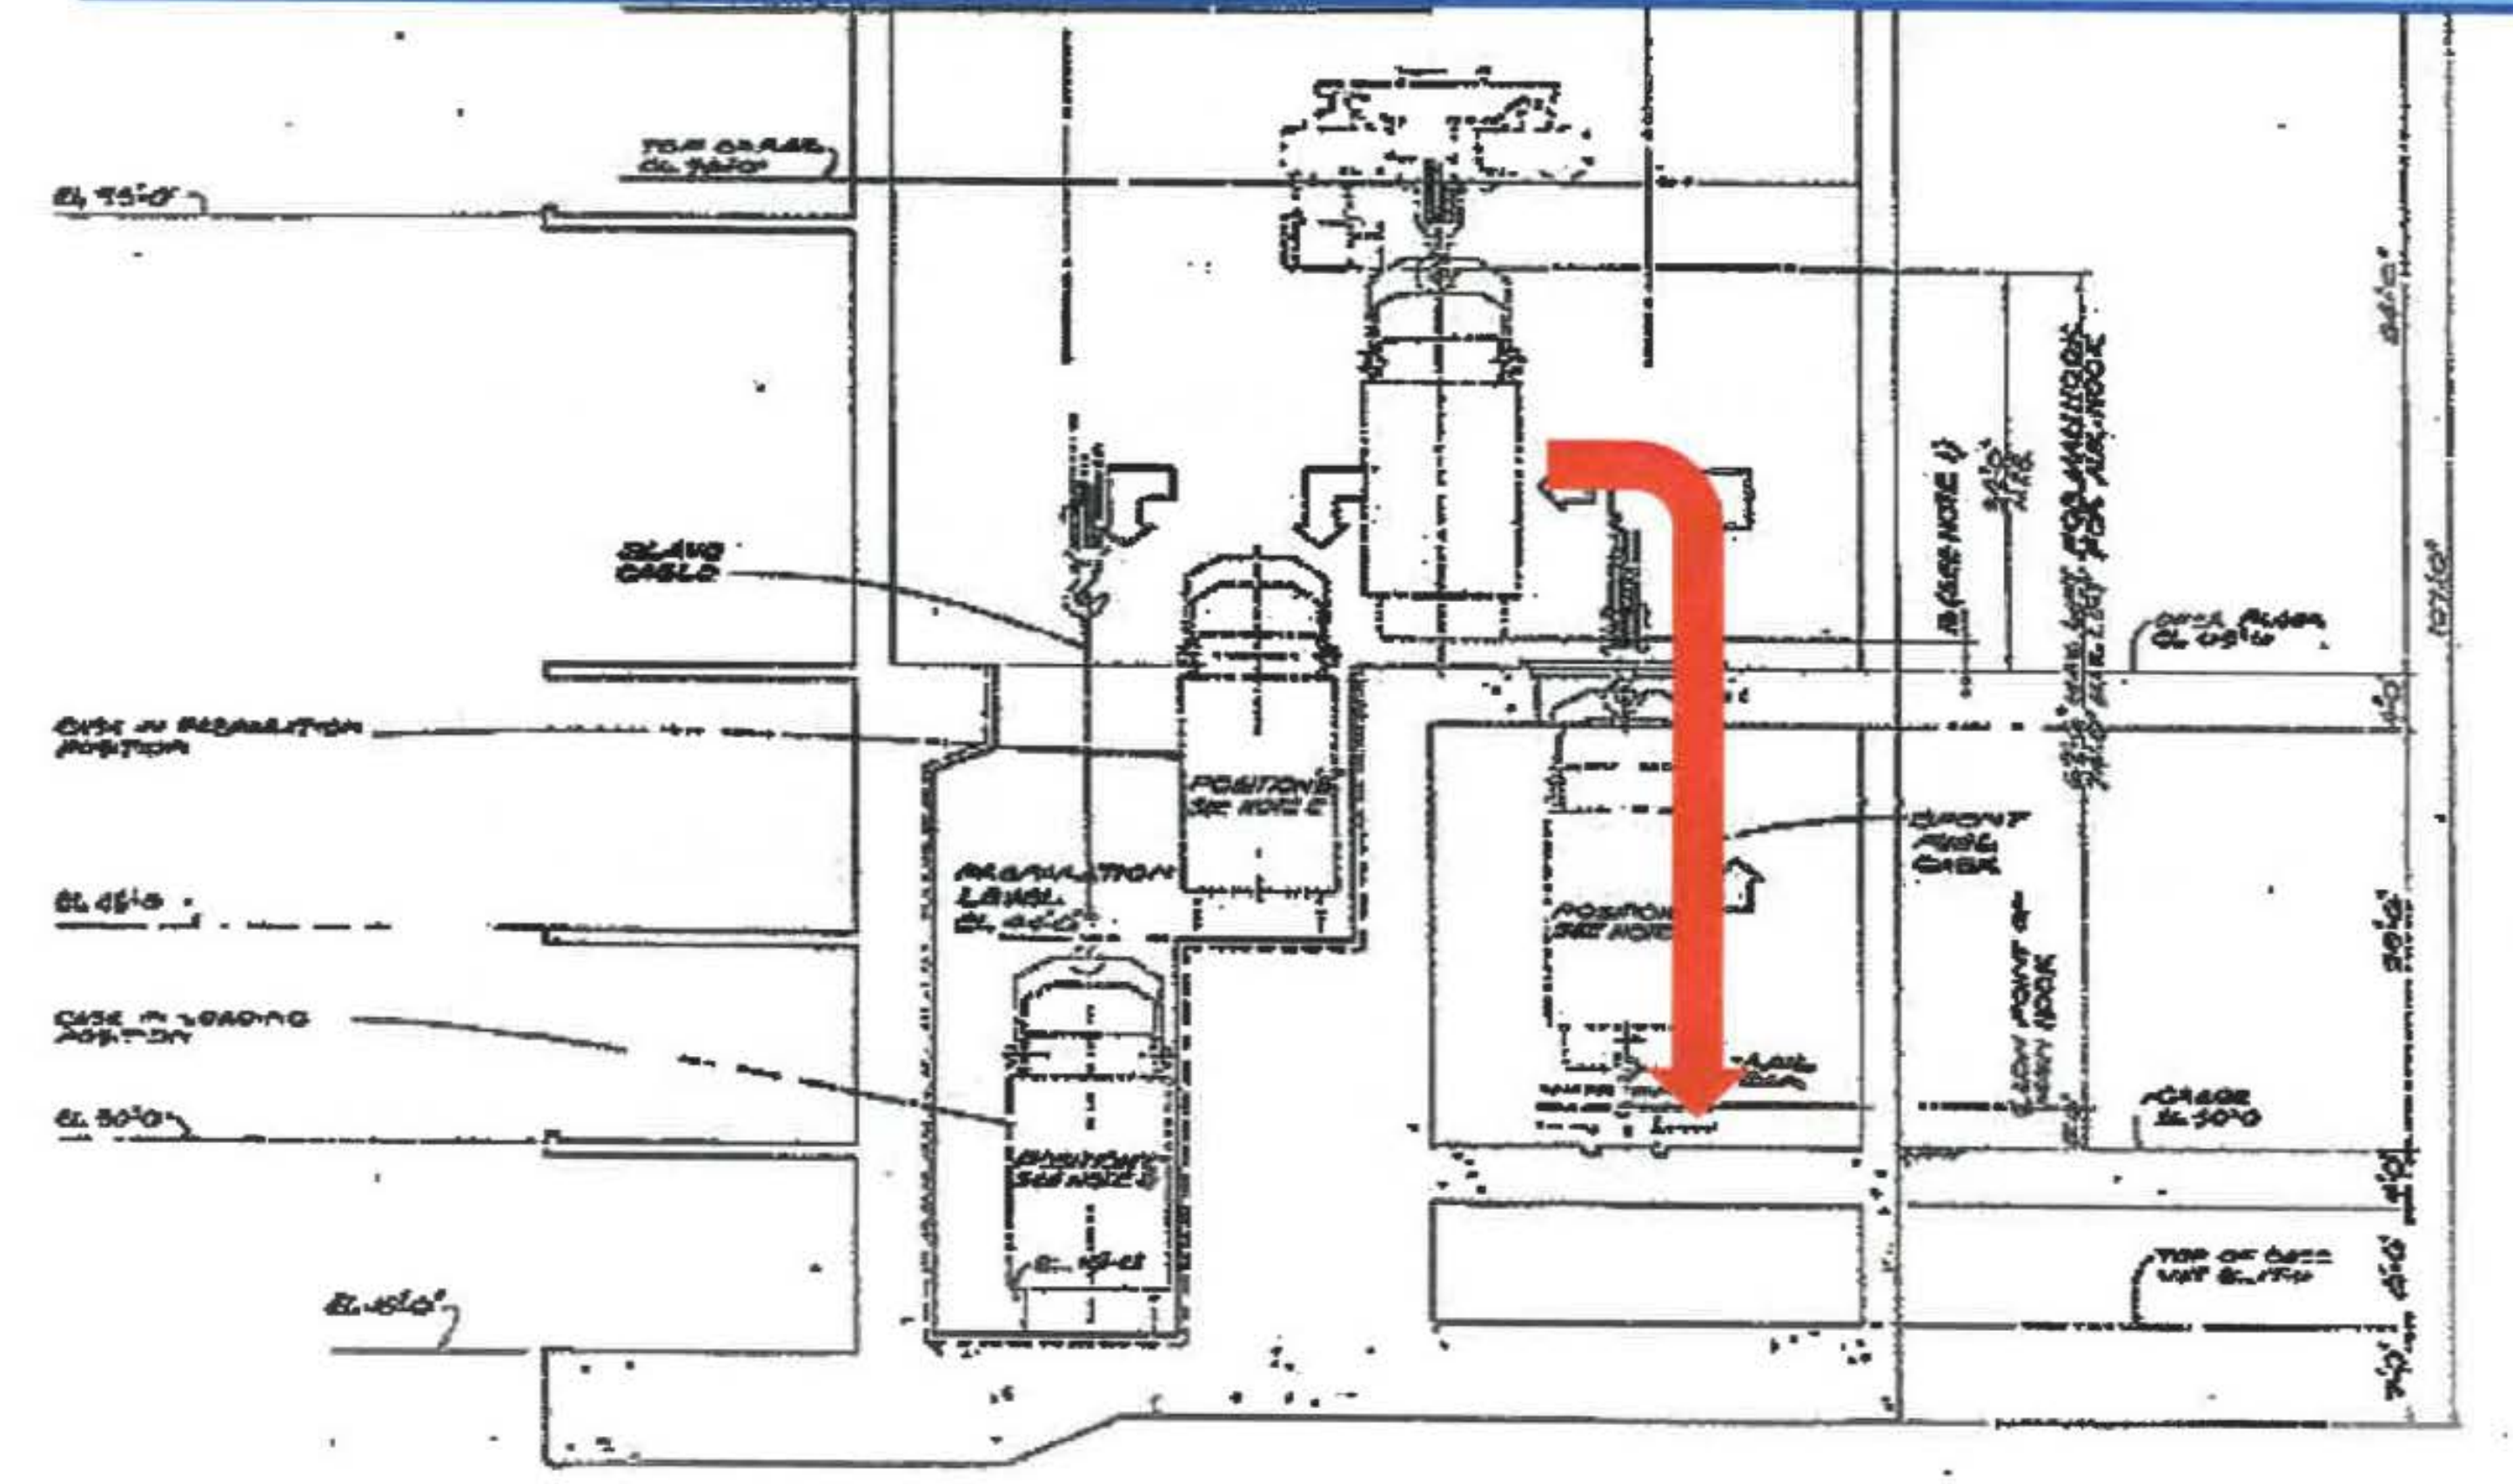
The 30-foot drop of an MPC onto a flat surface (not likely to still be flat after impact from the 45-ton MPC) was also evaluated. Again, irradiated fuel inside the MPC might be damaged, but the MPC would remain intact to prevent any release of radioactivity.

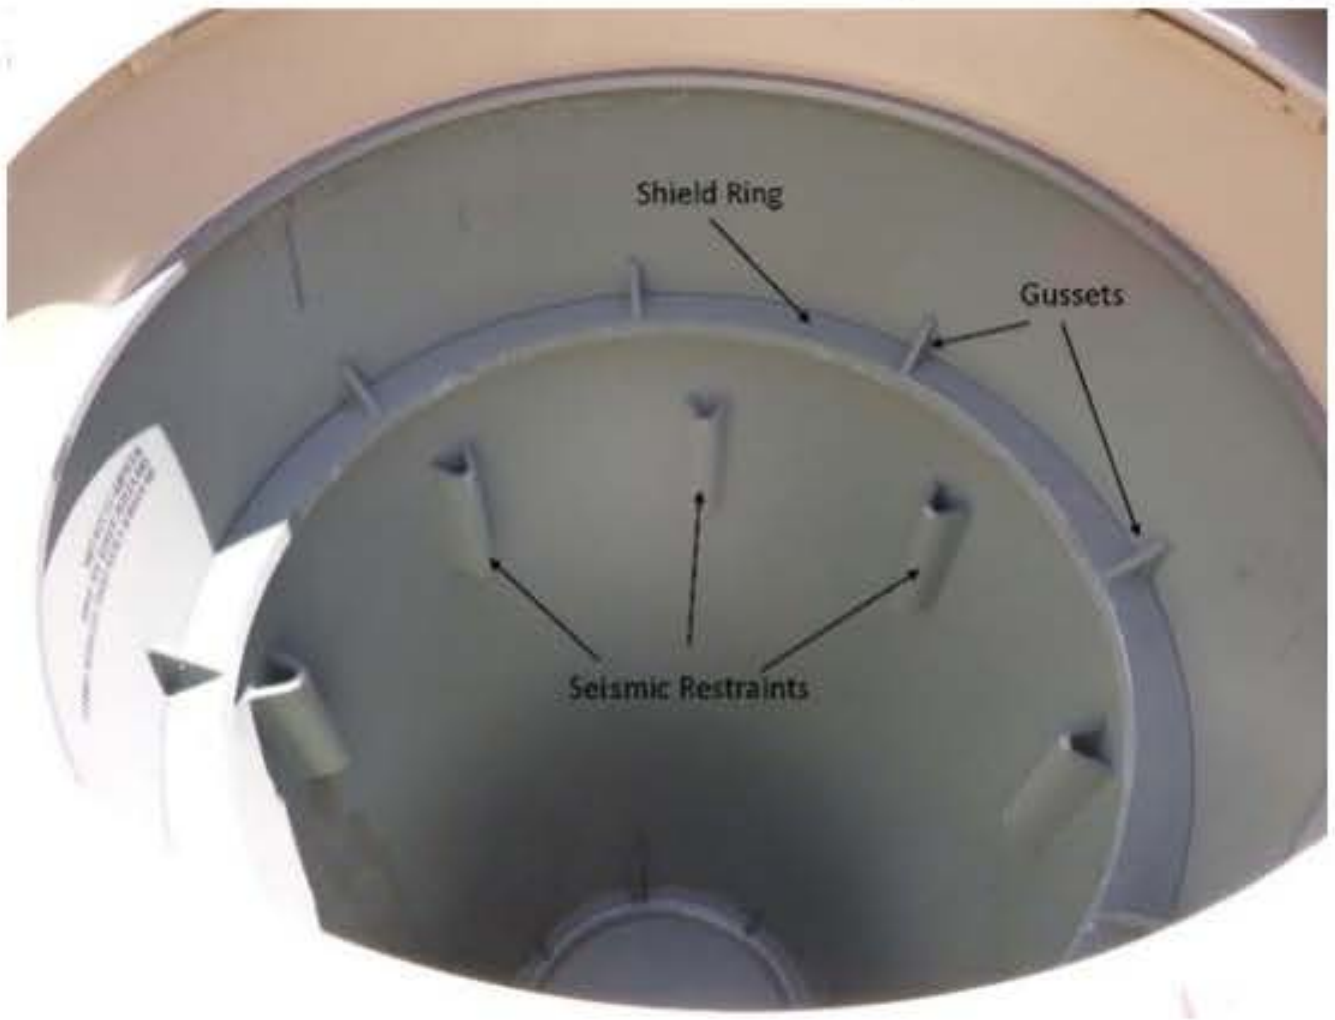
FIGURE 1 VAULT DIVIDER SHELL INTERNAL STRUCTURES

On August 3, 2018, San Onofre was engaged in operations involving movement of a loaded spent fuel storage canister into its underground Independent Spent Fuel Storage Installation (ISFSI) storage vault (Holtec HI-STORM UMAX storage system). This was canister number 29 of a planned 73 canisters to be loaded into the ISFSI. As the loaded spent fuel canister was being lowered into the storage vault using lifting and rigging equipment, the licensee's personnel failed to notice that the canister was misaligned and was not being properly lowered. The licensee continued to lower the rigging and lifting equipment until staff believed that the canister had been fully lowered to the bottom of the storage vault. However, a radiation protection technician identified radiation readings that were not consistent with a fully lowered canister. The licensee then identified that the loaded spent fuel canister was resting on a metal flange or metal gussets near the top of the storage vault, preventing it from being lowered, and that the rigging and lifting equipment was slack and no longer bearing the load of the canister.

In this circumstance, with the important-to-safety lifting equipment completely lowered and the connecting slings completely slack and incapable of suspending the load, the equipment was no longer capable of performing its designed safety function of holding and controlling the loaded canister from a potential canister drop condition. The licensee reported that they believed that the canister was resting on a metal flange (shield ring) within the storage vault.

It was estimated that the canister could have experienced an approximately 18 foot drop into the storage vault if the canister had slipped off the metal flange or if the metal flange failed. This load drop accident is not a condition analyzed in the dry fuel storage system's Final Safety Analysis Report.

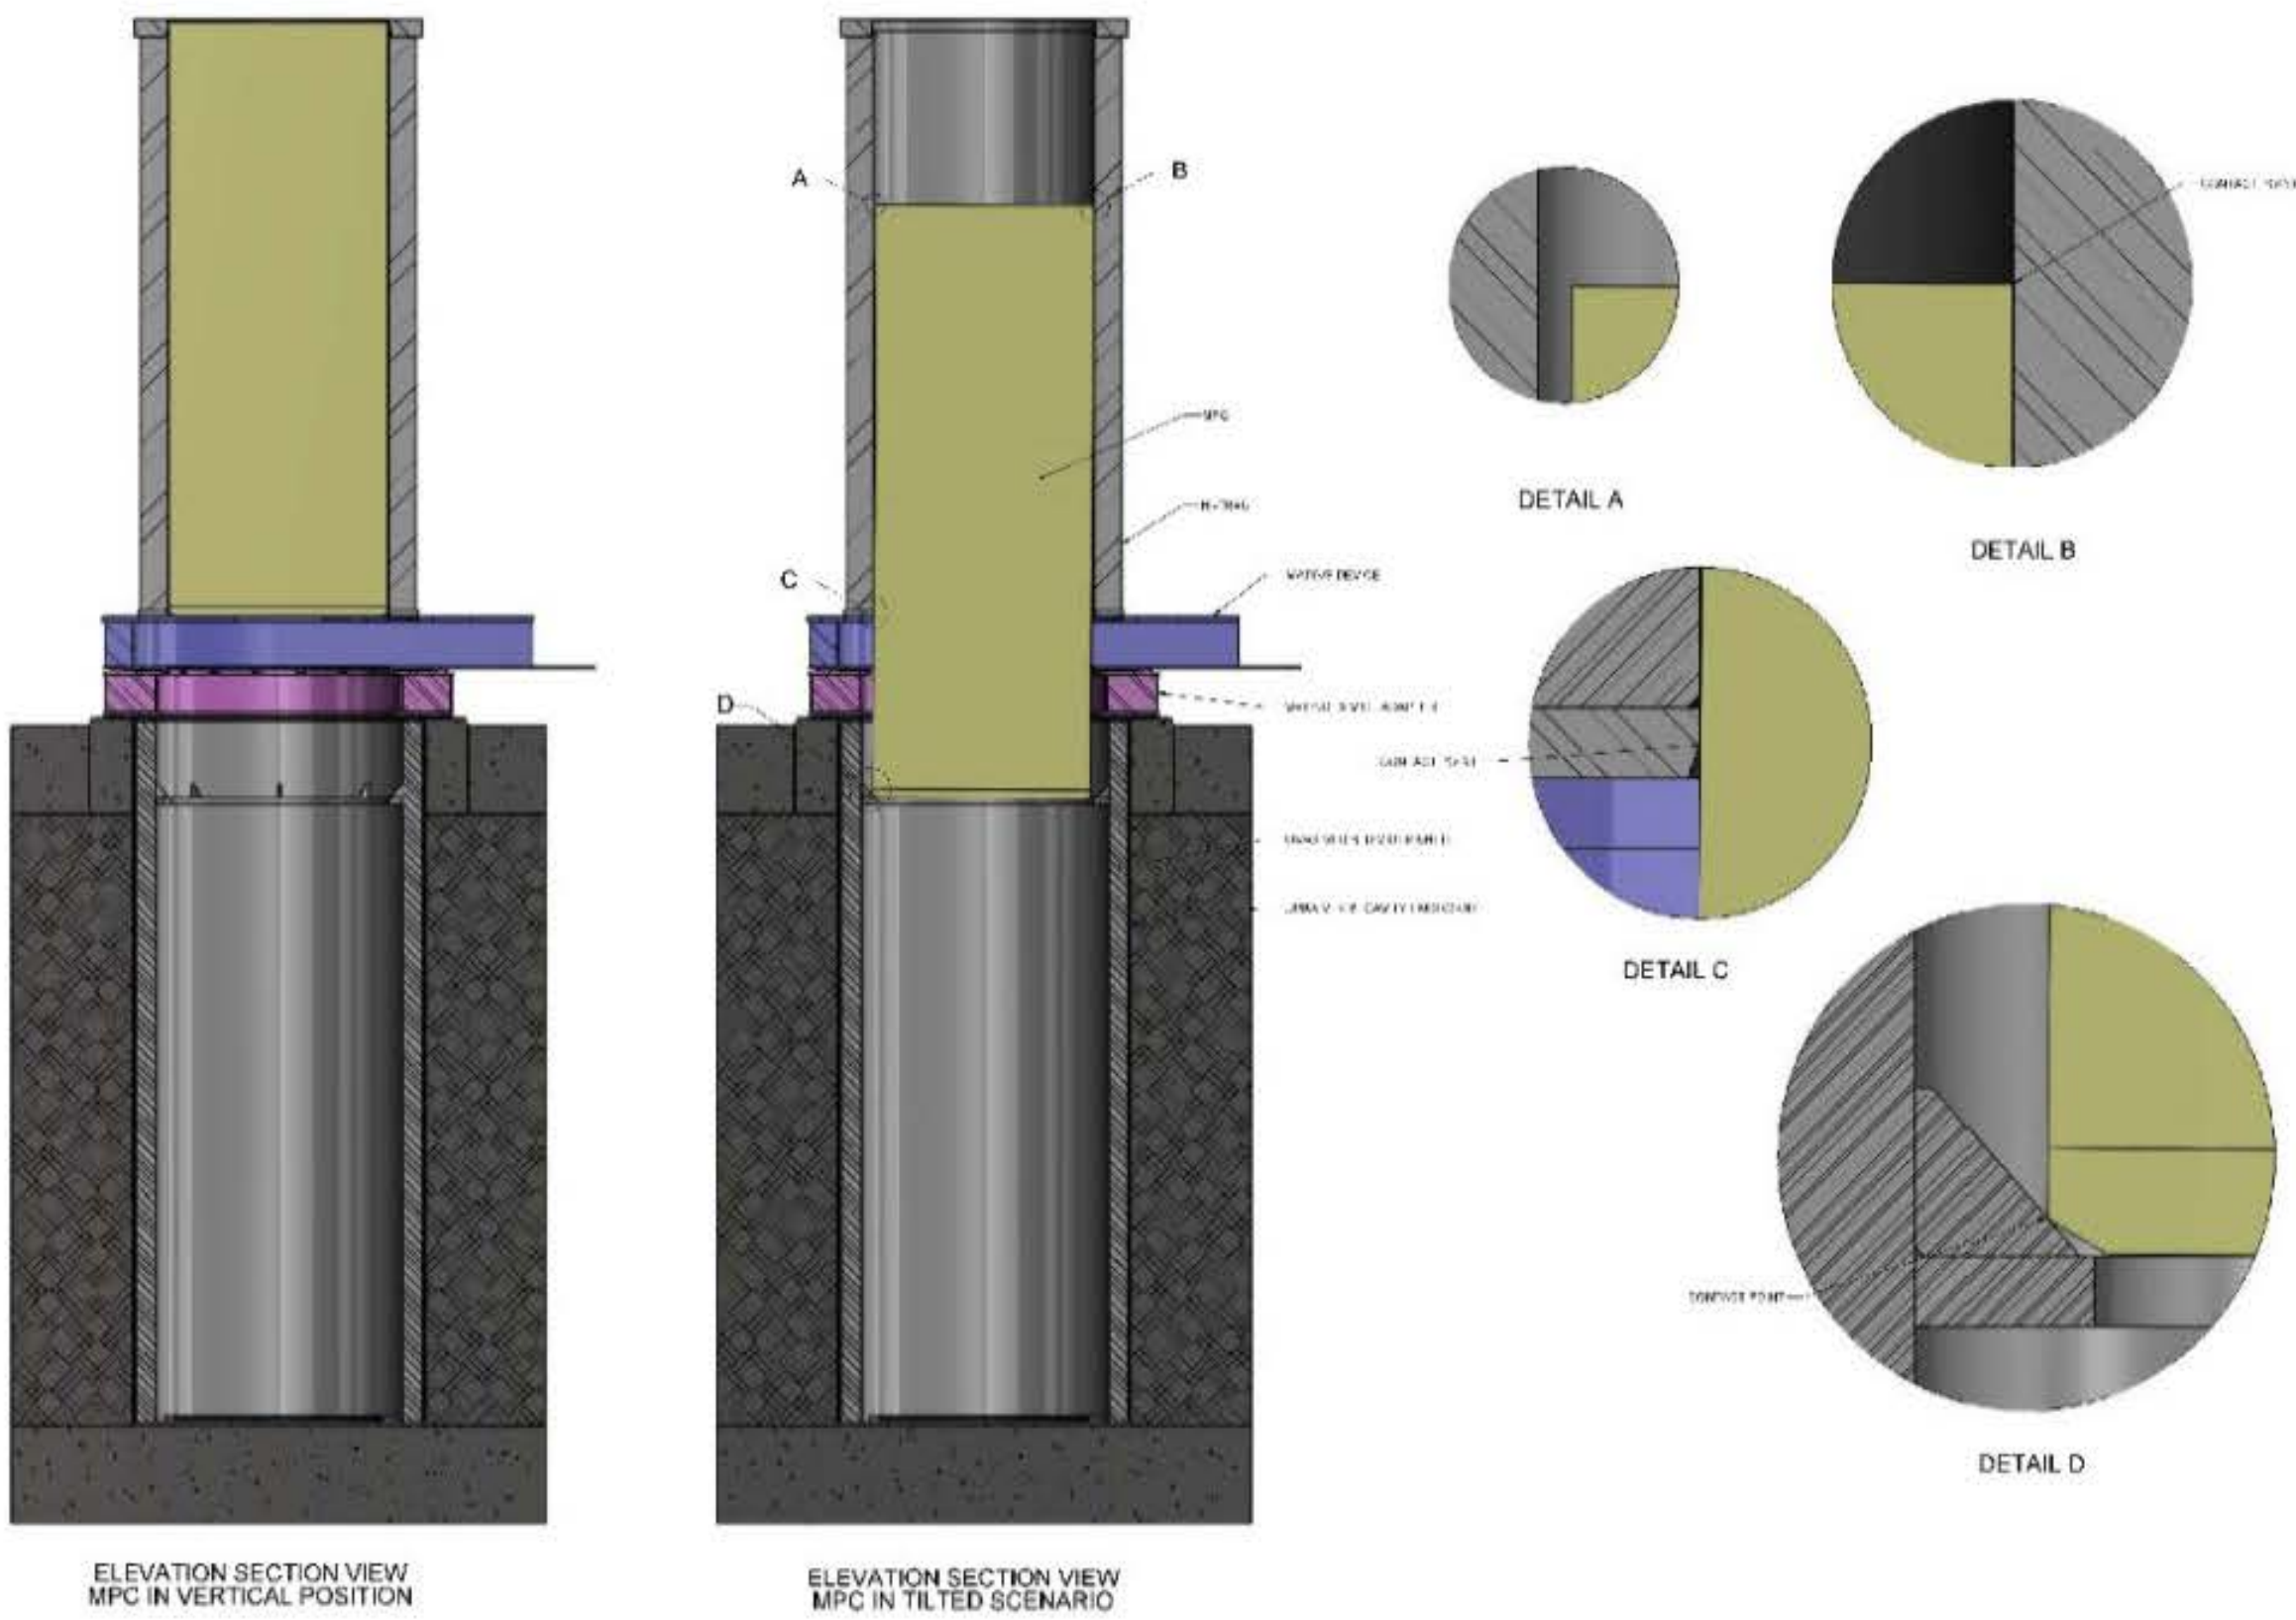
FIGURE 2 MPC DOWNLOADING W/ MPC STUCK ON DIVIDER SHELL SHIELD RING

Southern California Edison agreed to suspend fuel loading operations until such time as their senior management is satisfied with all short term corrective actions, the NRC inspection is complete, and NRC has determined that corrective actions taken are sufficient to prevent a similar occurrence.

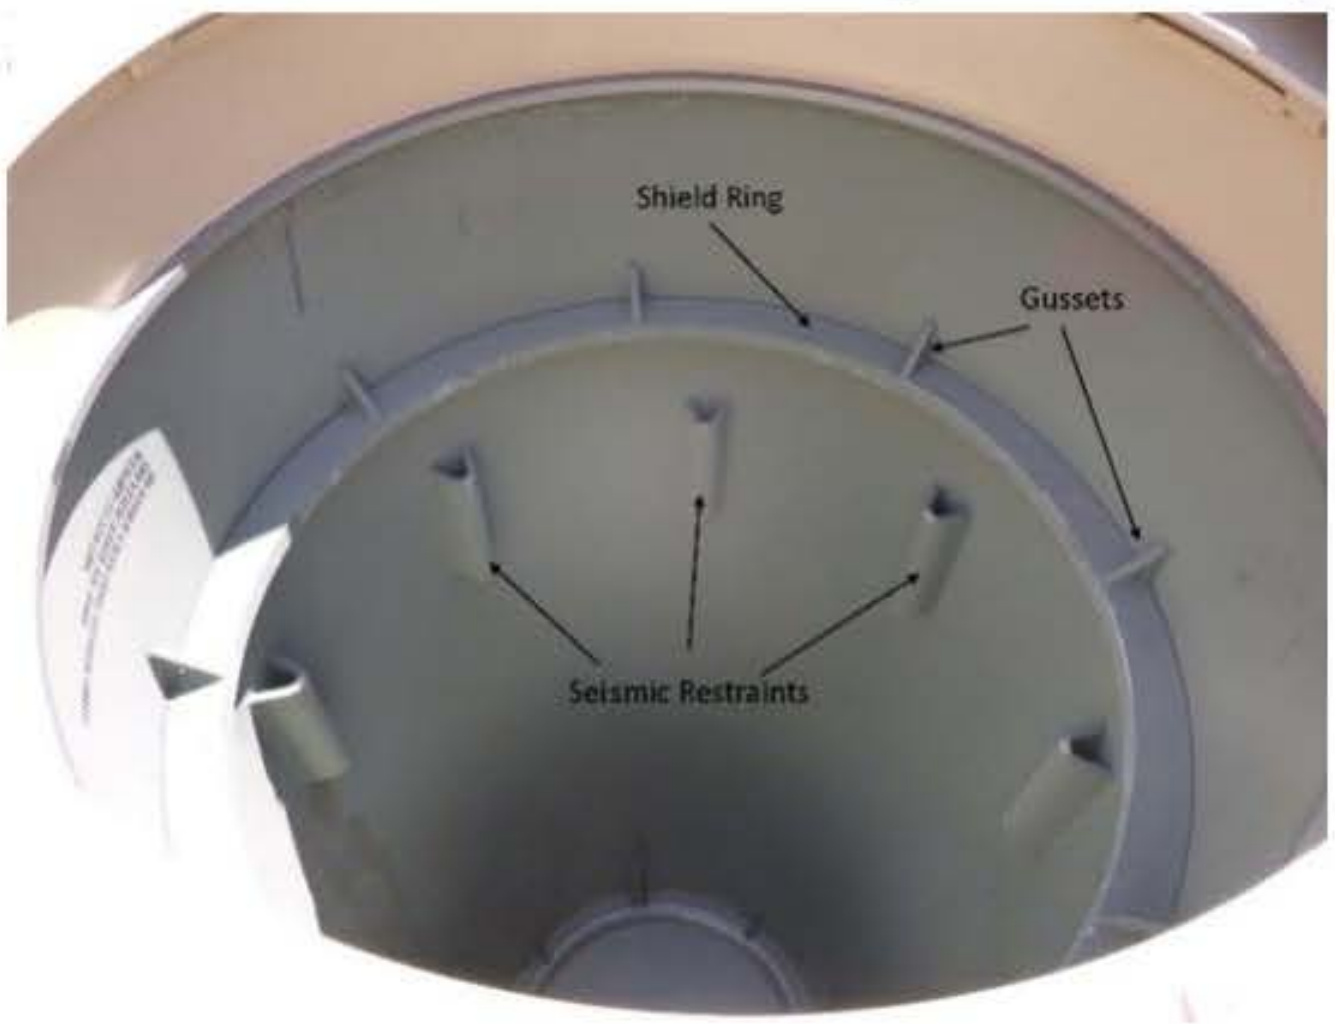
FIGURE 1 VAULT DIVIDER SHELL INTERNAL STRUCTURES

On August 3, 2018, San Onofre was engaged in operations involving movement of a loaded spent fuel storage canister into its underground Independent Spent Fuel Storage Installation (ISFSI) storage vault (Holtec HI-STORM UMAX storage system). This was canister number 29 of a planned 73 canisters to be loaded into the ISFSI. As the loaded spent fuel canister was being lowered into the storage vault using lifting and rigging equipment, the licensee's personnel failed to notice that the canister was misaligned and was not being properly lowered. The licensee continued to lower the rigging and lifting equipment until staff believed that the canister had been fully lowered to the bottom of the storage vault. However, a radiation protection technician identified radiation readings that were not consistent with a fully lowered canister. The licensee then identified that the loaded spent fuel canister was resting on a metal flange or metal gussets near the top of the storage vault, preventing it from being lowered, and that the rigging and lifting equipment was slack and no longer bearing the load of the canister.

In this circumstance, with the important-to-safety lifting equipment completely lowered and the connecting slings completely slack and incapable of suspending the load, the equipment was no longer capable of performing its designed safety function of holding and controlling the loaded canister from a potential canister drop condition. The licensee reported that they believed that the canister was resting on a metal flange (shield ring) within the storage vault. It was estimated that the canister could have experienced an approximately 18 foot drop into the storage vault if the canister had slipped off the metal flange or if the metal flange failed. This load drop accident is not a condition analyzed in the dry fuel storage system's Final Safety Analysis Report.

In response to the discovery that the canister was not fully lowered, the licensee's staff took immediate actions to restore the control of the load to the rigging and lifting devices. The estimated time the canister was in an unanalyzed drop condition was approximately 45 minutes to 1 hour. The staff regained control of the load, repositioned the canister, and lowered it into the storage vault. The licensee halted all dry fuel storage movement operations in order to fully investigate the incident and develop corrective actions to prevent recurrence.

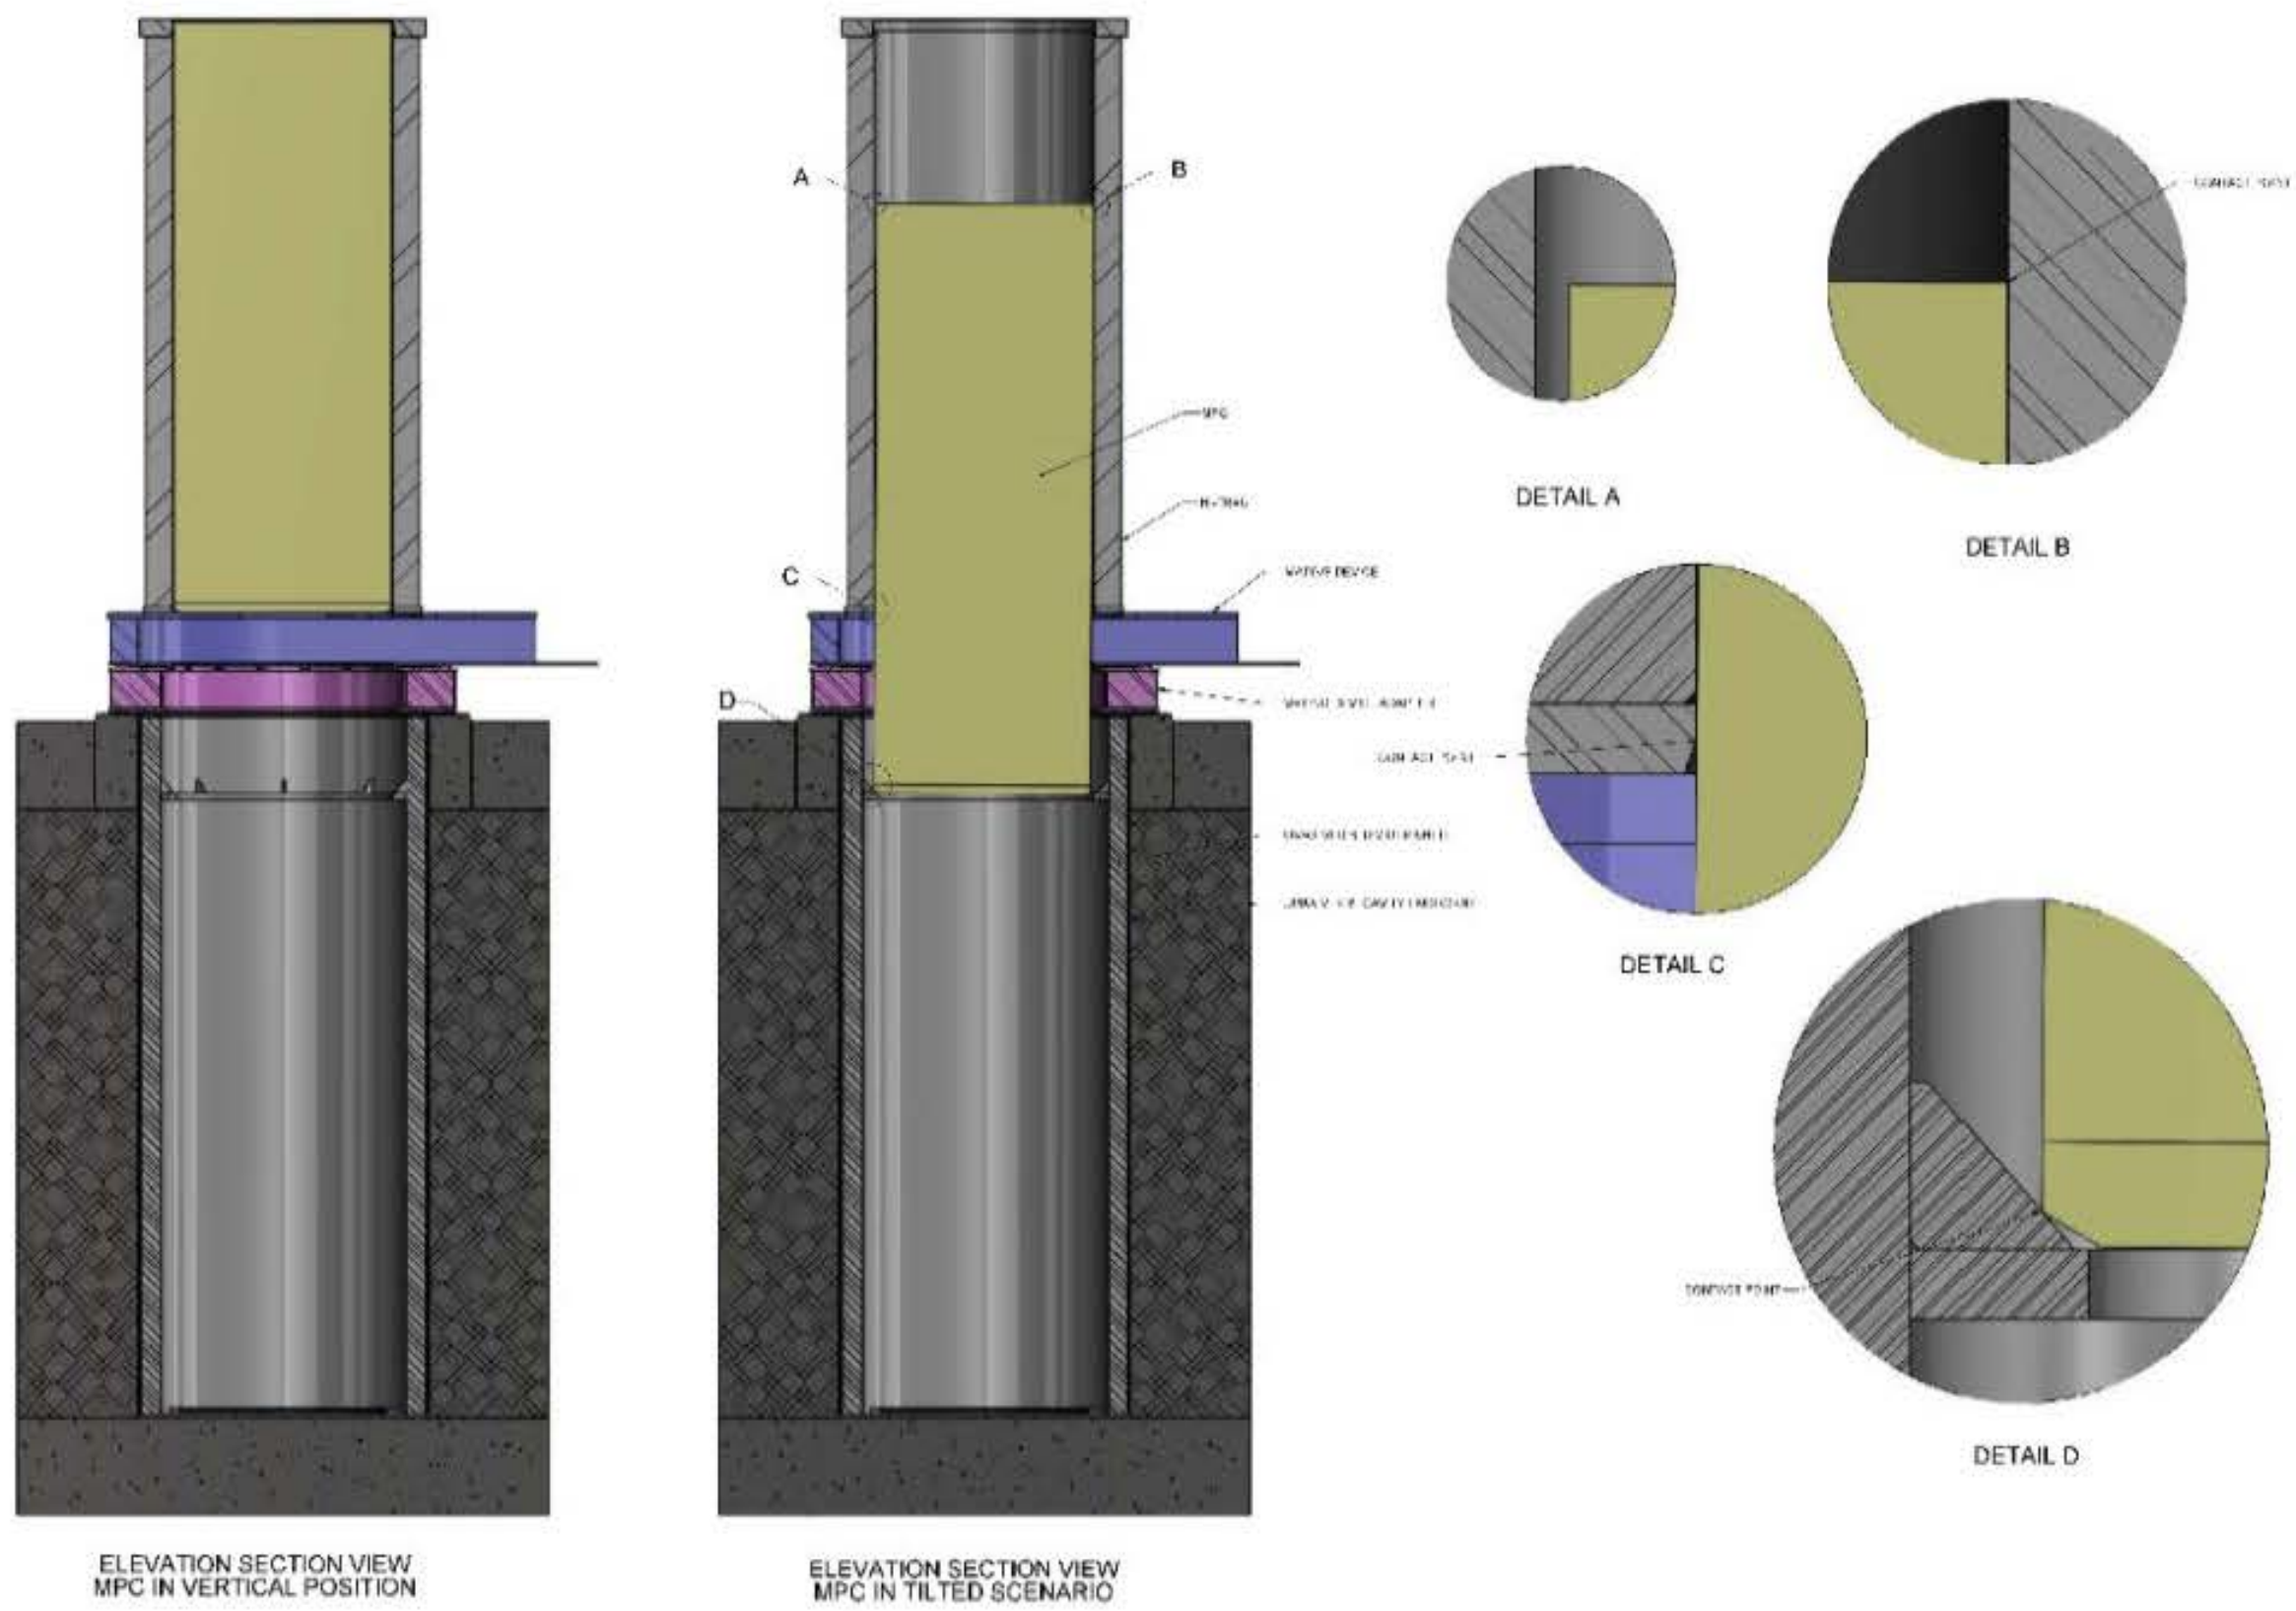
FIGURE 2 MPC DOWNLOADING W/ MPC STUCK ON DIVIDER SHELL SHIELD RING

Southern California Edison agreed to suspend fuel loading operations until such time as their senior management is satisfied with all short term corrective actions, the NRC inspection is complete, and NRC has determined that corrective actions taken are sufficient to prevent a similar occurrence.

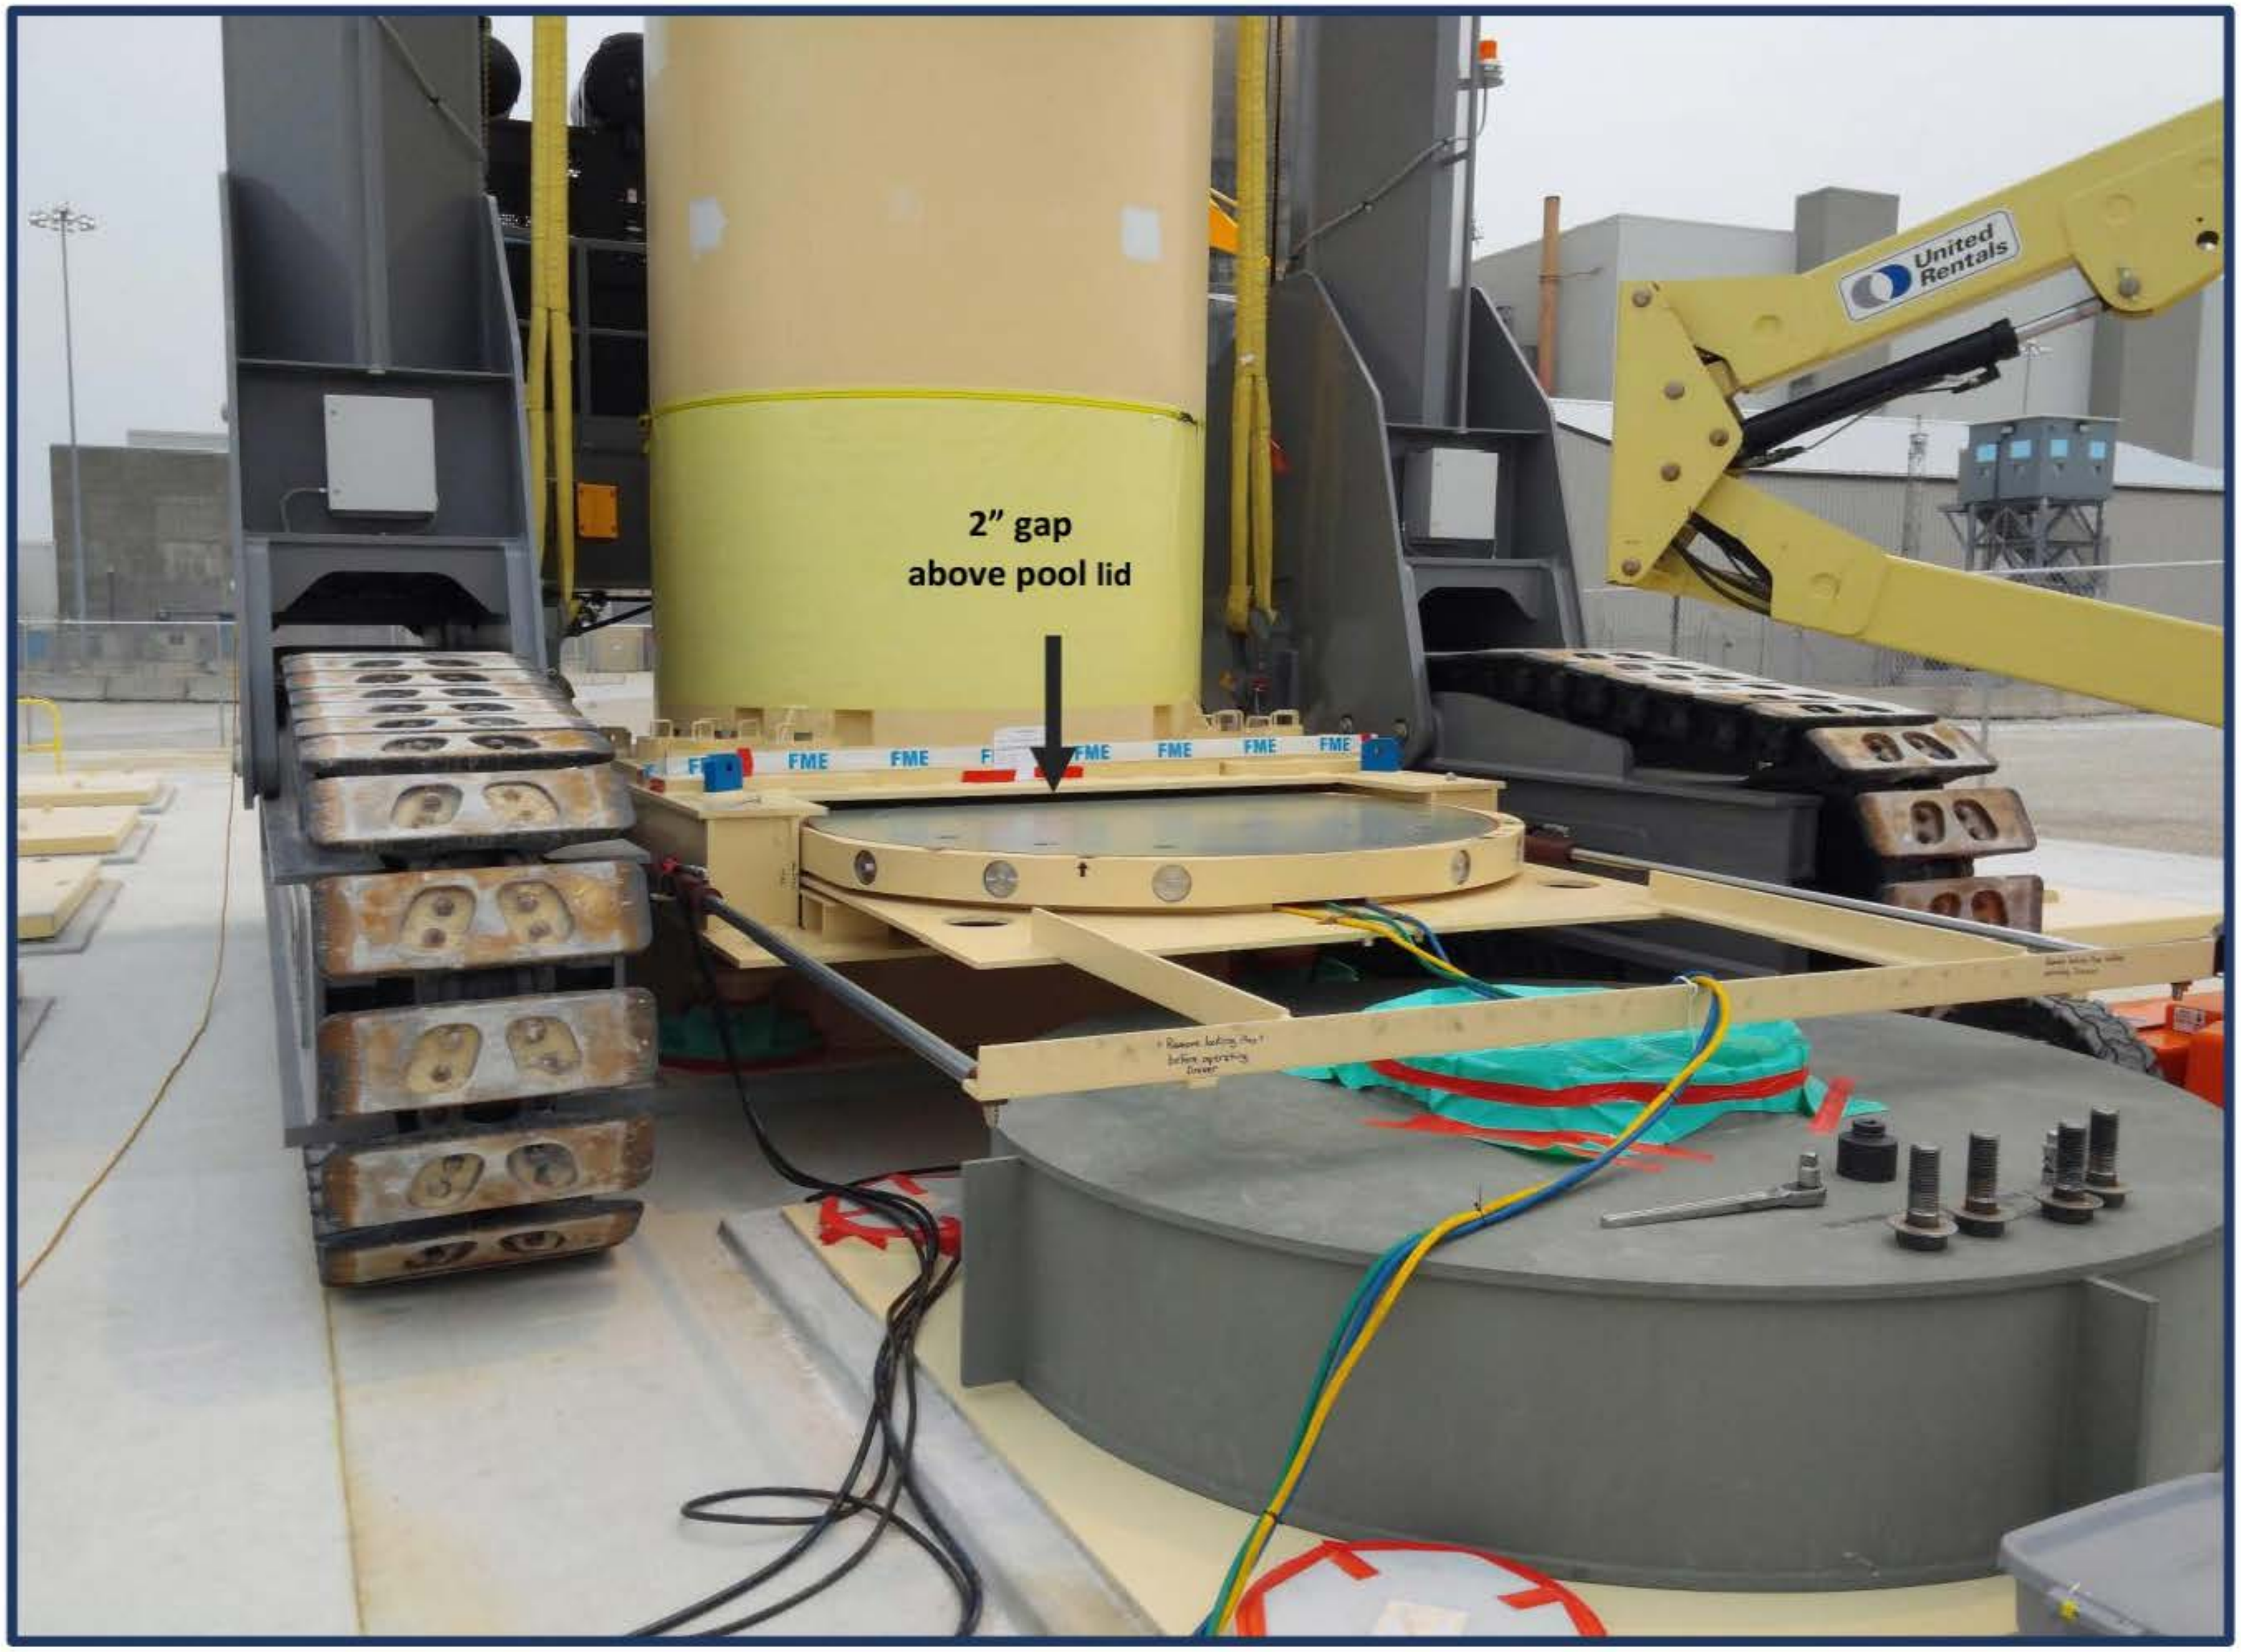
RADIATION STREAMING FROM 2 INCH GAP ABOVE POOL LID DURING DOWNLOAD

7/22/18 FTO26 VVM23 MEASURED DOSE RATES
